# Collocation Impacts on the Vulnerability of Lifelines During Earthquakes with Applications to the Cajon Pass, California

Earthquake Hazard Reduction Series 59

# COLLOCATION IMPACTS ON LIFELINE EARTHQUAKE VULNERABILITY AT THE CAJON PASS, CALIFORNIA

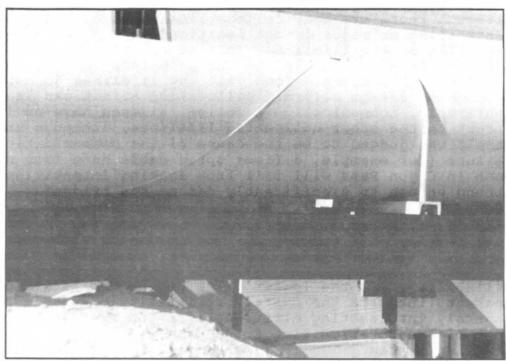
Figure 3 Fiber Optic Conduits Hung Under a Water Distribution Pipe on a Bridge Over a Railroad

At the bridge locations along the Cajon Blvd. extension, the fiber optic conduits are brought to the surface and hung from the bridges, using light anchoring systems. The practice of hanging the fiber optic cables from bridges and other lifeline structures is common throughout the Cajon Pass area, they are on bridges over railroads (see Figures 3 and 4) and on the bridges over the California Aqueduct. They are routed at the foot of a crib wall used to retain the I-15 road bed, after which they are brought to the surface and hung from the wall of a concrete culvert that passes under I-15. Figure 5 shows the details of the typical light wall anchors and supports that are used.

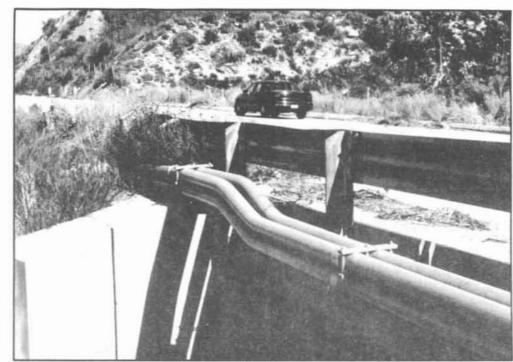
The communication lifelines (the fiber optic cable systems) had no impact on increasing the probable time to restore service for any of the other lifelines. The fact that all four cable conduits are routed together for much of their routes through the Cajon Pass increases the potential that these valuable lifelines will be lost during an earthquake event. The practice of hanging the conduits from bridges and other lifeline structures using very light anchor supports increases the risk of failure of these communication lifelines at earthquake shaking intensities which would not impact them if they had been buried or supported by more robust anchors.

Figure 4 Fiber Optic Conduits on a Bridge on an Abandoned Portion of Highway 66

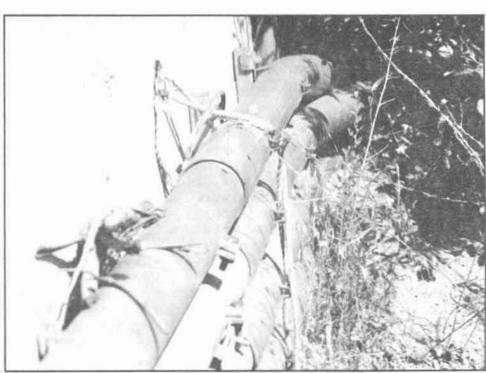
optic cables transmit more calls per cable than do hardwired systems means that the impact of a lost cable will be more significant than the impacts previously experienced when a hardwired line has been lost. Finally, the construction practices do not appear to have considered earthquake impacts, further

Figure 5 Details of Fiber Optic Conduit Supports on a Highway Culvert Wall

increasing the risk to the fiber optic systems. However, since these are not problems associated with collocation, they do not necessarily impact the results of the present study. The fact that a fiber optic cable fails on a bridge due to shaking failure of its anchor system is not a collocation impact if the bridge itself does not contribute to the failure.

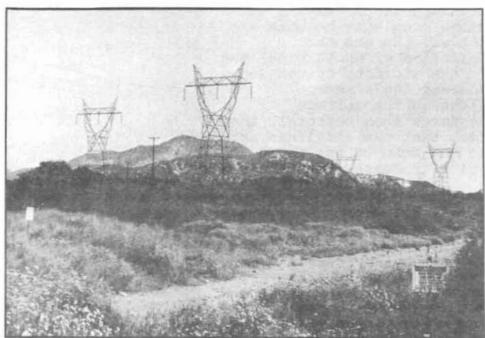
Figure 6 Power Line, Natural Gas and Petroleum Products Pipelines Over the San Andreas Fault

Figure 6 shows the location where the two separate electric power

transmission lines are in close proximity to both a natural gas and the petroleum products pipelines in the vicinity of the San Andreas fault zone. Although the surface features look pastoral, the fact that the lifelines are in the zone of the fault trace increases both their risk and the potential magnitude of the damage that could be induced. Figure 7 is a photograph in the opposite direction to the one shown in Figure 6. shows an electric power transmission tower located at the edge of a steep embankment, suggesting that a foundation failure may also be a contributing factor to causing the power lines to drop to a height where they could readily interact with spilled fuel.

The triple collocation of high voltage power lines, petroleum pipelines, and natural gas pipeline at the San Andreas fault rift zone caused the largest single delay due to the resulting fire, the need to remove spilled fuel that failed to burn, and the general level of confusion and construction expected at that location.

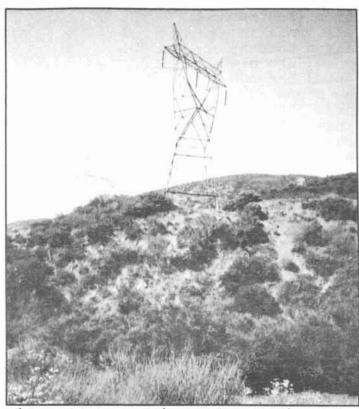
Figure 7 Power Lines At a Ravine Edge at the San Andreas Fault

From that location, the western most pipeline heads south and crosses I-15. It continues south passing across Lone Pine Canyon just north of Blue Cut. The San Andreas earthquake fault zone is in that canyon, and the two petroleum products pipelines also are routed parallel and in the fault zone. Thus, when the natural gas pipeline crosses the petroleum products pipelines, it too is in the fault zone. In addition, two high voltage power lines cross within a few hundred feet from the pipeline intersections (see the discussion for Figures 6 and 7 for additional details about this collocation condition).

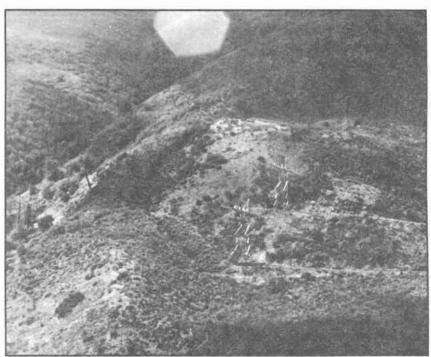
South of the San Andreas fault zone there are two additional areas where the electric transmission lines pass through a region susceptible to landslides and where there are nearby railroad and buried natural gas pipeline lifelines. Figure 8 shows two transmission towers that were rebuilt when the prior ones were damaged by a local landslide. Not shown at the bottom of the figure are a buried natural gas pipeline and a railroad.

Figure 8 Electrical Towers on a Landslide Scar (Directly Above a Fuel Pipeline & a Railroad)

transmission towers are quite resistant to shaking intensity. Although actual earthquakes have demonstrated that line vibration can cause separate circuits on the same pole or support tower to gallop and electrically short by either touching each other or by arcing between adjacent lines, this failure mode has not been characterized in the available data bases. Thus, only tower failure by ground motions was considered in the present analysis. Liquefaction and landslide conditions were identified as causing a light, moderate, and heavy damage state, depending on the local conditions; whereas, the surface displacement at the fault rift zone causes a catastrophic damage.

The collocation impacts at the landslide locations included increasing the damage state when there was a fuel pipeline present as well as increasing the time delay to initiate repairs due to the general congestion and the need to allow for debris removal from collocated railroad beds or environmental cleanup to remove the hazard from spilled fuels.

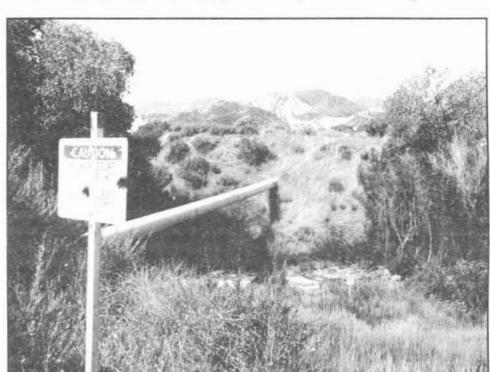
Figure 9 shows a section (north of Cajon Junction and next to Highway 138) where the two pipelines are routed parallel to each other. A 1990 realignment of Highway 138 (to remove curves) placed the exposed section of the one pipeline about 40 feet from the road bed. The gas line markers shown in the figure identify the route of the buried pipeline.

Figure 9 Two Natural Gas Pipelines, One Exposed One Buried, Next to Highway 138

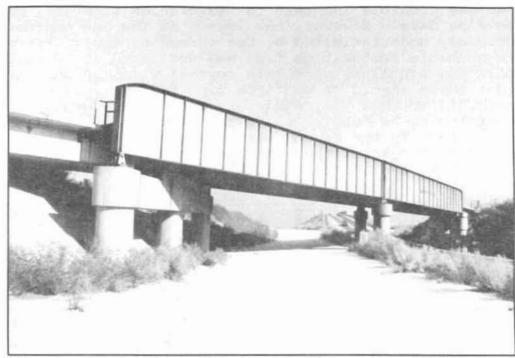
The highway bridges and road beds, in general, are not subjected to damage from other nearby lifelines. The exception is when a railroad bridge crosses over a highway. At such locations, the failure of the bridge has a direct impact on the highway. Figure 10 shows one such bridge. Because of its skew and simple supports, the bridge was estimated to collapse onto Highway 138, effectively removing that segment of the road as a bypass or detour route for

traffic past I-15's damaged sections. It is noted that the bridge span that crosses Highway 138 is the right span in the Figure. Very close to this bridge was a highway bridge over the railroad. Even though it had the same amount of skew with respect to the road alignment, its

Figure 10 A Railroad Bridge Estimated to Collapse Onto Highway 138 (Highway 138 is located under the right span)

continuous column design is more robust and it was not estimated to collapse onto the railroad. None of the highway bridges were predicted to completely collapse, although partial collapse is possible. Fortunately, the "diamond" interchange design used in the Pass provides a direct detour route (although one with reduced capacity compared to the I-15 road beds) past any partially damaged bridge.

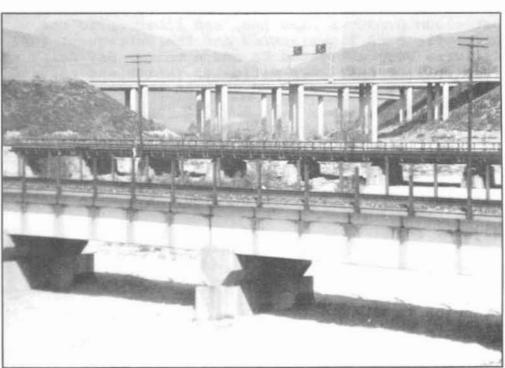
Figure 11 Railroad and I-15 Bridges in Cajon Wash Subject to Liquefaction Damage
