# **Supporting Document for Rehabilitation Cost Estimates of FEMA Existing Buildings**

H. S. Lew

Prepared for

March 1999

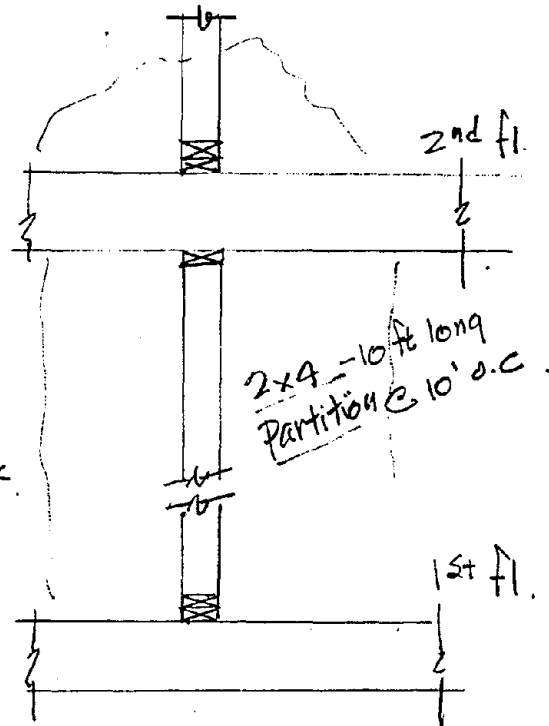
There are over twenty 2x4 Gypsum wall partitions in transverse directions. 2x4 plates are nailed to wood joists and to roof ratters.

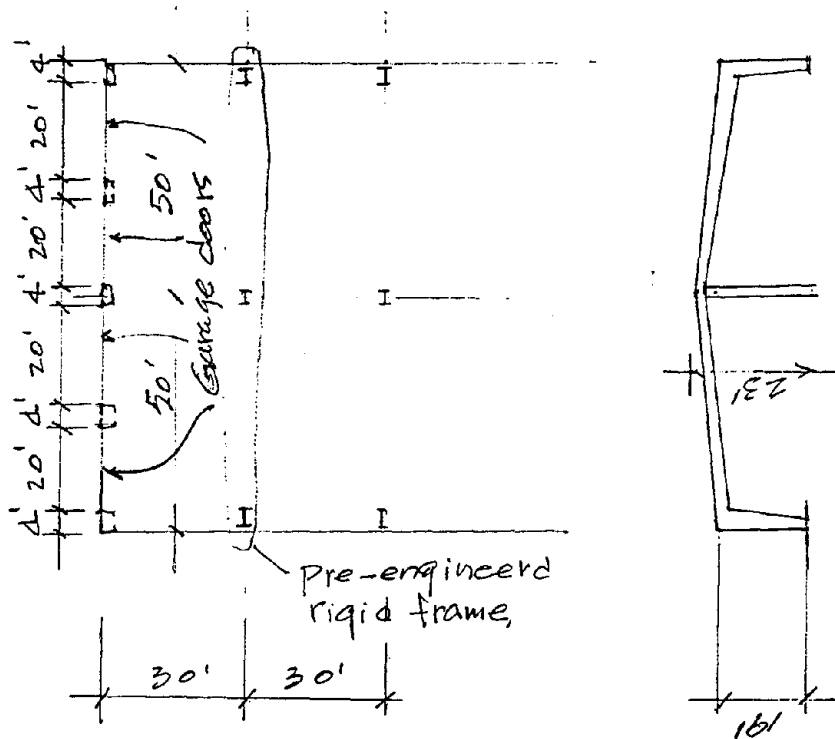
CHECK THE WEST END BAY OF THE VEHICLE BARN

THE WEST END WALL HAS A LARGE GARAGE DOORS AND JUDGED TO HAVE INADEQUATE LATERAL LOAD RESISTING STRENGTH.

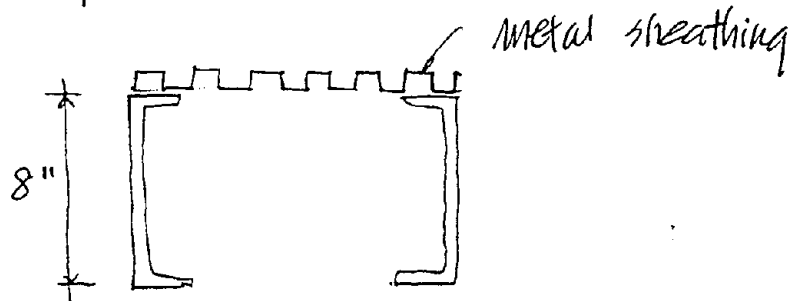
The end wall is comprised of 10 8" C in the vertical direction, spaced 4' between two adjacent channels.

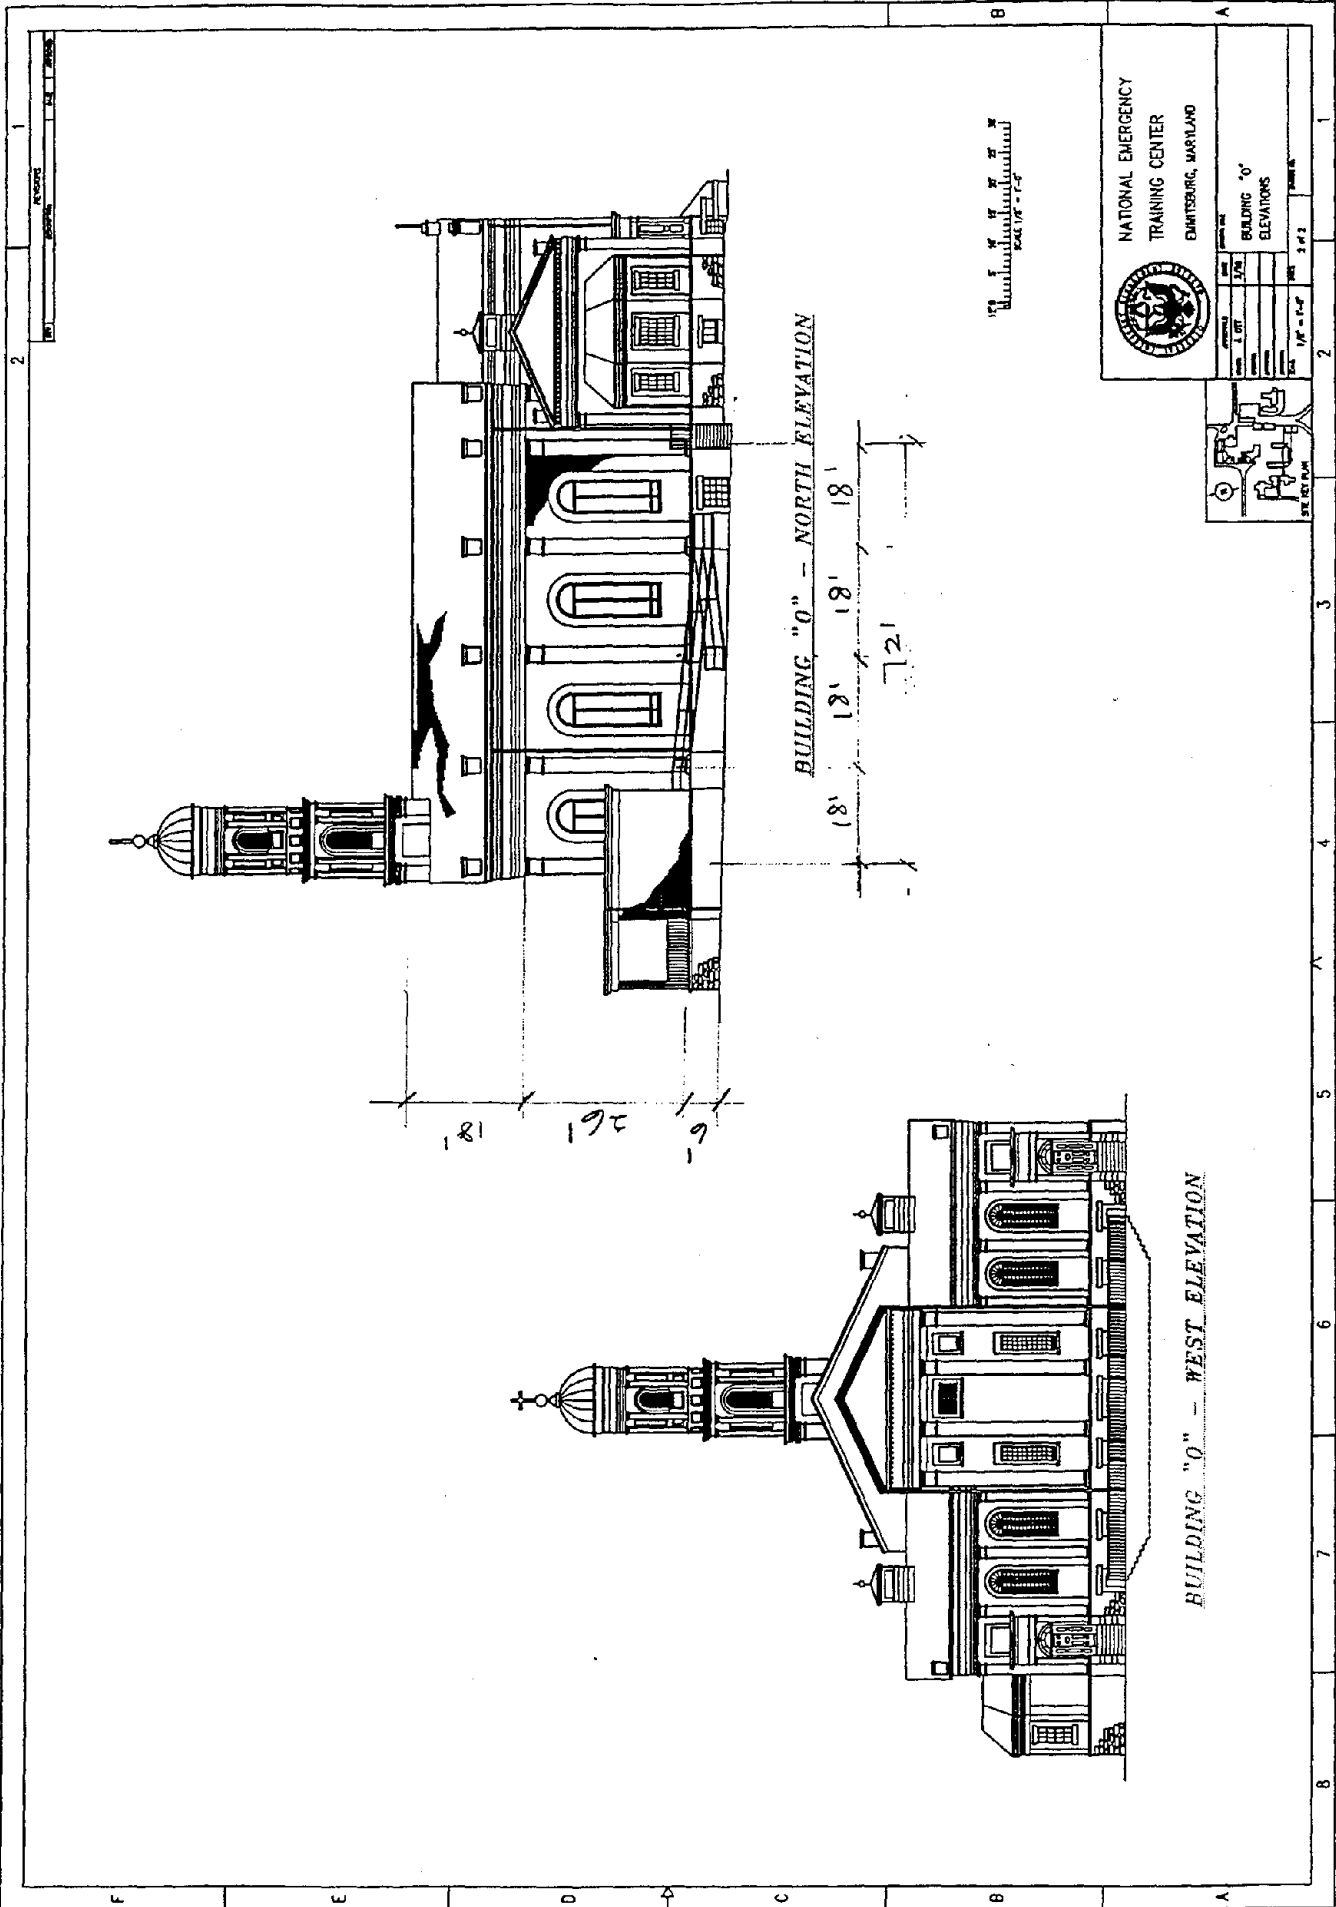
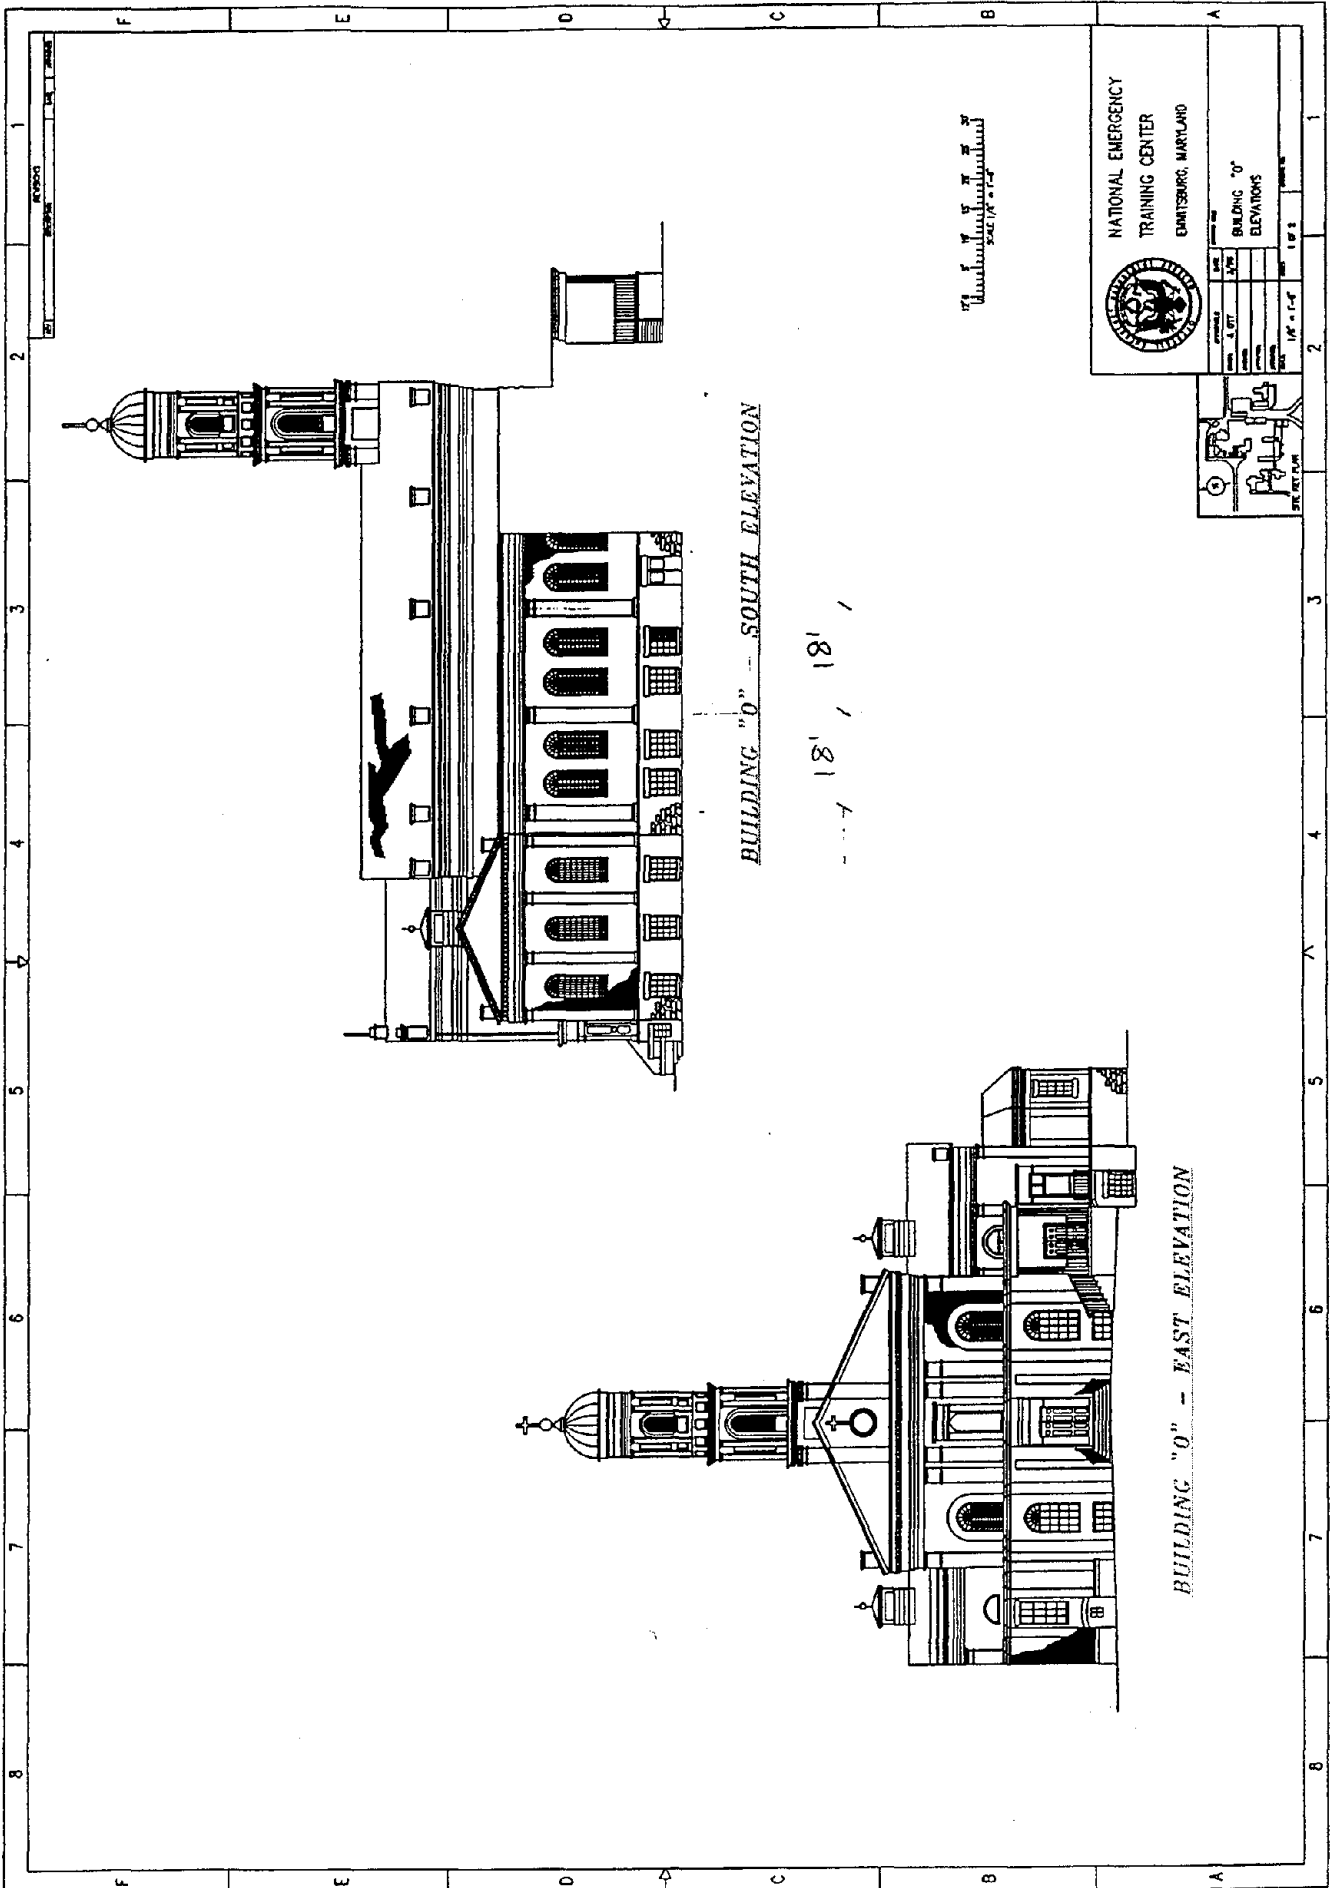
Historic register.  
Timber steeple needs a special attention.
