OBSERVATIONS ON THE BEHAVIOR OF BUILDINGS IN THE ROMANIA EARTHQUAKE OF MARCH 4, 1977

NBS SPECIAL PUBLICATION 490

U.S. DEPARTMENT OF COMMERCE / National Bureau of Standards

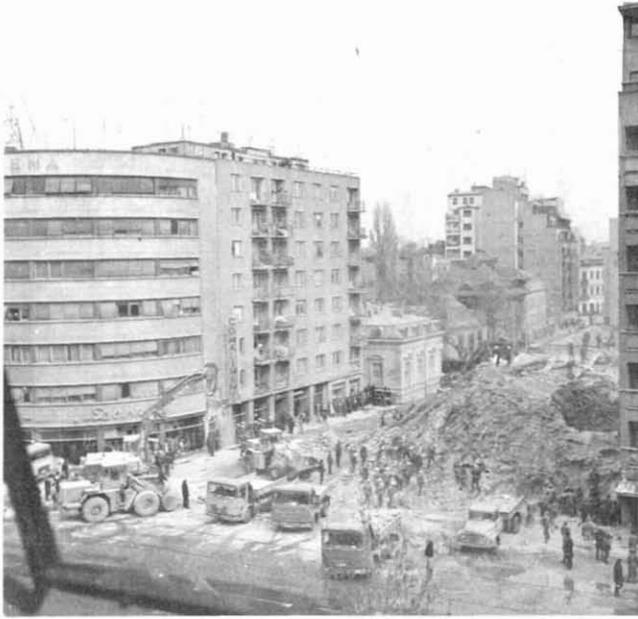
A peculiar phenomenon associated with the collapse of the older structures is evidenced by the extensive pulverization of the concrete as indicated in Figures 3.2 and 3.4. A member of the INCERC team that examined wrecked structures immediately after the earthquake noted that in many instances the concrete had disintegrated completely and a haze of dust particles hung in the air surrounding the sites. This pulverization effect, also noted during the November 1940 earthquake (see Ref. 3 and Section 2.3.2), may possibly be attributed to the cumulative degradation of concrete through exposure to cyclic loading during past earthquakes. Well-rounded ends of story-high concrete columns that had pried loose and fallen to the ground (see, for instance, Figures 3.3 and 3.6), as opposed to jagged ends normally found in concrete failures, may be evidence of internal pulverization of concrete in the joints attributable to past extreme events. It should also be noted that the use of relatively low-strength concrete (as low as grade B100 with approximately 10 MN/m^2 cube strength) was prevalent in the construction of pre-1940 buildings.

Figure 3.2. Cafe Scala apartment building totally destroyed by the earthquake.

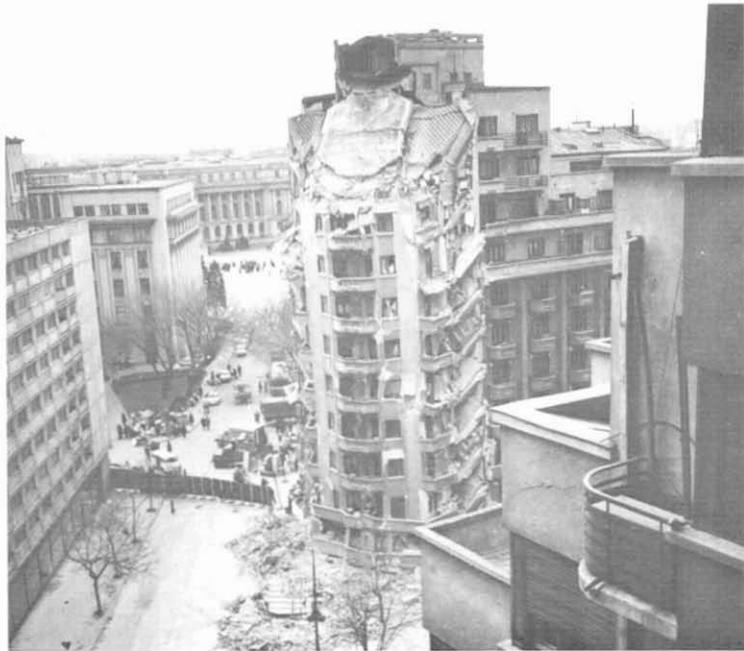
A typical example of partial building collapse precipitated by failure in the lower stories is provided by the photographs in Figures 3.7 and 3.8 taken

soon after the earthquake. Referred to as the Wilson Building, this was a 12-story apartment structure in which failure of the first story columns caused the corner bays to shear off from adjacent bays and vertically impact the ground. The collapse of the top story roofs shown in Figure 3.7 was possibly a follow-up action triggered by this impact.

Figure 3.7. General view of failure of Wilson apartment building.

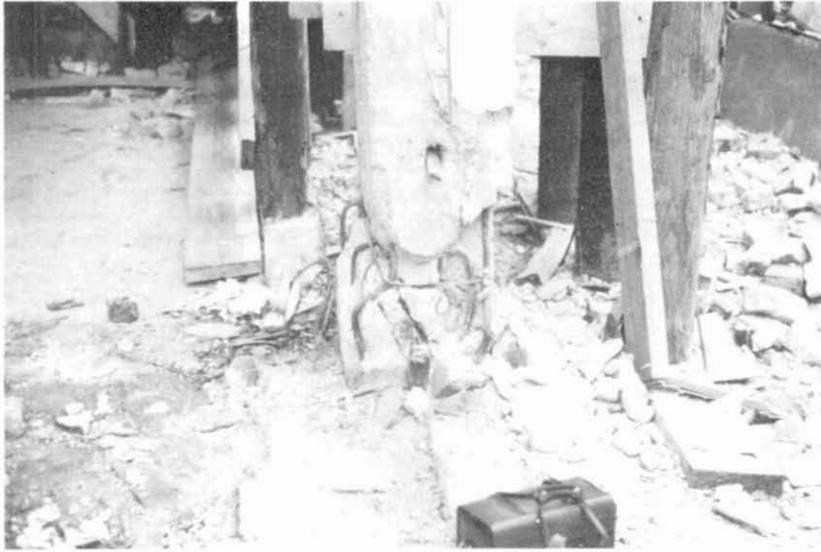
The failure of an interior column (Figure 3.20) exposed four vertical bars, approximately 20mm in diameter, and a single tie, approximately 6mm in diameter, spaced from the base a distance equal to the depth of the column. Four hooked footing dowels projected into the base of the column. The column that failed in shear (Figure 3.21), did not appear to have any ties within the height of the spalled concrete which was twice the depth of the column. All bars were plain.

Figure 3.20. Failure of interior first story column at the base indicating lateral displacement.

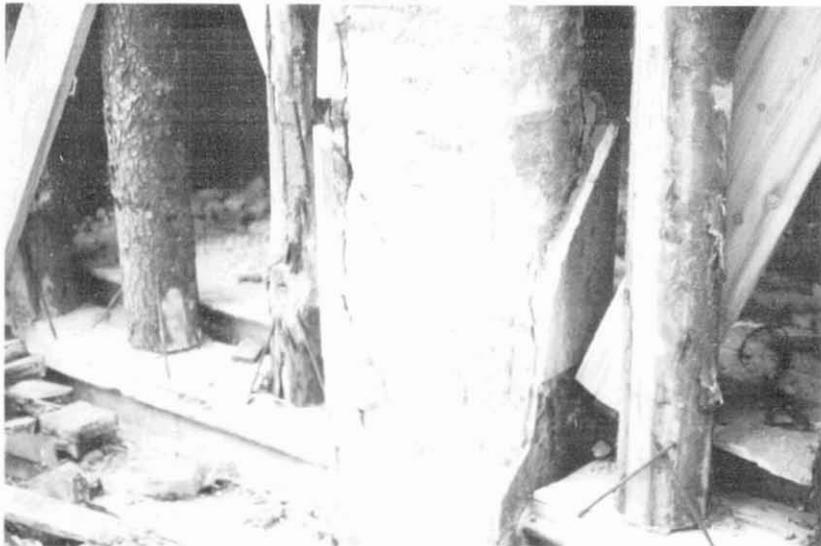
Figure 3.18 shows an 8-story apartment building with stores in the ground floor, located at the end of a block behind the Lido gas station. From Figure 3.19, the building appears to be U-shaped in plan, overlooking an interior court, and adjoining shorter structures on both sides. Approximately the left half of the building collapsed to the ground. The rest of the building was severely damaged, probably beyond repair. In the standing portion, the first story exterior columns had failed at the top (Figure 3.18), while those at the interior exhibited shear failure at the base (Figures 3.20 and 3.21).

Figure 3.21. Shear failure at the base of first story interior column.

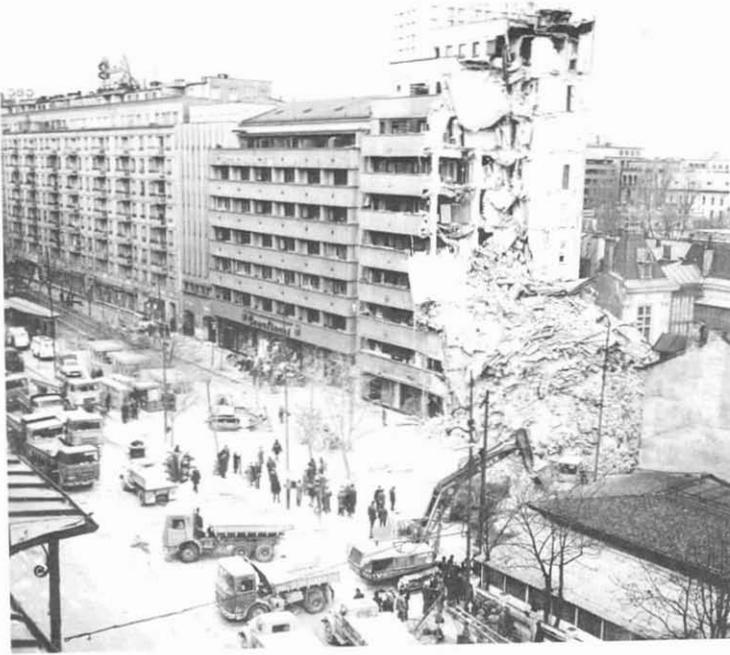
Figures 3.22 to 3.26 show the partial collapse of a 10-story building which is the end unit of a block of buildings along the east side of Boulevard Magheru. General views of the building before and after removal of the debris are shown in Figures 3.22 and 3.23, respectively. The wreckage in Figure 3.22 indicates extensive pulverization of the concrete, which was observed at other sites as well.

Figure 3.22. General view of the collapse of the end bays of Casata building.

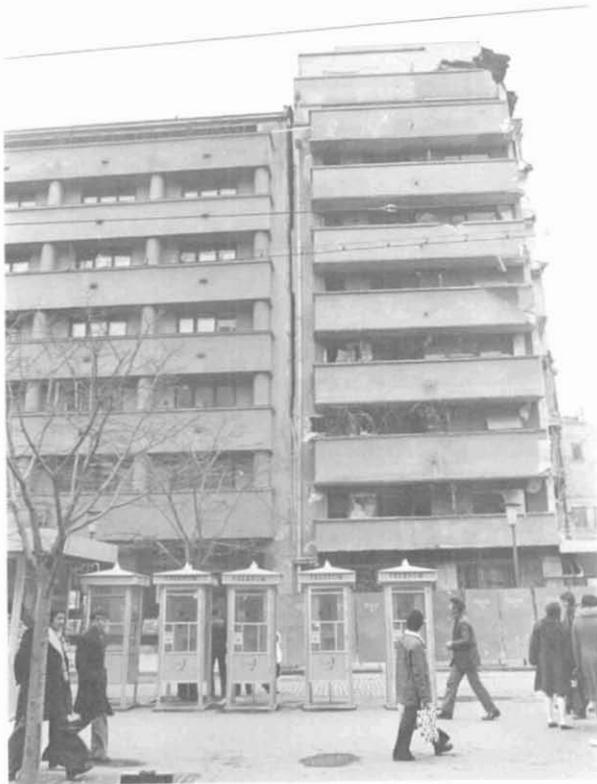
Figure 3.24. Damage due to pounding of the Casata building with the next structure.

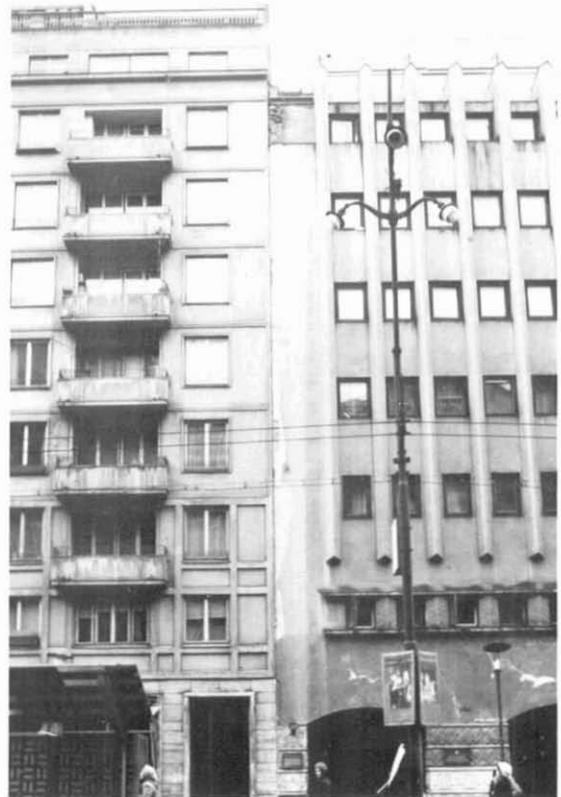
In Figure 3.23 it is noted that the 9th and 10th stories of this building, both of which are set back, have much longer transverse spans than the stories below. It appears that the setback wall of the 10th story is supported only by the 9th story roof slab. Figure 3.24 shows pounding damage observed between this and the next buildings. Note the slight tilt of this building to the right. Pounding damage had also occurred between other buildings in this row (Figure 3.25).

Figure 3.25. Pounding damage to other structures in the Casata building block.

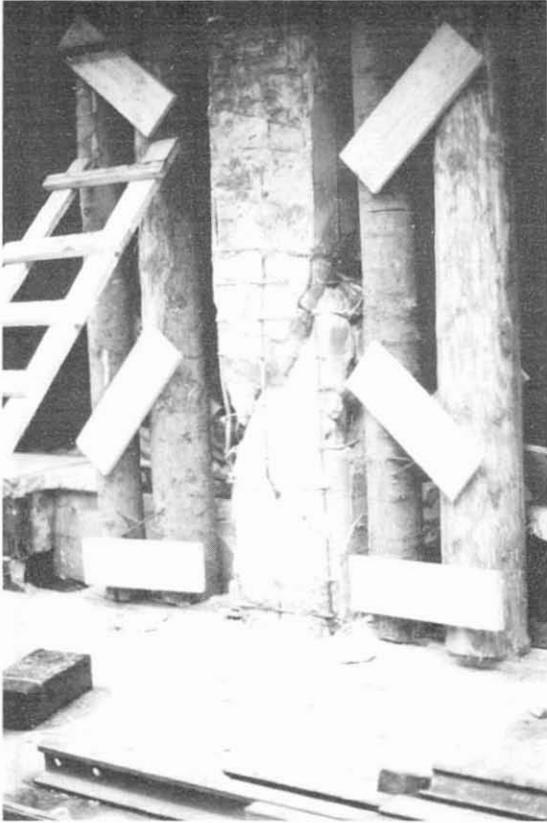
Figure 3.26 shows shear failure observed in an interior first story column. A total of six vertical bars were used in the column, three in each face, and approximately 16mm in diameter. The single ties were approximately 6mm in diameter and were bent only around the corner bars. In general, concrete cover was insufficient and at certain locations non-existent. Note, for instance, that on the unspalled top surface of the column, ties as well as vertical bars are visible with one of the ties inclined 15 degrees with respect to the horizontal.

Figure 3.26. Damage to interior column in the first floor.

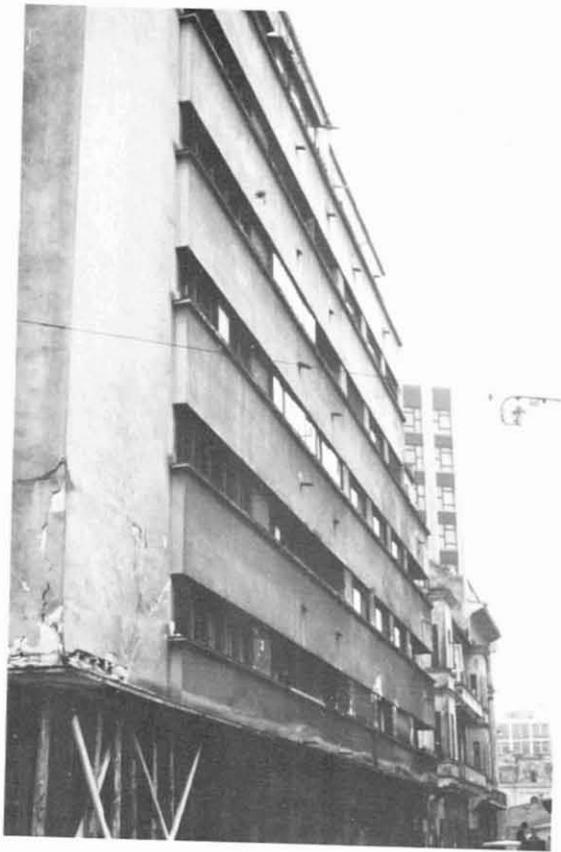
Figure 3.30. West view of Turist building showing substantial facade and masonry damage.

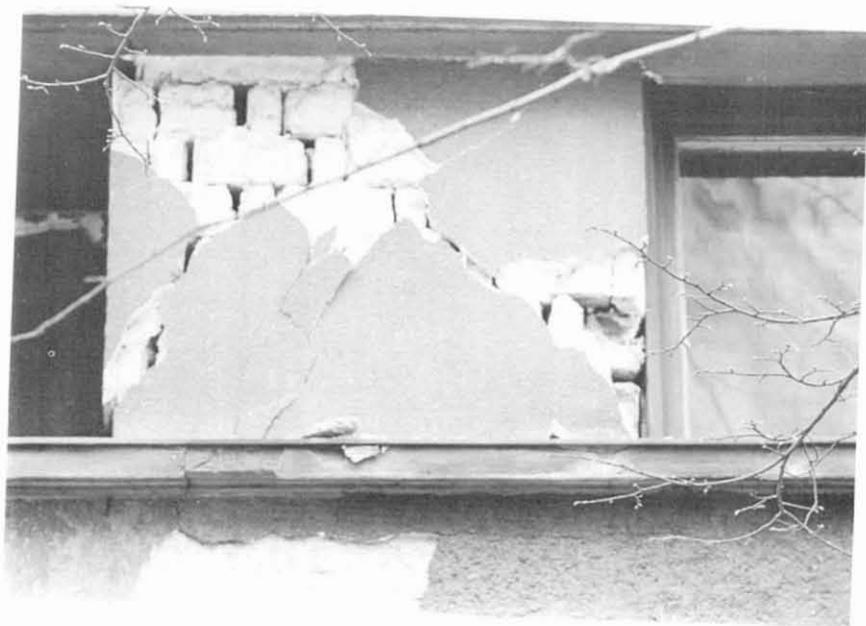
Figure 3.31. Close-up of damaged masonry pier beneath spalled plaster.

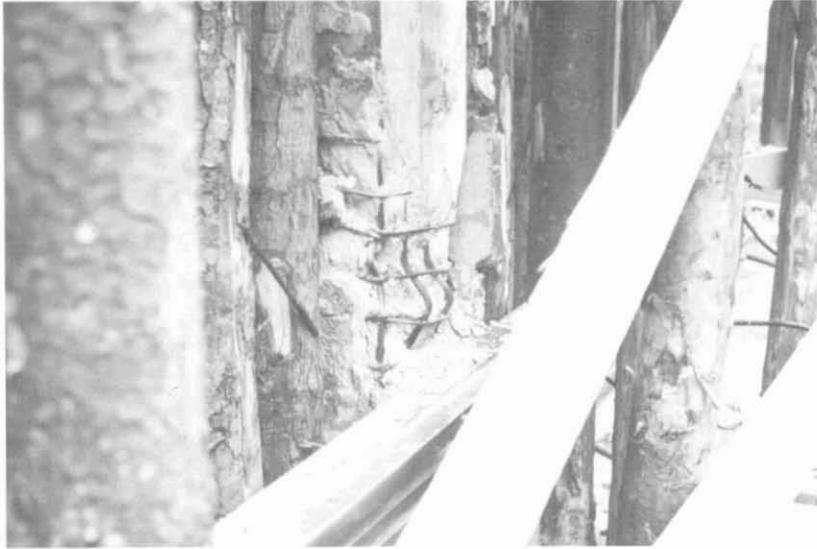
Figure 3.32. Interior view showing failure of first story column at the base.

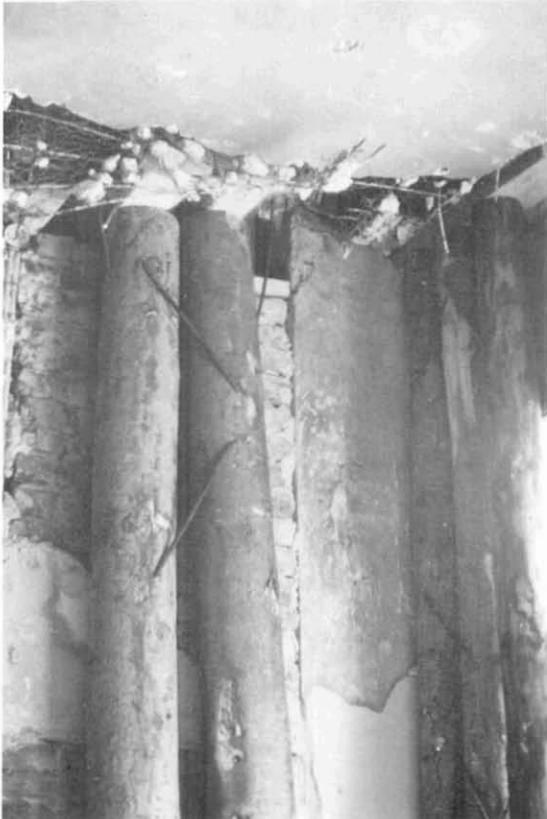
Figure 3.33. Timber logs shoring partially damaged floor slab of second story.

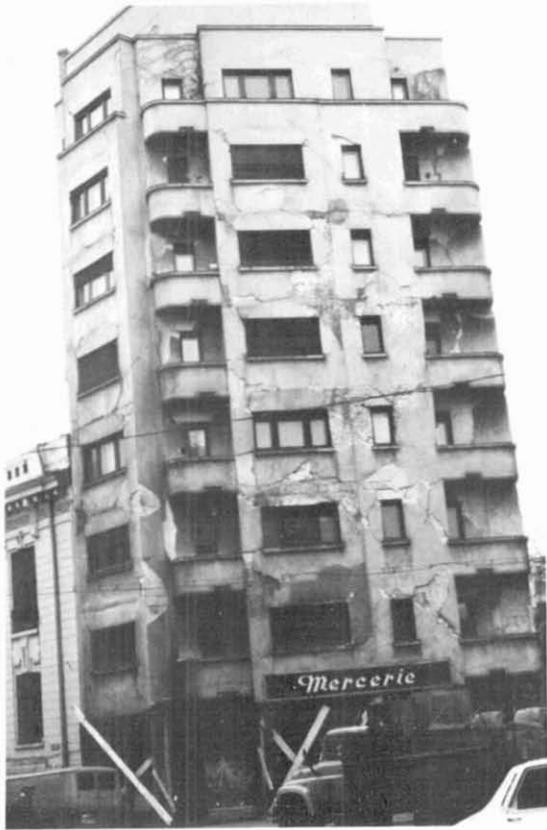
Figure 3.36. Damage of eight-story Mercerie building.

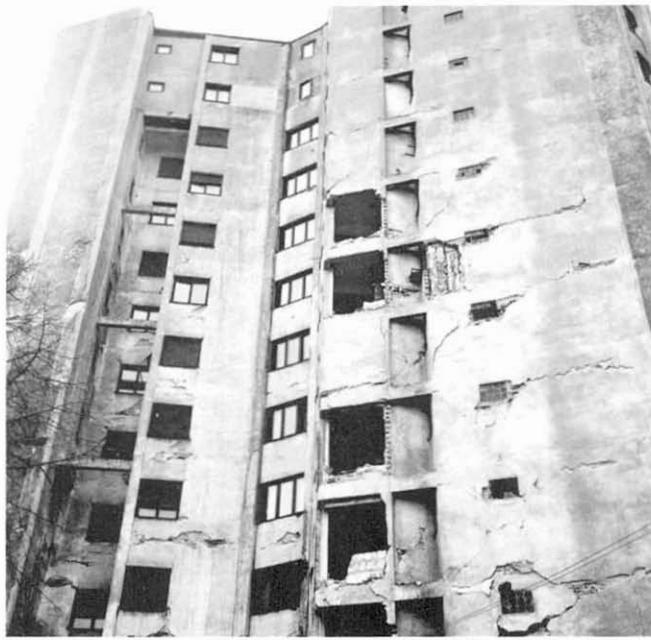
Figure 3.38. Damage of multistory Ambassador Hotel, rear view.

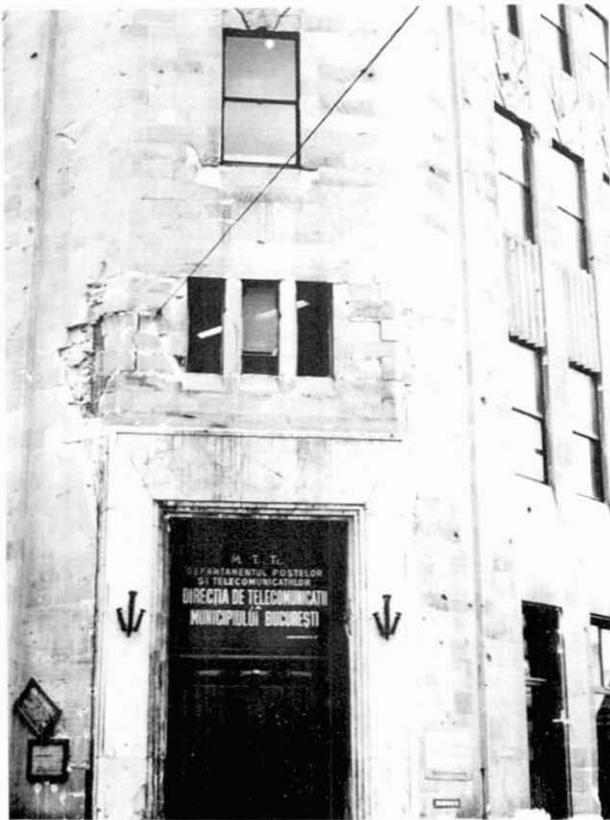
Figure 3.39. Post Office and Telecommunications building showing damage to exterior walls.

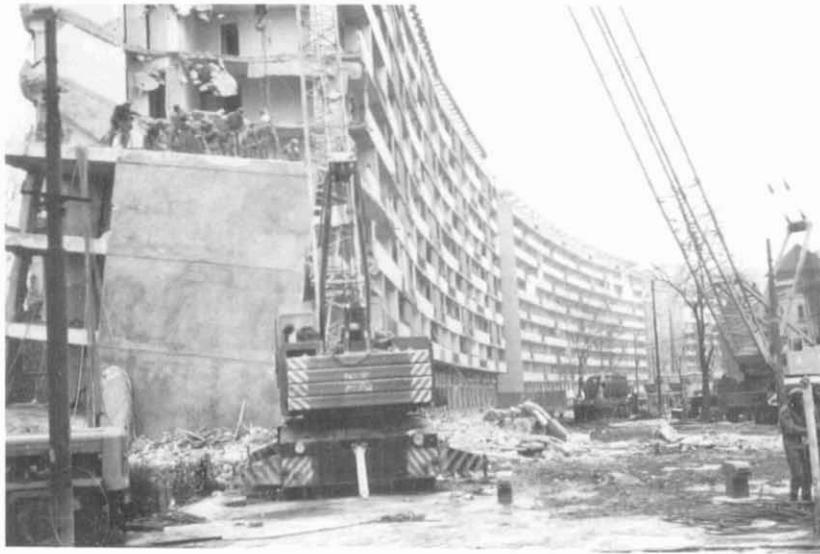
Figure 3.40. End view of partially collapsed Lizeanu building taken from Lizeanu Street looking towards east.

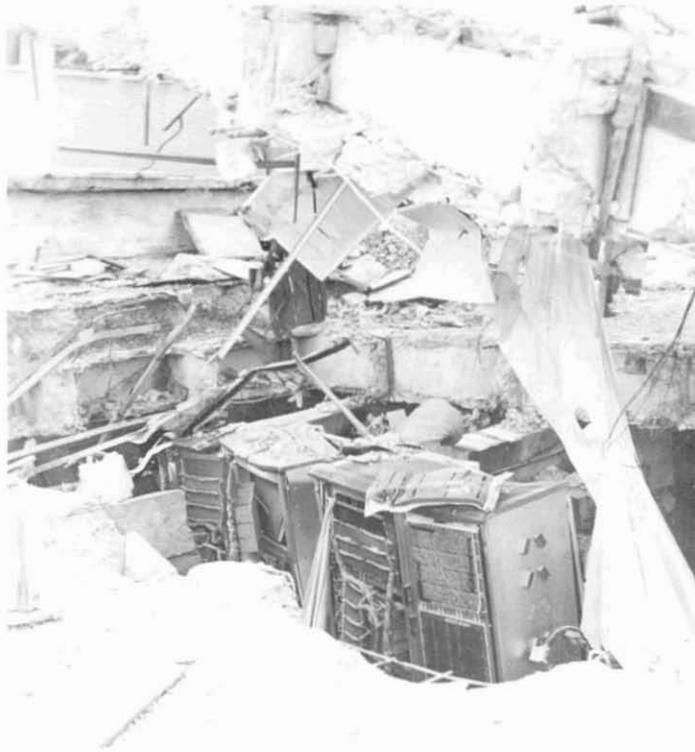
Figure 3.52. Damaged central computer unit.

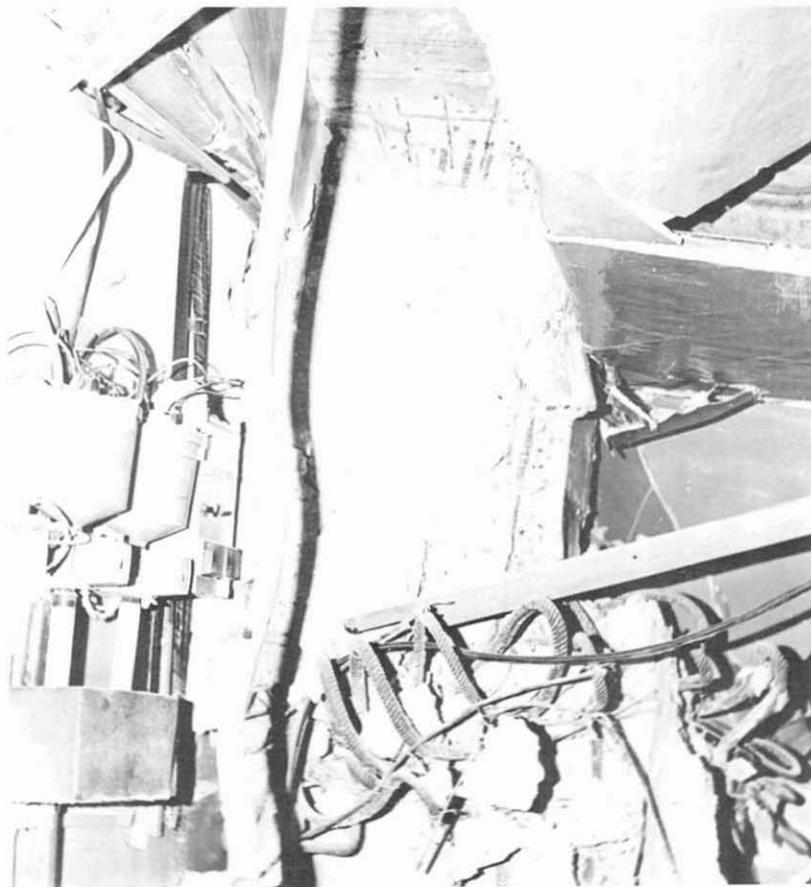
Figure 3.54. Failure of second story column located in the air conditioning room.

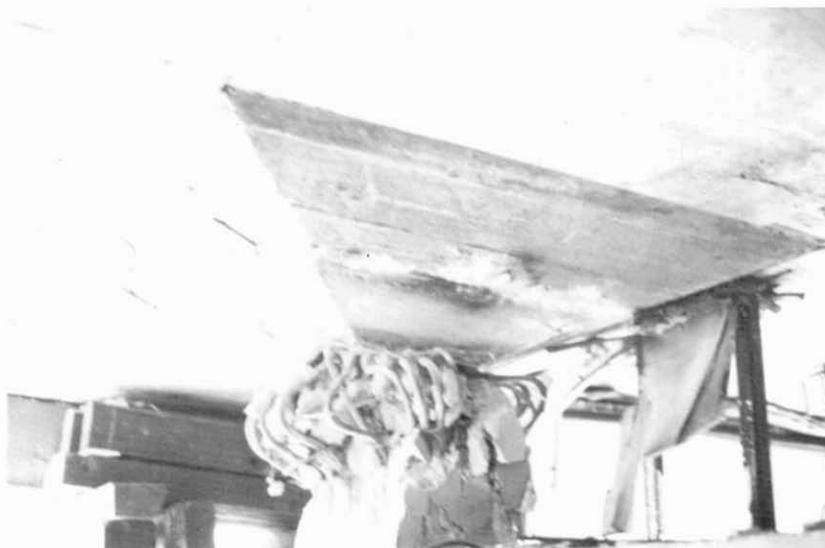
Figure 3.55. Failure at the top of the northwest column in the first story.

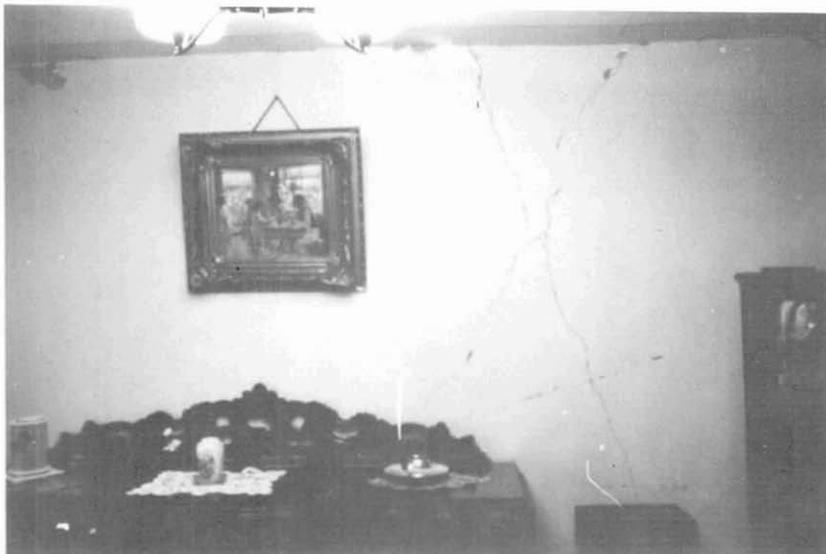
Figure 3.61. Cracking of wall plaster inside second story apartment Building 16.

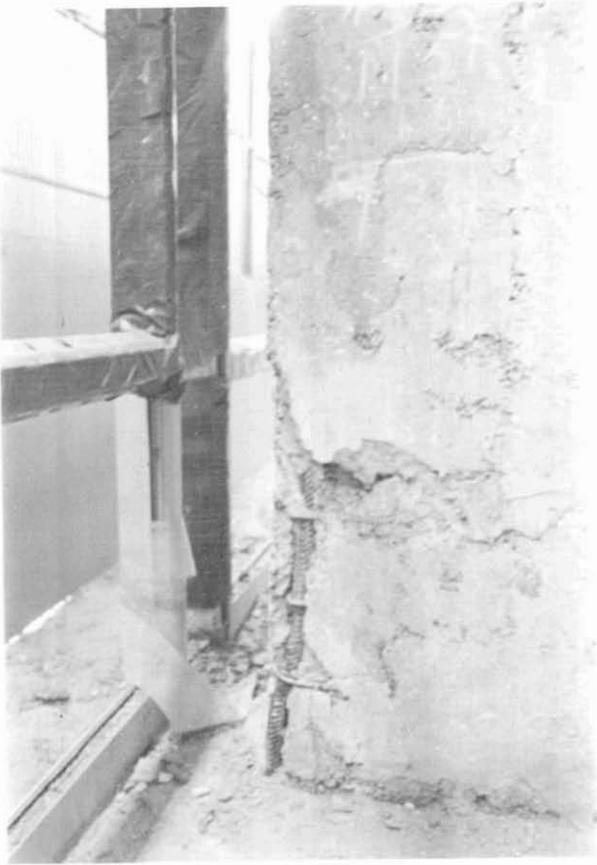
Figure 3.66. Damage at the base of first story exterior column.

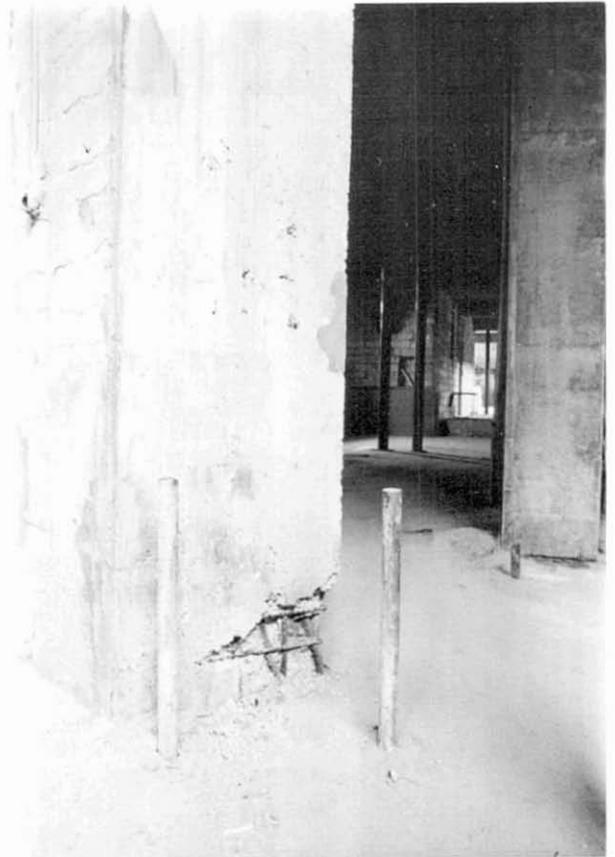
Figure 3.67. Damage at the base of first story interior column.

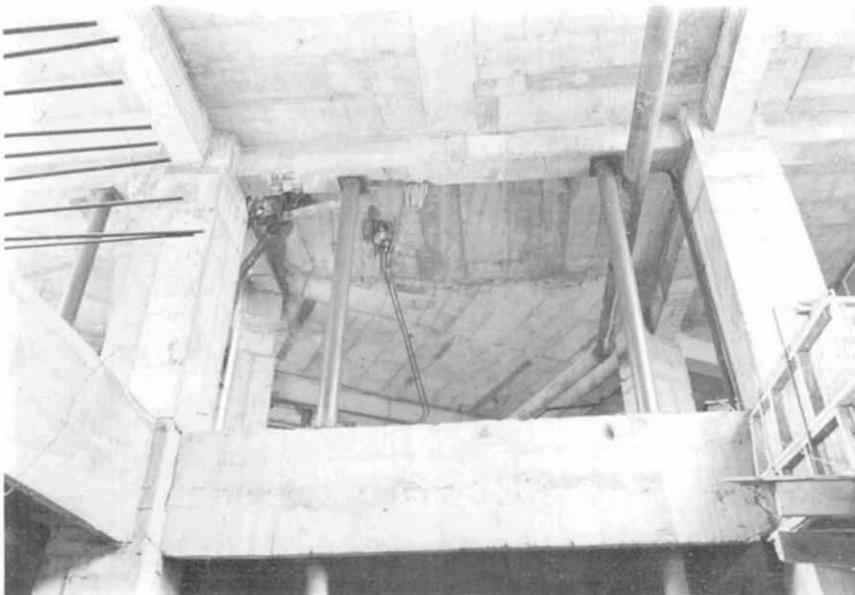
Figure 3.69. Metal pipes used in shoring damaged transverse beams.

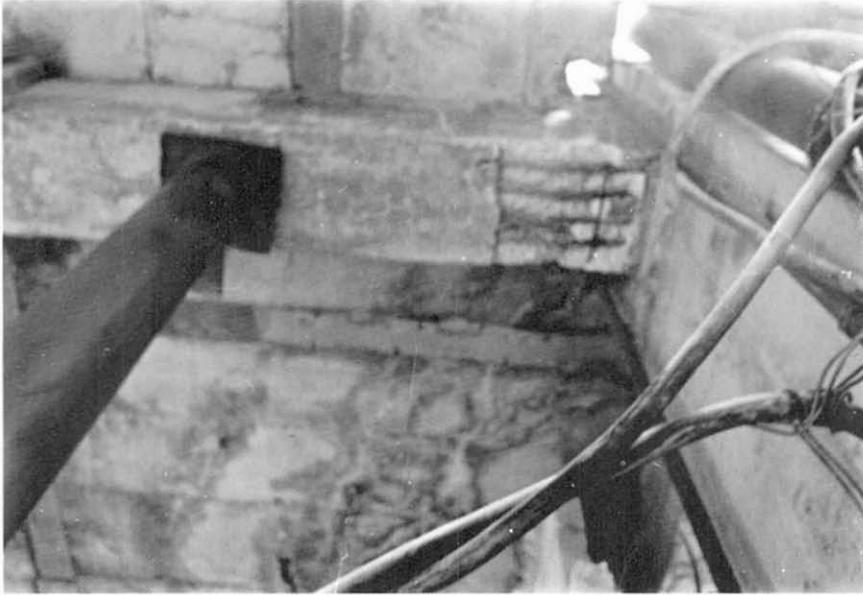
Figure 3.70. Failure of transverse beam at the support.

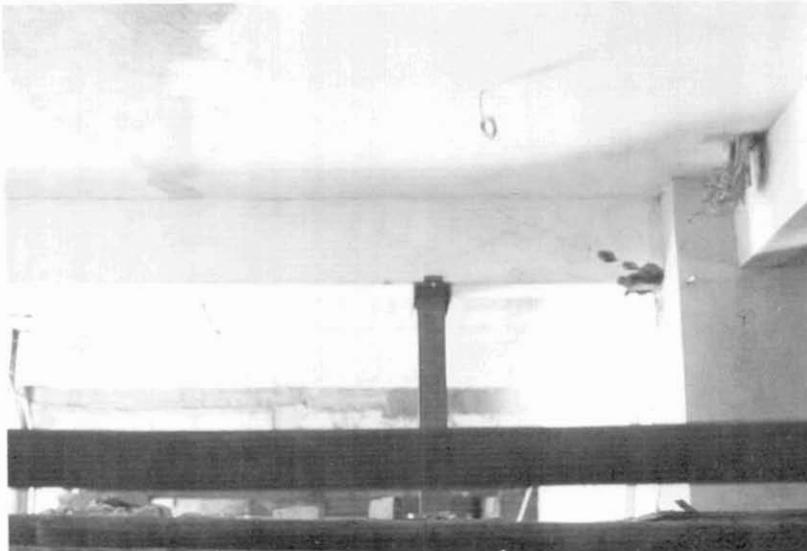
Figure 3.71. Shoring of damaged first story beam in multistory concrete frame building. (Building No. 18)

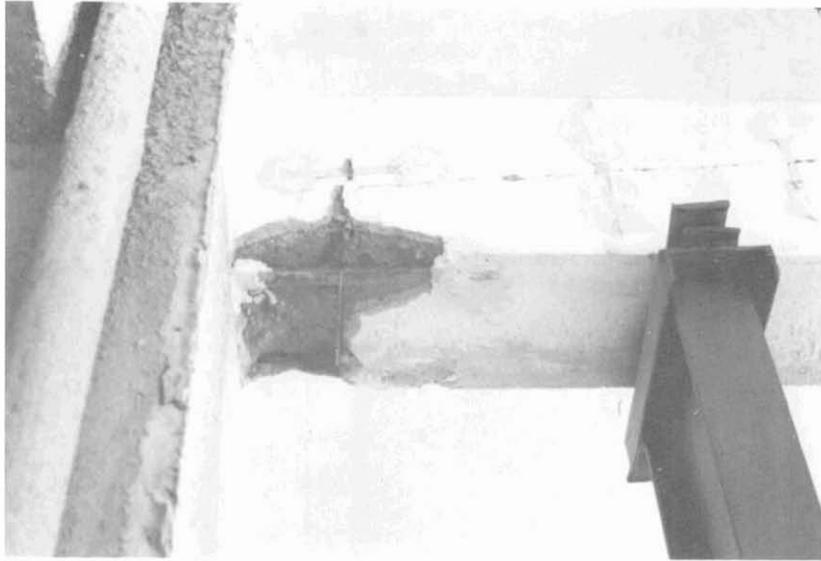
Figure 3.72. Close-up and opposite view of damaged first story beam.

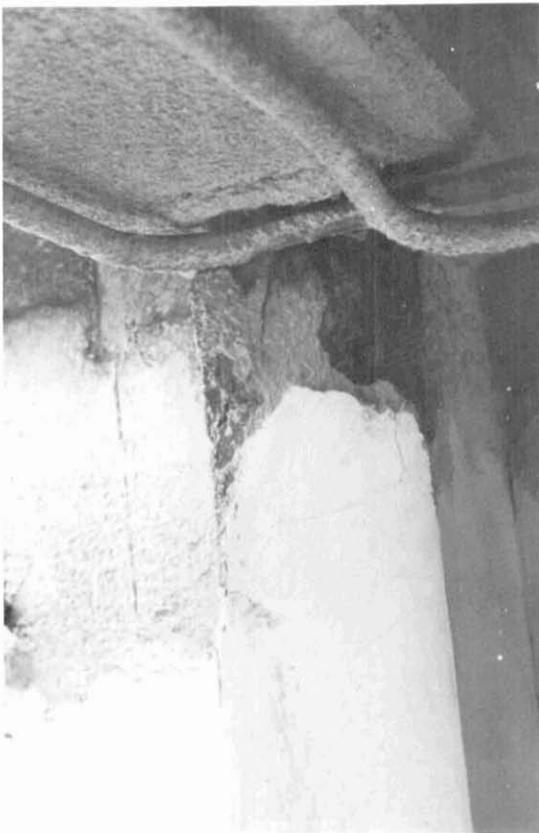
Figure 3.73. Damage at the top of first story column.

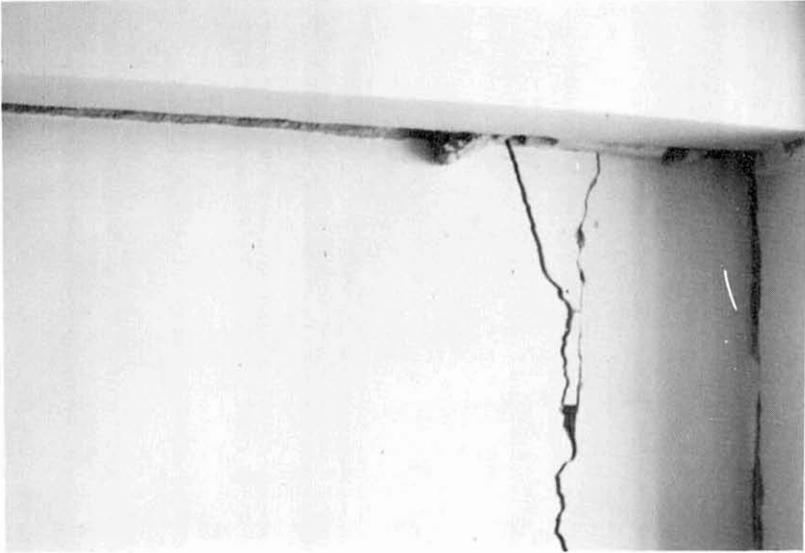
Figure 3.74. Cracking of wall within second story apartment unit.

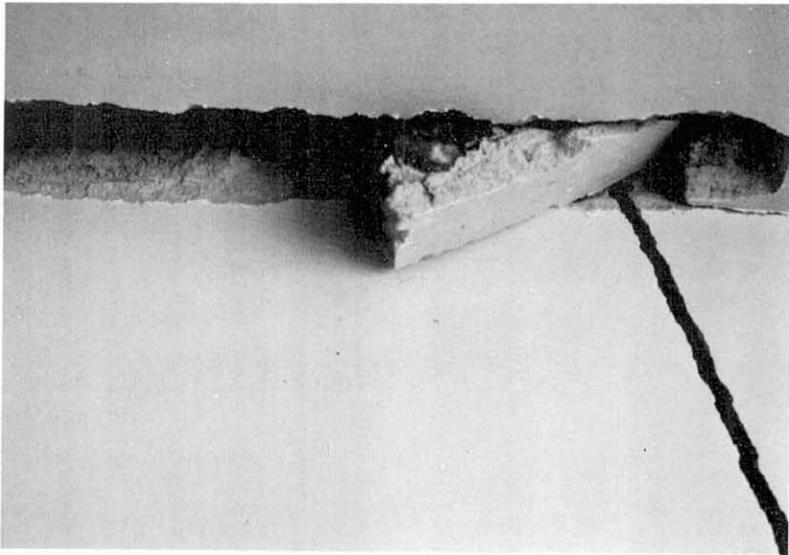
Figure 3.75. Detached masonry units between ceiling and wall.

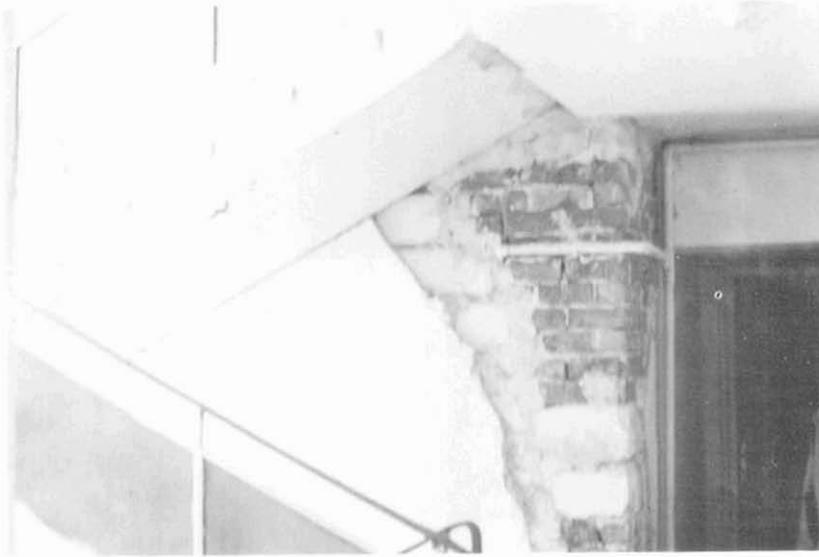
Figure 3.76. Damage within second story hallway.

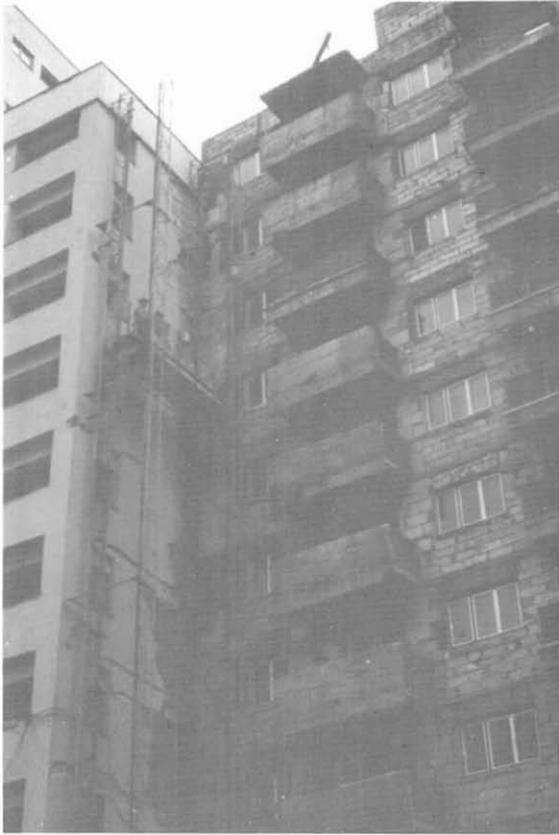
Figure 3.78. Rear view of building shown in Fig. 3.77 showing pounding damage.

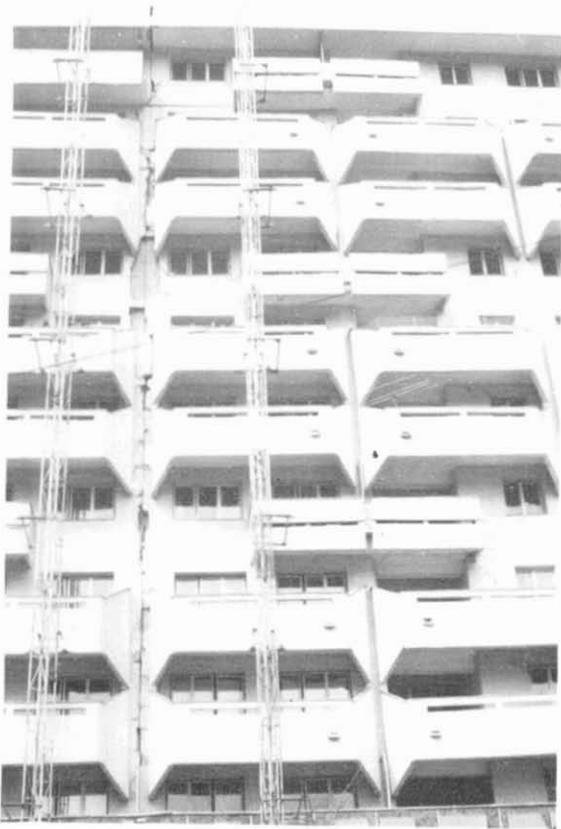
Figure 3.82. Pounding damage to adjacent buildings.

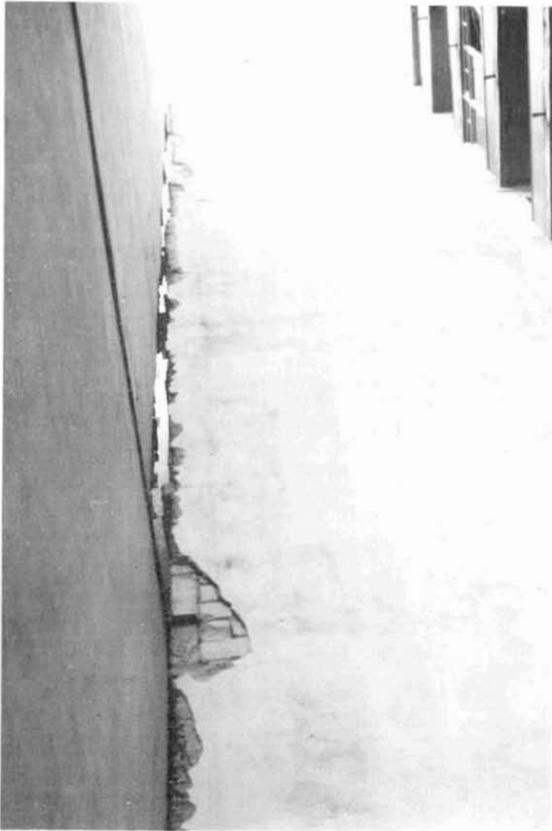
Figure 3.84. Same pounding damage viewed from the opposite side.

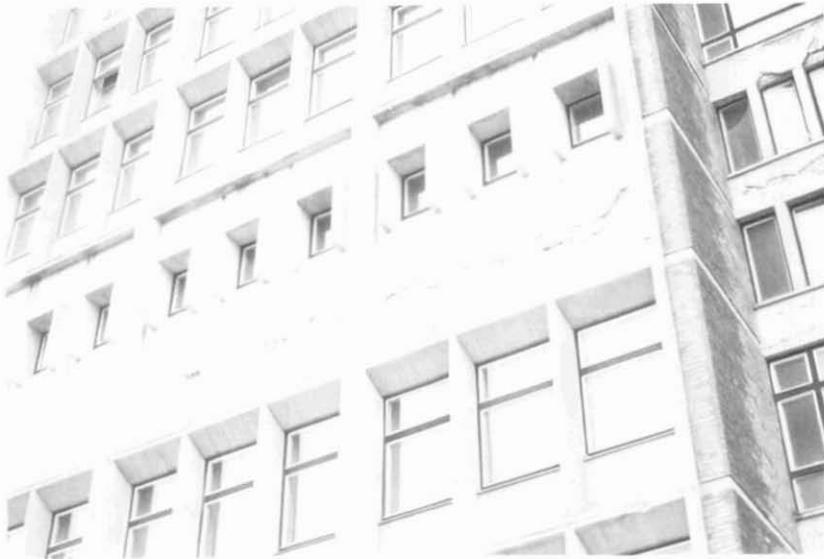
Figure 3.93. Superficial damage of multistory building on campus of National Center for Physics.

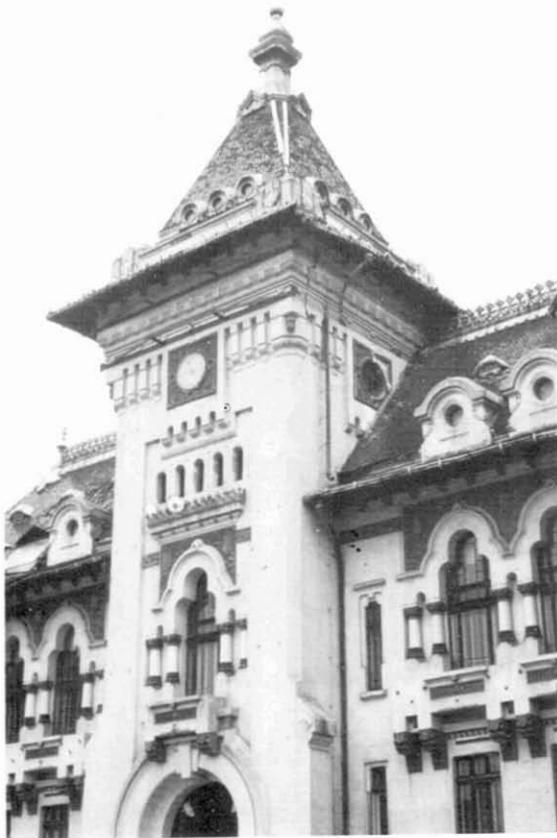
Figure 3.95. View of city administration headquarters building in Craiova showing damaged tower and roof.

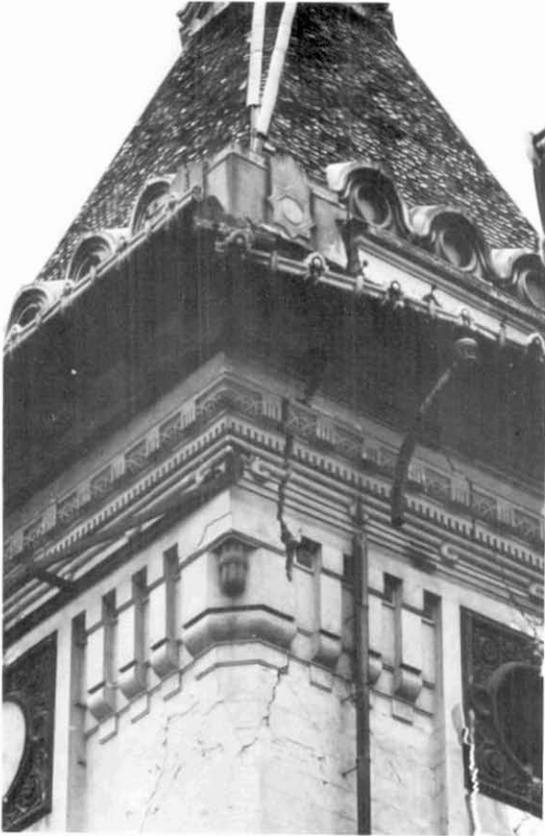
Figure 3.96. Close-up view of damaged tower of city administration building.

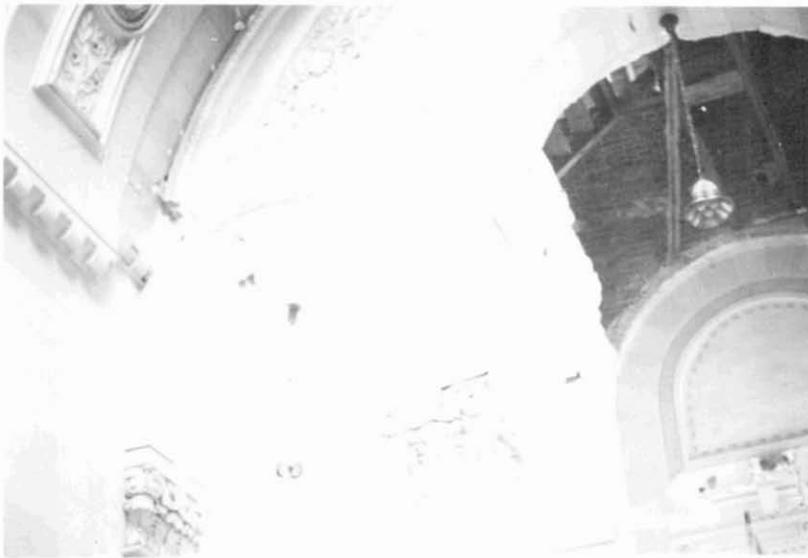
Figure 3.97. Partial collapse of vaulted ceiling within administration building.

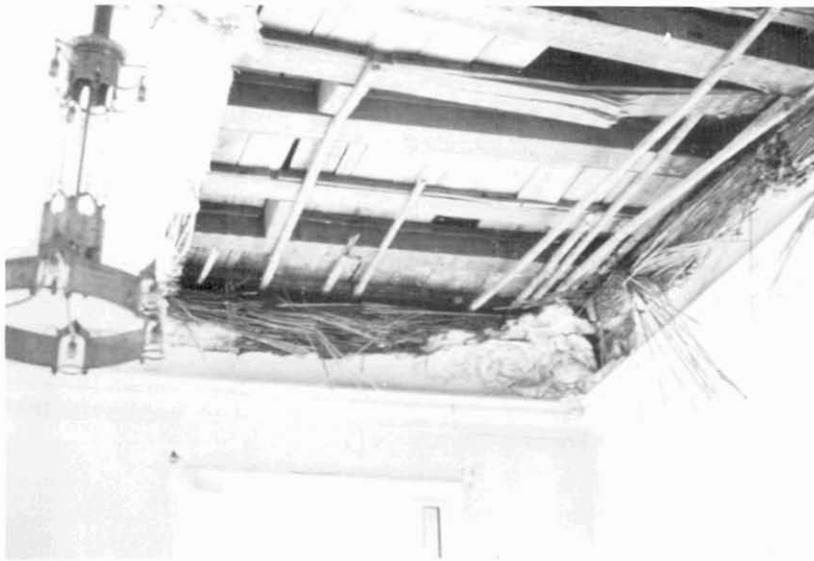
Figure 3.100. Partial collapse of the second story floor of the museum.

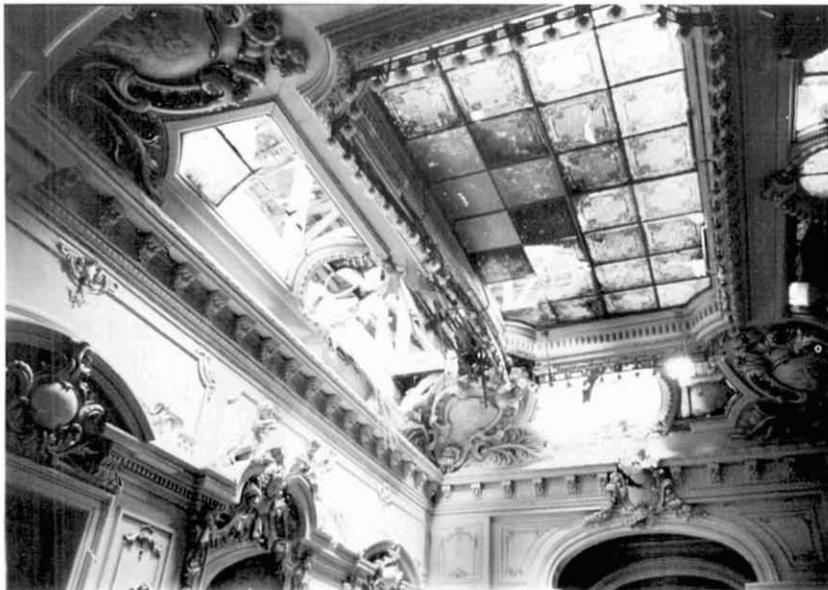
Figure 3.101. Damage of decorative skylight within the first story of the museum.

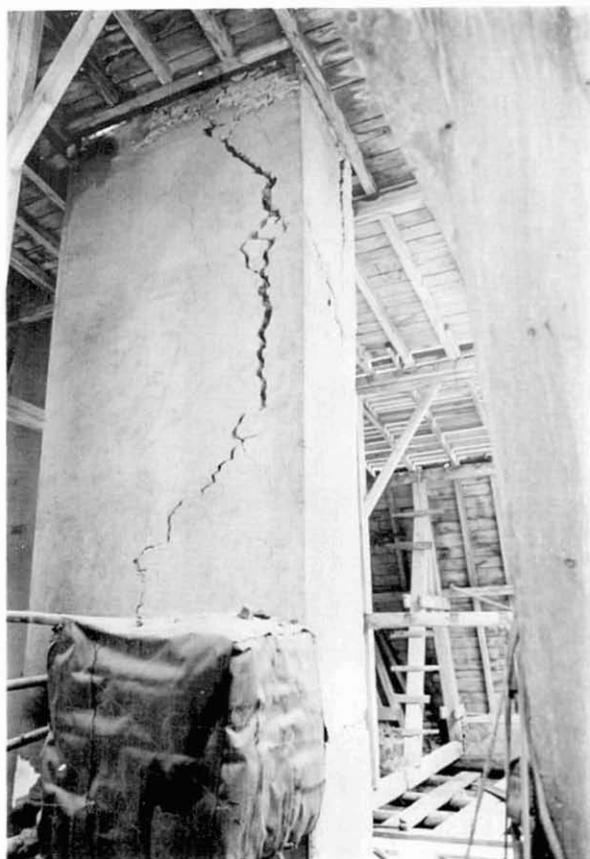
Figure 3.103. Ruptured masonry chimney in the museum attic.

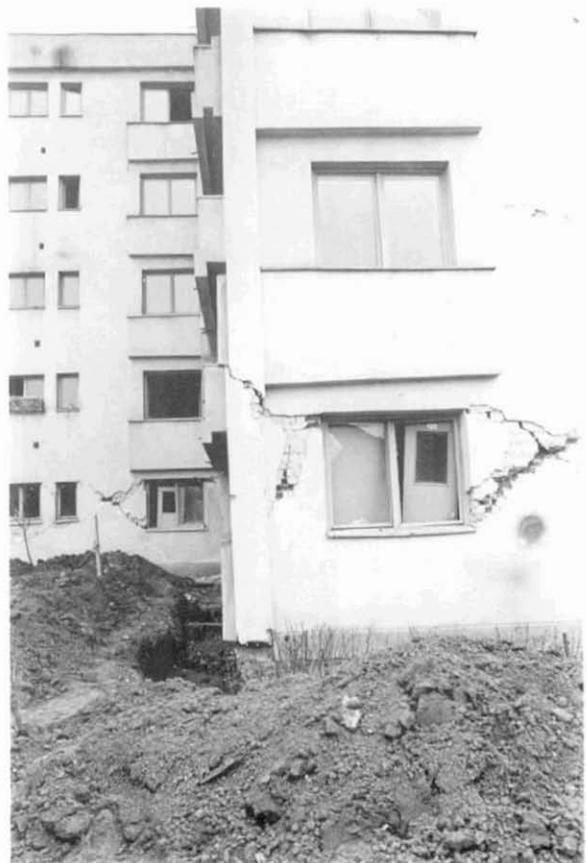
Figure 3.105. Damage of first-story exterior bearing walls.

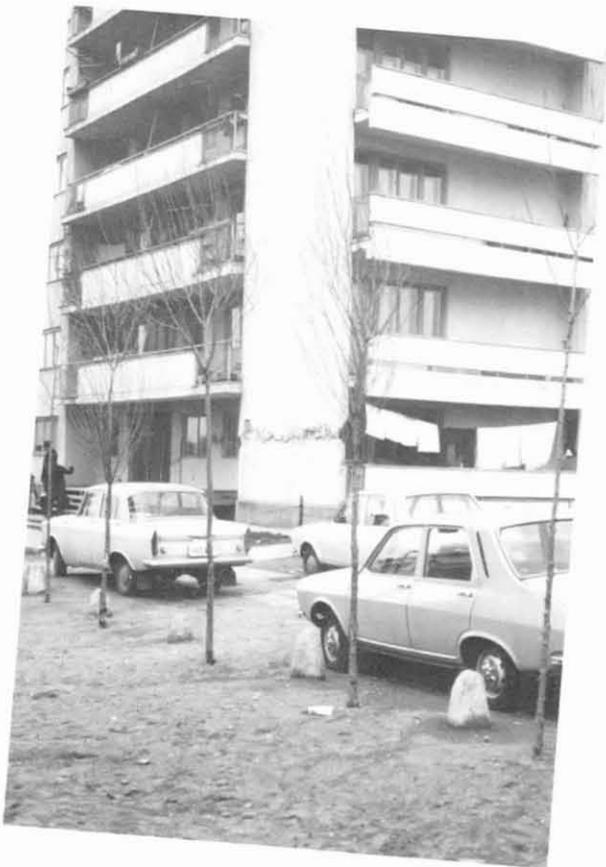
Figure 3.110. Cracking of facing wall in multistory apartment building
