NBS SPECIAL PUBLICATION **592**

U.S. DEPARTMENT OF COMMERCE / National Bureau of Standards

An Investigation of the Miyagi-ken-oki, Japan, Earthquake of June 12, 1978

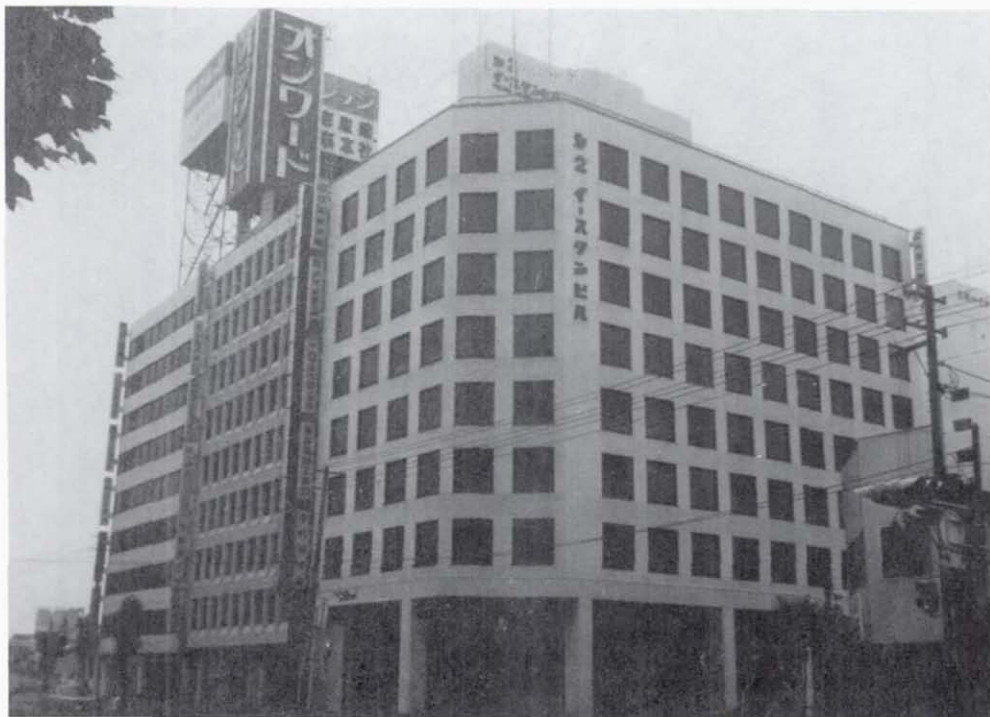
Figure 5.6 Second Eastern Building Company Building, Sendai. A typical modern building in Sendai; the only apparant damage to the glazed tile veneer on the exterior was cracking on spandrels and shear walls.

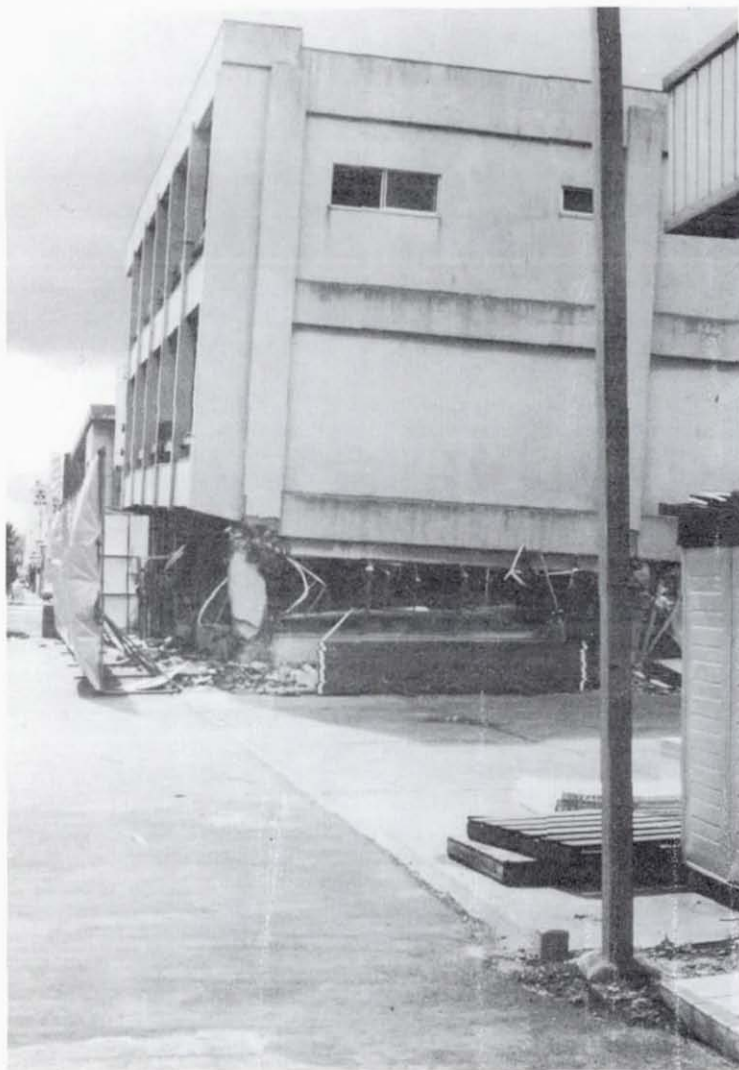
Figure 5.24 Maruyoshi Building, view from the east. Failure of first story columns occurred in shear.

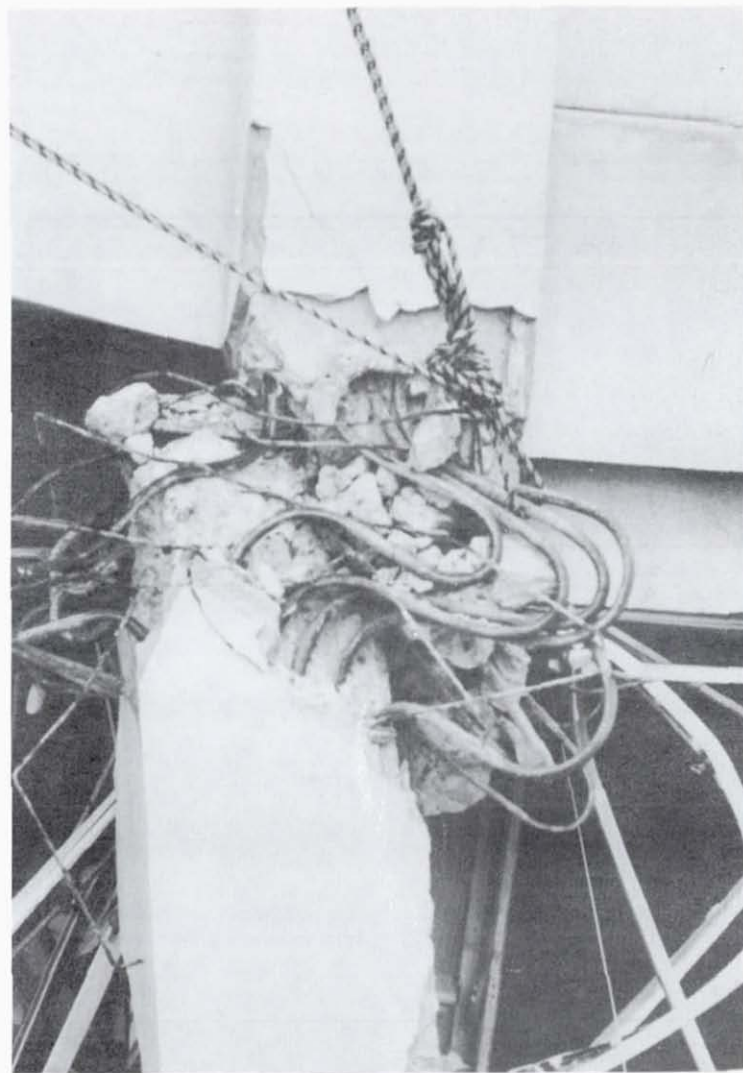
Figure 5.25 Maruyoshi Building. Detail of a joint at the top of a first story column.

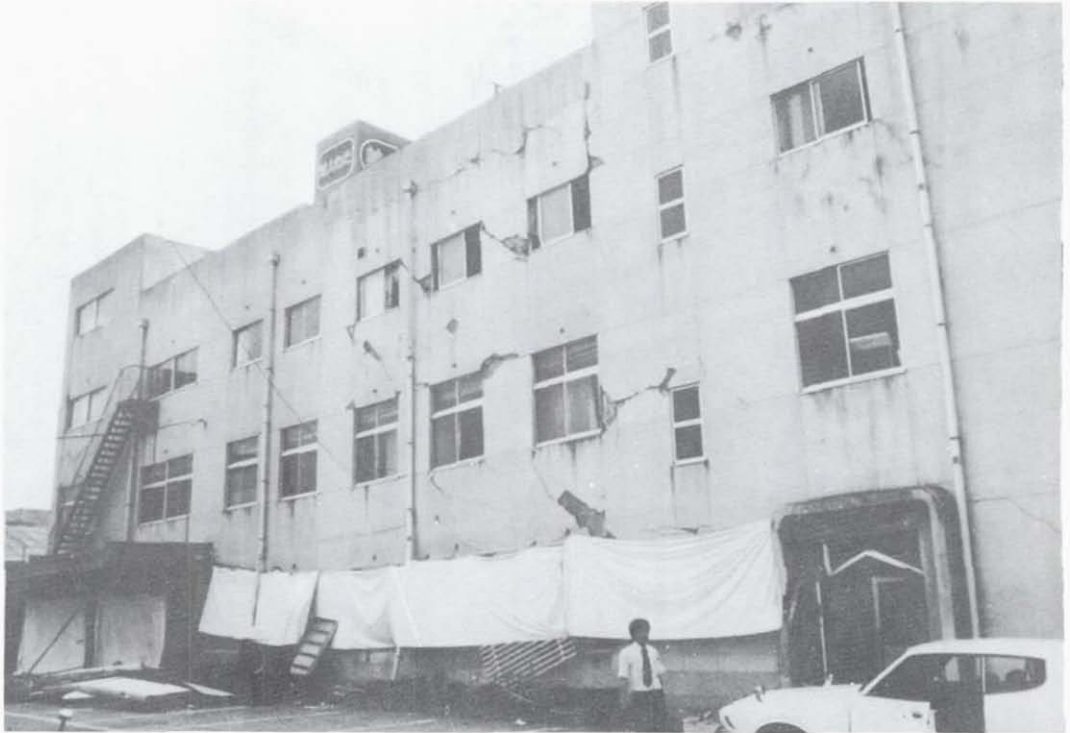
Figure 5.32 Kinoshita Building, Oroshicho area, of Sendai. Extensive diagonal cracking was observed on the east face (rear) of the building.

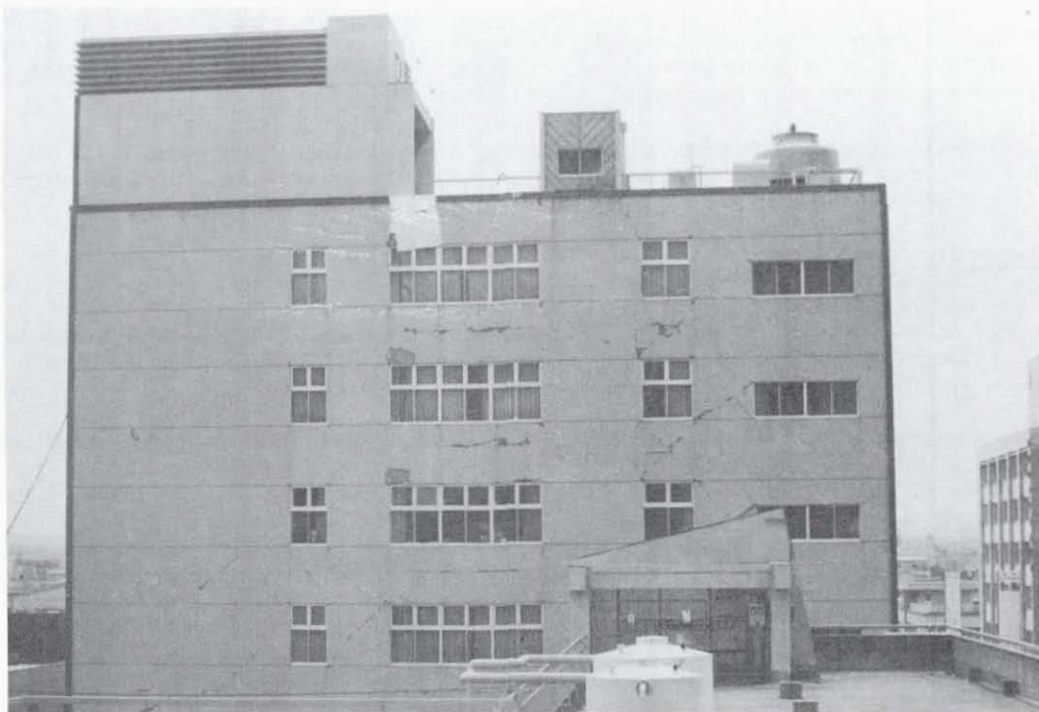
extensive diagonal cracking in the panels between window openings on both east (Figure 5.34) and west faces (Figure 5.35); this damage is especially severe on the west face, as shown in the detail in Figure 5.36. The decorative ceramic brick facing on the north side of the building did not appear to be damaged.

Figure 5.34 Maruhon Building, Oroshicho area, showing shear cracking in the panels on the east face between window openings.

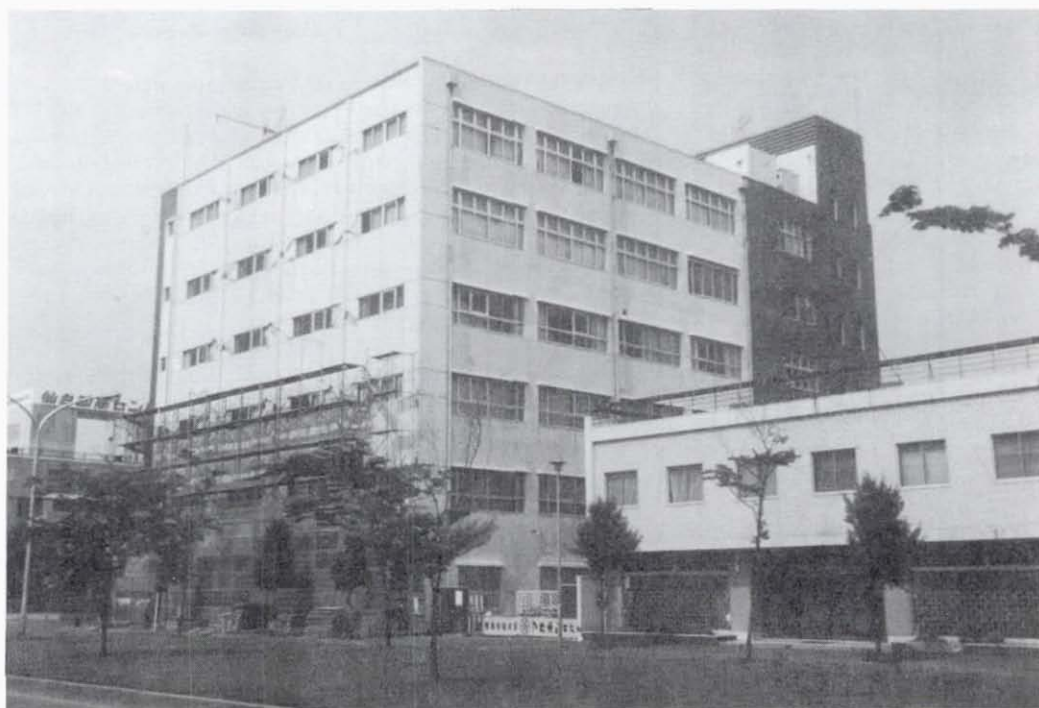
Figure 5.35 Maruhon Building, west face, showing cracking of curtain wall panels.

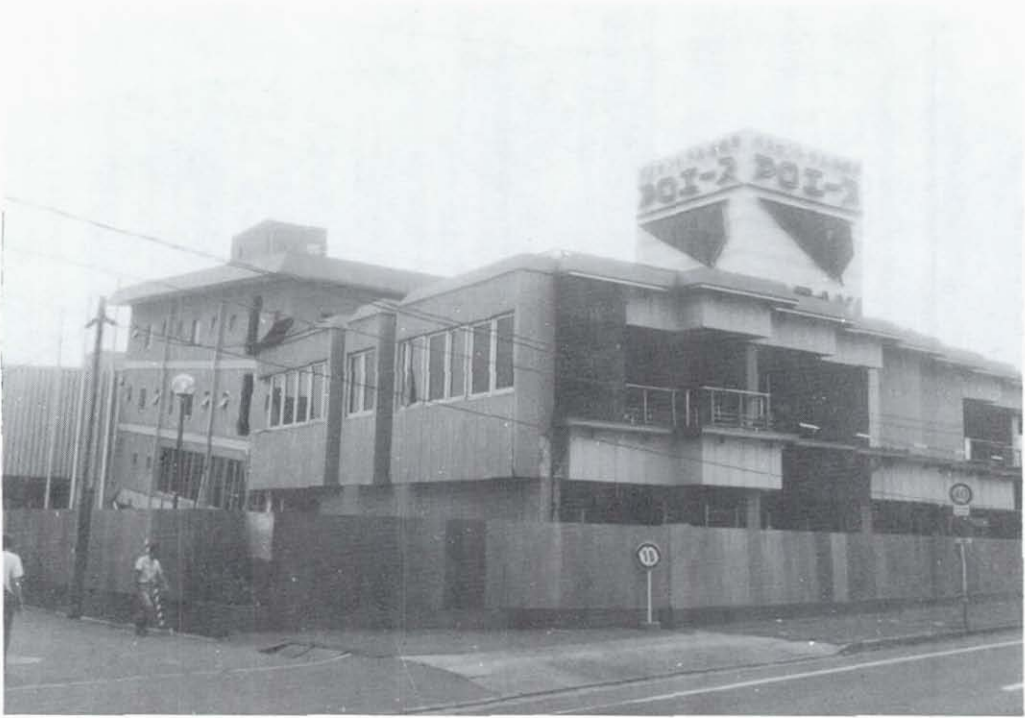
Figure 5.38 Yazaki Industries Buildings, viewed from the northeast, Oroshicho area. Portions of three Yazaki buildings are shown. Failure of the reinforced concrete middle building caused it to rack forward against the front steel structure.

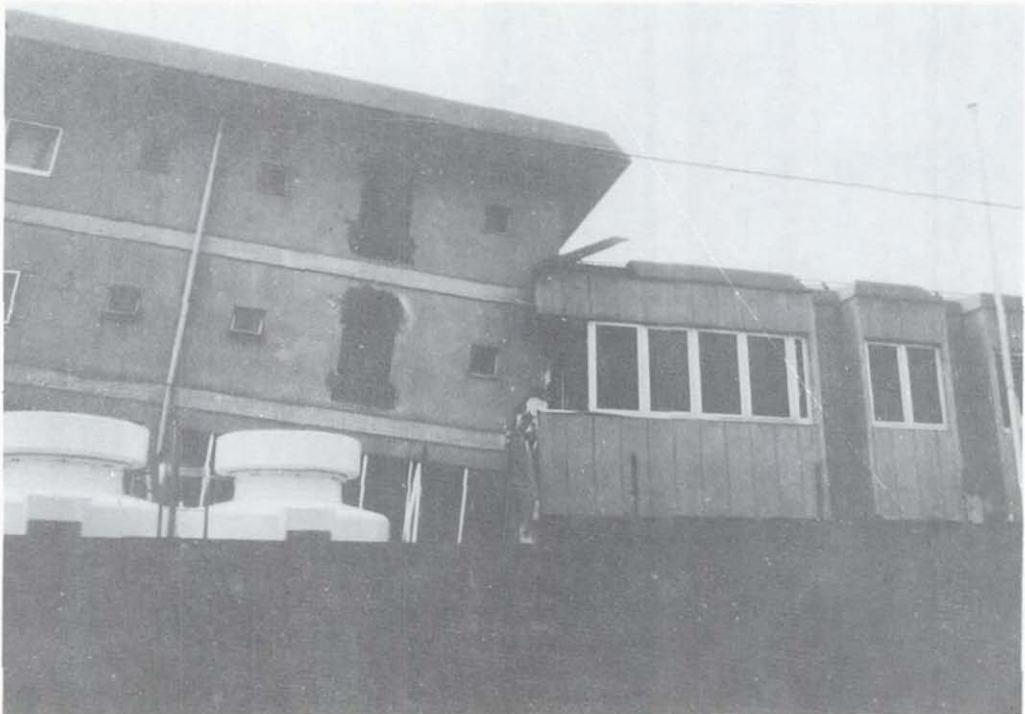
Figure 5.40 Yazaki Industries, showing area of impact between steel and reinforced concrete frames.

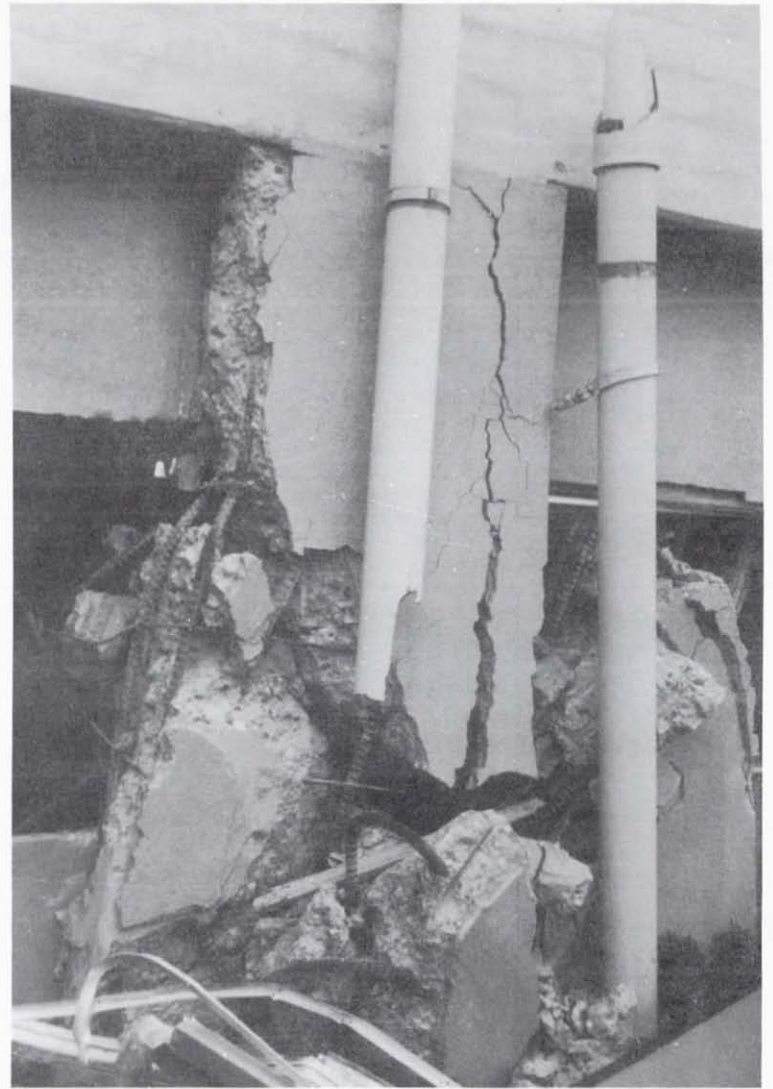
Figure 5.41 Yazaki Industries, showing damage to lower story reinforced concrete column.

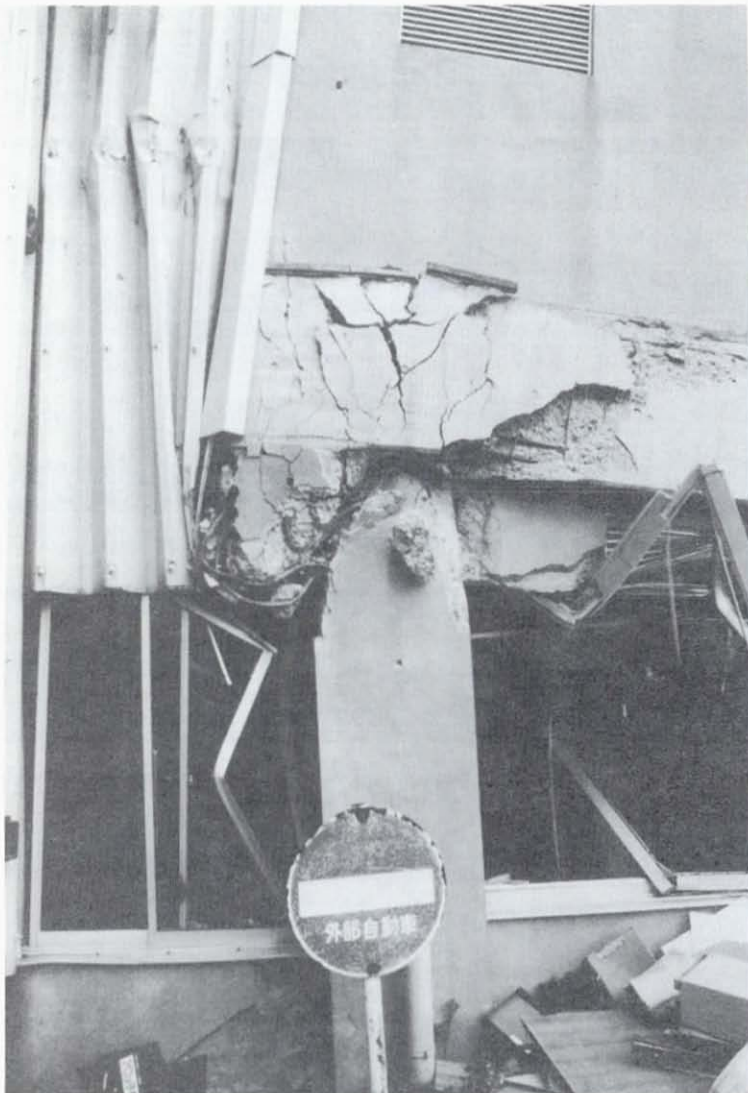
Figure 5.42 Yazaki Industries Building, showing beam-column joint at top of first story column, east side.

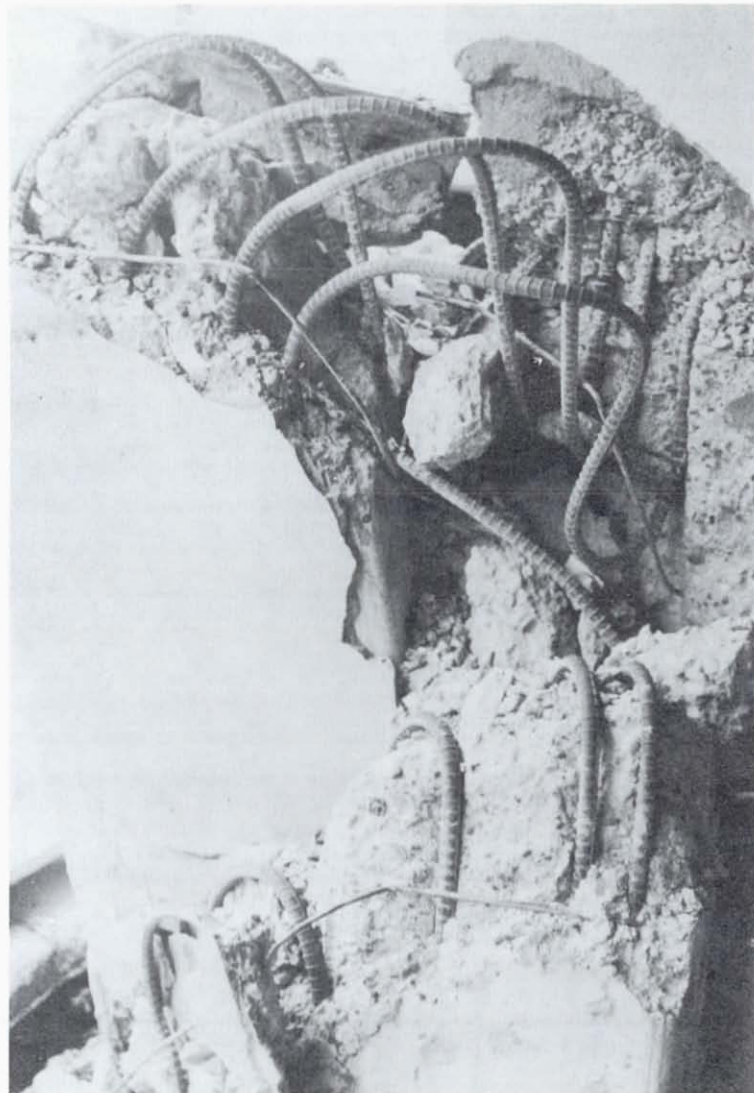
Figure 5.43 Yazaki Industries Buildings. Detail of column shear failure, east side. Note use of deformed bars.

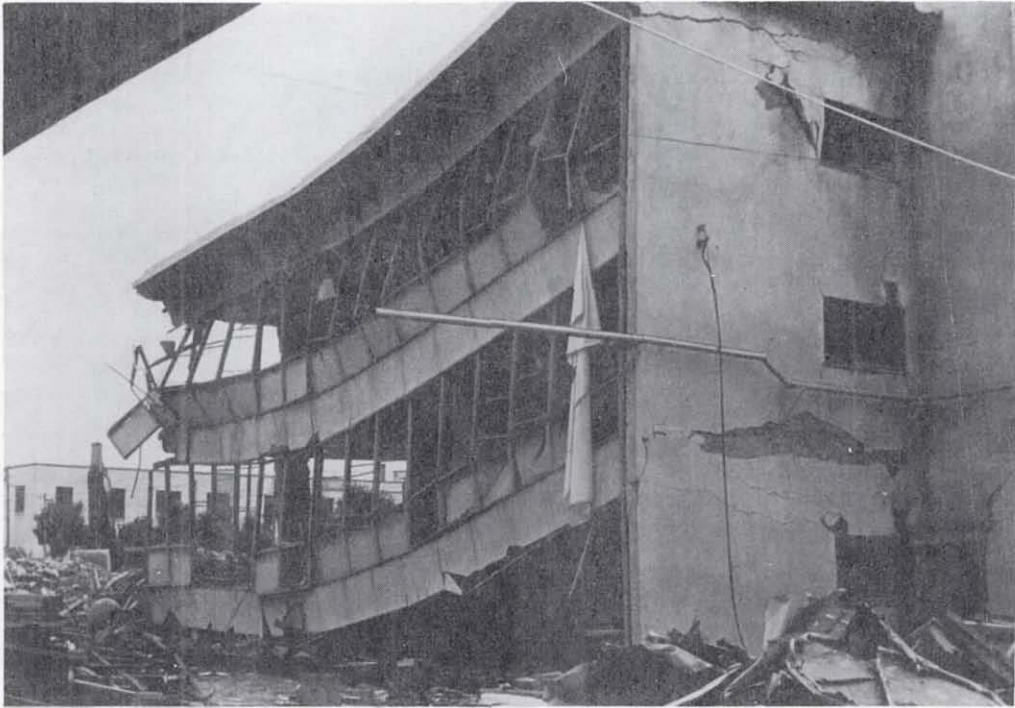
Taiyo Fisheries Plant (No. 11, Figure 5.3). This was a three-story building with a reinforced concrete frame, one span by five, the main axis of which was in the N-S direction. There were shear walls on the north and south ends of the structure. As shown in Figures 5.51 and 5.52, the first-story columns in the middle of the building failed, causing the central portion of the building to collapse but leaving the ends standing. The shear walls at the north end of the structure (running in the E-W direction) were badly cracked. At the time the site was visited, the building was being demolished.

Figure 5.52 Taiyo Fisheries Plant, viewed from the northeast. The reinforced concrete shear wall on the north end was badly damaged.

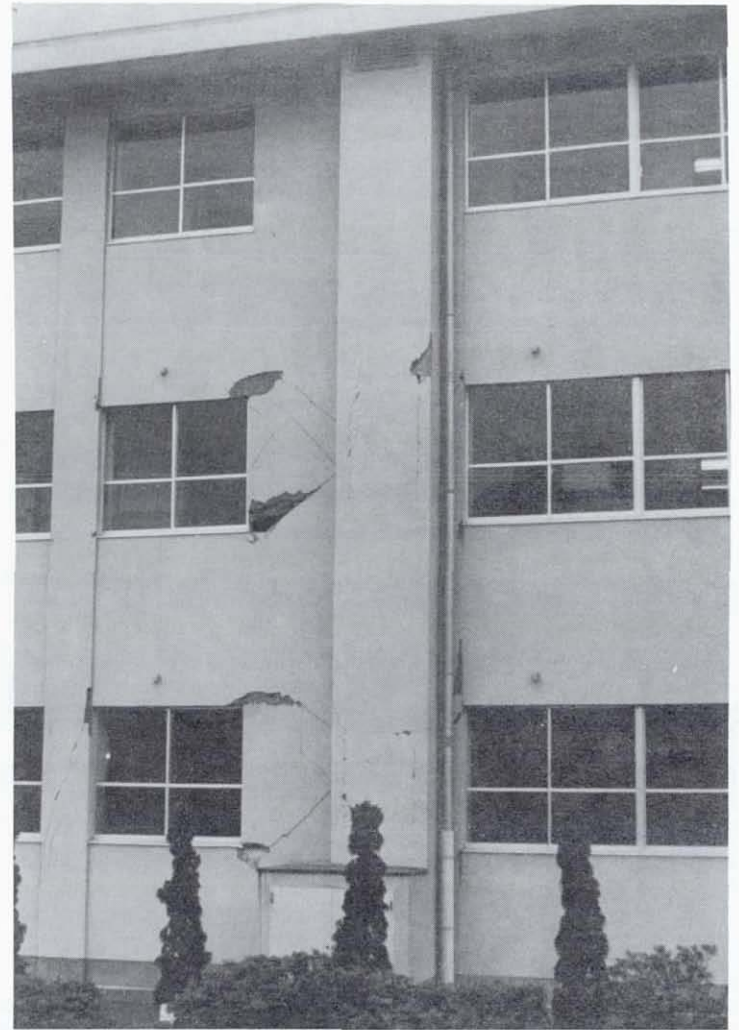
Figure 5.63 Izumi High School, typical classroom building, north face. All faces with the larger infill panels were similarly damaged.

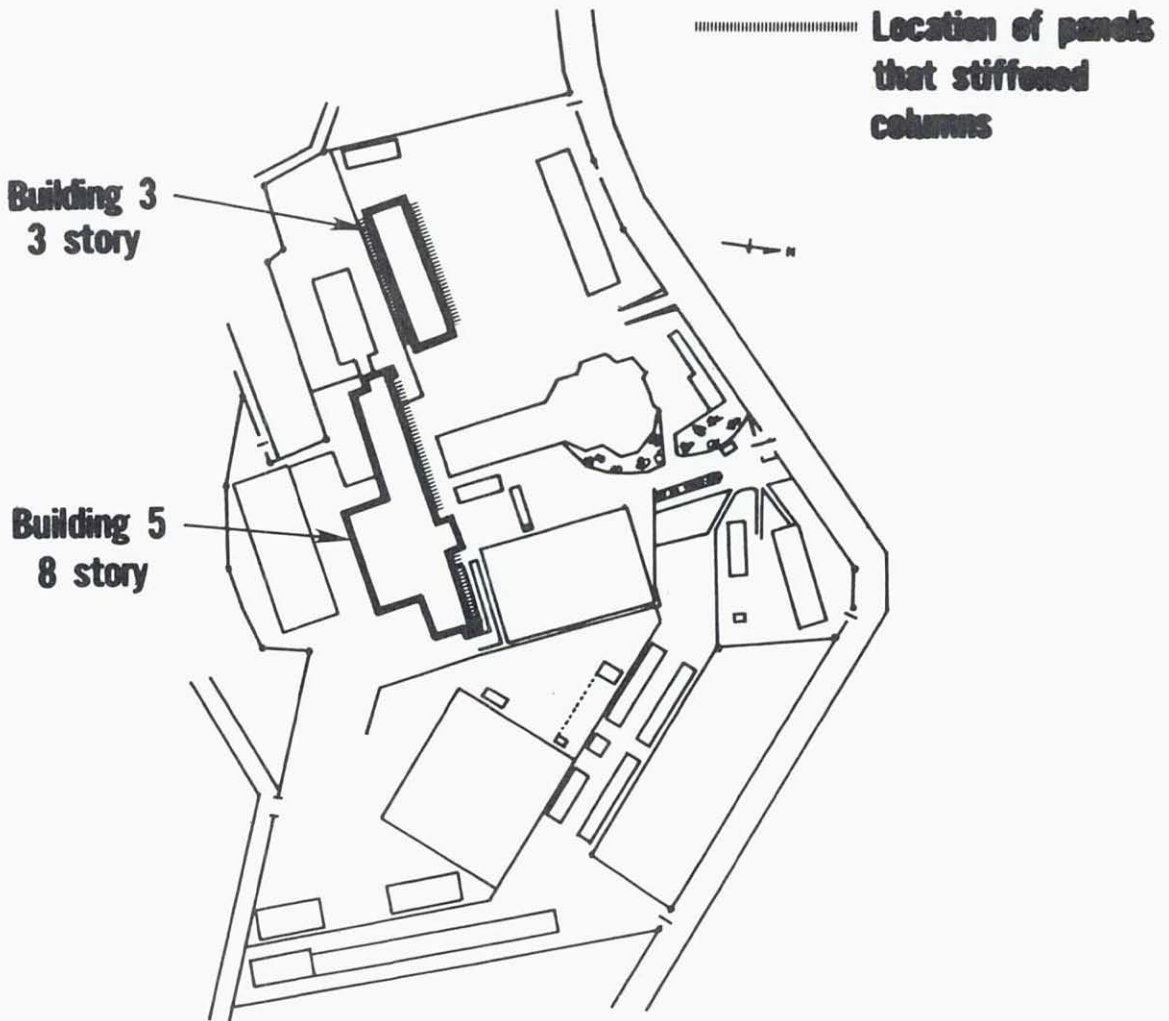
Figure 5.64 Tohoku Institute of Technology, Sendai, plan of campus. Hatching along walls of buildings 3 and 5 shows location of severely damaged columns.

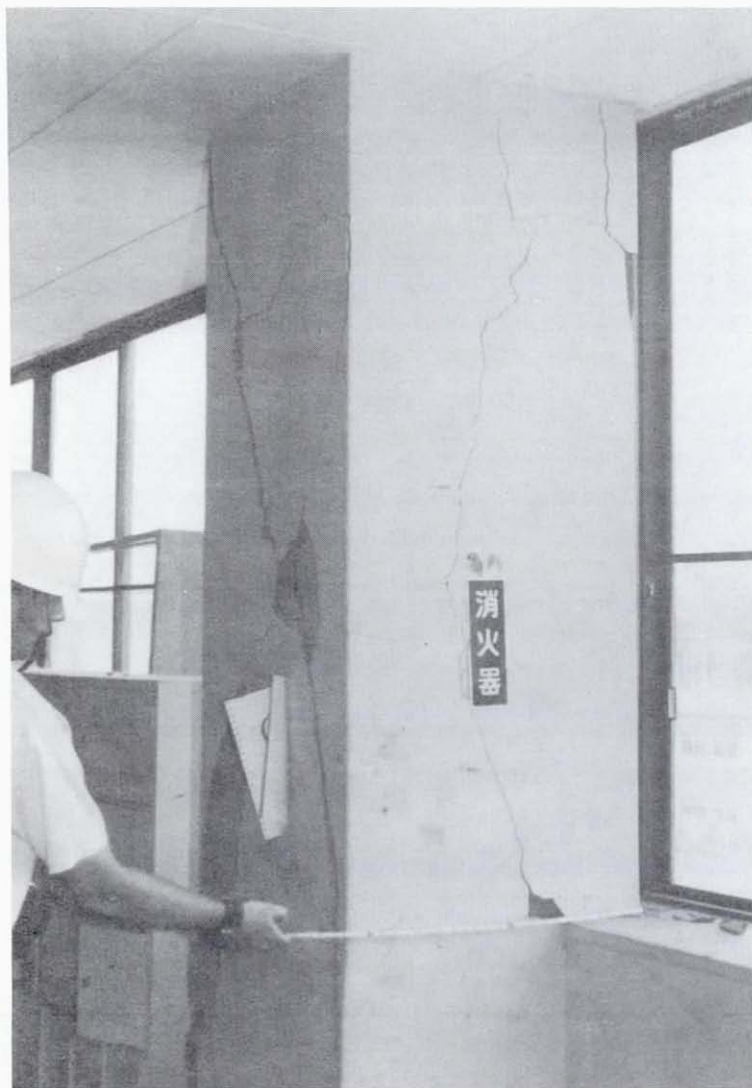
Figure 5.67 Tohoku Institute of Technology. Typical damage to seventh story column of the north facade of building 5.

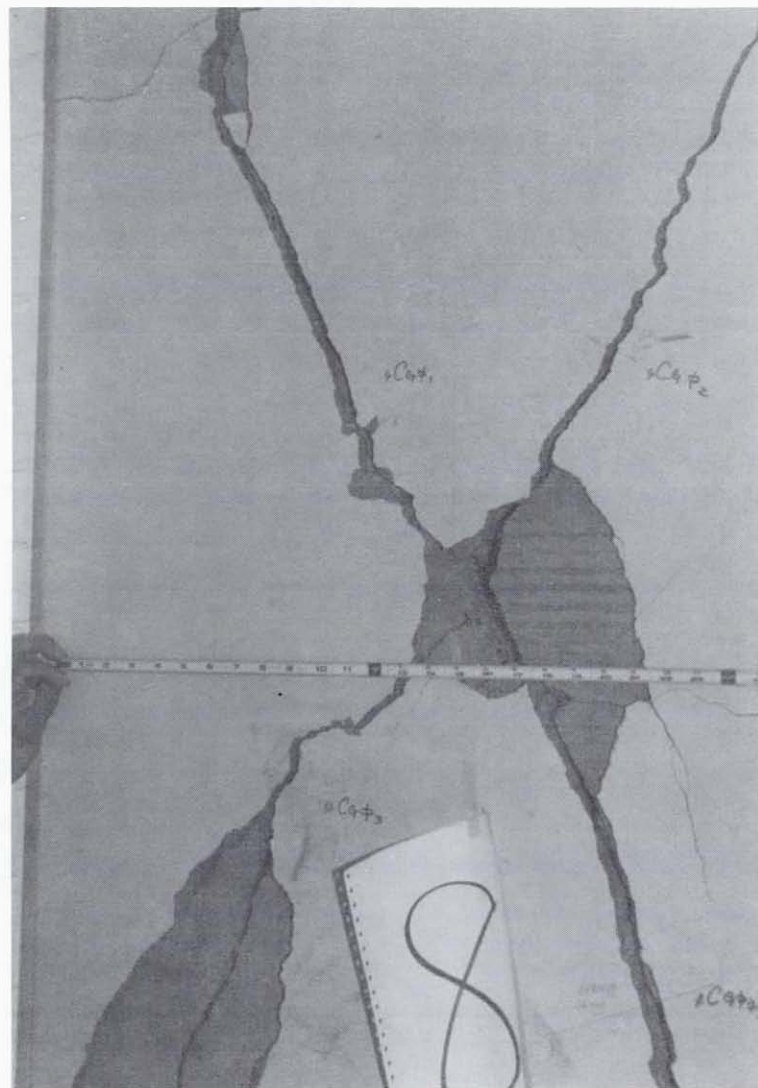
Figure 5.68 Tohoku Institute of Technology, Building 5. Detail of column damage.

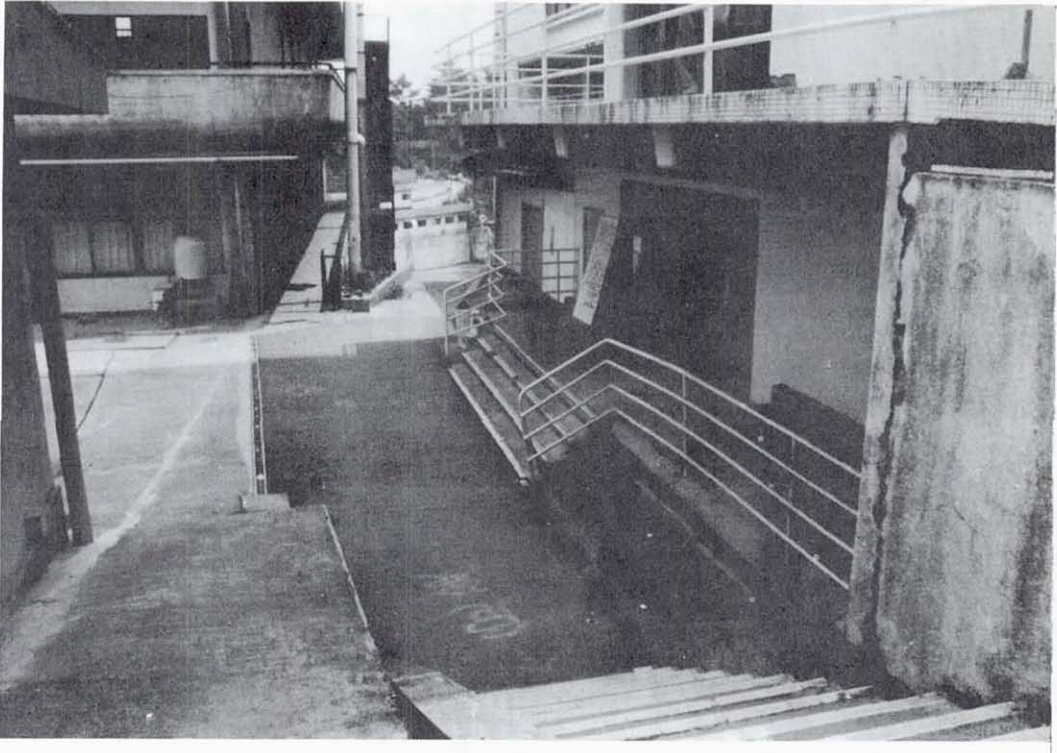
Figure 5.79 Tohoku Institute of Technology, walkway and north entrance of building 5 shows settlement of backfill along length of building.

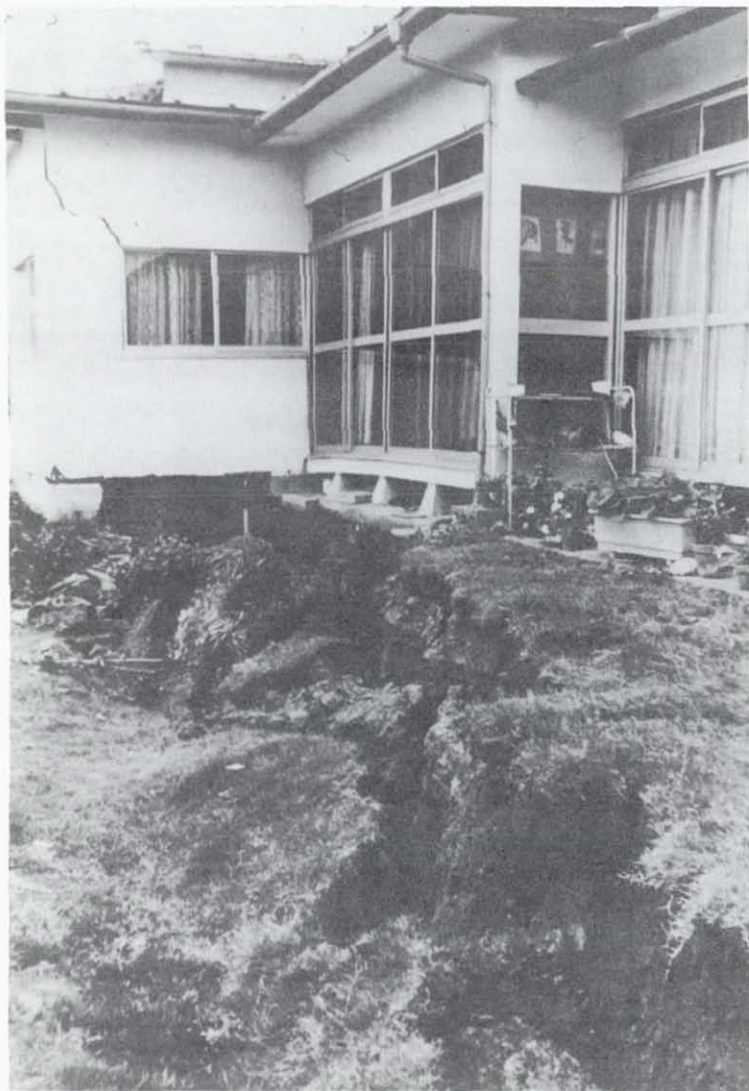
Figure 5.84 shows an example of the ground cracking resulting from subsidence in one of the hilly areas in Sendai. The loss of foundation support has caused extensive cracking in the building walls. In Figure 5.85, the front steps and breezeway have separated some 30 cm

Figure 5.84 Sendai. Damage to single family residence due to loss of foundation support. (Japan National Land Agency photograph)

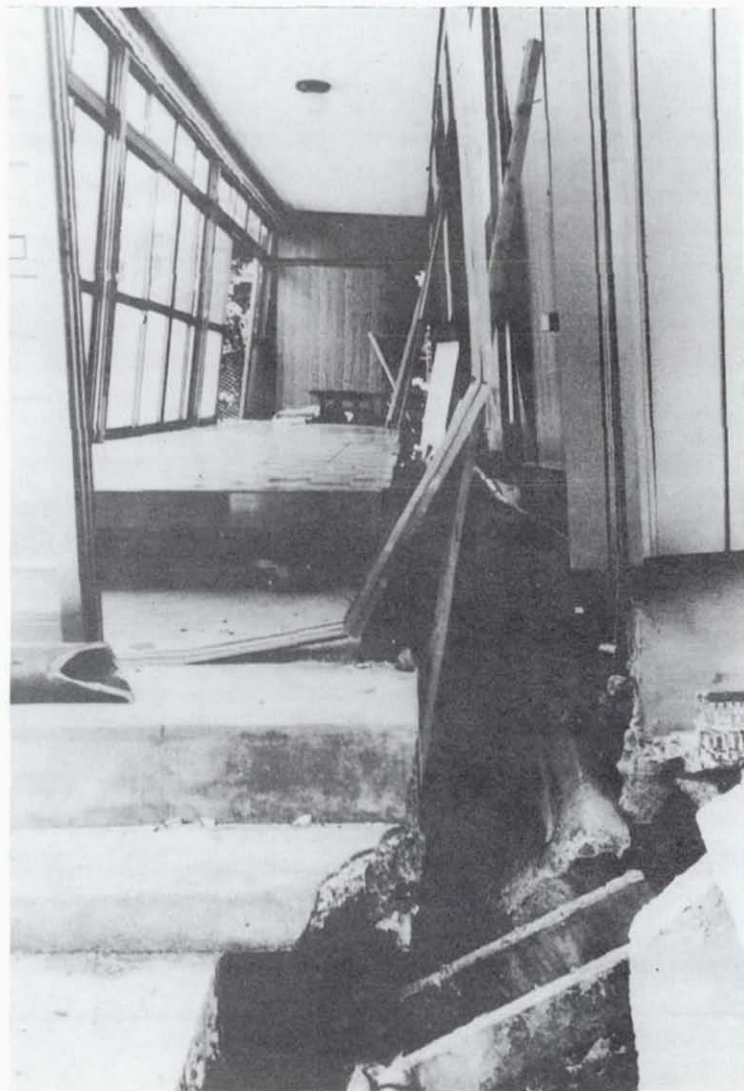
Figure 5.85 Sendai. Damage to single family residence due to ground settlement. (Japan National Land Agency photograph)

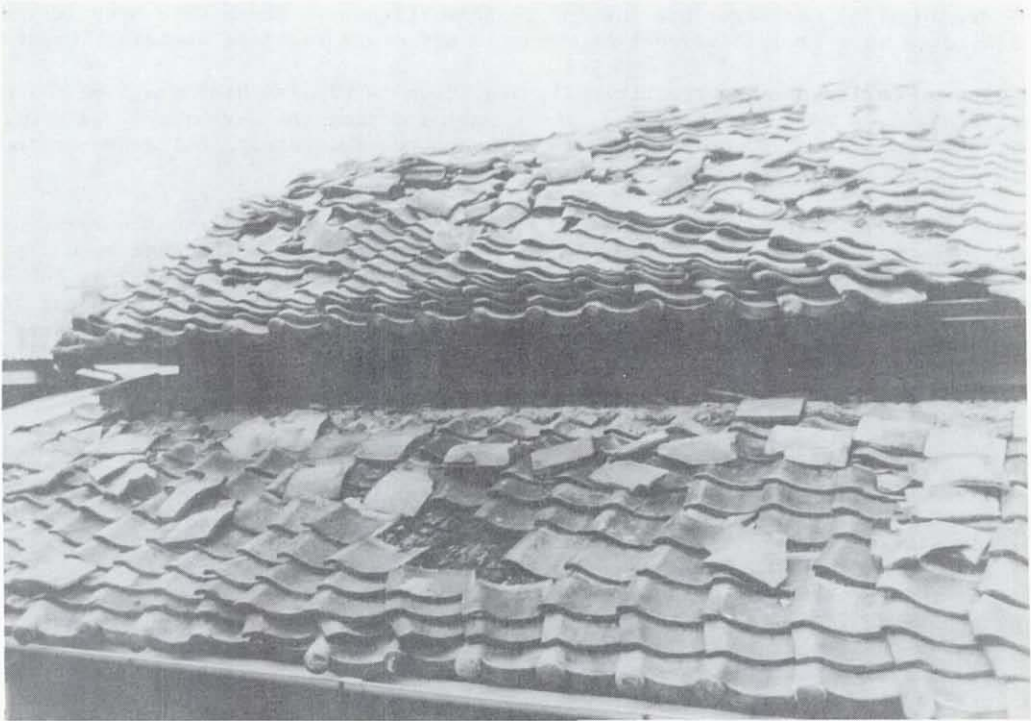
Figure 5.86 Typical damage to tile roofs in Sendai (Japan National Land Agency photograph)

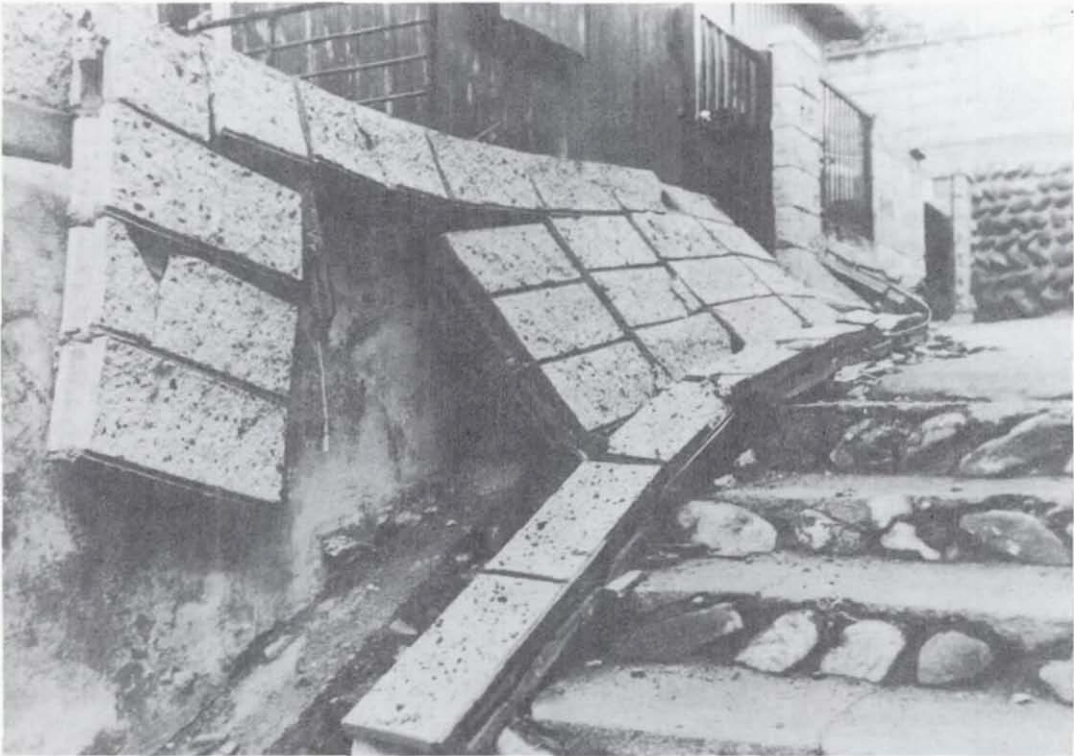
Figure 5.88 Failure of a reinforced concrete masonry privacy wall in Sendai.
(Japan National Land Agency photograph)

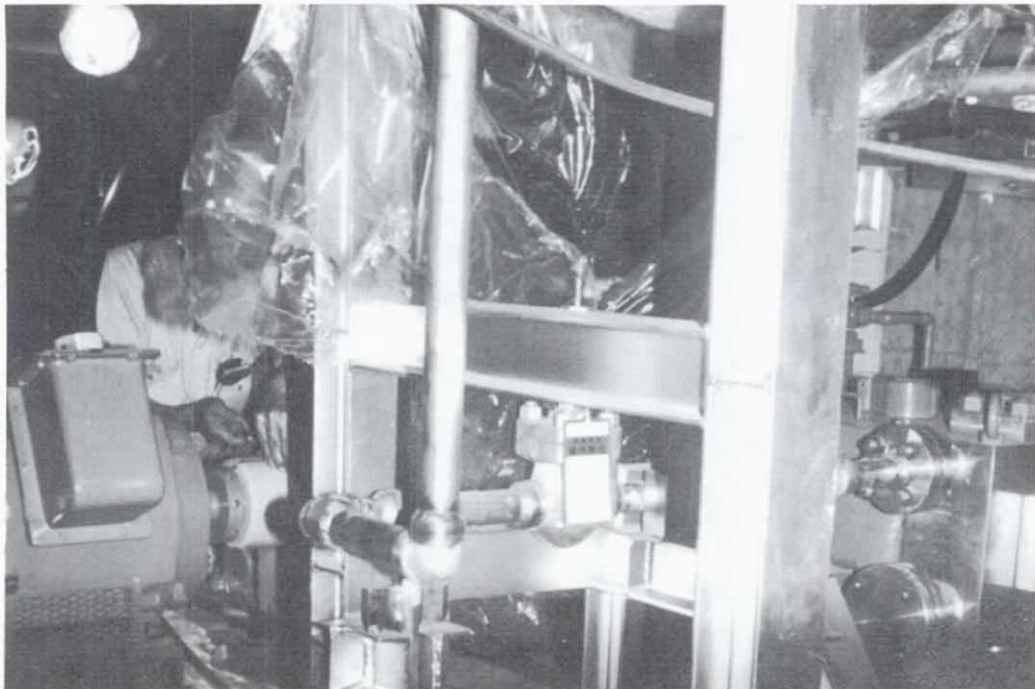
Figure 6.15 New Sendai Power Plant, Tohoku Electric Power Company: damage around the water intake structure from minor settlement. Other examples of minor settlement were observed throughout the site.

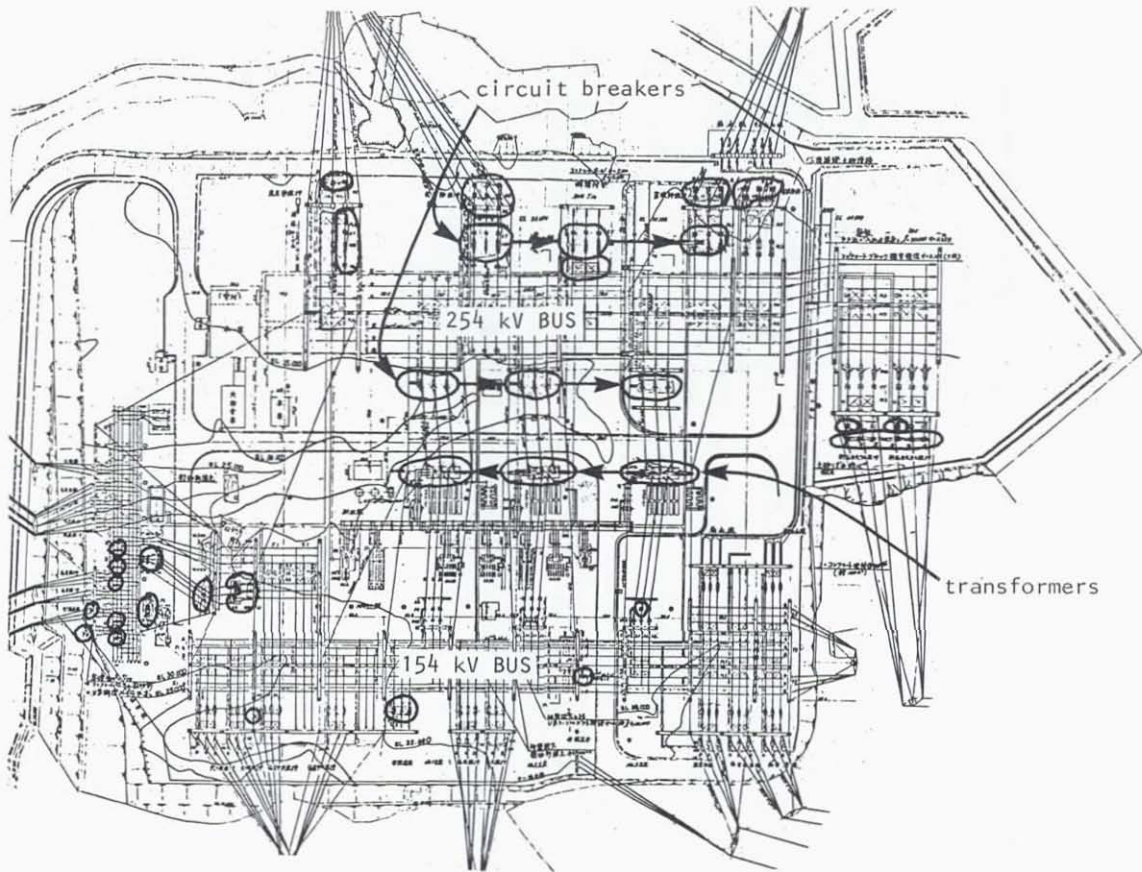
Figure 6.20 Sendai Substation, Izumi: plan of the facility showing the location of damaged equipment (circled). The solid contour lines indicate areas that were filled.

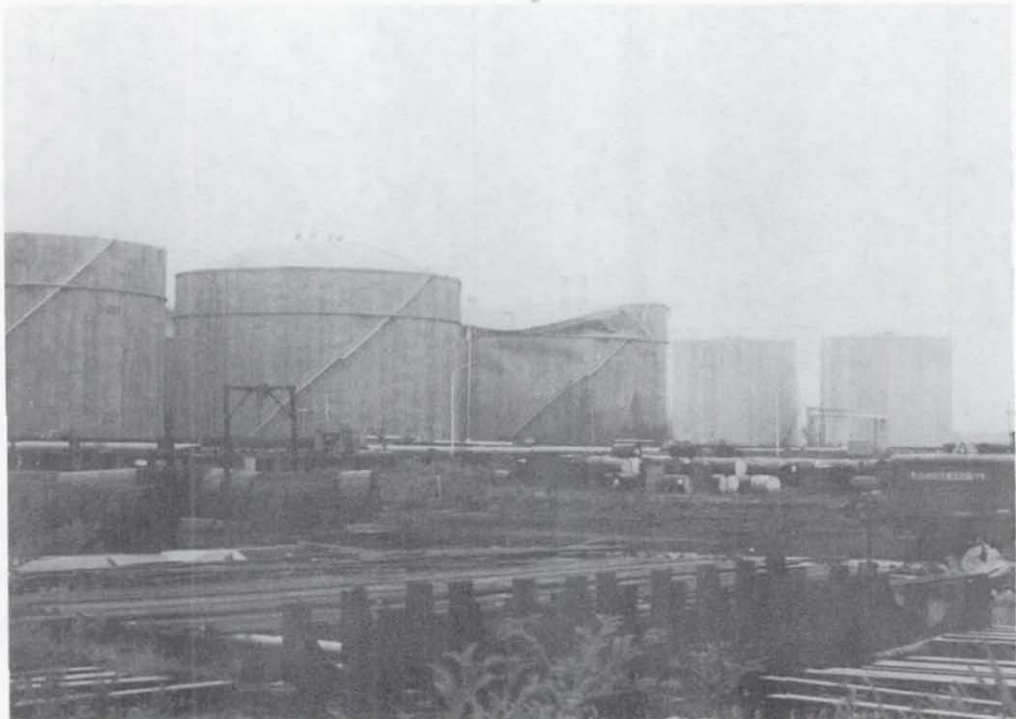
Figure 6.43 Sendai Refinery, Tohoku Oil Company, Ltd. Two other failed TC oil storage tanks.

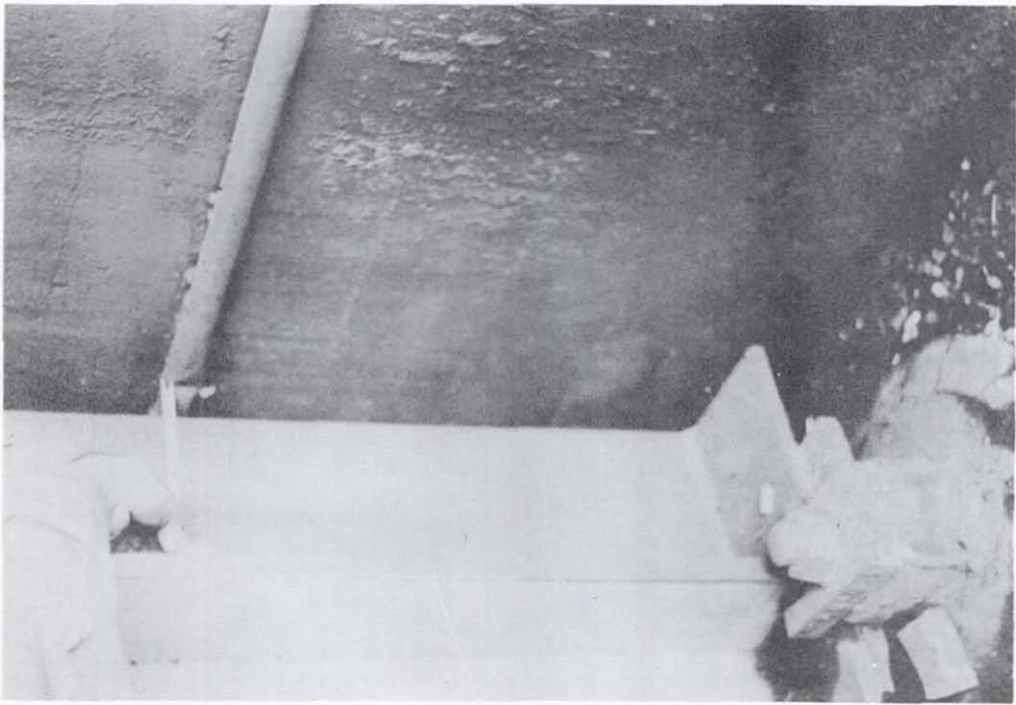
Figure 7.27 Sendai Ohashi Bridge. Abutment damage. Bearing plate broken and evidence of girder impact at abutment.

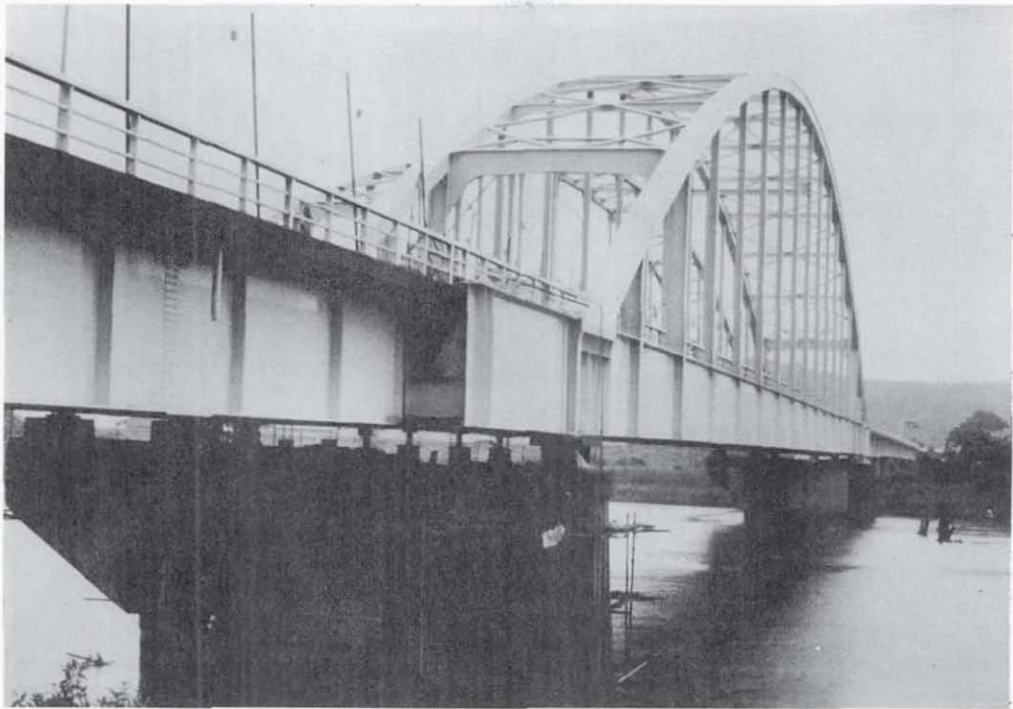
Figure 7.33 The main tied arch span of the Tenno Bridge with the cracked wall pier in the foreground. Note the smaller, pedestrian bridge in the background.

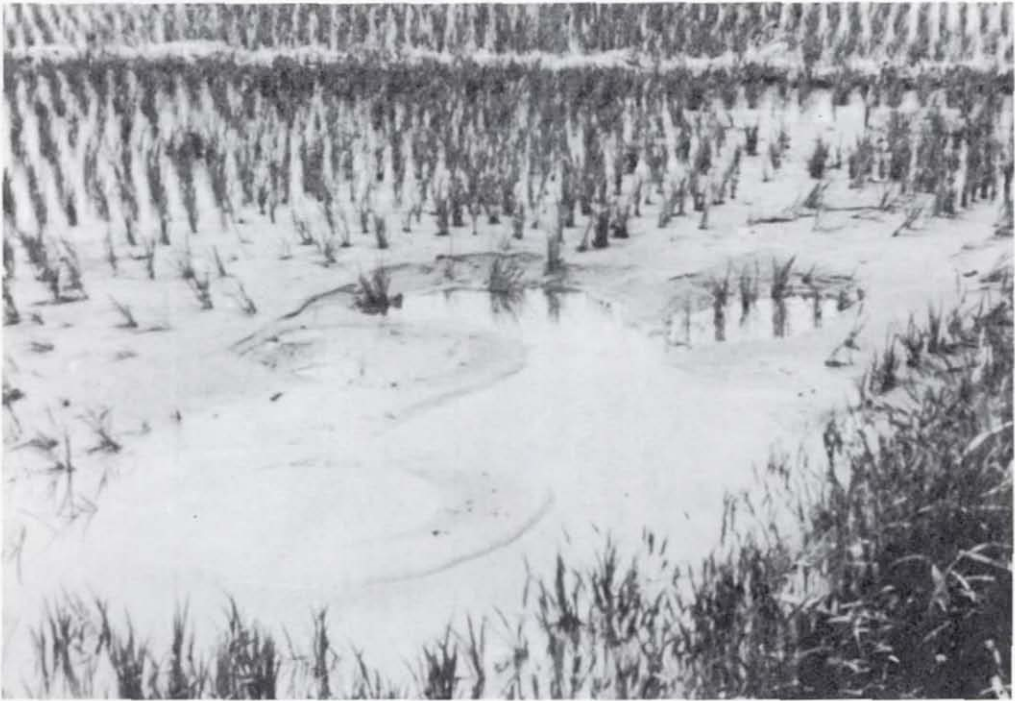
Figure 8.16 Site 5, Old Kitakami River ~ Sand boils in rice field. Plants are several centimeters tall. Damage to the dike at this site was minor. (Photo courtesy K. Kawashima, PWRI)
