NBS SPECIAL PUBLICATION **592**

U.S. DEPARTMENT OF COMMERCE / National Bureau of Standards

An Investigation of the Miyagi-ken-oki, Japan, Earthquake of June 12, 1978

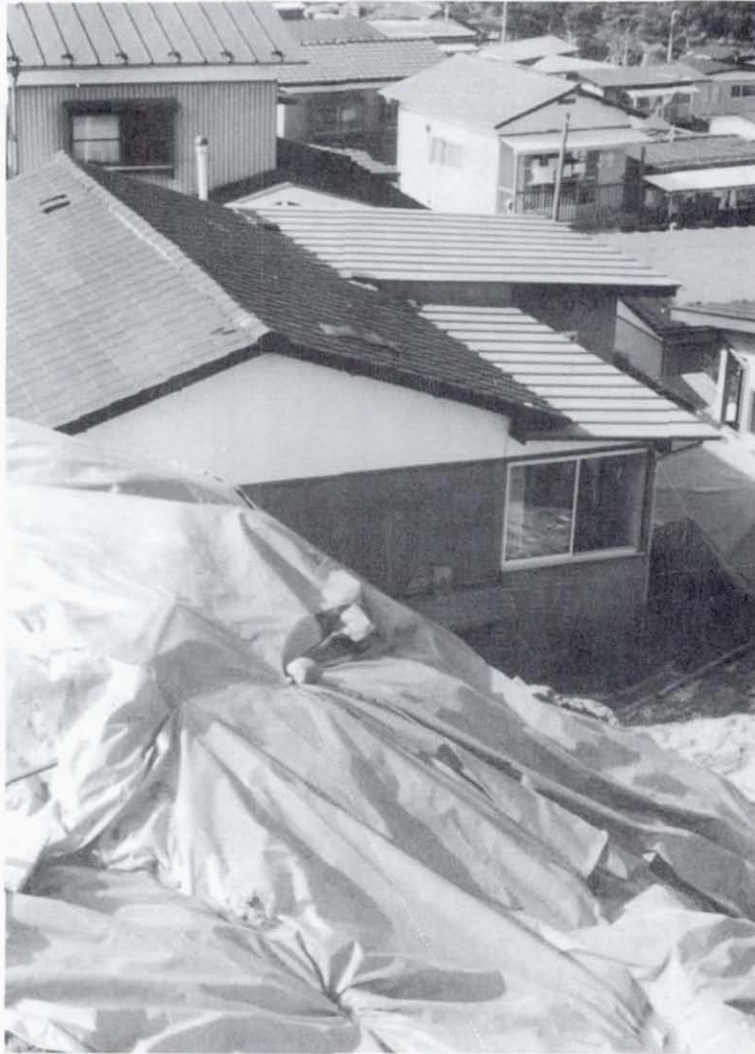
Figure 9.19 Toe of slump and house below in danger of being overridden by slide mass. House has been evacuated.
