NBS BUILDING SCIENCE SERIES 165

**Engineering Aspects
of the September 19, 1985
Mexico Earthquake**

Following the September 19, 1985 Mexico earthquake, a team consisting of four engineers and one seismologist from the National Bureau of Standards (NBS) and the United States Geological Survey (USGS) was dispatched to Mexico City to provide technical advice to the US rescue effort and to assess structural damage. This report is primarily based on data gathered by the team, but it also contains a compilation of other available information. The report addresses the origin and characteristics of the observed ground motion, the ability of buildings designed in accordance with present and proposed seismic design provisions to resist this type of ground motion, and observed data on structural and foundation failures.

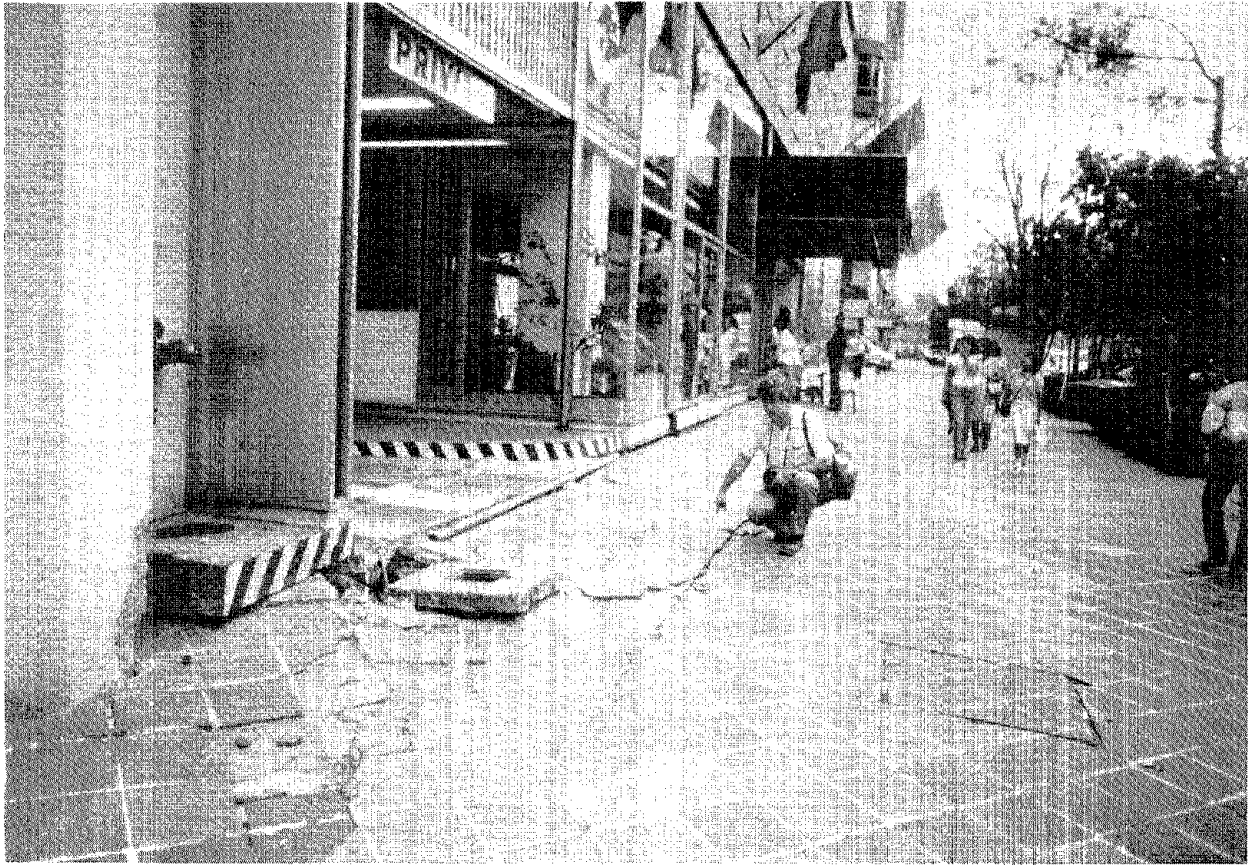
Figure 4.2. Disturbances caused by differential displacement between the sidewalk and the Bank of America Building.

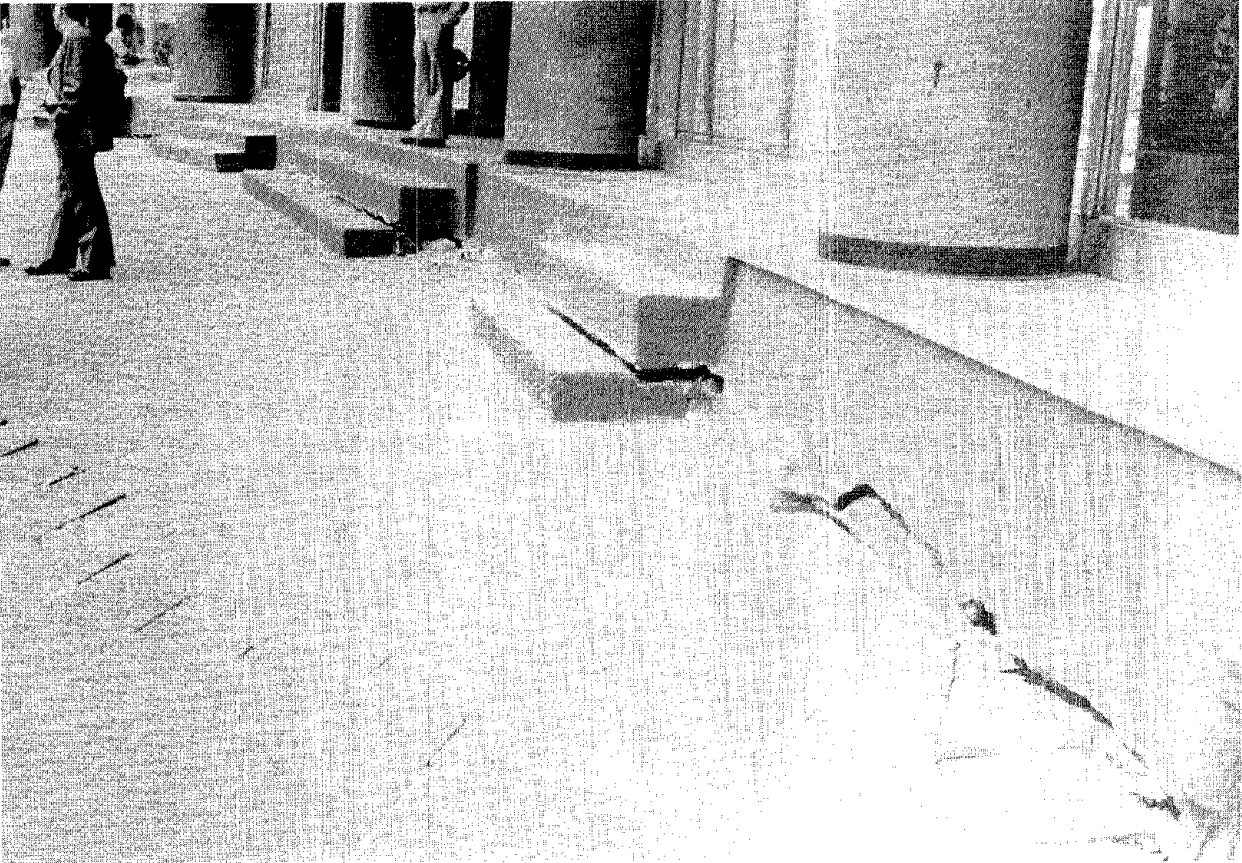
Figure 4.3 Differential displacement between sidewalk and building at the east corner of Versailles and Reforma.

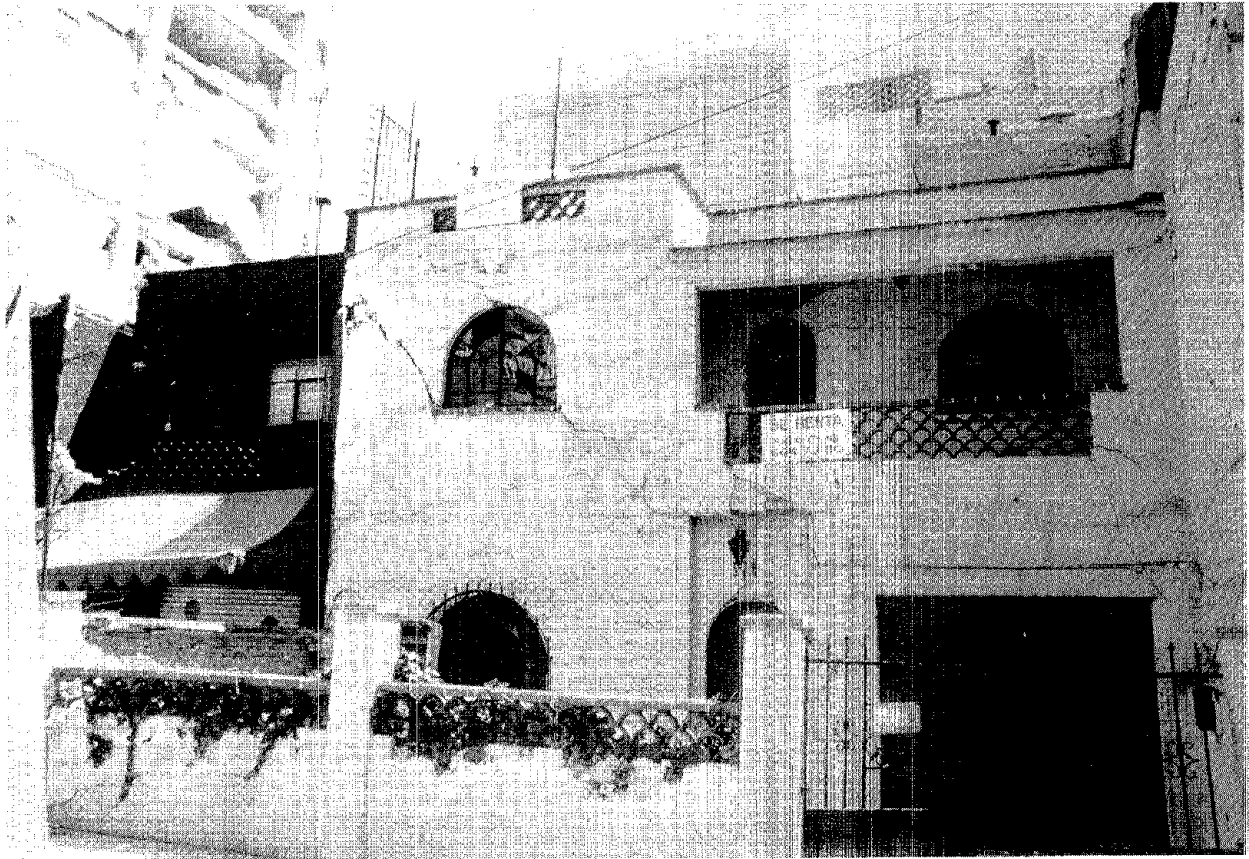
Figure 4.7. Damage to adjacent structures caused by the tilting of a ten story building at Lazaro Cardenas and Fernando.

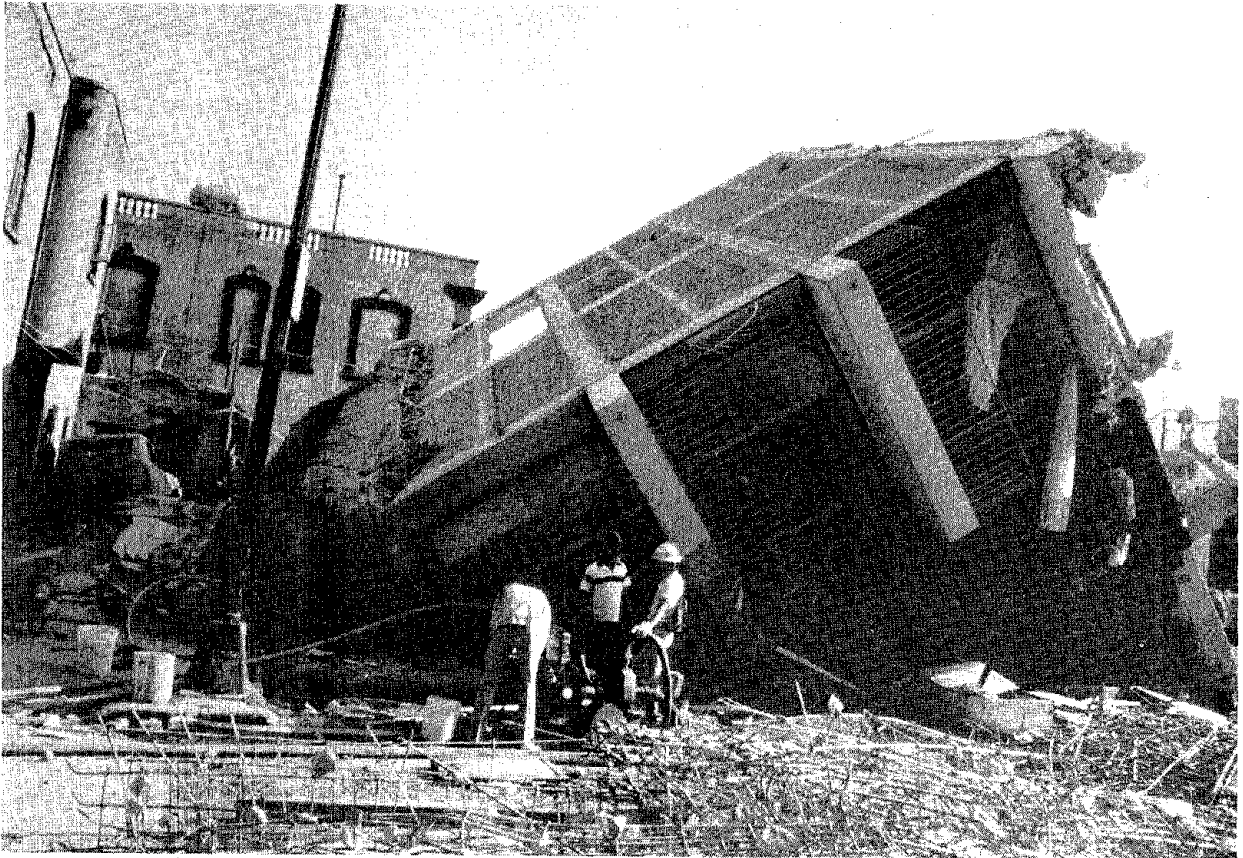
Figure 4.11. Overturned building at southeast corner of Zacatecas and Orizaba.

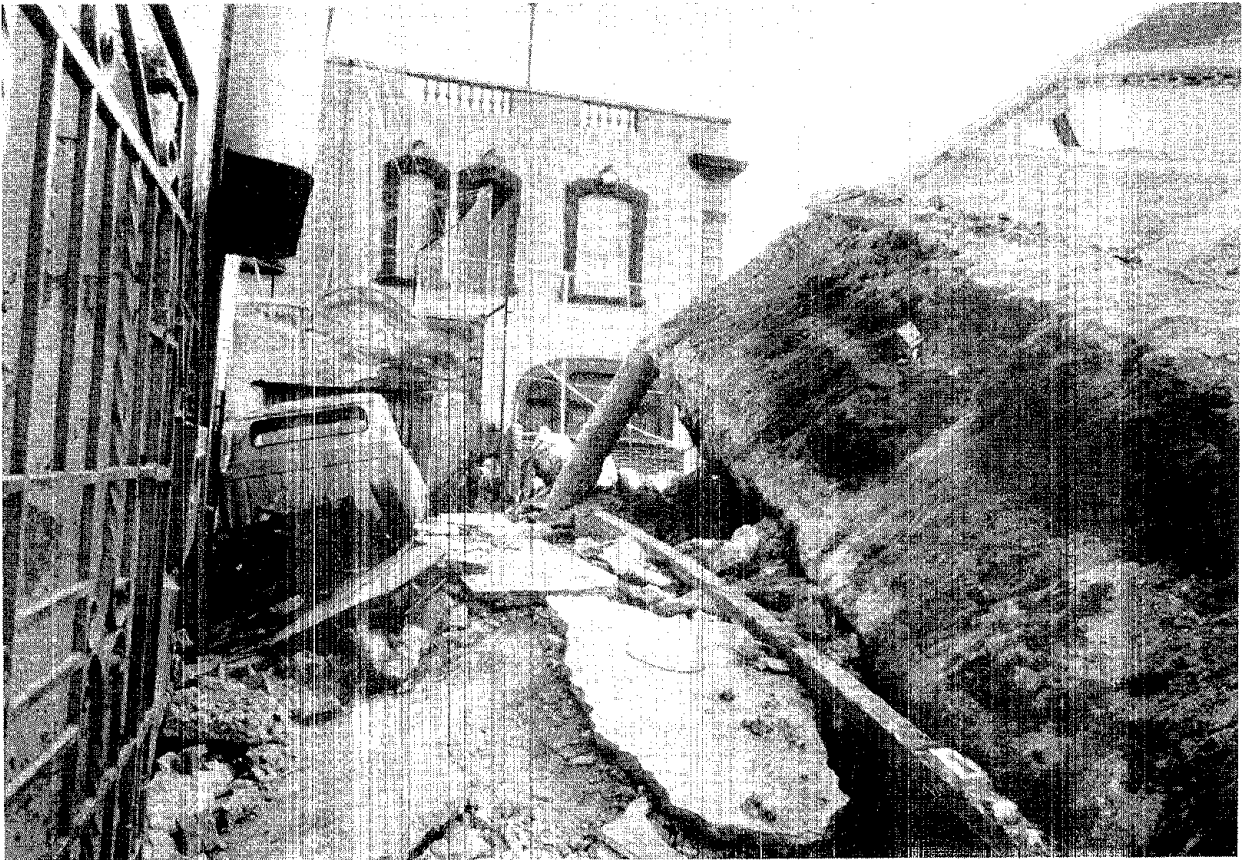
Figure 4.12. Exposed foundation of overturned building at Zacatecas and Orizaba.

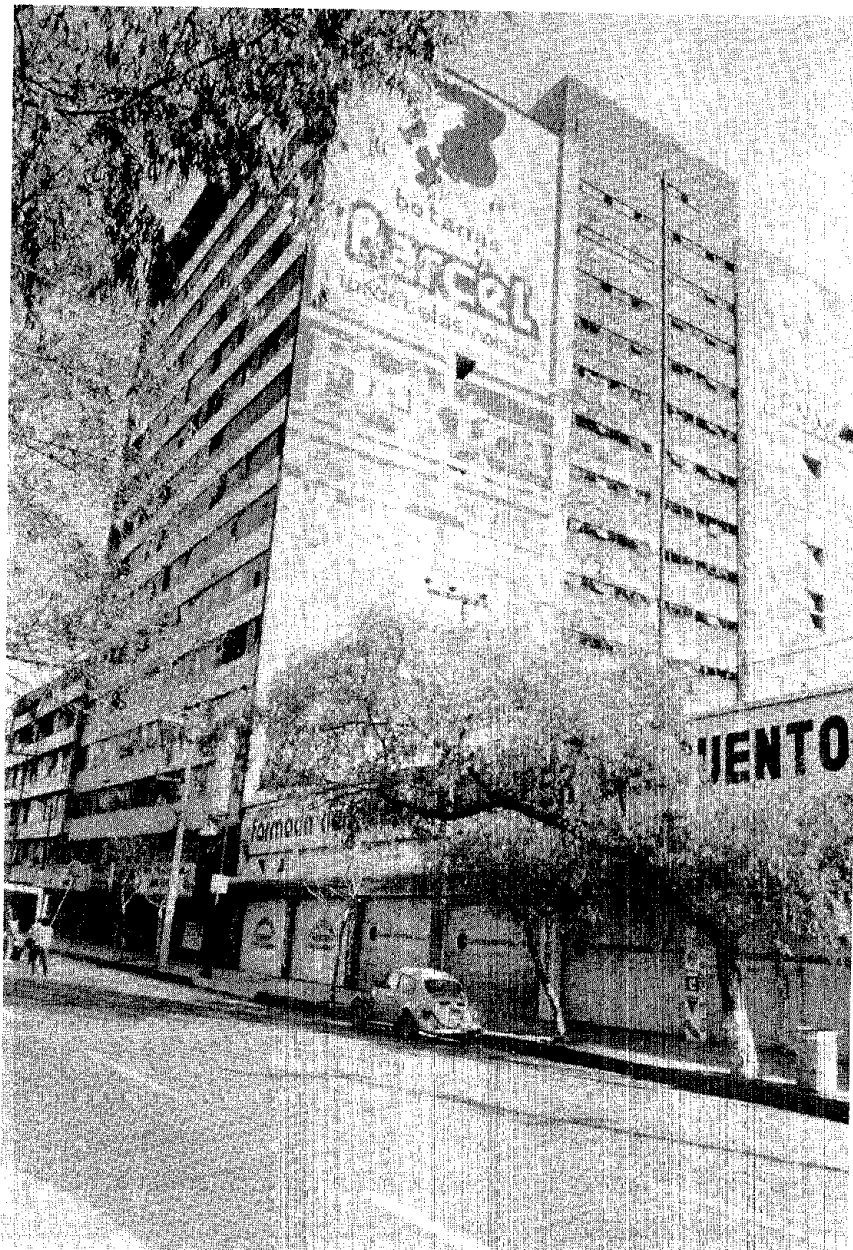
Figure 4.14. Building on the south side of Teresa de Mier which settled in one corner.

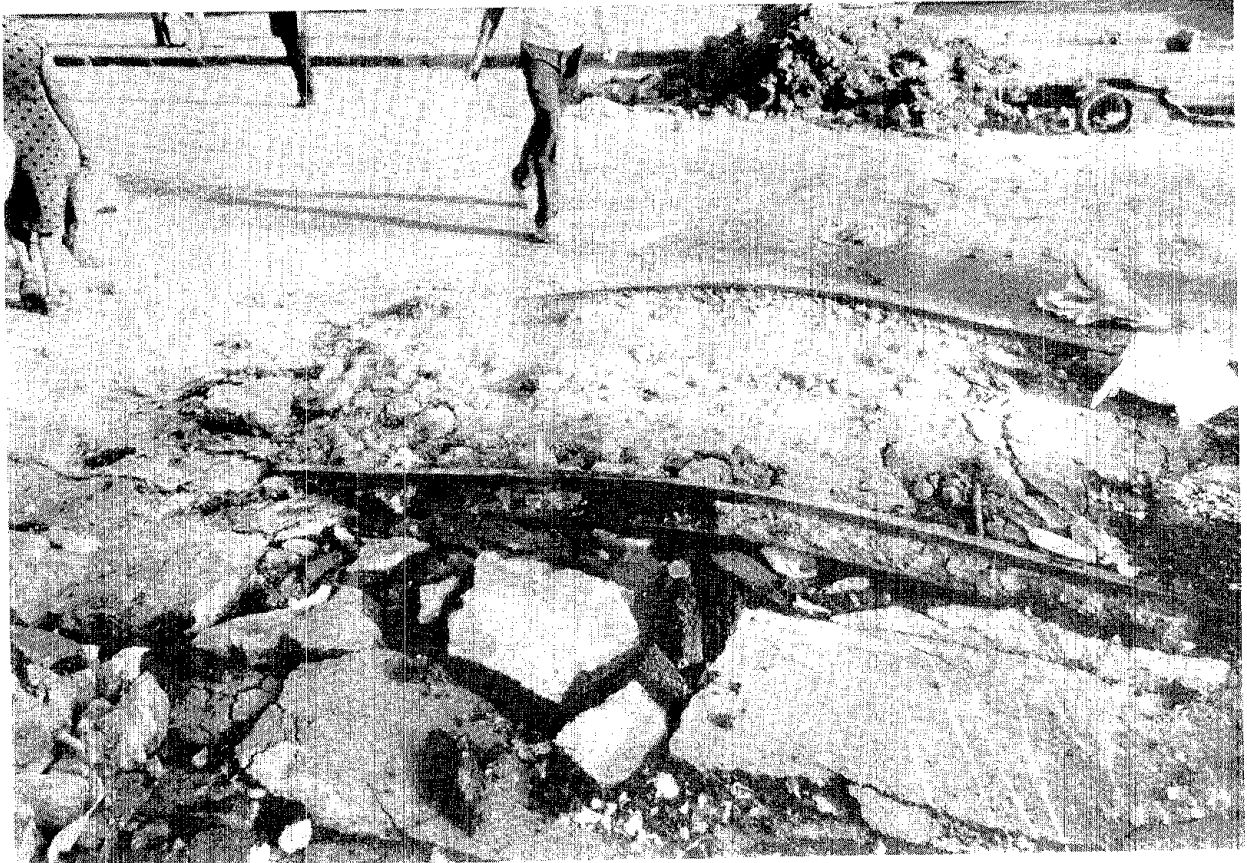
Figure 4.17. Buckled old trolley line on Obregon.

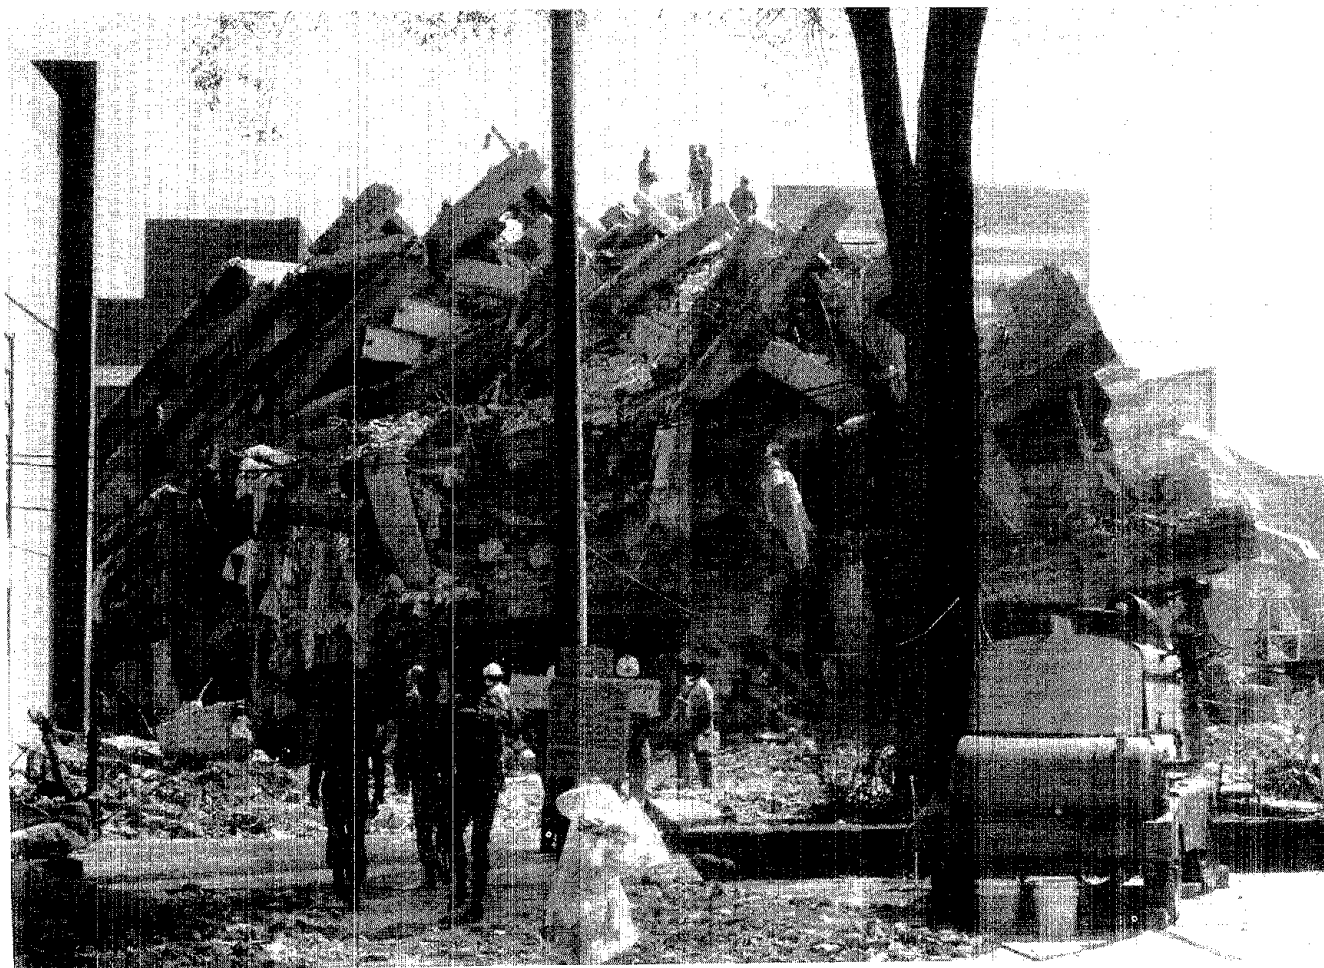
Figure 5.9. View of collapsed maternity wing of the Juarez Hospital looking south.

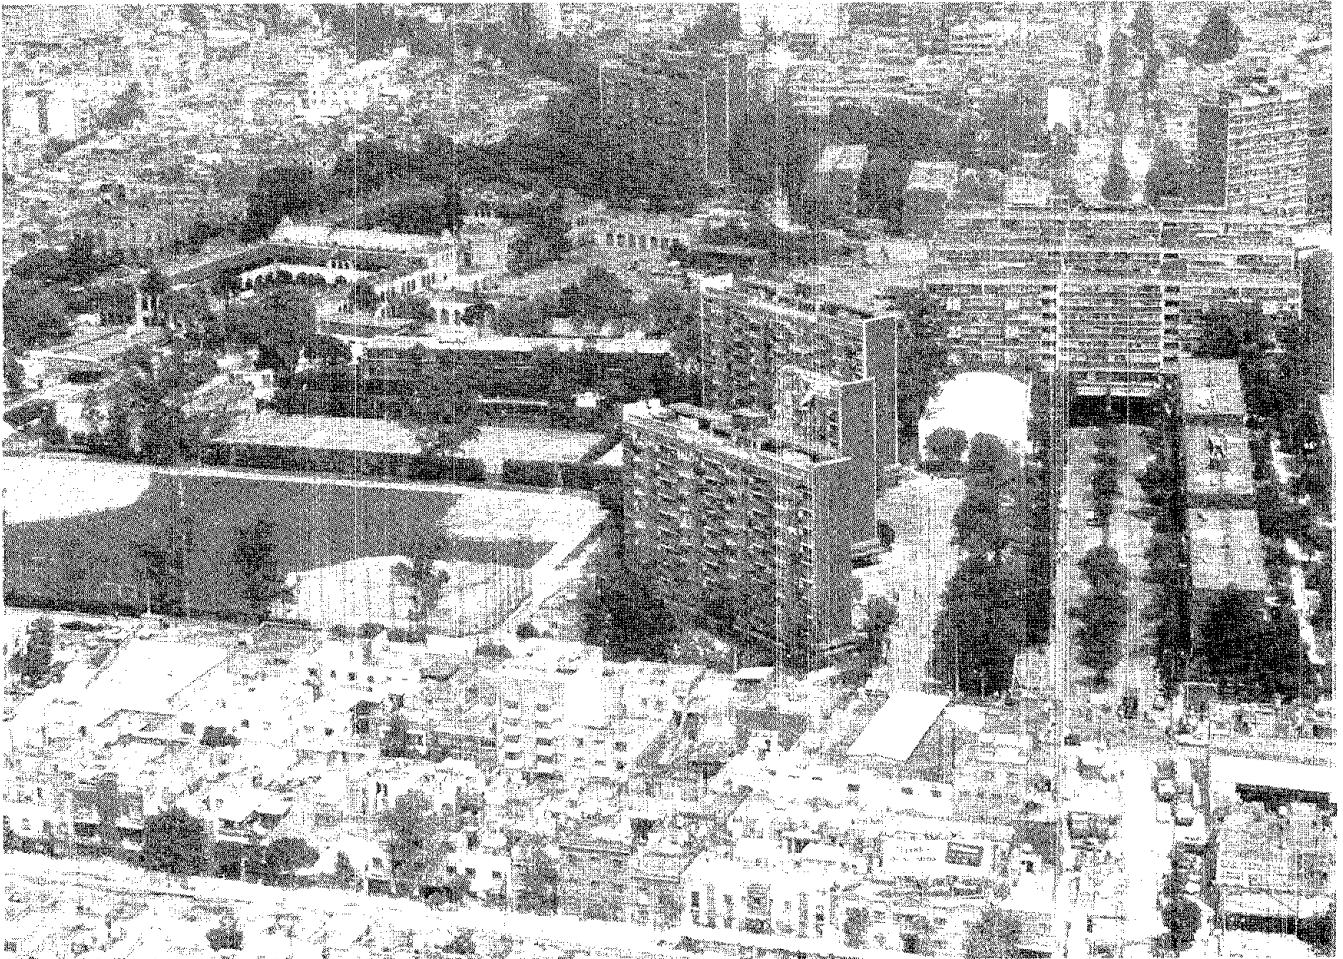
Figure 5.14. Damaged Urbana Juarez Apartment Complex west of General Hospital.

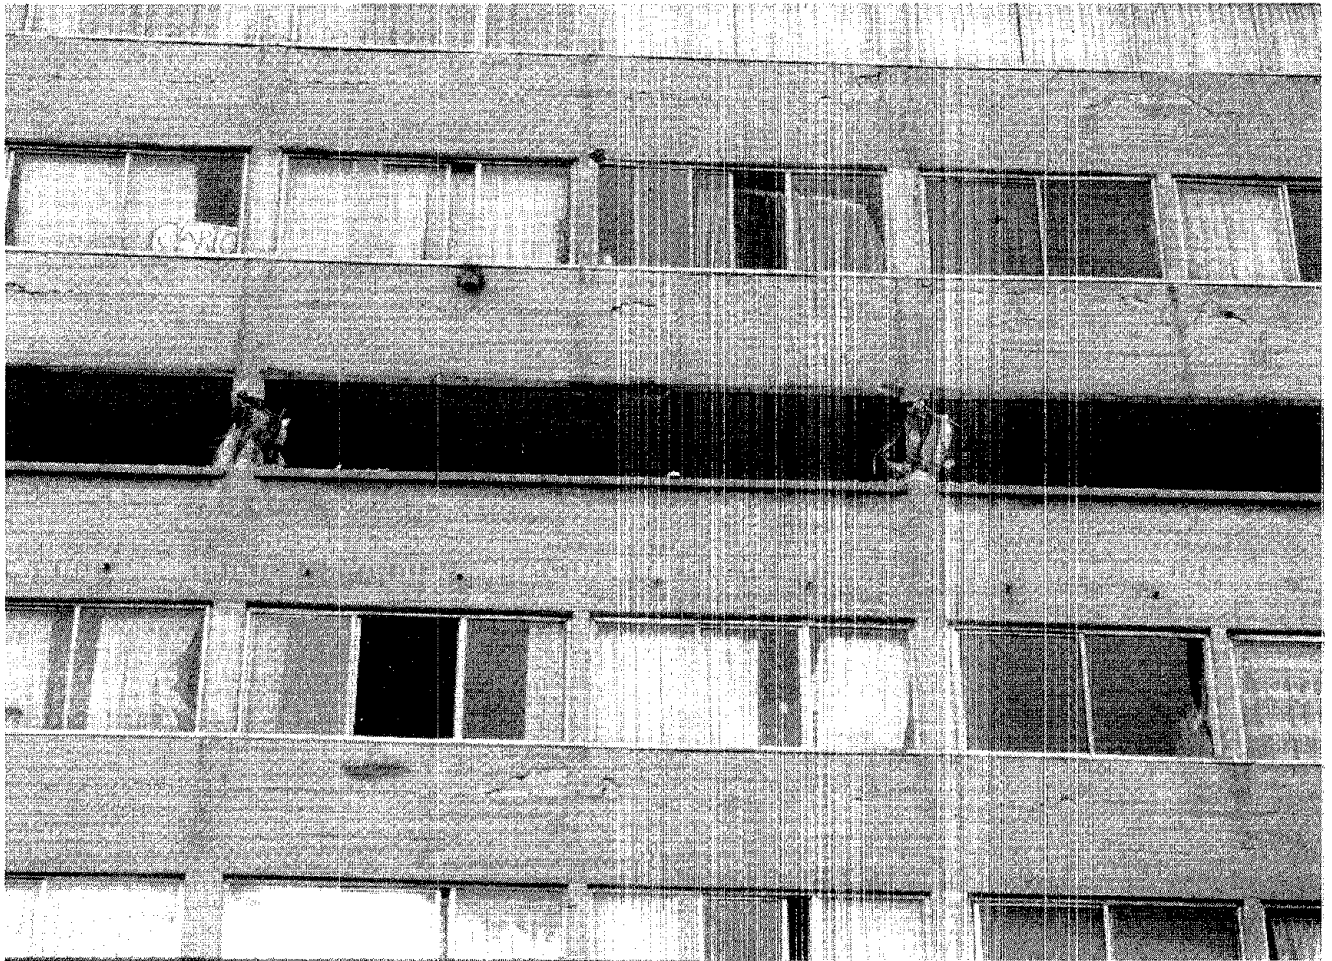
Figure 5.33. Failures in columns of the southern Nuevo Leon apartment tower (the only unit of the group of three to remain standing).

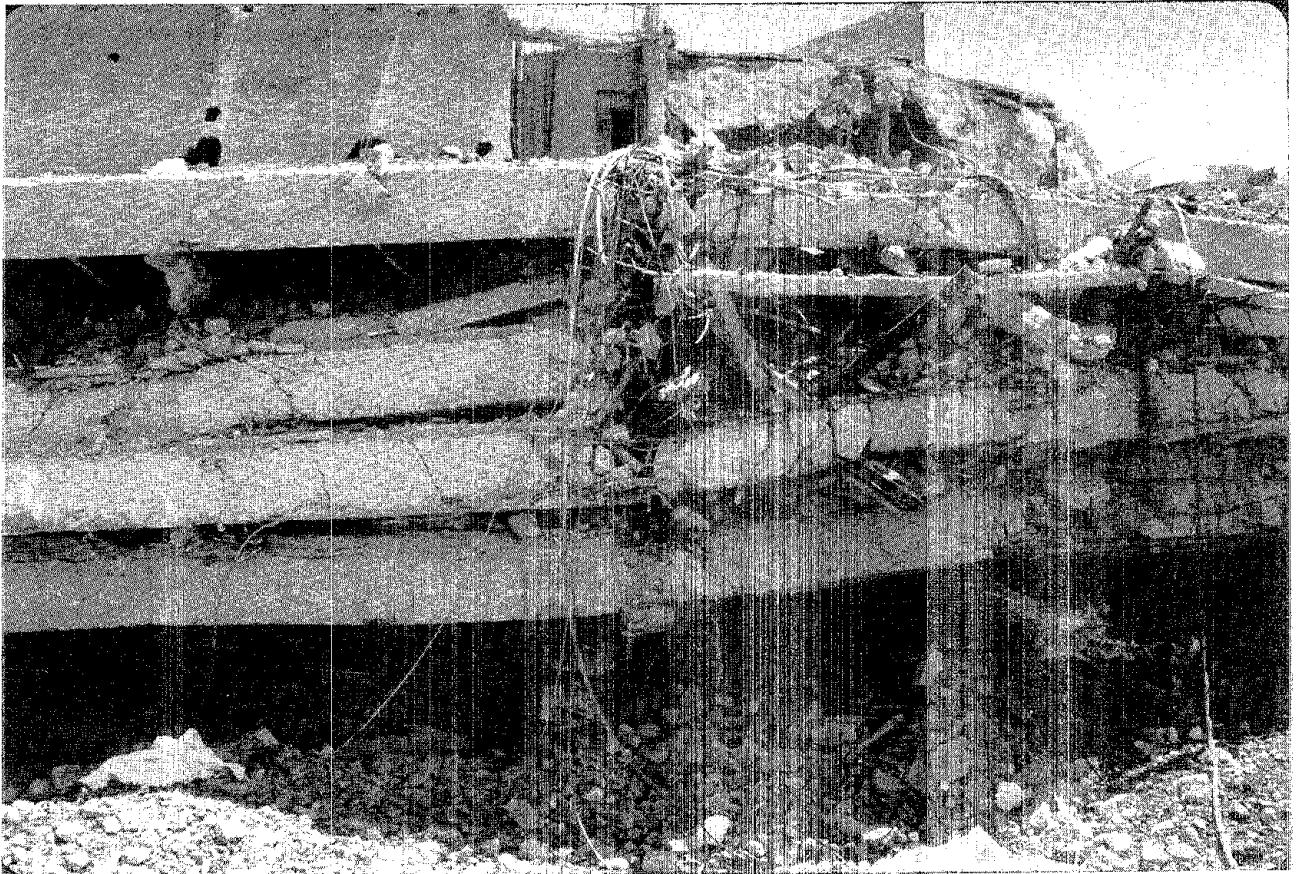
Figure 5.34. Collapsed office building near the corner of Neva and Barragan Streets.

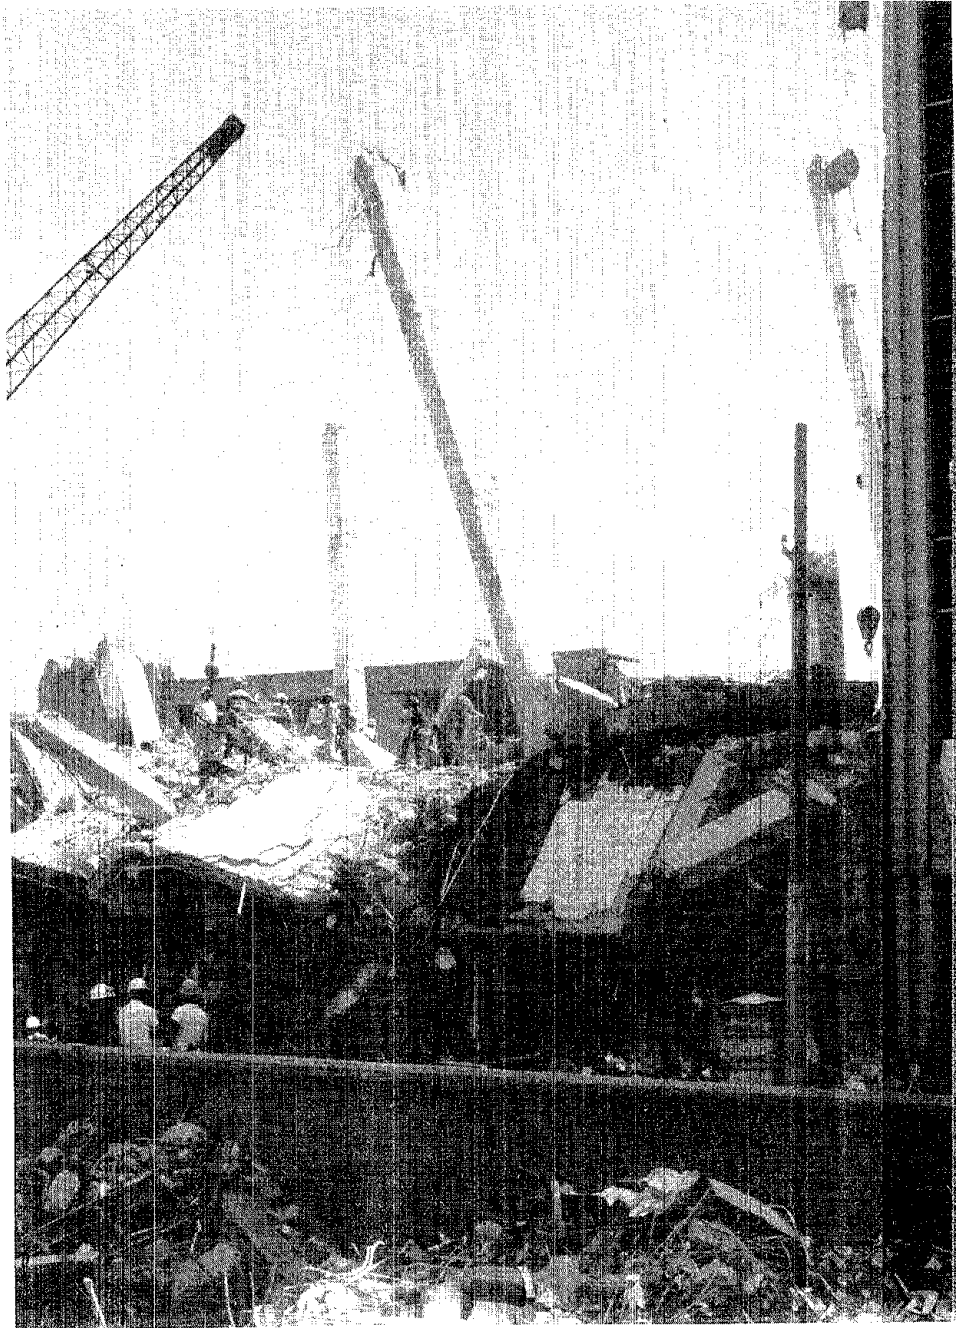
Figure 5.36. Punching shear failure of the 10 story Bancomer Building.

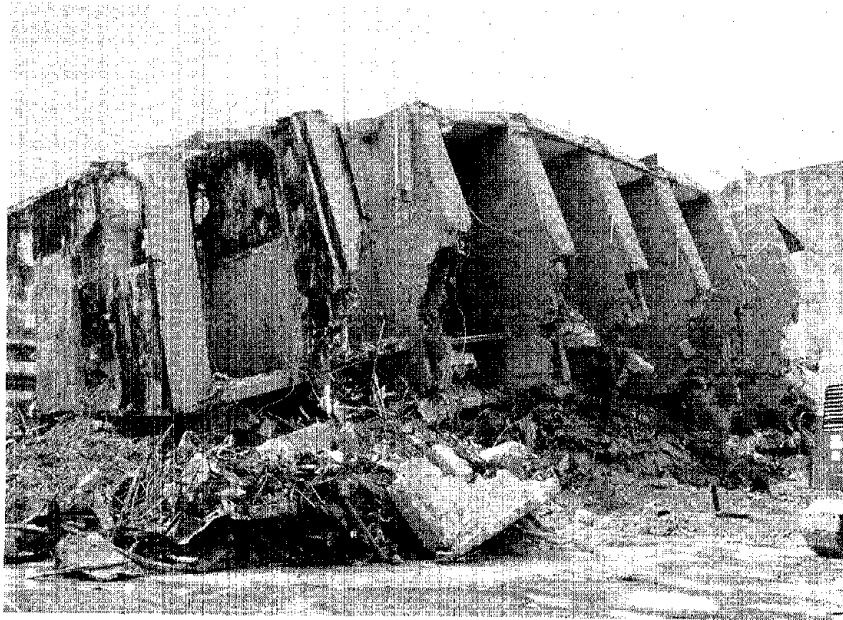
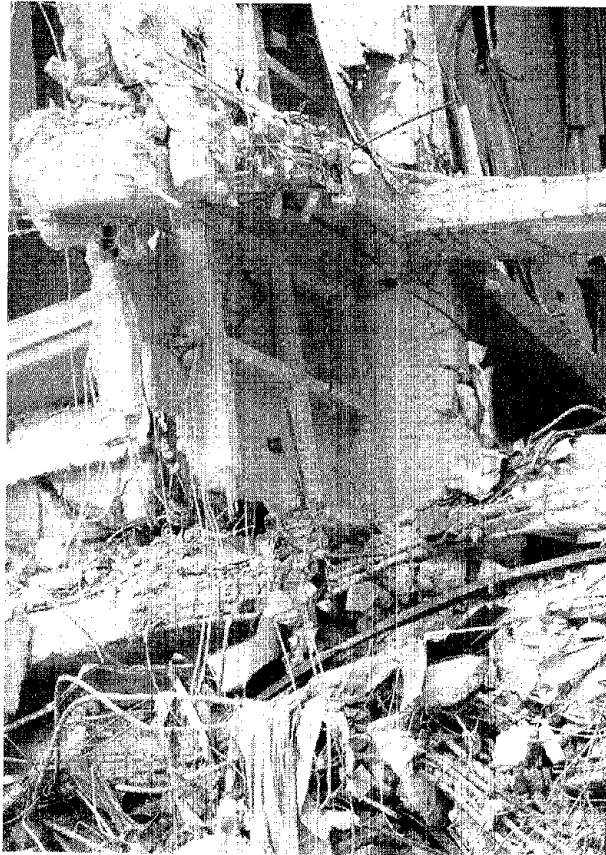
Figure 5.39. Collapsed 10 story apartment building in the corner of Dinamarca and Chapultepec. This waffle slab structure failure is attributed to base column failure and possible pounding with the neighboring structure.

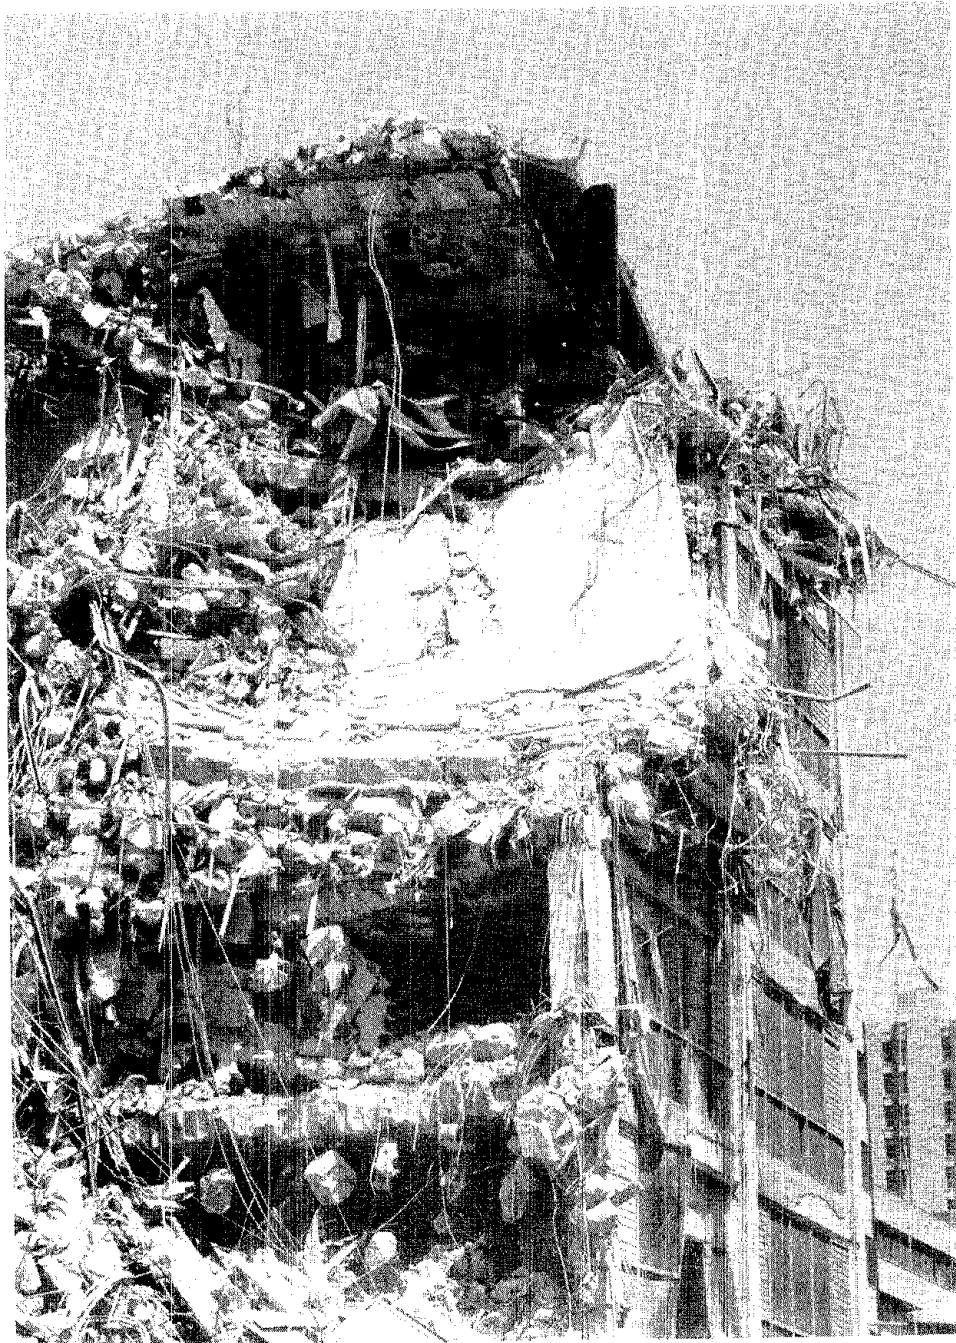
Figure 5.42. The "floor dropout" phenomenon observed in waffle slab structures with concrete block for pan forming.

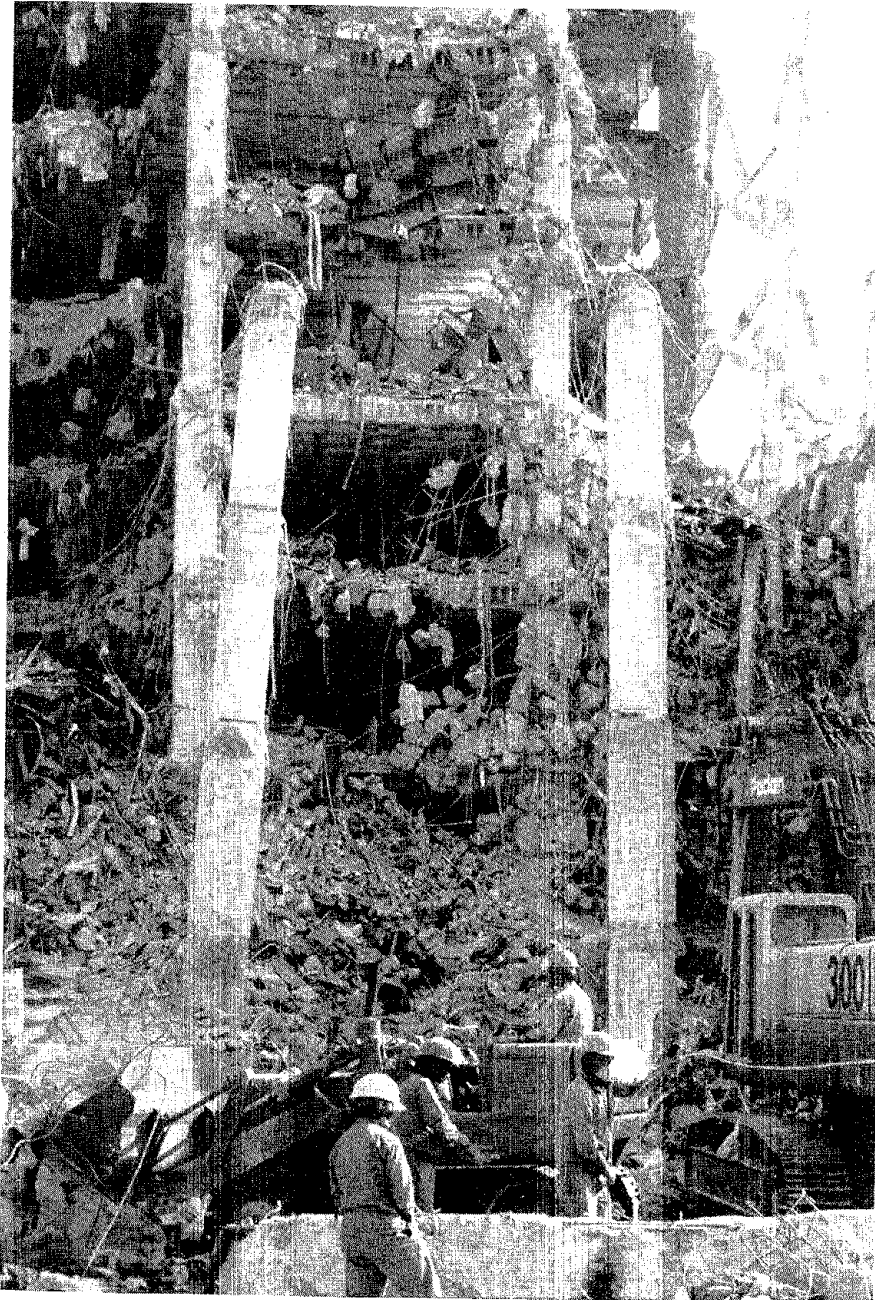
Figure 5.43. Punching shear failure in concrete-cinder block floor.

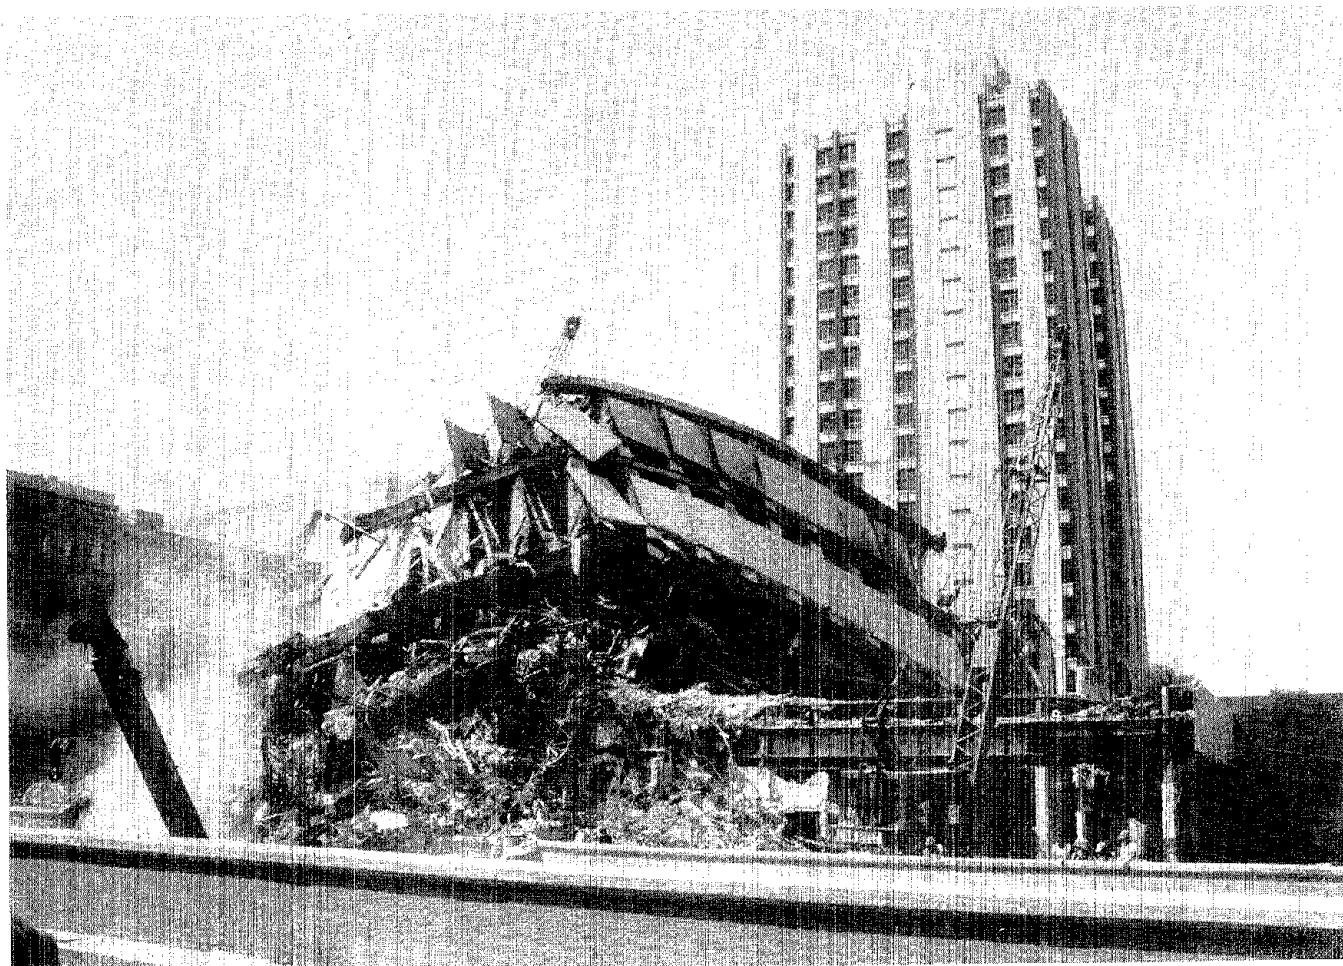
Figure 5.44. Southern towers of the Consumo Pino Suarez Complex shortly after collapse.

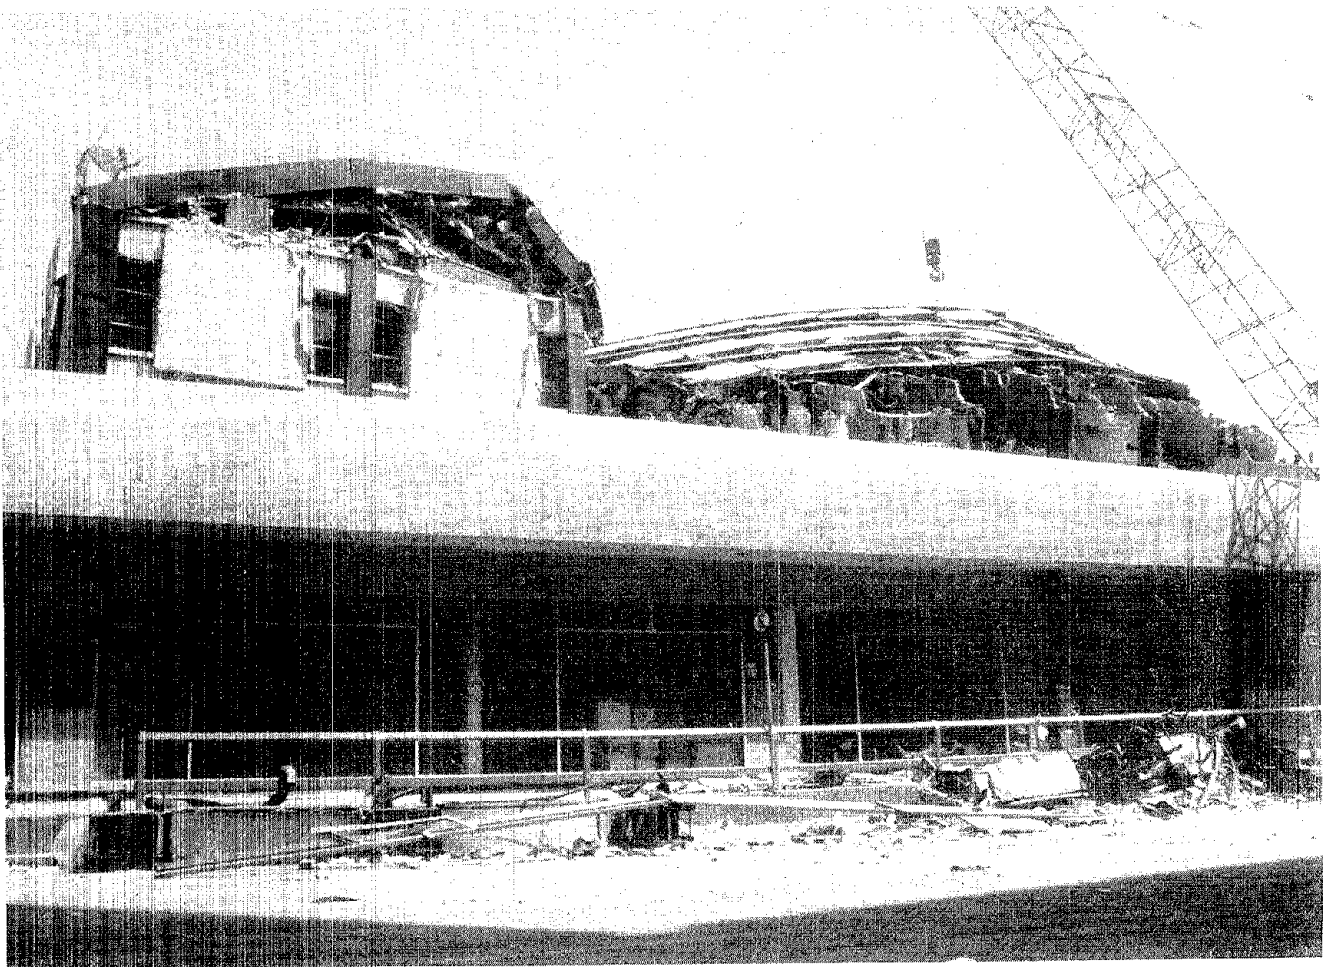
Figure 5.53. Closeup of fractured column line near second story, north side, of the southernmost 23-story structure in Pino Suarez Complex, shortly after collapse.

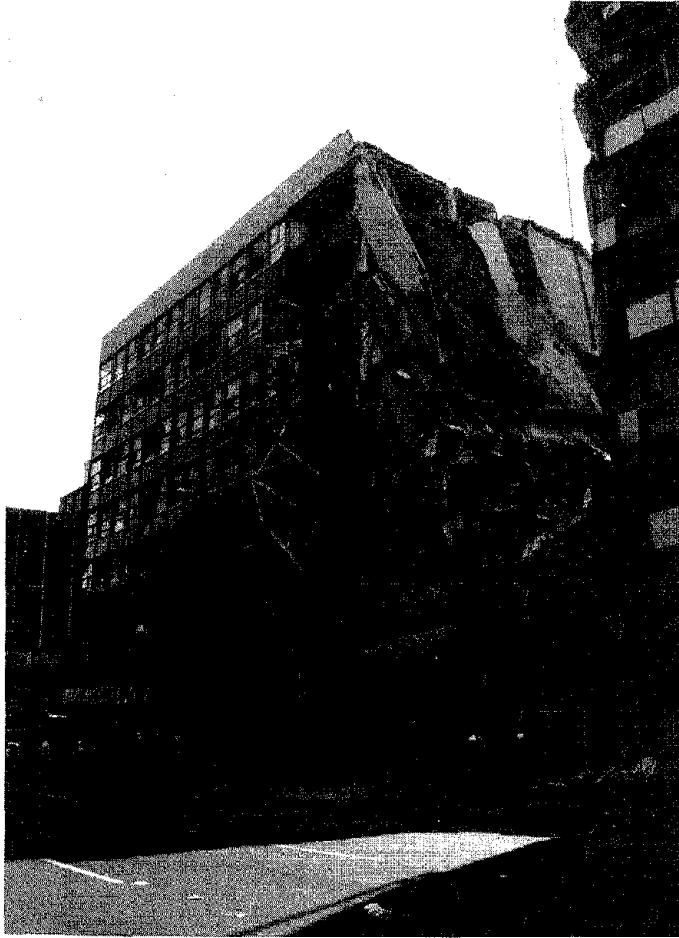
(a) Seven story office building on Ave. 20th de Novembre which collapsed due to pounding.

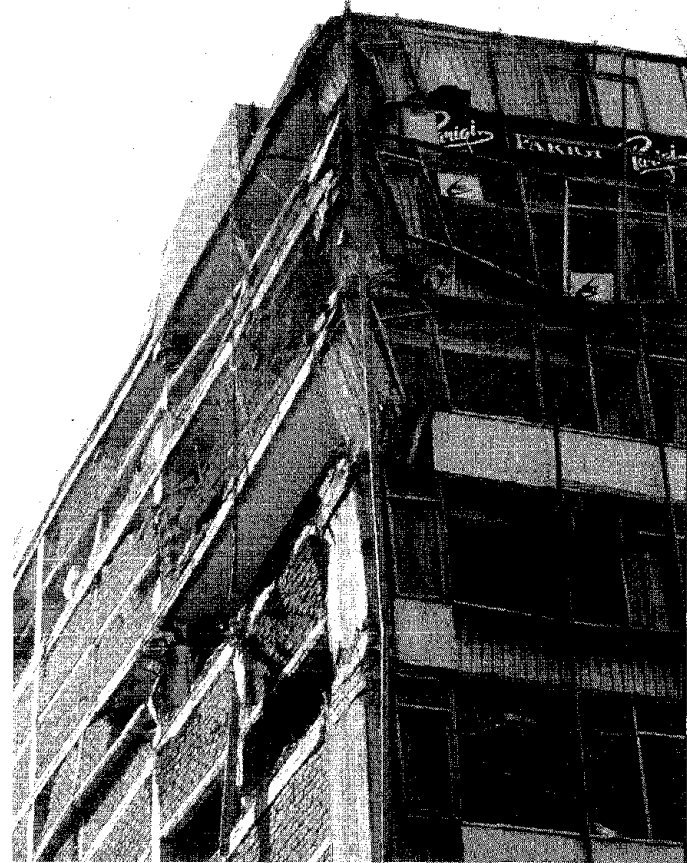
(b) Neighboring nine story building showing impact damage to columns.

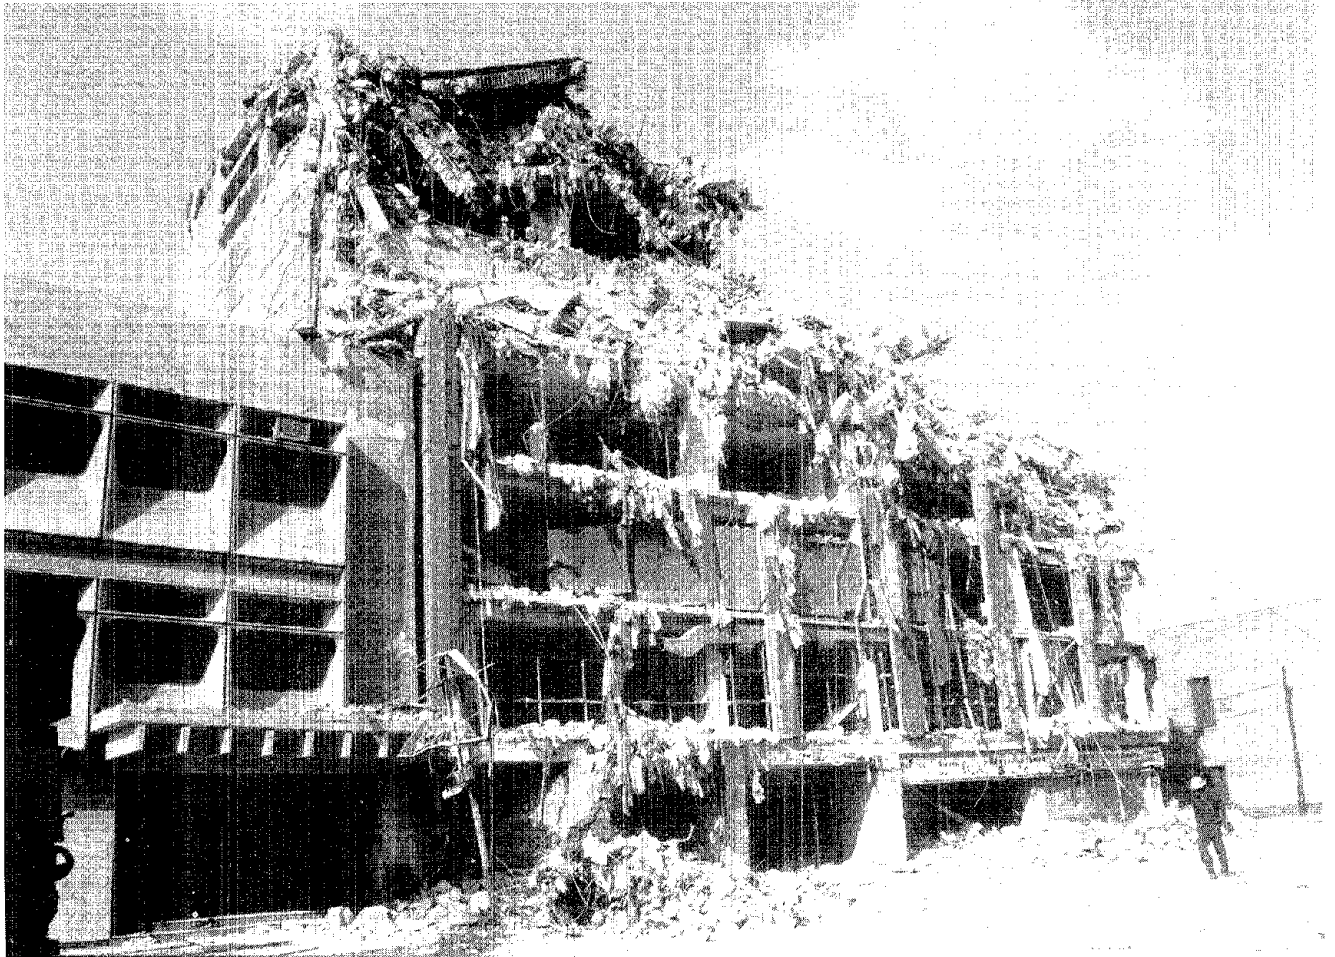
Figure 5.59. Pounding damage between buildings of dissimilar heights and stiffnesses. The upper floor of this 9-floor clothing store collapsed following pounding with its much stiffer neighboring 3-story structure. The separation between the structures was approximately 10 cm.
