NBS BUILDING SCIENCE SERIES 165

**Engineering Aspects
of the September 19, 1985
Mexico Earthquake**

Following the September 19, 1985 Mexico earthquake, a team consisting of four engineers and one seismologist from the National Bureau of Standards (NBS) and the United States Geological Survey (USGS) was dispatched to Mexico City to provide technical advice to the US rescue effort and to assess structural damage. This report is primarily based on data gathered by the team, but it also contains a compilation of other available information. The report addresses the origin and characteristics of the observed ground motion, the ability of buildings designed in accordance with present and proposed seismic design provisions to resist this type of ground motion, and observed data on structural and foundation failures.

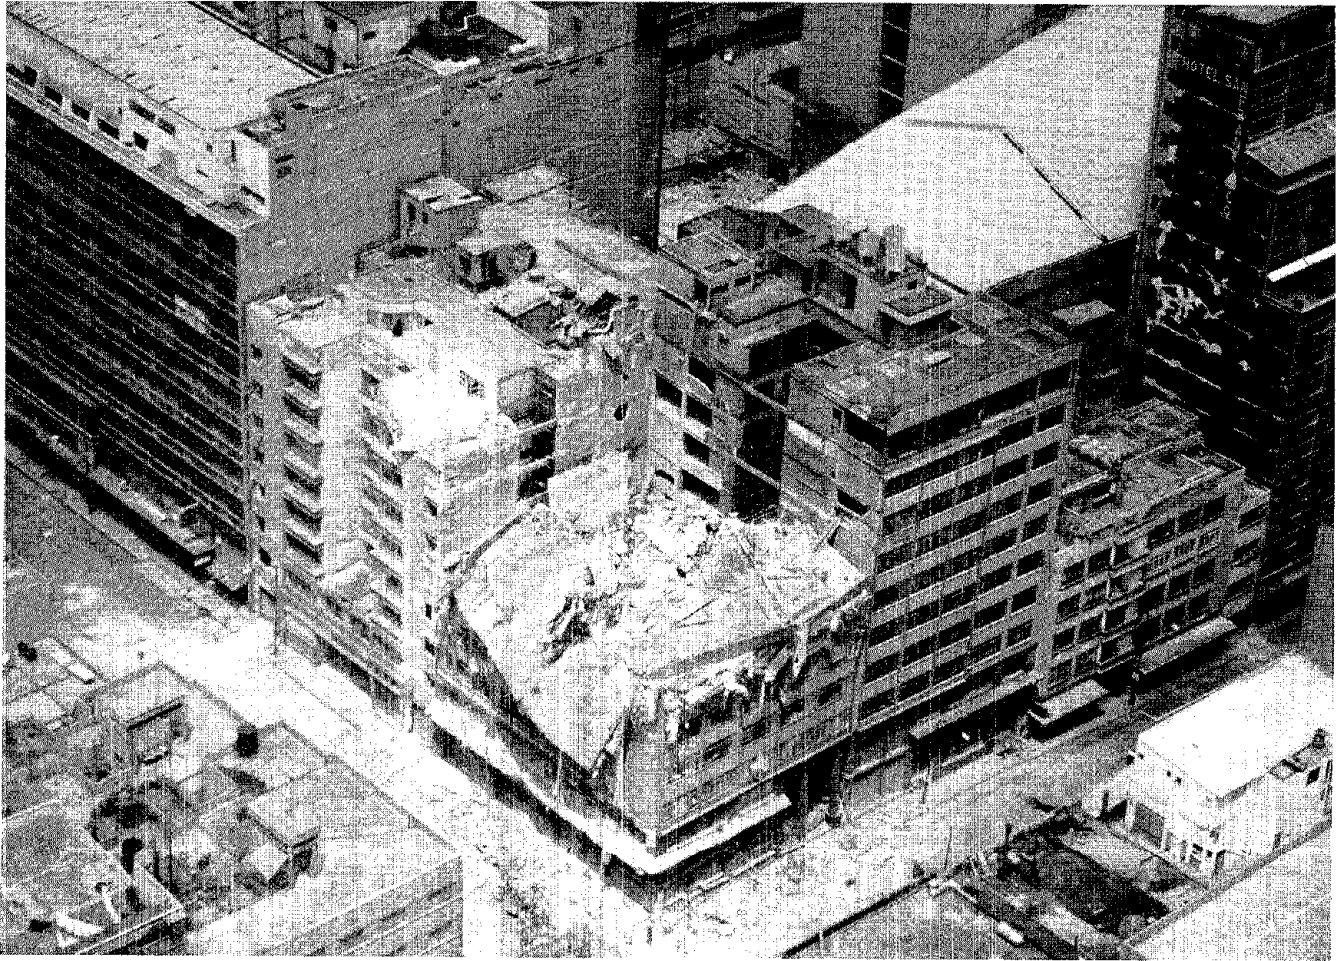
Figure 5.66. Torsionally induced pounding in corner building south of Alameda Park, near Torre Latino Americana.

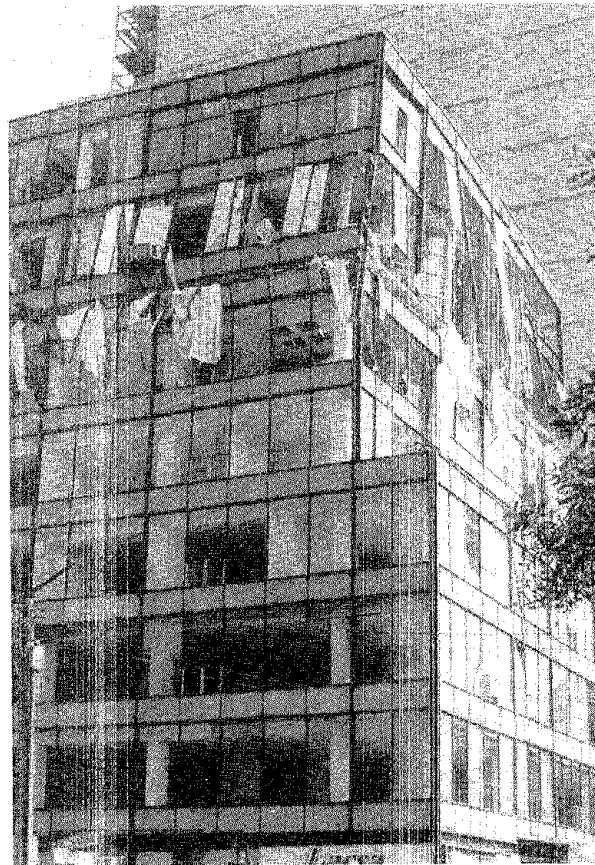
Figure 5.68. LASCA Building on Paseo de la Reforma and Marne, showing large change in column stiffness in upper two floor penthouse.

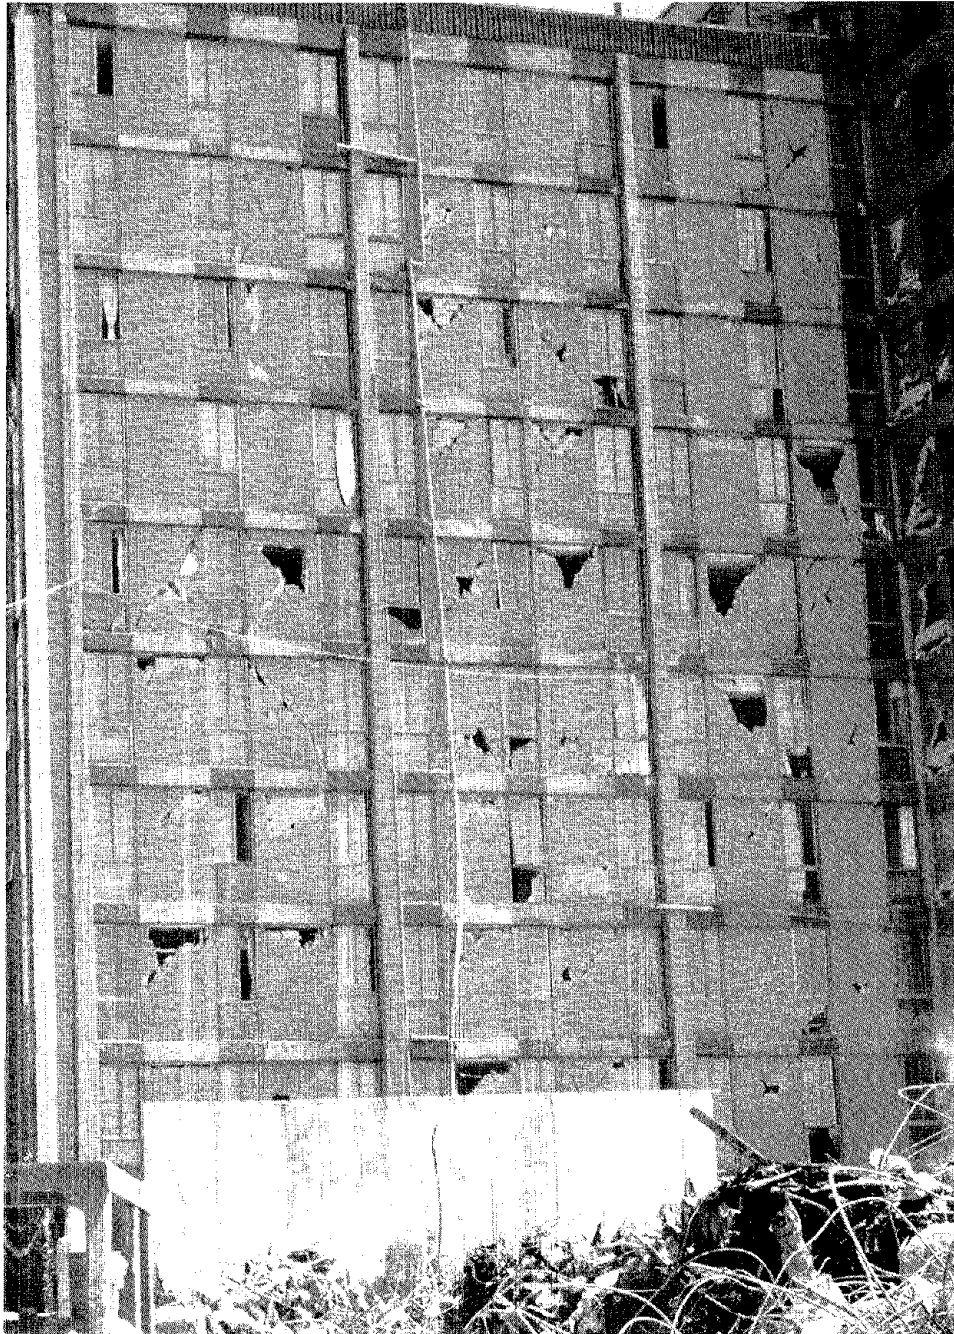
Figure 5.72. Significant diagonal shear cracking in a masonry infill structure on Ave. T. de Mier. Enough energy was dissipated in the walls to prevent collapse of the building.
