NBSIR 87-3667

# The Whittier Narrows Earthquake of October 1, 1987 A Reconnaissance Report

By H. S. Lew

November 1987

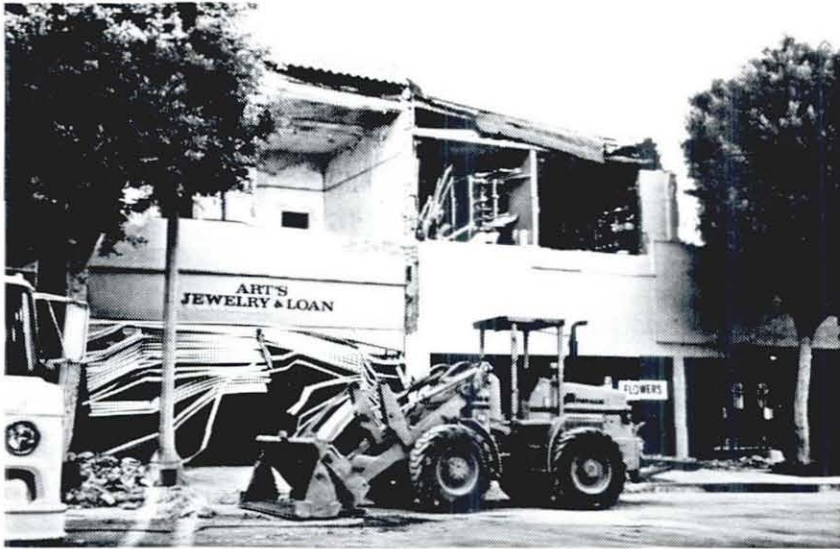
Photo 1 Total collapse of brick masonry wall of 2-story unreinforced masonry building in Uptown, Whittier.

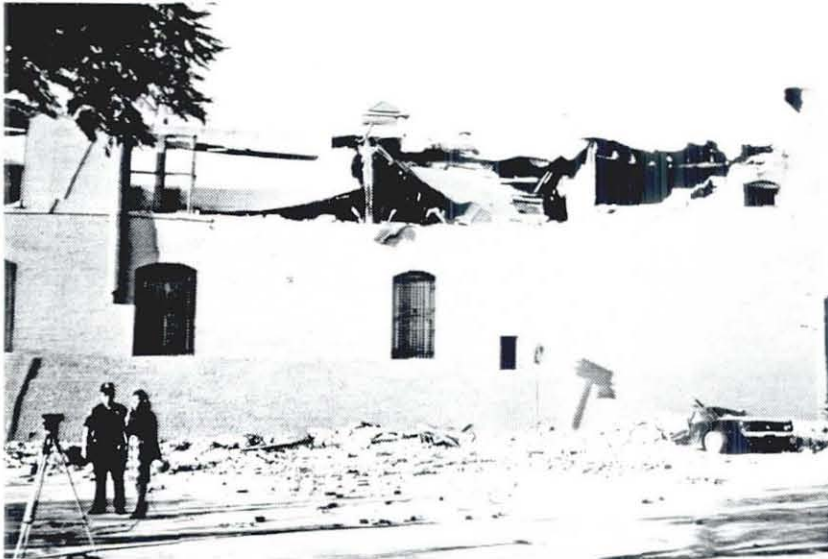
Photo 2 Collapsed unreinforced brick parapet and wall of a building in Uptown, Whittier. Falling bricks crushed cars parked adjacent to the building.

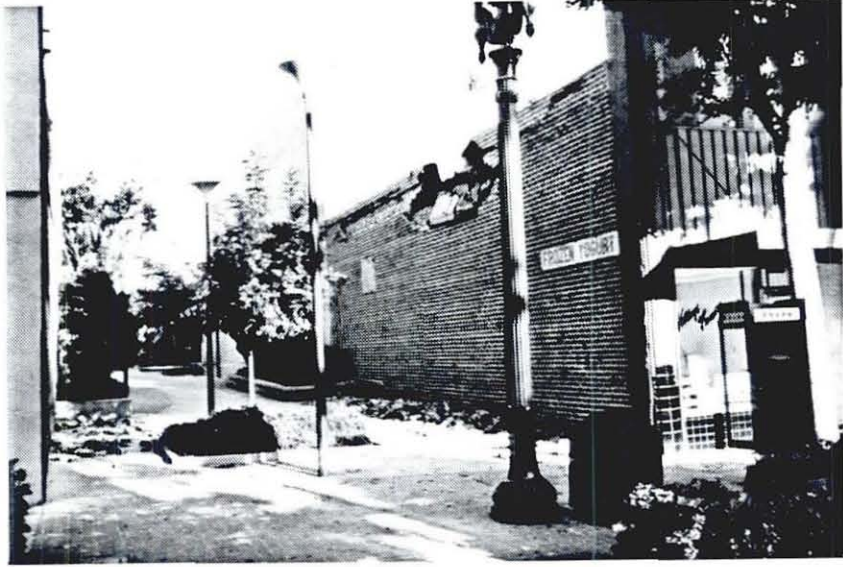
Photo 3 Typical collapse of unreinforced brick wall, Whittier.

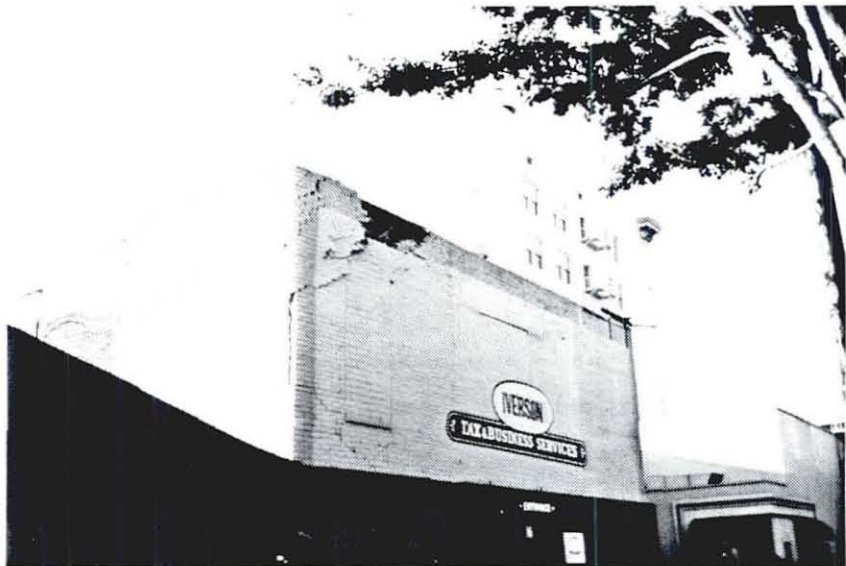
Photo 4 Partially collapsed and severely cracked unreinforced brick wall, Whittier.

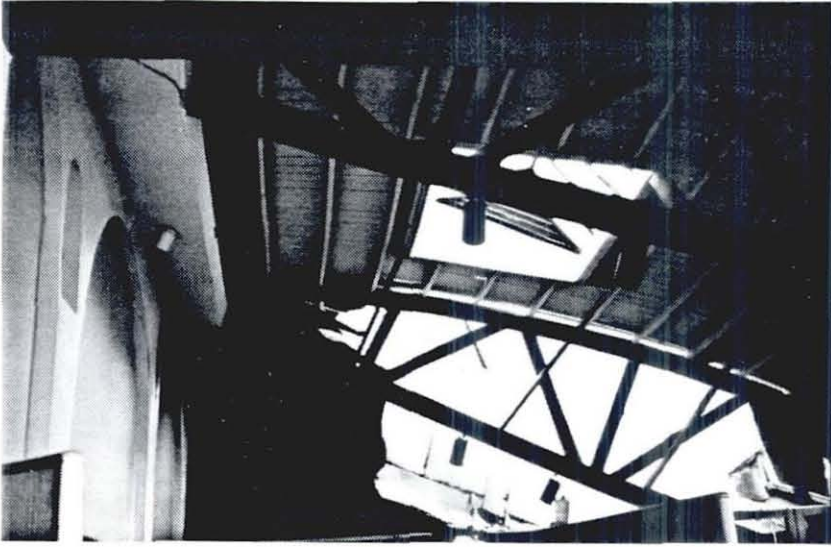
Photo 5 Wood trusses fell from a damaged masonry wall resulting in a partial collapse of the roof of a store, Whittier.

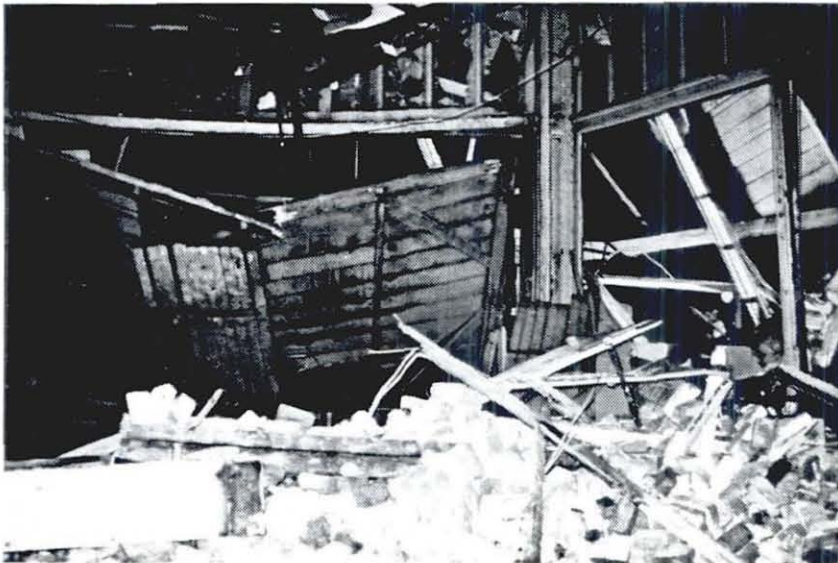
Photo 6 Masonry parapet of a three-story unreinforced masonry building fell, causing the collapse of an adjacent building, Pasadena.

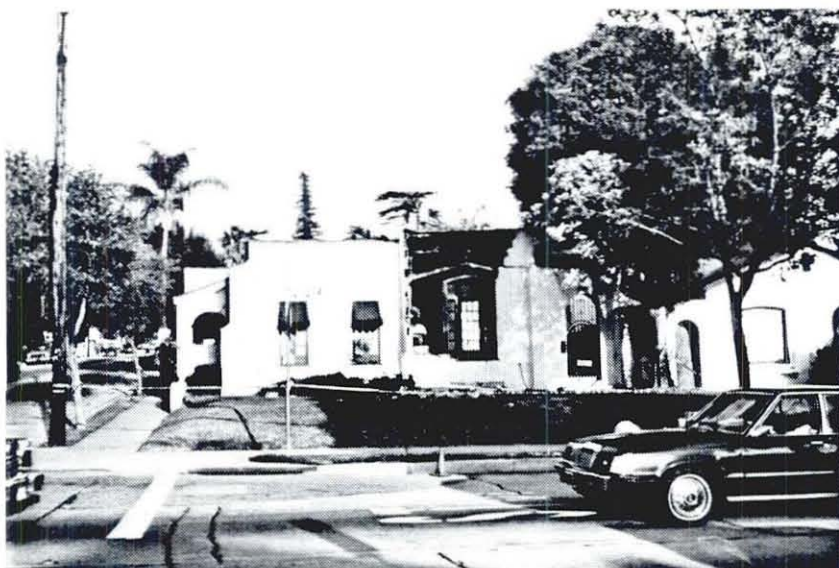
Photo 7 Many houses with unreinforced hollow clay tile walls sustained severe damage. This house at the corner of Greenleaf Avenue and Beverly Blvd. in Whittier lost the front wall.

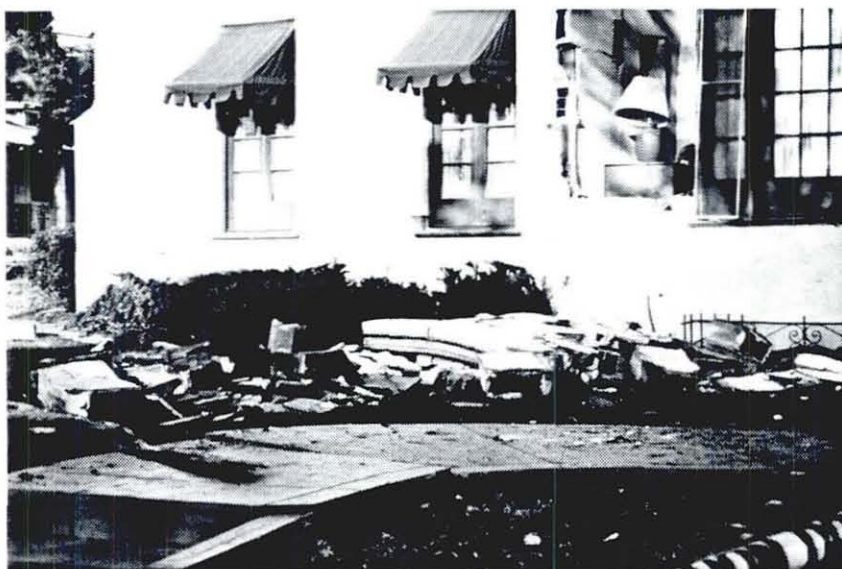
Photo 8 Large pieces of clay tile fell on the front yard of the house shown in Photo 7.

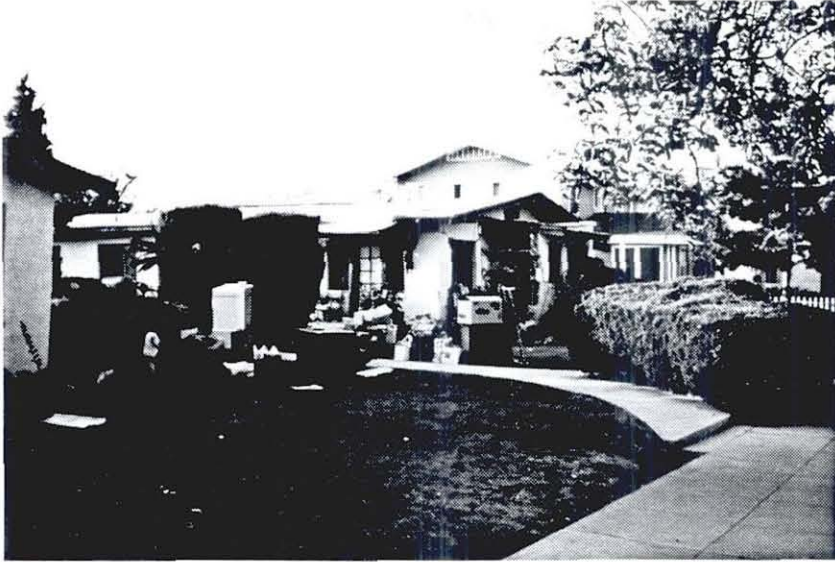
Photo 9 This house on Greenleaf Avenue lost part of the entrance and sustained severe cracks in the walls of unreinforced hollow clay tile.

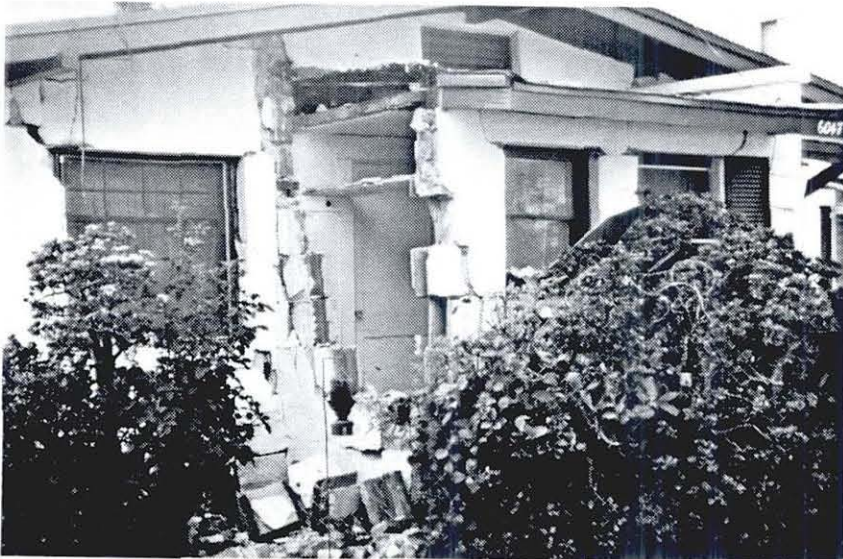
Photo 10 Close-up view of the partially-collapsed front entrance to the house in Photo 9. Exterior walls were unreinforced clay tile and stucco.

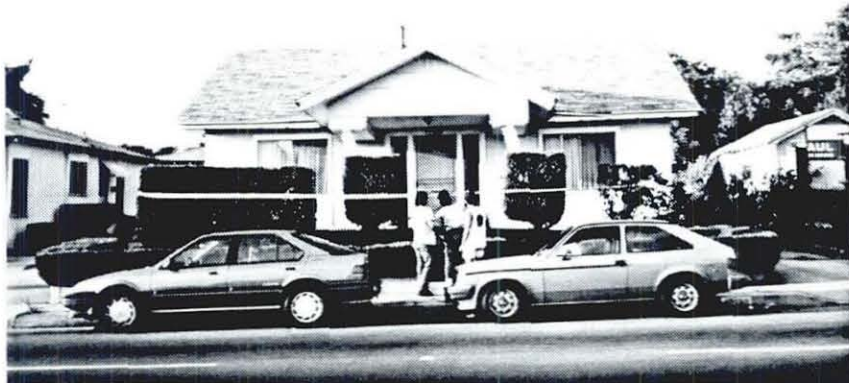
Photo 11 A wood-frame house on Beverly Blvd., Whittier, was damaged severely when it slid off its foundation wall.

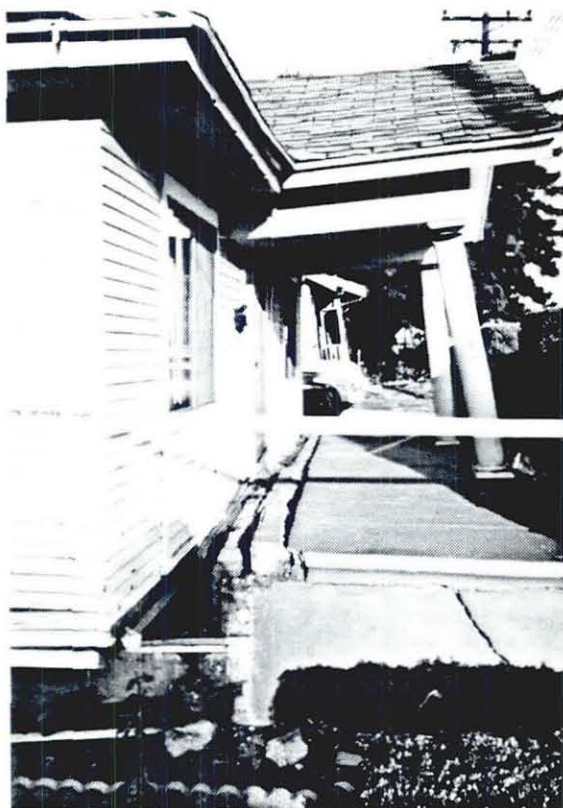
Photo 12

The house in Photo 11 dropped vertically about one ft. and moved laterally about one and a half ft.

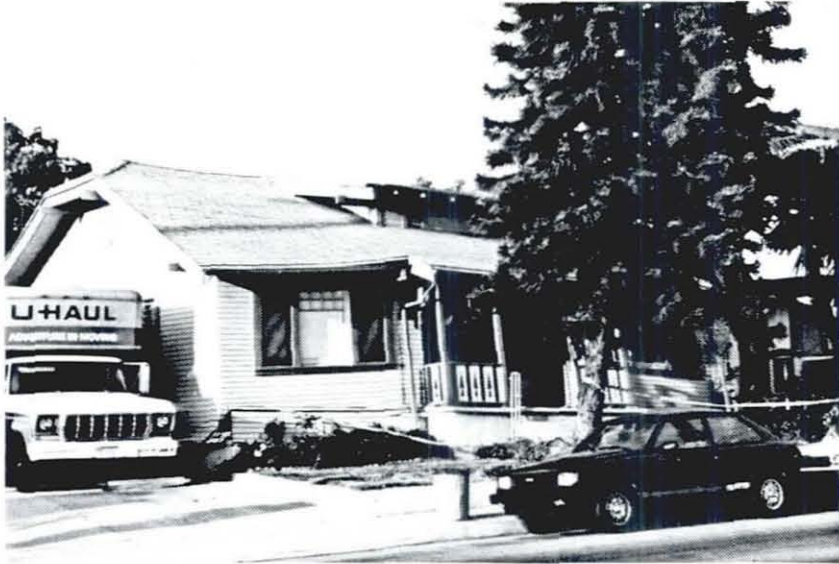
Photo 13 A wood-frame house adjacent to the house in Photo 11 on Beverly Blvd., Whittier, also sustained severe damage when the earthquake dislodged the house from its foundation wall.

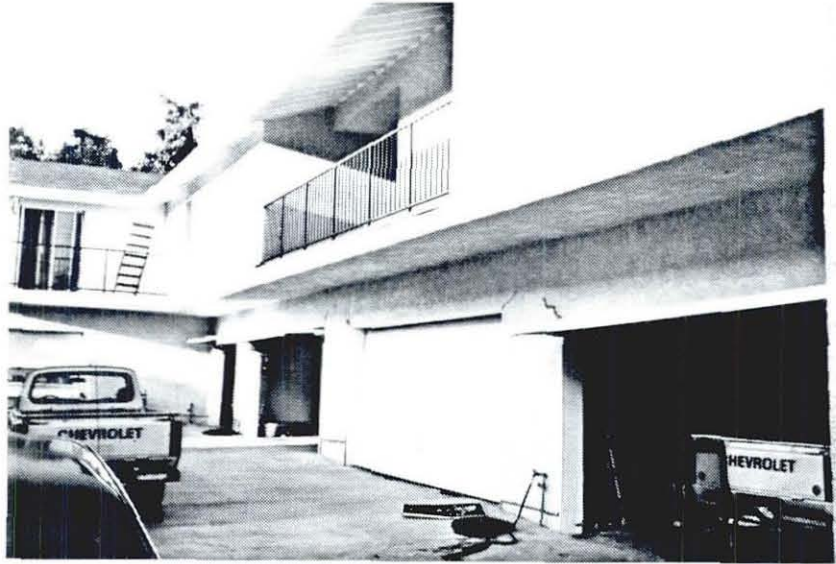
Photo 15 Damaged two-story wood frame apartment building in Whittier. Large garage door openings reduced the stiffness of the wall in the plane of the garage doors and reduced the resistance to lateral loads.

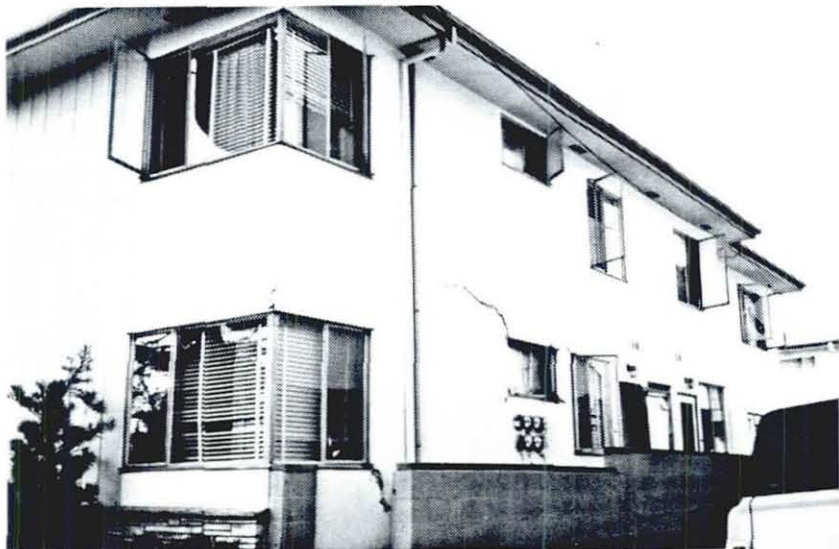
Photo 16 Large cracks developed at the corners of window openings. Note broken window panes at the corner of the building, Whittier.

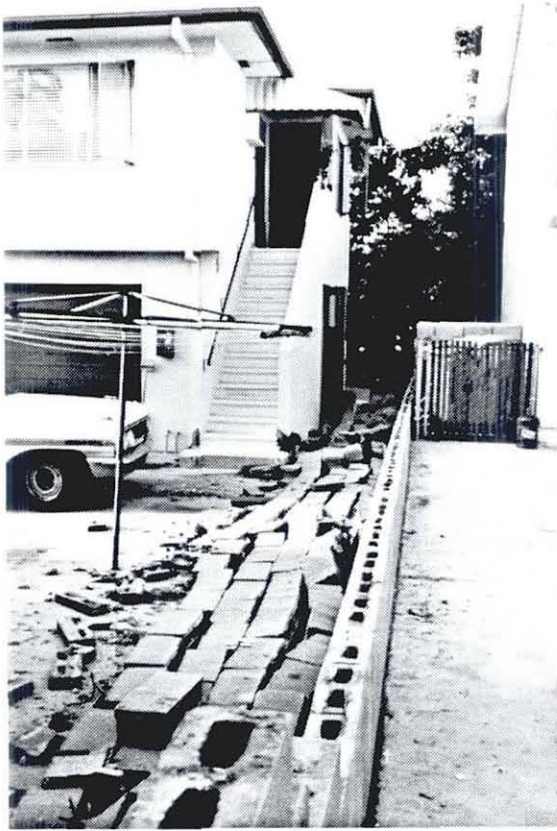
Photo 17

Collapsed unreinforced concrete block wall in the residential section of Whittier.

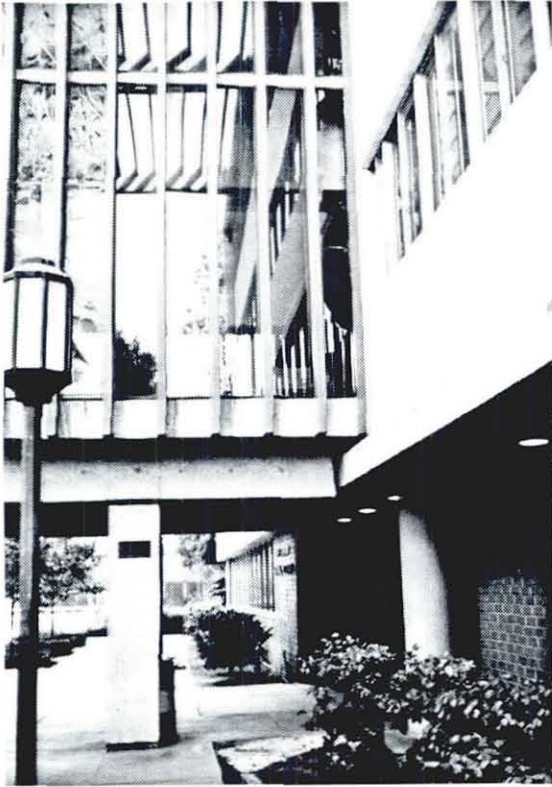
Photo 19

Glass panels at both ends of the walkway structure were broken due to an inadequate gap in the connection joint.

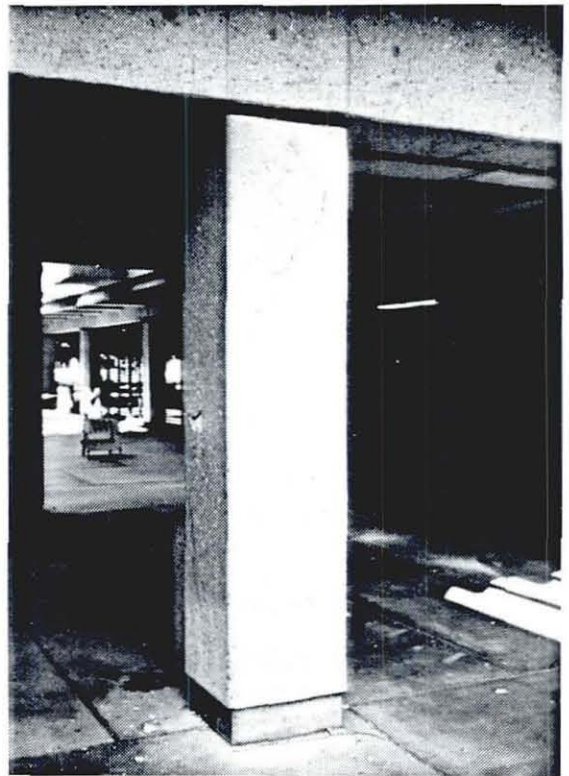
Photo 20

Cracks developed in some of the first-story columns of the walkway structure.

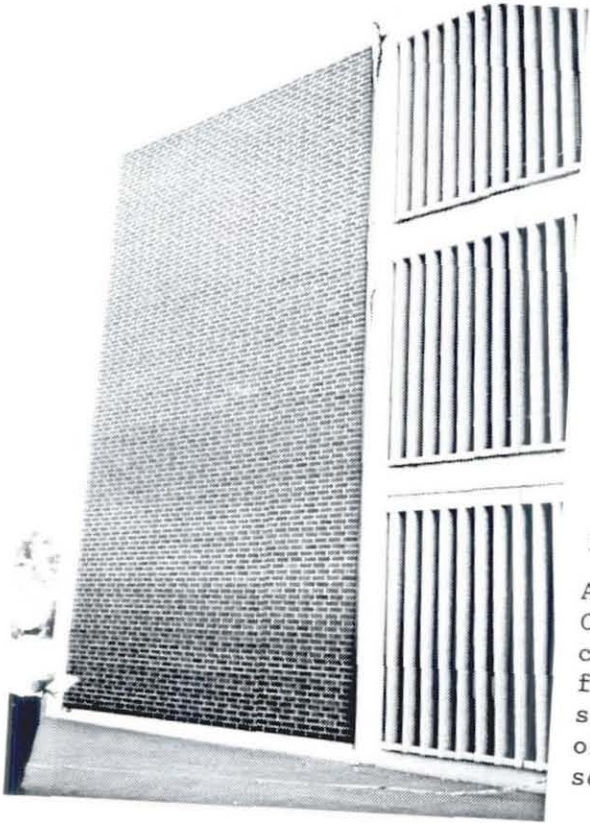
Photo 21

A class room building on the California State University campus. The exterior concrete frame for the precast concrete sun screen was damaged due to pounding of two structurally separated sections of the building.

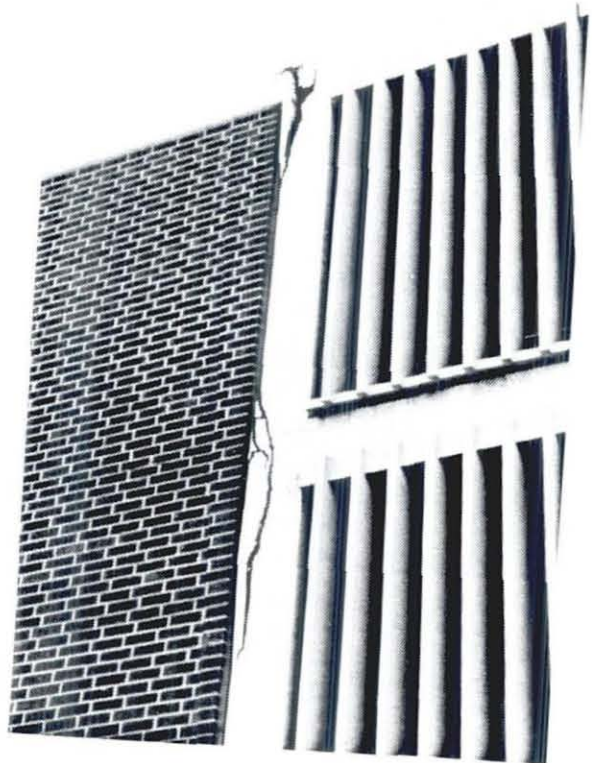
Photo 22

Close-up view of the damaged concrete frame.

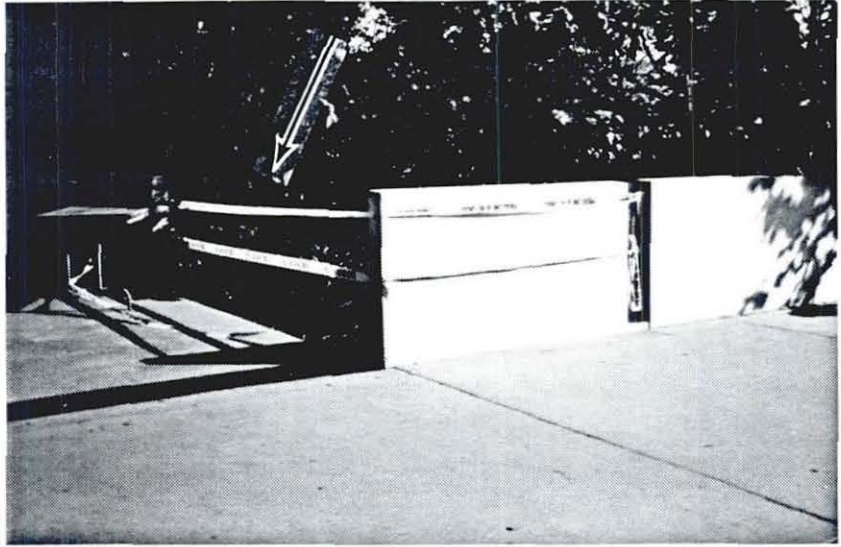
Photo 23 A precast concrete fascia unit fell when anchors held it to the concrete frame failed.

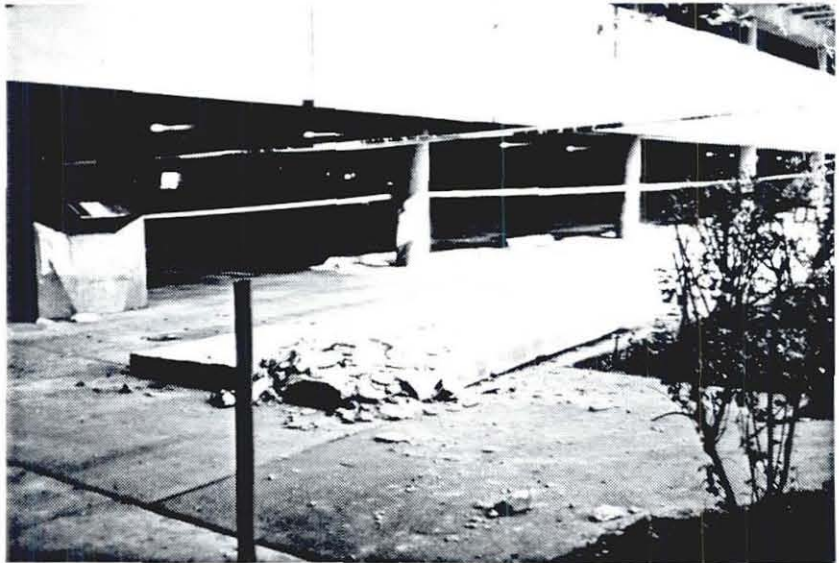
Photo 24 A precast concrete fascia unit fell two stories and fatally injured a passer by. This was the only fatality of the earthquake due to a structural failure.

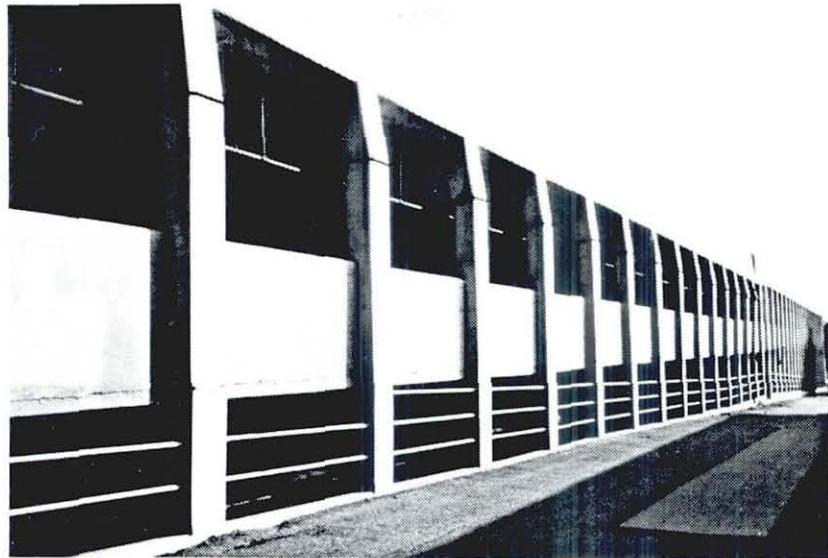
Photo 25 A damaged reinforced concrete parking garage at the Whittier Quad shopping center. Deep beams at the columns slant toward the inside of the structure due to the loss of support at the other side.

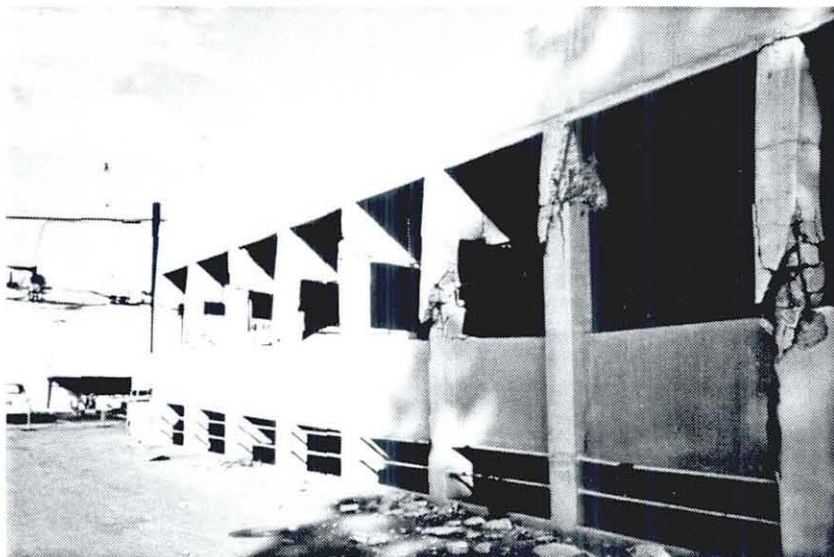
Photo 26 Extensive damage to relatively short columns and the ends of deep beams.

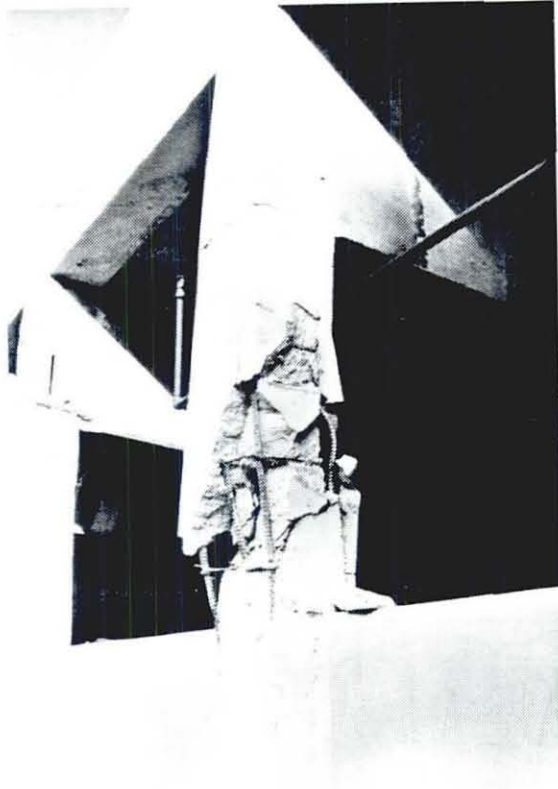
Photo 27

Typical shear failure of columns. Note #2 bars with large vertical spacing were used for ties.

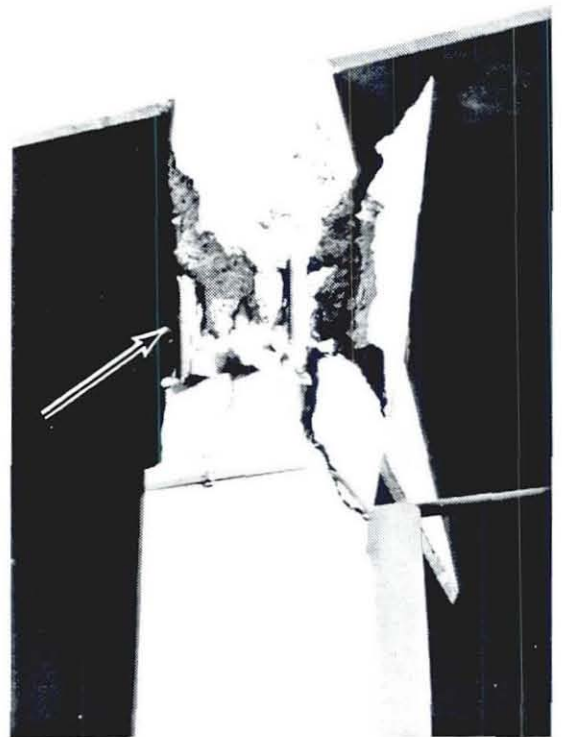
Photo 28

Damage to a beam-column connection. Note that cardboard used to protect vertical column reinforcement during the construction stage was not removed when concrete was placed. This resulted in no bond between reinforcing bars and concrete.

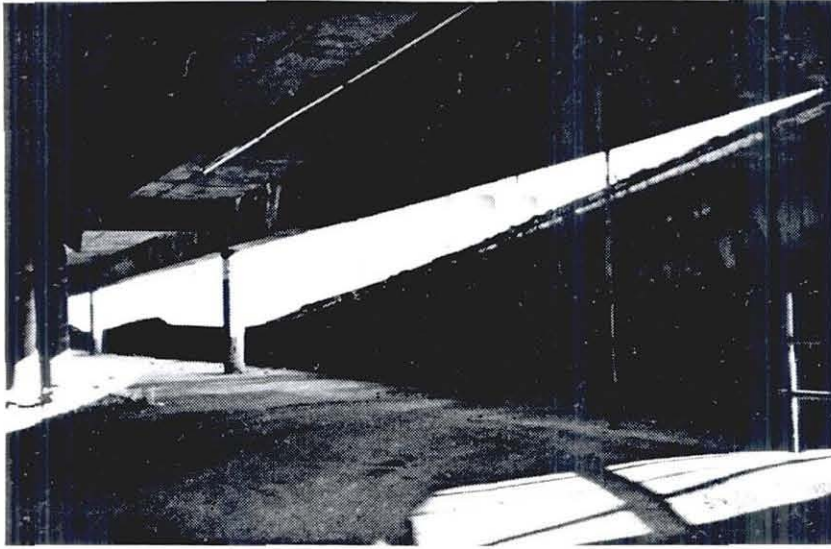
Photo 29 A collapsed upper level portion of the parking garage.

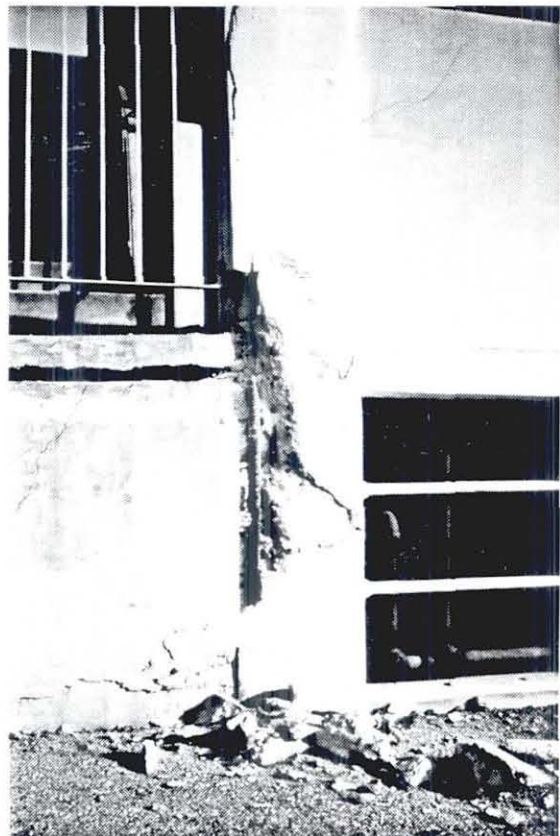
Photo 30

Damage to a concrete column between the ground level and the lower level. Note that no ties are around the vertical bar.

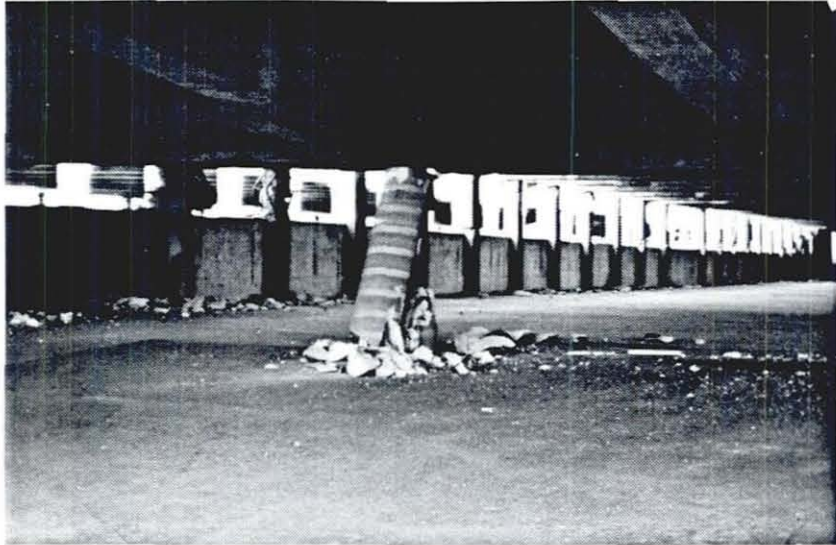
Photo 31 Non-ductile failure of a concrete column in the garage structure.

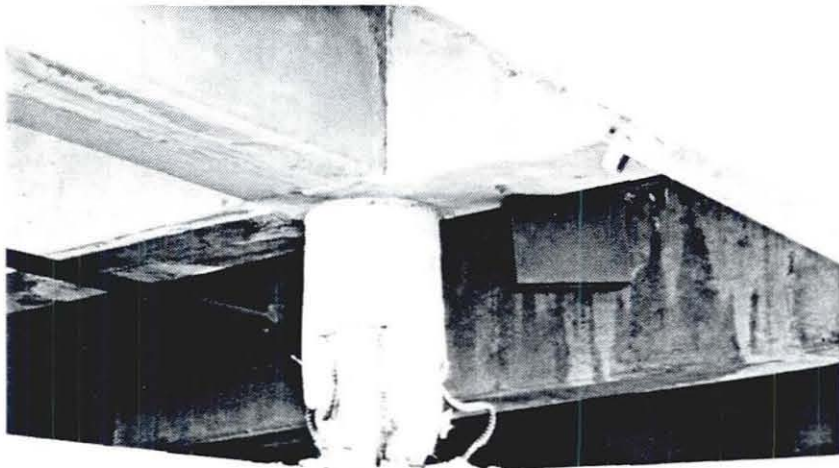
Photo 32 Non-ductile failure of a short column. Note fractured #2 tie and buckled vertical bars.

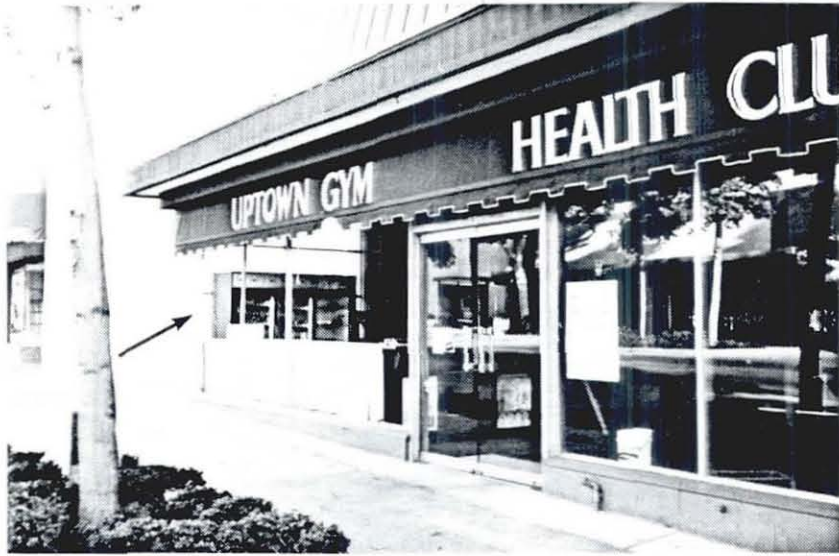
Photo 33 Distortion of the building caused damage to windows at the corner of the building in the Uptown Whittier shopping section.

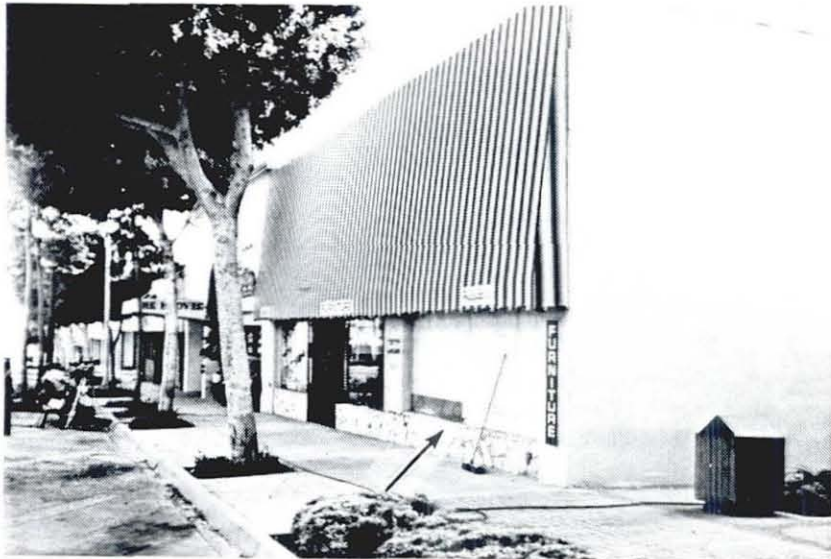
Photo 34 Damage glass in a store in the Uptown Whittier shopping section.

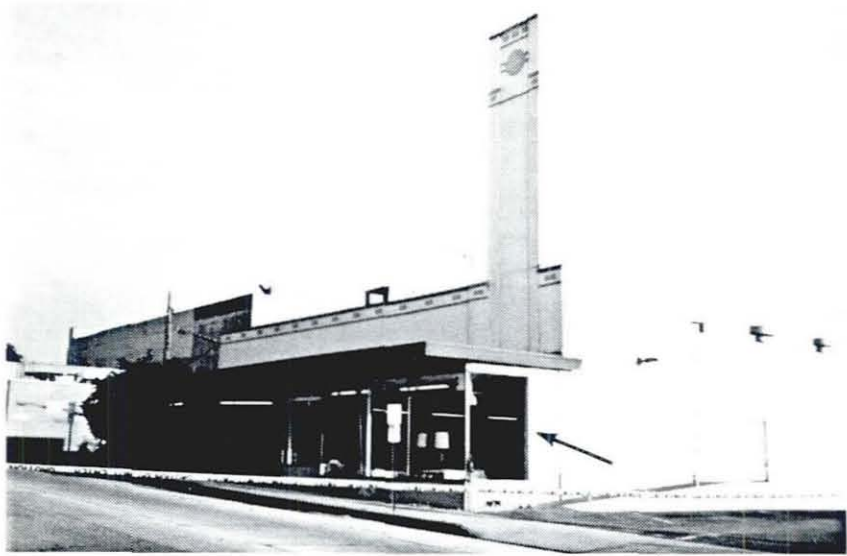
Photo 35 This remodeled masonry building experienced considerable damage to windows. Because large pieces of broken glass were strewn on the sidewalk, the building was cordoned off.

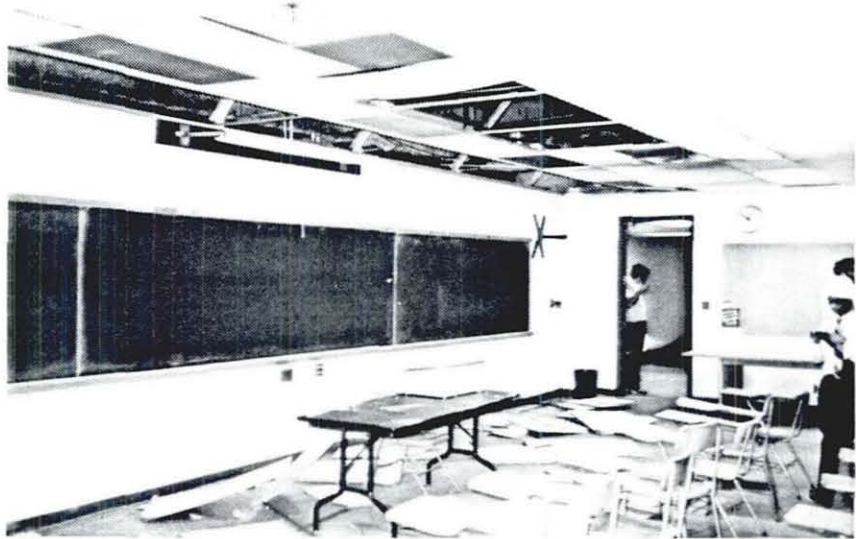
Photo 36 Fallen ceiling tiles in a classroom at the California State University at Los Angeles.

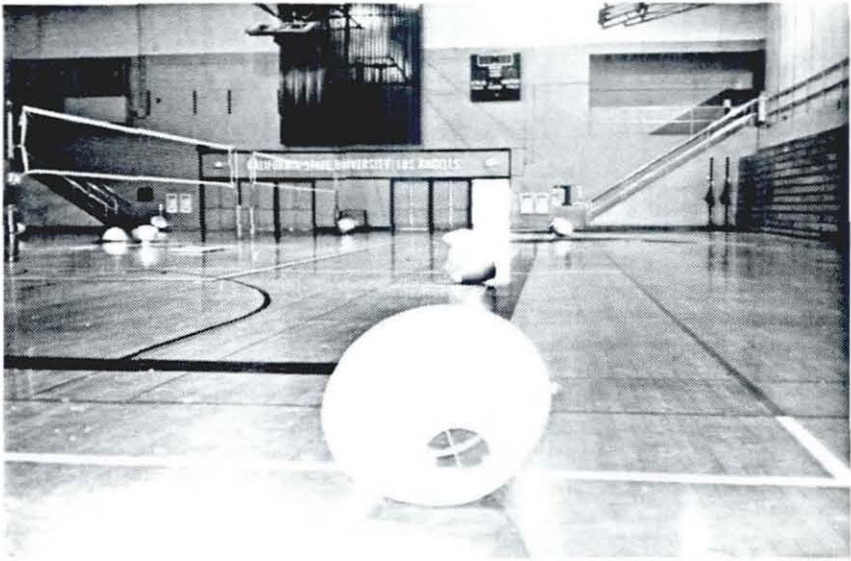
Photo 37 Fallen large light fixtures in the gymnasium at the California State University at Los Angeles.

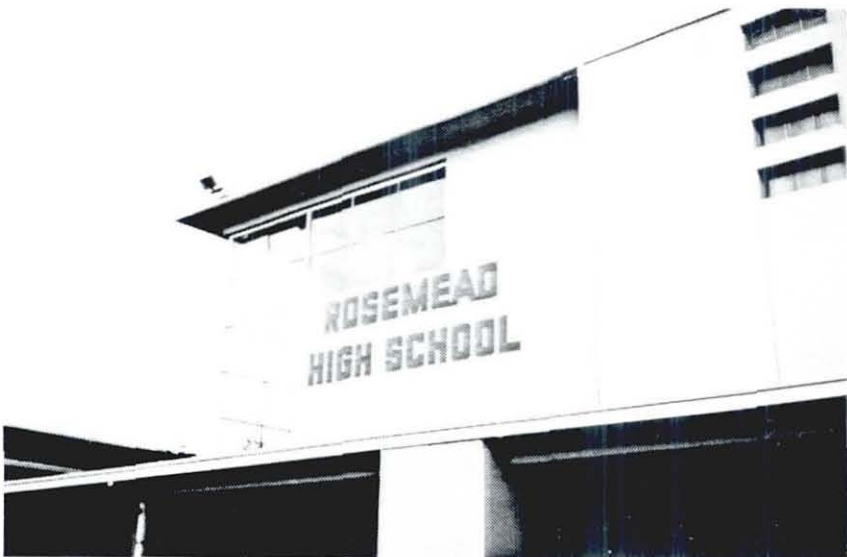
Photo 38 This school building experienced minor structural damage. Note no glass was broken at the corner of the building.

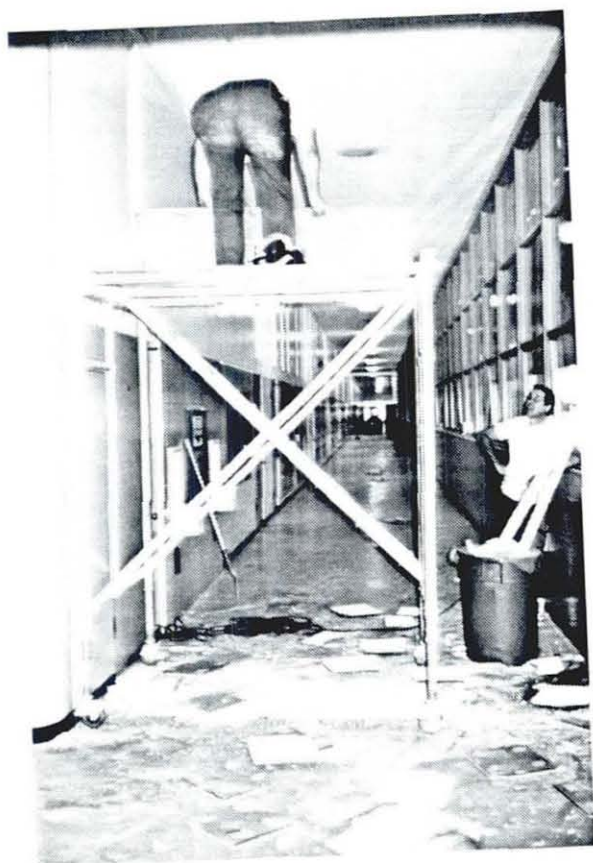
Photo 39

Acoustic ceiling tile fell in corridors and stair wells at Rosemead High School.

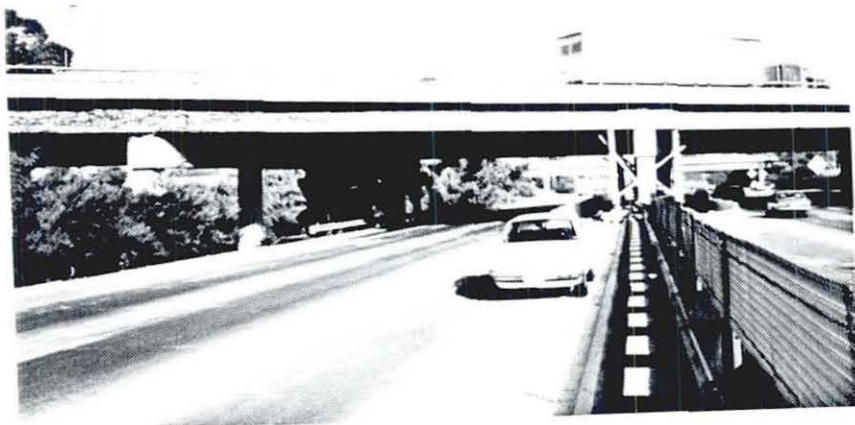
Photo 40 Interstate I-605/I-5 interchange. Temporary shores have been installed at the center bent which support the I-605 overcrossing. The bent has five concrete columns.

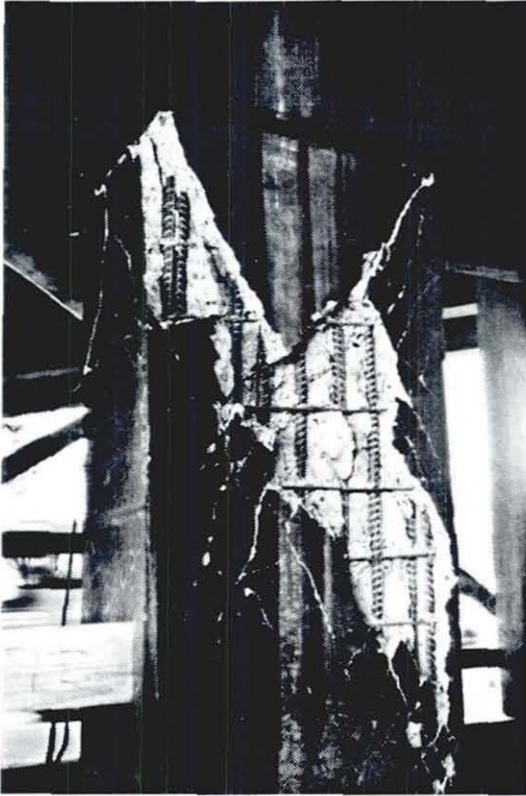
Photo 43

Close-up view of damaged column in the center bent. Note the cracked concrete core is confined by the ties.
