1994 Northridge Earthquake

Performance of Structures, Lifelines and Fire Protection Systems

NISTIR 5396

March 1994
Building and Fire Research Laboratory
National Institute of Standards and Technology
Gaithersburg, MD 20899

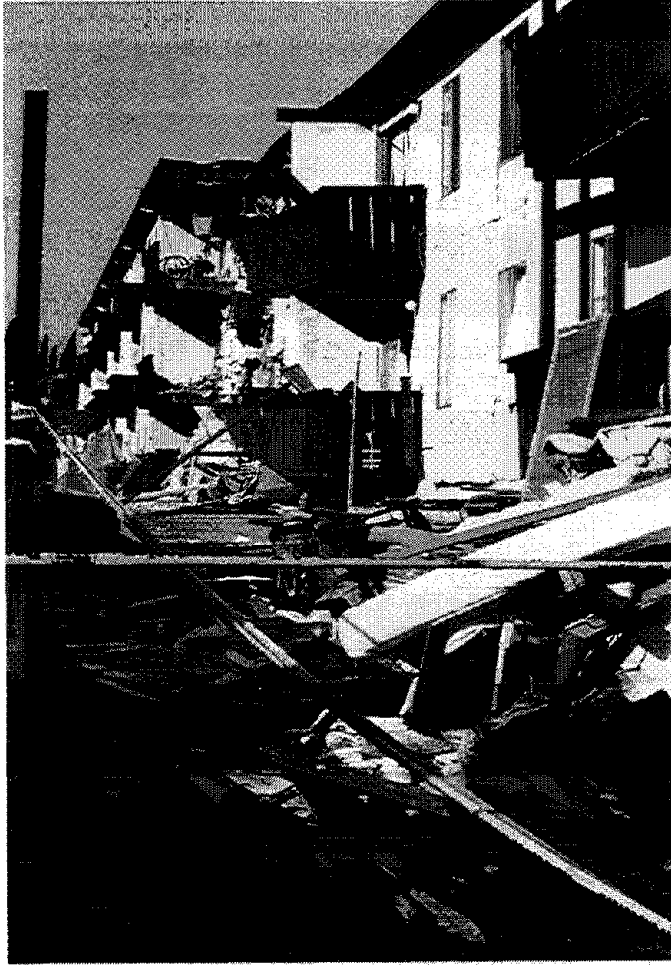
Figure 3.4 At the Northridge Meadows apartment complex near the epicenter the first story in several of the buildings collapsed, killing sixteen people. The second and third stories remained essentially intact. Large portions of the first story in these buildings were open space for parking. This type of collapse occurred in a significant number of similar apartment buildings throughout the affected area.

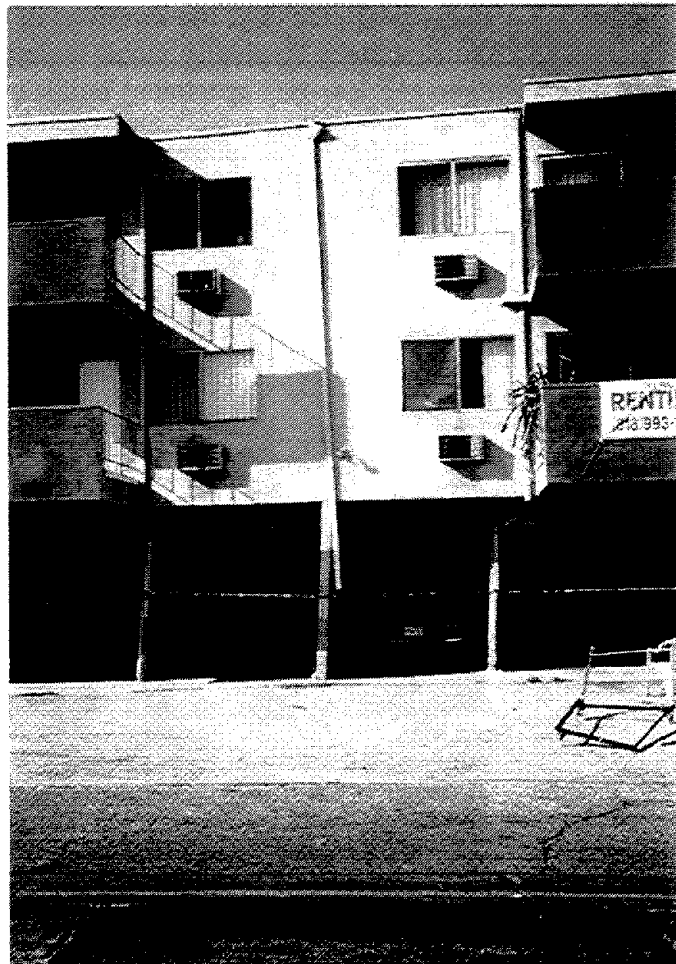
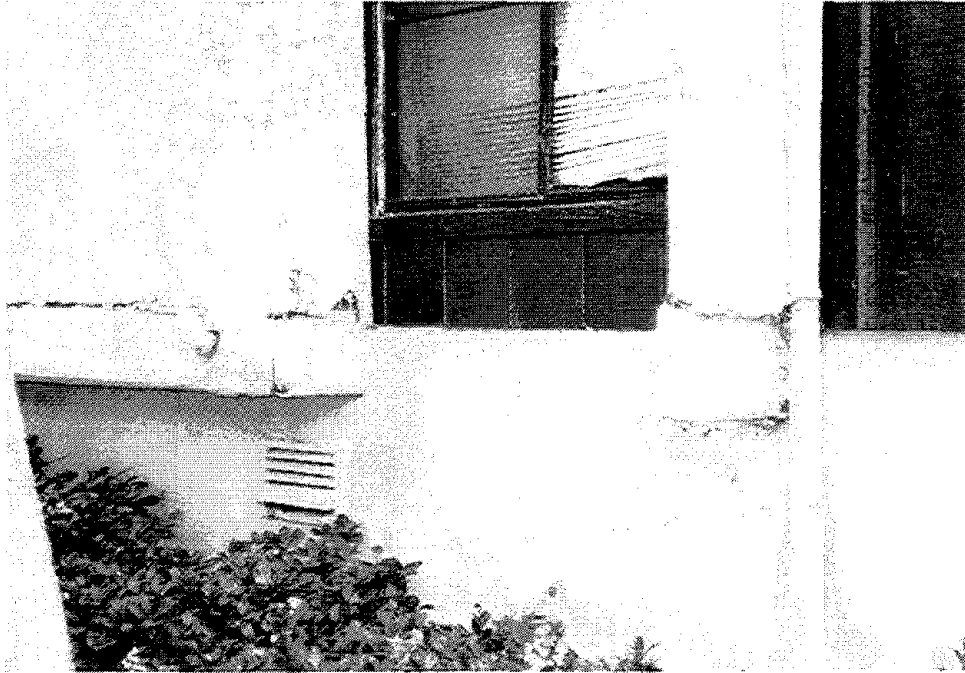
Figure 3.8 Horizontal cracks at the interface of the foundation wall (usually concrete) and the first story (typically wood-framed with stucco facade) were often seen in damaged low-rise apartment buildings.

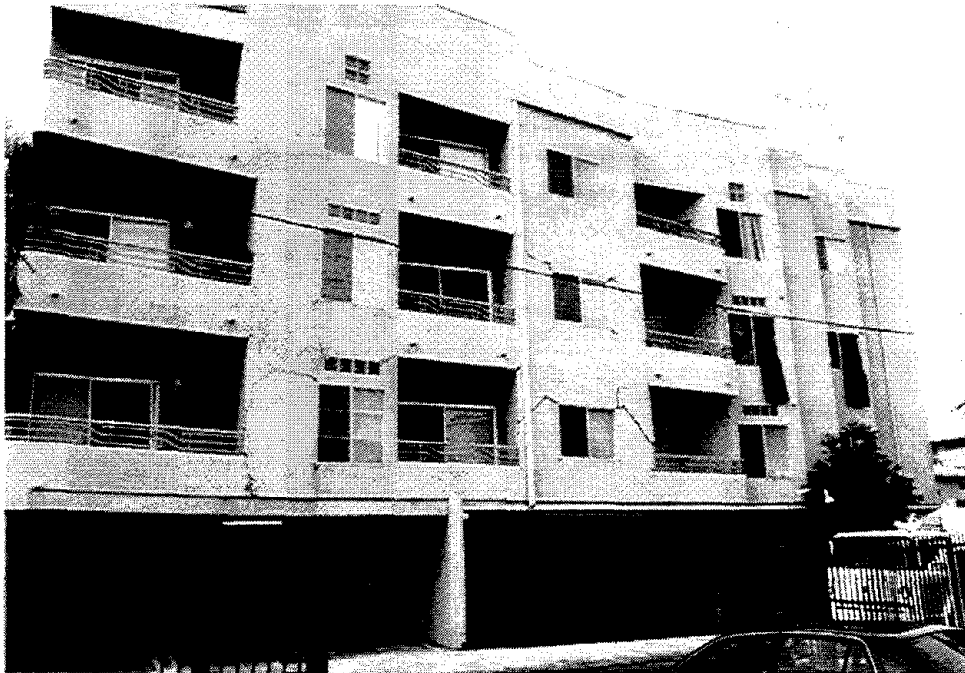
Figure 3.9 Typical damage in to low-rise apartment buildings included diagonal cracks in the stucco facade at the corners of windows and other openings.

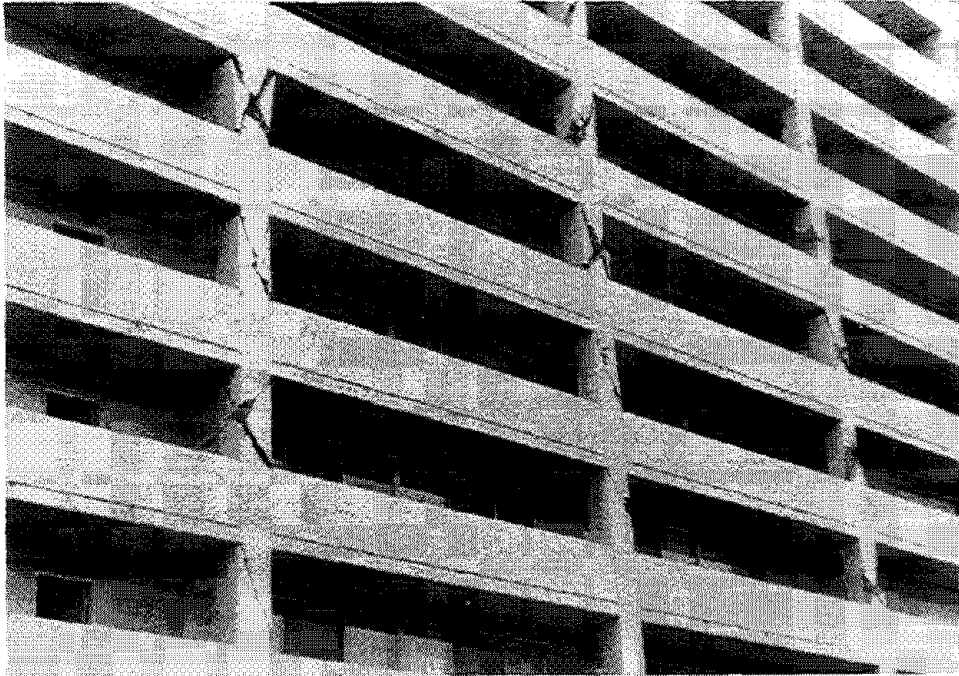
Figure 3.14 The back of the Champagne Towers building was badly damaged. The railings here are solid infill, which effectively stiffen the lower half of the columns. The shortened upper half of the columns were forced to accommodate all the displacement, and they failed in shear.

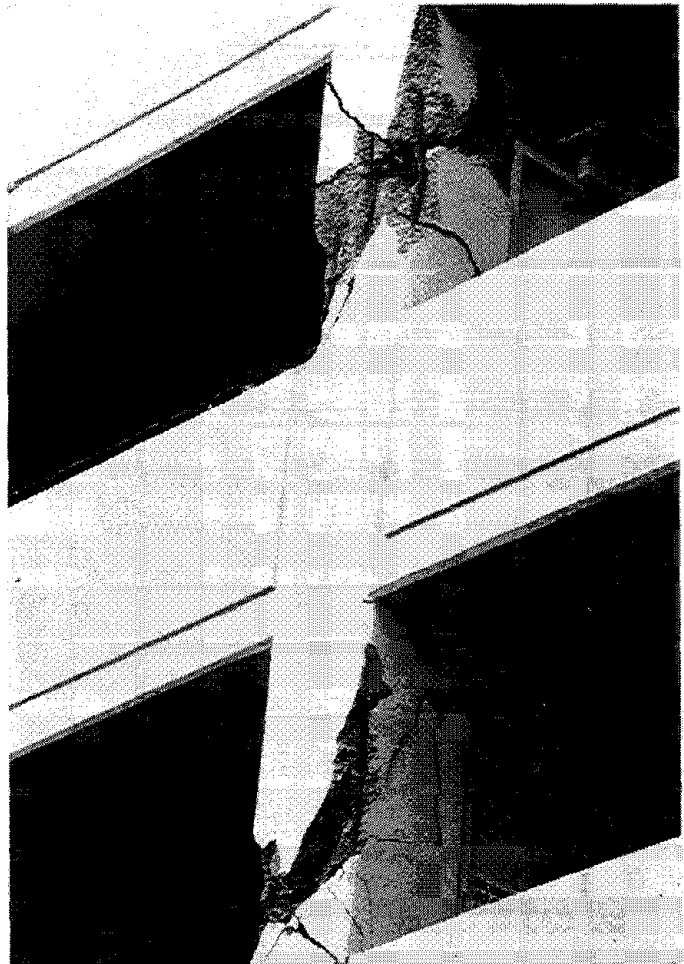
Figure 3.15 A closer view of the failed columns at the back of Champagne Towers shows minimal transverse reinforcement.

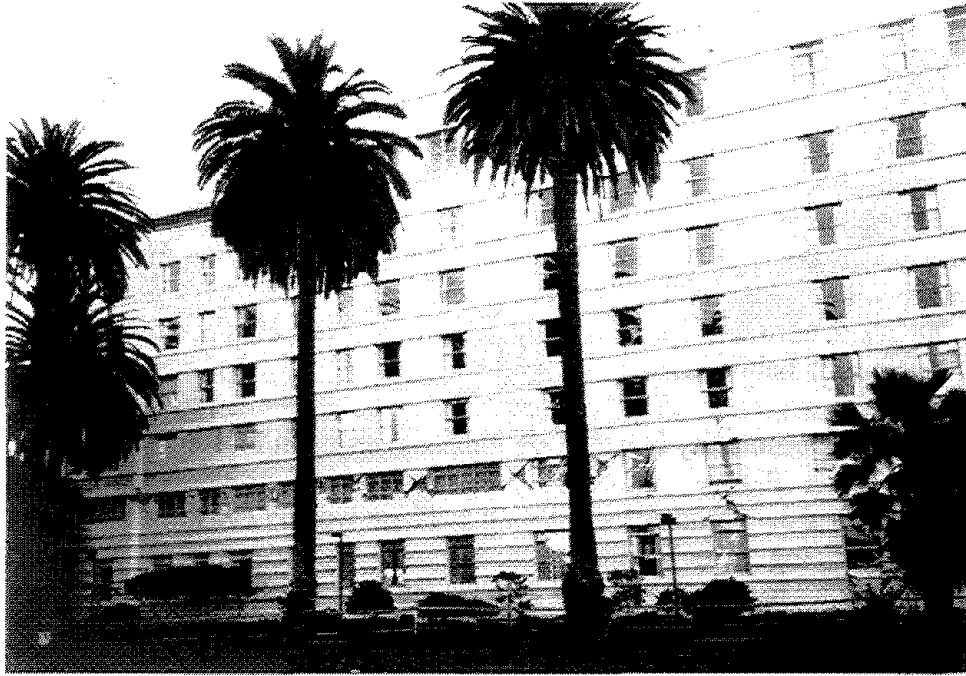
Figure 3.23 The seven-story northwest wing of St. John's hospital in Santa Monica experienced severe X-cracking in the piers between the second story windows.

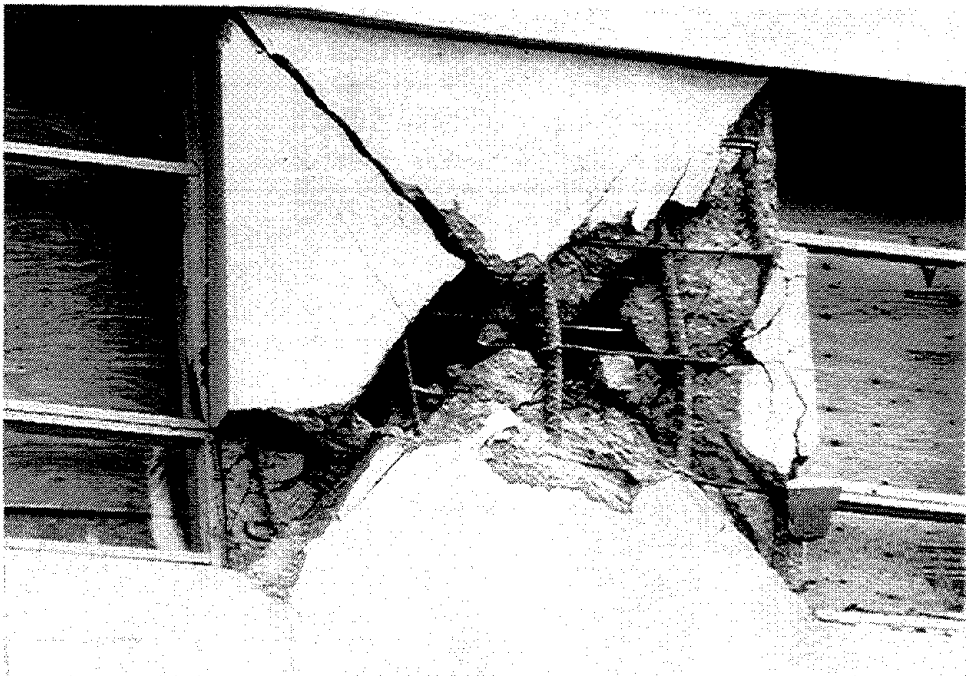
Figure 3.24 The transverse reinforcement in the St. John's hospital window piers was spaced at about 150-200 mm on center with 90° hooks at the ends, typical for construction of its age (about 50 years old).

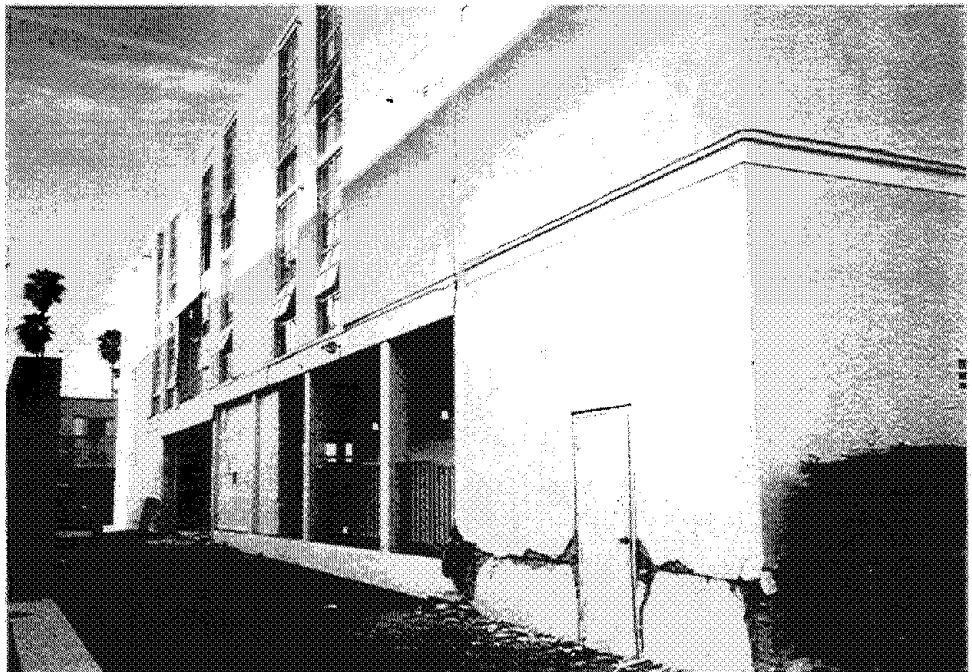
Figure 3.27 The facade of the five-story Berkley Convalescent Hospital directly adjacent to the St. John's Hospital complex consisted of two wythes of brick masonry with a reinforced and grouted space between. In some places, all three layers of this facade were destroyed along lines of diagonal cracking. The facility was evacuated.

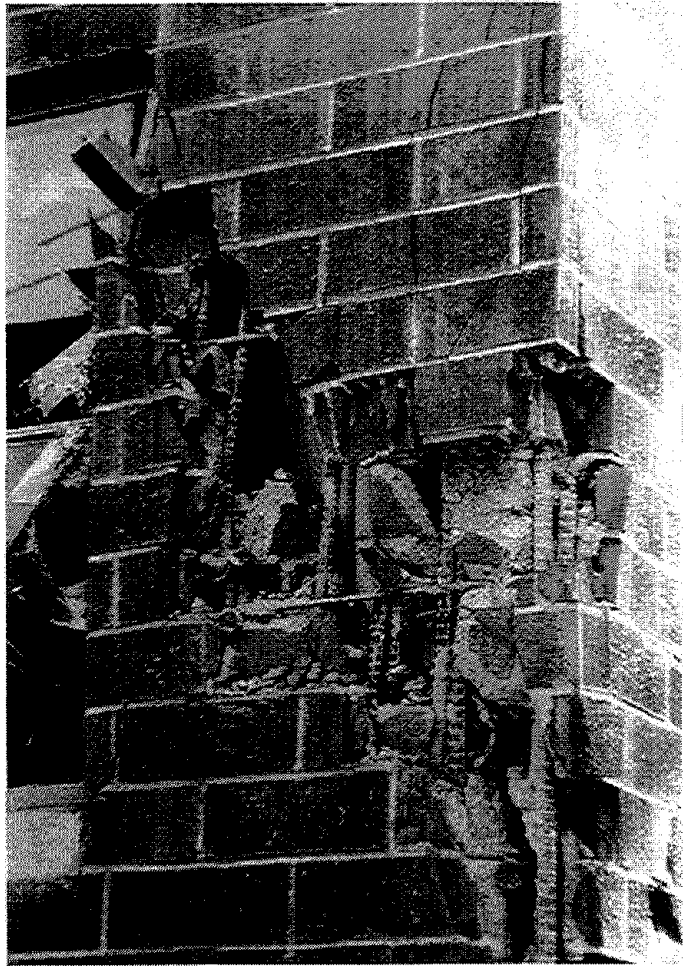
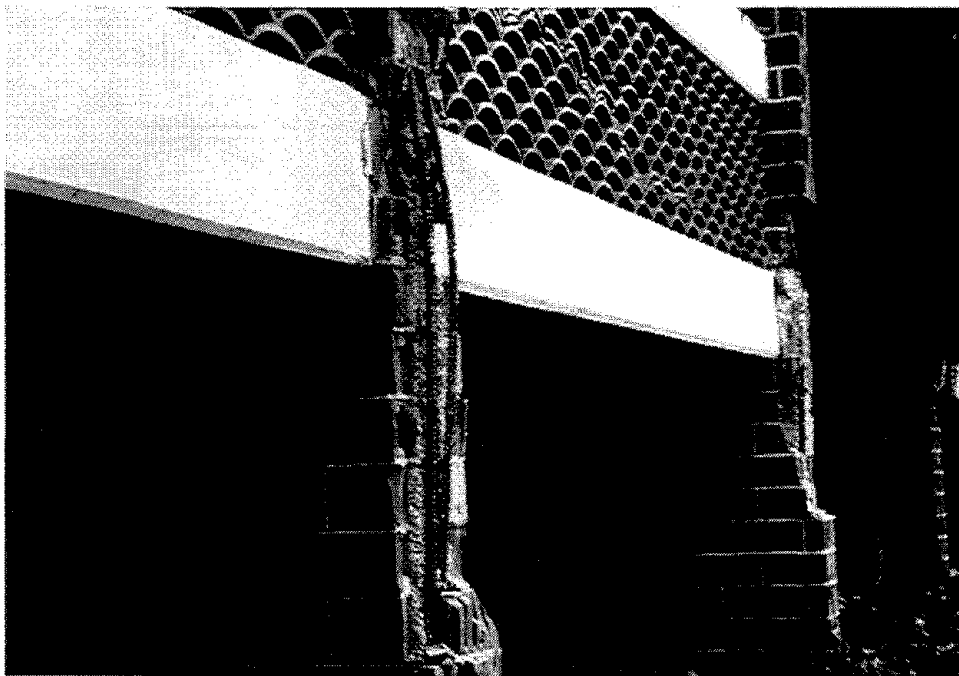
Figure 3.28 Two faces of the Berkley Convalescent Hospital had wing walls separating balconies. The ends of these wing walls spalled at the lower stories.

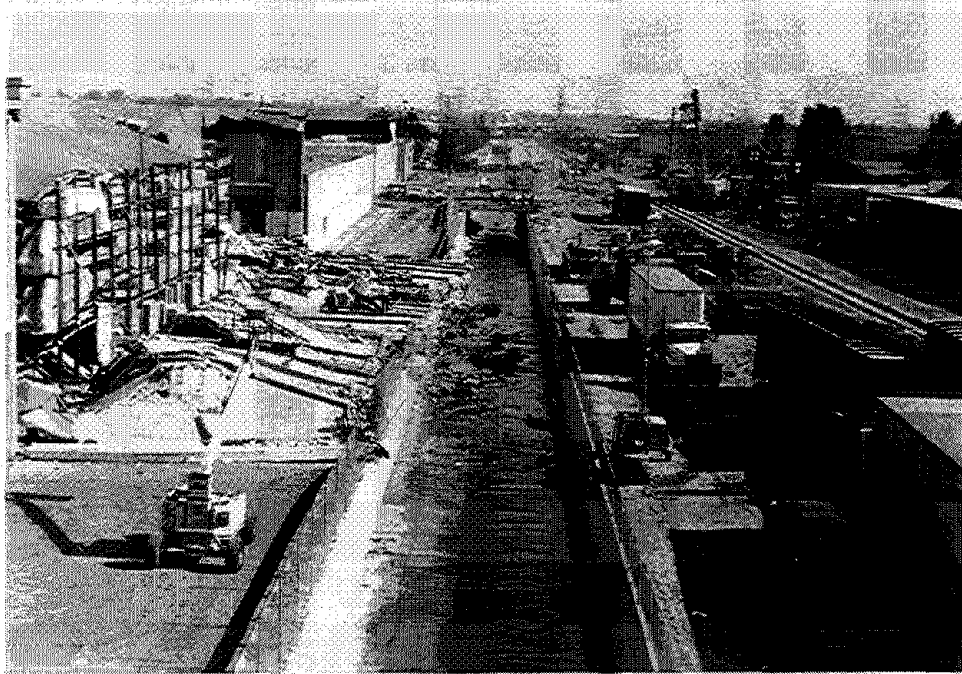
Figure 3.33 The south wall of the concrete tilt-up Levitz furniture store/warehouse south of the Northridge Fashion Center fell away from the building into the alley and stream channel. The damaged roof was being supported by the racks of furniture. On the south side of the stream channel a freight train derailed during the earthquake. That clean-up effort was still underway three days after the quake.

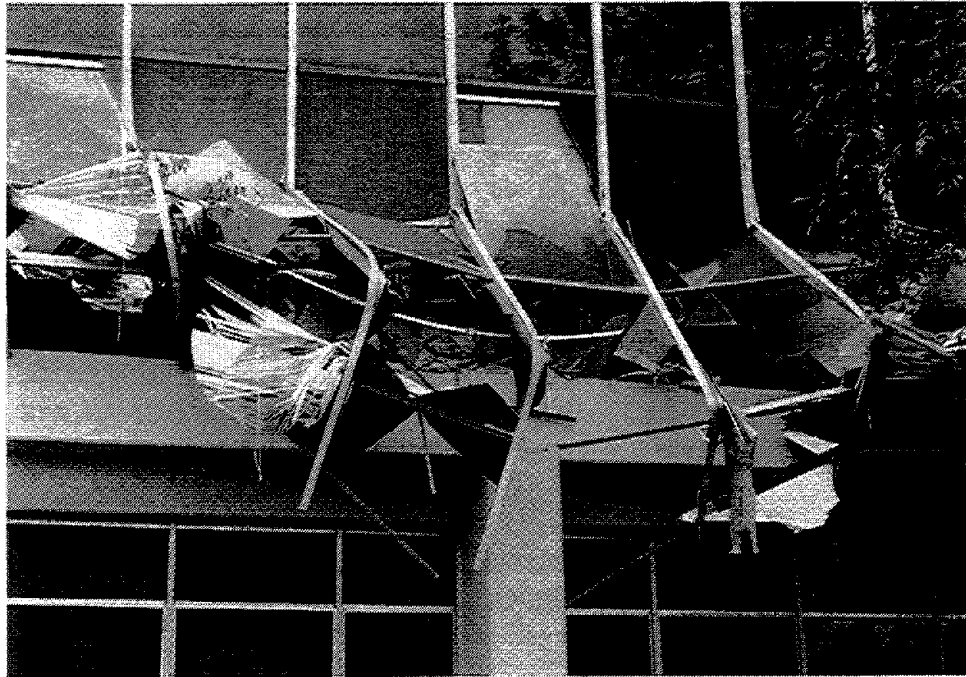
Figure 3.41 The second story of the concrete frame Kaiser Permanente office building on Balboa Avenue in Northridge completely collapsed. The first story was relatively undamaged, suggesting it was far stiffer than the story above.

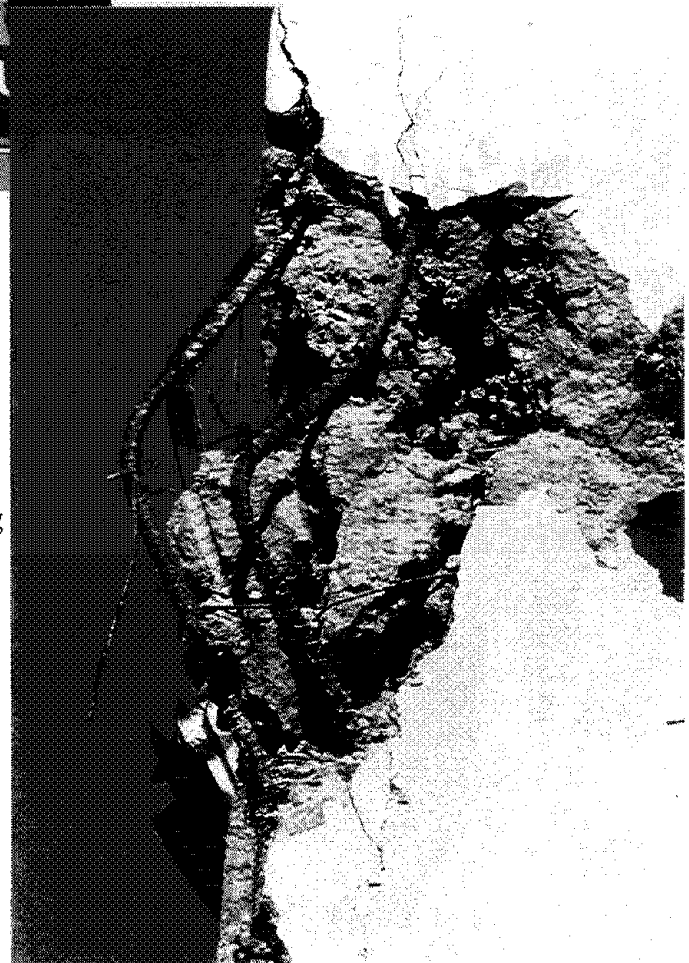
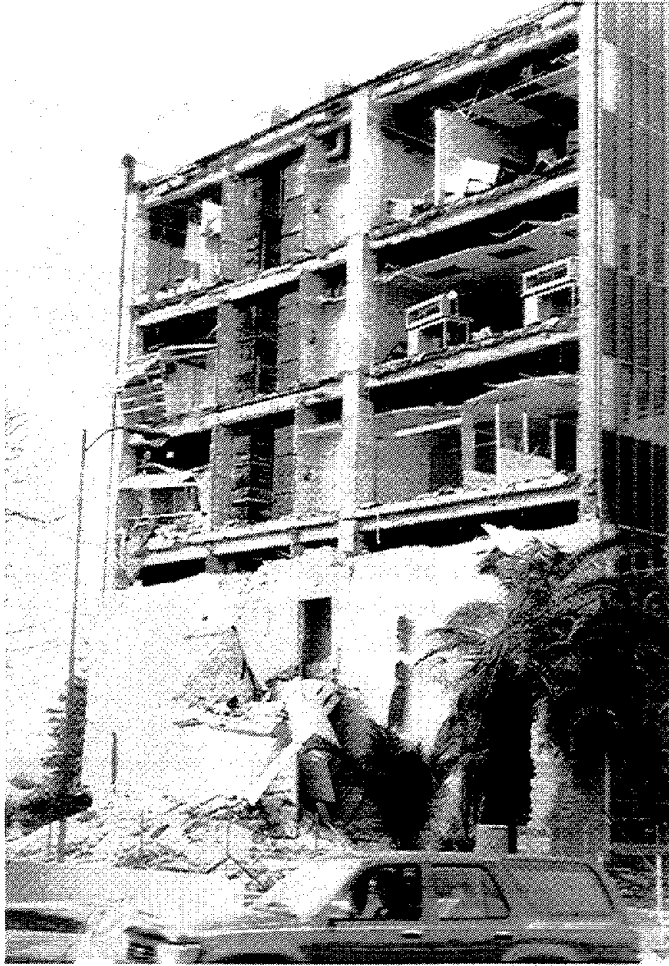
Figure 3.49 The east end wall and stair tower of a five-story apparently steel-framed office building on Sherman Way in Reseda collapsed. The enclosing masonry wall became detached from the structure and slid to the ground, with the upper stories remaining intact. The doorway opening in the wall, shown here resting at about the second story level, originally provided access from the top story to the stair tower.

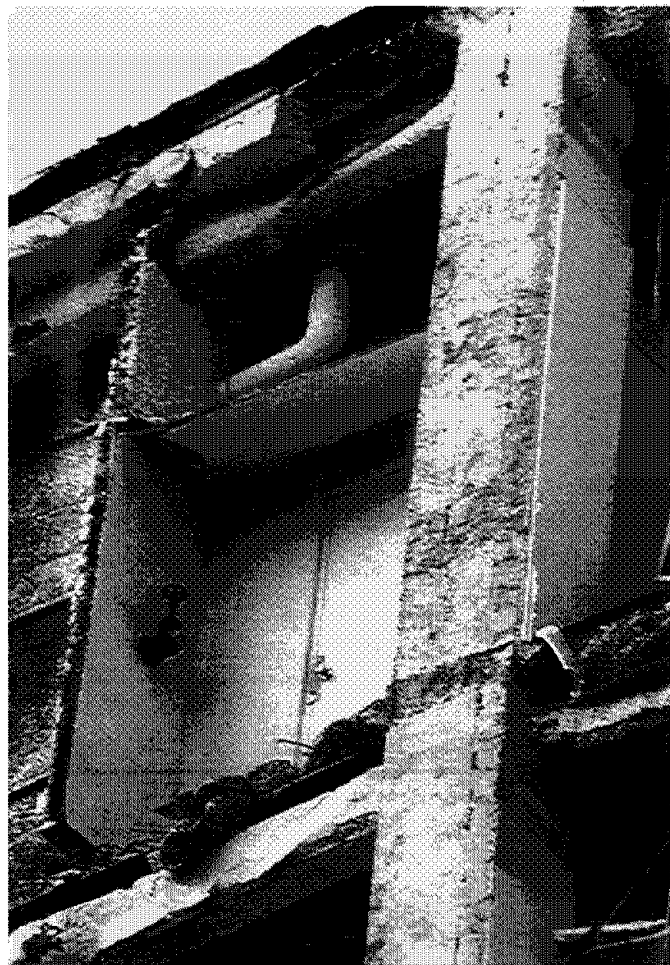
Figure 3.52 The first-story columns of the steel-framed building housing the American Savings Bank on Topanga Canyon Road in Canoga Park flexed during the quake and ended up slightly displaced from their original positions.

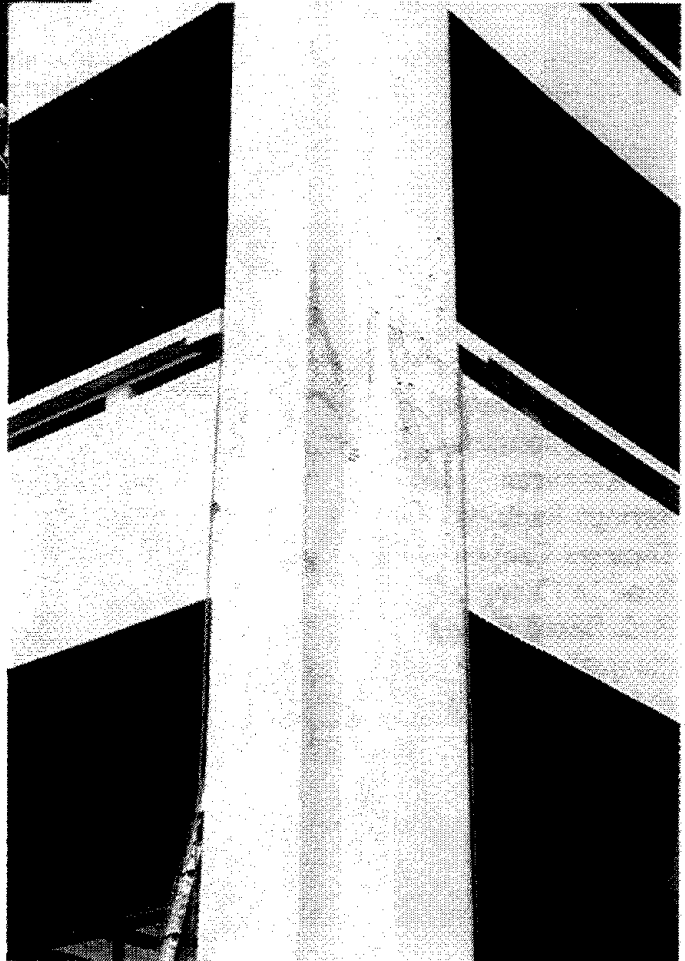
Figure 3.55 The concrete Radisson Valley Center Hotel in Sherman Oaks had serious damage to the columns at the first and fifth stories.

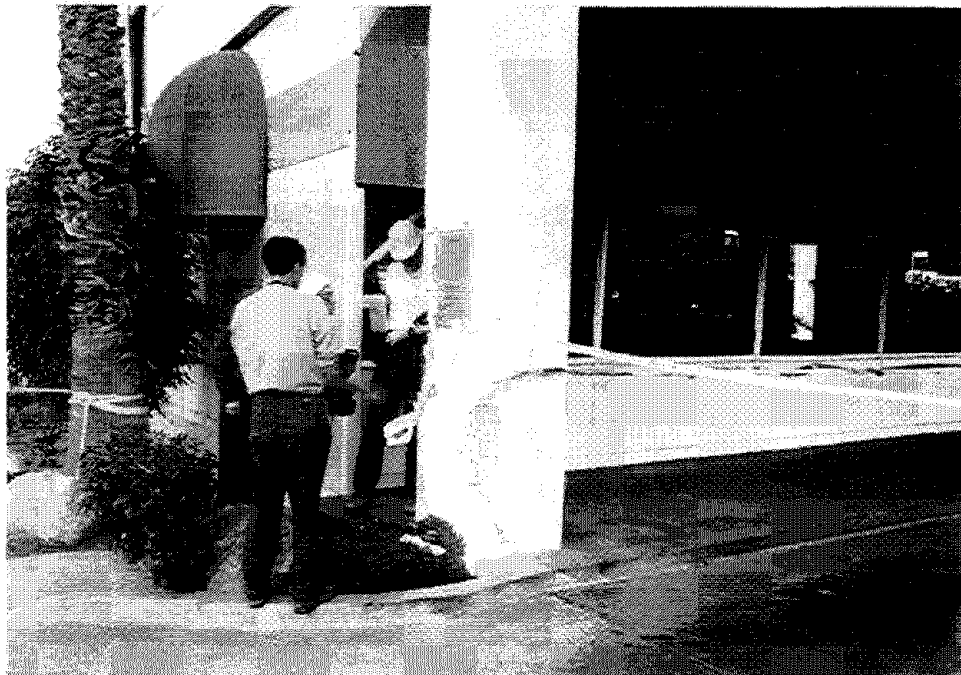
Figure 3.56 The columns supporting the three-story appendage at the front of the Radisson Hotel had serious shear cracks and related spalling.

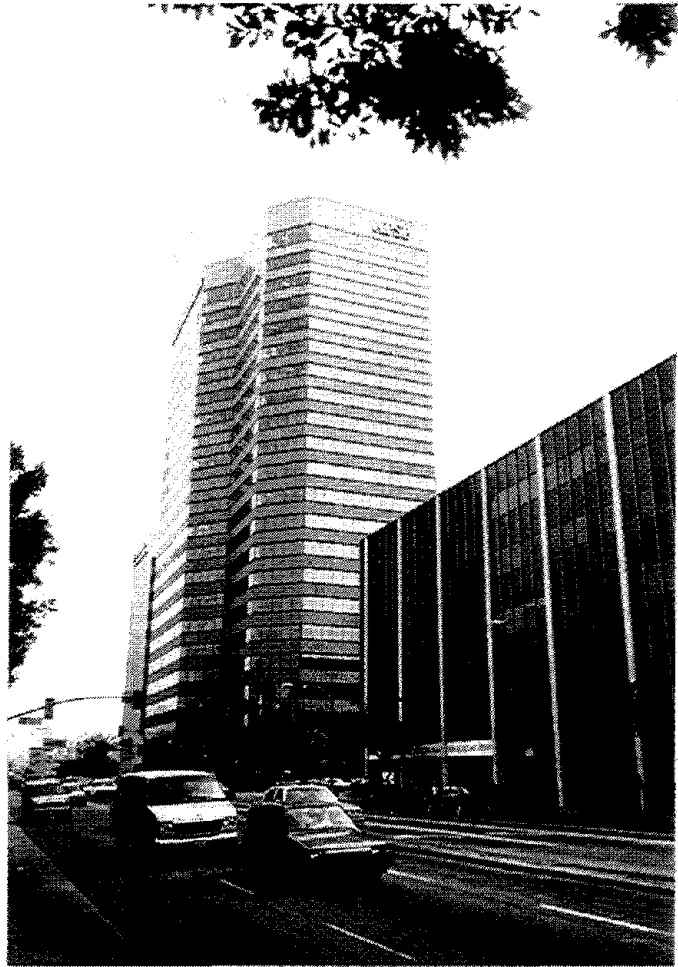
Figure 3.58 The reinforced masonry facade of this steel-framed building was badly damaged.

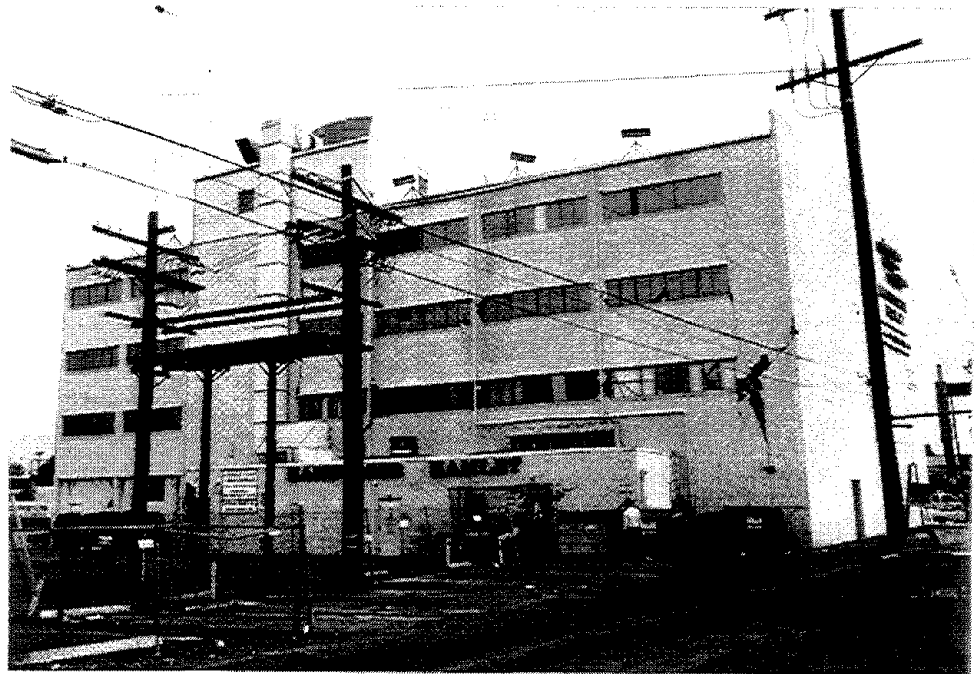
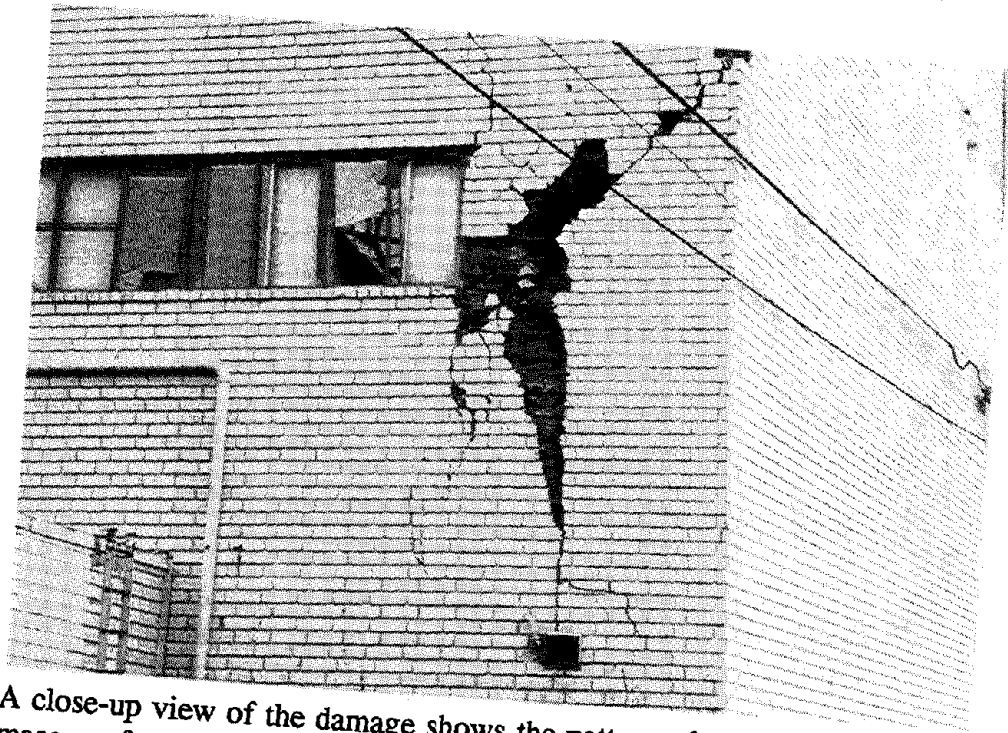
Figure 3.59 A close-up view of the damage shows the pattern of reinforcing used in the masonry facade.

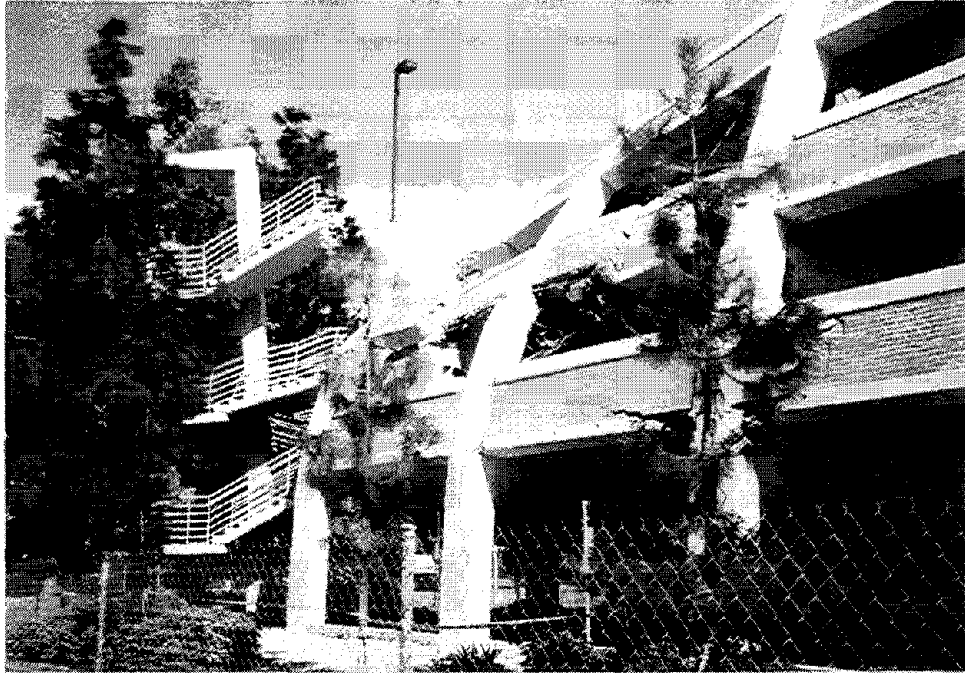
Figure 3.60 The three-year old four-level parking garage at the Northridge campus of California State University partially collapsed in the earthquake. The collapse apparently started at the interior, causing the exterior walls to be pulled in to the middle of the structure. Precast concrete "trees" were connected to form a moment-resisting frame at the exterior of the structure.

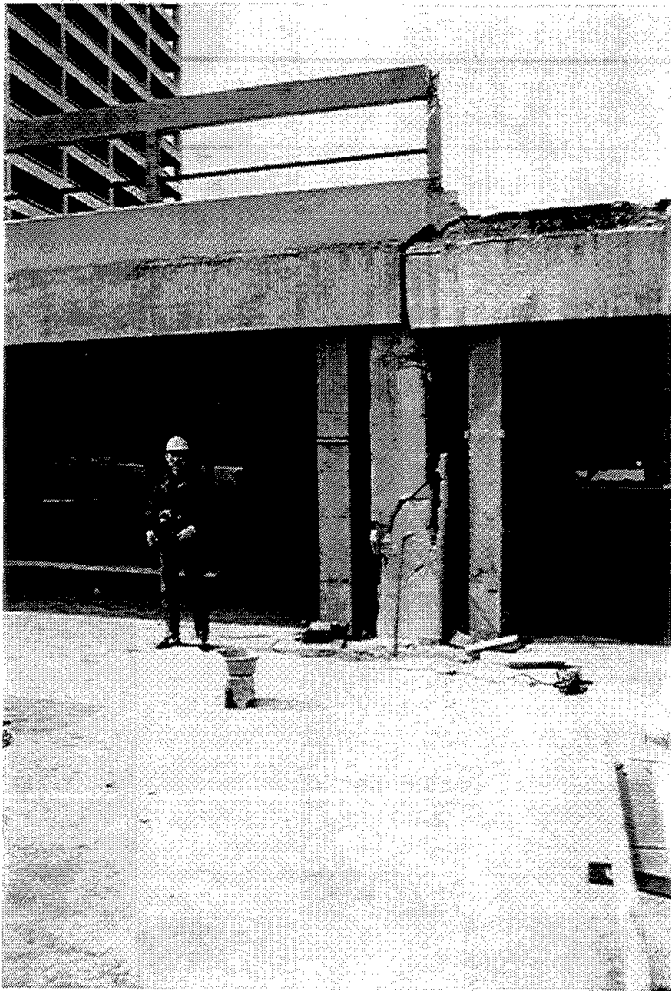
Figure 3.65 The exterior columns of the Trans World Bank parking garage, which had not been strengthened, were badly damaged.

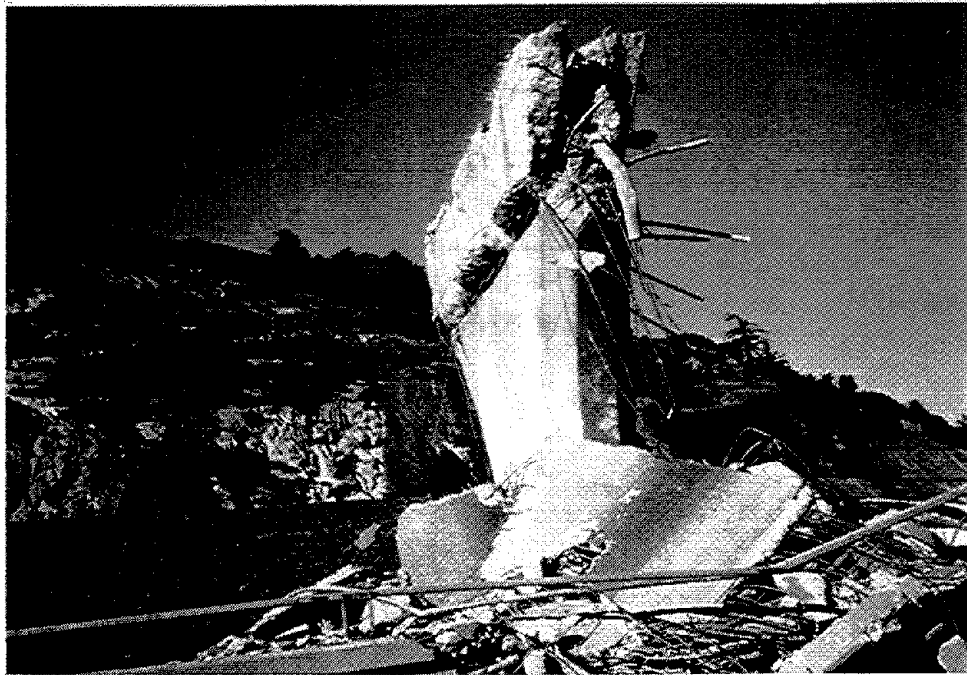
Figure 4.12 Damage at Pier 3 of the SR14/I5 Separation and Overhead, Ramp C, looking to the west (Courtesy of EERC)

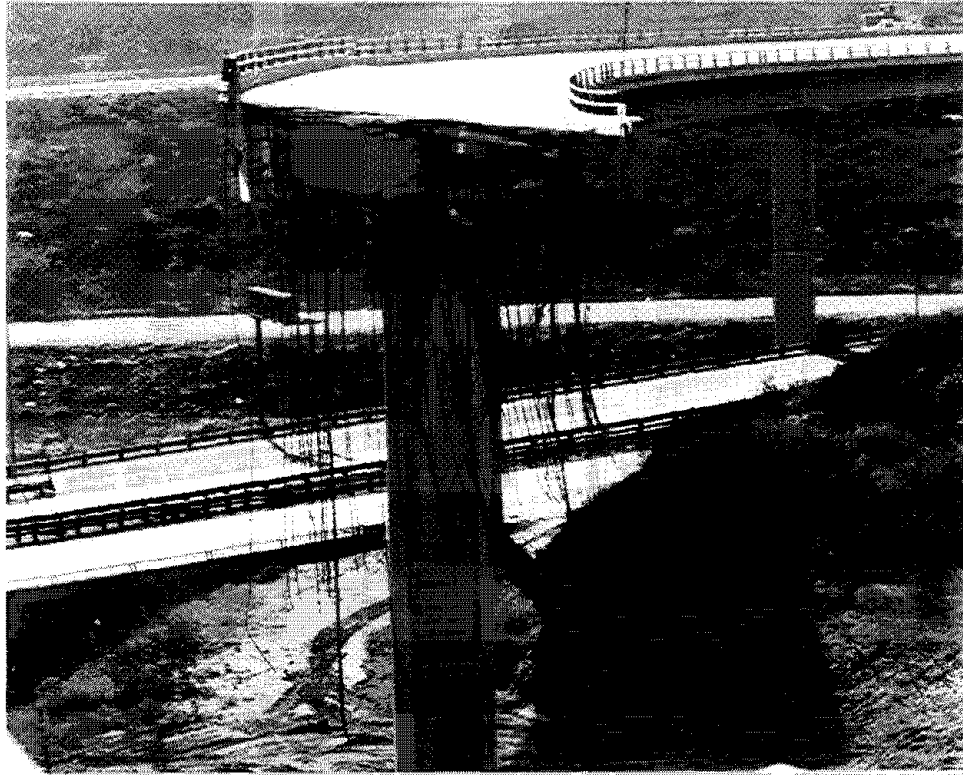
Figure 4.15 View of the flexural failure at Pier 3 of the SR14/I5 North Connector Overcrossing, looking to the south

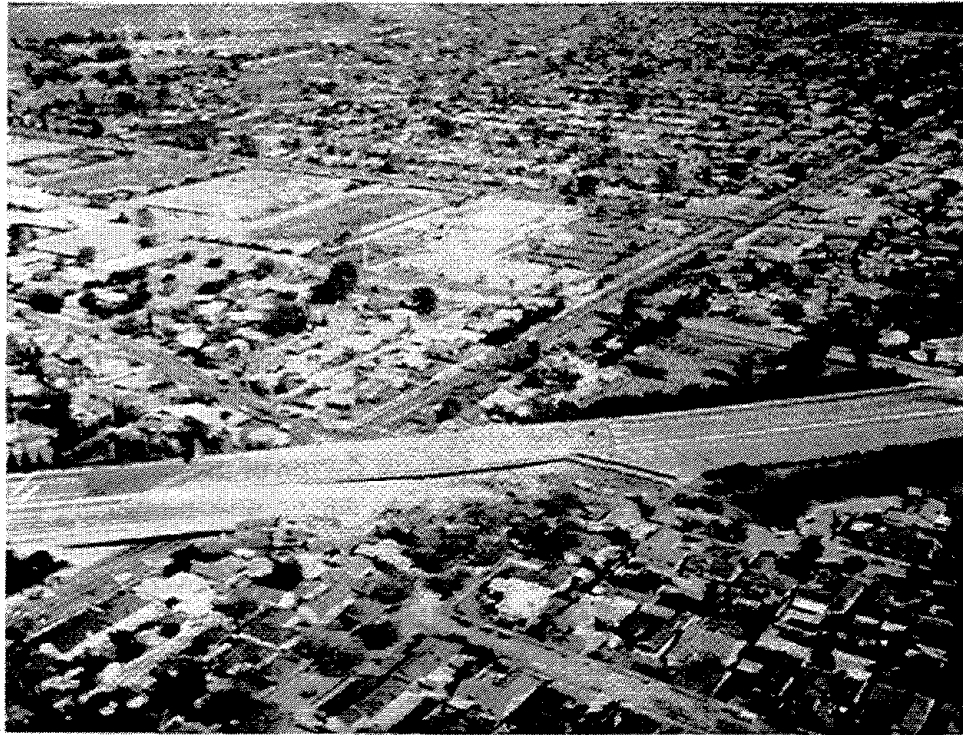
Figure 4.19 Aerial view of the SR118 Mission-Gothic Undercrossing, looking to the north showing collapsed eastbound bridge (Courtesy of FHWA)

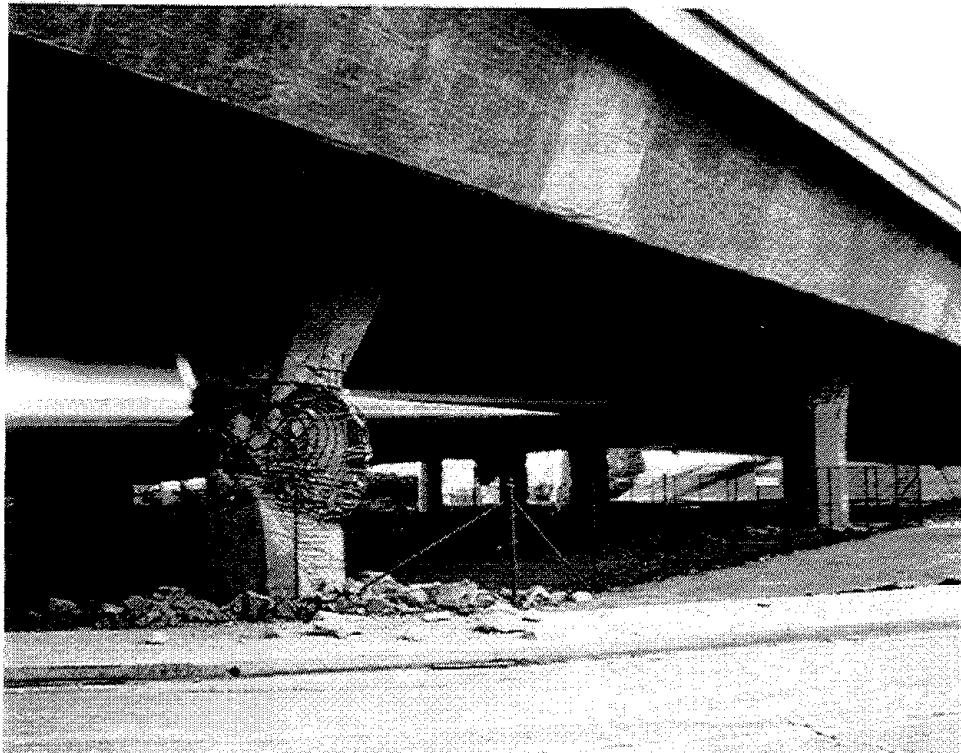
Figure 4.20 Damage to piers of the SR118 Mission-Gothic Undercrossing, looking to the northwest at the north face of the westbound bridge, Bents 3 (foreground) and 2.

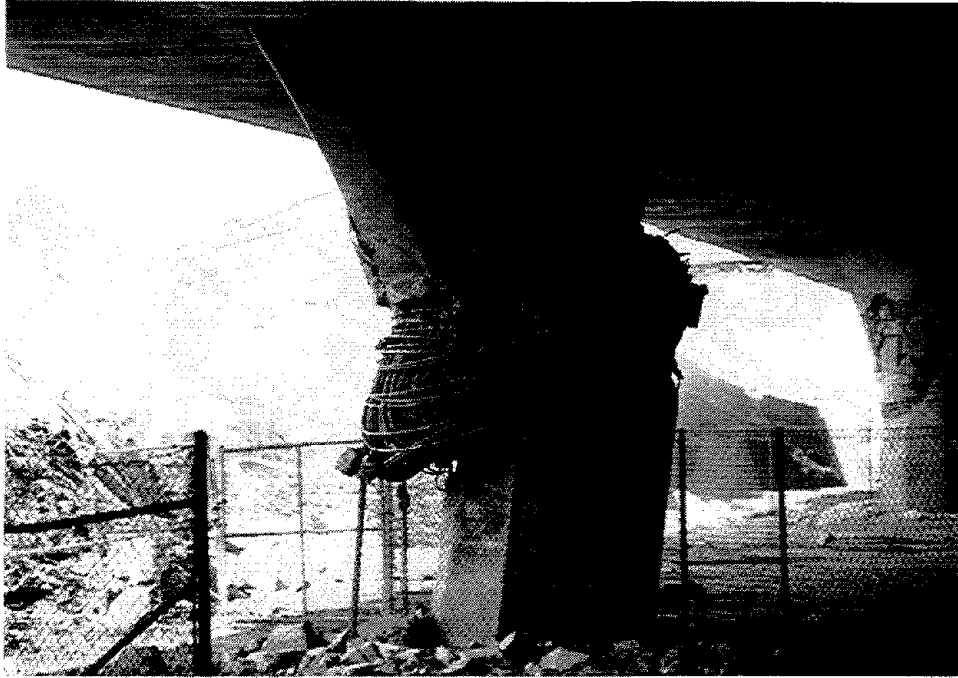
Figure 4.21 Damage to a pier of the SR118 Mission-Gothic Undercrossing, looking to the northwest at the southernmost pier of Bent 3 of the westbound bridge.

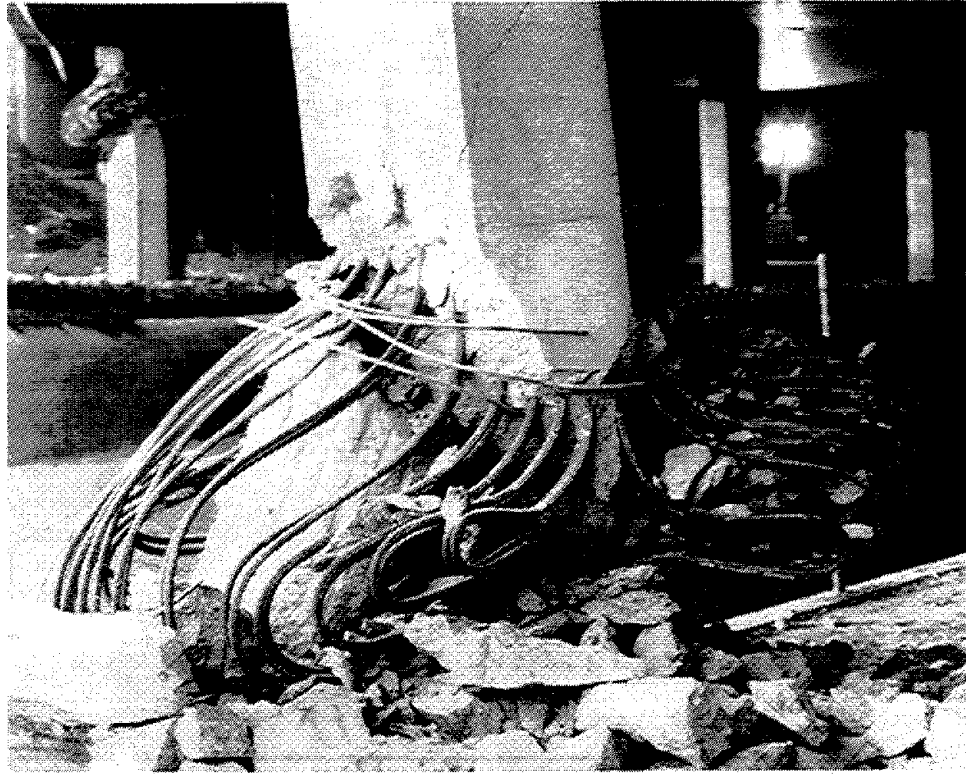
Figure 4.27 Damage to pier 3S-1 of State Route 118 at Bull Creek Canyon Channel, looking to the northwest

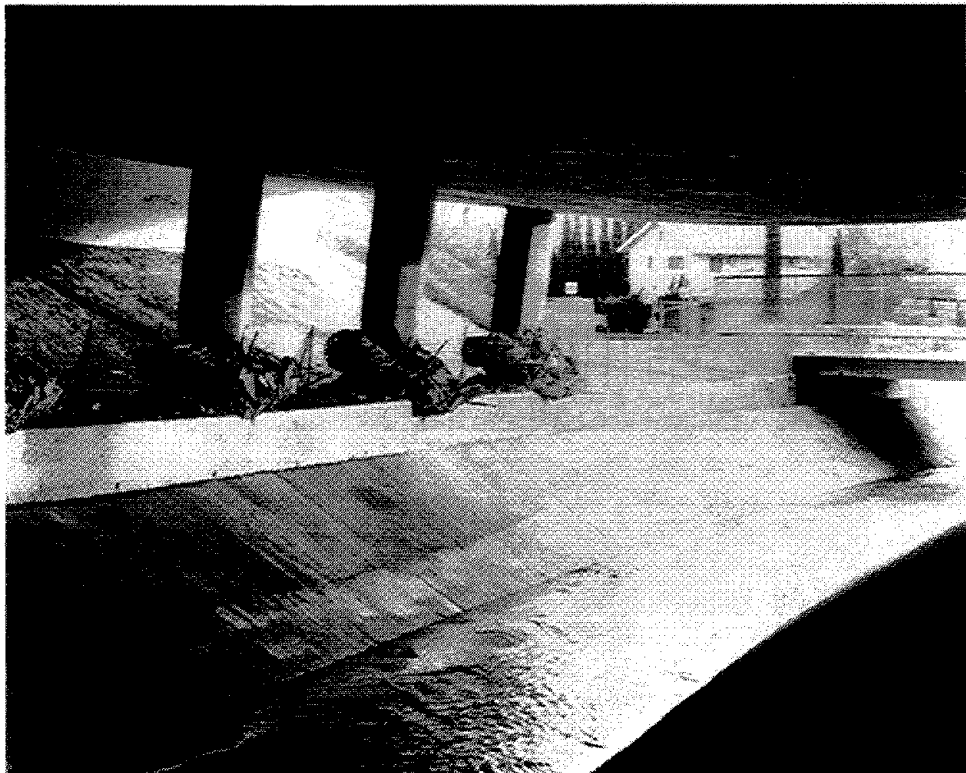
Figure 4.28 Damage to piers of Bent 3S of State Route 118 at Bull Creek Canyon Channel, looking to the southeast.

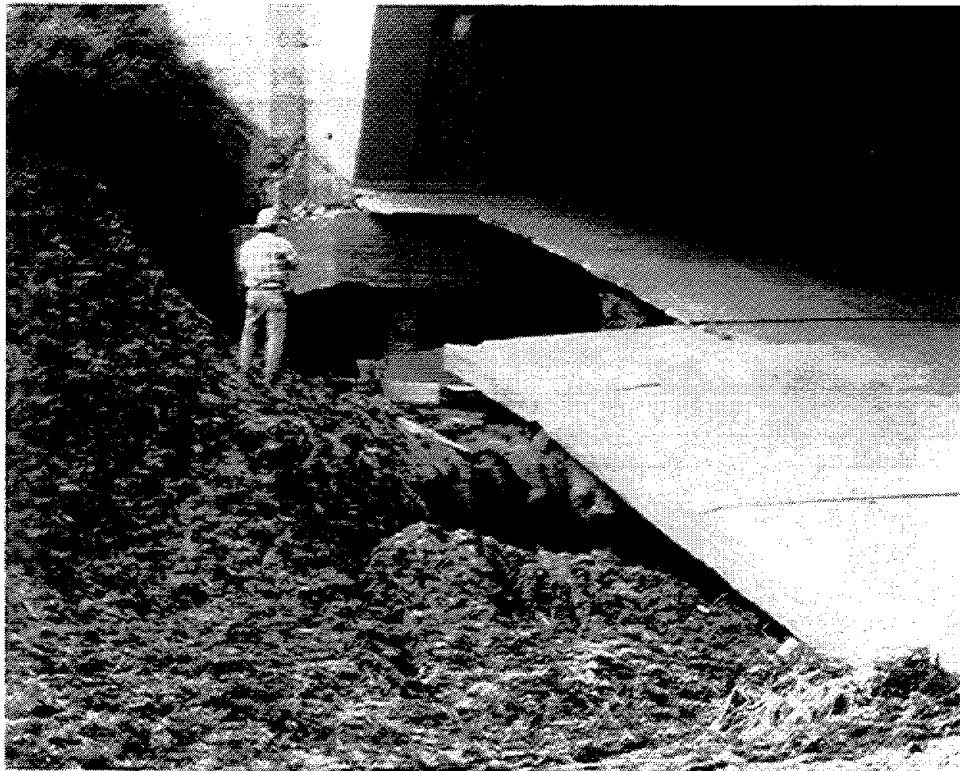
Figure 4.32 SR118 Balboa Avenue Overcrossing, view of the washout on the east side of the south abutment, caused by a ruptured water main

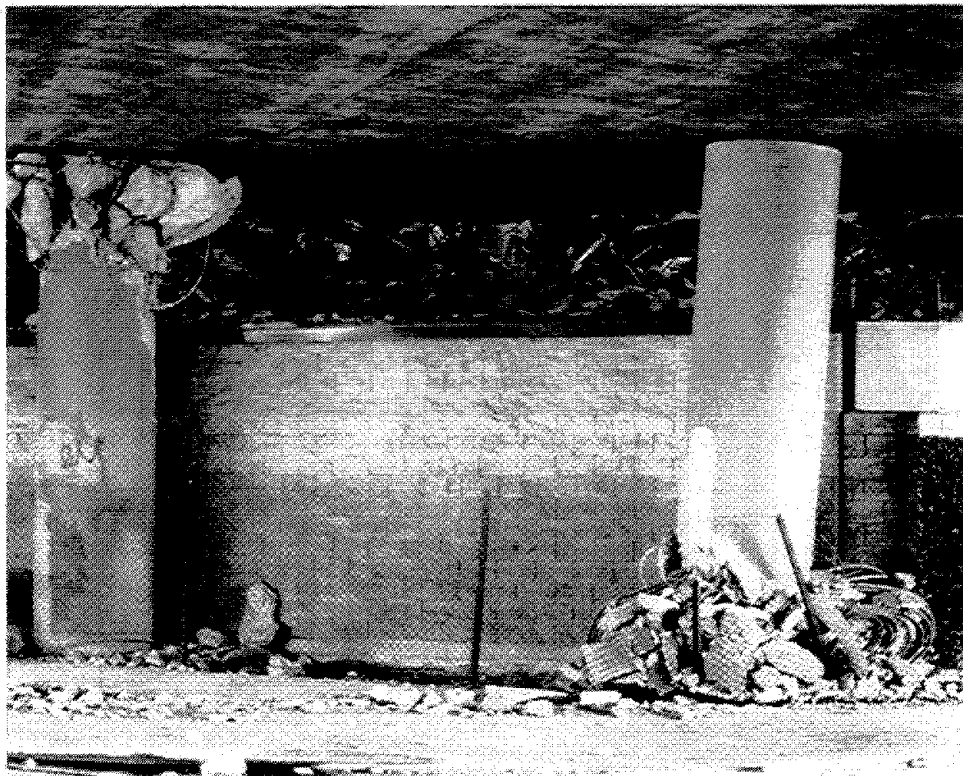
Figure 4.39 Failed piers in Bent 7 supporting westbound lane of I10 at Venice Blvd.
