1994 Northridge Earthquake

Performance of Structures, Lifelines and Fire Protection Systems

NISTIR 5396

March 1994
Building and Fire Research Laboratory
National Institute of Standards and Technology
Gaithersburg, MD 20899

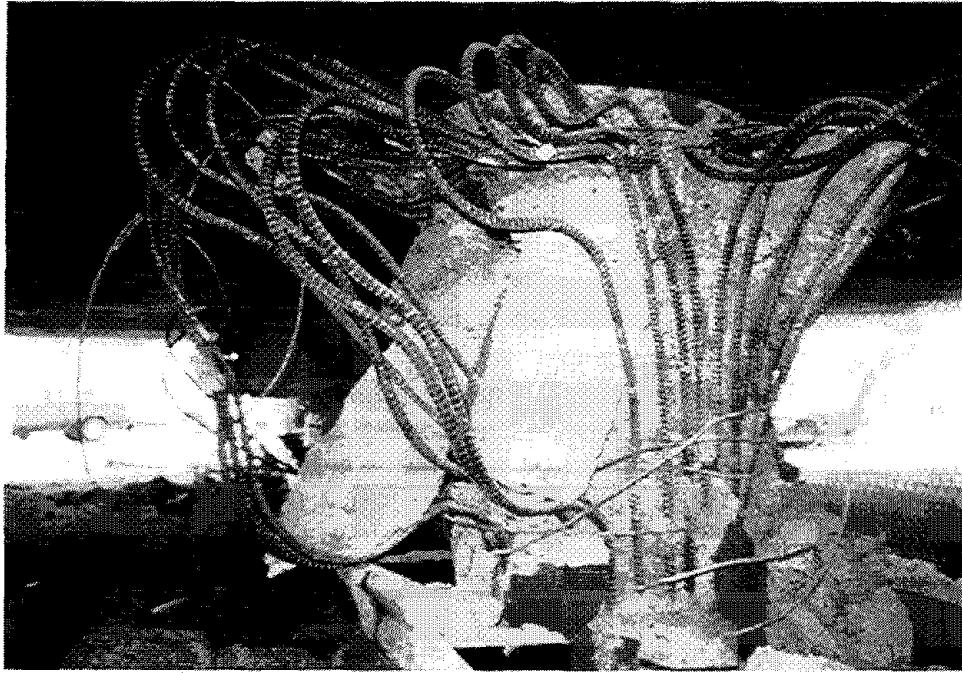
Figure 4.45 Failed column in Bent 3 of I10 at Fairfax Ave. (Courtesy of EERC)

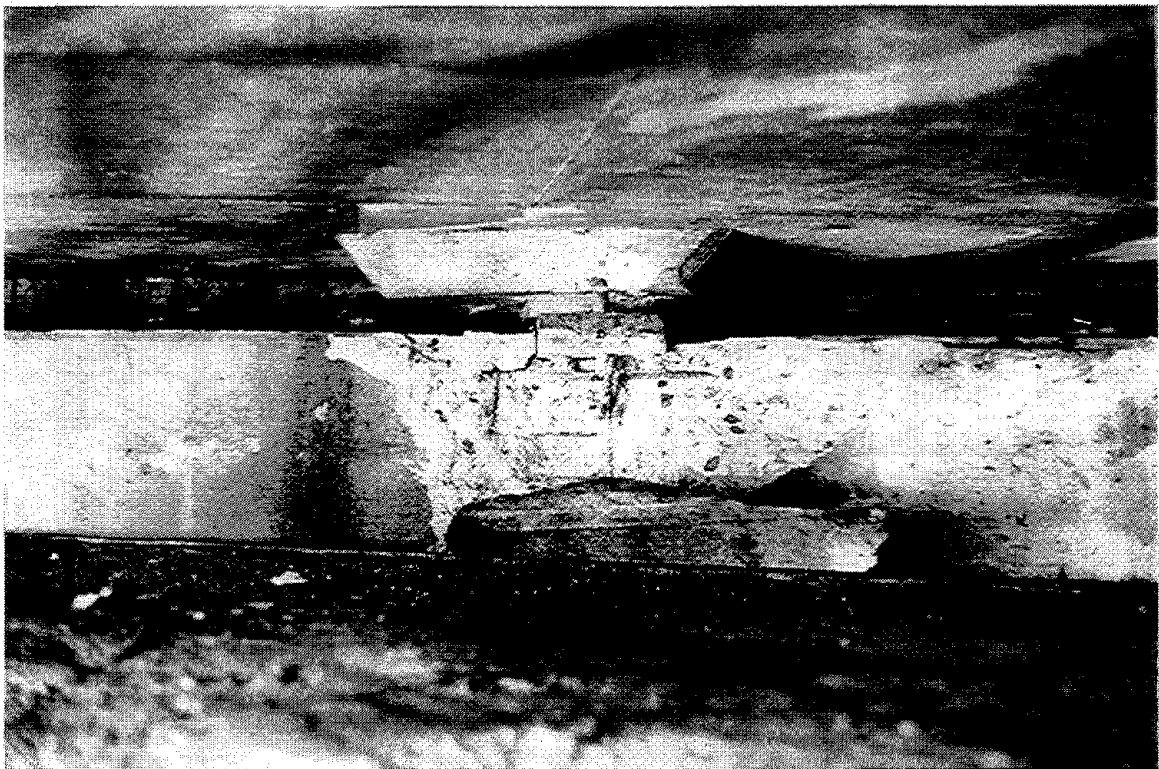
Figure 4.48 Abutment damage at sliding-type bearing

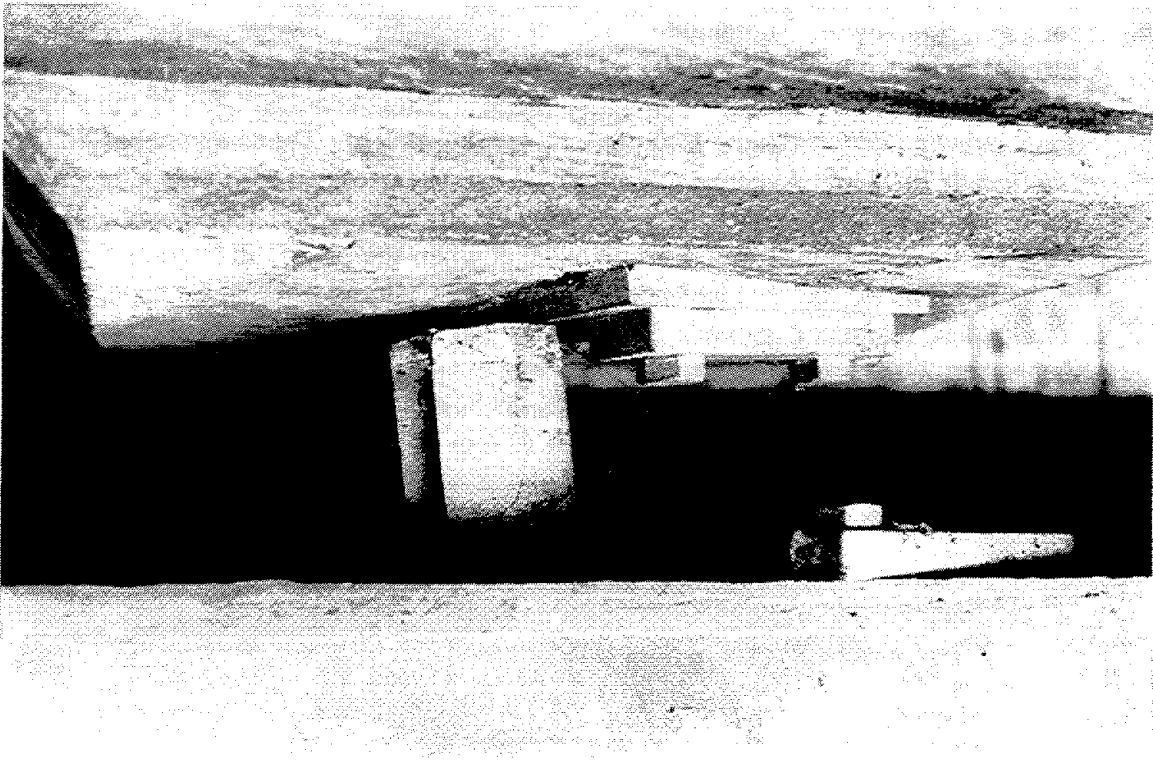
Figure 4.49 Displaced bearing block in rocker-type bearing

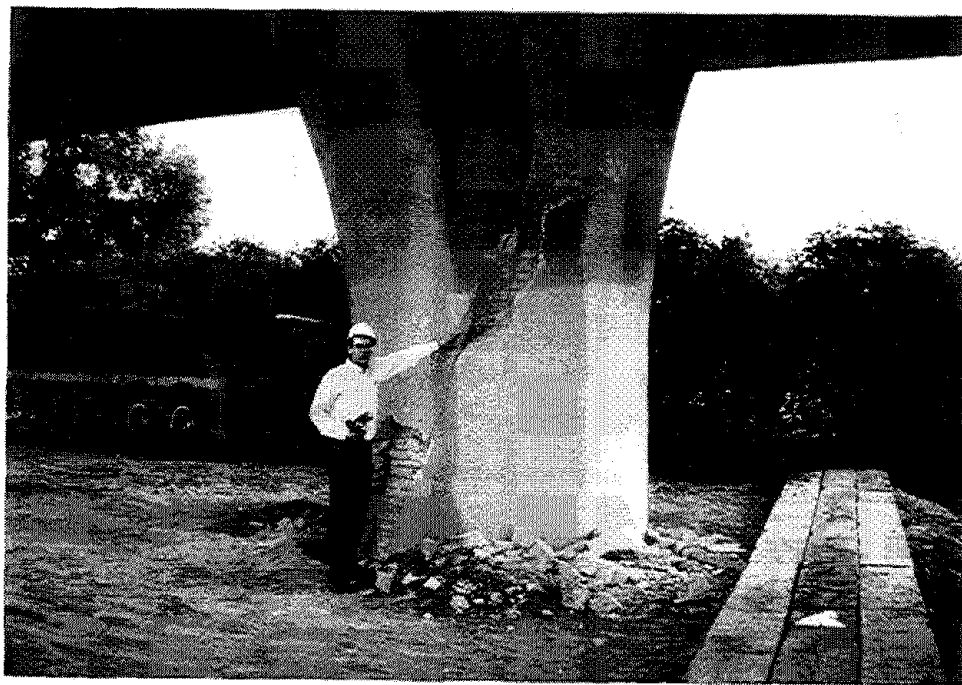
Figure 4.51 View of the westernmost pier at the Interstate 5, State Route 118, Southwest Connector, looking to the southeast. Loose cover concrete has been removed by Caltrans.

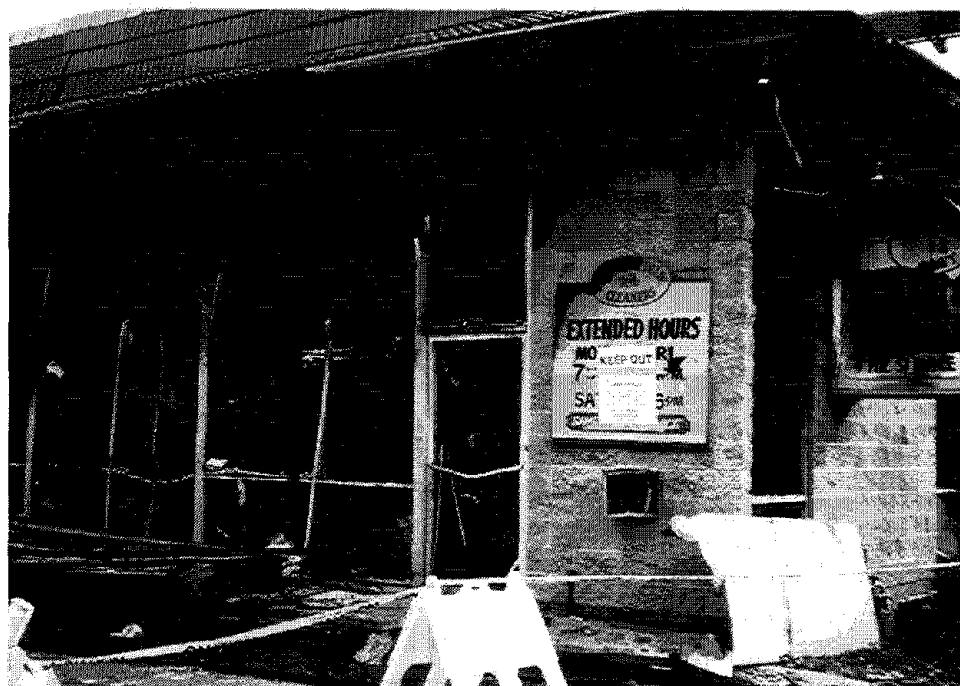
Figure 6.1 Fire damage in a single story commercial building.

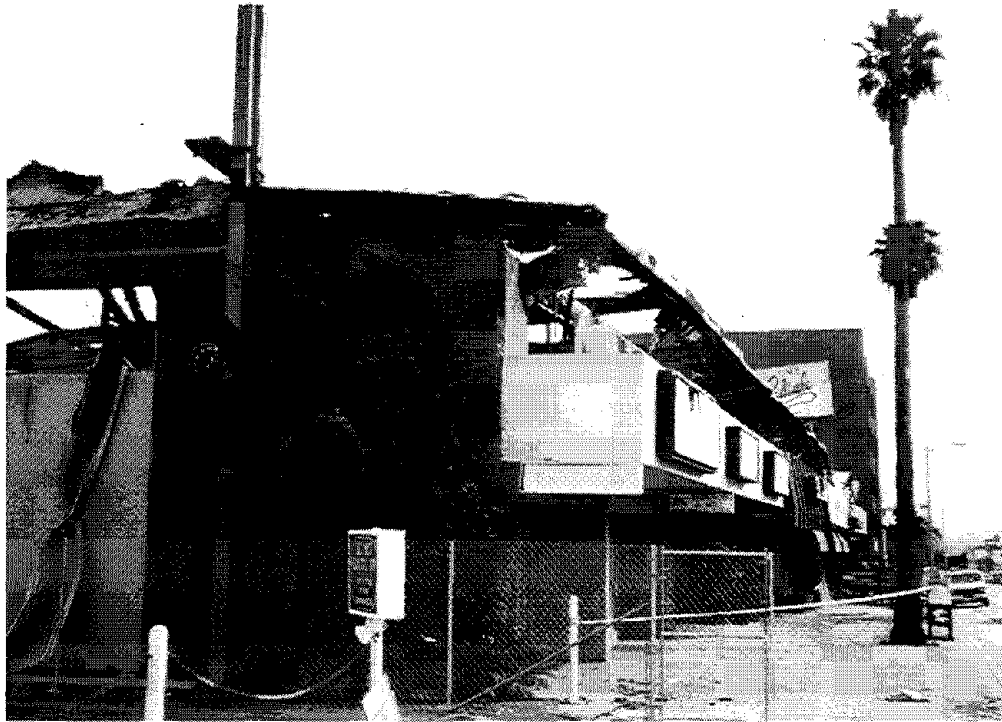
Figure 6.2 Fire damage in a two story commercial building.

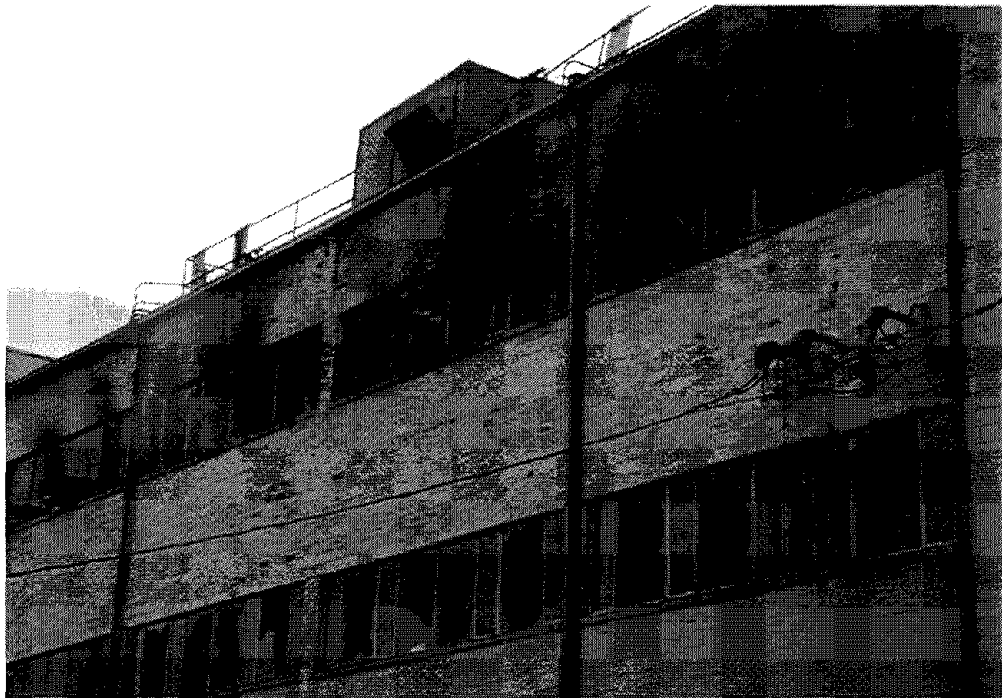
Figure 6.3 Fire damage in a three story commercial building.

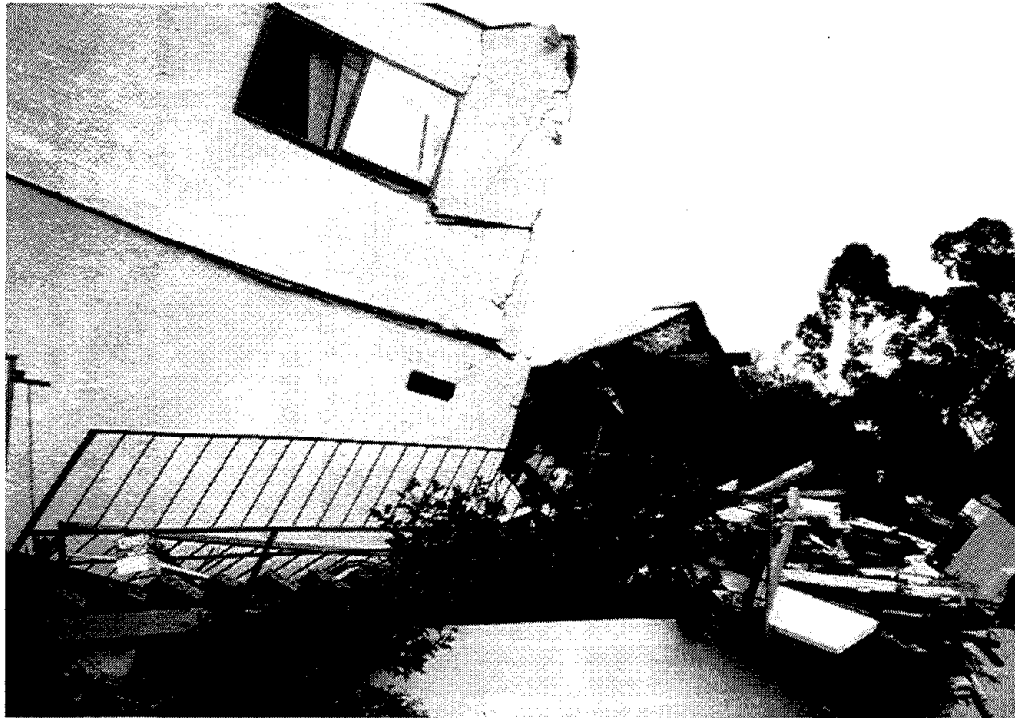
Figure 6.4 Partially collapsed apartment building with fire damage in the rear.

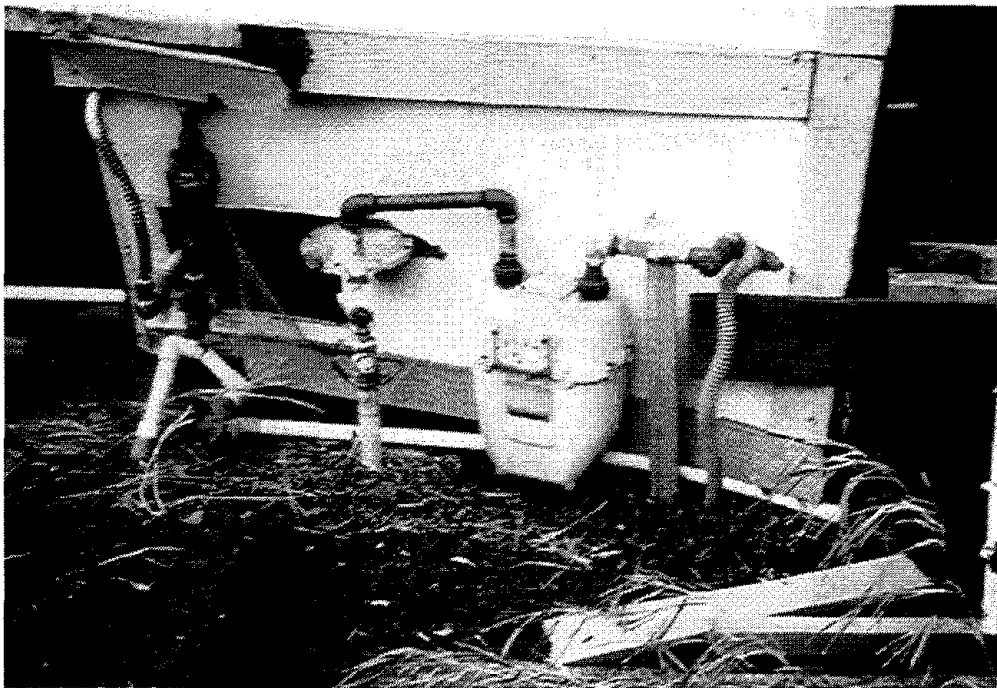
Figure 6.5 Damaged gas service in a manufactured housing development.

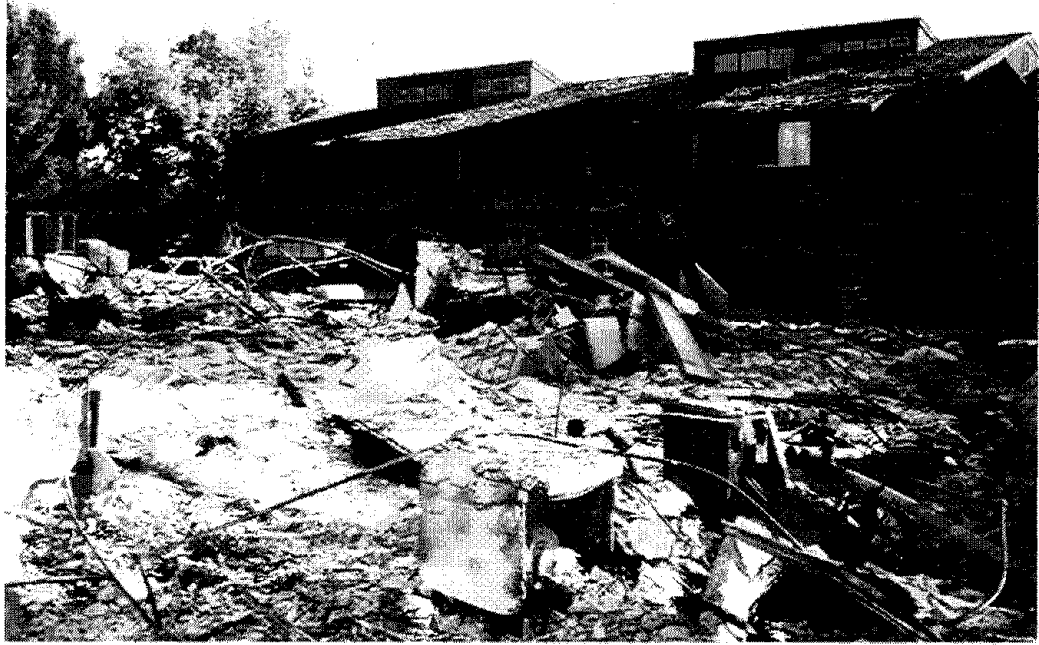
Figure 6.6 Multi-family residential building destroyed by fire.

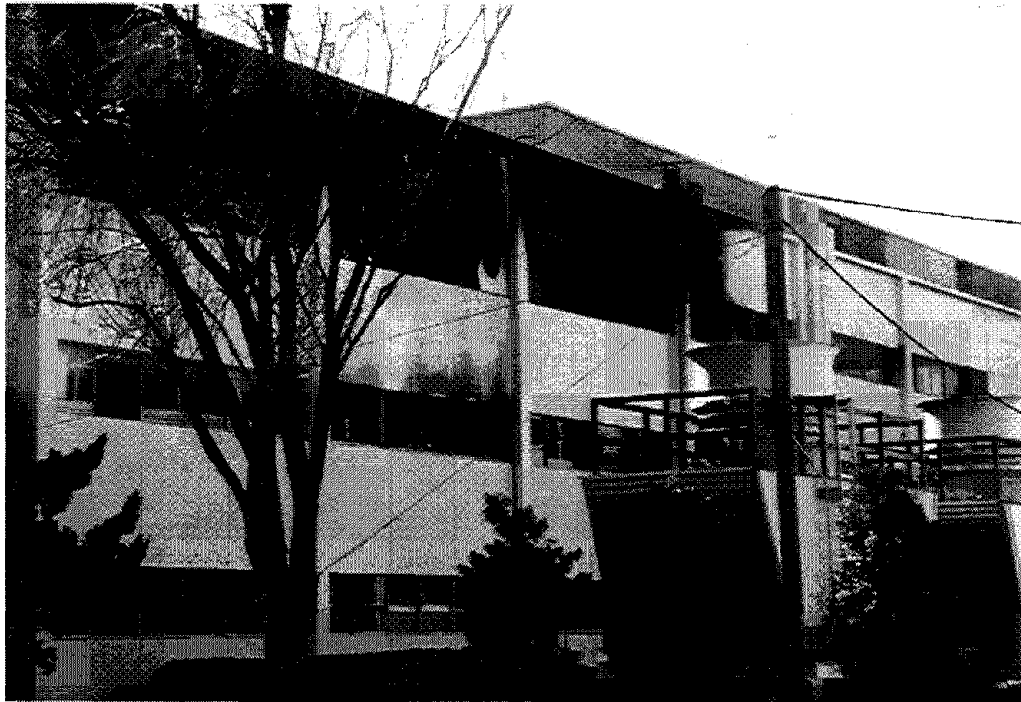
Figure 6.7 University science building damaged by fire.
