1994 Northridge Earthquake Performance of Structures, Lifelines, and Fire Protection Systems

Building and Fire Research Laboratory
National Institute of Standards and Technology
Gaithersburg, MD 20899-0001

May 1994

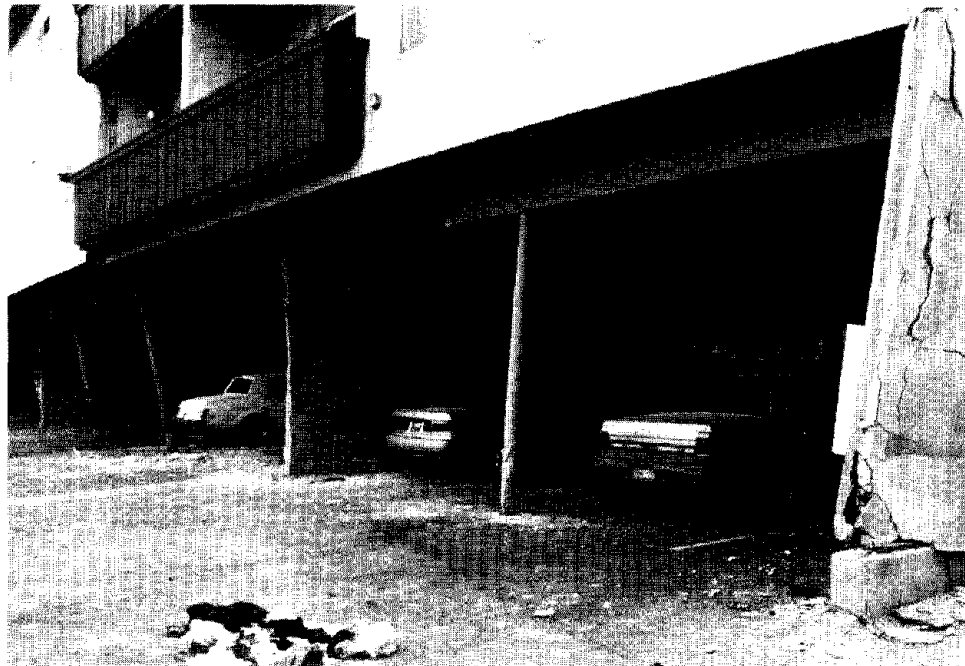
Figure 3.7. Racking, or leaning, of open first story parking areas was a common feature of damaged two and three-story apartment buildings.

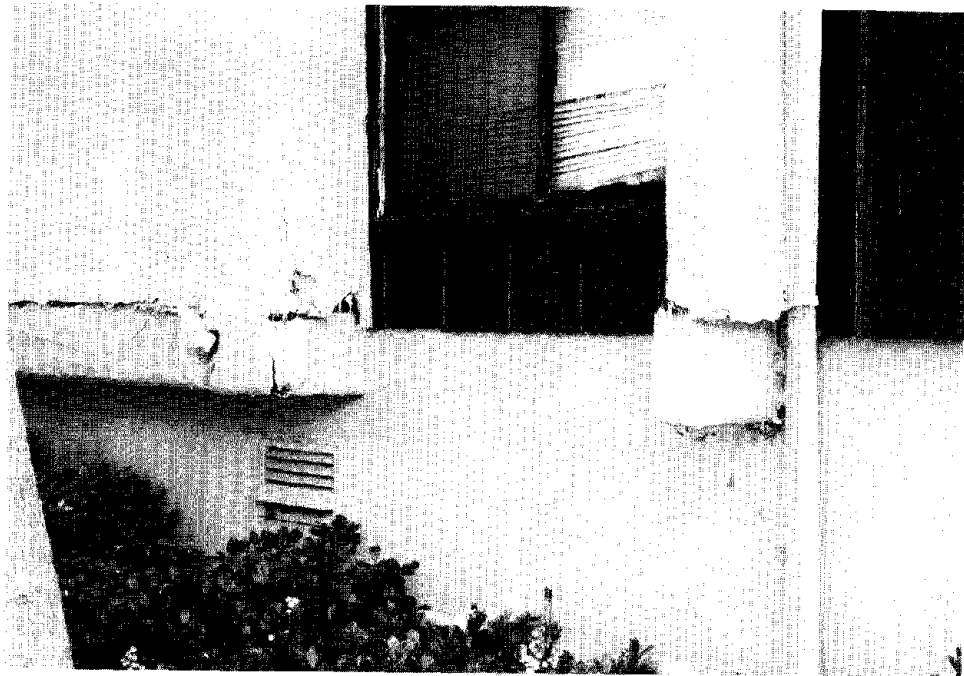
Figure 3.8. Horizontal cracks at the interface of the foundation wall (usually concrete) and the first story (typically wood-framed with stucco facade) were often seen in damaged low-rise apartment buildings.

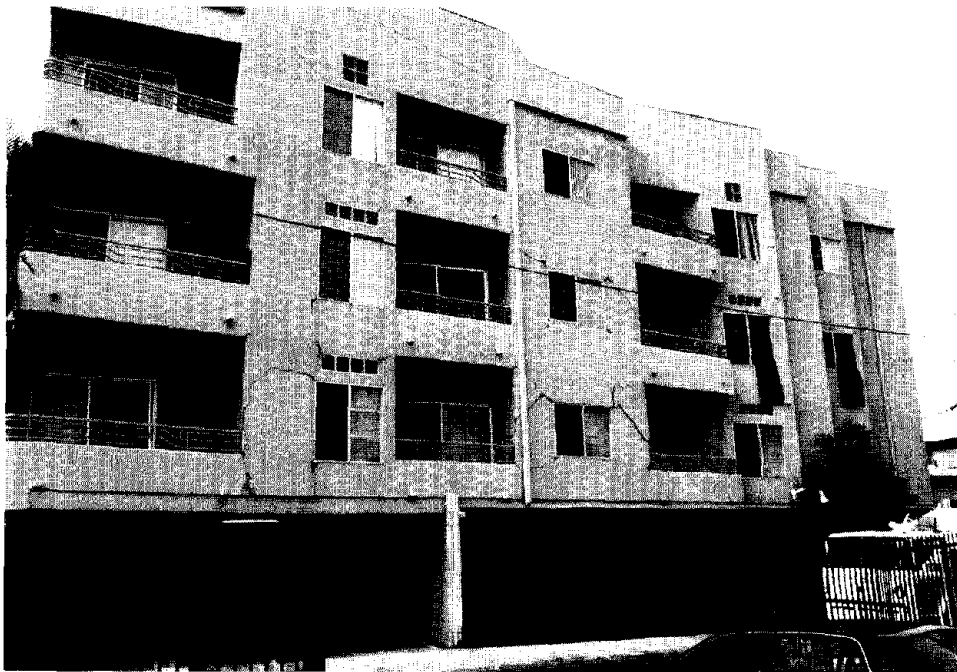
Figure 3.9. Typical damage in to low-rise apartment buildings included diagonal cracks in the stucco facade at the corners of windows and other openings.

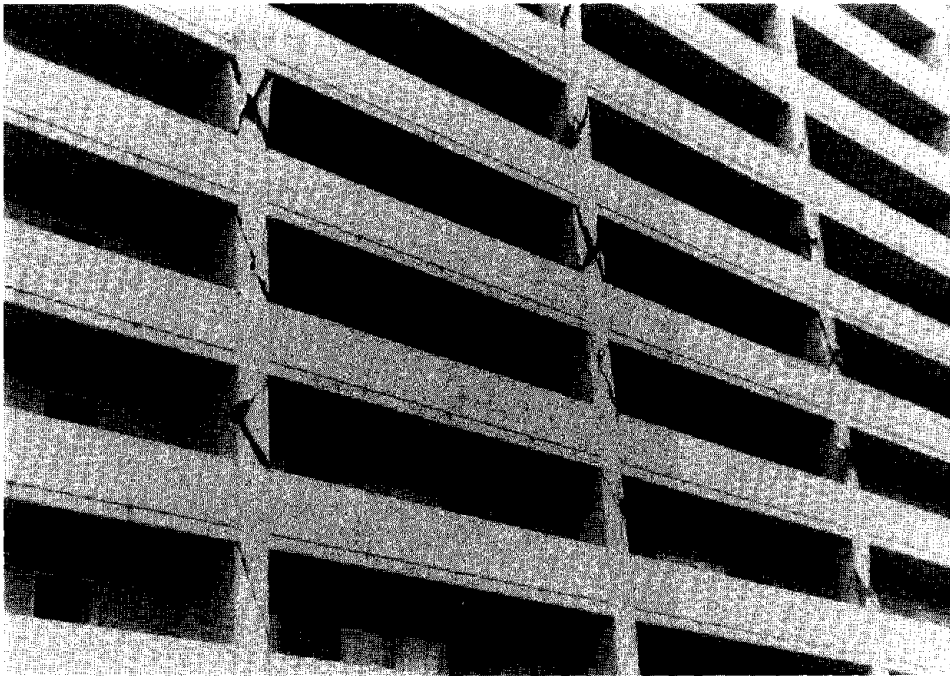
Figure 3.14. The back of the Champagne Towers building was badly damaged. The railings here are solid infill, which effectively stiffen the lower half of the columns. The shortened upper half of the columns were forced to accommodate all the displacement, and they failed in shear.

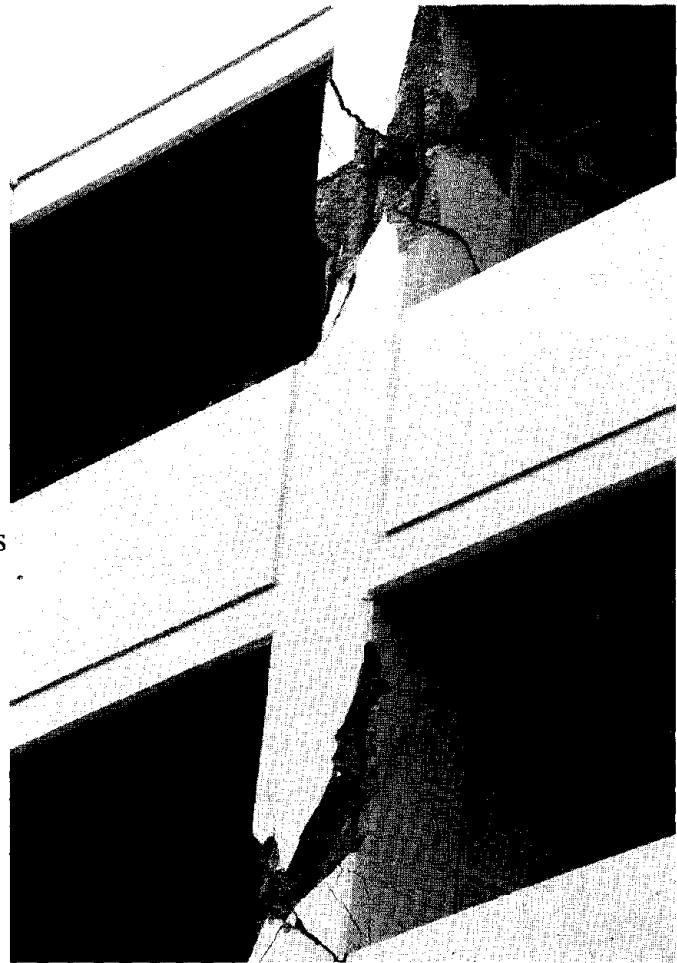
Figure 3.15. A closer view of the failed columns at the back of Champagne Towers shows minimal transverse reinforcement.

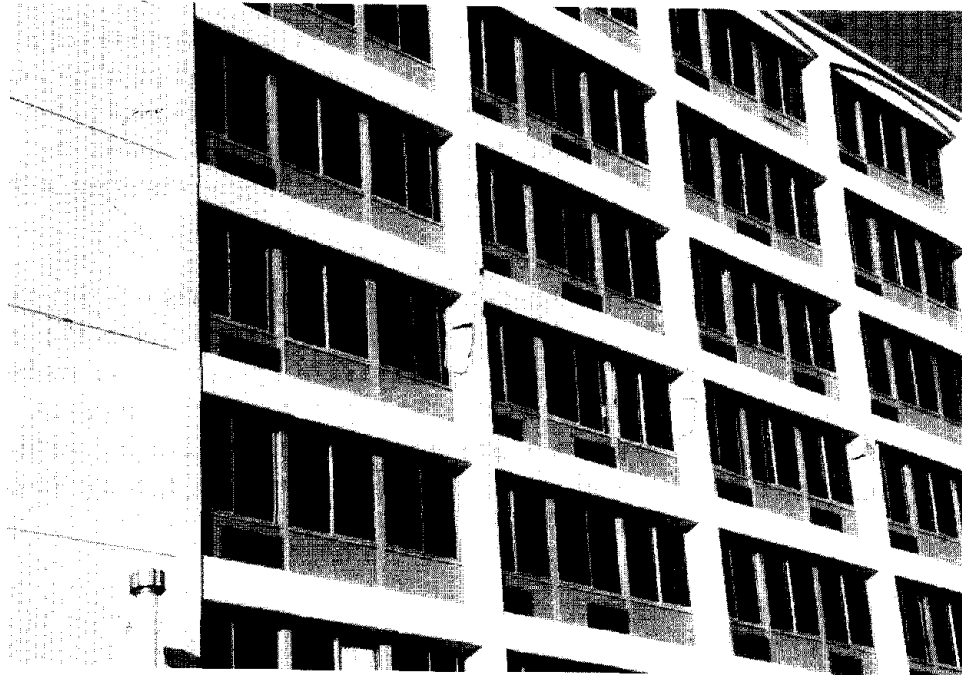
Figure 3.16. The bottom two stories of the concrete frame Holiday Inn in Van Nuys were damaged in the 1971 San Fernando quake and subsequently repaired. In the 1994 Northridge quake, damage was concentrated at the top of the fourth floor columns.

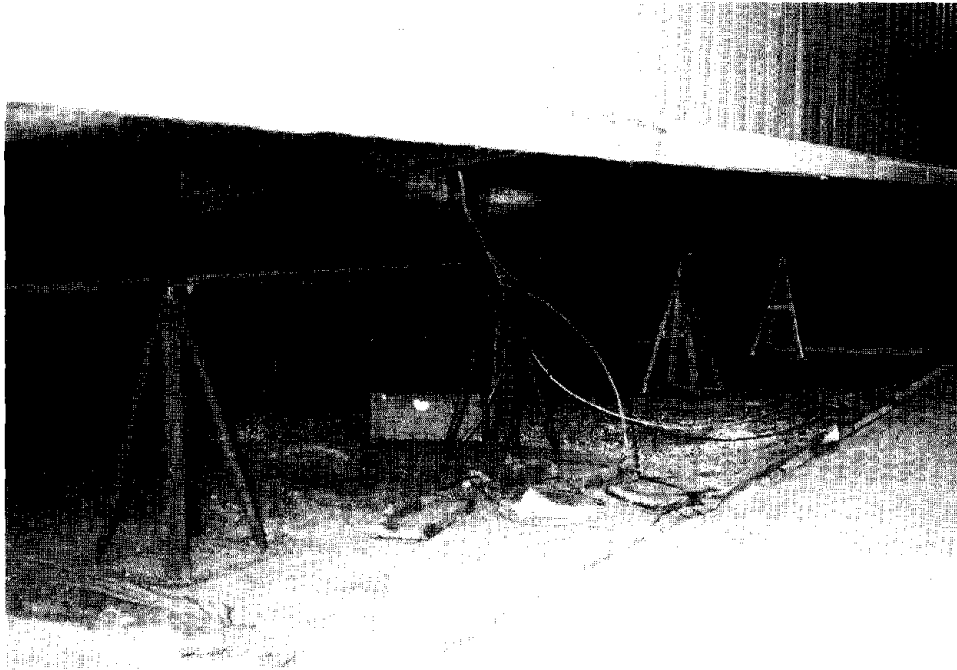
Figure 3.21. Another foundation system used for manufactured housing consists of supports constructed of small metal angles.

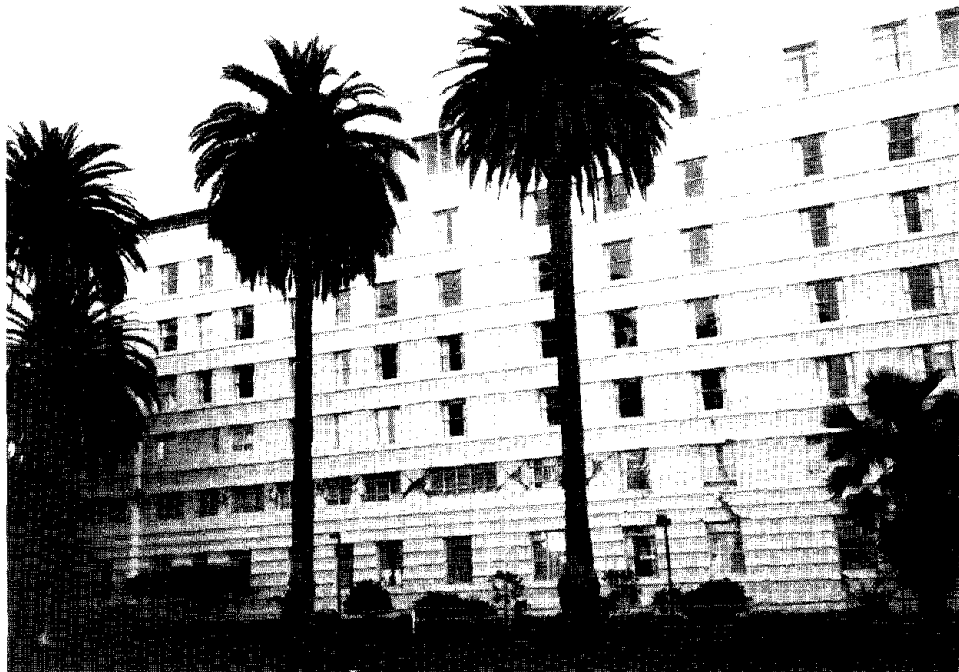
Figure 3.23. The seven-story northwest wing of St. John's hospital in Santa Monica experienced severe X-cracking in the piers between the second story windows.

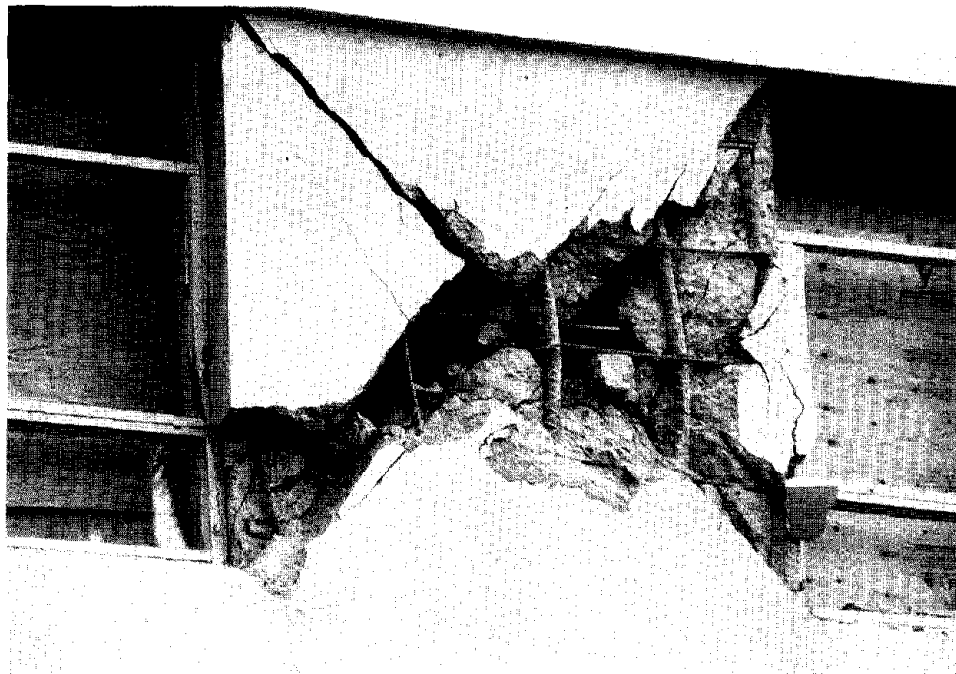
Figure 3.24. The transverse reinforcement in the St. John's hospital window piers was spaced at about 150-200 mm on center with 90° hooks at the ends, typical for construction of its age (about 50 years old).

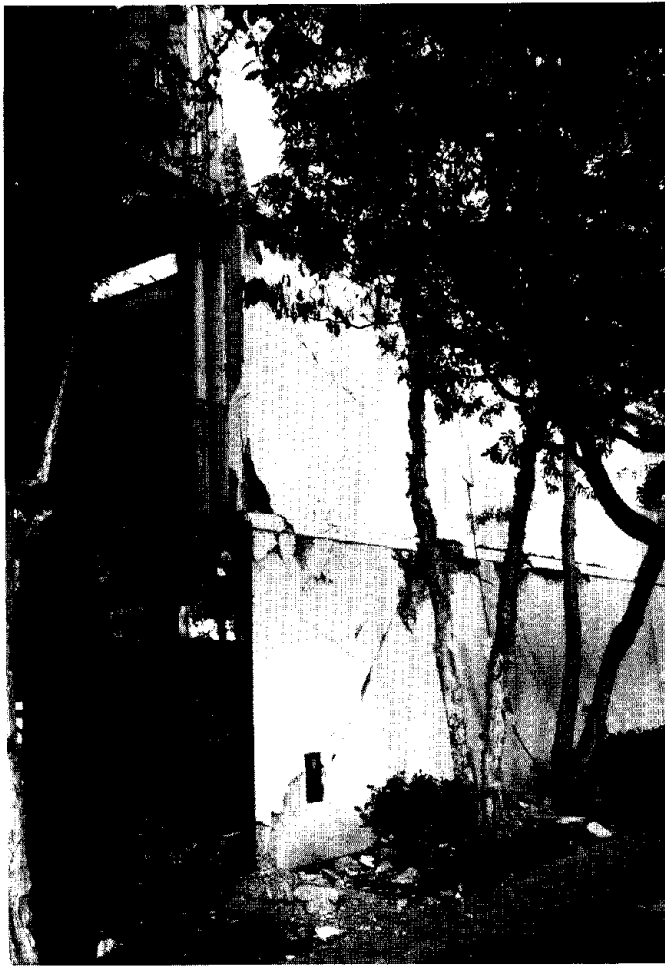
Figure 3.25. The concrete facade panels of the St. John's hospital parking garage had diagonal cracks and crushed toes.

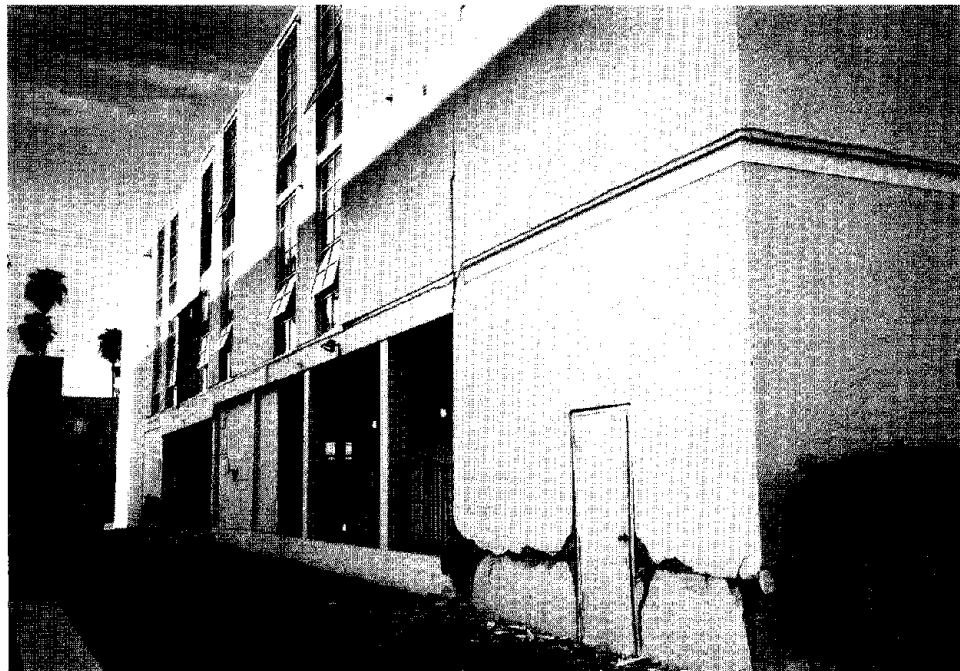
Figure 3.27. The facade of the five-story Berkley Convalescent Hospital directly adjacent to the St. John's Hospital complex consisted of two wythes of brick masonry with a reinforced and grouted space between. In some places, all three layers of this facade were destroyed along lines of diagonal cracking. The facility was evacuated.

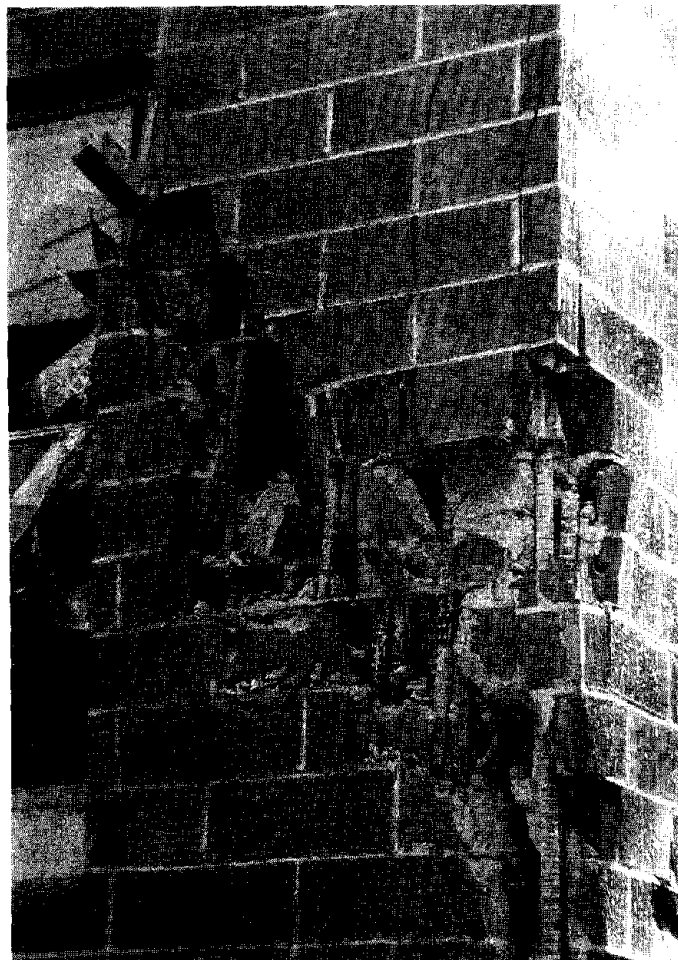
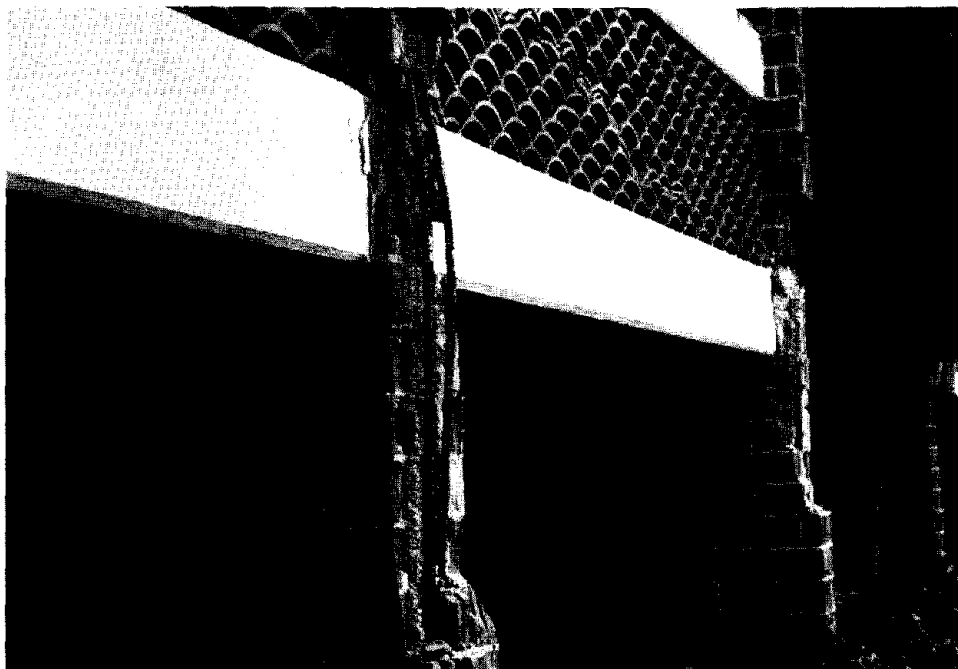
Figure 3.28. Two faces of the Berkley Convalescent Hospital had wing walls separating balconies. The ends of these wing walls spalled at the lower stories.

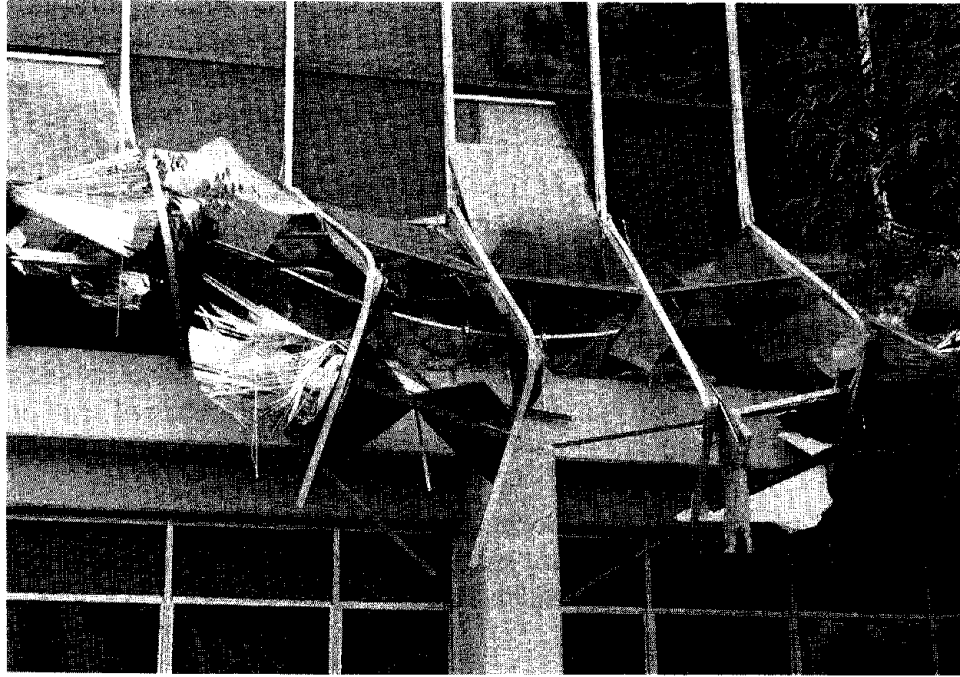
Figure 3.41. The second story of the concrete frame Kaiser Permanente office building on Balboa Avenue in Granada Hills completely collapsed. The first story was relatively undamaged, suggesting it was far stiffer than the story above.

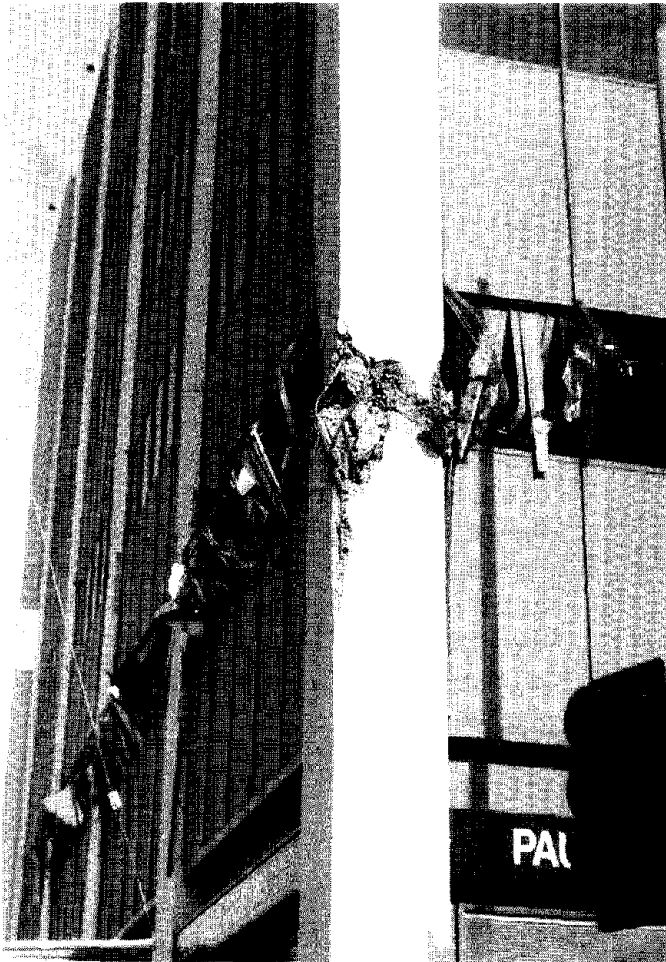
Figure 3.47. The cracking in the concrete columns at the second story was so extensive that the vertical-load carrying capacity of the building was affected. The building settled 50-100 mm at the second story, as these bulging window frames attest. The worst damage was at the southeast corner, the outside corner of the L-shape, pictured here. The building, which developed a slight list, was demolished within days of the quake.

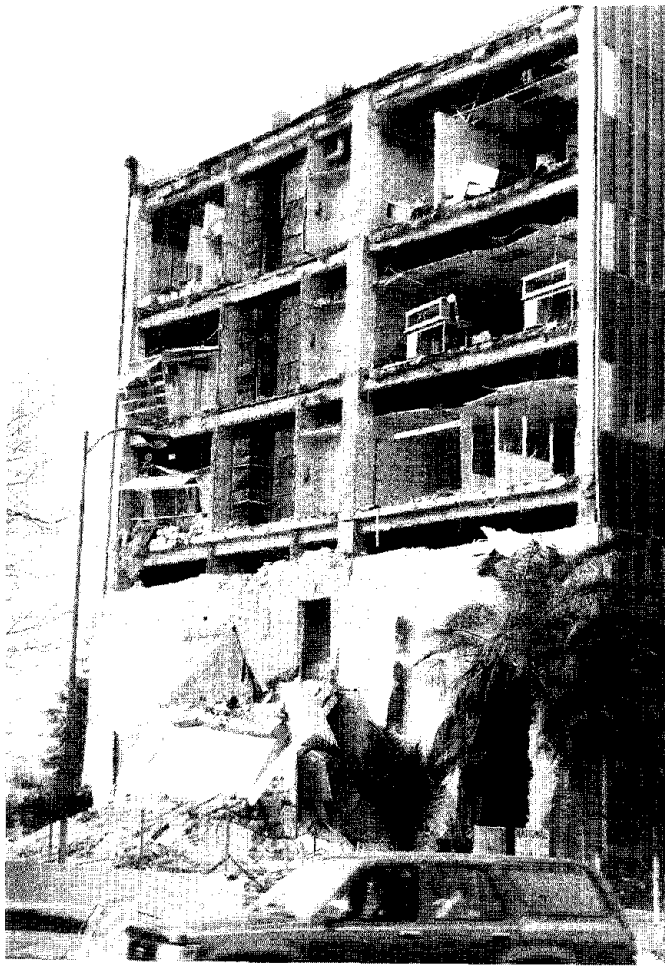
Figure 3.49. The east end wall and stair tower of a five-story apparently steel-framed office building on Sherman Way in Reseda collapsed. The enclosing masonry wall became detached from the structure and slid to the ground, with the upper stories remaining intact. The doorway opening in the wall, shown here resting at about the second story level, originally provided access from the top story to the stair tower.

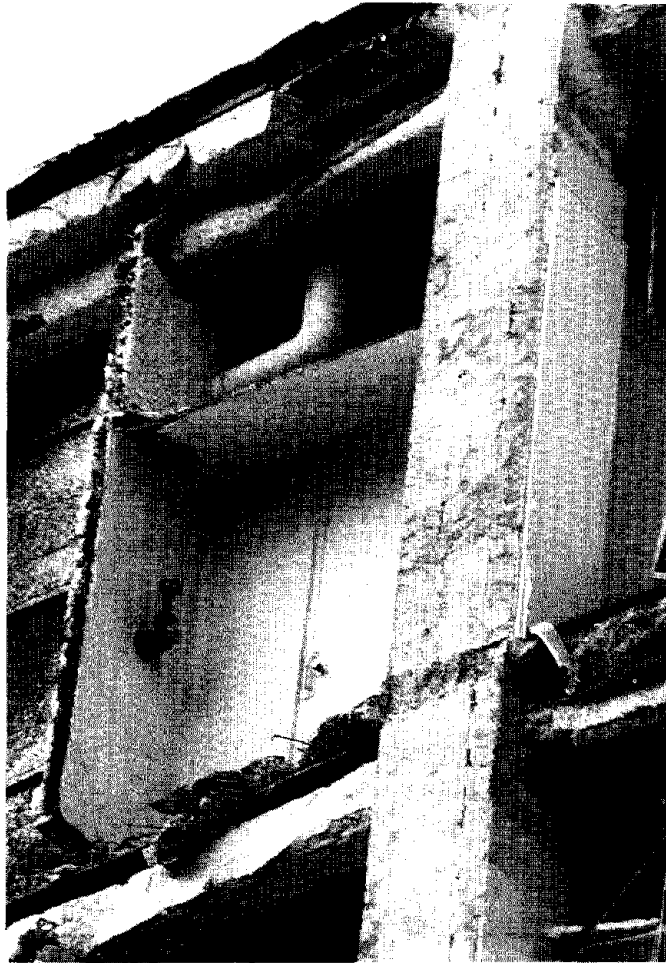
Figure 3.52. The first-story columns of the steel-framed building housing the American Savings Bank on Topanga Canyon Road in Canoga Park flexed during the quake and ended up slightly displaced from their original positions.

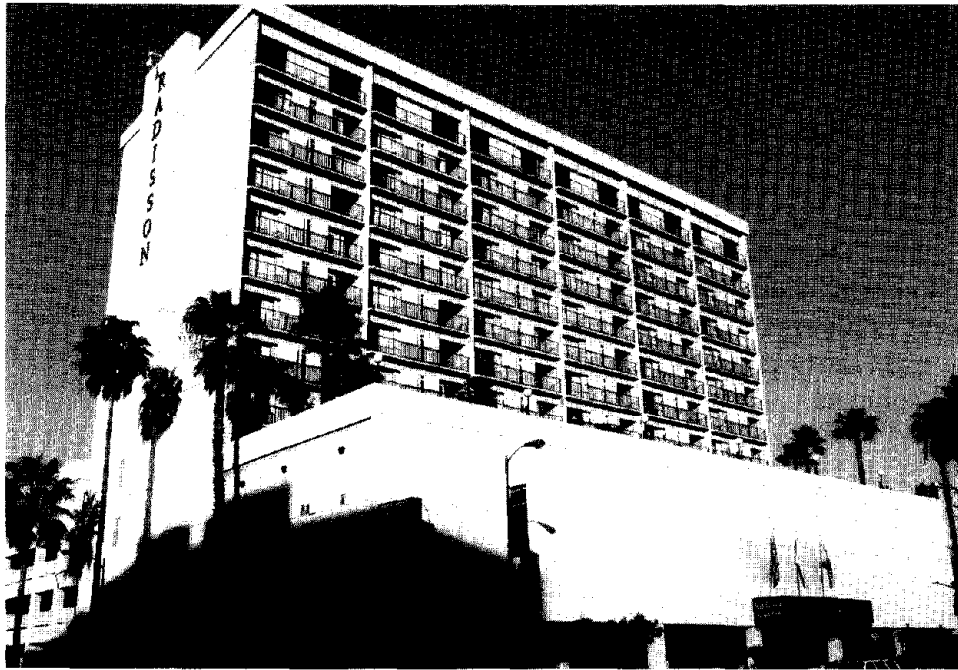
Figure 3.55. The concrete Radisson Valley Center Hotel in Sherman Oaks had serious damage to the columns at the first and fifth stories.

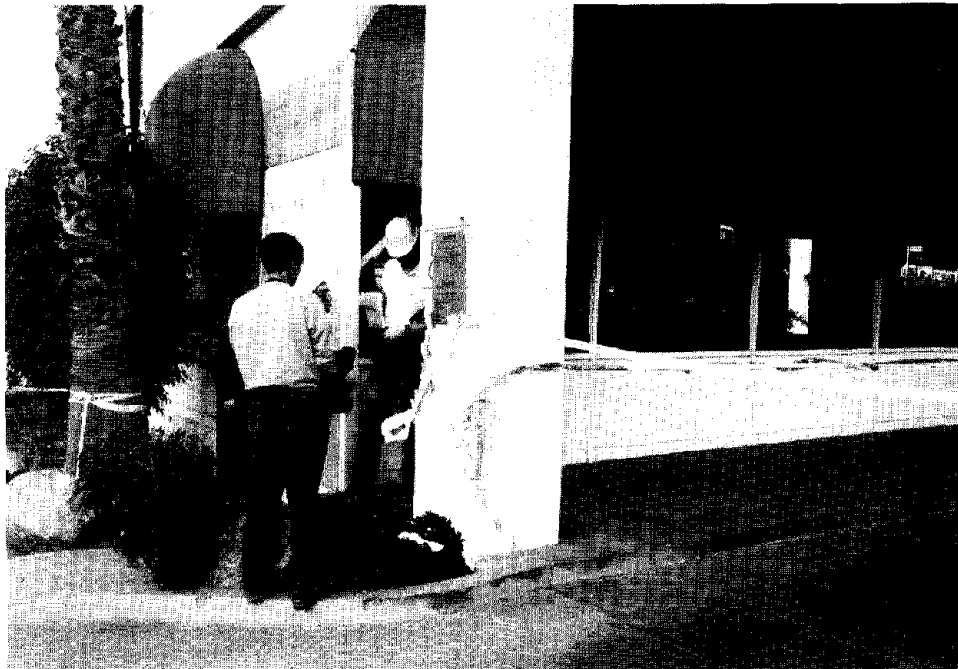
Figure 3.56. The columns supporting the three-story appendage at the front of the Radisson Hotel had serious shear cracks and related spalling.

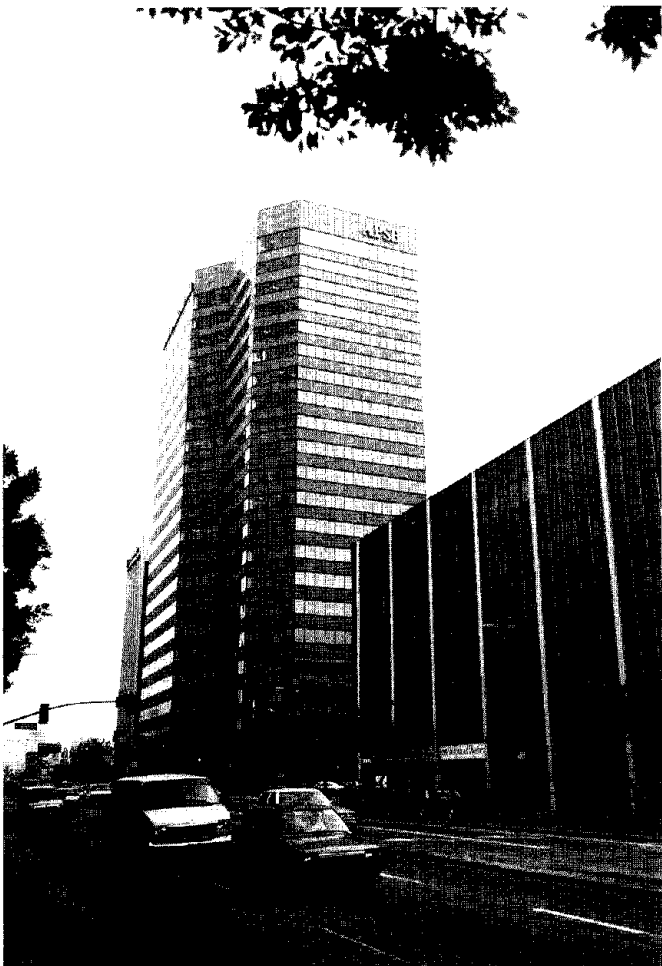
Figure 3.58. The reinforced masonry facade of this steel-framed building in Sherman Oaks was badly damaged.

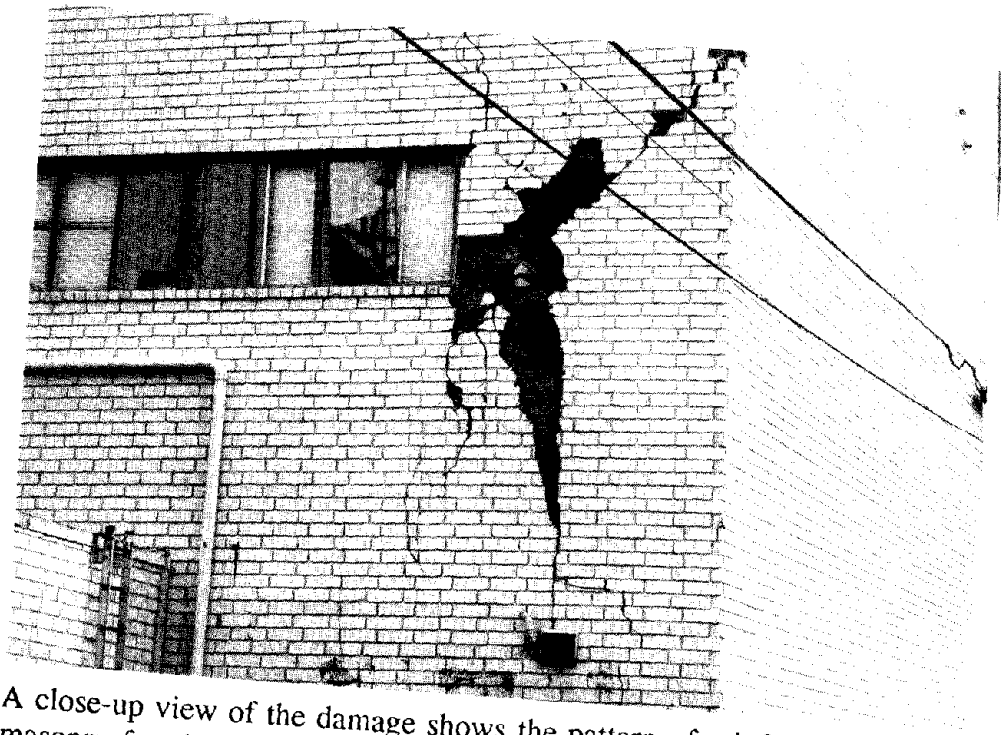
Figure 3.59. A close-up view of the damage shows the pattern of reinforcing used in the masonry facade.

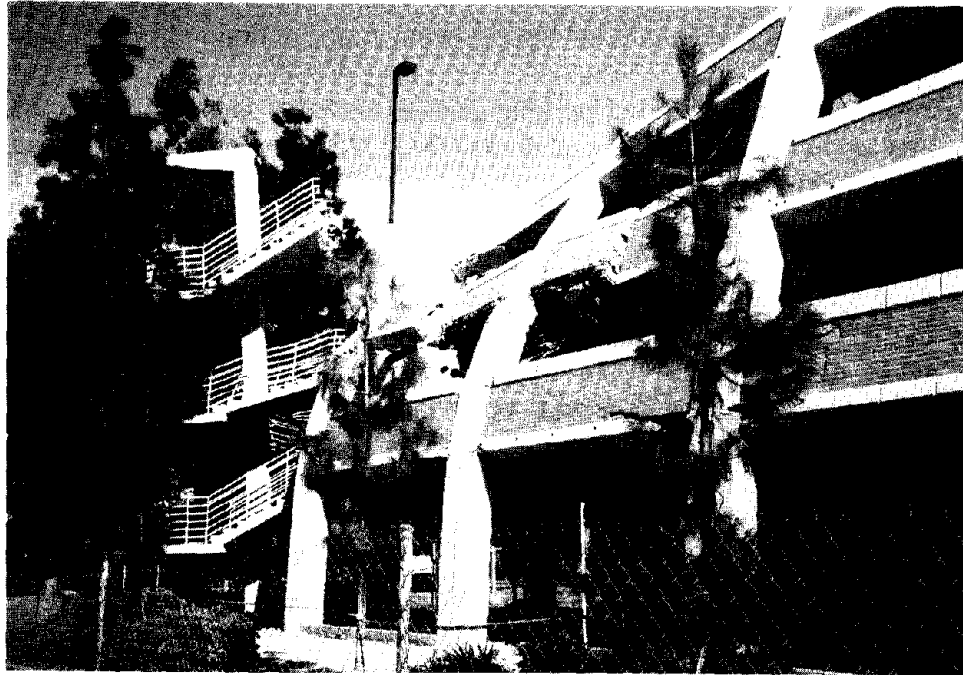
Figure 3.60. The three-year old four-level parking garage at the Northridge campus of California State University partially collapsed in the earthquake. The collapse apparently started at the interior, causing the exterior frame to be pulled in to the middle of the structure. Precast concrete "trees" were connected to form a moment-resisting frame at the exterior of the structure.

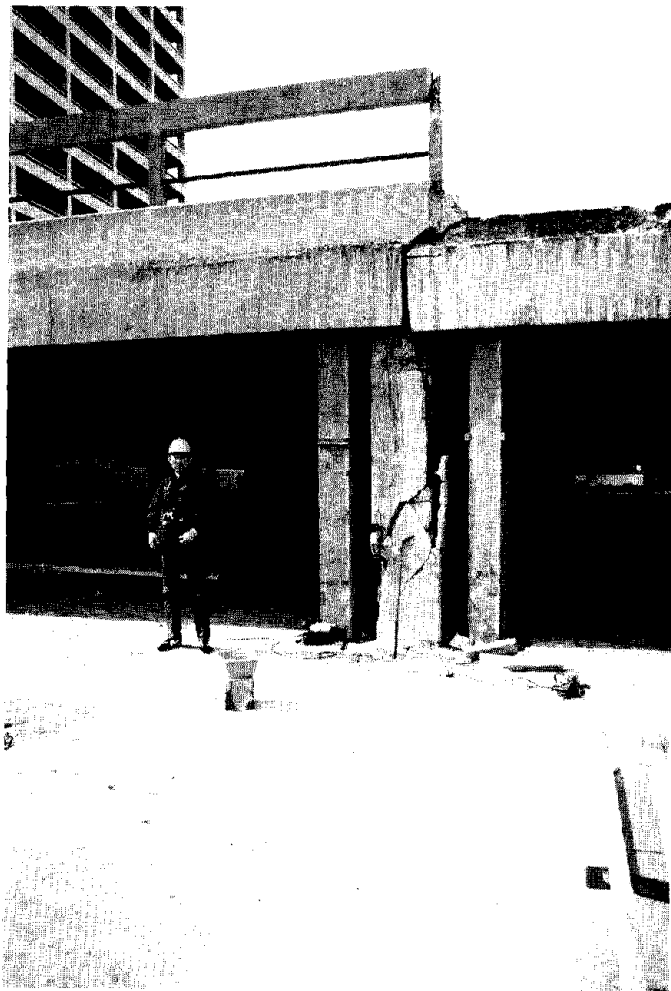
Figure 3.65. The exterior columns of the Trans World Bank parking garage, which had not been strengthened, were badly damaged.

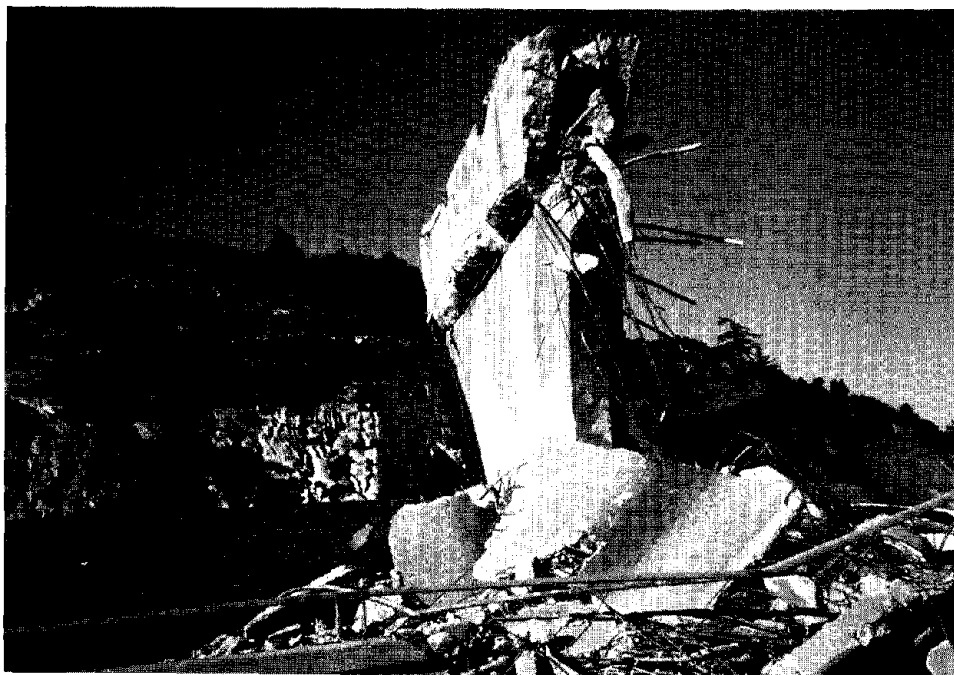
Figure 4.12. Damage at Pier 3 of the SR14/I5 Separation and Overhead, Ramp C, looking to the west (Photo courtesy of EERC).

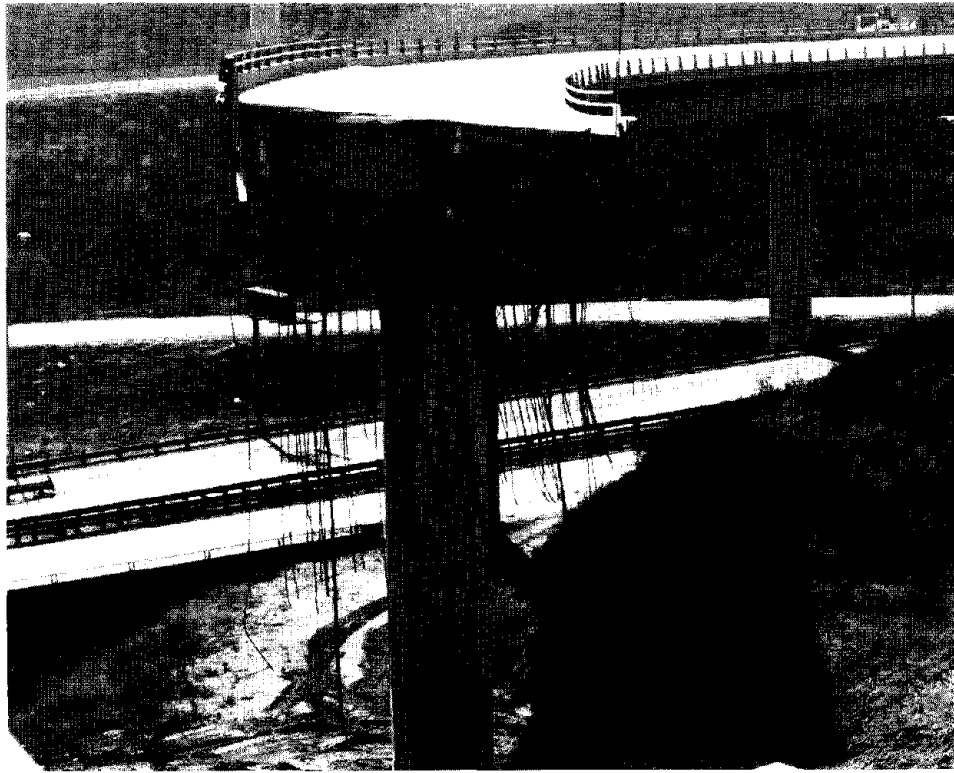
Figure 4.15. View of the flexural failure at Pier 3 of the SR14/I5 North Connector Overcrossing, looking to the south.

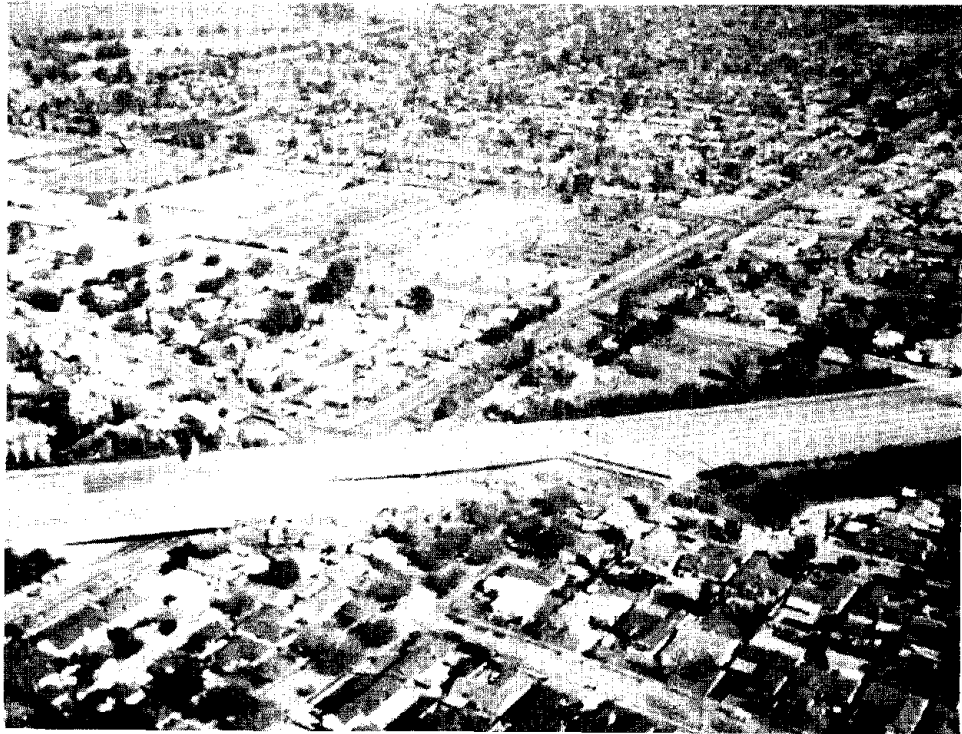
Figure 4.19. Aerial view of the SR118 Mission-Gothic Undercrossing, looking to the north showing collapsed eastbound bridge (Photo courtesy of FHWA).

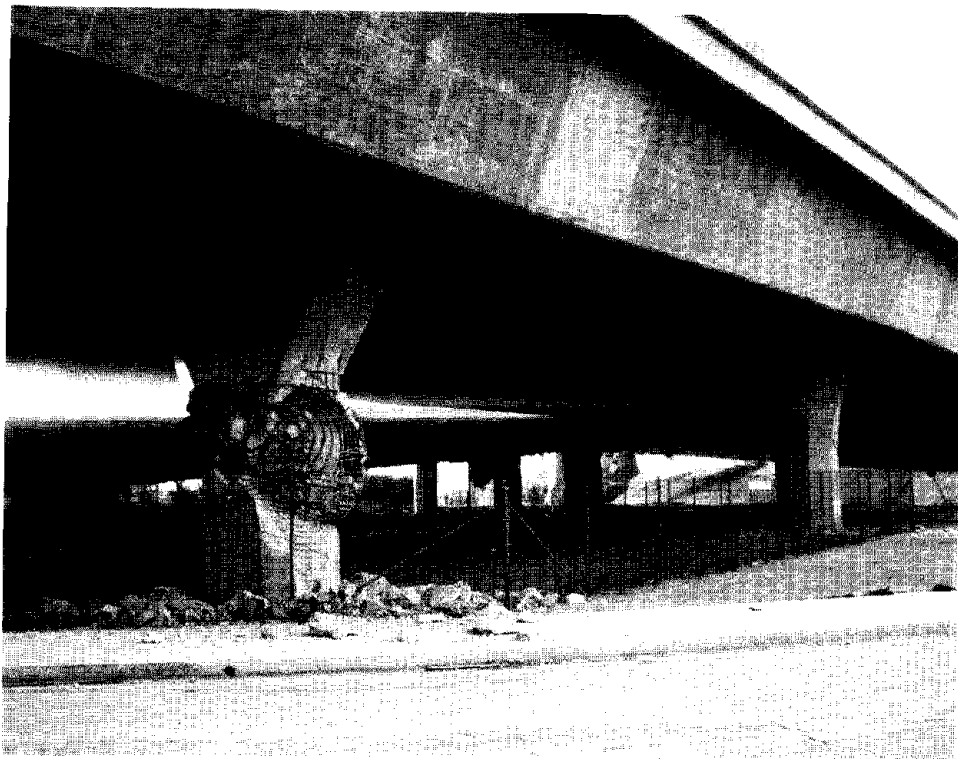
Figure 4.20. Damage to piers of the SR118 Mission-Gothic Undercrossing, looking to the northwest at the north face of the westbound bridge, Bents 3 (foreground) and 2.

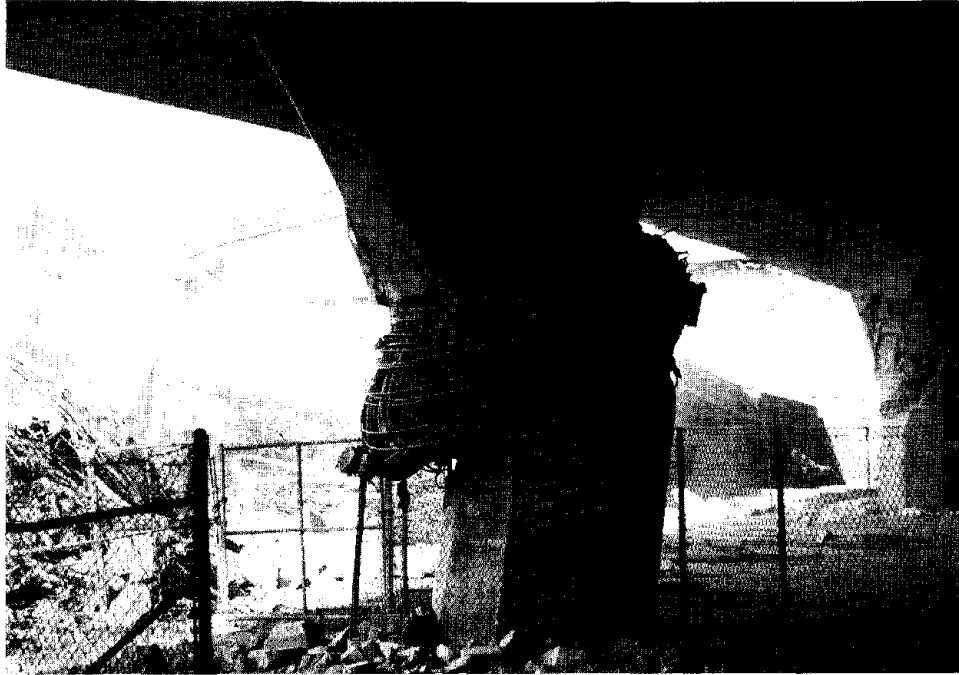
Figure 4.21. Damage to a pier of the SR118 Mission-Gothic Undercrossing, looking to the northwest at the southernmost pier of Bent 3 of the westbound bridge.

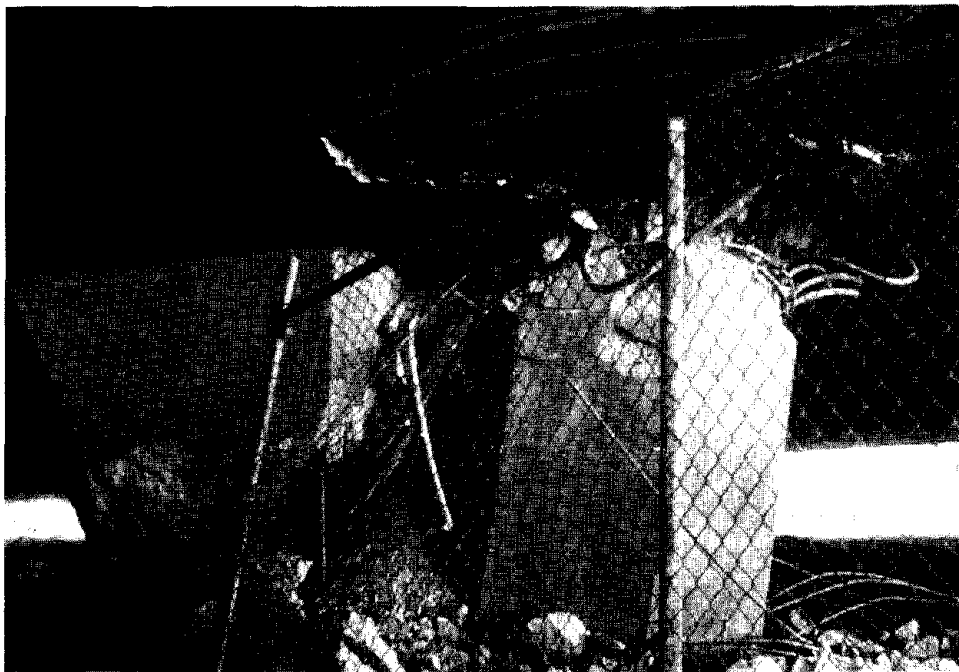
Figure 4.22. Damage to a pier of the SR118 Mission-gothic Undercrossing, looking to the west at Bent 4 of the eastbound bridge, which collapsed (Photo courtesy of EERC).

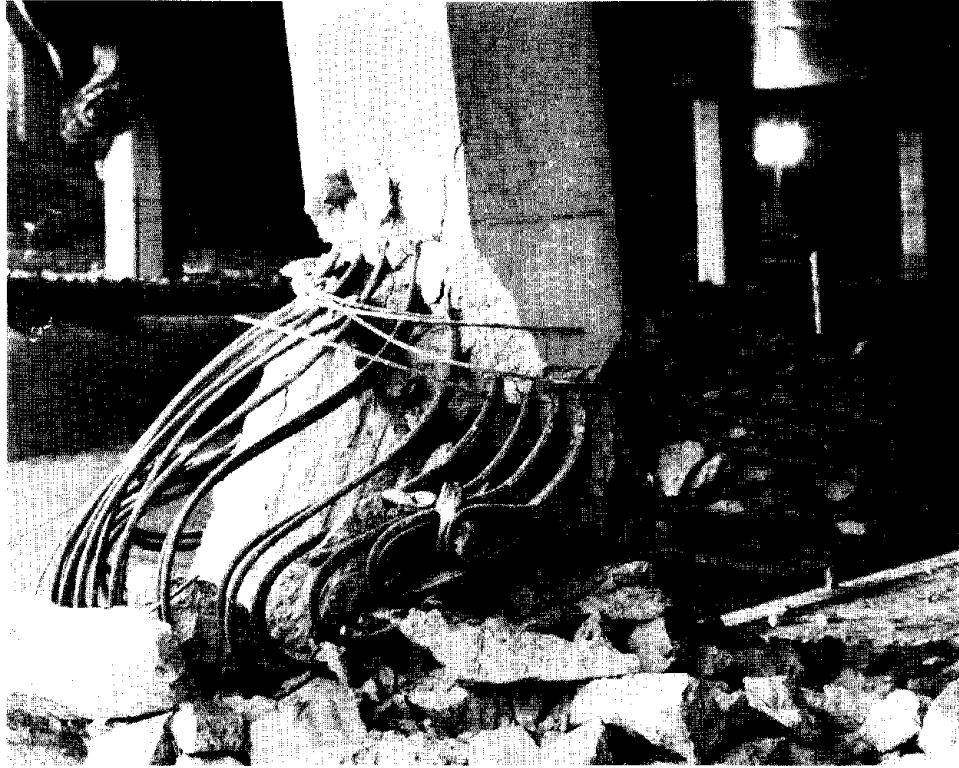
Figure 4.27. Damage to pier 3S-1 of State Route 118 at Bull Creek Canyon Channel, looking to the northwest.

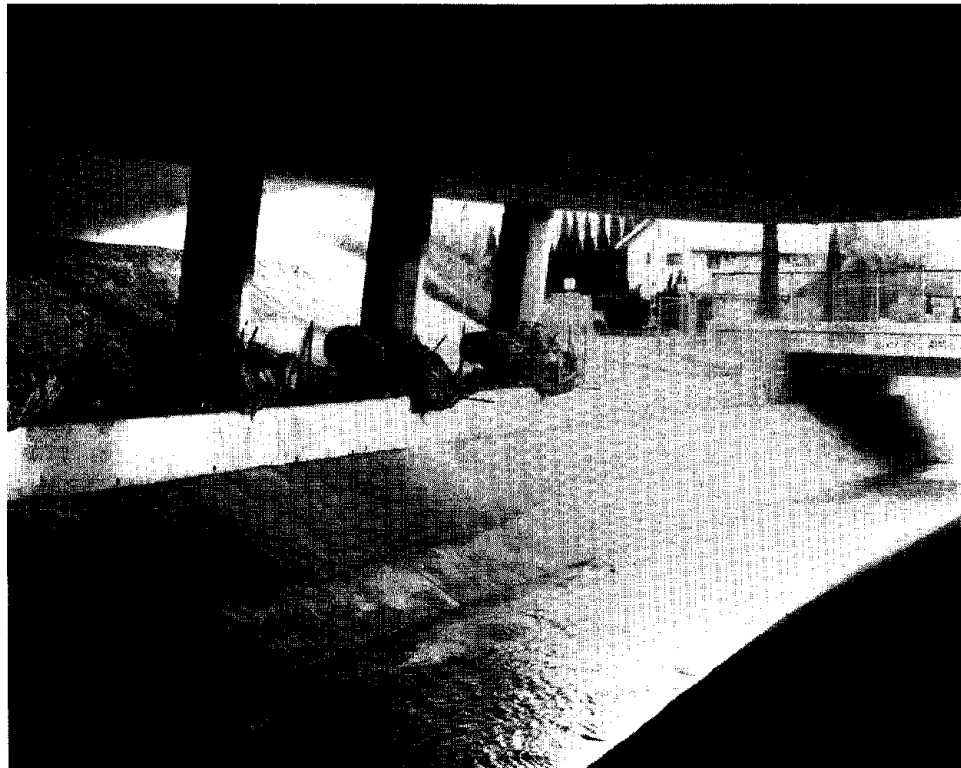
Figure 4.28. Damage to piers of Bent 3S of State Route 118 at Bull Creek Canyon Channel, looking to the southeast.

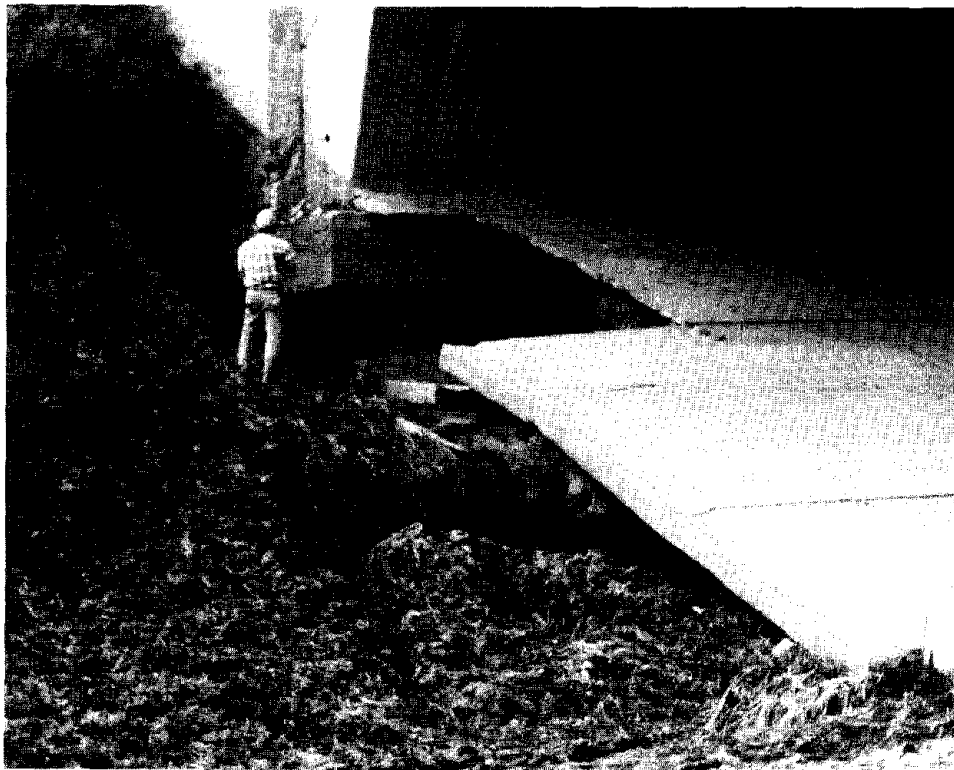
Figure 4.32. SR118 Balboa Avenue Overcrossing, view of the washout on the east side of the south abutment, caused by a ruptured water main.
