1994 Northridge Earthquake Performance of Structures, Lifelines, and Fire Protection Systems

Building and Fire Research Laboratory
National Institute of Standards and Technology
Gaithersburg, MD 20899-0001

May 1994

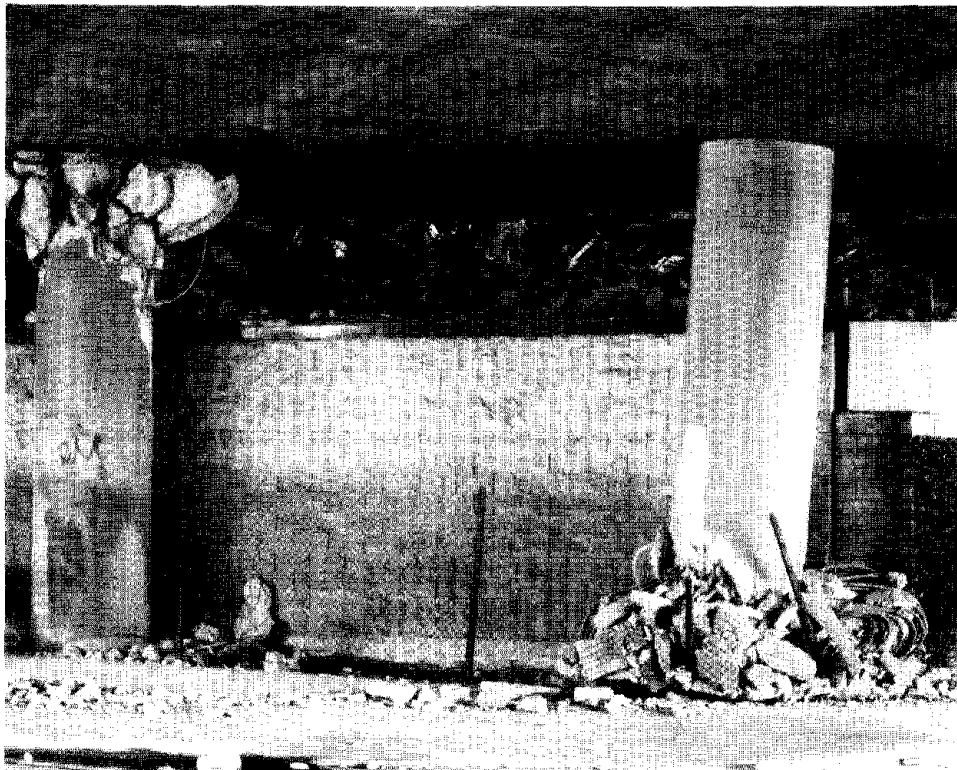
Figure 4.39. Failed piers in Bent 7 supporting westbound lane of I10 at Venice Blvd.

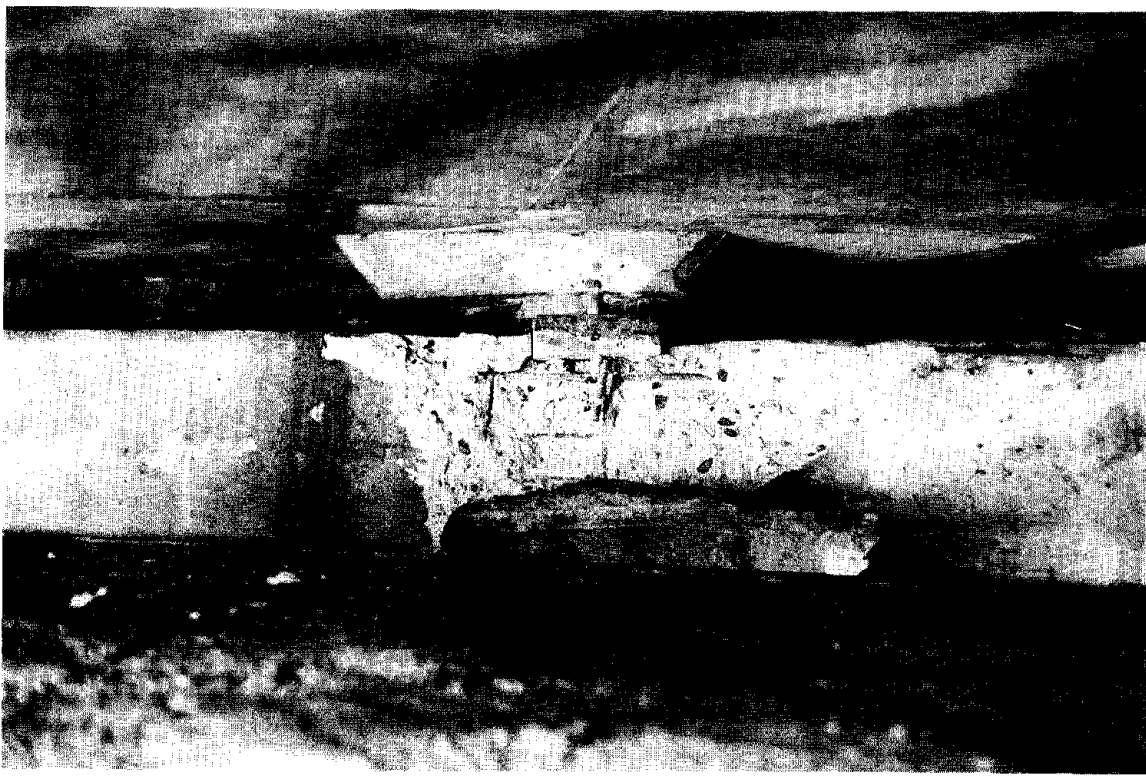
Figure 4.48. Abutment damage at sliding-type bearing.

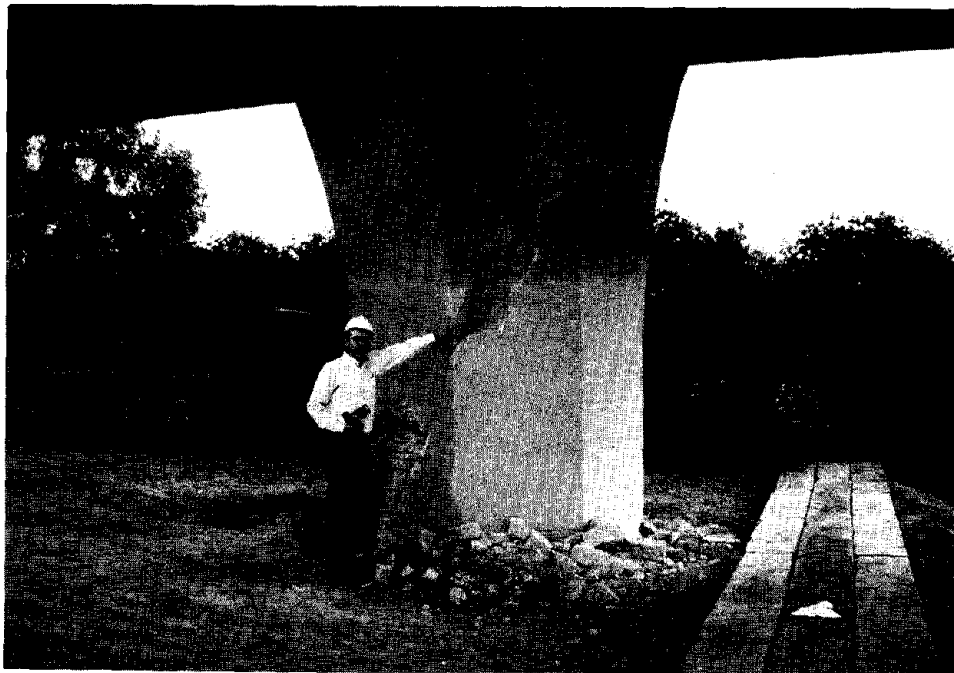
Figure 4.51. View of the westernmost pier at the Interstate 5, State Route 118, Southwest Connector, looking to the southeast. Loose cover concrete has been removed by Caltrans.

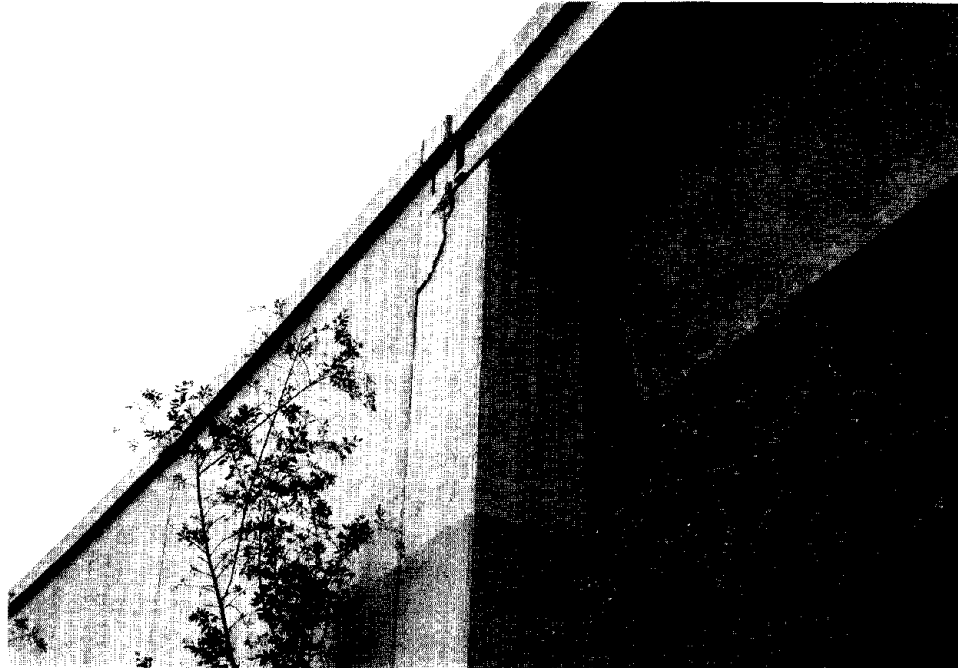
Figure 4.57. Close-up of abutment wall cracking at the east end of the ramp connecting eastbound SR118 with northbound I210.

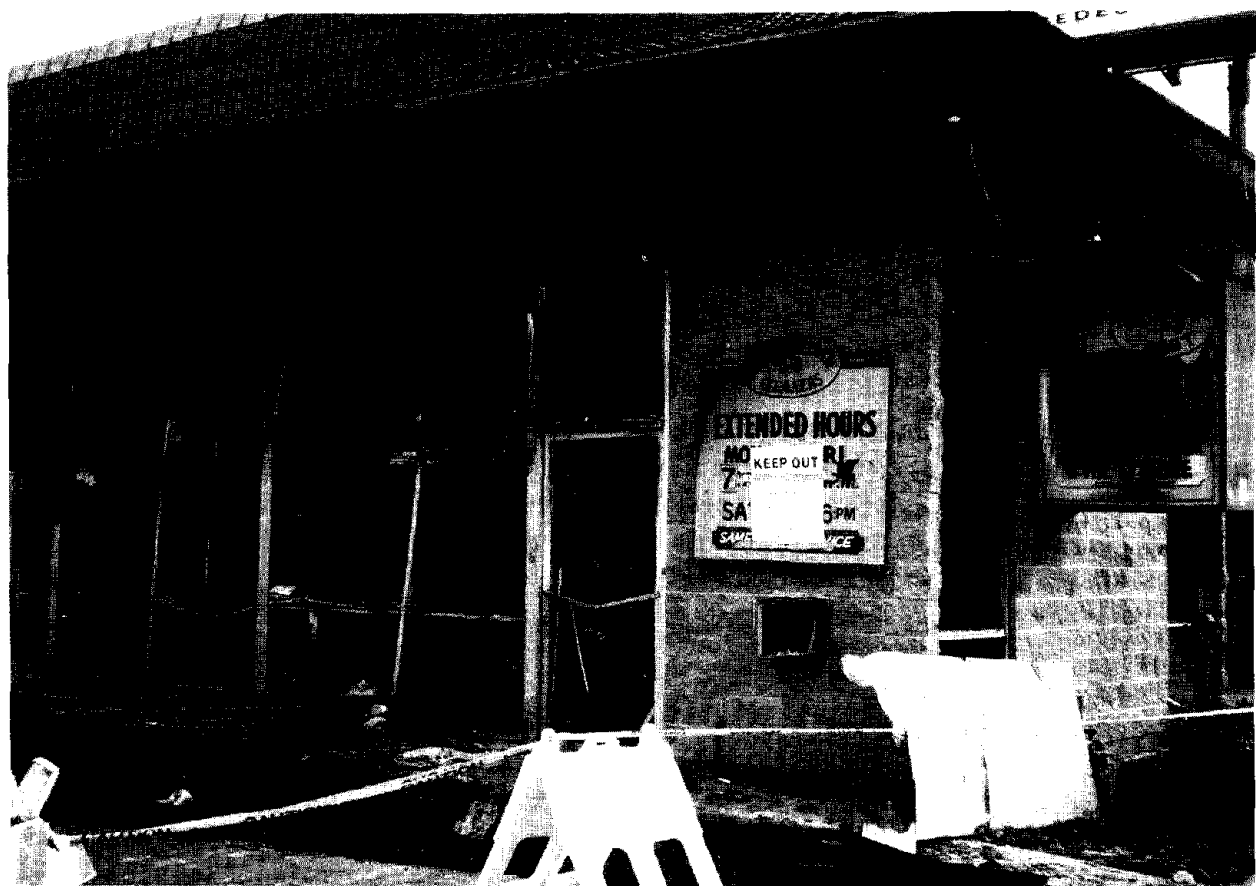
Figure 6.1. Fire damage in a single story commercial building.

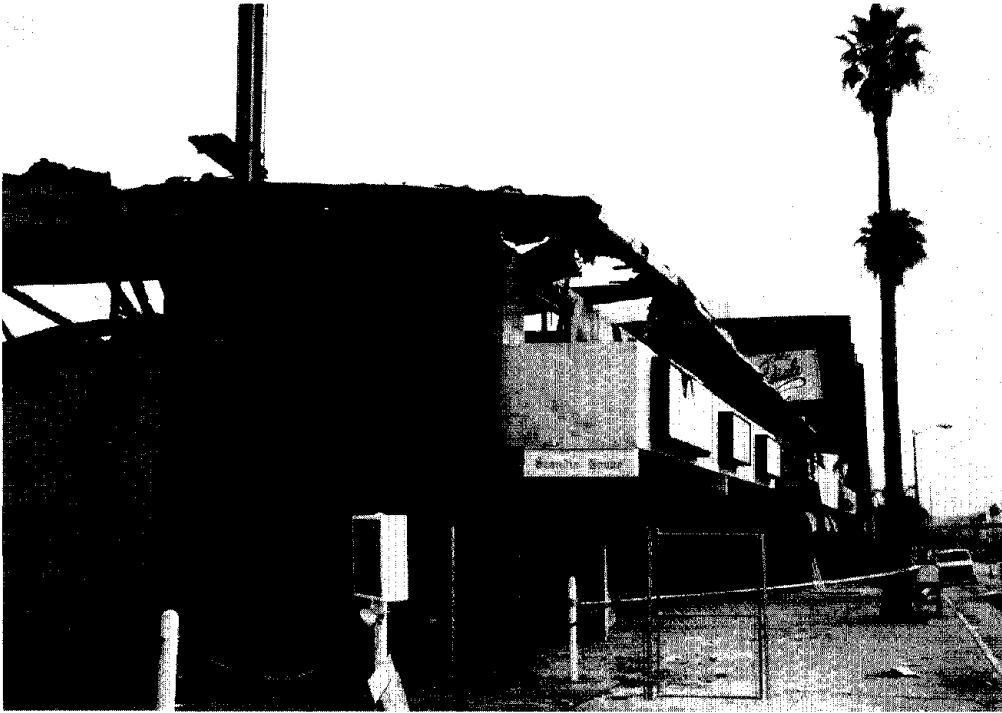
Figure 6.2. Fire damage in a two story commercial building.

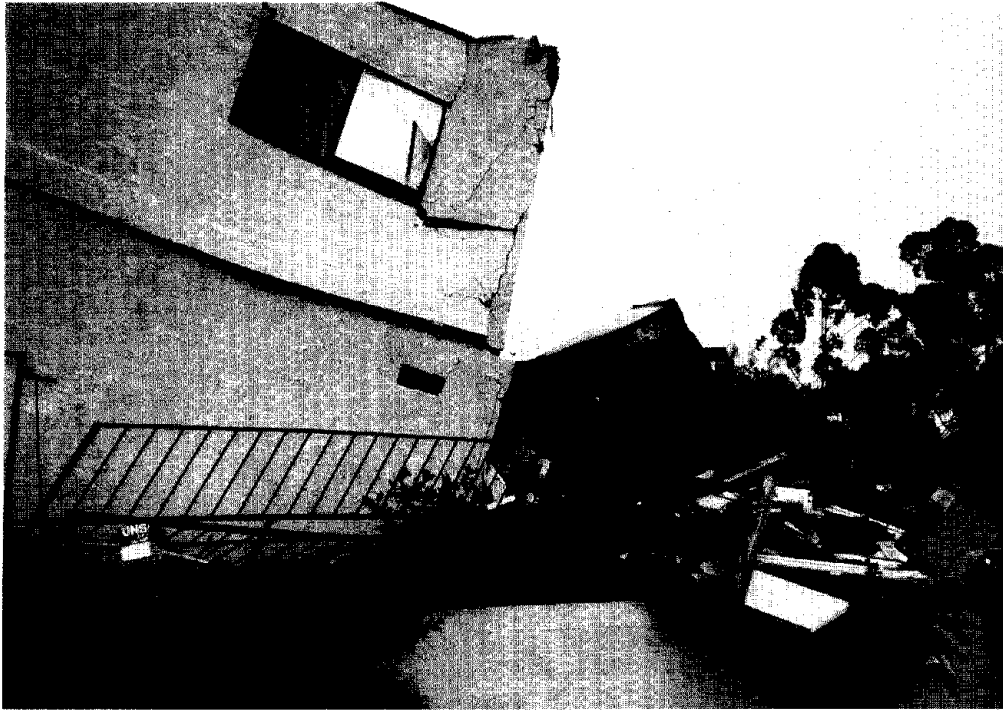
Figure 6.4. Partially collapsed apartment building with fire damage in the rear.

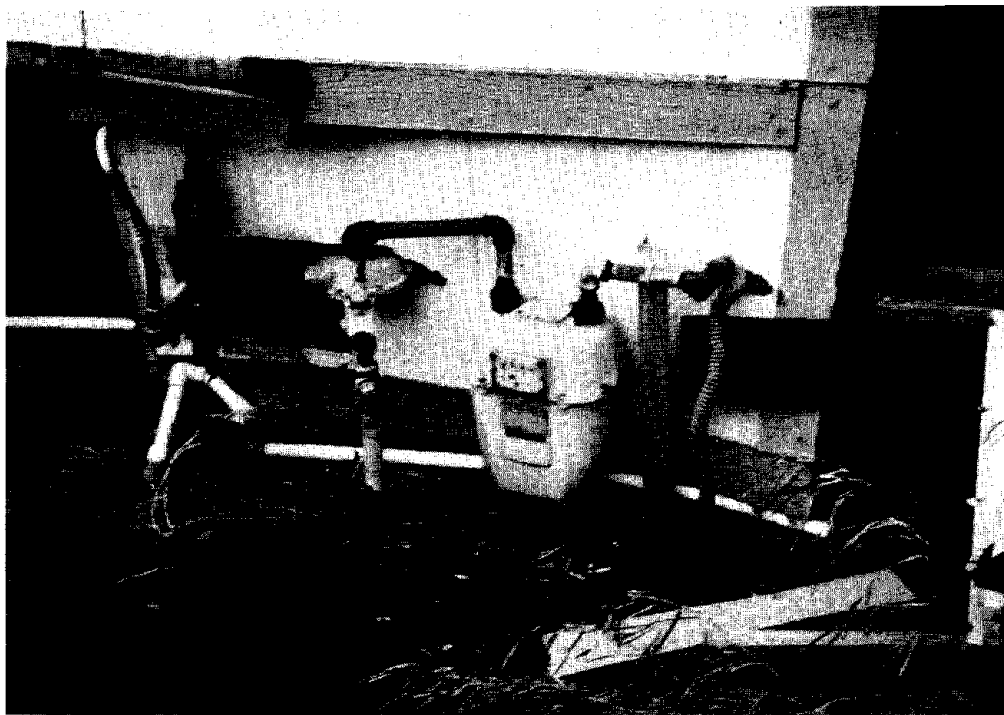
Figure 6.5. Damaged gas service in a manufactured housing development.

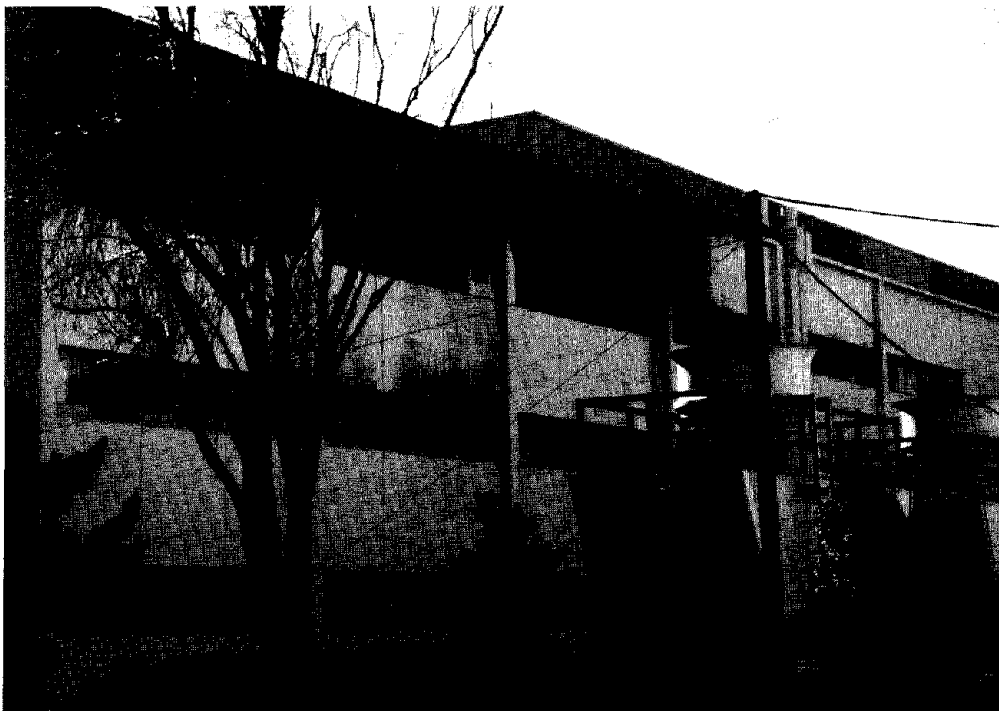
Figure 6.7. University science building damaged by fire.
