Performance of HUD-Affiliated Properties During the January 17, 1994 Northridge Earthquake

Diana Todd
Erik Anderson, Nicholas Carino, Geraldine Cheok,
Riley Chung, John Gross, Long Phan, Arturo E. Schultz,
Harry W. Shenton III, Andrew Taylor, Charles W.C. Yancey

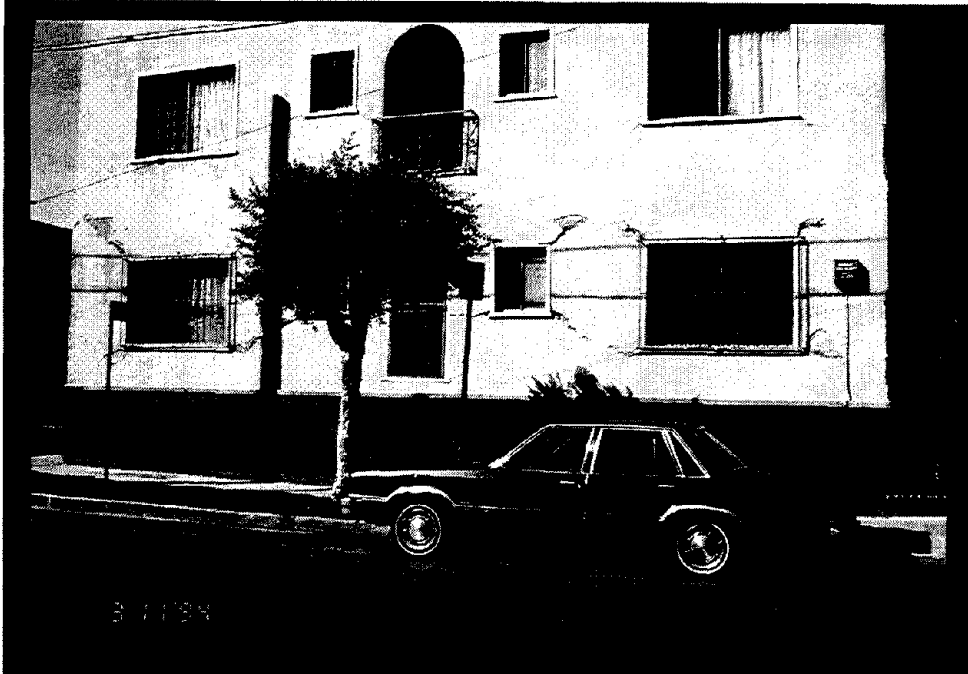
Figure 1 Residential construction is characterized by multiple door and window openings. The corners of these rectilinear openings create stress concentrations, making these locations particularly vulnerable to cracking.

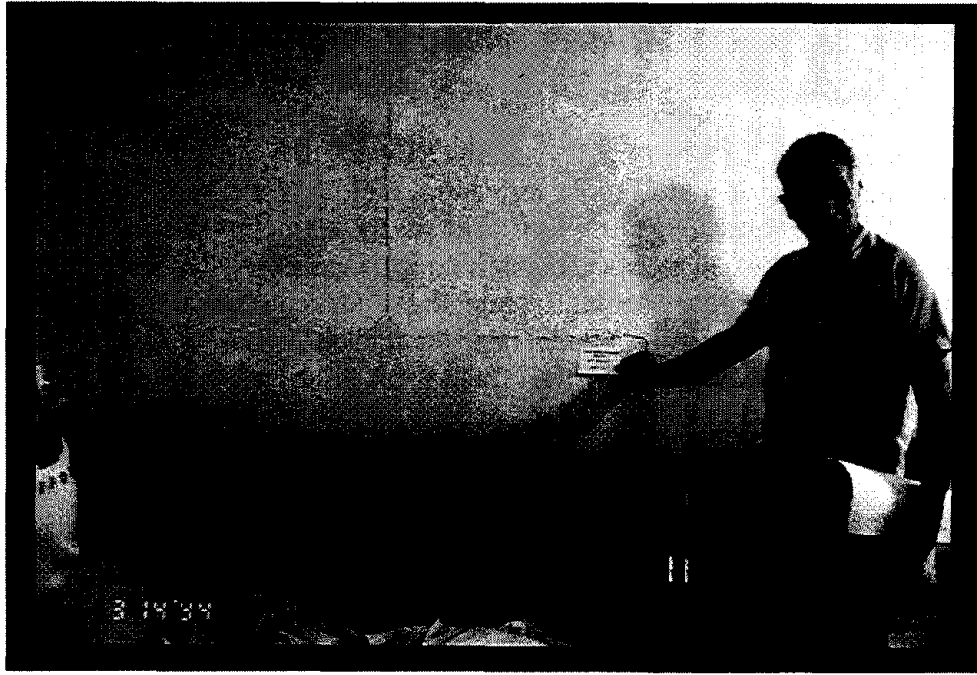
Figure 2 Typical nonstructural damage caused by the Northridge earthquake in residential buildings included cracks in interior partition walls, such as these horizontal and vertical cracks at the edges of the gypsum wallboard panels.

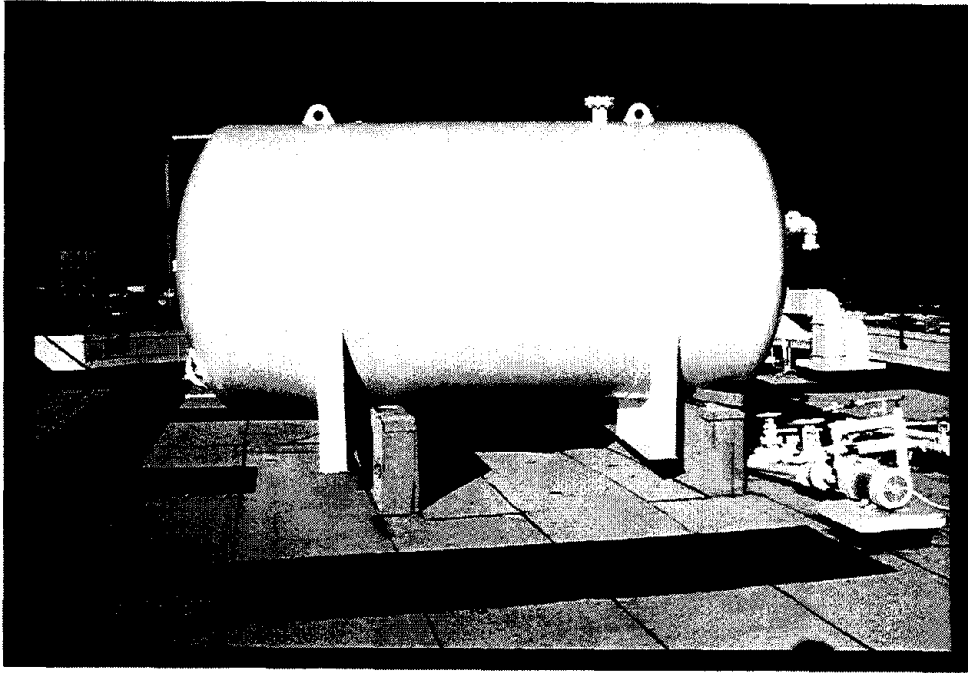
Figure 3 Movement of equipment, such as this 130,000 liter rooftop water tank at Fickett Towers, caused collateral damage in some cases. When this tank dropped from its supports, rupturing a water pipe, water damage to the building interior resulted.

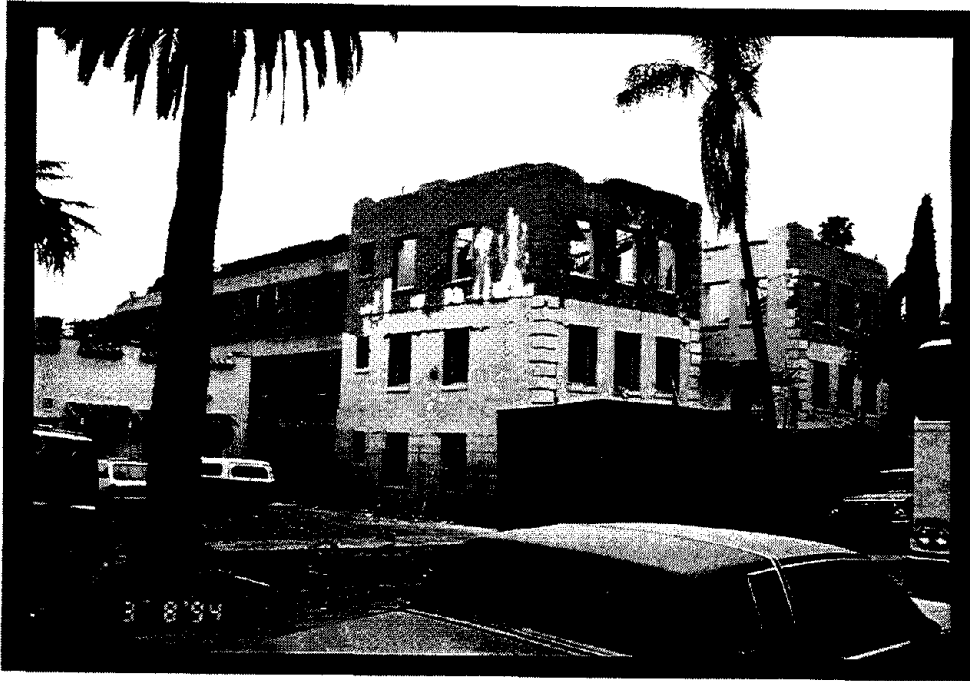
Figure 4 Vadehra IV, an unreinforced masonry building, was condemned because of extensive earthquake damage. When this photograph was taken, the top story had already been removed by the demolition team.

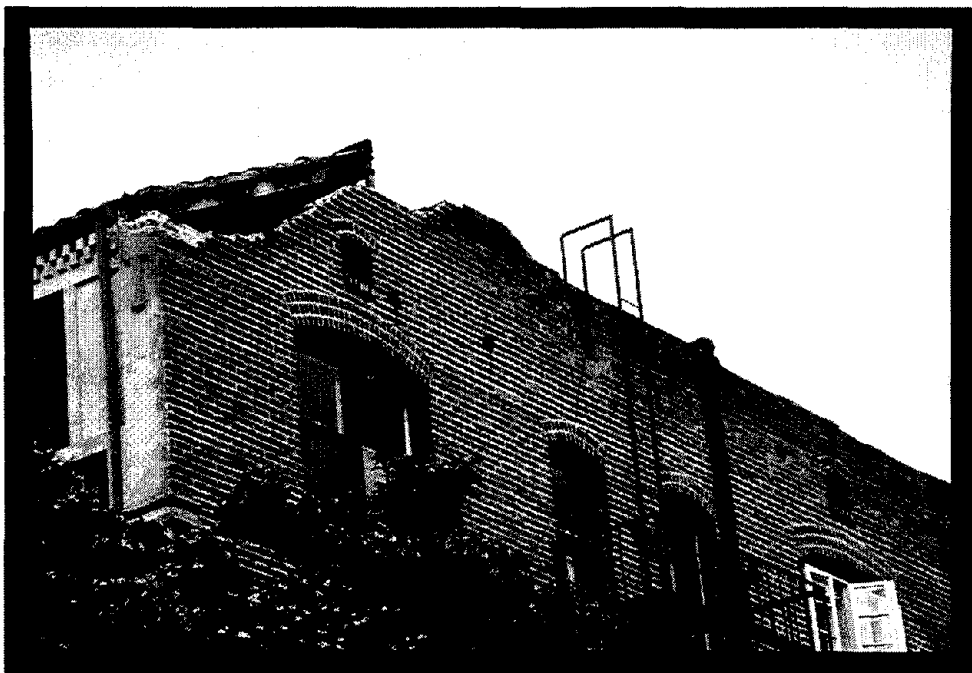
Figure 5 Loss of portions of the parapet and wall at Uptown Manor, an unreinforced masonry building, caused several living units to be declared unsafe by city inspectors.

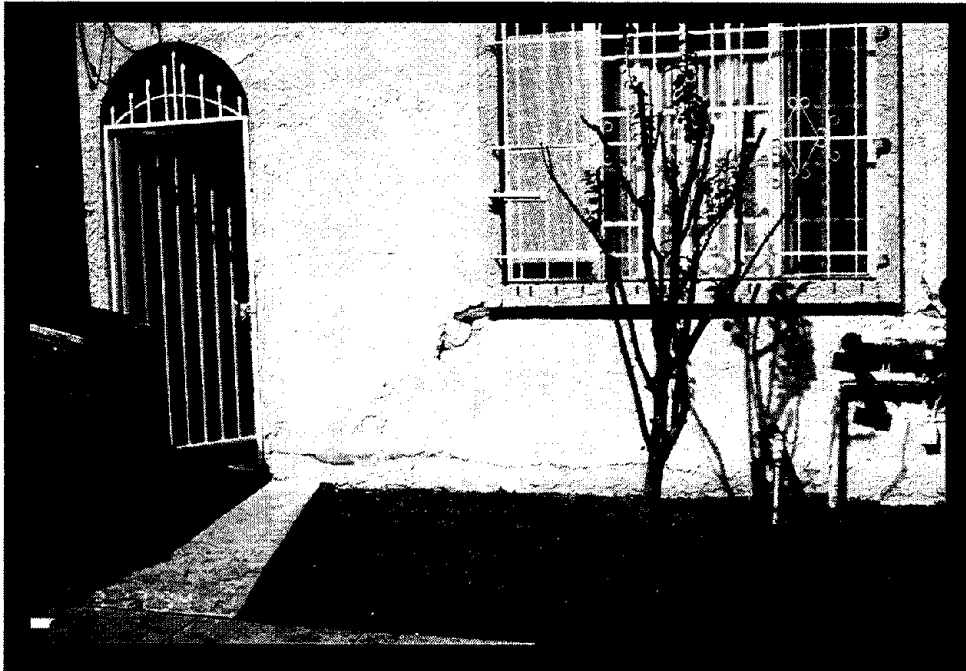
Figure 6 *Sunset Apartments E, a three-story wood-frame apartment building, was declared by city inspectors to be potentially unsafe pending more detailed evaluation (yellow tagged). Note the horizontal crack in the stucco at the foundation line, the vertical crack to the right of the window, and the diagonal crack and buckled area of stucco at the lower corner of the window.*

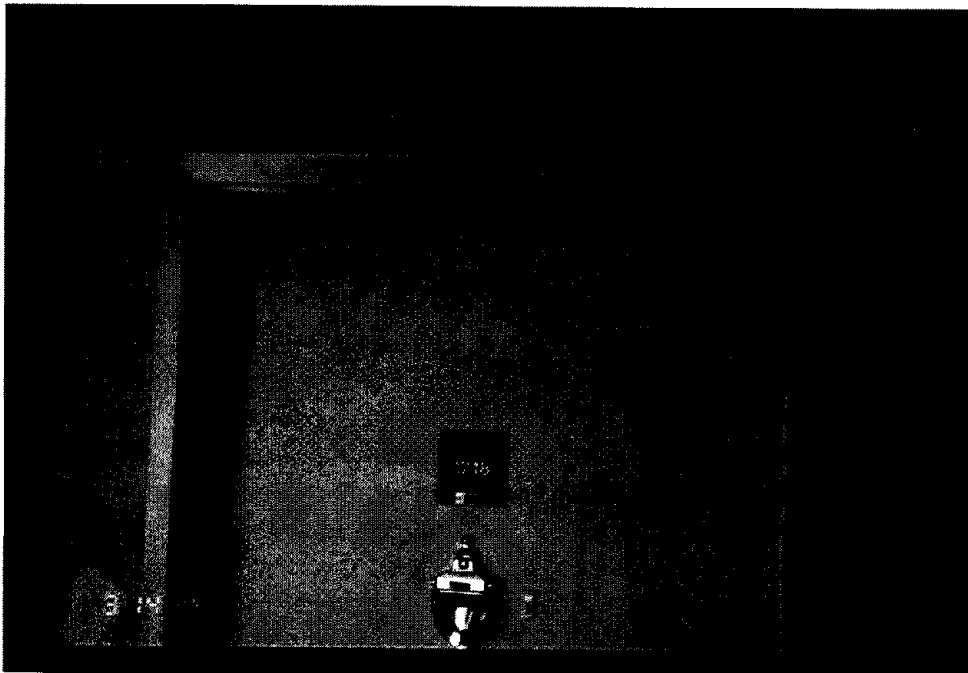
Figure 7 *Buckled door frames occurred in several buildings.*

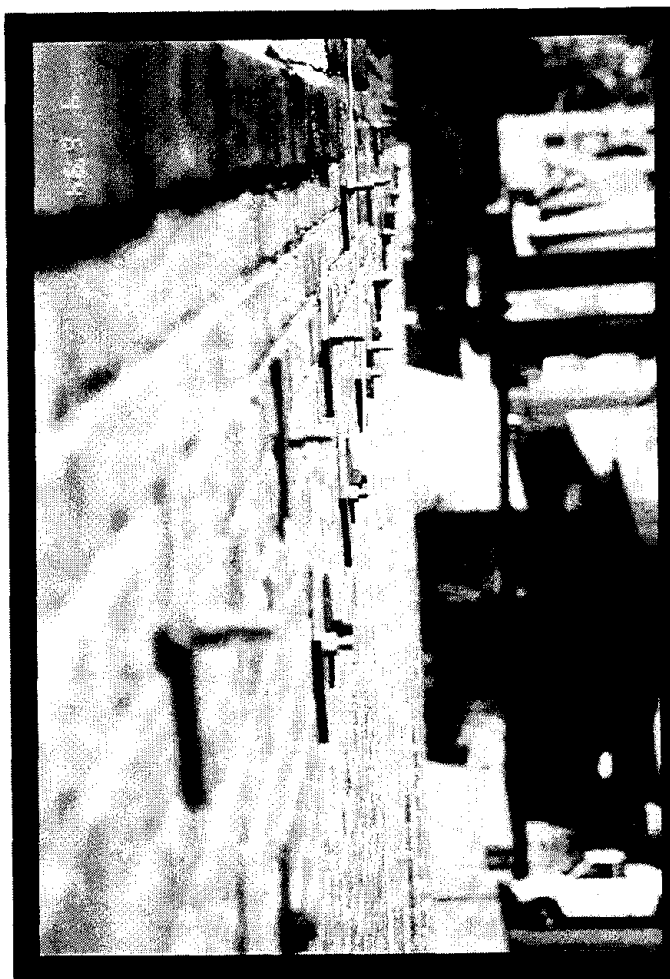
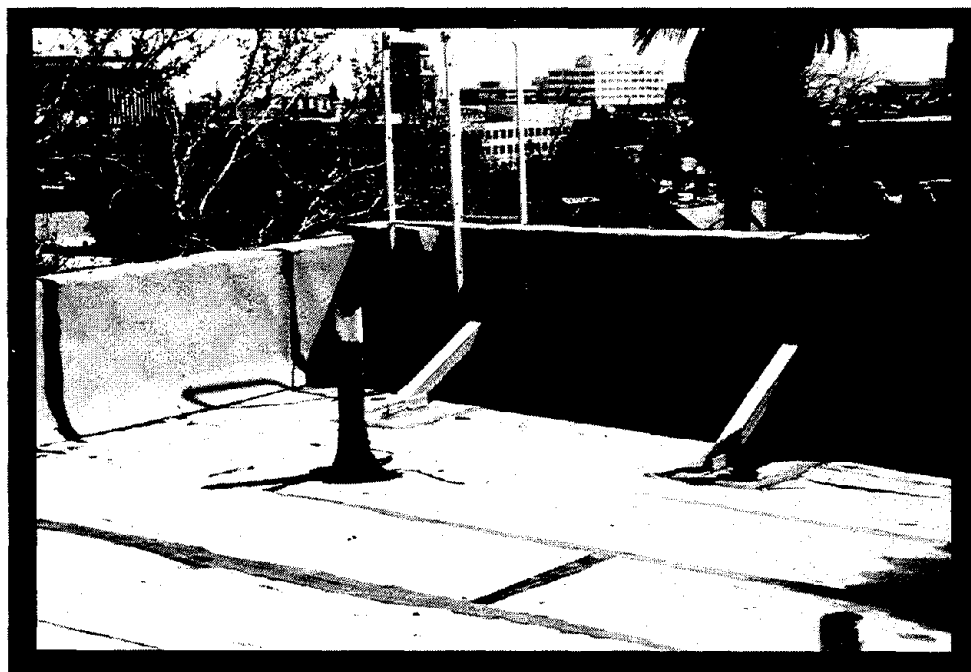
Figure 9 Unreinforced masonry buildings that had been rehabilitated prior to the earthquake typically had had their parapets braced.

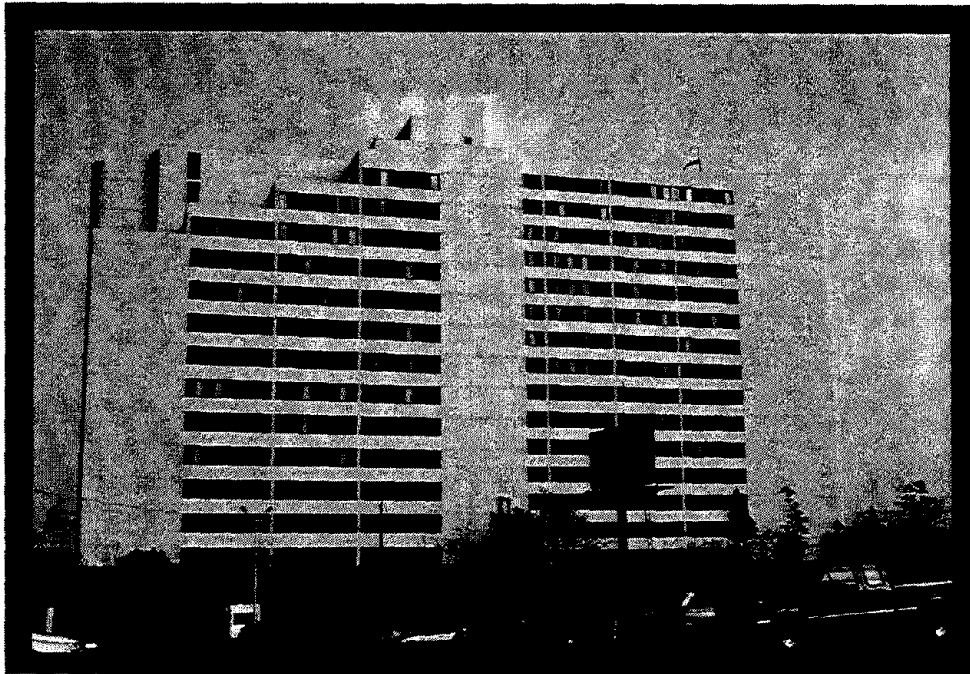
Figure 10 Cathay Manor, a 16-story building about 33 km from the epicenter, was determined to be a concrete shear wall building.

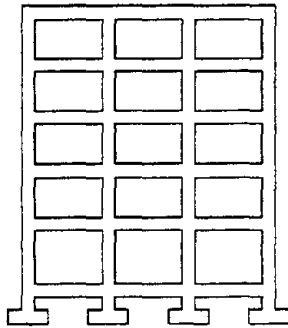
moment-resisting frame

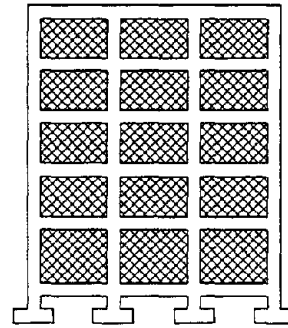
frame with masonry infill

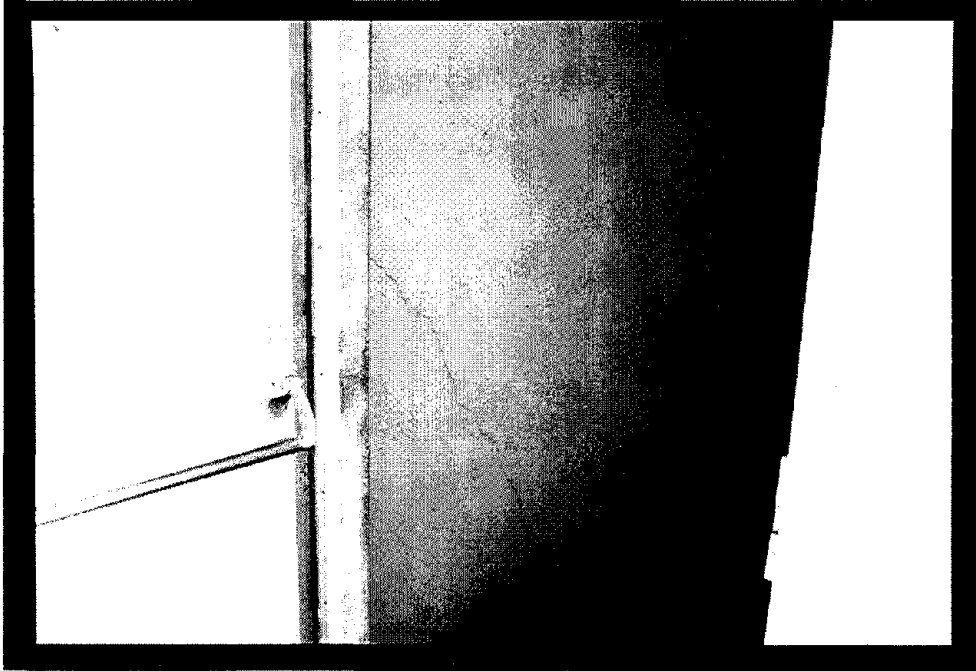
Figure 12 Structural damage in concrete buildings included diagonal cracks in shear walls, such as these in Beverly Towers.

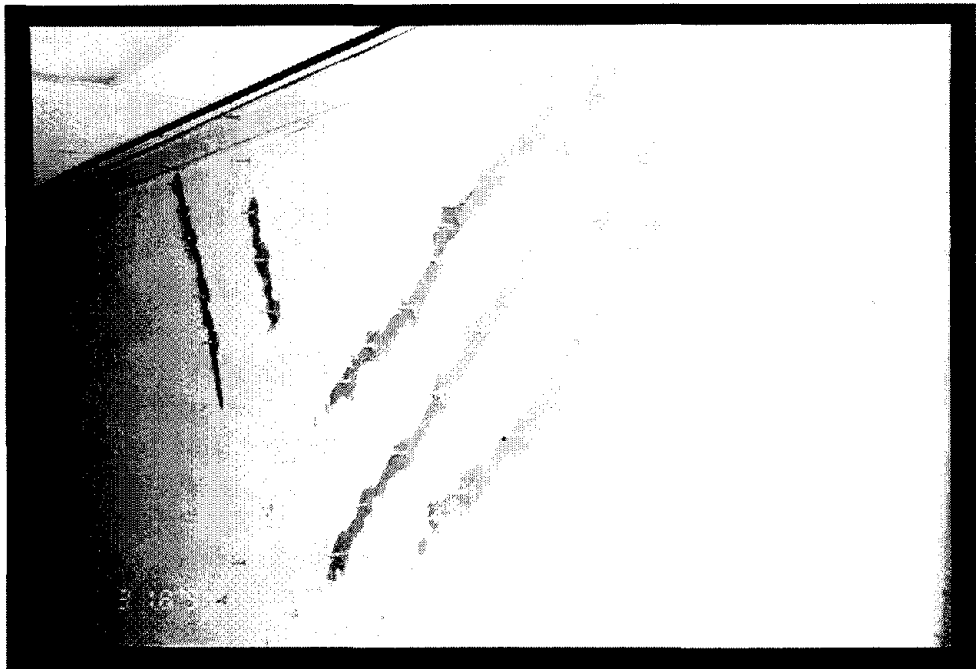
Figure 13 Some of the diagonal cracks in concrete shear walls were already under repair at the time of this study. At Santa Monica Christian apartments, cracks were being repaired using an epoxy injection technique.

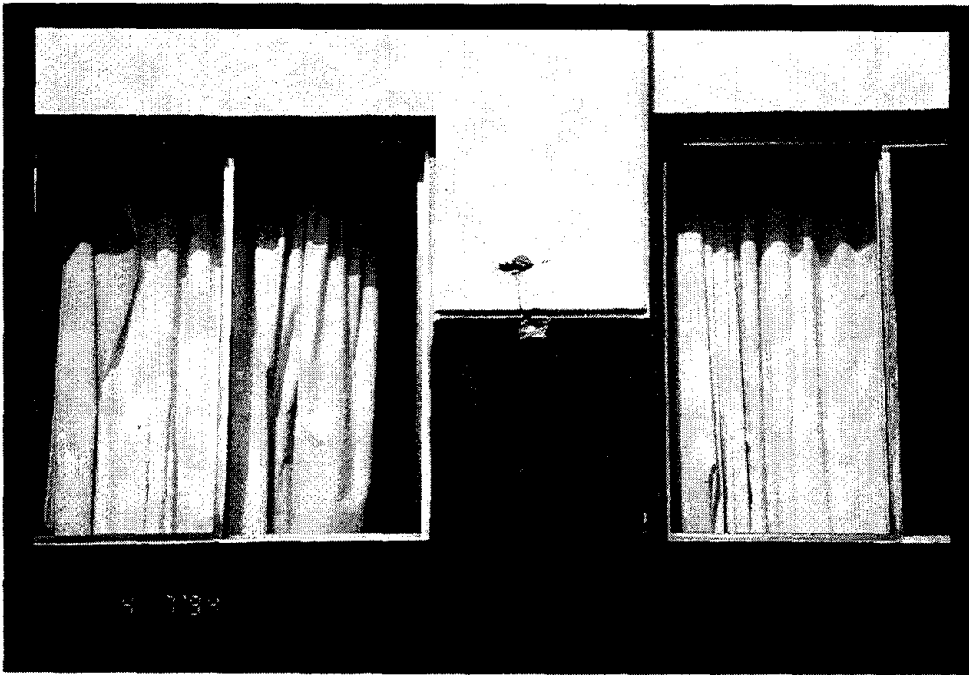
Figure 14 In concrete frame buildings, such as Westminster Towers, diagonal cracks in concrete columns were observed.

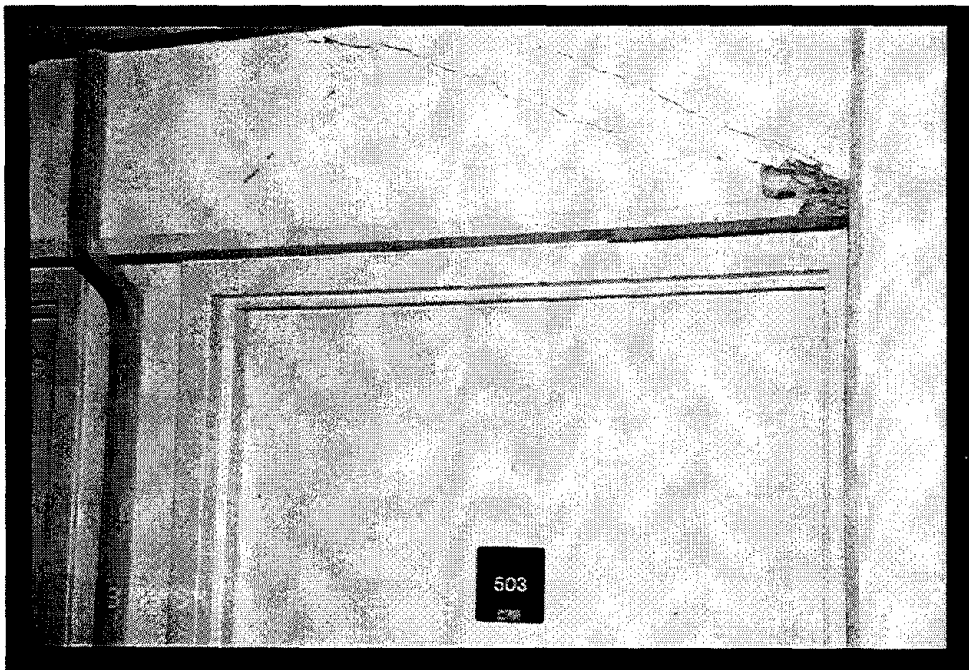
Figure 15 Diagonal cracks between openings in shear walls, such as these above a doorway at Fickett Tower, are examples of commonly observed earthquake damage in concrete shear wall buildings.

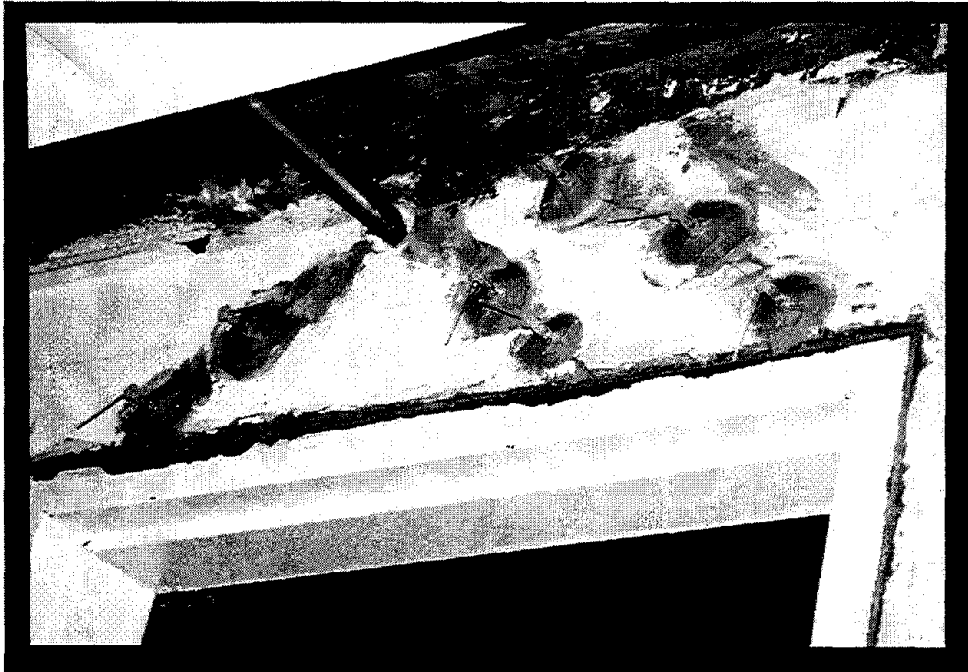
Figure 16 Diagonal cracks in the portions of the concrete shear wall above the doors at Santa Monica Christian apartments were being repaired using epoxy injection. This photograph shows the injection ports.

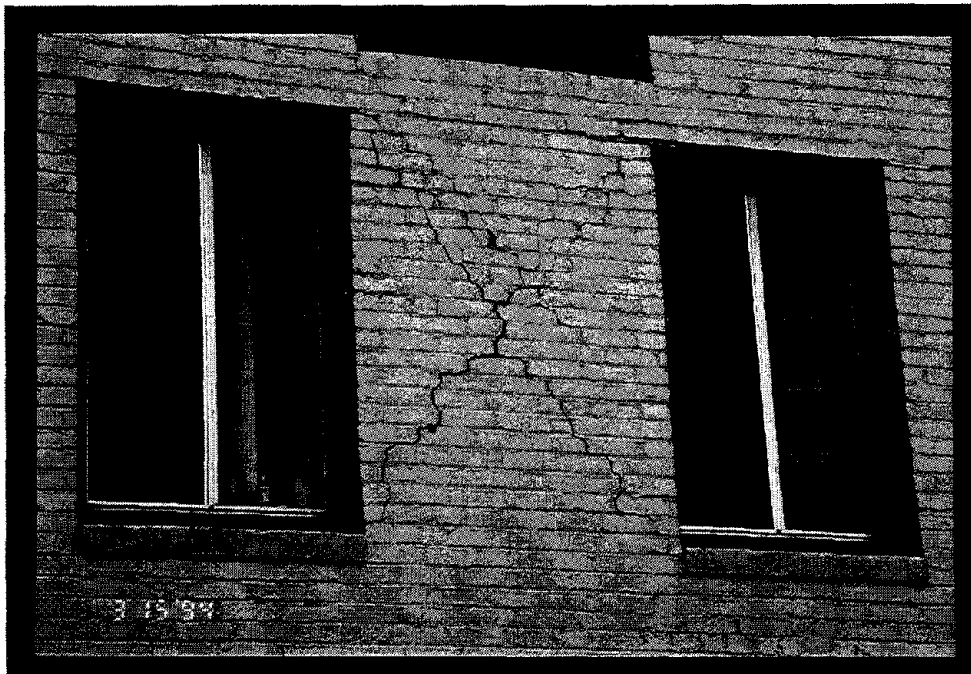
Figure 17 The masonry facade between windows at the Hollywood Knickerbocker, a 63-year old concrete frame building, displayed earthquake-induced X-cracking.

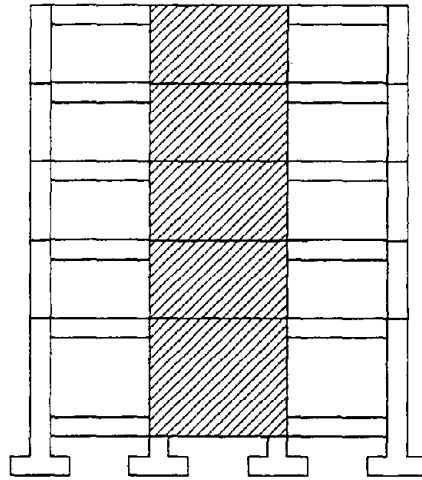
Precast concrete buildings typically include components of both walls and frames, assembled in the field from pre-formed wall, column, and beam units.

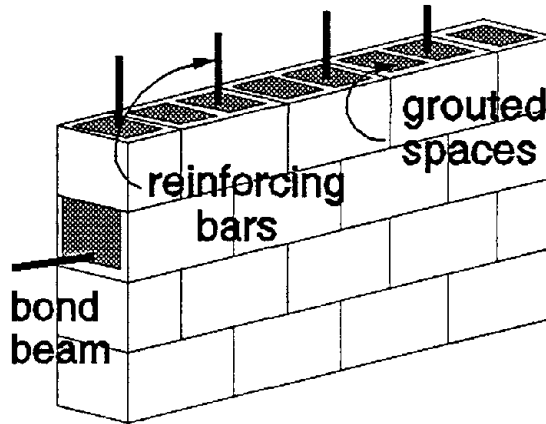
The other two sites had one building each. Casa La Merced is a 5-story building about 46 km from the epicenter which suffered only hairline cracks to interior nonstructural wall surfaces and no damage to structural or mechanical systems. Pledgerville Senior Citizens Villa is a 6-story building about 13 km from the epicenter that suffered vertical cracks in the walls near the base of the door openings (fig. 18).

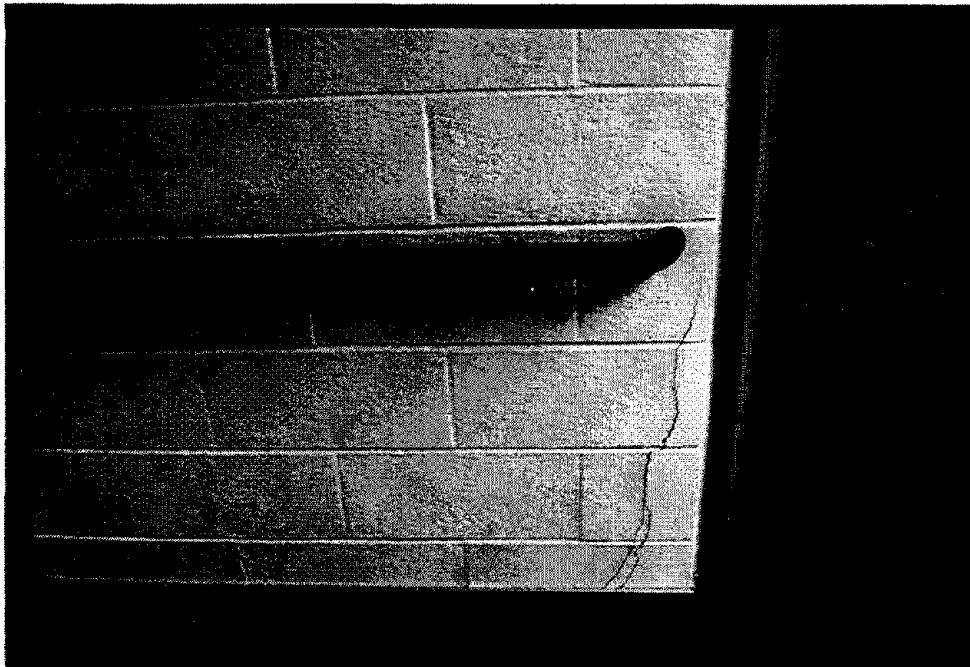
Figure 18 At Pledgerville Senior Center, a 9-year old reinforced masonry building about 13 km from the epicenter, inclined vertical cracks were observed adjacent to door openings.

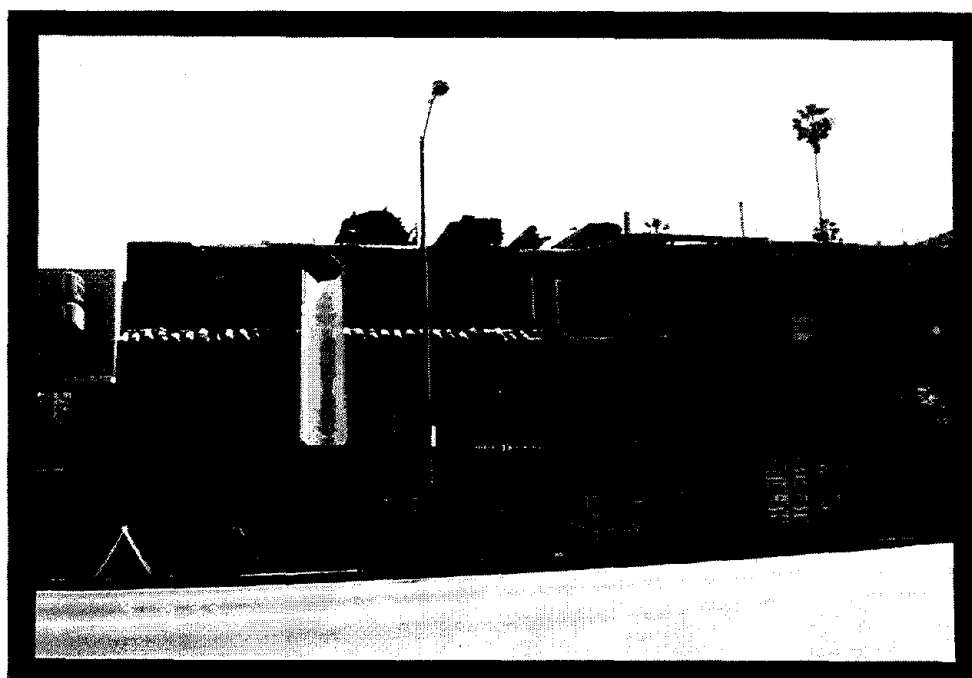
Figure 19 Vadehra Vb, an unreinforced masonry building, was already under demolition at the time of this study. The top floor of this four story building had already been removed at the time this photograph was taken.

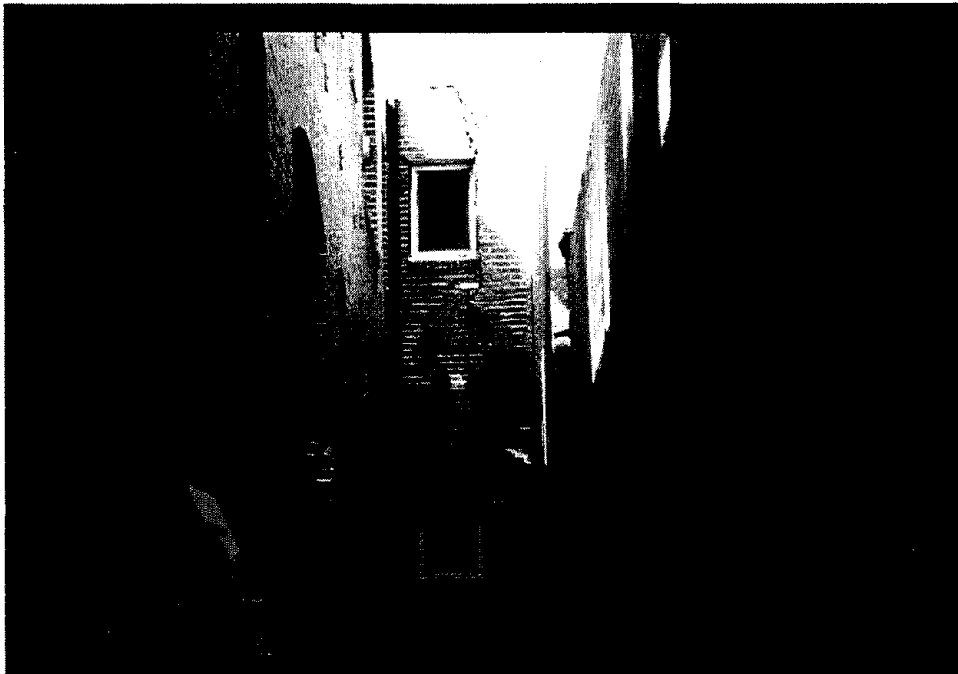
Figure 20 This view of an the inside corner of the T-shaped Vadehra Vb building shows substantial vertical cracks and movement of portions of the wall. Note that this building, which had been condemned and was under demolition, had been rehabilitated before the earthquake with through-bolts.

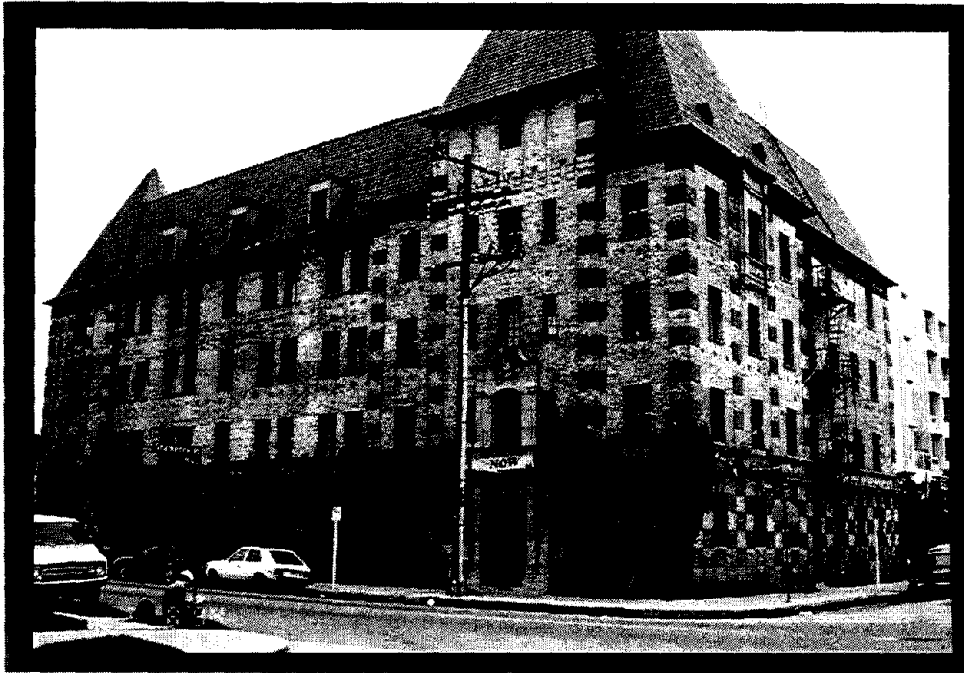
Figure 21 Villa Park Merridy, an unreinforced masonry building that had been rehabilitated prior to the Northridge earthquake, suffered no structural damage and only minor nonstructural damage.

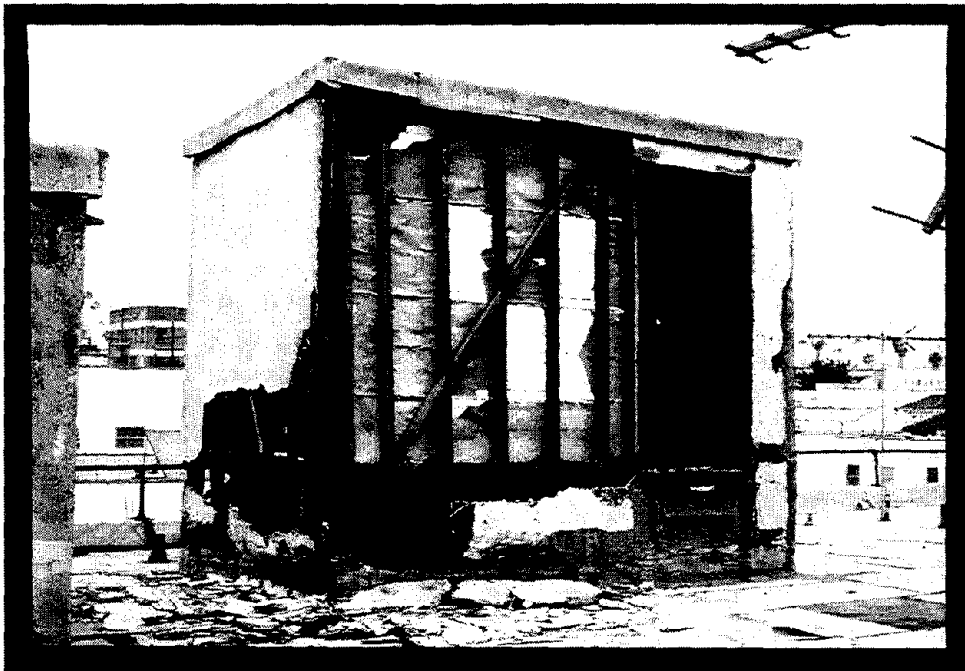
Figure 22 The wood-framed, stucco-clad elevator penthouse on the roof of the 3-story Vadehra IIIb building experienced extensive damage to the stucco, but the operation of the elevator was not affected.

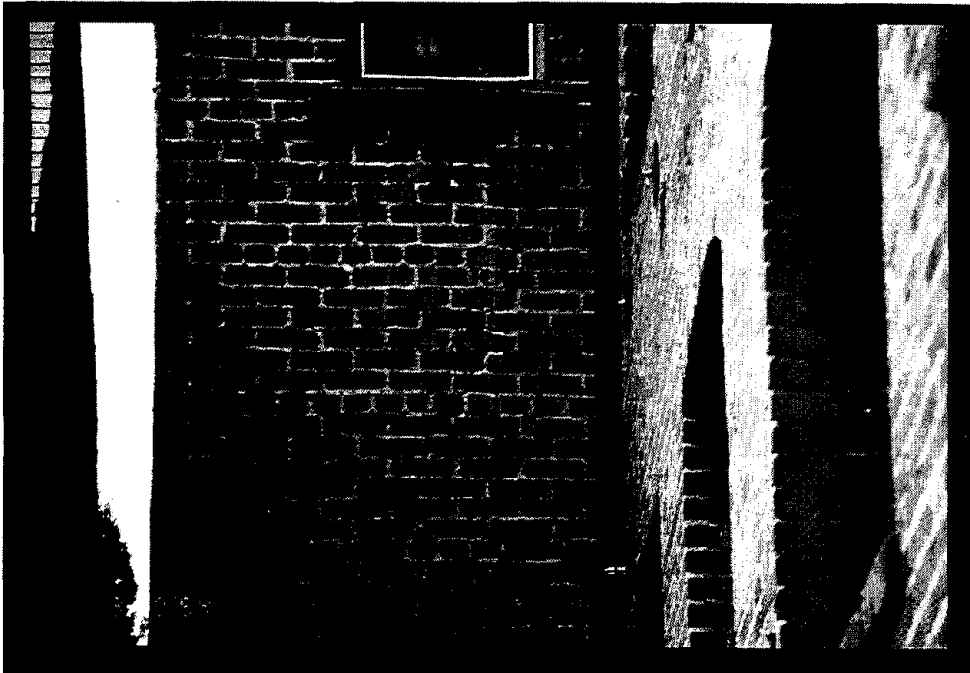
Figure 23 Vadehra IVb, a T-shaped unreinforced masonry building, suffered cracks in the short walls at the inside corner of the T that in some locations followed the line of the mortar and in other locations cracked brick units.

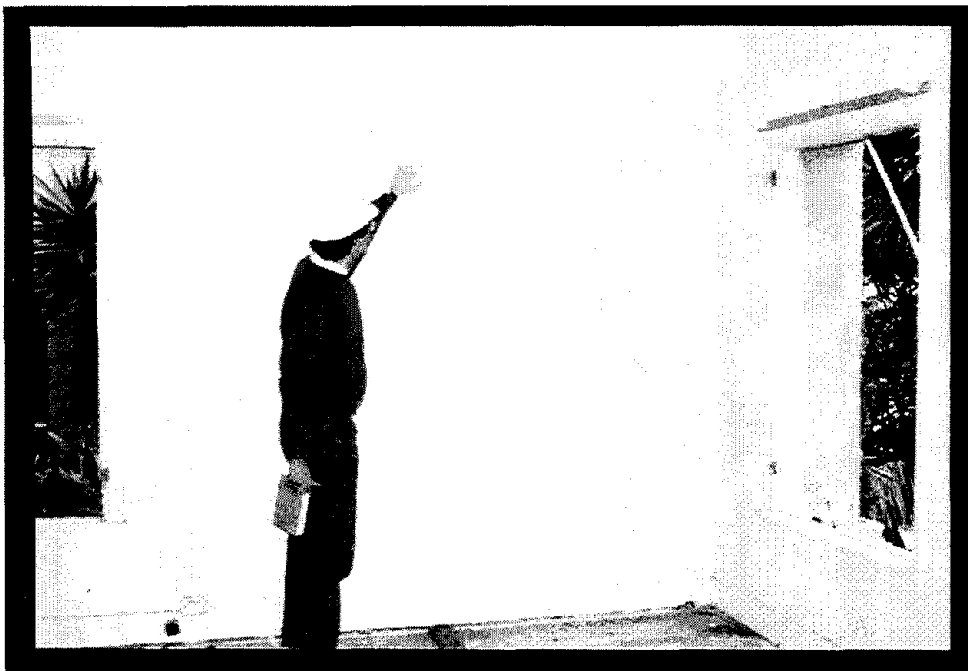
Figure 24 Damage observed in unreinforced masonry buildings included cracks in the interior plaster.

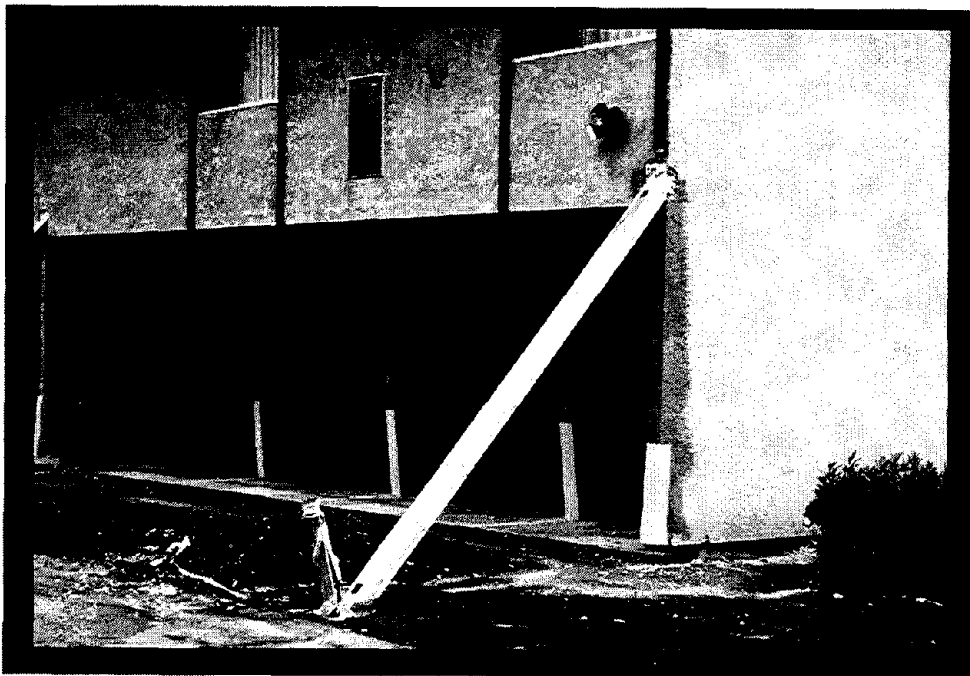
Figure 25 At Granada Gardens, many of the two-story wood frame buildings that had open first levels for parking experienced significant racking and permanent offsets.

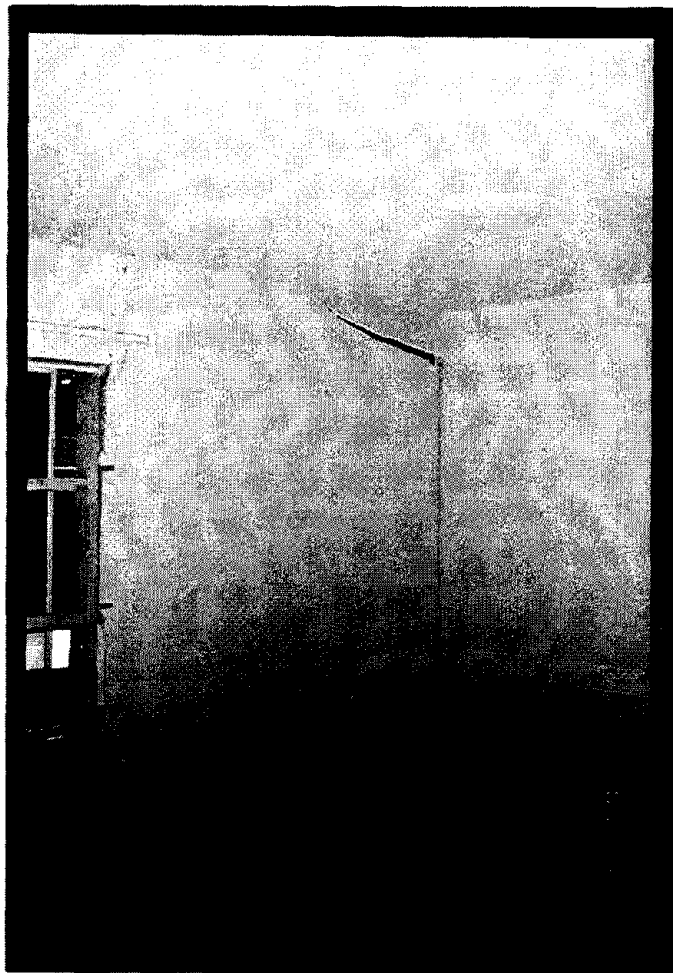
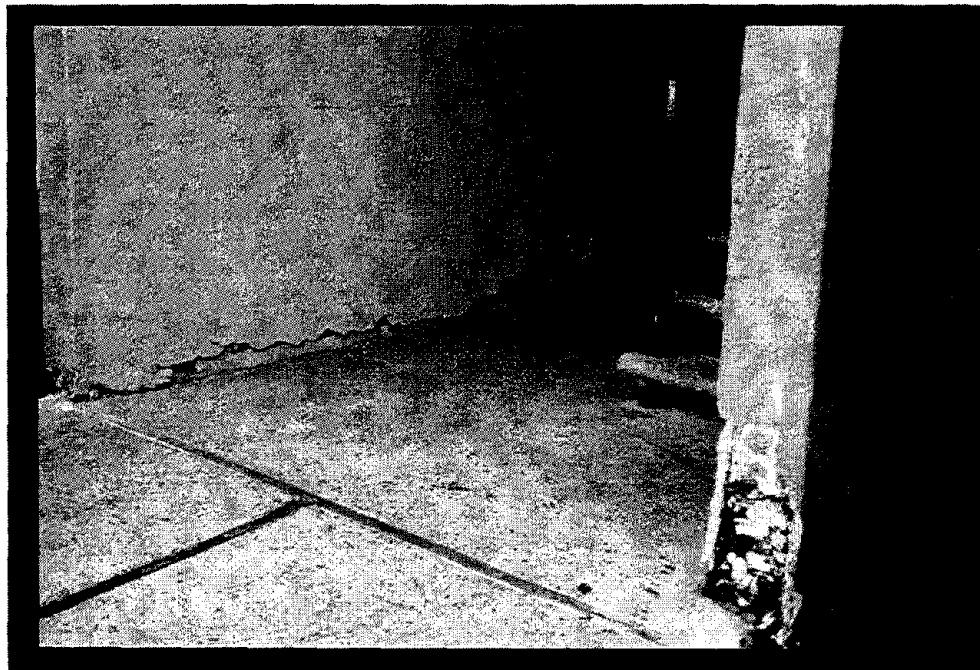
Figure 27 Horizontal cracks in exterior stucco occurred where the relatively flexible wood frame walls joined the more rigid concrete foundation walls.

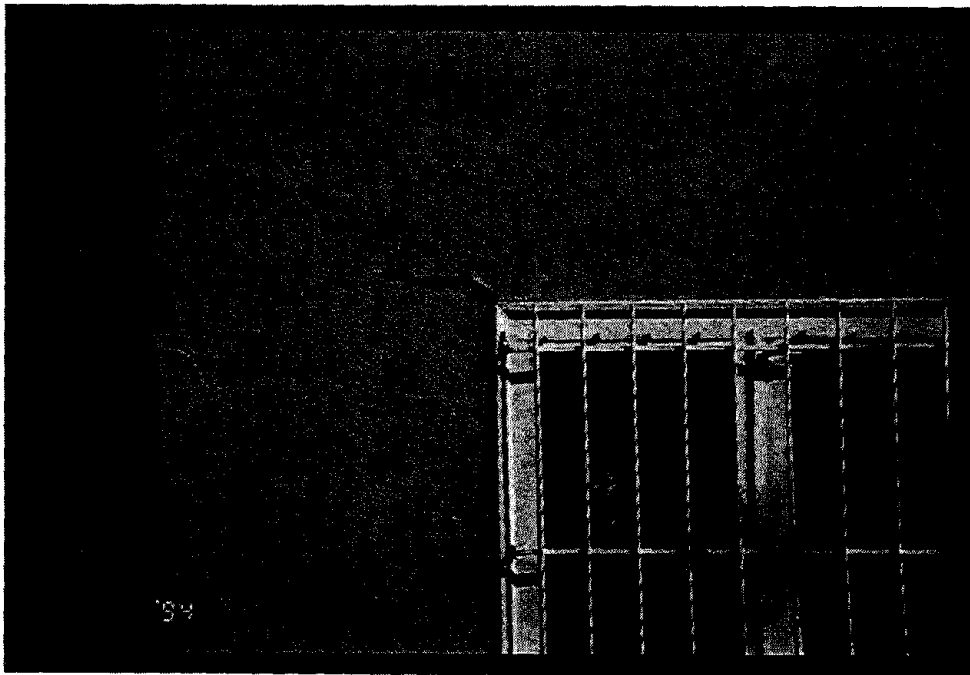
Figure 28 Diagonal cracks in exterior stucco at window openings in wood-framed buildings occurred in many locations, such as at this window at Miramar Manor.

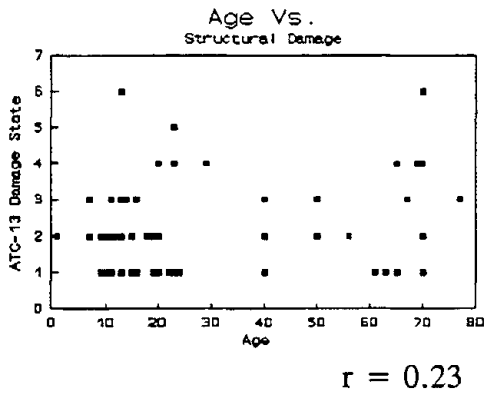
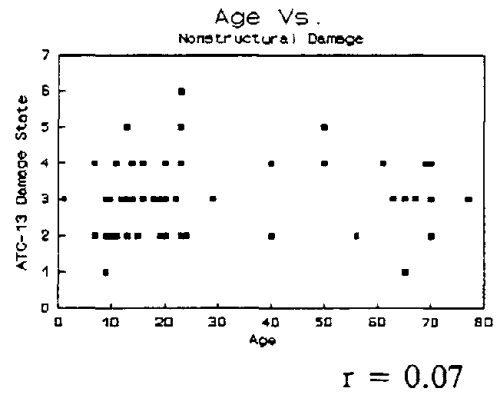
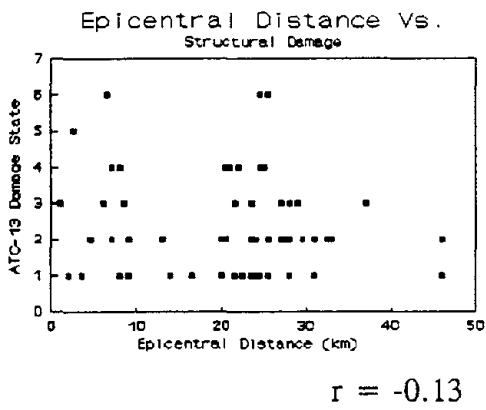
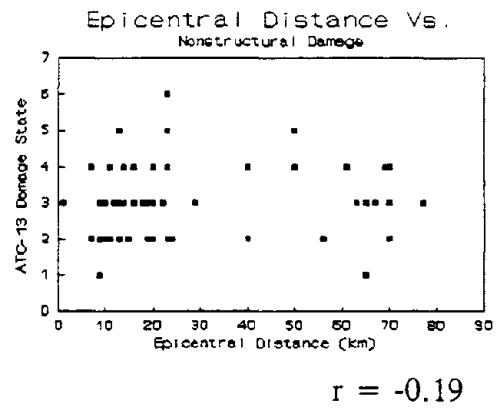
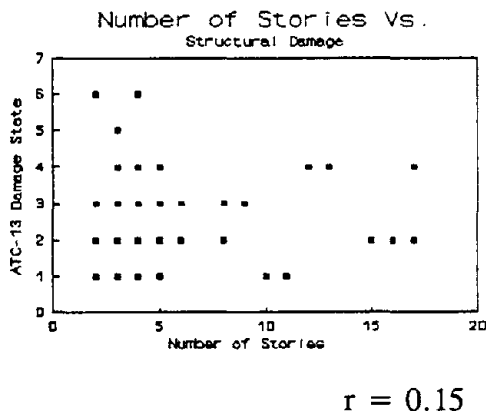
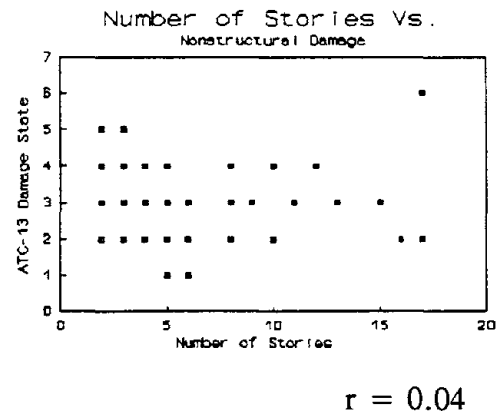
Figure 29
Scatter Plots and Coefficients of Correlation
Age, Epicentral Distance and Number of Stories
Compared to Structural and Nonstructural Damage States

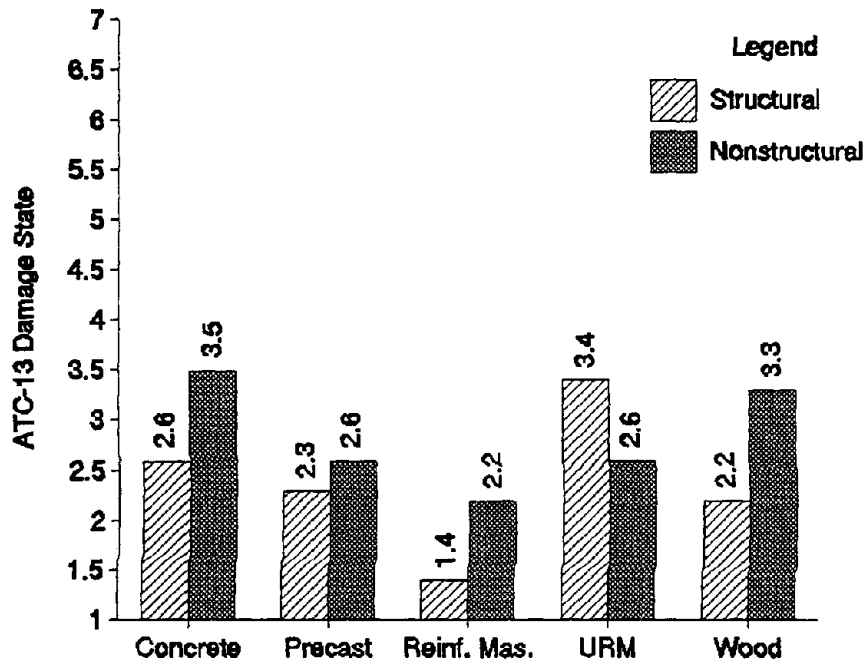
Figure 30 Bar graph showing weighted averages of ATC-13 structural and nonstructural damage states by structural system.

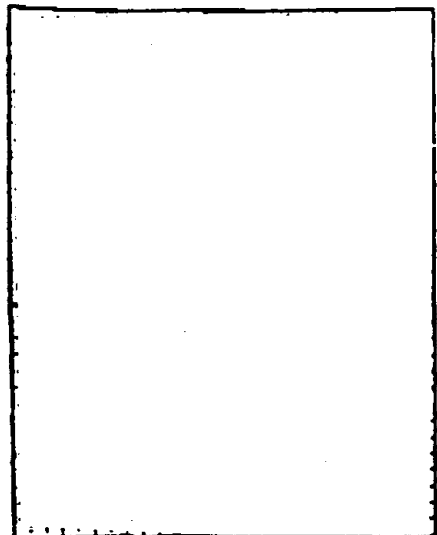
PROVIDE A PLAN SKETCH OF BUILDING, WITH NORTH ARROW
