Performance of HUD-Affiliated Properties During the January 17, 1994 Northridge Earthquake

Diana Todd
Erik Anderson, Nicholas Carino, Geraldine Cheok,
Riley Chung, John Gross, Long Phan, Arturo E. Schultz,
Harry W. Shenton III, Andrew Taylor, Charles W.C. Yancey

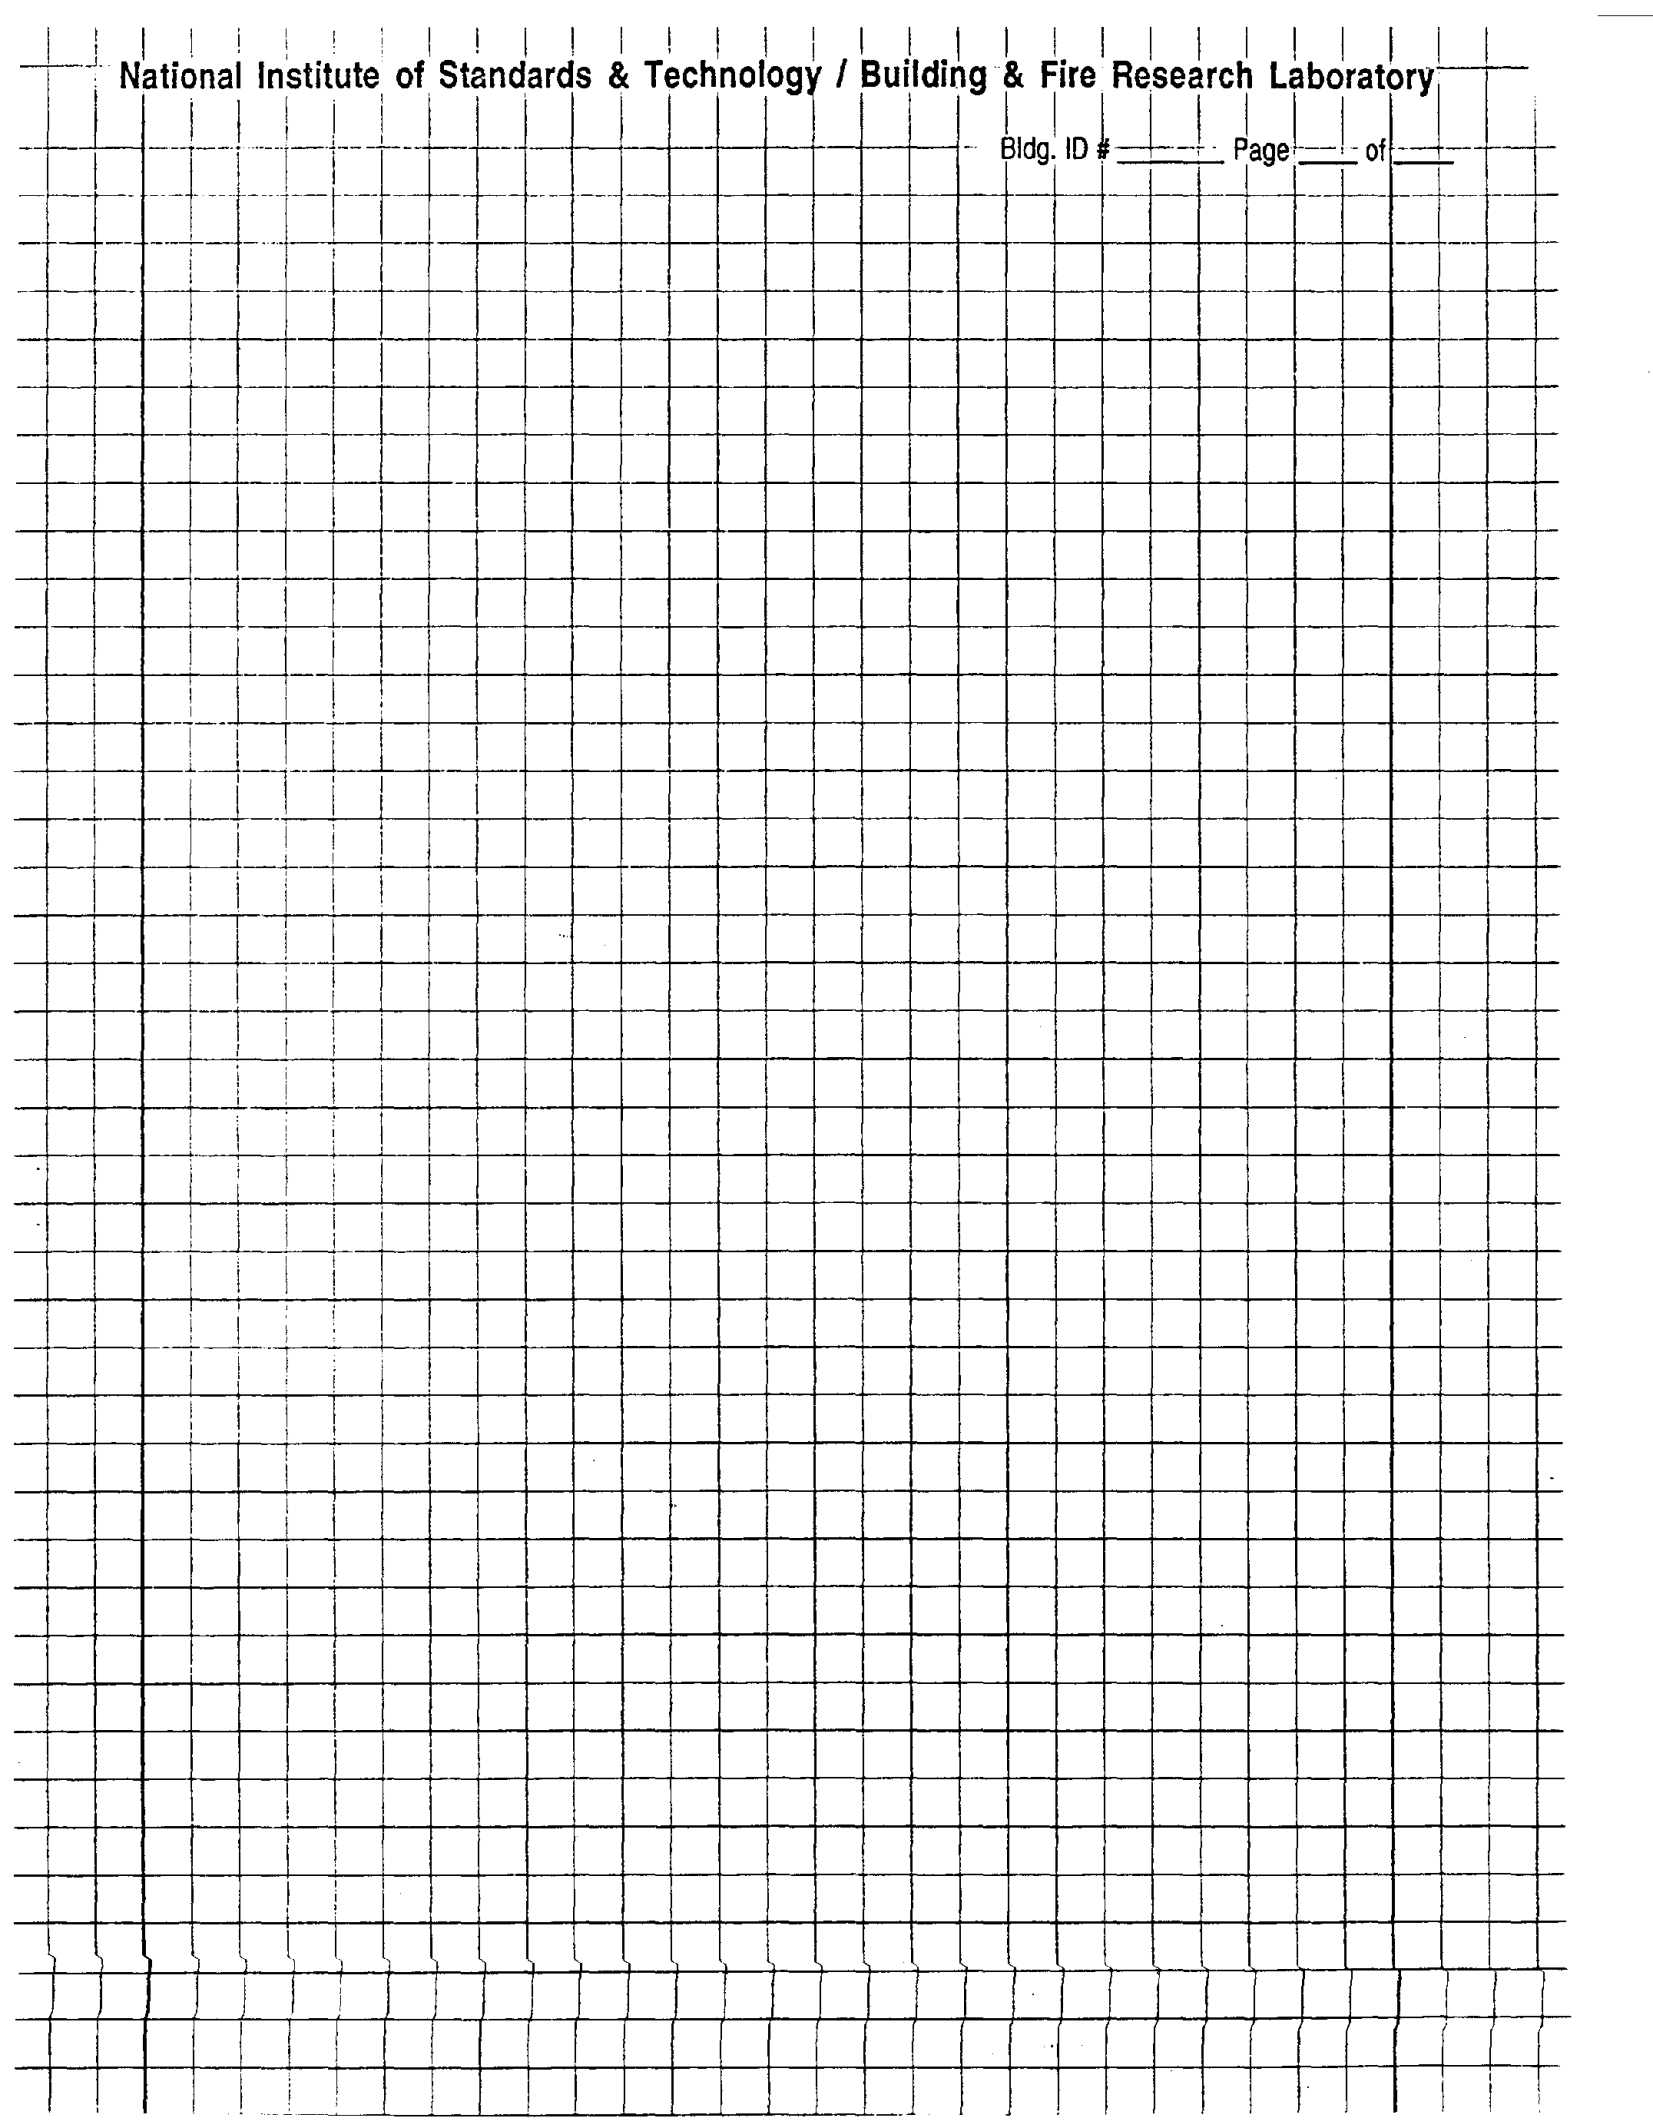
DESCRIPTION OF DAMAGE: _____
