**NORTHRIDGE EARTHQUAKE: LIFELINE
PERFORMANCE AND POST-EARTHQUAKE
RESPONSE**

Date: Apr 97

Authors: A. J. Schiff.

Performing Organization: American Society of Civil Engineers, New York. Technical Council on Lifeline Earthquake Engineering.

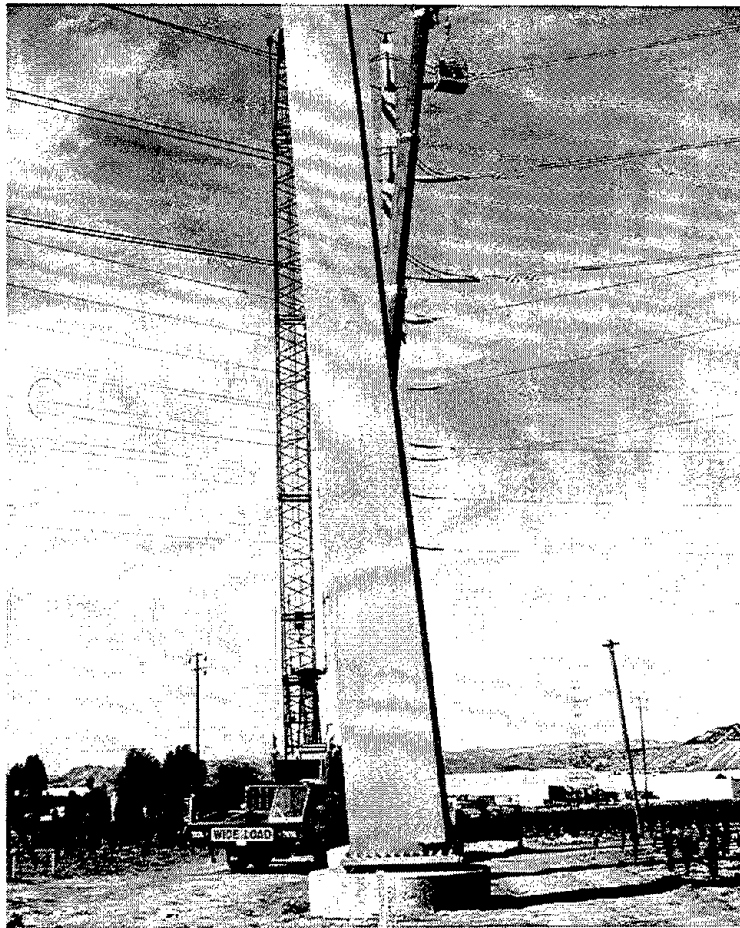
Fig. 3.44 Dead-end transmission tower tipped due to liquefaction and crack in tower.

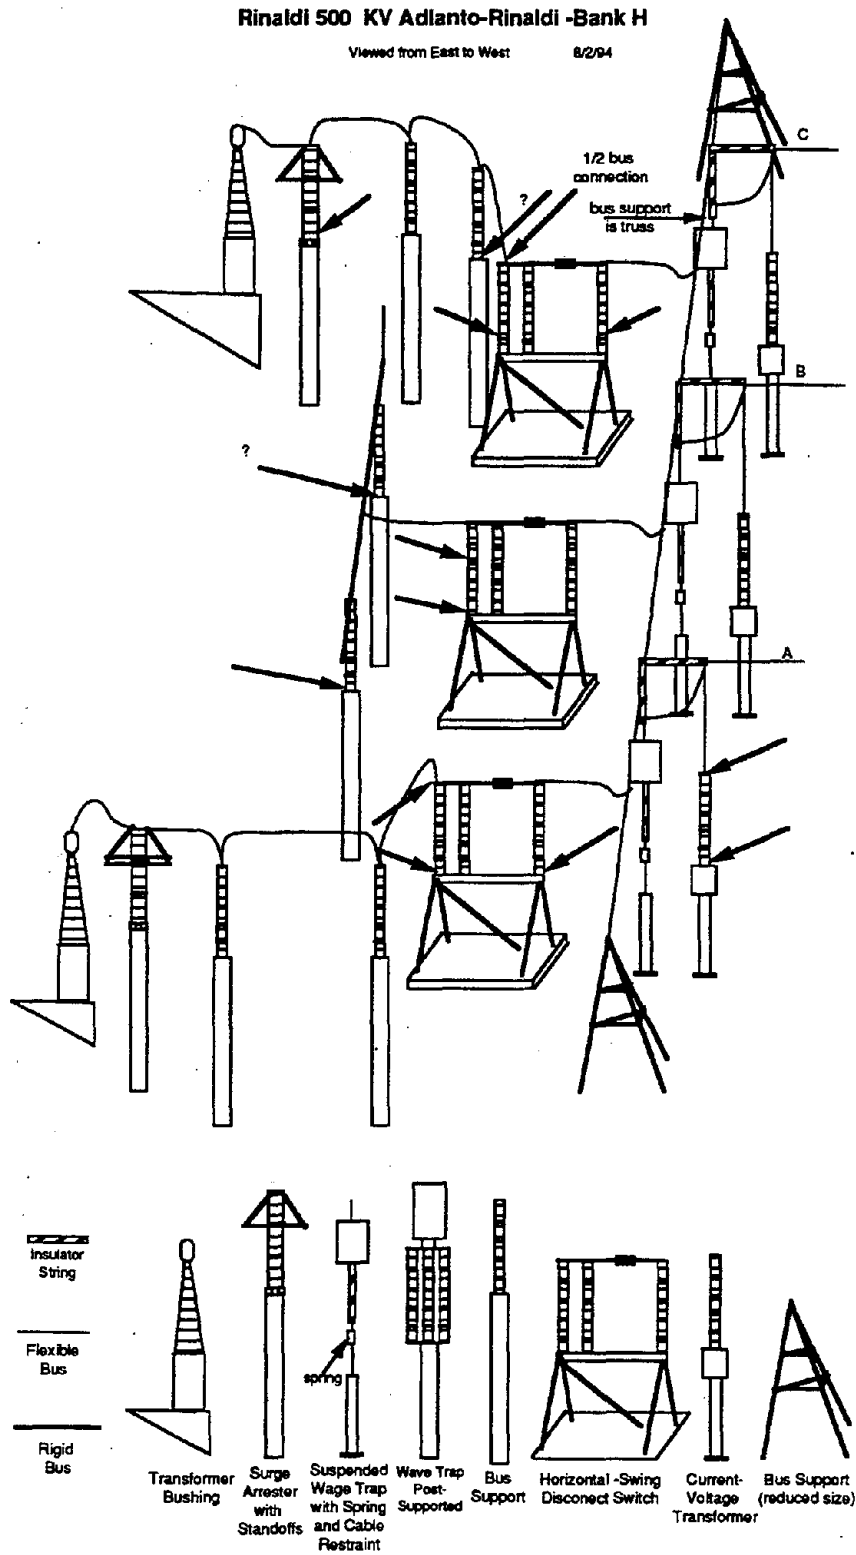
Fig. 3.51 Schematic diagram showing damage to 500 kV switchyard at Rinaldi Substation - Part 1. Note that arrows indicate damage locations.

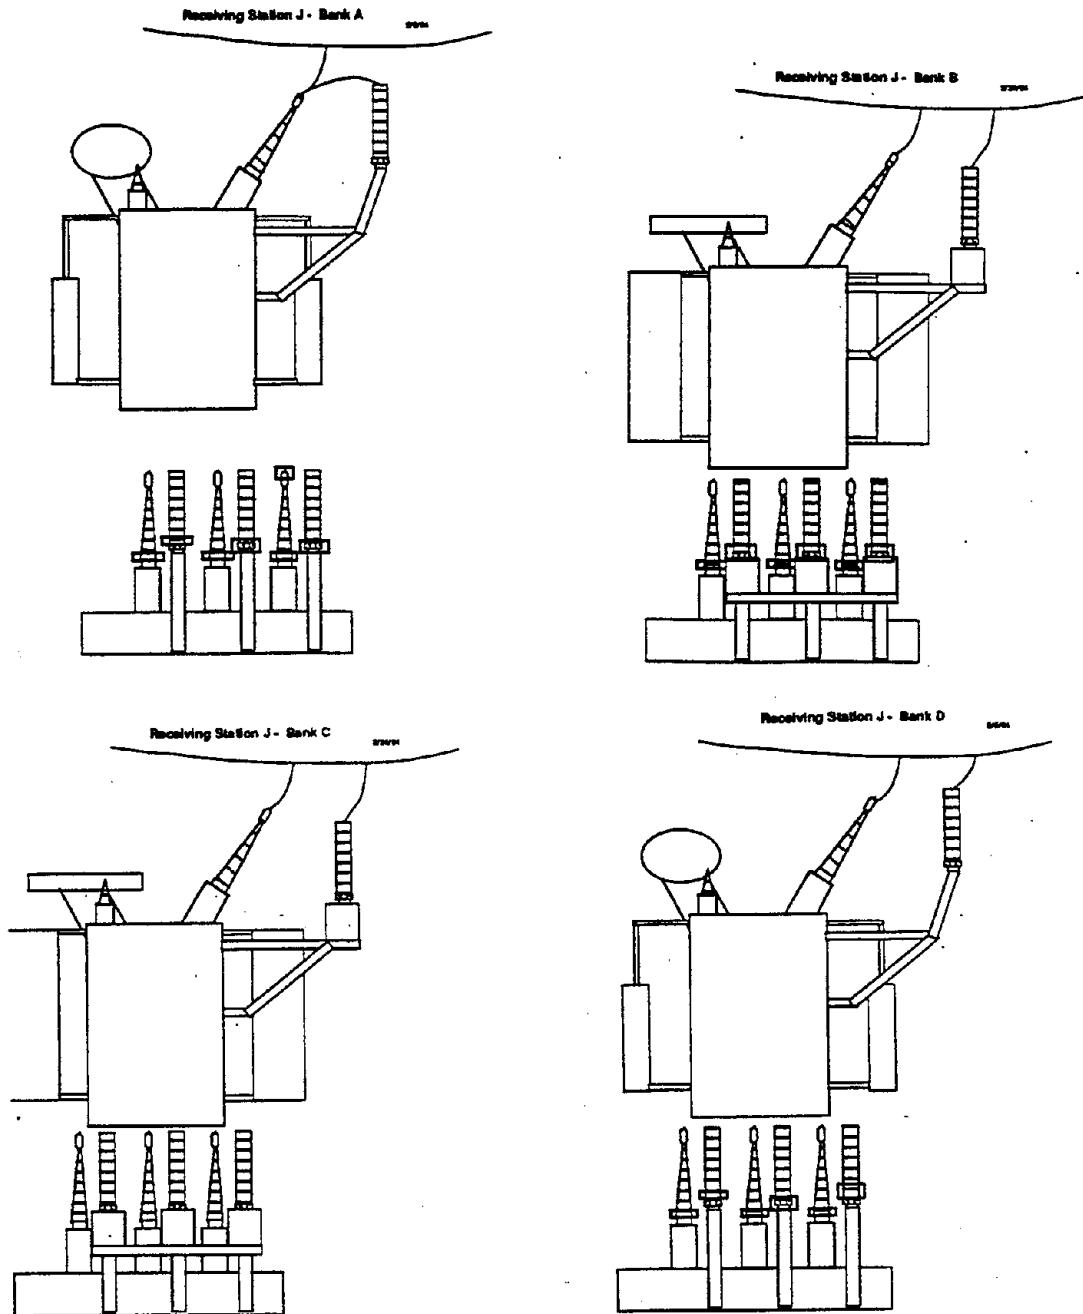
Fig. 3.54 Schematic diagram showing damage to transformers at Receiving Station J.

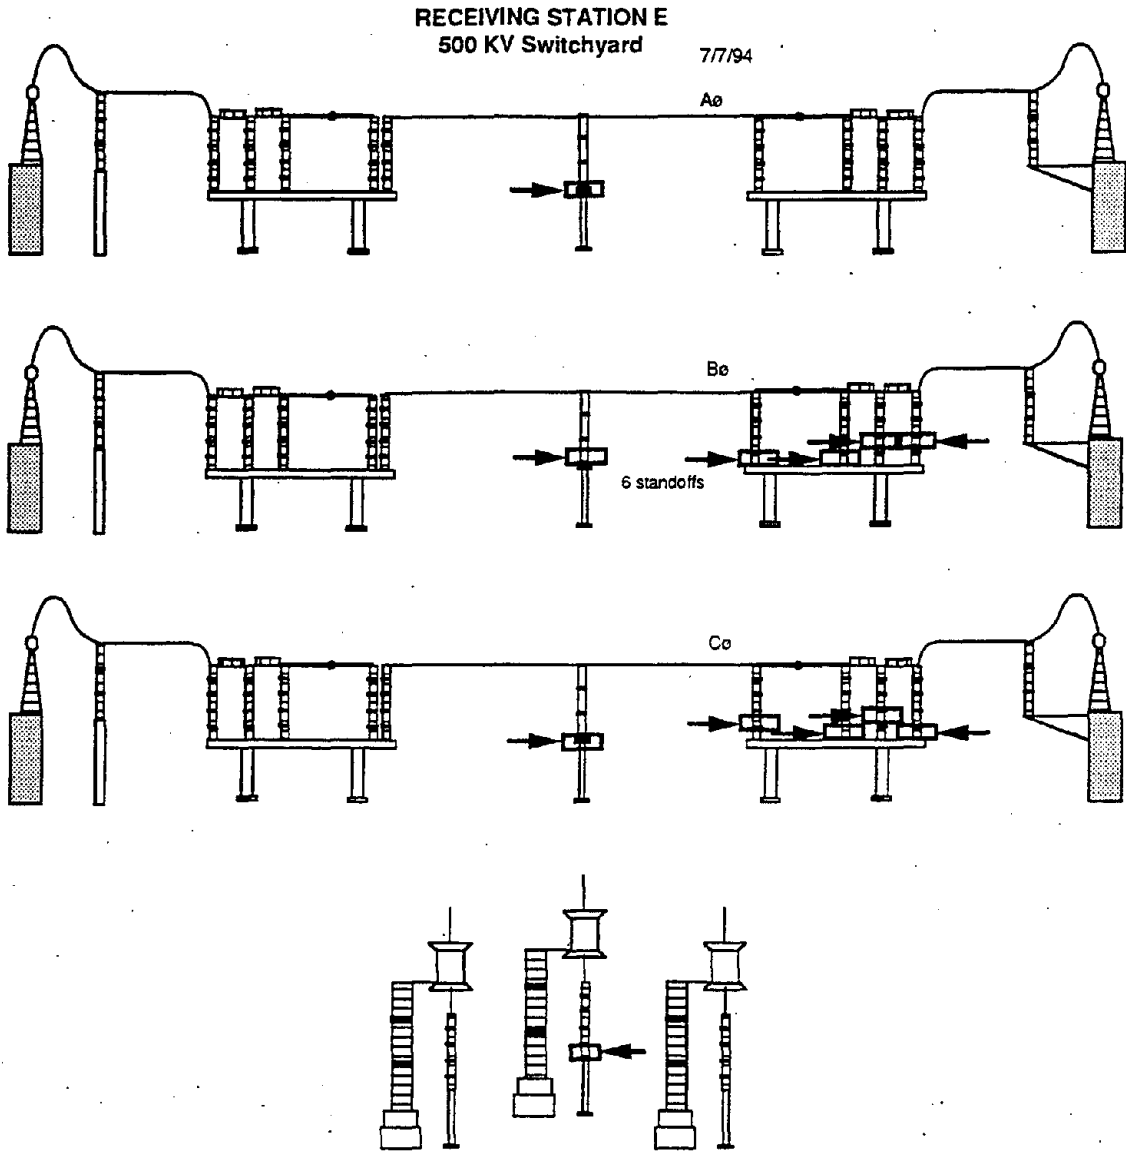
Fig. 3.58 Schematic diagram showing damage to 500 kV switchyard at Receiving Station E.

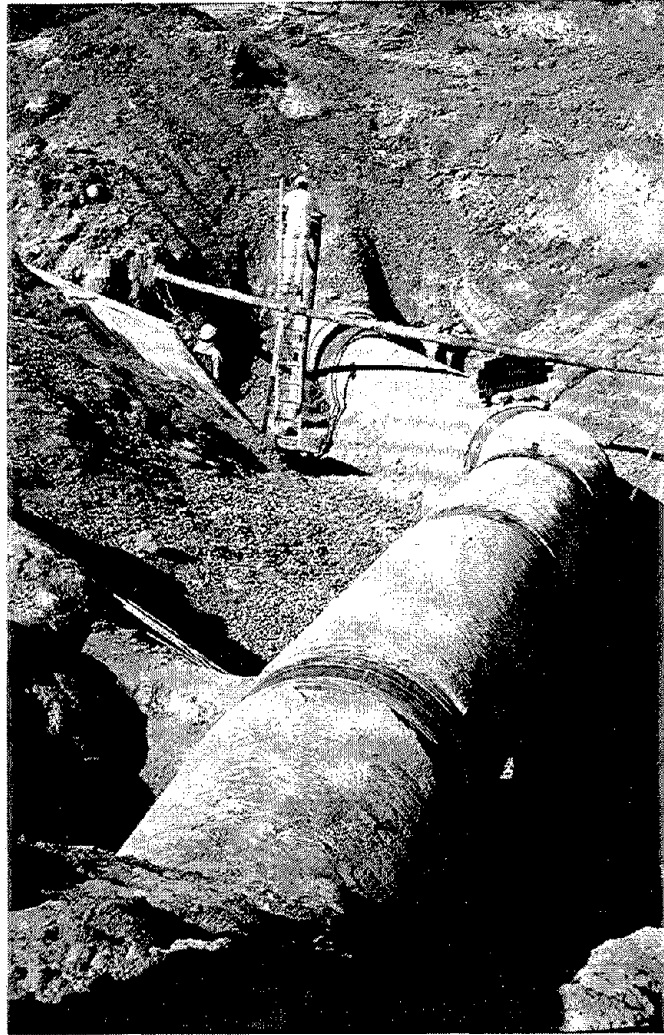
A pipe manufacturer fabricated new compound bend sections and a contractor welded these sections together with butt straps, Fig. 4.3. The pulled rubber gasket joints were welded in place. Backer rods were used to fill the annular space between the bell and spigot to facilitate the welding. The conduit was placed back in service March 25th. While the conduit was out of service the supply to the Santa Clarita Valley after the earthquake was supplied from local groundwater.

Fig. 4.3 Repaired 54-inch using contractor fabricated WSP compound bend with welded butt straps near Rye Canyon.

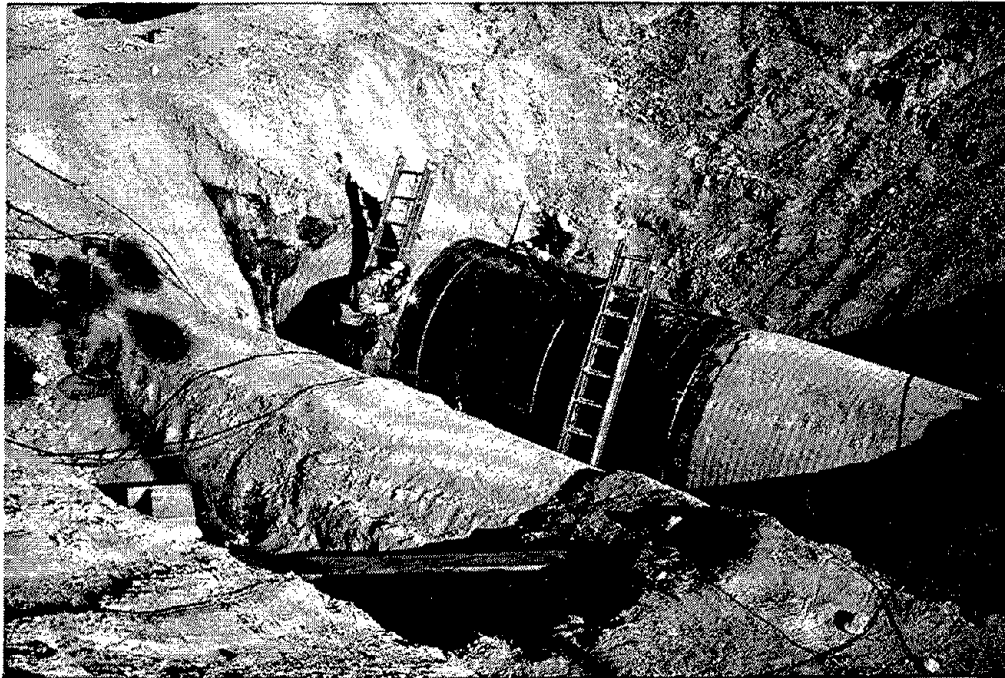
Fig. 4.5 Repaired Jensen influent 85-inch WSP, two 5 ft lengths of pipe, connected with three butt straps.

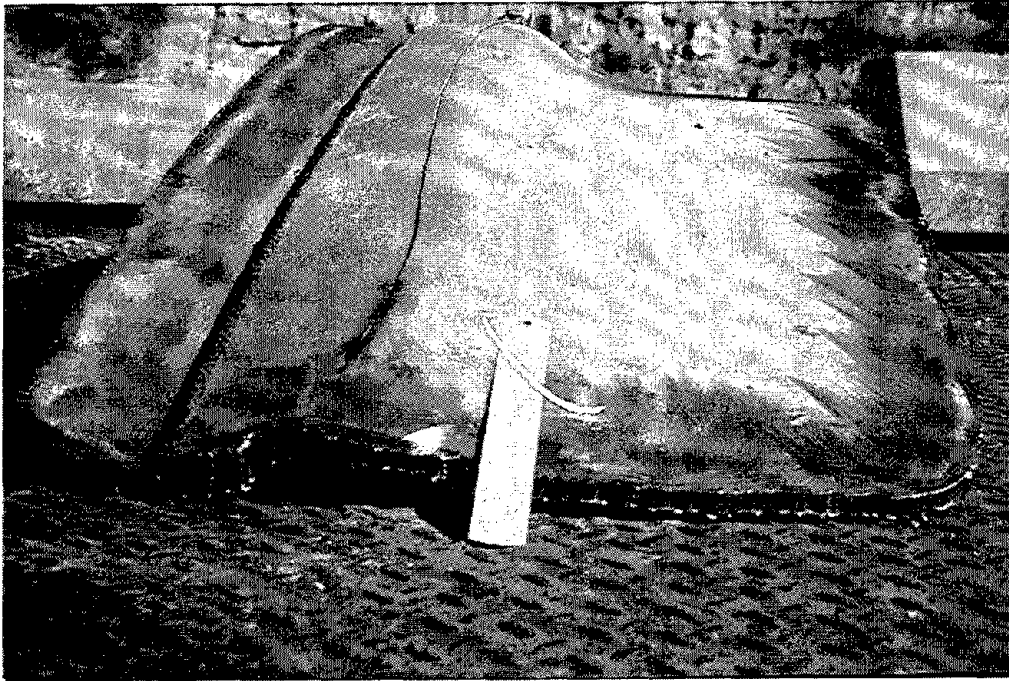
Fig. 4.8 Removed section of Soledad Siphon, 5-foot long split in top of pipe on the curve portion of the bell.

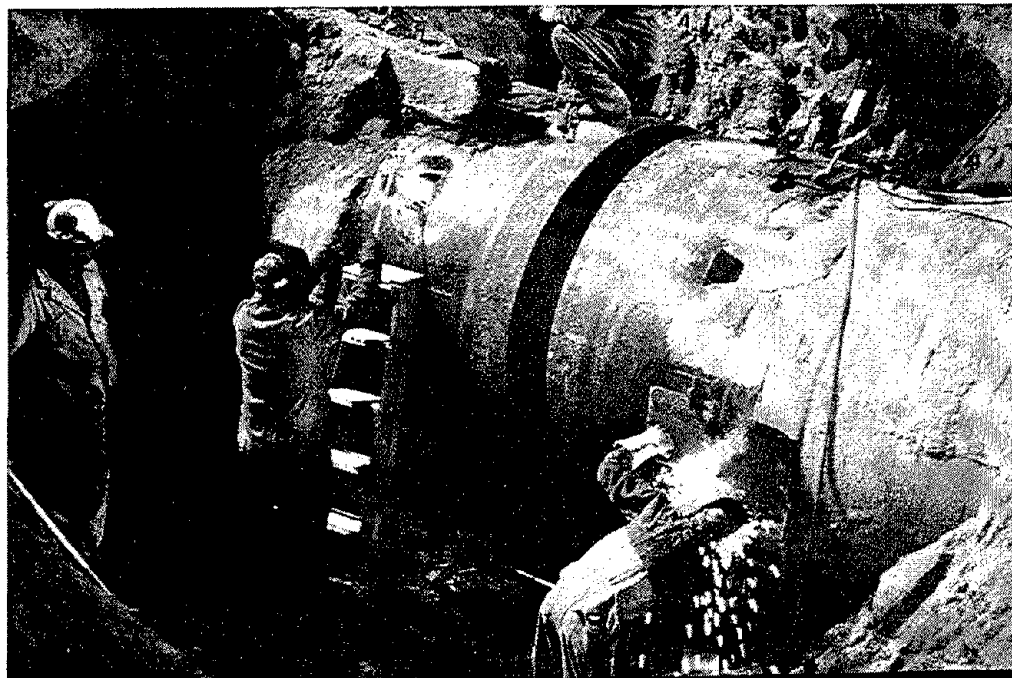
At Terminal Hill the 77-in (1955-mm) welded steel pipeline was shut down twice to repair two pulled mechanical couplings, Fig. 4.11, and an eight-inch long split in the wye branch stiffener. This required the draining and filling the pipe twice during the first week after the earthquake. The pulled couplings were temporarily repaired by welded butt straps. Permanent repair was made by the installation of double restrained mechanical couplings, Fig. 4.12. The wye branch stiffener at this location was rewelded, Fig. 4.13.

Fig. 4.11 Temporary repair in progress of 77-inch WSP pulled mechanical coupling at Terminal Hill. (LADWP)

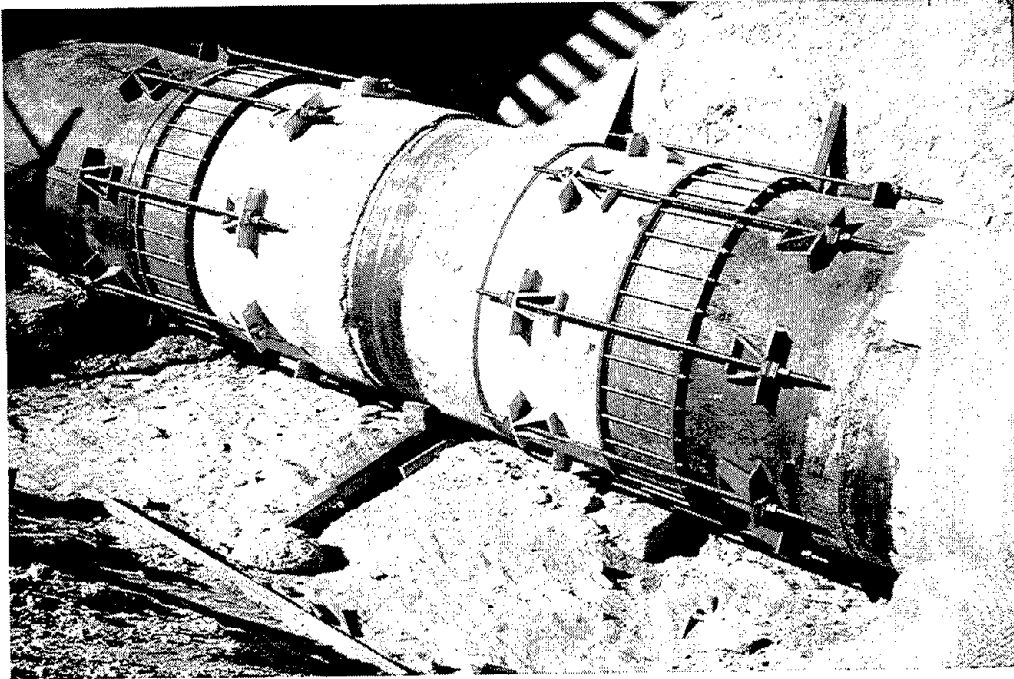
Fig. 4.12 Permanent repair of 77-in WSP by double restrained mechanical couplings.

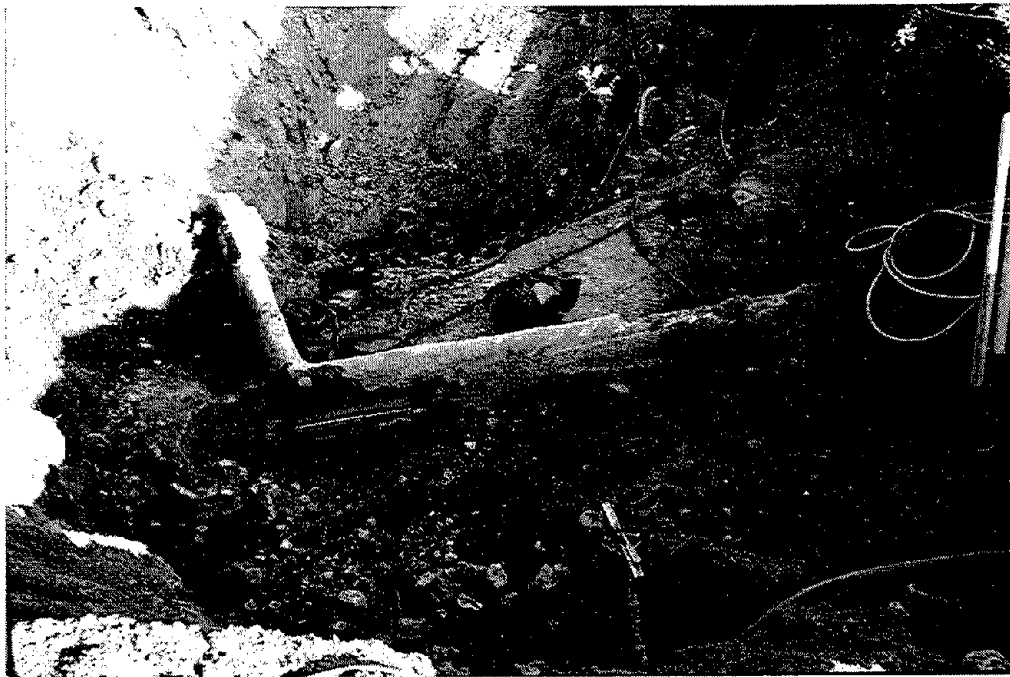
Fig. 4.13 Repaired 77-inch WSP wye branch stiffener at Terminal Hill.

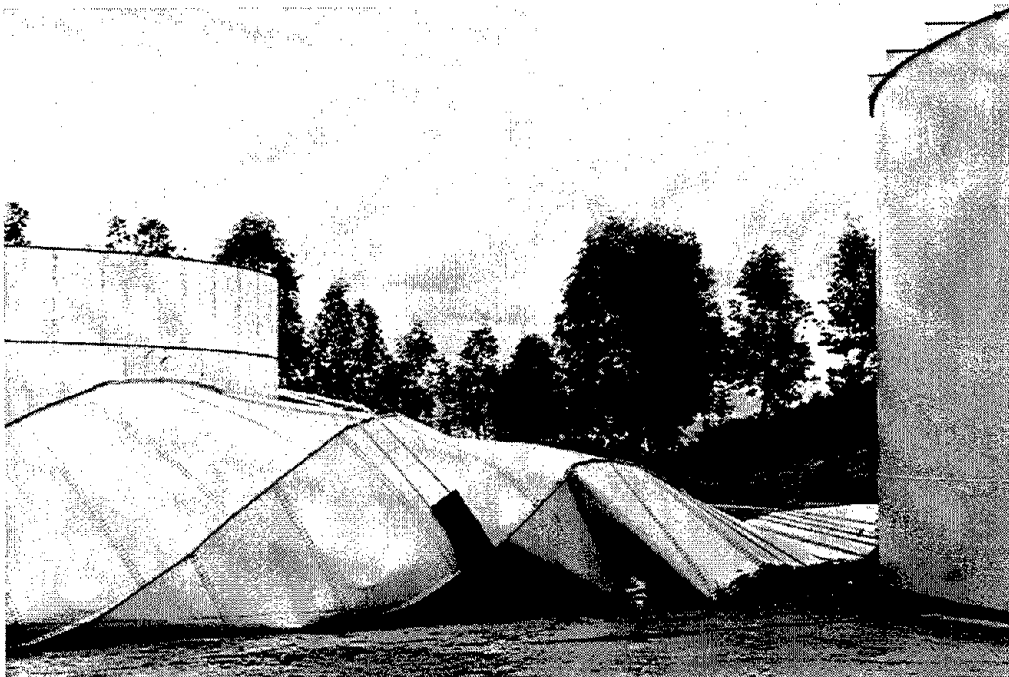
Similarly, there were two structural failures in the Valencia area, with a third tank suffering damage from an adjacent tank failure, Figs. 4.19 and 4.20. Failure modes were severe shell buckling and uplift, inlet-outlet piping failure, roof/rafter damage and in one case shell ripping at the tank bottom, Figs. 4.21 and 4.22. The two tanks with structural failures have been removed. Figure 4.23 shows a tank with a damage roof and upper walls and one of seven temporary portable Baker tanks.

Fig. 4.19 Collapsed 0.50 mg bolted steel tank (MM I) in Valencia area. MM II, at the left, was damaged by outflow from MM I. Large tank to right was undamaged. (T. Cooper)

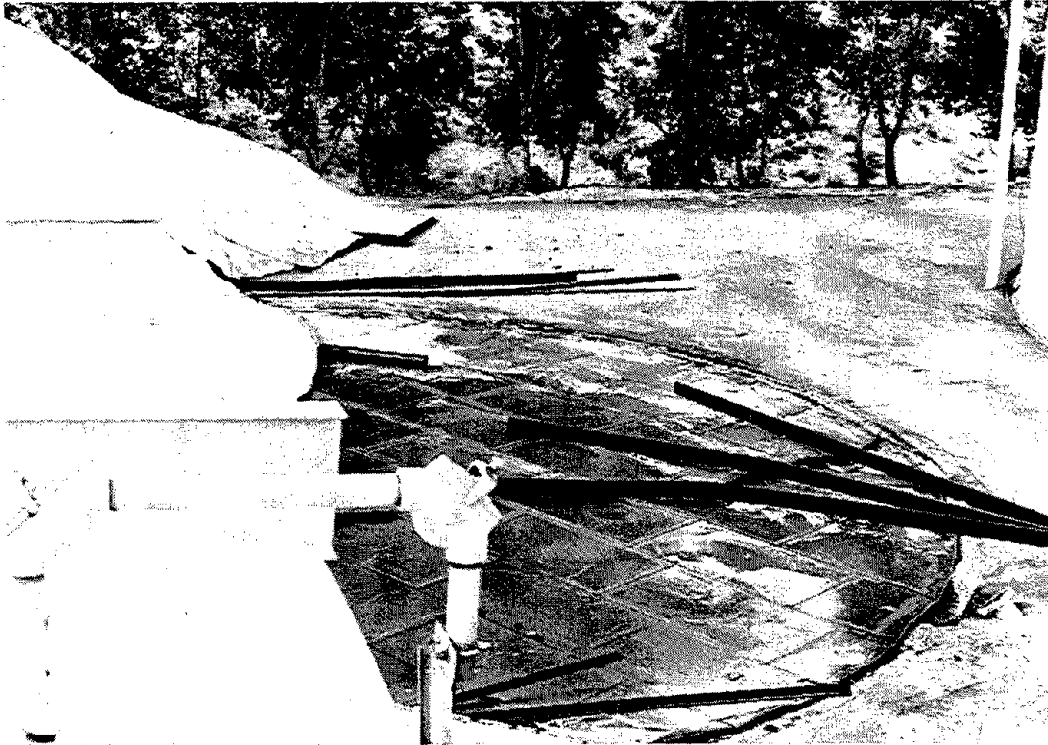
Fig. 4.20 Floor of collapsed bolted tank. Tear in side wall can be seen at edge of base. (T. Cooper)

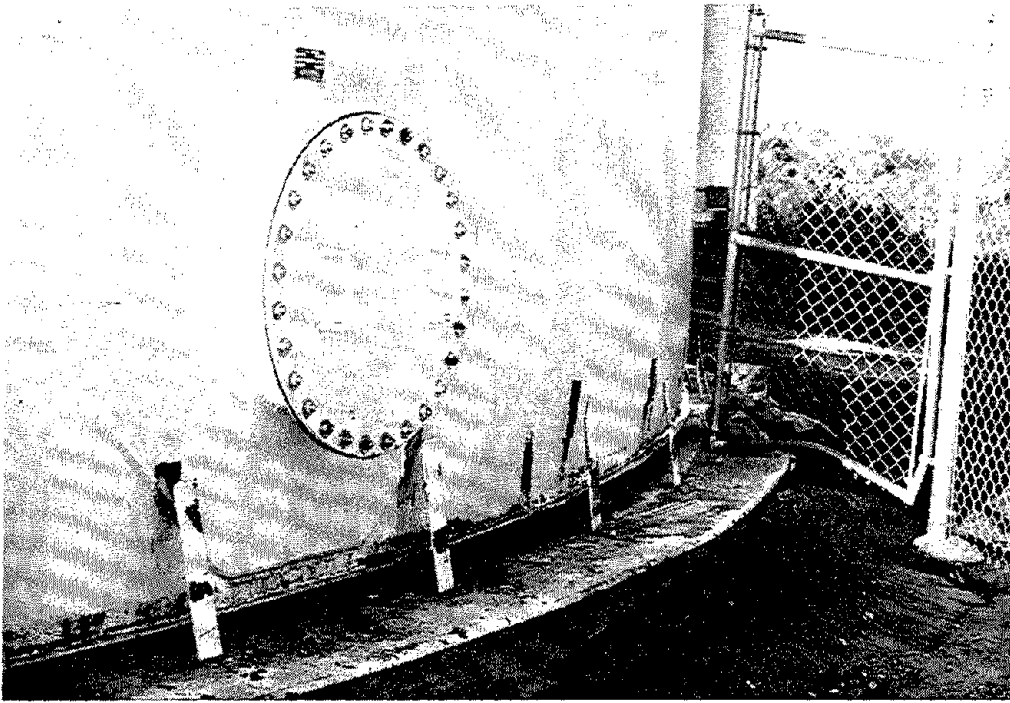
Fig. 4.22 Opposite side of tank shown in Fig. 4.2. Welds at anchor straps failed. (T. Cooper)

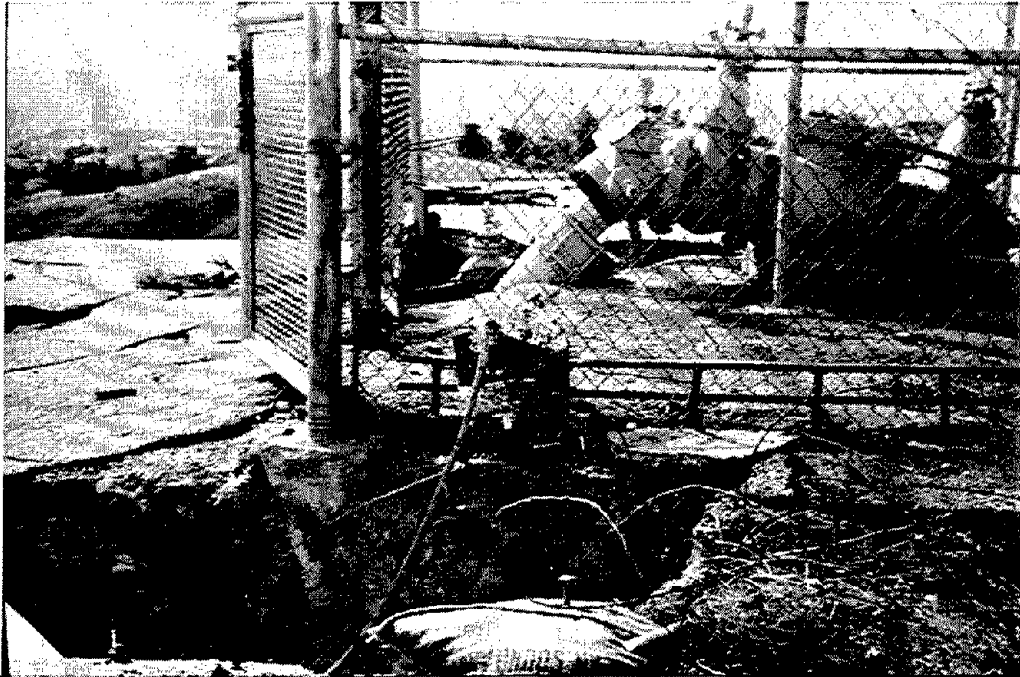
Fig. 4.25 Typical ground erosion from tank draining. (LADWP)

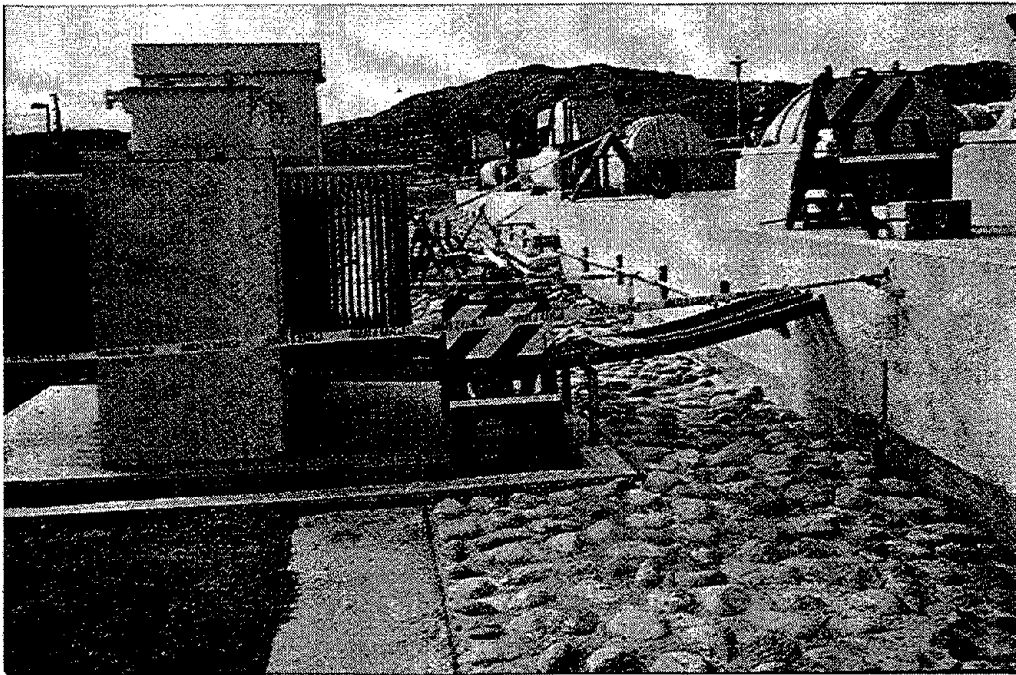
Fig. 4.28 Ground settlement adjacent to water treatment plant (U. of Tokyo)

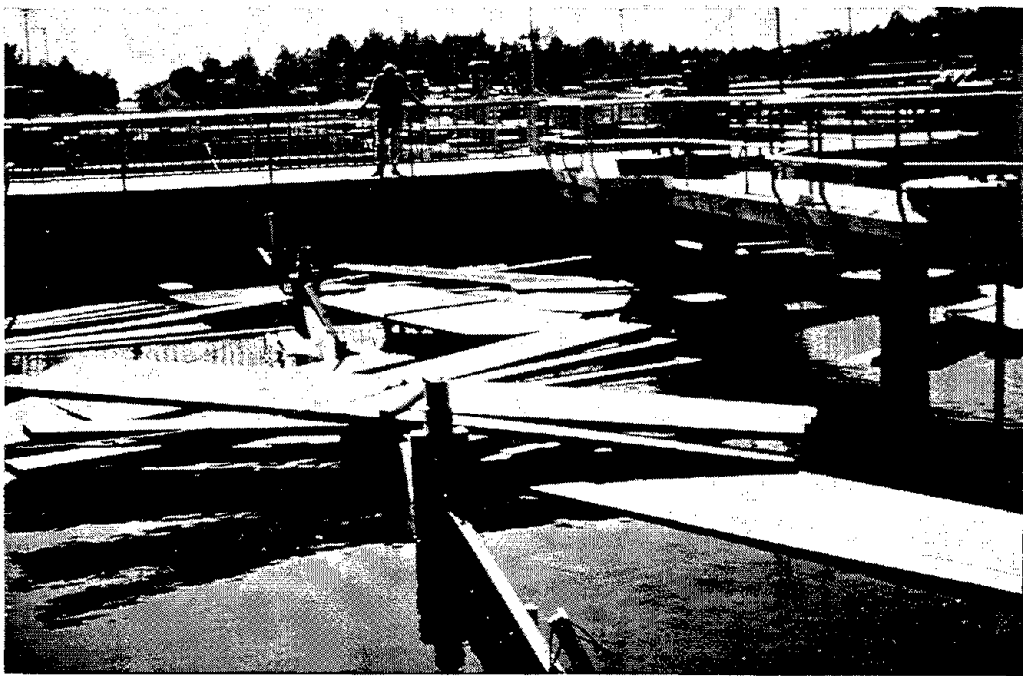
Fig. 4.32 Wood baffles damaged by sloshing at water treatment plant. (MWD)

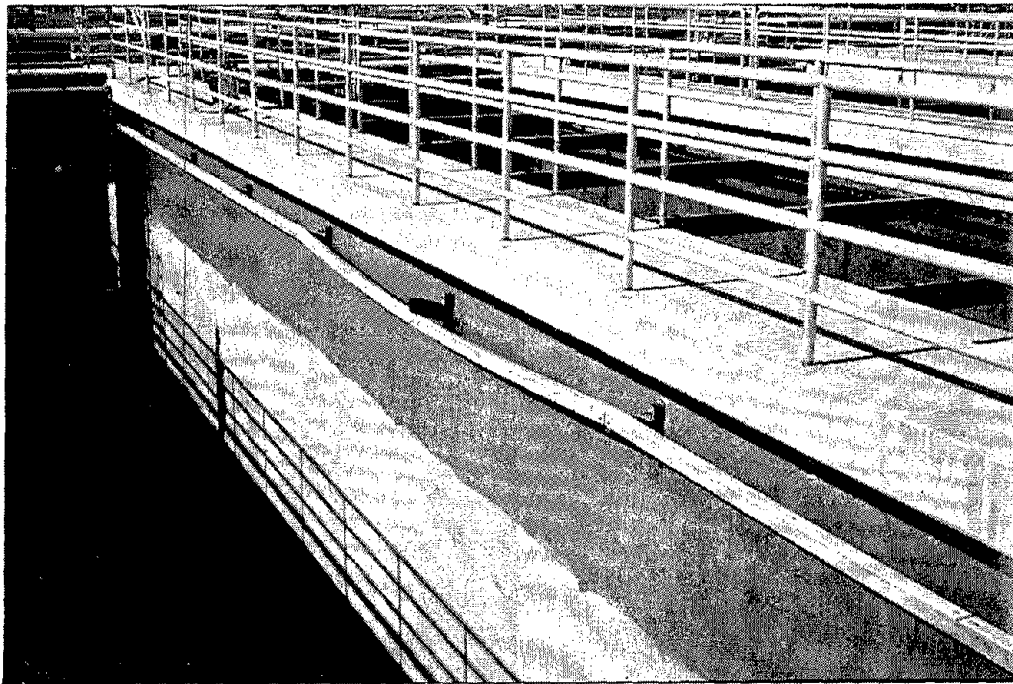
Fig. 5.5 Tillman plant final clarifier, sloshing unseated return sludge scraper chain rail.

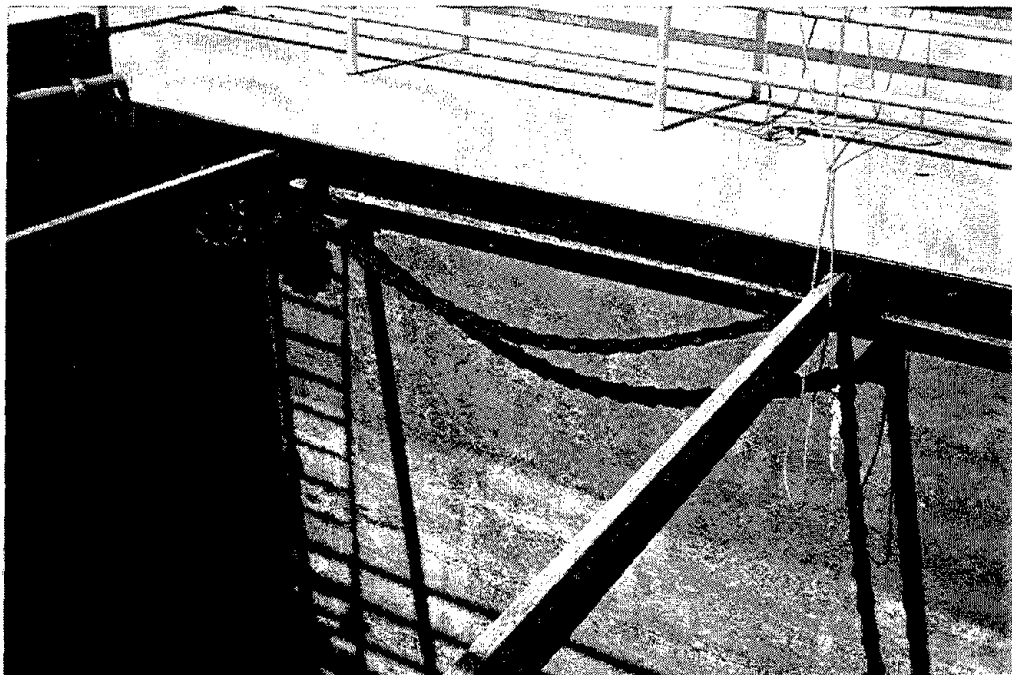
Fig. 5.6 Tillman plant final clarifier. Sloshing jammed sludge scraper chain drive.

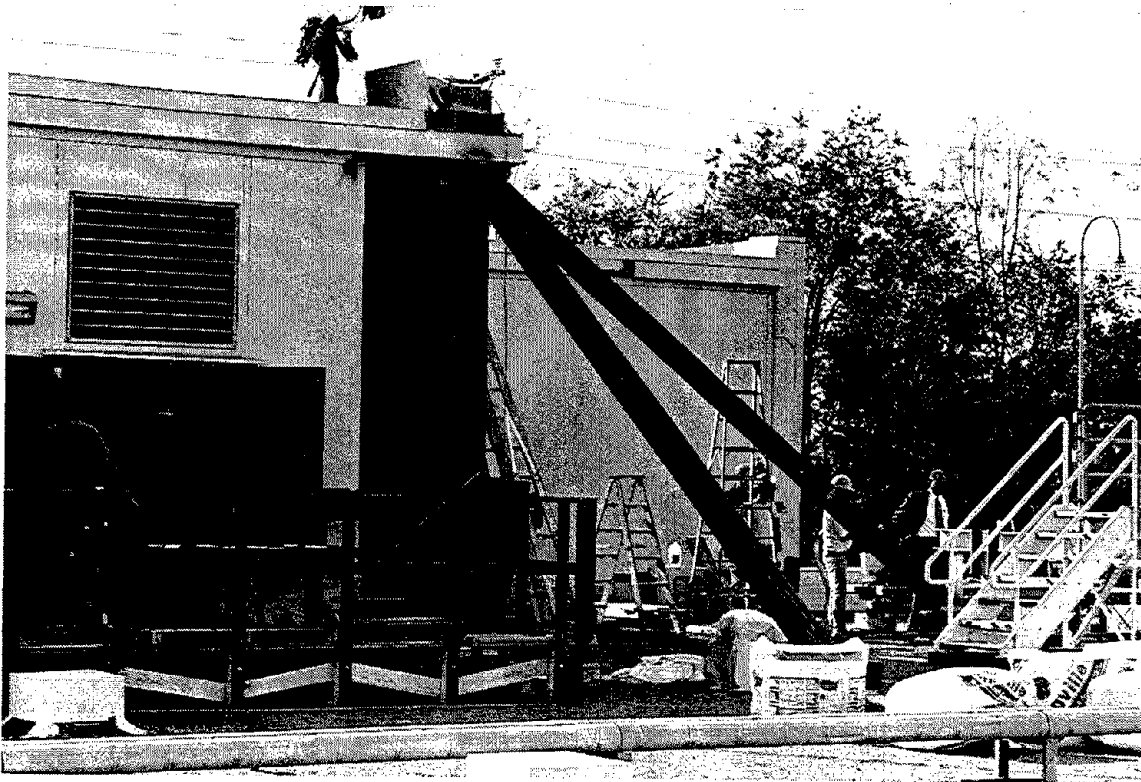
Fig. 6.3. Shoring up structural damage to a central office building.

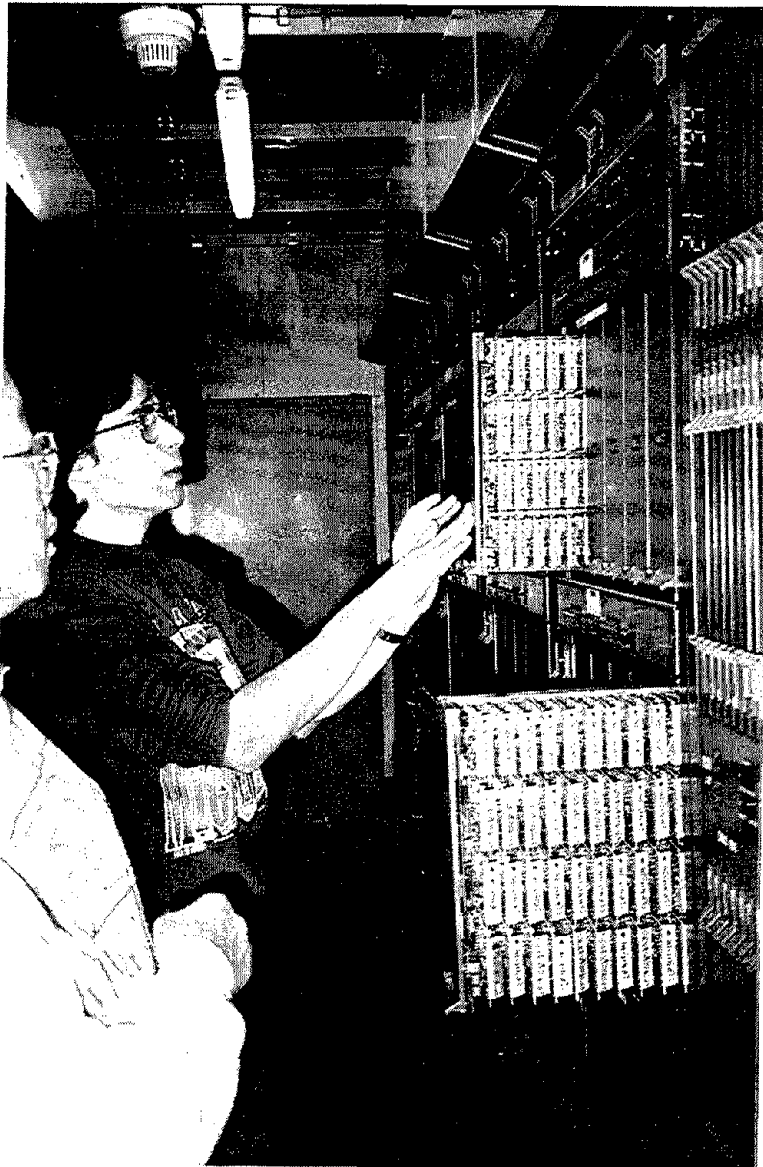
Fig. 6.4. Line disruption due to unseated or damaged circuit boards.

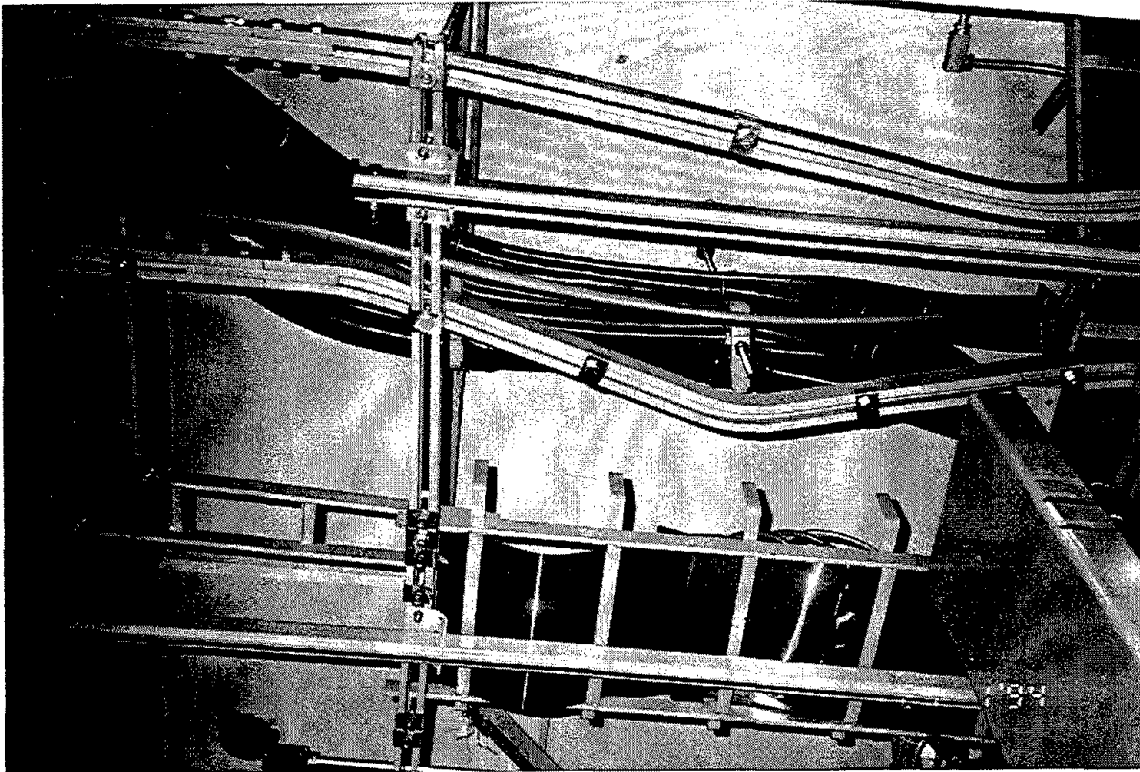
Figure 6.5. Buckled bars in overhead ironworks.

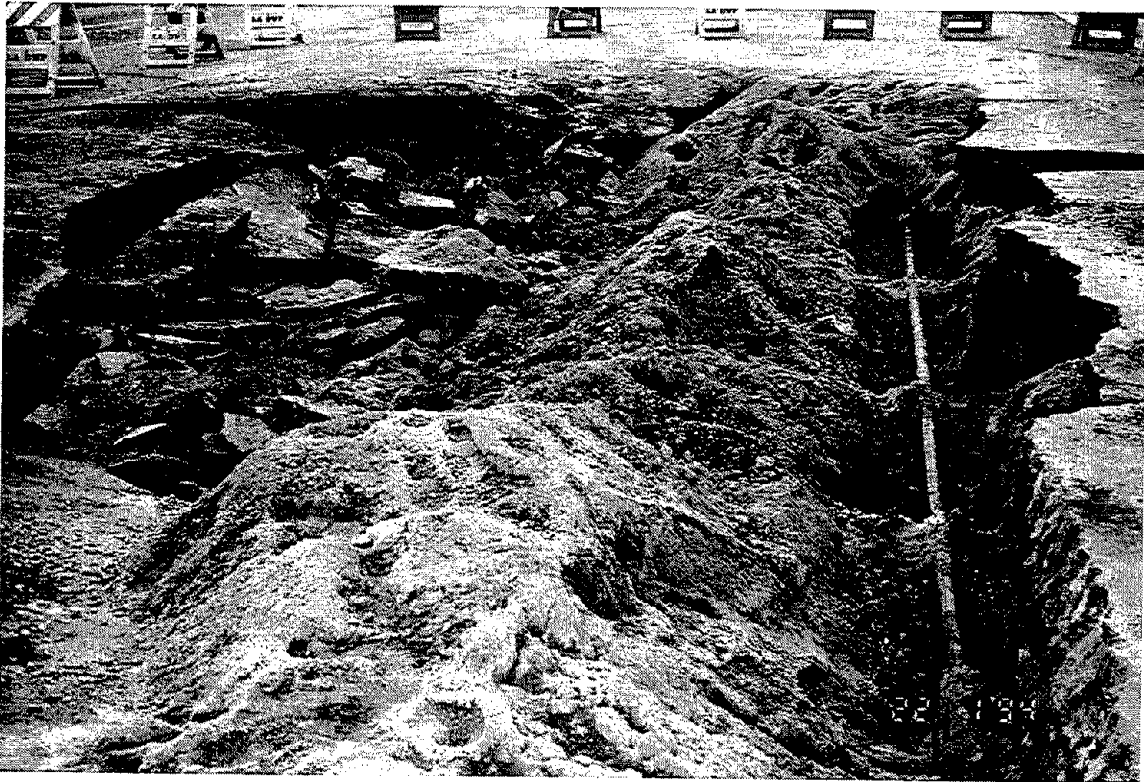
Fig. 6.6. Gas explosion led to fire, busted water mains and severed communications cables.

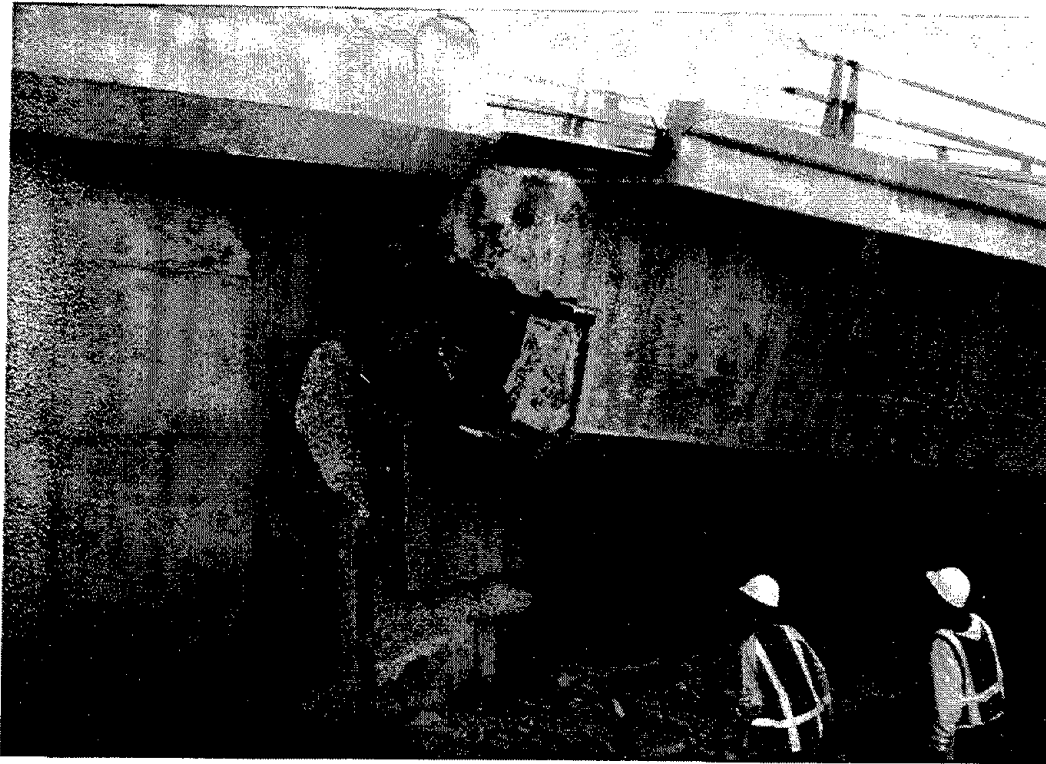
The first two spans along with Pier #2 fell during the earthquake. There was also a great deal of movement at hinge #2. There was no damage at Pier #3.

Figure 7.10. Earthquake Damage at Abutment #1 to the North Connector.

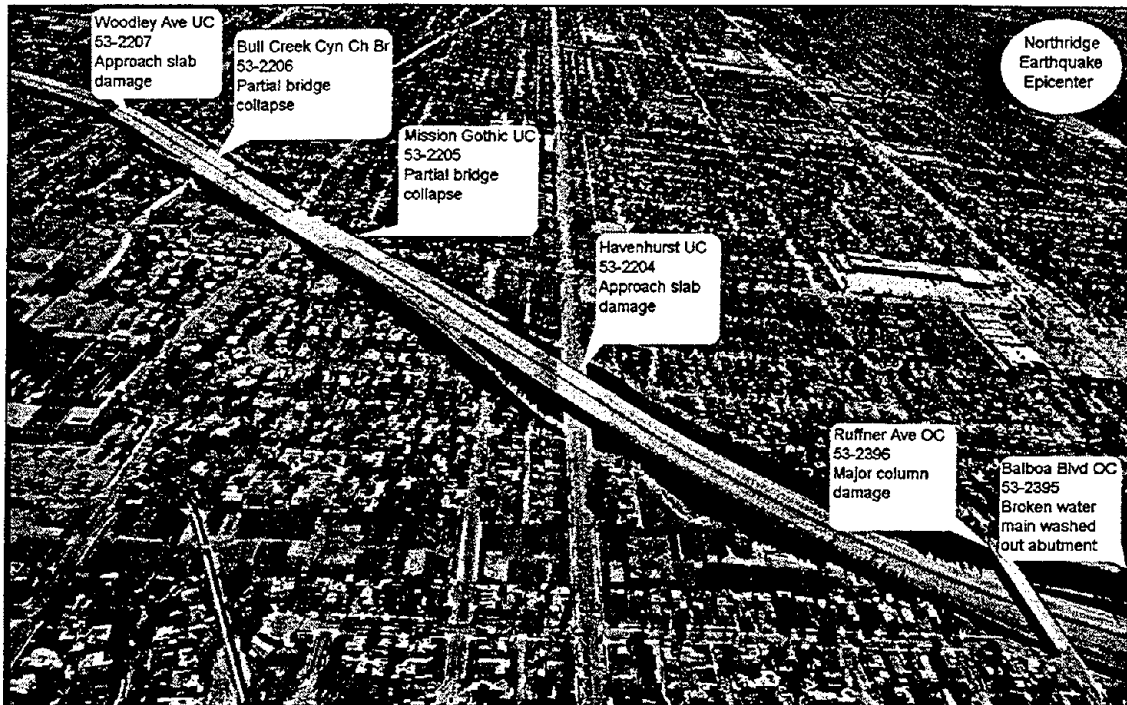
Figure 7.11. Bridge Damage at Location #3 -Route 118 west of Route 405.

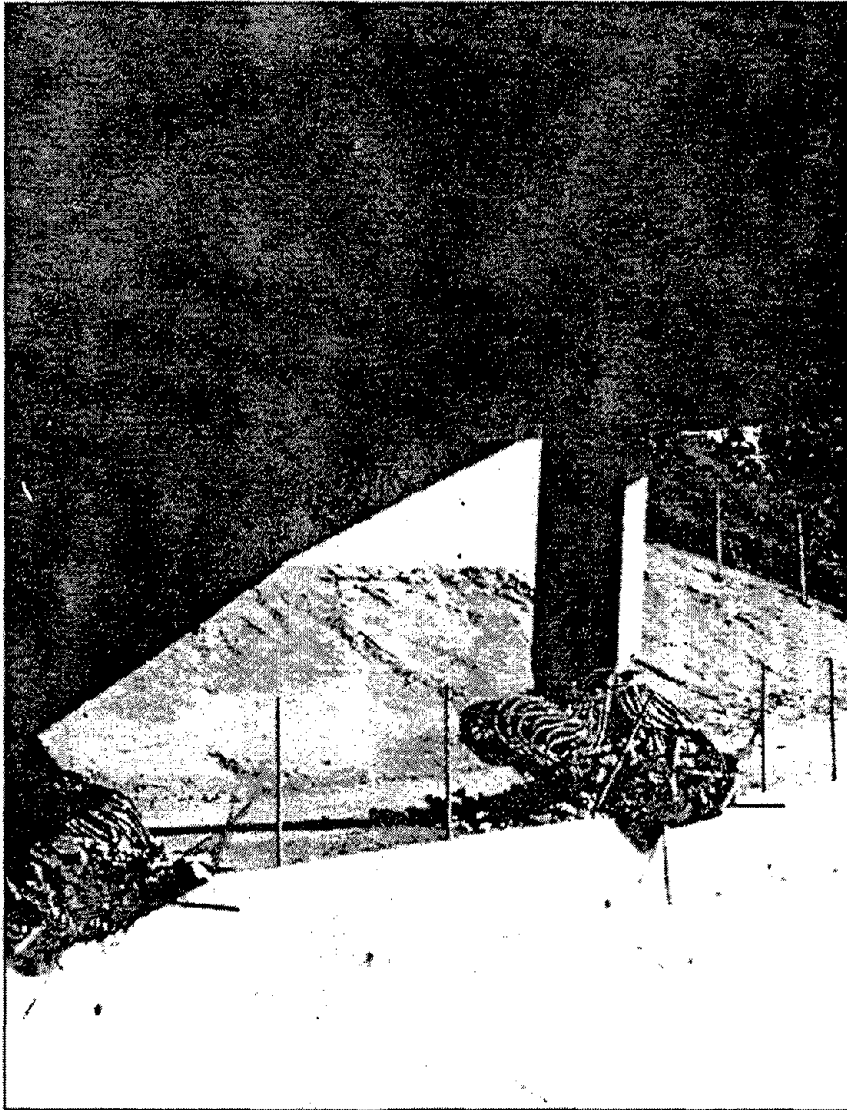
Figure 7.15. Earthquake Damage at Bent #3.

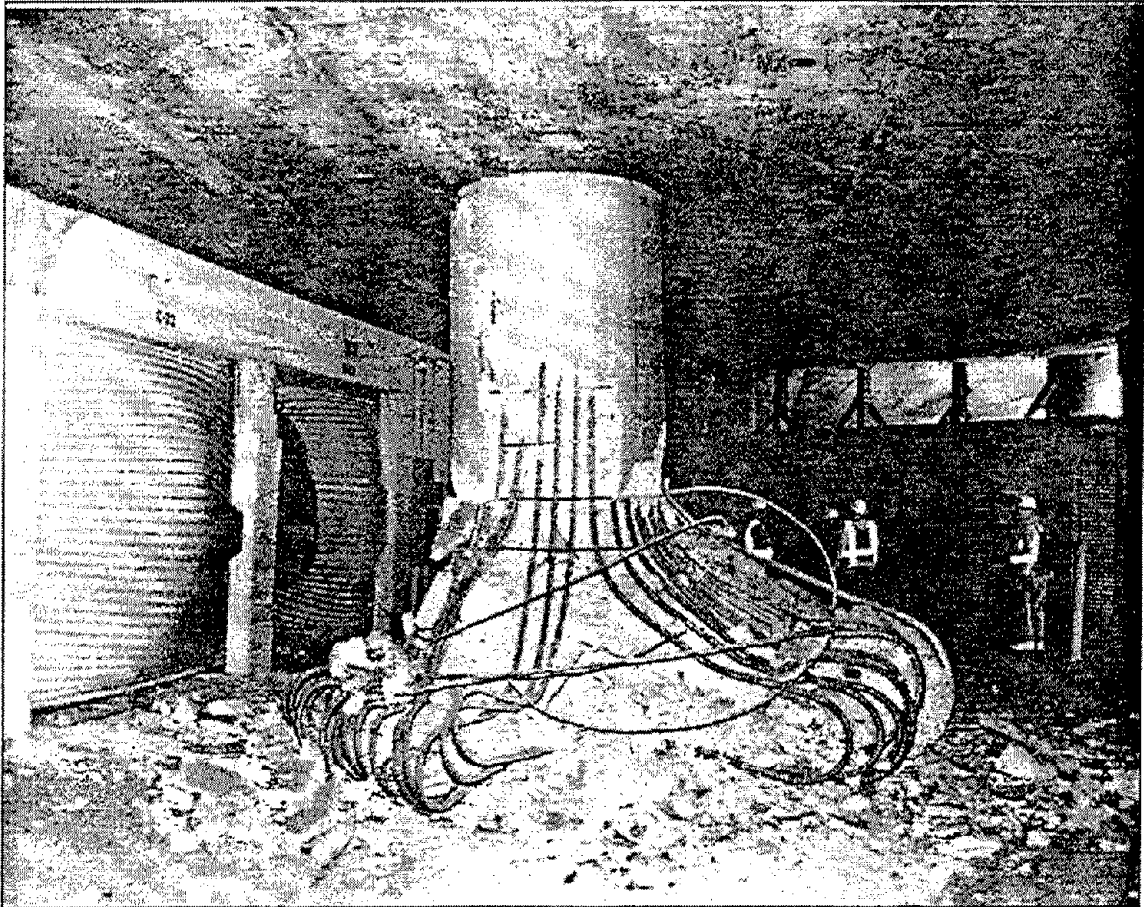
Figure 7.18. Damage to La Cienega-Venice Undercrossing.
