**NORTHRIDGE EARTHQUAKE: LIFELINE
PERFORMANCE AND POST-EARTHQUAKE
RESPONSE**

Date: Apr 97

Authors: A. J. Schiff.

Performing Organization: American Society of Civil Engineers, New York. Technical Council on Lifeline Earthquake Engineering.

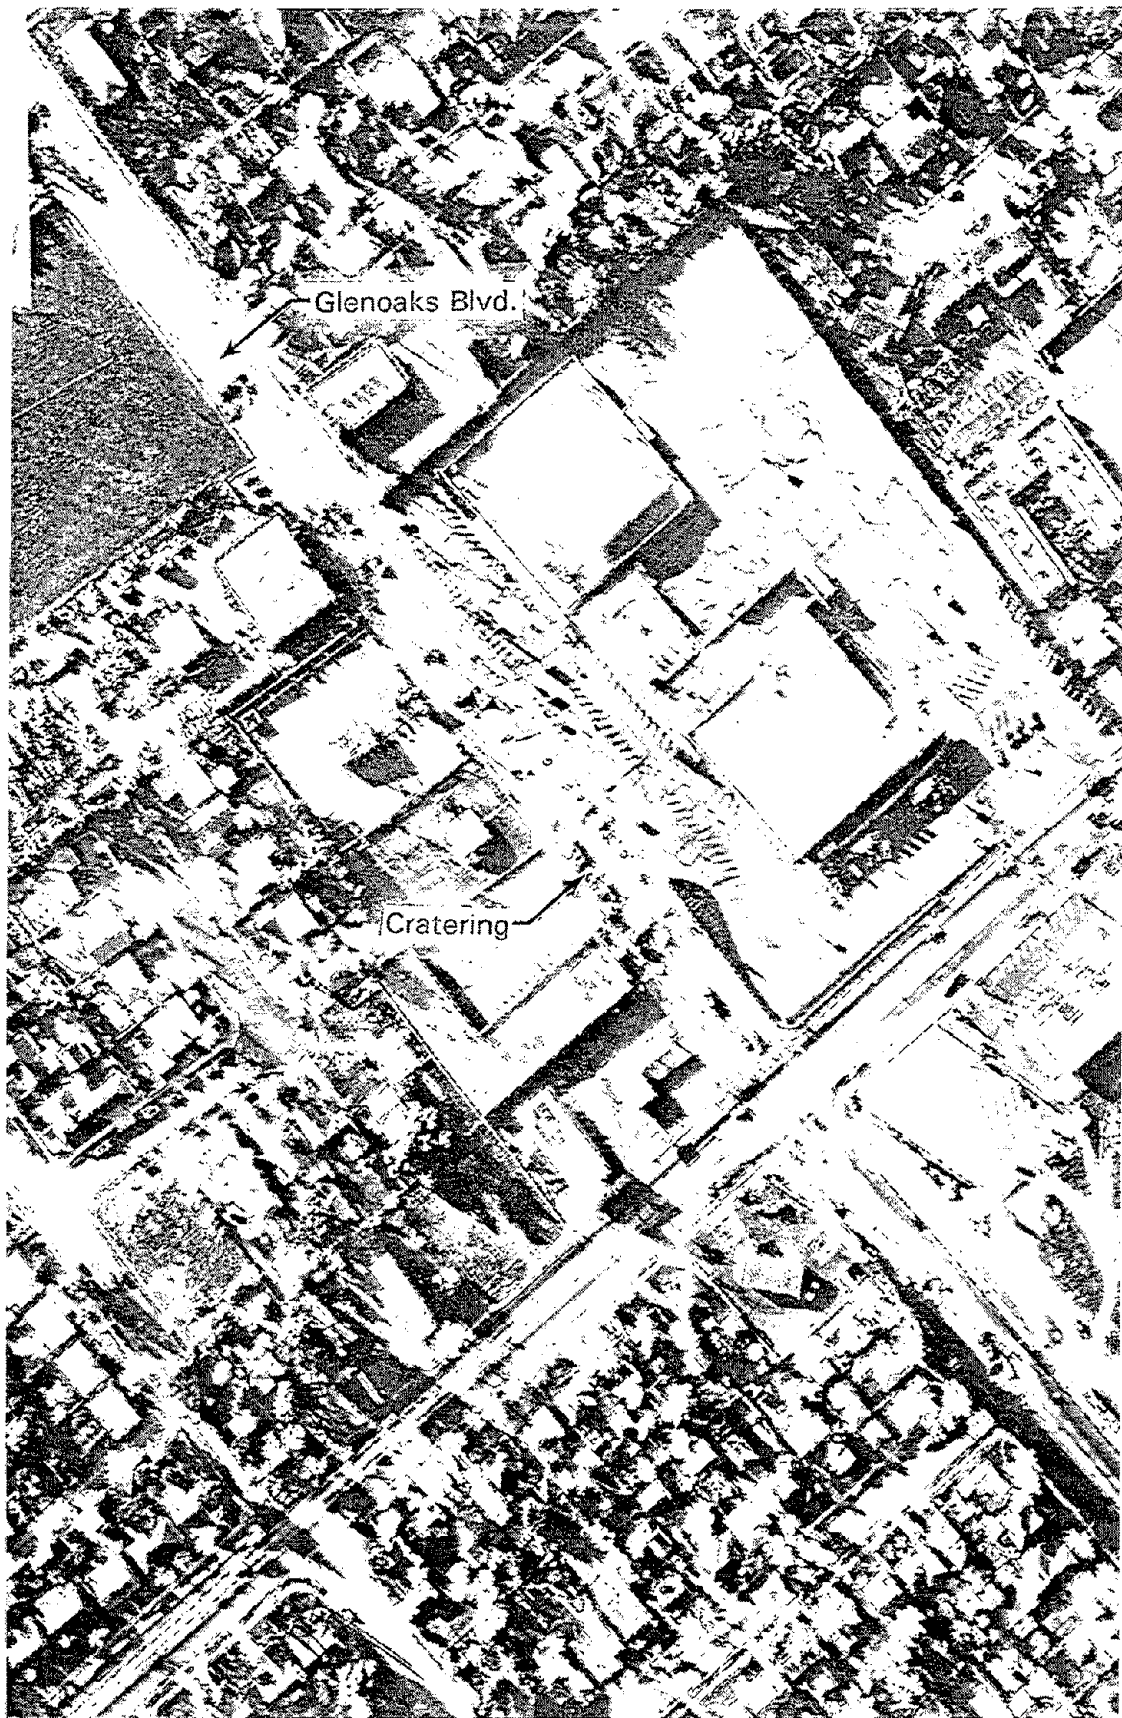
Fig. 14.2 Cratering caused by gas leakage and explosions along Glenoaks Boulevard after the 1971 San Fernando Earthquake.
