NIST-GCR-98-743

FIRE-RELATED ASPECTS OF THE NORTHRIDGE EARTHQUAKE

**Charles Scawthorn, Andrew D. Cowell
and Frank Borden**

October 1996

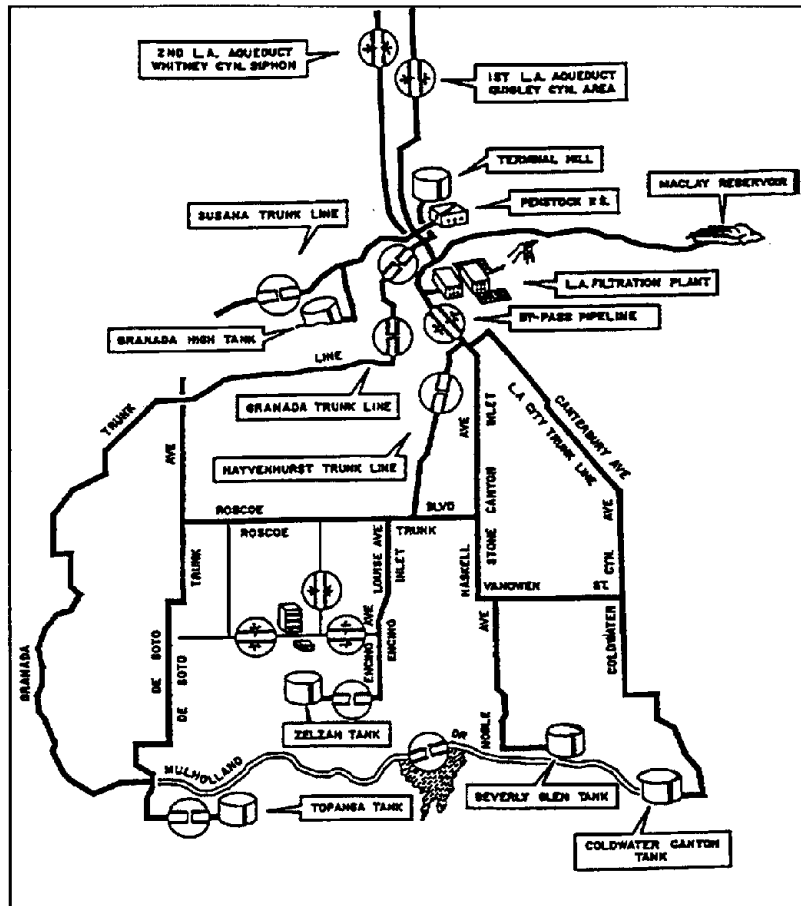
Figure 2-4. Water System Damage, Northridge Earthquake (Courtesy of LAFD)

The Northridge earthquake affected the water supply for portions of the San Fernando Valley. The damage in that area is shown in Figure 2-4. Breaks occurred in at least six trunk lines and a large number of leaks occurred at other locations. The Department of Water and Power estimated that approximately 1,400 leaks were caused by the earthquake, including two lines of the Los Angeles Aqueduct (Lund et al, 1995). Pump stations and storage tanks also sustained damage. The damage to the system resulted

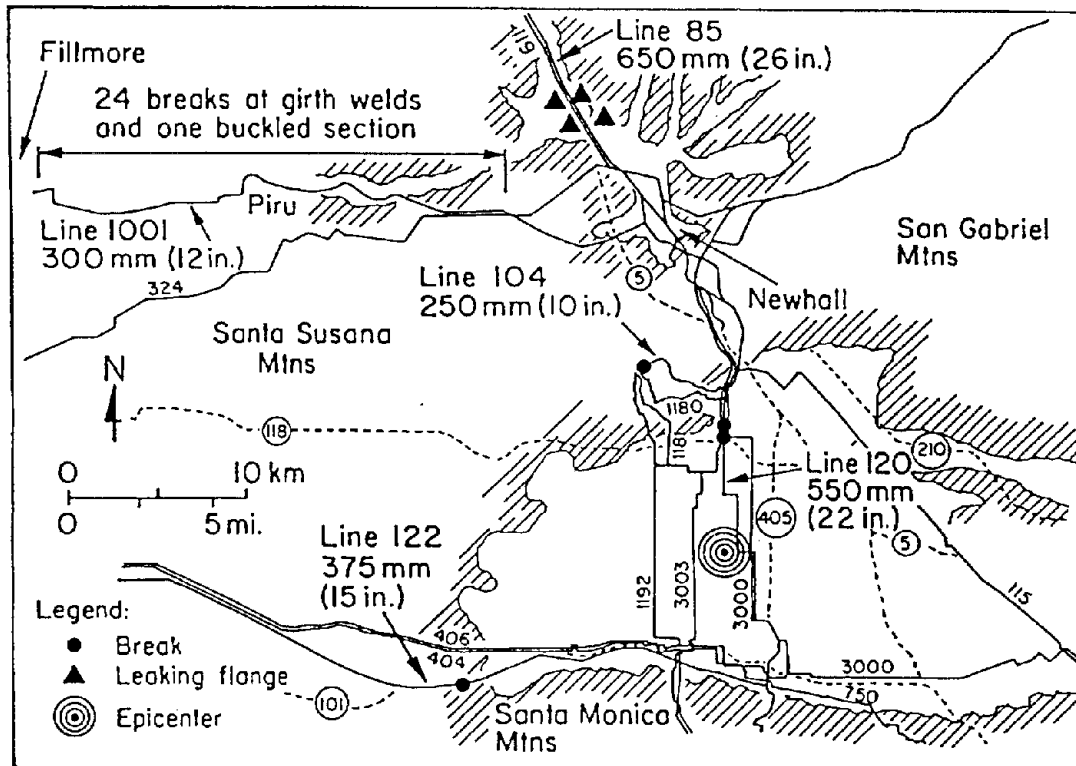
Figure 2-5: Map of selected gas transmission pipes in the Northridge earthquake (after Holzer et al, 1996)

There were 35 non-corrosion-related repairs made to the transmission system, of which 27 were at cracked or ruptured oxacetylene girth welds in pre-1932 pipelines, Figure 2-5. Gas escaping at the break in Line 1001 under Hwy. 126 near Fillmore ignited, possibly by a downed power line. On Balboa Blvd. between Rinaldi and Lorillard, significant permanent ground deformations were experienced due to liquefaction (Holzer et al, 1996), resulting in distinct tension and compression regions affecting several water and gas transmission lines under Balboa Blvd. (Figures 2-6 and 2-7). Line 120 (22 inch. diam. steel) failed, and escaping gas was ignited, reportedly by sparks from the ignition

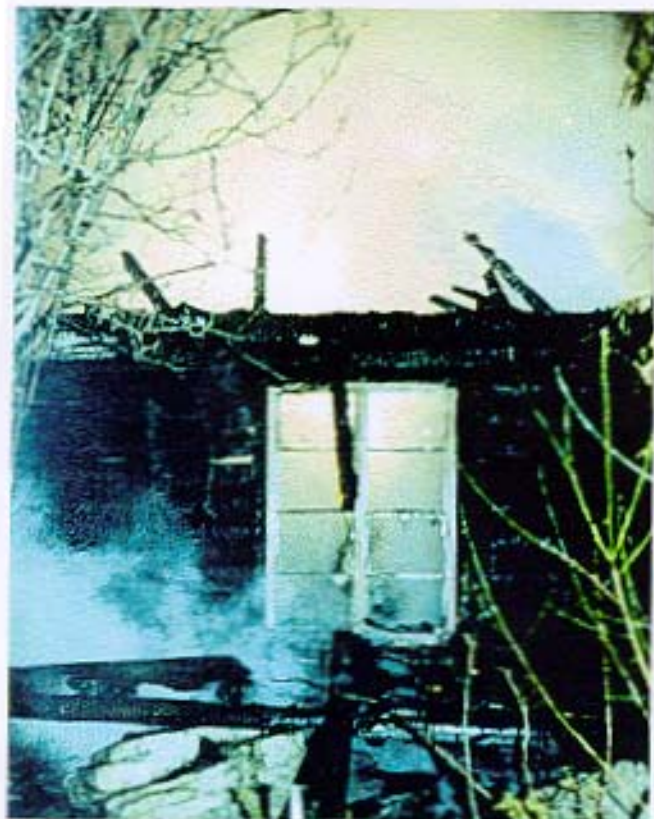
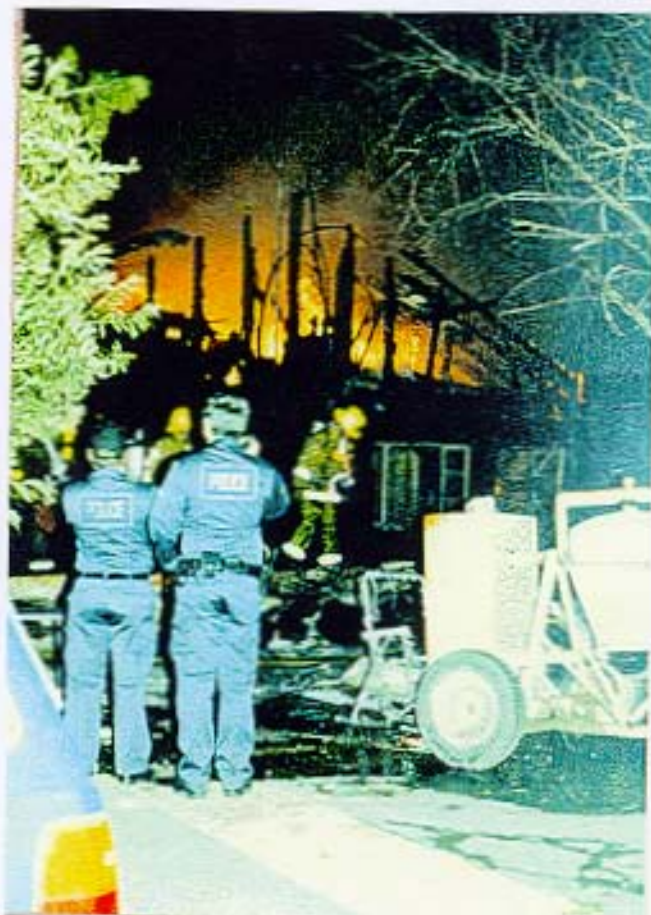
3-1 (left) and 3-2 (right): Fire in wood-frame dwelling (location unidentified)

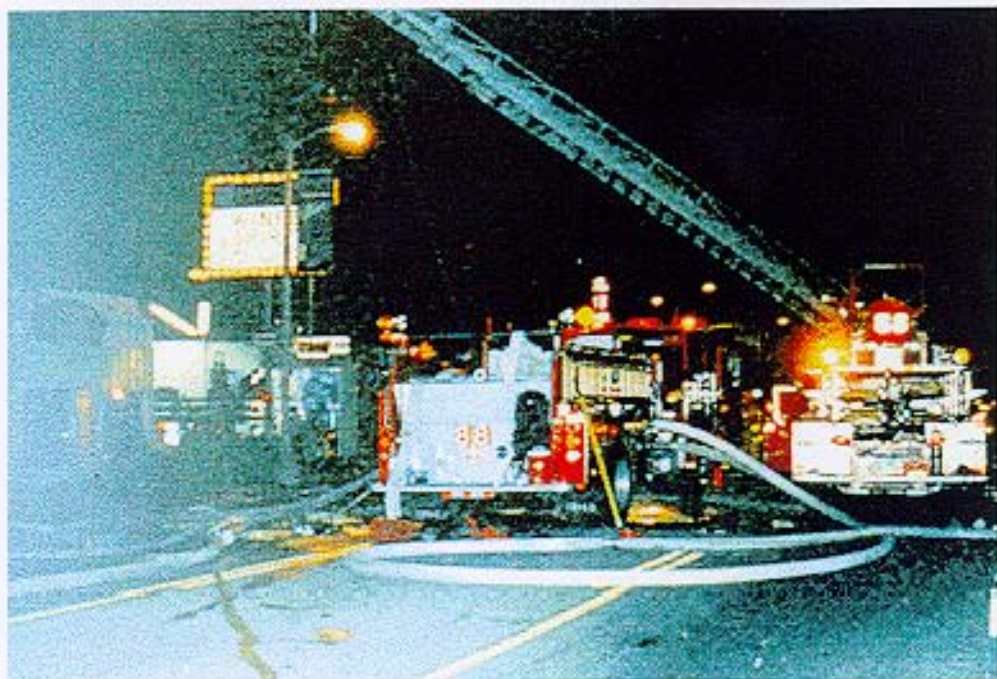
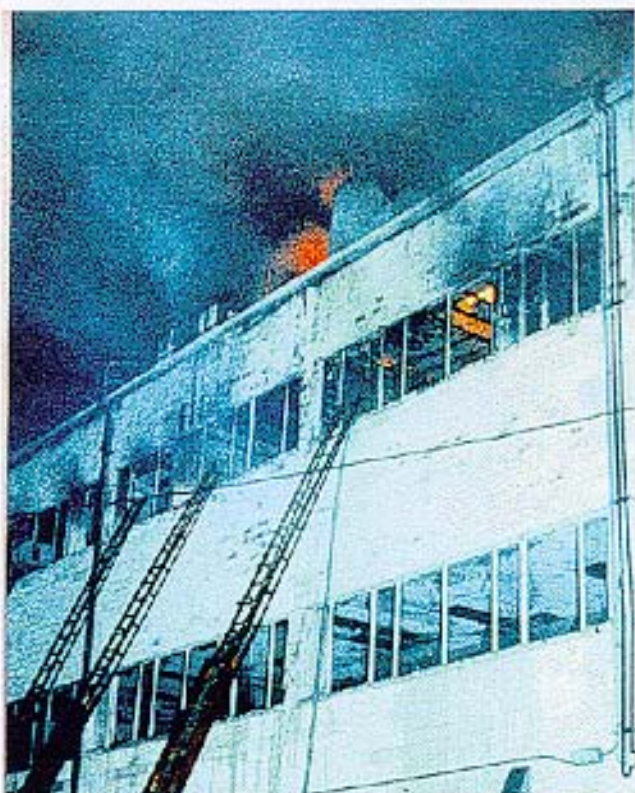
3-3 (top) and 3-4 (bottom):
Commercial office building fire, Ventura Blvd., Sherman Oaks

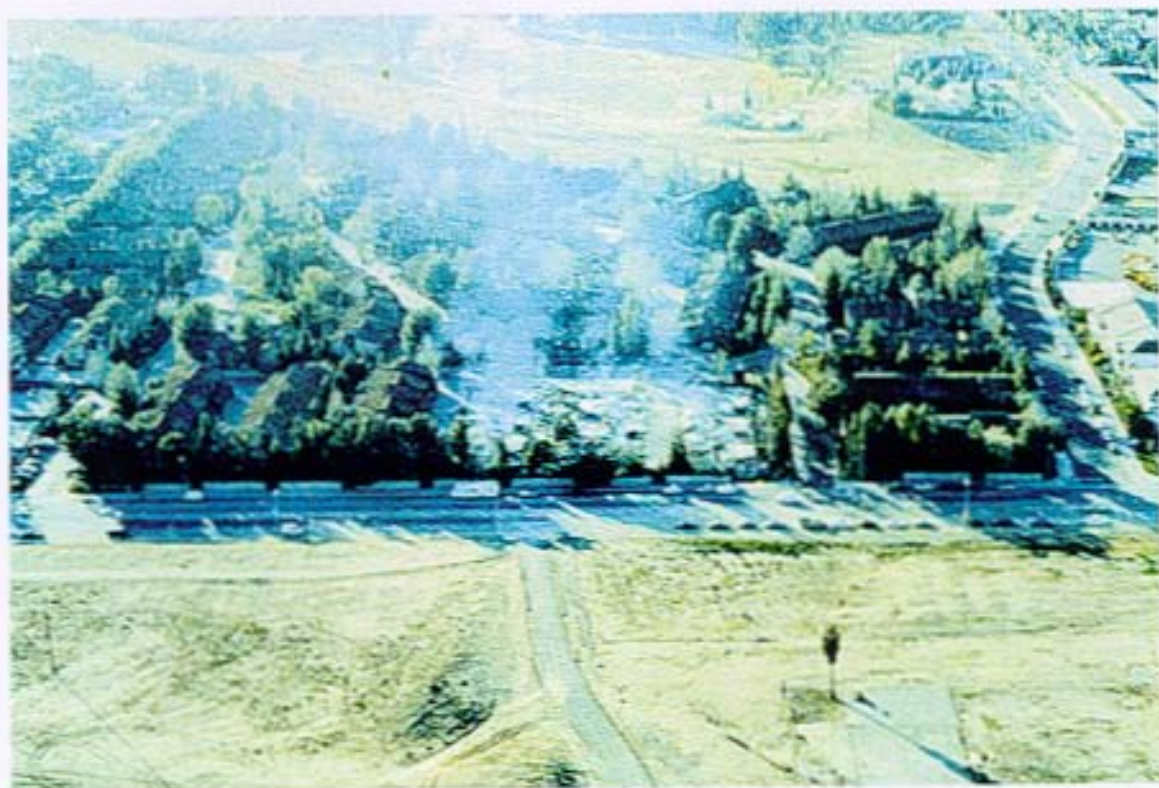
3-5: Multiple structure fire spread, 18110 Andrea Circle North, North San Fernando Valley. (Loss: 17 units, 3 buildings, ~ \$500,000; cause: gas meter damage)

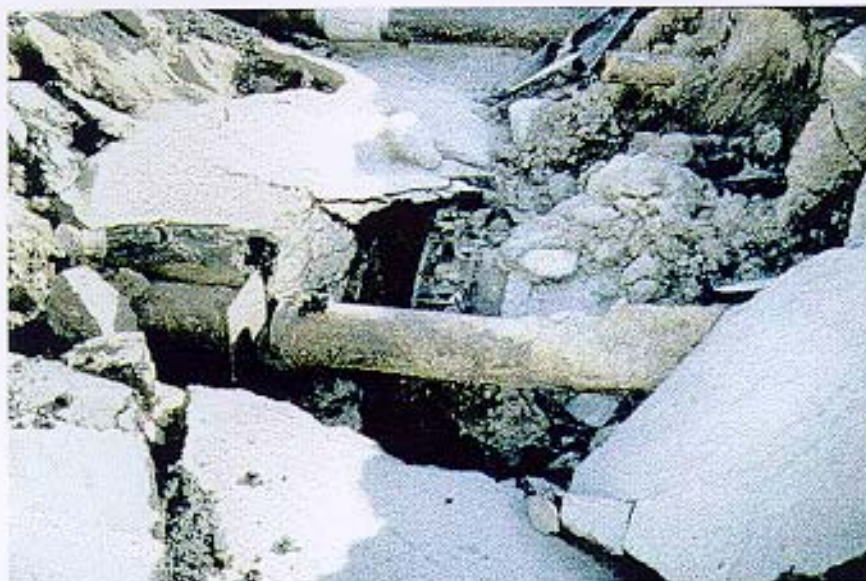
3-6: Broken water and gas mains on Balboa Boulevard in an area of extensive ground failures possibly caused by faulting. The broken gas main (foreground) ignited and caused a fire that burned down five houses and damaged several more.

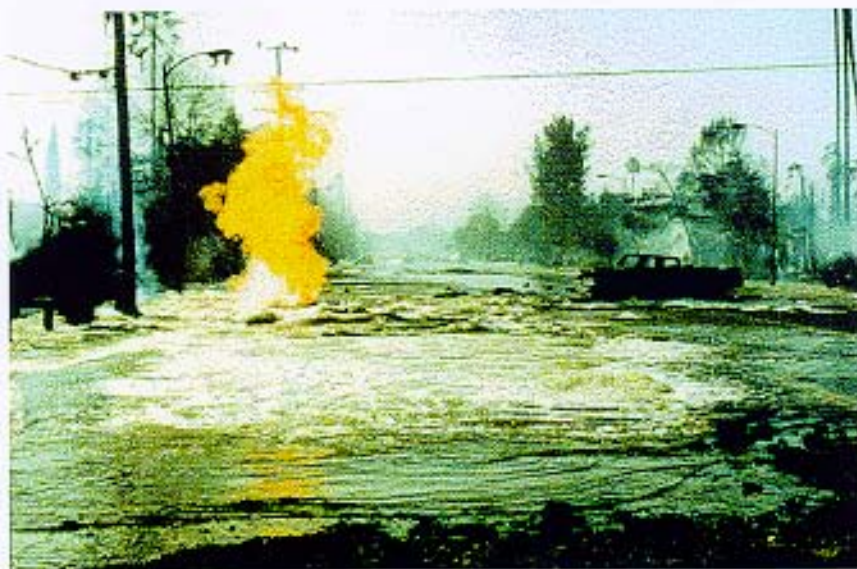
3-7: This fire on Balboa Boulevard in Granada Hills destroyed several homes and was caused by an unusual sequence of events. Adjacent water and gas mains broke because of ground failure (possible faulting). According to eyewitness, the truck stalled because of the flooding, and when the driver attempted to restart the vehicle, the leaking gas was ignited.

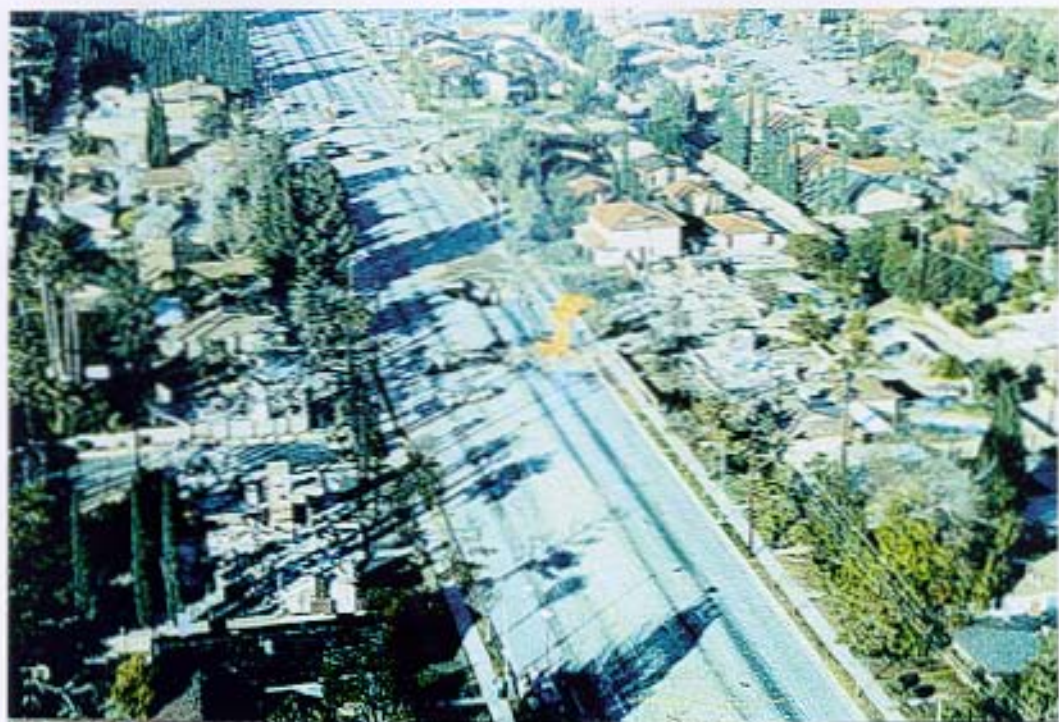
3-8: Burning gas main on Balboa Boulevard, Granada Hills, January 18, 1994.

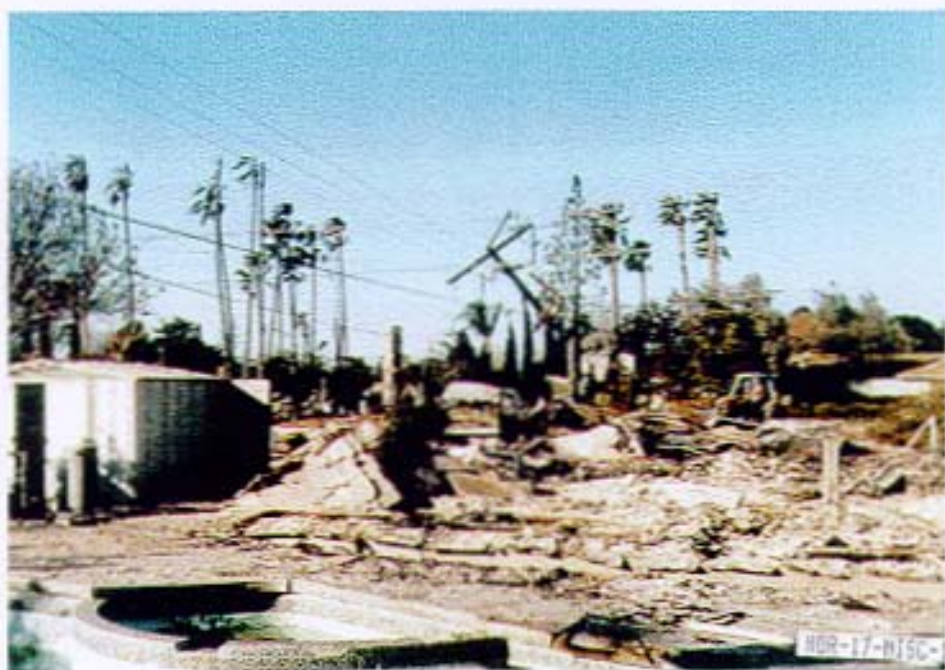
3-9: The remains of a few of the homes destroyed by the fire on Balboa Boulevard.

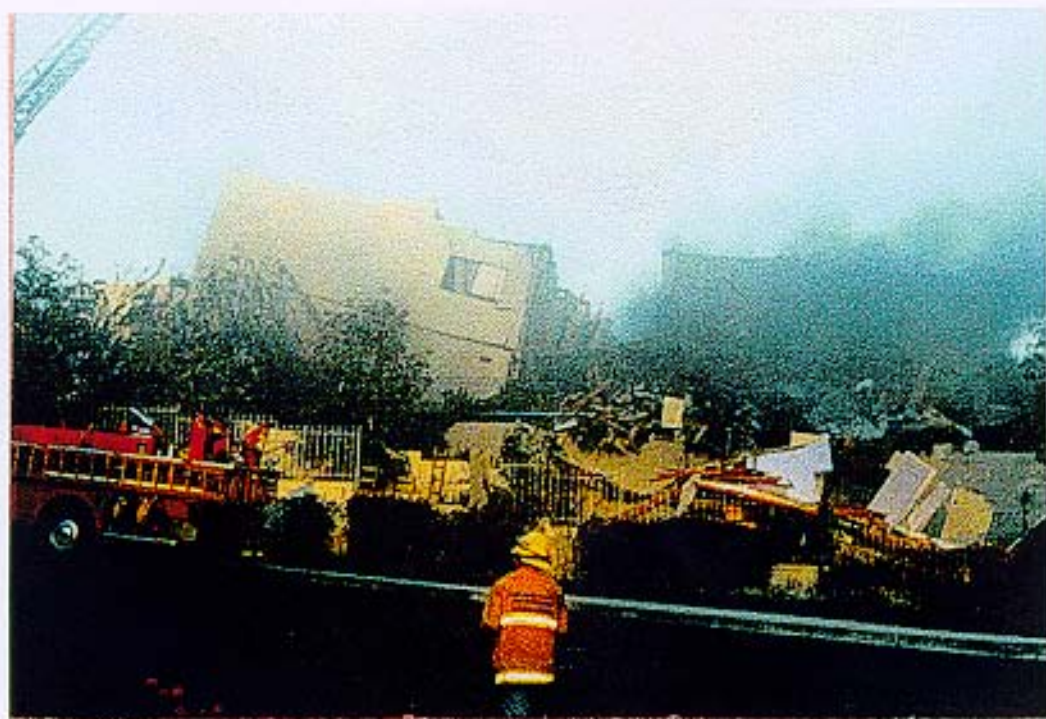
3-10: Collapsed 2-story condominium with fire in debris, 11611 Blucher Ave., Granada Hills.

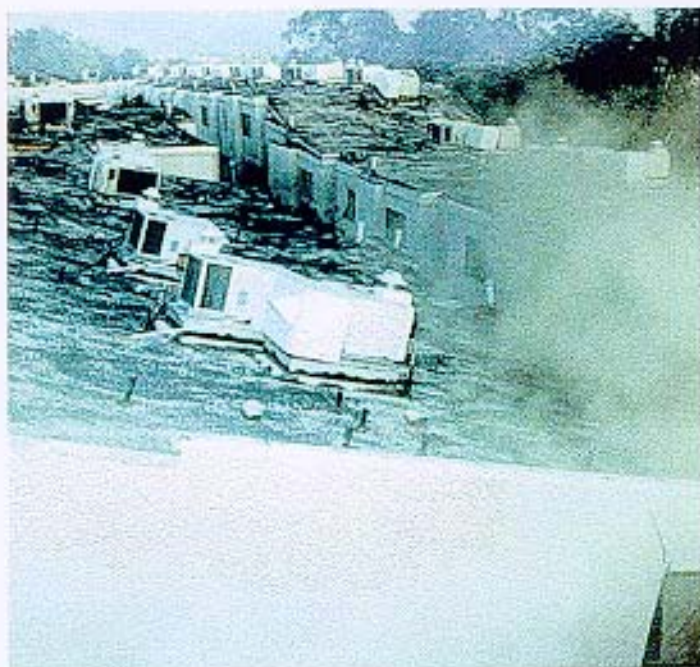
3-11: Roof area of collapsed condominium, Granada Hills.

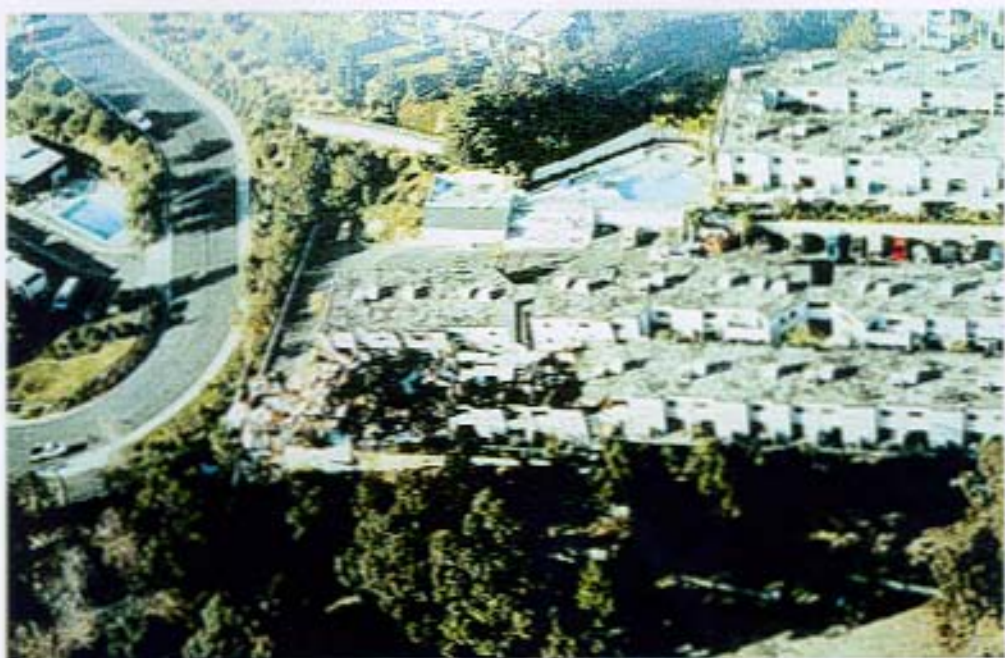
3-12: Aerial view, collapsed condominium, Granada Hills.

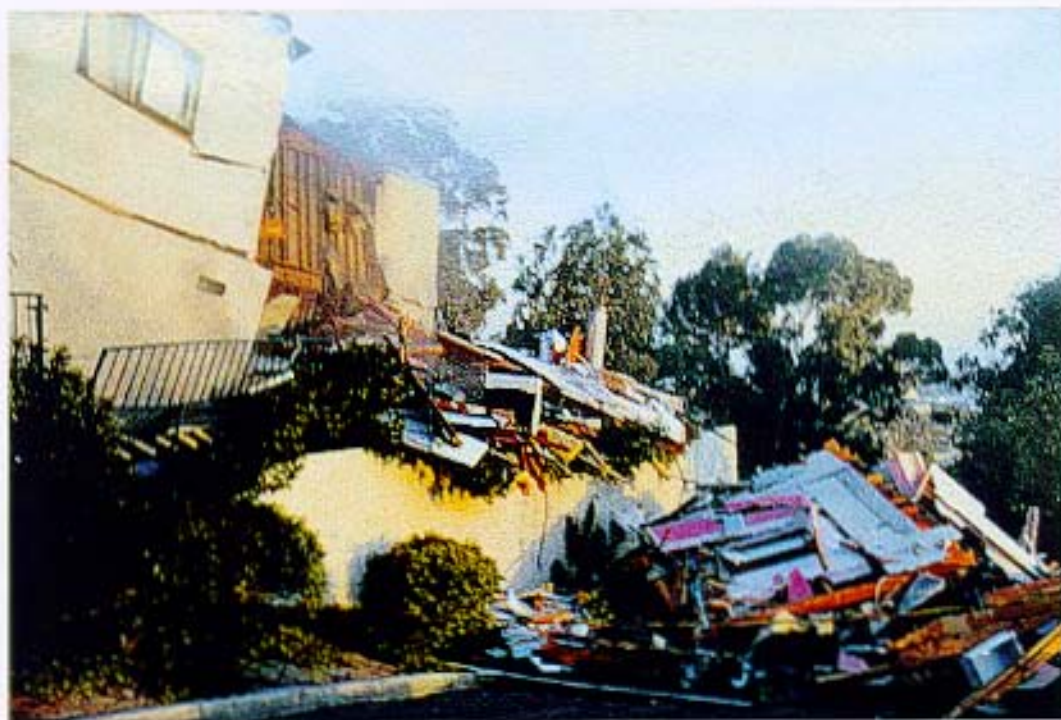
3-13: Total collapse of end units of condominium, Granada Hills.

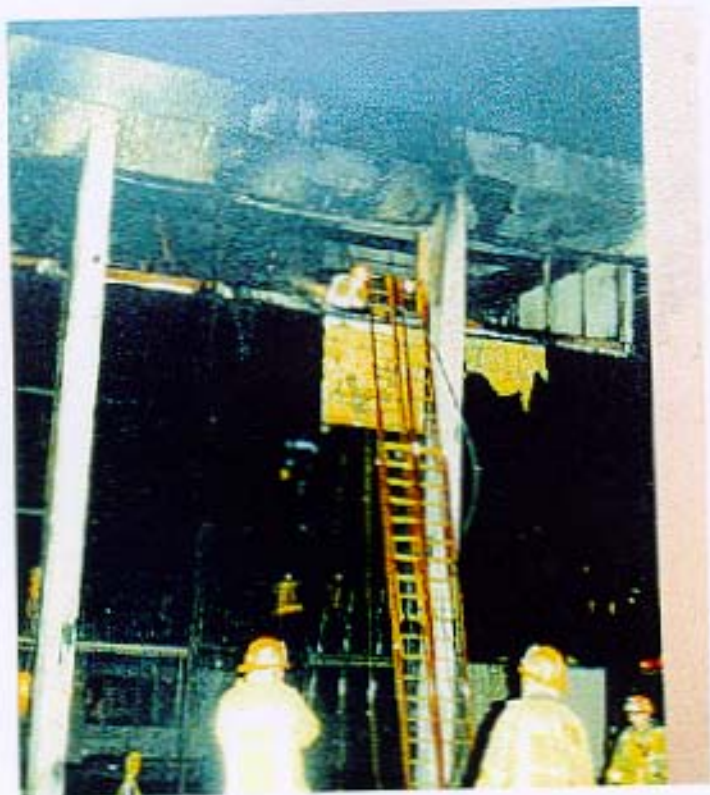
3-14: Structure fire, California State University, Northridge, Science Building

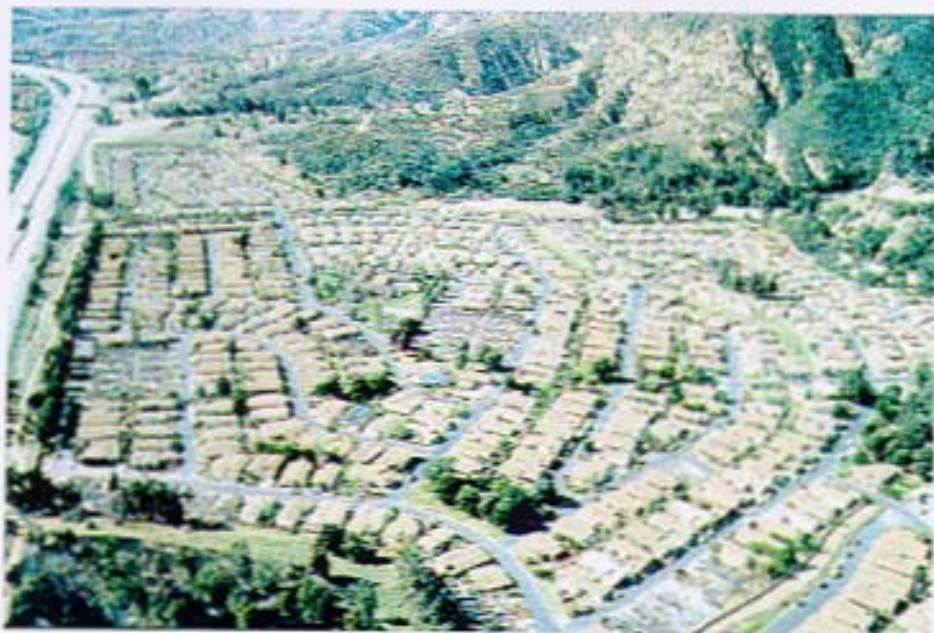
3-15: The large mobile home in San Fernando had at least five separate fires, all caused by mobile homes coming off of their foundations and severing gas lines. The rate of ignitions in mobile home parks was much higher than for housing developments. The rate is higher because in some mobile home parks, as many as 95% of the homes collapsed off their supports.

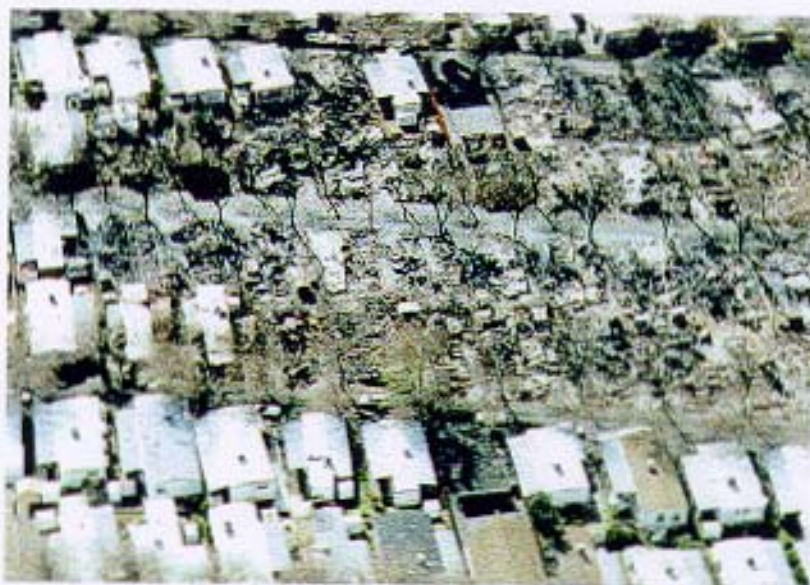
3-16: The remains after a fire in a mobile home development that destroyed at least 36 homes, 15445 Glen Oaks Blvd.

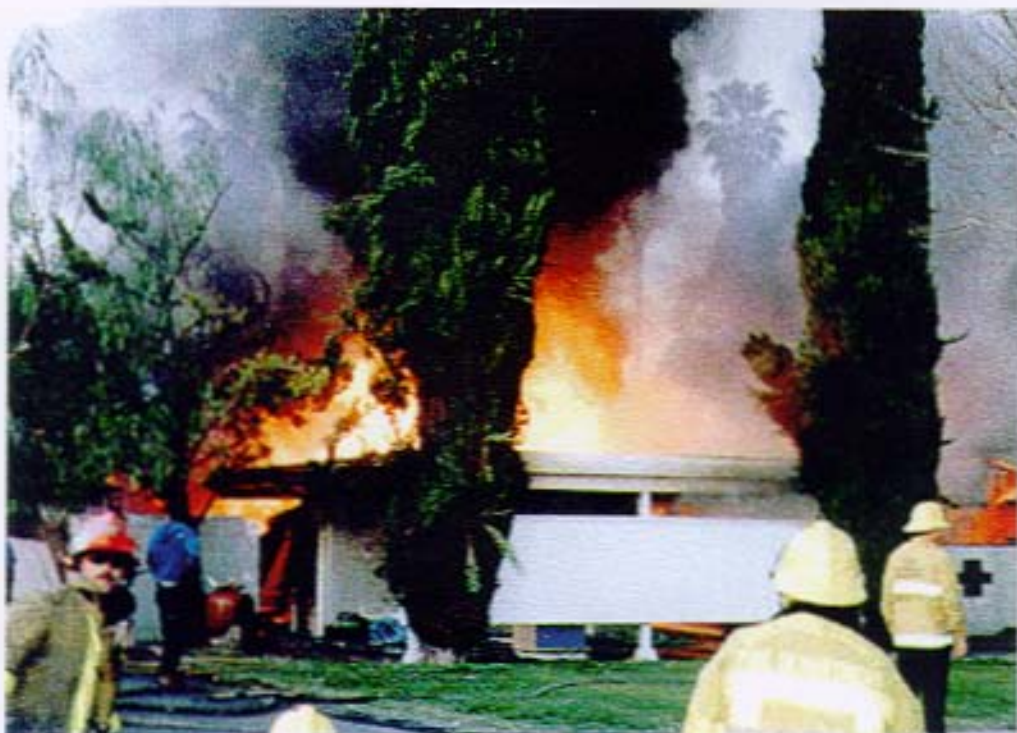
3-17: Residential fire in 18500 block of Strathern St., Reseda, approximately 11AM January 19 (two days after the earthquake). Fire fighters were still hampered by lack of water in the neighborhood to fight the fire. The only water available to fight this fire was from water tenders (tanker trucks) supplied by the Riverside County Fire Department. (Photo: S.P. Harris, EQE)

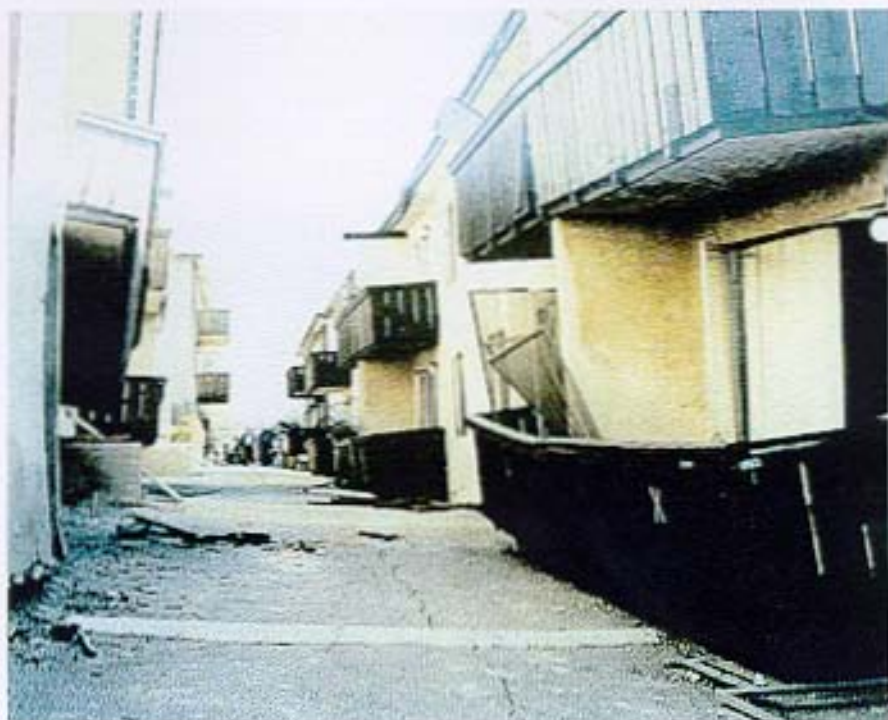
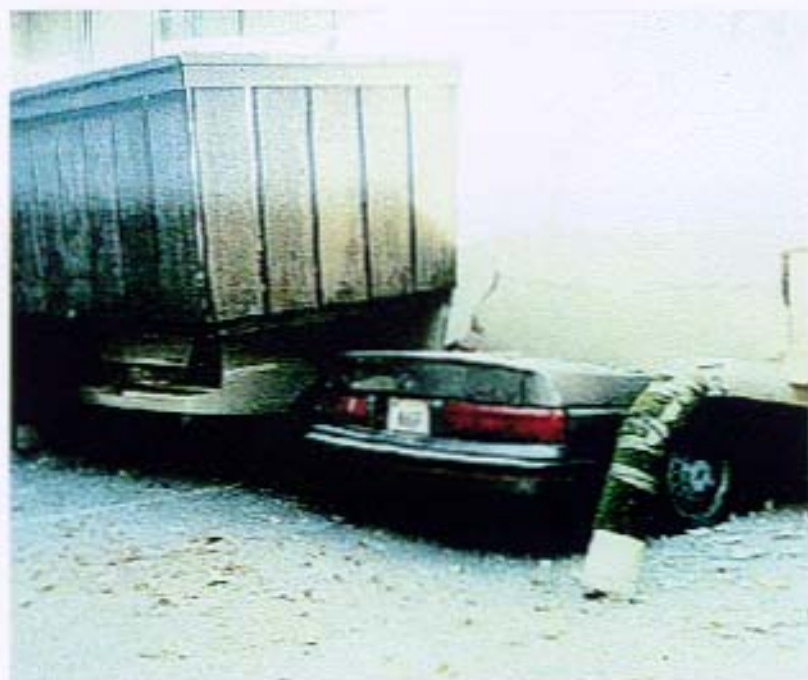
3-19 (top) and 3-20 (bottom): Northridge Meadows Apts. collapse of structure from soft first story parking garage. Three story building, 16 killed, hundreds rescued, 9565 Reseda Blvd.

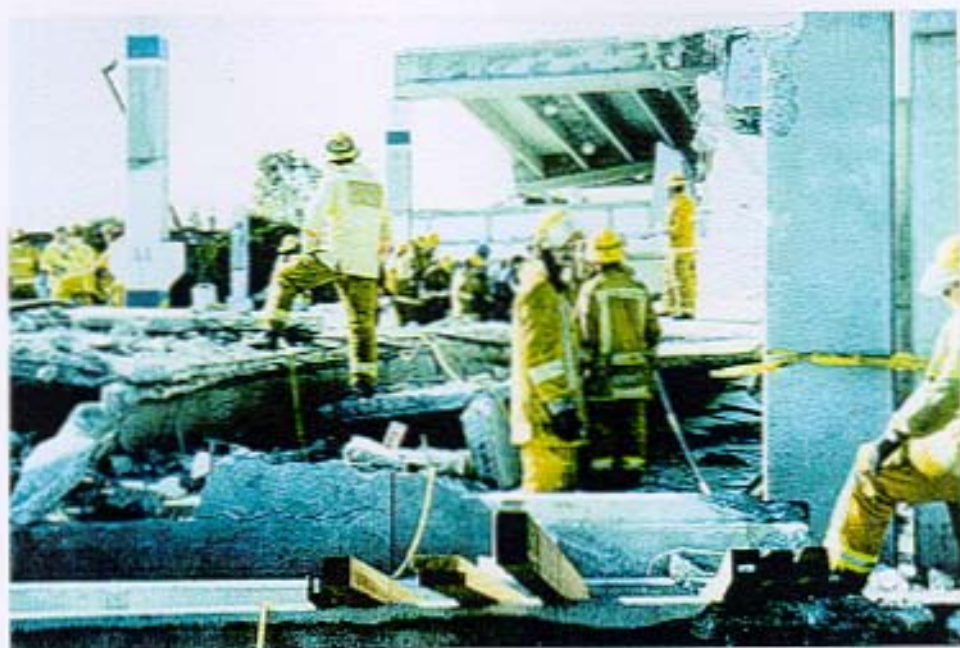
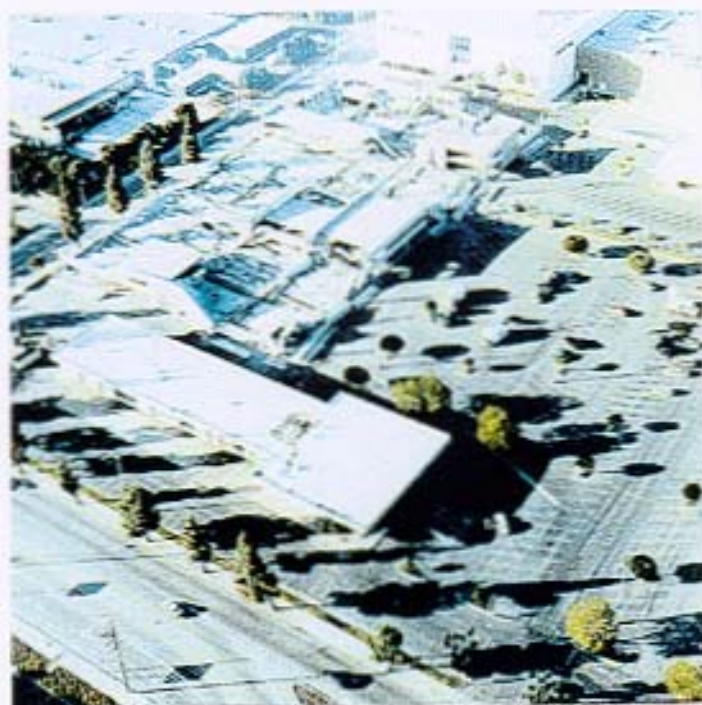
3-21 (top) and 3-22 (bottom): 9301 Tampa Avenue, Northridge Fashion Center three-story parking structure—rescue of one trapped person.

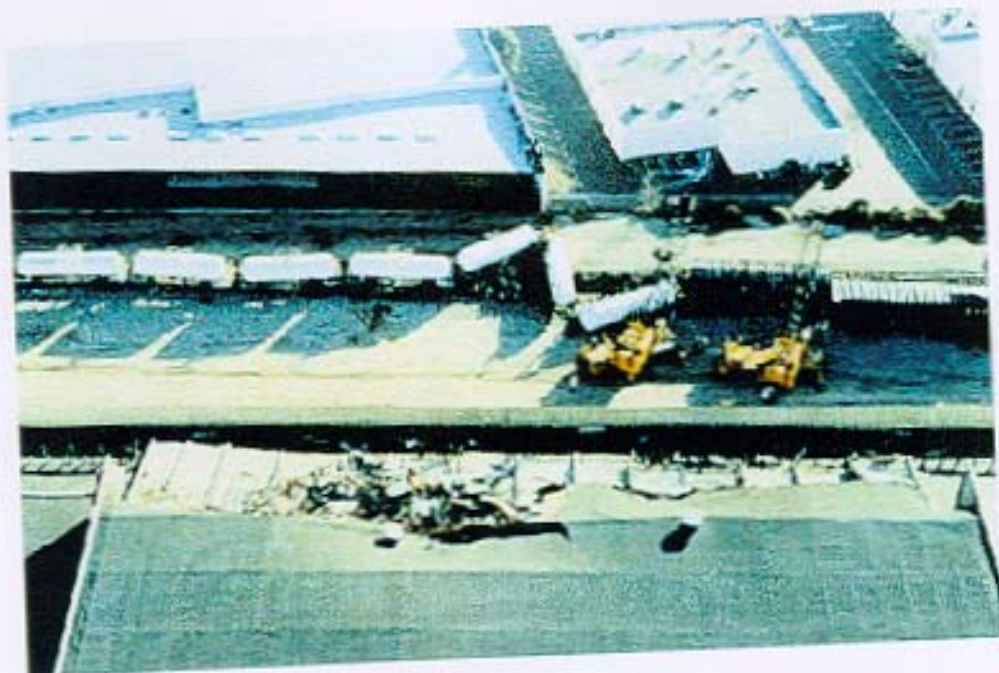
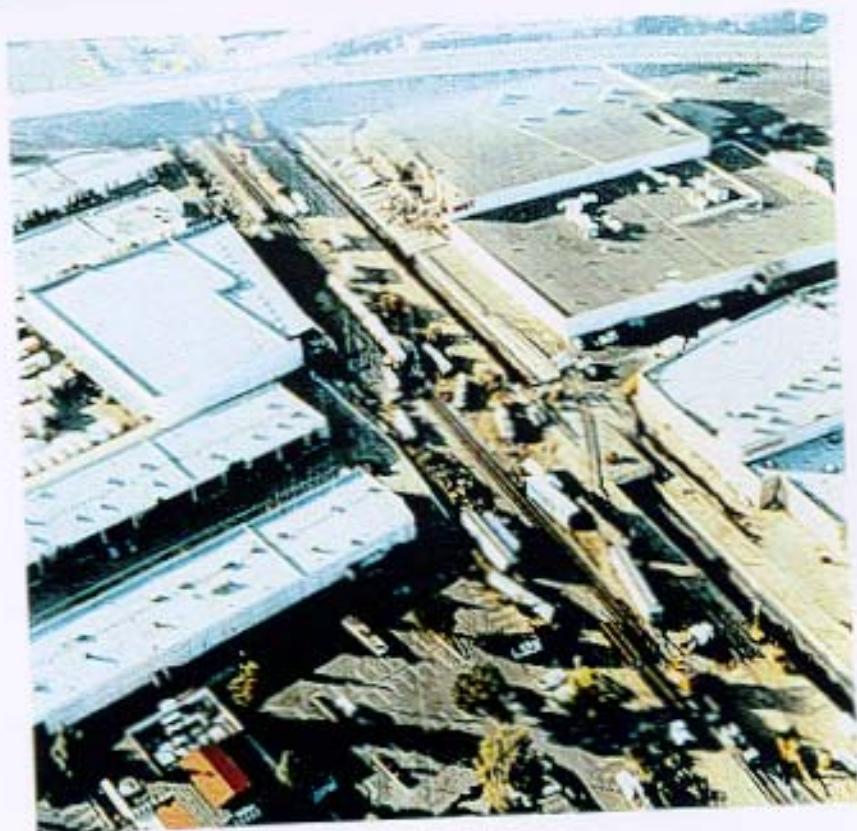
3-23A (top) and 3-23B (bottom): Train derailment at Tampa and Nordhoff.

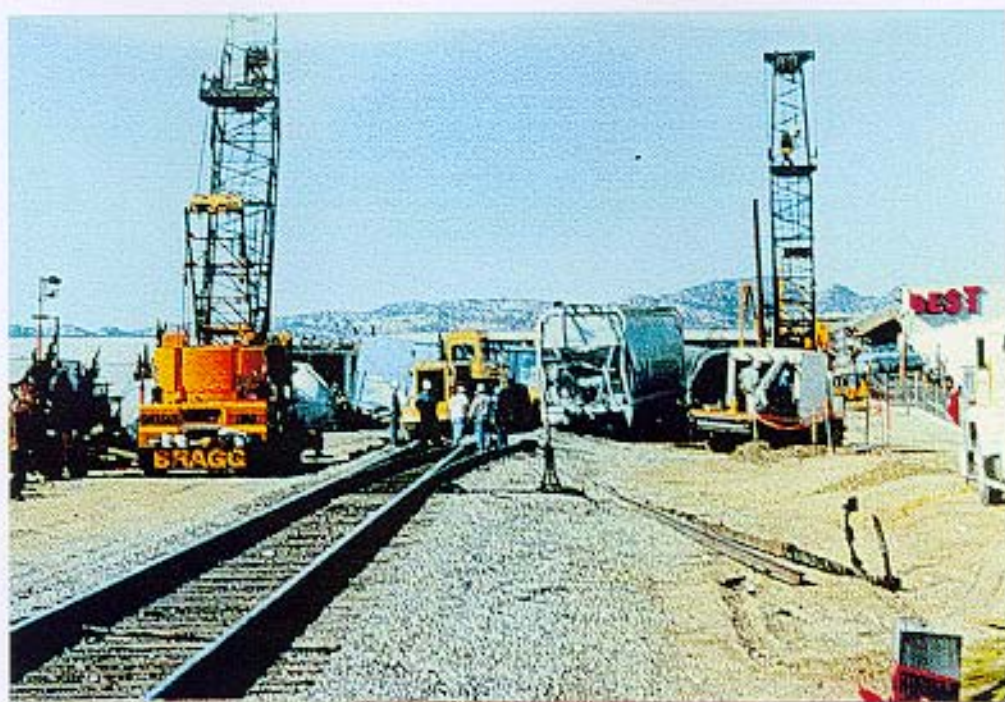
3-23C: Train derailment at Tampa and Nordhoff, 20 cars, one leaked 1,500 gallons of sulfuric acid

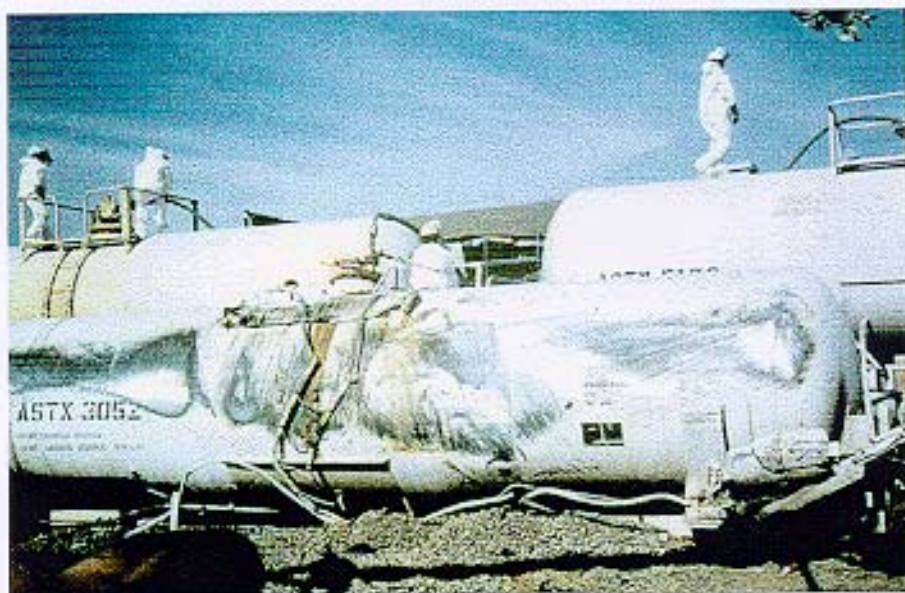
3-23D: These tank cars containing sulfuric acid derailed during the earthquake. Only one leaked.
