NIST GCR 97-720

**A STUDY OF THE PERFORMANCE OF
PETROLEUM STORAGE TANKS DURING
EARTHQUAKES, 1933-1995**

Thomas W. Cooper
T.W. Cooper, Inc.

June, 1997

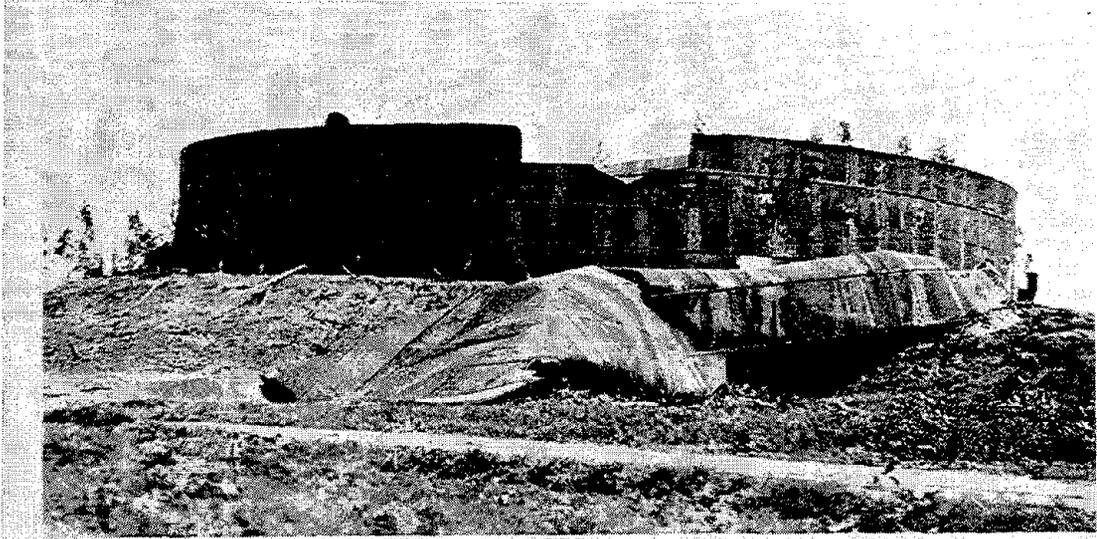
Tank "C" was a tank 45.4 m (150 ft) in diameter and 19 m (63 ft) high which had a 14.5 m (48 ft) water depth at the time of the earthquake. This tank had eleven shell courses and the failure was at the top of the fourth shell course. Portions of the tank shell were up to 60 m (200 ft) from the tank after the failure. This tank was 45 km from the epicenter and was probably within 1-2 km of the fault; see Figure 2.2 [10].

Figure 2.2 CLADWP Western Avenue Tank. The top of this steel tank was thrown about 200 feet due to sloshing liquids [L. Lund/Steinbrugge Collection at UCB EERC/Richmond].

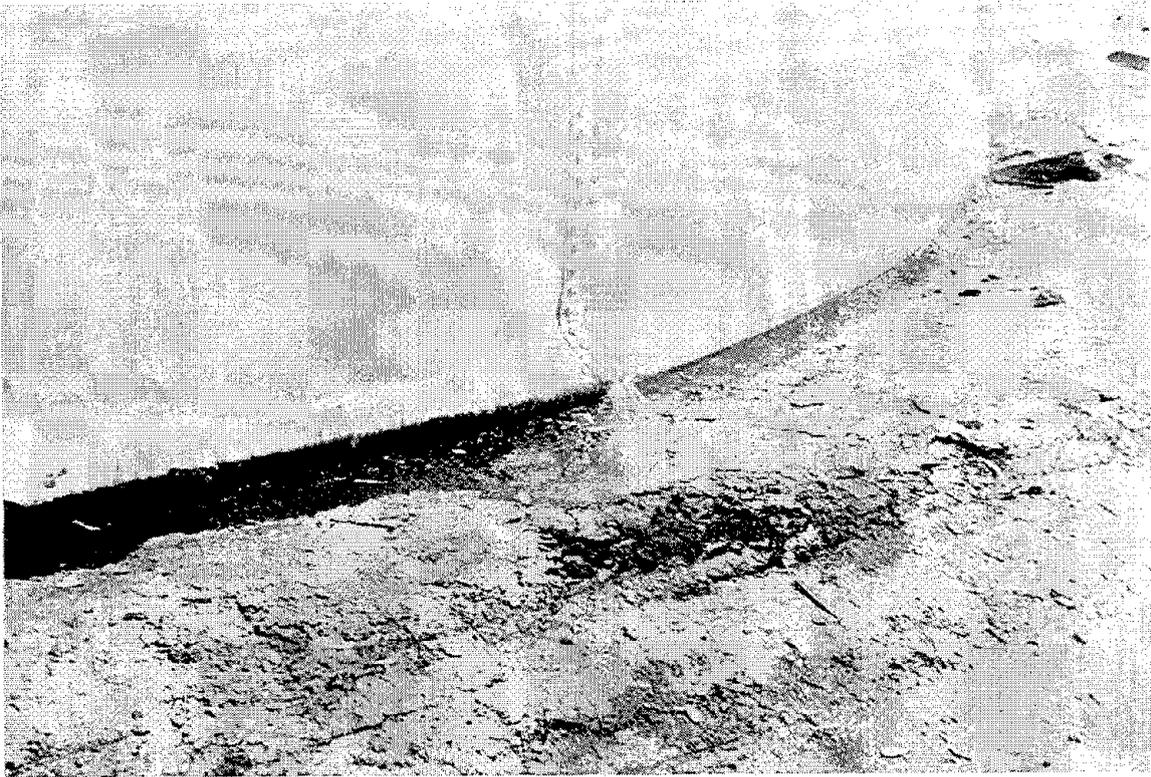
Virtually all of the tanks listed in Table 3.1 were riveted tanks, with thick shells to allow for acceptable tensile stresses at the riveted splice between the shell plates. Considering the proximity of the facilities to the epicenter and severity of the earthquake, one would expect more tank damage, especially considering the extensive damage to older buildings from this earthquake. Continental Station, not listed in Table 3.1, sustained no damage. Damage to the tanks at the A.M. Kelly Station was reported not significantly different from that at the General Petroleum Stations listed in Table 3.1. Figure 3.2 shows the elephant foot buckling on a bolted tank at the General Petroleum Emidio Station.

Figure 3.2 Bolted Tank at General Petroleum Emidio Station [Steinbrugge Collection at UCB EERC Richmond]

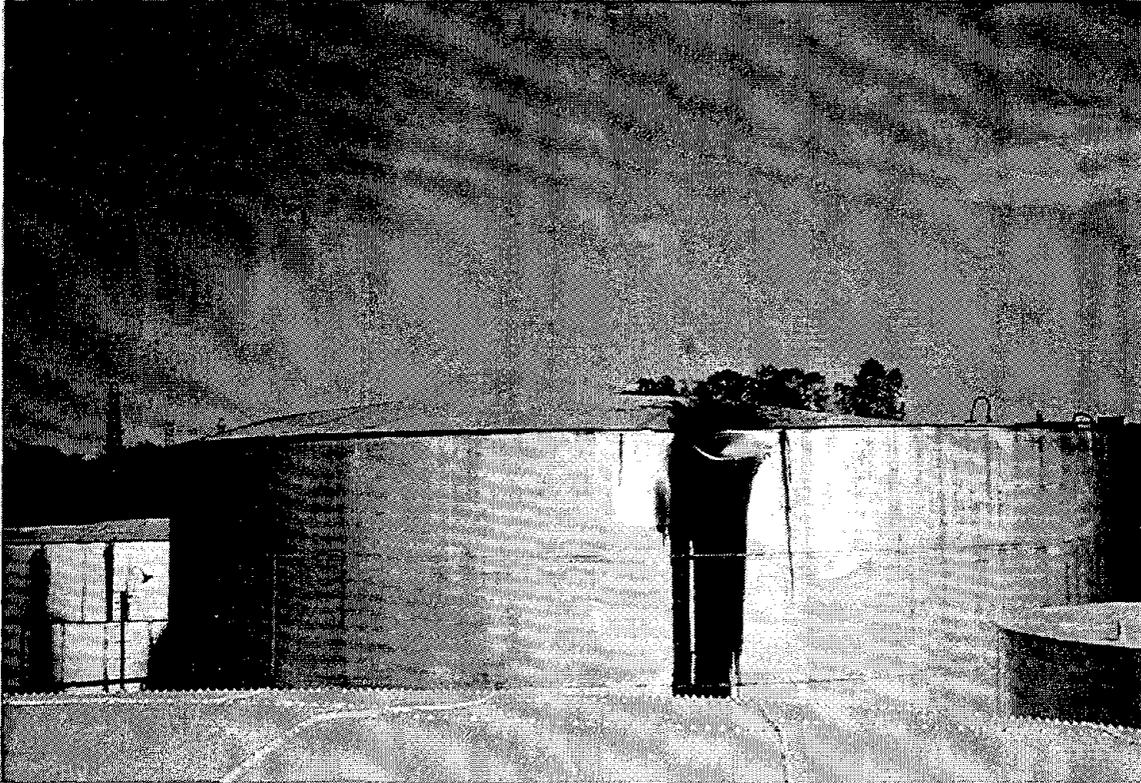
Damage also occurred to tank floating roofs at the Pacific Gas and Electric (PG and E) Kern Power House (Steam Station). The damage was principally to the floating roof seals accompanied by some sloshing and oil spillage. Tank damage at Weed Patch consisted of sloshing in full (or nearly full) cone roof tanks, with the roof/shell weld being broken on two tanks with the consequent spillage of oil by sloshing. See Figure 3.3. Similar damage occurred at two oil refineries closer to Bakersfield. Information on the PG and E tanks is given in Table 3.3 [13]. In most cases where damage to floating roof tanks occurred, there was also rotation of the roof and breakage of the roof anti-rotation guide and/or gage well.

Figure 3.3 Roof/shell buckling and tearing at Weed Patch [Steinbrugge Collection at UCB EERC Richmond]

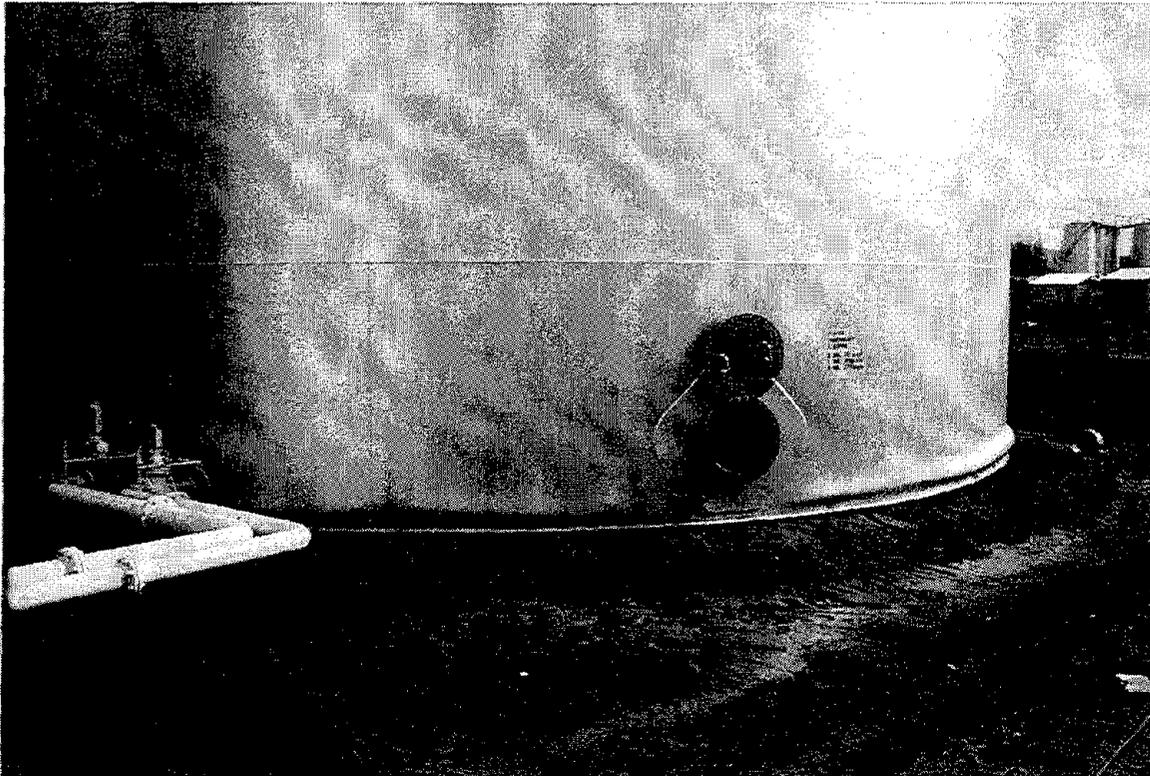
Figure 4.2 Elephant foot buckling and shell/floor failure [Courtesy G. Housner].

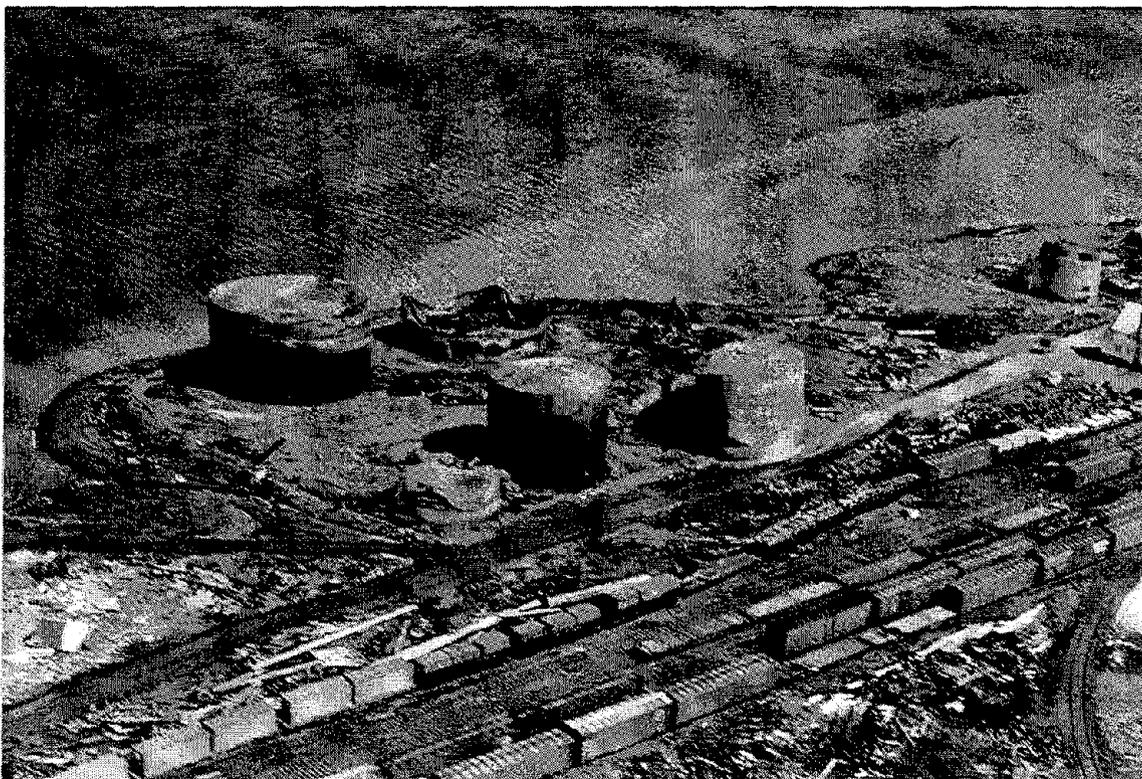
Figure 4.5 Whittier tanks, fire and tsunami damage (Courtesy W. Daniels)

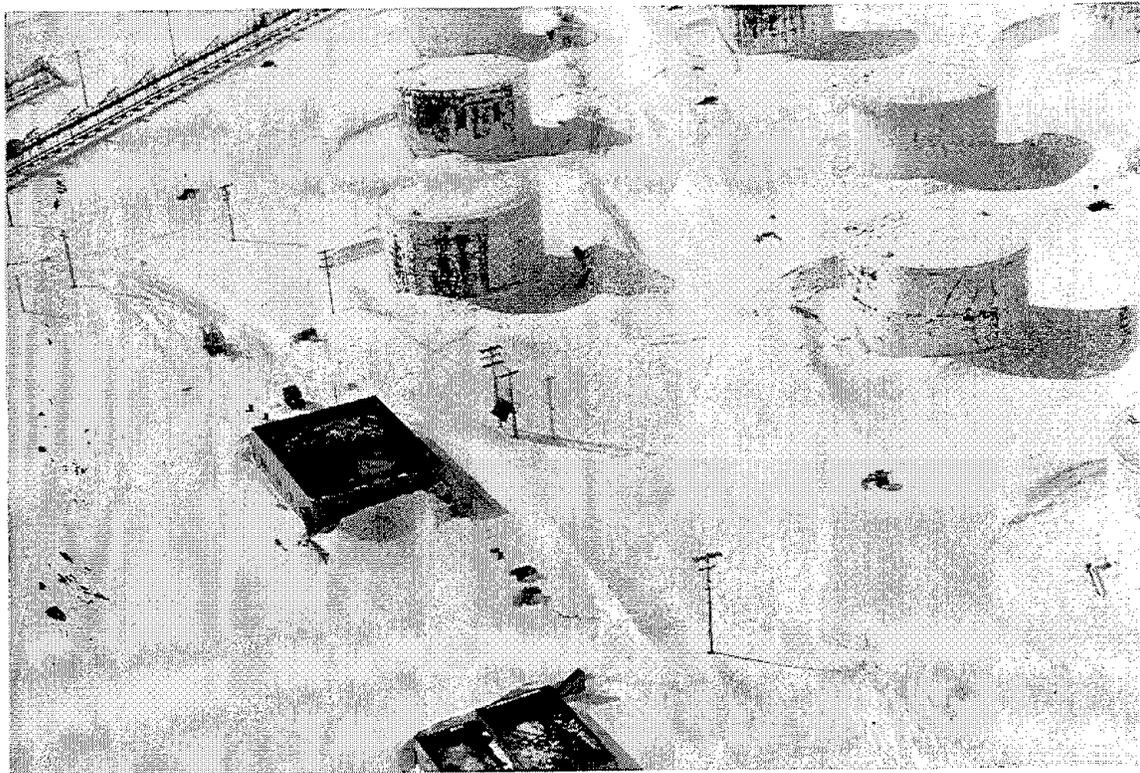
Figure 4.7 Whittier tanks which survived both the earthquake and tsunami with minimal damage [Steinbrugge Collection at UCB EERC Richmond]

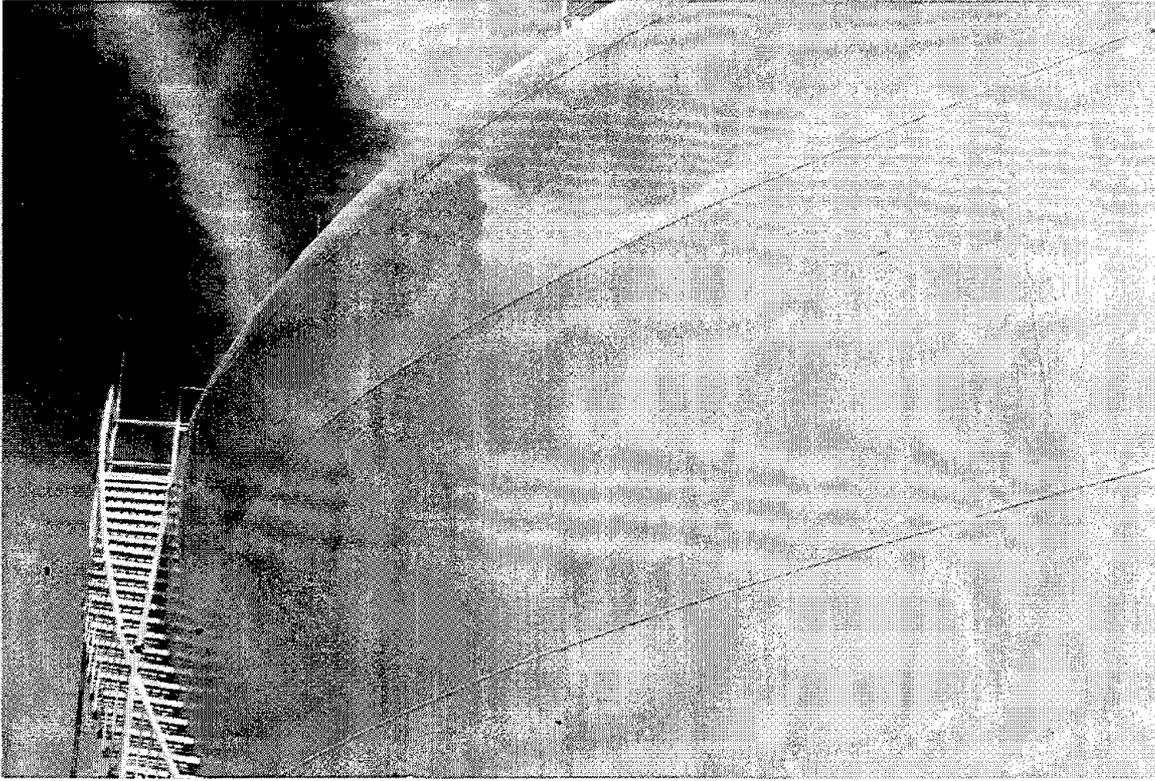
Tank damage in this earthquake seems to have been confined to the general area north of where ground breakage occurred. A 31 m (100 ft) diameter by 11 m (36 ft) high water tank at the Metropolitan Water District Jensen Plant, near or on the faulted zone, uplifted at least .33 m (13 in) on the south side based on maximum anchor bolt ($d=25.4$ mm /1 in) stretch on the south side. The minimum stretch was .035 m (1 3/8 in) on the north side. This tank which sets atop a bluff had roof and upper shell damage but no elephant foot buckling. The tank was one-half to two-thirds full at the time of the earthquake. The tank has a knuckled roof/shell joint. Shell buckling damage was in the upper shell course but not in the knuckle joint and was on the south side of the tank. This tank sat on a ring foundation and had foundations under the nine interior columns. The lowest shell course was 17.5 mm (11/16 in); the upper course (below the knuckle section) was 12.7 mm (1/2 in). The floor plate was 8 mm (5/16 in). The roof was 4.8 mm (3/16 in) [21] [22]. See Figures 5.2 and 5.3.

Figure 5.2 MWD Jensen Tank showing upper shell buckling [Steinbrugge Collection at UCB EERC Richmond]

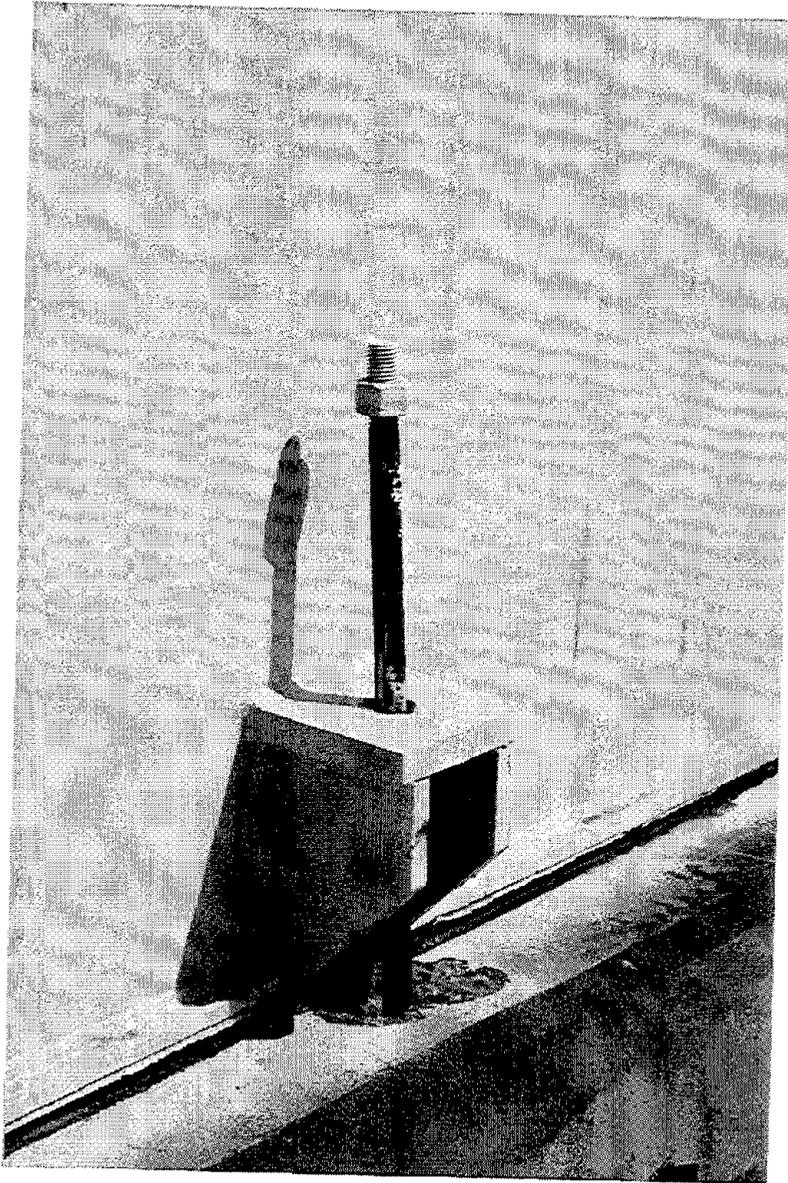
Figure 5.3 Jensen tank, pulled or stretched 1 inch anchor bolt [Steinbrugge Collection at UCB EERC Richmond]

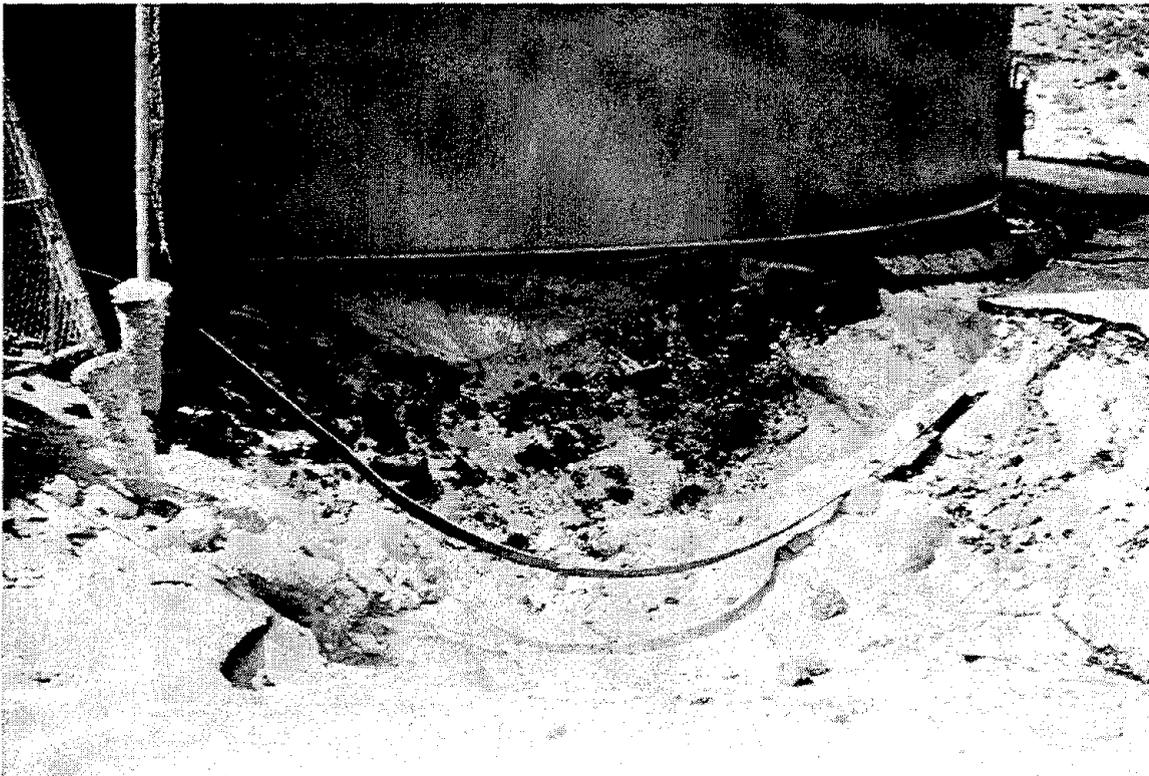
Figure 5.4 Olive View Hospital Tank which had a shell/floor failure [Steinbrugge Collection at UCB EERC Richmond]

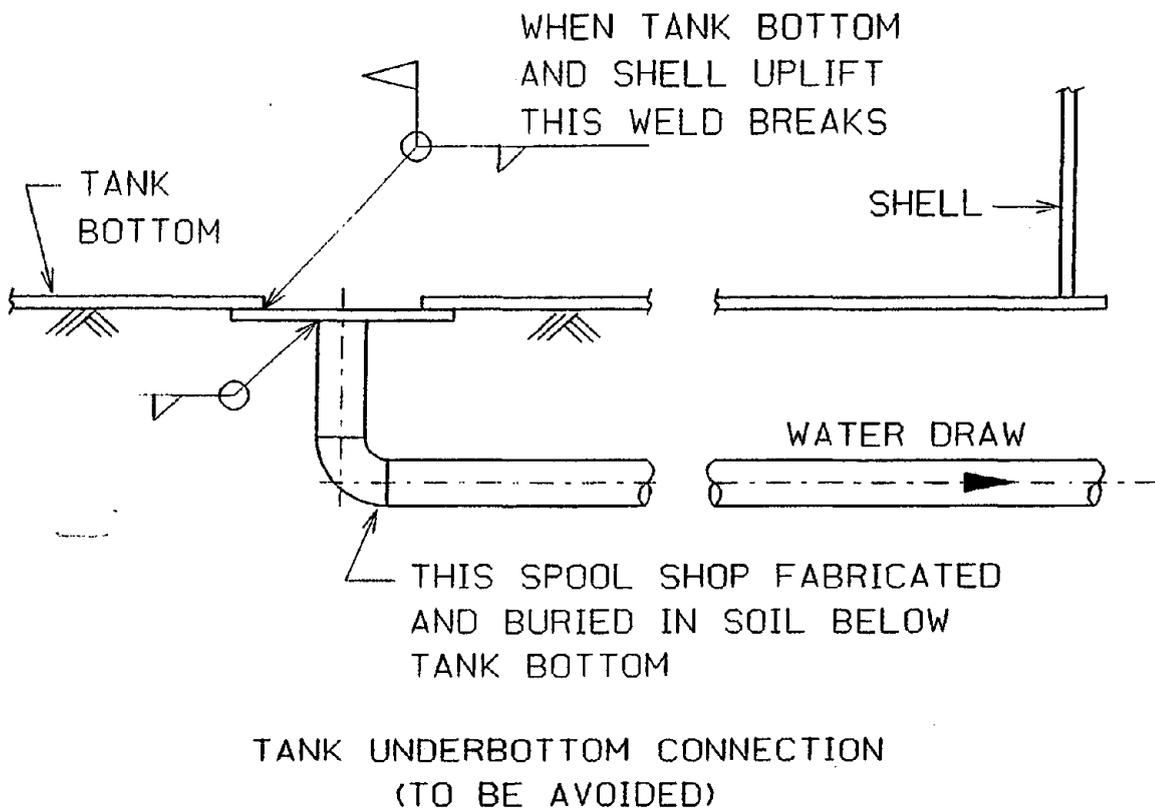
Figure 7.2 Waterdraw piping on Tank 7, Mainline pumping station. Field weld failed, allowing contents to leak.

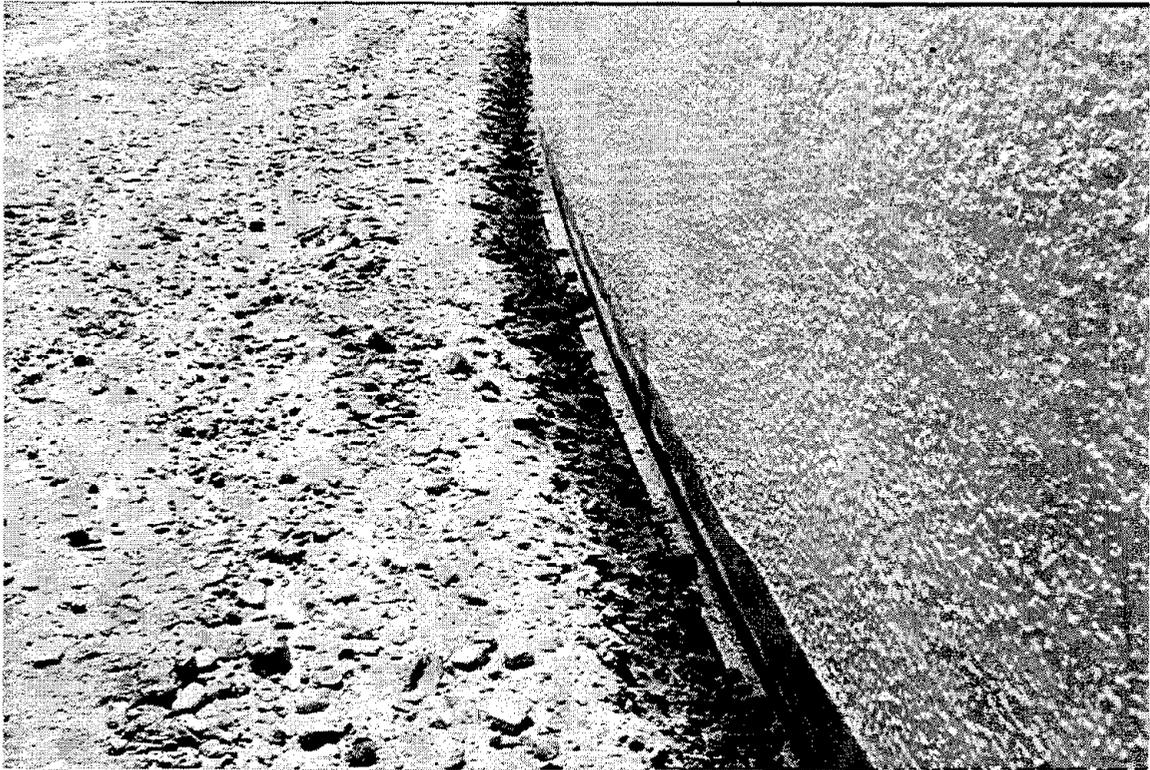
Figure 7.3 Tank 7, 61 m (200 ft) diameter by 14.8 m (48 ft) high with oil pounded into adjacent soil about 10 cm (4 in) in a NE-SW direction. Other tanks with only 3.05 m (10 ft) of oil did not do this.

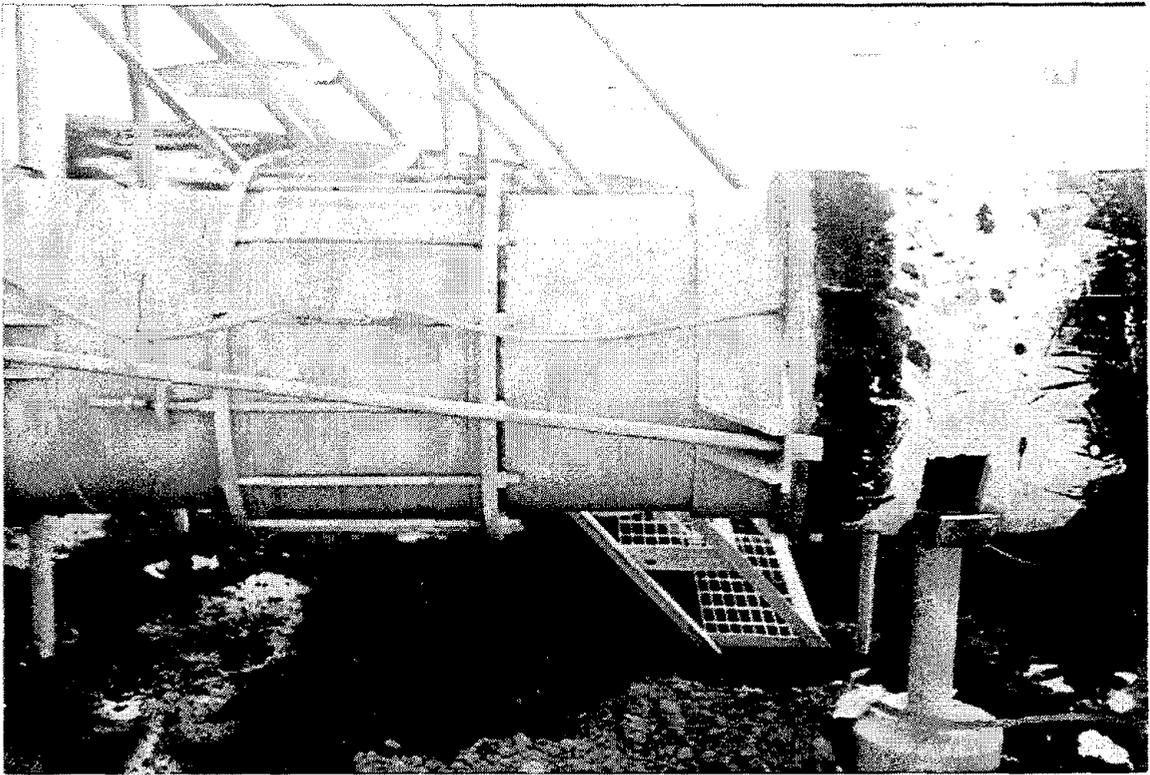
Figure 7.4 Inlet/outlet line on Tank 7, support was battered on both sides of pipe.

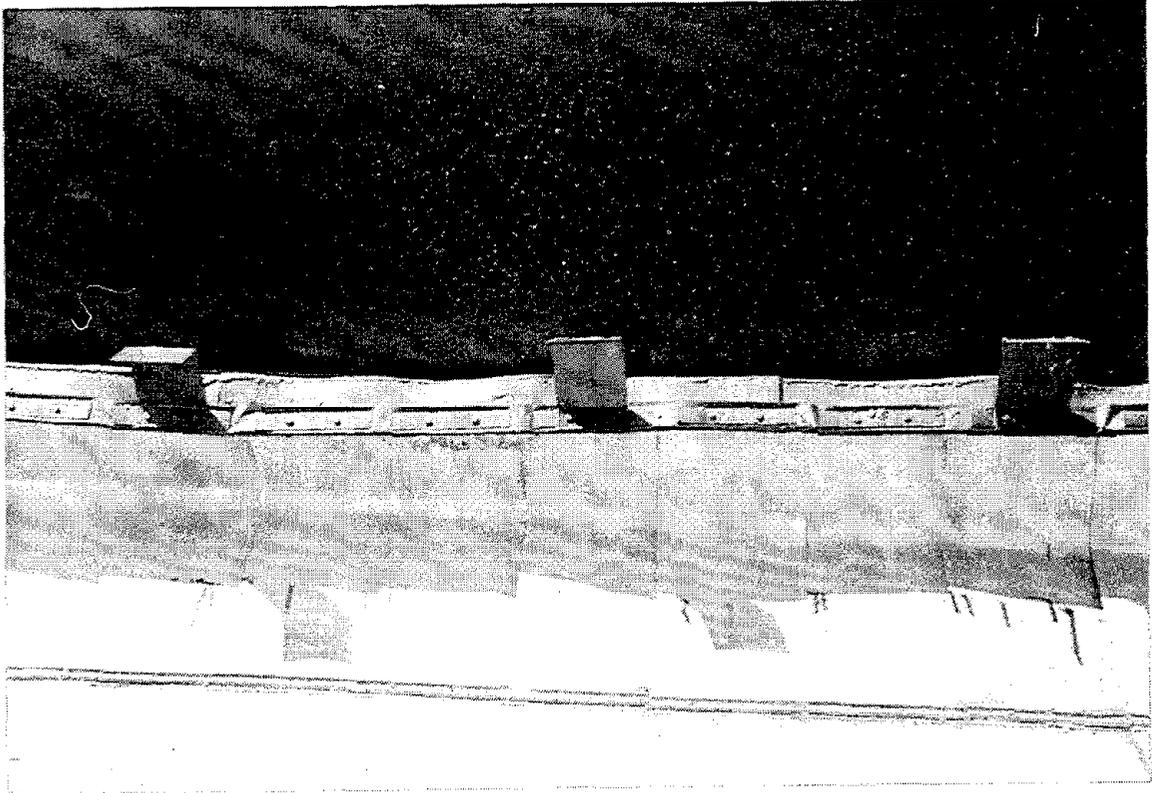
Figure 7.5 Bent secondary seal on Tank 8, this bending was maximum in NE-SW directions.

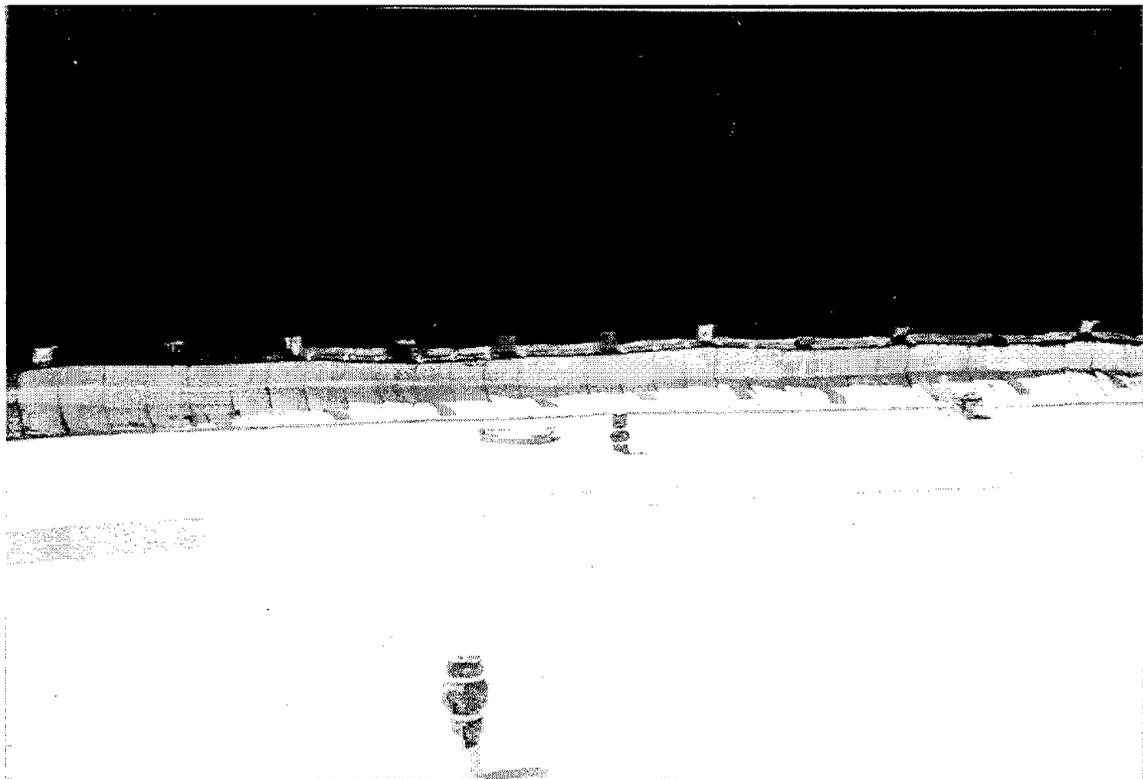
Figure 7.8 Bent seals in Tank 7.

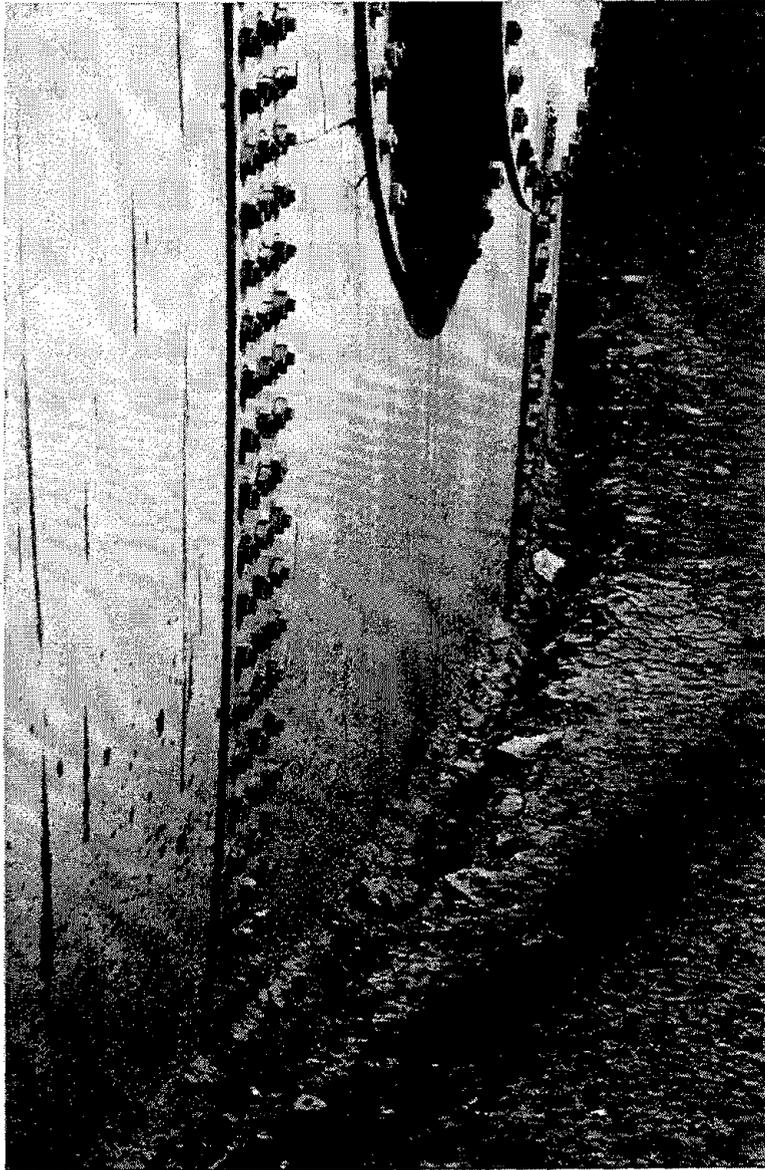
Figure 7.9 Bolted tank which pounded into the ground [Steinbrugge Collection at UCB EERC Richmond].

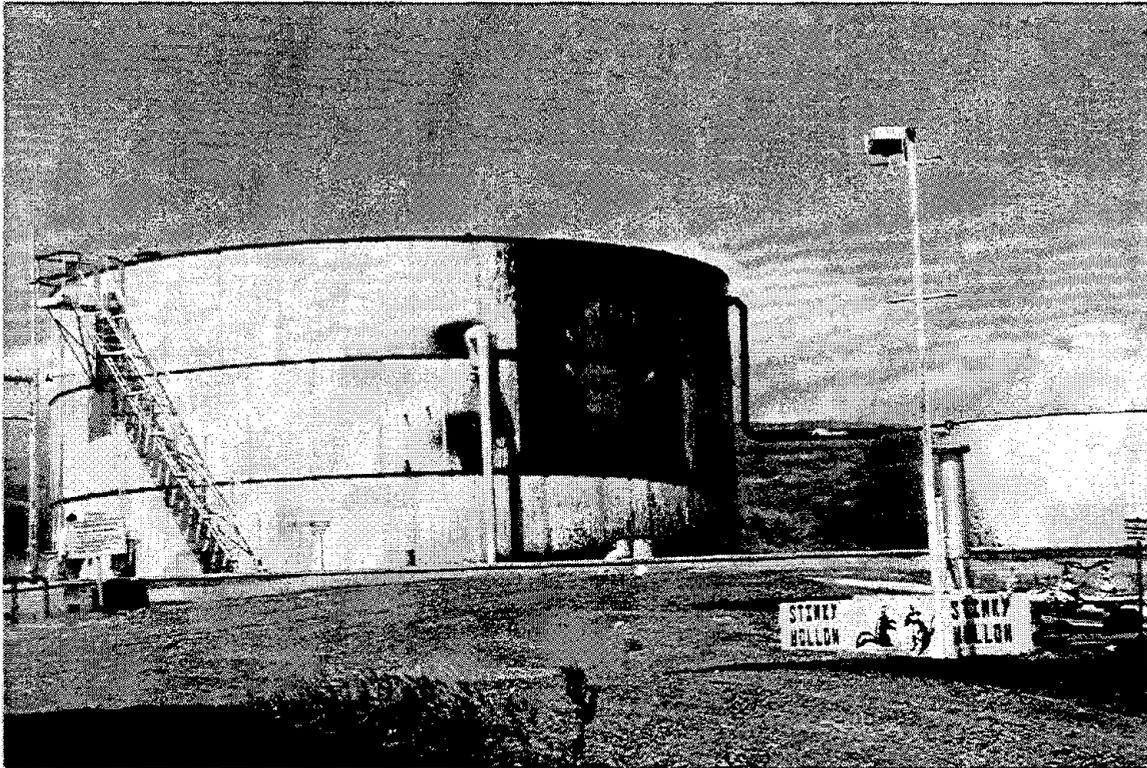
Figure 7.10 Roof spillage on this bolted tank [Steinbrugge Collection at UCB EERC Richmond].

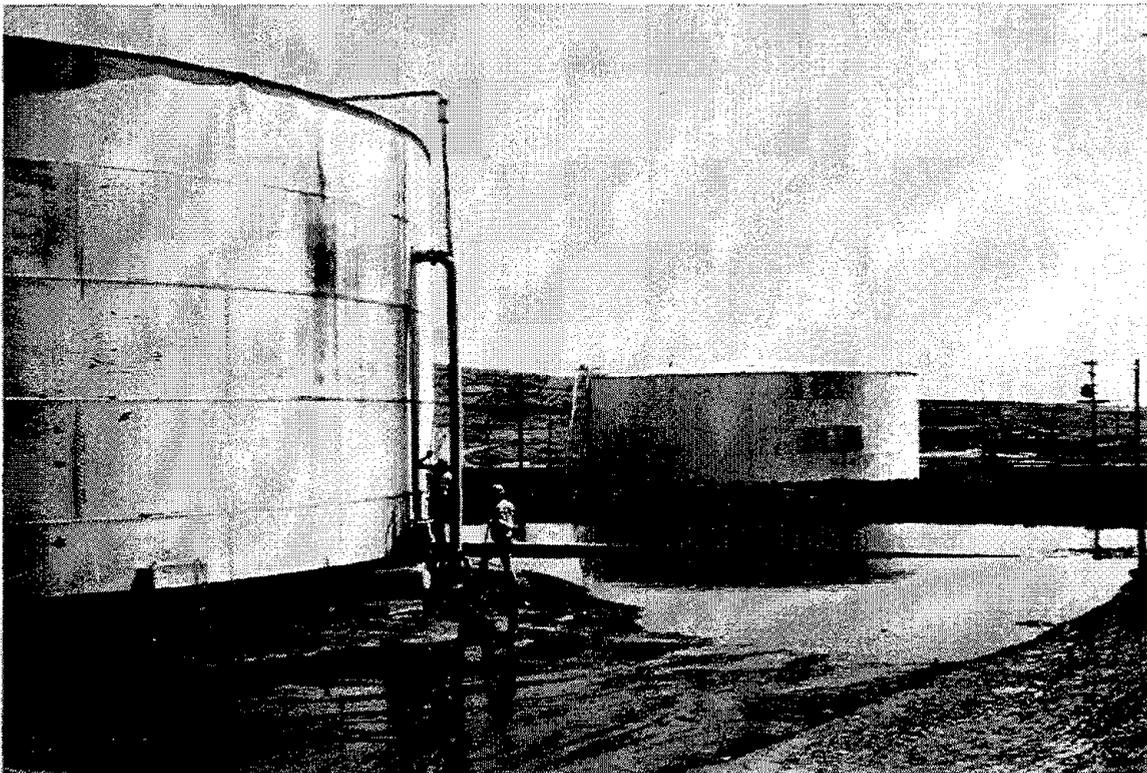
Figure 7.11 Broken valves/fittings caused this spillage [Steinbrugge Collection at UCB EERC Richmond].

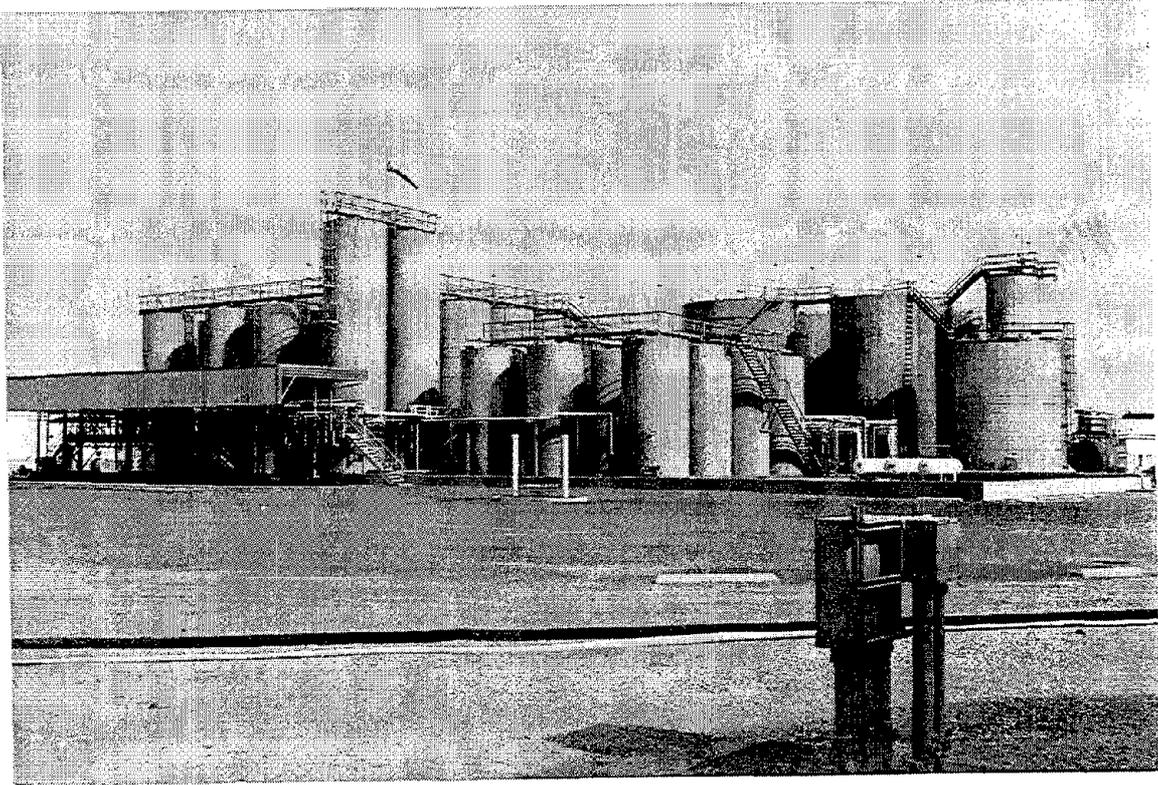
Figure 8.2 Tank block at a lube oil plant where severe damage occurred to larger tanks. Only one 9.2 m (30 ft) diameter by 12.3 m (40 ft) high nearly full tank had elephant foot in this tank block. The 3.7 m (12 ft) diameter by 14.8 m (48 ft) high tank - with the wind sock - had anchor bolt action shown in Figure 8.3. All tanks on pile and concrete mat foundation.

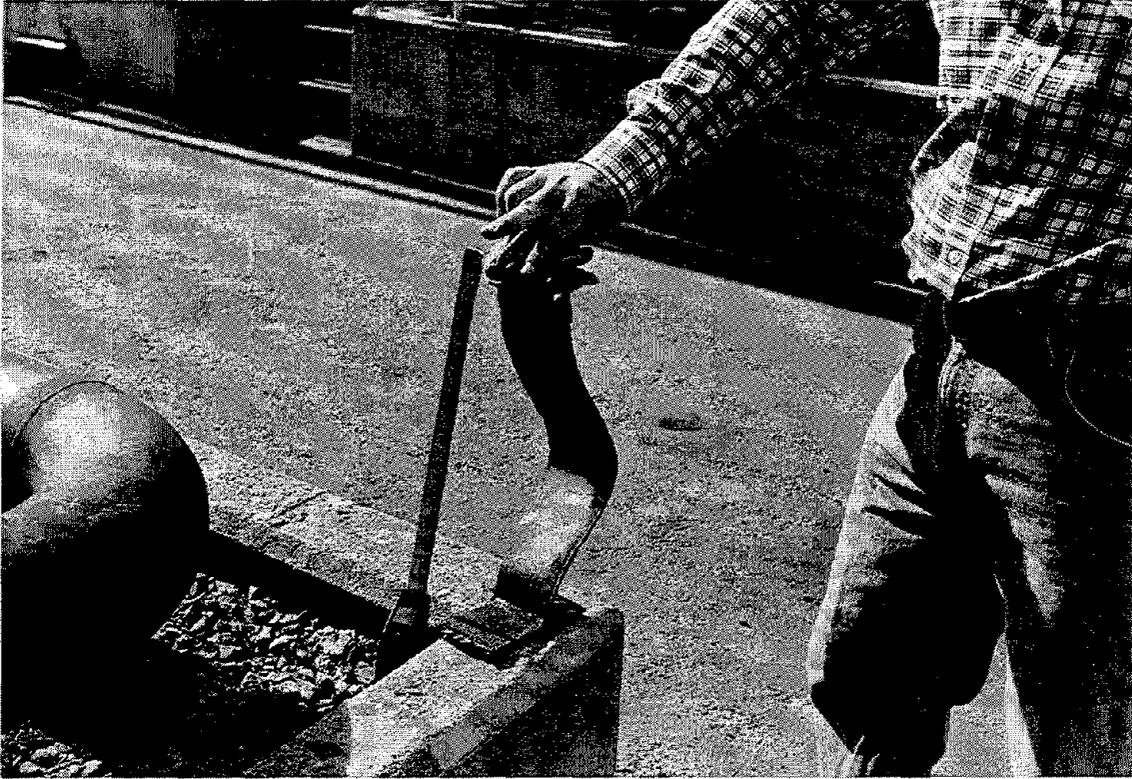
Figure 8.4 View of cut-out of elephant foot shell of 9.2 m (30 ft) diameter by 12.3 m (40 ft) high tank which was nearly full at time of earthquake.

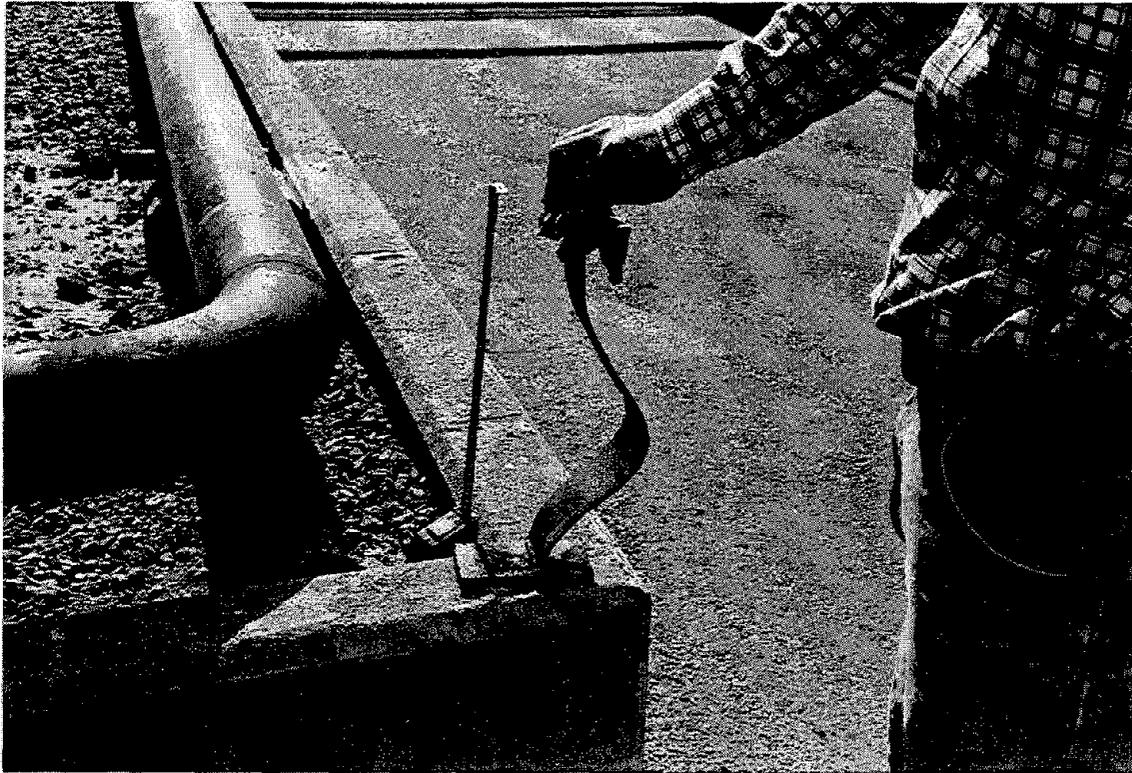
Figure 8.5 Additional view, same tank as Figure 8.4.

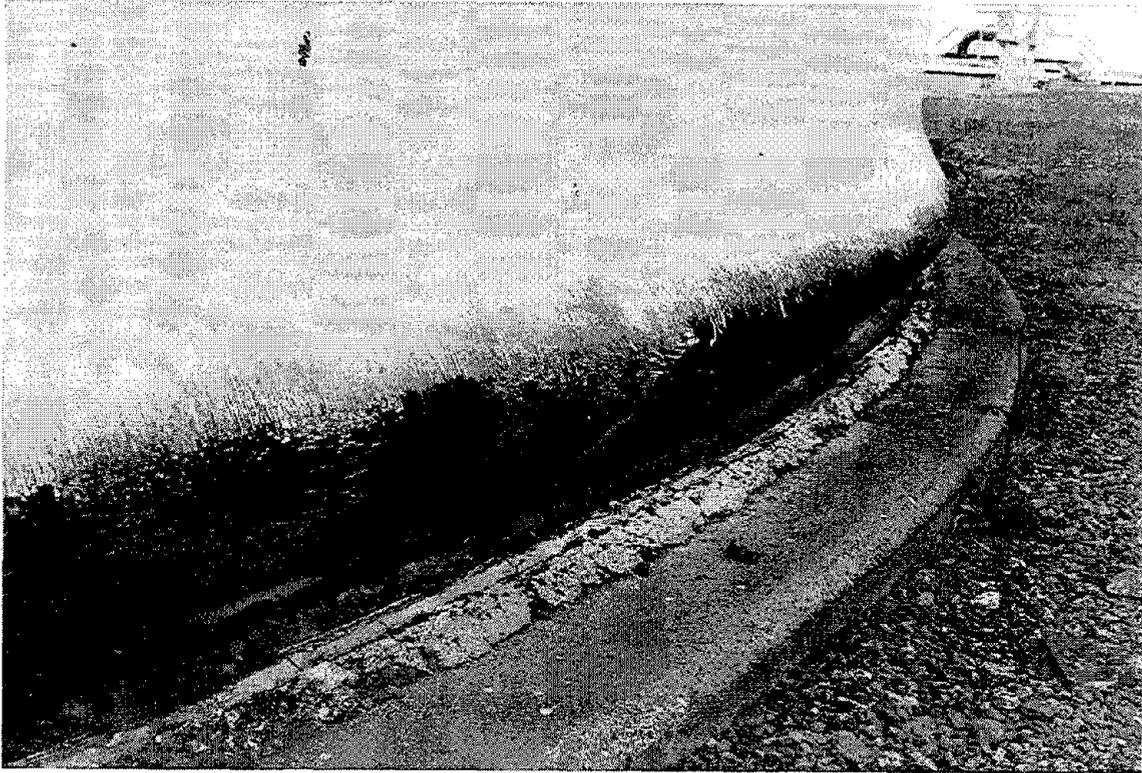
Figure 8.6 Elephant foot on 12.2 m (40 ft) diameter by 9.7 m (32 ft) high tank. Note absence of vertical crack lines in paint at weld.

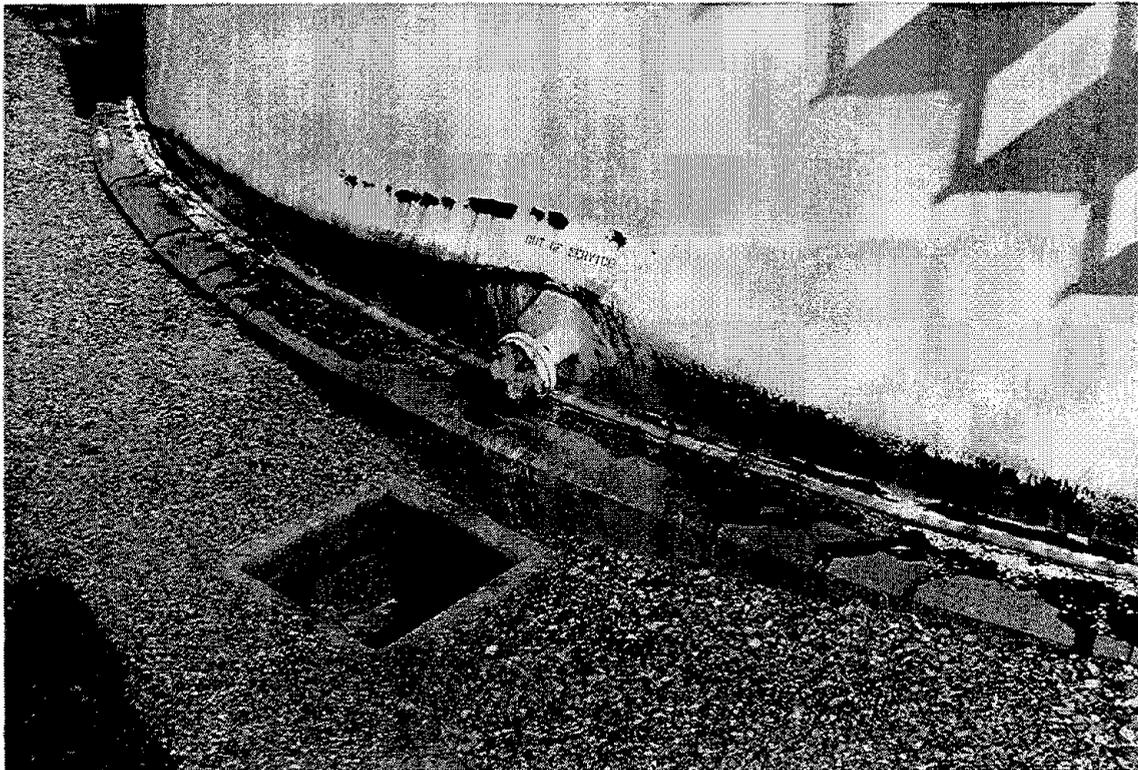
Figure 8.7 Same tank as Figure 8.6, elephant foot maneuver around reinforcing plate at nozzle.

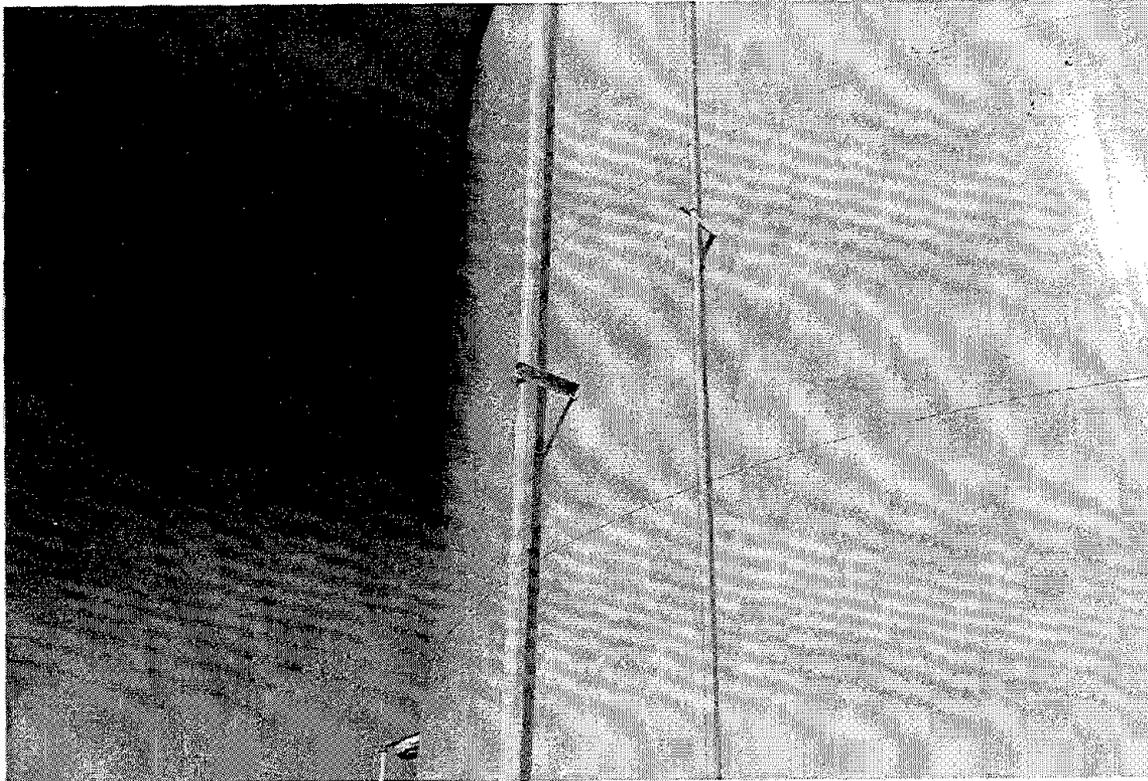
Figure 8.8 Bracket on pipe pulled out making a hole in the tank shell, through which product drained.

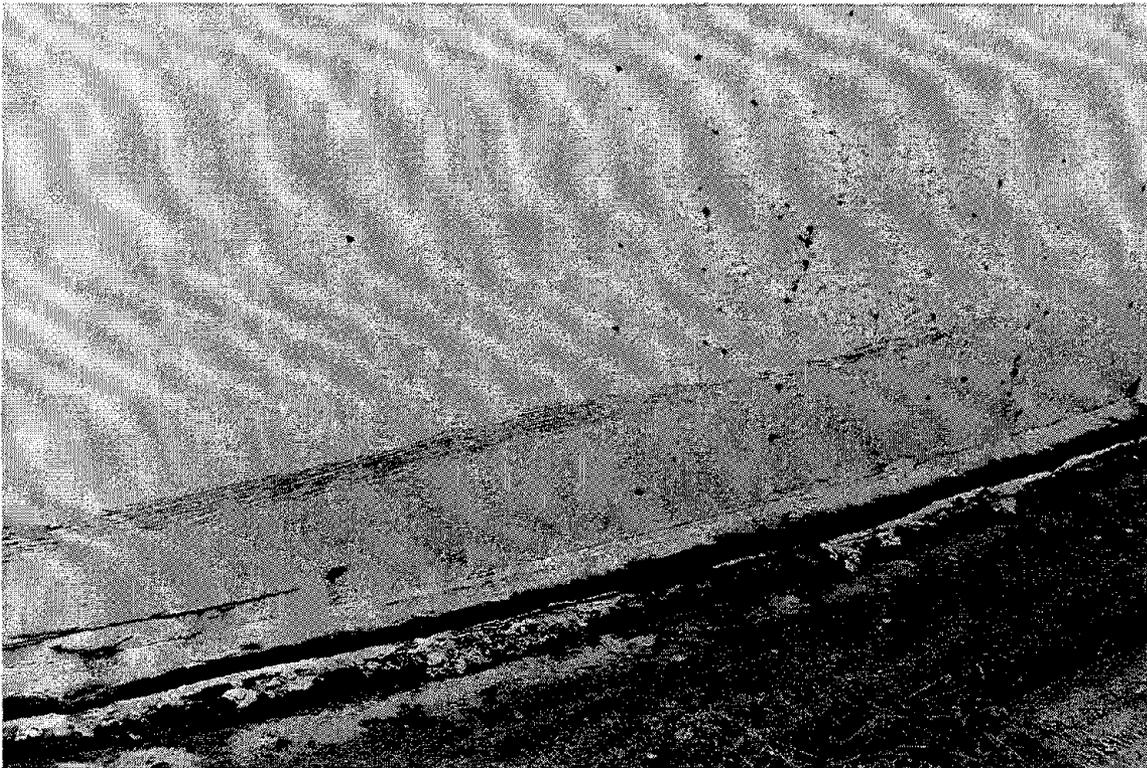
Figure 8.9 Start of an elephant foot buckle.
