NIST GCR 97-720

**A STUDY OF THE PERFORMANCE OF
PETROLEUM STORAGE TANKS DURING
EARTHQUAKES, 1933-1995**

Thomas W. Cooper
T.W. Cooper, Inc.

June, 1997

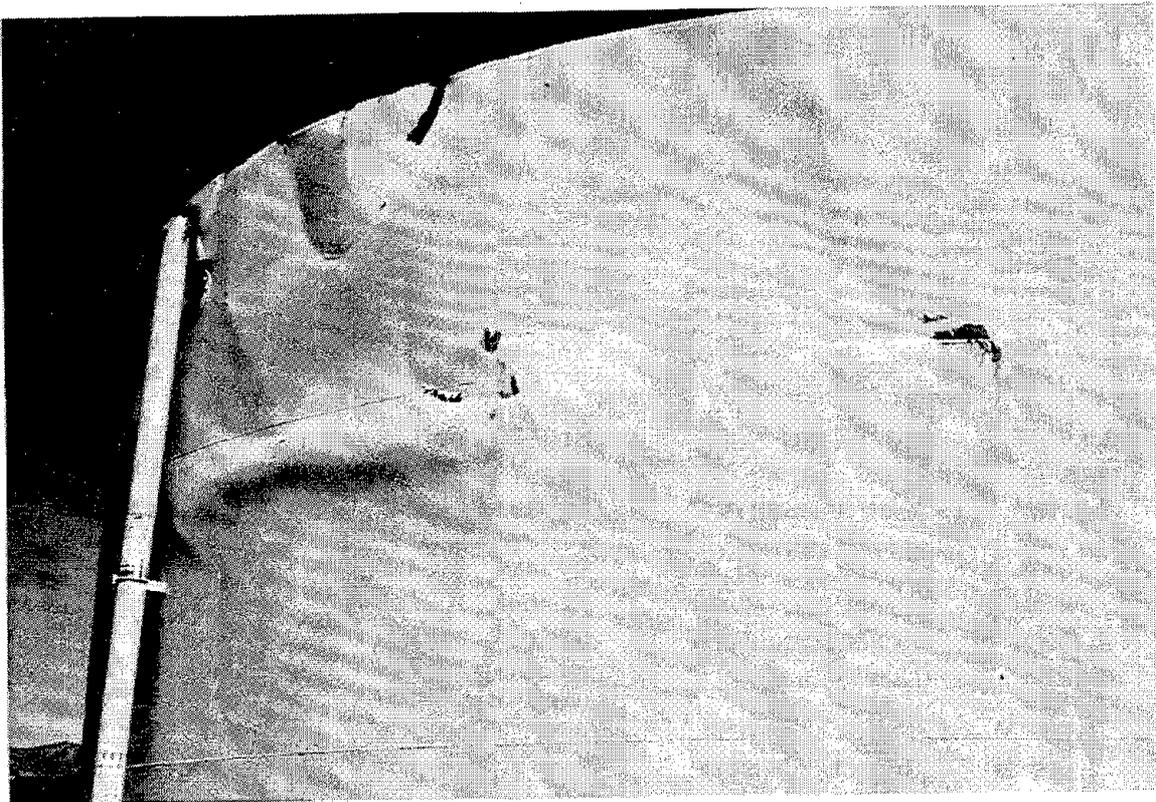
Figure 9.4 South side of Tank A. Pipe clamp slide was 0.6 m (22 in).

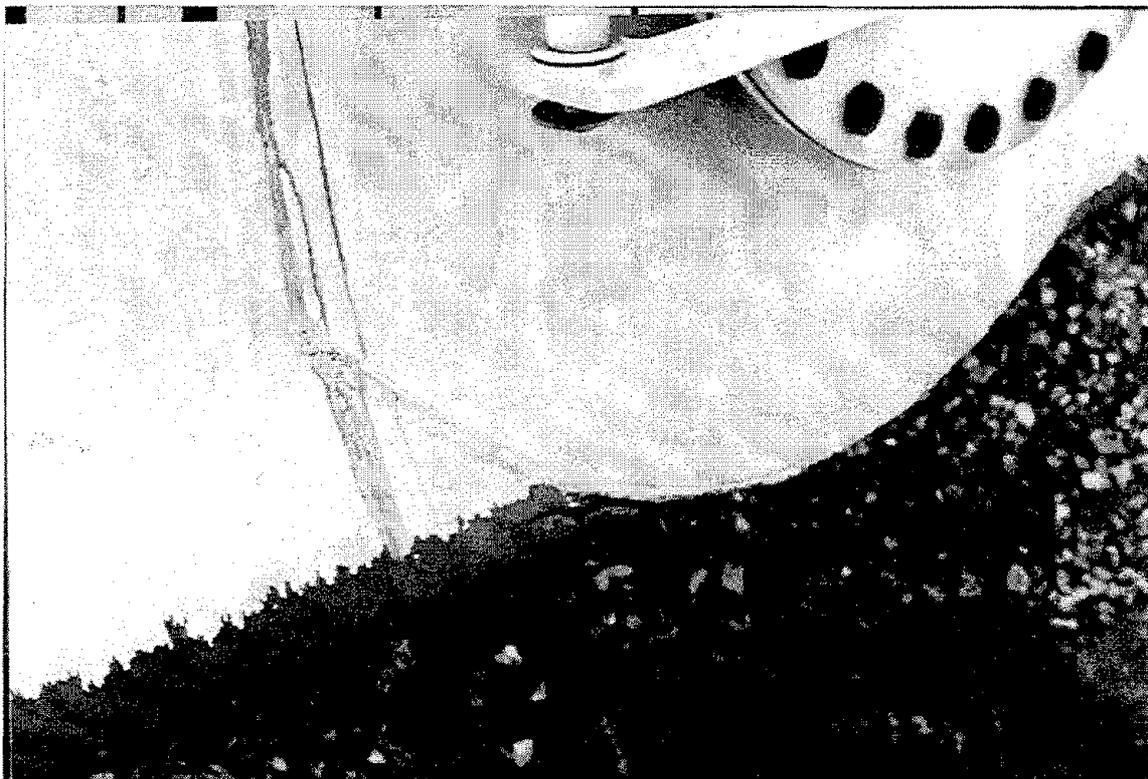
Figure 9.5 Tank A, tear on shell at the bottom of reinforcing plate.

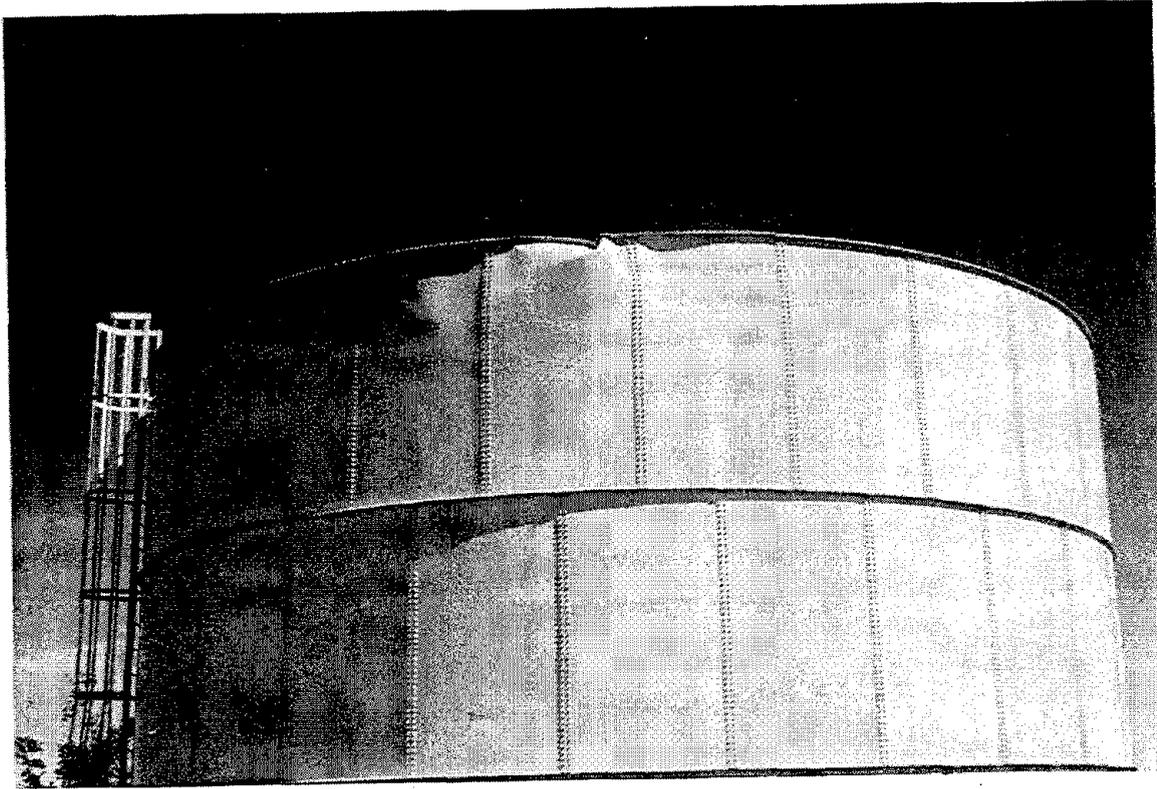
Figure 9.6 Roof/shell buckling on CSA-70.

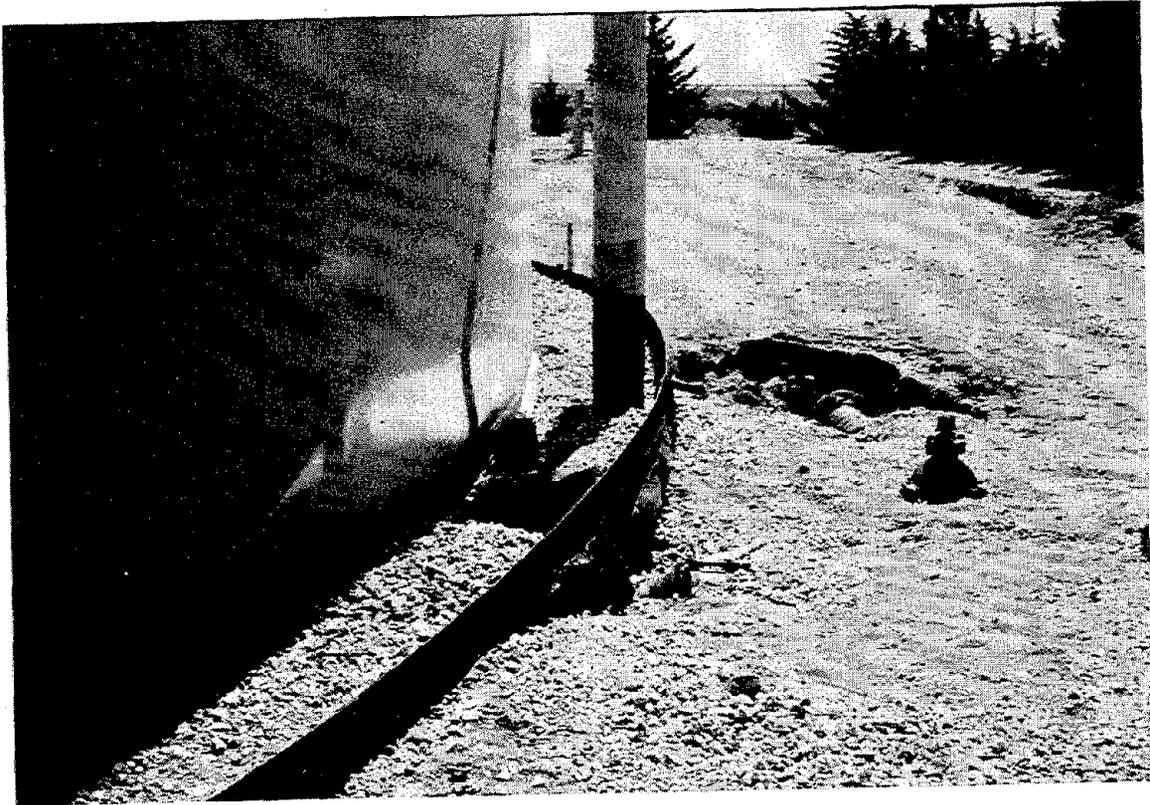
Figure 9.8 Tank A, riser pulled piping and rock retainer ring out of the ground.

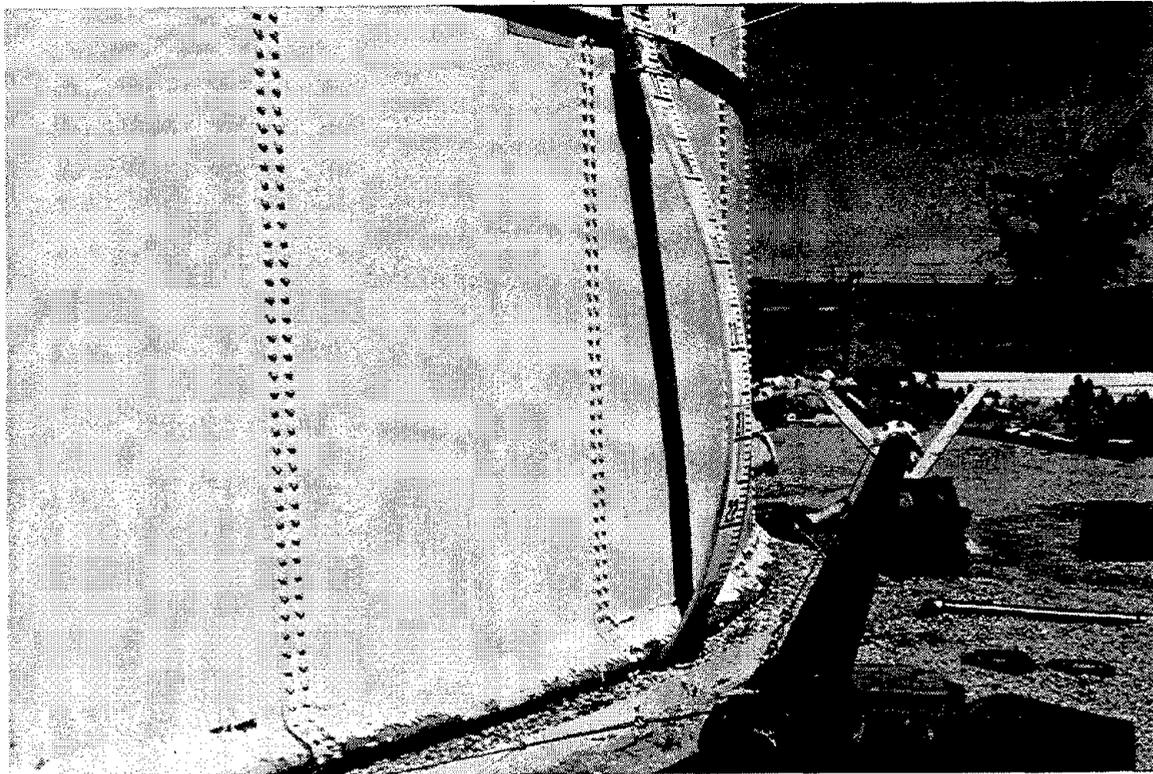
Figure 9.10 CSA-70 tank, elephant foot was fairly uniform around tank.

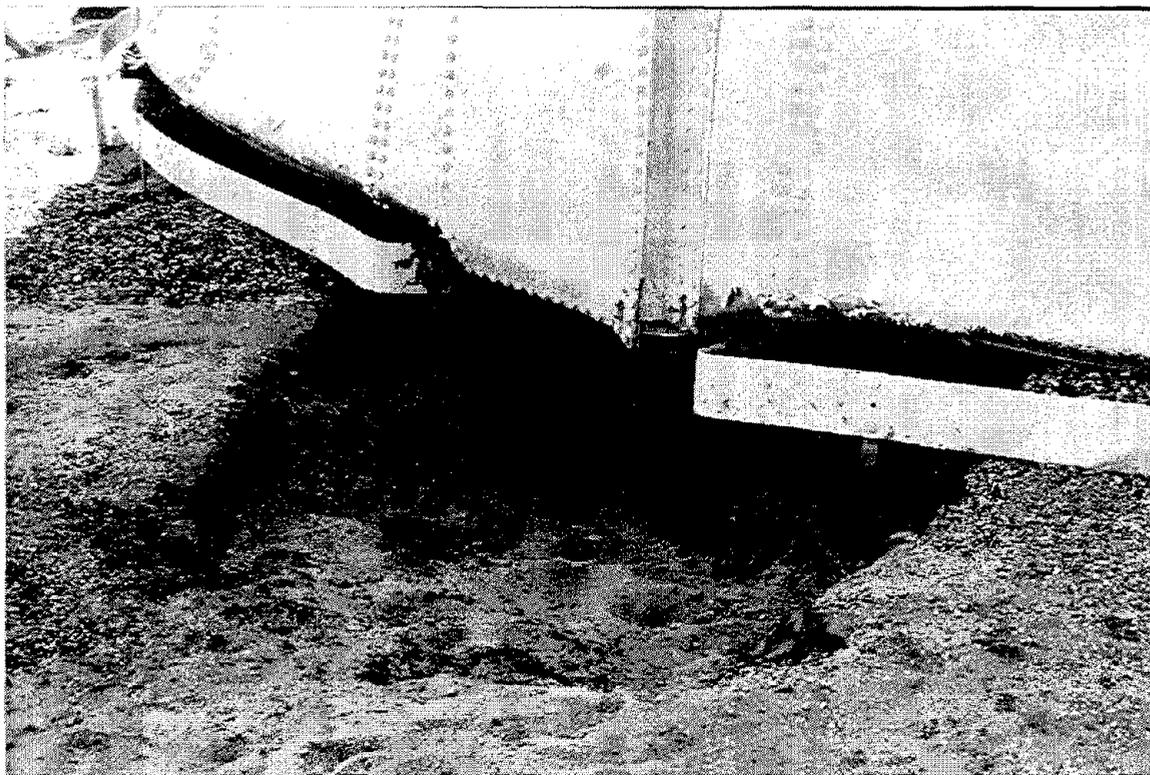
Figure 9.11 CSA-70 tank, damage of clean-out door, and washout of soil.

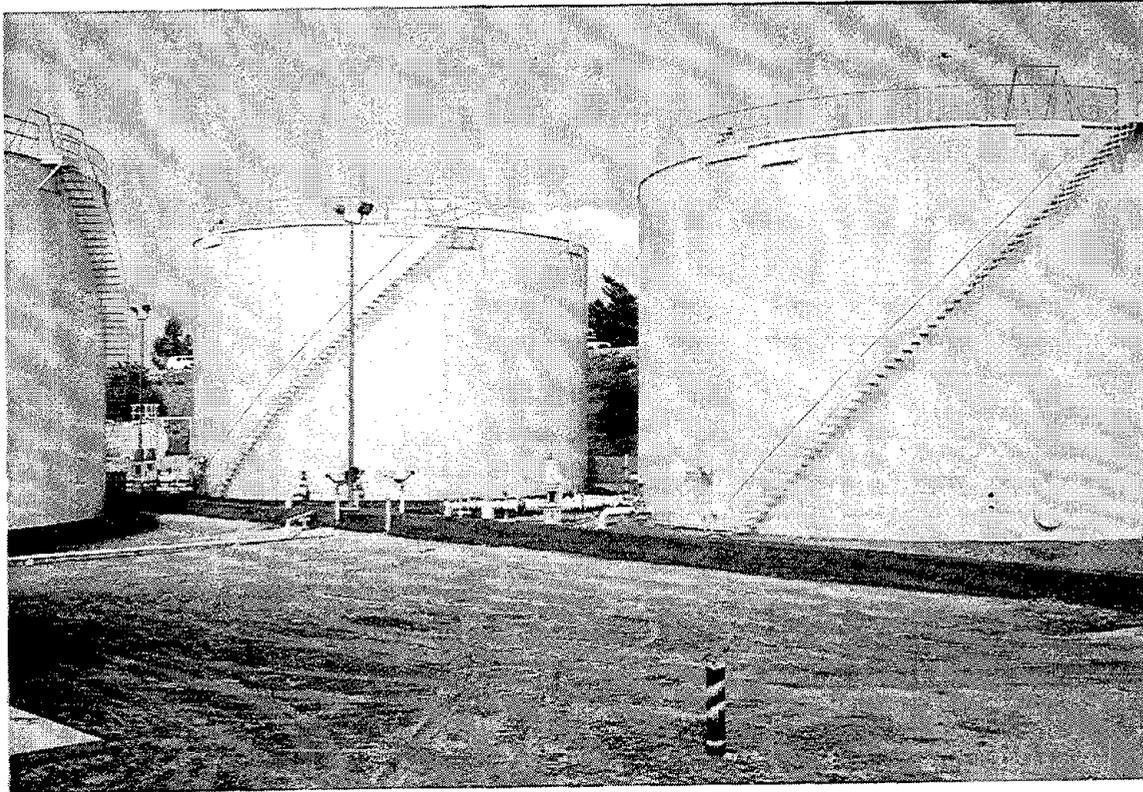
Figure 10.3 Sepulveda Products Terminal, internal pan tanks had no damage but product did slosh on the top of the pans.

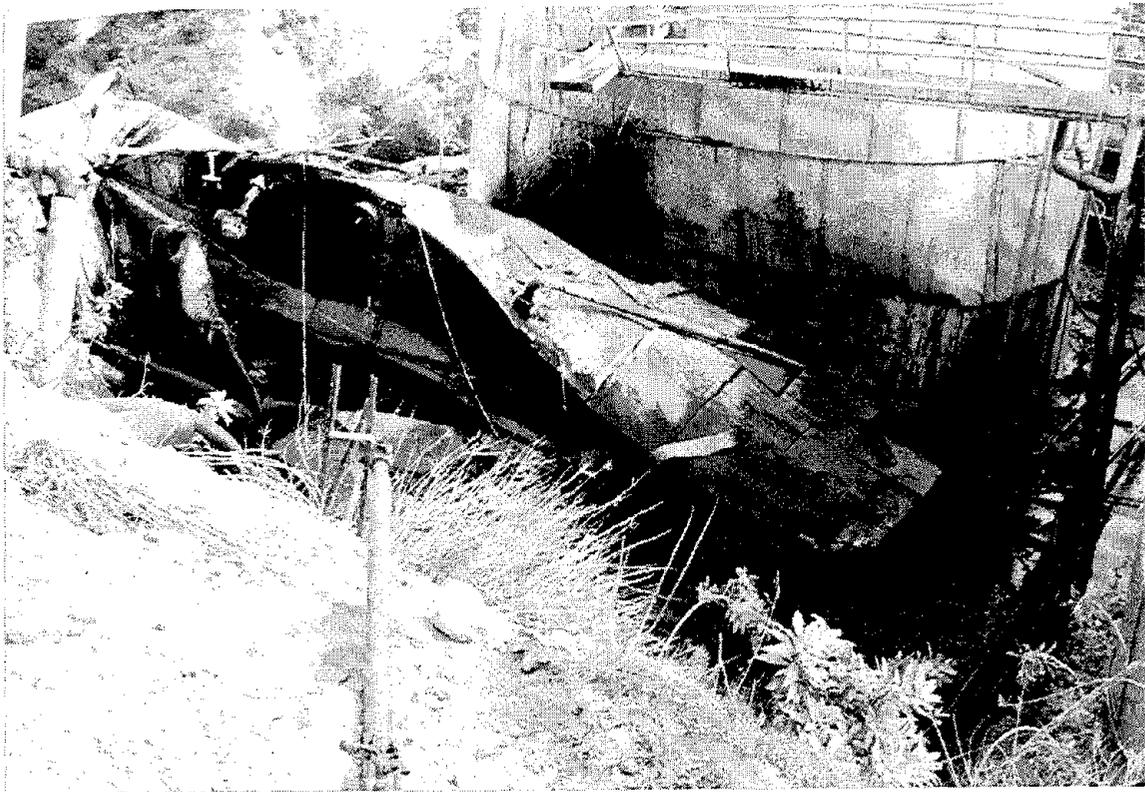
Figure 10.7 Aliso Canyon bolted oil production tank, which collapsed [Courtesy of L.Lund].

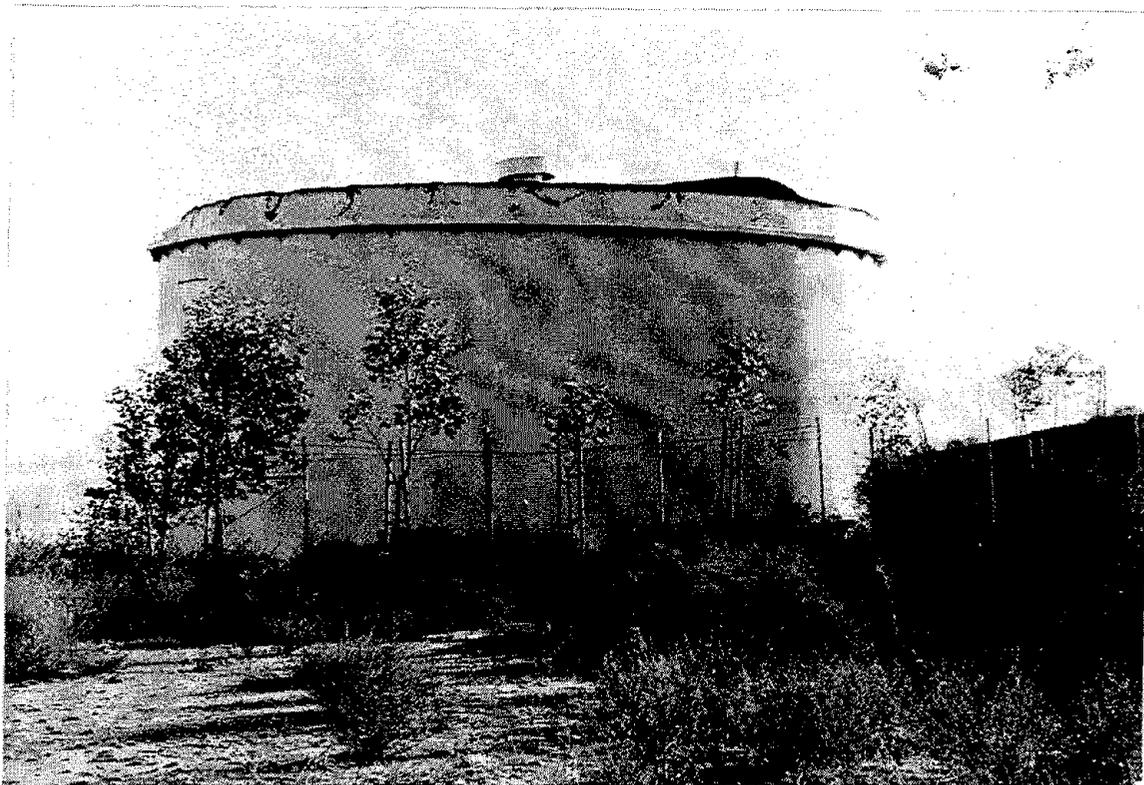
Figure 10.8 Larwin tank, 18.3 m (60 ft) in diameter by 12.2 (40 ft) high showing roof damage [Courtesy of L. Todd].

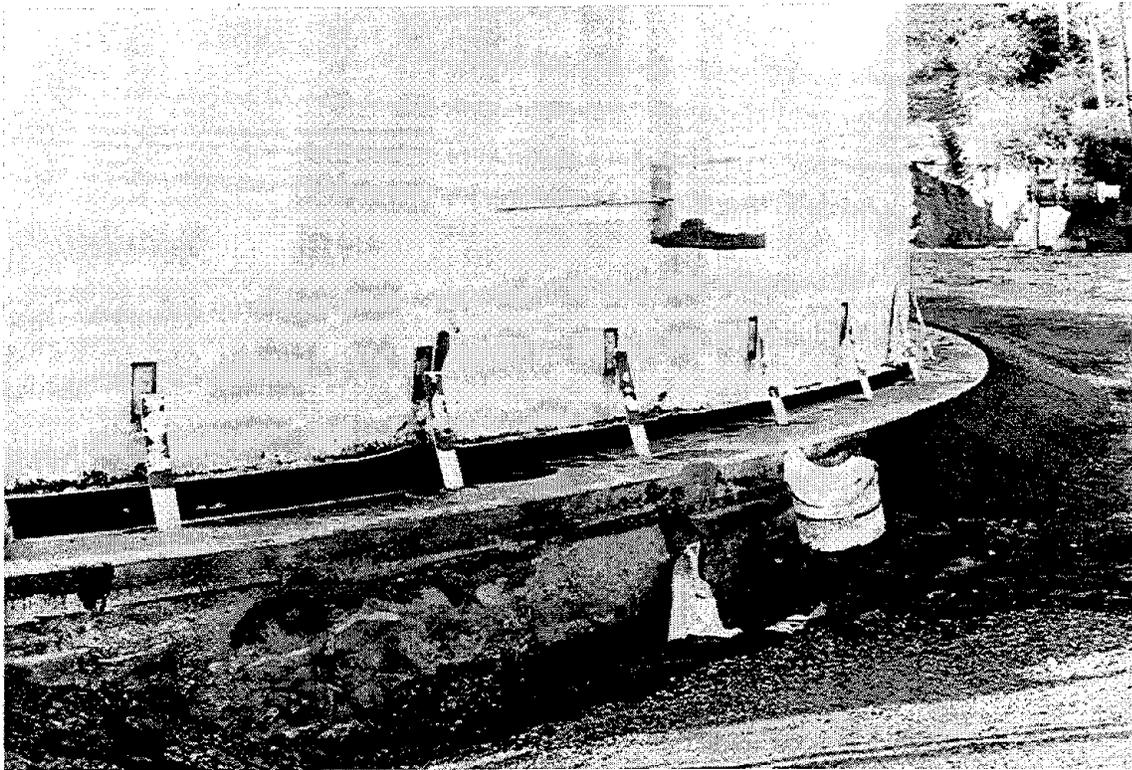
Figure 10.9 Larwin Tank, shows permanent bottom distortion and uplift and stripping of anchor straps [Courtesy of L. Todd].

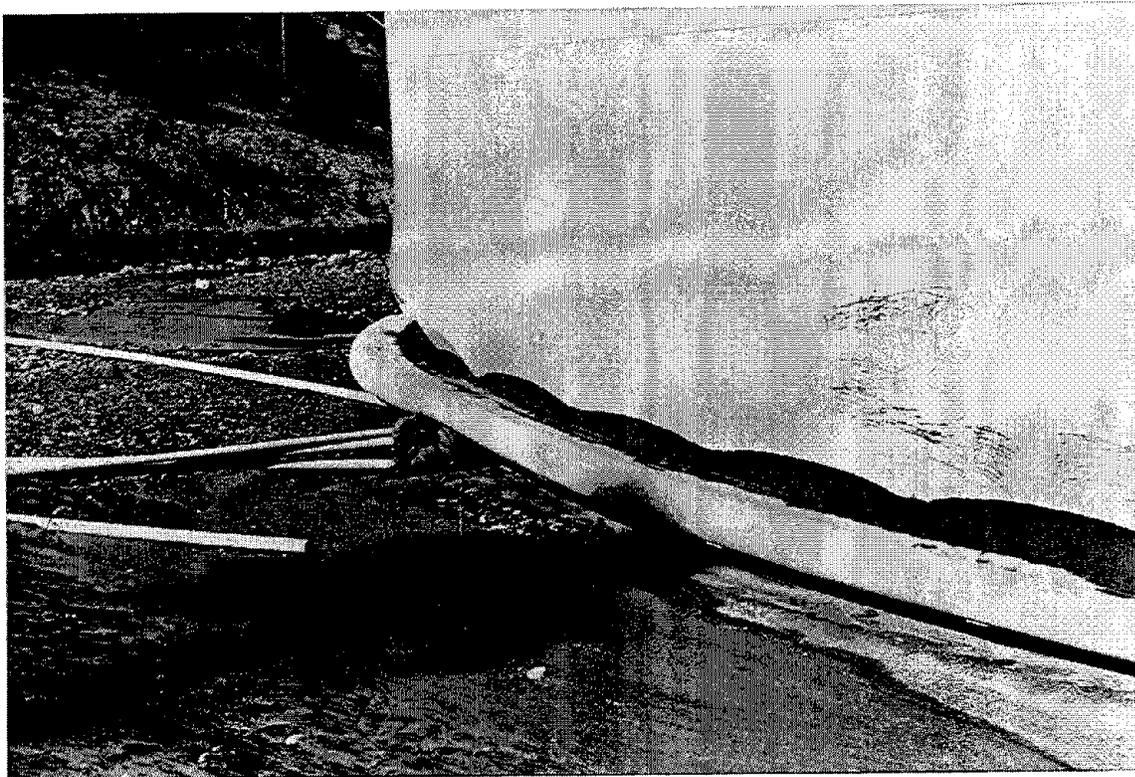
Figure 10.10 Elephant foot, and start of second bulge, straps on this side completely rolled over. (Courtesy of L. Todd)

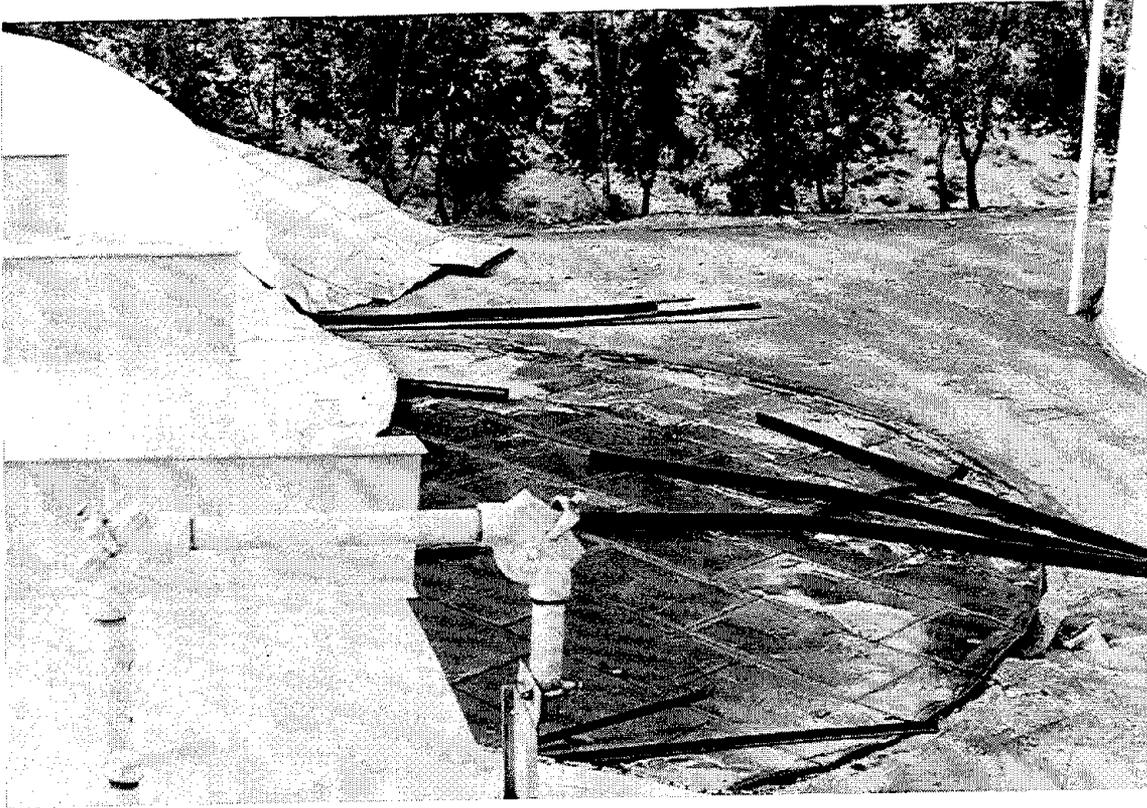
Figure 10.11 MMII, showing bottom and shell rip, note exterior rafters on MMIII [Courtesy of L. Todd].

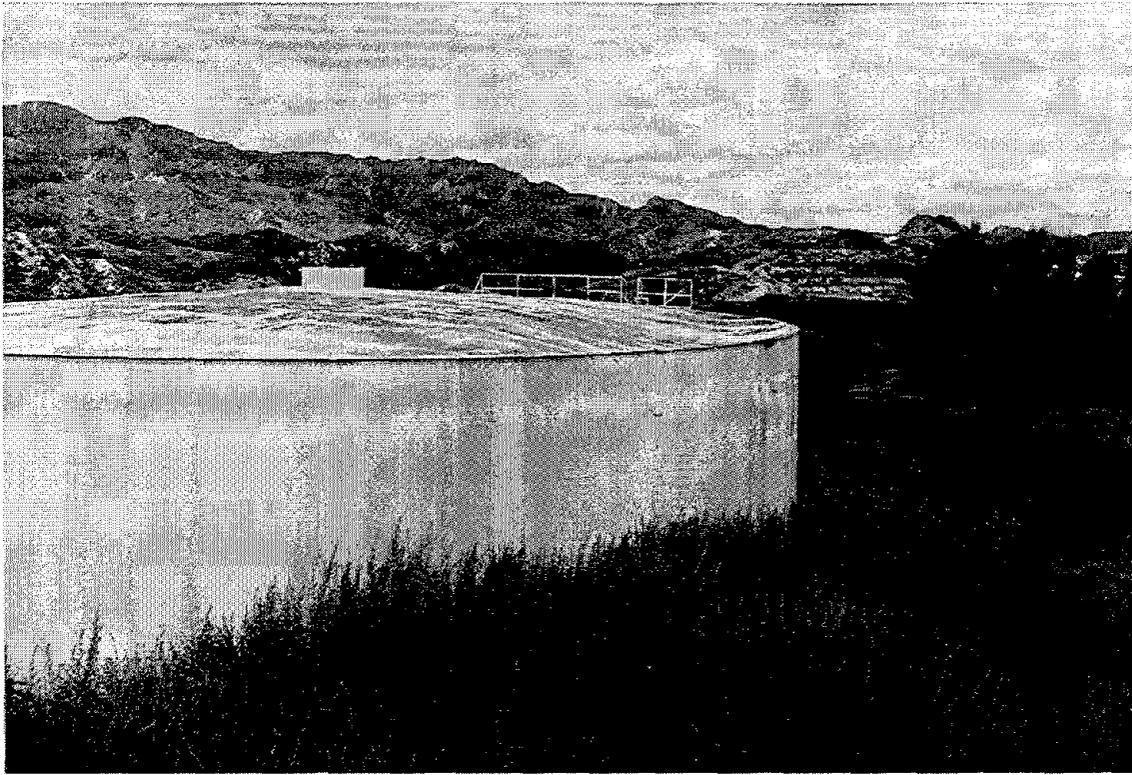
Figure 10.13 Roof, rafter, and shell damage on Tank 7, NCWD. This tank had a 12.7 mm (1/2 in) annular ring (or bottom plate) and did not elephant foot.

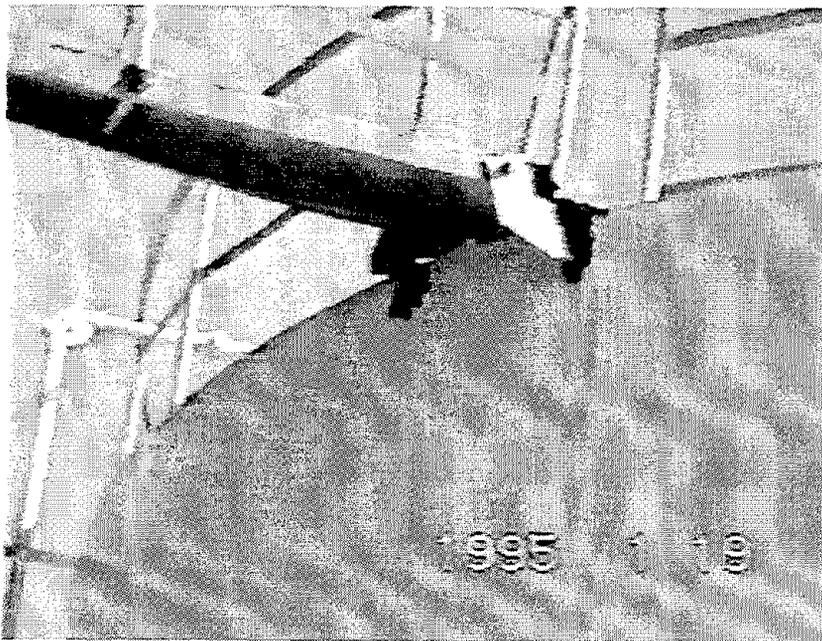
Figure 11.3 Inter-tank walkway joint failure (GATX video).

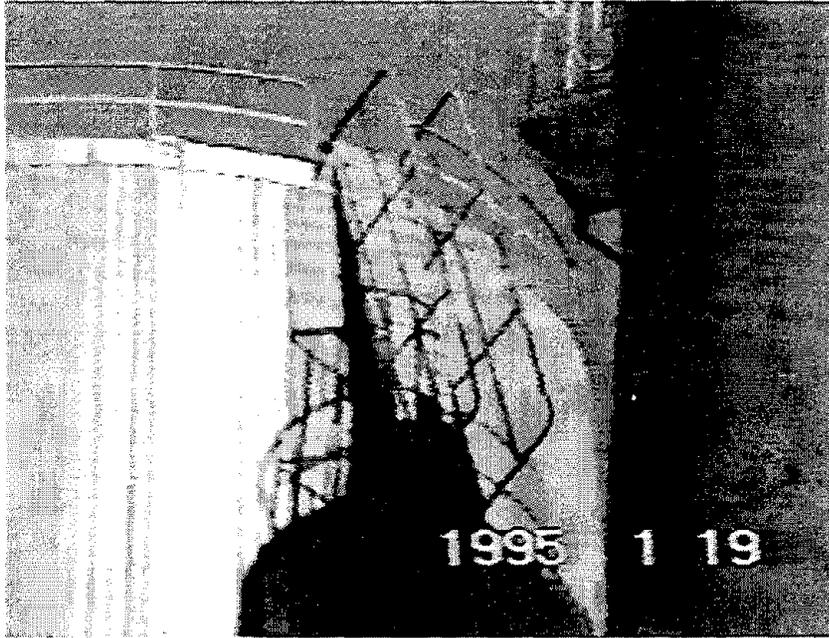
Figure 11.4 Walkway brackets pulled from tank shell (GATX video).

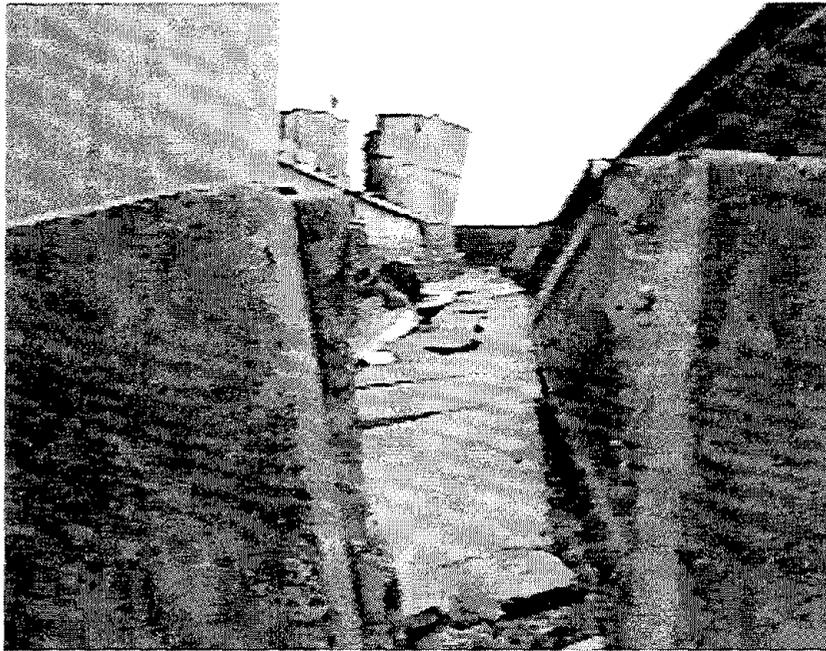
Figure 11.6 Seawall settlement and tilted tanks (GATX video).

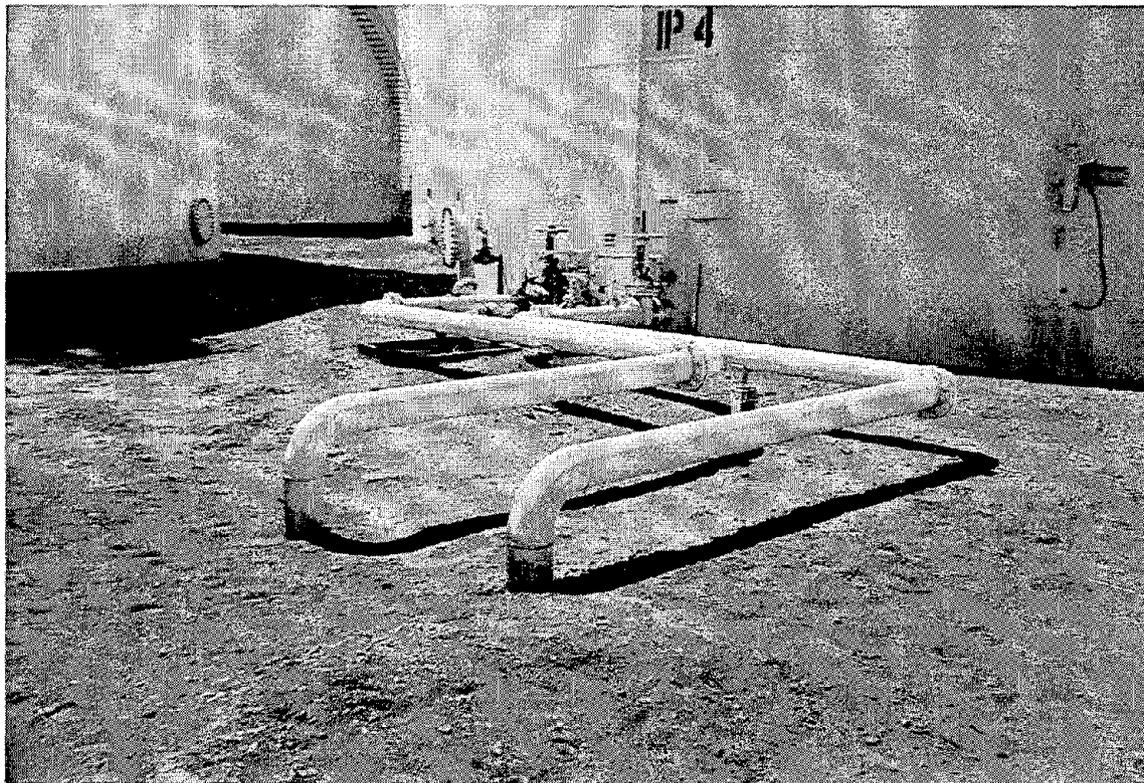
Figure 13-1 Inlet-Outlet piping which provides flexibility, note that the flanges in the horizontal runs are lap-joint stub end flanges. (Courtesy of J. Englehardt, SFPPL).

12. Inlet-outlet piping should be made more flexible, and consideration should be given to making inlet-outlet piping from steel (including steel valves).
13. Additional studies should be made on tanks with d/H ratios of less than two to determine if elephant foot buckling can be eliminated, either by increasing shell thickness (Sesnon) or anchorage.
