The Marmara, Turkey Earthquake of August 17, 1999: Reconnaissance Report

Edited by
Charles Scawthorn¹

Technical Report MCEER-00-0001

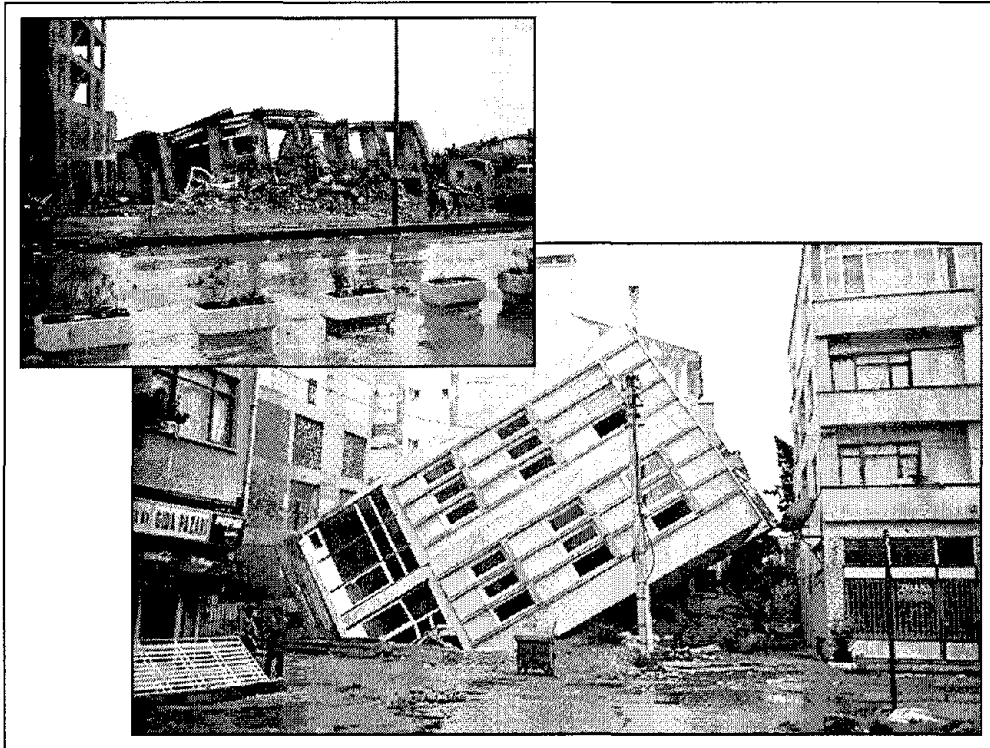
Figure 3-4 Buildings in Adapazarı that either toppled or partially overturned because soil beneath them liquefied and weakened the foundation

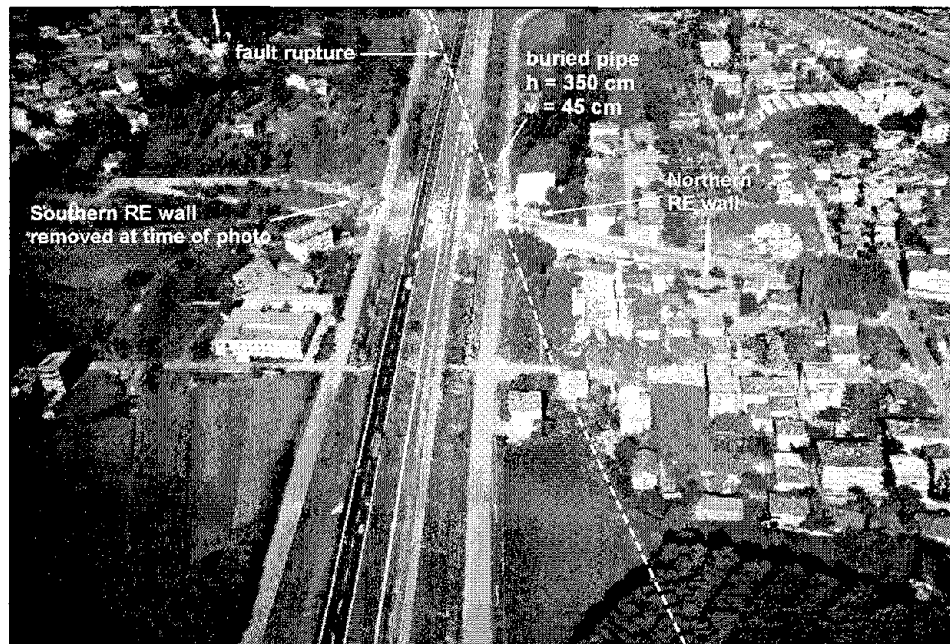
Figure 3-15 Aerial photograph showing surface fault rupture transecting the Arifiye Bridge site. The fault displacement caused collapse of the bridge and large deformations of the reinforced earth abutments.

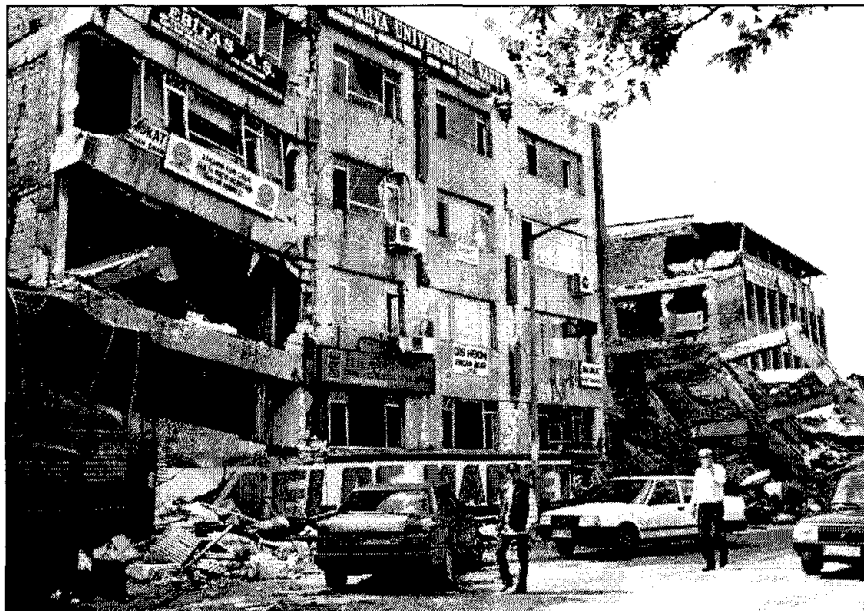
Figure 4-6 Failure of soft first story

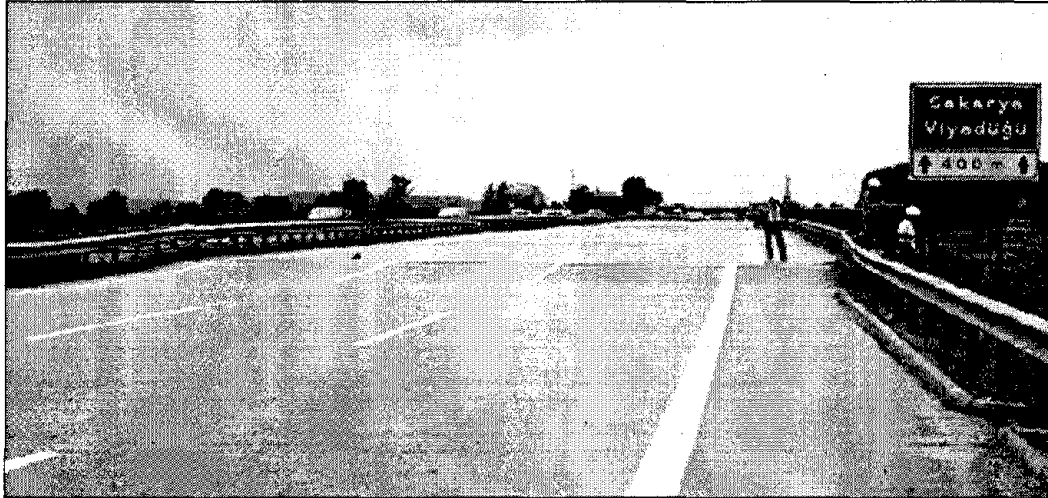
Figure 5-6 The east abutment of the eastbound E-80 Motorway bridge showing the 500 mm offset of the span with respect to the approach road

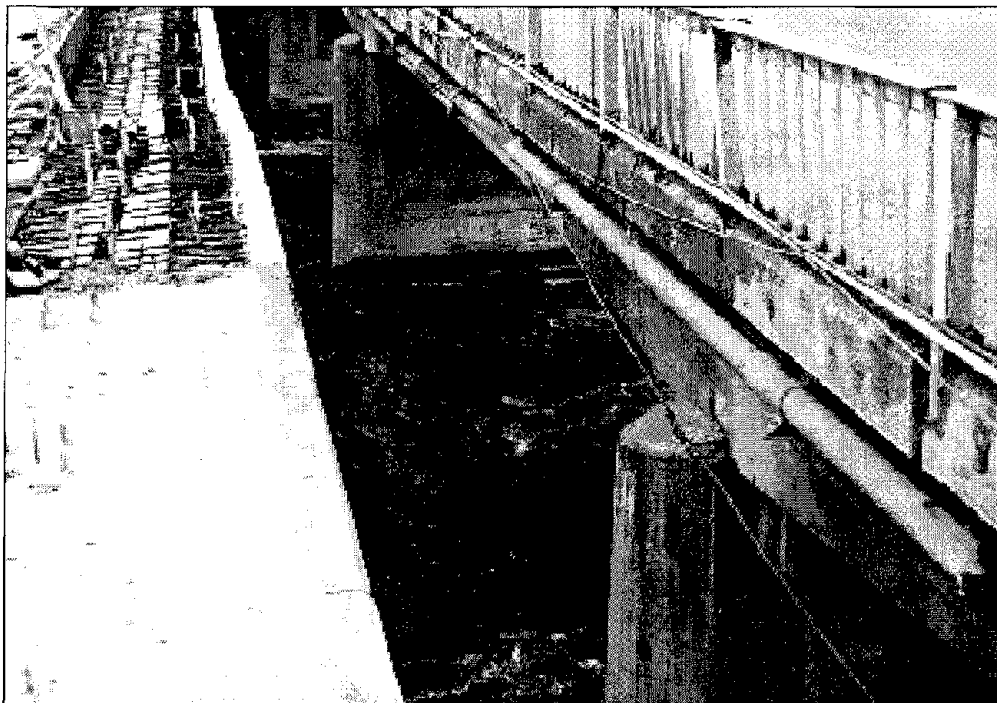
Figure 5-9 The two bridges crossing the Sakarya River on the D100 Highway. The left hand bridge at the time of the earthquake was a new prestressed concrete bridge still under construction. The right hand bridge is the original reinforced concrete, two-lane highway bridge. The damage can be noticed on the new bridge where the fascia girder is misaligned near the top left hand corner of the photograph. Damage to the old bridge can be seen at the junction of the pier cap to span connection in the mid right portion of the photograph.
