Quindío, Colombia Earthquake of January 25, 1999: Reconnaissance Report

Alejandro P. Asfura¹ and Paul J. Flores²

Technical Report MCEER-99-0017

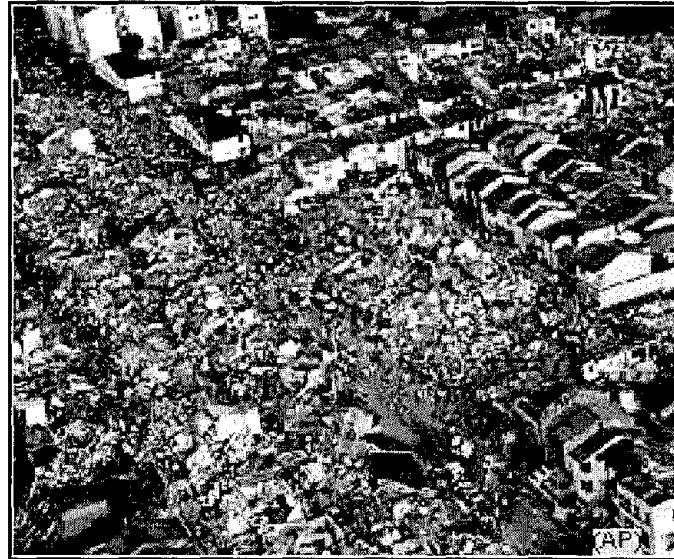
The Armenia's central business district or downtown was also severely damaged. A large number of engineered buildings collapsed or will have to be demolished (see figure 3-4). The Municipal Government building, a 20-story concrete frame tower with two lateral five-story separated wings suffered extensive damage and had to be evacuated. The left wing was severely damaged during the main shock and collapsed during the 17:44 aftershock.

Figure 3-3 Complete Damage in Brasilia, Armenia

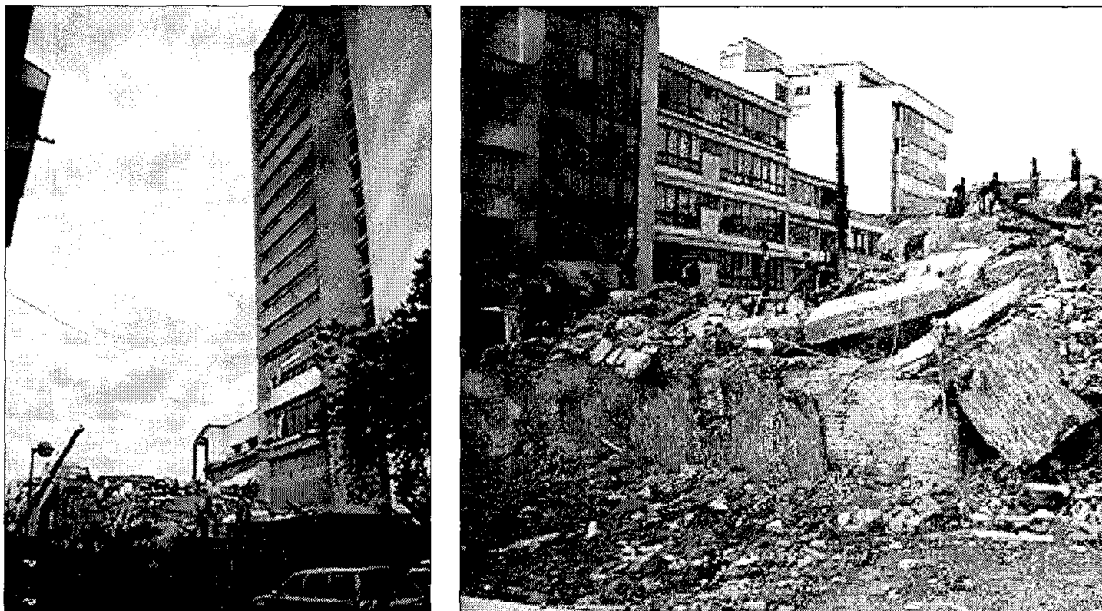
Figure 3-4 Damaged Wing of Armenia Government Building

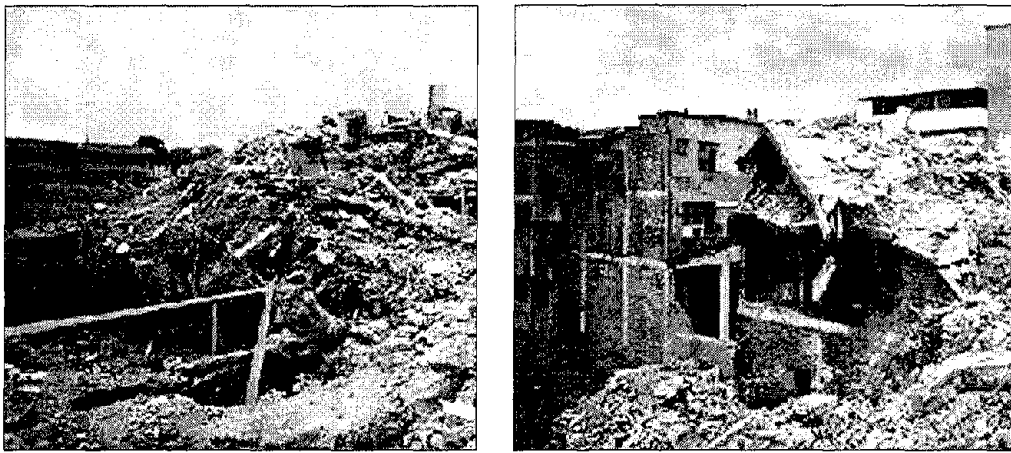
Figure 3-5 City of Pereira: Damage on Corner of Carrera 11 and Calle 21, 4-Story Building

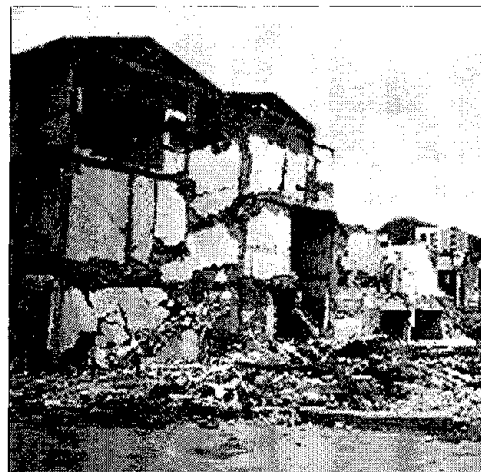
Figure 3-6 City of Pereira: Carrera 12/Calle 22, 3-Story Building, Collapsed

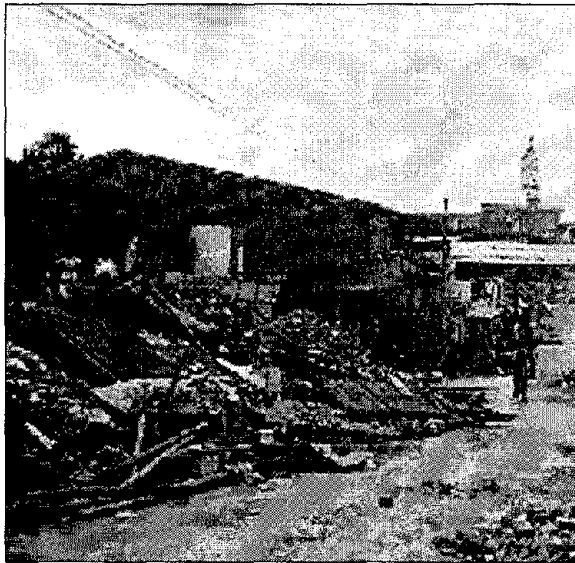
Towns such as La Tebaida and Barcelona, located on a deep layer of soft soil, were severely damaged (see figure 3-7). In comparison, the town of Córdoba, much closer to the epicenter and located on bedrock, suffered less damage. In Pereira, the area most affected was between *calles* 15 and 26 and *carreras* 8 and 16, which is located on man-made non-engineered fill (see figures 3-5 and 3-6).

Figure 3-7 City of La Tebaida: Damage on Carrera 6

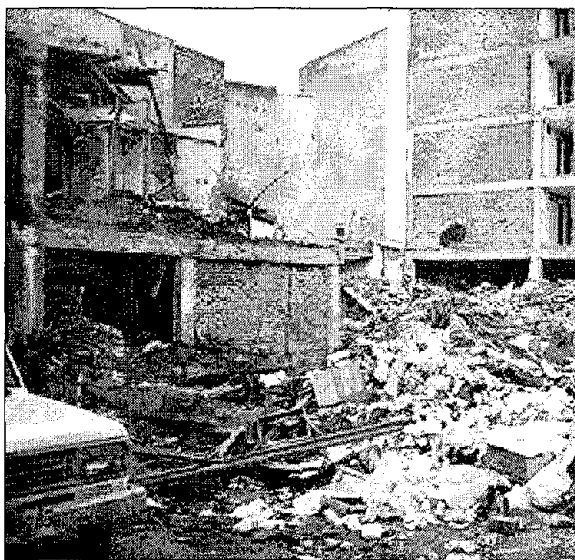
The typical construction in the area affected by the earthquake consists of unreinforced masonry for low structures and concrete frames with either solid clay brick or hollow clay tile unreinforced infill panels for taller structures. The infill panels are normally not connected to the concrete frames. As expected, heavy damage in the unreinforced masonry structures and unreinforced infill panels occurred (see figure 3-8 through 3-10). Poor confinement and detailing was typical in the concrete frame structures that collapsed or were damaged.

**Figure 3-8 Hotel Armenia-Plaza, Unreinforced Masonry
Calle 22/Carreras 14 y 15, Armenia**

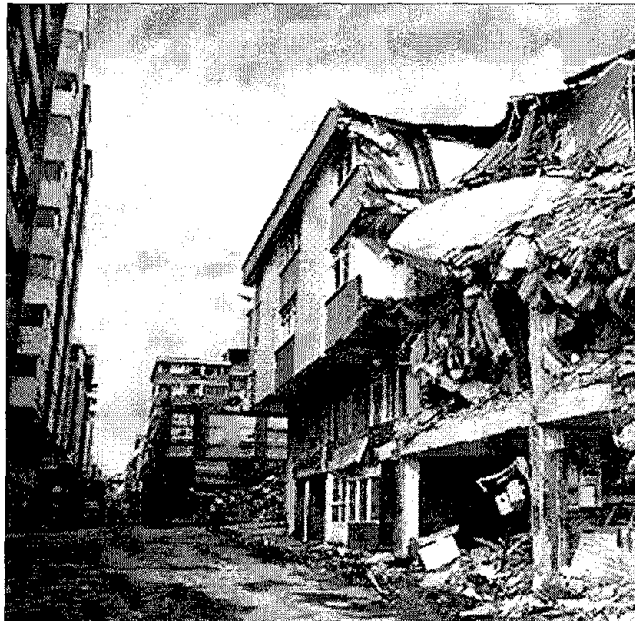
**Figure 3-10 Kokorico Restaurant, Carrera 15/Calle 21, Armenia,
4-Story, Concrete Frame, Masonry Infill**

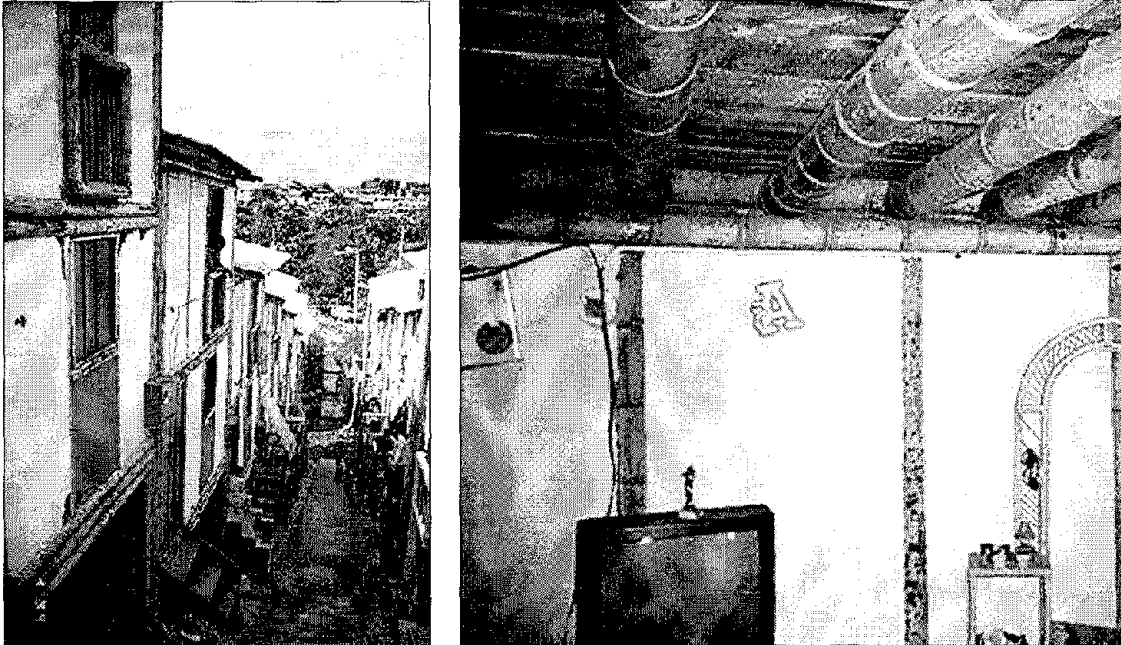
A group of 73 two story houses in the Miraflores neighborhood of Armenia, built with frames of *guadua* (similar to bamboo), behaved well and did not suffer any damage (see figure 3-11). Many masonry houses in this neighborhood were damaged. The same was observed in some rural areas.

Figure 3-11 Miraflores Neighborhood, Armenia: 73 Houses Built with Guadua Frames, No Damage

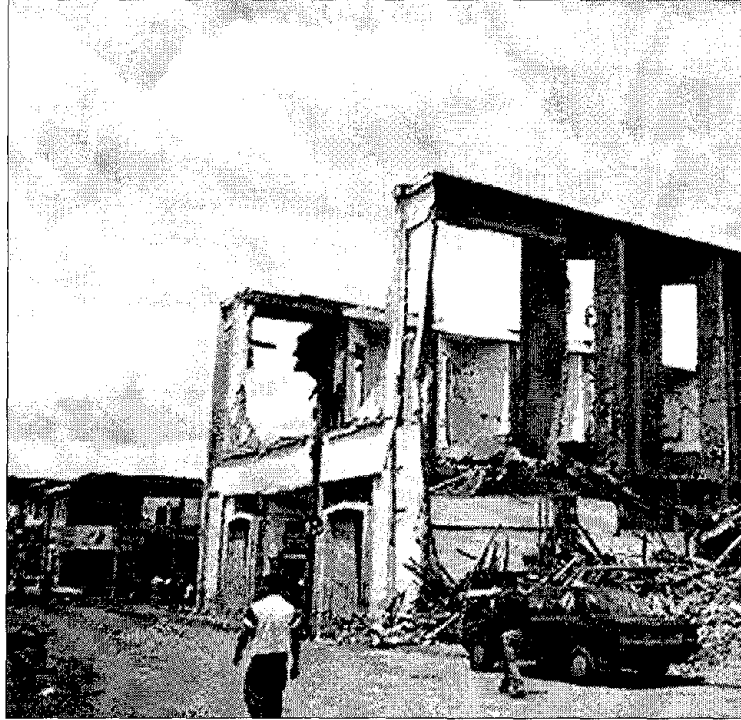
Churches built with unreinforced stone or solid brick masonry were severely damaged in the whole area affected by the earthquake. Also, churches built with concrete frames and unreinforced masonry infill panels suffered severe damage in those panels (see figures 3-12 and 3-13).

Figure 3-12 Pereira Church on Carrera 12/Calles 22 and 23

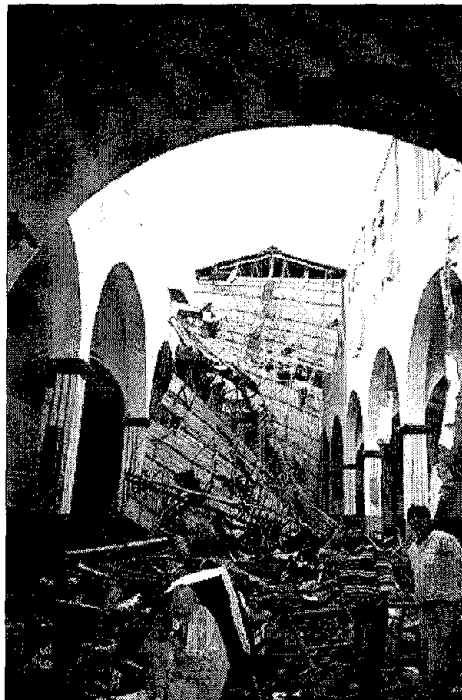
Figure 3-13 Damaged Church in Pijao

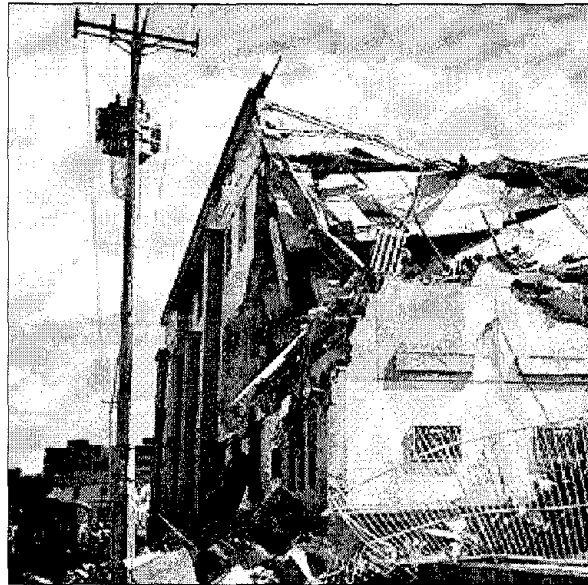
The educational infrastructure suffered considerable damage. It is estimated that about 35% of the school buildings in the city of Armenia collapsed during the earthquake or needed to be demolished afterward (see figure 3-14). Fortunately, the school year had not started at the date of the earthquake, otherwise the casualty toll could have been dramatically higher.

**Figure 3-14 Damage to San Francisco Solano School in Armenia.
URM Building**

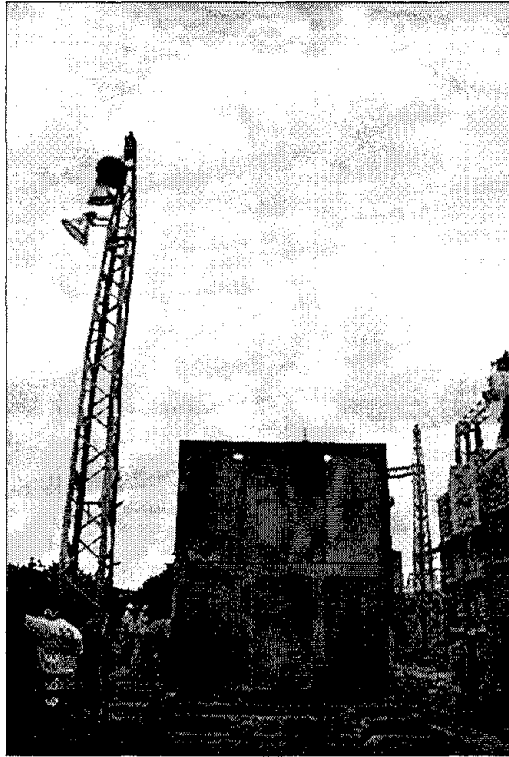
- Substation Regivit (115 KV/33 KV, 60 MVA, built in 1960). It is one of the two substations that connect the Colombian grid to the department grid, suffered damage in the transformers and circuit breakers. The three transformers (20 MVA each) were not anchored and mounted on wheels and they jumped out of their rails. One of them fell inside the oil-pit and suffered heavy damage, the other two did not completely fall inside the pits but suffered damage in the supports and the bushings. Two ceramic column circuit breakers broke close to their base. This substation is located in the north area of Armenia, in a zone with very little reported damage; however, the transformers were located about 4 meters from a very deep ravine (about 200 meters deep). The substation was out of service at the time of the visit (see figure 4-1).

**Figure 4-1 Substation Regivit (115 kv/33 kv, 60 mva, 1960) in Armenia:
Damage on Tower Due to Transformer Fall**

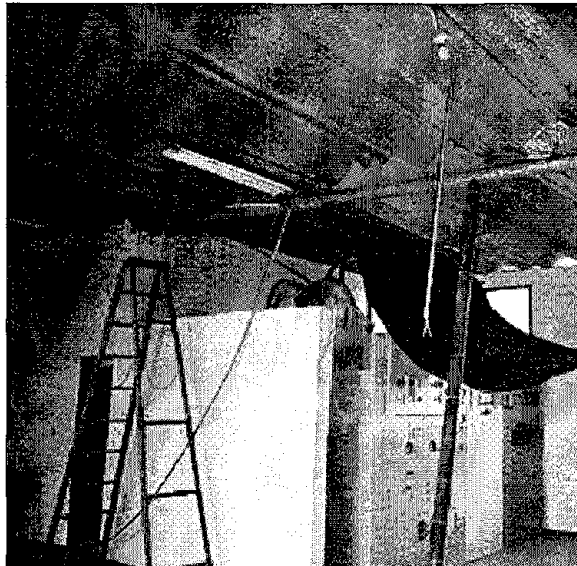
- Substation Sur (33 KV/13.2 KV, 15 MVA, built 1982). Located in the south area of Armenia has two transformers (10 MVA, 5 MVA) mounted on wheels, they moved but did not fail. Some oil leakage in the 10 MVA transformer was reported. The equipment in the control room was not anchored and moved approximately 2". No equipment failure was reported though. The control room is a one story URM building. The walls and roof were damaged. This substation was still in service (see figure 4-2).

**Figure 4-2 Substation Sur (33 kv/13.2 kv, 15 mva, 1982) in Armenia:
Roof Control Room Almost Collapsed Due to Truss Failure,
Temporary Support**

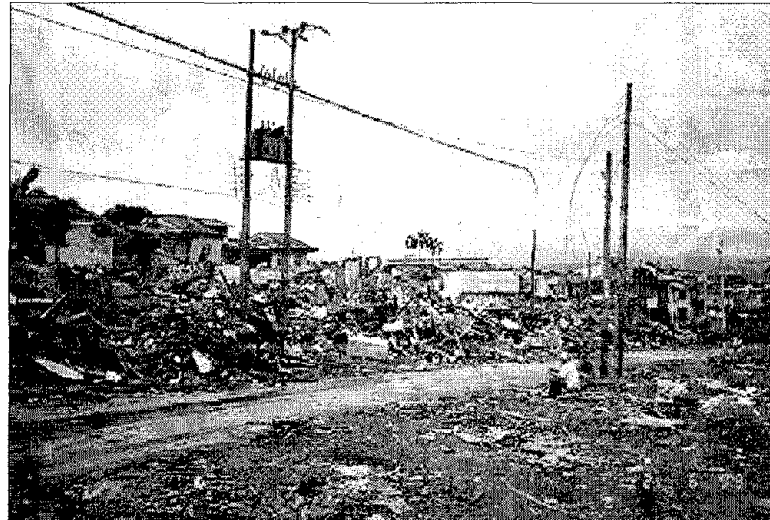
The distribution lines in the cities were damaged due to collapsing structures; however, they were repaired very quickly. The large majority of the street poles and the distribution elevated transformers did not suffer any damage due to the earthquake shaking (see figure 4-3).

Figure 4-3 Damage to Electrical Distribution Lines in Brasilia, Armenia

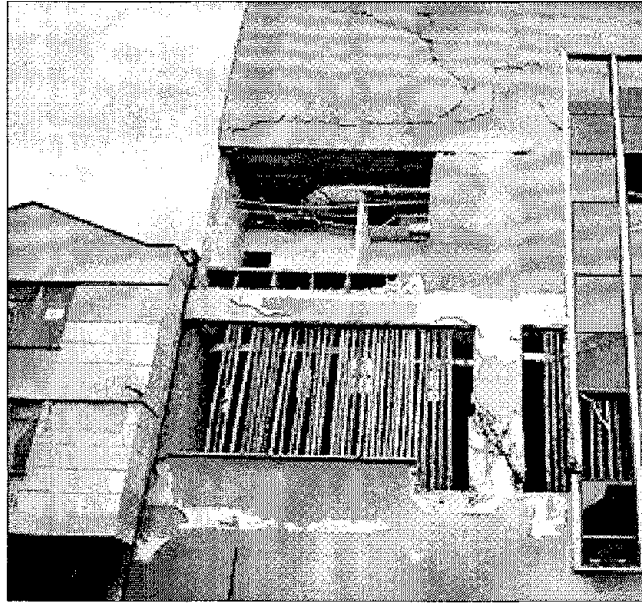
Figure 4-4 Telecom Building in Armenia Suffered Severe Structural Damage

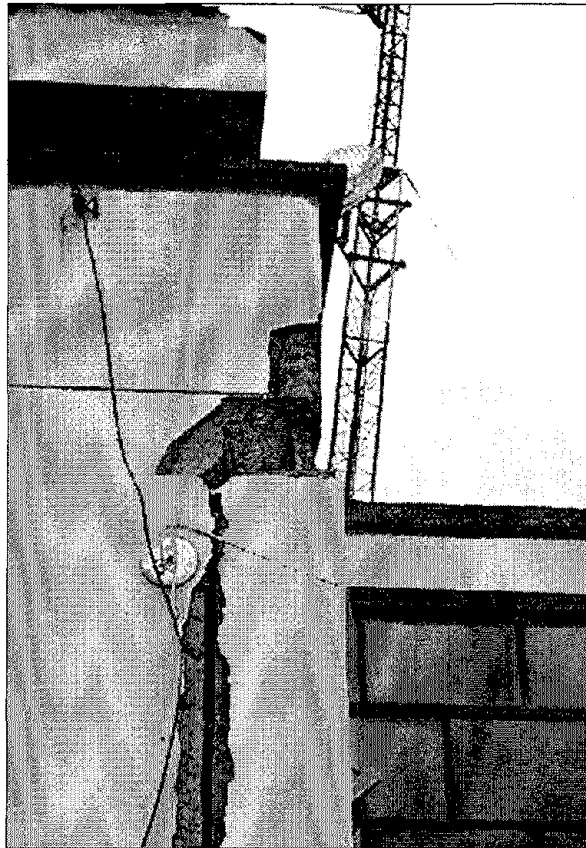
**Figure 4-5 Telecom Building in Cordoba Suffered Severe Damage
(Concrete Columns with Masonry Infill)**

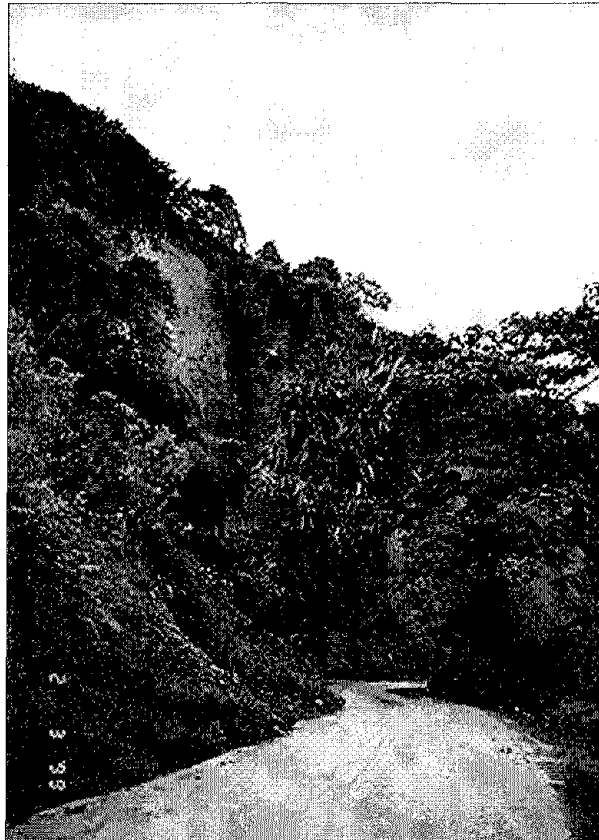
Several two-line paved roads, highways, and bridges were affected by the earthquake. No major damage was detected in the pavement, only some local cracks in the road between Armenia and Pijao were observed. However, four roads were blocked (Armenia-Buena Vista, Armenia-Pijao, Armenia-Córdoba, Armenia-Ibagué) and three municipalities of Quindío were isolated due to landslides. The most affected road was the Armenia-Pijao, which, in about 14 km, had approximately 100 landslides, several of them large enough to completely block the road (see figures 4-6 and 4-7).

Figure 4-6 Landslides on Road Armenia-Pijao

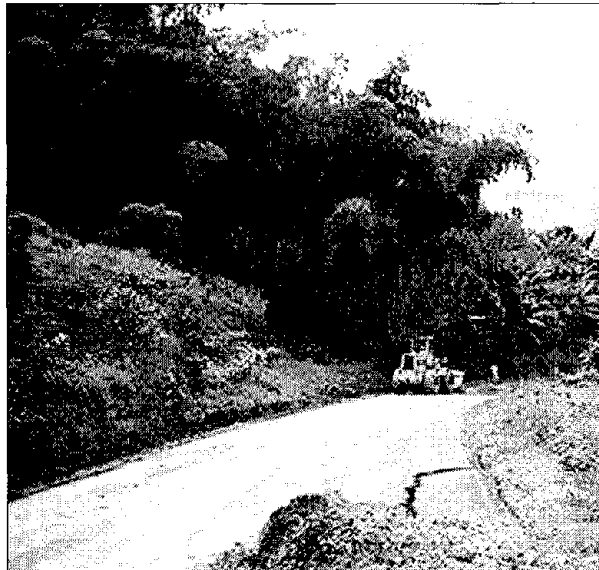
Figure 4-7 Crack on Pavement Due to Movement of Downhill Side of the Road on Road Armenia-Pijao

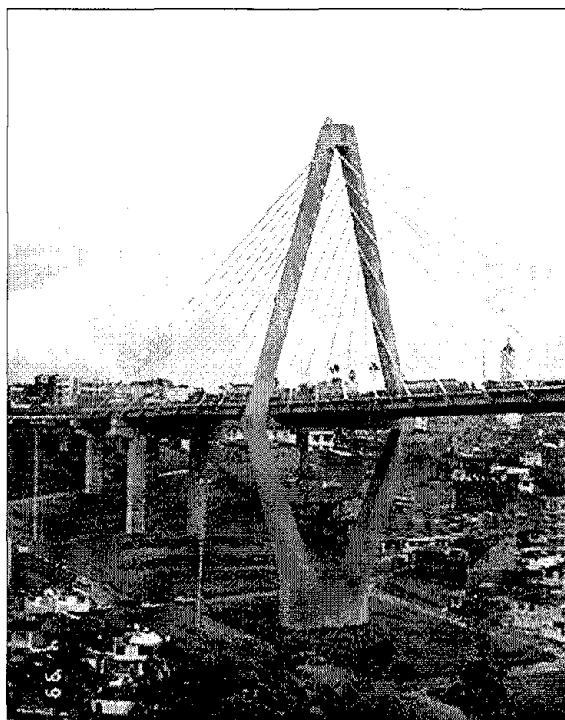
Bridges behaved well in the affected area and no structural damage or settlement was observed. Near Pereira (between Pereira and Dos Quebradas) there is a newly built cable stayed bridge, with two tall central towers and a total length of approximately 1 kilometer, with absolutely no damage (see figure 4-8).

Figure 4-8 Pereira: Bridge Between Pereira and Dos Quebradas

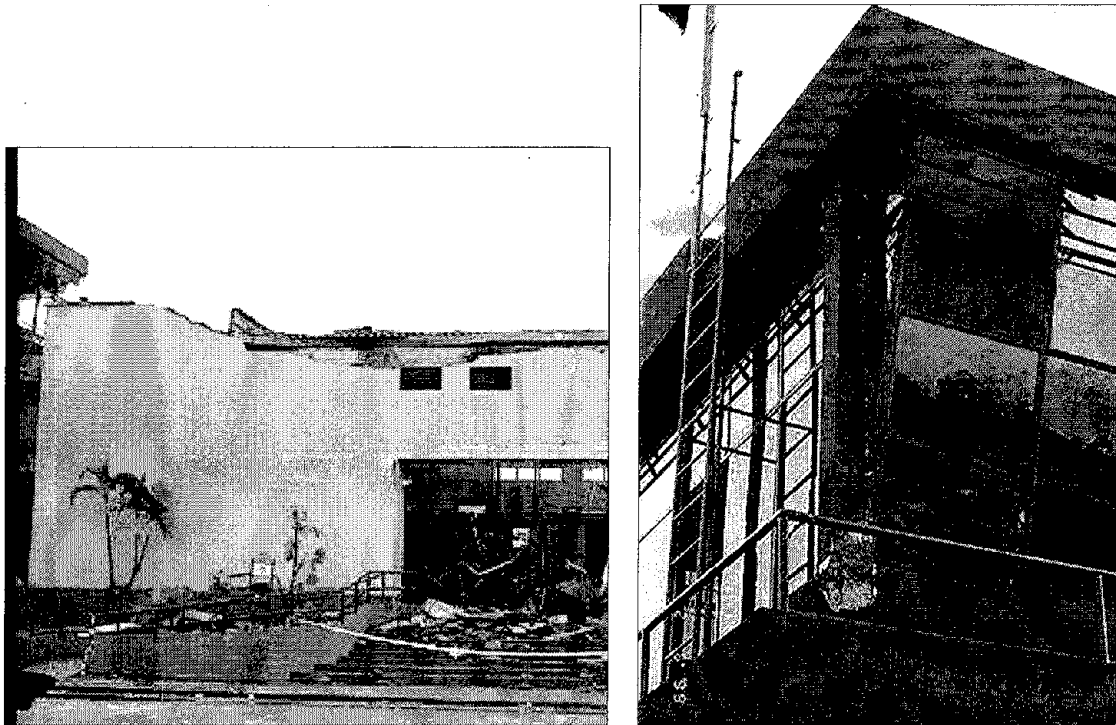
The buildings of the airport El Edén of Armenia were damaged. However, the runway and the outside equipment were not affected and the airport remained functional and able to receive flights carrying emergency personnel and resources. The terminal building is a one-story concrete frame building with masonry infill. It suffered heavy nonstructural damage and damage on the roof (see figure 4-9). The columns of the top floor (3rd) of the control tower were damaged. The concrete slab on top of the tower is supported by two columns located at the back corners of the slab and by two very close columns at the central part of the slab. This floor will be demolished. Apparently, none of the equipment was damaged.

Figure 4-9 Structural Damage to Armenia Airport Terminal and Tower

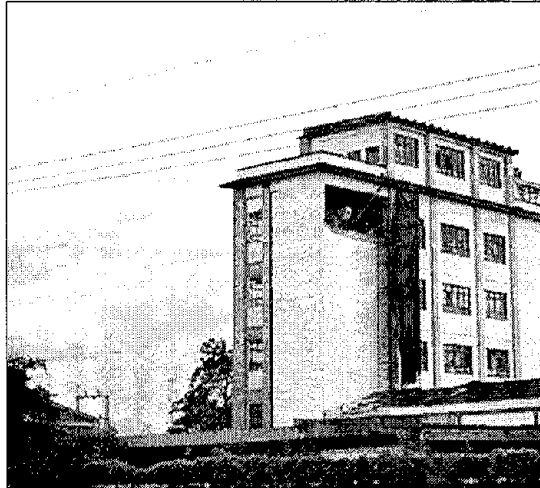
In the industrial area of Dos Quebradas, north-east of Pereira and about 48 kilometers north of the epicenter, damage was observed in concrete frame buildings of two industrial installations (see figure 4-10). No equipment failure was observed or reported. This area is on layers of natural soil. Very close to the two visited installations, there is an accelerometer. The maximum acceleration recorded were 0.184g in the e-w direction, 0.192g in the n-s direction, and 0.075g in the vertical direction.

Figure 4-10 Industrial Building in Dos Quebradas was Damaged and Repaired in 1995, Suffered Damage in Nonstructural Panels and Some Deep Beams

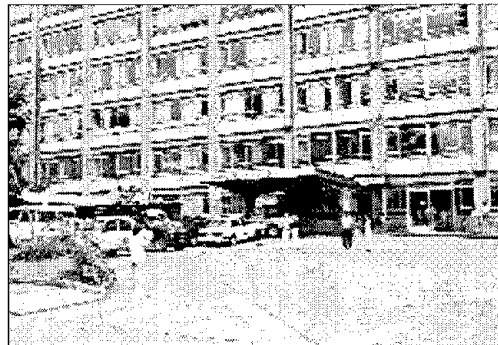
Hospitals and other health care centers were severely affected by the earthquake. The regional hospital in Armenia is a five-story concrete frame structure with masonry infill. Significant non-structural damage was noted to the building, although the hospital continued operating (see figure 4-11). The emergency department was in a new wing of the hospital that suffered little damage. The hospital had emergency generators and was able to operate in the immediate aftermath. In addition to the regional hospital in Armenia, seven of the twelve primary care health centers in the city were also damaged. Three of the clinics, in the hardest hit areas of the city, collapsed. Four additional clinics suffered severe damage and were yellow-tagged although the clinics continued to function. The one clinic visited was a one-story masonry building. The roof of the structure collapsed over all but the front two rooms of the building. In addition, landslides under the rear of the structure were threatening the back two rooms.

Figure 4-11 Regional Hospital in Armenia Suffered Extensive Nonstructural Damage but was Kept Operational

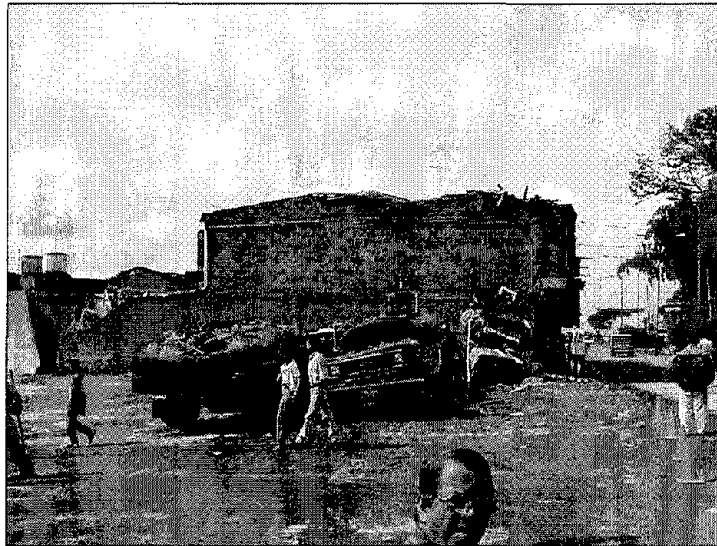
The fire department for the city of Armenia was centralized. The city's fire department and all of its personnel and equipment were housed in only one facility. The building collapsed during the earthquake, destroying all the fire trucks and killing several fire fighters (see figure 4-12). The building was a three-story concrete frame building with masonry infill (mainly in the two top floors). According to the information available, it was built around the 1950's. Fortunately, only one fire broke out due to the earthquake, in a collapsed three-story building, where the first floor was used as a warehouse for chemical products.

Figure 4-12 Damaged Fire Trucks in Area Where Armenia's Centralized Fire Department Facility Stood

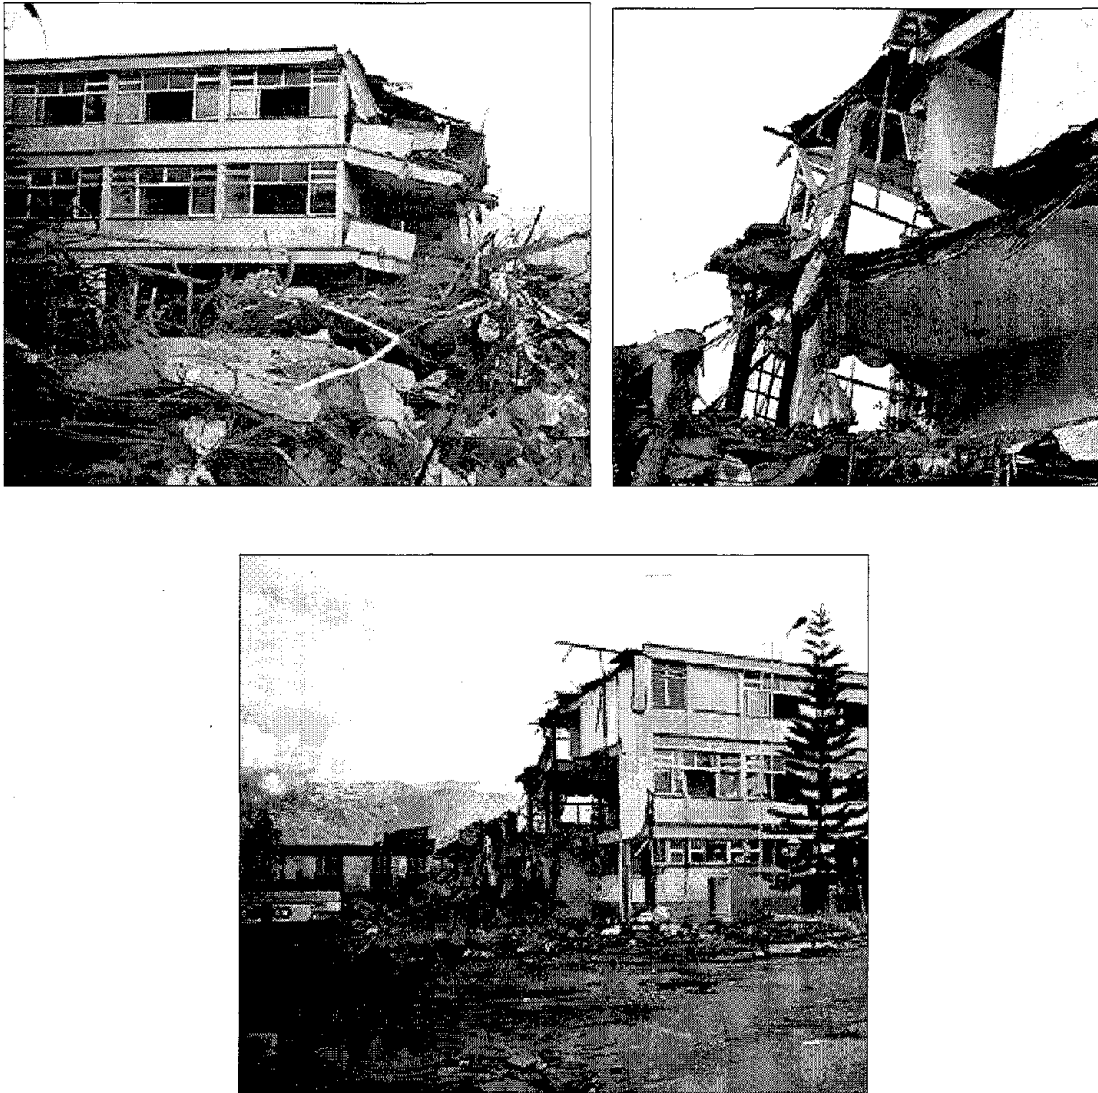
The police department of Armenia was also centralized, and one facility housed all personnel and equipment. This building also collapsed, killing 18 policemen (see figure 4-13). The station consisted of three sections forming a U. They were three-story and five-story concrete frame buildings with masonry infill. It was founded on approximately three meters of volcanic ash. It had a new section that opened in 1998. This new section was severely damaged and will need to be demolished.

Figure 4-13 Collapse of Armenia's Centralized Police Station
