The Chi-Chi, Taiwan Earthquake of September 21, 1999: Reconnaissance Report

Edited by
George C. Lee¹ and Chin-Hsiung Loh²

Publication Date: April 30, 2000

Technical Report MCEER-00-0003

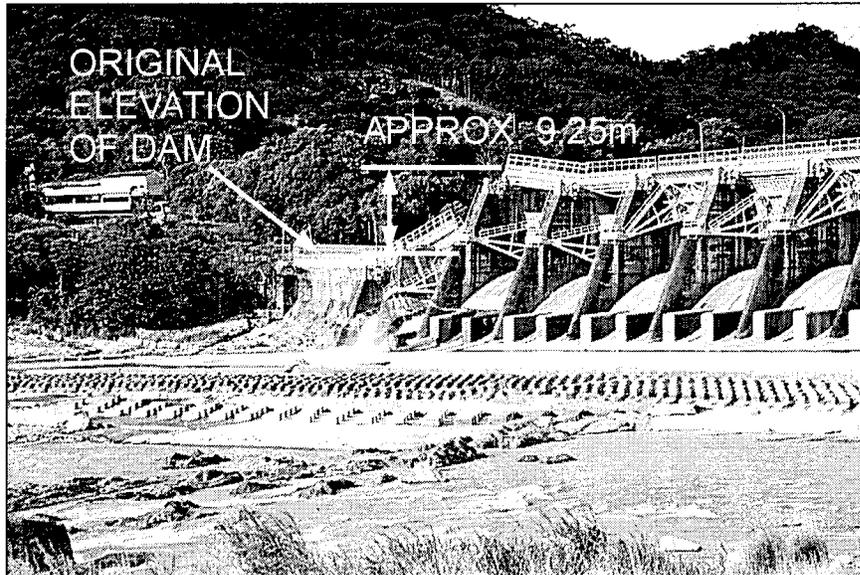
Fault rupture with a vertical offset exceeding 9 m was responsible for failure of the Shih-kang Dam and subsequent release of approximately two million m³ of water. This loss represents 40% of the raw water supply for Taichung County. Figure 3-11 is a photograph of the northern abutment area taken downstream of the dam, and Figure 3-12 is a photograph of the northern abutment from the vertically displaced southern part of the dam.

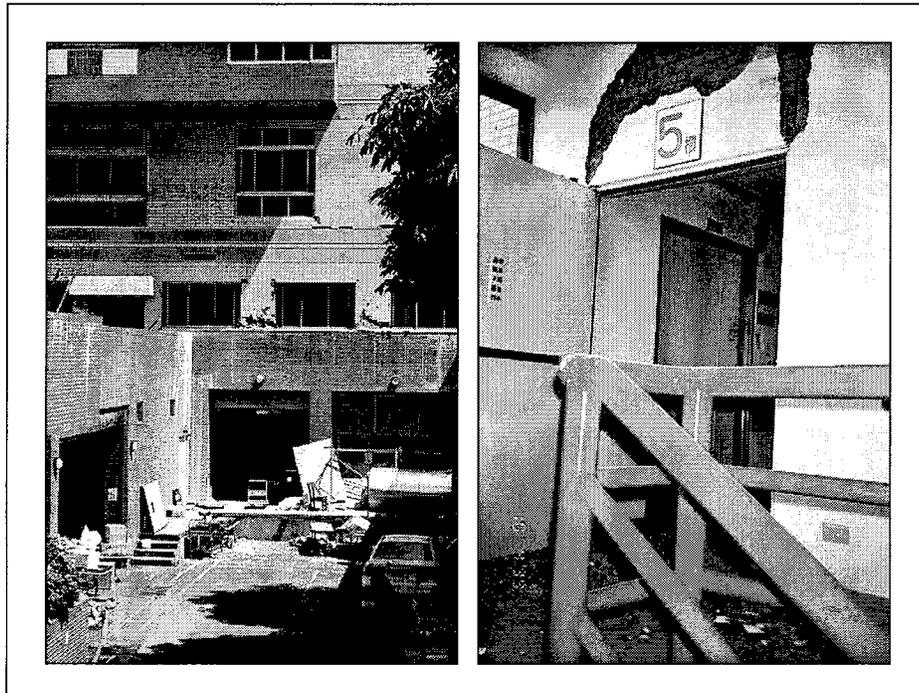
Figure 4-1 The Christian Hospital sustained considerable damage. Photos show (left) part of the exterior damage to the hospital; and (right) interior damage to partitions and ceilings.

- New section sustained considerable damage from the main event on 9/21/99. Out of safety concerns primarily due to nonstructural damage (water damage, equipment failure, etc.), the building was evacuated with patients housed in tents on the hospital ground. The building was immediately inspected and considered safe. Upon interior cleaning, patients were returned to the building.
- The building suffered significant nonstructural damage again from the 9/27/99 M6.8 aftershock. Patients were again evacuated and housed in temporary trailers with considerably reduced capacity (about 50 beds), with overflow transferred to other area hospitals.

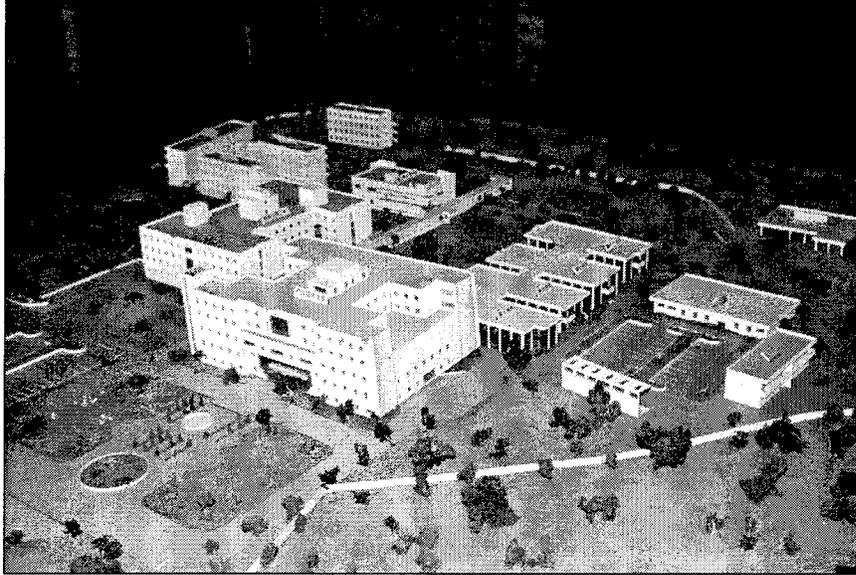
Figure 4-3 An overview model of the Veterans Hospital in Puli. The two white buildings are the newest and both sustained considerable damage.

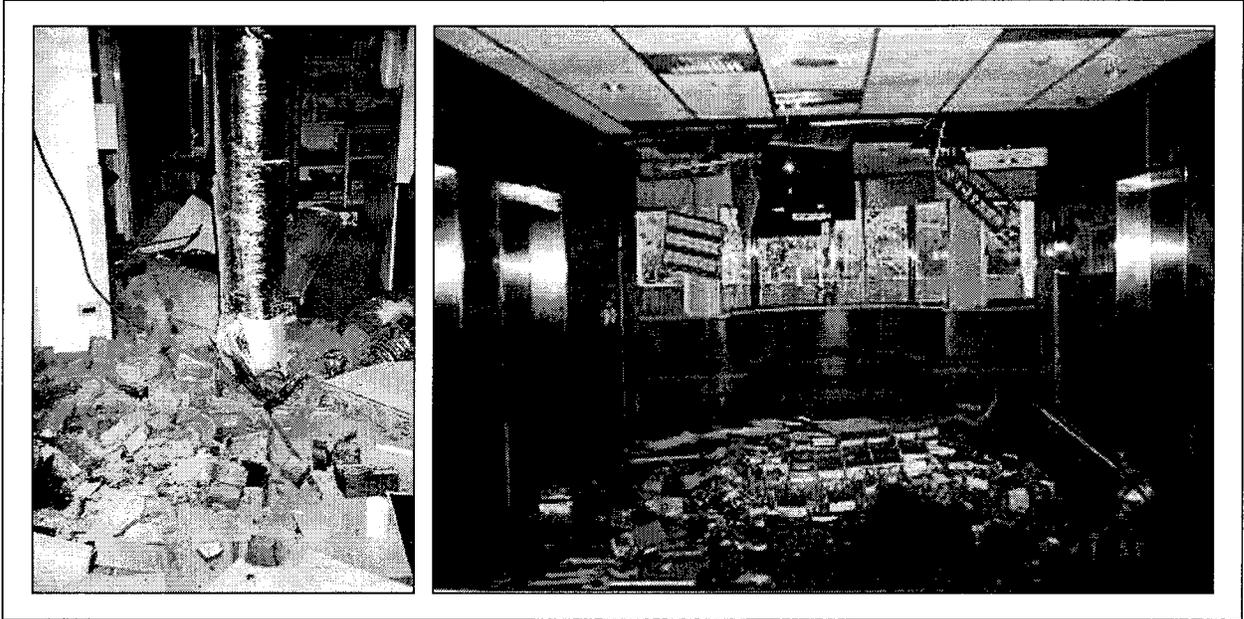
Figure 4-5 Interior damage in the Shiu-Tuan Hospital. Shown are (left) fallen brick inside the hospital and (right) a damaged interior glass brick wall.

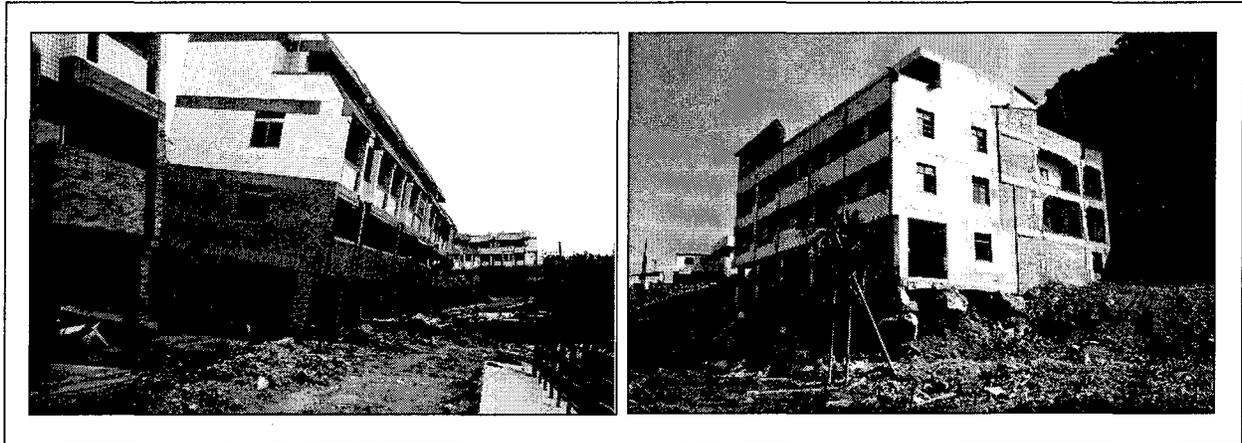
Figure 5-1 Damage to buildings straddling fault line

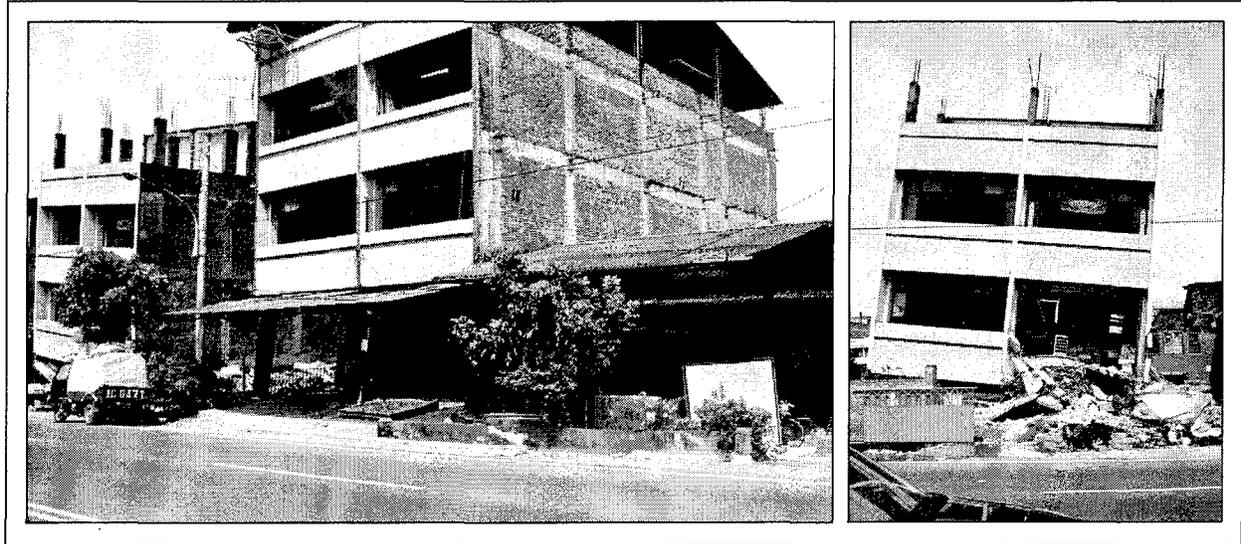
Figure 5-4 Large sway in progression toward collapse (left) and building failure due to soft first story (right)

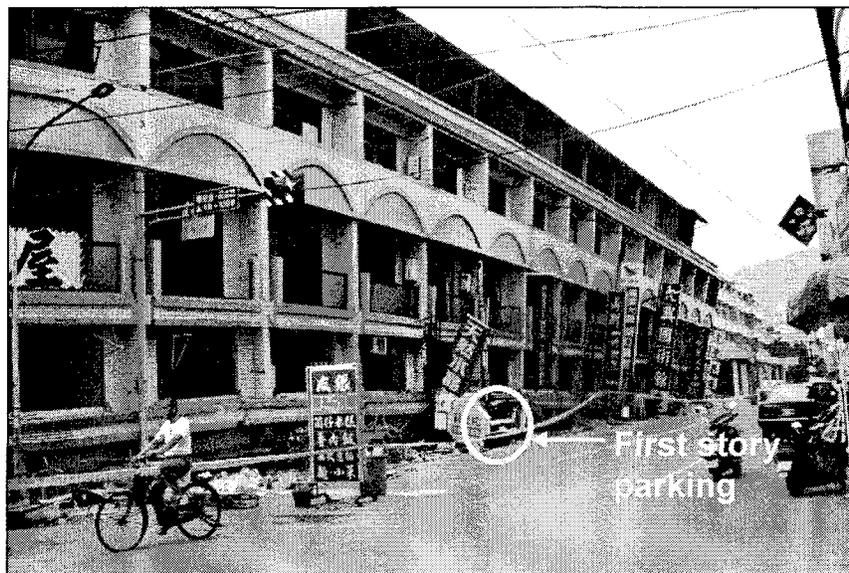
structural frame than on the back-side where walls with few openings are generally found. This structural eccentricity accelerates the soft-story damage on the street side, often resulting in toppling of the building toward the street (Figure 5-7), or toward the intersection in the case of buildings located on street corners and thus having two open sides (Figure 5-8). Note that buildings in Taiwan often project over the sidewalk, which is one common architectural feature that increases this structural eccentricity.

Figure 5-5 Soft-story failure of building having numerous large openings at first story on street side

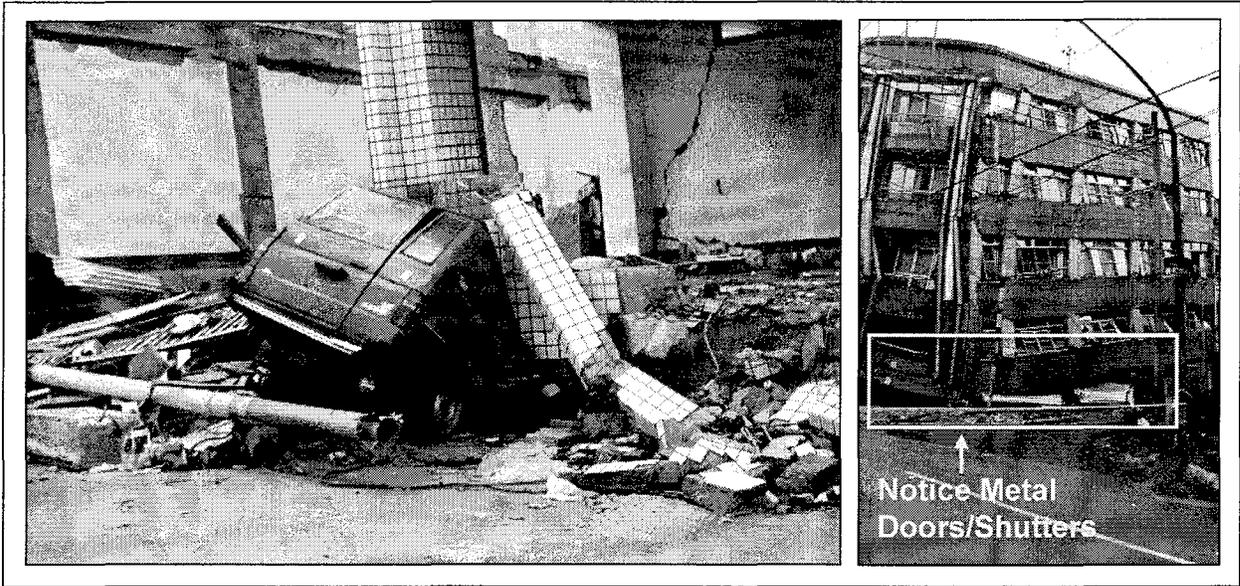
Figure 5-6 Damage due to irregular structural configuration

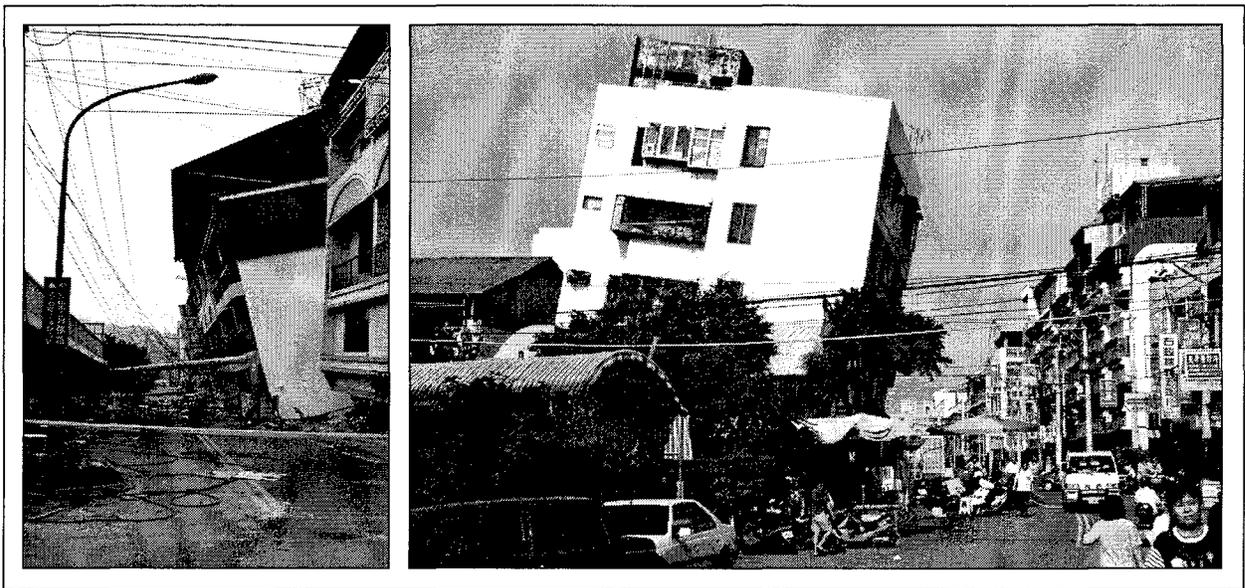
Figure 5-7 Damage due to soft first story on street side of buildings, causing them to topple toward the street

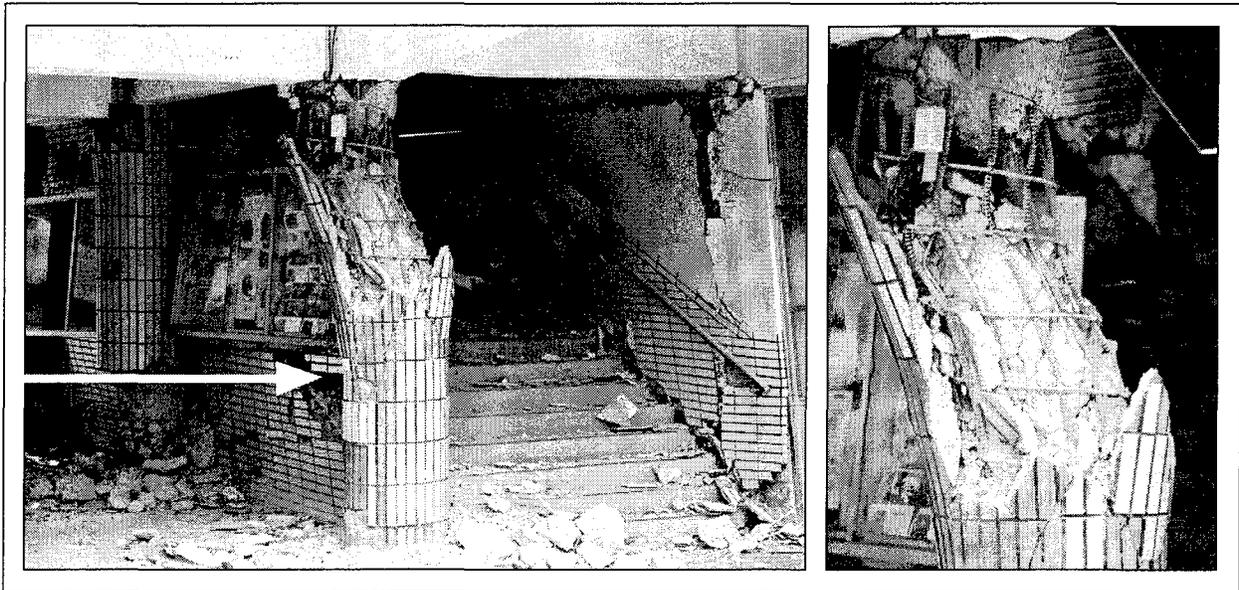
Figure 5-10 Damage to column having widely spaced stirrups and trapped by a partition

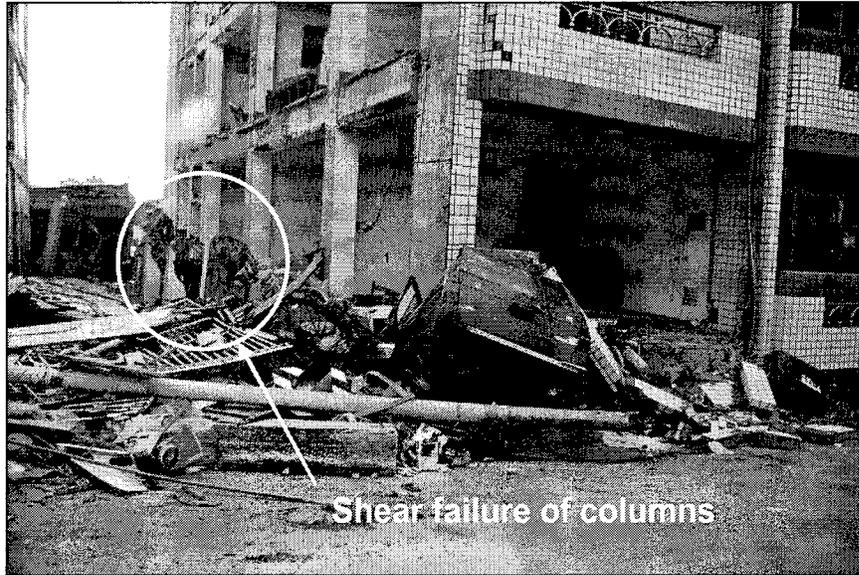
Figure 5-11 Shear failure of columns

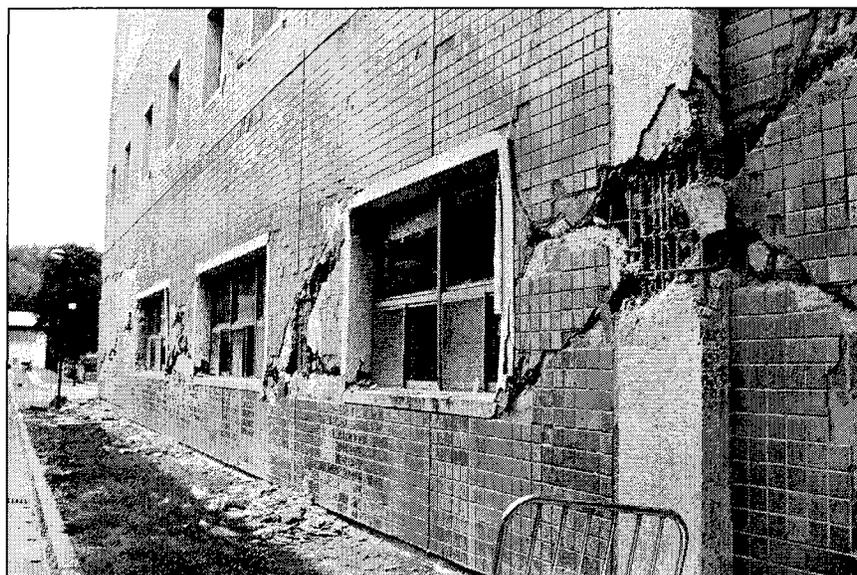
Good examples of this behavior are shown in Figures 5-16 and 5-17. Figure 5-16 shows the typical X-type shear cracks that were observed and would be expected when windows such as the one present in this building locally weakens a reinforced concrete shear wall. In this case, the cracks intersected a column at its mid-height, exposing its reinforcement and damaging it in a way that would otherwise not occur in a moment frame. This illustrates how infills can completely change the structural behavior of a structure, from the moment-frame conceived by the engineer and intended in the original design, to a shear wall system. When such infill walls extended over the entire building height, including ground level, collapse was typically avoided, as shown in Figures 5-16 and 5-17.

Figure 5-16 Damage due to infill walls at ground level

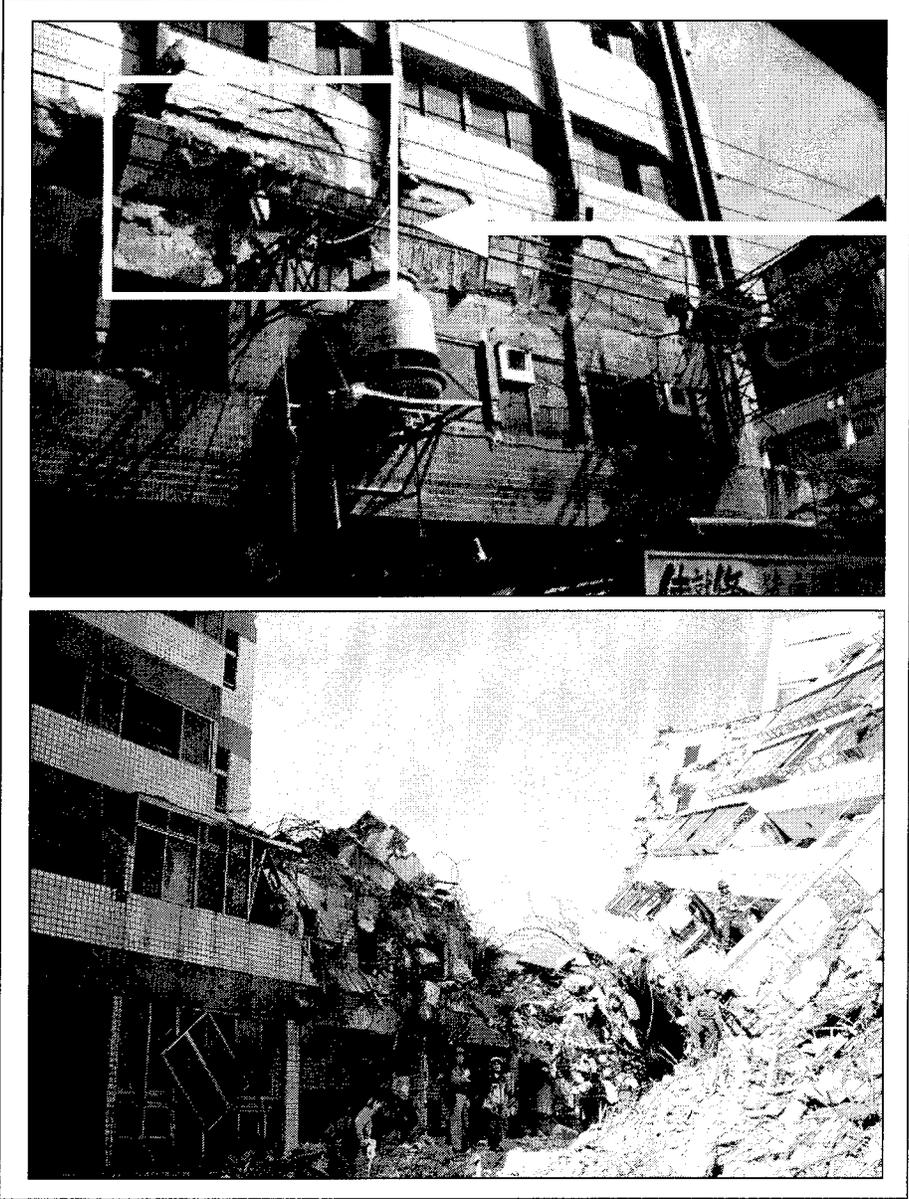
Figure 5-19 Severely damaged building complex; (top) out-of-plane collapse of third story infill wall; (bottom) collapse due to poor detailing practice

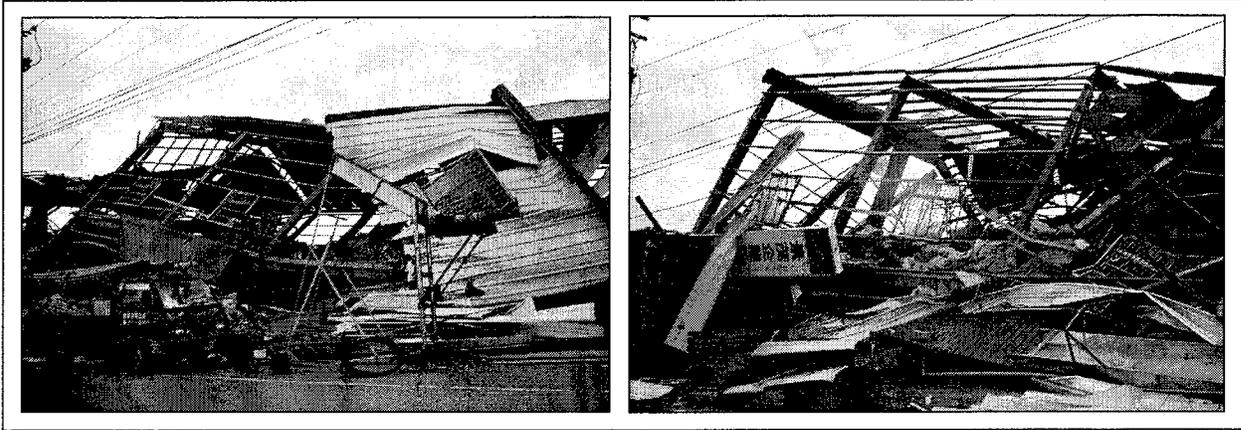
Figure 5-22 Collapse of non-ductile light metal structures

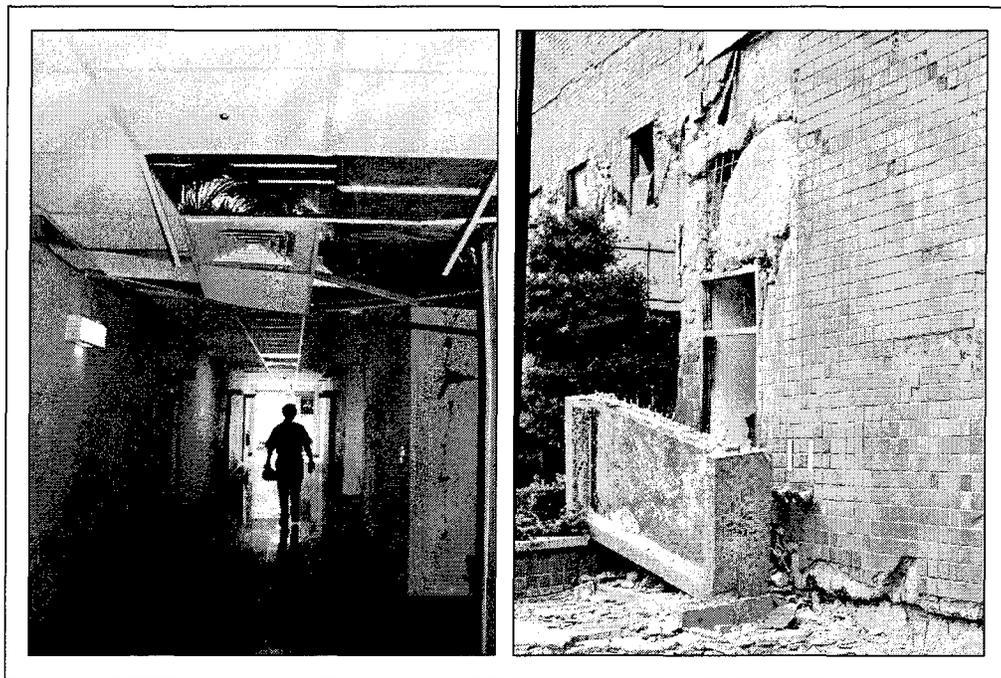
Figure 5-24 Examples of interior and exterior nonstructural damage that may prevent safe egress; collapse of suspended ceiling (left) and collapse of canopy above an exit door (right)

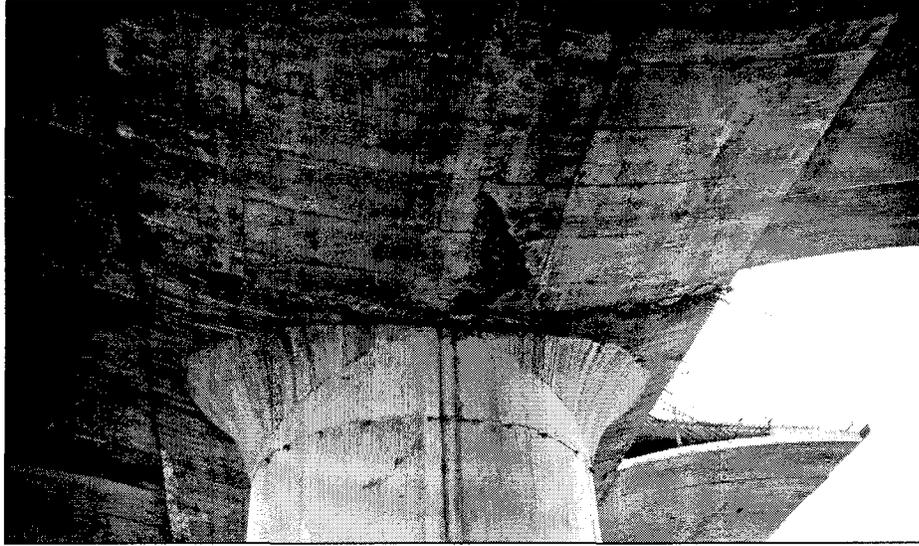
Figure 6-21 Damage at bent cap of south abutment, Ji-lu bridge; bent cap wall has been knocked off

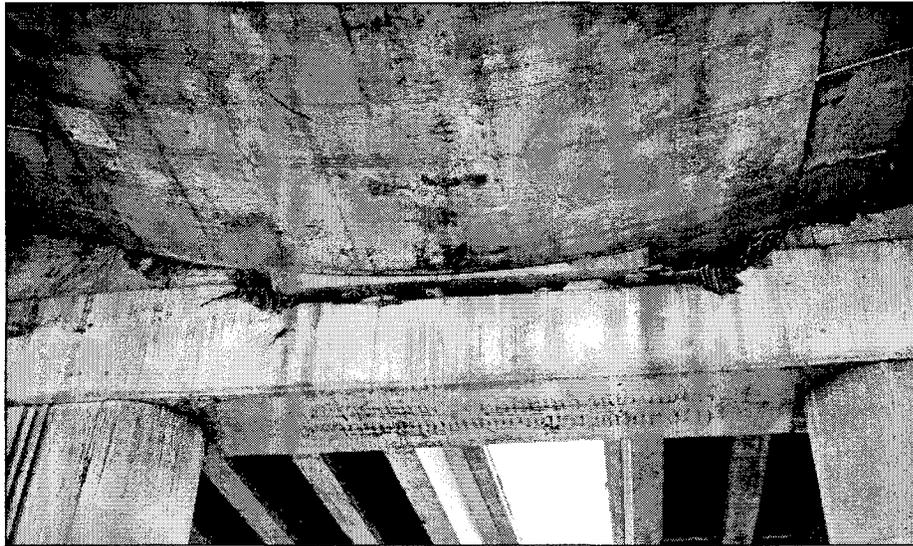
Figure 6-22 Damage to the soffit of the main girder near the pylon of the Ji-lu bridge; missing cantilevered section (right) had not been placed at time of the earthquake

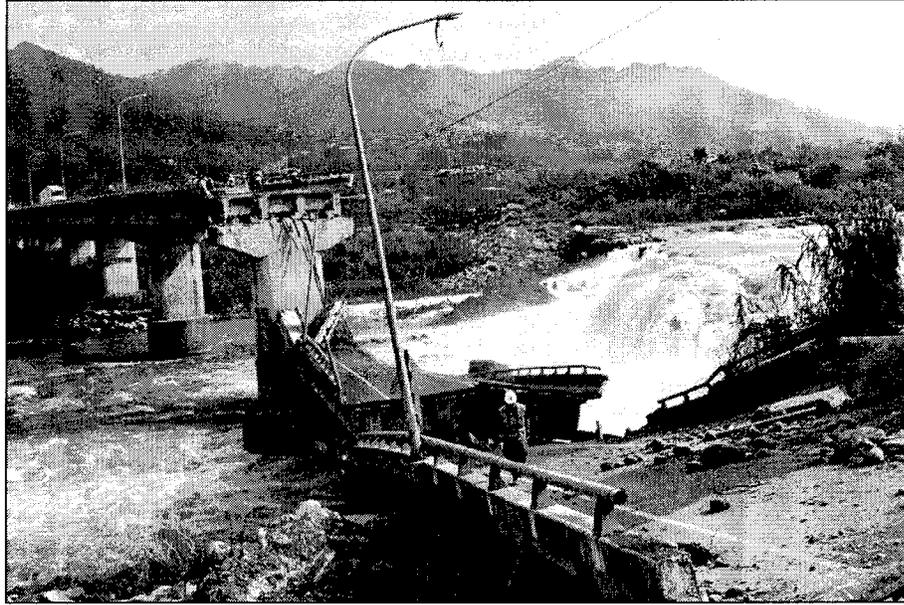
Figure 6-25 Collapse of end spans of Bei-feng bridge due to abutment and bent failures triggered by fault dislocations. Vertical offset of fault is seen crossing the river immediately upstream.

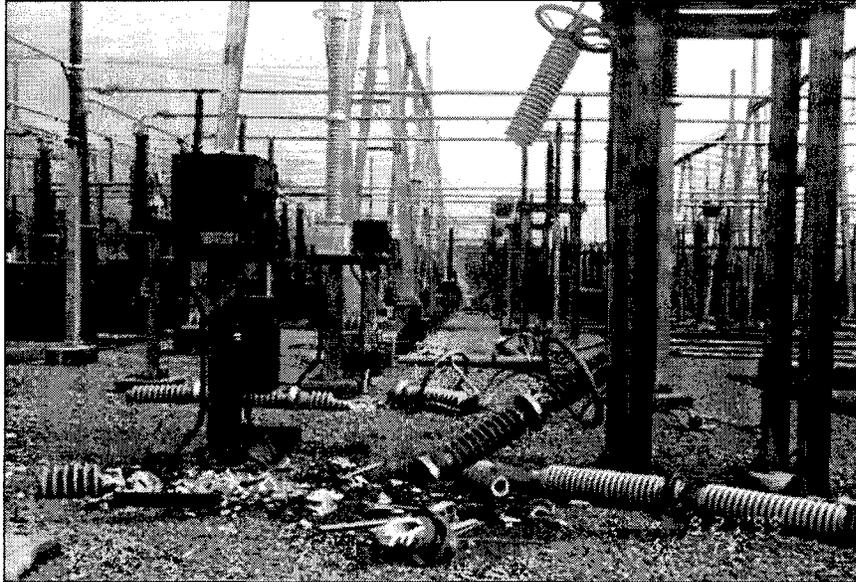
Figure 7-6 Damage at Chung-Liaw switchyard
