Seismic Rehabilitation of Concrete Bridges: Verification Using In-Situ Tests at South Temple Bridge on Interstate 15

Final Report

Research Report UUCVEEN 00/1
Department of Civil & Environmental Engineering
University of Utah
Salt Lake City, UT 84112

July 2000

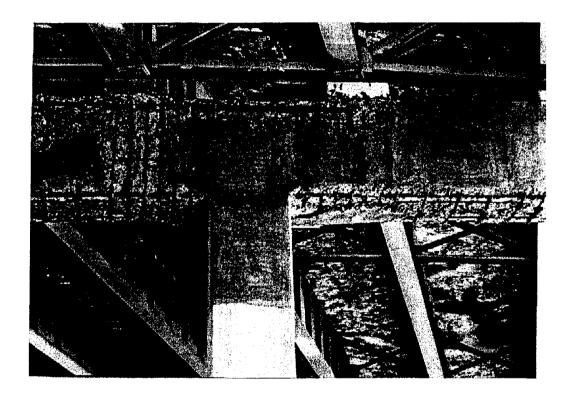
The amount of corrosion of the reinforcement is important for evaluating the remaining capacity of bridge bents. At the South Temple Bridge site, all of the beam caps had some corrosion, including the bents to be tested, as well as those that were not tested as part of this research. There was no obvious sign of corrosion in the columns of Bents #5 and #6. It is interesting that the majority of the observed corrosion occurred in the stirrups of the beam cap. There was only one observed occurrence of corrosion in the longitudinal column bars at one of the joints of Bent #6, as shown in Fig. 6. The diameter of the bar, which was originally 31 mm, was reduced to 30 mm. It should be noted, that the corrosion was visible at the north, south and bottom sides of the beam caps, where the concrete had spalled. Corrosion was present at the topside of the beam cap; however, the concrete was still in place and only after removal of the concrete cover with hydro blasting was the corrosion visible.

Figure 6. Corrosion in the beam cap of Bent #6

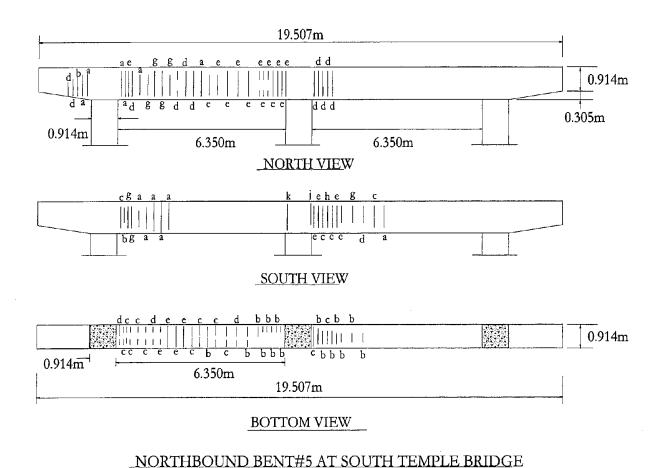
The two bents had a similar amount of corrosion. A detailed summary for each bent is presented below, as well as the effect of the observed corrosion on the shear capacity of the beam cap. The following assumptions are made in compiling the data: (1) the topside of the beam cap has identical corrosion as the bottom side, which is shown in Figs. 8 and 9, (2) even though the length of the exposed stirrup is drawn in Figs. 8 and 9, it is assumed that the total length of the stirrup on that face of the beam cap is corroded; this assumption was verified after hydro blasting.

Figure 8. Corrosion map for Bent #5

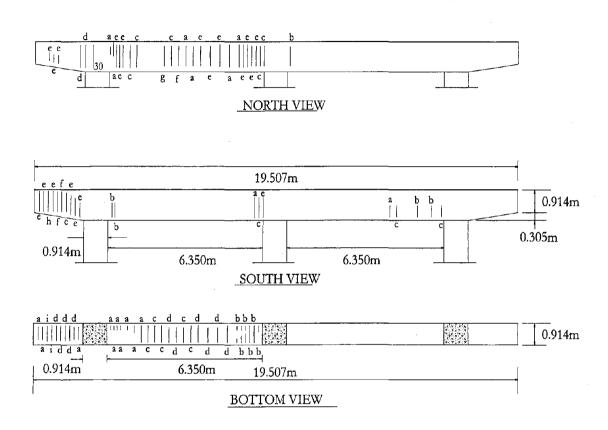
It important to note that the actual shear capacity contributed by the stirrups is governed by the vertical area of the stirrups. Considering the vertical area of the stirrups reveals that Bent #5 shows an average loss of area of 15.5%, and Bent#6 an average loss of area of 12%. If one assumes that the same corrosion is possible for the interior stirrups, then these percentages represent the loss of shear strength contributed by the stirrups. This may be critical in the regions close to the column supports.

Figure 9. Corrosion map for Bent #6

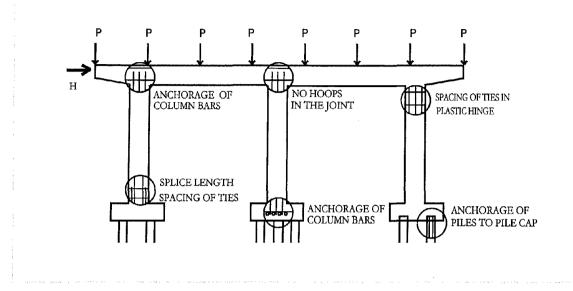
By performing a static pushover analysis for the bent, an estimate of the peak lateral load and the maximum horizontal displacement were determined. The yielding sequence of the structural members was observed, and member forces were calculated at the ultimate displacement. This information was necessary for the rehabilitation design of Bent #6 using FRP composites. To construct the 2-D model of the structure, the existing conditions had to be evaluated and compared with the original design plans. The reinforcement details of the bent were presented in Fig. 4; the columns had a reinforcement ratio of 1.6%. It can be seen that the column transverse reinforcement was inadequate in the lap-splice region, and the anchorage of the longitudinal reinforcement in the pile cap and in the cap joint was insufficient. In addition, there are no transverse hoops in the column cap-beam connection. Since the lap splice in the column base is mostly unconfined, it would break down under cyclic inelastic action. The spacing of ties in the plastic hinge region at the top of the columns was insufficient. In addition, the anchorage of the piles into the pile cap was insufficient. These deficiencies are identified in Fig. 55.

Figure 55. Reinforcement details showing deficiencies of Bent #5 for resisting large earthquakes

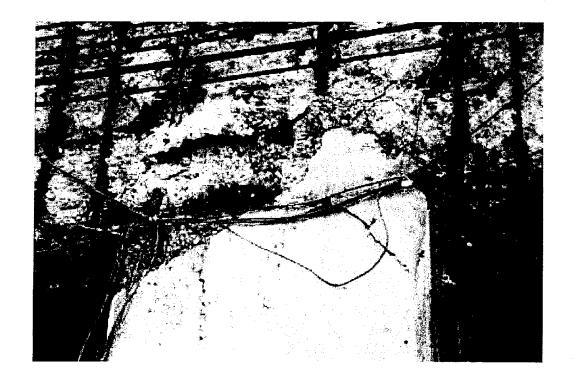
Significant diagonal tension cracks formed in the beam cap-column joint region, revealing a gradual degradation of the concrete as shown in Fig. 64. After the test, the loose concrete was removed from the joint, and it was apparent that there was not much left from the outside 100 mm (3.9 in.) to 150 mm (5.9 in.) layer. Flexural cracks developed at the top of the columns that opened as the bending capacity was reached. These cracks had various widths with the largest being at the interface of the column and the beam cap which reached approximately 2 mm (3/32 in.) as shown in Figs. 64-66. The cracks went all around the column perimeter in the plastic hinge region. The first layer of the column longitudinal reinforcement extending into the joint was exposed on the south

Figure 64. Damage in the interior joint of Bent #5

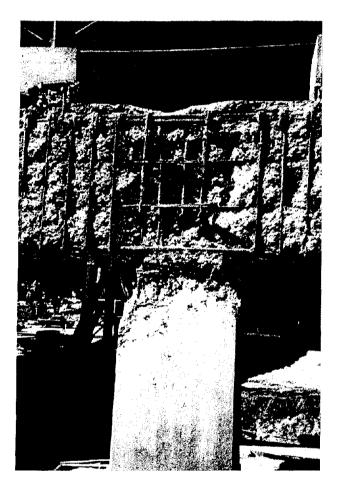
where ν_i is the average of the horizontal and vertical joint shear. From equation (6.2), the principal tensile stress is obtained as $\sigma_i = 1.99$ MPa, and the principal compressive stress as $\sigma_c = 2.53$ MPa. Thus, the principal tensile stress is 0.44 (f'_c)^{0.5} MPa or 5.26 (f'_c)^{0.5} psi, which indicates that the joint has developed full diagonal cracks and joint degradation is anticipated (Priestley et al. 1996). This is clearly shown in Fig. 67.

Figure 67. Bond detrrioration and bar slippage at interior beam cap – column joint

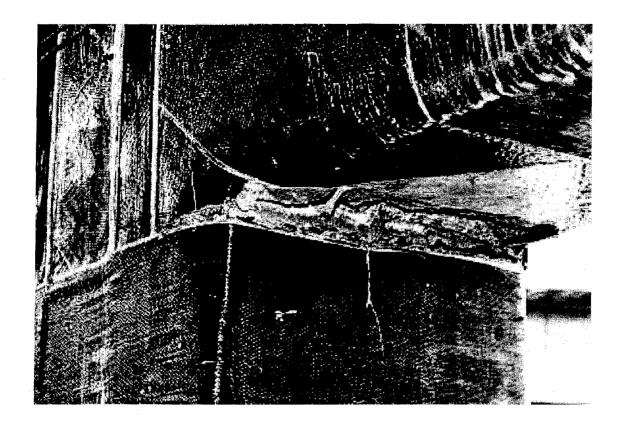
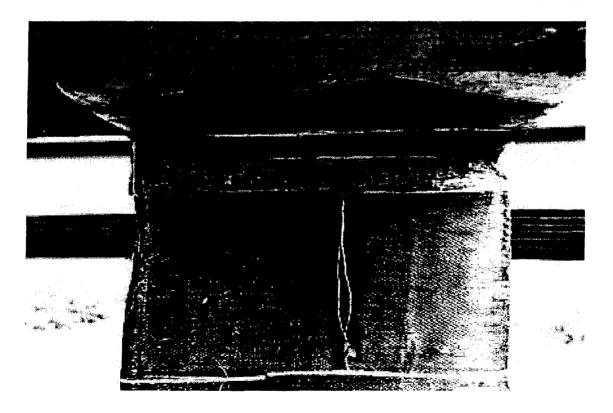
Large cracks in the concrete were visible at the interface between the column and the beam cap, which reached 6 mm in width as shown in Fig. 96. These interface cracks propagated from the concrete into the FRP composite as shown in Fig. 97. In addition, at both column ends, shallow spalling cracks in the 51 mm gaps were formed. The FRP advanced composite layers

Figure 96. Cracking at the beam cap-column interface of Bent #6

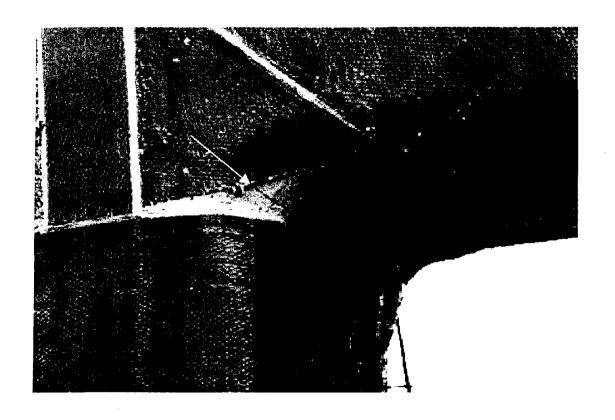
Figure 97. Cracks at the beam to column interface propagating into the FRP composite

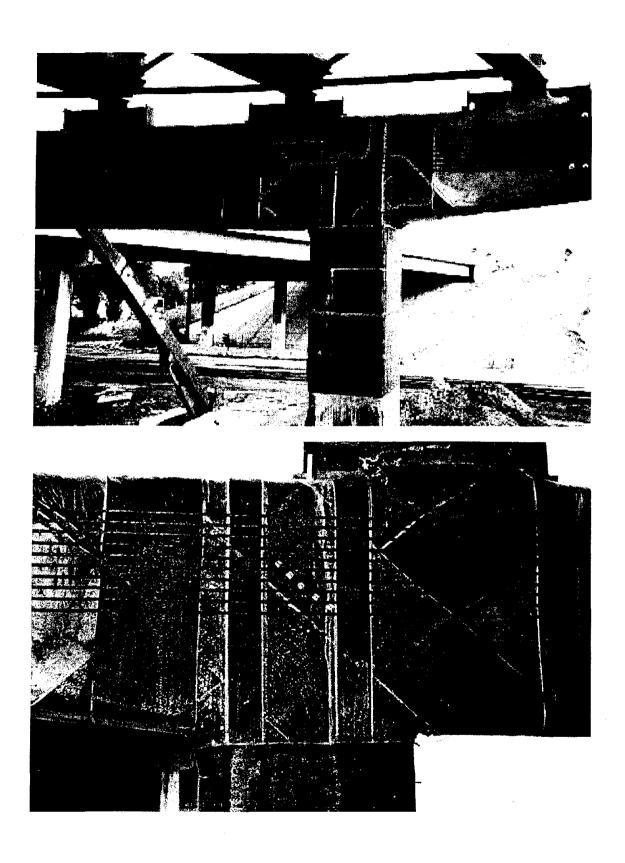
Figure 98. Delamination of FRP composite at the beam cap-column joints

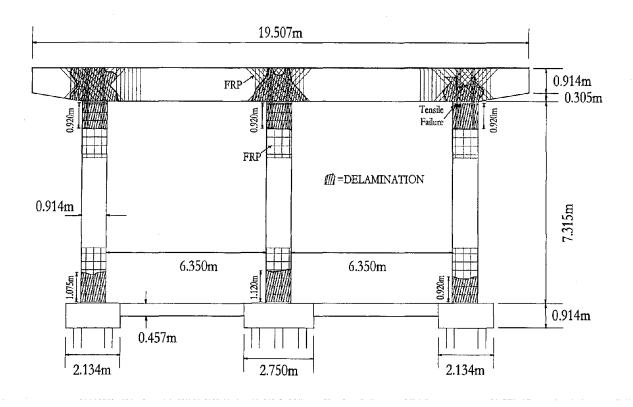
Figure 99. Delamination and tensile failure of FRP composite in Bent #6

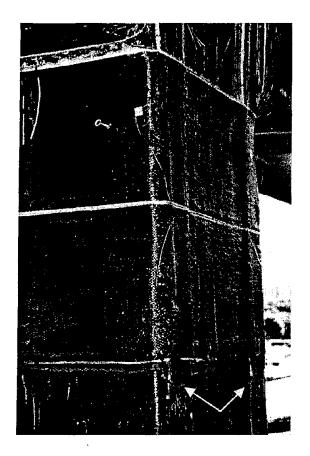
Figure 100. Tensile failure of FRP composite in the U straps on the columns

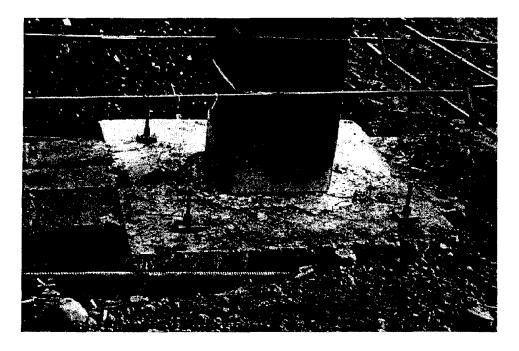
Figure 101. Radial and circular cracks at top of pile cap around the column

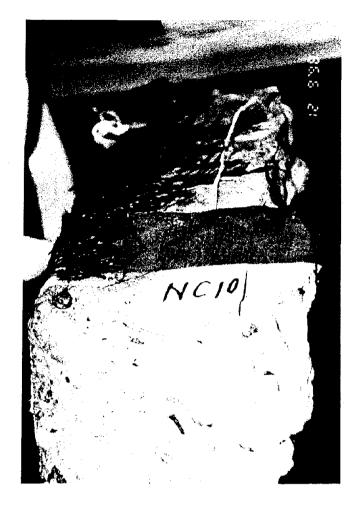
Figure 103. Condition of FRP composite and adhesion of FRP composite to the concrete

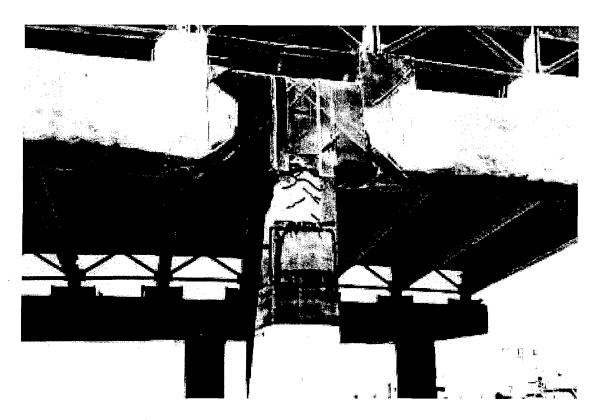
Figure 128. Diagonal cracks in plastic hinge region at the top of the middle column underneath the FRP composite

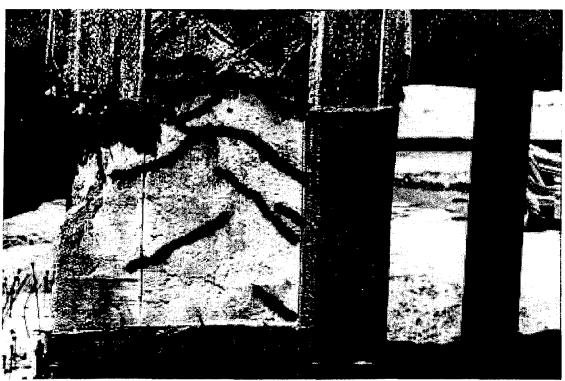
Figure 129. Close up of diagonal cracks in plastic hinge region of column

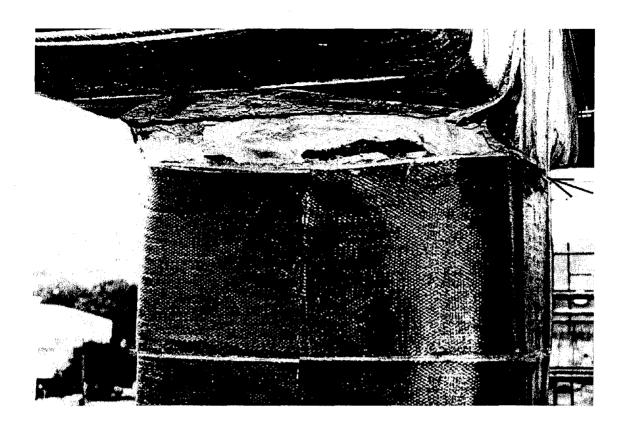
Figure 130. Tensile failure of FRP composite in U strap at the column

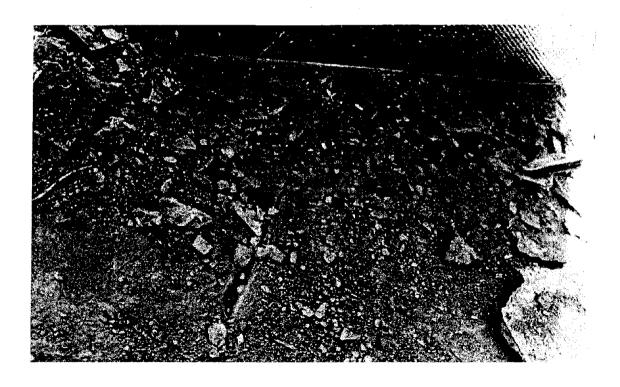
Figure 134. Radial cracks at pile cap surface of Bent #5R

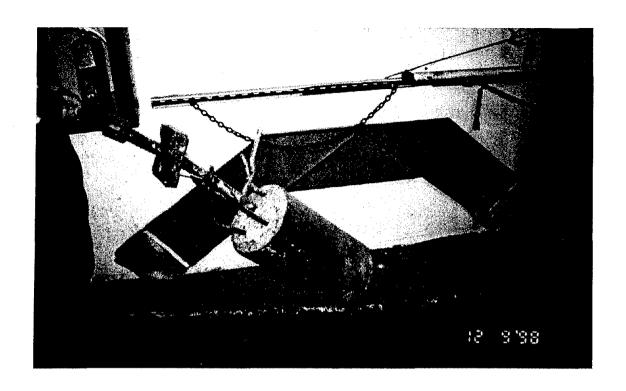
Figure 135. Damage of pile to pile cap connection

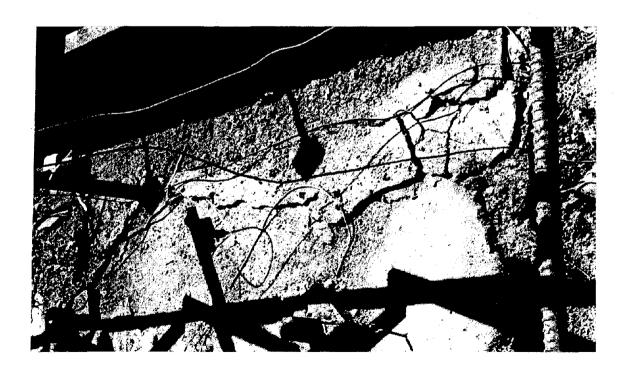
Figure 136. Damage in rigid link beam between pile cap and load frame footing
