MCEER NHRAIC RESPONSE

FIELD REPORT:

COLLECTION OF SATELLITE-REFERENCED BUILDING DAMAGE INFORMATION IN THE AFTERMATH OF HURRICANE CHARLEY

Beverley J. Adams, J. Arn Womble, Michael Z. Mio, John B. Turner, Kishor C. Mehta and Shubharoop Ghosh

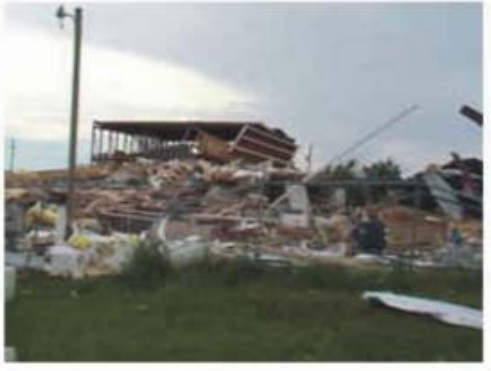
Figure 8. Photo mosaic of damage to commercial/industrial and government structures in Port Charlotte and Punta Gorda: (a) the roof and walls of a steel framed auto shop collapse, only the hydraulic lift is left standing; (b) wall and roof failure at an industrial park warehouse; (c) roof failure at the Punta Gorda Holiday Inn; and (d) loss of roof cover at a Port Charlotte middle school. For image/photo locations, see Figure 4.

Commercial structures sustained varying levels of damage. The field team witnessed many examples where the roof of steel framed warehouse structures had been ripped off and the walls had fallen in (see, for example the auto shop in Figure 8a and the warehouse in a Port Charlotte industrial park in Figure 8b). Some commercial buildings, such as hotels, responded similarly to apartment blocks. Figure 8c shows roof structure failure at the Punta Gorda Holiday Inn. Interestingly, from a remote sensing perspective, this commercial structure is indistinguishable from similar shaped and sized apartment blocks, and would probably be categorized as such if ground truth data were unavailable. The team also assessed damage to a number of publicly owned buildings. Several schools were hard hit, with a Port Charlotte middle school (Figure 8d) and the Punta Gorda high school respectively sustaining loss of roof cover and roof failure.

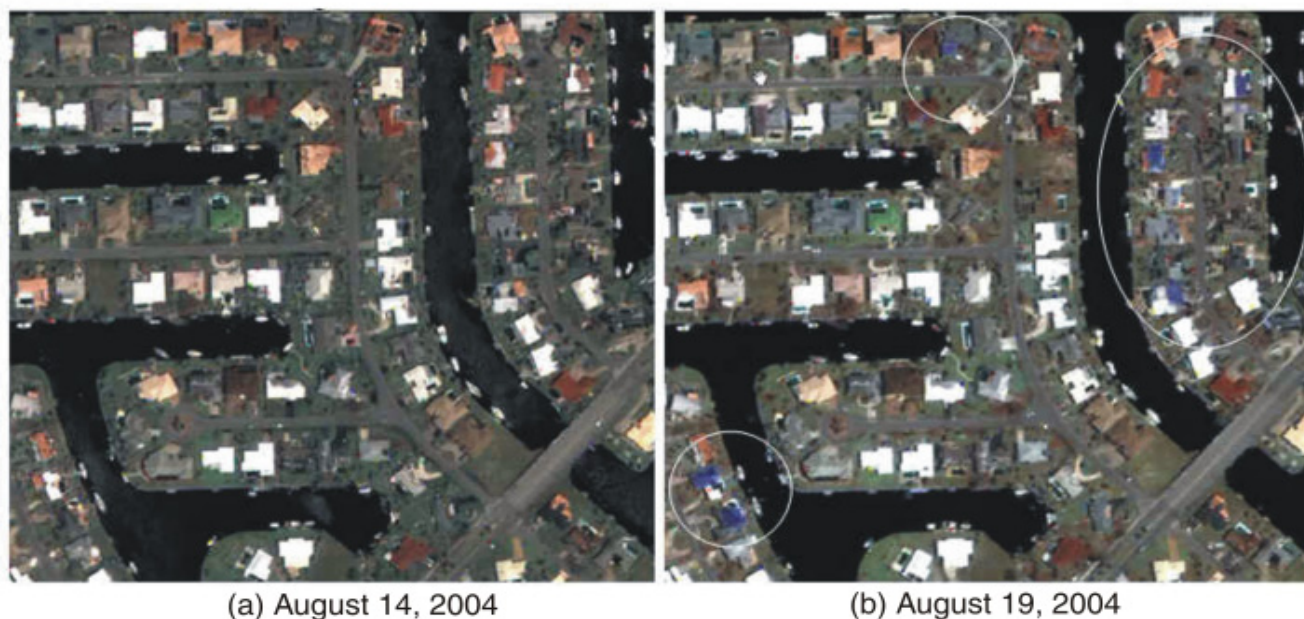
The perishable nature of post-disaster building damage data is borne out by differences to residential properties observed between the two field deployments and between the temporal sequence of 'after' satellite images (see Table 2). In the days immediately following the disaster, many damaged roofs remained exposed to the elements. During the initial field deployment, comparatively few

were tarped, and there was little evidence of repair. At this stage, residents appeared to be focusing on securing of personal effects and building contents and on the clearance of debris and vegetation. Temporary roof-covering materials may have also been in short supply in the local area immediately following the hurricane. During the second deployment, there was a substantial increase in the presence of tarps and plastic covers. This trend is apparent from the Quickbird satellite scenes in Figure 9, which were acquired 1- and 6-days after the hurricane struck. During the second field visit, workers were observed making permanent repairs to the roofs of family dwellings. However, recovery efforts were progressing far more slowly in the mobile homes, where in many cases, debris clearance was only just commencing. Many of the mobile home in these parks are apparently used as winter vacation homes by people living elsewhere, and thus many residents may not have been in the area at the time of the storm to make temporary repairs to their properties.

Figure 9. The perishable nature of building roof damage data is evident by comparing the Quickbird scenes acquired on: (a) August 14, 2004, 1 day after; and (b) August 19, 2004, 6 days after Hurricane Charley. In the latter case, a number of roofs are now tarped.

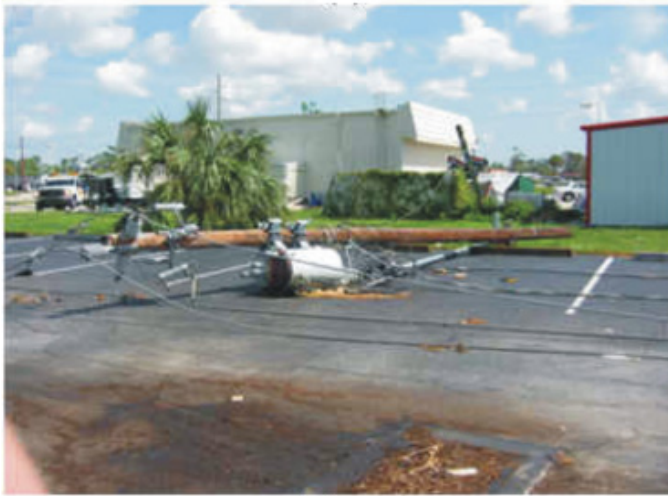
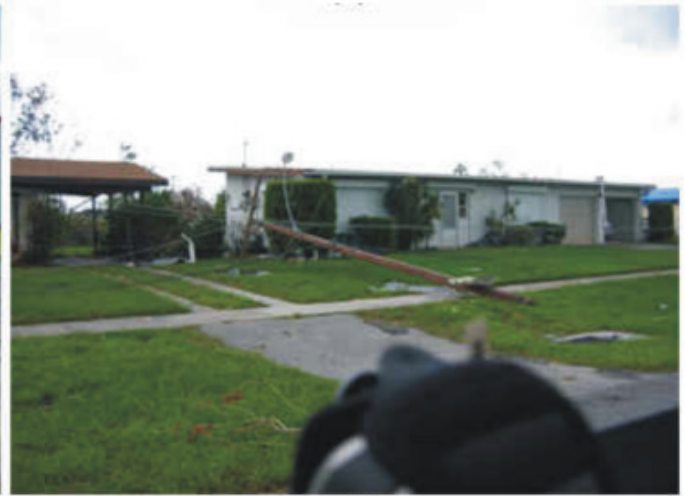
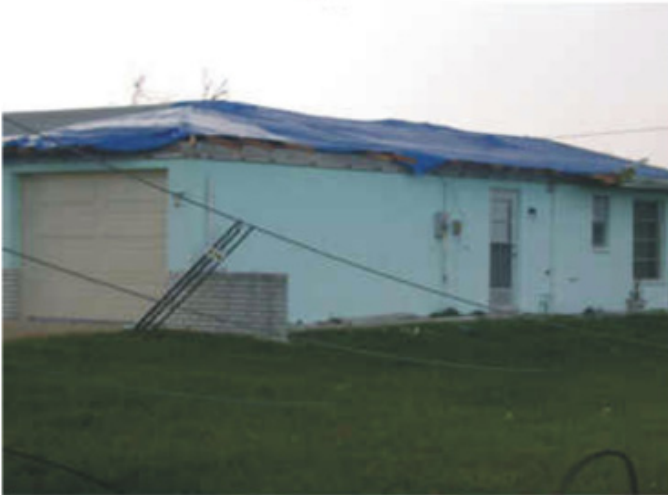
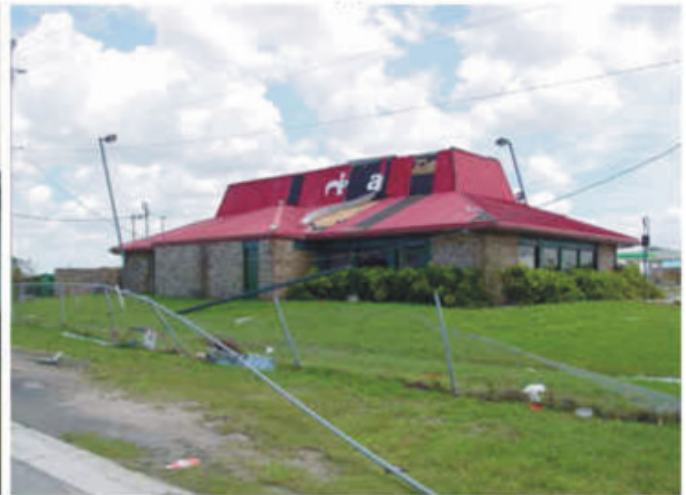
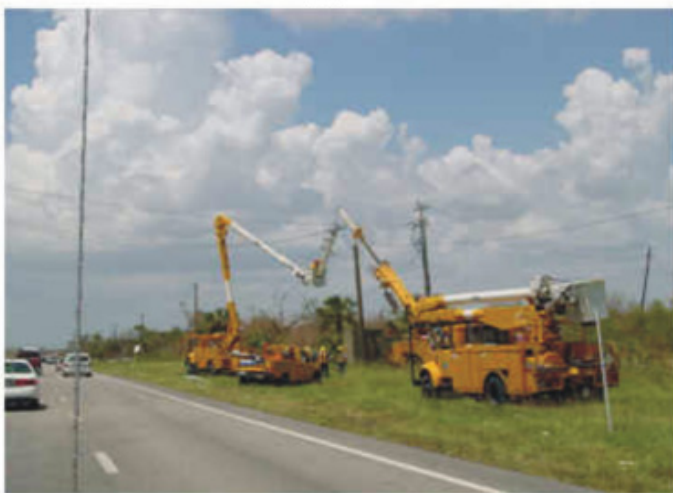
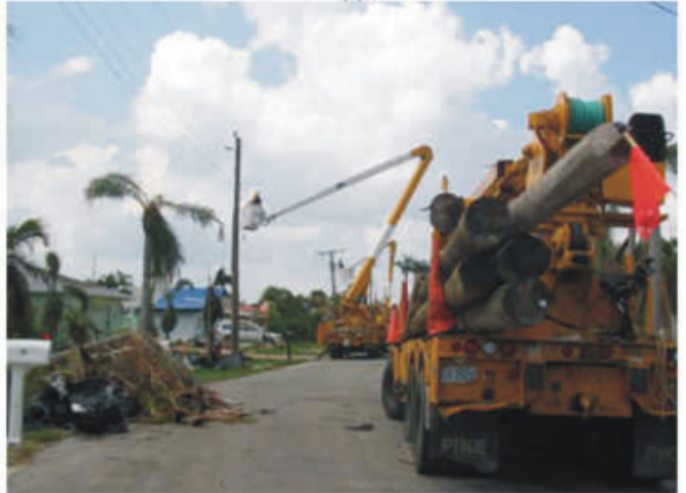
because stop lights were not working and the police were directing traffic. Damage to the supply system was severe (Figure 11a). Residential neighborhoods were hard hit, with power lines lying cross people's front yards (Figure 11b), several occurrences of power poles impacting roofs, and evidence of severed connections (Figure 11c). Most businesses in Port Charlotte and Punta Gorda were closed at this time (Figure 11d), since there was no power supply. When the field team returned on August 25, some businesses had re-opened along the major highways 175 and SR41. During the initial reconnaissance trip, a number of routes were obstructed by fallen power poles and power lines. For the second visit, roads instead were closed by repair teams (Figure 11e-f). At the present time, the manifestation of windstorm-related damage to the power system on high-resolution remote sensing imagery has yet to be explored. This remains a topic for future research.

Figure 11. Damage to the power system in Port Charlotte and Punta Gorda. Residential and commercial properties experienced loss of supply as power poles were toppled and lines severed. During the second field deployment, repairs were ongoing.
