MCEER SPECIAL REPORT SERIES
Engineering and Organizational Issues Before,
During and After Hurricane Katrina

Damage to Engineered Buildings and Lifelines
from Wind, Storm Surge and Debris in the
Wake of Hurricane Katrina

Gilberto Mosqueda and Keith A. Porter

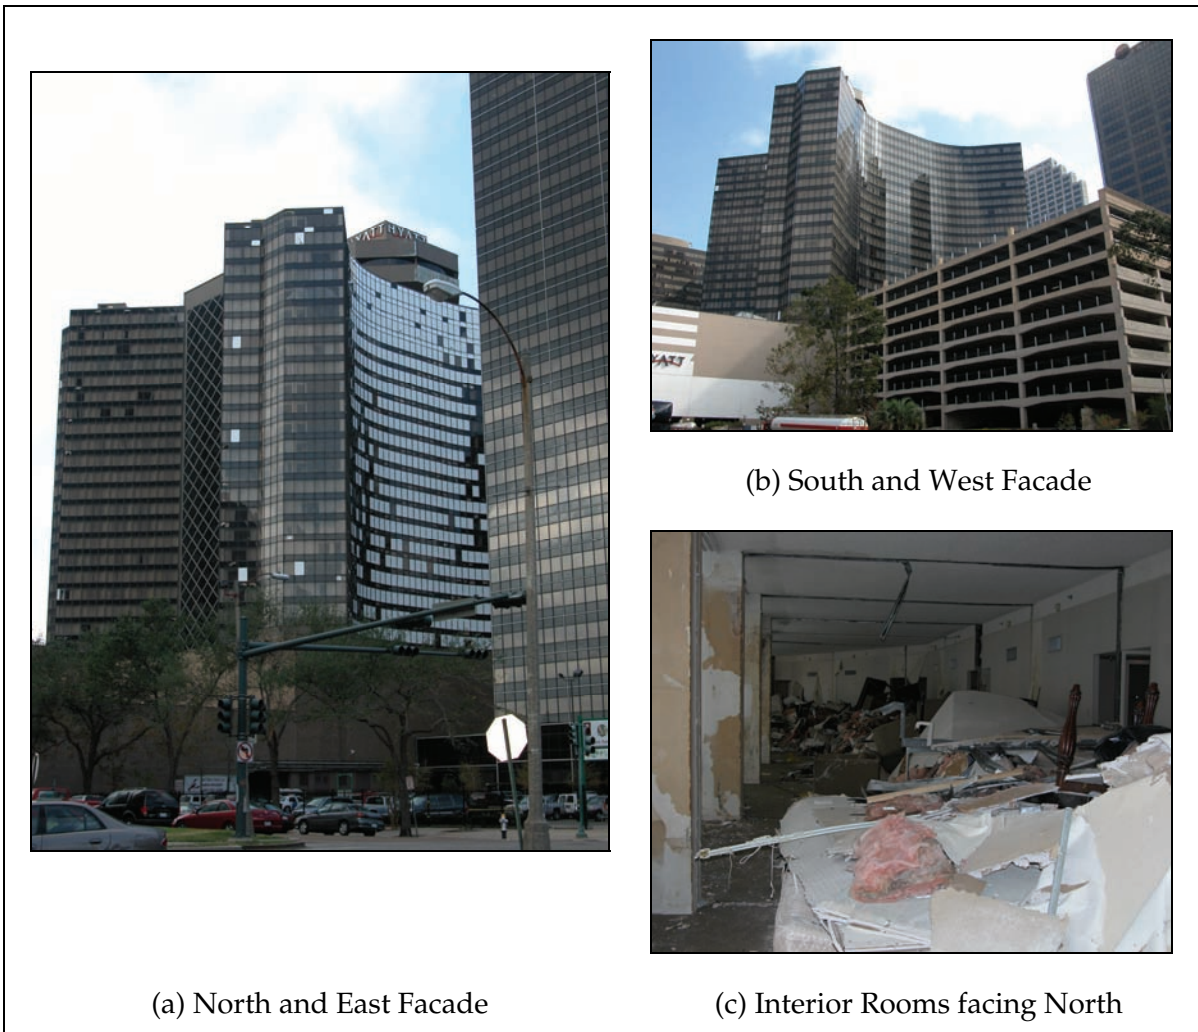
The Hyatt Regency 28-story reinforced concrete building suffered extensive window damage as well as some damage to its asphalt shingle roof, loss of some rooftop fans, and extensive damage to the soffit of a mushroom-shaped rooftop structure housing a bar. Three fourths of the glazing on the north facade curtain wall above the 5th floor broke during the storm as shown in Figure 3-2. The curtain wall comprises 1/4-in tempered single-pane vision glass, and 1/4-in non-tempered single-pane black spandrel glass. Wind, water and wind-born debris including pea gravel infiltrated several of the rooms on the north side, the gravel appeared similar that blown off of the tar and gravel roofing of one or more adjacent buildings north of the hotel. As a result of the damaged exterior, furniture, carpets and gypsum drywall that were dampened by the infiltrating water were infested with mold and were being removed at the time of investigation. This building has no basement and stands on a site slightly above the highest level of flooding. (One block to

Figure 3-2. The Hyatt Regency Hotel in the New Orleans Business District had extensive window damage on the north facade (a) and limited damage on other sides (b). Broken windows allowed wind-driven rain and debris into the building causing additional interior damage (c).

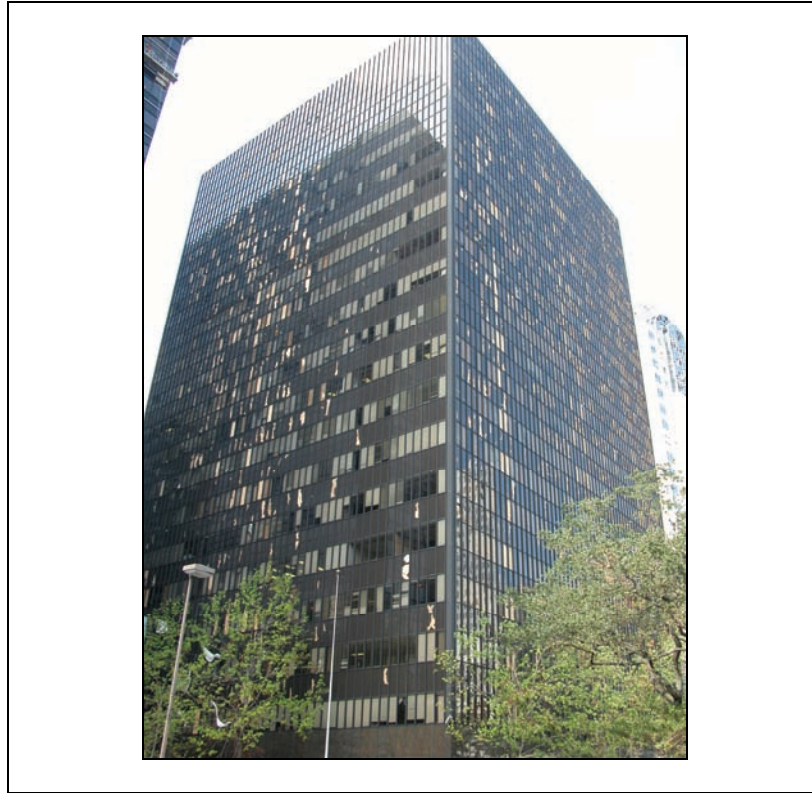
The Amoco Building is an approximately 24-story high-rise in downtown New Orleans to the north west of the Hyatt Regency. This building also suffered extensive damage to its glass curtain wall, with 10 to 20% of its glazing broken. Although close inspection was prevented, the glass was judged to be likely 1/4-in annealed. Eastbound lanes of Poydras St. just north

Figure 3-3. The Amoco building in New Orleans Business District had extensive window damage on the north and east facades and limited damage on other sides

of the building were closed because of the risk of falling glass from broken windows. It may be noteworthy that, though the east facade of the Amoco building was heavily damaged (Figure 3-3), the east facade of the adjacent building to the east was largely undamaged (Figure 3-4). These two structures and the Hyatt directly south of them enclose a narrow space, which could perhaps have produced local vortices that aggravated the window damage in the plaza. This serves as a possible explanation to the difference in performance of the east facades of the two buildings. The north facade of the Hyatt, which was also heavily damaged, faces the enclosure.

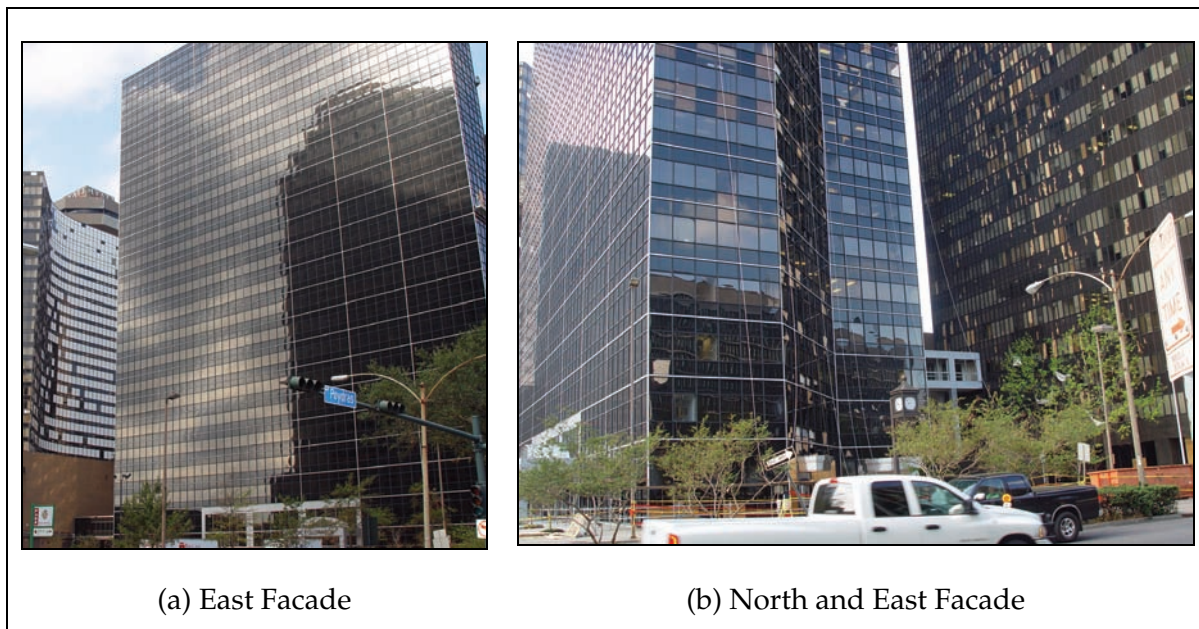
1250 Poydras is a 24-story building on the southwest corner of Poydras St. and Loyola Ave. and adjacent to the Hyatt and Amoco buildings. Although the east facade appears to have suffered no damage, the backside of the building adjacent to the Amoco building, had significant window damage as shown in Figure 3-4. Note the proximity of this building on the left of Figure 3-4(b) to the Amoco building shown on the right.

Figure 3-4. This office building in the New Orleans Business District had extensive window damage on the west facade (a) and limited damage on opposite sides (b).

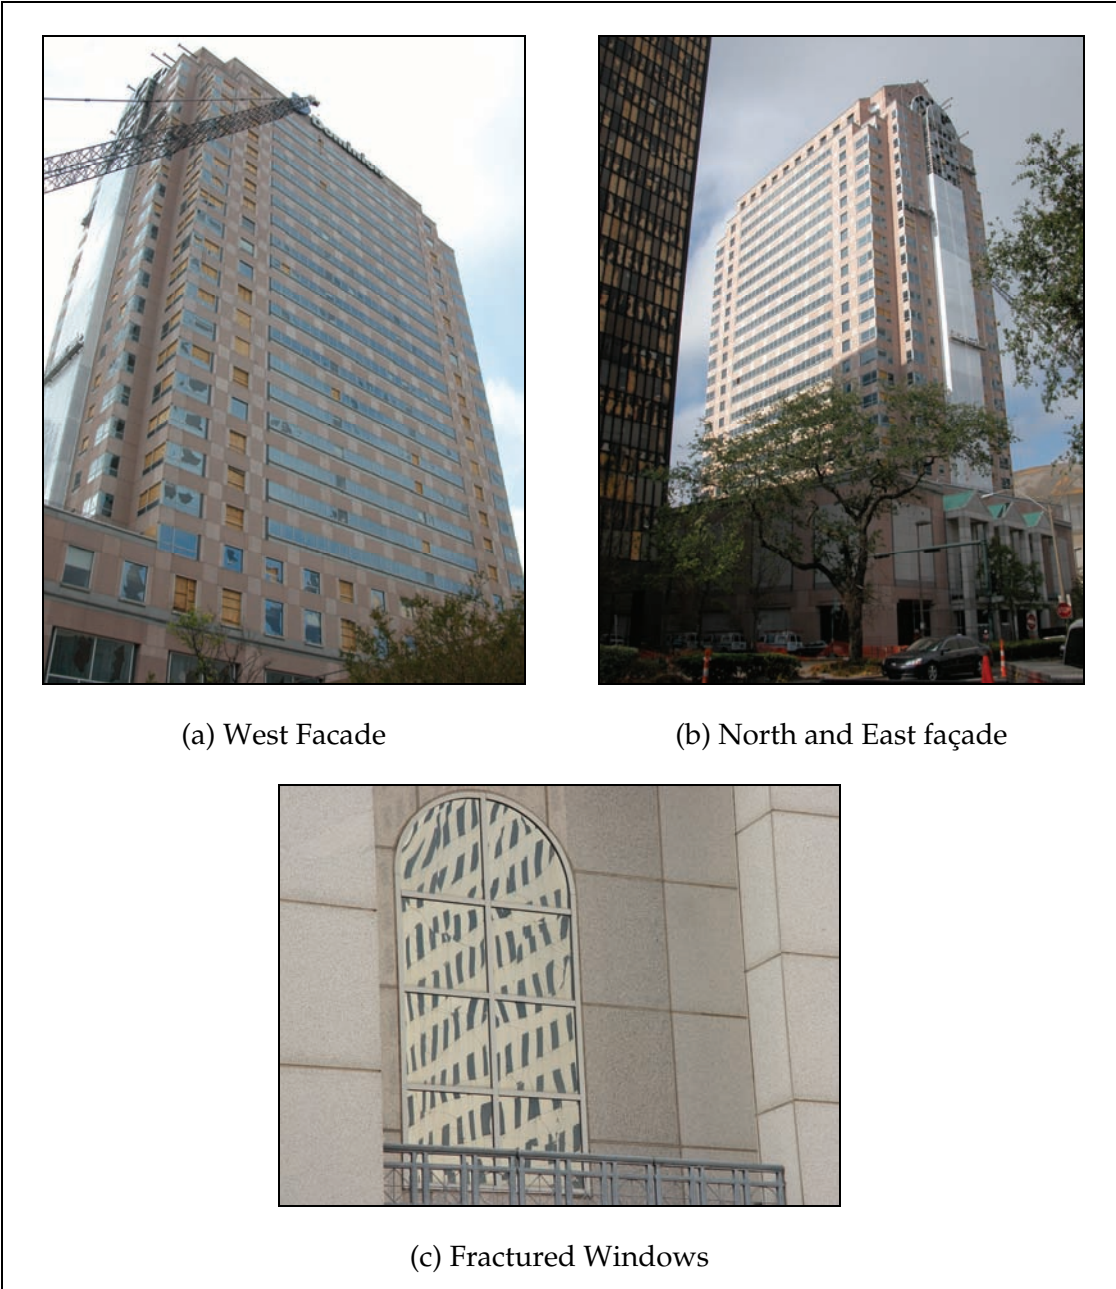
The Dominion Tower is 25-story high rise commercial building to the west of the Amoco building, and just east of the New Orleans Superdome. Glazing on this building also suffered widespread damage. About half of the windows on the north and west facades were broken as shown in Figure 3-5. Windows on the east facade appeared to have suffered minimal damage. The glazing was a mix of 1/4-in insulated and annealed glass. Safety film appears to have prevented fallout of some broken glass as shown in Figure 3-5 (c).

Figure 3-5. The Dominion Tower in the New Orleans Business District had extensive window damage on the north and east facade (a) and limited damage on other sides (b). Many windows were fractured but remained in place.

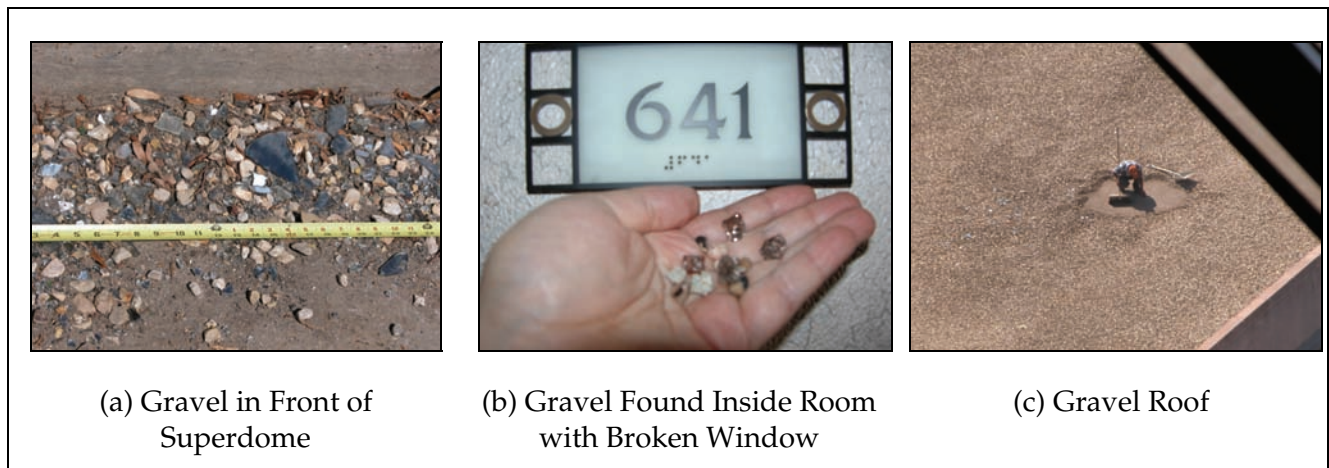
Figure 3-6. Gravel found on adjacent street curbs and inside substantially damaged buildings in New Orleans (a/b). Source of gravel was likely roofs from building upwind of damaged windows(c).

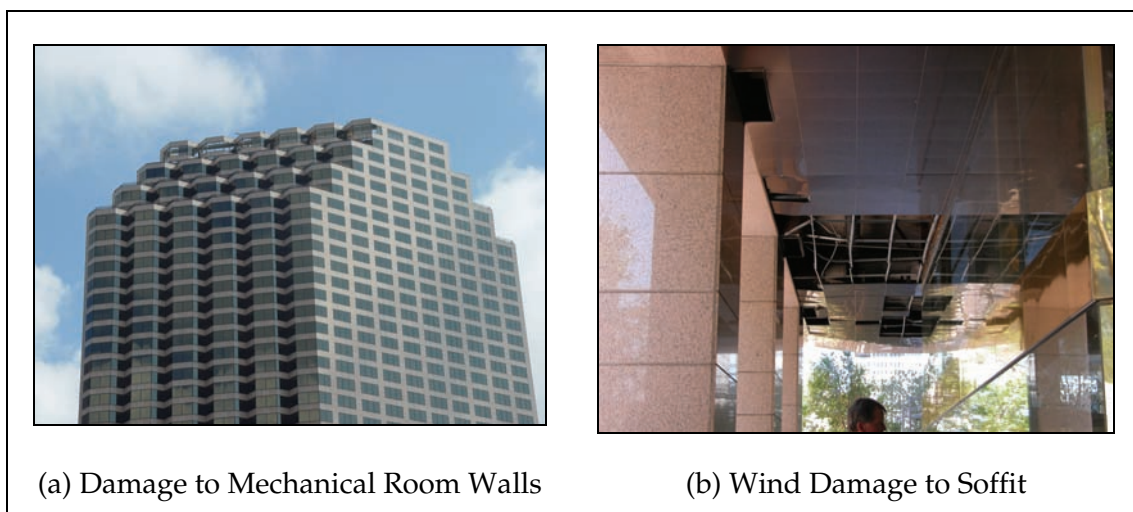
The Energy Centre, a 40-story building on the southeast corner of Poydras Street and Loyola Avenue, appeared to have relatively little damage and was in limited operation by mid-October 2005. The building, shown in Figure 3-7 (a), is located across Loyola St, to the east of 1250 Poydras. Four windows reportedly broke during the storm, but had already been replaced. The remaining visible damage consisted of broken windows on the two upper stories that housed mechanical equipment. Neighboring buildings to the east also appeared to have similar damage concentrated on the upper story mechanical rooms that were not fully enclosed. The main entry area of this building also had a few soffit tiles missing and damaged supporting grid as

Figure 3-7. Only visible damage to this building appeared to be broken windows on upper levels corresponding to mechanical rooms and soffit near the main entrance.

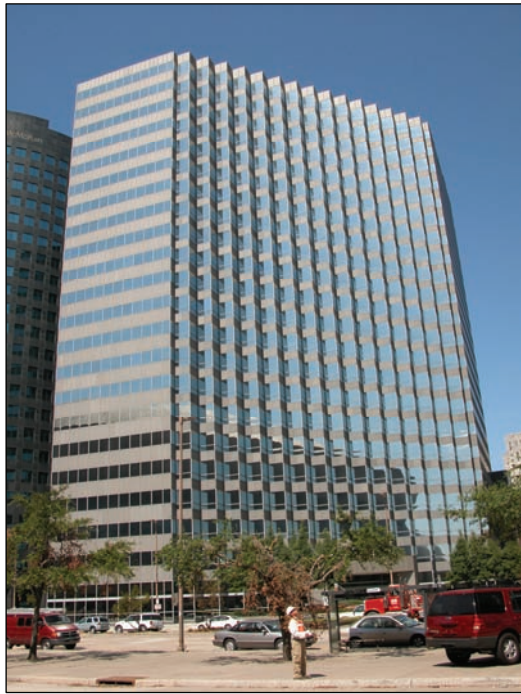
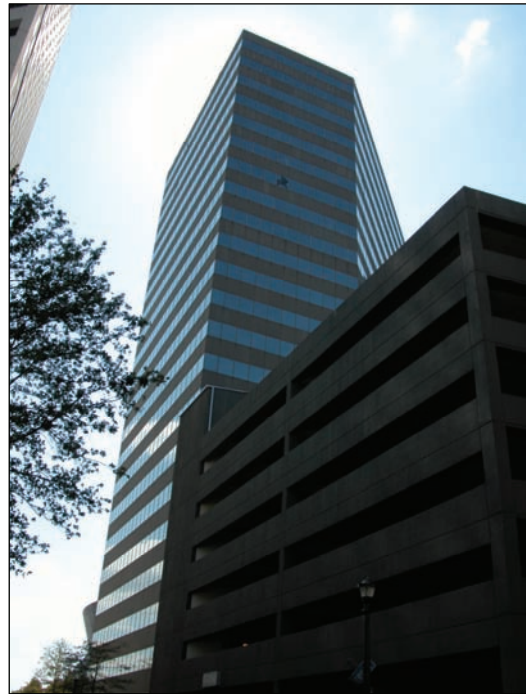
Figure 3-8. Office building in the New Orleans Business District was exposed to wind forces and 1-2 feet of flooding but quickly recovered.

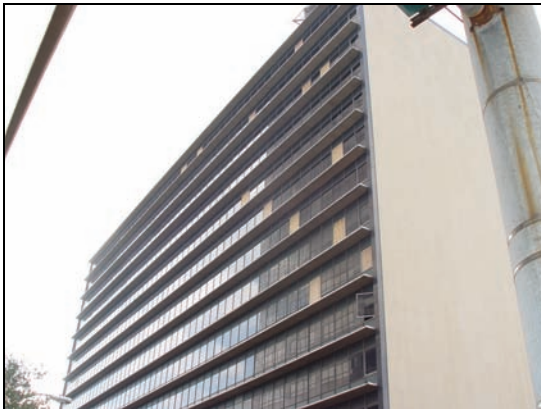
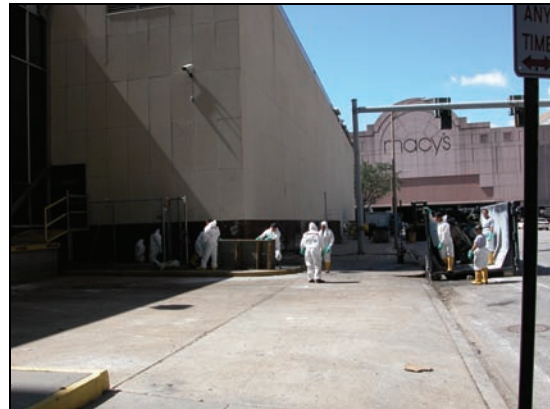
The US Postal Services Building in the New Orleans Central Business district appears to be a 14-story steel-frame building. The south facade of the building had about five broken windows that were boarded up as shown in Figure 3-9. More window damage occurred on the north side shown in Figure 3-9(a), yet fewer than 2% of the windows were fractured. Likely, the most significant source of damage to the Postal Service Building resulted from flooding in the basement. There was no evidence of flooding above the street level at its location. At the time of inspection, the basement flood water had been pumped out and removal of all furniture, electronic components and other items was in progress. Figure 3-9(b) captures the remediation efforts to clean out mold and contaminated equipment from the flooded basement.

Figure 3-9. The US Postal Service Building had a few fractured windows and flooded basement, though there was no flooding at street level.

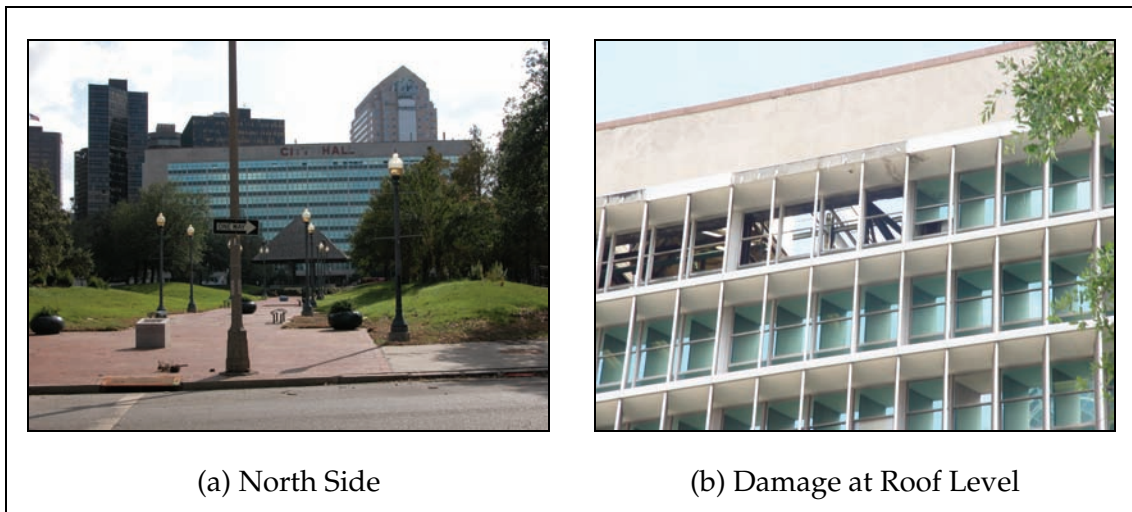
The nine-story City Hall building in New Orleans appeared to have suffered no significant damage during the hurricane. The structural framing appeared to be made of steel. The building was in service at the time of the investigation as indicated by the high traffic of city employees using the south entrance. Potable water was not available, thus occupants were cautioned against coming in contact with the water. Electric power and phone service was currently available in this and surrounding buildings. There were no apparent watermarks above the street level to indicate flooding in the area. Figure 3-11 shows the north side of the building with several open windows at the top level. The only noticeable damage was concentrated on the south side and included a one-third row of broken windows on the top story. Daylight was visible through a few of these windows, indicating that this section of the building was probably used to house mechanical equipment. If roof damage had occurred, the building would have had extensive water damage and likely be out of service. The building is located just north of the Amoco building which suffered extensive glazing damage.

Figure 3-11. New Orleans City Hall suffered damage mainly at the roof level.

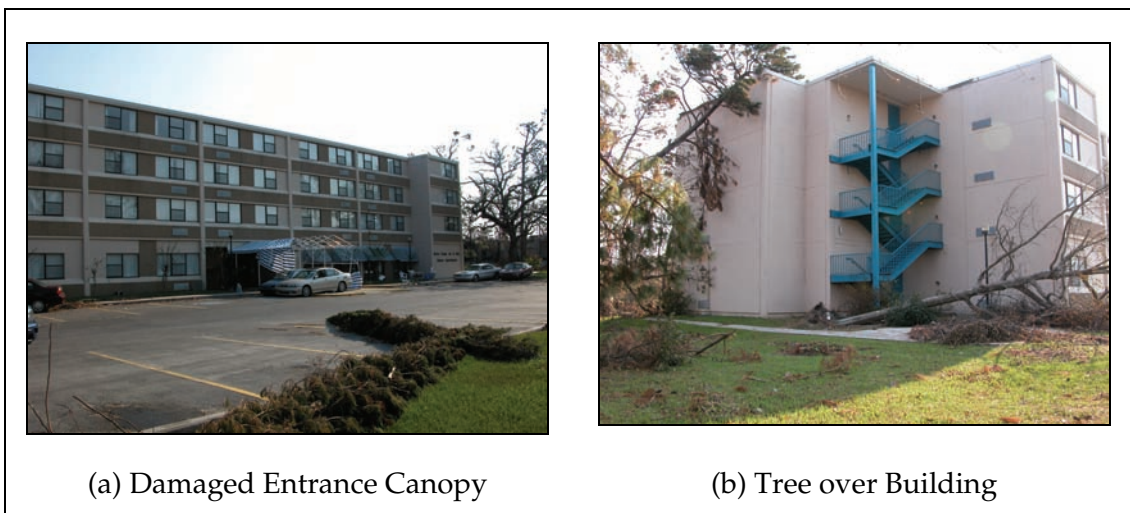
The “Notre Dame de la Mer Manor Apartments” suffered only minor damage despite being located in one of the areas hardest hit by Hurricane Katrina. The four-story reinforced-concrete shear-wall building shown in Figure 3-12 is located on US-90 about 0.5 miles west of the St. Louis Bay Shoreline. Powerful storm surge and winds in the area are evident by the displaced cars in the parking lot shown in Figure 3-12(a) and trees falling onto the building in Figure 3-12(b). The only damage readily apparent on the exterior on this building was one broken window in the rear of the building and a collapsed canopy at the main entrance. Windows in the upper stories of the building were open at the time of inspection, indicating that residents had returned to the building.

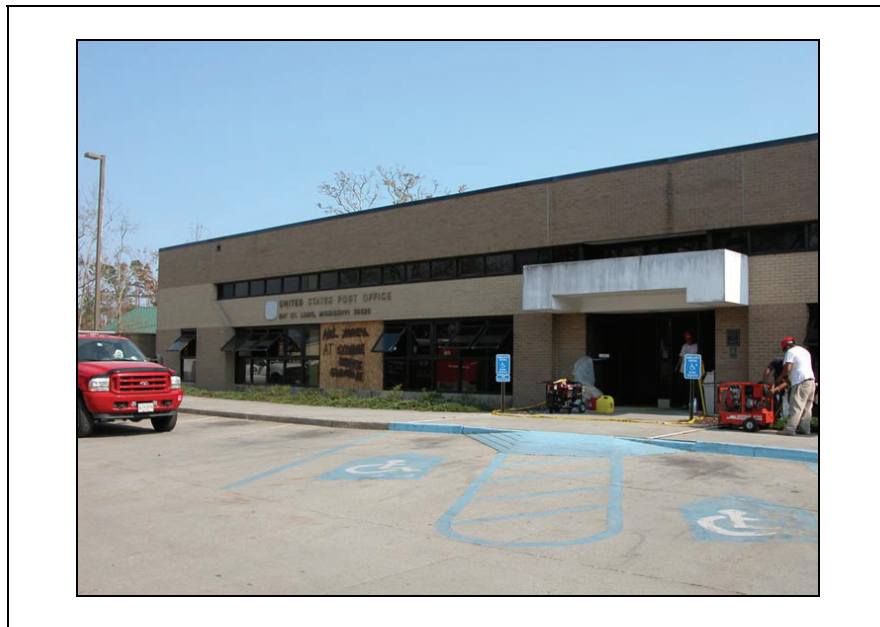
The Bay St. Louis Post Office is housed in a one-story building that performed well structurally, but 4 to 6 ft of flooding from the storm surge caused extensive nonstructural damage. Plaster and other interior finishes were removed and the building underwent environmental remediation. The post office was expected to be in operation within two weeks of the hurricane. On the exterior, there was only limited window breakage, as shown in Figure 3-13. Most of the damage appeared to be storm surge related.

Figure 3-13. Post Office in Bay St. Louis.

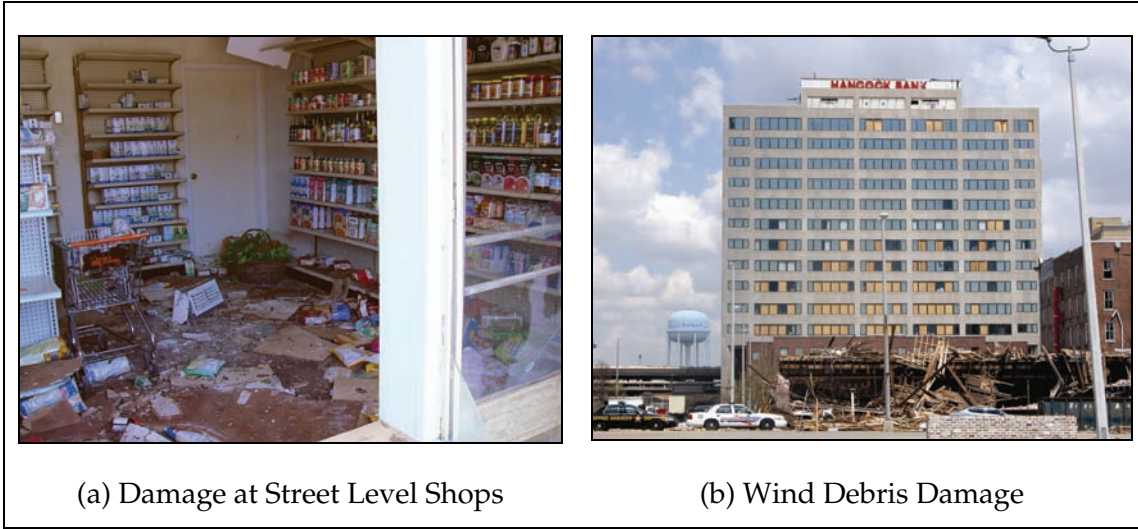
The downtown area of Gulfport, Mississippi, located about one-half mile north of the shoreline, generally appeared to have experienced 1-2 feet of storm surge. All of the buildings in the region had water damage at the ground level, as shown in Figure 3-14(a). Many other buildings had additional wind and wind-debris related damage at the upper stories. A few collapsed buildings were observed in the area as well. Figure 3-14(b) shows a collapsed unreinforced masonry structure at the forefront. The background shows the Hancock Bank building, which appeared to be the tallest building in the downtown area at 14 stories. About 30 percent of the windows were shattered on the south face above the third level. The windows that appear tinted black lost the exterior pane only. The concentration of damage at the lower levels suggests that the windows were shattered from debris picked up by the wind from the ground. At the time of investigation, restoration efforts were under way to clear debris and repair water damage to building interior from water that penetrated it through the damaged windows.

Figure 3-14. Flooding and wind damage in downtown Gulfport.

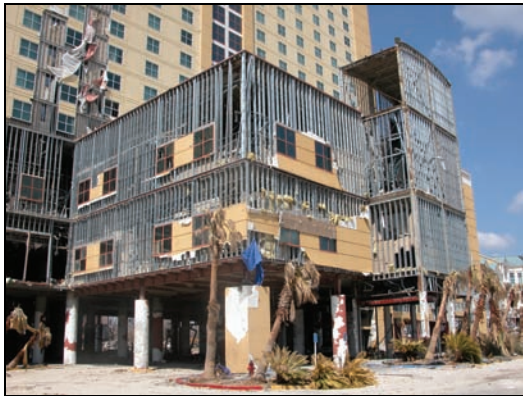
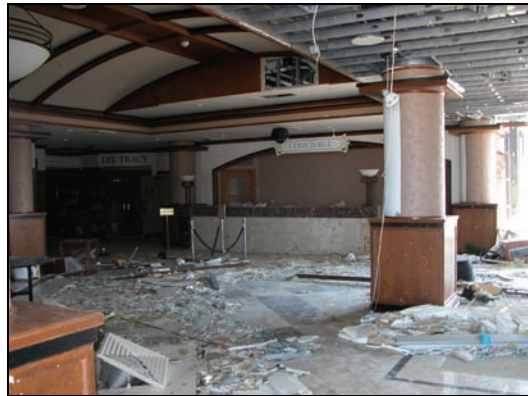
The extent of damage along the Mississippi coast is demonstrated by the beachfront 17-story Grand Casino Hotel constructed of reinforced concrete frame with shear walls. The approximately 20 ft. first story was partially enclosed, probably with break-away walls, to serve as a welcome lobby with access to stairs and elevators. Only the bare structural concrete columns and shear walls remained at this first level, with all else apparently swept away by the storm surge. The second and third stories, with heights of about 15 feet each, housed reception, shops and banquets rooms, among others. A light steel frame extended these two levels over the drive-thru valet parking. The exterior of these two stories suffered extensive damage to cladding. Figure 3-15(a) shows the front view (east facade) of the hotel building, and the exposed nonstructural framing. The building exterior was finished with layers of gypsum board, Styrofoam foam board that allowed for contouring the surface, and fabric lathe with a thin coat of colored plaster. These finishes were stripped from the nonstructural steel stud framing. As a result of exterior damage, high winds entered into the building and destroyed the interior space as shown in Figure 3-15(b). The exterior cladding was also stripped at several locations above the third-story level, exposing the steel stud framing. The casino barge associated with this hotel remained anchored

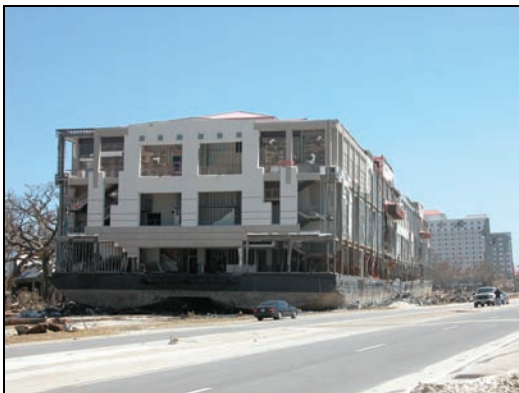
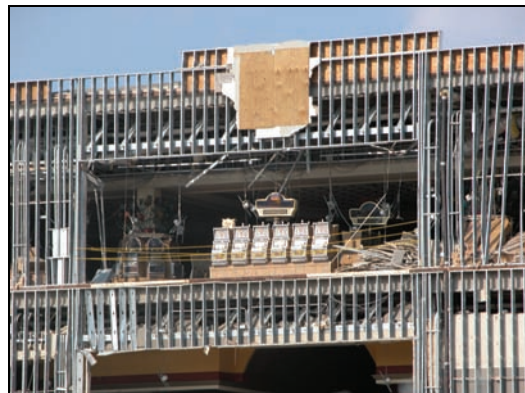
Many casinos, which were originally stationed along the Mississippi shoreline, were carried inland by the storm surge. A few of the casinos were deposited north of the coastal US 90 as shown in Figure 3-16(a). Impact between the barges and structures along the coast resulted in the partial collapse of at least one building and one parking structure. The casinos themselves were severely damaged on the exterior and interior. Figure 3-16(b) shows a close-up view through the third-level opening of another casino that crossed the US-90.

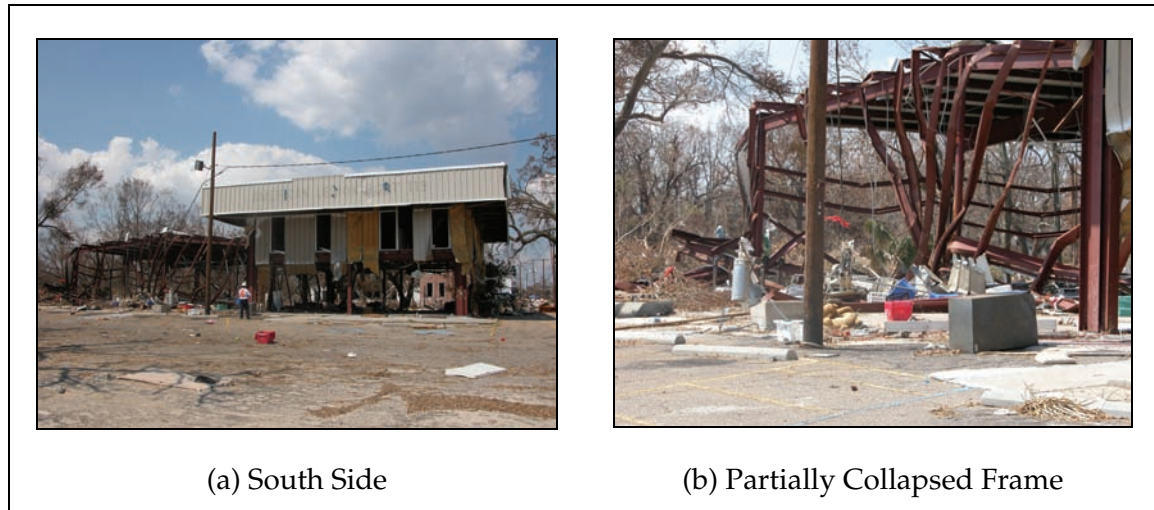
A light steel frame building located on US 90, opposite to the coast in Gulfport, was also severely damaged. The building consists of a two-story rectangular frame adjoined with a single story frame that appears to have served as an auditorium for the American Legion Post 119. The majority of the cladding, made of insulated metal panels, has been stripped from the frame as shown in Figure 3-17(a). Also, the southern bay of the single story portion of the building collapsed as shown in Figure 3-17(b).

Figure 3-17. Damage to steel building in Gulfport coast.

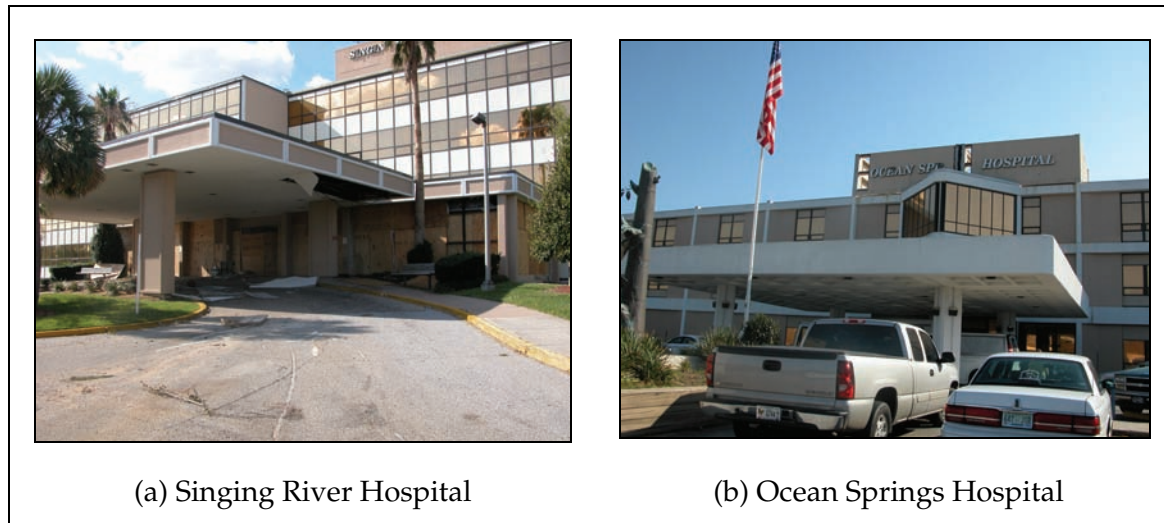
Oceans Spring Hospital shown in Figure 3-19(b) is part of the Singing River Hospital system. Similar to the Singing River Hospital building in Pascagoula, MS, the hospital building suffered minor structural damage.

Figure 3-19. Hospitals in Mississippi mile at a distance from the coast had minor damage and remained operational through storm.

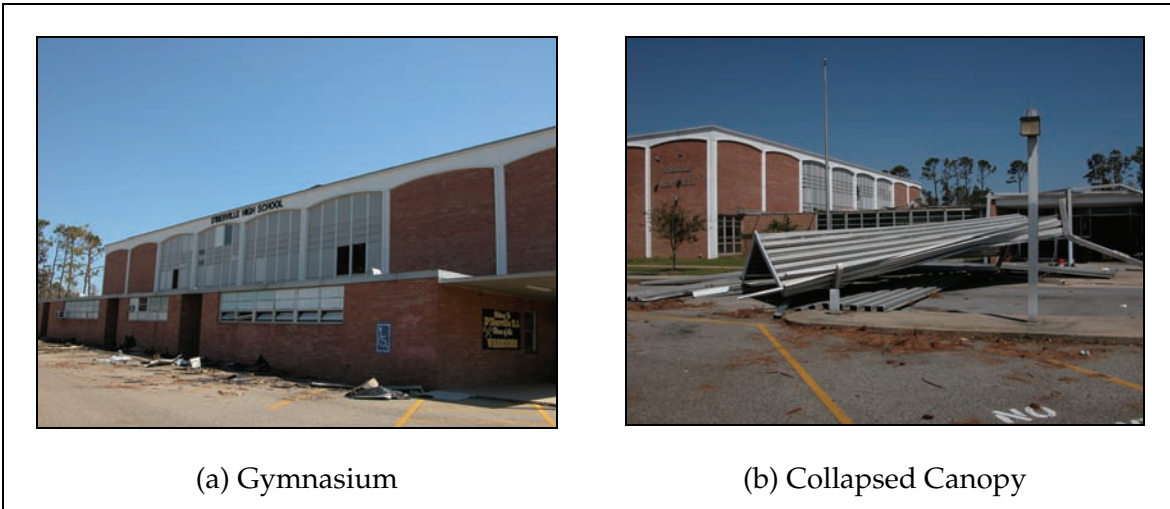
rooftop air conditioning units were damaged, and a 25-ft-by-50-ft light metal entrance canopy shown in Figure 3-20(b) was destroyed. The gymnasium structure, a concrete or steel-frame building, suffered damage to its masonry veneer. The school is located in a suburban neighborhood, in an area that was lightly wooded with pine trees; there was a debris field of pine boughs and pinecones. Approximately 10% of the windows were broken.

Figure 3-20. D'Iberville high school in Biloxi Bay.

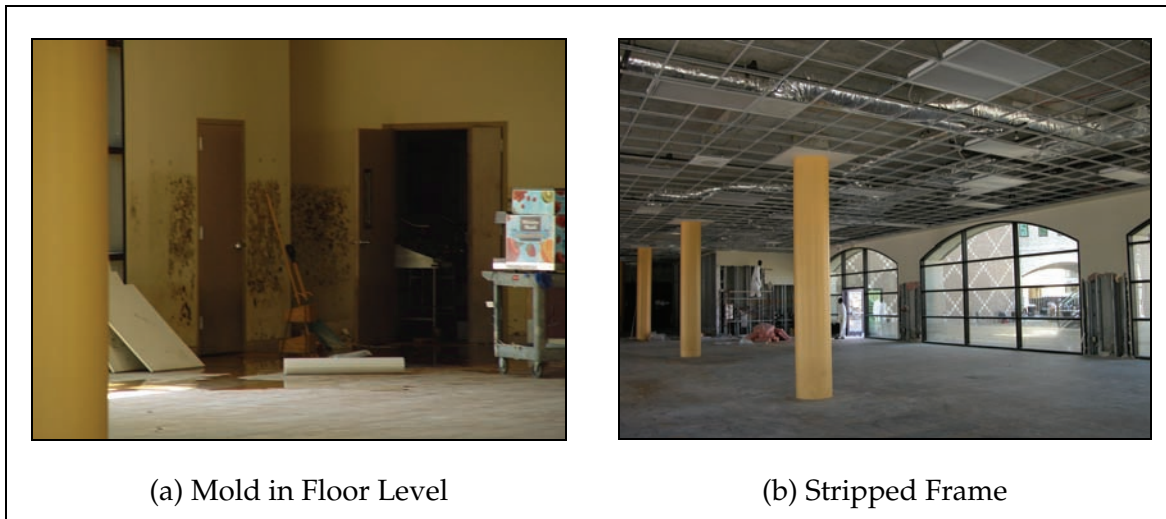
Figure 3-21. Flood damage to new student center in university near New Orleans.

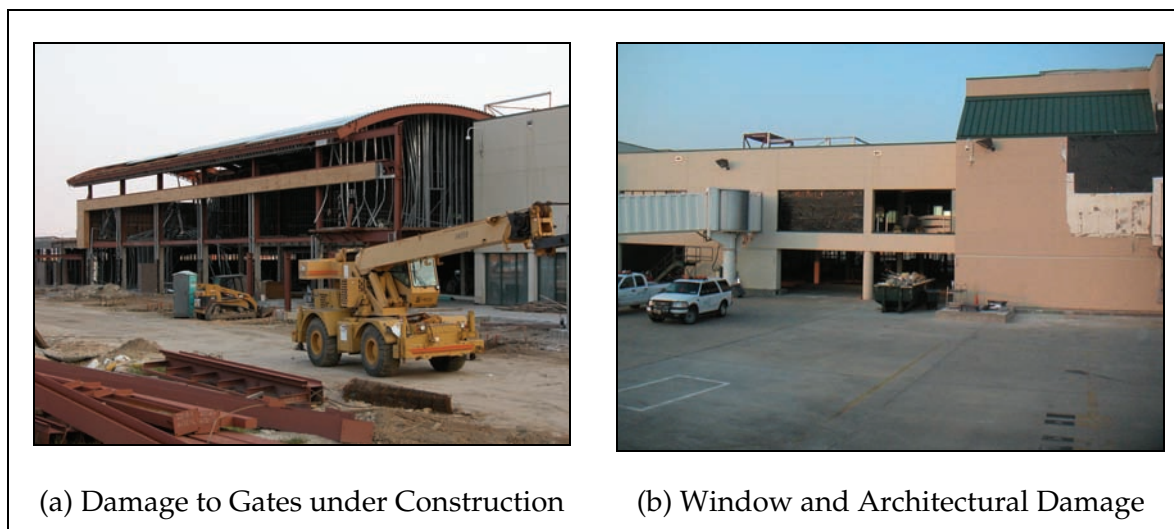
The three-story Gulfport-Biloxi International Airport shown in Figure 3-22 was served by four major airlines, had four existing gates and two under construction at the time of Hurricane Katrina. Its structural system is a steel moment frame clad with gypsum wallboard partition over metal studs. There was no flooding in the terminal and no structural damage, although window breakage and roof damage caused extensive architectural damage to two of four gates. Some window breakage occurred in the air traffic control tower, but not at the level of the control room. There was extensive damage to

Figure 3-22. Gulfport-Biloxi airport was under construction and suffered damaged to existing and new gates.

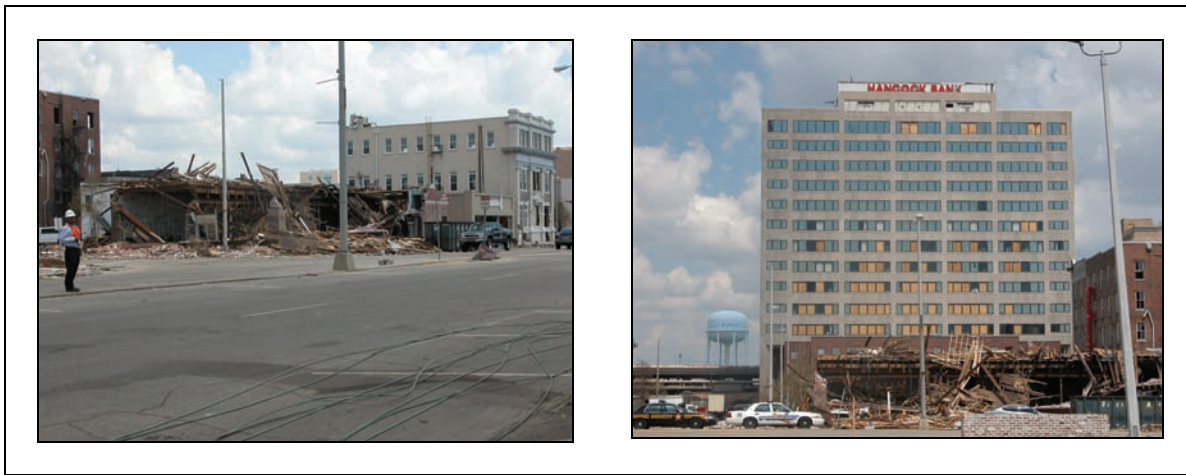
Figure 4-1. Left: partial collapse of unreinforced masonry bearing-wall building, downtown Gulfport MS. Debris from this building may have impacted a high-rise building downwind, causing extensive wind damage (right).

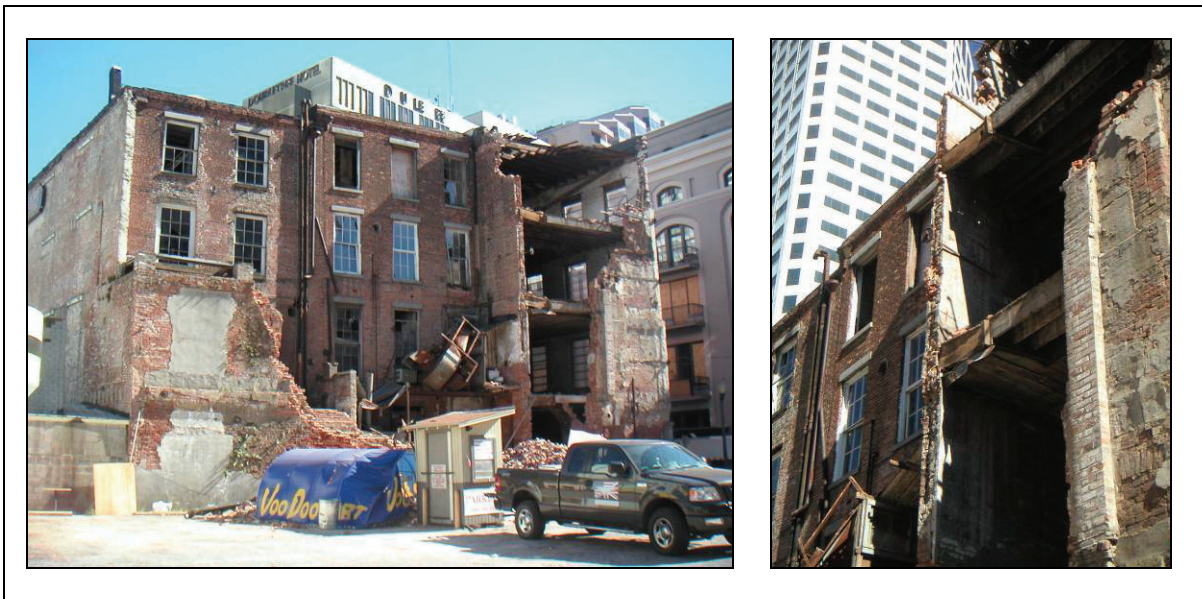
Similar damage was observed in an unreinforced masonry bearing-wall building in downtown New Orleans (Figure 4-2), where according to Vickery (2005), 10-meter peak gusts in exposure C were approximately 90 mph.

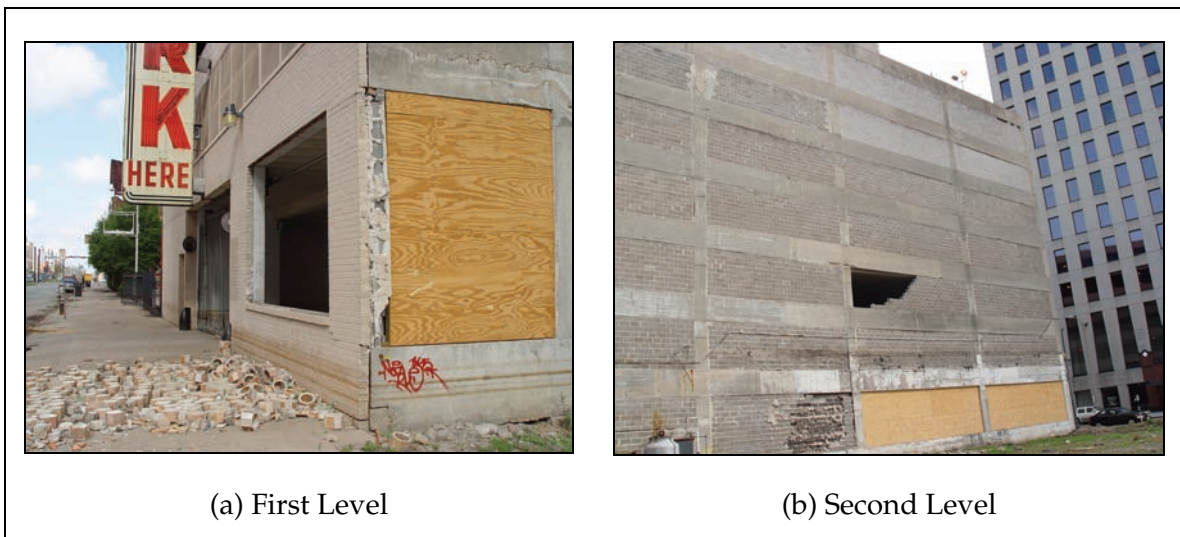
Figure 4-4. Masonry infill damage.

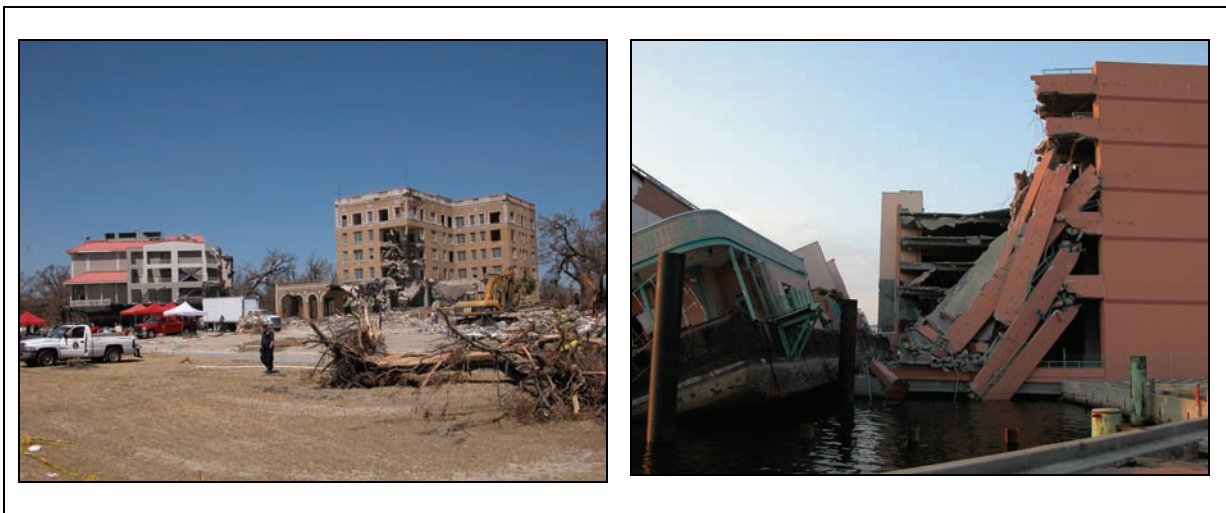
In a similar situation, a five-story (six-level) parking structure constructed of cast-in-place reinforced concrete partially collapsed. The parking structure formed part of a hotel and casino complex in Biloxi, with adjacent barges housing the gambling halls. Four bays on the west facade collapsed, apparently because of impact from the adjacent casino barge that impacted four columns as it was raised by the storm surge (Figure 4-5 right).

Figure 4-5. Structural damage resulting from surge-borne debris.

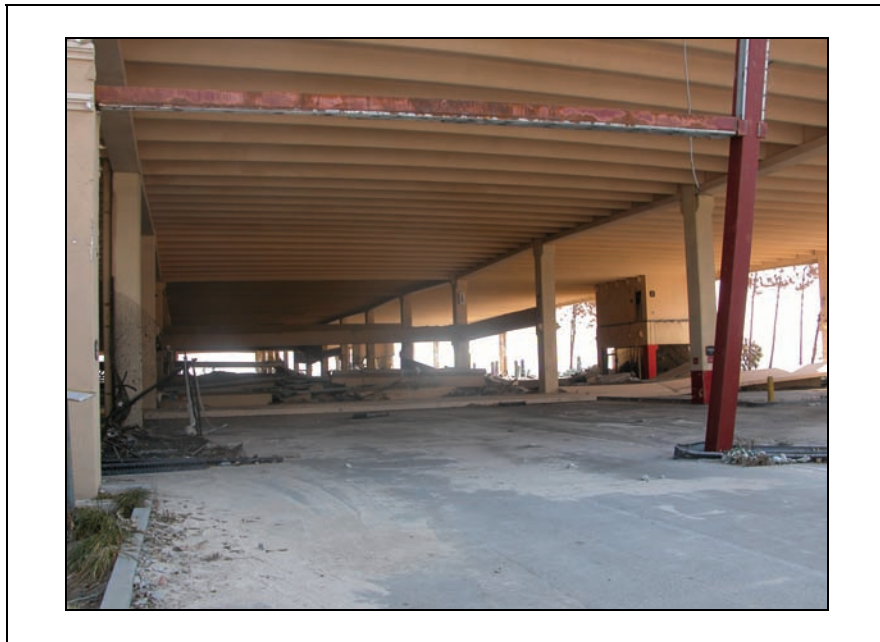
Figure 4-7. Collapsed deck beams oriented parallel to the seashore.

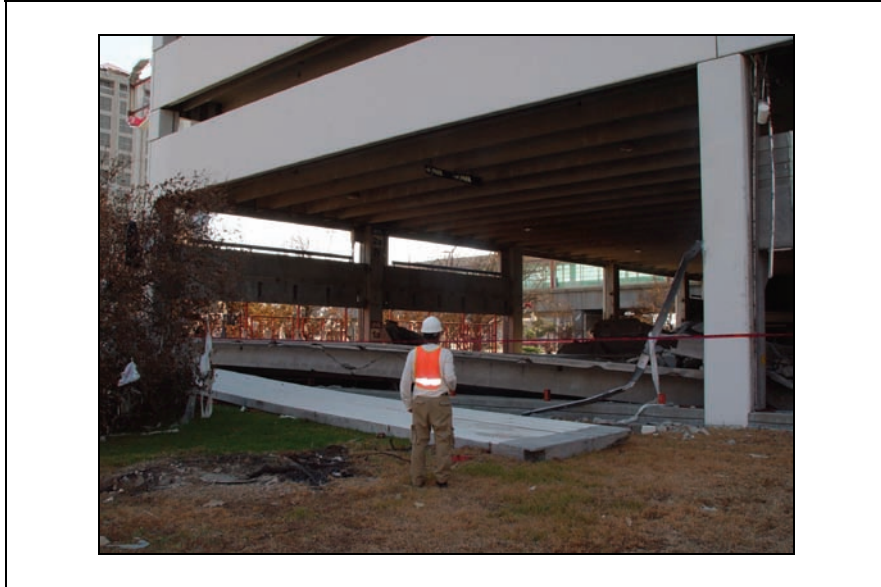
Figure 4-8. Collapsed deck beams oriented perpendicular to the seashore.

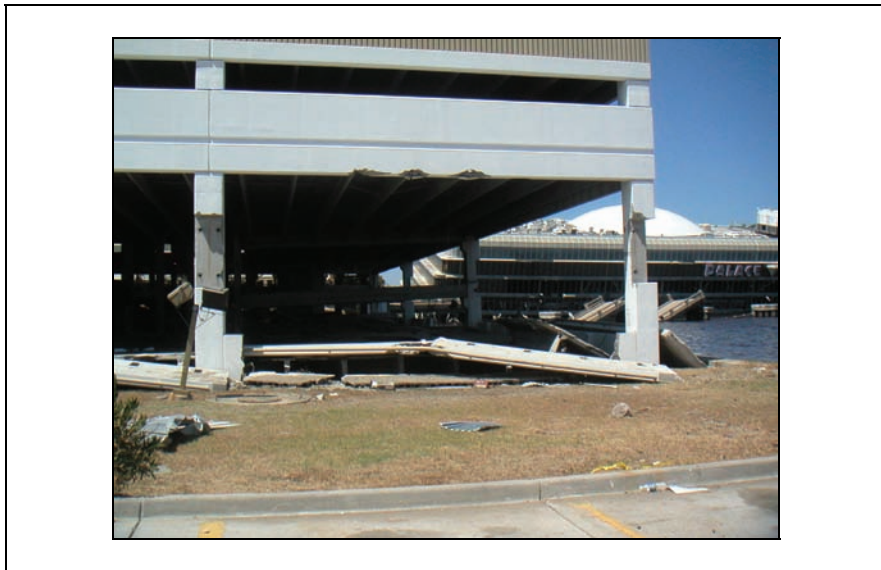
Figure 4-9. Support of spandrel beam on the outside of the column.

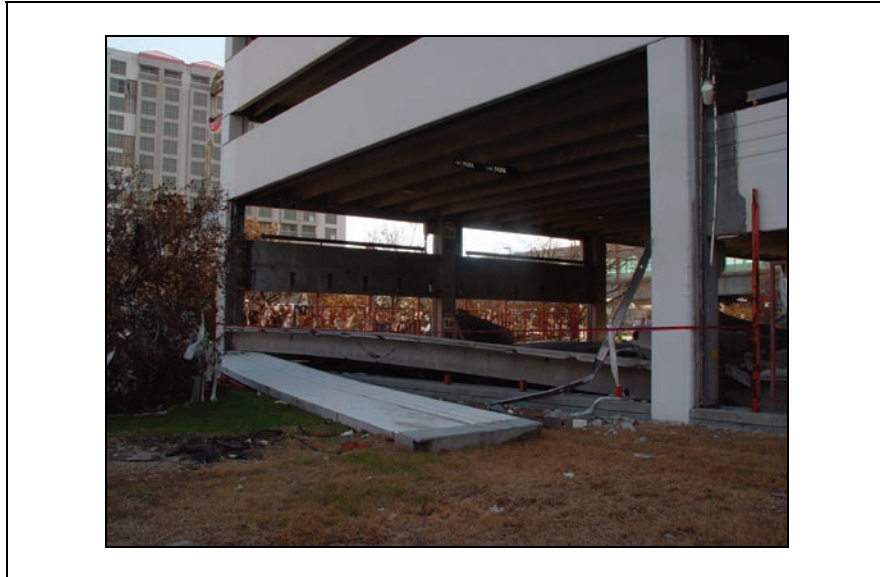
Figure 4-10. Flexibility of spandrel beams.

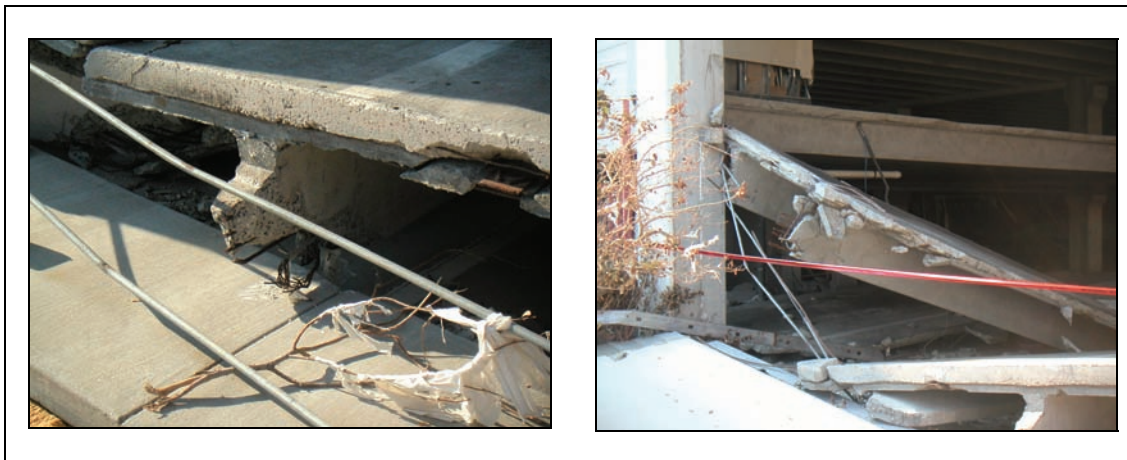
Vertical loading was clearly substantial. Shear failure was observed in deck-beam shear keys (Figure 4-11) and in supporting girders (Figure 4-12(a), the interior girders in the background of Figure 4-12(b), or the three bites in the 3rd-level spandrel beam in Figure 4-12(c)). Such loading could have been caused by pounding resulting from deck beams being lifted and then dropped, or by the weight of water accumulated on the top of the deck before it could pour down a ramp. If the latter occurred though, why would damage tend to be concentrated at the seaward side or corner of the deck? Water would probably flow quickly enough to distribute around the entire second-floor deck and cause more general damage.

Figure 4-11. Shear failure in deck-beam shear keys.
