MCEER SPECIAL REPORT SERIES
Engineering and Organizational Issues Before,
During and After Hurricane Katrina

Damage to Engineered Buildings and Lifelines
from Wind, Storm Surge and Debris in the
Wake of Hurricane Katrina

Gilberto Mosqueda and Keith A. Porter

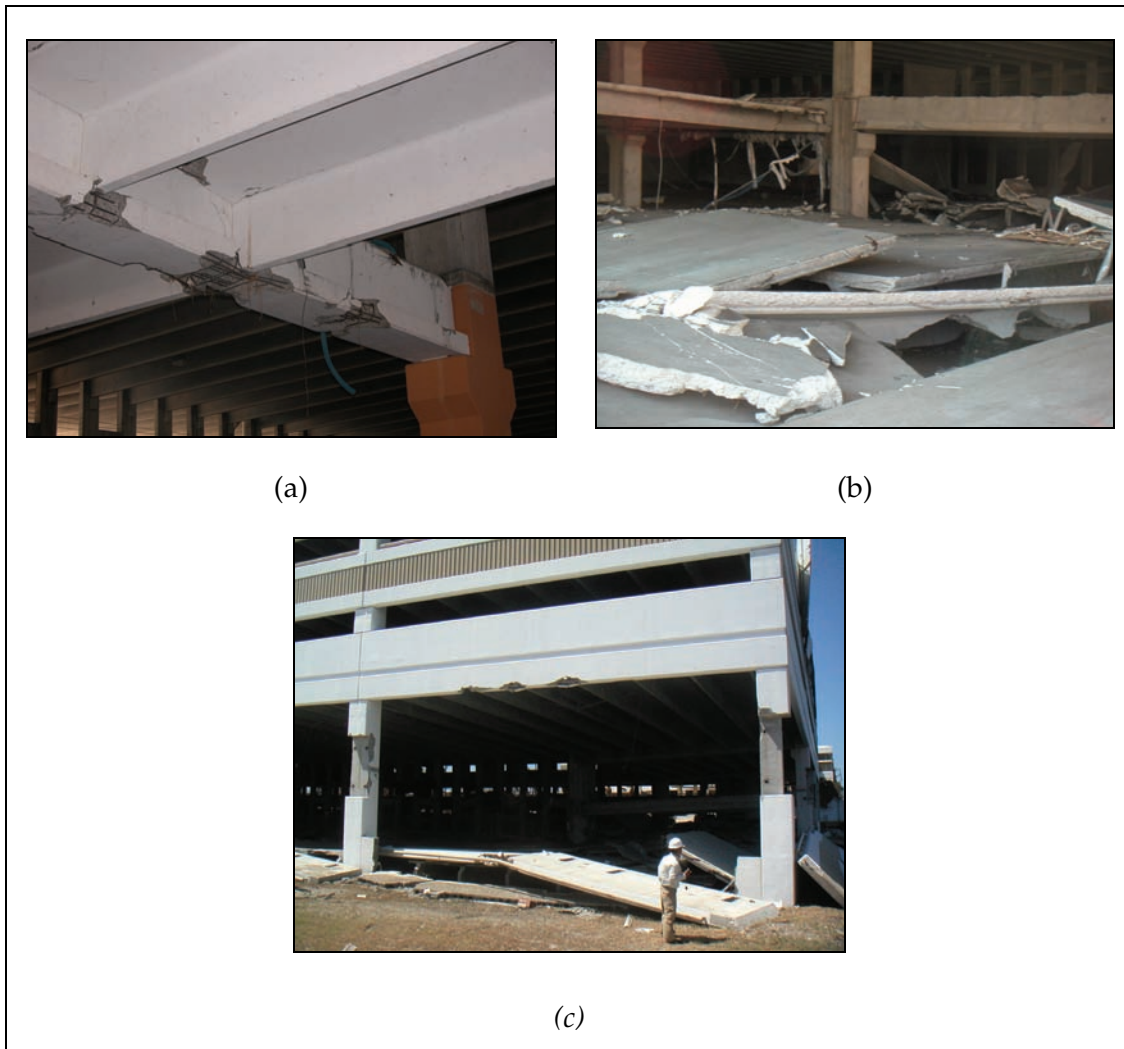
Vertical loading was clearly substantial. Shear failure was observed in deck-beam shear keys (Figure 4-11) and in supporting girders (Figure 4-12(a), the interior girders in the background of Figure 4-12(b), or the three bites in the 3rd-level spandrel beam in Figure 4-12(c)). Such loading could have been caused by pounding resulting from deck beams being lifted and then dropped, or by the weight of water accumulated on the top of the deck before it could pour down a ramp. If the latter occurred though, why would damage tend to be concentrated at the seaward side or corner of the deck? Water would probably flow quickly enough to distribute around the entire second-floor deck and cause more general damage.

Figure 4-12. Shear failure in girders supporting deck beams.

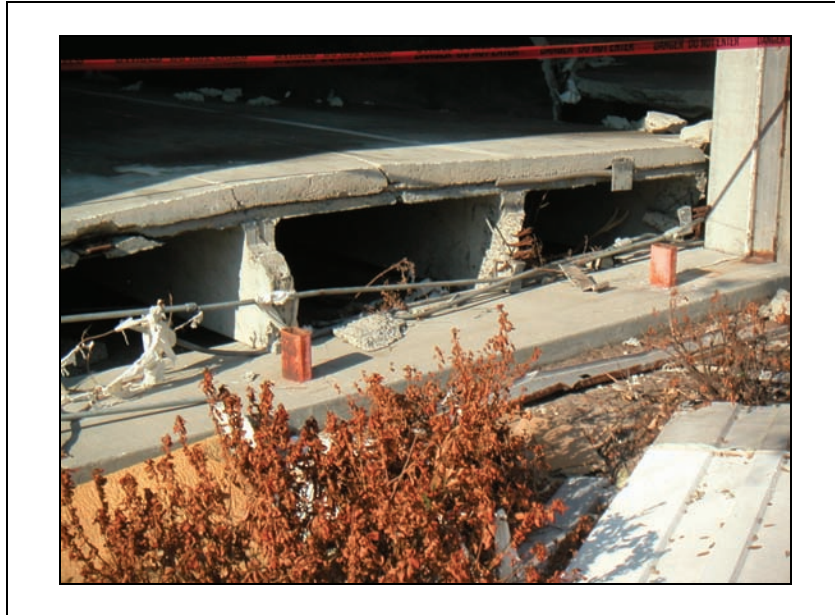
If it were uplift and dropping of the deck beams, rather than the weight of water, what caused the uplift? Wave action alone might conceivably have lifted the deck beams, but it seems likely that buoyant forces contributed strongly. The deck beams and their concrete topping weigh approximately 150 pcf; seawater weighs approximately 66 pcf. By Archimedes' Principle, buoyancy alone would have reduced the downward vertical load on the deck beams by almost half, a loading condition for which these pre-tensioned members were probably not designed. In addition to buoyancy of the deck beams and topping, the shape of the double-tees, whose ends were enclosed by their supporting girders, would have allowed for the creation of air pockets (Figure 4-13). As the storm surge rose to the soffit of the second-level deck, the concrete topping over the deck would have greatly limited the

Figure 4-13. Space where air pockets could have been created.

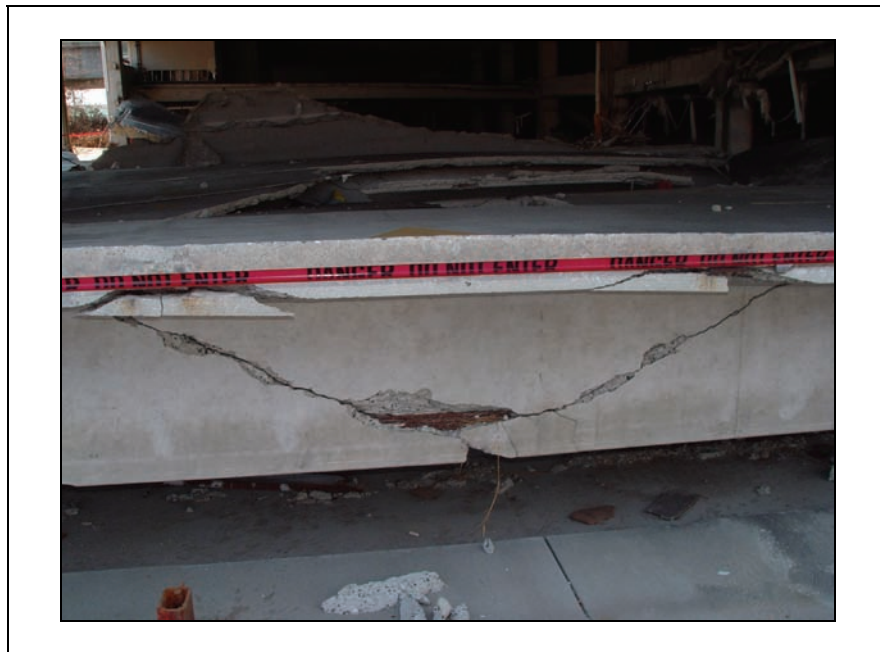
Figure 4-14. Spalling of concrete at the bottom fiber of deck beams.

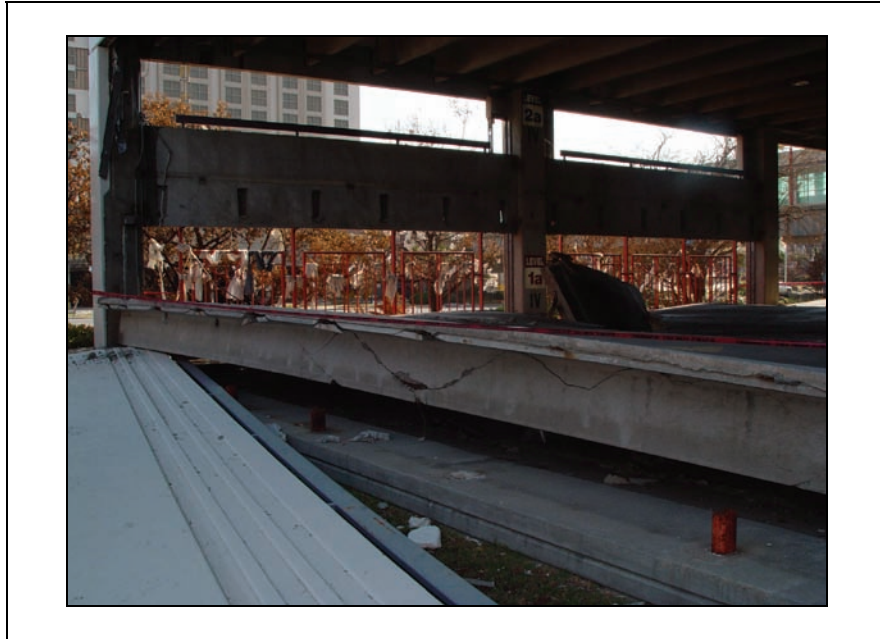
Figure 4-15. Concrete cover at deck-to-spandrel connections spalled downward, implying that the midspan of the deck moved up.
