MCEER SPECIAL REPORT SERIES

Engineering and Organizational Issues Before,  
During and After Hurricane Katrina

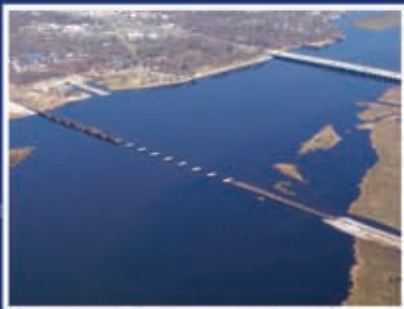
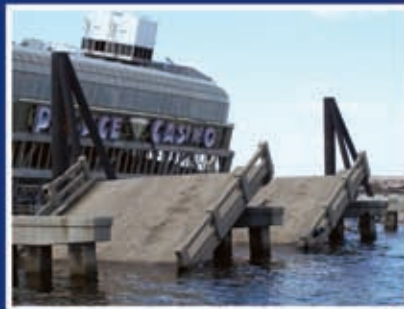
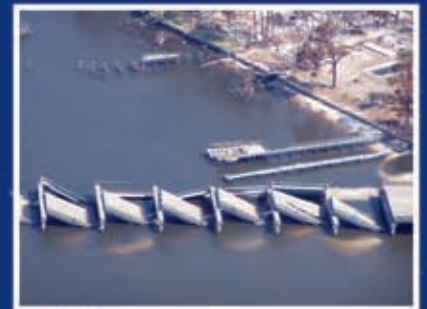
Damage to Bridges from Wind, Storm Surge and  
Debris in the Wake of Hurricane Katrina

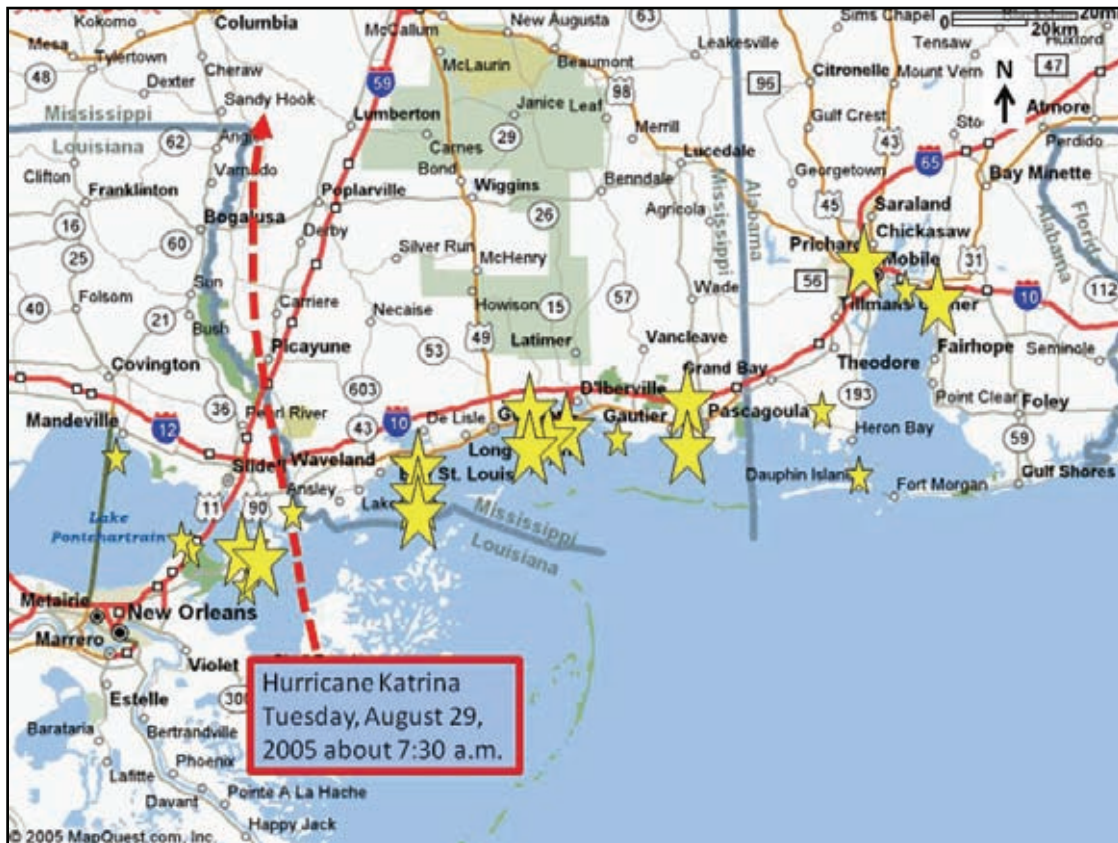
*Figure 1-1. The stars on this map of the U.S. Gulf Coast provide an indication of the scope and location of bridge damage.*

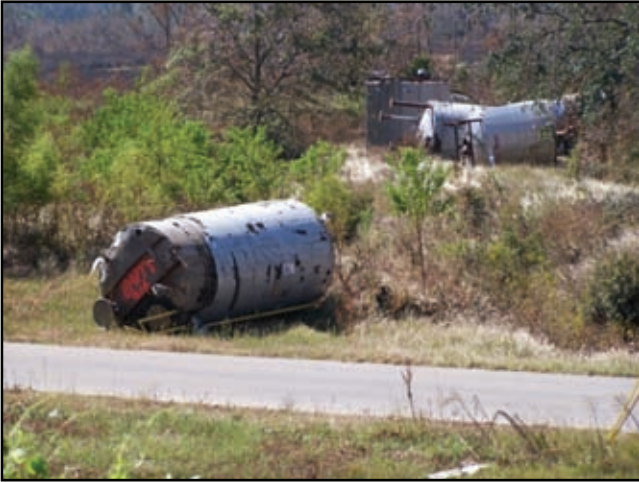
(a) Tanks carried by the surge caused damage.

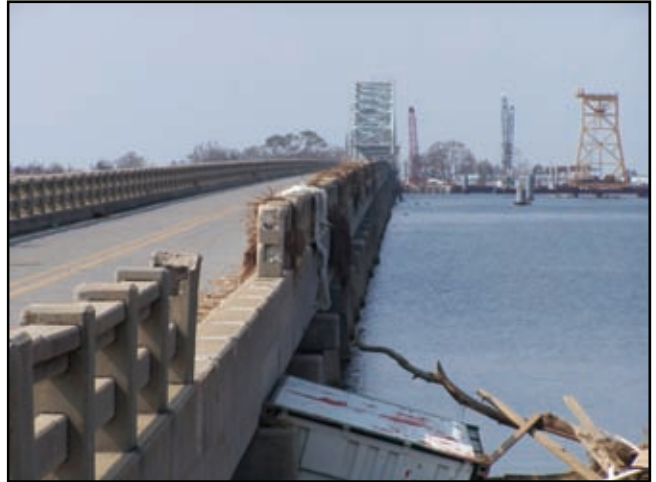
(b) Shipping containers hit bridges.

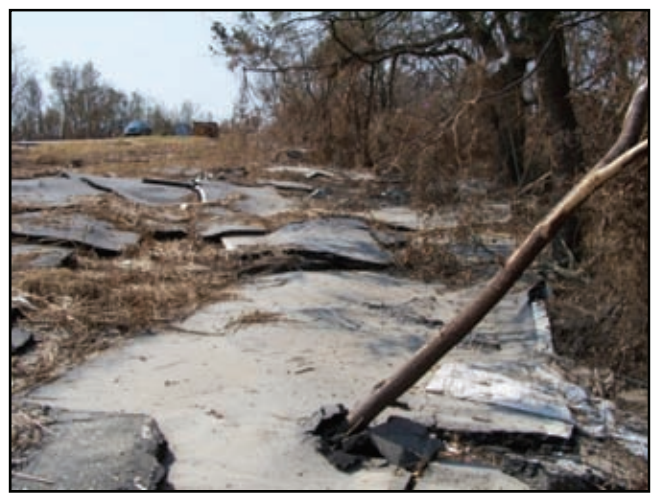
(f) Layers of pavement moved 50-100 feet.

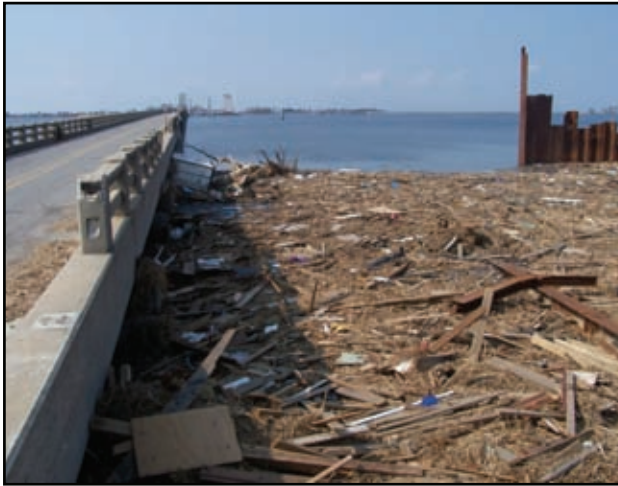
(g) Debris fields made walking hazardous.

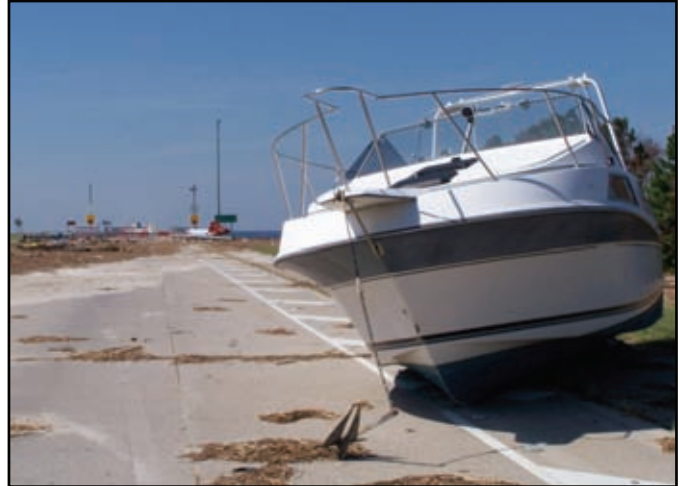
(h) Hundreds of boats were lost, then found.

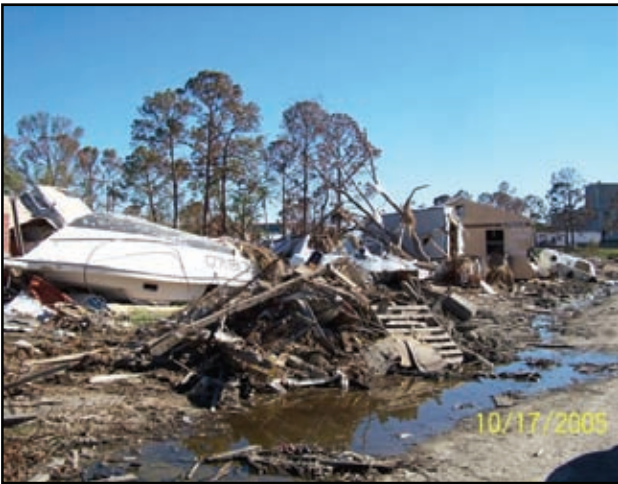
(i) A neighborhood in Biloxi, MS.

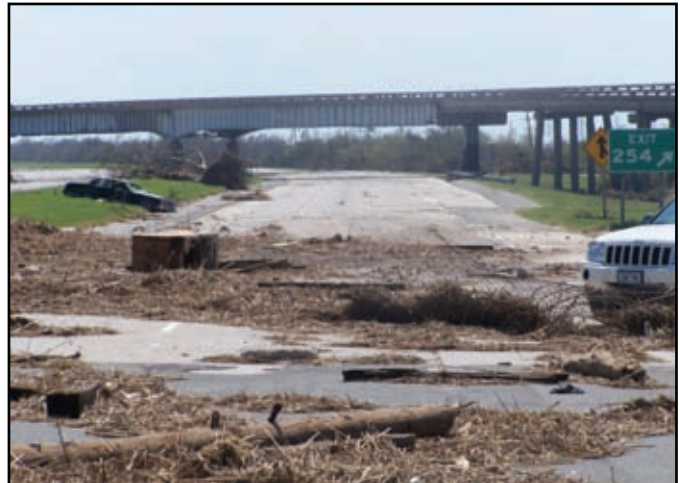
(l) Debris covered highways.

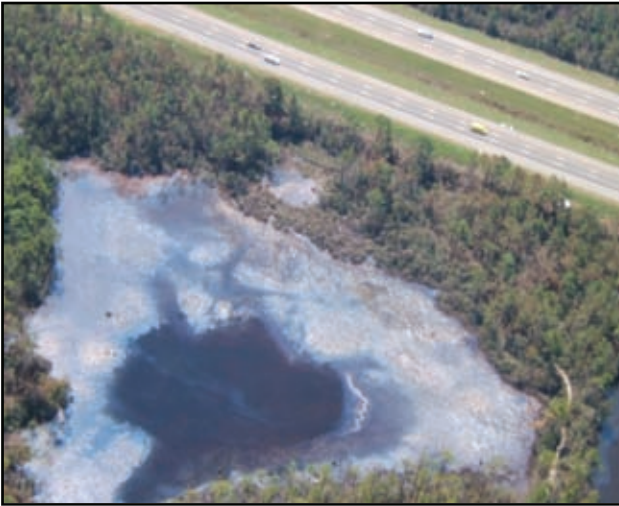
(m) Oil spill in a pond.

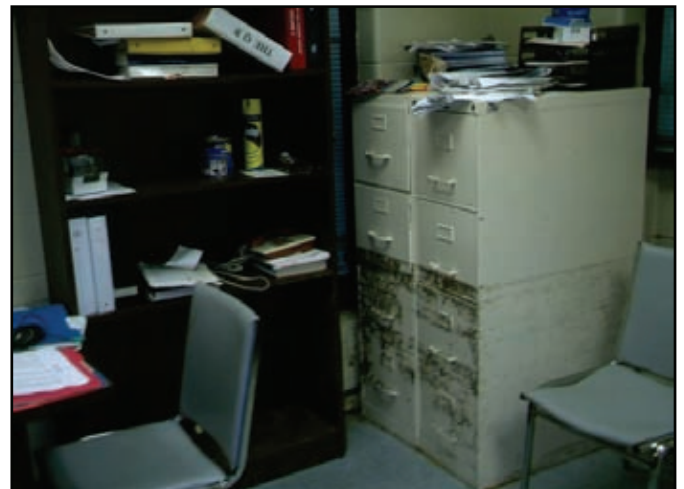
(r) Watermarks helped mark surge levels.

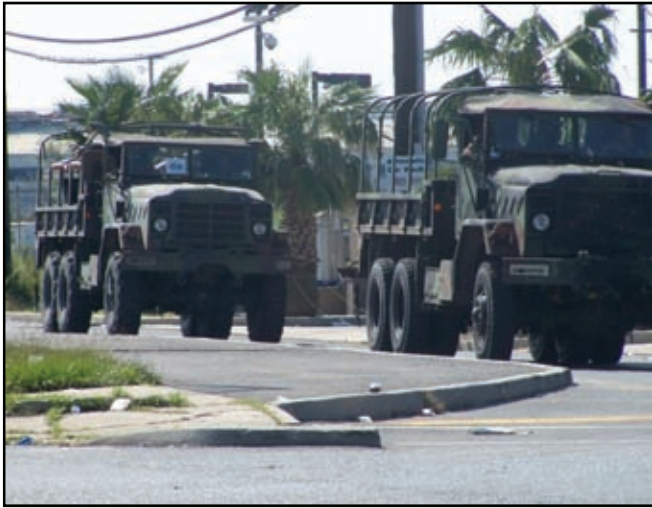
(s) New Orleans was guarded by the military.

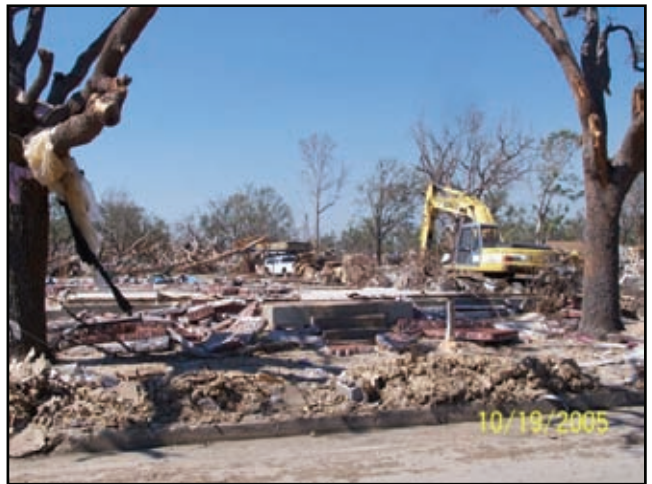
(x) Most houses near the beach were leveled.

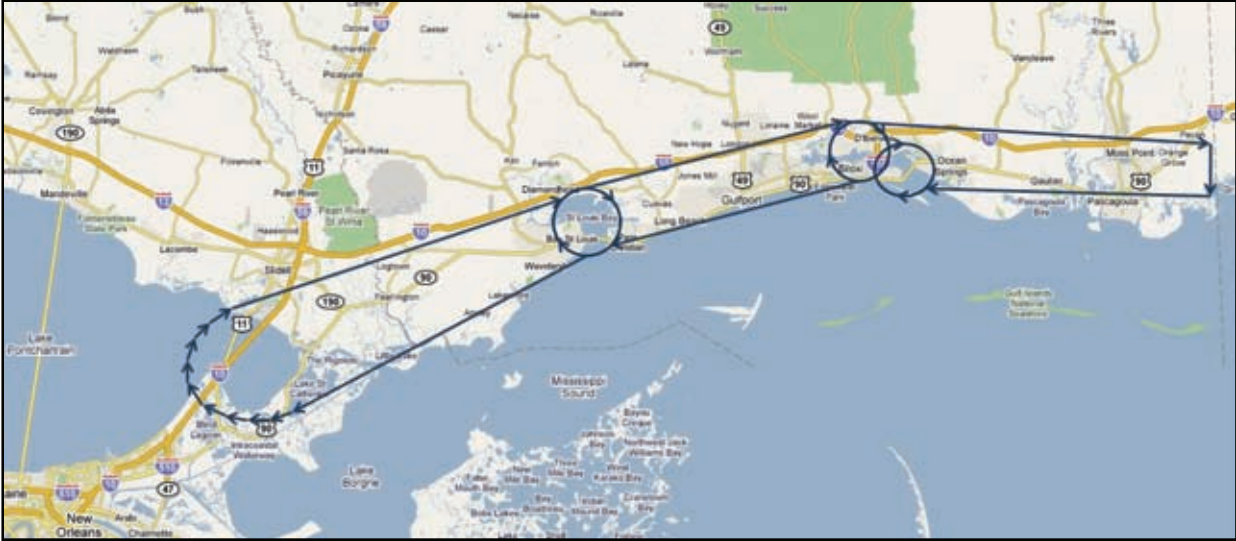
The conclusion that an aerial view was necessary came after a week of on-the-ground inspections. Being on the ground gave access to detailed information but did not allow an assessment of macro patterns of the bridge failure such as a count of the spans in the bridge, direction of span displacements, etc. Any future reconnaissance surveys should, if at all possible, start with an aerial view of the entire region to detect the most important damage on major routes and on routes inaccessible from the ground. It also would have been useful to look at the bridges from the water, though that was not as critical. To provide a flavor of the flying experience, only minor modifications have been made to the original narrative.

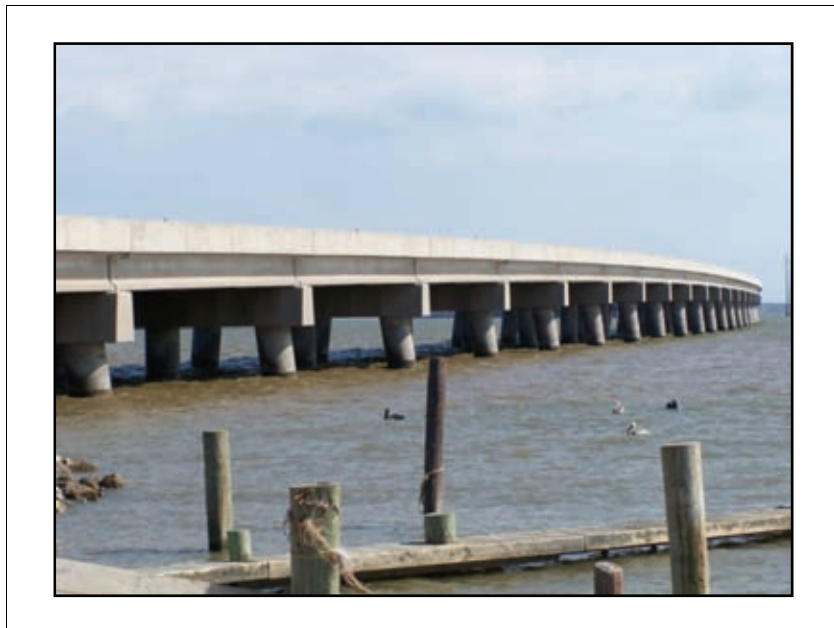
*Figure 2-3. The Route 193 bridge to Dauphin Island, facing south.*

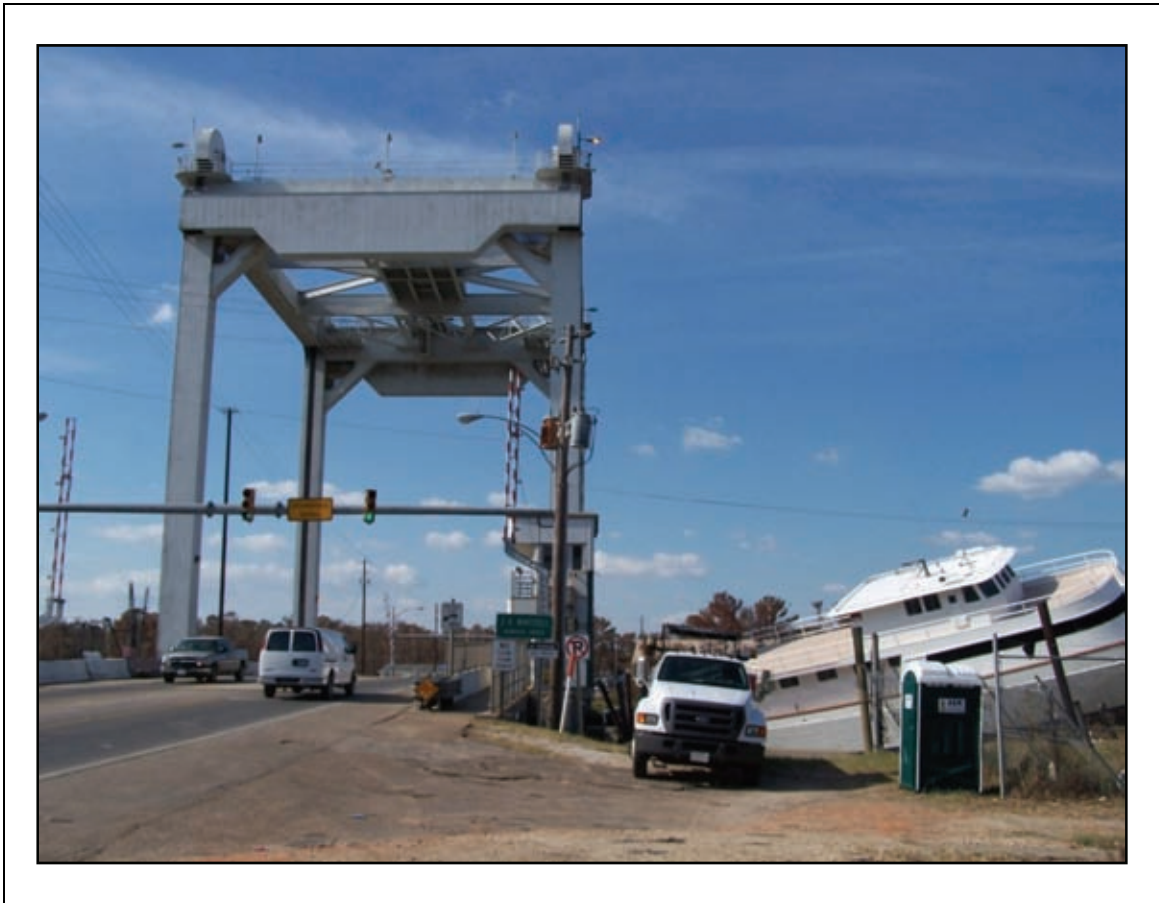
*Figure 2-6. The boat on the right hit this lift bridge. The control room was also flooded.*

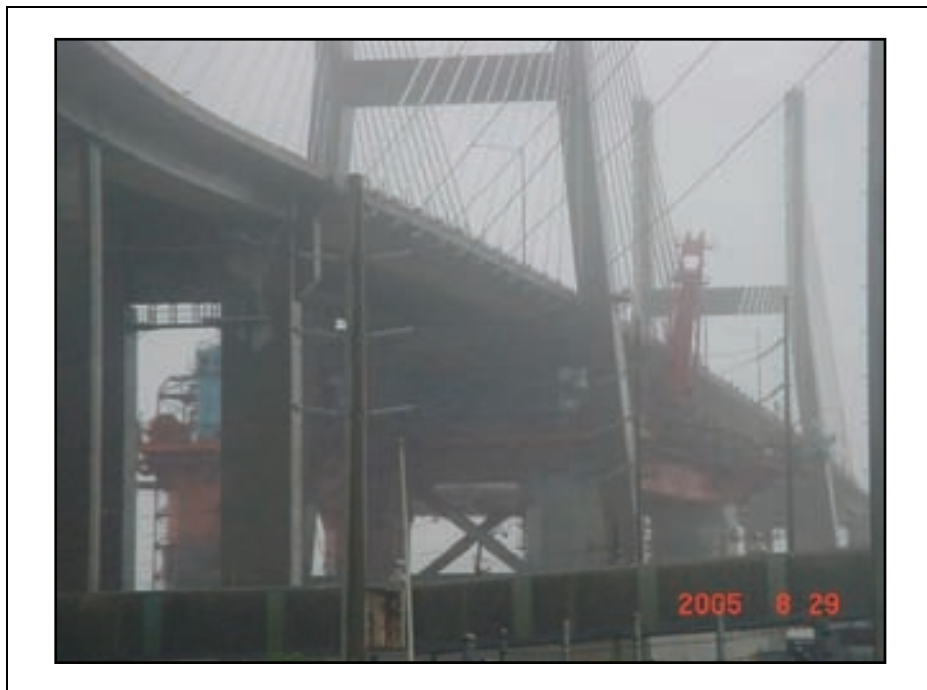
Photo courtesy of the Federal Highway Administration

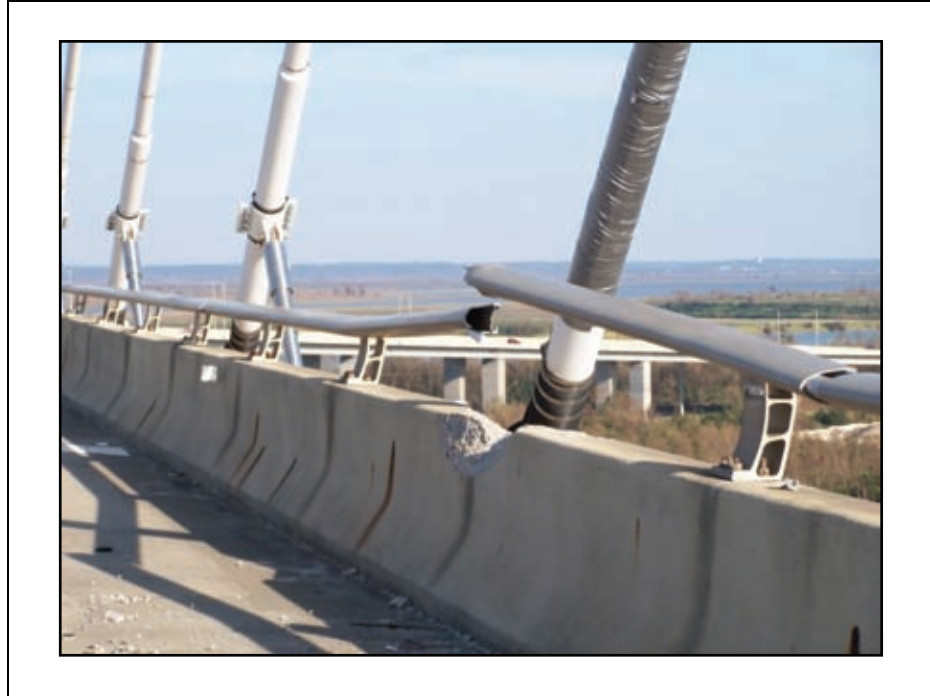
*Figure 2-10. From the topside, damage to the railing and concrete barrier can be seen. A cable is wrapped to prevent moisture ingress, suggesting that it also was struck by the part of the oil platform. Note the silver damping devices on the other cables. These are commonly used on this type of structure to control wind vibration.*

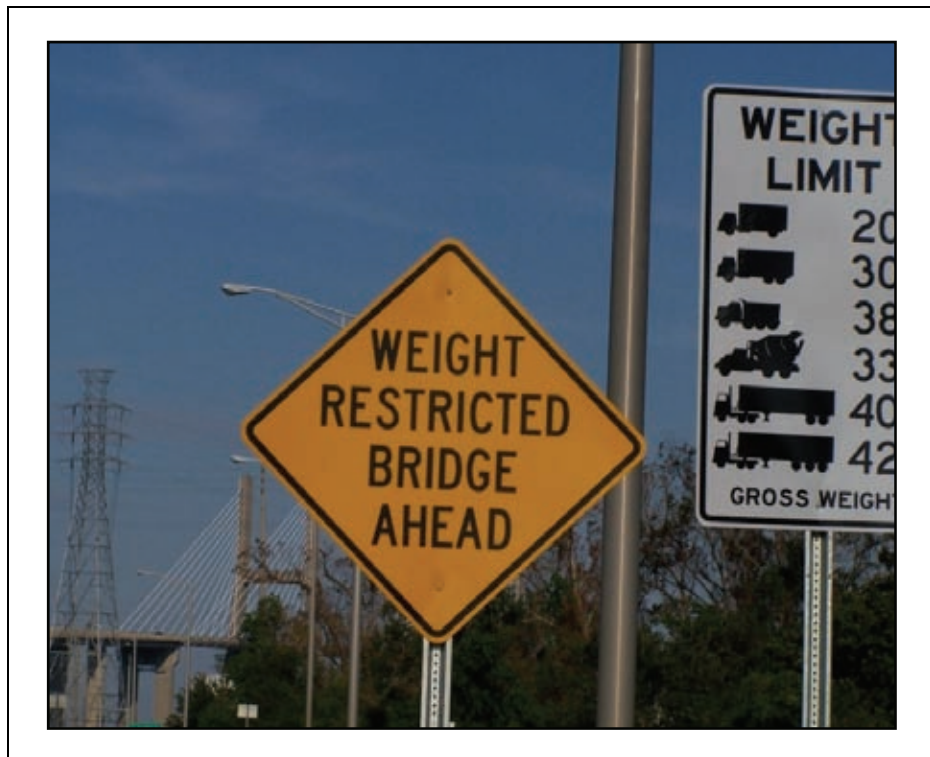
*Figure 2-11. Lane and weight restrictions were necessary after the impact.*

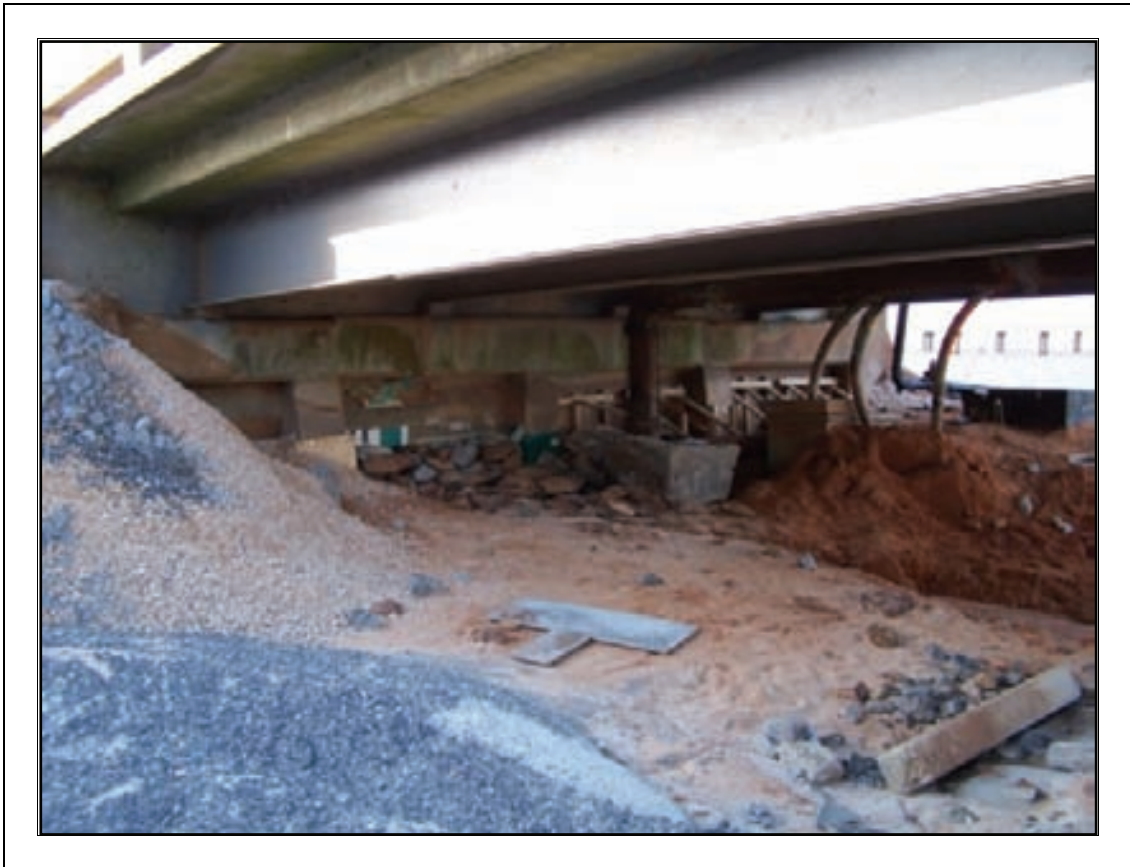
*Figure 2-12. Erosion at the west abutment.*

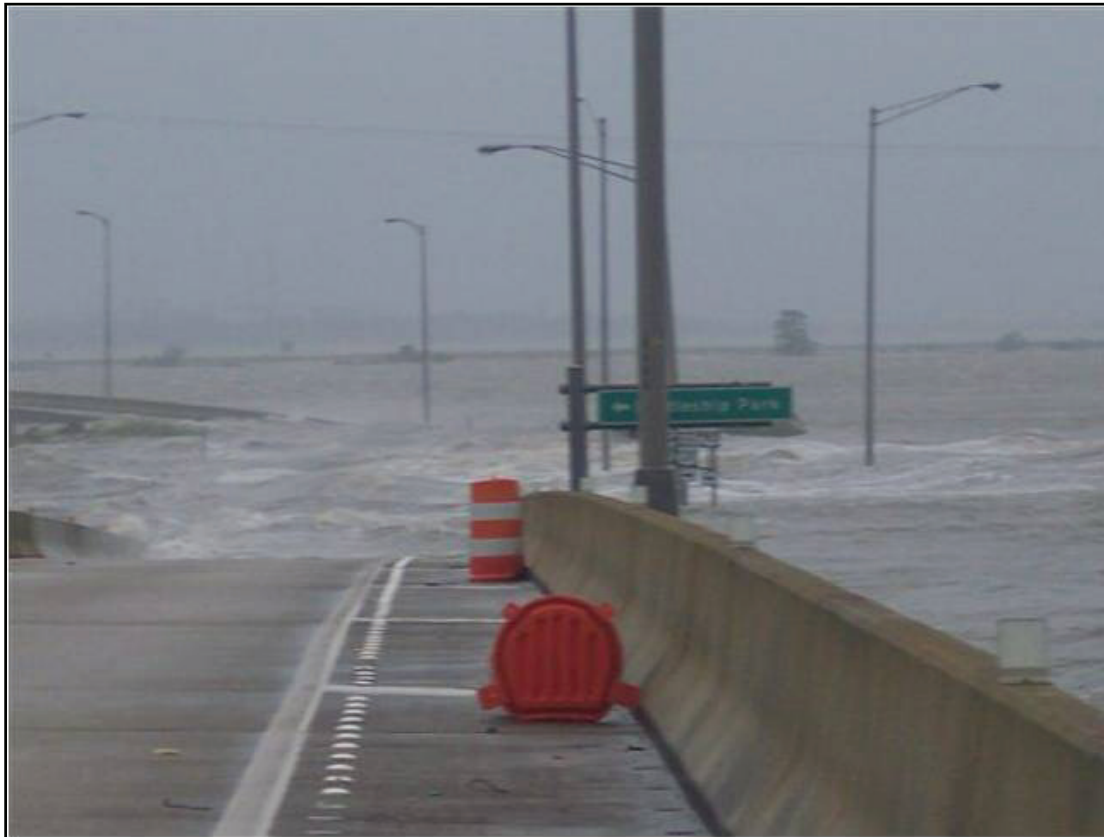
*Figure 2-14. Several spans washed out the day of the storm. This photo faces east.*

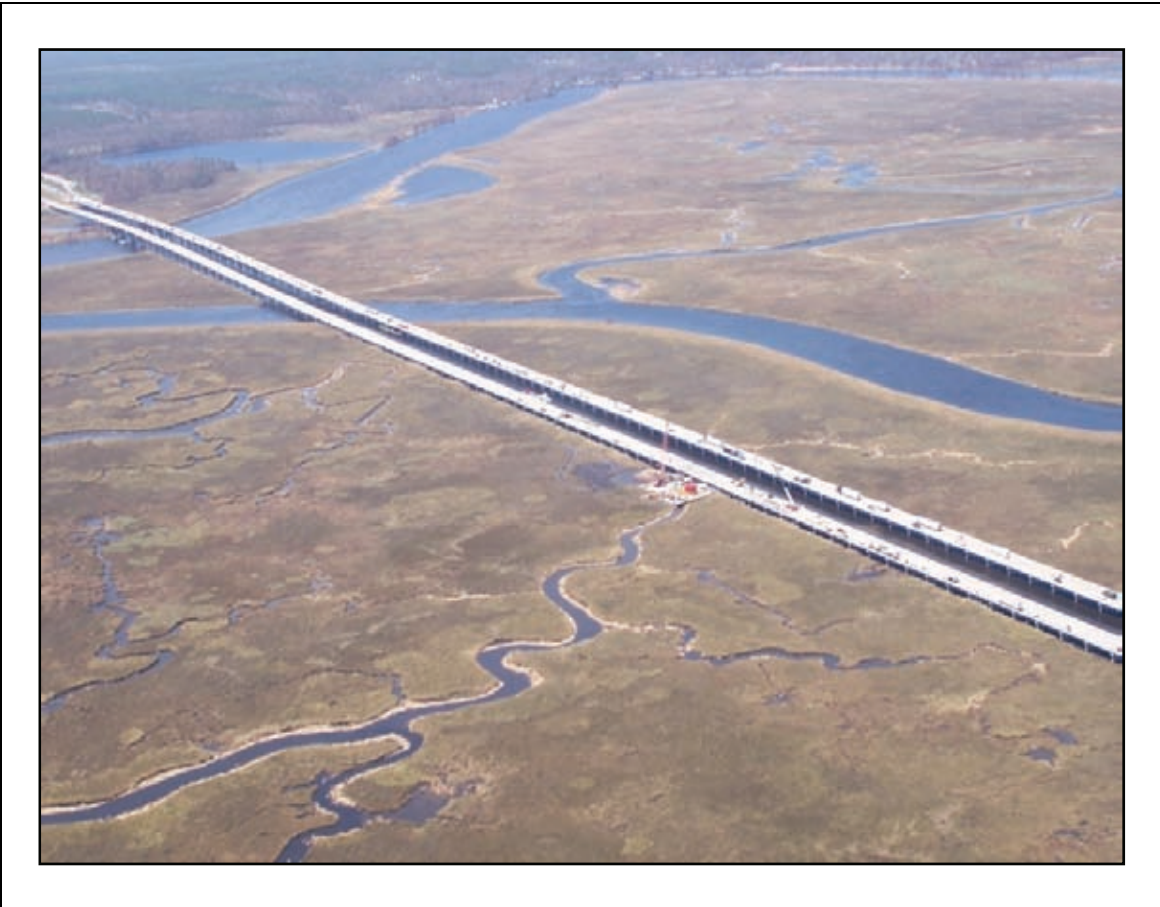
*Figure 2-25. I-10 traverses a large salt bayou near Moss Point.  
It was hit and damaged by a stray barge.*

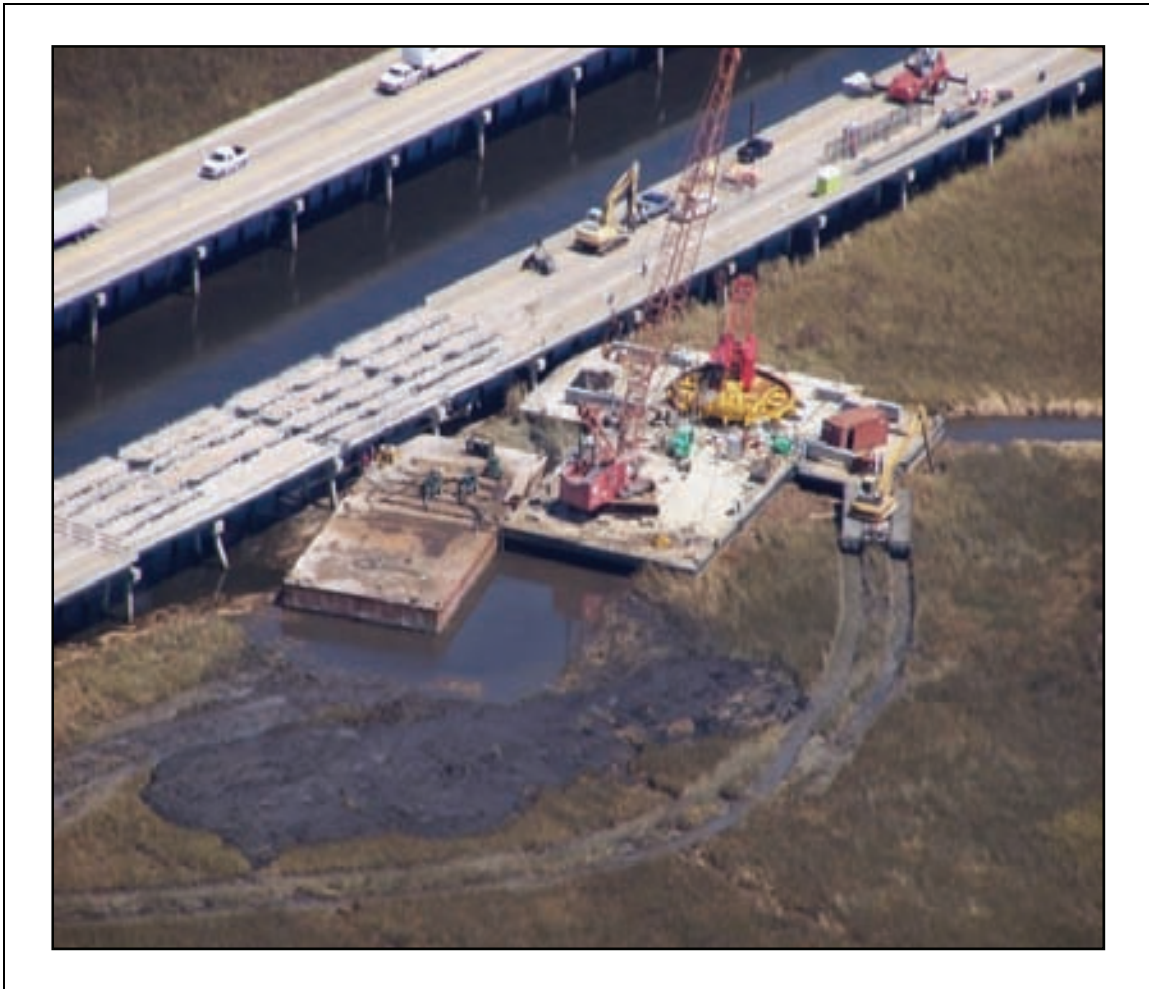
*Figure 2-26 The concrete deck was being removed from the I-10 EB bridge on September 11, 2005.*

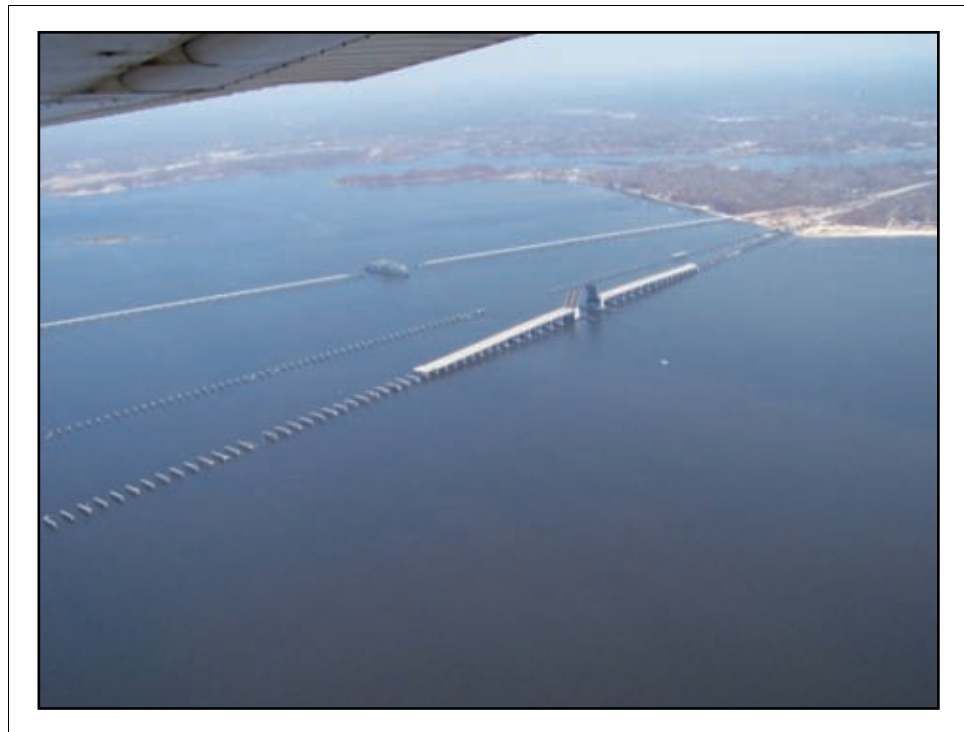
*Figure 2-33. This Post-Katrina photograph (taken 9/11/05) shows the three bay crossings from Biloxi facing east toward Ocean Springs. Many spans are missing.*

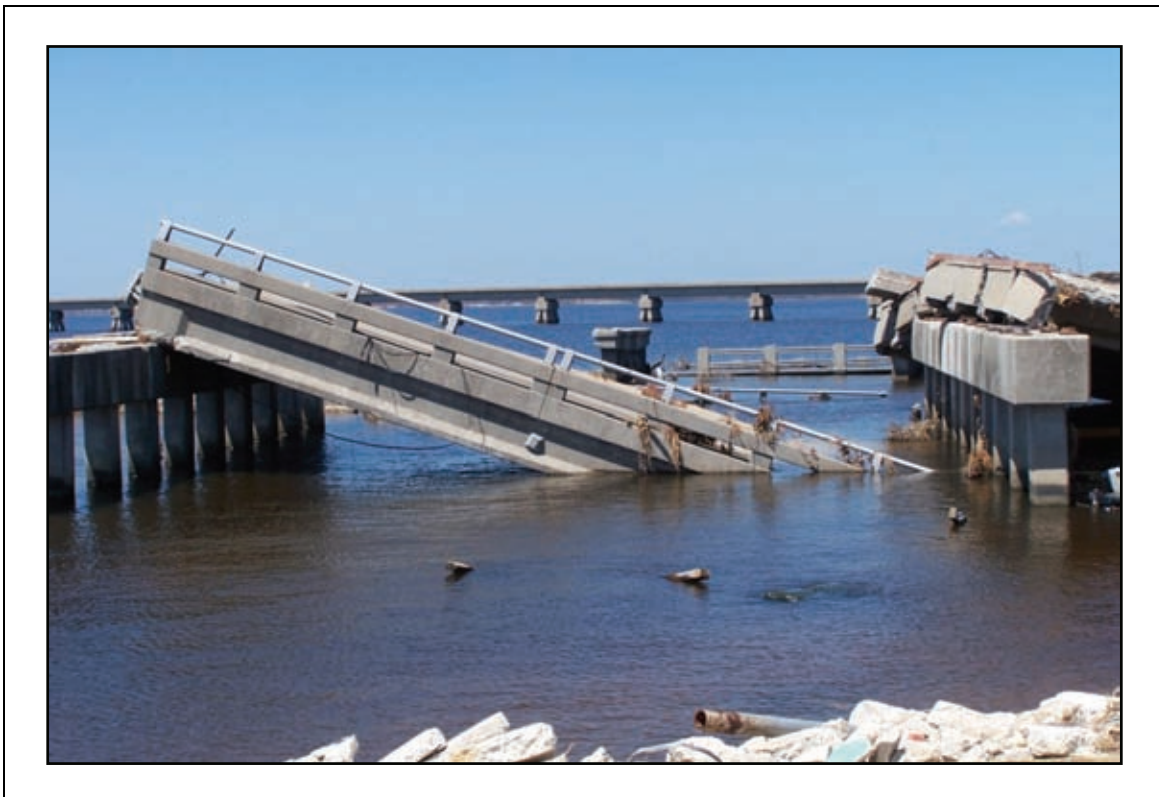
*Figure 2-36. Although both were subjected to essentially the same conditions, there was a remarkable difference in performance between the US-90 (foreground) and CSX bridges (background).*

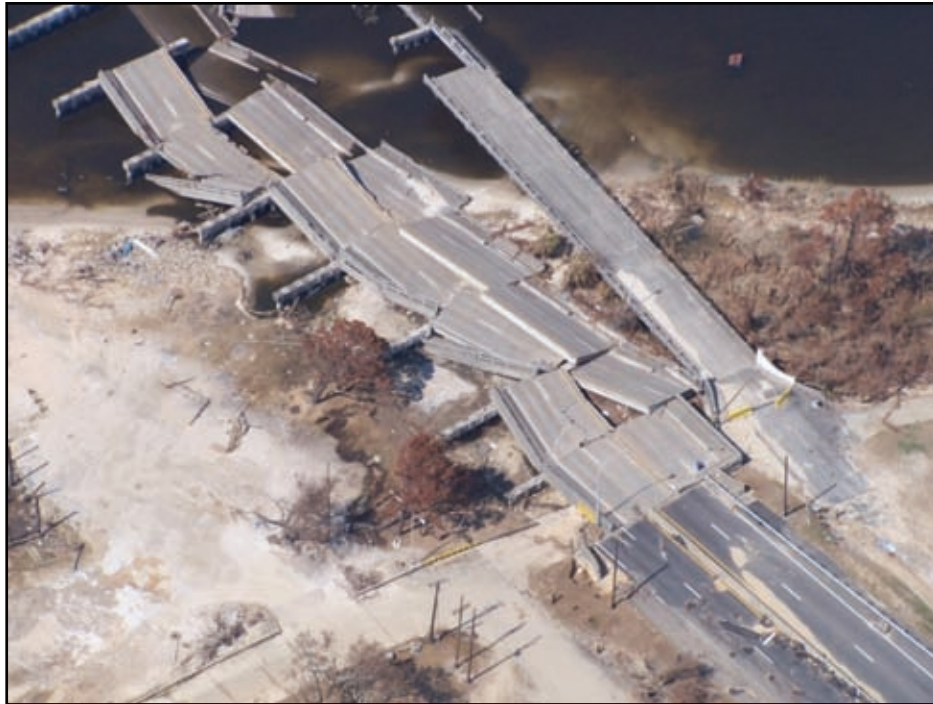
*Figure 2-37. US-90 (and old route 90 on the right) at the east abutment, looking NW.*

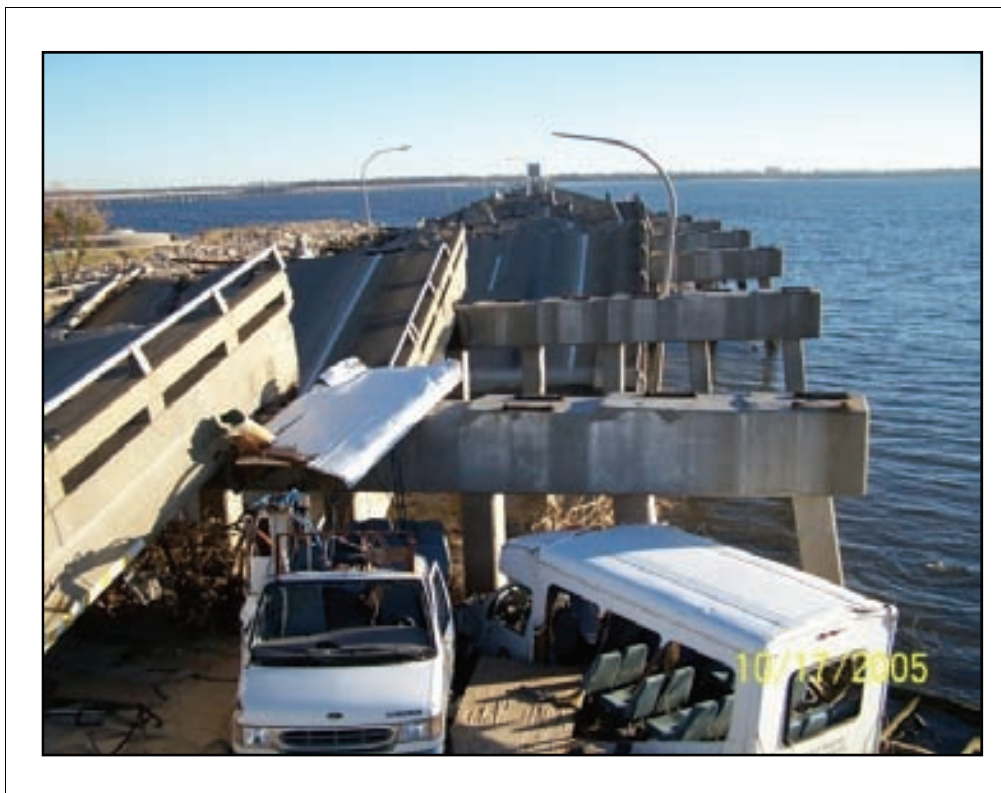
*Figure 2-40. Floating debris such as vehicles and shipping containers also caused damage to bridges. This photo was taken at the west end of the US-90 bridge.*

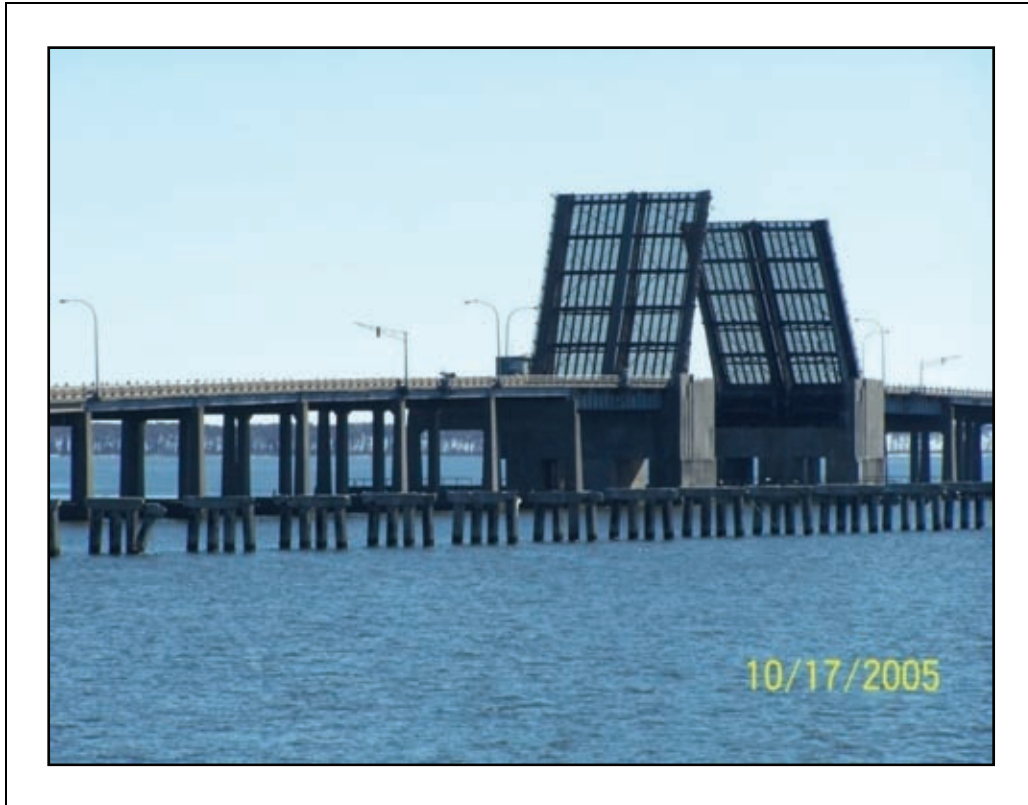
*Figure 2-41. The center spans survived because they were at an elevation above that of the surge level.*

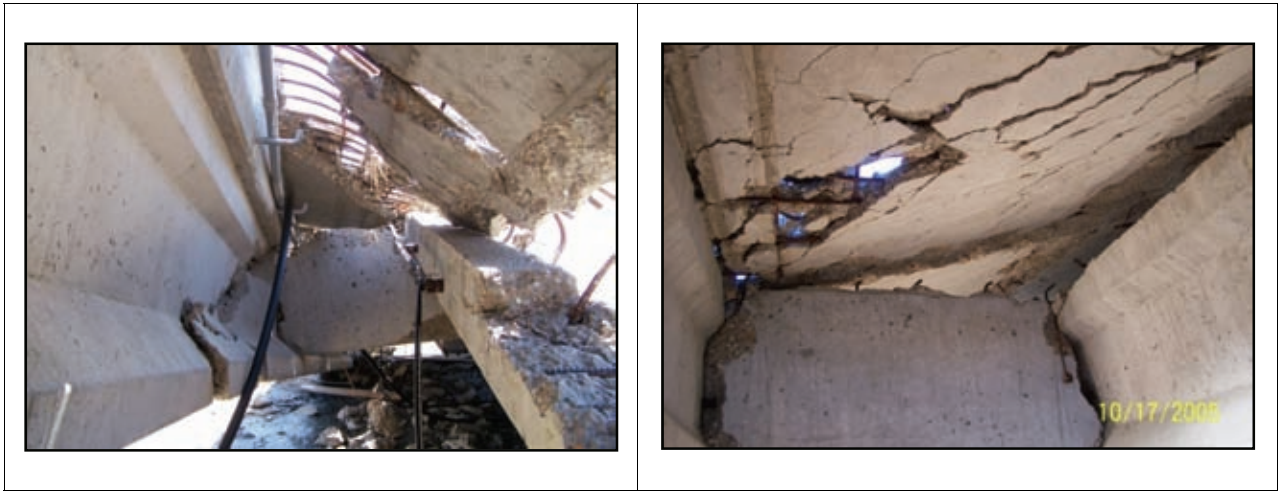
*Figure 2-44. The beam, deck and diaphragm failed under surge loading.*

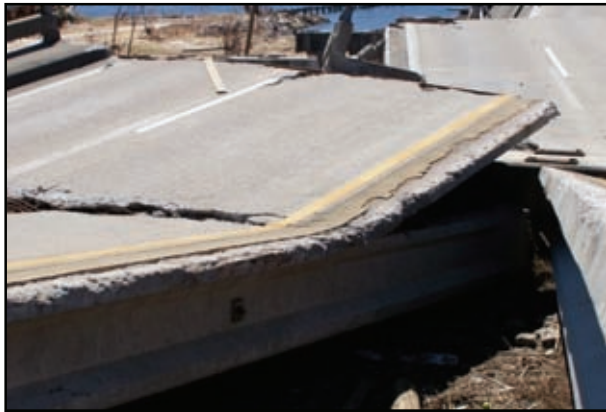
*Figure 2-46. The 7 inch CIP composite deck has been peeled away from the P/S concrete beam and has broken transversely, exposing its steel reinforcement. This photo was taken at the east end of the US-90 bridge.*

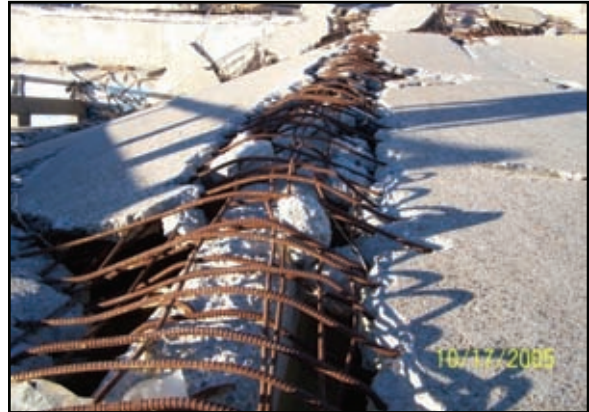
*Figure 2-47. Steel reinforcing bars is all that remains of the concrete deck above the concrete girder. This photo was taken at the west end of the US-90 bridge.*

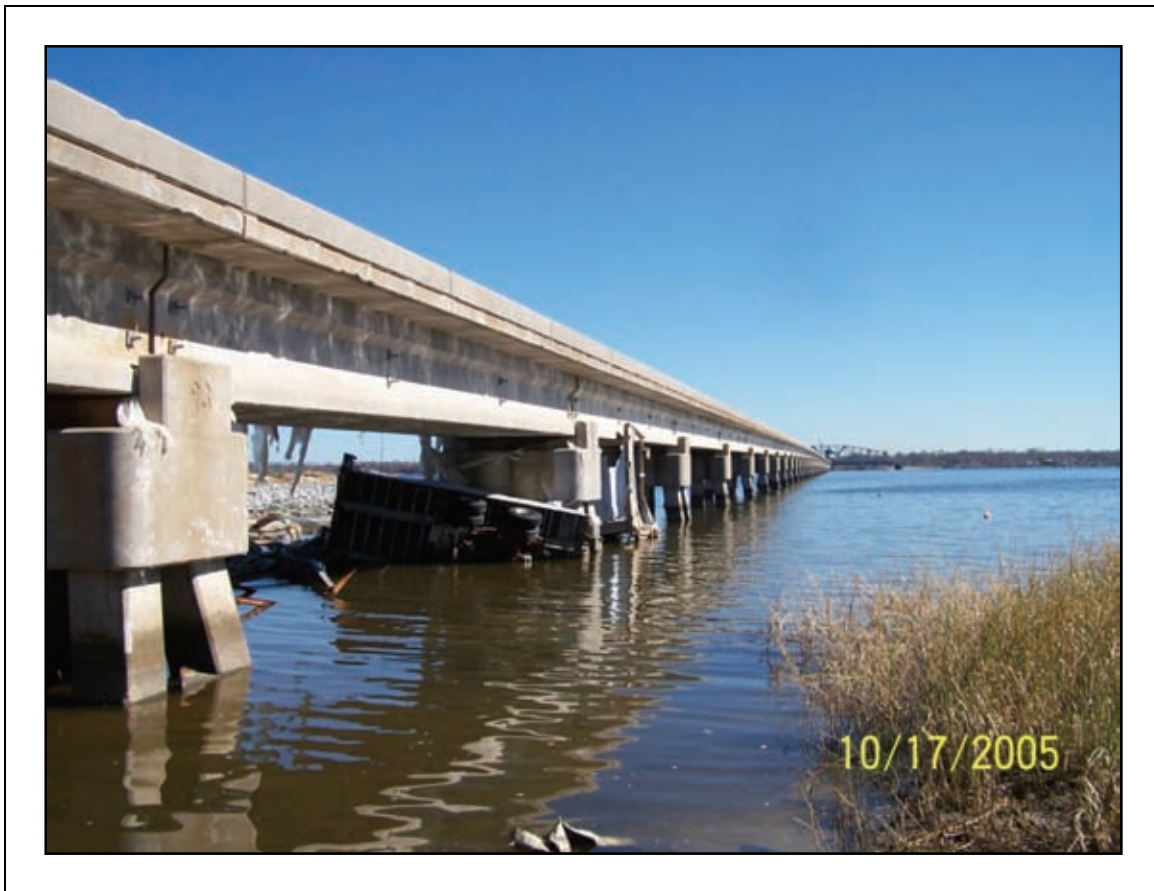
Figure 2-53. CSX railroad bridge, looking east from the west abutment.

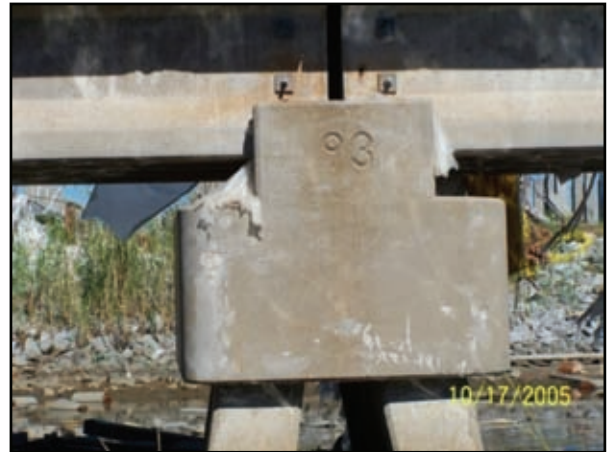
*Figure 2-61. A simple concept, like permanently inscribing the pier number in the concrete, makes for positive identification and clear communication. This undoubtedly served the owner well when during repair operations as well as being useful during reconnaissance surveys.*

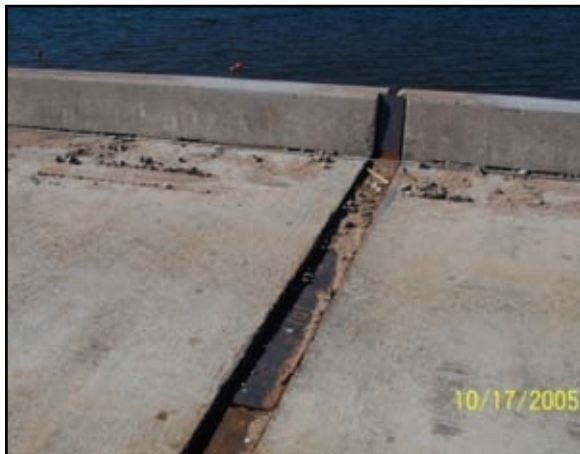
*Figure 2-62. This steel plate prevents debris from falling through the joints between spans but also tightens up the superstructure assembly to restrict movement.*

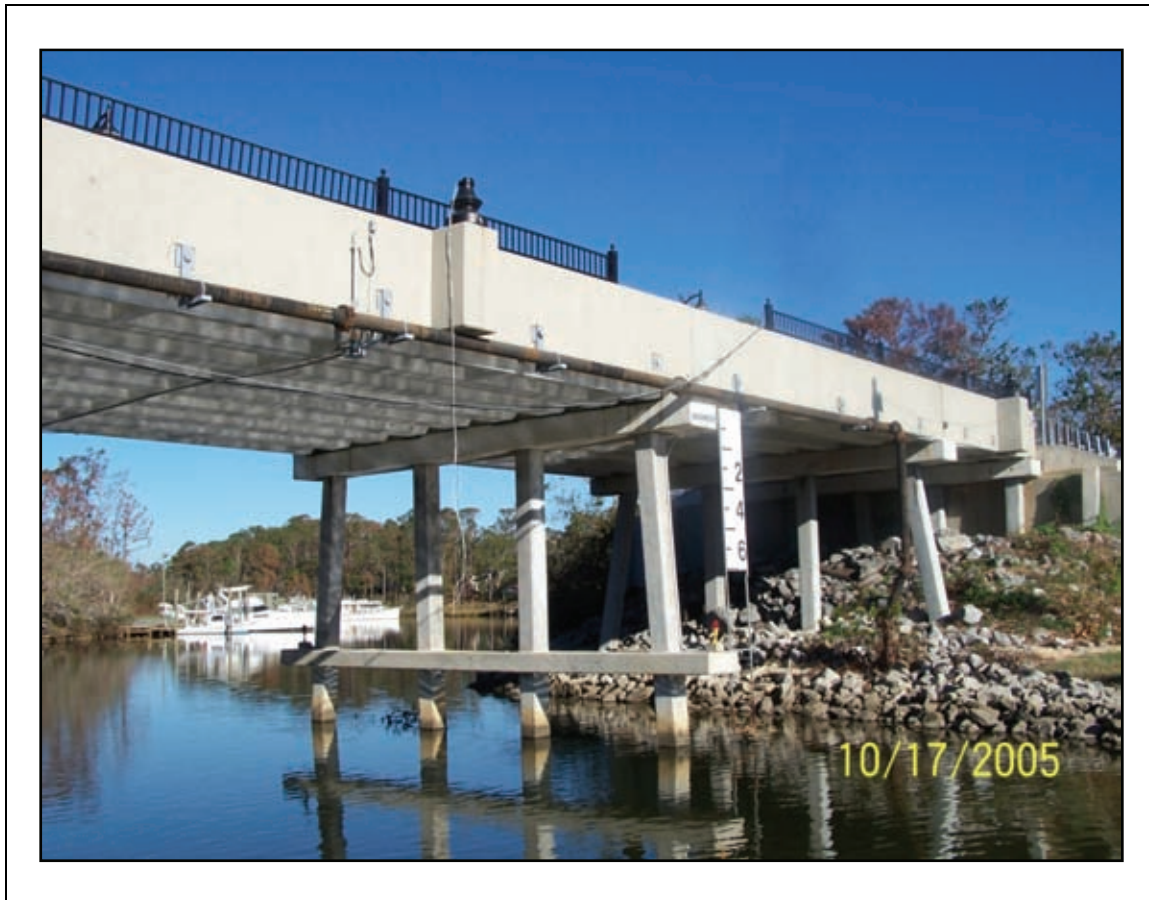
*Figure 2-64. The Shearwater bridge is very close to Biloxi Bay and was submerged under water.*

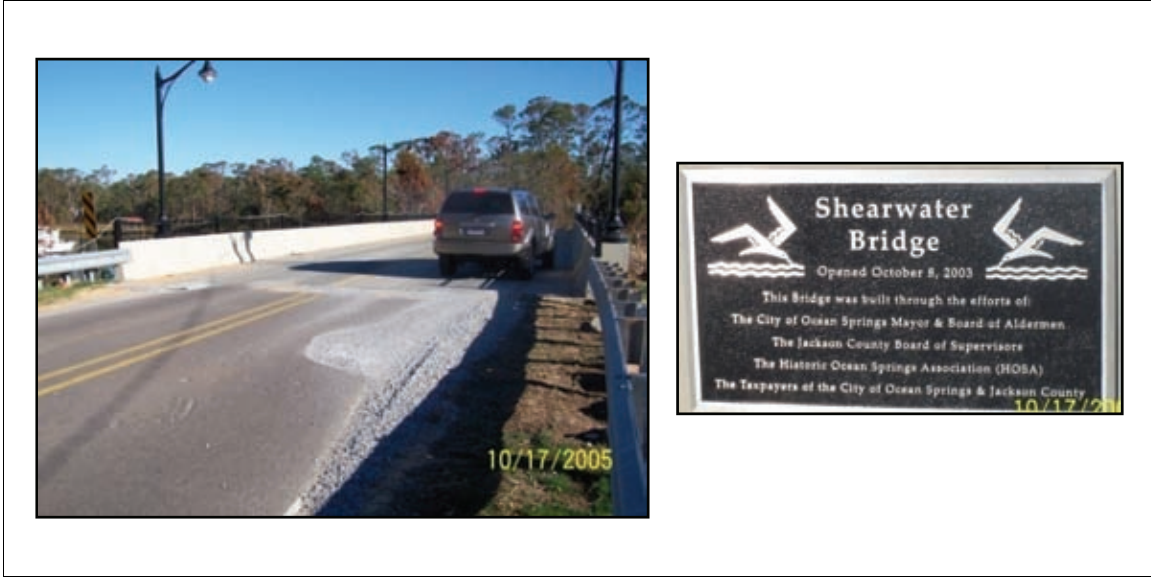
Figure 2-65. Approach erosion was easily repaired.
