MCEER SPECIAL REPORT SERIES

Engineering and Organizational Issues Before,  
During and After Hurricane Katrina

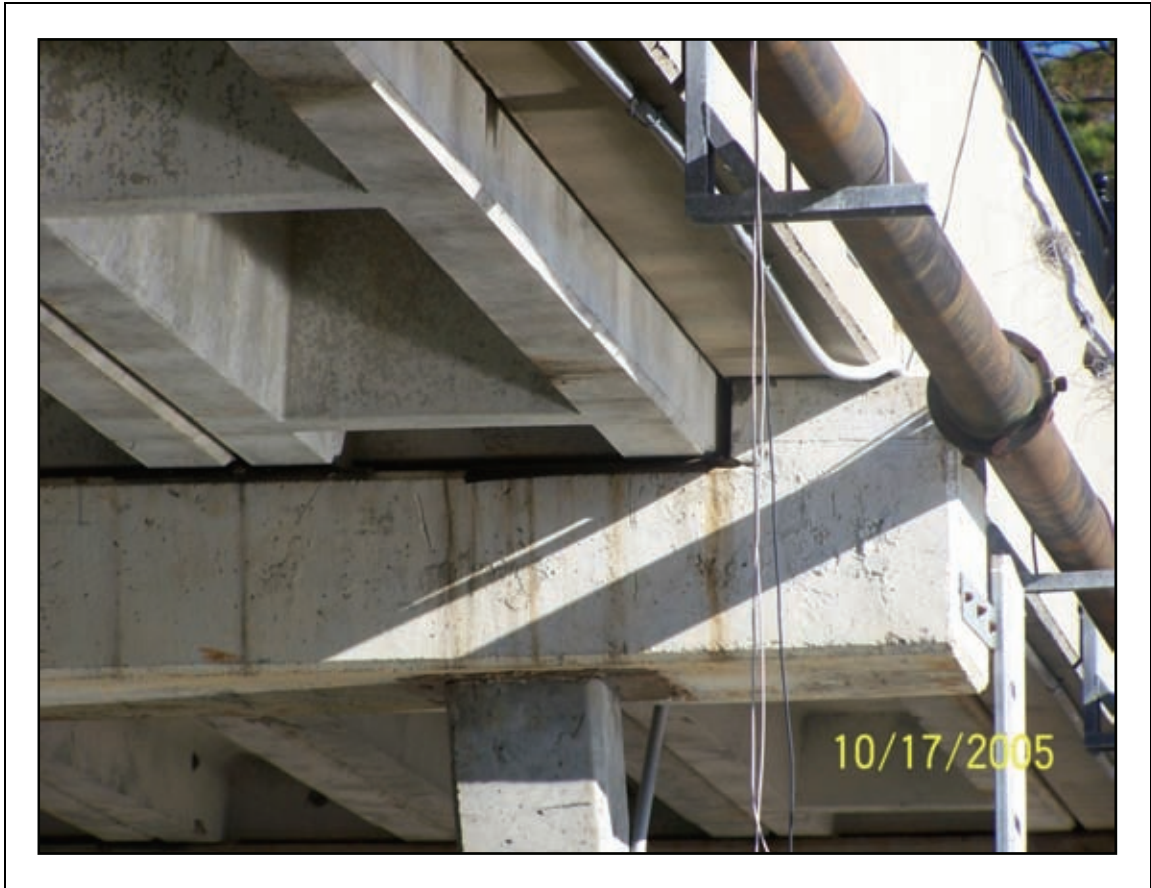
Figure 2-66. The shear block at the end of the pier cap restrained the precast superstructure units.

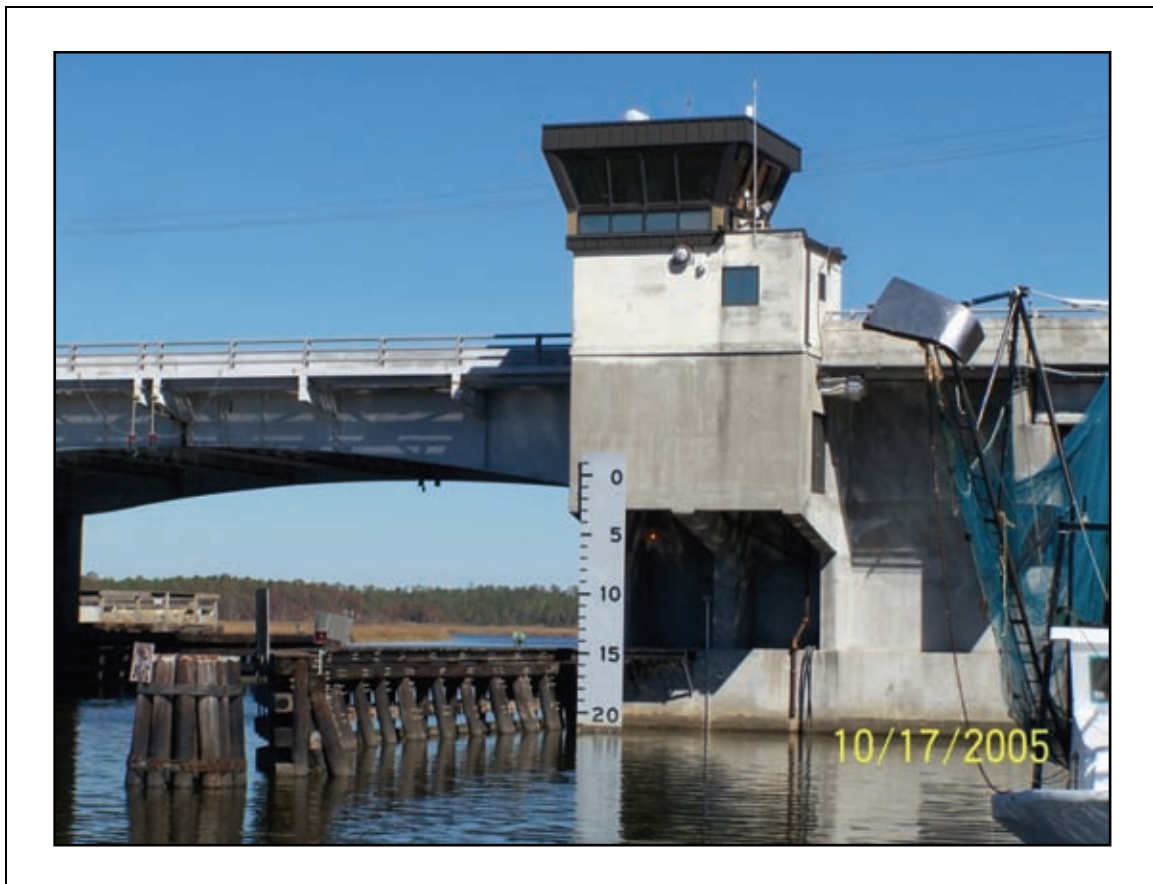
*Figure 2-67. The mechanical room of this moveable bridge flooded, making the bridge inoperable.*

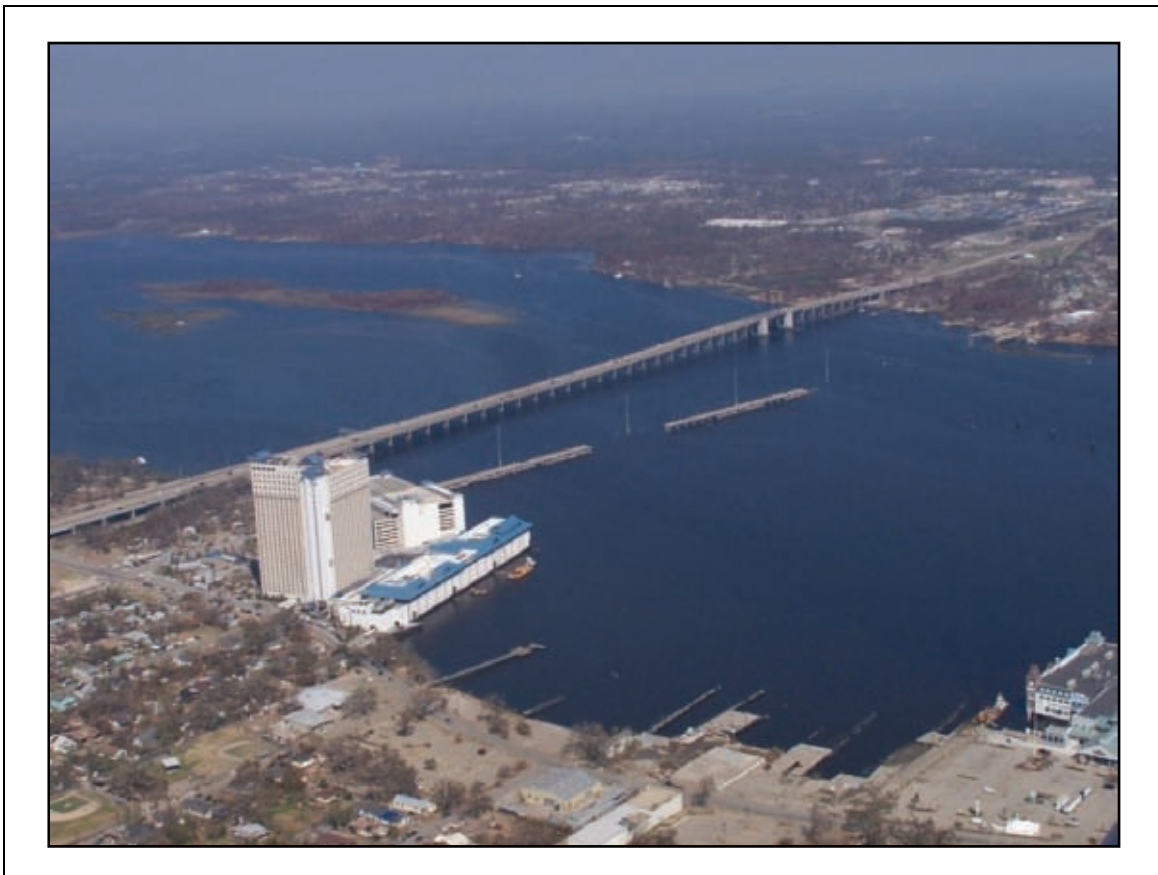
*Figure 2-69. This photograph was taken facing NW. A hotel and floating casino are shown in the foreground. Near it is the bridge referred to as old route 110, with several sections missing. I-110 at the top of the picture was hit by a barge and debris but remained functional.*

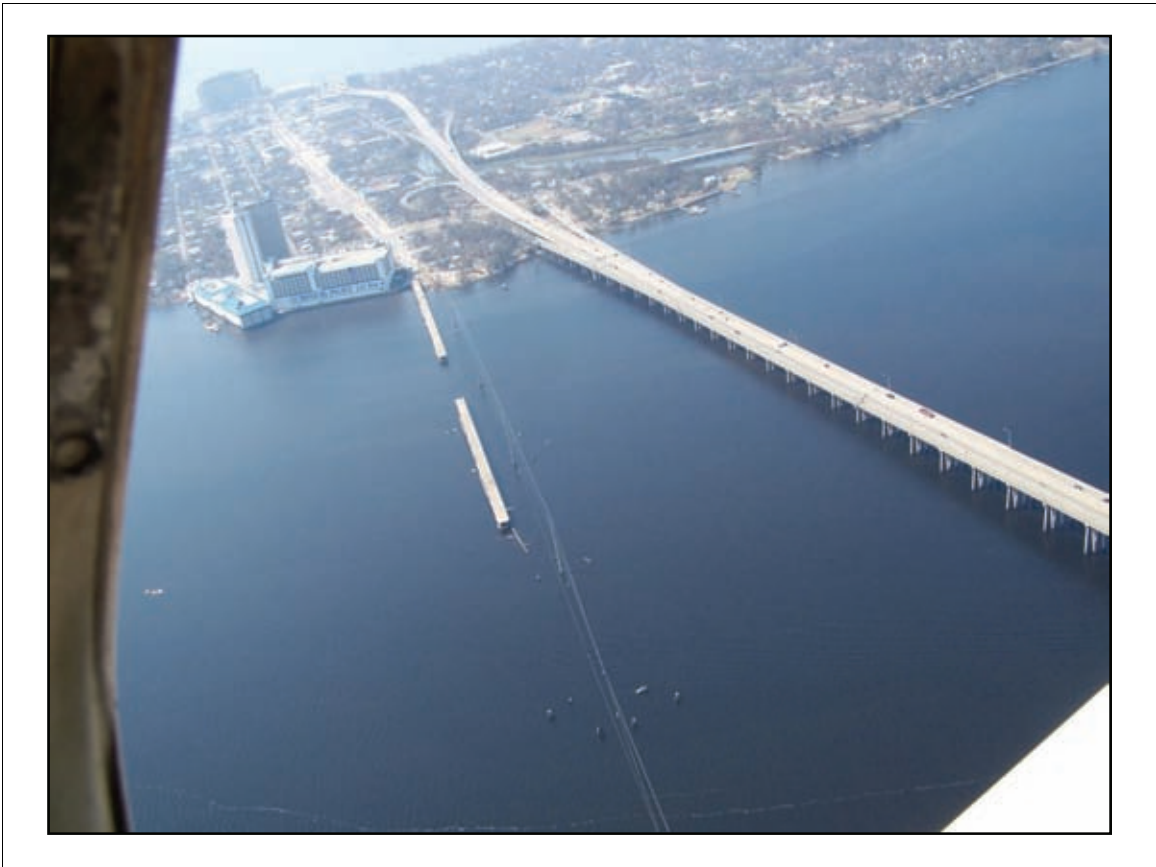
*Figure 2-70. Facing south over Back Bay toward Biloxi and the Gulf.*

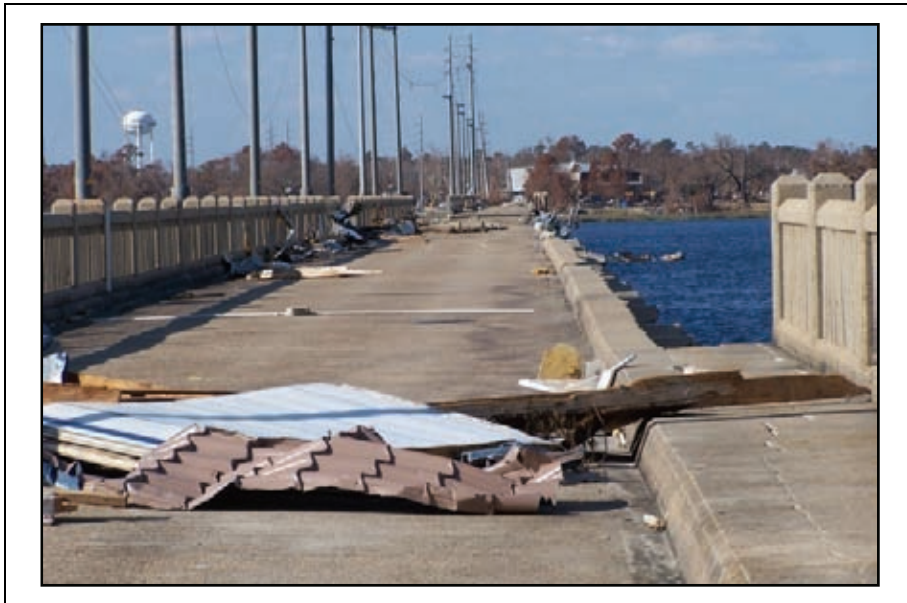
*Figure 2-71. Looking north onto old 110 over Back Bay. Note the missing sidewalk and railing on the east side.*

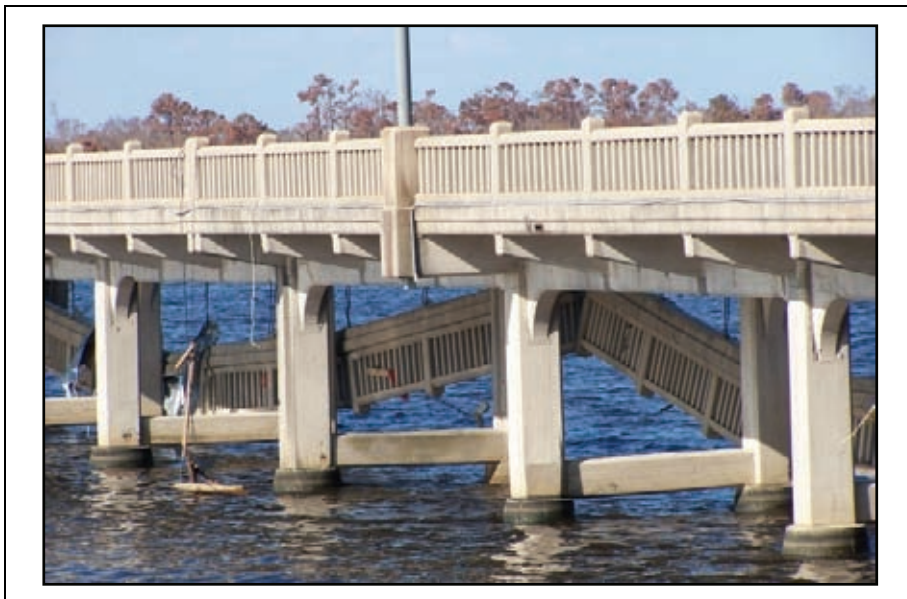
*Figure 2-72. Elevation view looking NE at the old 110 over Back Bay which had been used for a fishing pier. Note the dangling concrete railing on the far (east) side.*

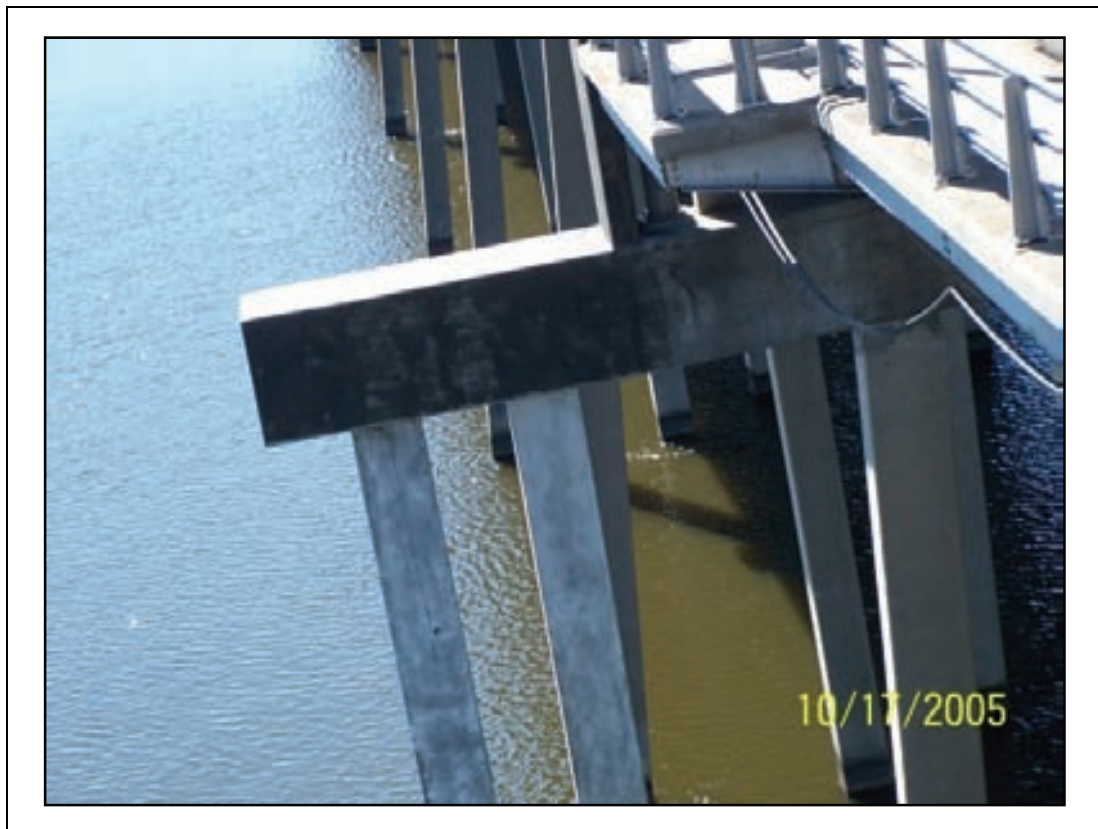
*Figure 2-73. Repairs were made within a few weeks, allowing the bridge to be returned to full service.*

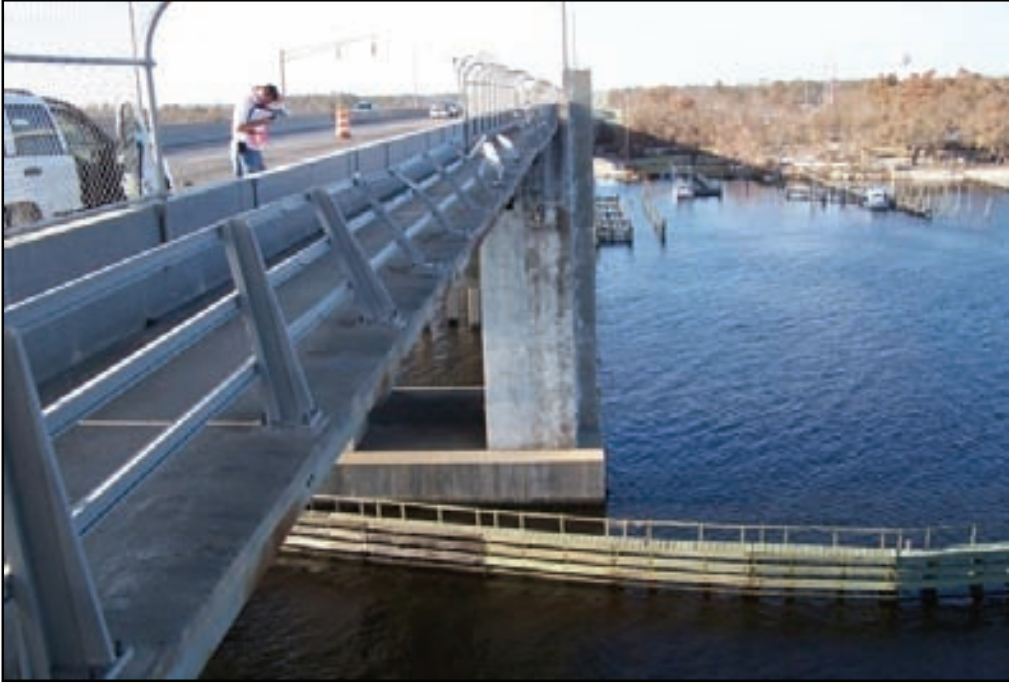
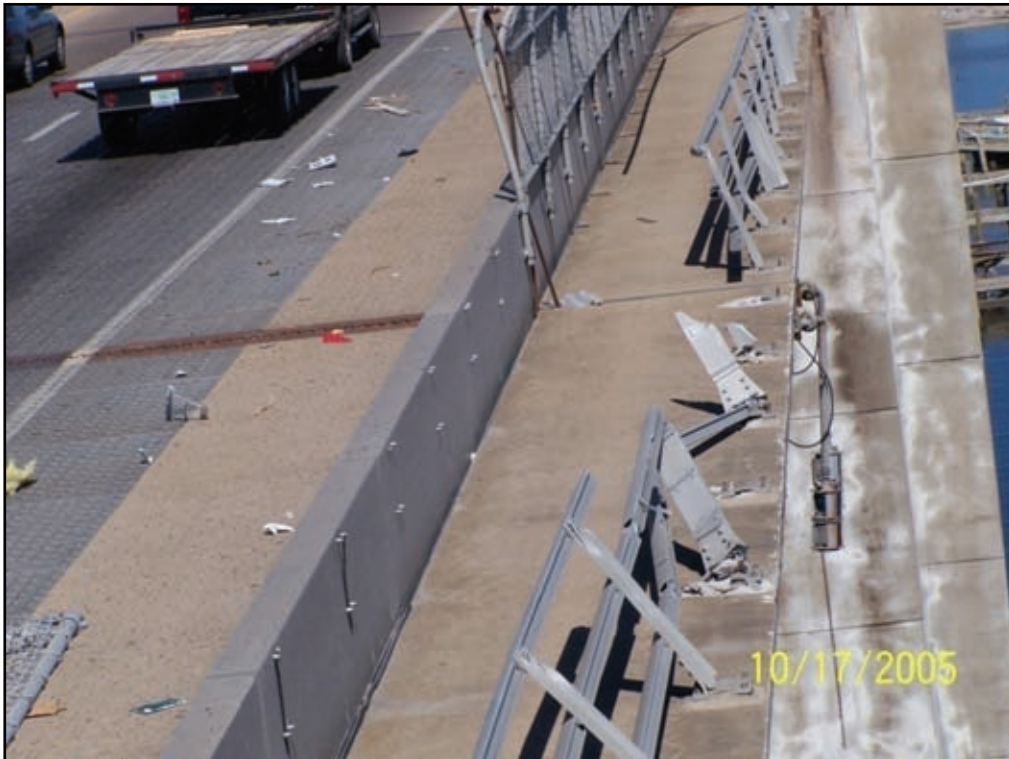
*Figure 2-74. The metal railing on the east fascia of the span that carries I-110 over the navigation channel of Back Bay of Biloxi was damaged by boats or debris carried by the surge.*

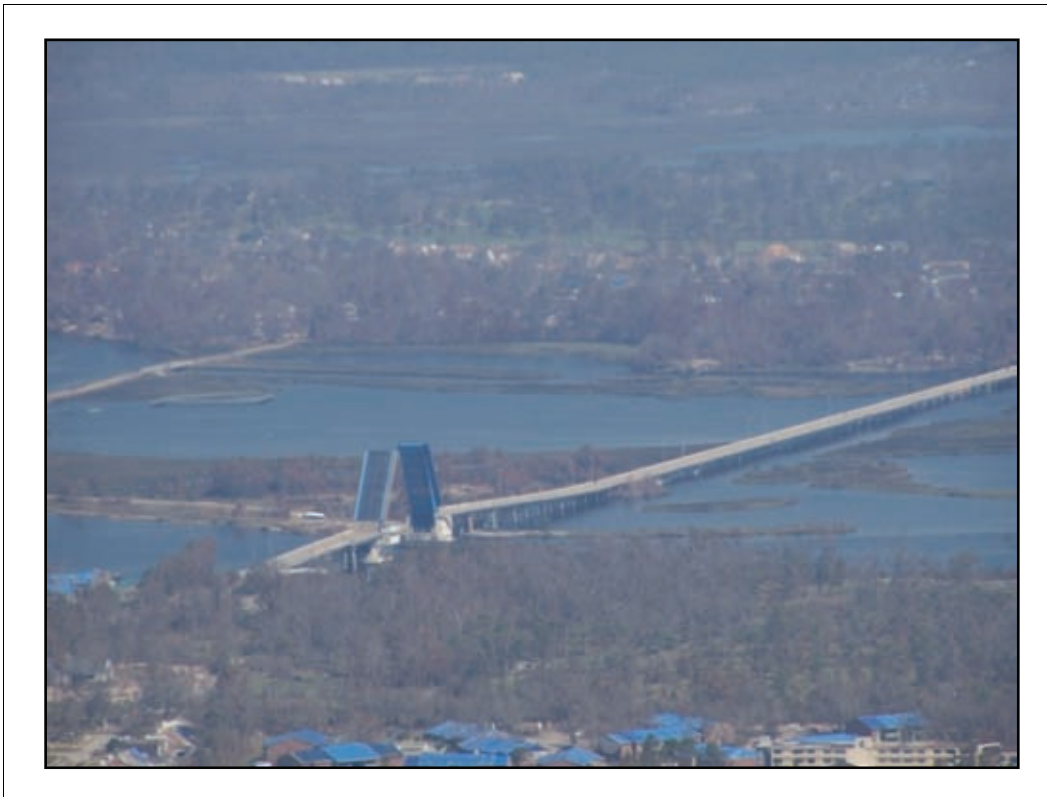
*Figure 2-76. Popps Ferry over Back Bay, upstream of I-110.  
The photograph was taken facing NW.*

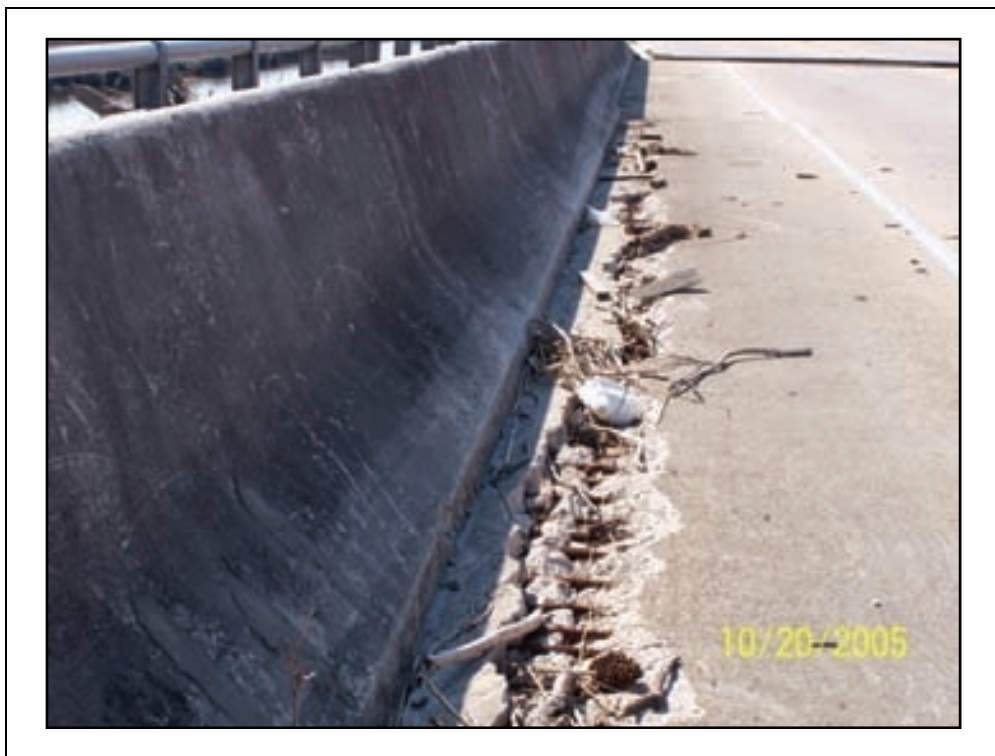
*Figure 2-78. Hydraulic pressure on the backside of this barrier probably caused the spalling found at its toe. This photo is along the east fascia of the bridge.*

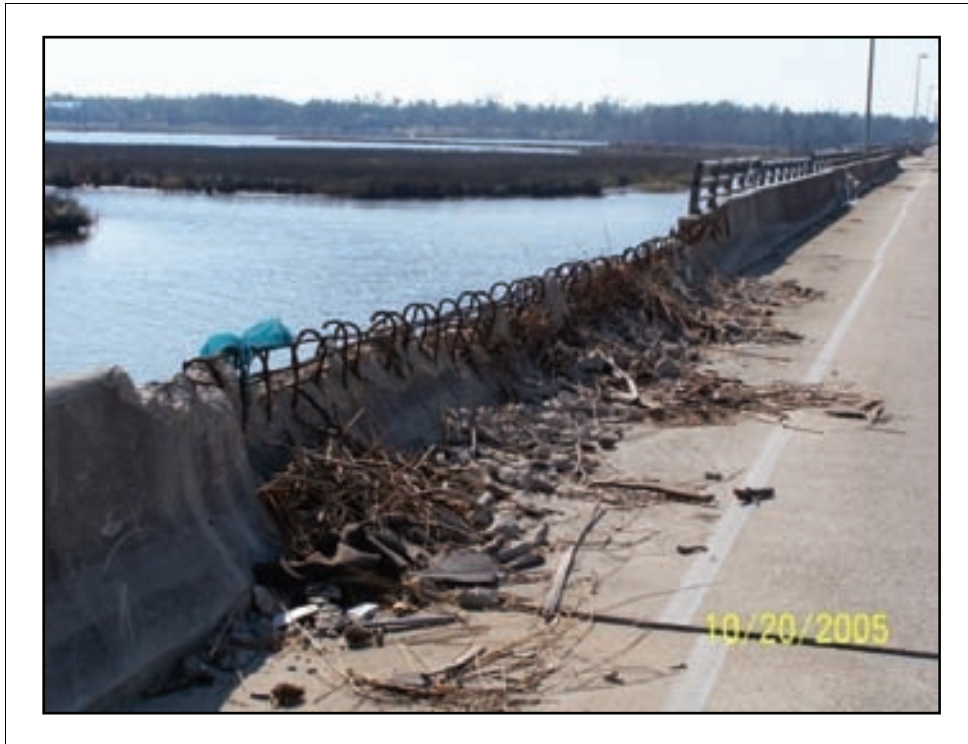
*Figure 2-79. A debris dam pounding on the east fascia probably caused this damage to the concrete parapet.*

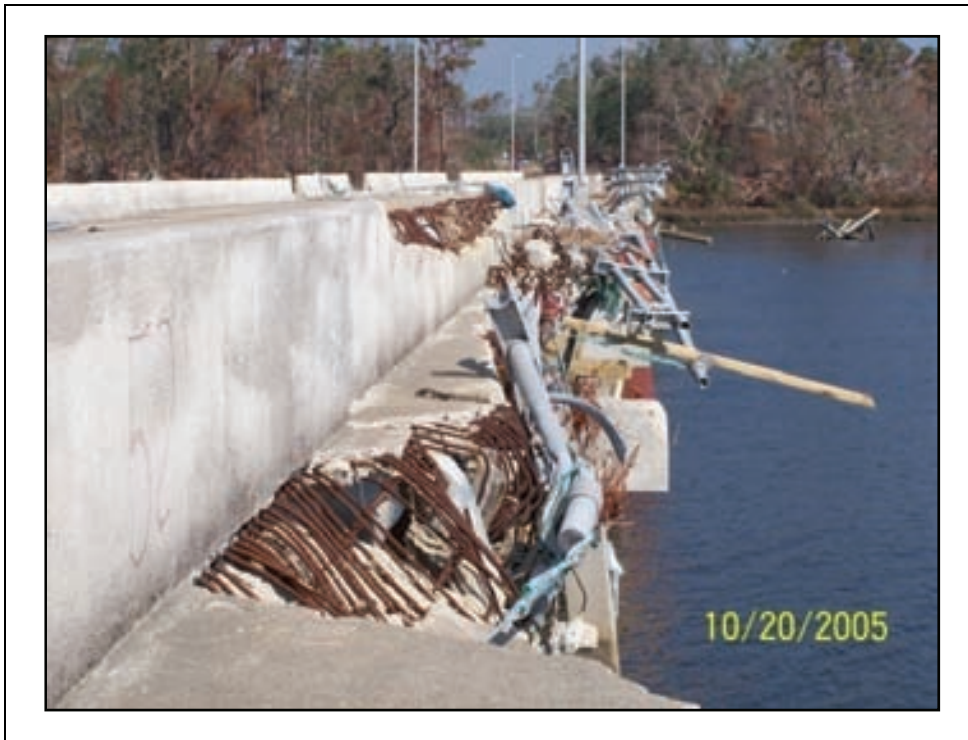
*Figure 2-80. The east fascia was destroyed by debris engulfed in the surge.*

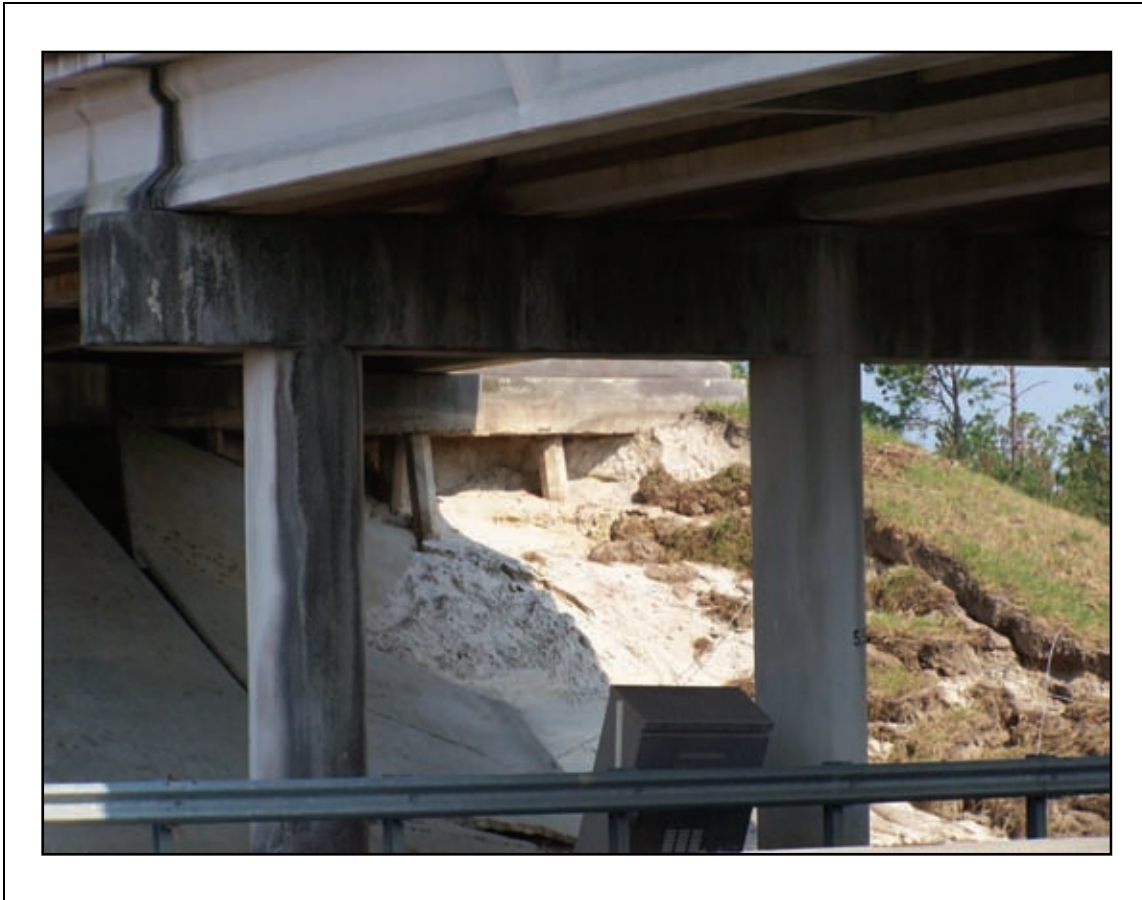
*Figure 2-85. Scour is usually associated with water crossings, but this bridge over a road saw scour.*

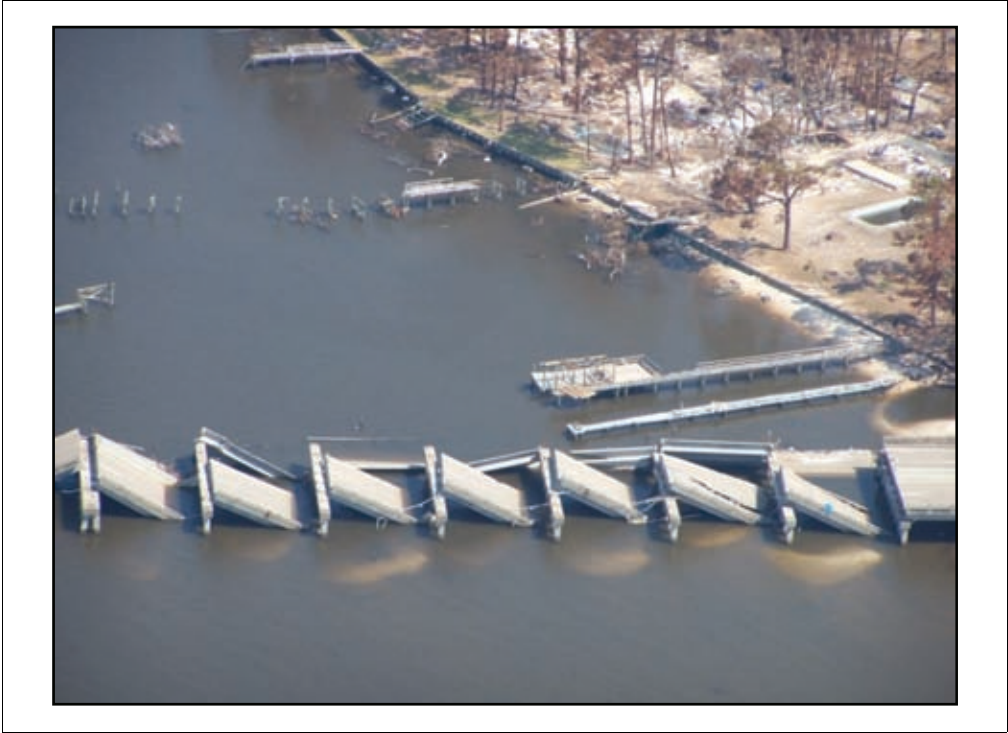
*Figure 2-91. Eastern terminus of US-90 over St. Louis Bay, facing north. Lack of structural continuity contributed to the collapse of many spans in a failure pattern that is almost identical to that witnessed after earthquakes.*

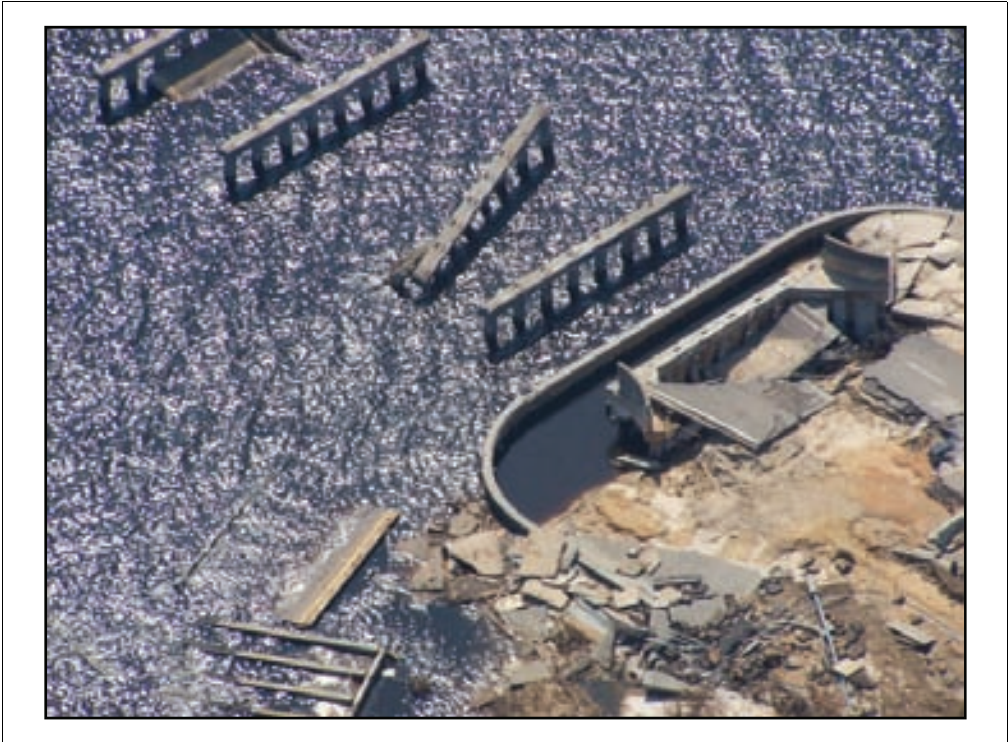
*Figure 2-92. West abutment, looking SE, with an overturned span in the foreground.*

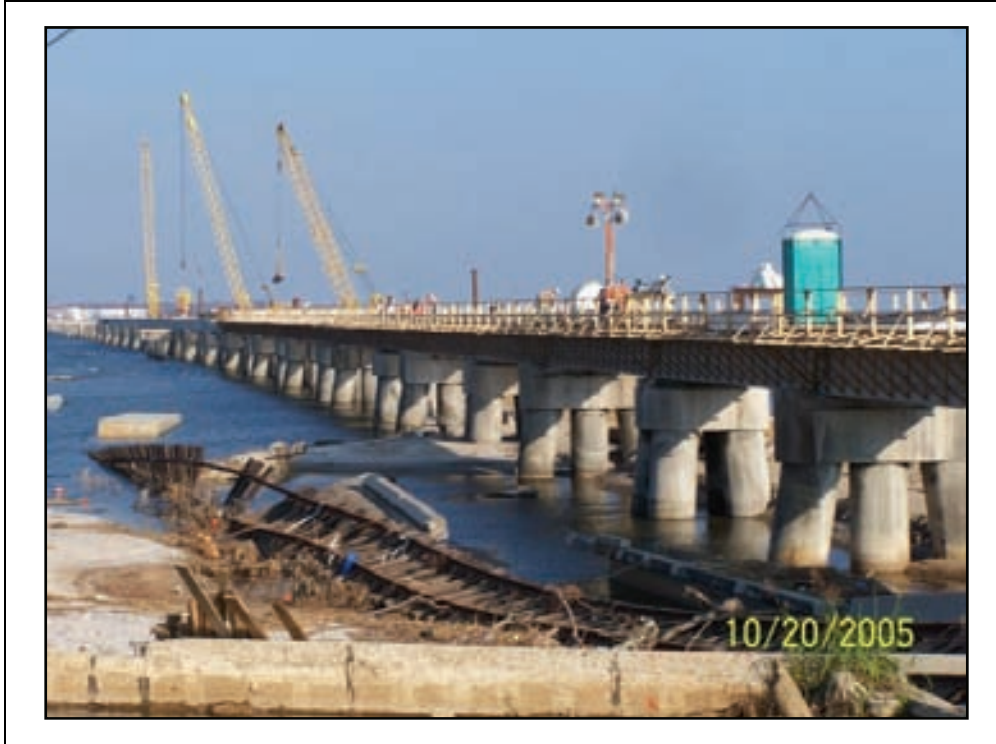
*Figure 2-99. By October 20, repairs the CSX bridge had already begun. In the foreground, on the north side of the bridge, the tracks that had been washed off can be found.*

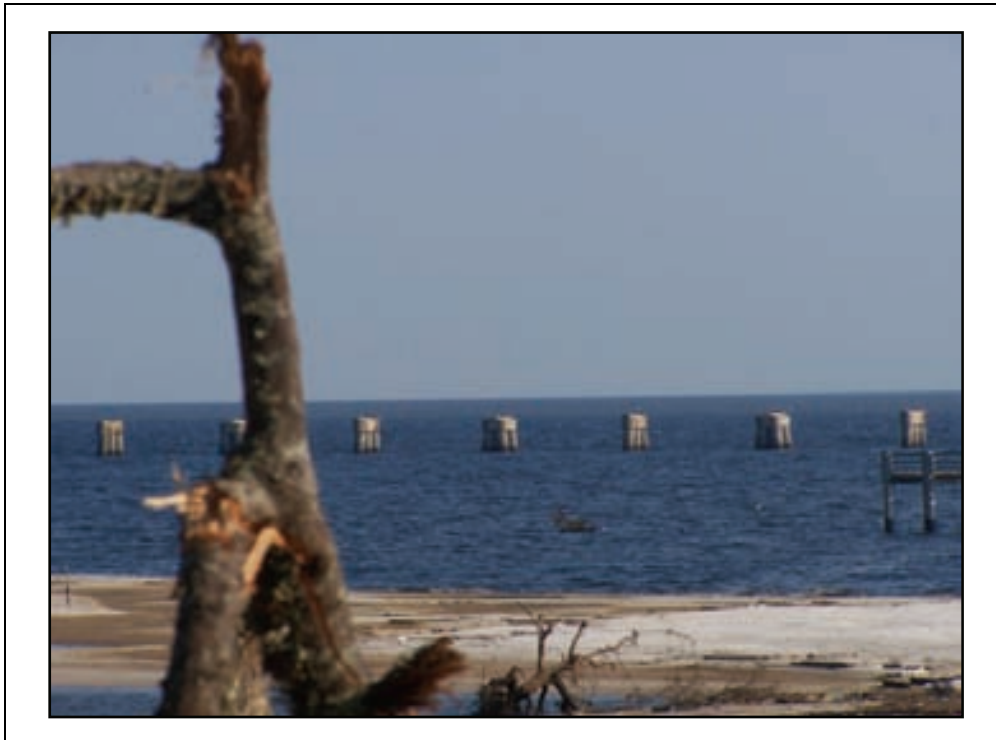
*Figure 2-100. Piers from the CSX railroad bridge remain but the superstructure has been lost.*

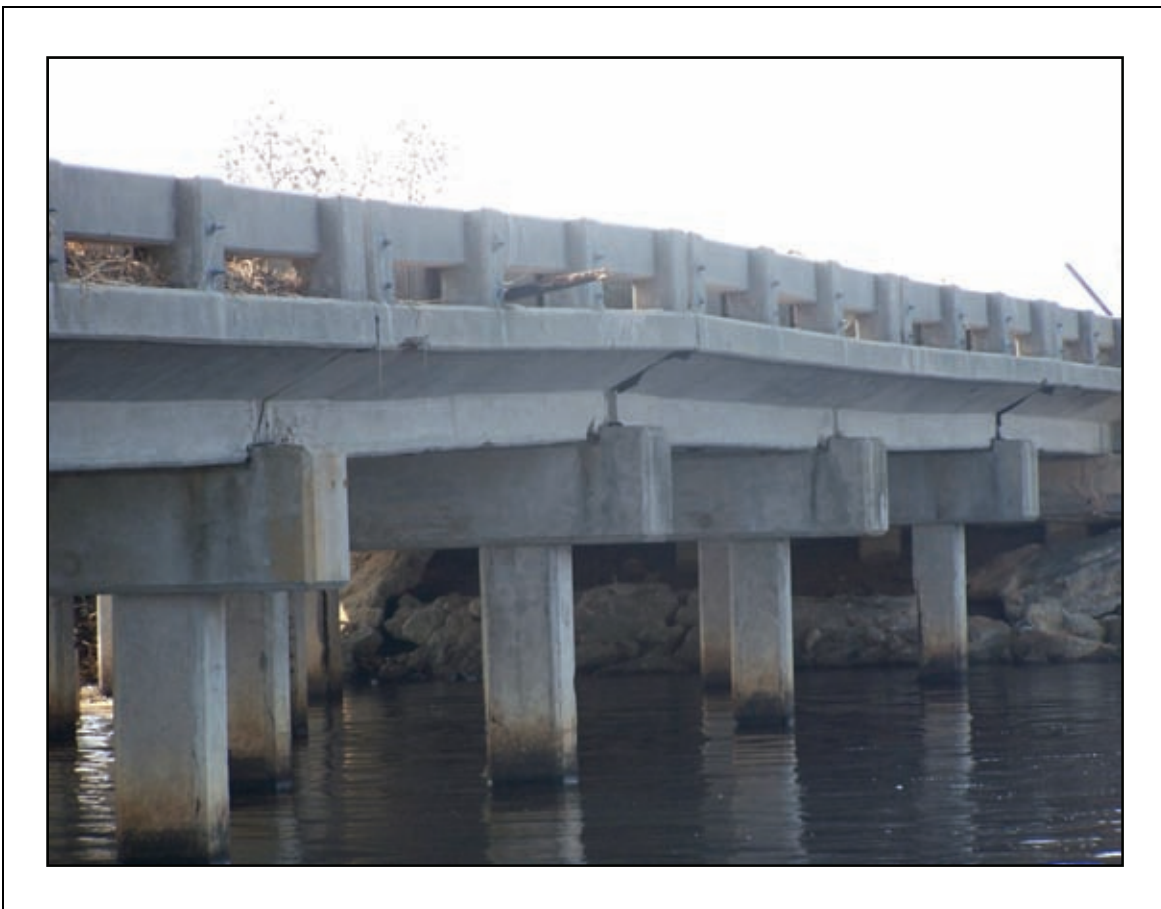
*Figure 2-103. Rte 433 over Salt Bayou was inundated but survived with little damage.*

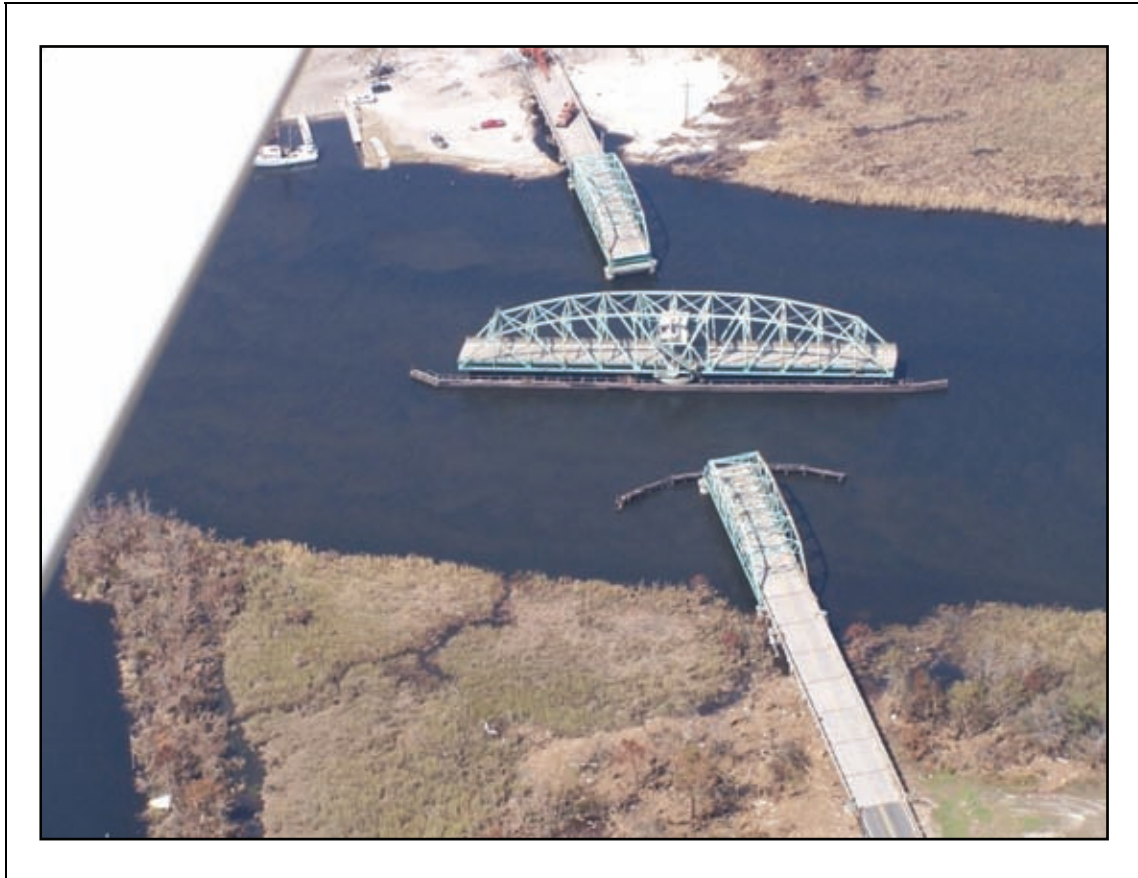
*Figure 2-106. US-90 at East Pearl River; facing west.*

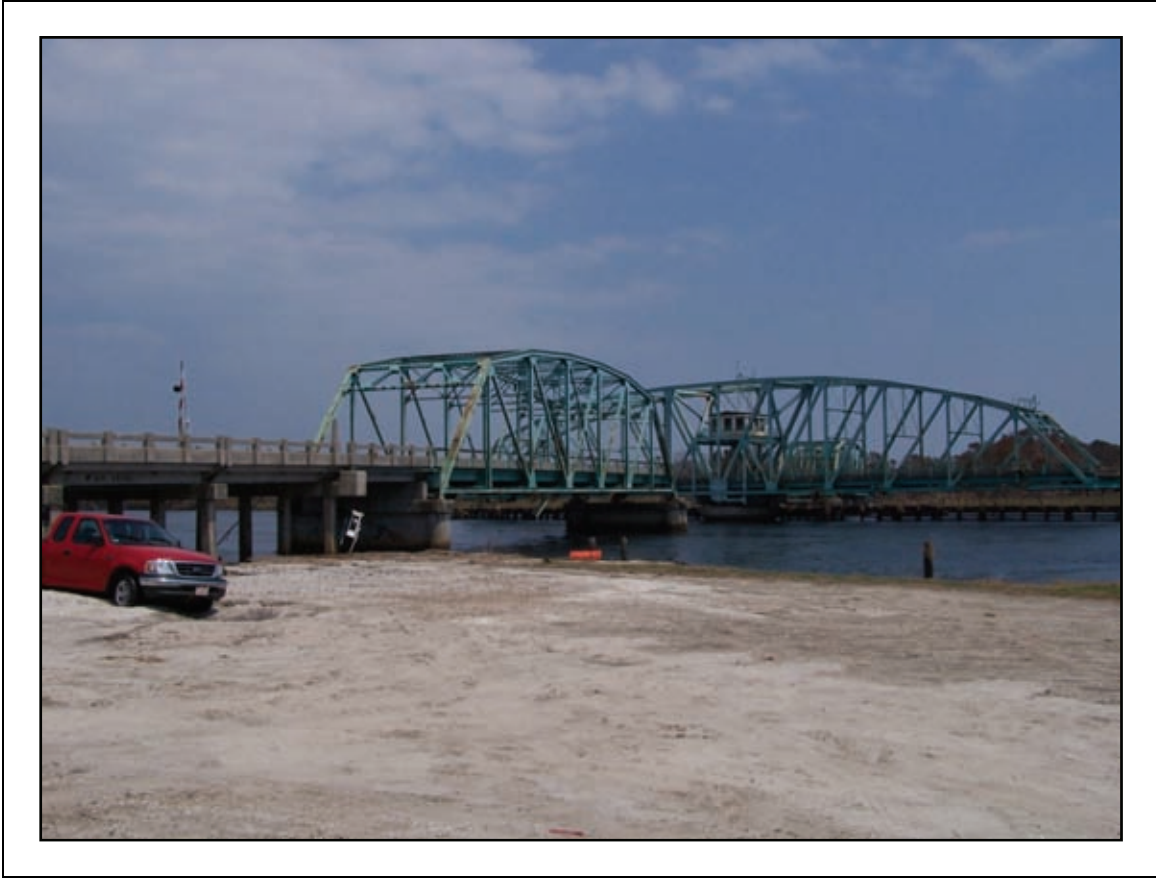
*Figure 2-107. US-90 over East Pearl River*

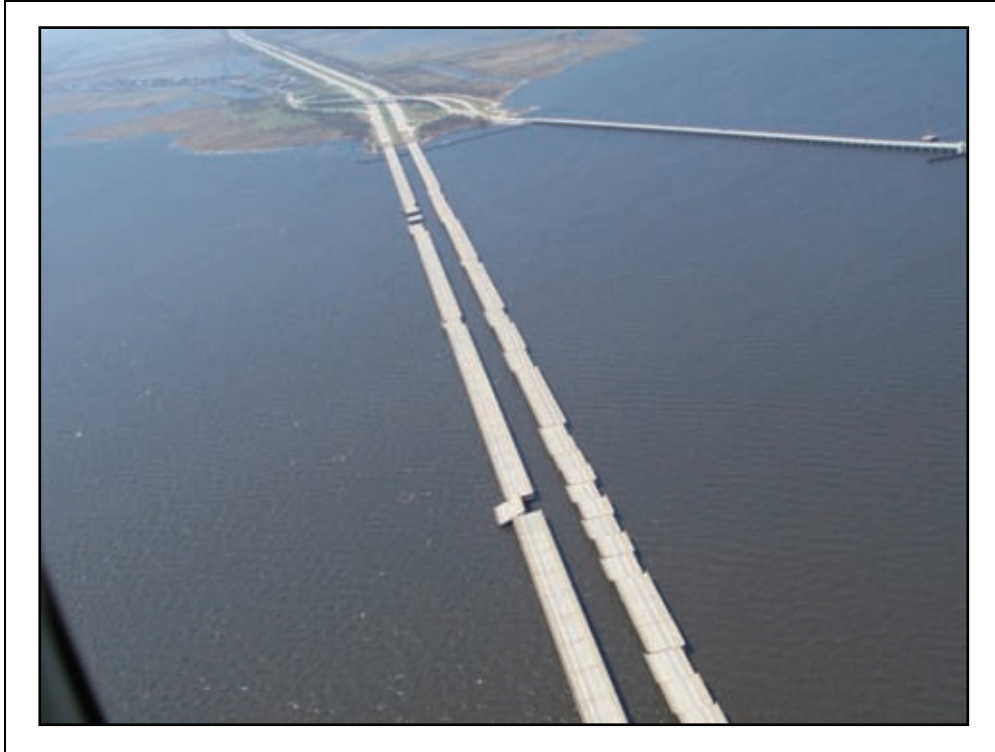
*Figure 2-111. I-10EB & WB, facing west toward New Orleans.  
US-11 is on the right.*

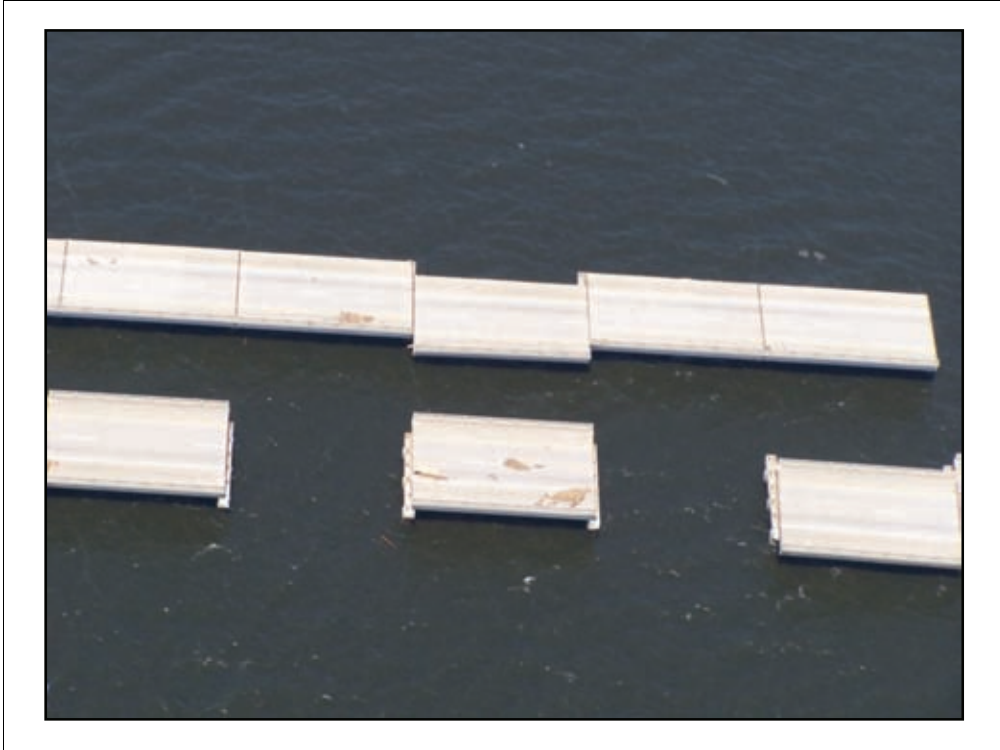
*Figure 2-117. I-10, showing spans missing after lateral displacement, facing North.*

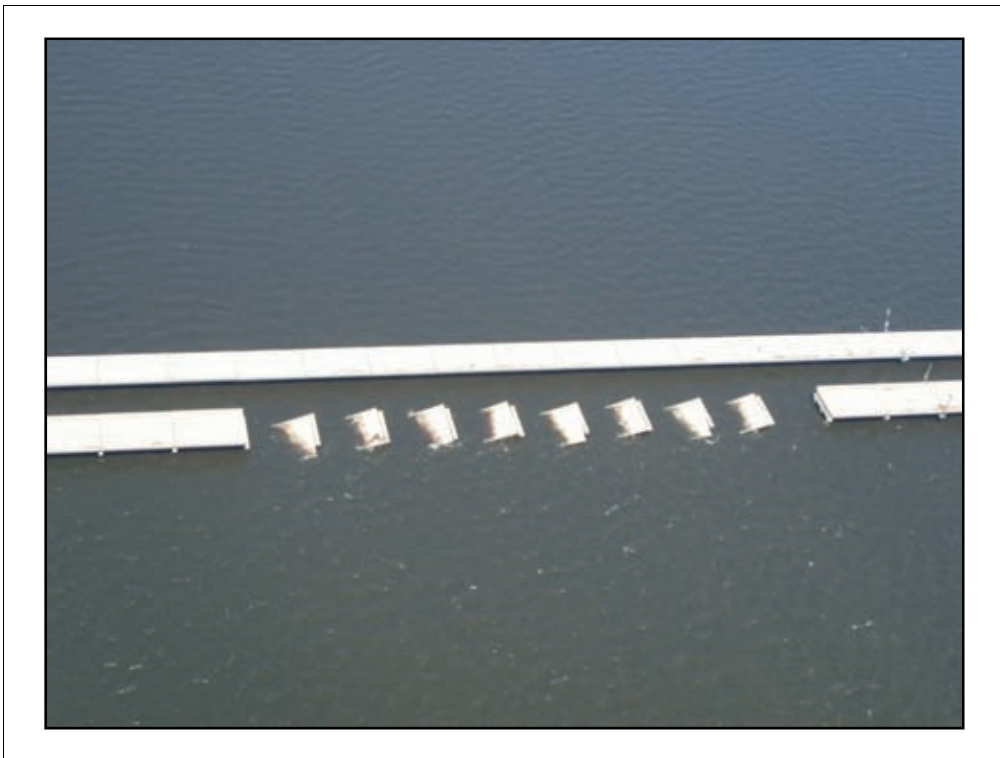
*Figure 2-118. The missing span on the far right seems to have slid out, causing the others to topple.*

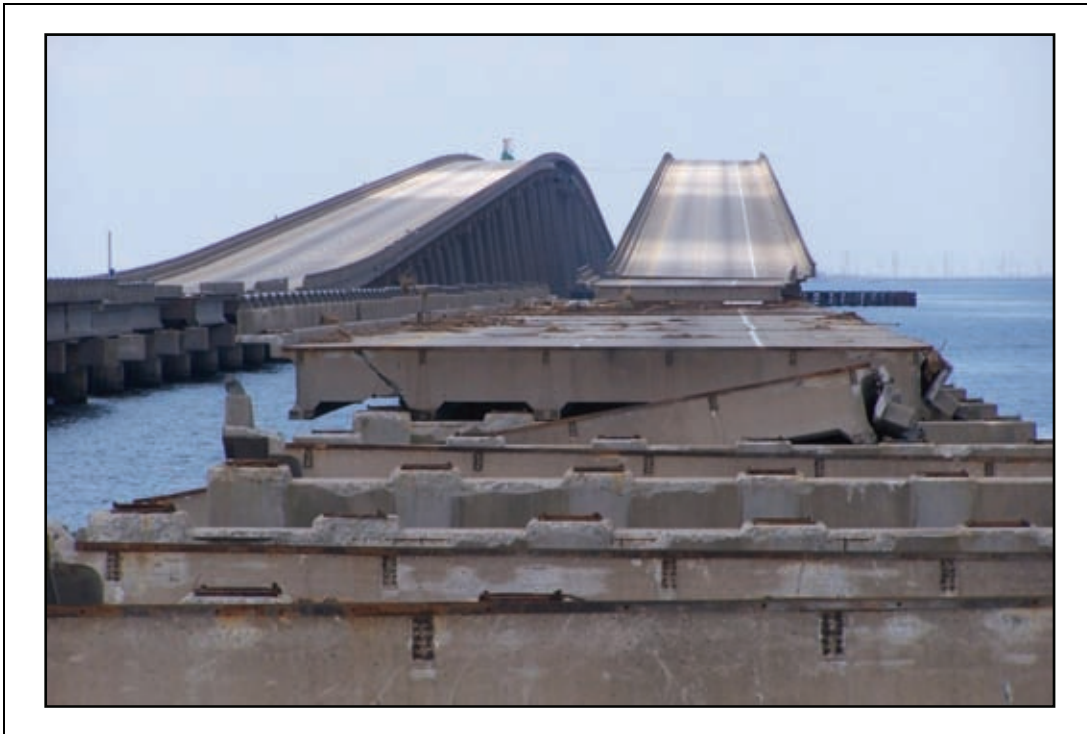
*Figure 2-119. I-10 WB, facing west to the high-rise spans over the navigation channel. Note the scrape marks on the pier caps, caused by the falling spans.*

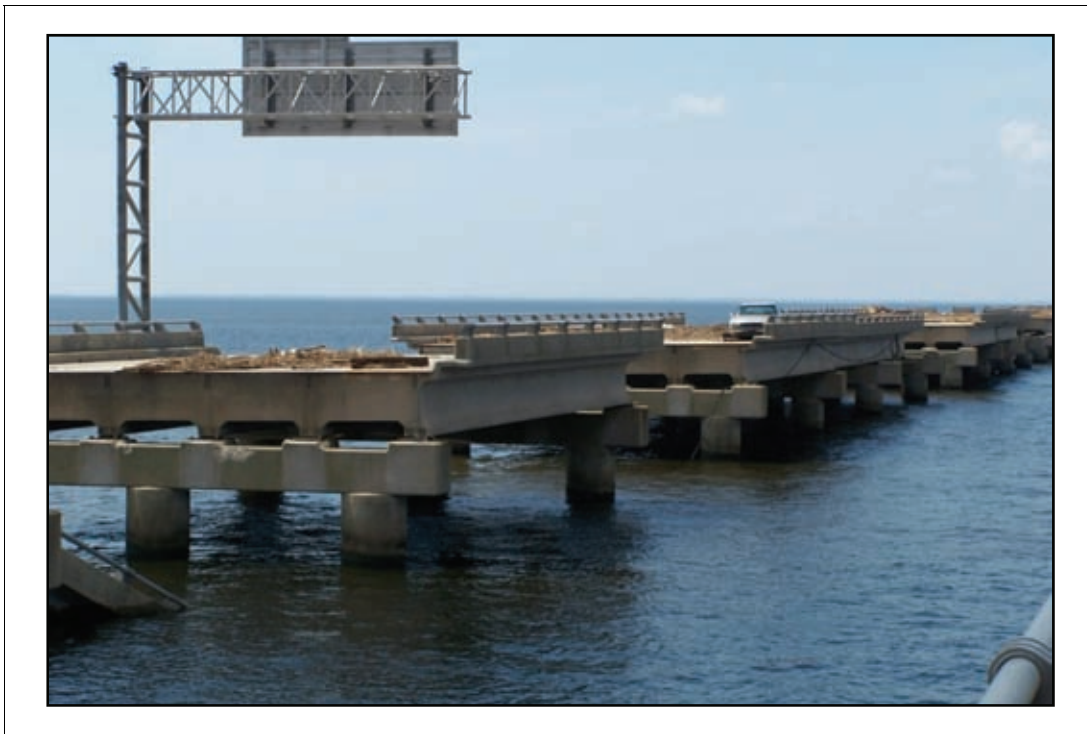
*Figure 2-120. I-10 EB facing west.*

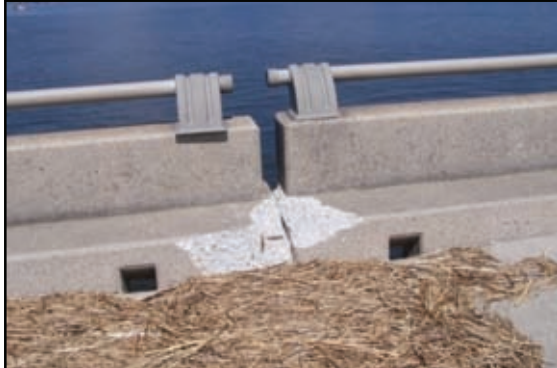
*Figure 2-124. The wave action exerted on the spans must have been violent as evidenced by the spalled concrete resulting from longitudinal pounding between spans.*

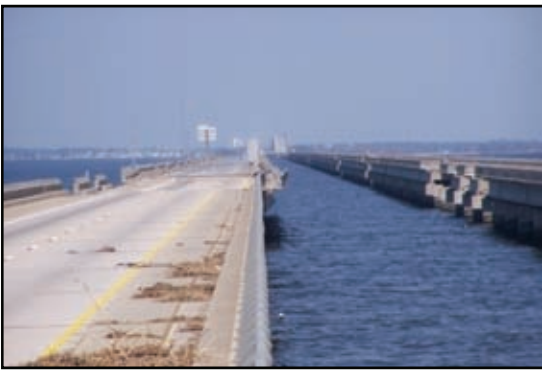
*Figure 2-125. WB bridge is on the left.*
