MCEER SPECIAL REPORT SERIES

Engineering and Organizational Issues Before,  
During and After Hurricane Katrina

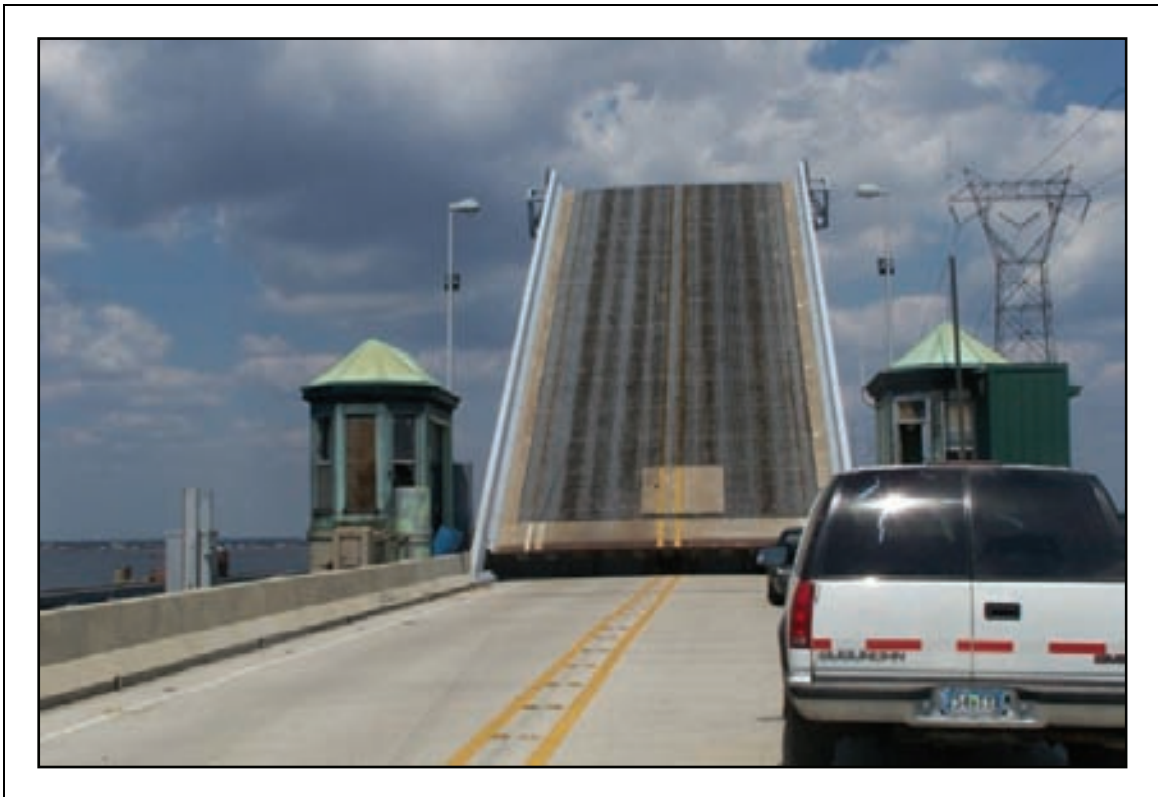
*Figure 2-136. The bridge was functional, even though some repairs were necessary.*

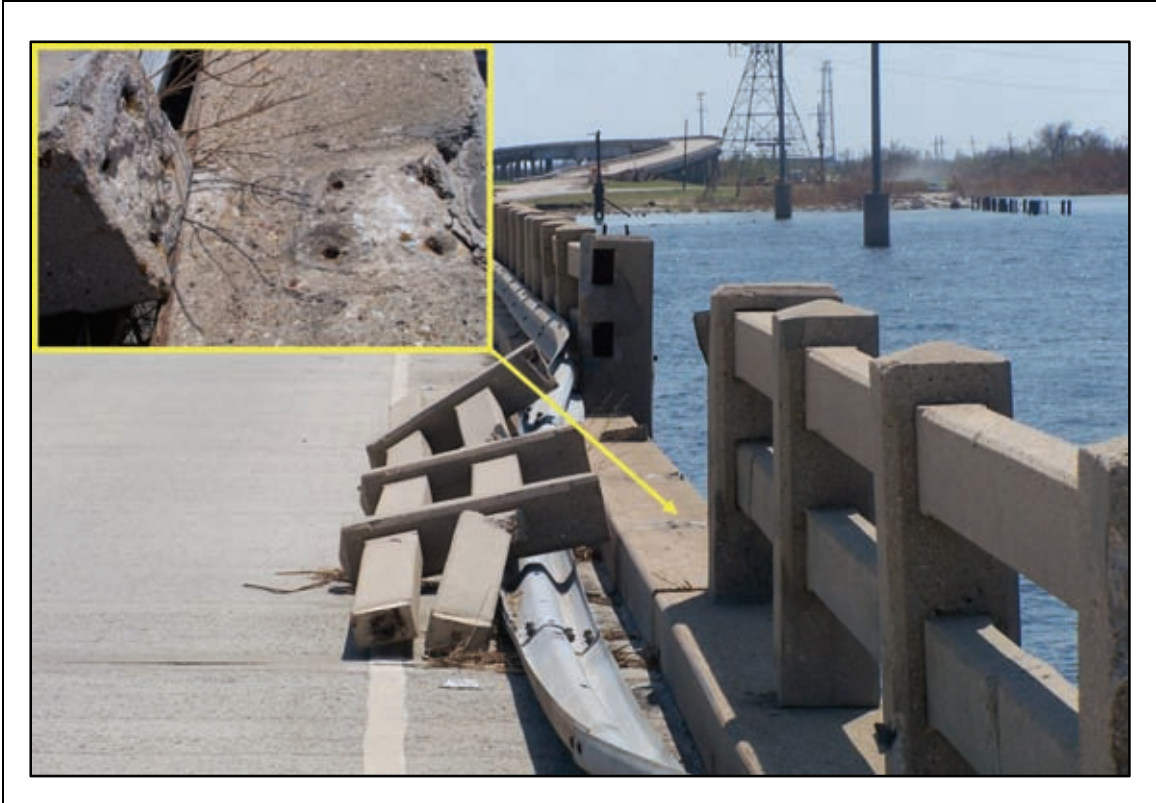
*Figure 2-137. This section of concrete parapet on US-11 failed from wave force but was already in a weakened state from corrosion prior to the storm. Corrosion in the concrete barrier contributed to its failure from wave action. A subsequent investigation by LADOTD led to plans for replacement of all of this barrier.*

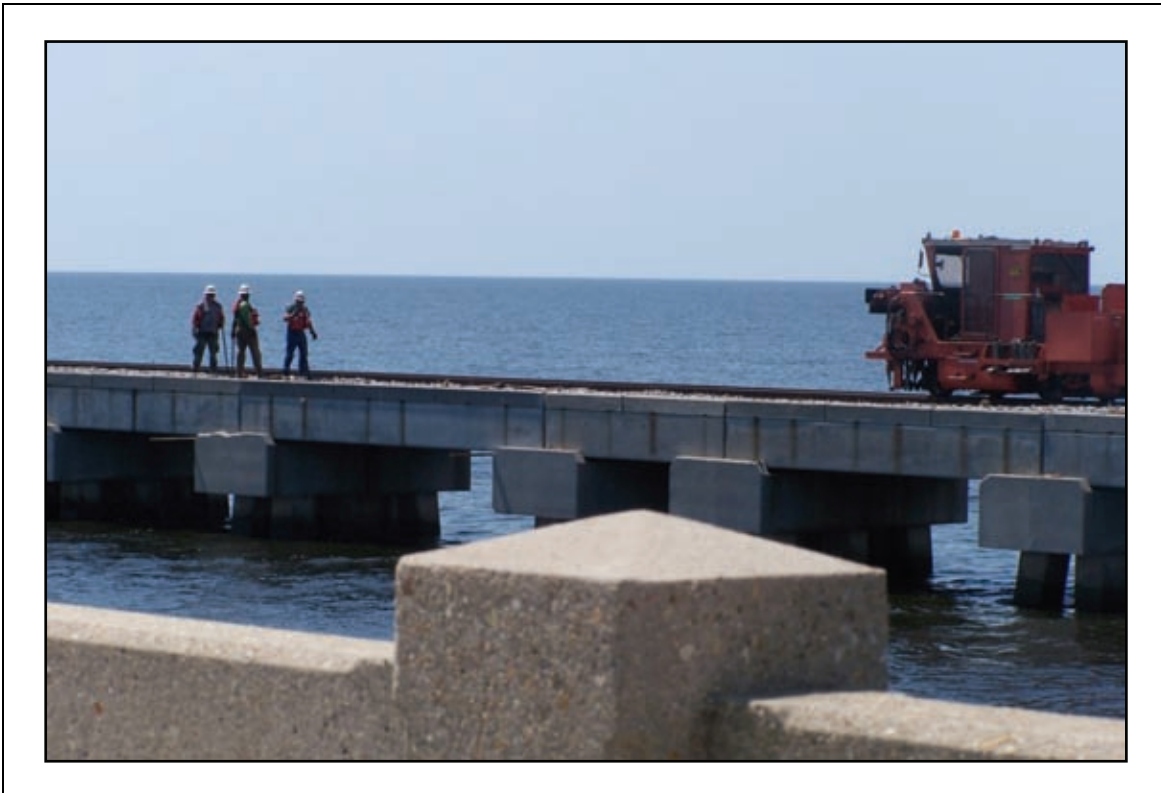
*Figure 2-138. Norfolk-Southern had a crew relaying track about a week after the storm.*

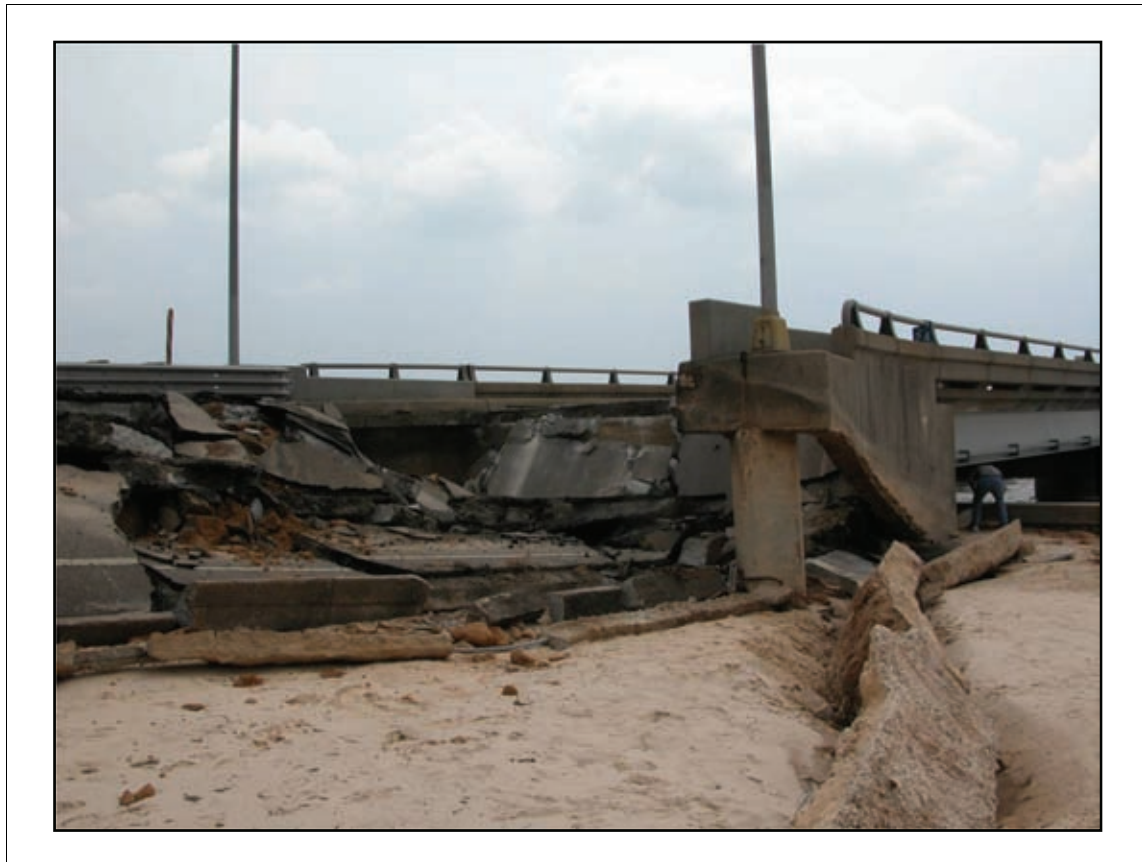
Photo courtesy of LADOTD

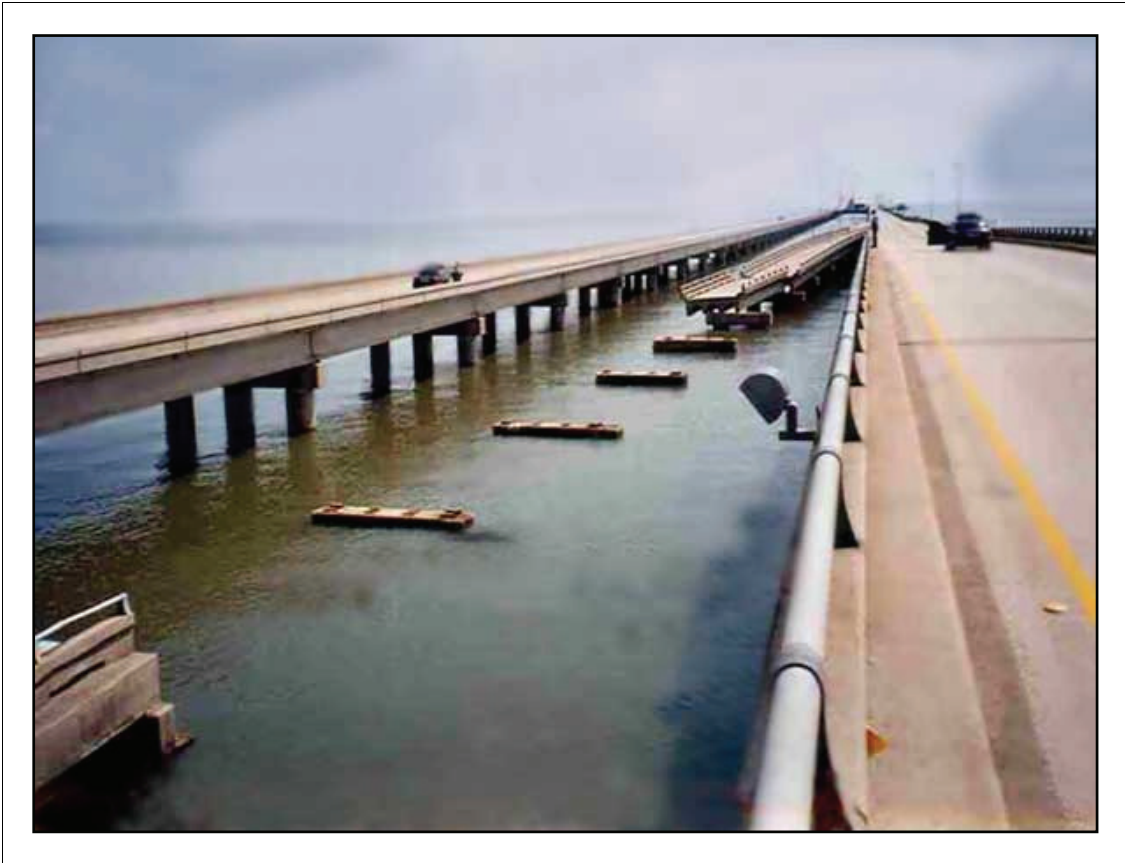
Photo provided by LADOTD

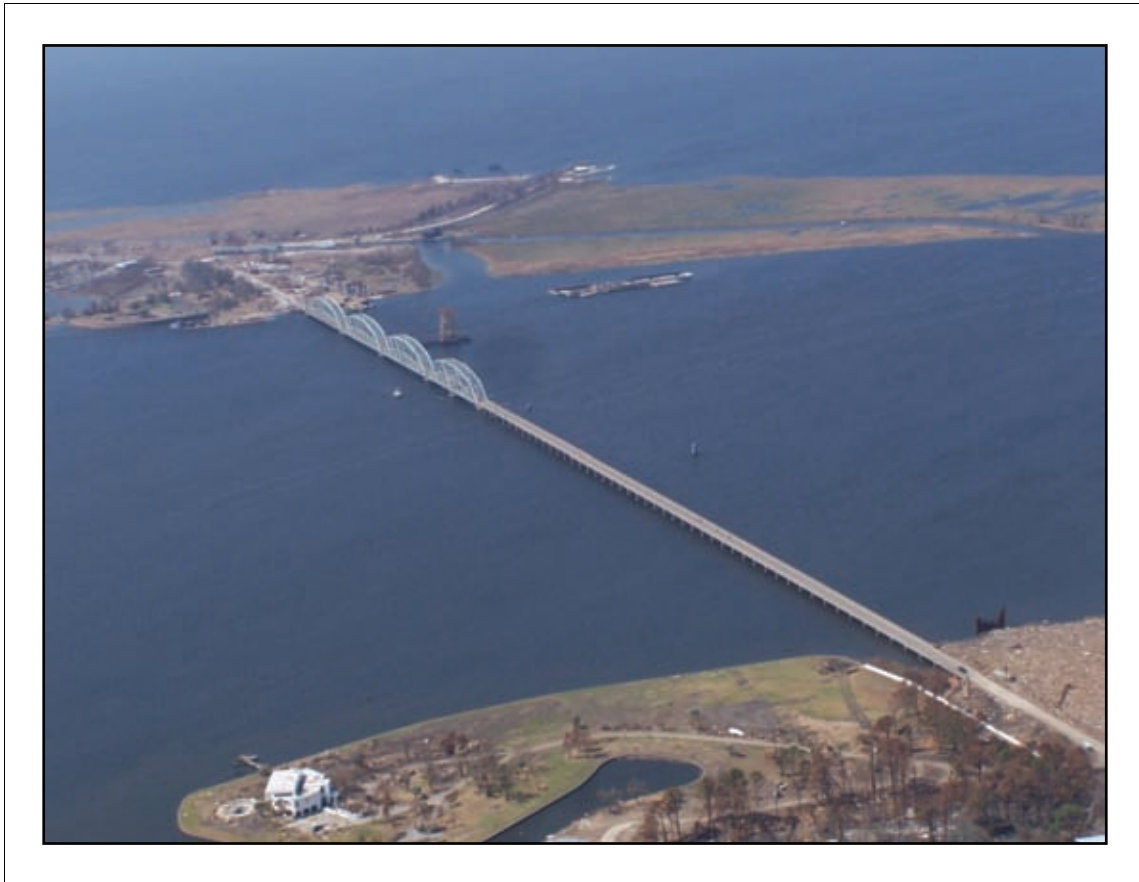
*Figure 2-146. Rigolets Bridge carries US-90 This photograph was taken facing west.*

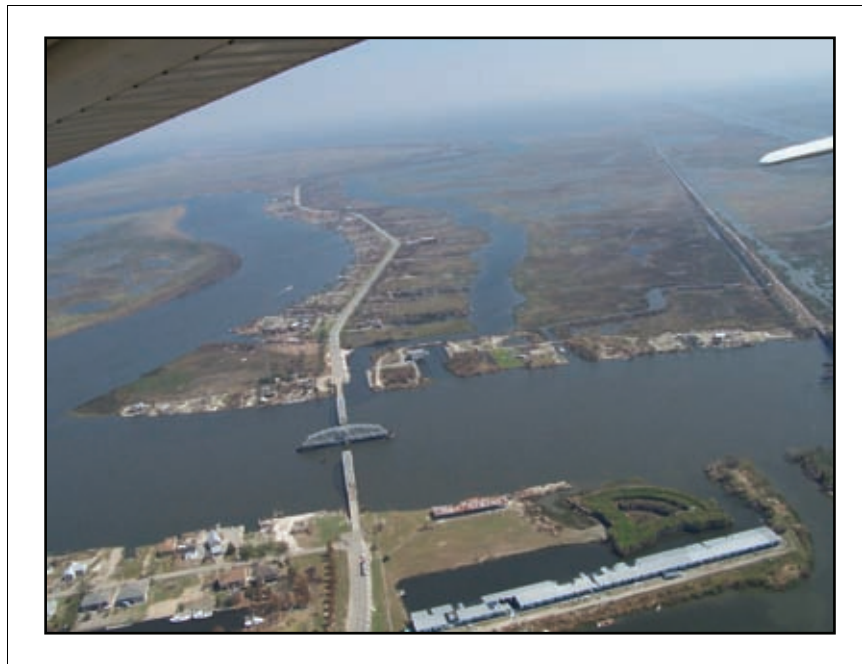
*Figure 2-147. US-90 over Chef Menteur Pass, facing east.*

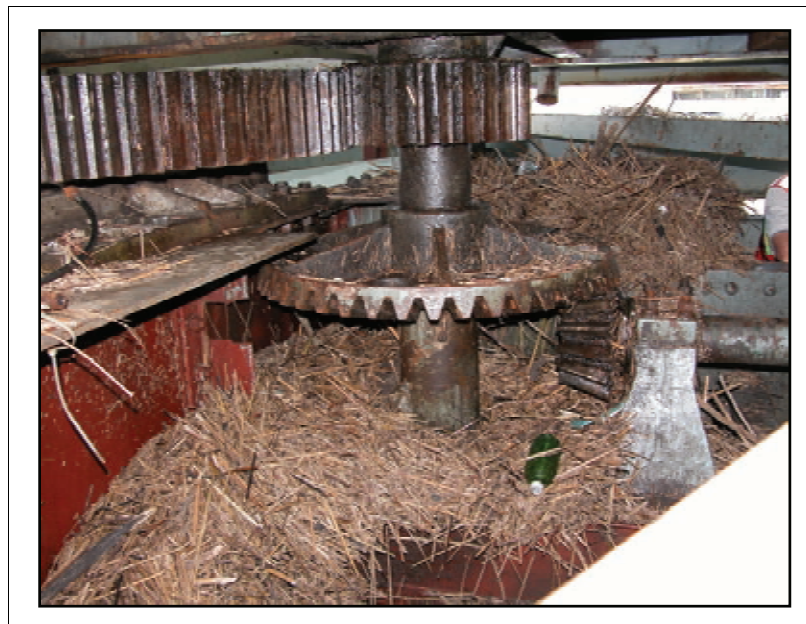
Photo courtesy of LADOTD

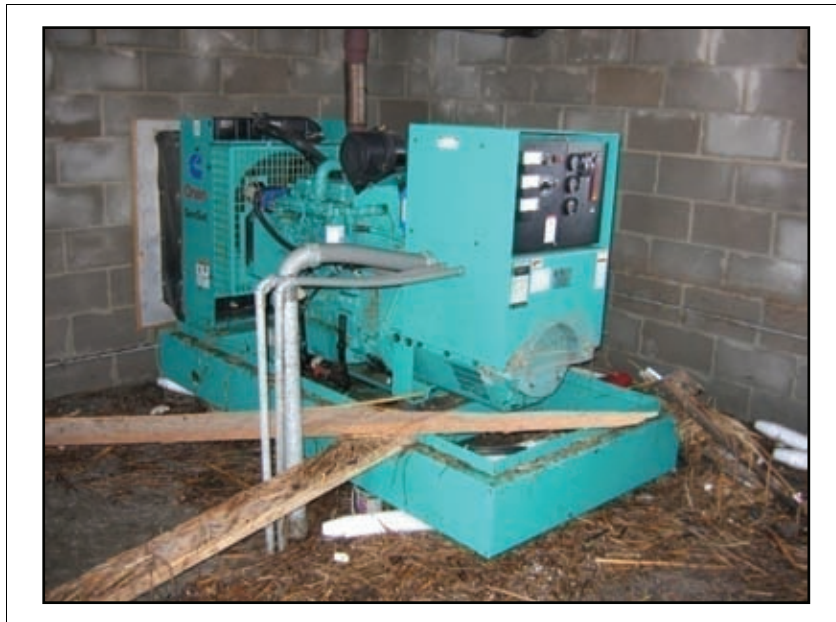
*Figure 2-153. Equipment failed after being submerged in salt water.*

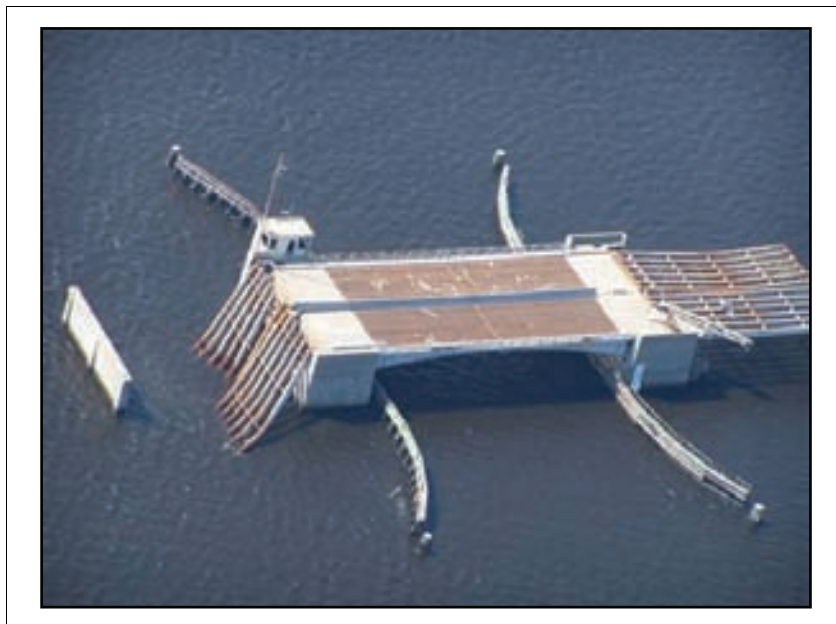
*Figure 2-154. Inoperable draw spans prevented use of the channel by vessels.*

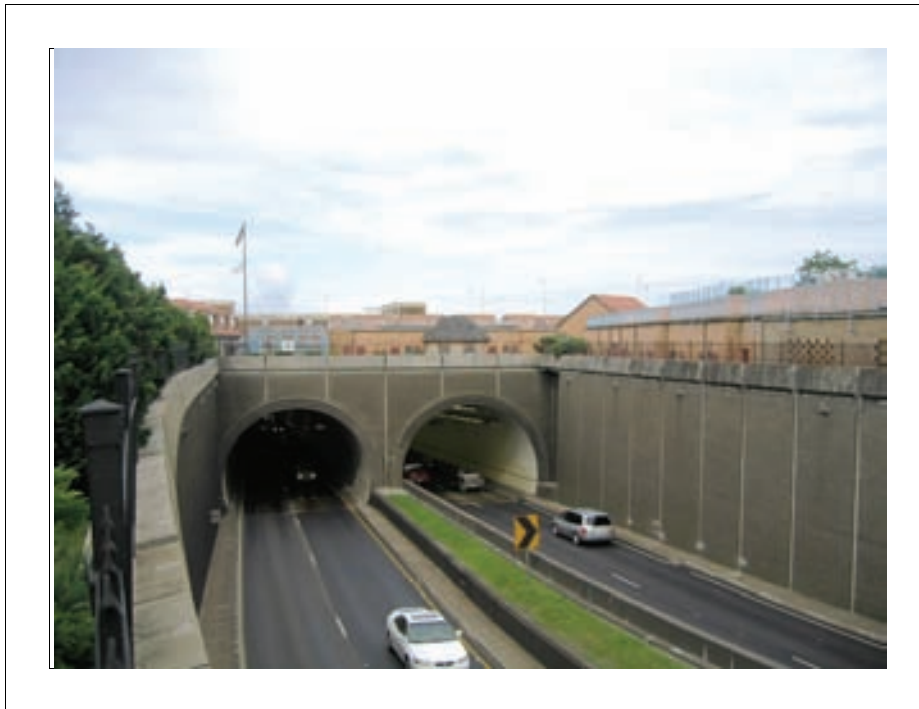
Photo Courtesy of SouthEastRoads.com

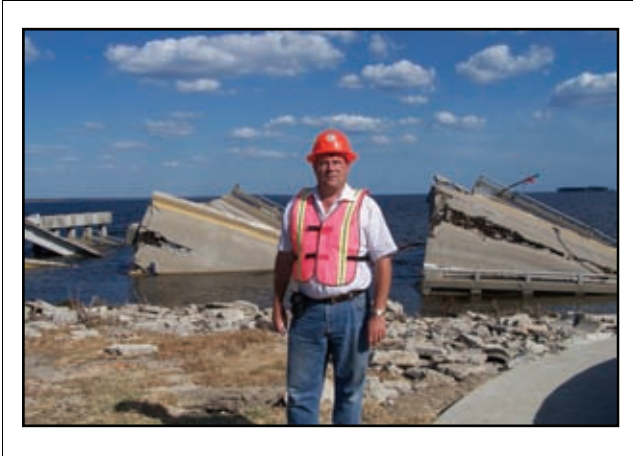
*Author Paul McAnany at Biloxi Bay*

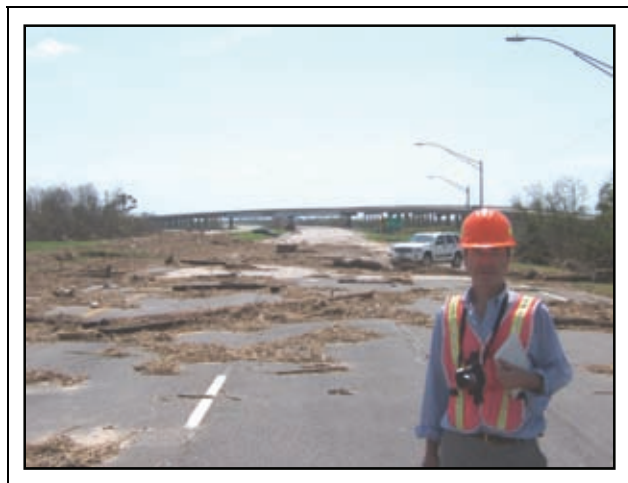
*Author Jerome O'Connor standing on closed I-10.*
