REPORT NO.
EERC 76-22
OCTOBER 1976

EARTHQUAKE ENGINEERING RESEARCH CENTER

RESPONSE OF THE OLIVE VIEW HOSPITAL MAIN BUILDING DURING THE SAN FERNANDO EARTHQUAKE

by
STEPHEN A. MAHIN
VITELMO V. BERTERO
ANIL K. CHOPRA
ROBERT G. COLLINS

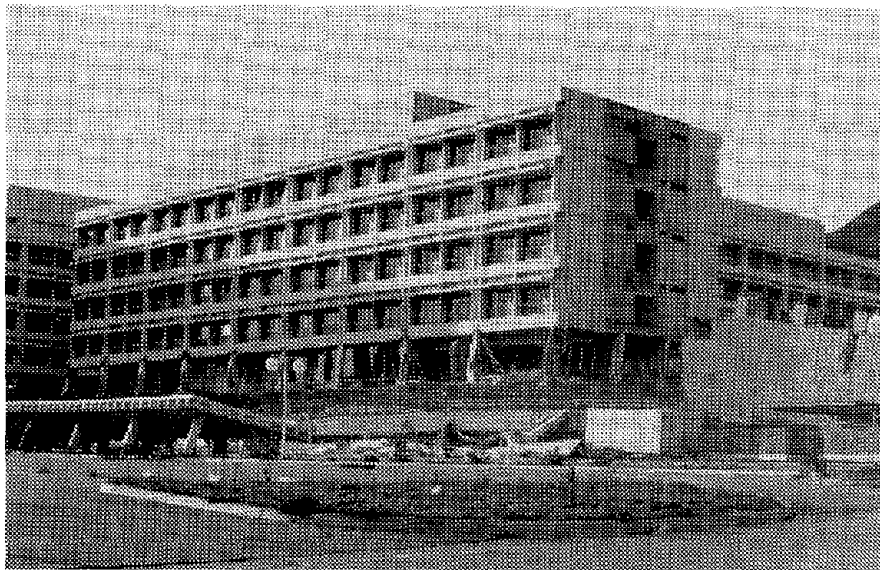
(b) GENERAL VIEW OF DAMAGE TO MAIN BUILDING
(WING D IN FOREGROUND)

FIG. I.4 GENERAL FEATURES OF DAMAGE TO OLIVE
VIEW MEDICAL CENTER

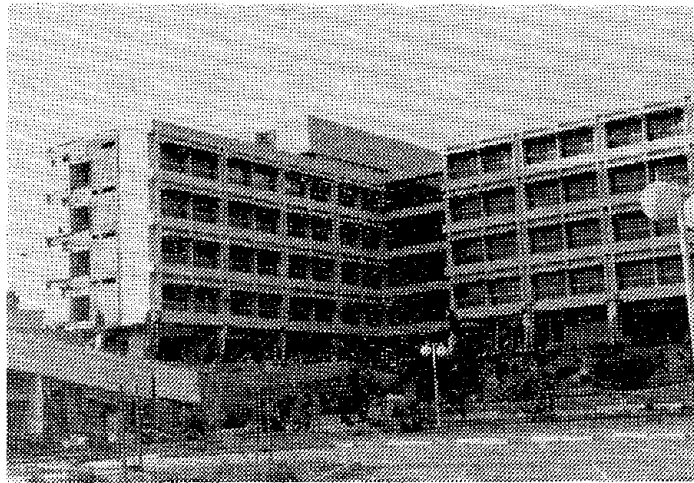
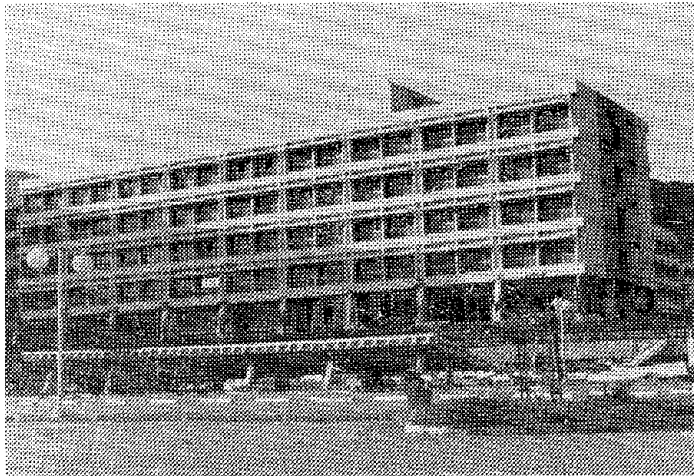
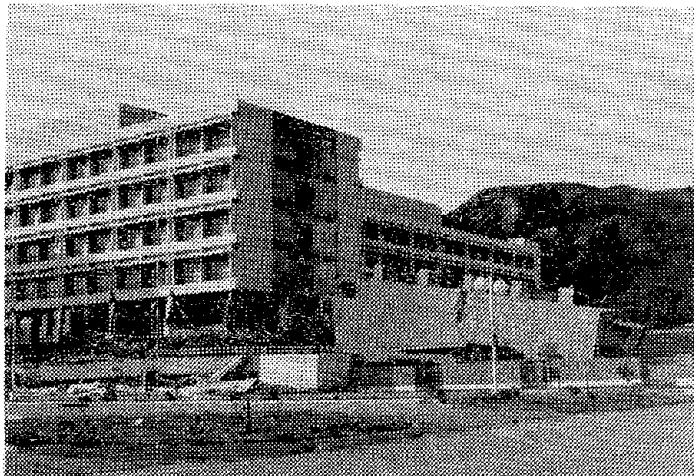
FIG. 3.1 DAMAGE TO MAIN BUILDING
VIEWED FROM SOUTHEAST

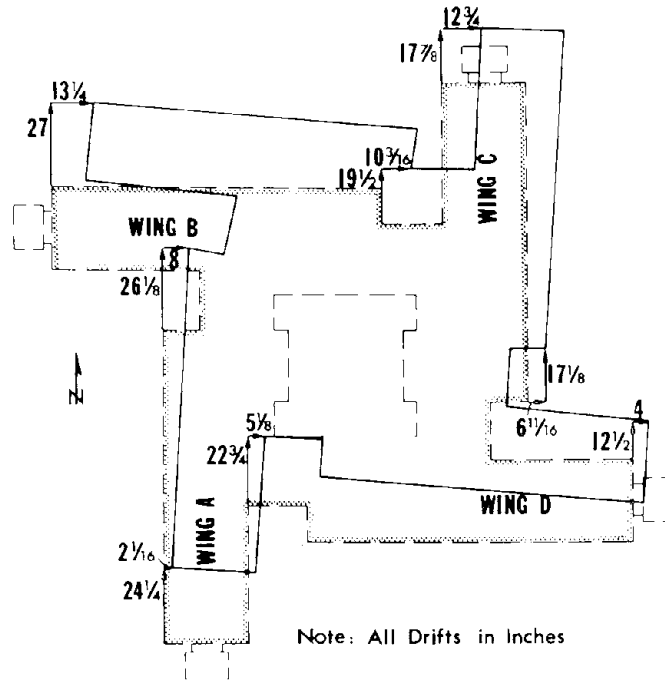
FIG. 3.2 PERMANENT STORY DRIFTS IN FIRST STORY

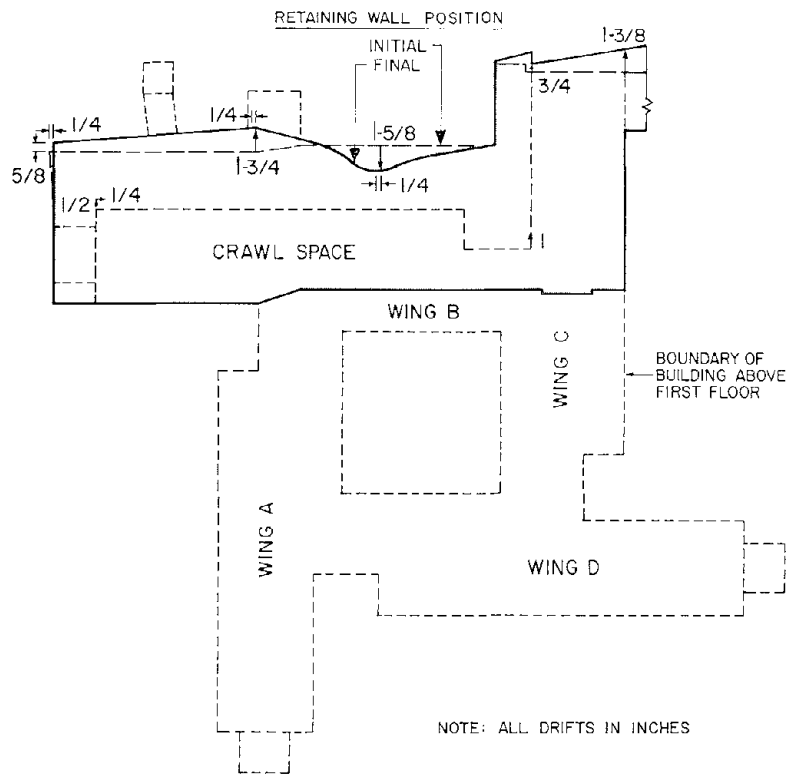
FIG. 3.4 DRIFTS OBSERVED IN CRAWL SPACE

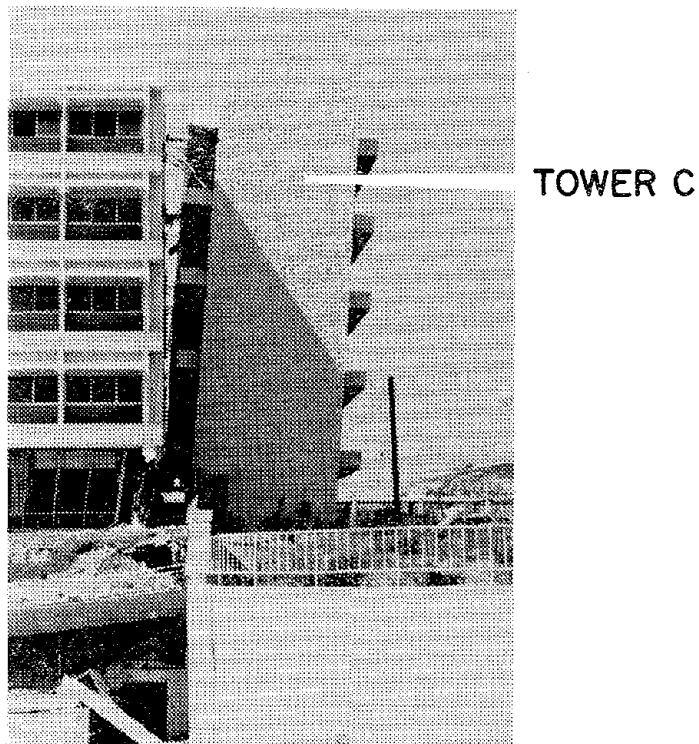
FIG. 3.5 IMPACT OF MAIN BUILDING CAUSED STAIRTOWER C TO TILT TOWARDS NORTH

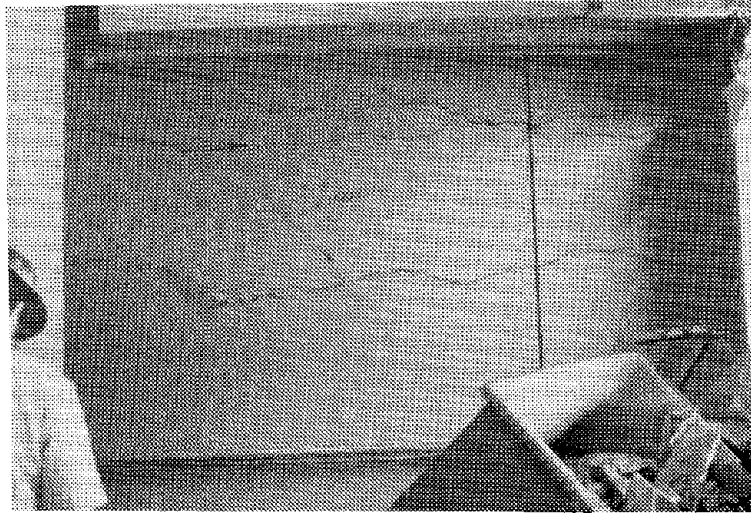
(a) DAMAGE TO NORTH RETAINING WALL BETWEEN COLUMN LINES 26 AND 26.6 ALONG LINE FF

FIG. 3.6 DAMAGE AT SEISMIC JOINT DUE TO HAMMERING OF BUILDING AGAINST RETAINING WALL

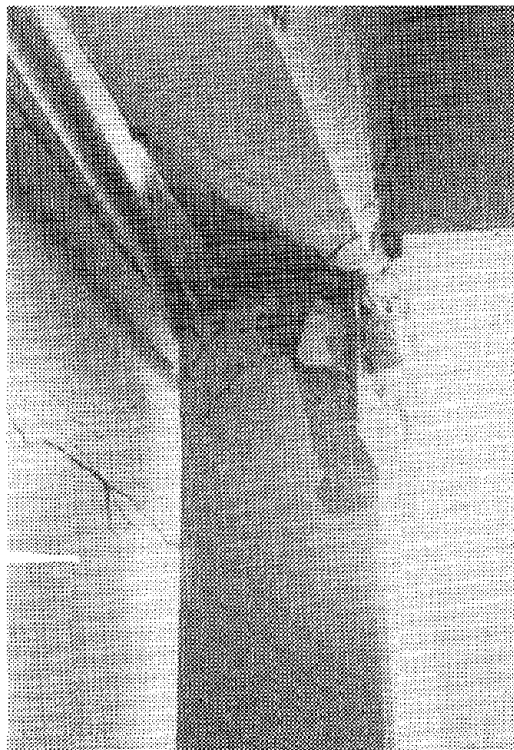
(b) DETAIL OF DAMAGE TO COLUMN FF-26.6 AND ADJACENT RETAINING WALL

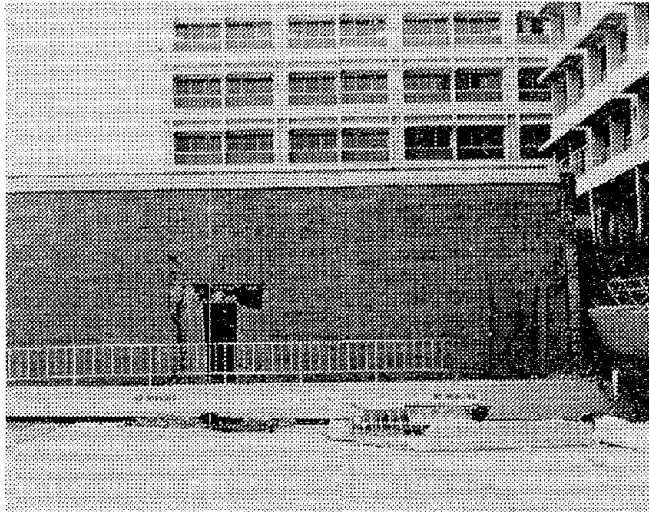
(a) DAMAGE TO MASONRY WALL ON NORTH SIDE OF WAREHOUSE. NOTE COLLAPSED TERRACE CANOPY ON RIGHT HAND SIDE OF PHOTO.

FIG. 3.7 DAMAGE AT SEISMIC JOINTS DUE TO HAMMERING OF BUILDING AGAINST WAREHOUSE

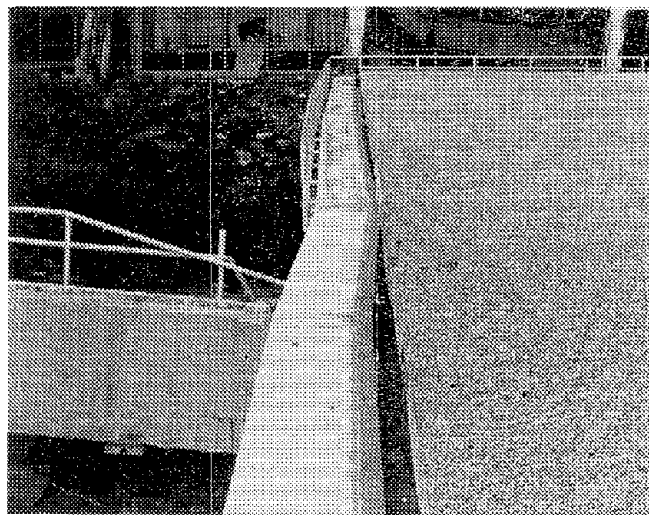
(b) DAMAGE TO SOUTH SIDE OF WAREHOUSE DUE TO IMPACT OF WING D TERRACE

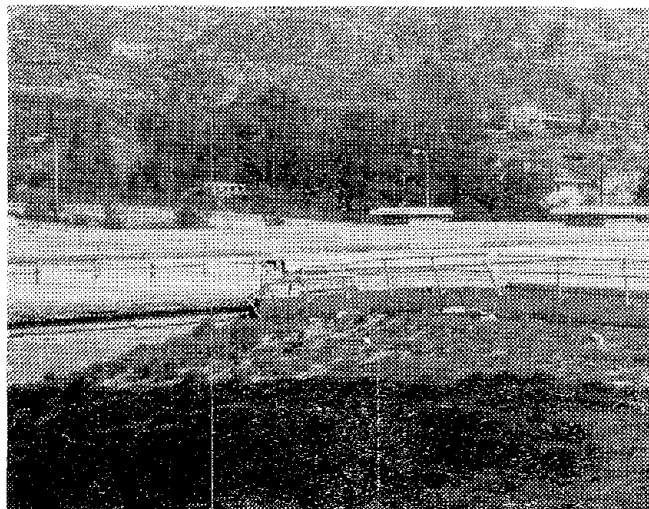
(c) DETAIL OF DAMAGE AT SEISMIC JOINT SEPARATING WING D AND WAREHOUSE. NOTE THAT TERRACE CANOPY HAS DROPPED SEVERAL FEET IN ELEVATION

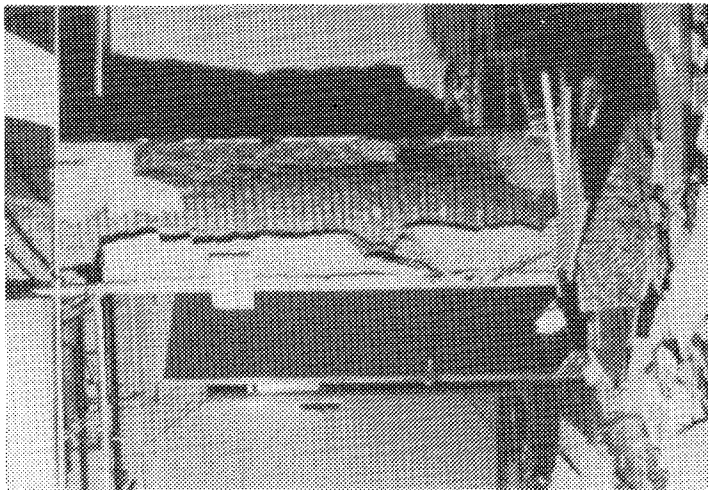
(a) EXTENSIVE SPALLING OF UNCONFINED CONCRETE COVER THROUGHOUT ENTIRE LENGTH OF COLUMN L-16

FIG. 3.8 TYPICAL GROUND STORY SPIRAL COLUMN DAMAGE

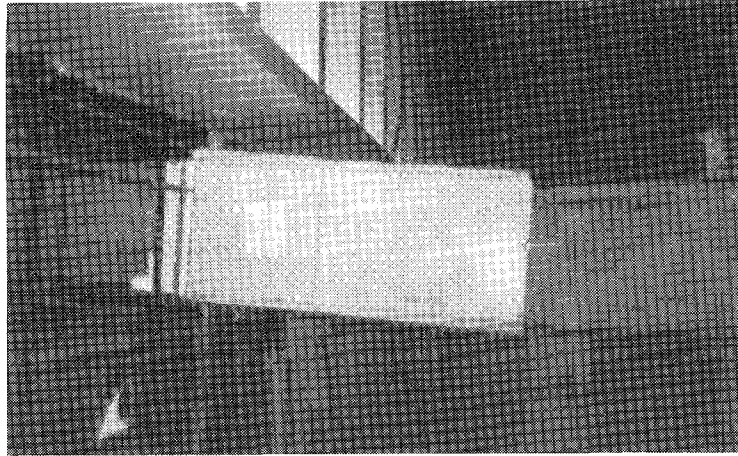
(b) YIELDING AT BOTTOM OF COLUMN H-17. PUNCHING SHEAR FAILURE IN SLAB AT TOP

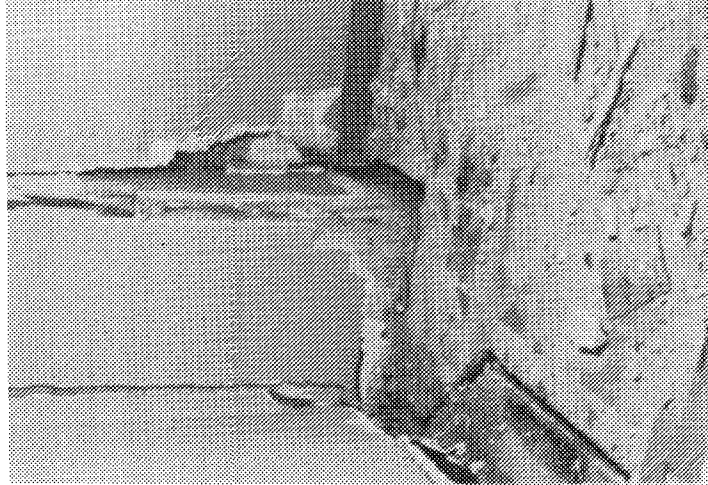
(c) SUBGRADE ROTATION AT COLUMN H-29. LITTLE DISTRESS NOTED IN COLUMN. EXPANSION JOINT OPENED SUBSTANTIALLY

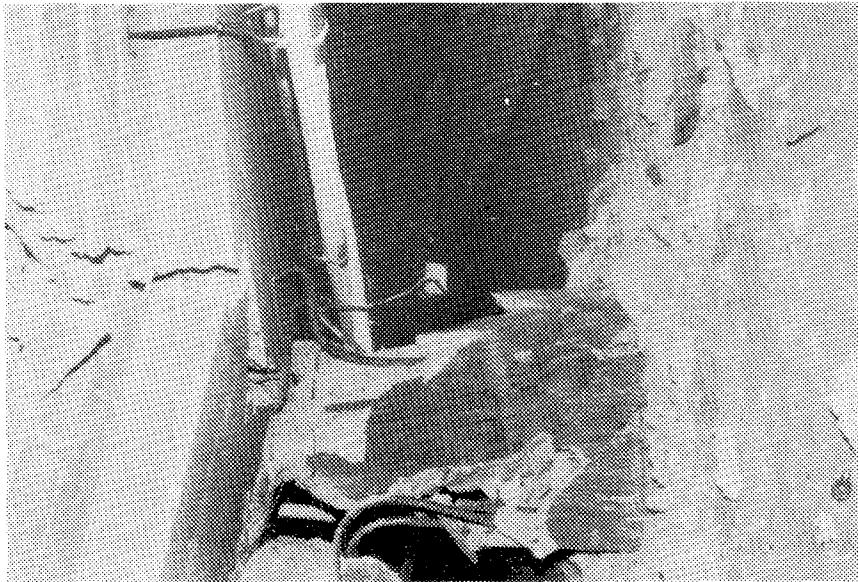
FIG. 3.9 FAILURE OF A TIED COLUMN
IN CRAWL SPACE

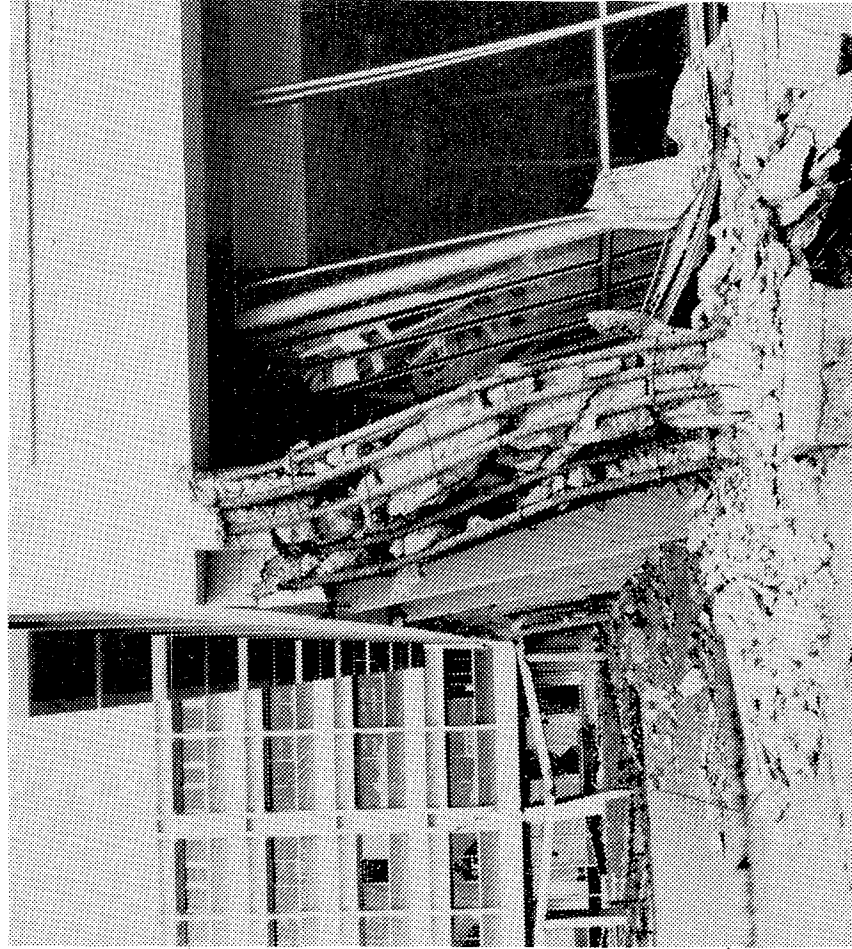
FIG. 3.10 DAMAGE TO FIRST STORY COLUMN BB-3
ILLUSTRATING SEVERITY OF FIRST
STORY DRIFTS AND SUBSIDENCE OF
NORTHERN TERRACE CANOPY DUE TO
FAILURE OF COLUMNS IN CRAWL SPACE

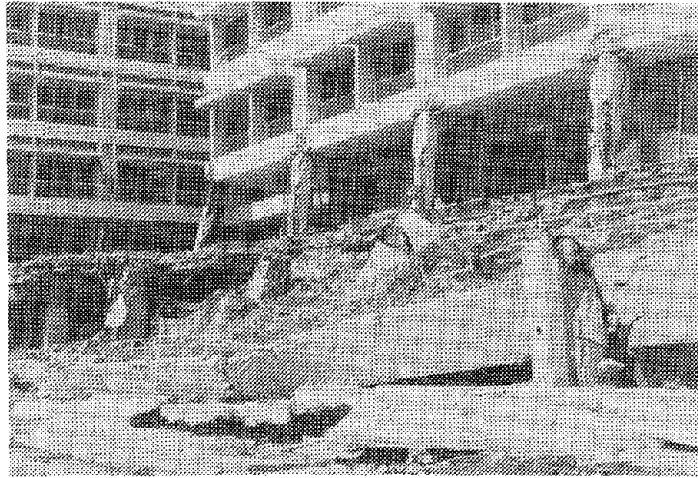
(a) SHEAR FAILURES IN GROUND, FIRST AND SECOND STORY TIED COLUMNS, AND SPALLING IN FIRST STORY SPIRAL COLUMNS AND BEAM-COLUMN JOINTS

FIG. 3.11 PUNCHING FAILURE OF UNIT D TERRACE CANOPY

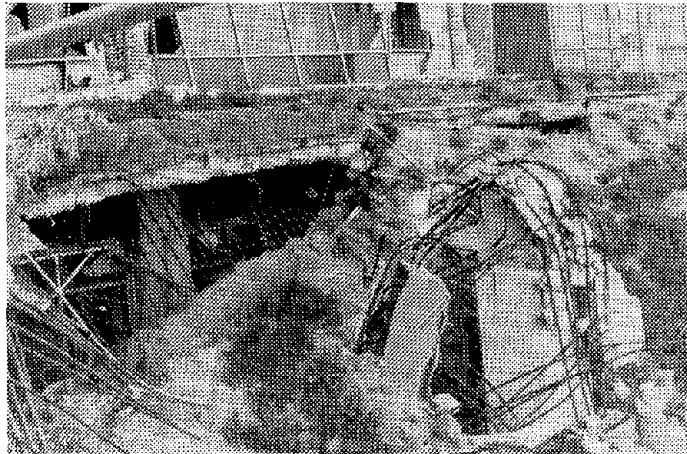
(b) DETAIL OF SLAB FAILURE

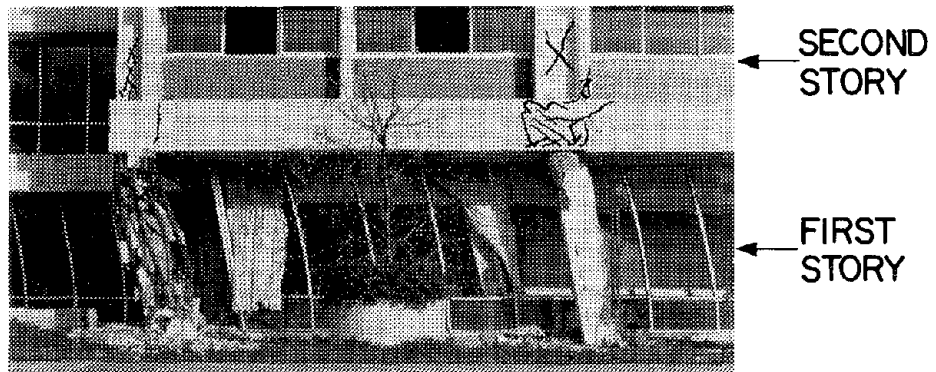
FIG. 3.12 COMPARISON OF DAMAGE TO FIRST STORY TIED AND SPIRAL COLUMNS (UNIT A). NOTE DISTRESS IN BEAM-COLUMN JOINT AND IN SECOND STORY TIED COLUMN

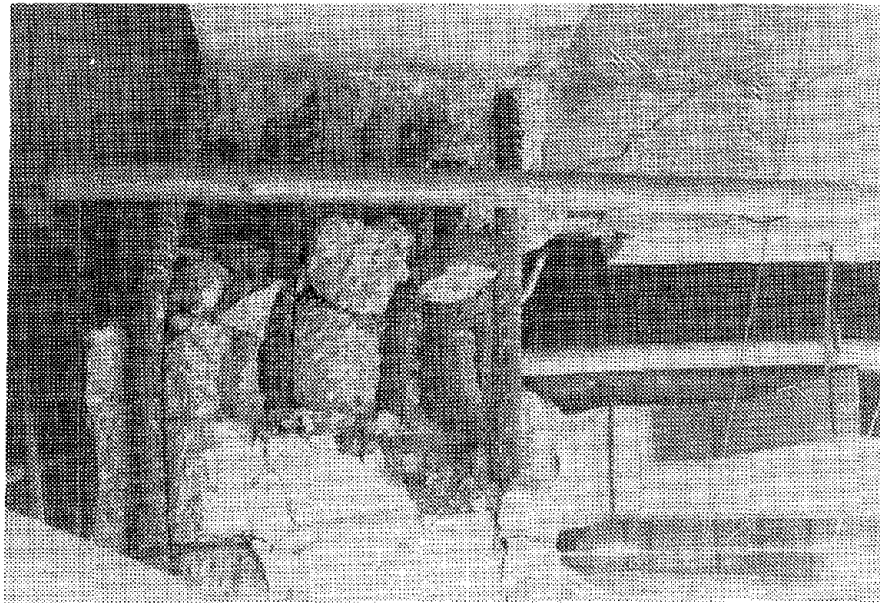
FIG. 3.13 SHEAR FAILURE AT TOP OF GROUND STORY COLUMN M-29 DUE TO TERMINATION OF SPIRALS BELOW LOWEST MEMBER FRAMING INTO COLUMN

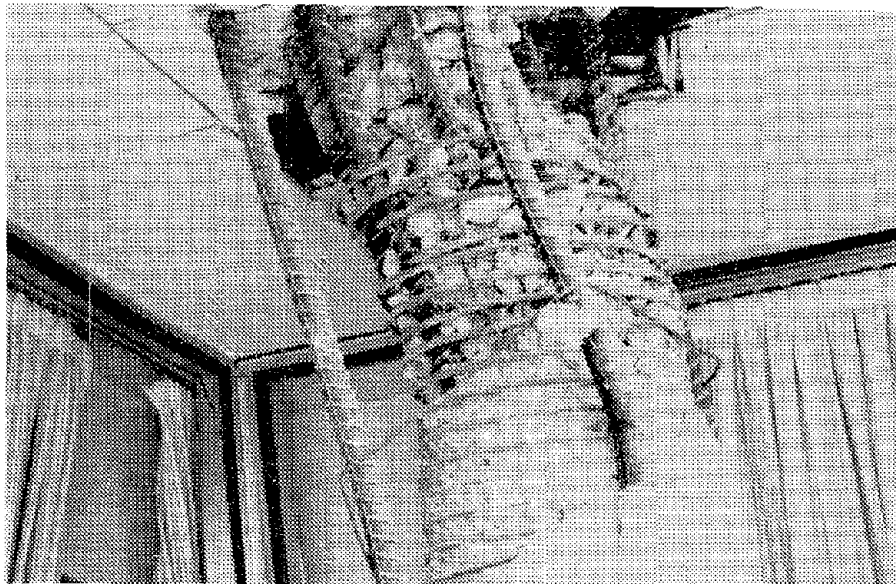
FIG. 3.14 SHEAR FAILURE AT TOP OF FIRST STORY COLUMN Z-18 DUE TO TERMINATION OF SPIRALS OUTSIDE OF BEAM COLUMN JOINT

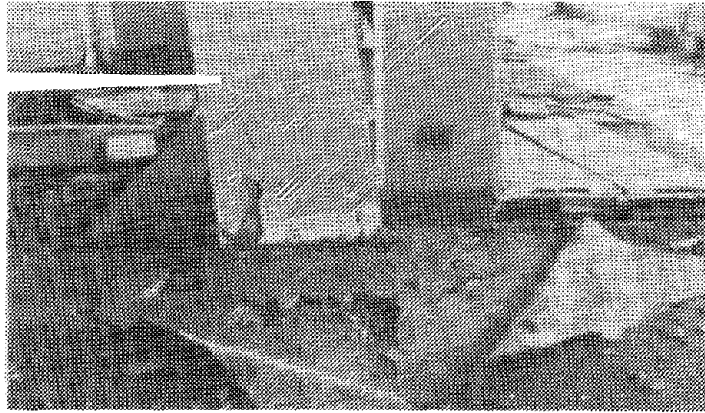
(a) SLAB NEAR COLUMN H-26

FIG. 3.15 DAMAGE TO FIRST FLOOR SLAB

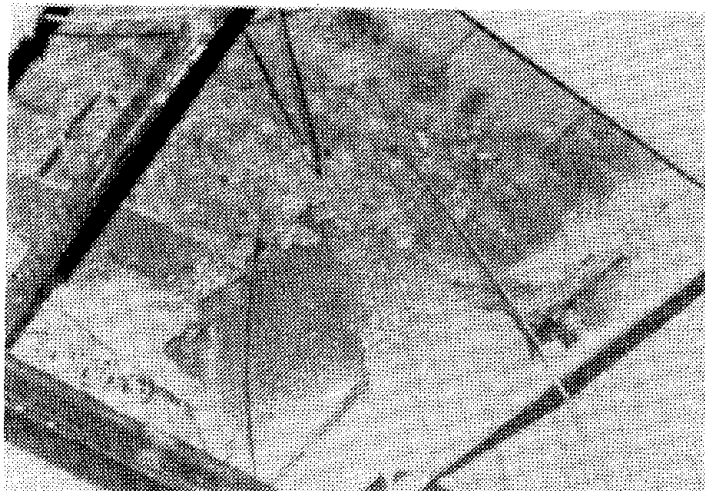
(c) UNDERSIDE OF SLAB NEAR COLUMN L-17

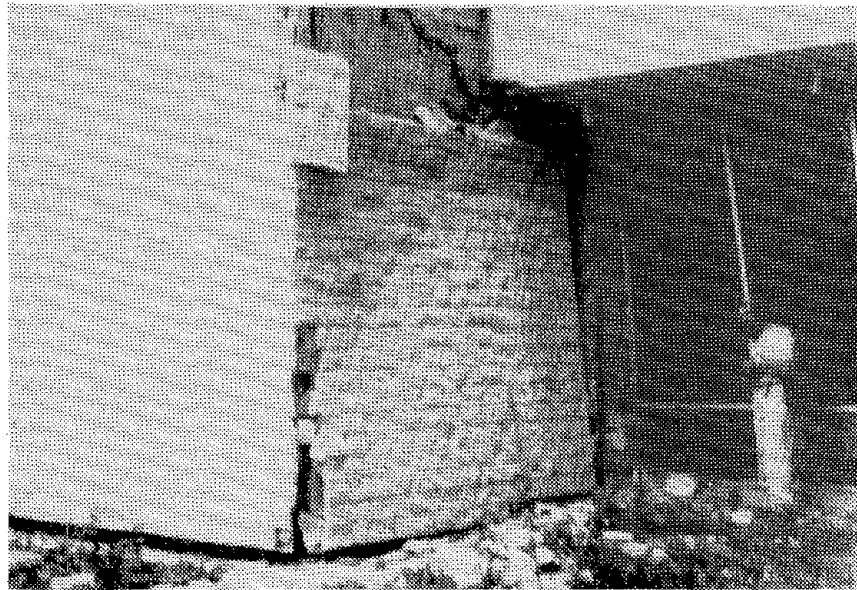
FIG. 3.16 DAMAGE IN FIRST STORY ELEVATOR SHAFT WALL NEAR P-19

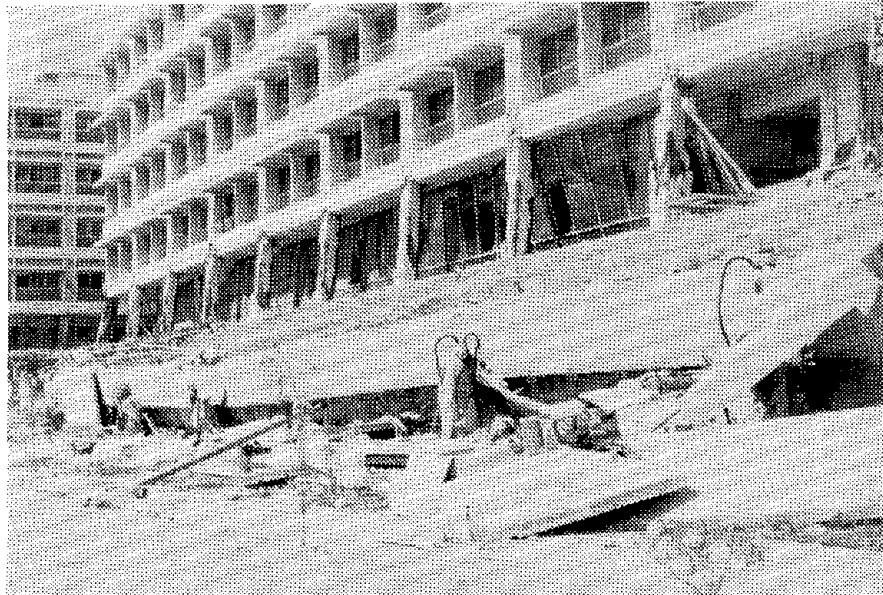
FIG. 3.19 DETAILS OF DAMAGE TO PRECAST PANELS

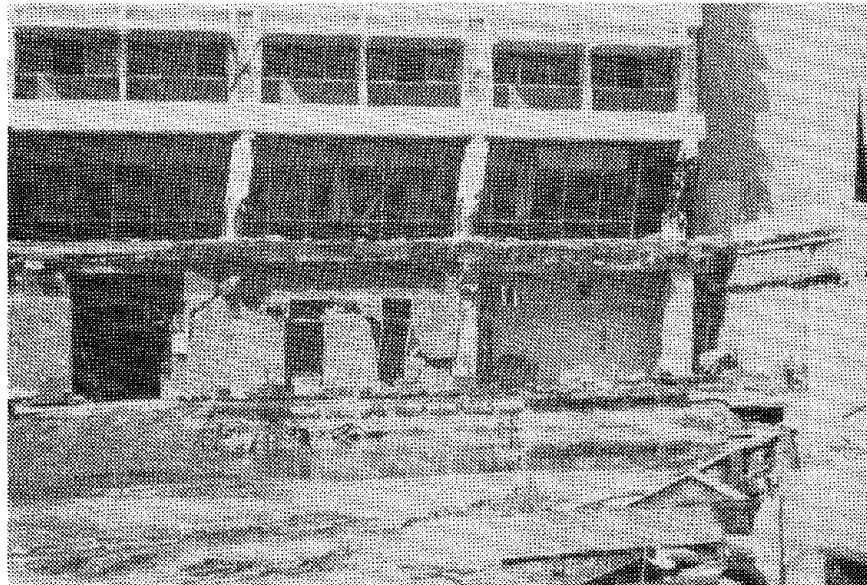
FIG. 3.20 DETAIL OF DAMAGE TO WING C AFTER REMOVAL OF COLLAPSED TERRACE CANOPY SHOWING DISTRIBUTION OF DAMAGE TO LOWER THREE STORIES. NOTE DAMAGE TO NONSTRUCTURAL MASONRY PARTITIONS IN GROUND STORY

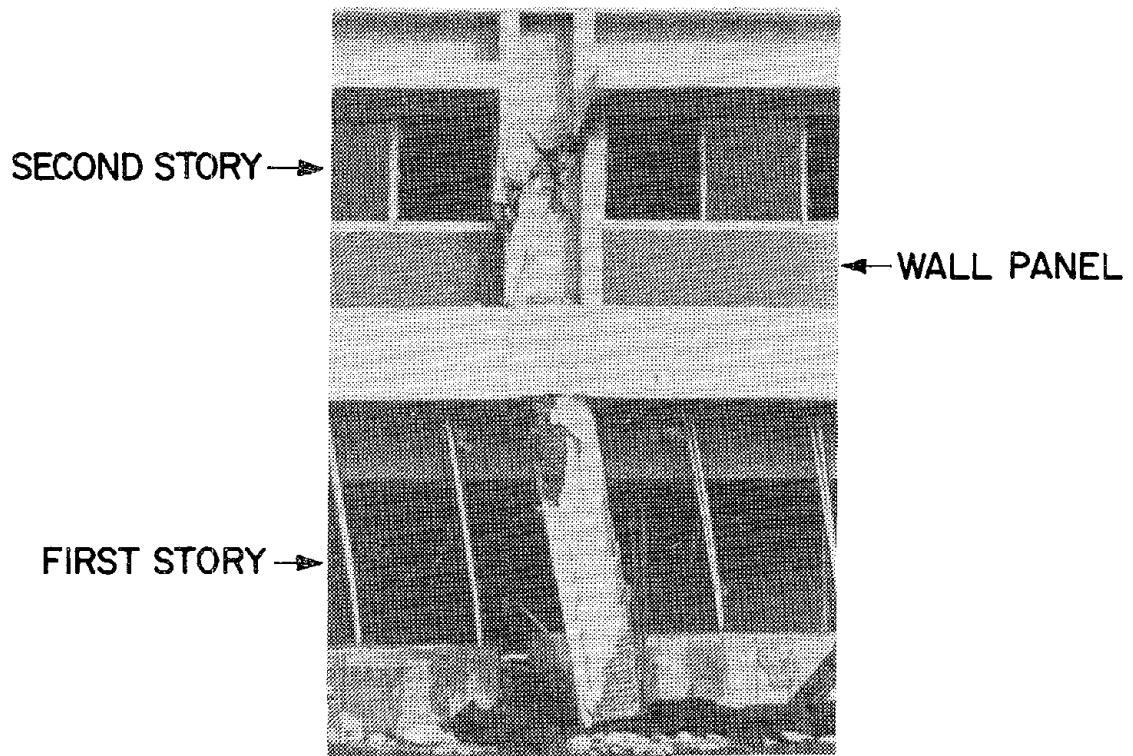
FIG. 3.21 COMPARISON OF DAMAGE TO FIRST STORY SPIRAL COLUMNS AND SECOND STORY TIED COLUMNS IN UNIT A (J-7). NOTE SEVERE NONSTRUCTURAL DAMAGE.

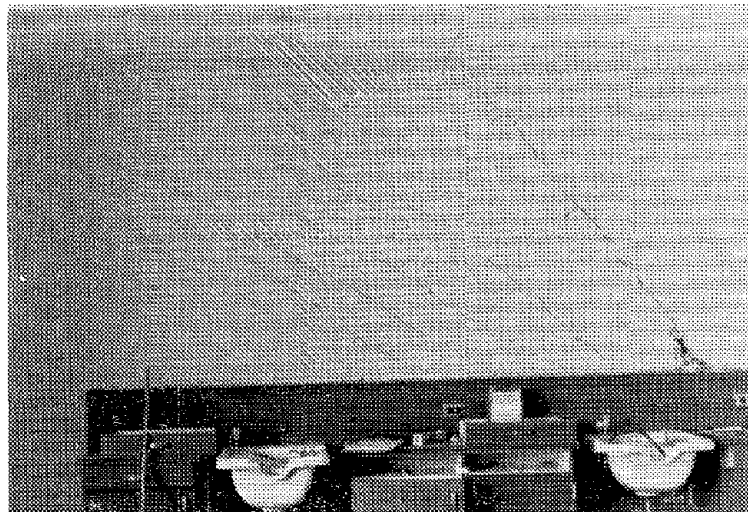
FIG. 3.22 CRACKING IN PLASTER COVERING STRUCTURAL WALL J-L-12 IN SECOND STORY

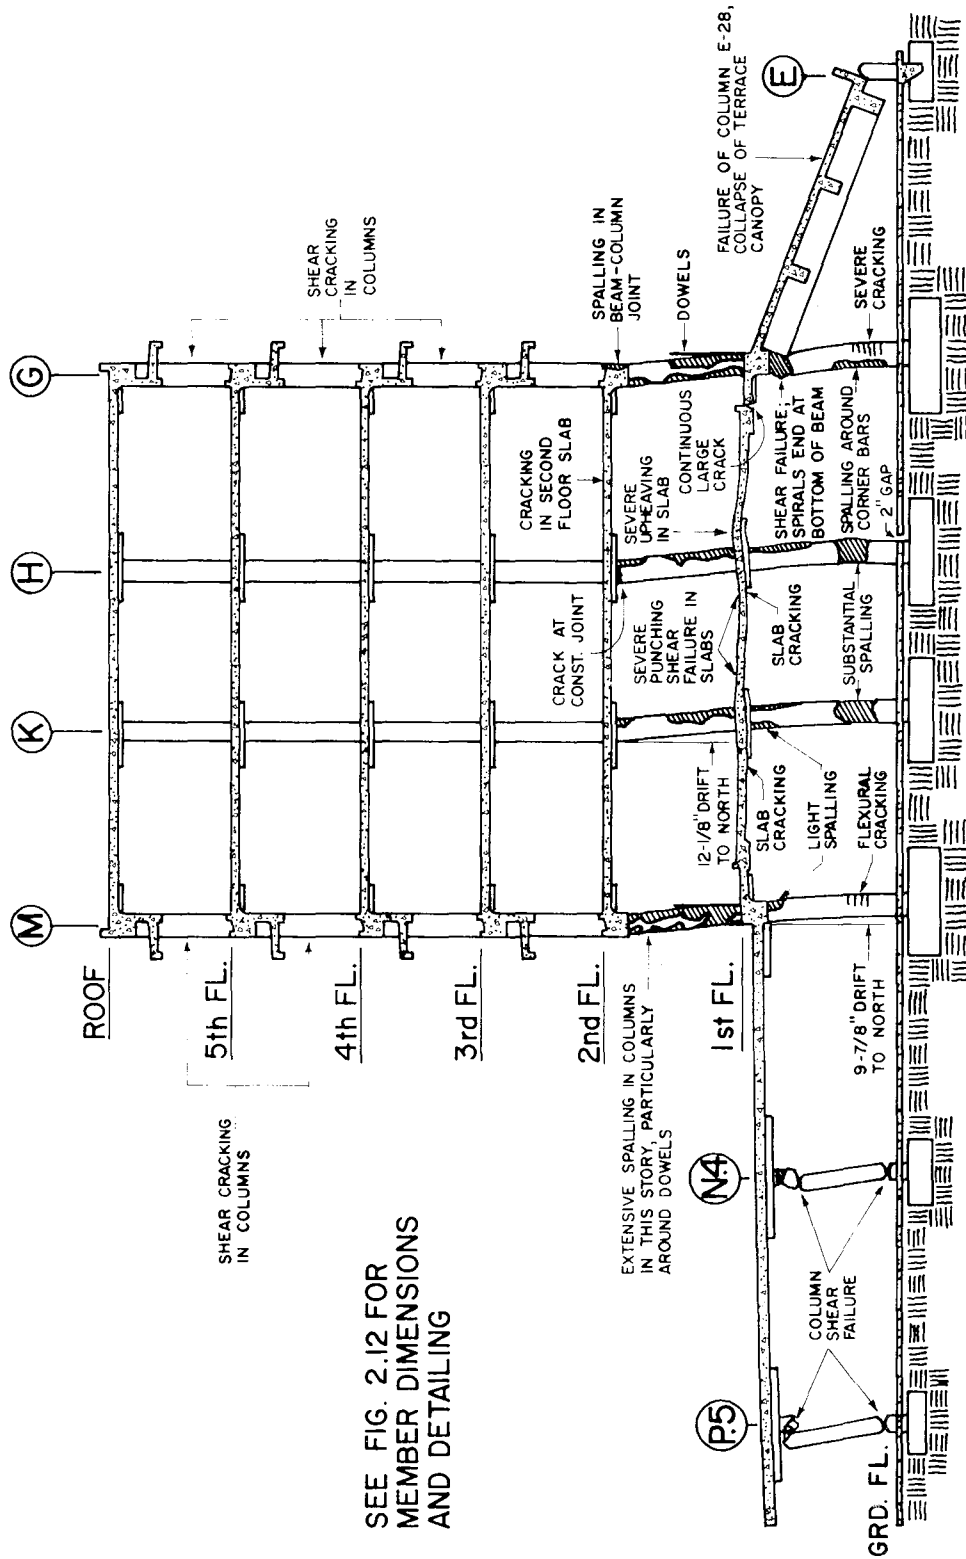
FIG. 3.23 SCHEMATIC DIAGRAM OF DAMAGE TO FRAME 28

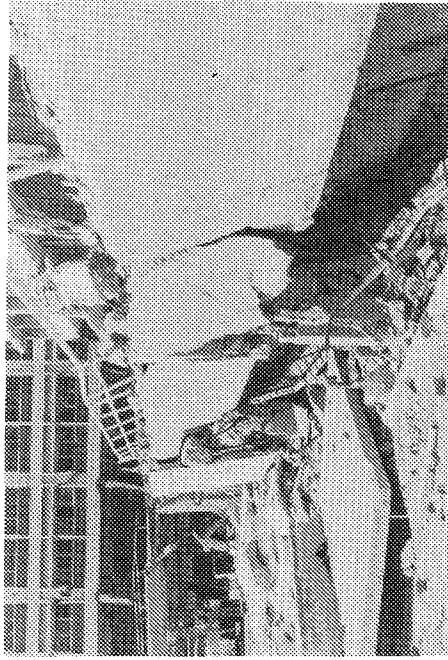
FIG. 3.25 BRITTLE SHEAR FAILURE OF TIED COLUMNS SUPPORTING SOUTHERN EDGE OF TERRACE CANOPY (COLUMN E-27 IN FOREGROUND)

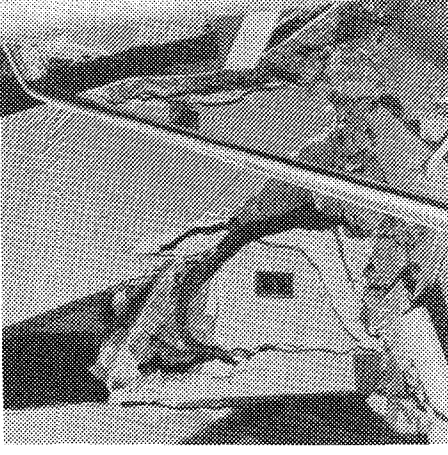
FIG. 3.26 SHEAR FAILURE AT BOTTOM OF TIED COLUMN P-27

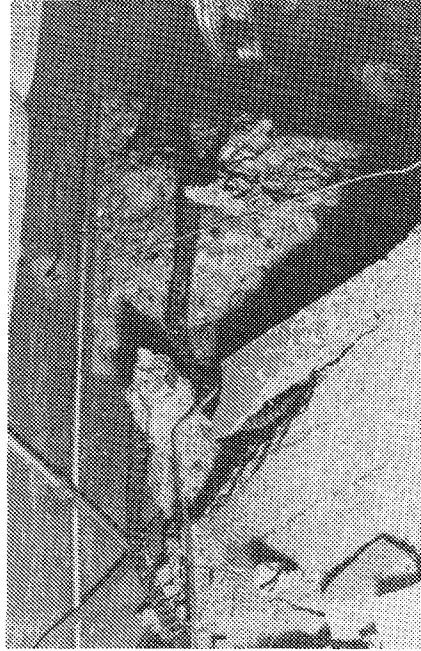
FIG. 3.27 SHEAR FAILURE AT TOP TIED COLUMN P-27

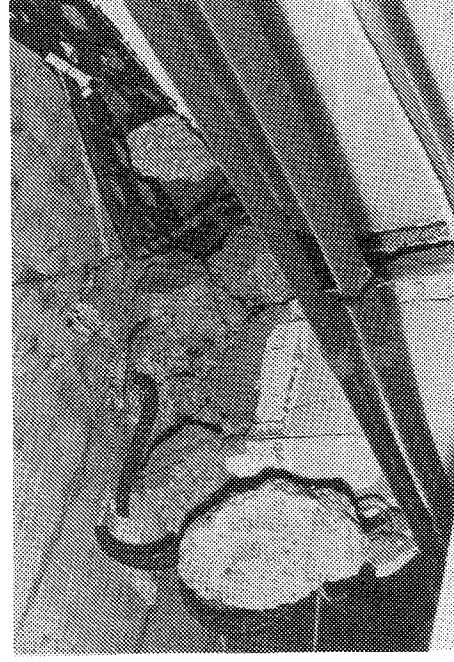
FIG. 3.28 SHEAR FAILURE AT TOP OF COLUMN P-16 SUPPORTING COURTYARD

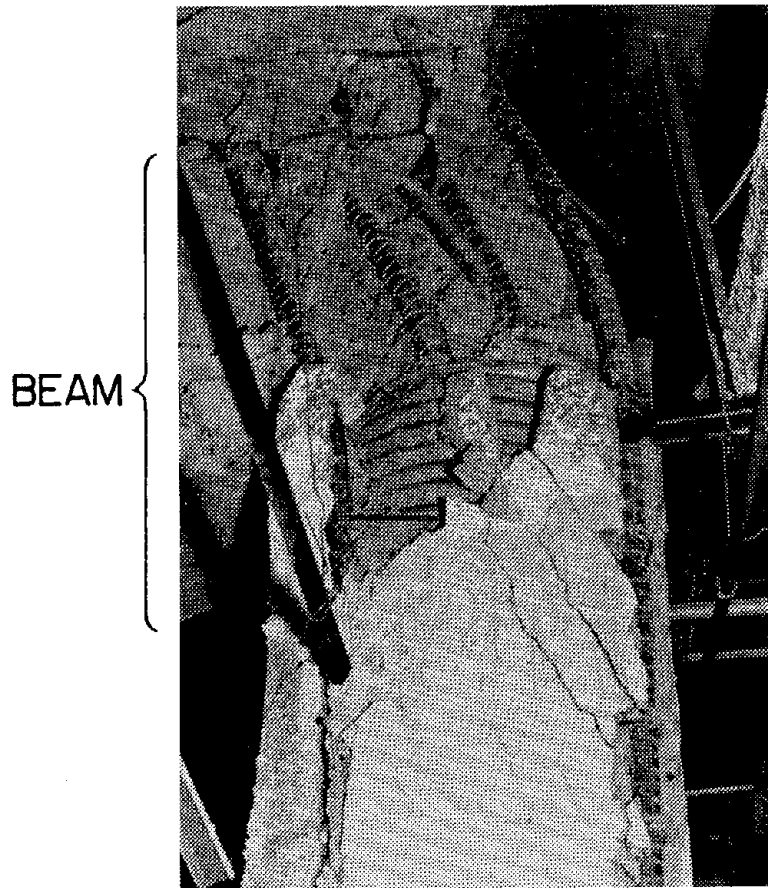
FIG. 3.29 JOINT FAILURE IN GROUND STORY COLUMN G-27. NOTE THAT SPIRALS TERMINATE BELOW DEEP BEAM FRAMING INTO COLUMN FROM TERRACE CANOPY ON LEFT

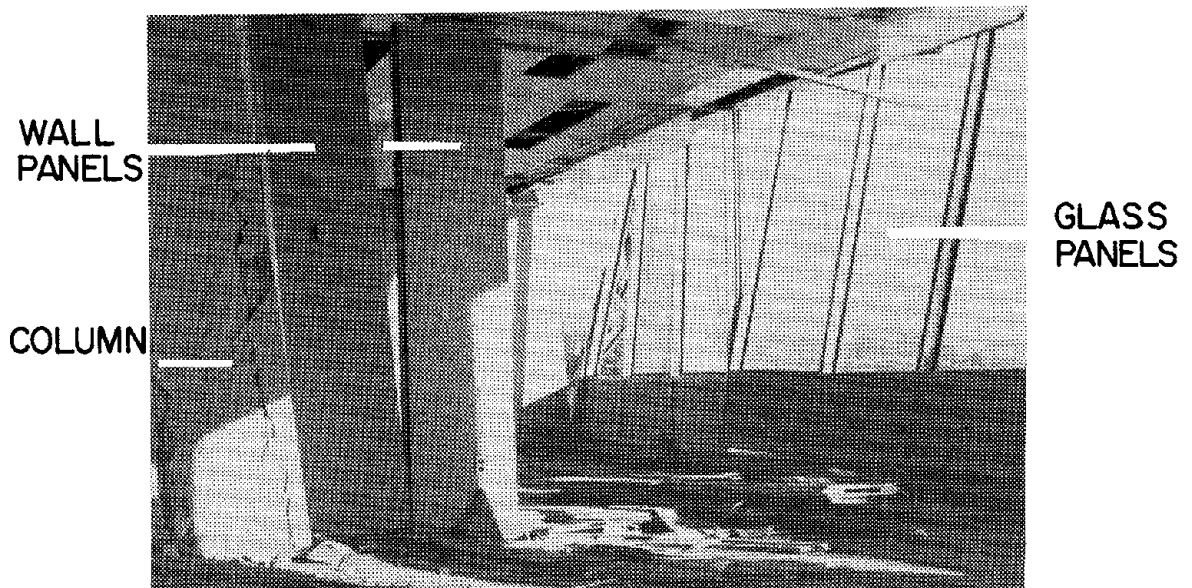
FIG. 3.30 GENERAL VIEW OF FIRST STORY DAMAGE AT H-27

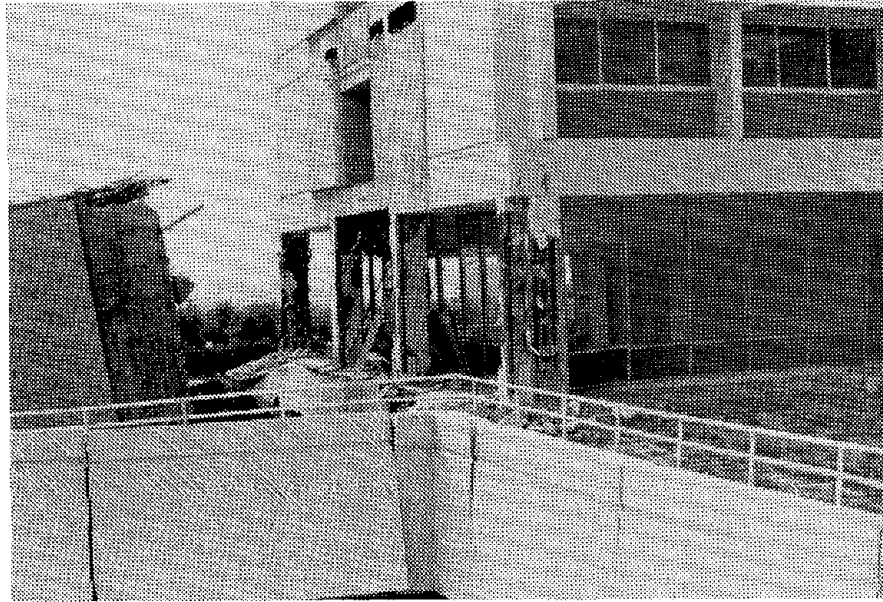
(a) GENERAL VIEW OF FRAME 29-FIRST STORY

FIG. 3.31 STRUCTURAL DAMAGE TO FRAME 29 IN FIRST STORY

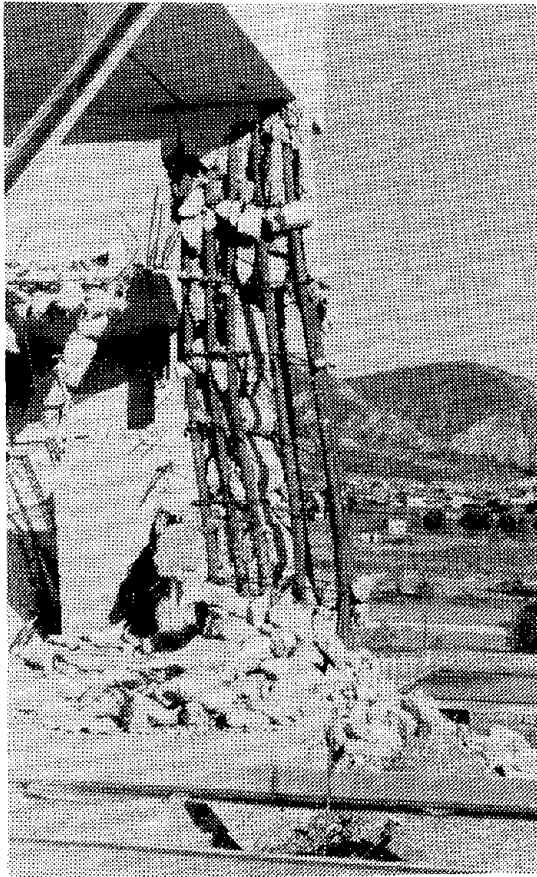
(b) DETAIL OF DAMAGE TO G-29

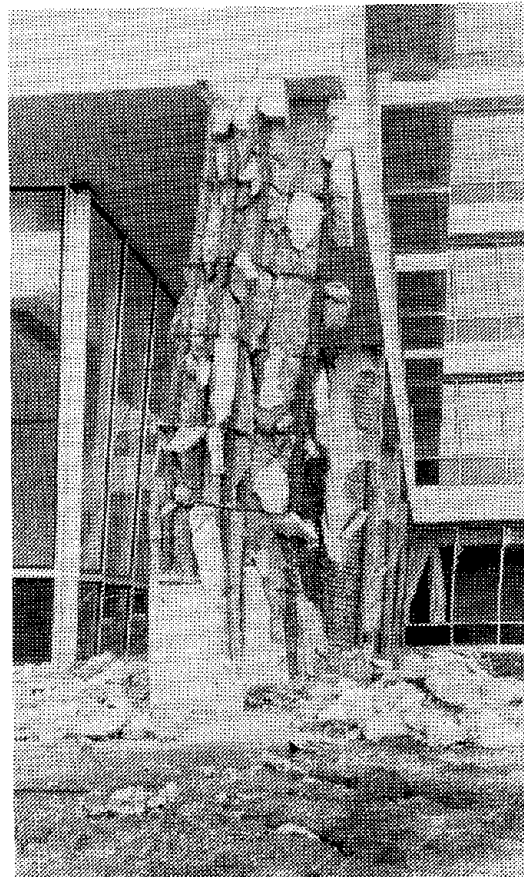
(c) DETAIL OF DAMAGE TO M-29

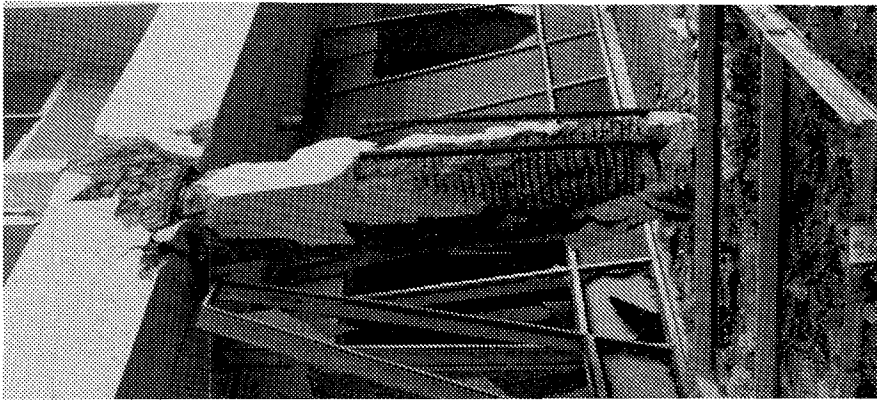
(a) COLUMN G-17

FIG. 3.32 TYPICAL FIRST FLOOR COLUMN DAMAGE

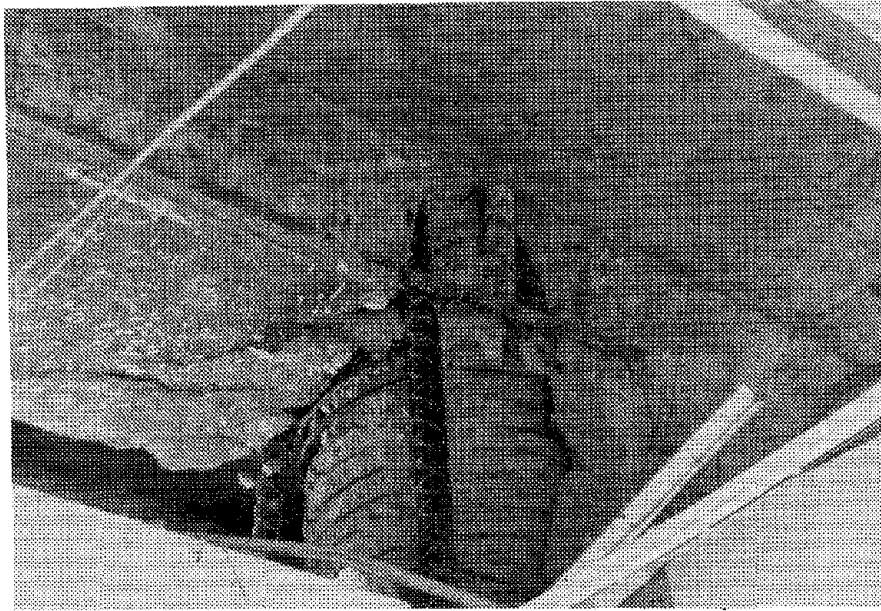
FIG. 3.33 SHEAR FAILURE OF JOINT AT TOP OF FIRST STORY SPIRAL COLUMN L-17. SPIRALS TERMINATE AT BOTTOM OF BEAM FRAMING INTO COLUMN FROM ONLY ONE SIDE

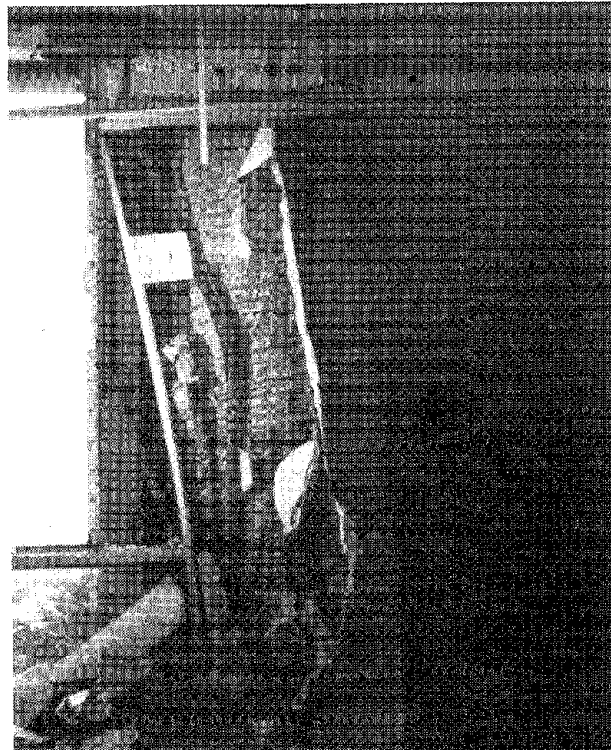
FIG. 3.34 FAILURE OF MECHANICAL CLAMPING DEVICE IN COLUMN

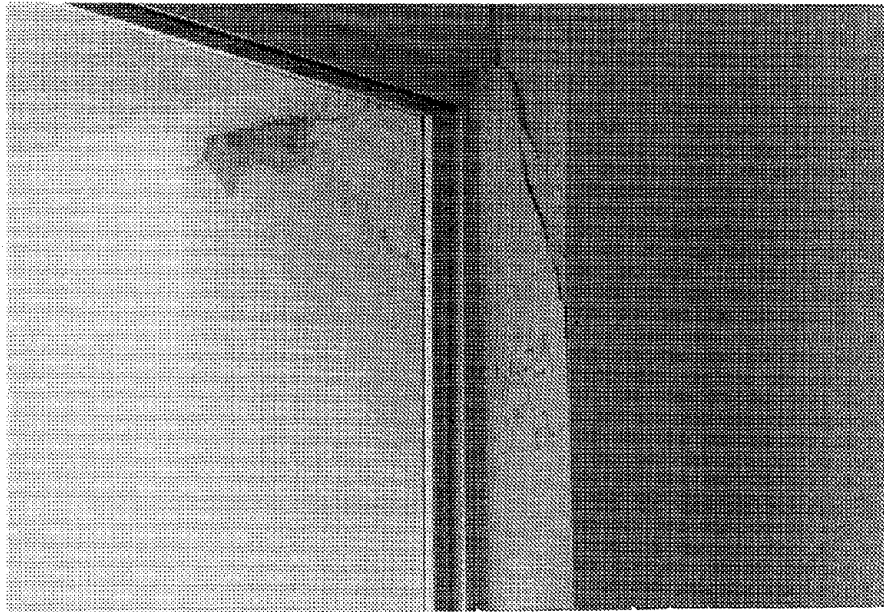
FIG. 3.35 CRACKING IN COLUMN M-29 IN THIRD STORY.
COLUMN MONOLITHIC WITH STRUCTURAL WALL

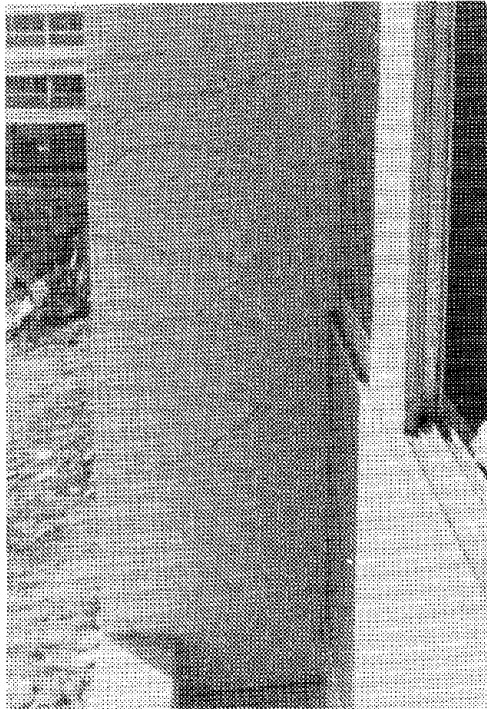
(a) EAST FACE OF COLUMN -28,
SECOND STORY

FIG. 3.36 DETAILS OF DAMAGE TO EXTERIOR CHANNEL
COLUMNS

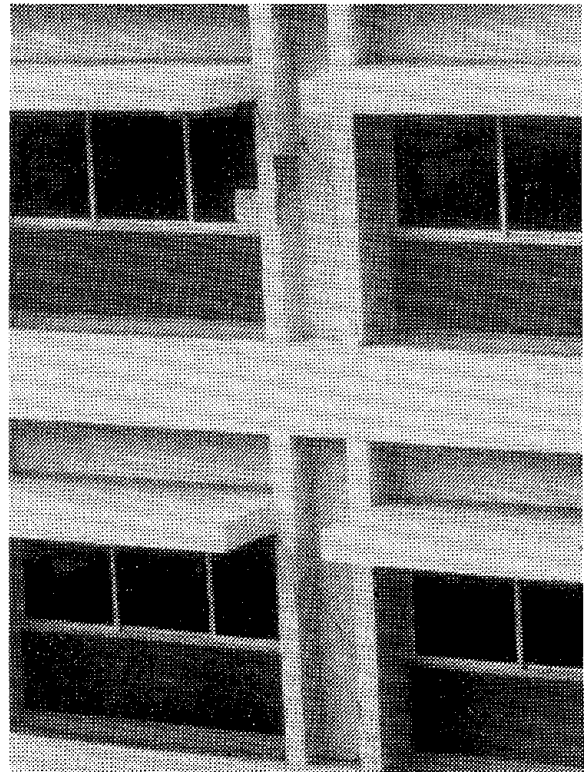
(b) NORTH FACE OF COLUMN -28,
FOURTH AND FIFTH STORIES

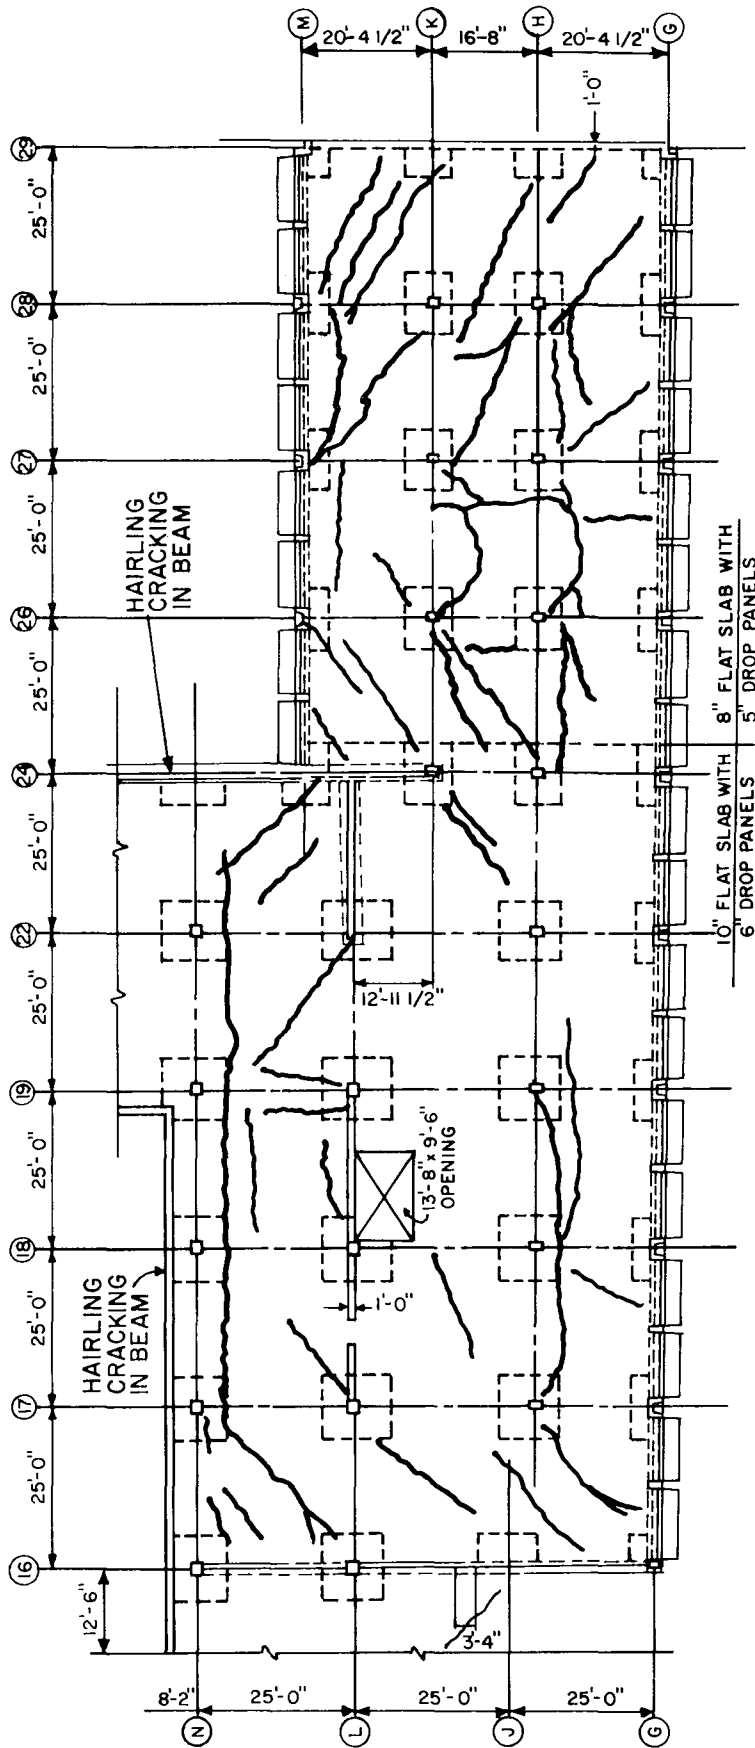
FIG. 3.37 CRACKING PATTERN OBSERVED AT TOP SURFACE OF SECOND FLOOR SLAB, WING D
