REPORT NO.
EERC 76-22
OCTOBER 1976

EARTHQUAKE ENGINEERING RESEARCH CENTER

RESPONSE OF THE OLIVE VIEW HOSPITAL MAIN BUILDING DURING THE SAN FERNANDO EARTHQUAKE

by
STEPHEN A. MAHIN
VITELMO V. BERTERO
ANIL K. CHOPRA
ROBERT G. COLLINS

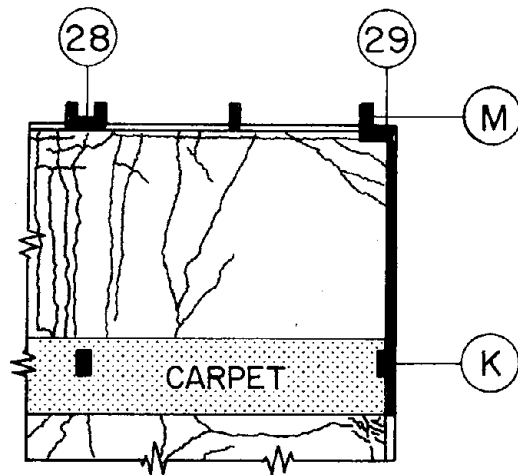
FIG. 3.38 CRACKING PATTERN OBSERVED AT TOP SURFACE OF FOURTH FLOOR SLAB, WING D

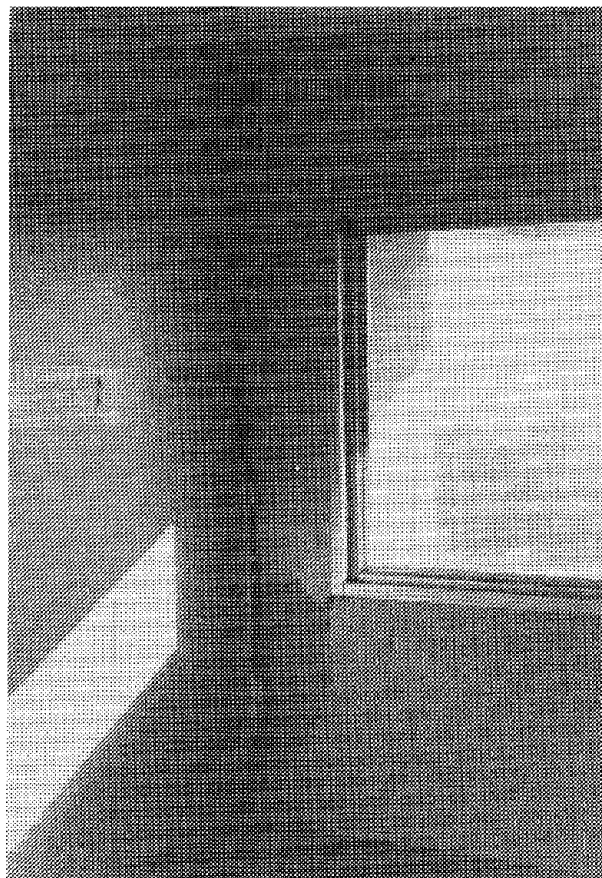
FIG. 3.39 DAMAGE TO PARTITIONS AT CONNECTIONS WITH STRUCTURAL ELEMENTS

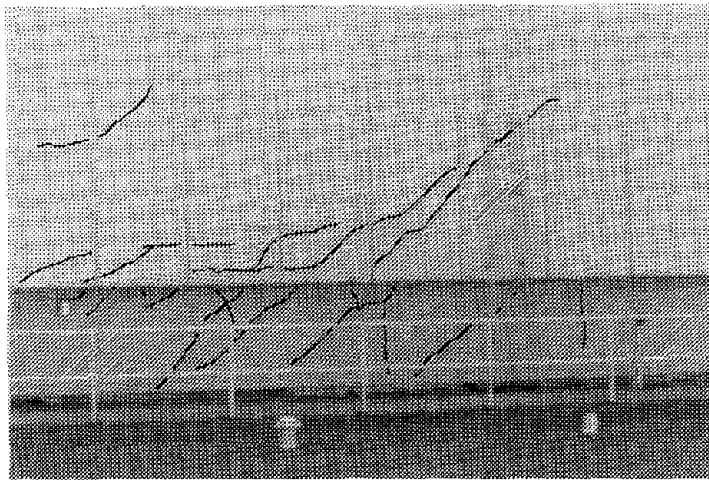
FIG. 3.40 CRACKING PATTERN IN NORTHWALL OF PENTHOUSE D BETWEEN COLUMN L-22 AND L-19
