THE ROLE OF CORROSION IN THE SEISMIC
PERFORMANCE OF BURIED STEEL PIPELINES
IN THREE UNITED STATES EARTHQUAKES

J. Isenberg

Grant Report No. 6

JUNE 1978

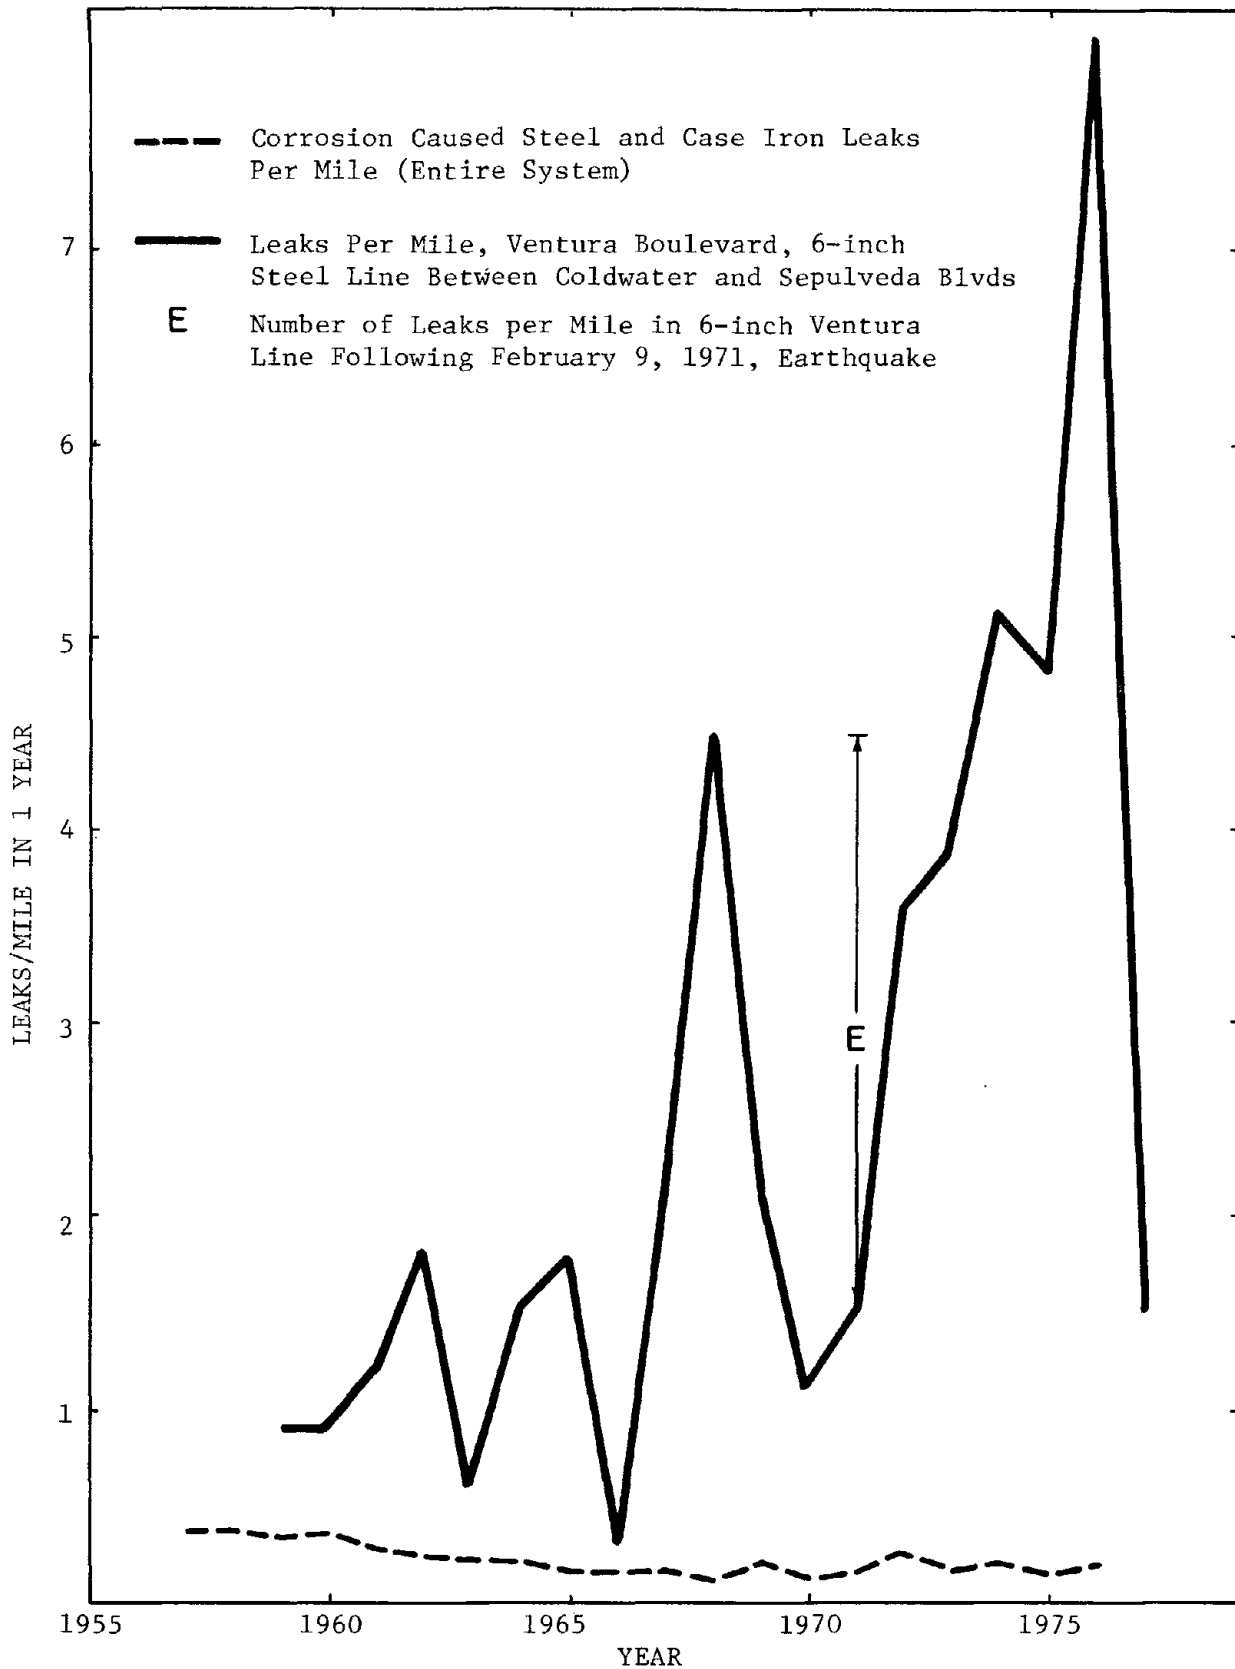
Figure 1. Leaks Per Mile Per Year in Ventura Boulevard Line and in All LADWP Cast Iron and Steel Lines

The performance of the line under normal conditions was poor. The number of leaks per mile per year (leak rate), shown in Figure 1, is of order ten times greater than that for all cast iron and steel pipes in the LADWP system (Reference 4). Poor performance of this segment of pipe is attributed to corrosion due to low soil resistivity. A profile along Ventura Boulevard, Figure 2, shows that electrical resistivity of the soil fluctuates around $1,000 \Omega/\text{cm}^3$, which, on the scale used by LADWP, is the border line between severe and extremely severe conditions for corrosion of steel.

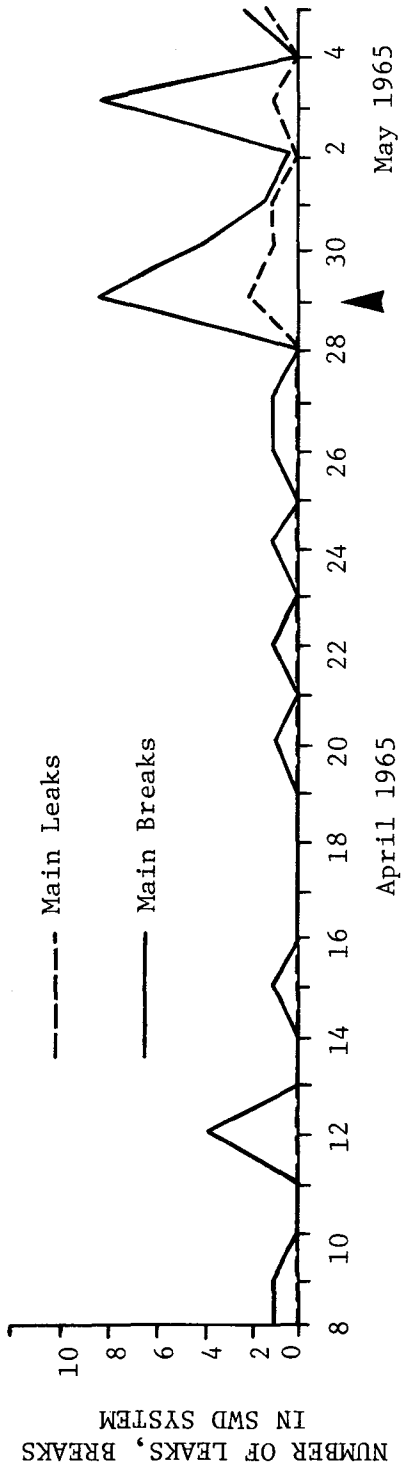
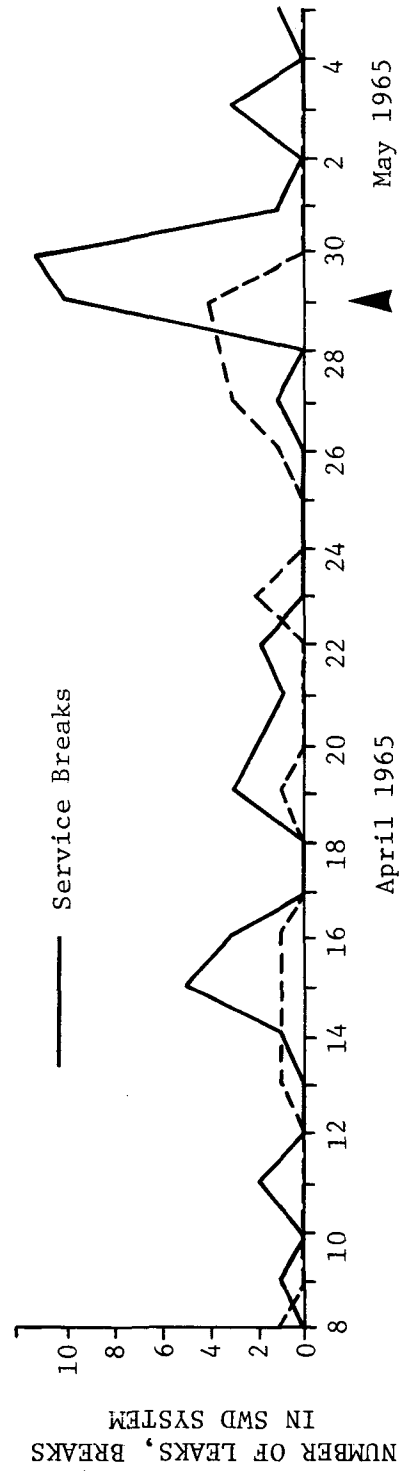
Figure 9. Leaks in Mains and Service Laterals for Seattle Water System Immediately Before and After 1965 Puget Sound Earthquake

The impact of the earthquake damage is also indicated in Figure 9 where leaks and breaks following the earthquake are contrasted to those during the earthquake are mostly due to leaky lead joints, whereas

the earthquake damage occurred in several modes, including leaks in rust spots. All service leaks in Figure 9 are corrosion-related. There are two fewer service leaks shown in Figure 9 than are indicated in Table 6. The reason for this is unknown, except that the information was prepared at two different times for two different purposes. There are many fewer main leaks in Table 7 than are shown in Figure 9 because the former lists only those which are considered to be related to corrosion whereas the latter lists leaks due to all causes.
