California Institute of Technology
Earthquake Engineering Research Laboratory

THE SALONICA (THESSALONIKI) EARTHQUAKE
OF JUNE 20, 1978

EERL 78-03

SALONICA EARTHQUAKE OF JUNE 20, 1978

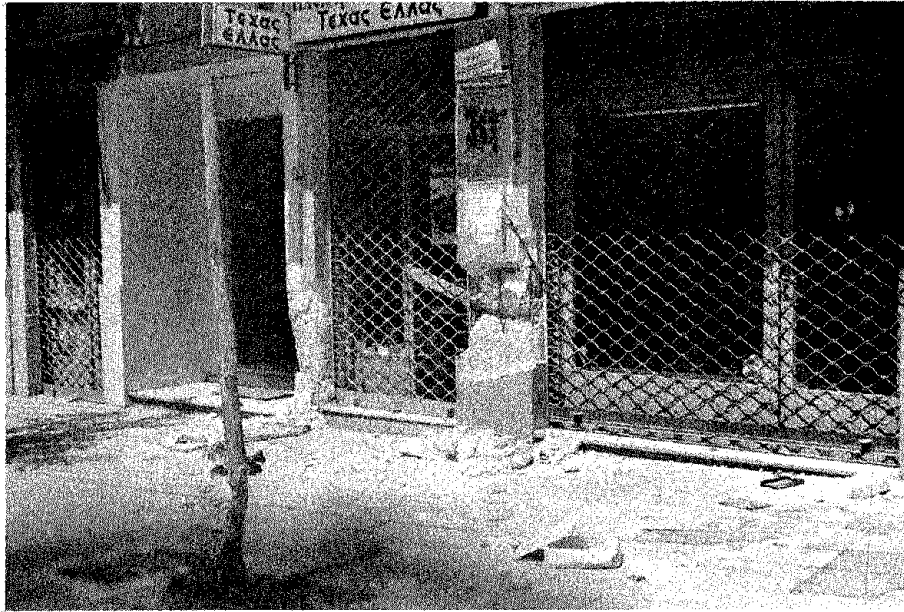
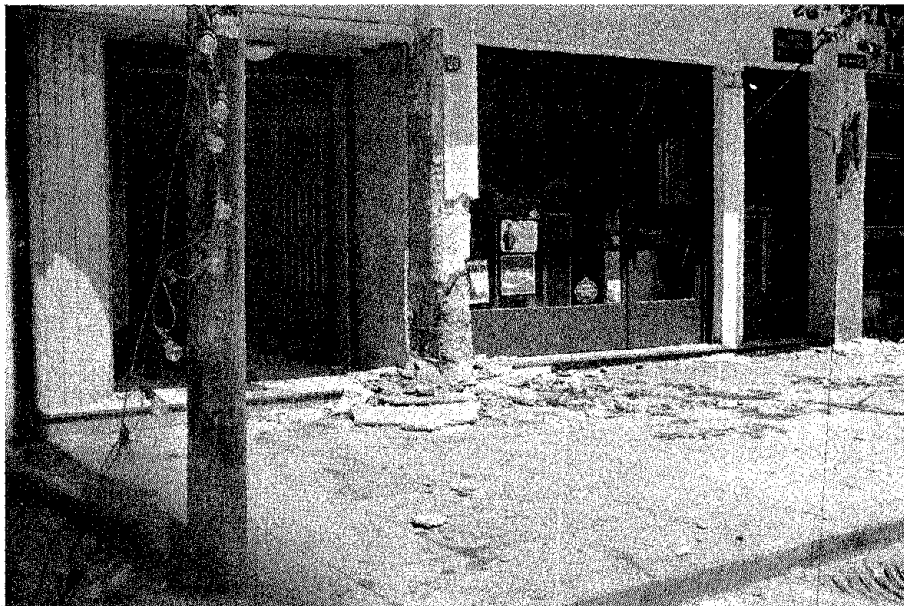
Two other apartment buildings on 23 and 25 Vasilisis Sofias street, of about the same height as the one which collapsed, were damaged to the point that they no longer could be occupied. The columns of these buildings were badly cracked above the ground surface and the steel reinforcing bars were bent (see figure 6a, b).

These buildings, like the one which fell, were built in the place of the old hippodrome, where the foundation soil was formed by fill. These poor foundation conditions might have played an important role in the

extent of the damage to these buildings. Other buildings in the same area also suffered considerable damage.

Figure 6. Severe damage to the columns of the buildings at 23 and 25 Vasilisis Sofias street.

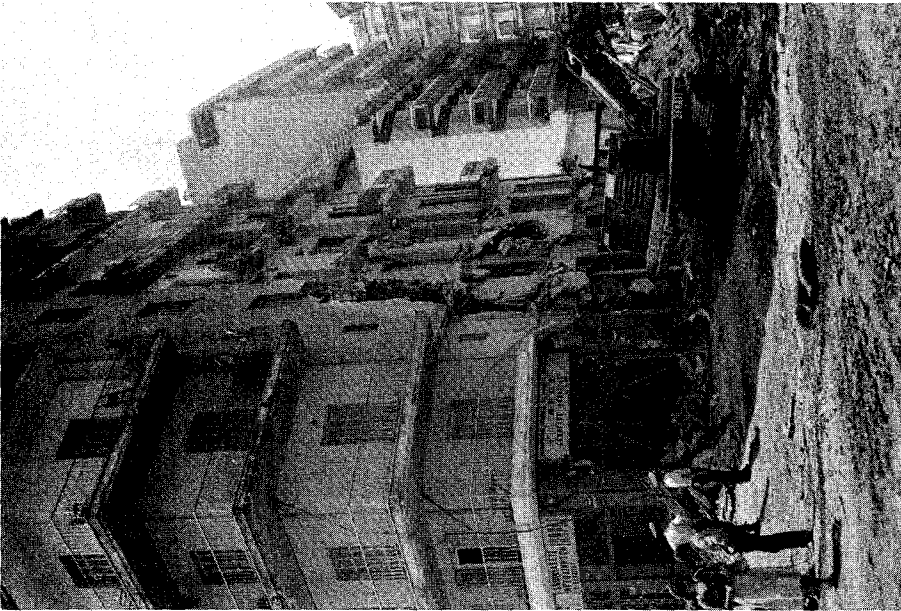
The 8-story apartment building, situated at the crossing of Nikiforou Foka and Ippodromiou streets, collapsed completely. Fortunately, 8 families who lived in the building had been on vacation at the time of the earthquake, otherwise the number of casualties would have been much higher. The building, which was an old one, was designed before the adoption of the modern building code. In any case, investigations started a few days after the quake in order to clarify the reason for the collapse.

Figure 7. Severe damage inflicted to adjacent buildings by the fall of the 8-storey apartment building at Ippodromiou street.

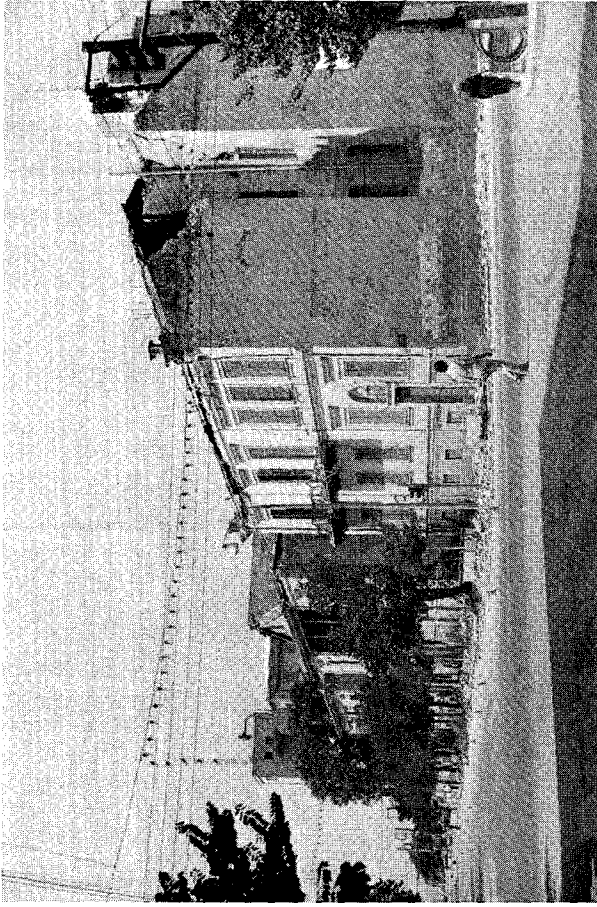
Figure 8. Damage to old buildings at Vasilisis Sofias street.

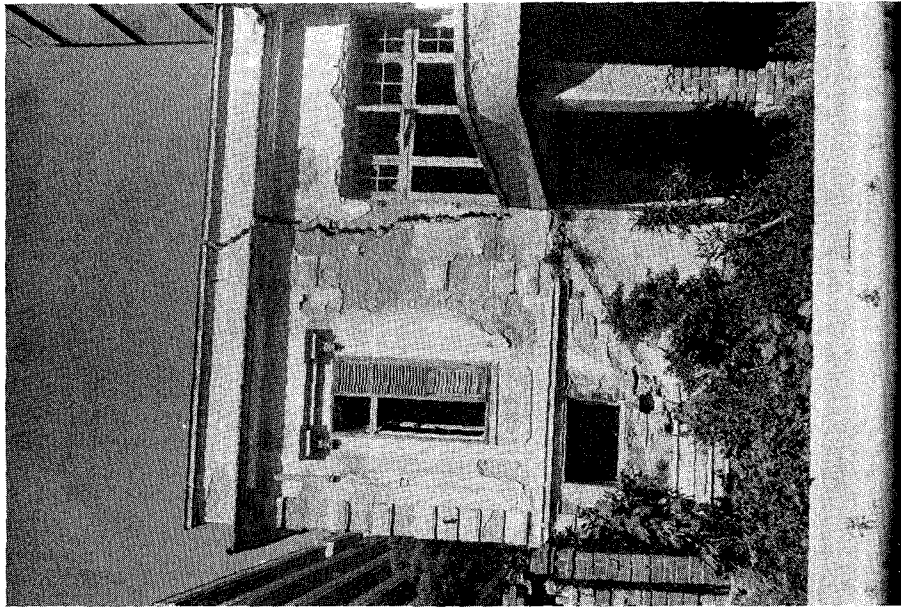
Figure 9. Damage to an old house not occupied at the time of the earthquake.

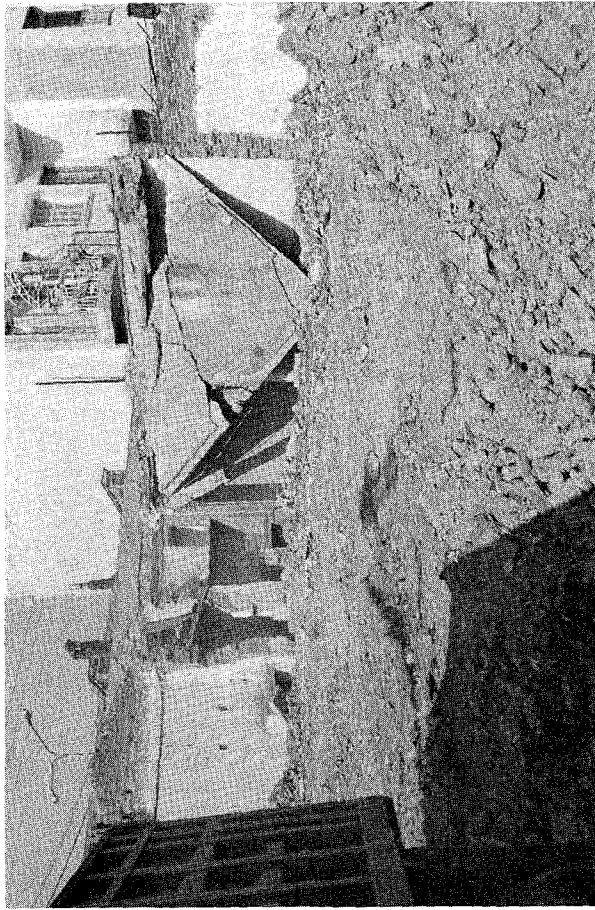
A lot of old weak houses were severely damaged, usually in the form of falling masonry. Walls fell down in such buildings, and the damage to the parapet walls and the balconies was also extensive. A 2-story house at Yiannitson street collapsed completely.

Figure 10. This was a 2-storey old house at Yiannitson street which collapsed.

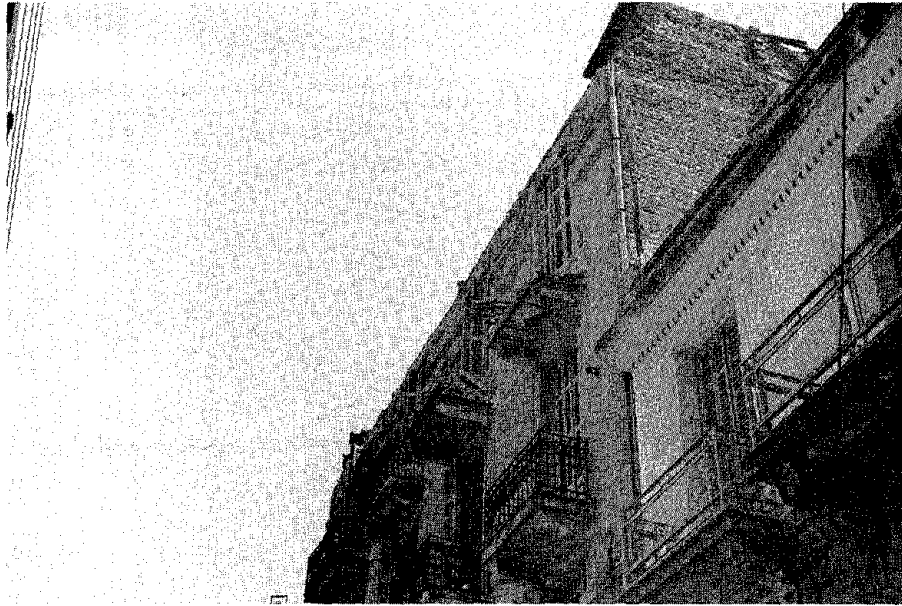
Figure 11. Damage to the parapet walls and the balconies of "Egyptos" Hotel.

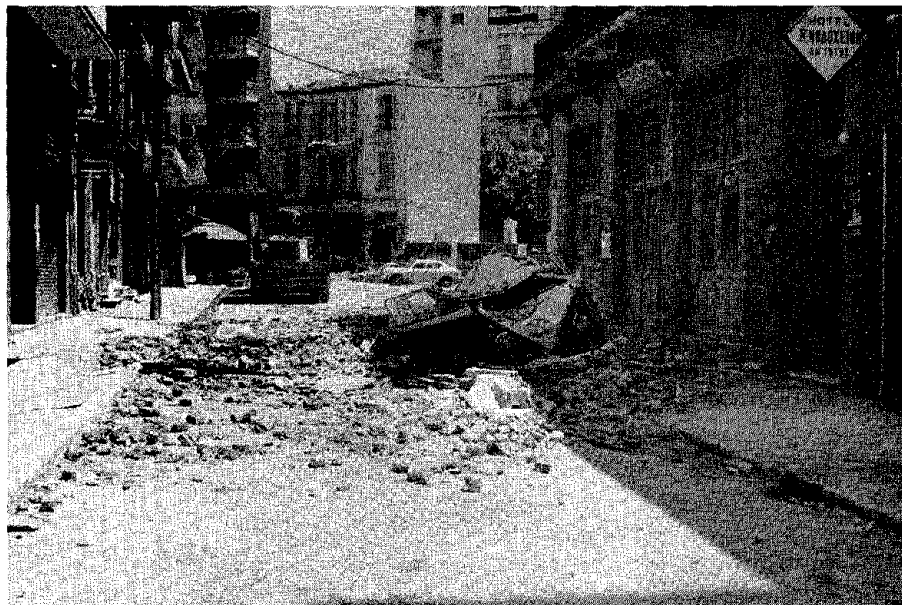
Figure 12. "Egyptos" Hotel. A person was killed here by falling bricks.

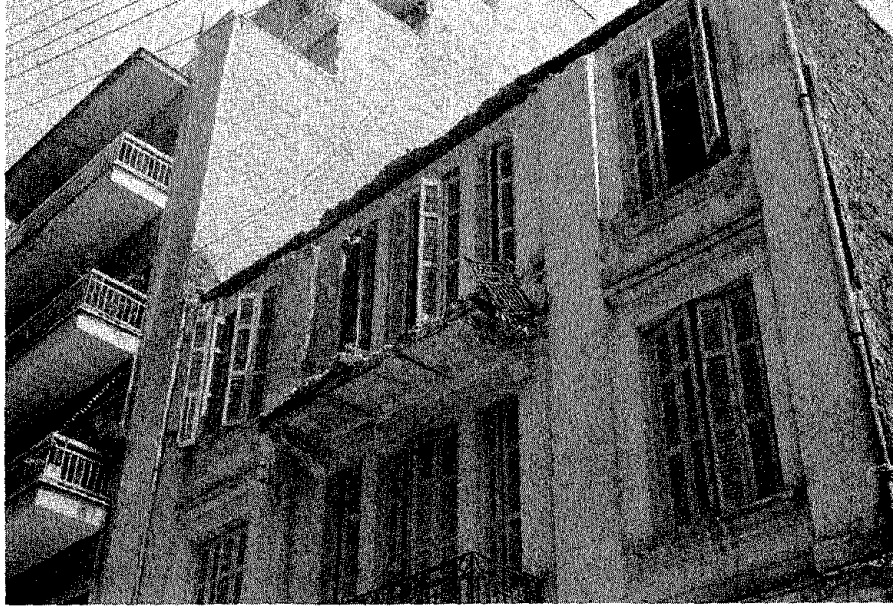
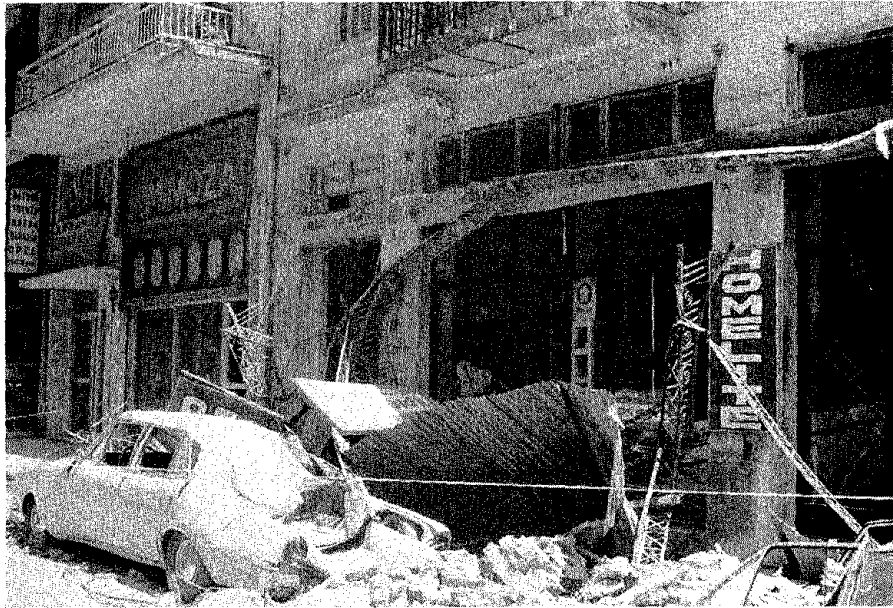
Figure 13. Damage to the balcony and parapet wall of an old house.

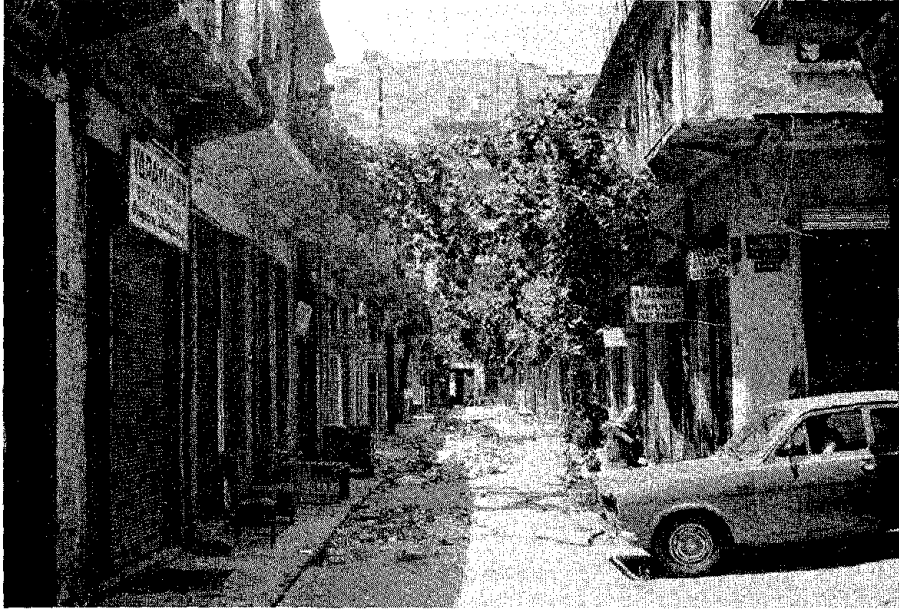
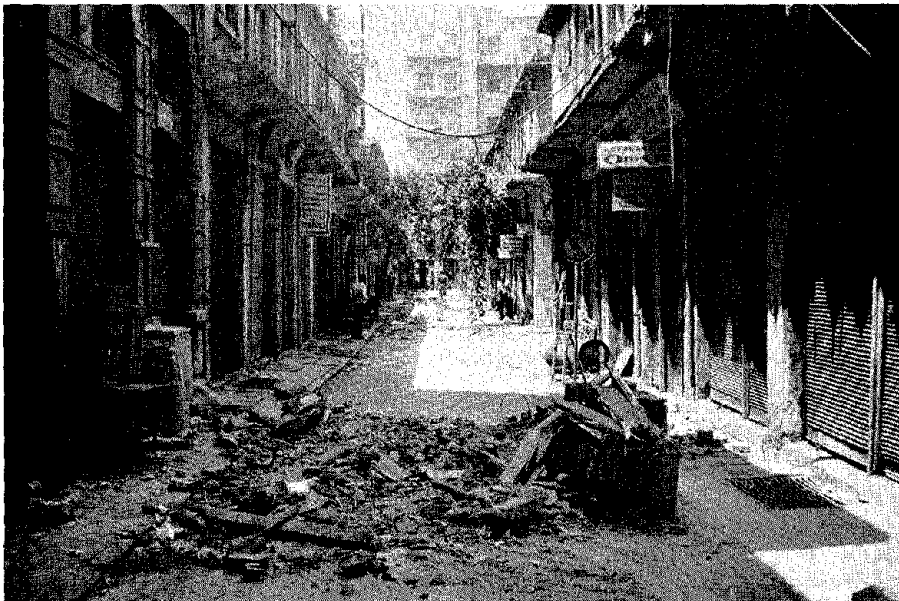
Figure 14. Extensive damage to the parapet walls and balconies of old houses.

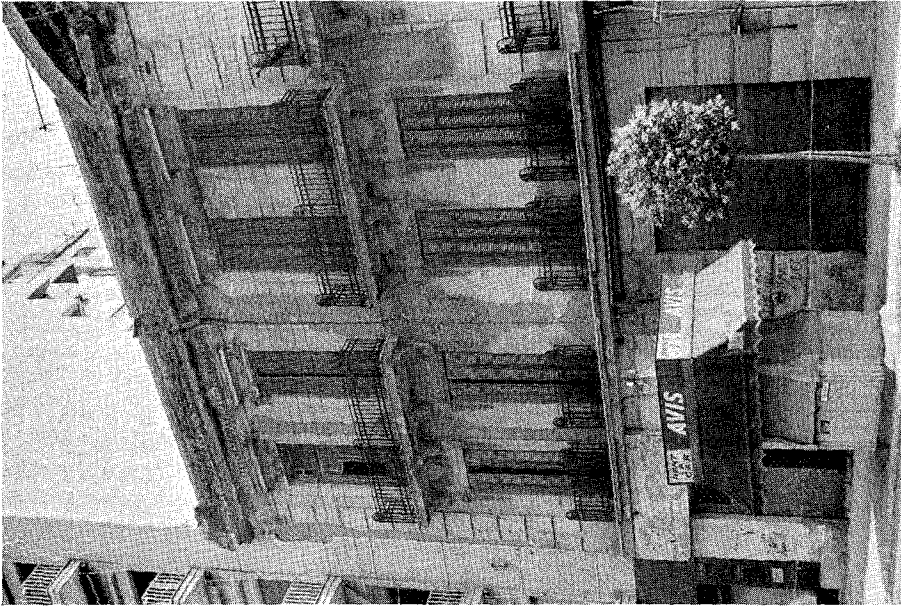
Figure 15. Separation of two old buildings after the earthquake.

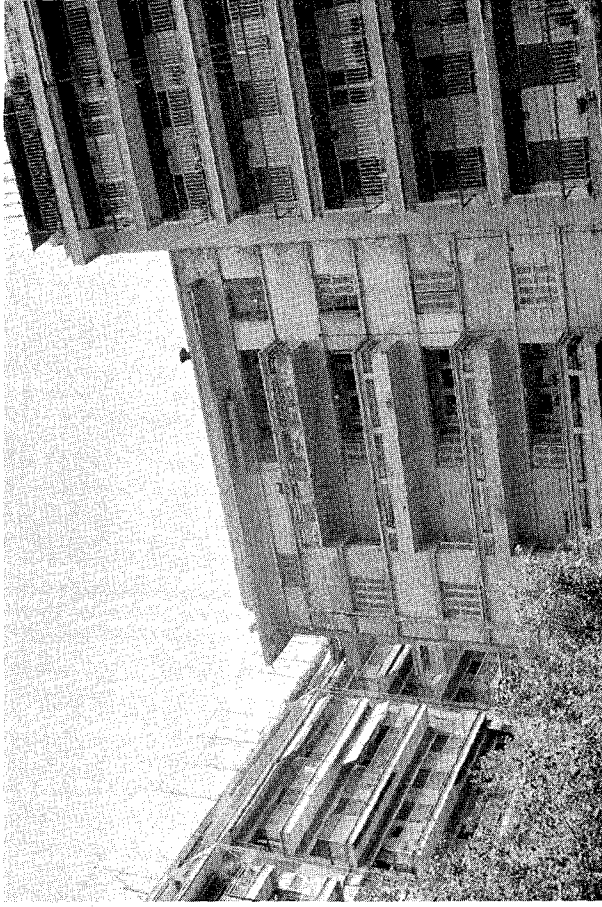
Figure 16. Damage to the plaster of the exterior walls. This kind of damage was very common.

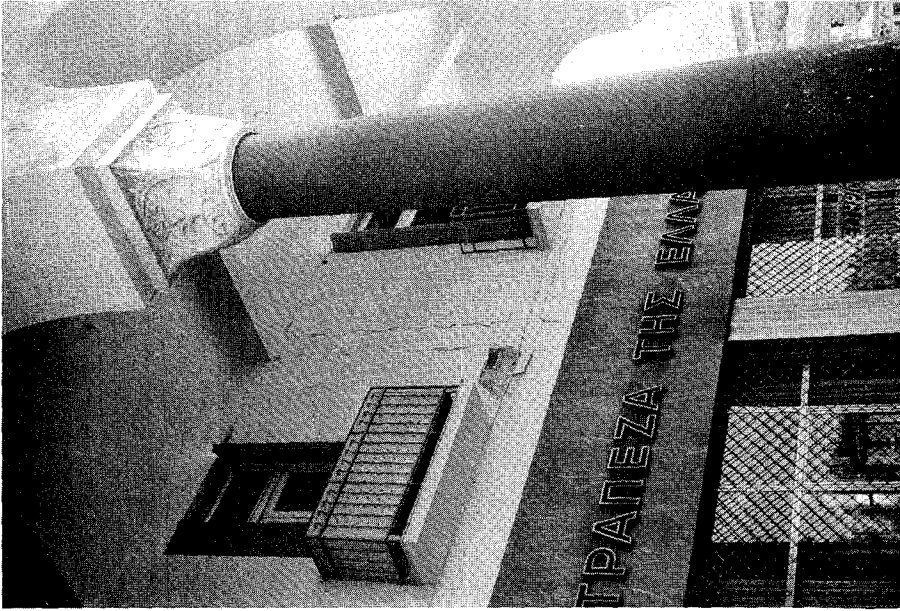
Figure 18. Cracks along the boundary of the concrete frame of a modern building.

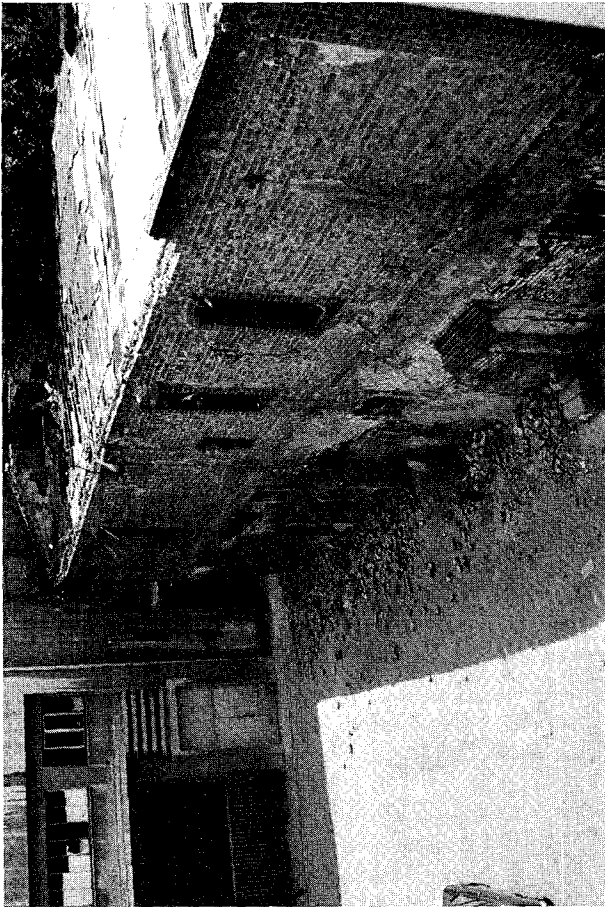
Figure 17. Damage to the parapet wall of an old building.

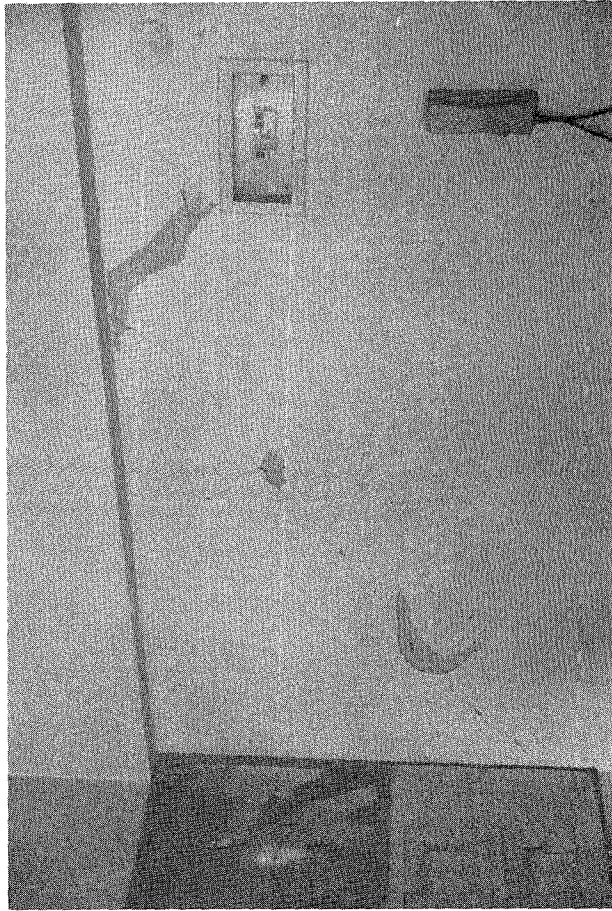
Figure 19. Cracks on an interior brick wall of a modern building.

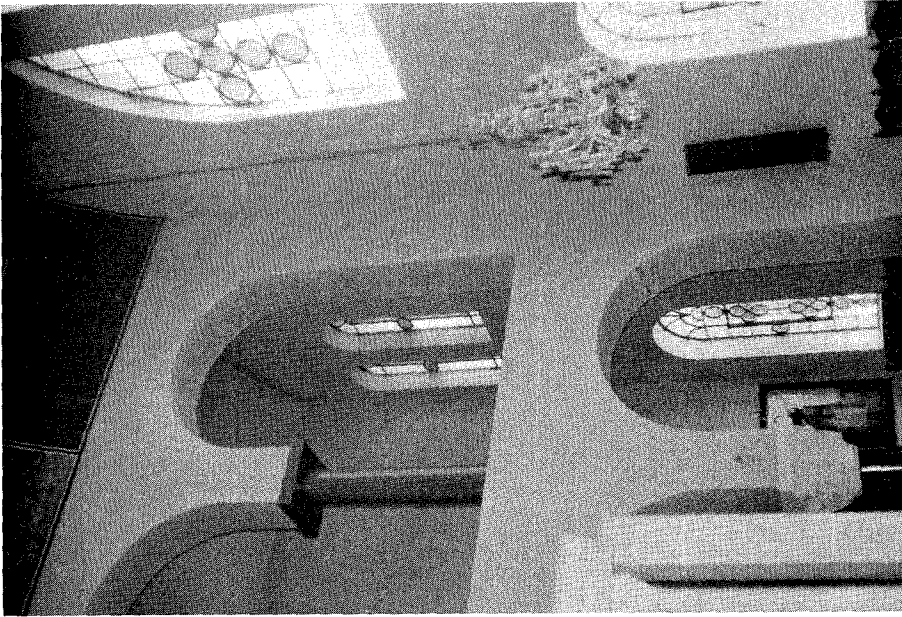
Figure 20. Church of Agia Barbara in Toumba. Cracks on the interior walls and arches.

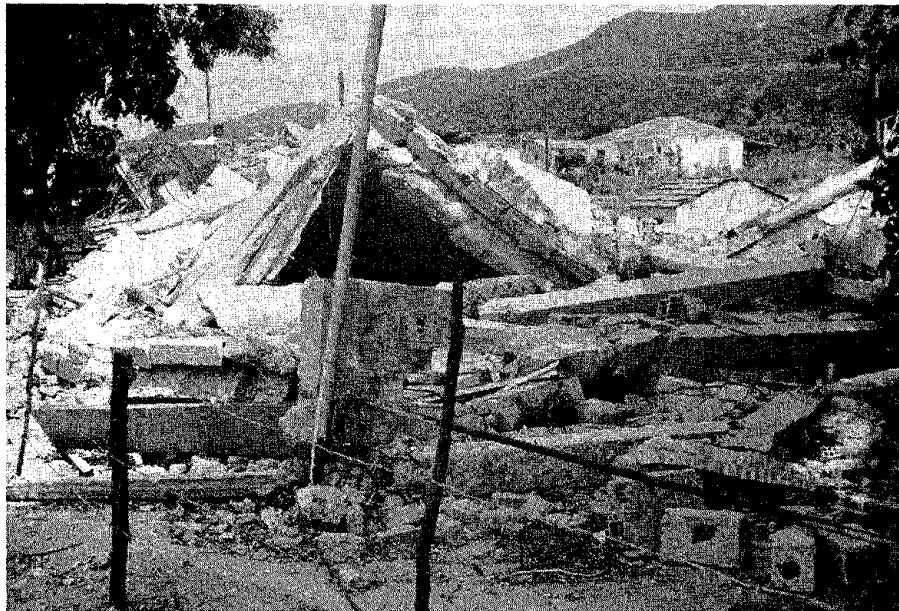
Figure 22. Collapse of a house at Stivos Village.

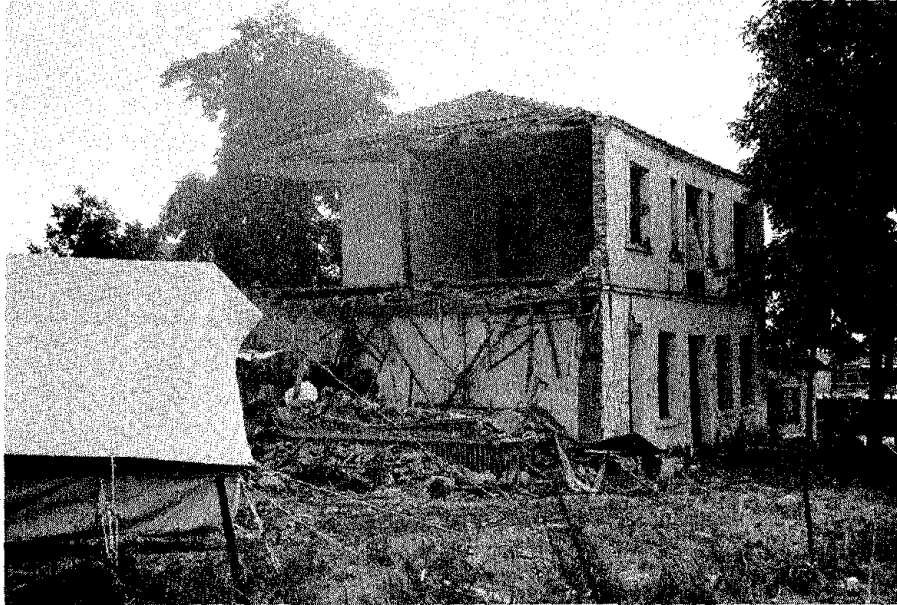
Figure 23. Fall of an exterior wall of a house at Stivos Village.

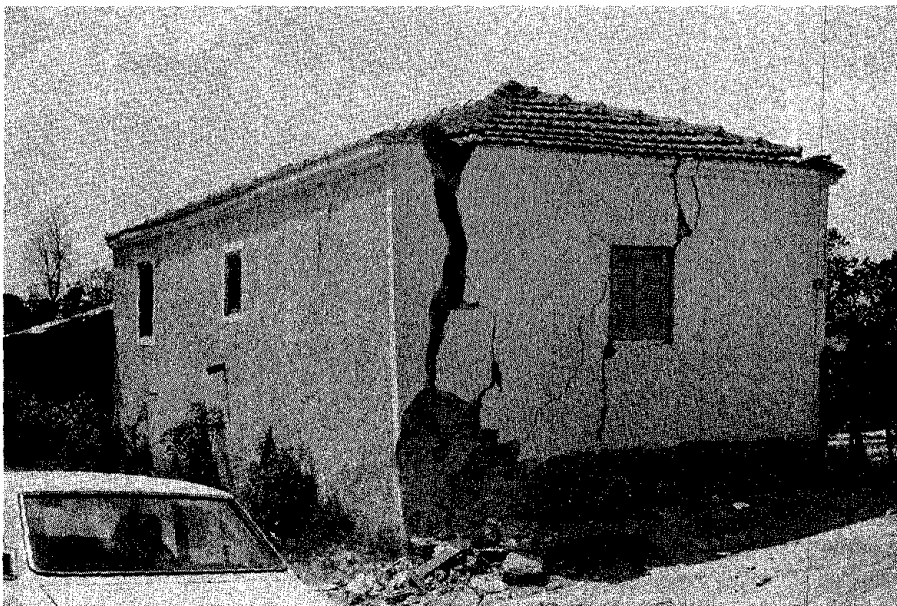
Figure 24. Typical damage to house at Stivos Village.

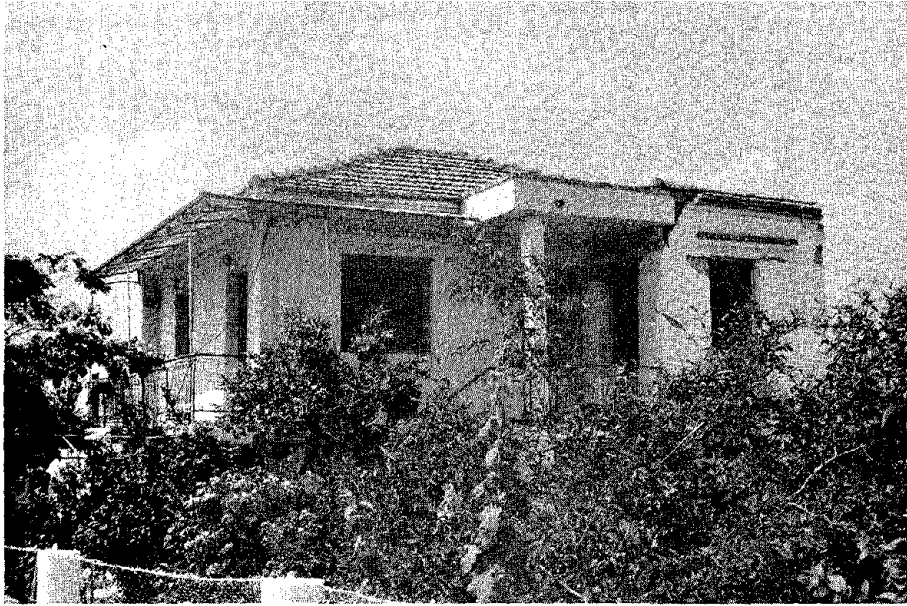
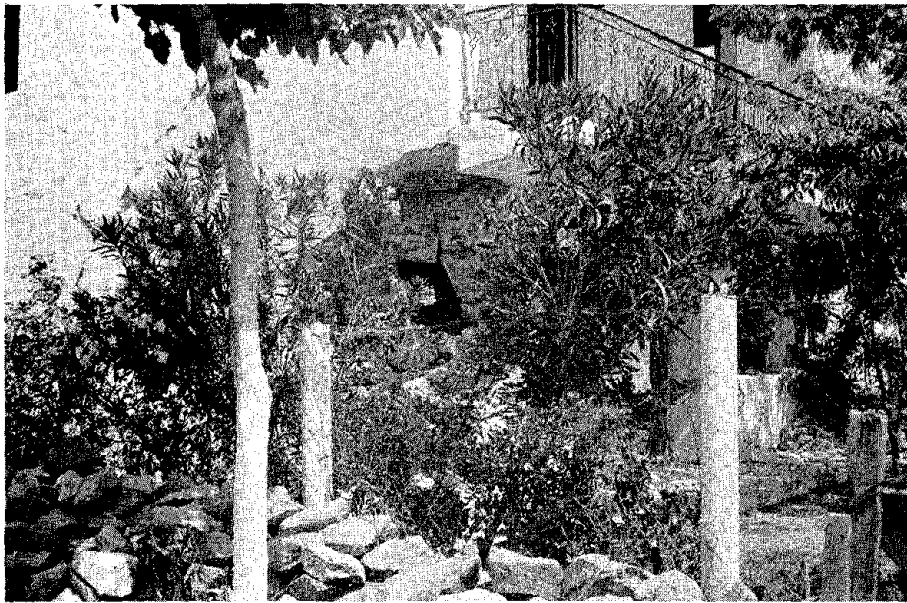
Figure 25. Damaged house at Stivos Village.

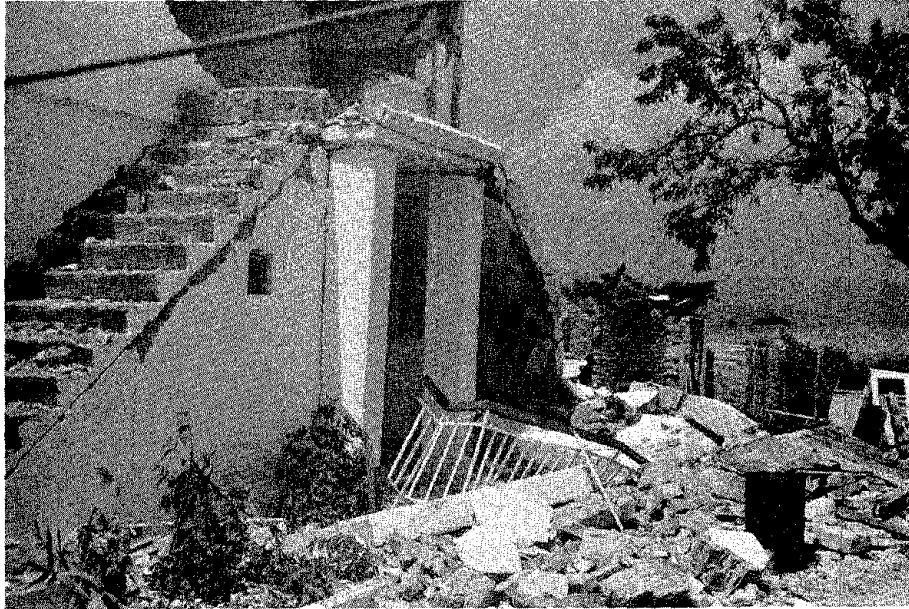
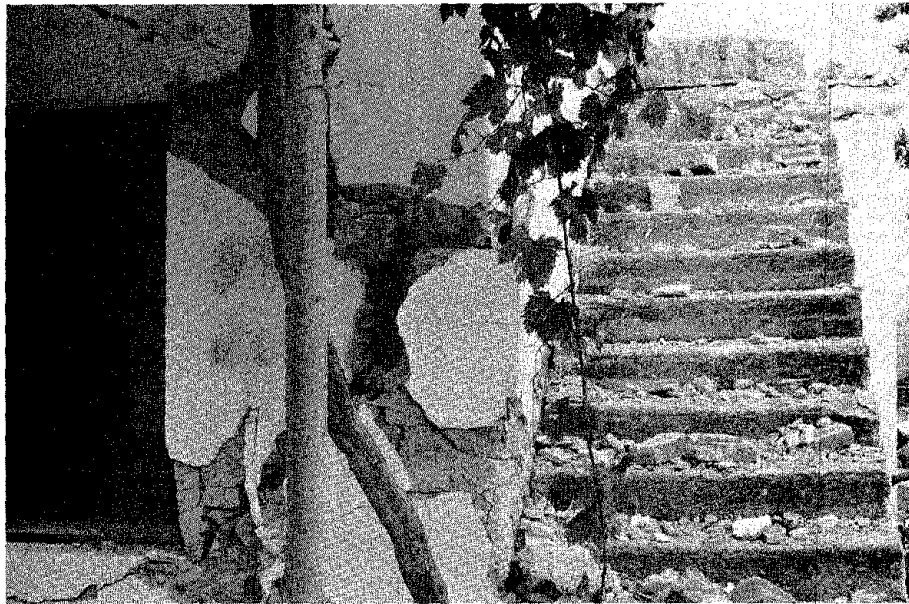
Figure 26. Damage to the stairway and the exterior wall of a house at Stivos Village.

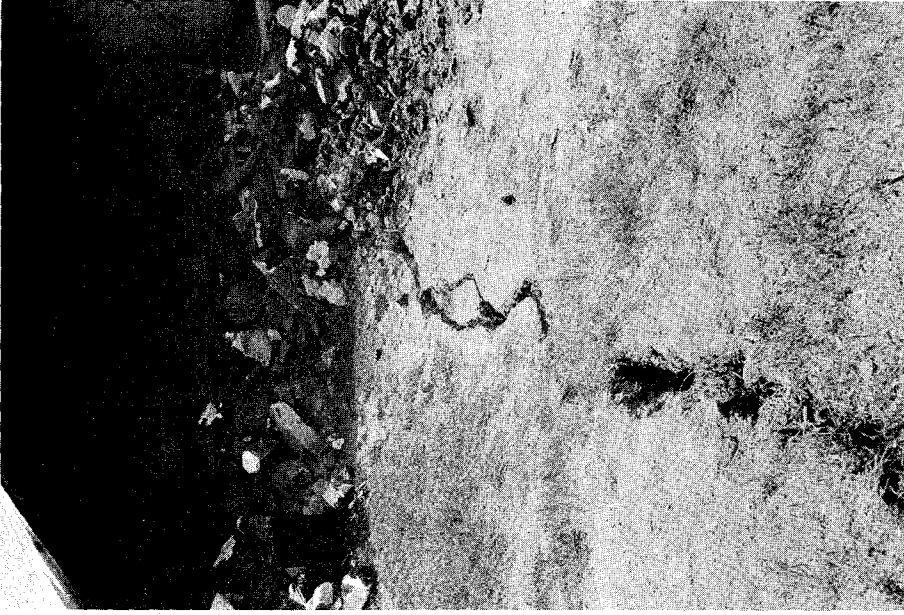
The earthquake produced a net of cracks, which appeared at two places in the epicentral region near the village of Yerakarou and between the villages of Stivos and Scholari. Near Yerakarou, the cracks were oriented E-W and the horizontal slipping was 2 cm. Between Stivos and Scholari, the cracks were oriented SE-NW with the same amount of motion. The width of the cracks in some places reached 20 cm. Local vertical slipping also occurred in some places, the maximum being 20 cm in a place at Scholari. As of mid-July, it was not known whether the cracks were related to faults or were merely local effects.

Figure 28. Crack which appeared on the earth at Stivos.

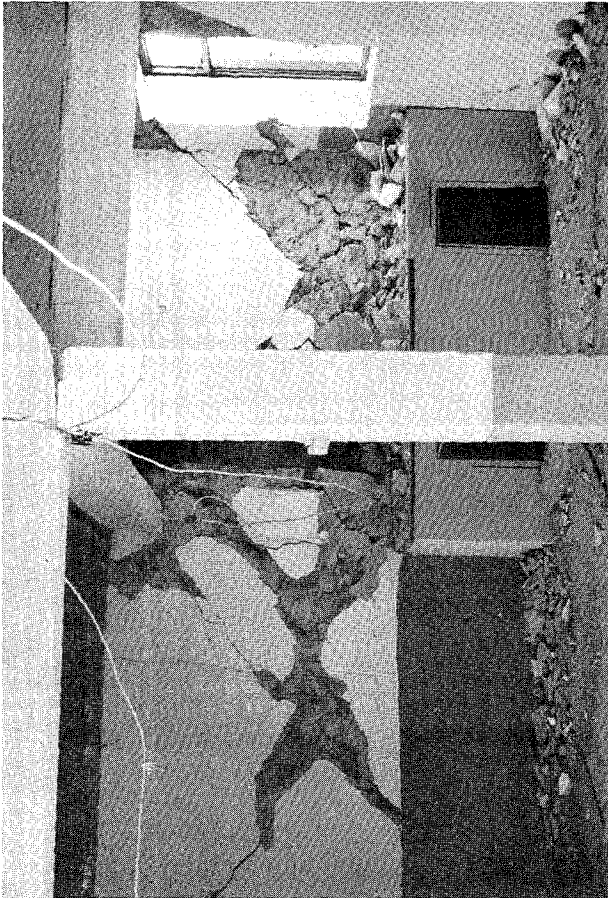
Figure 27. Damage to the interior of the same house.

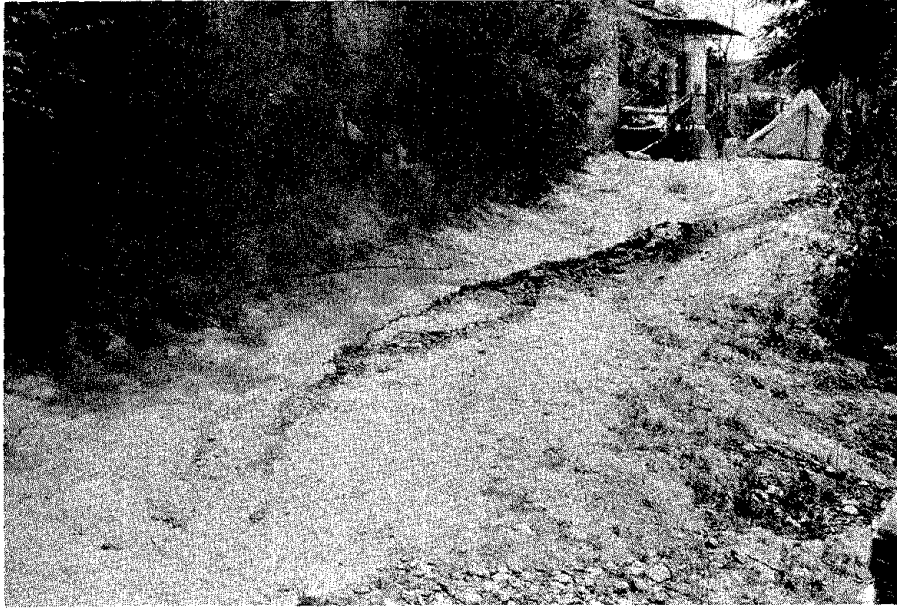
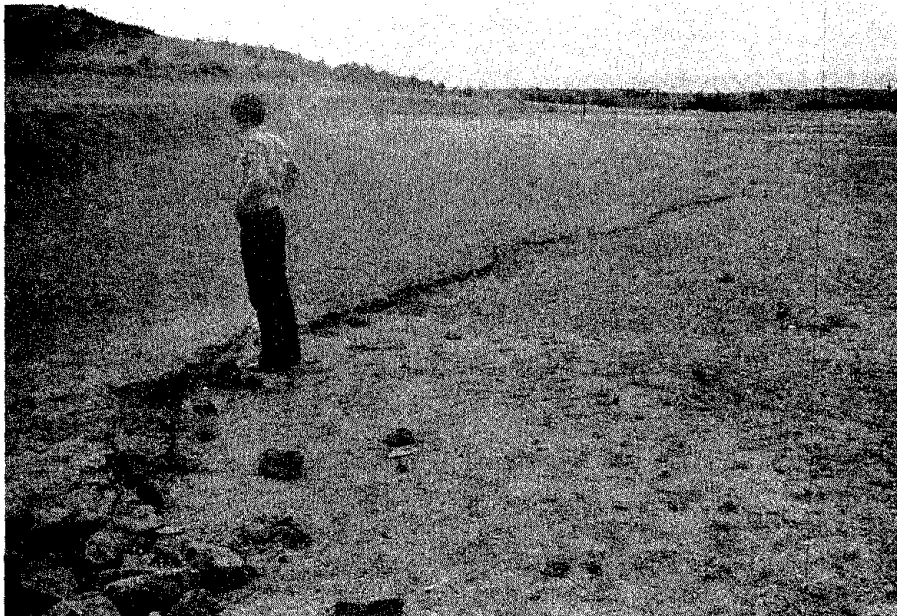
Figure 29. Cracks on the ground at Stivos.
