Earthquake Engineering  
Research Institute

**Reconnaissance Report**  
**MINDANAO, PHILIPPINES EARTHQUAKE**  
**August 17, 1976**

**August 1977**

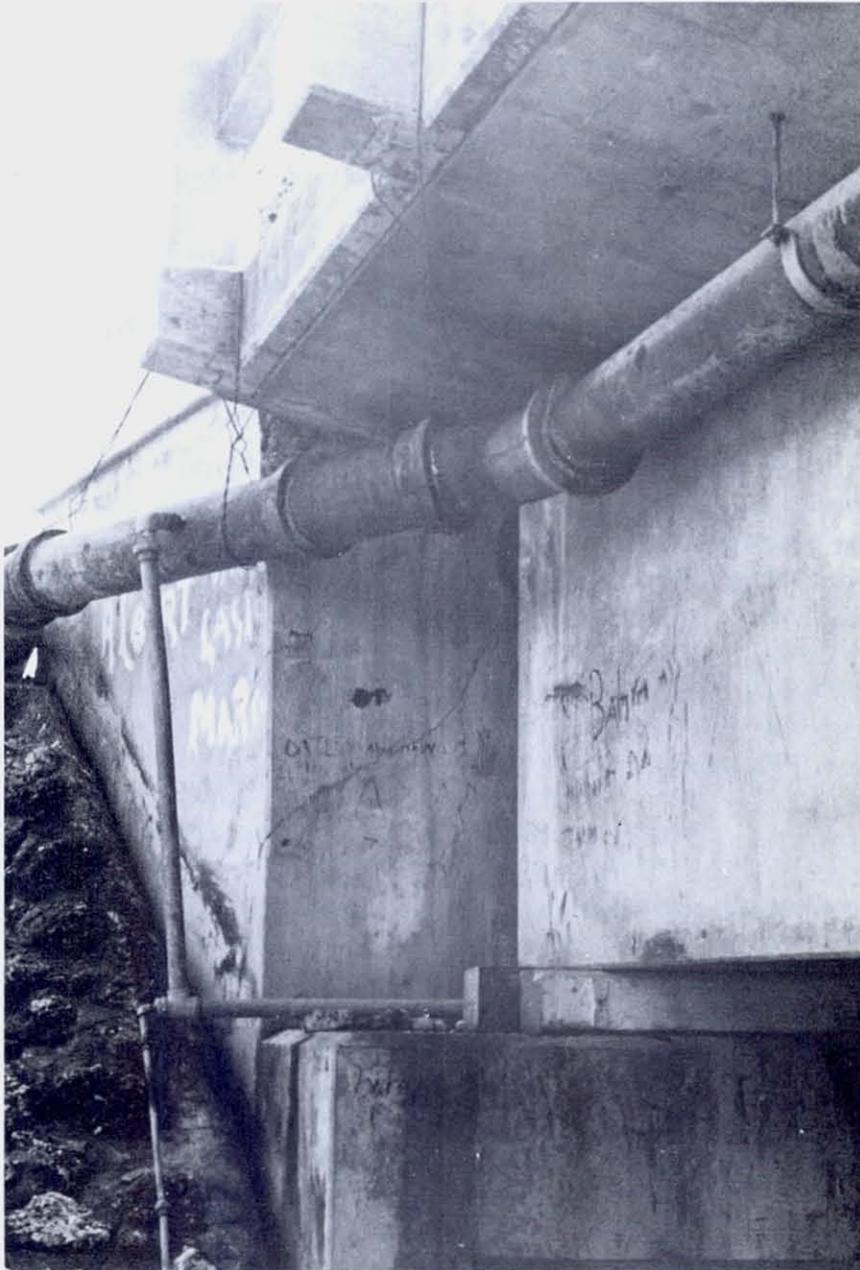
The bell and spigot joints broke at many places where the line crossed the Tamontaka River on the bridge near the airport and for a few km to the north. The 26 cm pipe sheared off where it went from the bridge deck into the north abutment (Figure 4). The joints were recaulked and otherwise repaired as rapidly as possible with lead and oakum caulking flown from Manila. The repair process was still under way on August 26, by which date much of the city was again receiving water.

Figure 4. Shearing of Pipe at Tamontaka River Bridge

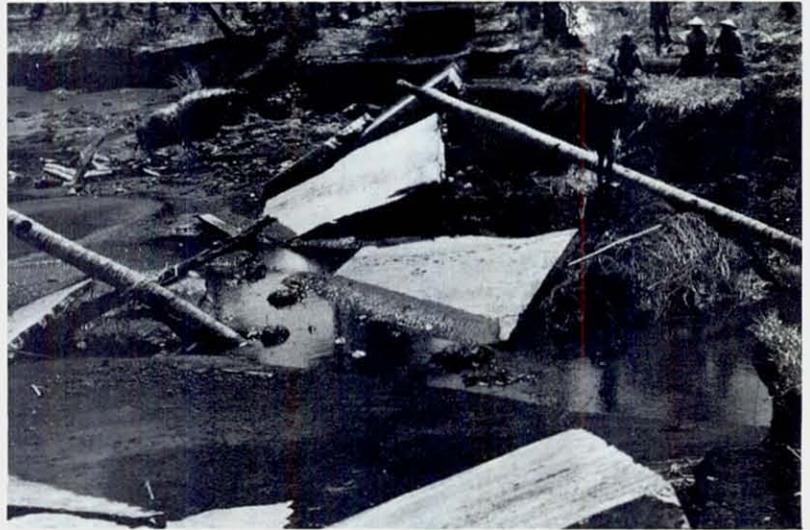
Figure 6. Tsunami Damage at Balabagan Wharf

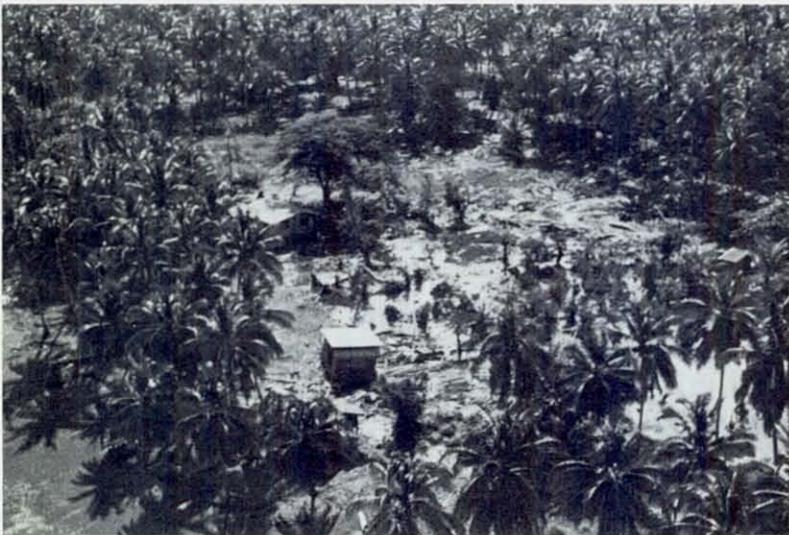
Figure 7. Seashore Damage South of Cotabato City

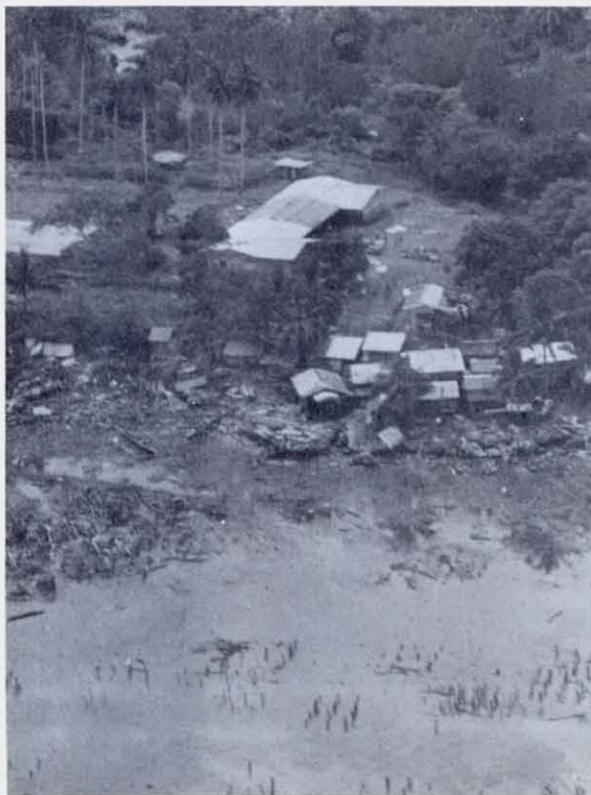
Bongo Island is located in Illana Bay 25 km northwest of Cotabato City. This island, approximately 10 km long, running parallel to the Mindanao Coast, reportedly took the brunt of the tsunami, reducing the damage to the adjacent Mindanao coastline along Illana Bay. A fishing village on the northern seaward side of the island was heavily damaged (Figure 8).

Figure 8. Tsunami Damage on Bongo Island

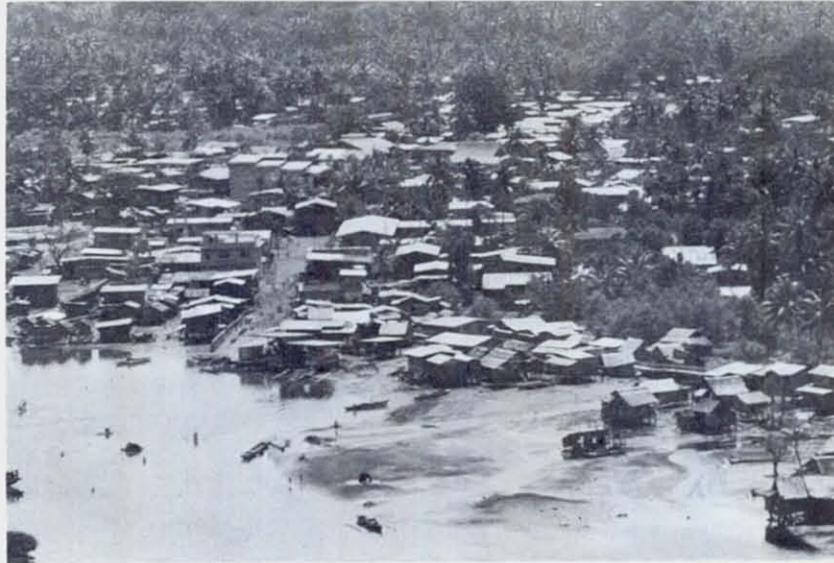
Figure 9. Residential Damage at Malabang Due to Surges in Mataling River

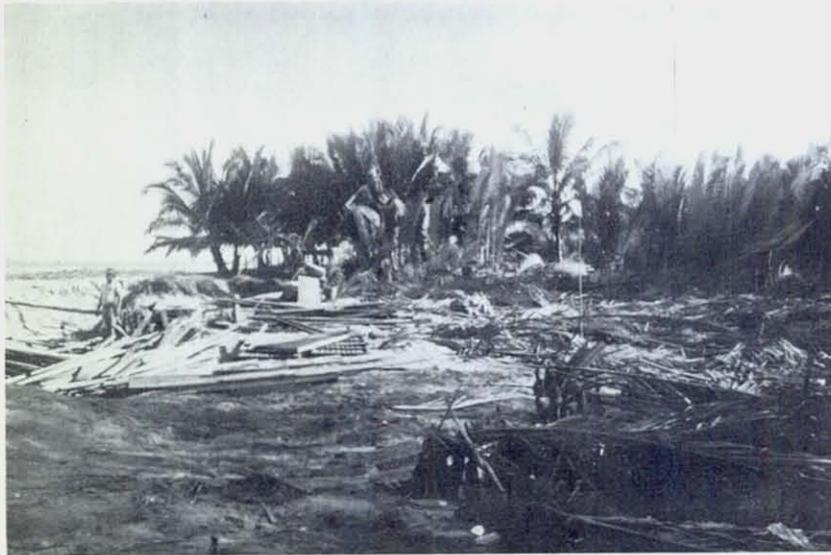
Figure 10. Tsunami Damage North of Zamboanga

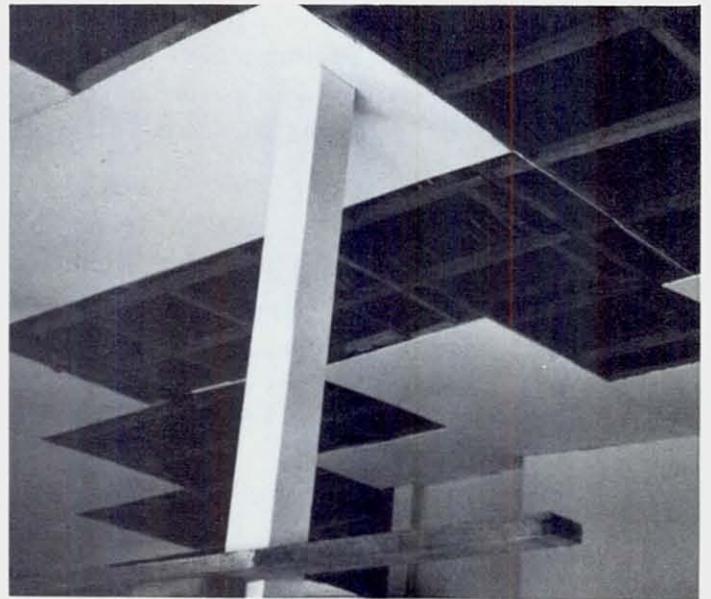
Figure 15. Interior Damage,  
Notre Dame Residence Hall

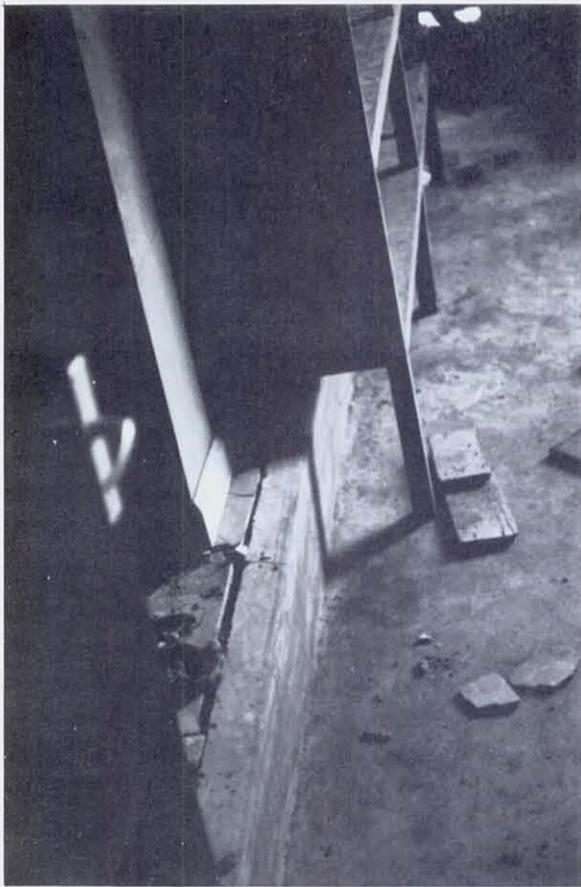
Figure 16. Slab Damage,  
Notre Dame Residence Hall

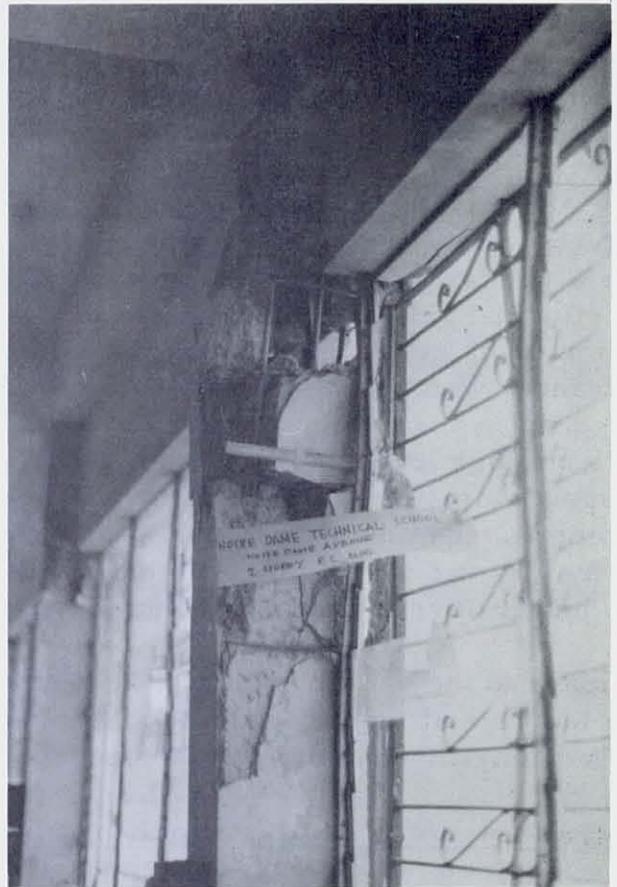
Figure 18. Column Damage,  
Technical Building

Damage to the structure was moderate. The first story columns were damaged at the head and sill levels, failing in shear (Figure 18). The fins were also damaged at similar locations. This canopy, supported on round steel columns, collapsed at its end bay.

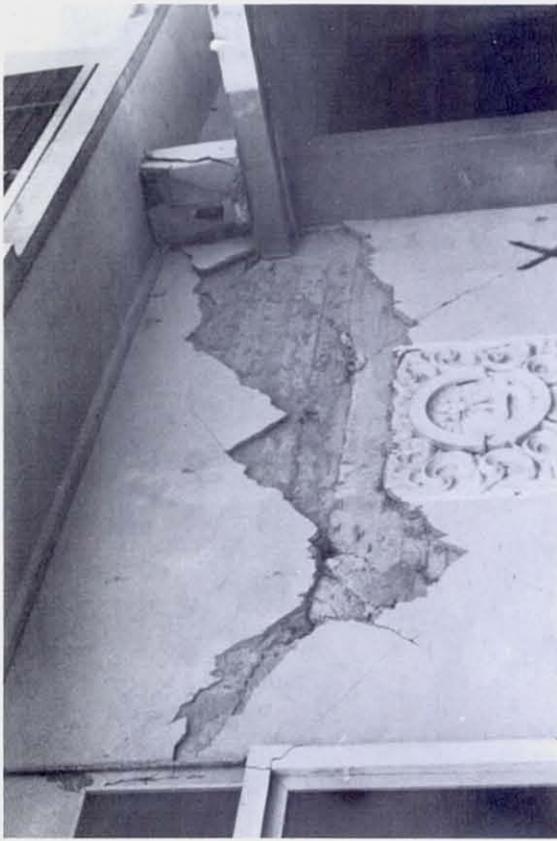
Figure 20. Diagonal Cracking, Exterior Panels

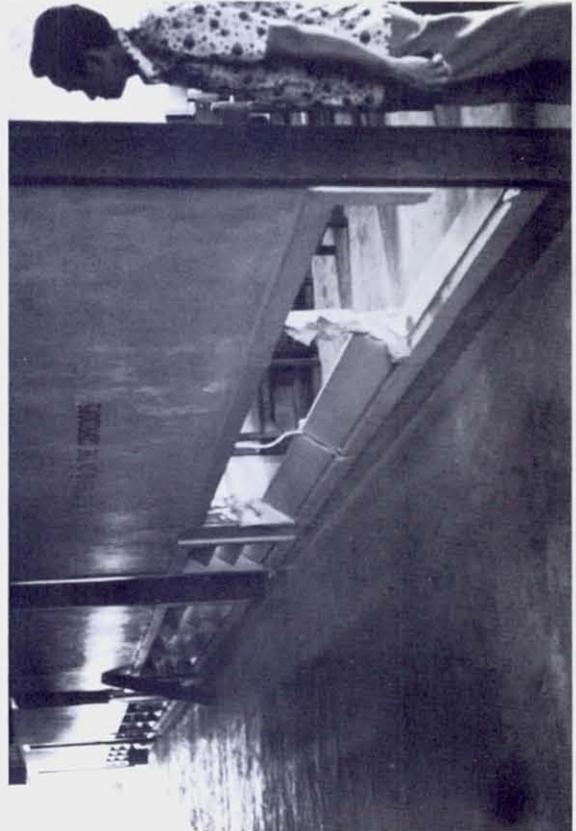
Figure 21. Lower Mullion Damage

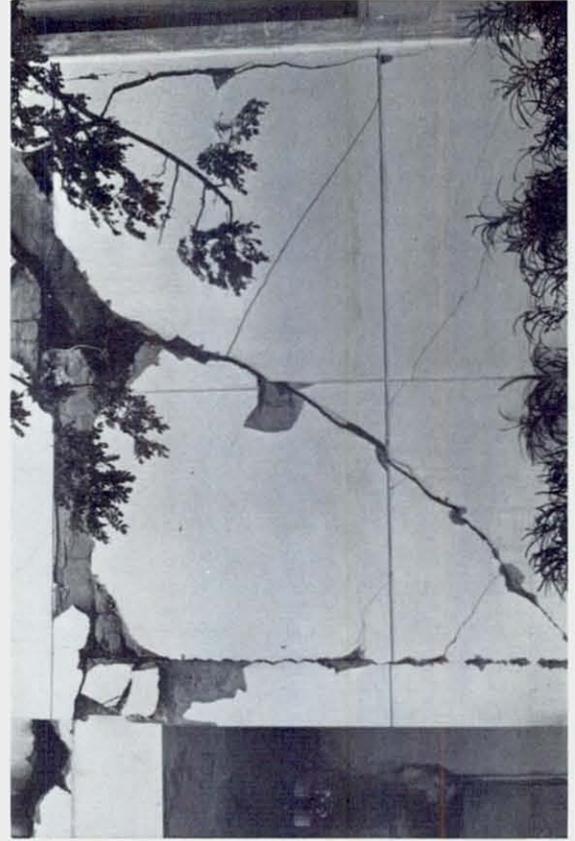
Figure 26. East Tower Damage

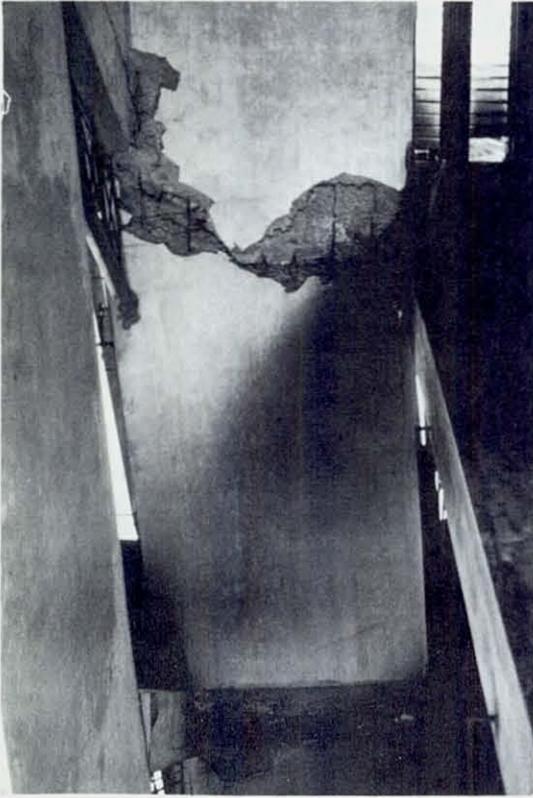
Figure 27. East Tower Damage

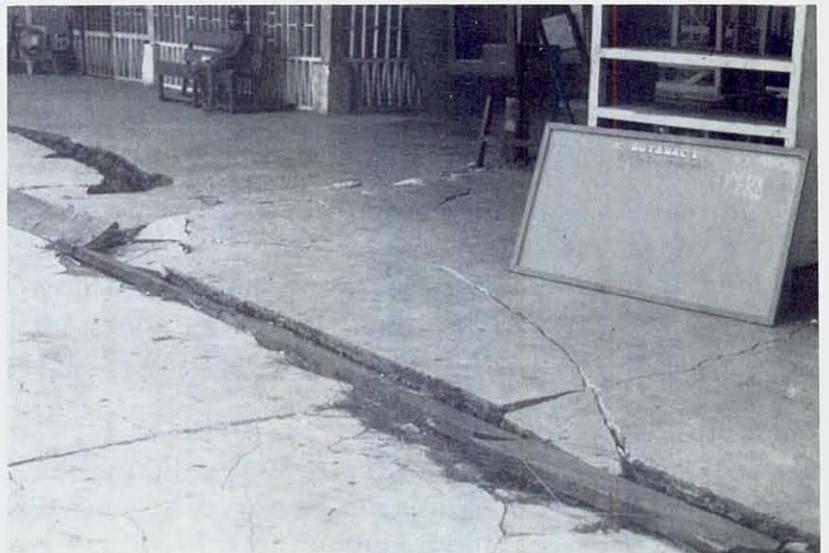
Figure 32. Cracking of Slabs on Grade at Harvardian College

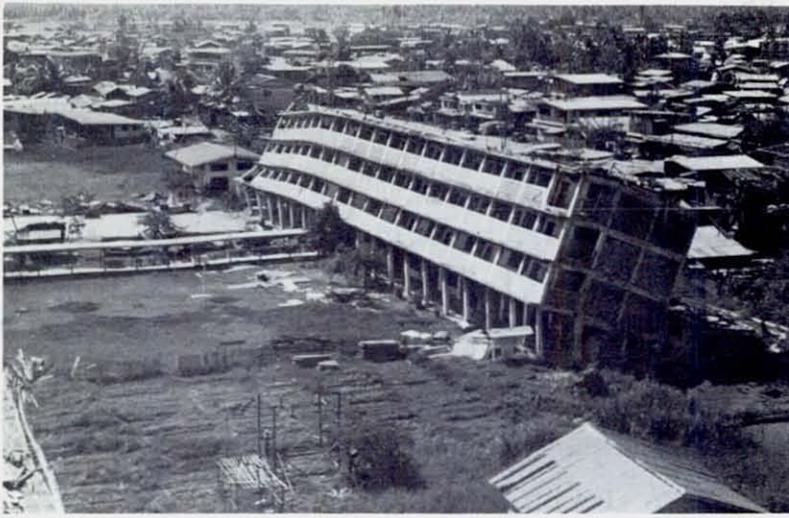
Figure 33. Harvardian College  
at West End Tilted Toward South

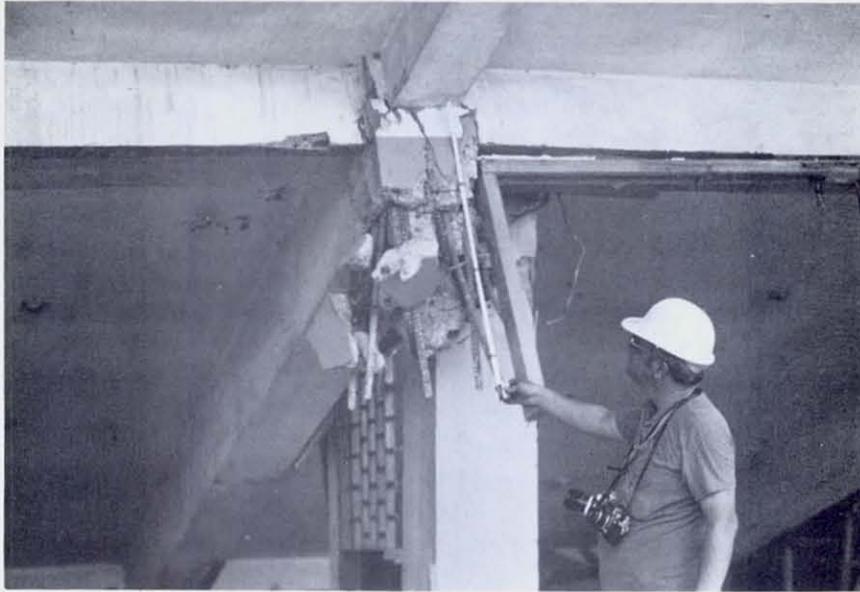
The structural failure and collapse were closely related to detailing of the columns. The south side first story columns failed because of: 1) column bar splices below the girder soffits; 2) wide spacing of column ties, especially at the splice zone; 3) masonry walls causing high column shears; and 4) cast iron downspouts encased in the column. Splicing column bars in a region of maximum moment is detrimental because bar bond stresses are at the largest value, allowing shear failures to be initiated more easily. Further, the wide tie spacing would not confine the concrete, thus increasing the chances of failure.

Figure 36. Shear Failure at Top of First Story Interior Columns

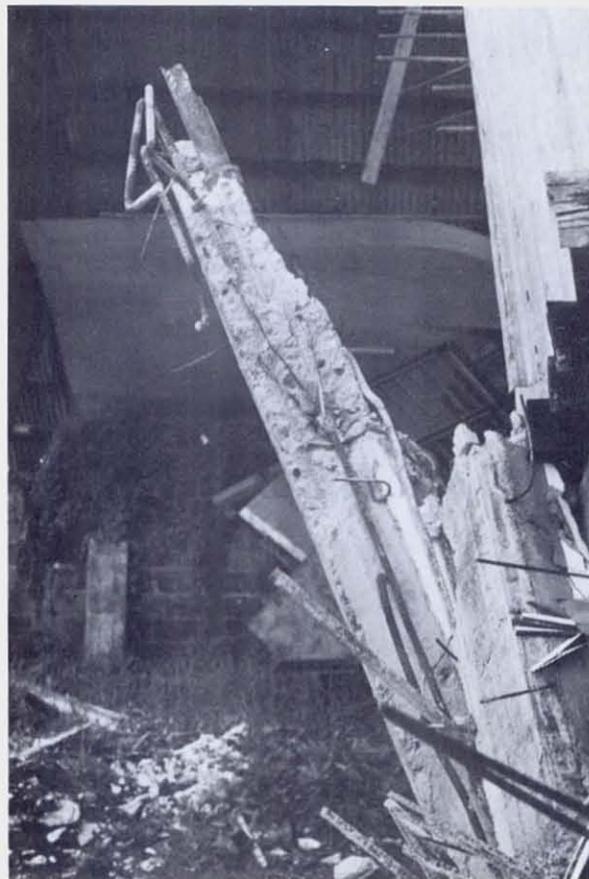
Figure 37. Vertical Fracture of First Story Column at Southeast Corner

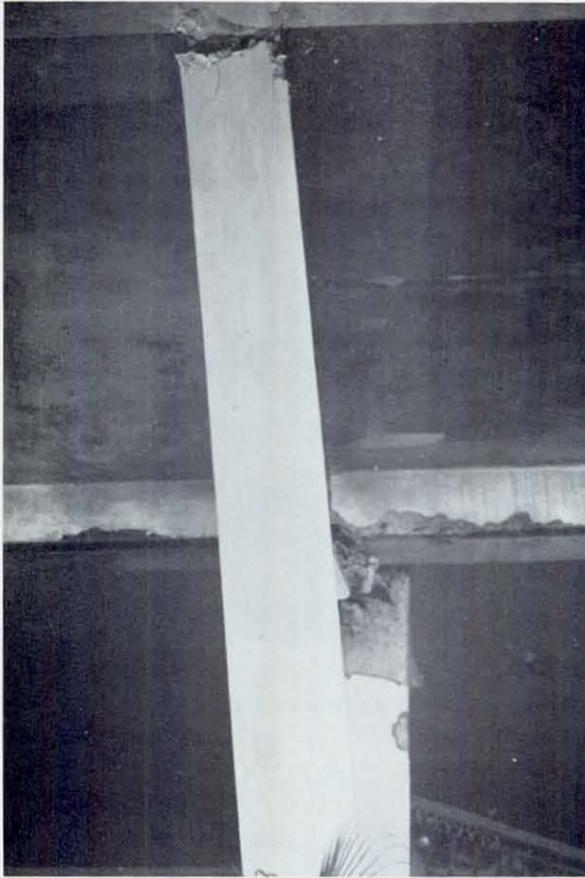
Figure 38. Moment Hinging of Northside Columns

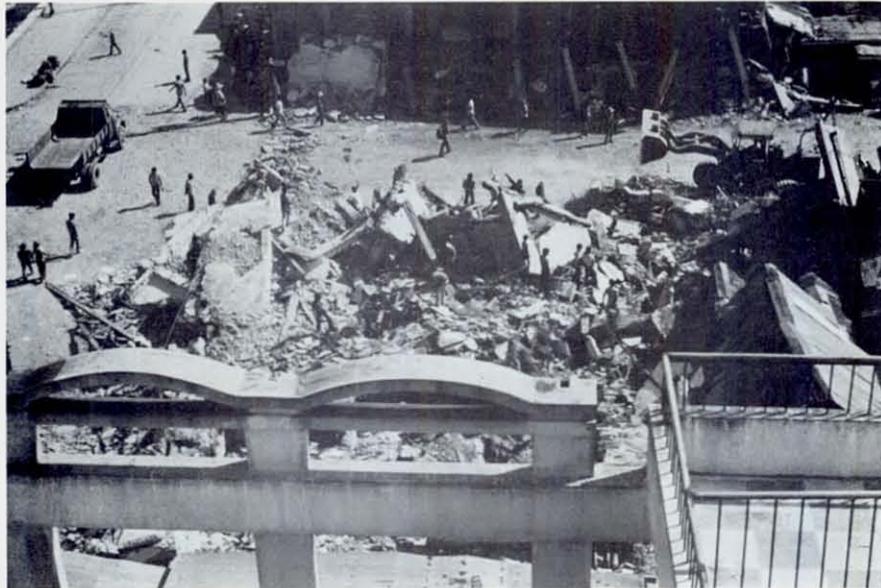
Figure 40. Collapsed Amicus Building, Sagittarius Hotel, and D'Max Restaurant

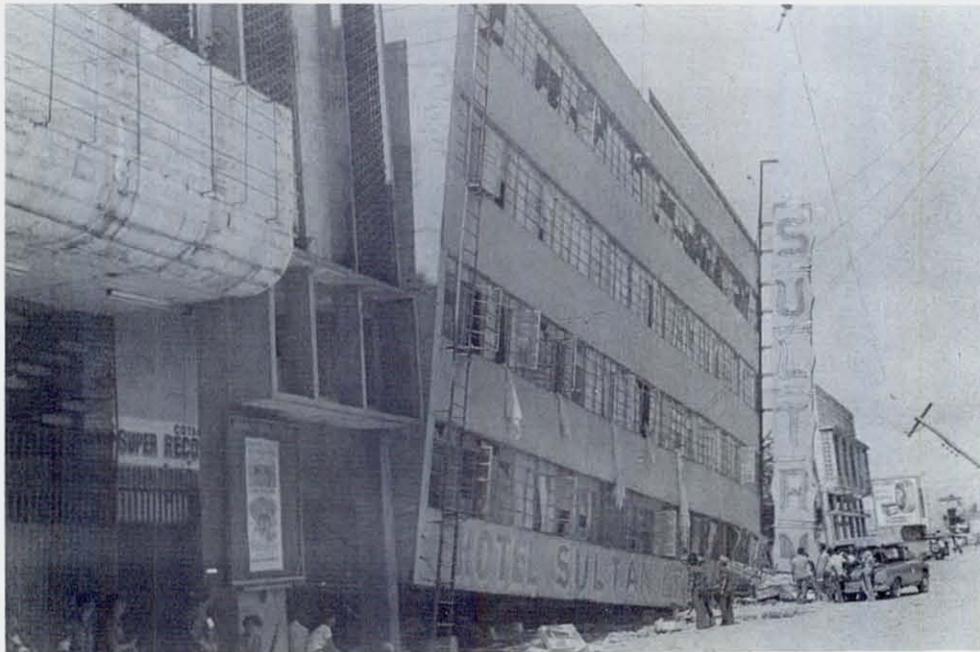
Sultan Hotel (Bldg 10). Figures 44 and 45 show the Sultan Hotel before and after the earthquake. The collapse of the structure with the second floor resting on the ground must have been rather slow since the portion above the second floor remained relatively intact. The portion above the second floor cantilevered out about 2.4 m past the front first story columns. Except for the front wall which had windows, the other three exterior walls were solid. The front wall above the second floor was relatively stiff due to short columns (in comparison to the other interior concrete frames designed for vertical loads only) and probably carried about half of the lateral load in the east-west direction. However, the wall in the first story was made up of tall columns only and high torsional forces were imposed on the first floor structural elements. This type of failure, with sudden change in rigidities compounding the torsional problem, has been noted in other earthquakes. Therefore, the structural engineer should carefully consider the

Figure 45. Sultan Hotel After Earthquake

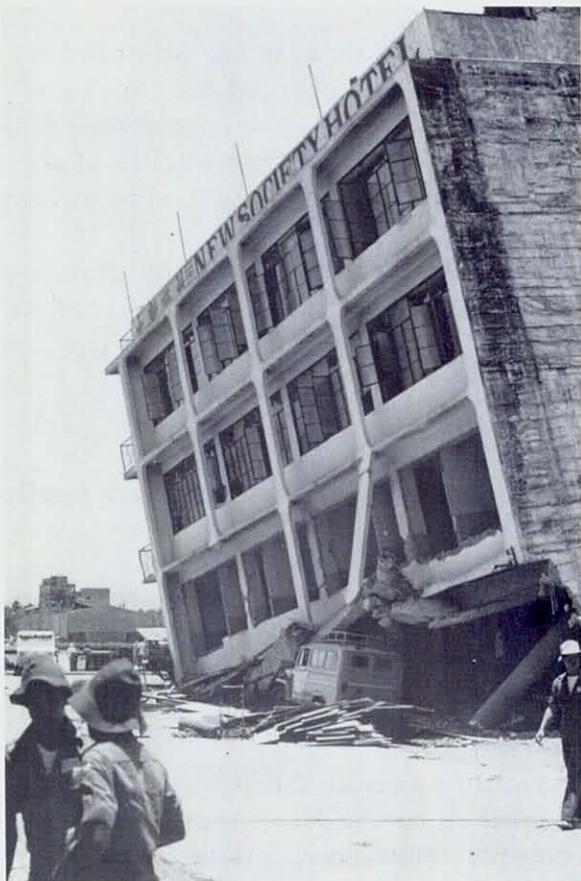
Proximity of the river and the high water table would suggest the possibility of specially strong ground shaking. The failure features of the New Society Hotel (Figure 48) also suggest possible ground settlement. However, other factors rule out these possibilities. These factors are: 1) the lack of cracking in adjacent

Figure 48. New Society Hotel After Earthquake

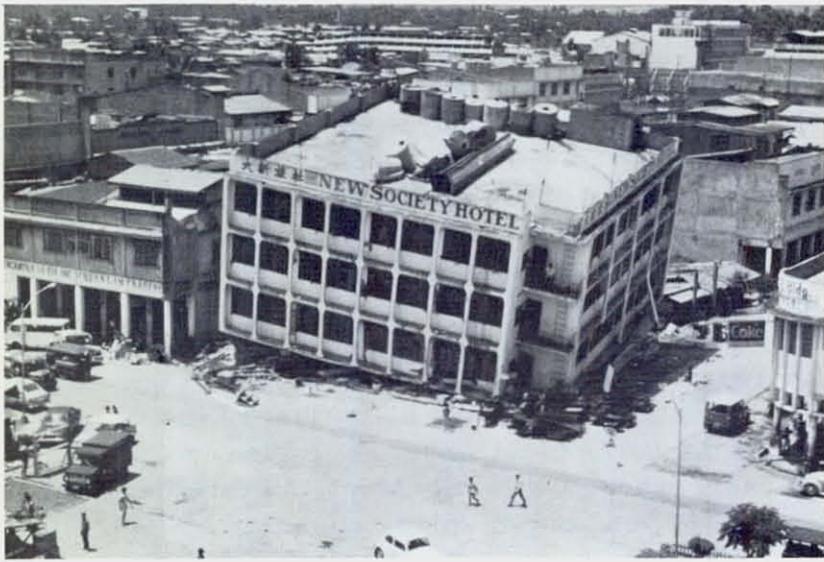
The first story of this building collapsed, with the upper stories coming to rest approximately 3 m west of its original location. The front and rear faces of the building were open with doors and windows, but the extent of the openings is not known. In any event, the openings left the structure with a softer first story. It should also be noted that the structure was not designed for seismic forces and,

Figure 49. Collapsed North and West Sides

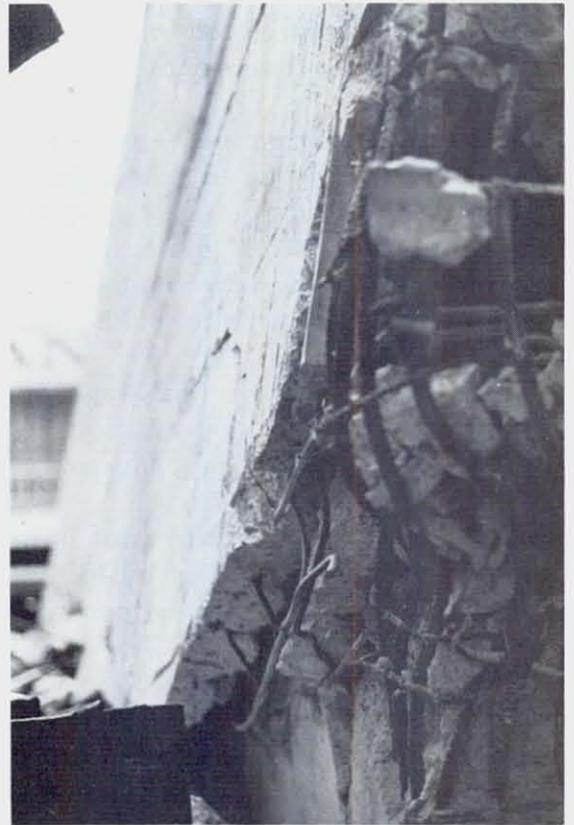
Figure 50. Failure of Southeast Corner Pilaster and Wall

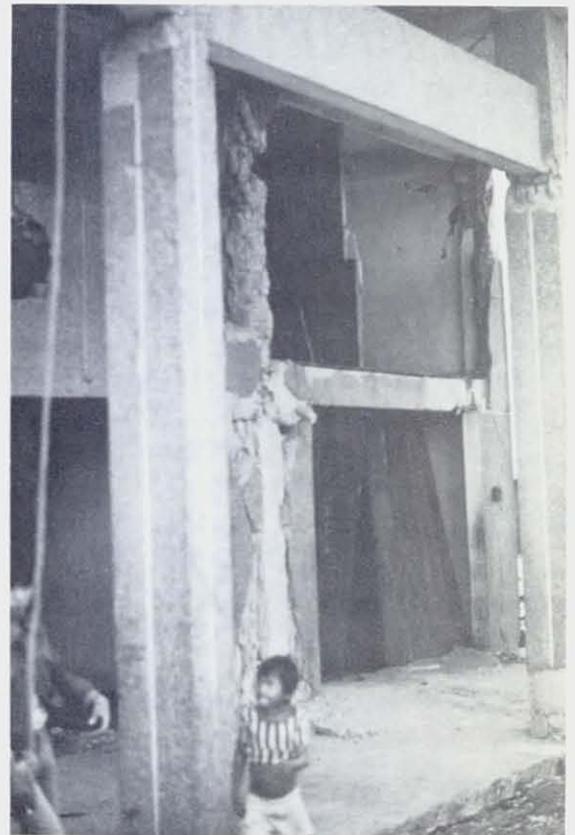
Figure 62. Hinging of First Story Columns Due to North-South Motion

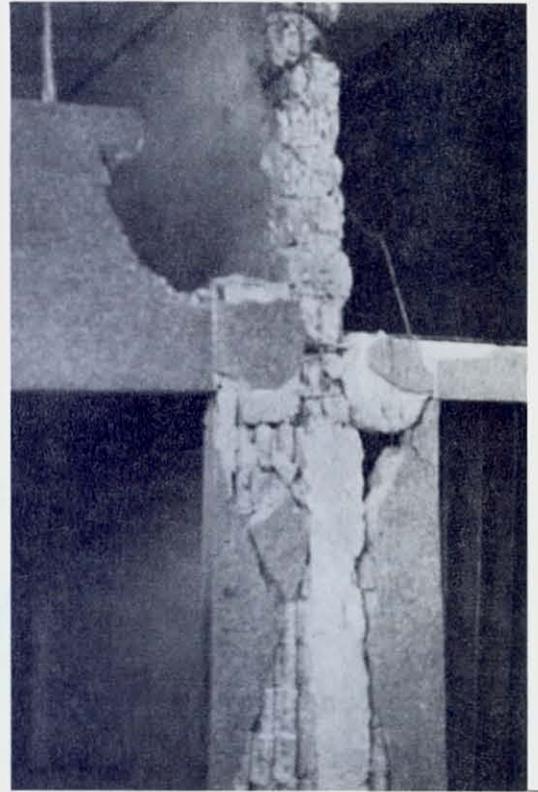
Figure 63. Shear Failures  
in Mezzanine Columns

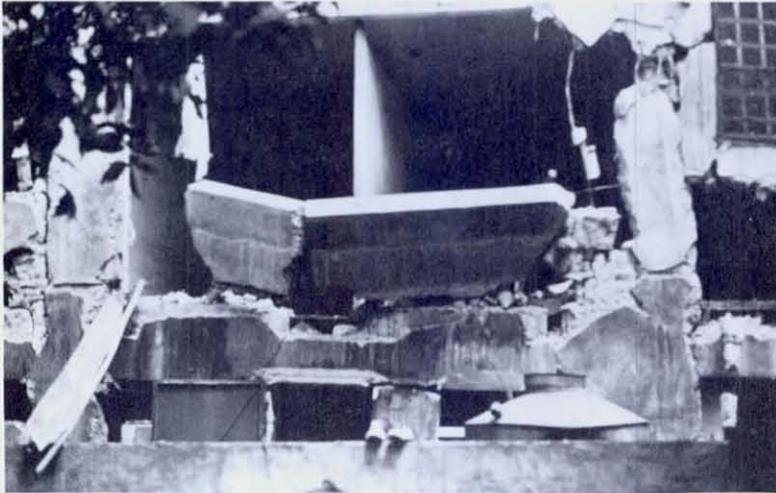
Figure 64. Mezzanine Story Damage  
on East Side of Melbourne Hotel

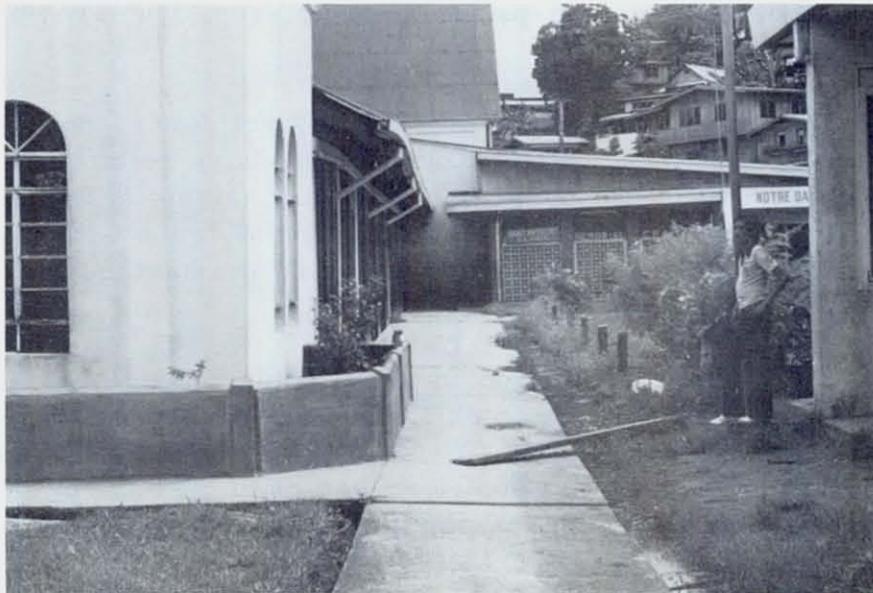
Figure 74. Loose Ornament Thrown Toward West

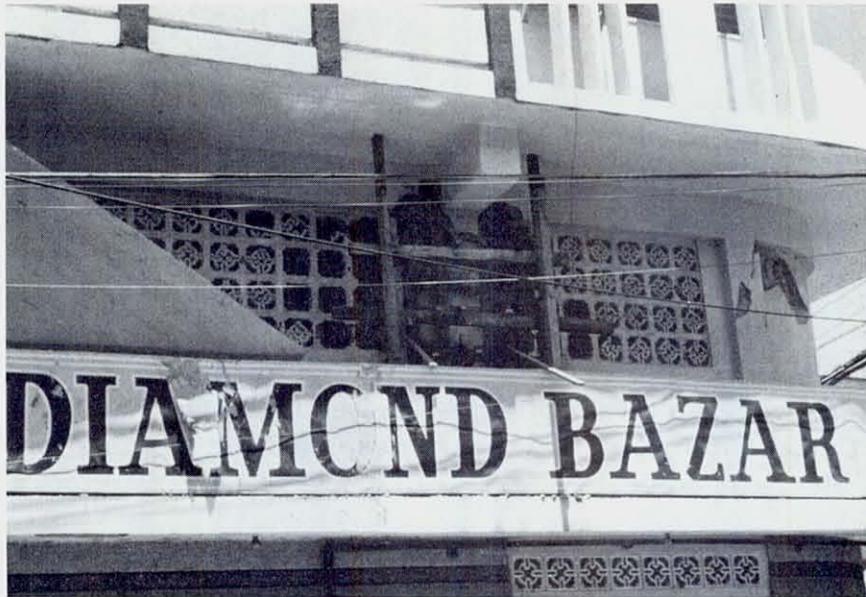
Figure 91. Diamond Bazaar Damage, Zamboanga

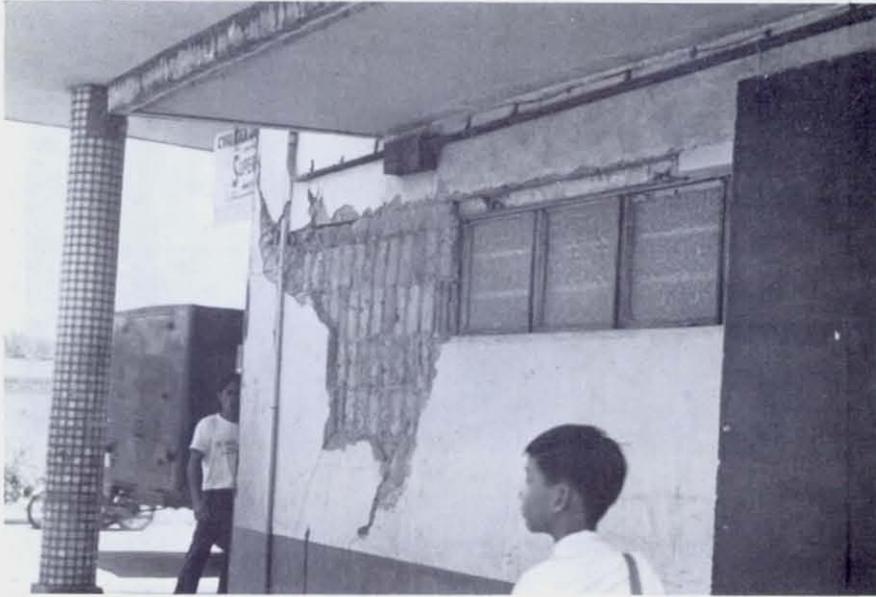
Figure 93. Chien Tian Un Building Damage

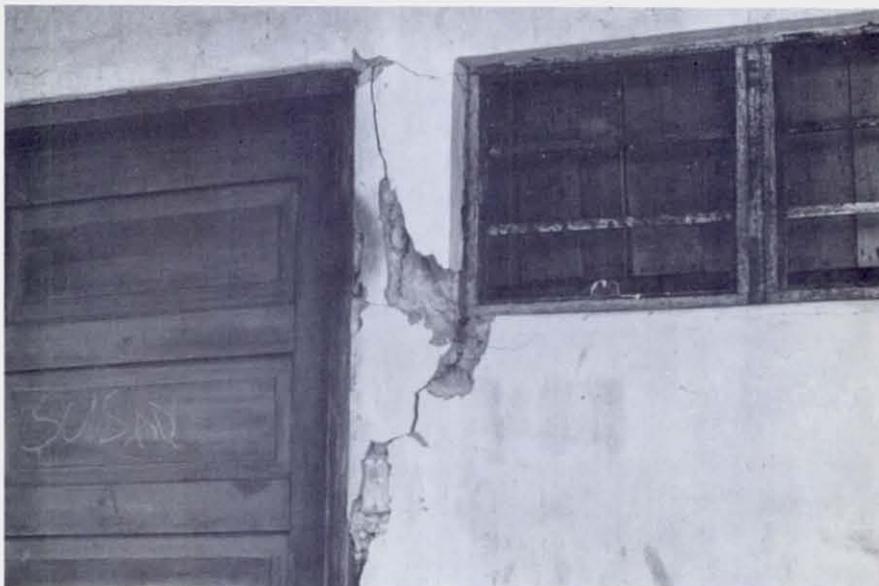
Figure 94. Chien Tian Un Building Damage

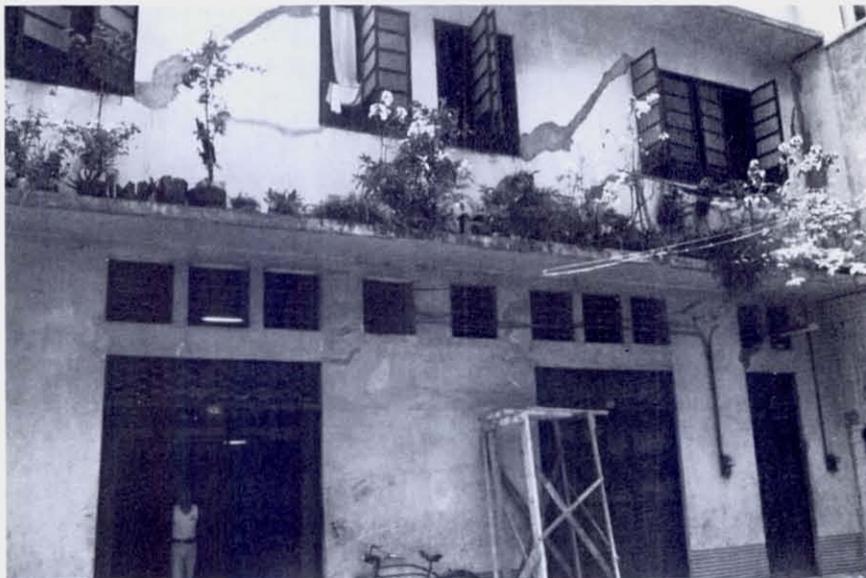
Asiatic Commercial Building is a two-story structure erected in 1950. The structural system is unknown except that the exterior had solid panels. Damage consisted of shear cracking of the piers in the windowed exterior walls (Figure 97).

Figure 97. Asiatic Building

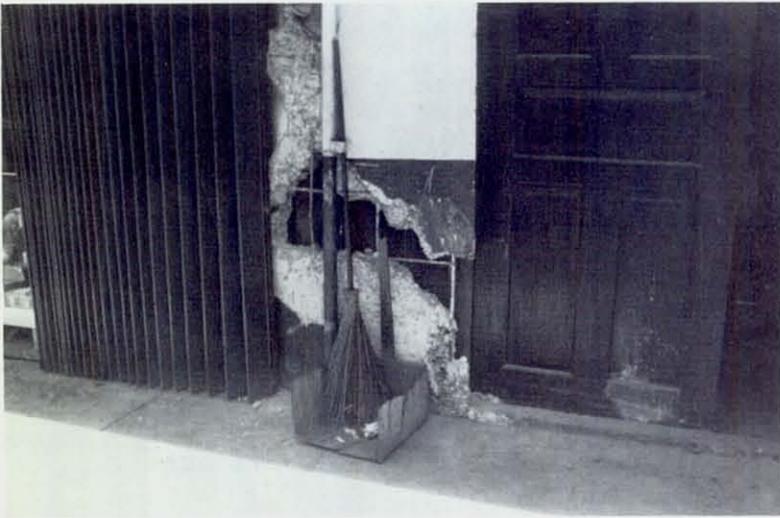
Figure 99. First Story Column Shear Damage

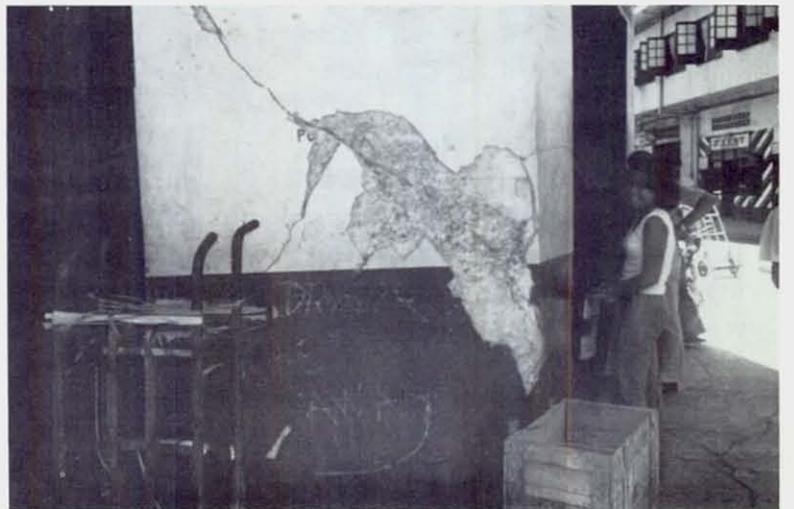
Figure 100. First Story Column Shear Damage

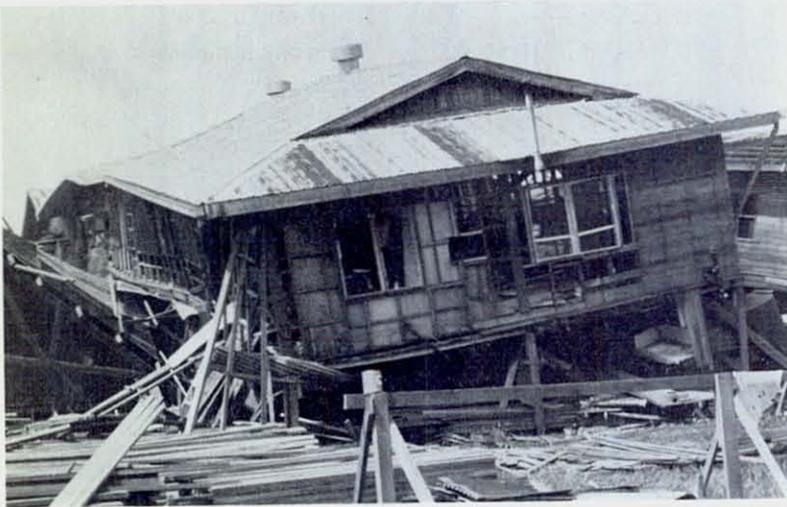
Figure 102. Damage to Quality Residence

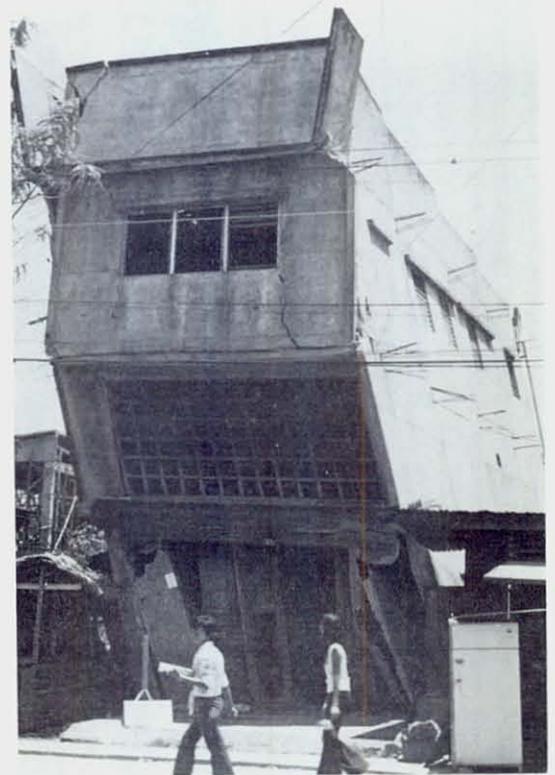
One residence constructed of concrete suffered dramatic failure (Figure 103). This residence was located across the street from the Harvardian College. Strong ground motion added to the problem at this location.

Figure 103. Damage to Concrete Residence

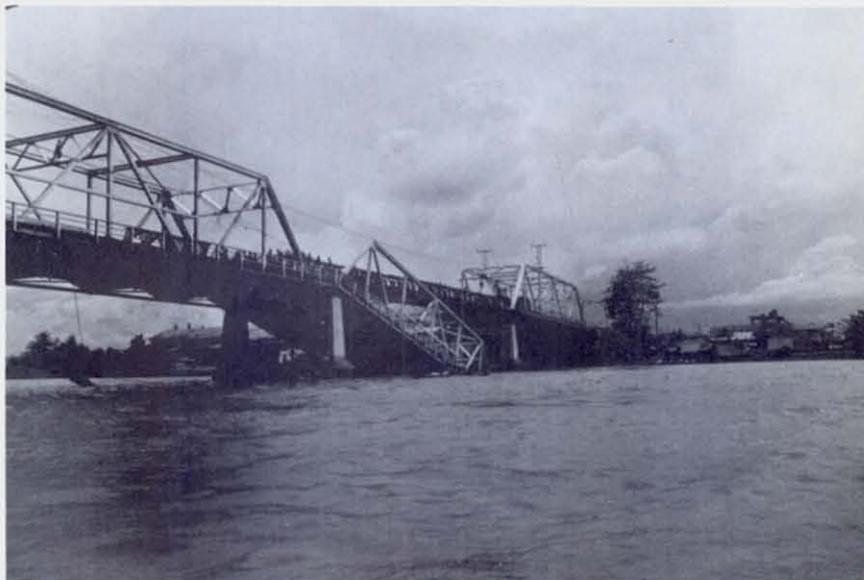
The failure occurred by the span sliding to the east off the dumbbell-shaped supports. The supports as constructed would not allow for much east-west movement before the spans would collapse. Figure 107 shows the pier, and it appears that a motion on the order of 60 cm would be sufficient to cause this collapse. Other notable damage is the near collapse of the third span from the south. Figure 108 shows new piling plus the tying together of spans two and three to prevent further damage. Figure 109 shows damage to the piles at the base of the south abutment. Shear cracks appear several centimeters below the base.

Figure 104. Quirino Bridge Collapse

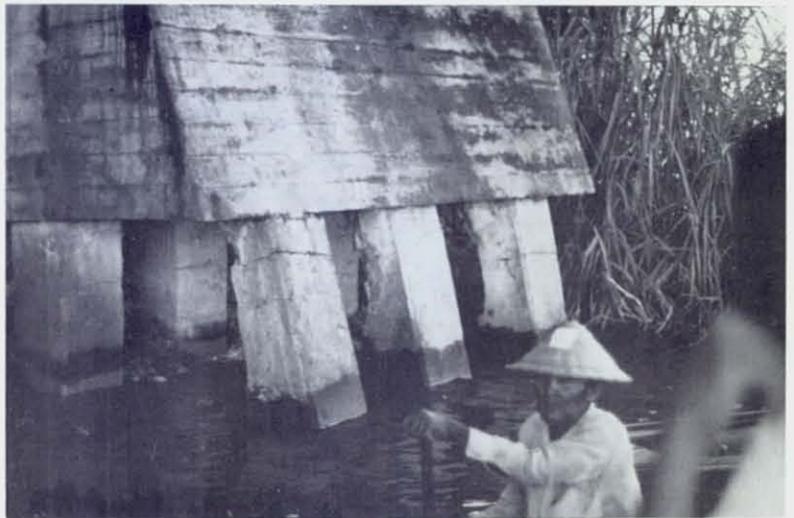
Figure 109. Abutment Pile Damage at Quirino Bridge

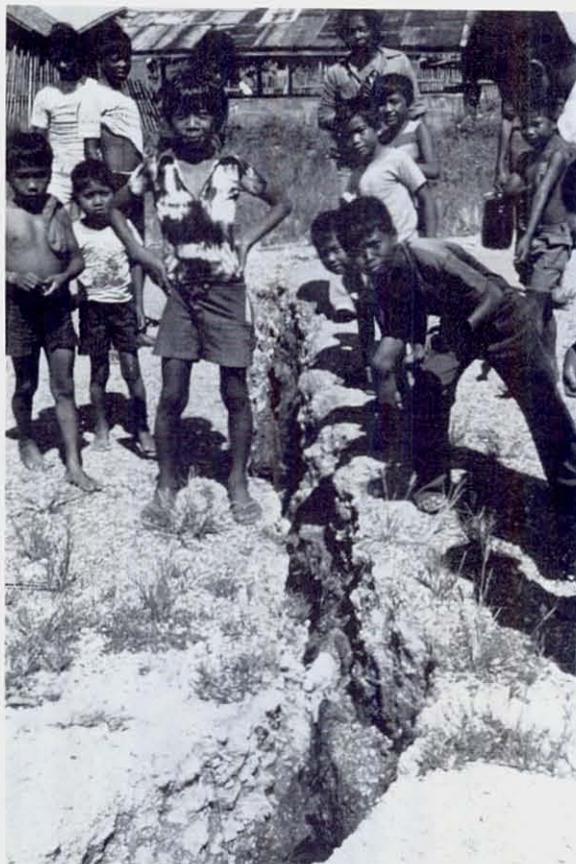
Approximately two blocks west of the Quirino Bridge, ground motion was very evident on both sides of the river. It appeared as though the ground were sloughing in on both sides toward the center of the river. Figure 110 shows a ground crack on the south bank about 20 cm wide and 1.5 to 1.8 m deep, with the river side some 20 to 26 cm lower. Similar ground motion was evident on the north side.

Figure 110. Ground Cracking Near Quirino Bridge

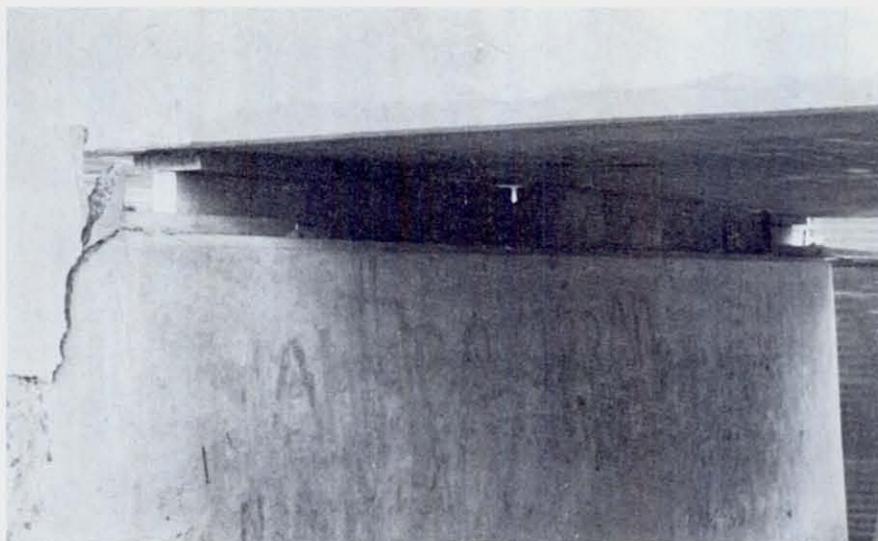
Figure 112. Keeper Damage at Tamontaka Bridge

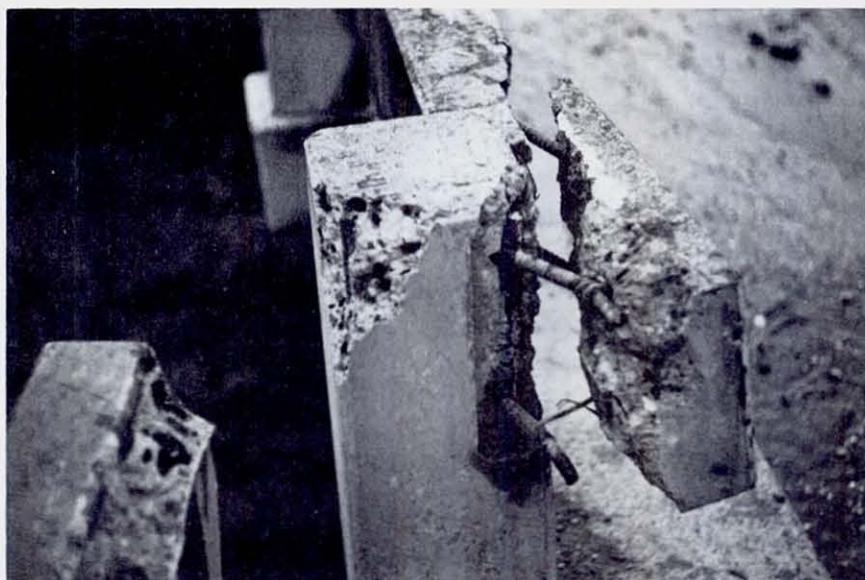
Figure 113. Railing Damage at North Abutment of Tamontaka Bridge

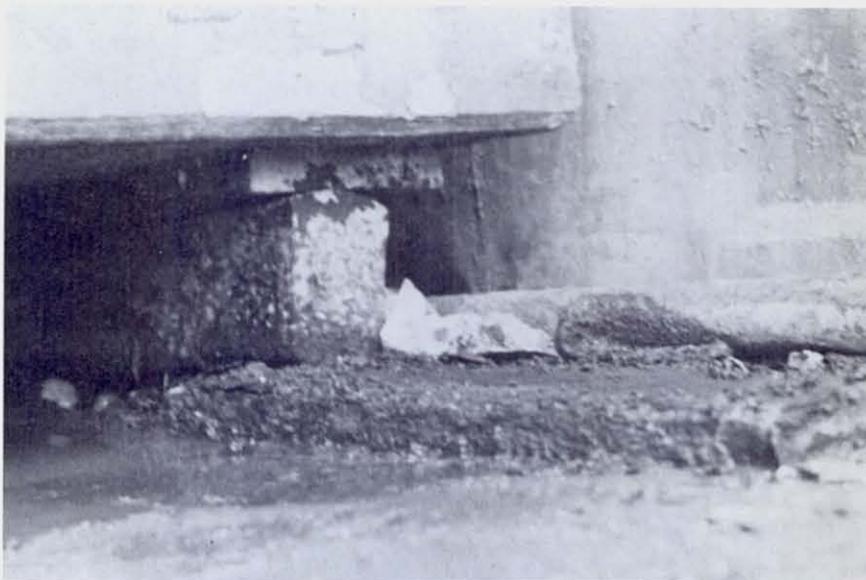
Figure 114. Rocker Movement, East Side, North Abutment of Tamontaka Bridge

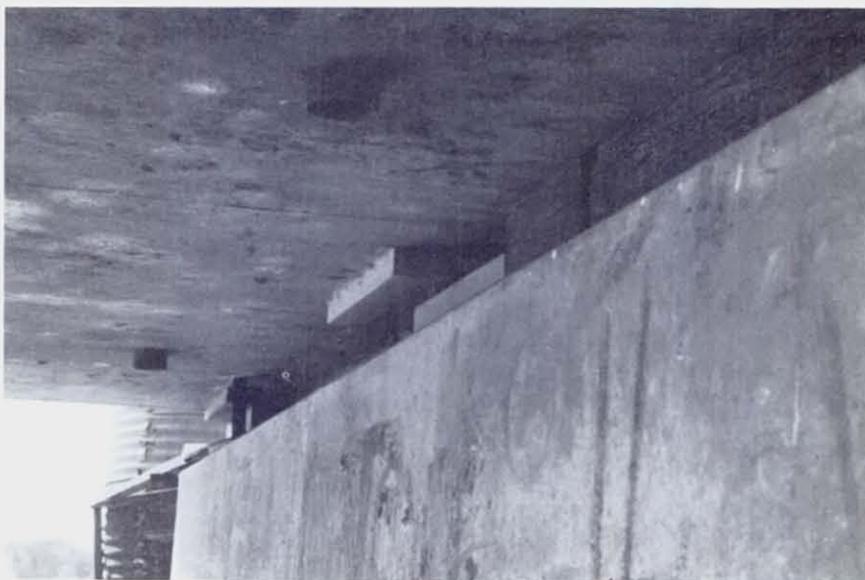
The box girder sections rested on the piers supported by bearing plates. There were two rockers per pier. Rockers were achieved by rounding the edges of the bearing surfaces. There were no keepers except for the concrete pieces cast with the piers. At the north abutment, where the greatest movement was seen, the bearing plates were very wet and badly corroded. At the east side, the rocker slid along the bearing plate (Figure 114). In fact, another few cm movement to the west would have caused the rocker to move off the bearing plate. At the west side, the rocker fell out. The sliding may also be seen on dryer plates in Figure 115, taken at the first pier from the north end.

Figure 115. Sliding of Bearing Plates at Tamontaka Bridge
