Earthquake Engineering  
Research Institute

**Reconnaissance Report**  
**MINDANAO, PHILIPPINES EARTHQUAKE**  
**August 17, 1976**

**August 1977**

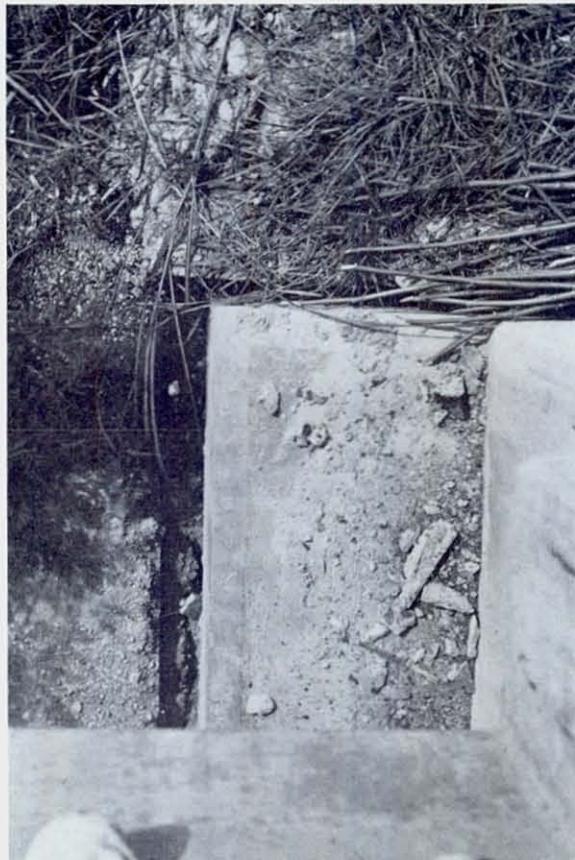
Soft, swampy land surrounds the bridge. The abutments also experienced some movement relative to the land, as can be seen in Figure 116. Some displacement was visible between the roadway and its apron, north of the bridge. Although these movements did not interrupt traffic on the bridge, they did interrupt the city water supply. As noted elsewhere in this report, the bridge carried a 26 cm cast iron pipe which supplied water to the city from the diversion dam south of this location. The 46 cm displacement of the north end of the abutment sheared the pipe (Figure 4).

Figure 116. Abutment Movement at Tamontaka Bridge
