THE HONOMU, HAWAII, EARTHQUAKE

report of inspection

N. Norby Nielsen and Augustine S. Furumoto
University of Hawaii, Honolulu, Hawaii

1977

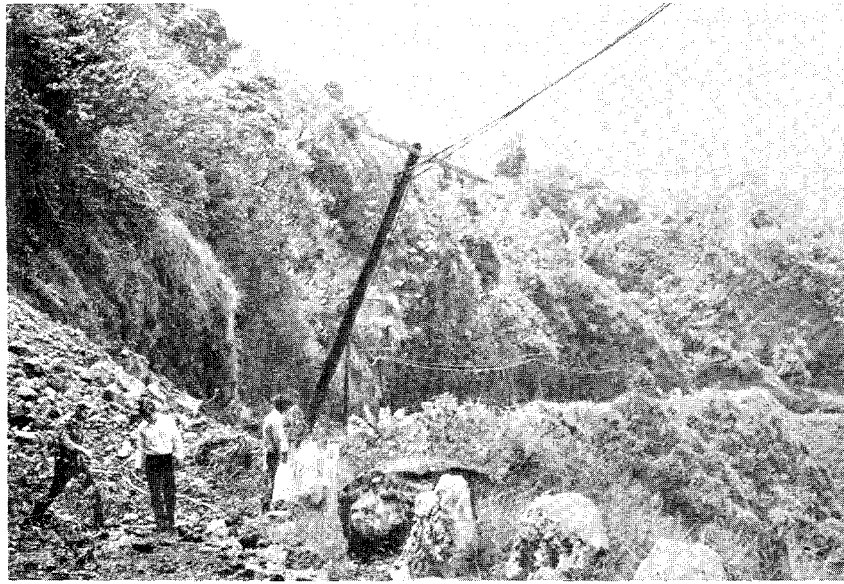
FIGURE 22 TYPICAL LANDSLIDE

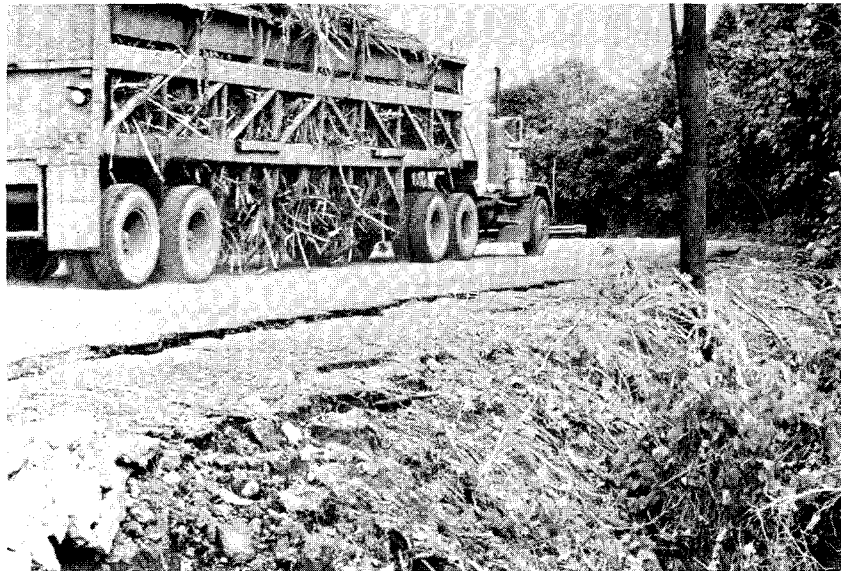
Construction equipment working directly on the ash tends to bog down after a few passes because the volcanic ash tends to liquefy under traffic. Road pavements over the ash are generally 24 to 30 inches thick and seem to carry heavy plantation truck traffic well. Soil dynamic analyses were made using standard formulas and charts available by Housner, Seed and others (Figures 16 through 22 and Tables 6 and 7) to estimate the natural periods and accelerations that may have contributed to the damages noted to structures constructed on ash.

FIGURE 23 HEAVY CANE TRUCK; ROAD ON VOLCANIC ASH

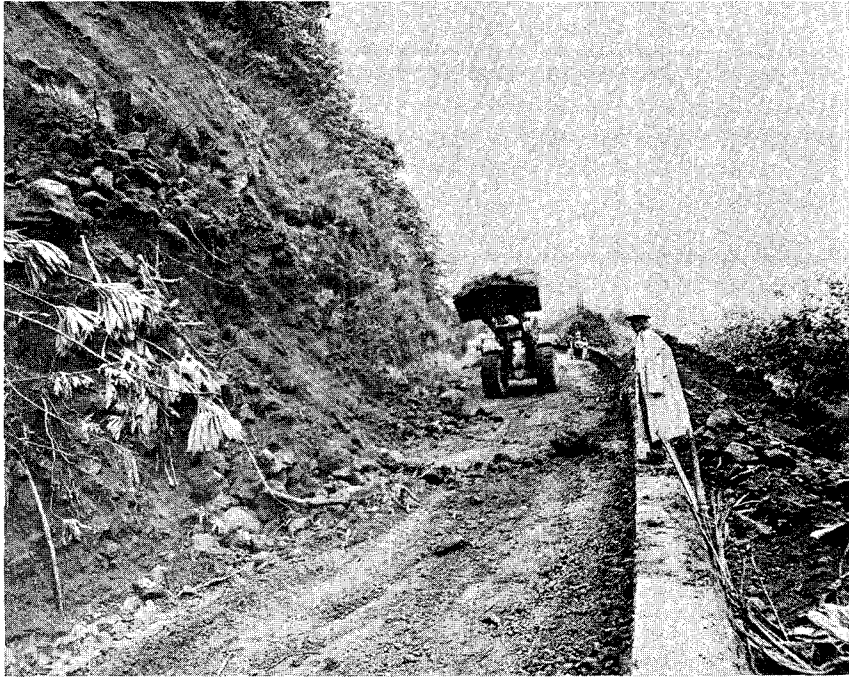
State and County roads were heavily damaged by numerous land and rock slides. Figure 14 shows the location of the damaged roads. Damage occurred along the coast highway from Hilo to the northeastern portion of the island. The heaviest damage occurred along the Laupahoehoe Gulch areas where the highway was closed at three points on the day of the 26th, and limited to one-way traffic on the 27th. Laupahoehoe is about 20 km north of the epicenter; the ash is very thin and the foundation soil is mostly lava rock. The heaviest damages occurred in the ash deposits from Hilo to Ookala. Typical pictures showing road damage, rock and soil slides are shown in Figures 22 through 26.

FIGURE 24 TYPICAL ROAD DAMAGE, NORTHEASTERN PORTION OF THE ISLAND

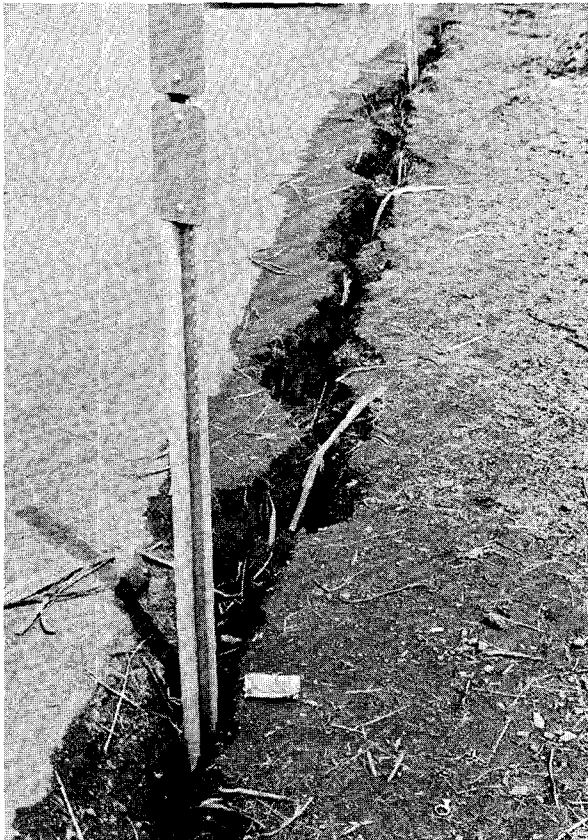
Following the earthquake, tension cracks and slumps of several inches were noted in the shoulders of the roadways, particularly in the northeastern part of the island. The toes of slopes in the above cases were usually being eroded by stream flows at the bottoms of the gulches.

FIGURE 25 TENSION CRACKS,
VOLCANIC ASH

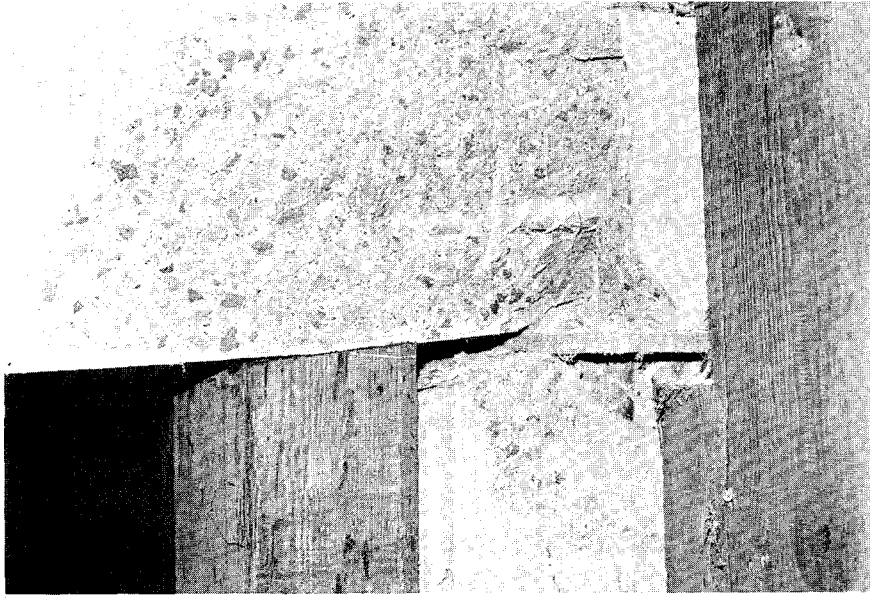
Several bridges suffered minor damages such as broken pipe railings and minor cracks in concrete columns. The most heavily damaged bridge was the Kaiwilahilahi Bridge, situated about 15 km from the epicenter. The concrete rockers and the bearing ends of the bridge beams were heavily damaged (Figures 26 and 27).

FIGURE 26 KAIWILAHILAH I BRIDGE, 15 km FROM EPICENTER

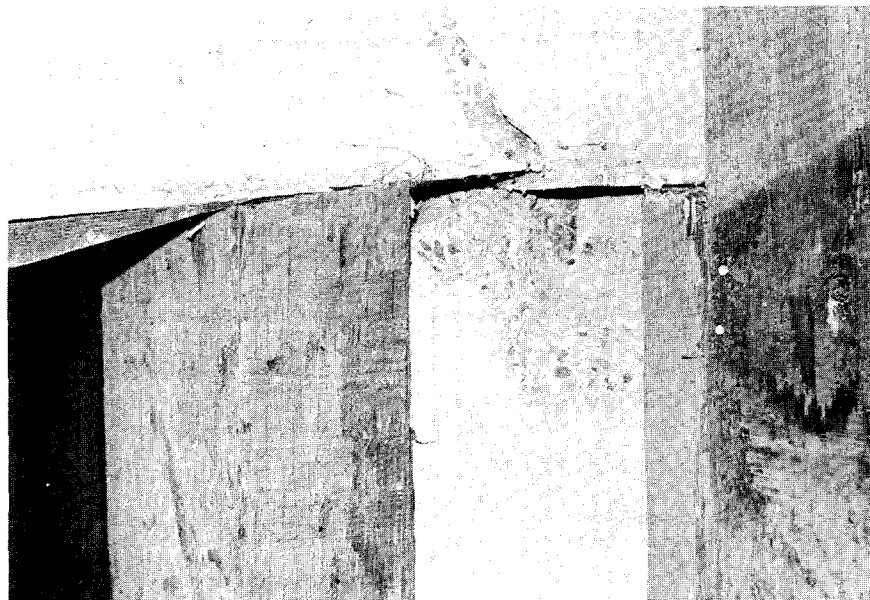
12 miles north of the epicenter where the ash is very thin and the foundation soil is mostly lava rock. The most serious damage to structural elements probably occurred at Papaaloa, 10 miles from the epicenter. The concrete rocker bearings cracked on the state's (Kaiwilahilahi) bridge.

FIGURE 27 KAIWILAHILAH I BRIDGE, 15 km FROM EPICENTER

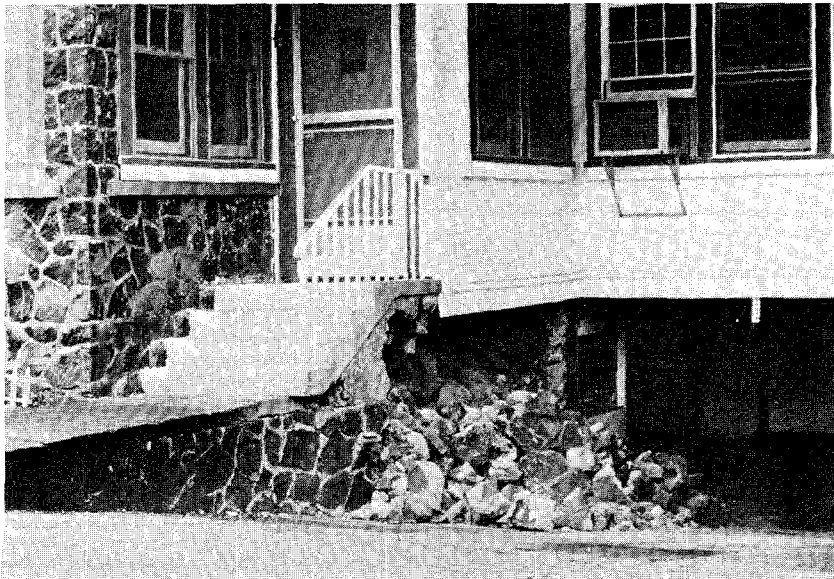
Many loose rock walls fell. The rock facings were between 10 to 15 ft in height. The natural slopes behind the rock facings that fell seem to stand up very well or approach a 1/2 to 1 slope.

FIGURE 28 TYPICAL FAILURE OF ROCK WALL, NORTH HILO

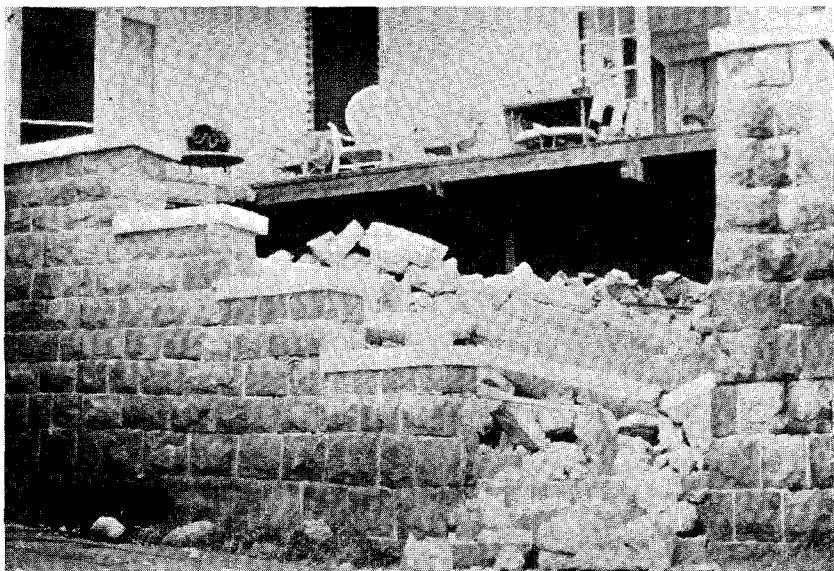
FIGURE 29 TYPICAL FAILURE OF ROCK WALL, NORTH HILO

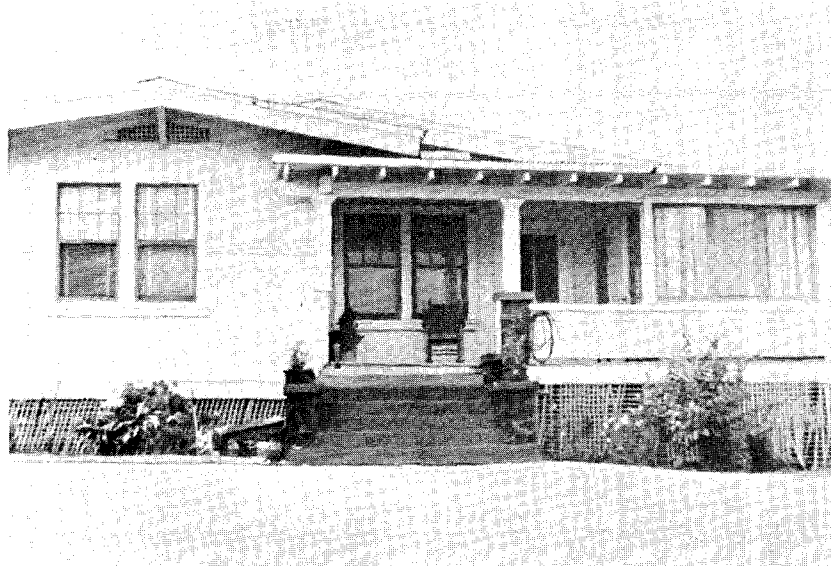
FIGURE 31 HOUSE SHIFTED ON FOUNDATION, NORTH HILO

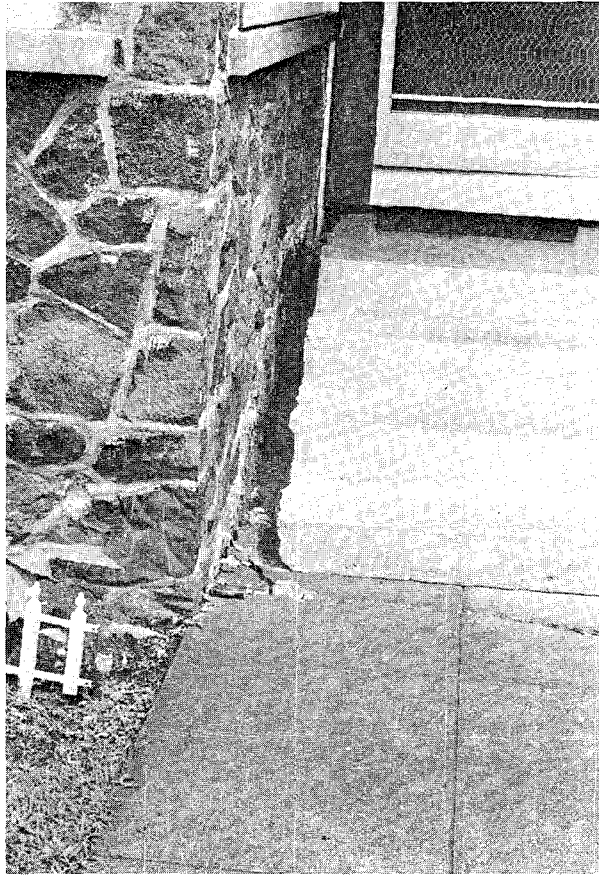
FIGURE 32 HOUSE SHIFTED ON FOUNDATION, NORTH HILO

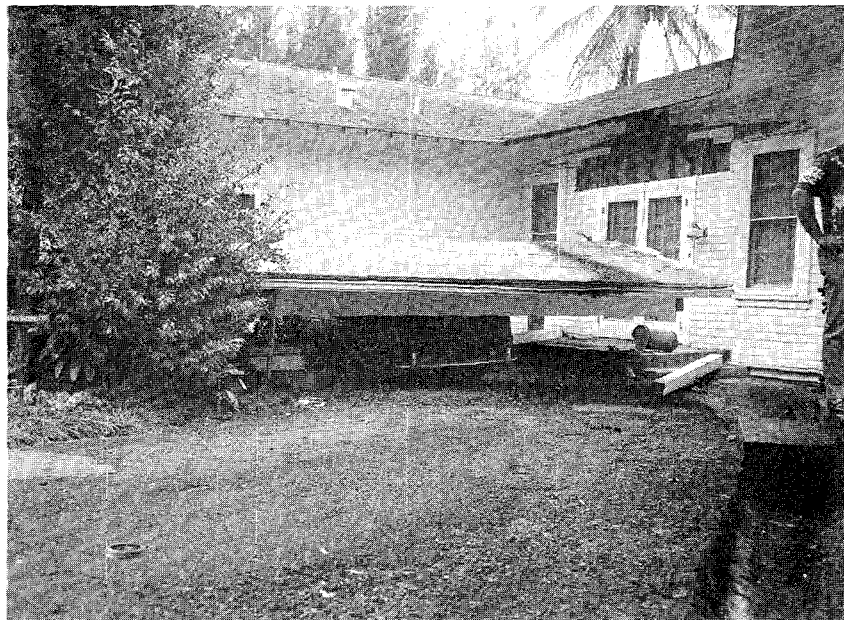
FIGURE 33 CARPORT COLLAPSE, NORTH HILO

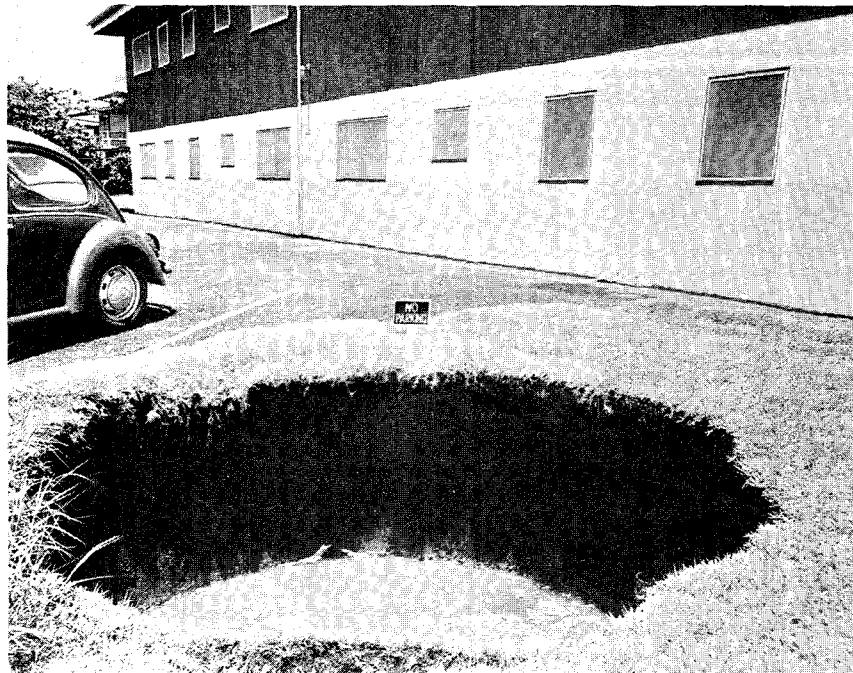
FIGURE 35 CESSPOOL FAILURE, VOLCANIC ASH

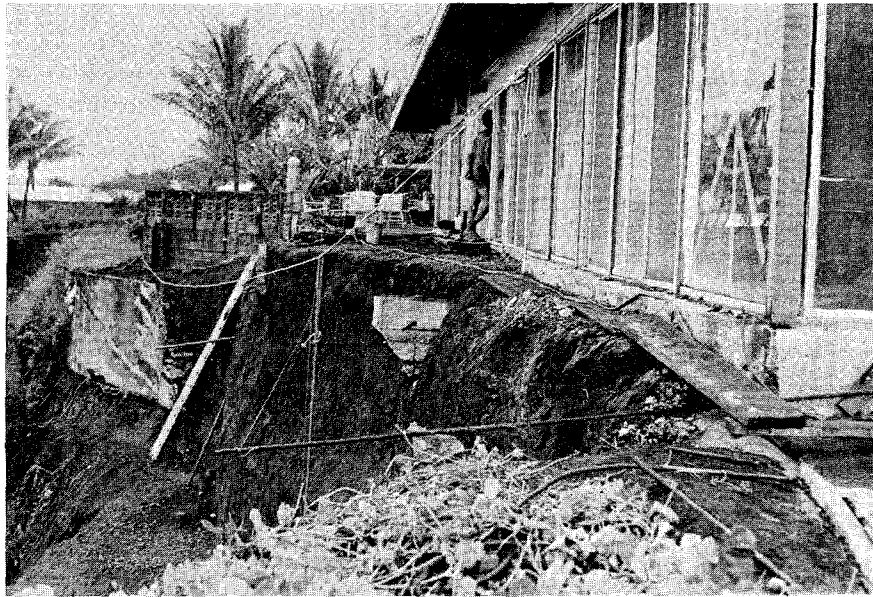
By far the most severe damage to residences occurred in the northern portion of Hilo, north of the Wailuku River in the volcanic ash deposits. There were numerous failures of rock walls (Figures 28 and 29). There were many cases where "mixed" construction of rock walls and wood framing led to damage (Figure 30). In many cases houses were shifted on their foundations (Figures 31 and 32); carports fell down (Figure 33); concrete block buildings saw typical damage (Figure 34); cesspools in volcanic ash failed (Figure 35). A soil fall caused the collapse of the lanai (porch) of a house located about 3 km north of Hilo on a sea cliff with a height of 25 m (Figure 36).

FIGURE 36 SOIL FALL, VOLCANIC ASH, 3 km NORTH OF HILO

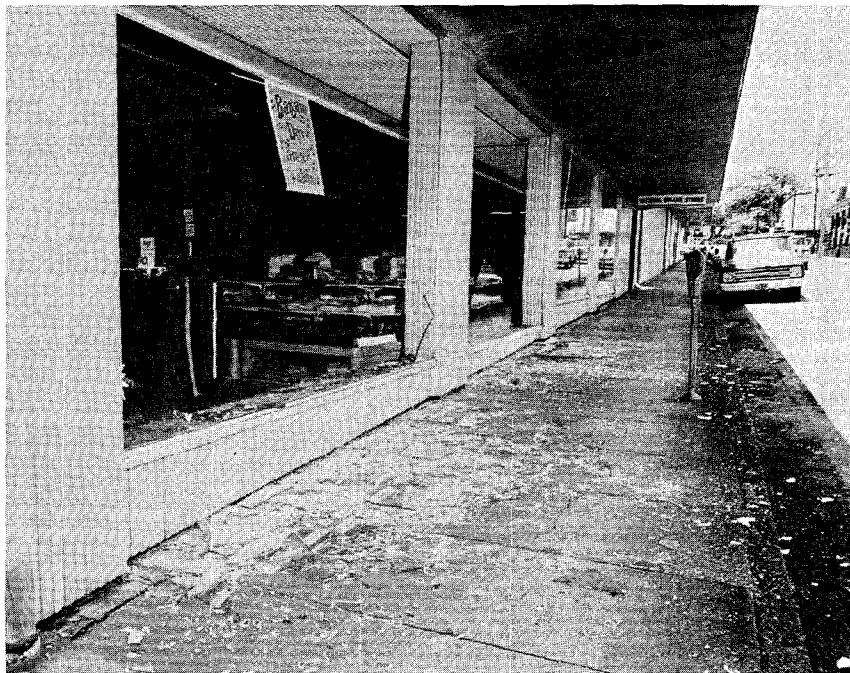
There were minor structural damages in downtown Hilo. In the business district there was considerable damage to plate glass windows (Figure 37). One building, the typewriter center, collapsed. One of the parapets of the fire walls between the buildings apparently fell on the wood trusses of the typewriter center and collapsed the roof. One man trapped in the building

FIGURE 37 BUSINESS DISTRICT, DOWNTOWN HILO

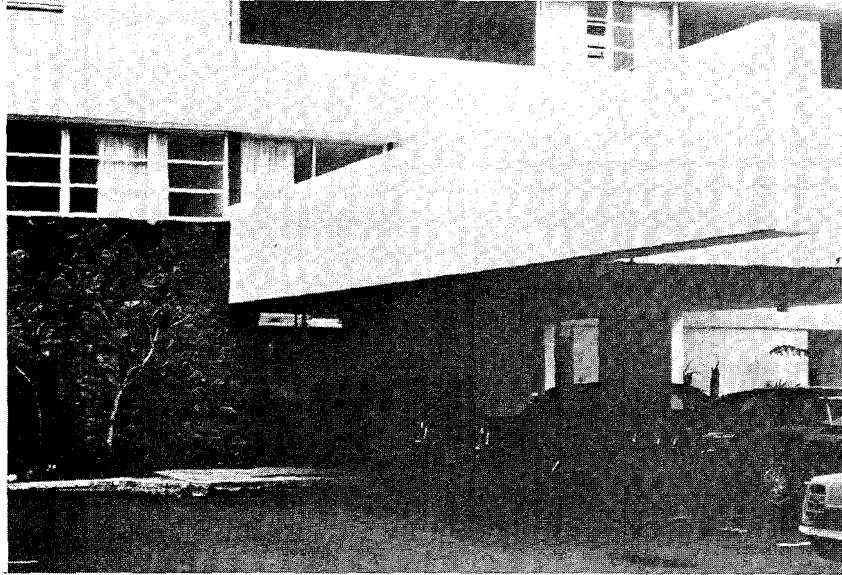
FIGURE 42 BAYSHORE TOWER, CANOPY BEAMS ATTACHED TO SHEAR WALLS

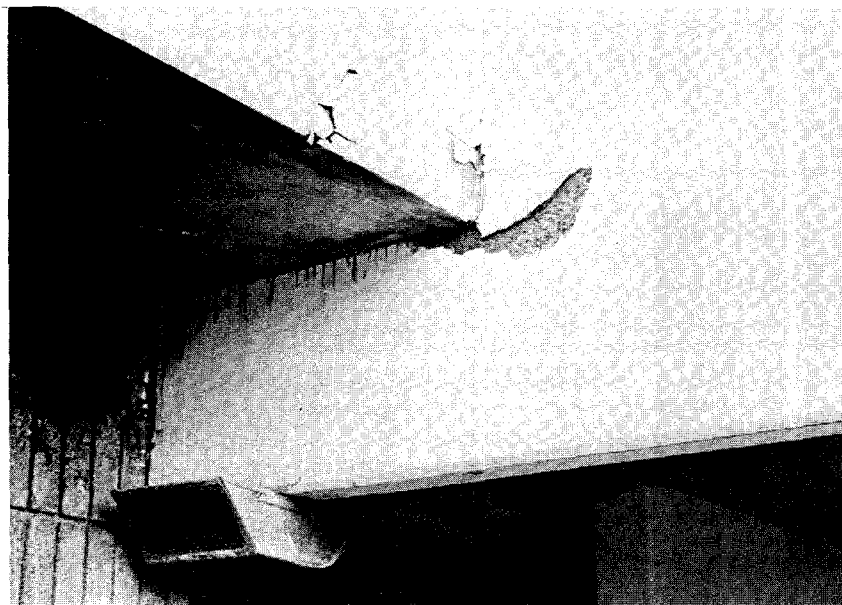
FIGURE 43 BAYSHORE TOWER, CONCRETE SPALLING

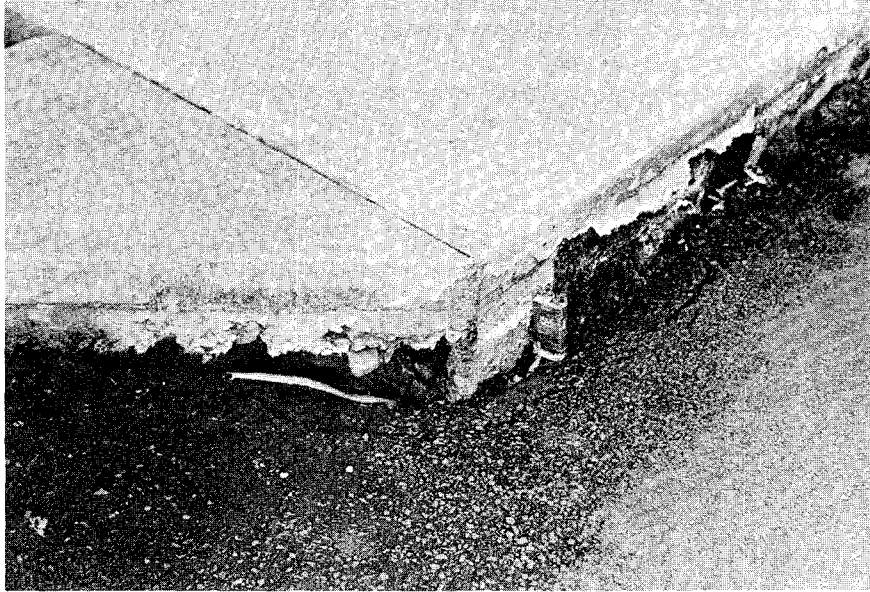
FIGURE 44 SETTLEMENT, FRONT OF BAYSHORE TOWER

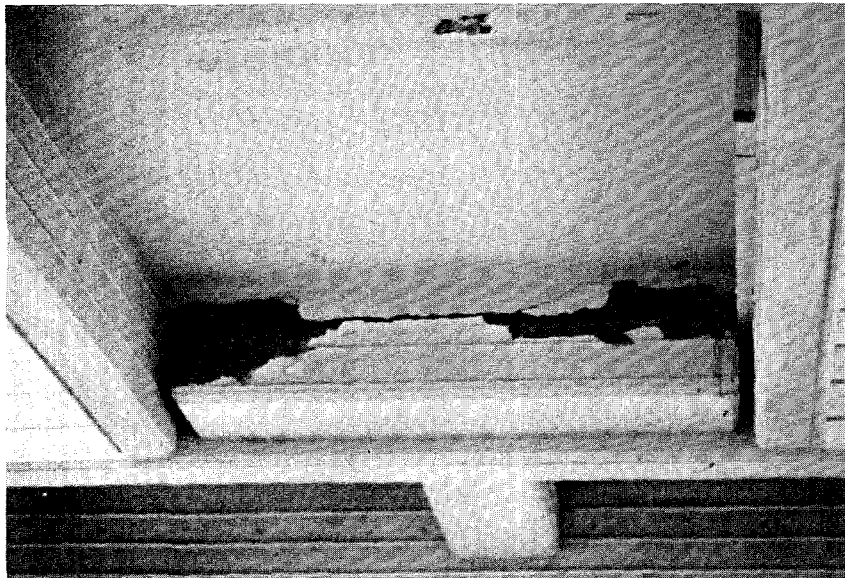
FIGURE 47 BRIDGE SEAT DETAIL, MAUNA KEA BEACH HOTEL

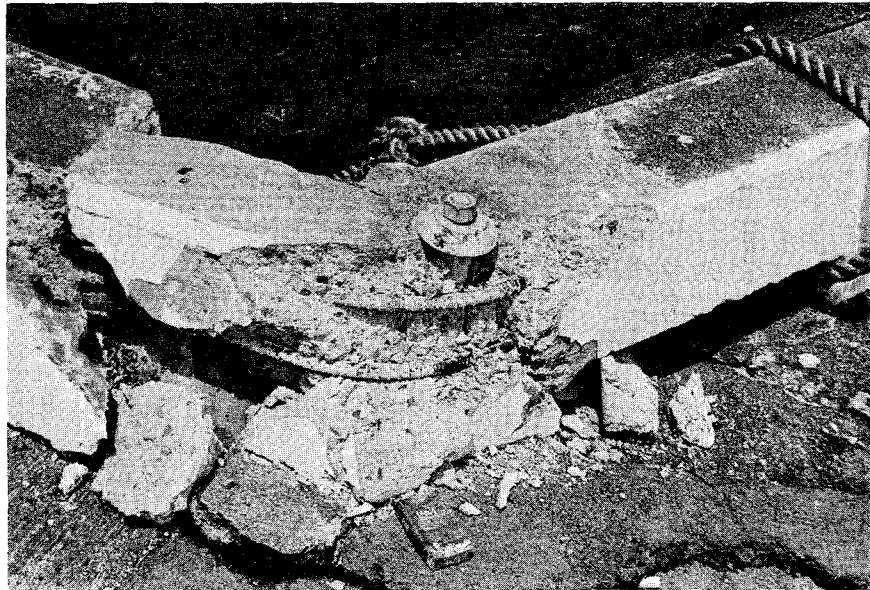
FIGURE 49 CONCRETE CURB, HILO HARBOR, PIER 1

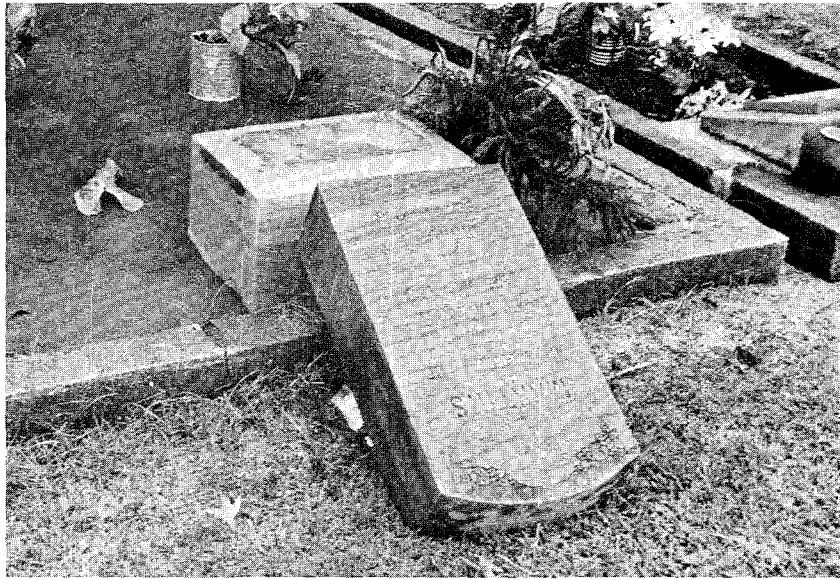
FIGURE 52 TOMBSTONE, TOPPLED OVER

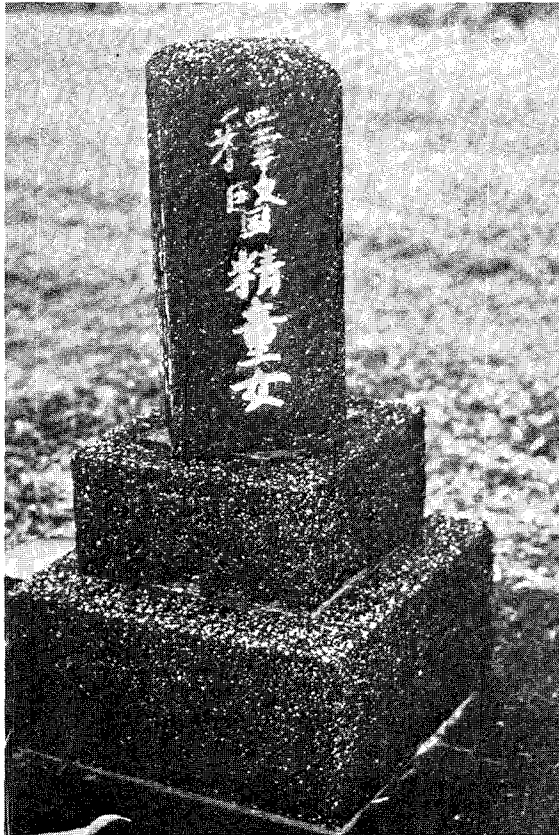
FIGURE 53 TOMBSTONE, ROTATED

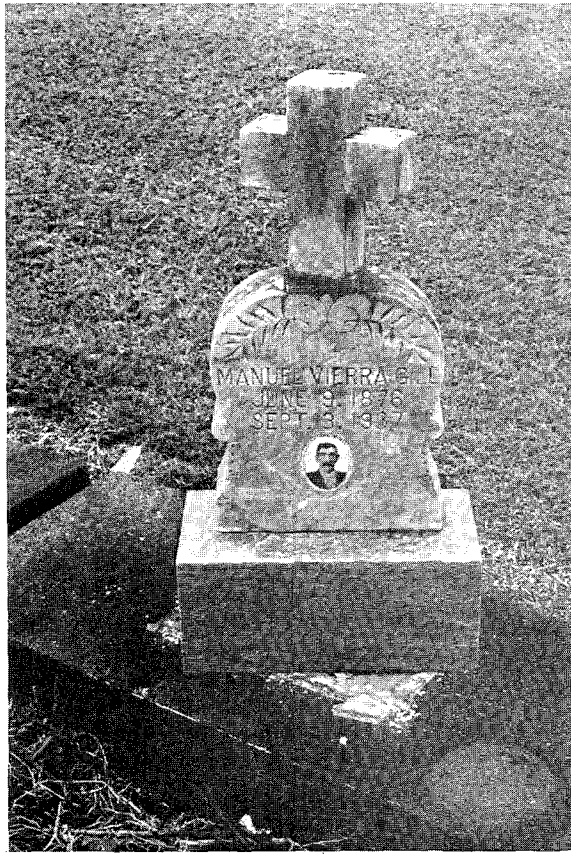
FIGURE 54 TOMBSTONE, ROTATED
