ENGINEERING REPORT
on the
MANAGUA EARTHQUAKE
of
23 DECEMBER 1972

a report
by
Meté A. Sozen
University of Illinois
and
R. B. Matthiesen
U.S. Geological Survey

submitted to the
Committee on Natural Disasters
Commission on Sociotechnical Systems
NATIONAL RESEARCH COUNCIL

NATIONAL ACADEMY OF SCIENCES
Washington, D.C.
1975

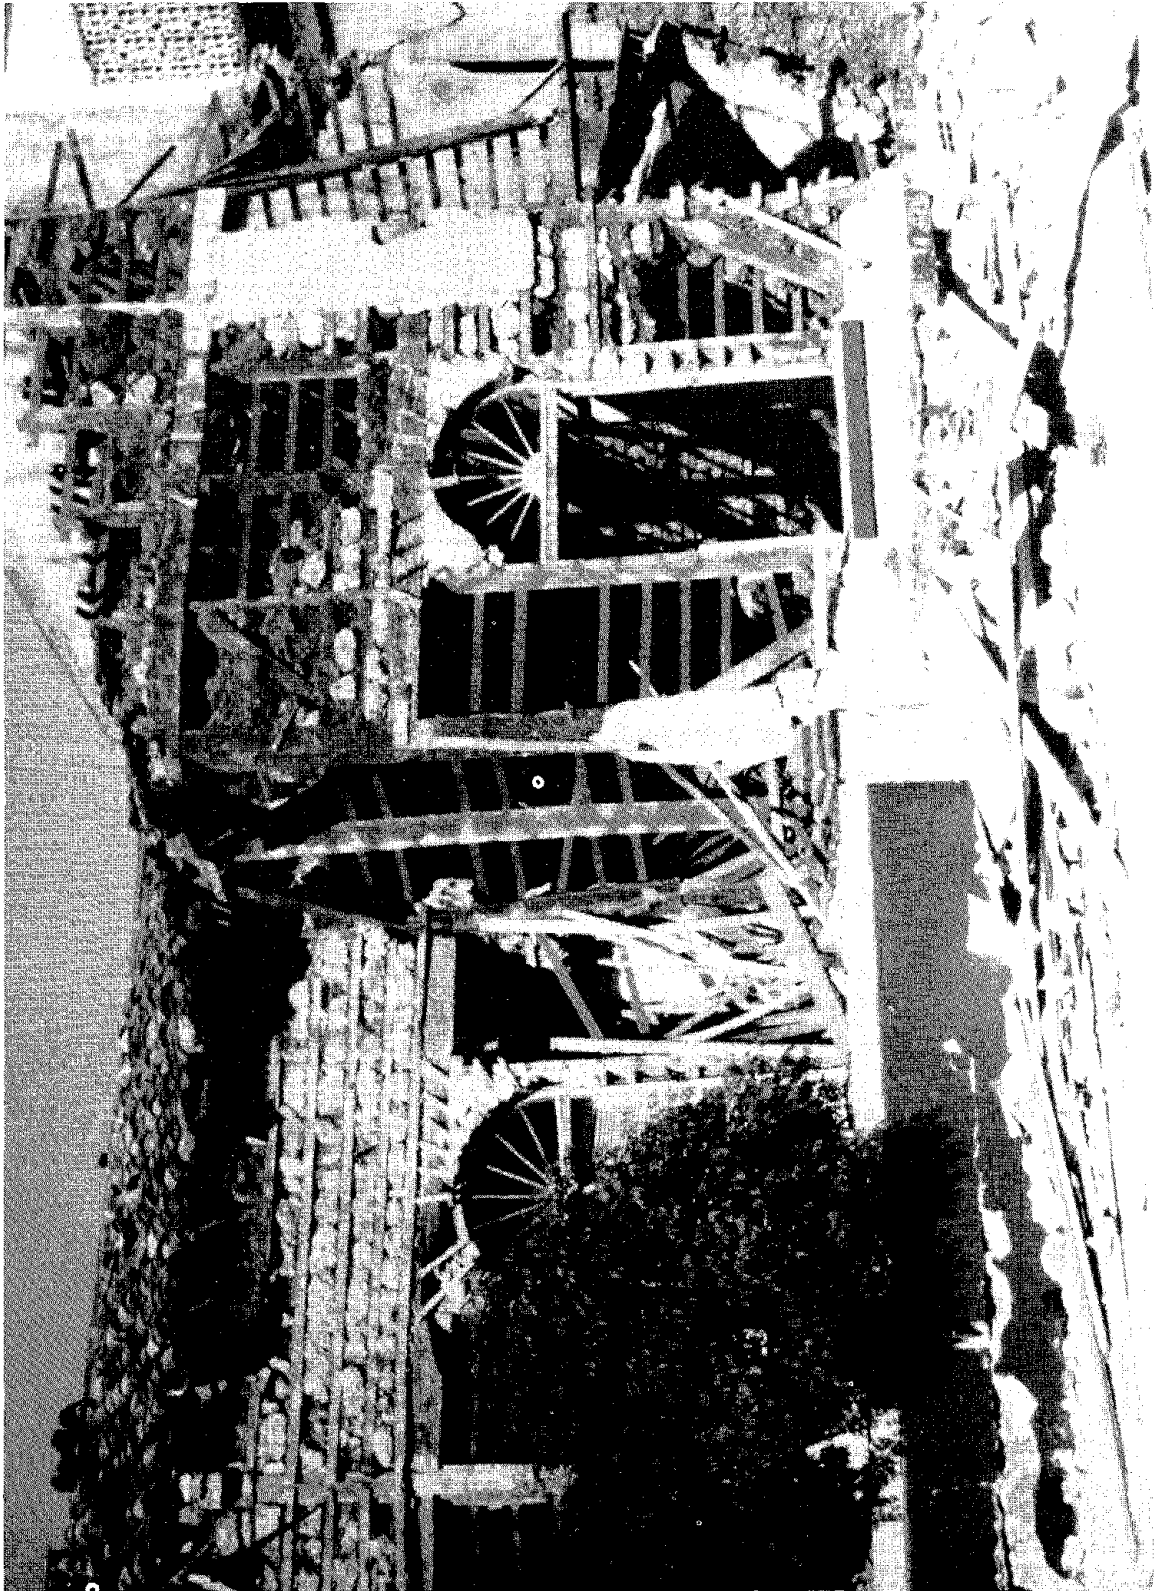
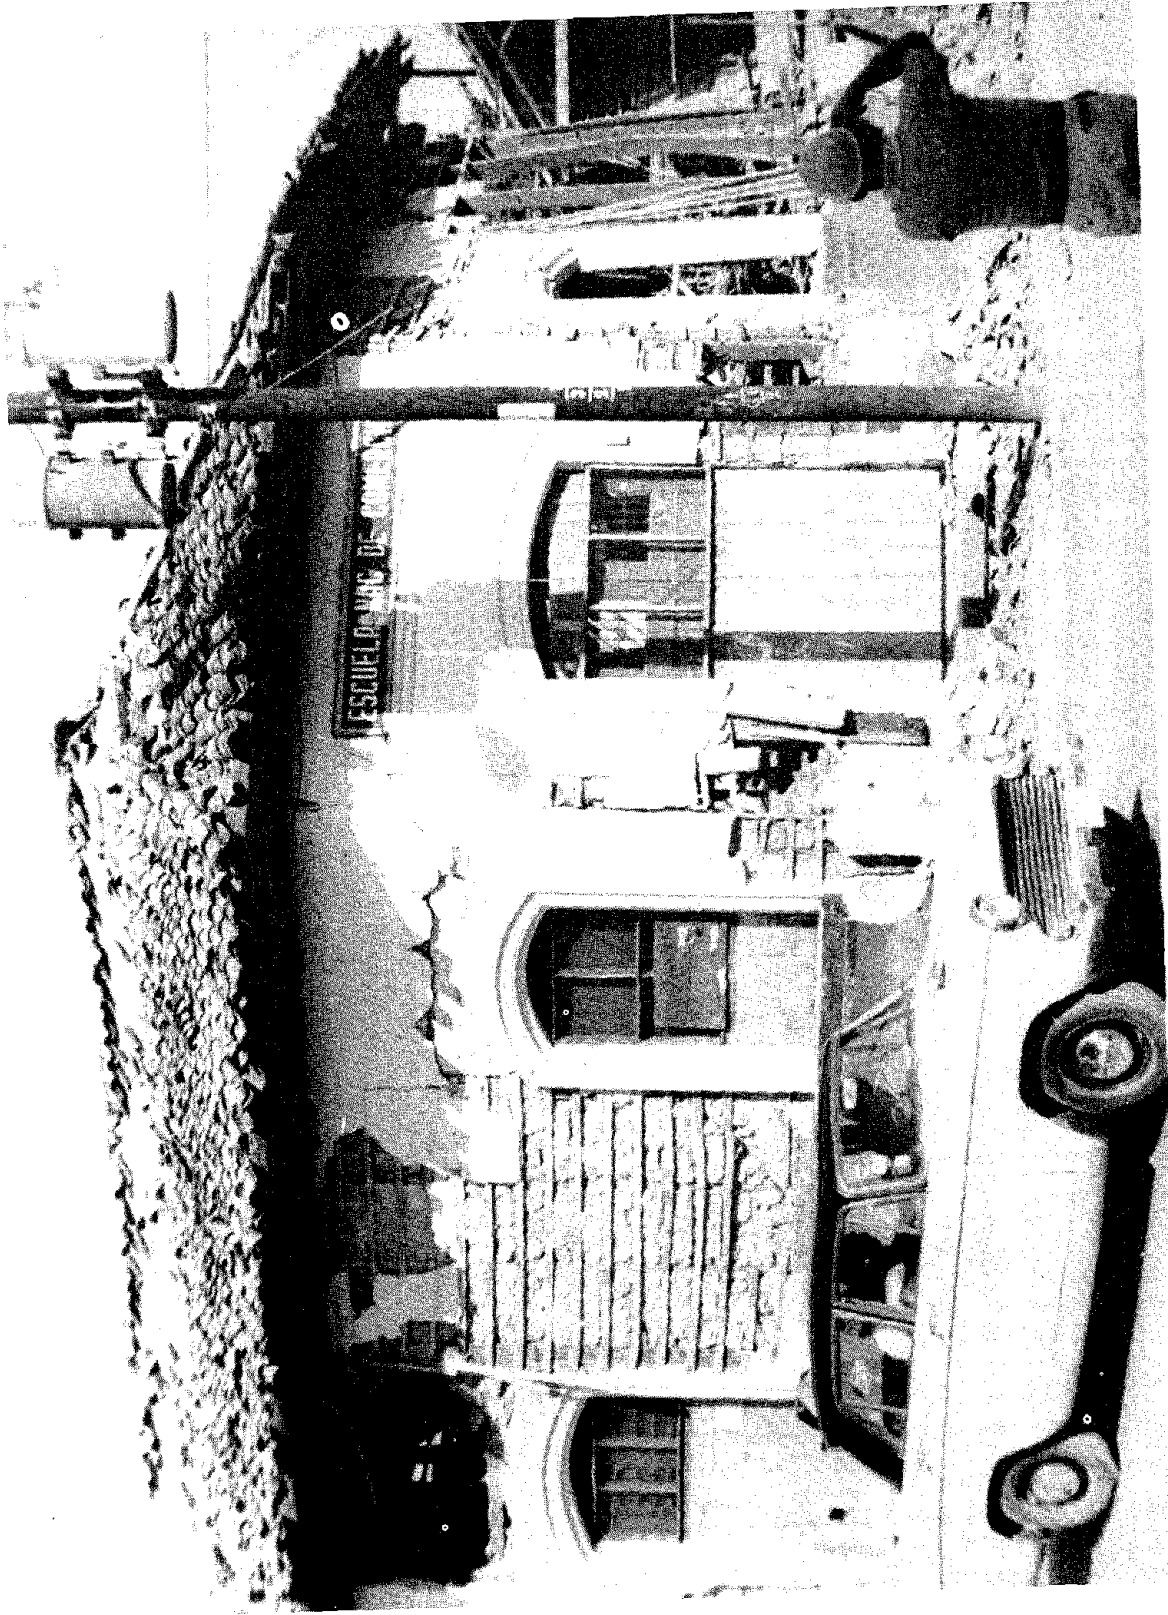
One- to Two-Story Construction: The dominant medium of construction in this category was taquezal, adobe bricks filling a light timber grillage or framework (Figures 9, 10). With a light roof, this system does present certain advantages in relation to earthquake resistance. Presumably its success during the 1931 earthquake was due to its capability to resist distortion with the help of tensile strength provided by the timber. The general failure of this type of construction in the 1972 event has been attributed to relatively heavy roofs and rotten timber.

FIGURE II-9a Taqezal Construction.

FIGURE II-9b Taquezal Construction.

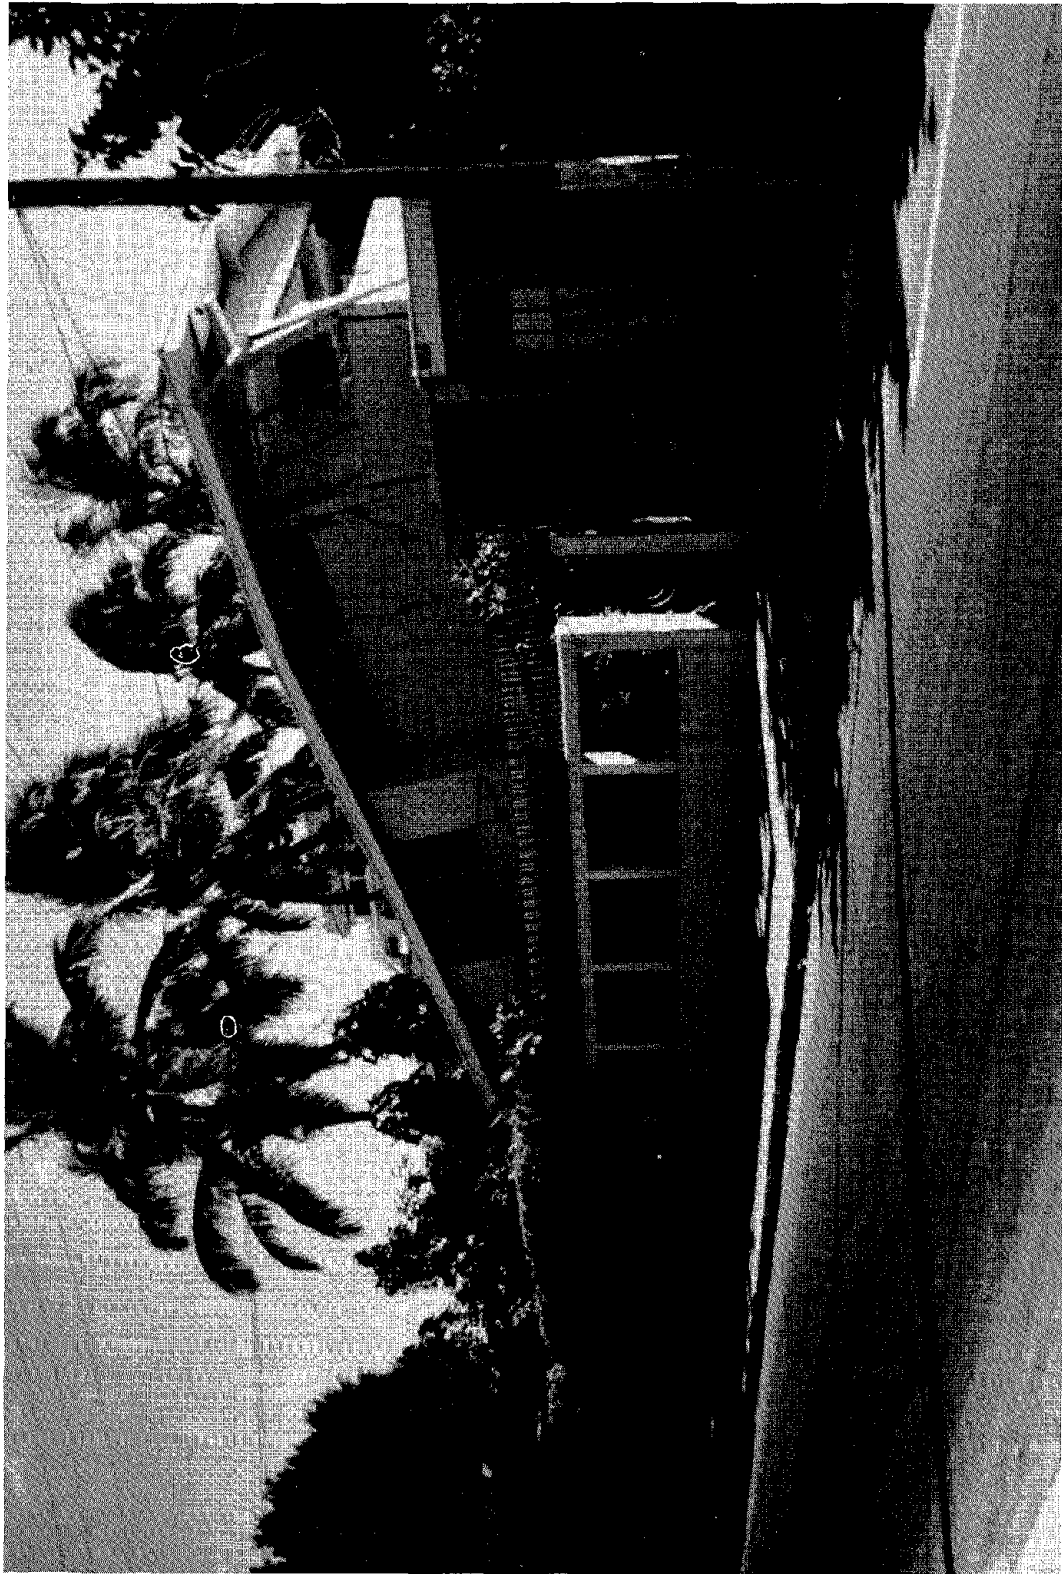
FIGURE II-10 Modern Taquezal.

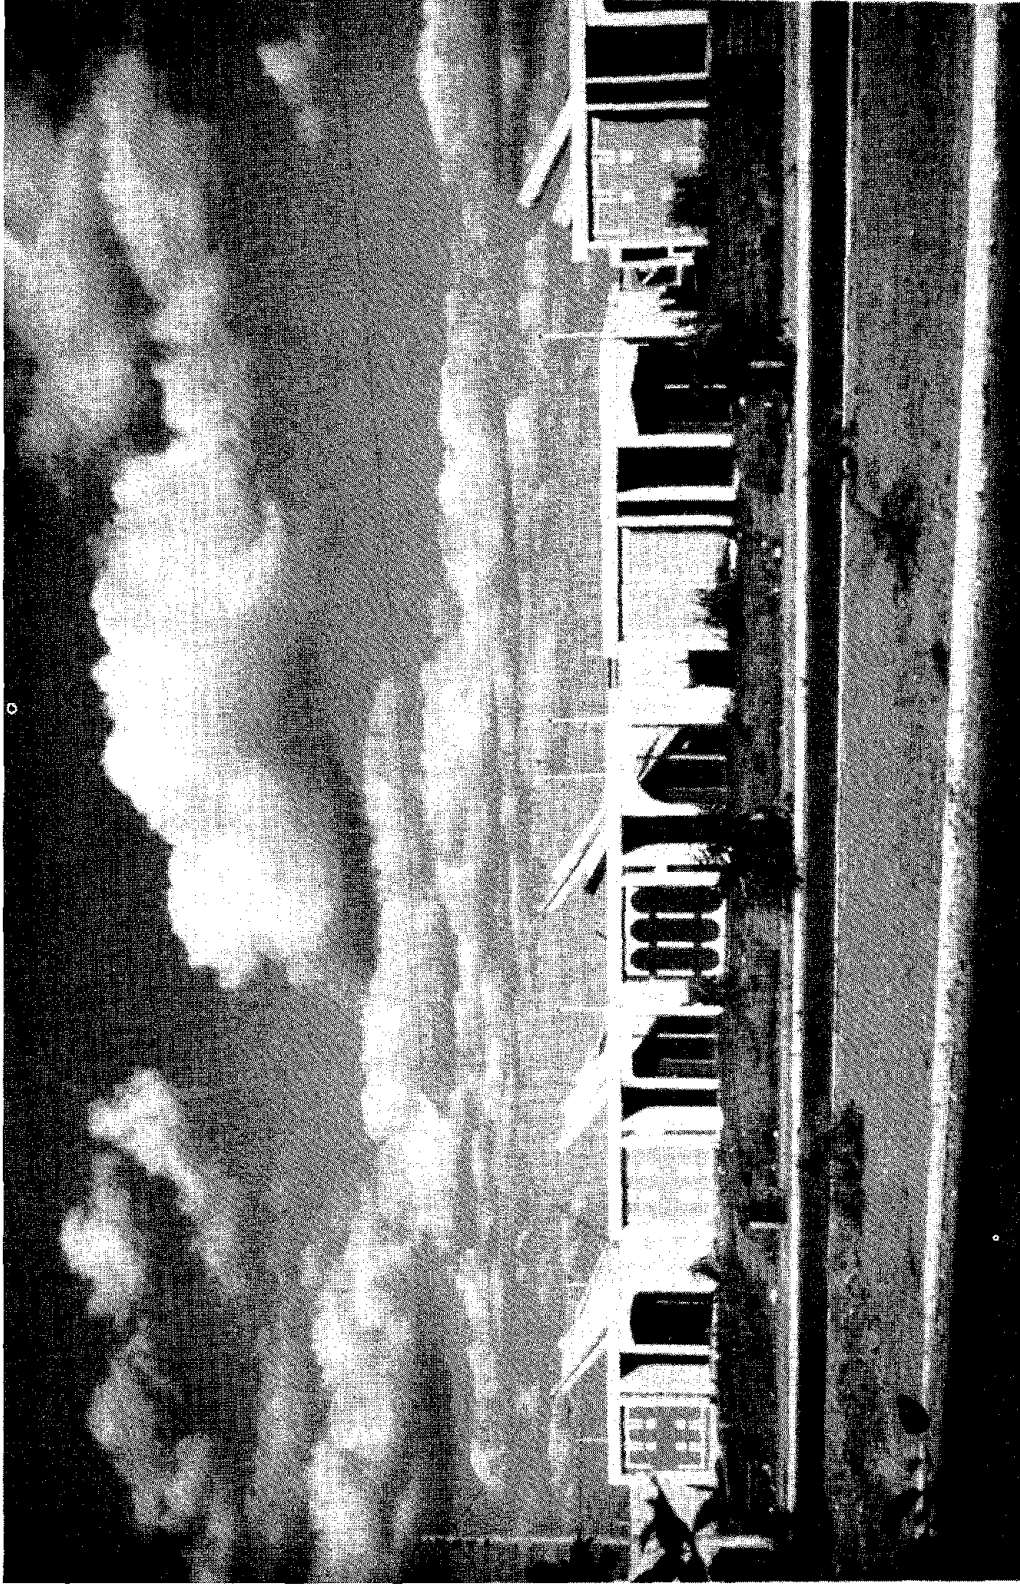
Suburban housing typically comprised reinforced masonry or concrete walls with heavy reinforced concrete roof slabs. The weight of the slab was in most cases resisted by the wall area provided, resulting only in cracked walls and displaced slabs. In the case illustrated in Figure 11, lack of adequate bearing surface made the displacement of precast concrete roof slabs a major problem.

FIGURE II-11 Precast Concrete Roof.

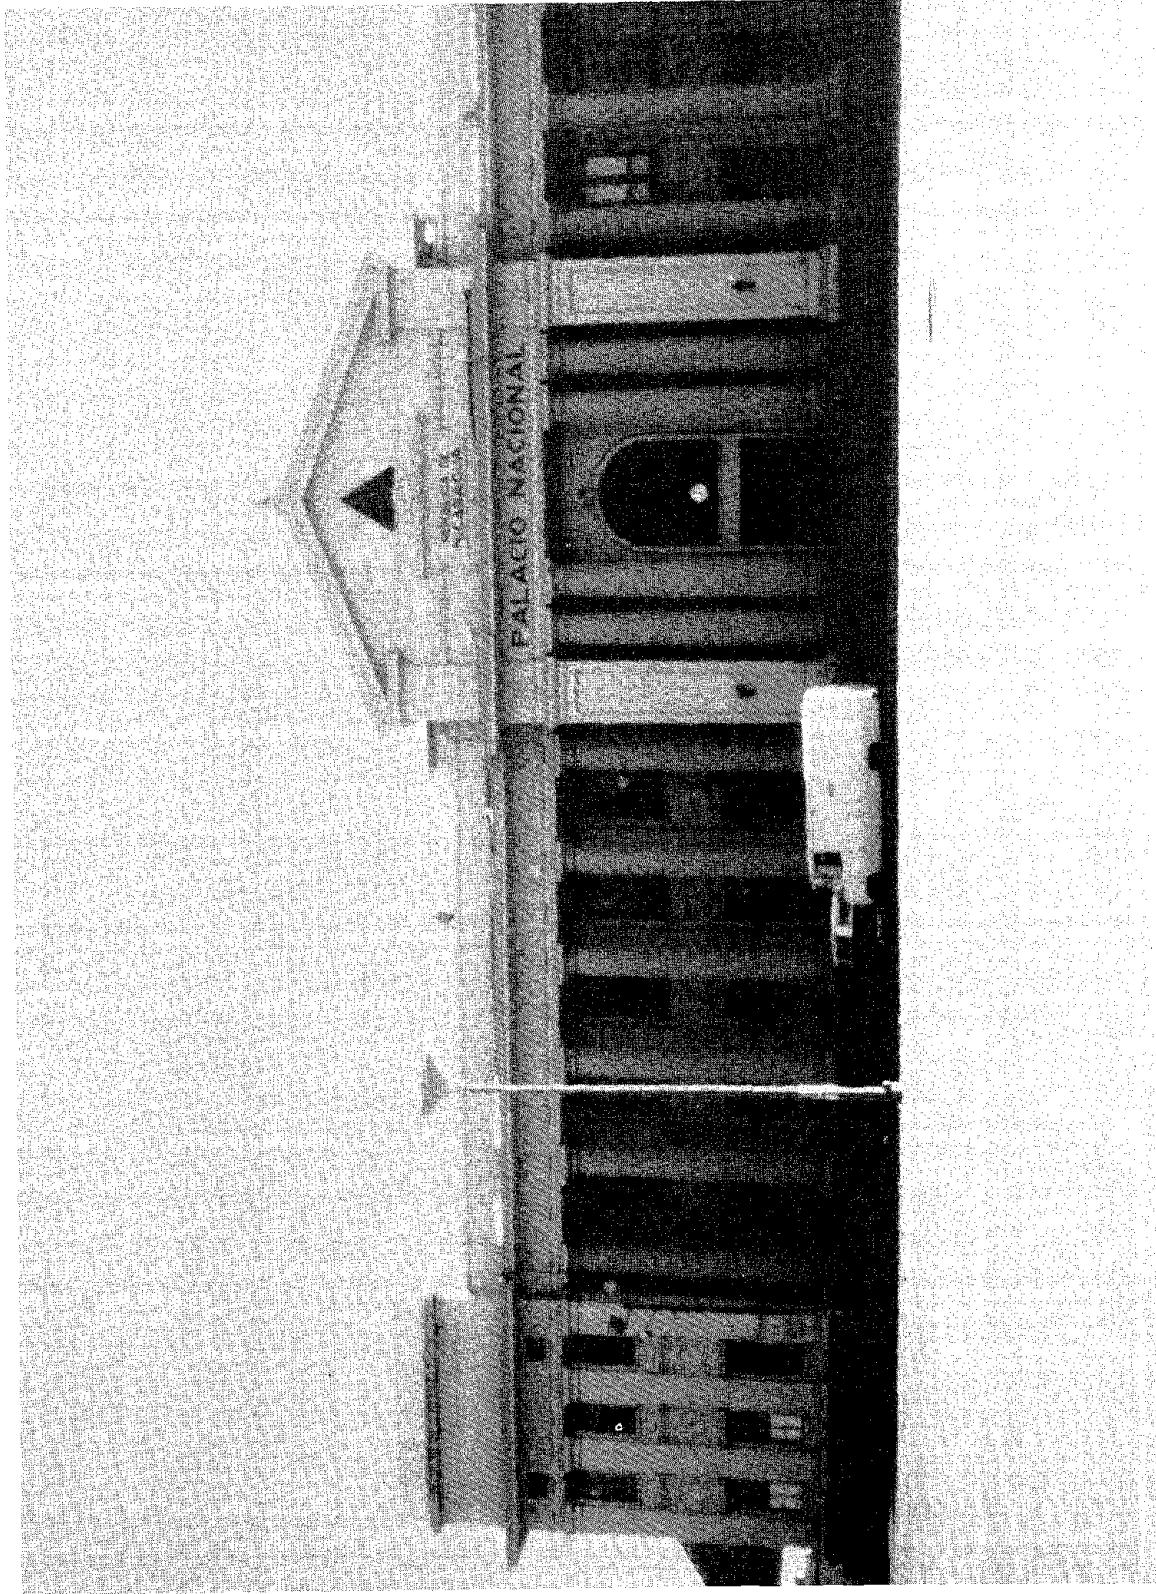
FIGURE II-12 National Palace.

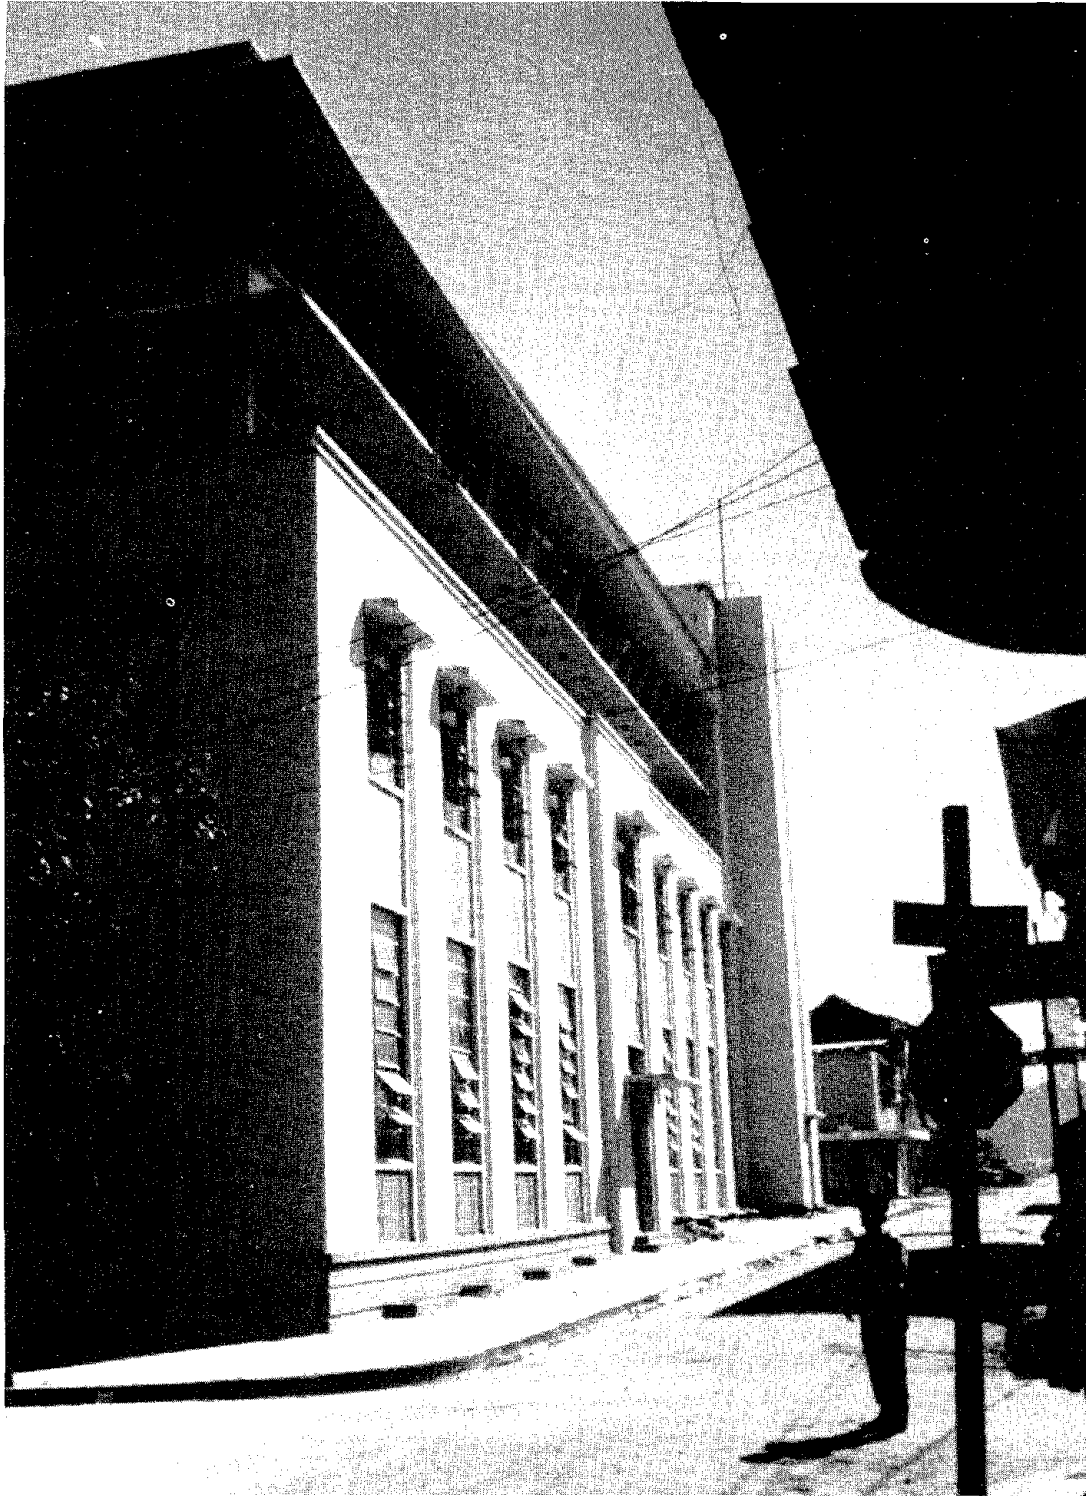
FIGURE II-13 Communications Building.

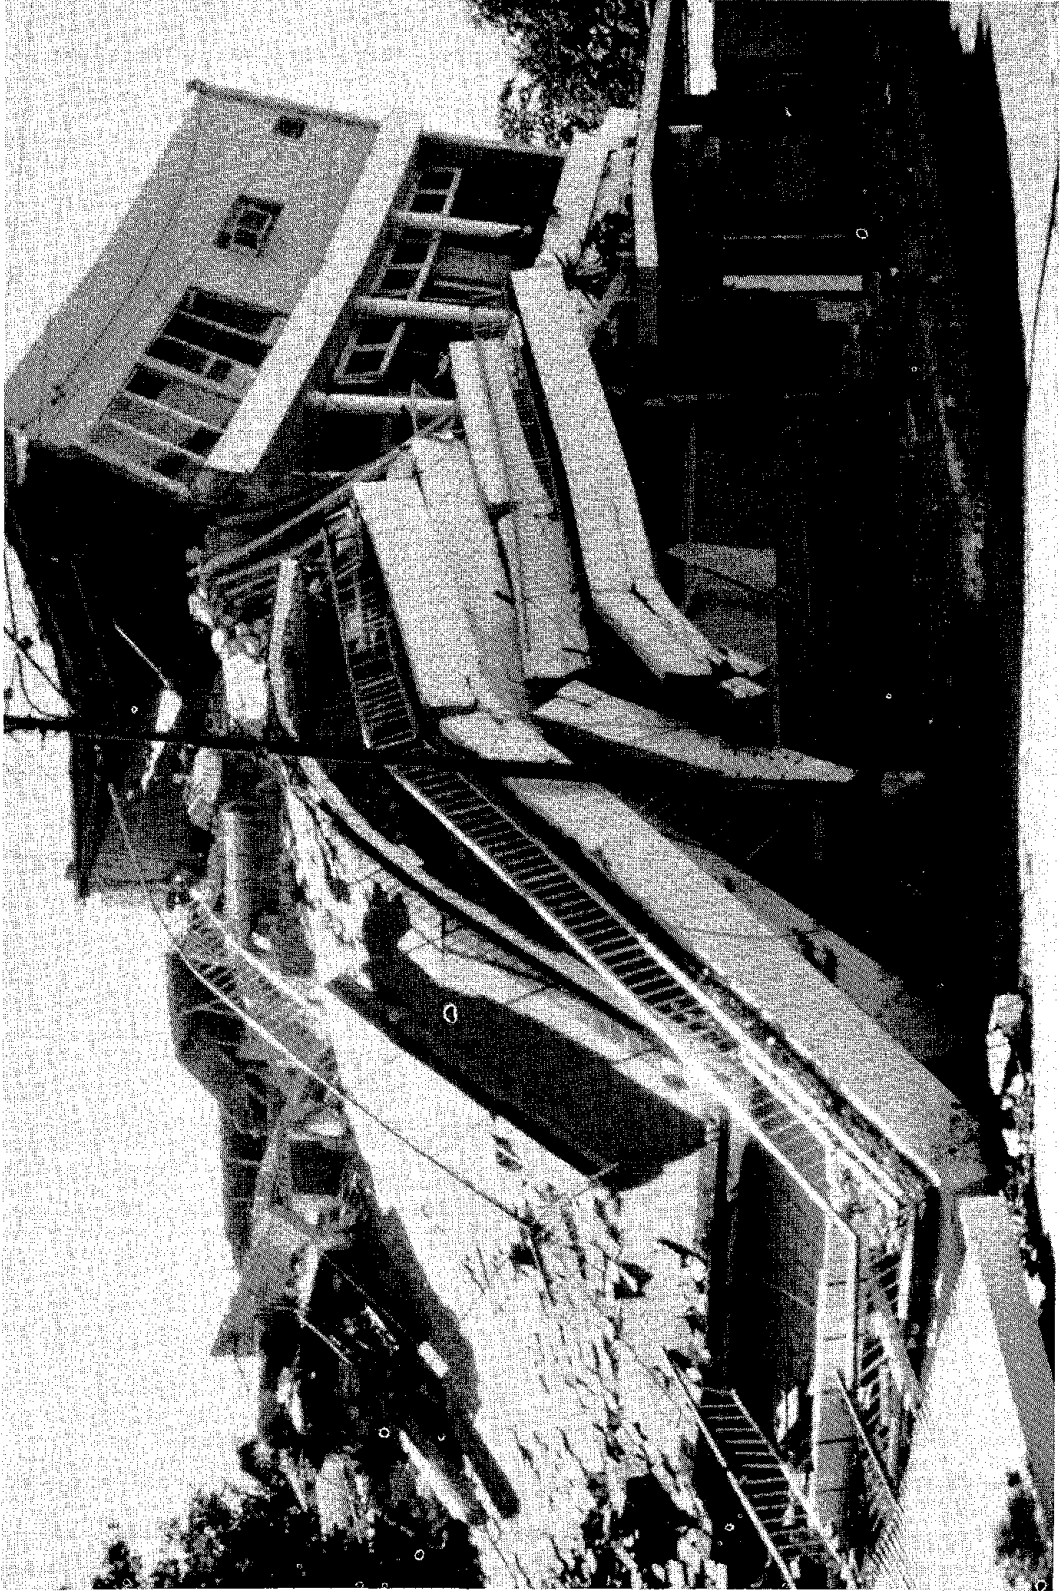
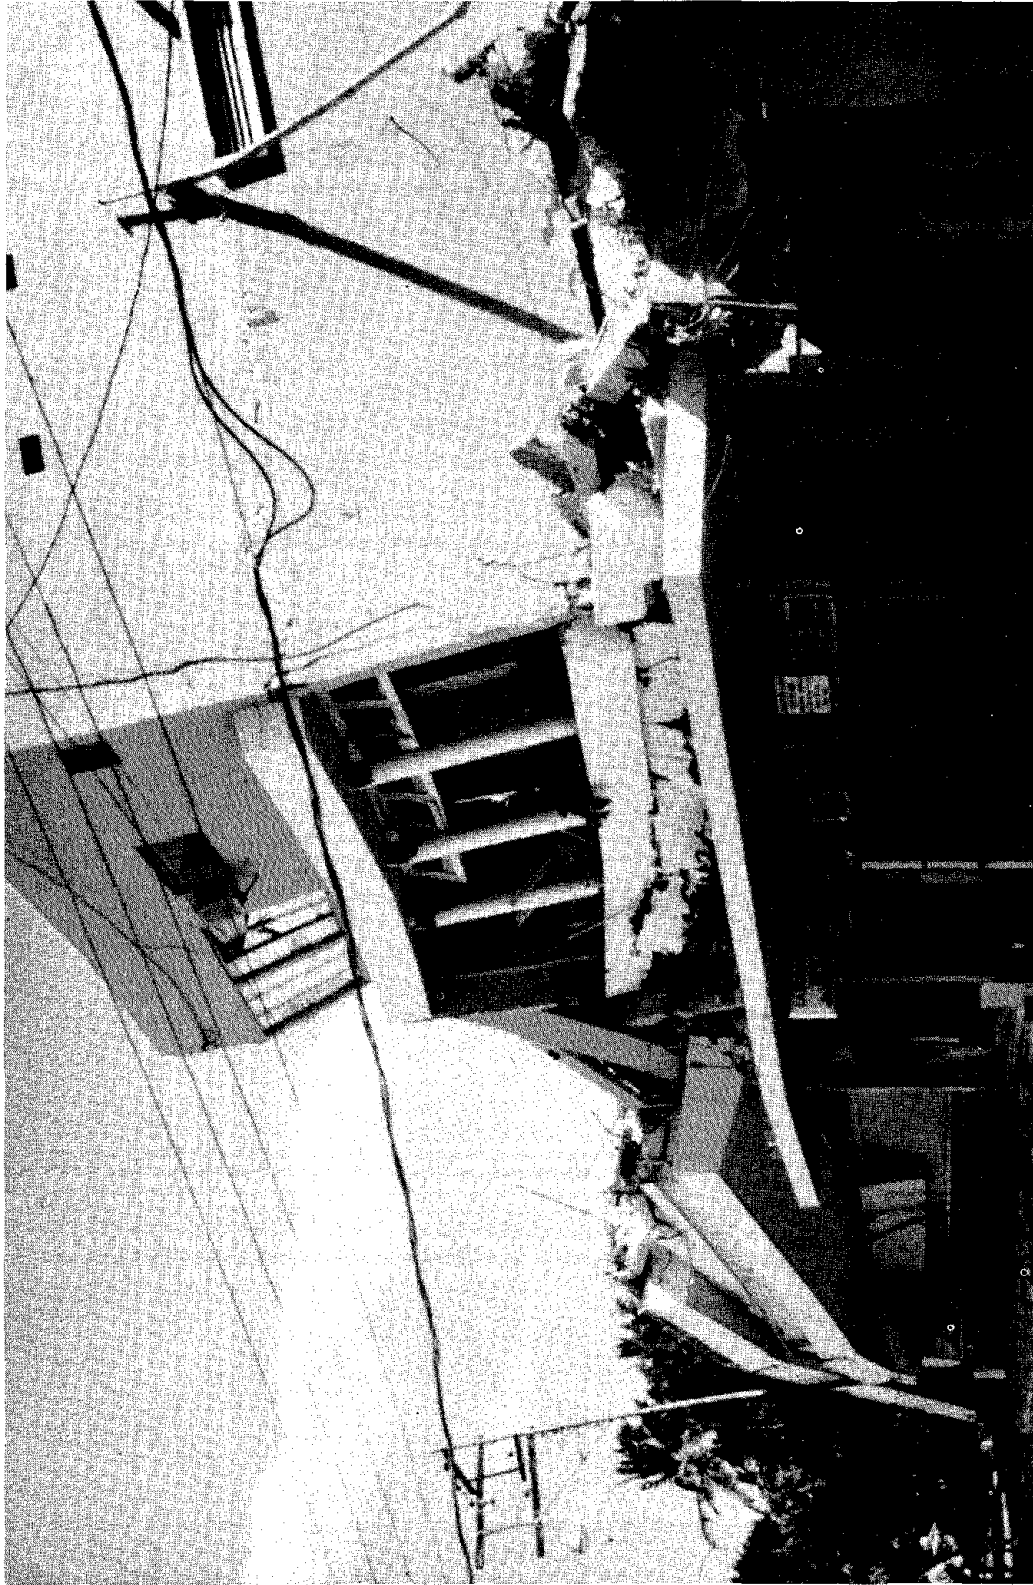
FIGURE II-14a Guerrero Pineda Building.

FIGURE II-14b Guerrero Pineda Building.

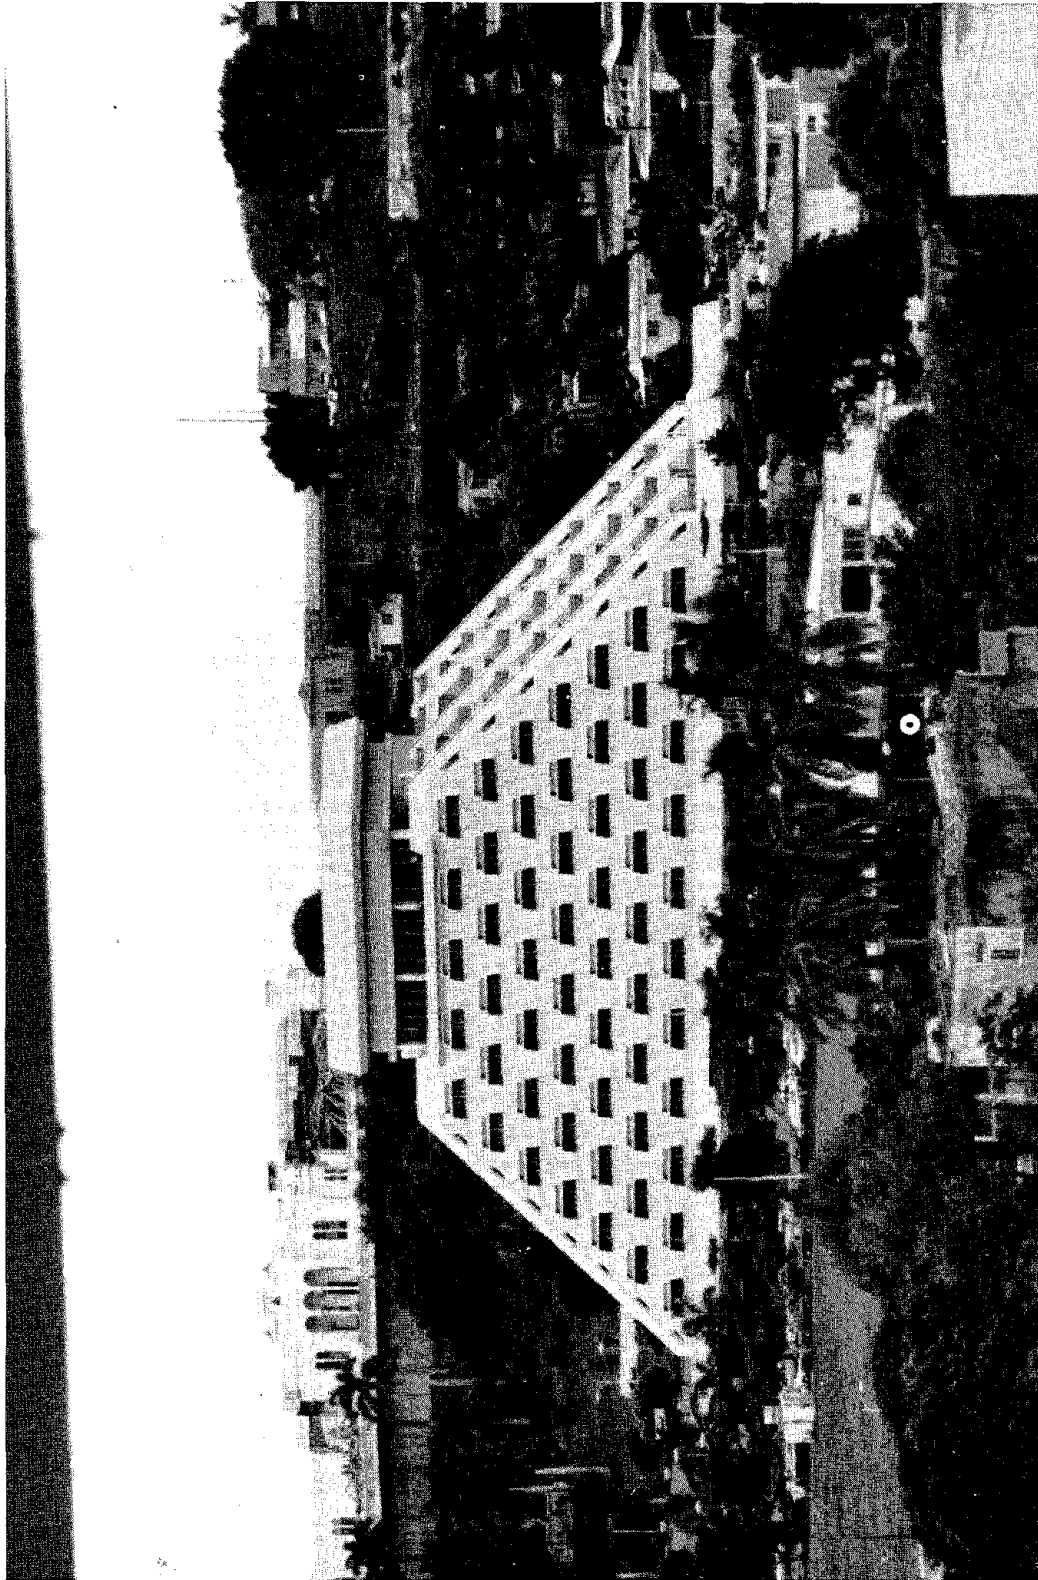
FIGURE II-15 Intercontinental Hotel.

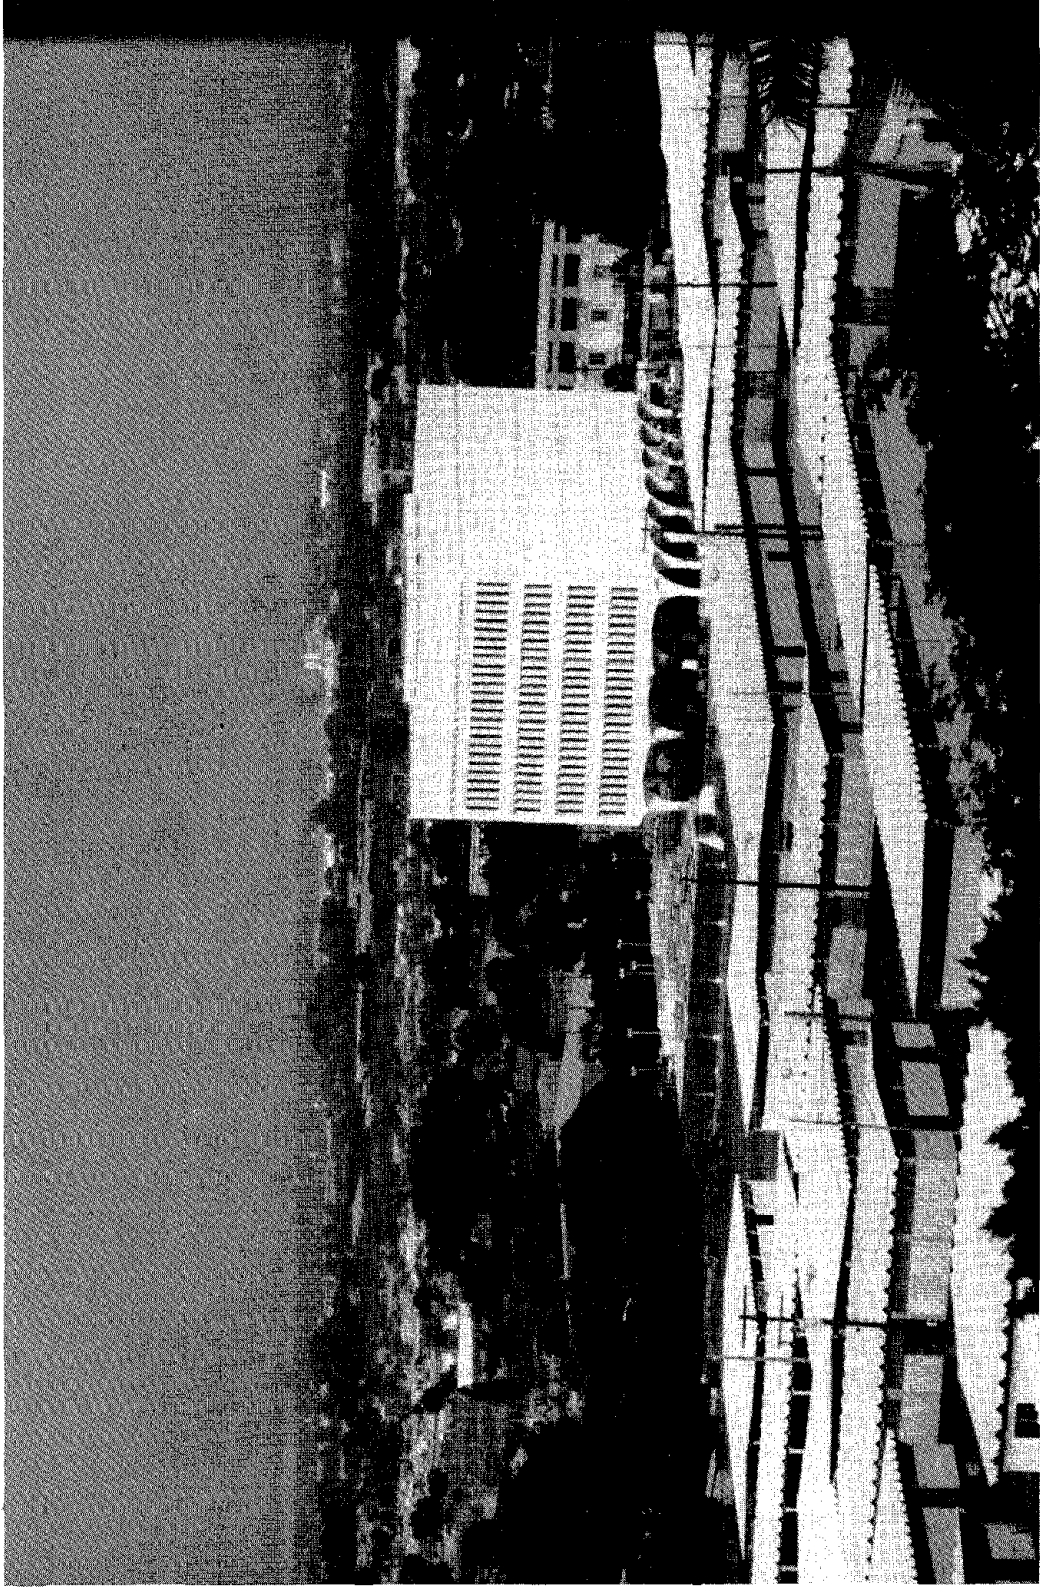
FIGURE II-16a ENALUF (Light and Power) Building.

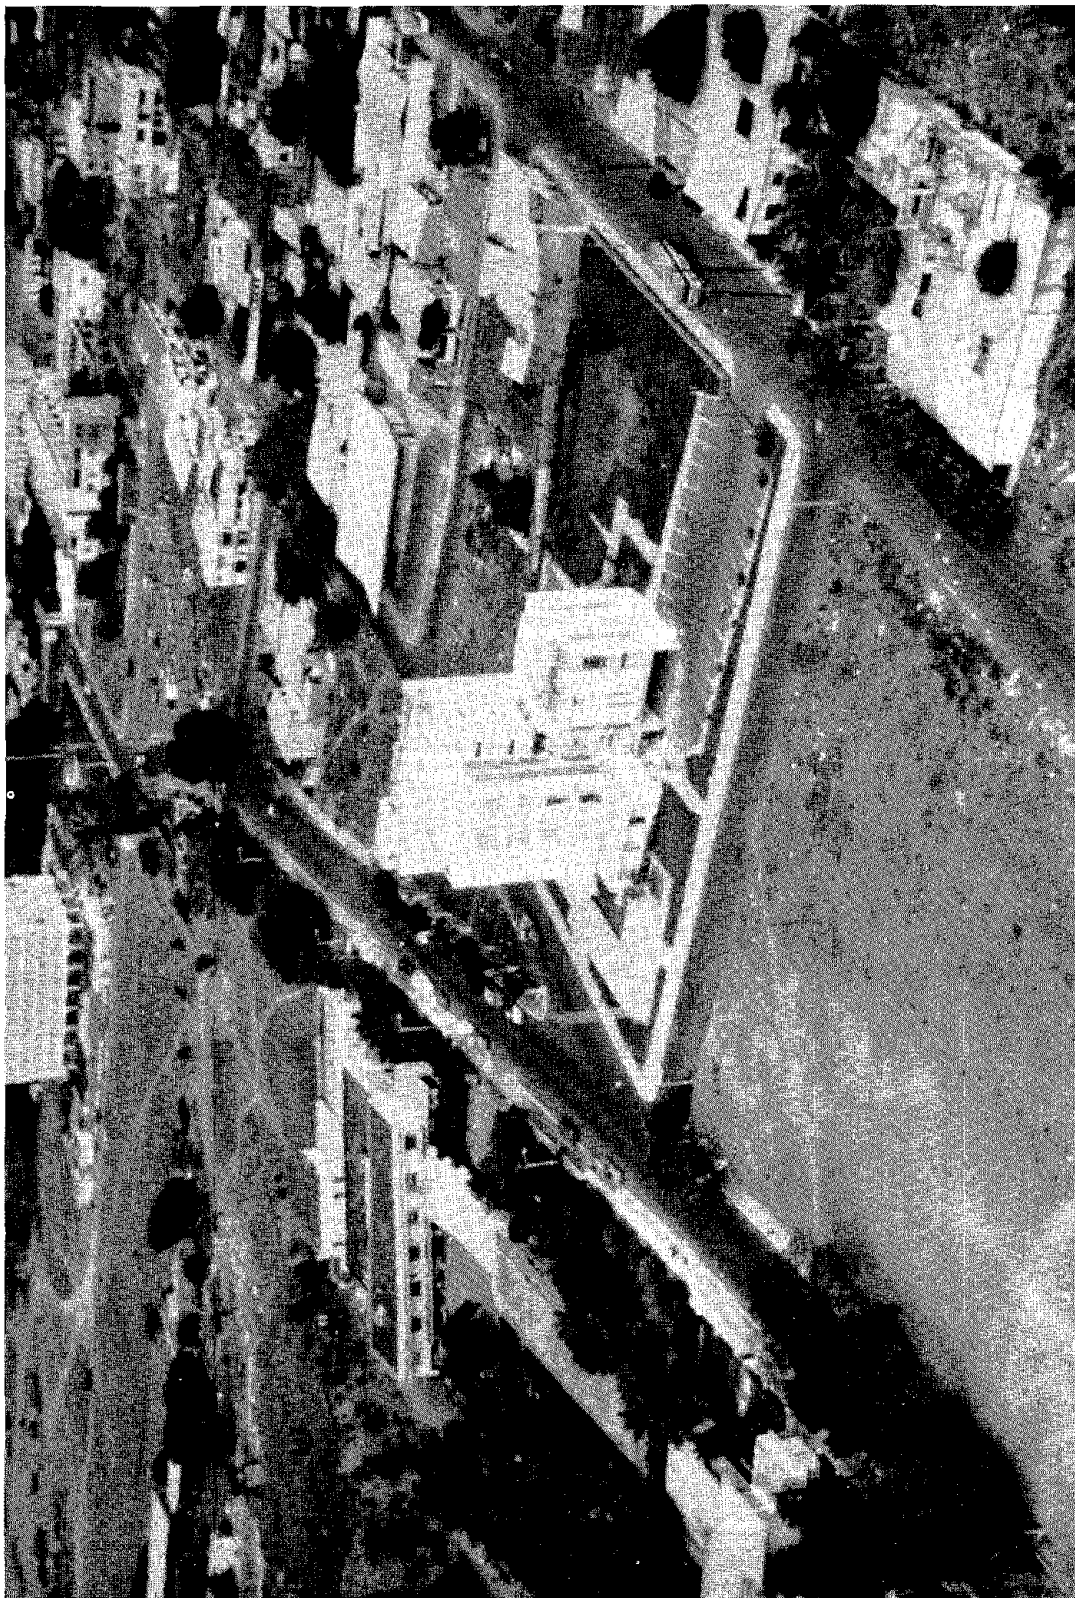
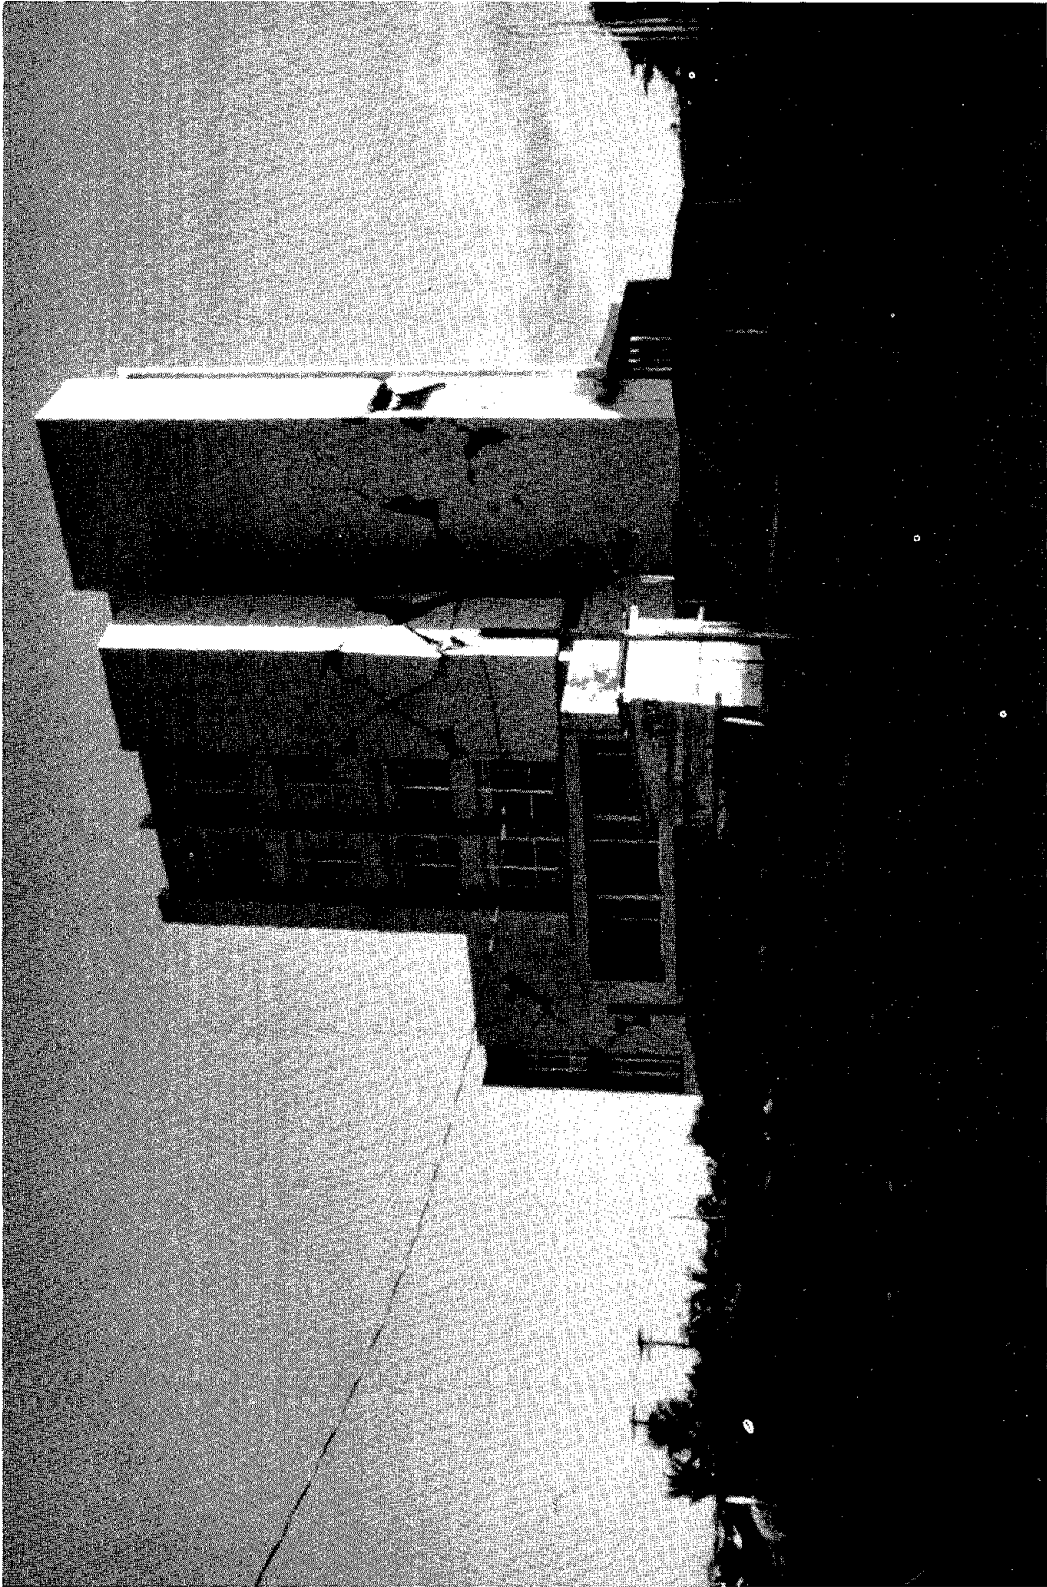
The recommendation by Freeman reproduced in Figure 41 (14) apparently went unheeded. The post-1931 U.S. Embassy building is the two-story (before the earthquake) structure with a heavy list, in the left middle portion of Figure 17a.

FIGURE II-17a La Protectora Building.

FIGURE II-17b La Protectora Building.

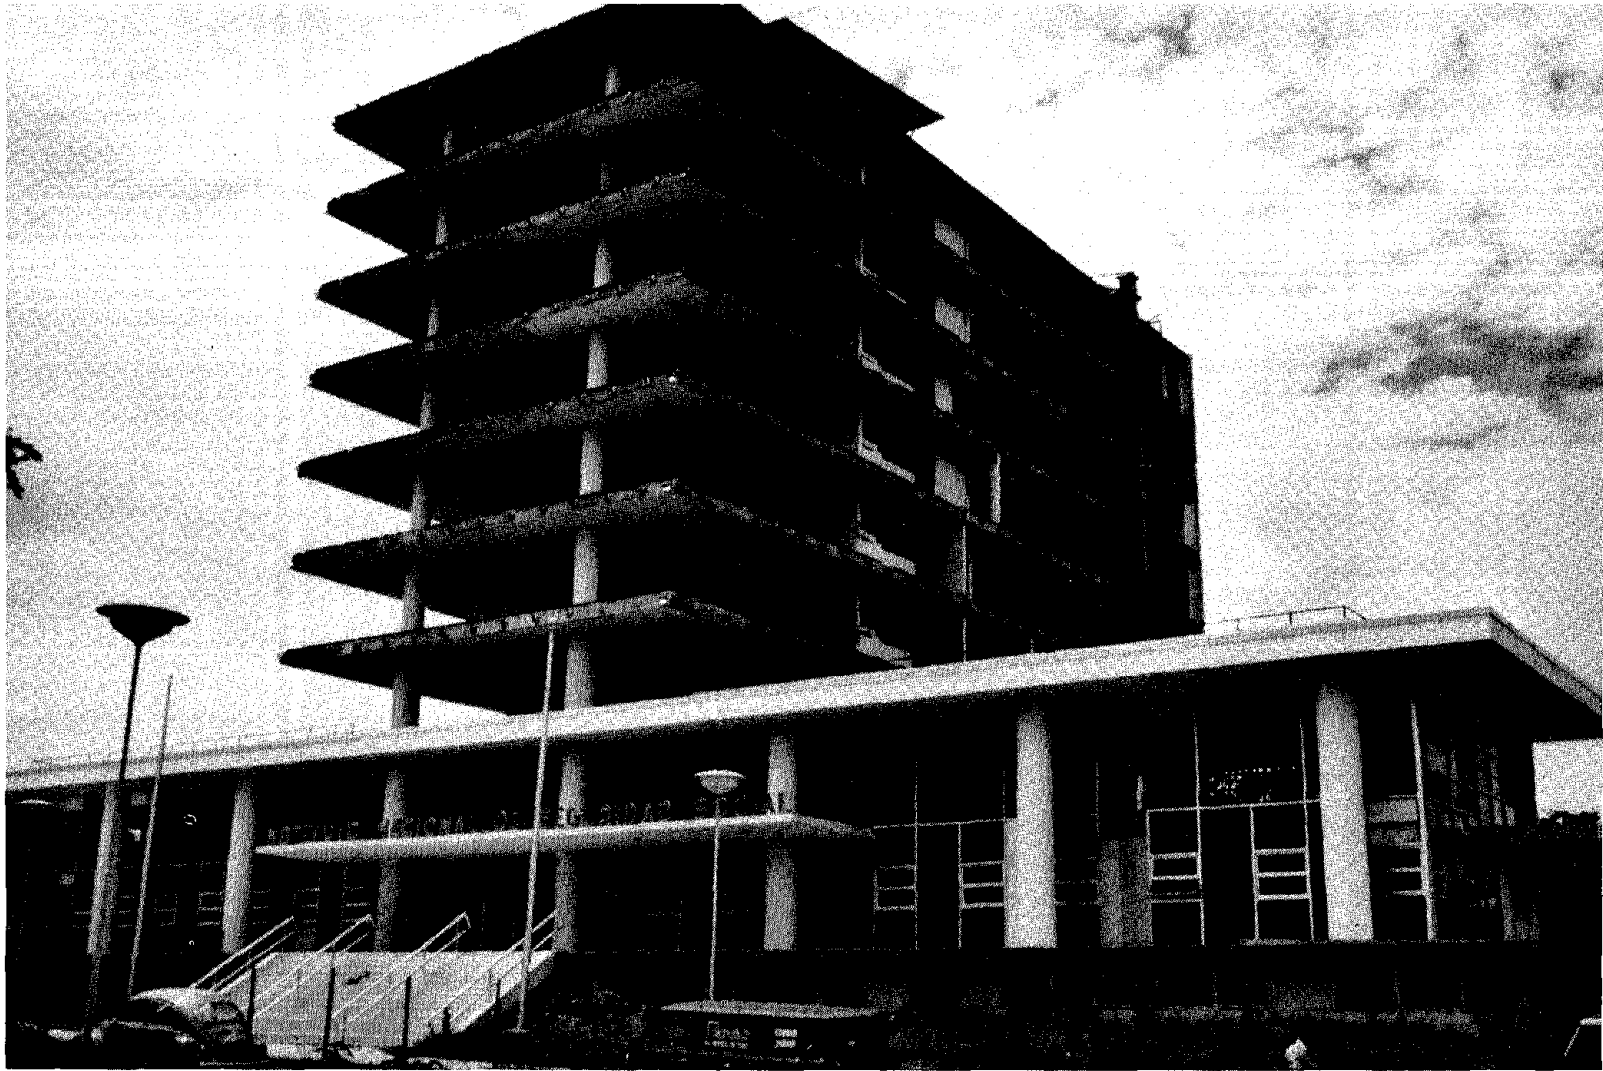
FIGURE II-19 . Social Security Institute Building After Removal of Non-structural Elements.
