ENGINEERING REPORT
on the
MANAGUA EARTHQUAKE
of
23 DECEMBER 1972

a report
by
Meté A. Sozen
University of Illinois
and
R. B. Matthiesen
U.S. Geological Survey

submitted to the
Committee on Natural Disasters
Commission on Sociotechnical Systems
NATIONAL RESEARCH COUNCIL

NATIONAL ACADEMY OF SCIENCES
Washington, D.C.
1975

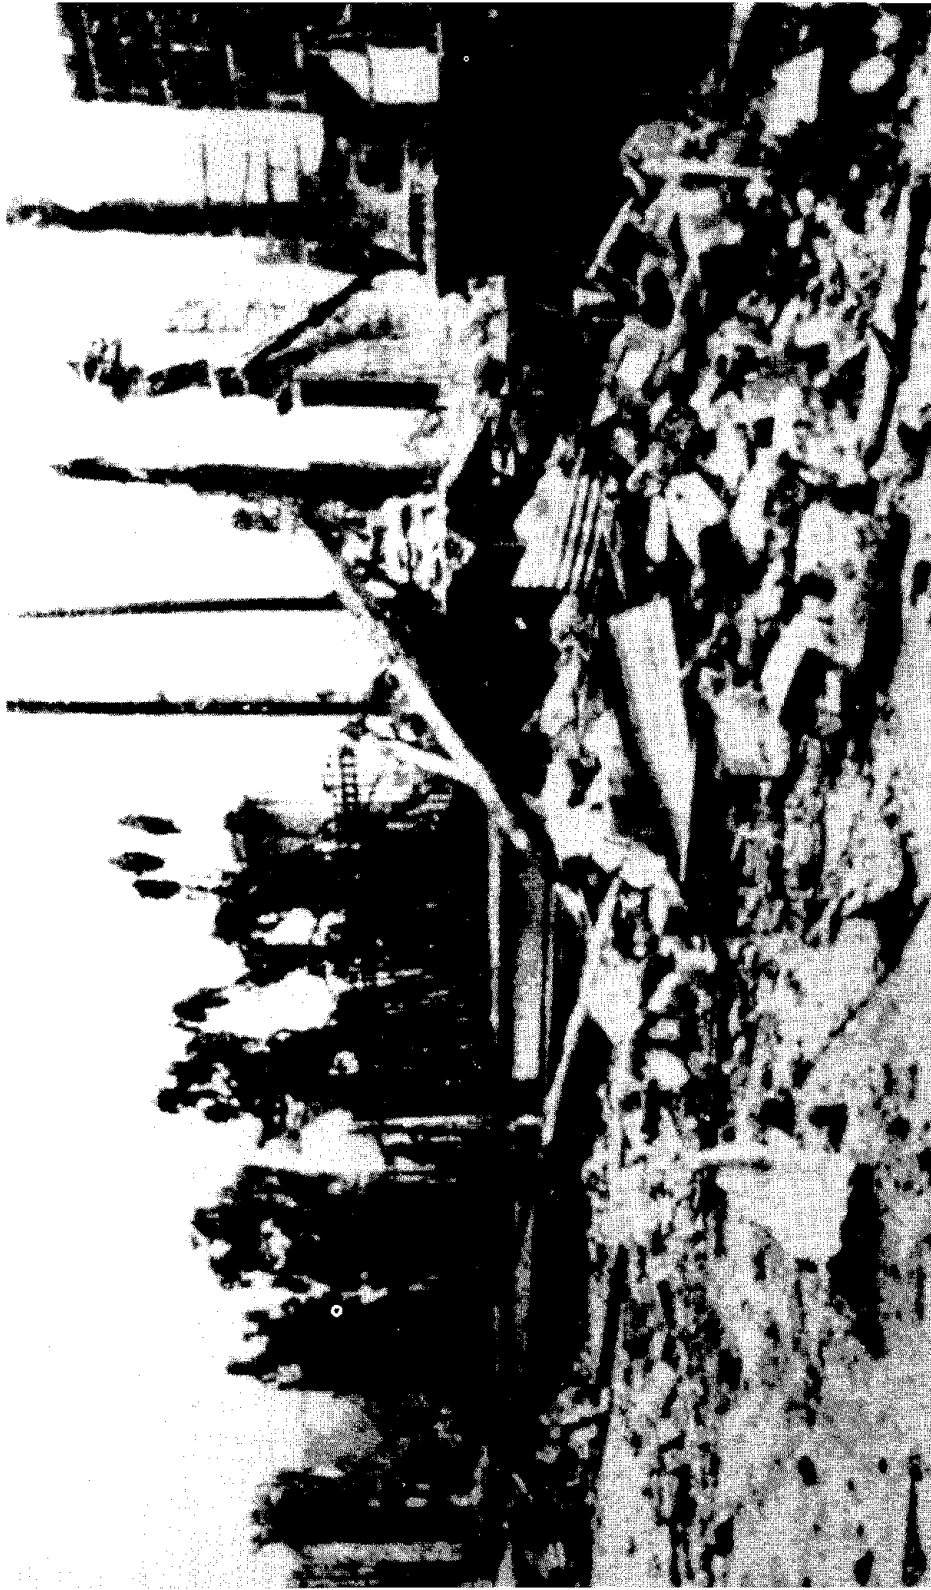
The recommendation by Freeman reproduced in Figure 41 (14) apparently went unheeded. The post-1931 U.S. Embassy building is the two-story (before the earthquake) structure with a heavy list, in the left middle portion of Figure 17a.

FIGURE II-41 United States Legation Building.

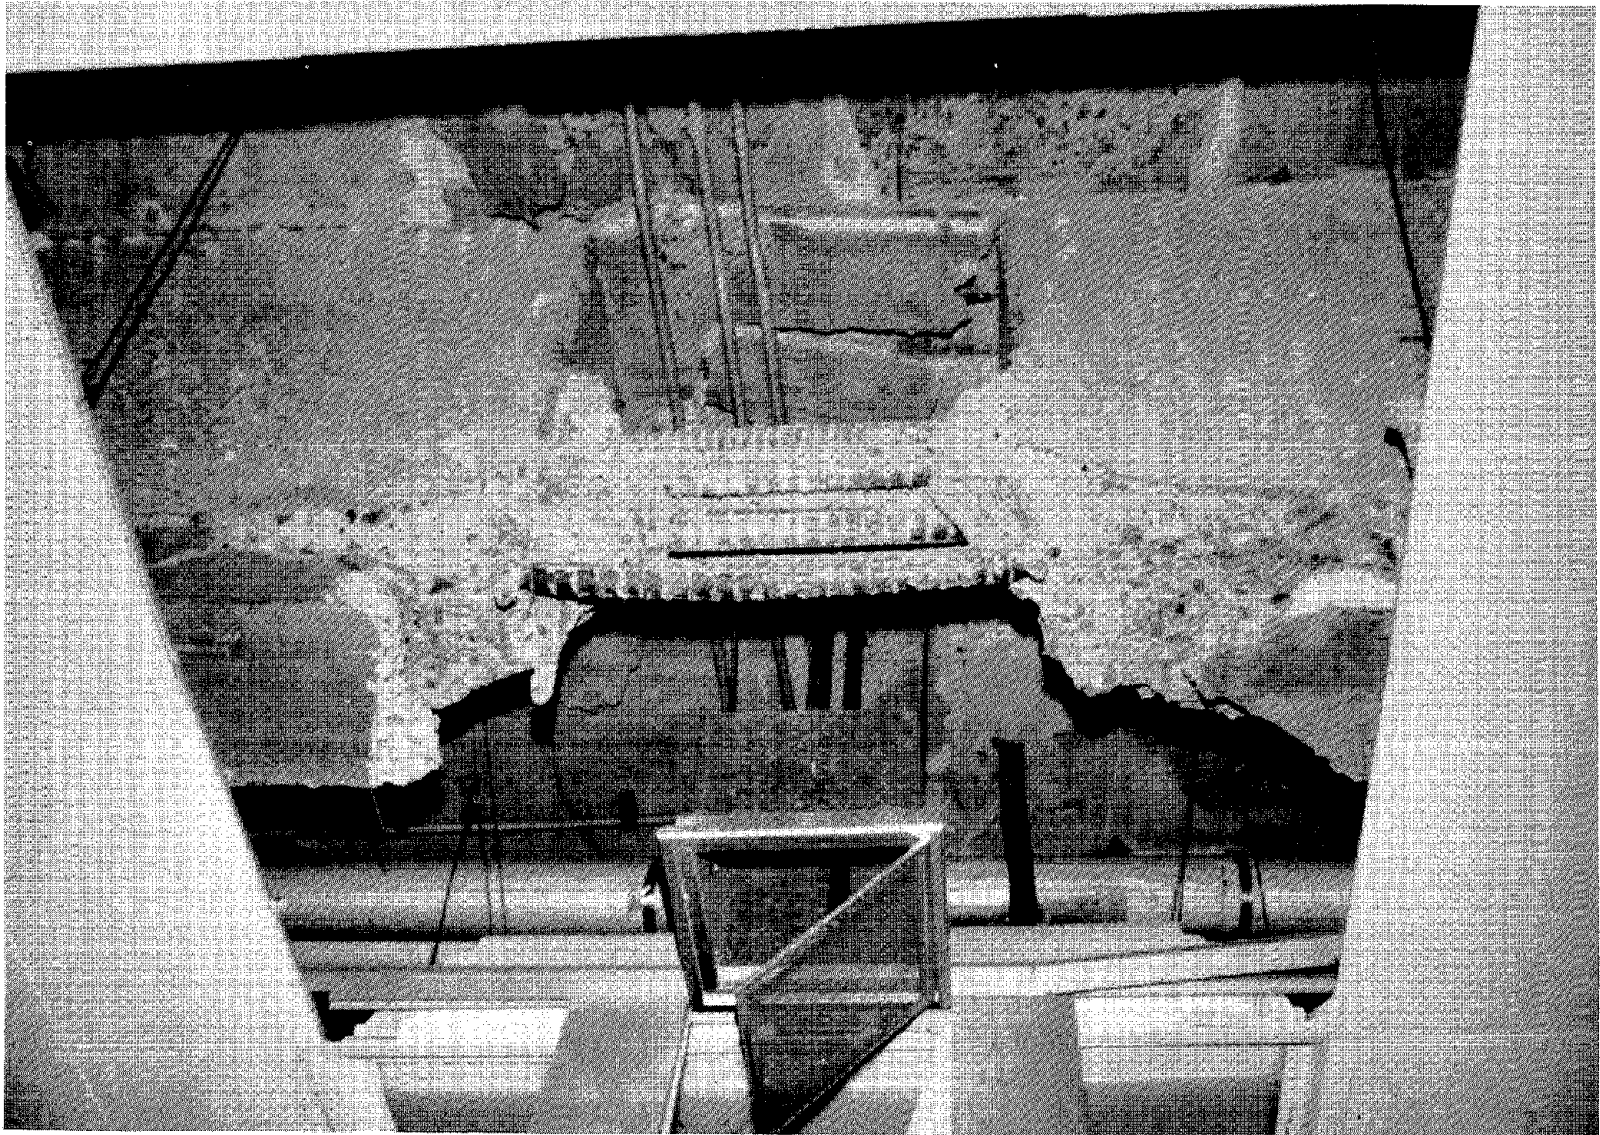
FIGURE II-46 Banco de America Building, Damaged Connecting Girder.

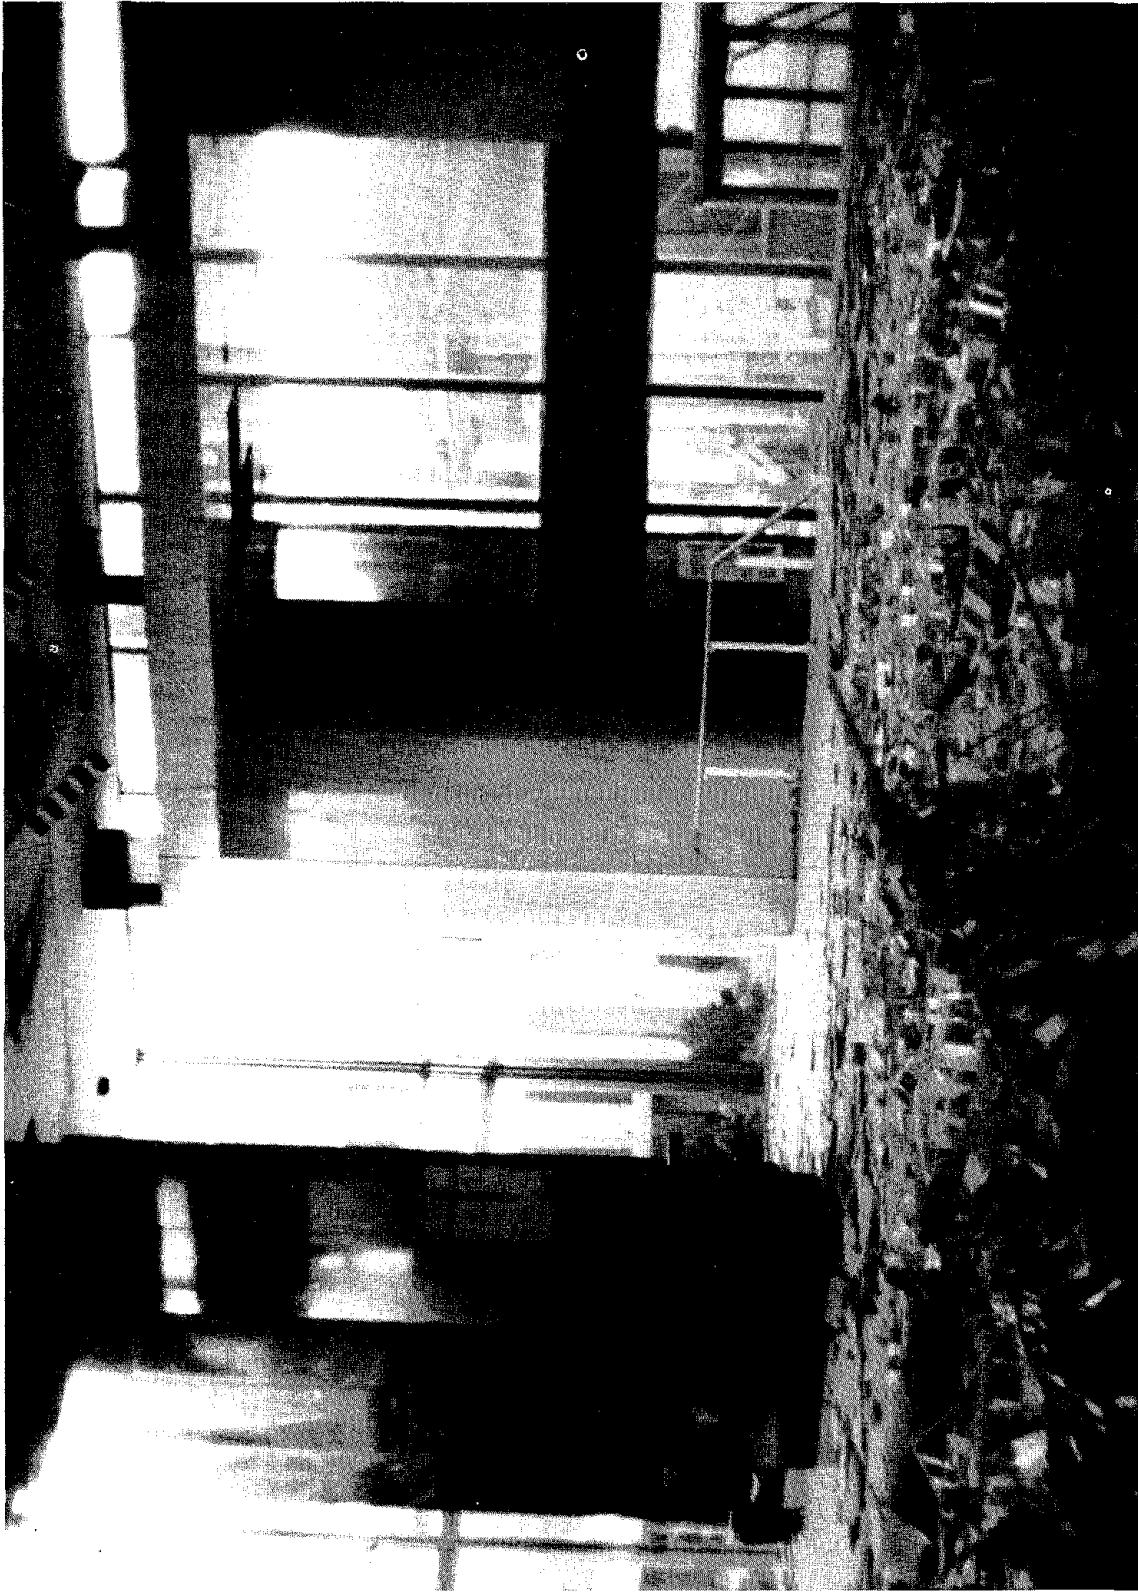
FIGURE II-47 Banco Central Lobby.

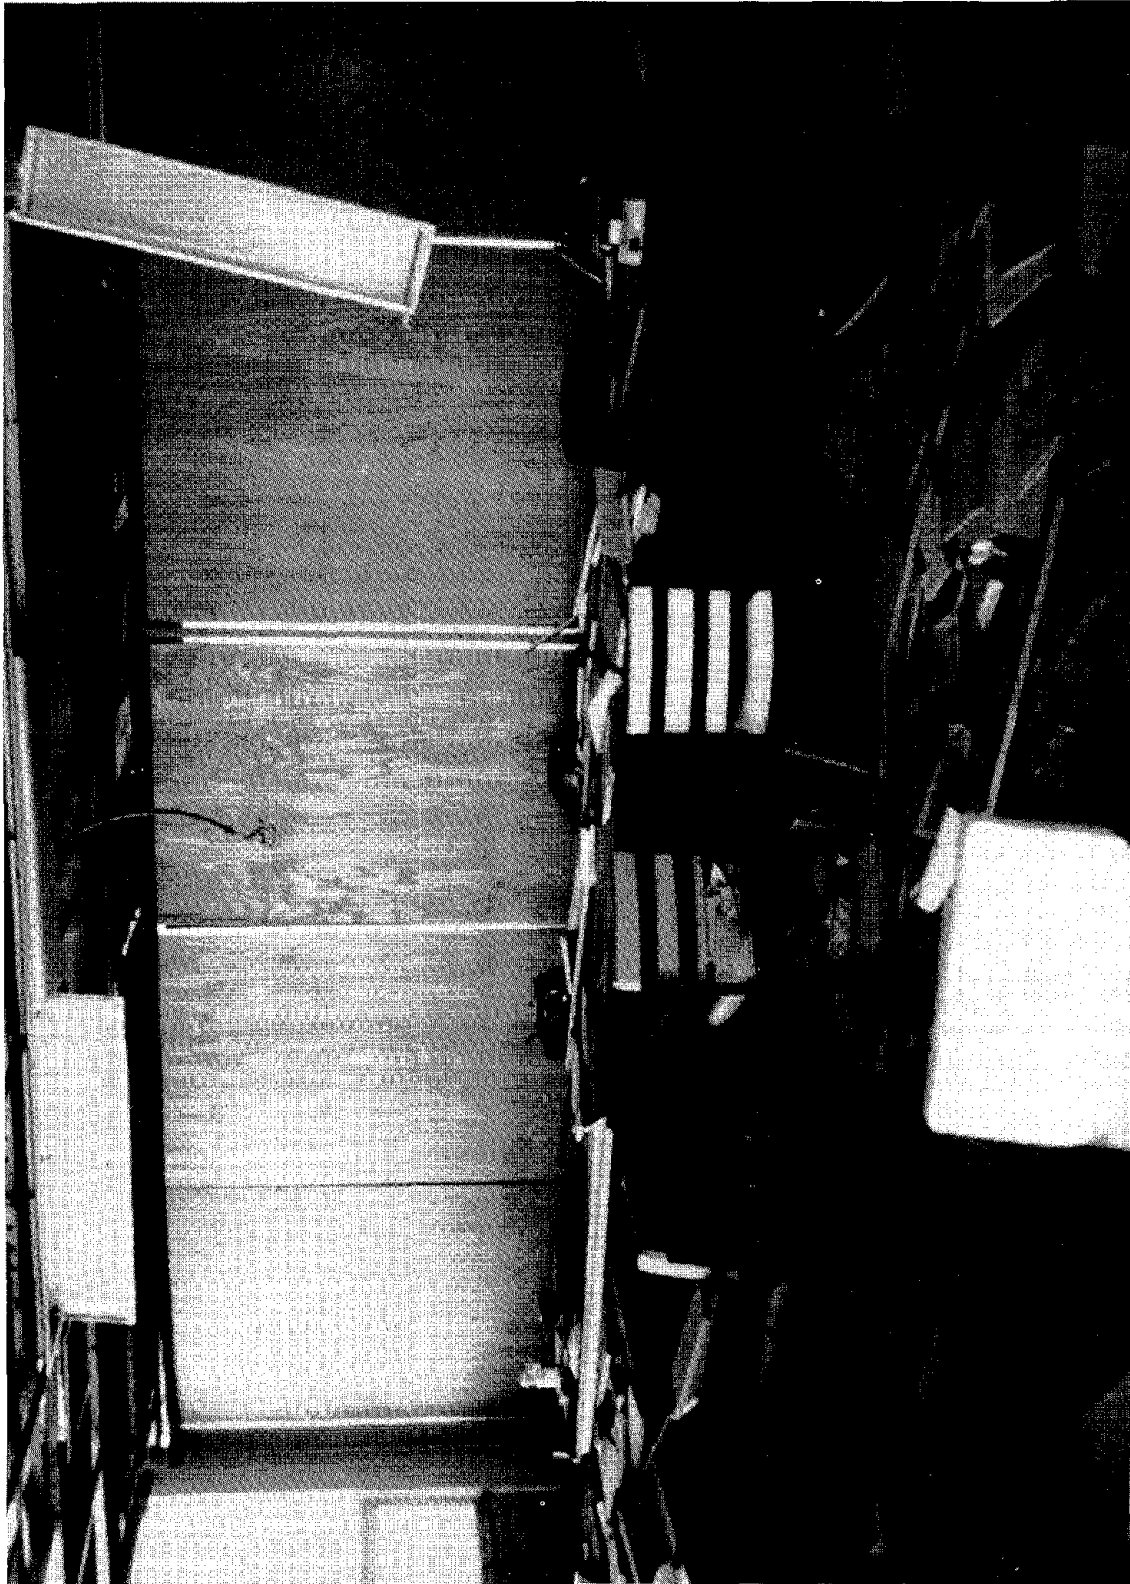
FIGURE II-48 Banco Central Office.

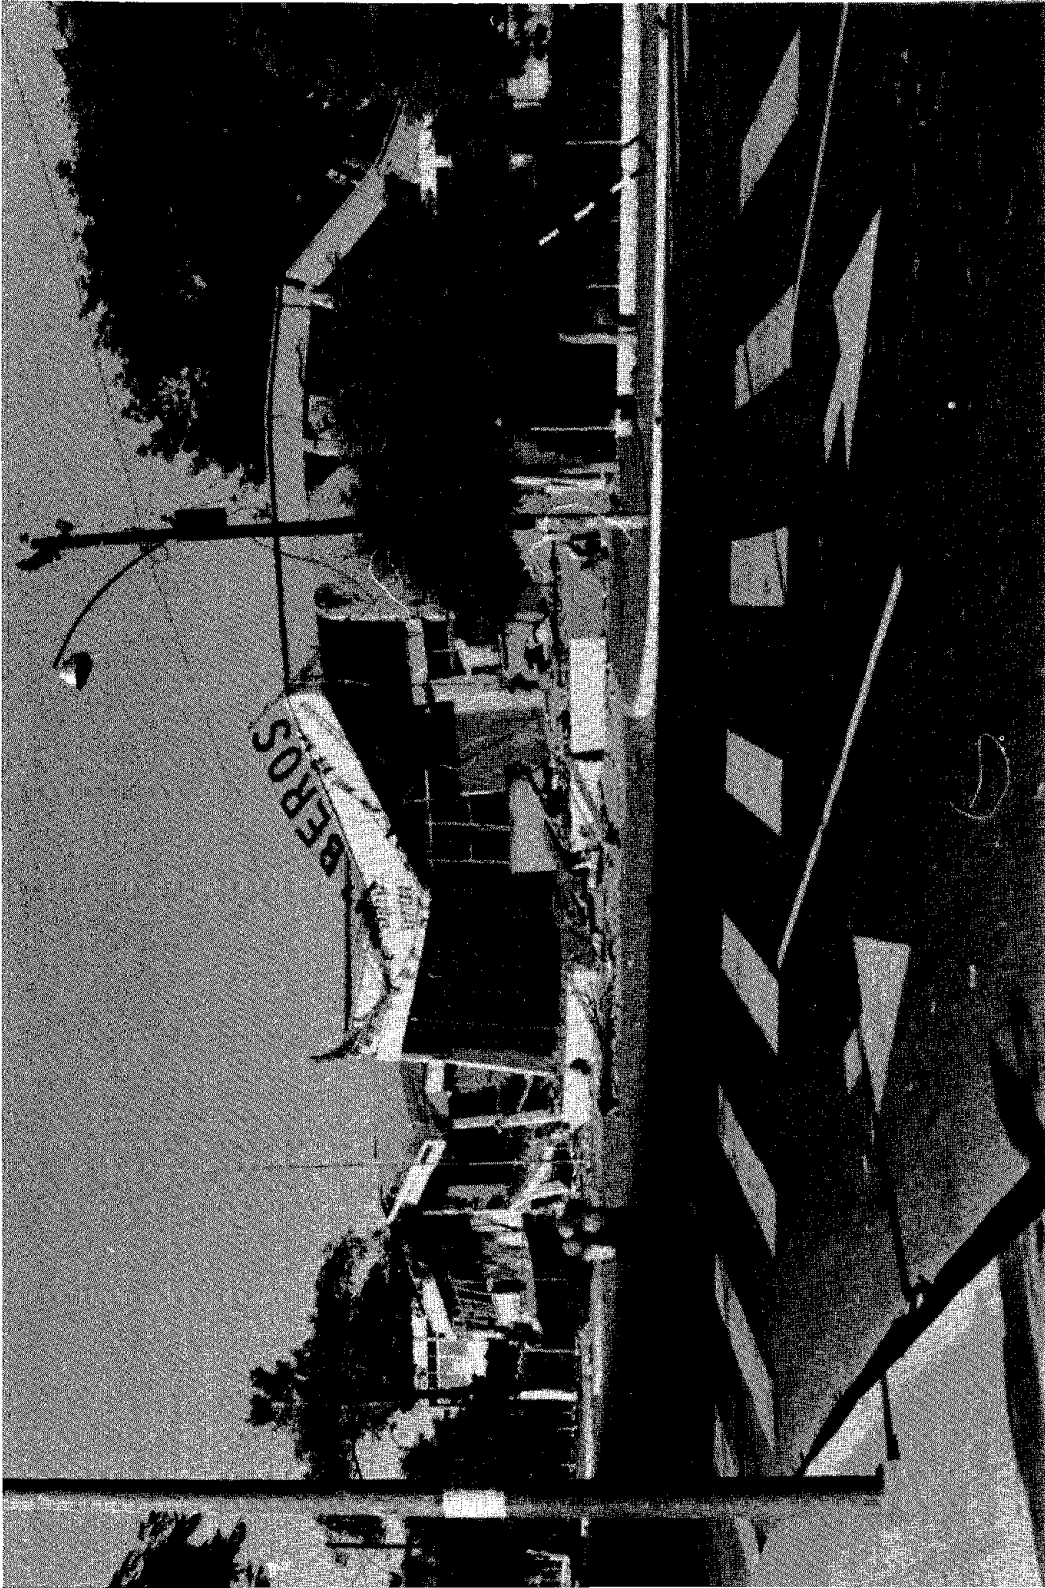
FIGURE II-49 Fire Station.

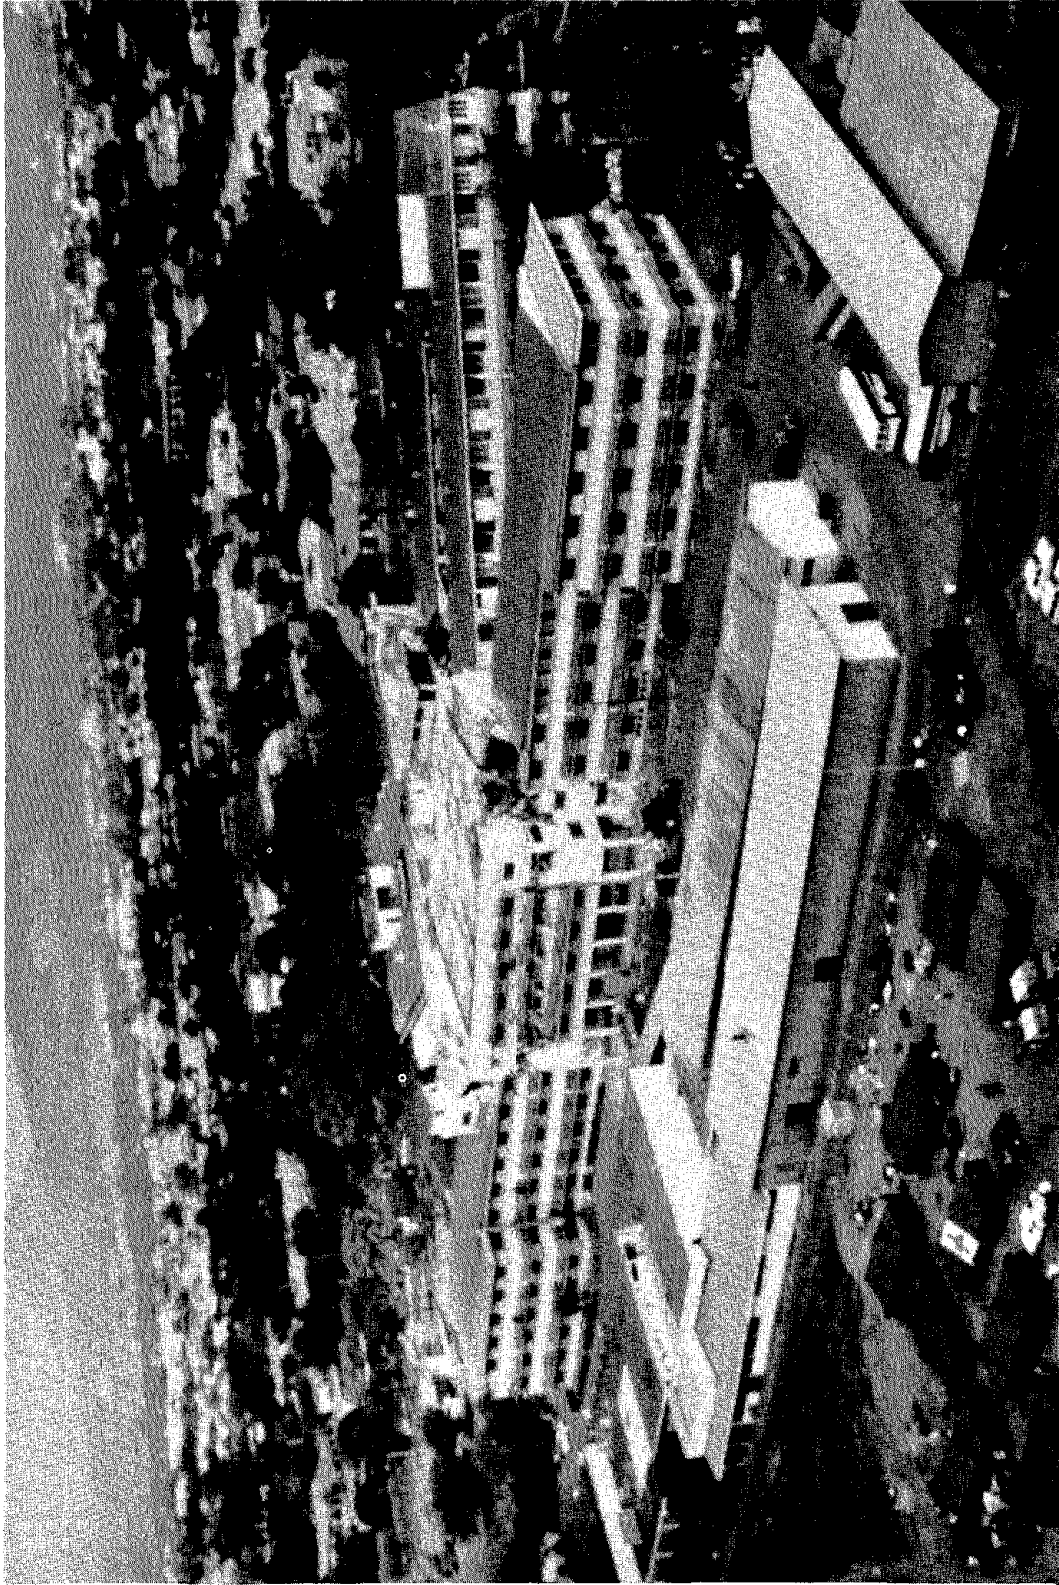
FIGURE II-50 General Hospital, Overall View.

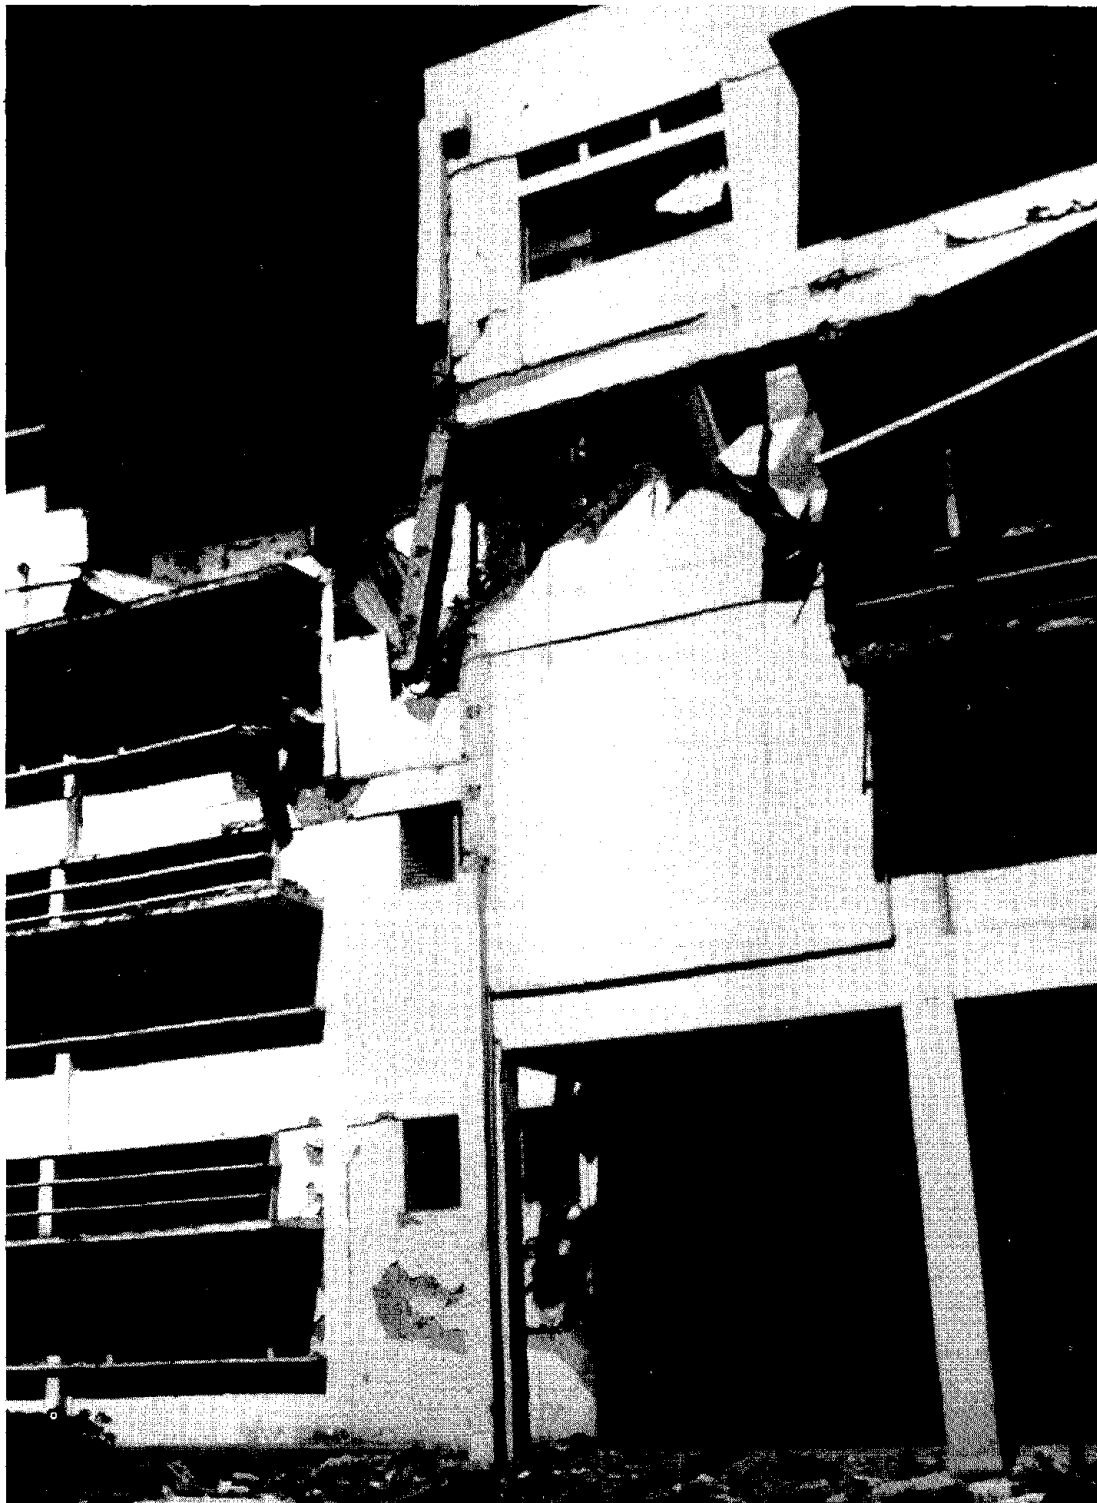
FIGURE II-51 General Hospital, Detail.

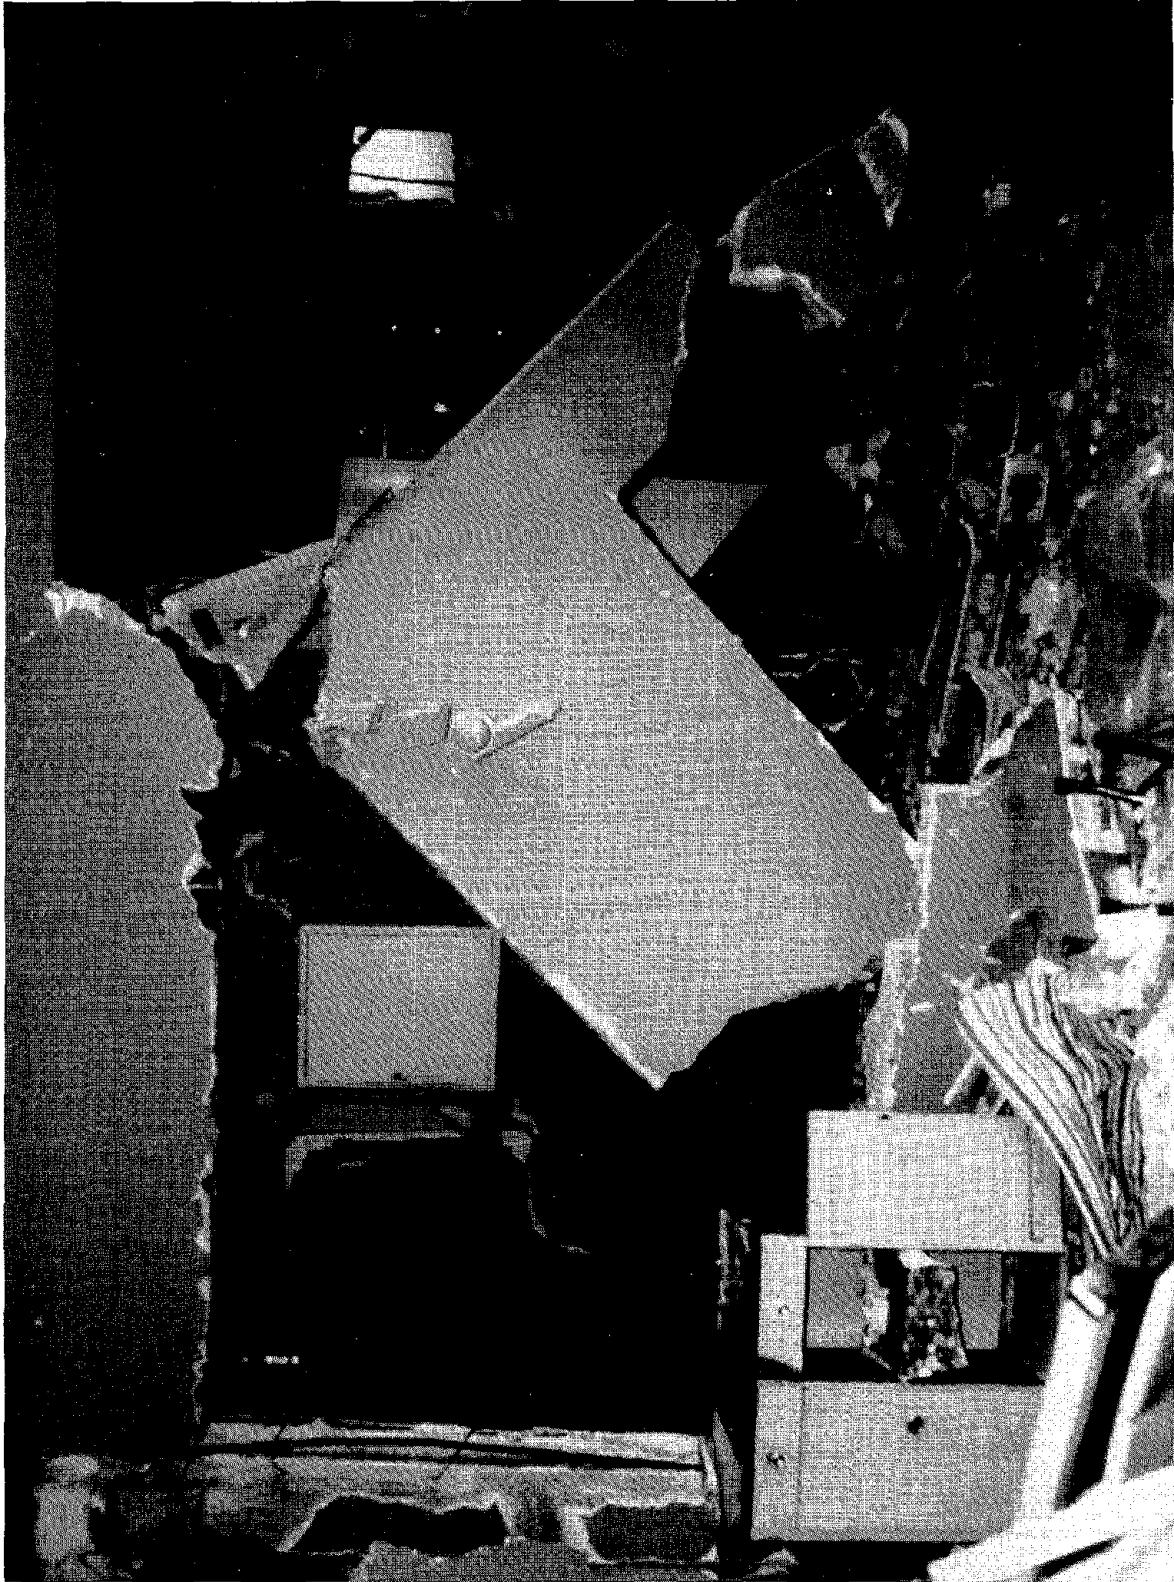
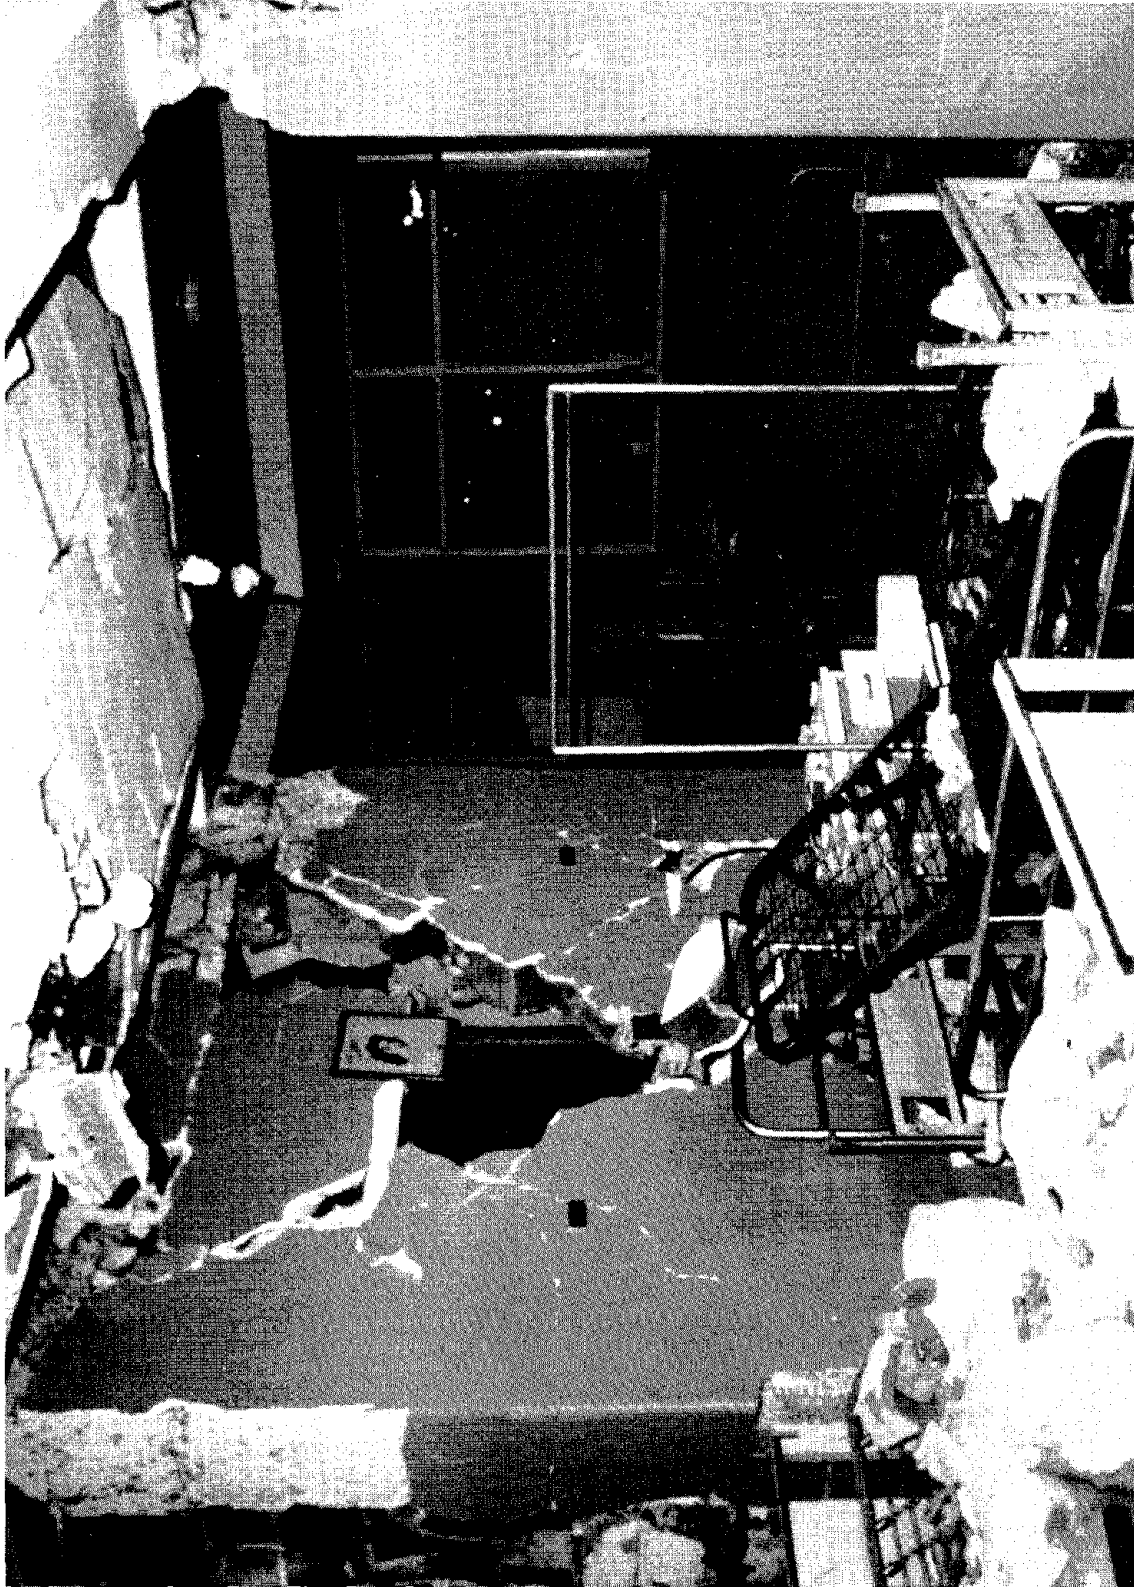
FIGURE II-52a Social Security Institute Hospital.

FIGURE II-52b Social Security Institute Hospital.

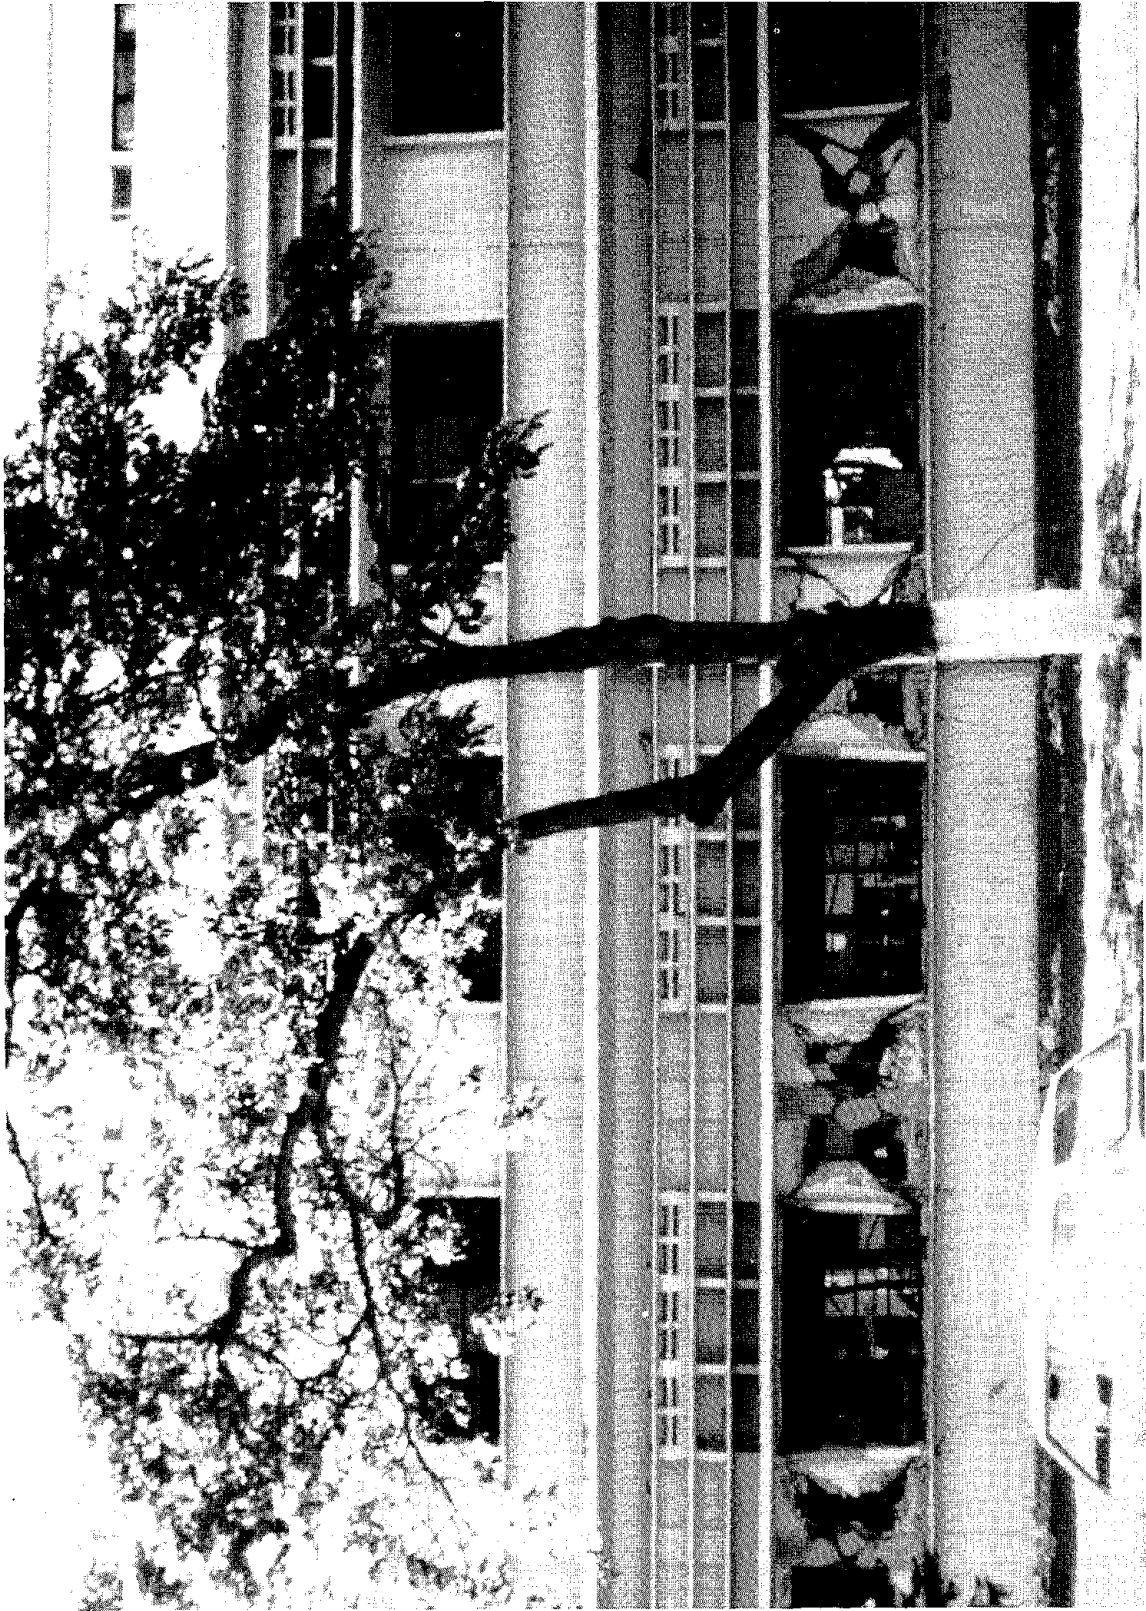
FIGURE II-54 General Hospital.

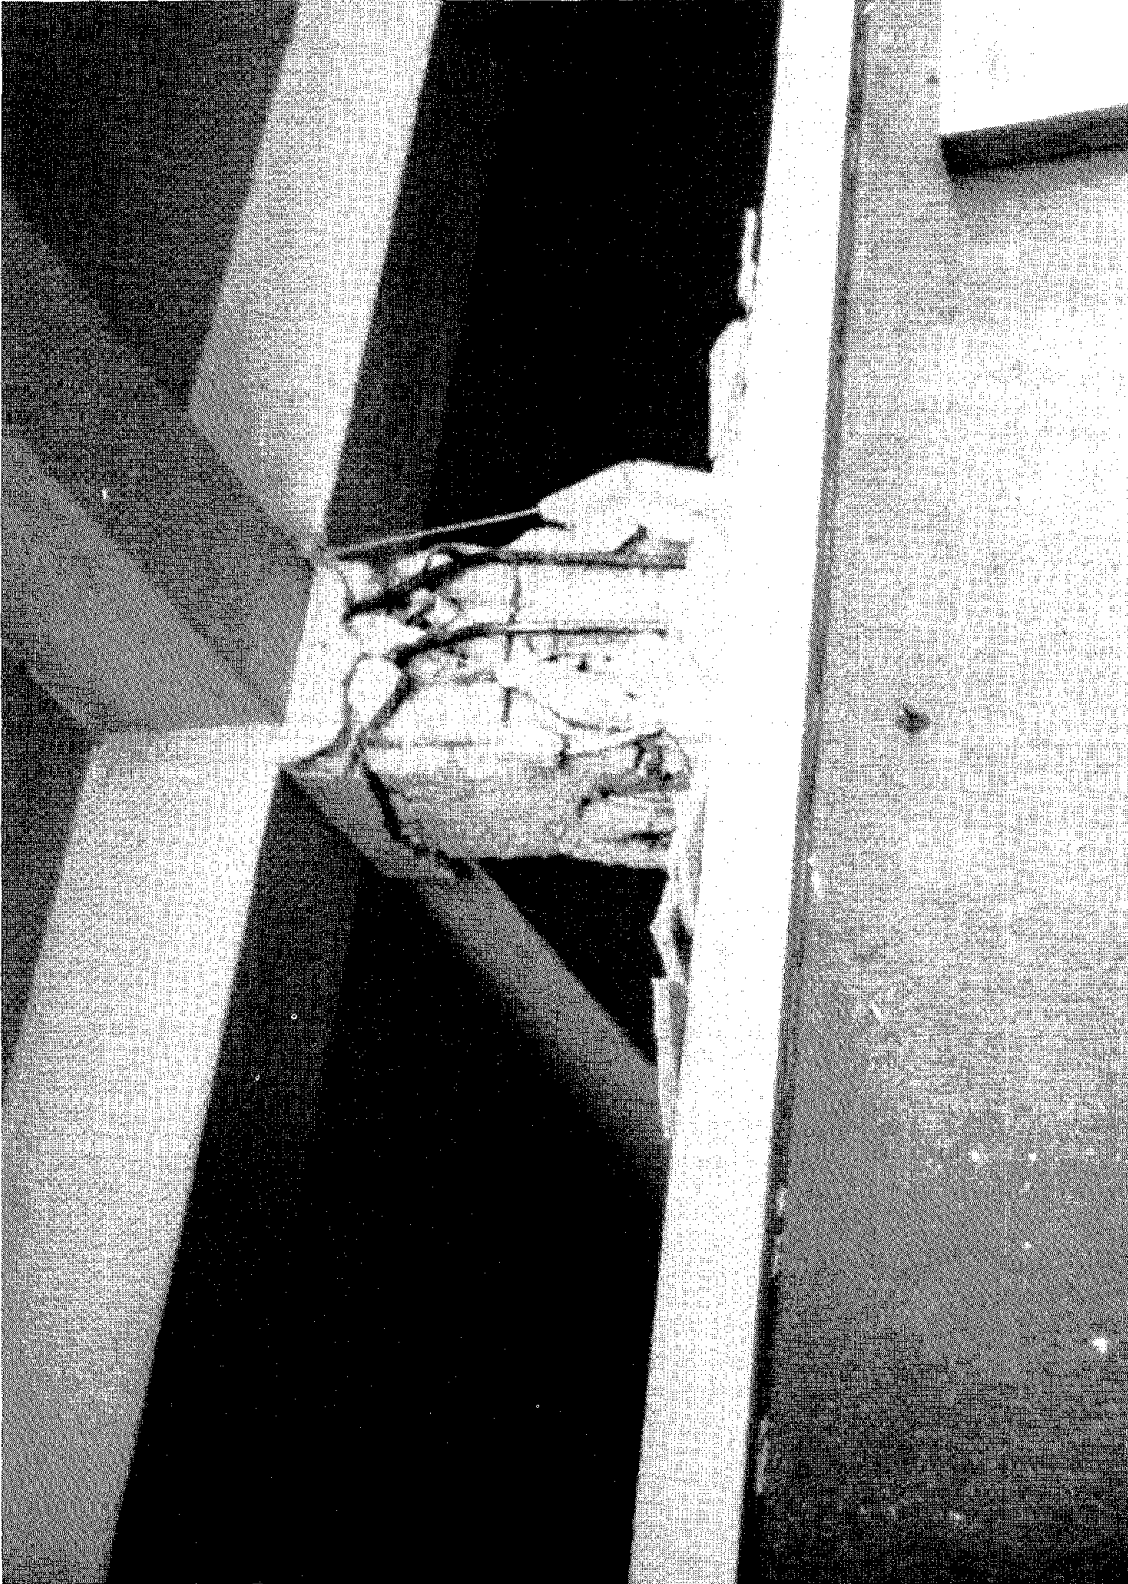
FIGURE II-55 "Short" Column.

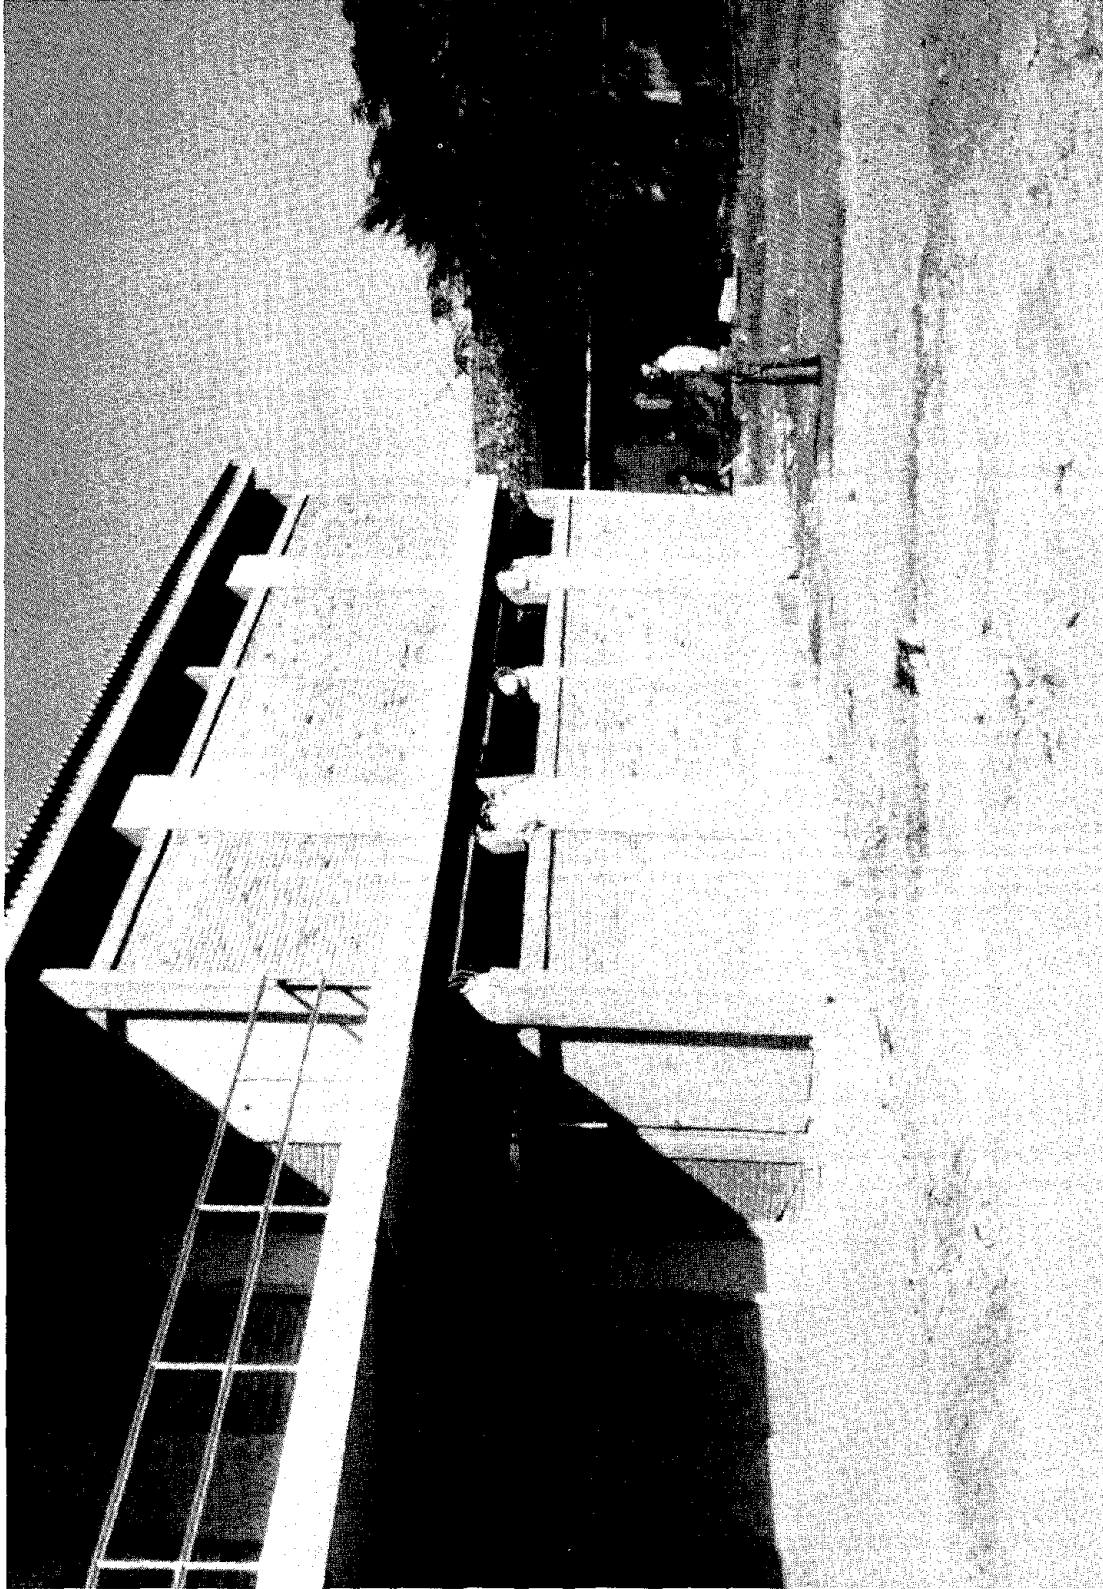
FIGURE II-56 "Short" Columns in School Building.
