SEISMIC PERFORMANCE OF UNDERGROUND WATER PIPELINES
IN THE SOUTHEAST SAN FERNANDO VALLEY
IN THE 1971 SAN FERNANDO EARTHQUAKE

Jeremy Isenberg

Grant Report No. 8

SEPTEMBER 1978

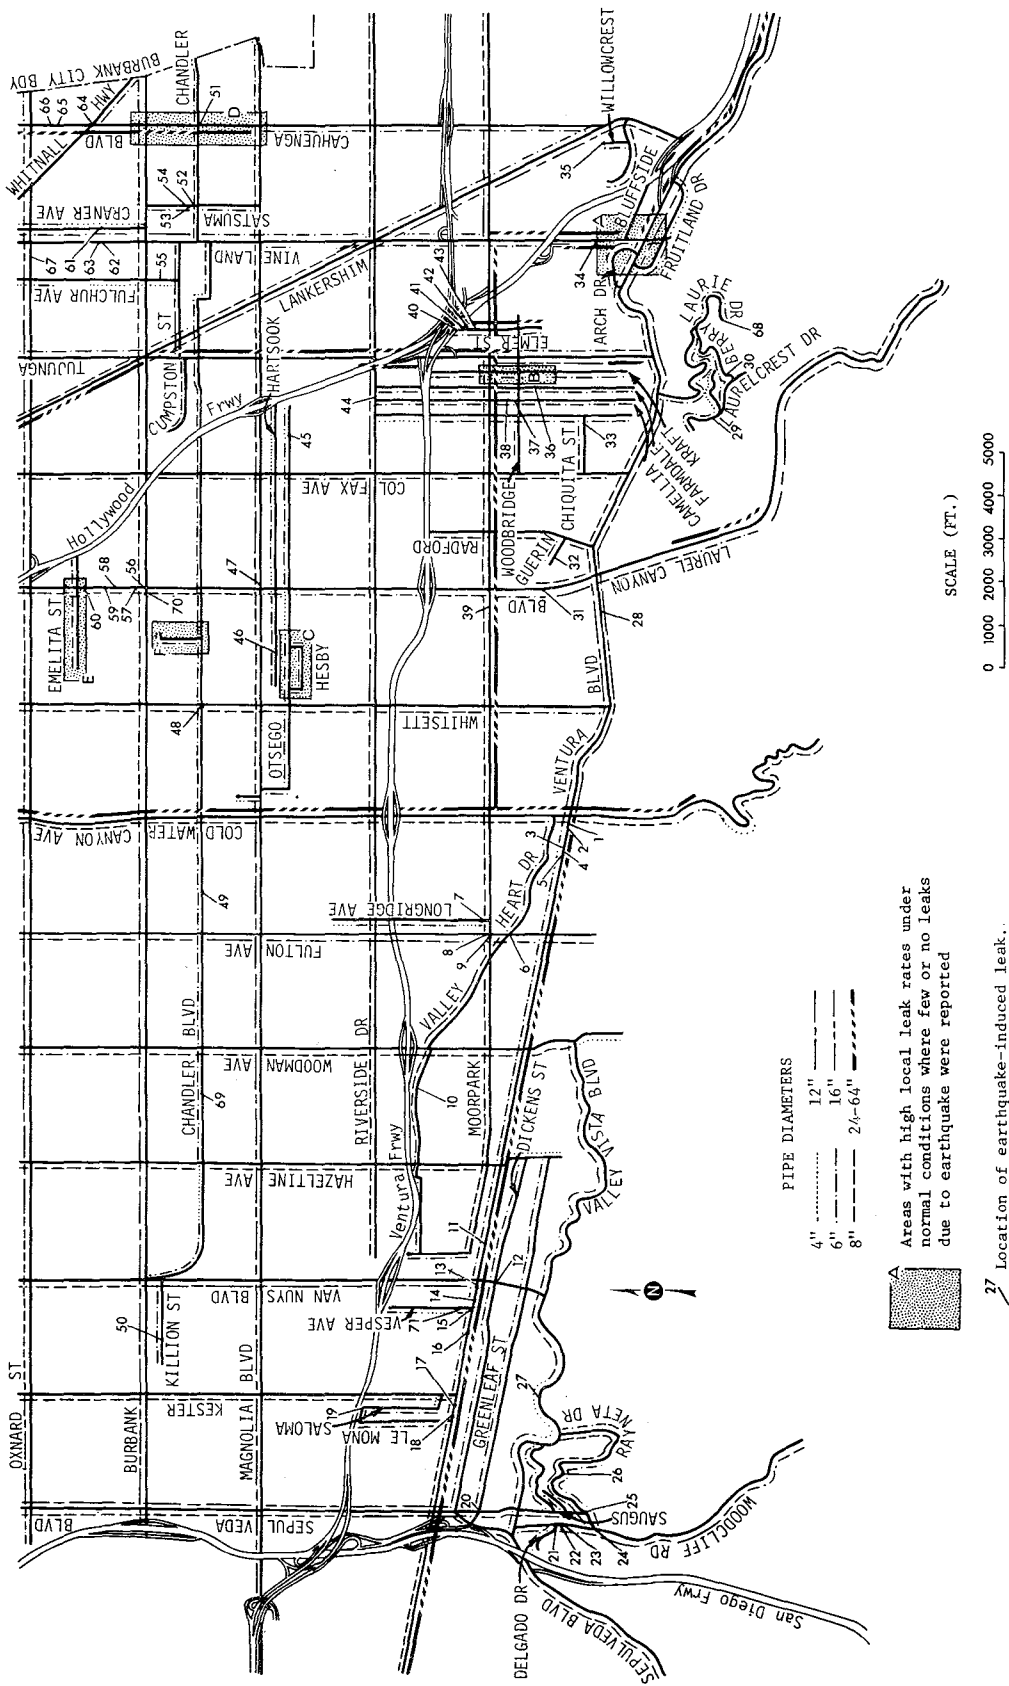
Figure 2-4. Selected pipelines within Los Angeles Department of Water and Power Map 8 South showing location of leaks after 1971 San Fernando Earthquake (see Figure 2-1).

Figure 2-4 shows 71 locations where leaks occurred in mains belonging to the LADWP due to the San Fernando earthquake. Repair reports are the principal source of information on the type of damage sustained. These reports, which were prepared by repair crews, indicate the location, size and type of pipe which was repaired, the type of damage (cracked joint or pipe, rust hole, etc.), the presence of internal or external corrosion and the type of soil. The type of repair is often informative regarding the cause of failure (for example, screw pins are commonly used to repair rust holes).

One place leaks are concentrated (1-5, 11, 13-18) is the 6-inch cement-caulked Mannesman steel line under Ventura Blvd. between Sepulveda Blvd. and Coldwater Canyon Blvd., most of which was installed about 1929. A second area of concentration (21-26) is on Woodcliff and Rayneta Drives where there is a similar type of pipe and joint. A third concentration (56-60) is on Laurel Canyon Blvd. between Burbank and Oxnard in a 6-inch Matheson steel line. Transmission lines which suffered a significant number of leaks (40-43) include the 51" welded steel line underlying Elmer Ave. between Moorpark Ave. and the Hollywood Freeway, and the 20-inch reinforced concrete line (51, 64-66) underlying Cahuenga Blvd. north of Chandler Blvd. These five regions contain 31 of the 71 leak locations covered by Map 8 South. The 6-inch Ventura Blvd. line alone contains 12 leaks. There is an apparent preference for leaks to occur in the southern part of the map; 45 of the 71 leak locations are south of the Ventura Freeway. This is an area where the depth to bedrock changes rapidly and, hence, where changes in ground motion that affect pipes might

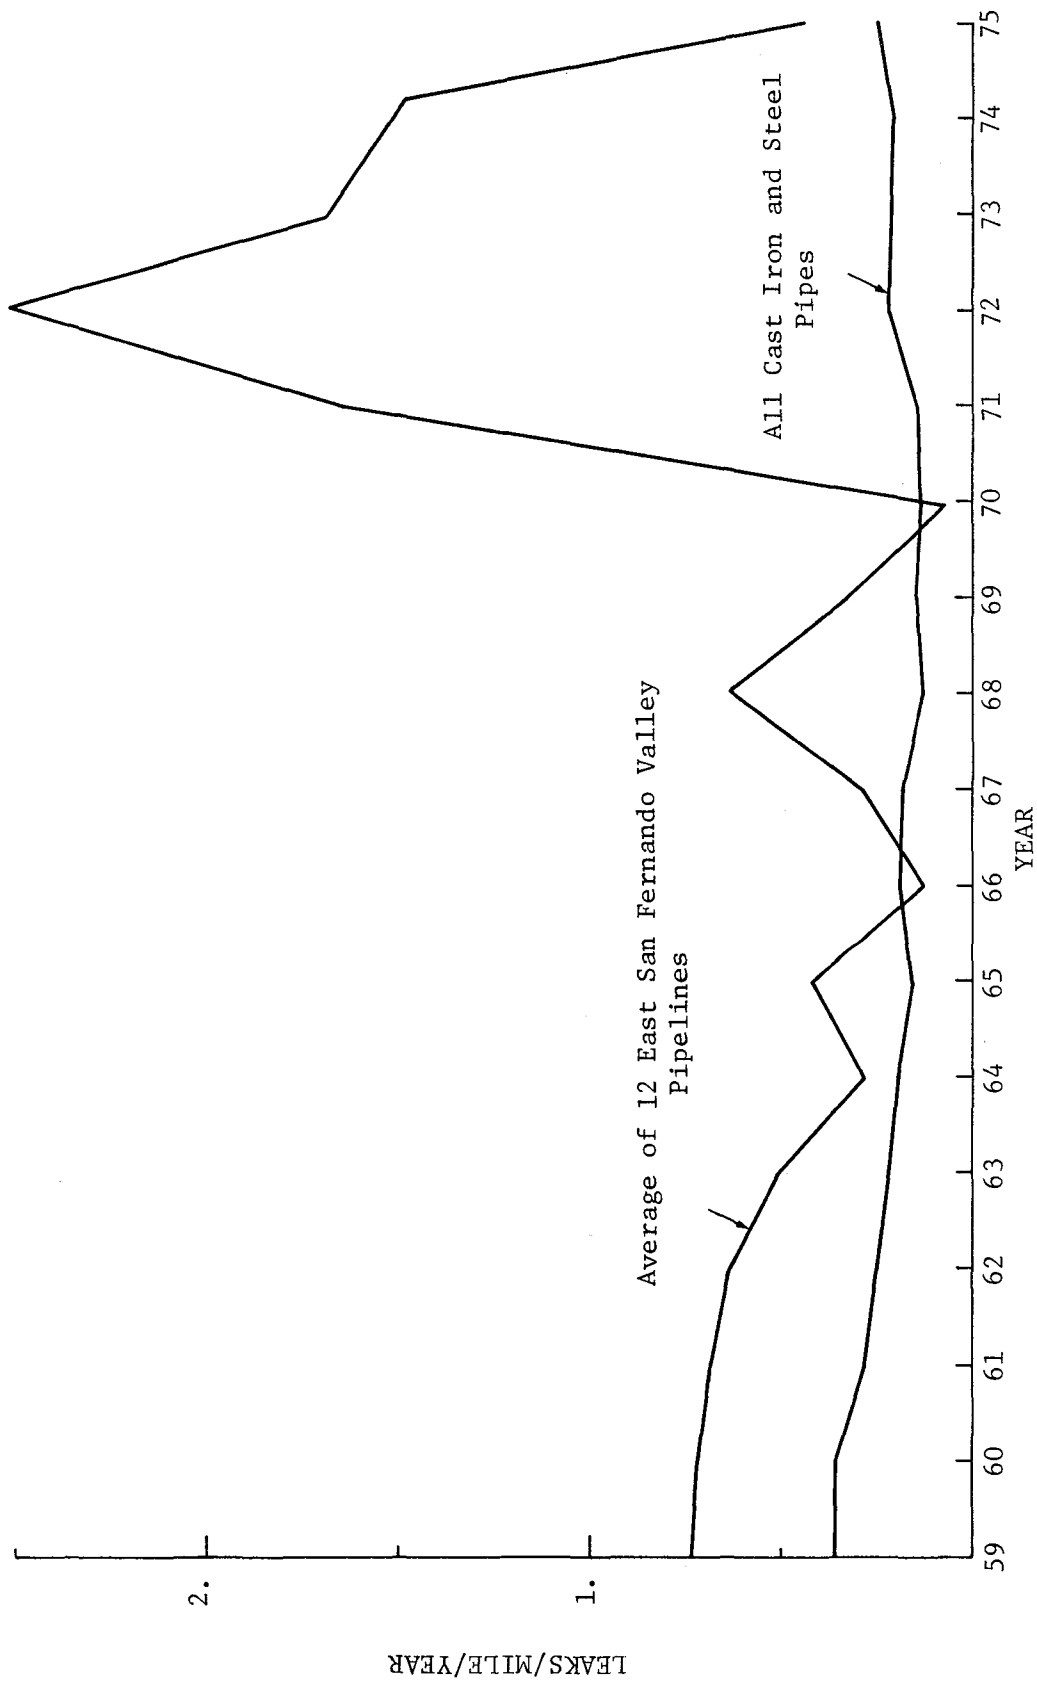
Figure 2-5. Average Annual Leak Rates for all Cast Iron and Steel Pipes in LADWP System and for 12 East San Fernando Valley Pipelines (total 51.4 miles) between 1959 and 1975.

The finding is that the leak frequency of both the 12 East Valley pipes and the entire LADWP system increased significantly over the previous leak rate during 1971 through 1974, whereas up to 1971 the rates had tended to decline. This suggests that the 1971 earthquake may have had a delayed effect on the pipe system, which only became apparent in subsequent years. This could happen if shaking accelerated the weakening of pipes and joints. A contributing factor was a change in the procedure for reporting leaks in cast iron mains in fiscal year 1974-75.

Under normal conditions, leakage is accelerated by corrosion. Low resistivity of the adobe soil is a major contributing factor; for example, the soil underlying Ventura Blvd. between Sepulveda Blvd. and Coldwater Canyon Ave. is on average about $1000 \Omega/\text{cm}^3$, which is borderline between severe and extremely severe conditions for corrosion of steel pipe. It is therefore to be expected that an unprotected steel pipe would experience corrosion-related damage, as does the 6-inch Ventura Blvd. main before, during and after the earthquake. An indirect measure of the importance of corrosion is the generally declining leak rate for all ferrous pipe between 1959 and 1970, during which time there was an active corrosion control program. This program is continuing and presumably will again be effective in reducing leak rates.

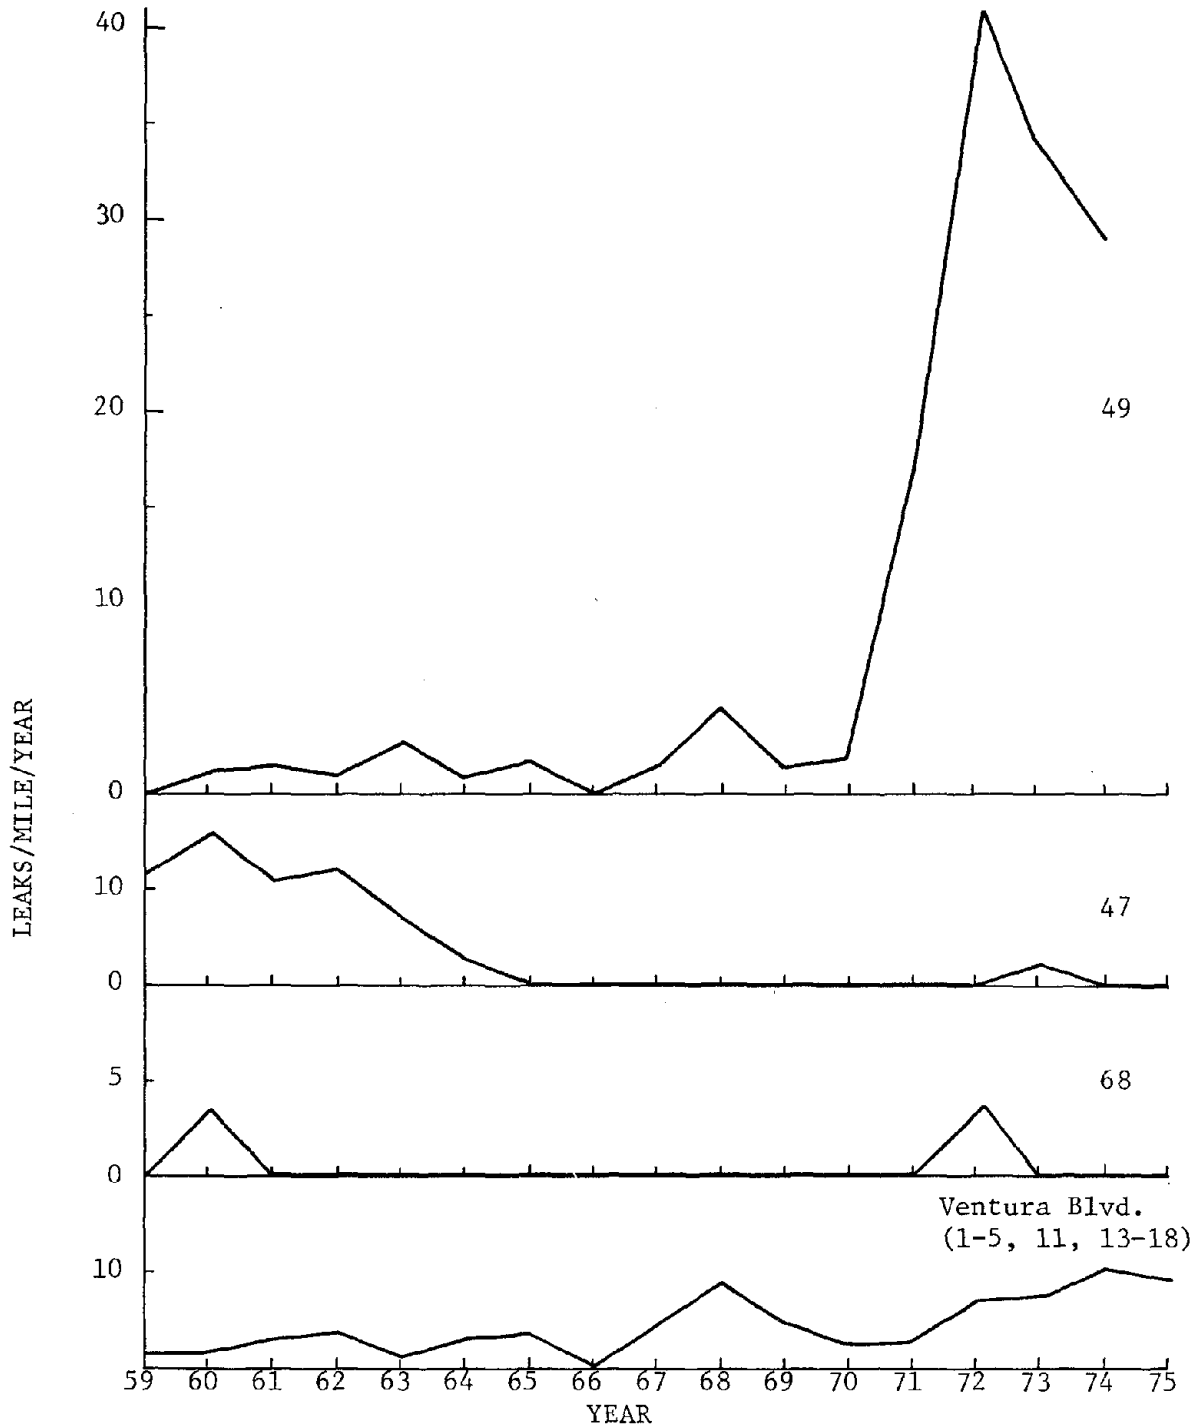
Figure 3-1. Average Annual Leak Rates in Four Southeast San Fernando Valley Pipelines Which Experienced Earthquake Damage From 1959 to 1975. Numbers refer to locations on Figure 2-4.

To illustrate this, locations 47, 49 and 68 (see Figure 2-4) are presented in Figure 3-1. The leak rate in the 6-inch Matheson steel pipe for 3/4 mile on either side of the break at location 49 exceeds the average rates prior to the earthquake. Accordingly, we might expect earthquake damage to occur here, and it did because the pipe was weakened by corrosion. Furthermore, the apparent leak rate increased dramatically in the years following the earthquake. This observation is similar to the one which was made for the 6-inch Mannesman steel pipeline underlying Ventura Blvd. In contrast, leakage was profuse at location 47 in the early 1960's; however, no leaks occurred between 1965 and 1972, except for the earthquake-related leak. The prior leak history at location 47 does not foreshadow the corrosion-related earthquake damage which occurred. The picture at location 68 is similar to that at location 47; the prior history of leakage gives no hint of the seismic vulnerability of this segment of pipe due to corrosion. These mixed results are found throughout the Map 8 South region, and they indicate that local leak rate alone cannot be relied upon to predict the location of corrosion-related leaks in earthquakes.

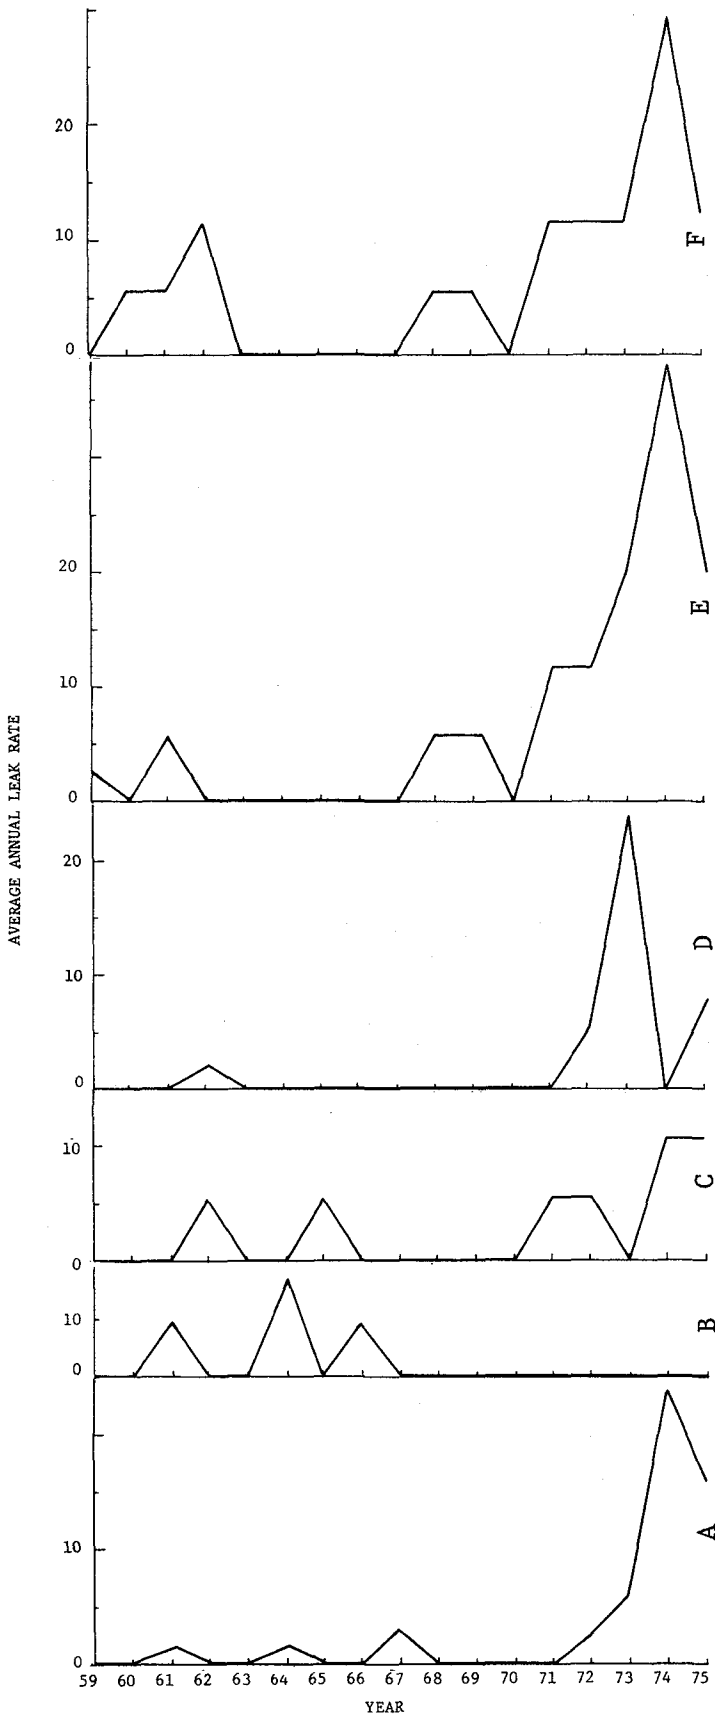
Another aspect of prediction is whether high local leak rates indicated that certain sections of pipe might be vulnerable to an earthquake but where little earthquake damage or none actually occurred. Figure 3-2 shows the historical leak rates at several locations (see Figure 2-4) where high leakage developed sporadically before the earthquake, but where few leaks or none developed immediately afterward. This finding also illustrates that local leak rate under normal conditions is an inaccurate or incomplete guide to specific locations of earthquake-induced leakage. As is the case in other reaches of pipe, however, the apparent leak rate in these areas significantly increased after the earthquake.

Figure 3-2. Average Annual Leak Rates in Six Areas of Southeast San Fernando Valley. These pipelines exhibited relatively high leak rates prior to the earthquake but suffered little or no damage immediately following the earthquake. Letters refer to locations on Figure 2-4.
