UCLA-ENG-7482
EWE 74-05
NOVEMBER 1974

FAILURE ANALYSIS OF A REINFORCED
CONCRETE FRAME STRUCTURE

TOMAS GUENDELMAN
GARY C. HART
RAUL HUSID

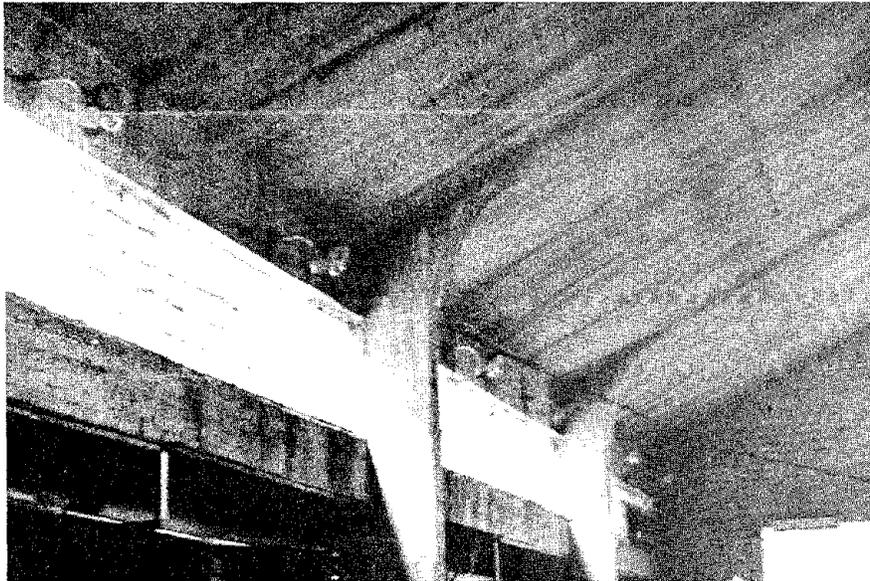
Figure 3. Photographs of Building: Pre-Earthquake

suffered complete structural collapse. Figure 2 shows plan and elevation views of these buildings and Figure 3 shows photographs of the building which remained standing after the earthquake.

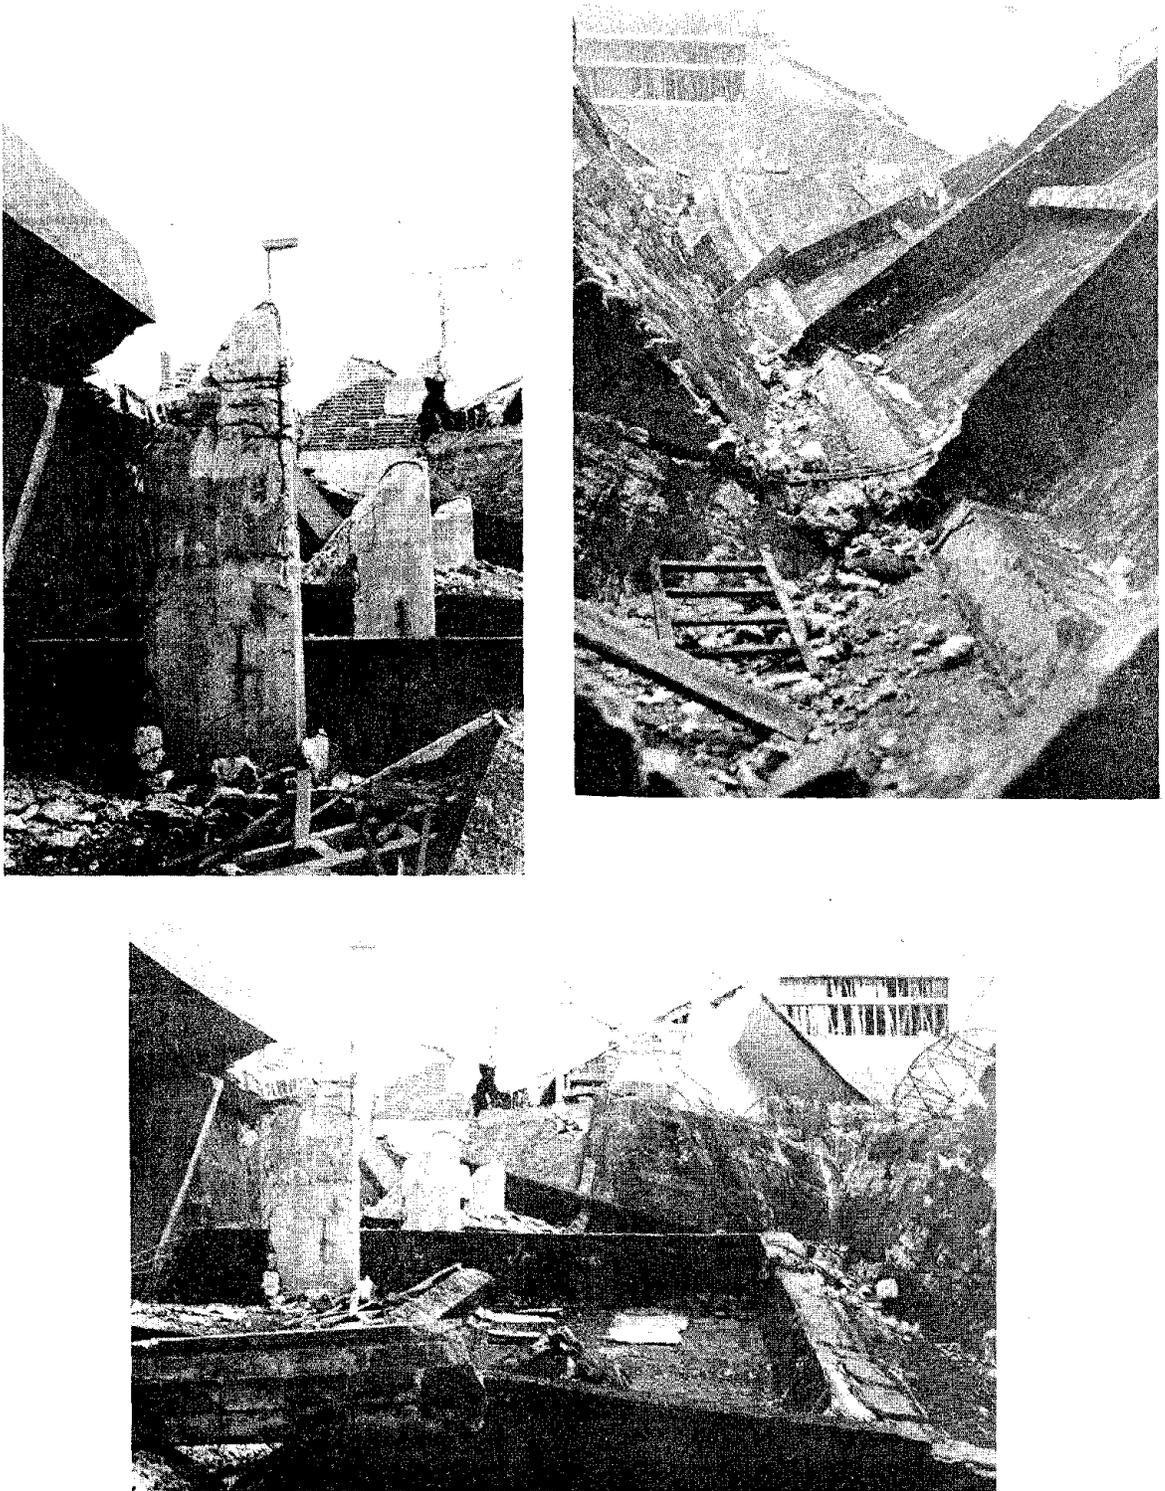
Figure 4. Photographs of Building: Post-Earthquake

The 8 July earthquake caused one of the above noted buildings to completely collapse. Figures 4 and 5 show the post-earthquake condition of the building.

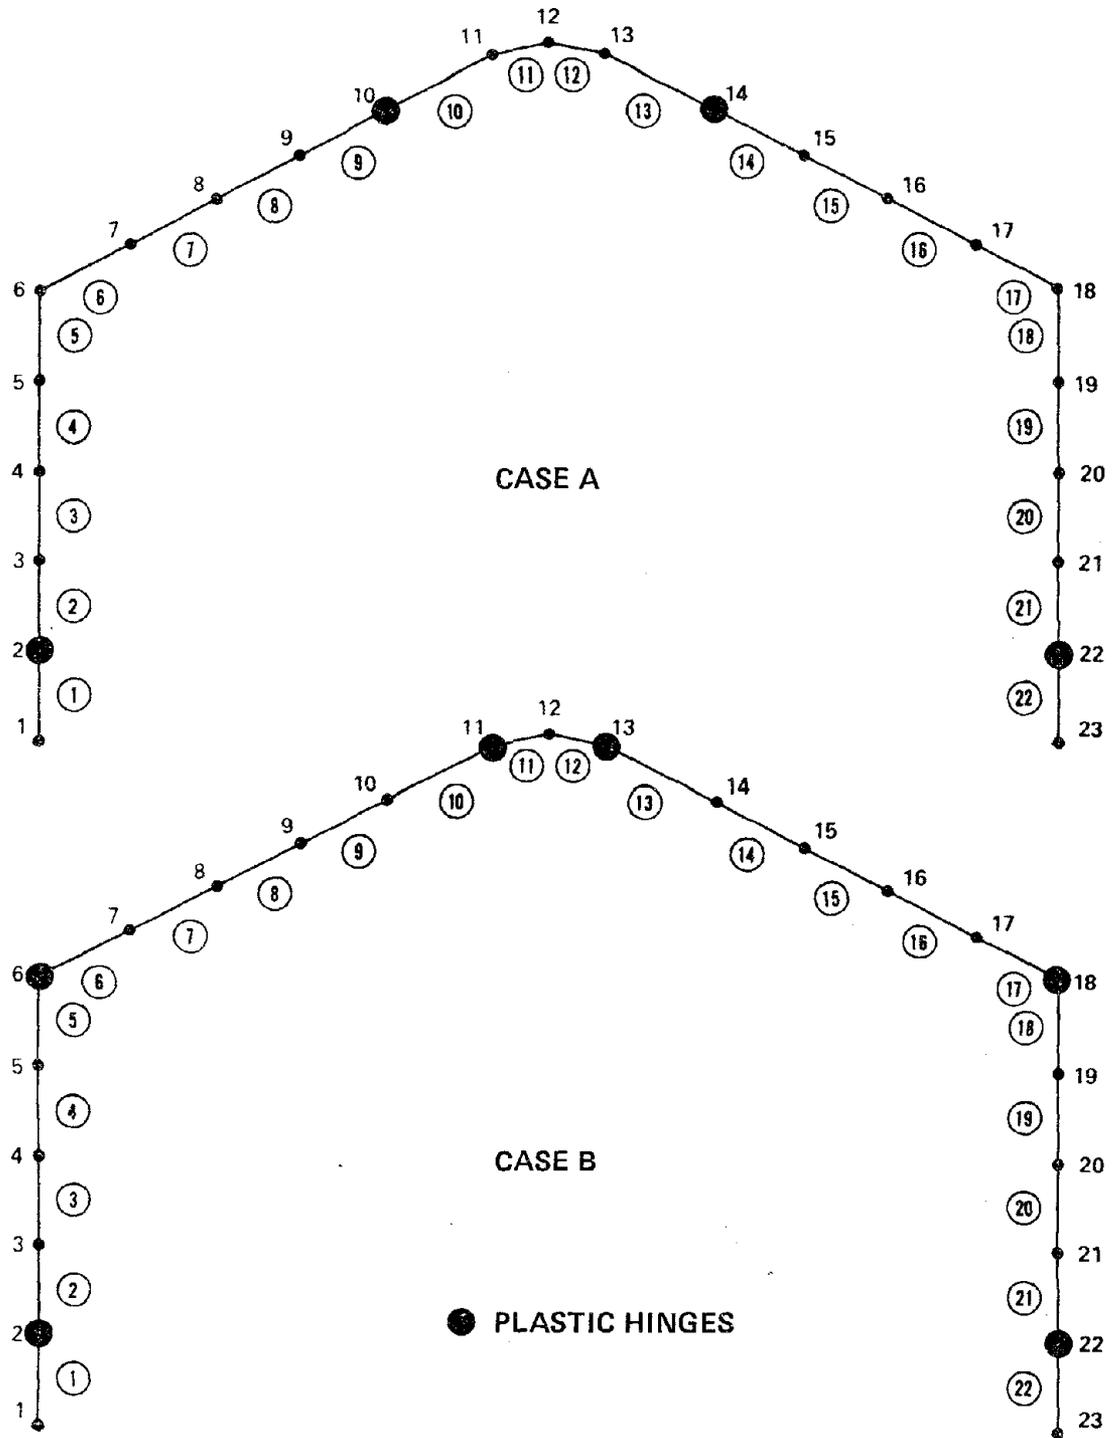
Figure 10. Failure Mechanisms.

Subjected to Case A type loading, the structure formed plastic hinges simultaneously at nodes 10 and 14 when $\alpha = 0.24$. The structure became a mechanism and hence collapsed at the slightly greater loading condition $\alpha = 0.25$. The mechanism of collapse was formed by the development of hinges at nodes 2, 10, 14, and 22. It is important that in this case where lateral

The plastic response of the structure under vertical loading was studied in Case B. Here it was found that hinges were first formed at nodes 11 and 13 when $\alpha = 0.15$. Note that this seismic coefficient is significantly less than that of Case A. However, in Case B it was found that not until $\alpha = 0.52$ did a structural mechanism exist by virtue of hinges forming at nodes 2, 6, 11, 13, 18, and 22. A sketch of this failure mechanism under both of these loading cases is shown in Figure 10.

It appears that the structural failure was a combination of vertical seismic forces which caused the formation of the first structural hinge and horizontal seismic forces which actually caused structural collapse.

This study recommends that seismic codes consider an extension of their static load concepts to include a seismic analysis of the type performed here in. Such an analysis includes both vertical and lateral seismic forces and their influence upon structural behavior.
