**THE VERACRUZ EARTHQUAKE OF
28 AUGUST 1973**

by
H. Max Irvine

EERL 73-06

Pasadena, California
October, 1973

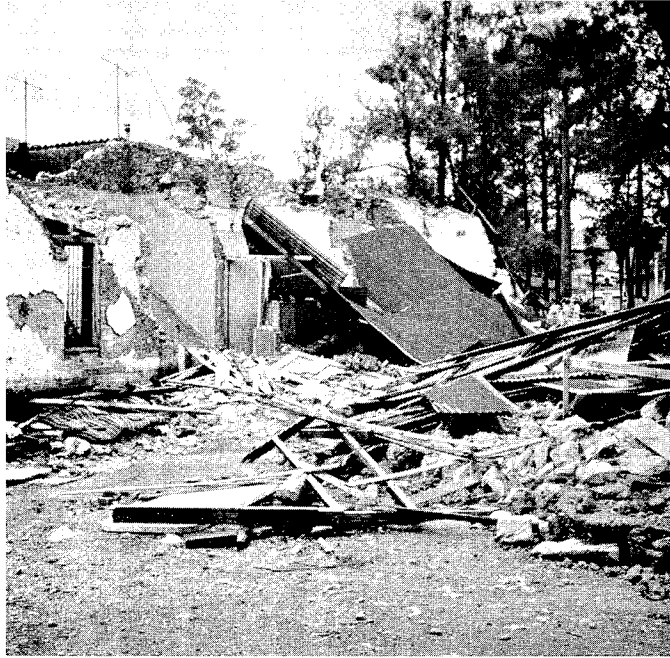
Figure 3

walls were of stone masonry or brick masonry with rather weak mortar. The roofs were either corrugated iron or tile. Figures 3 and 4 (p. 17) show typical damage to housing.

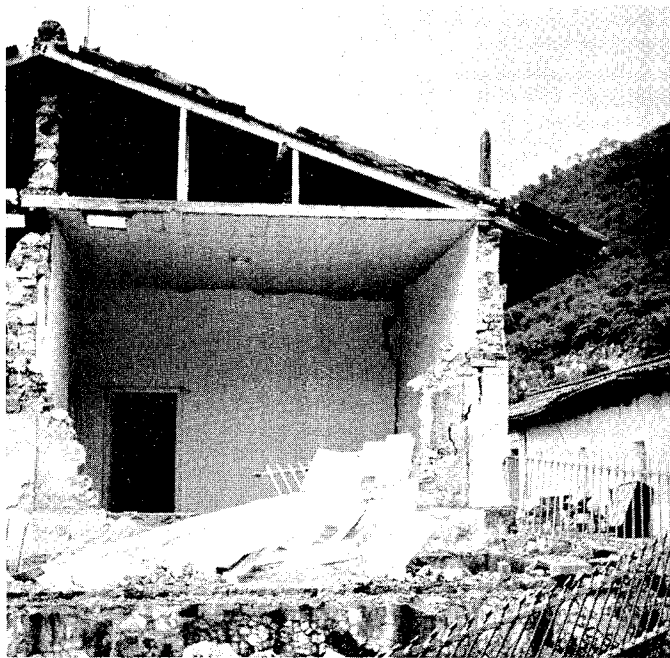
Figure 4 Typical damage to housing in Rio Blanco.

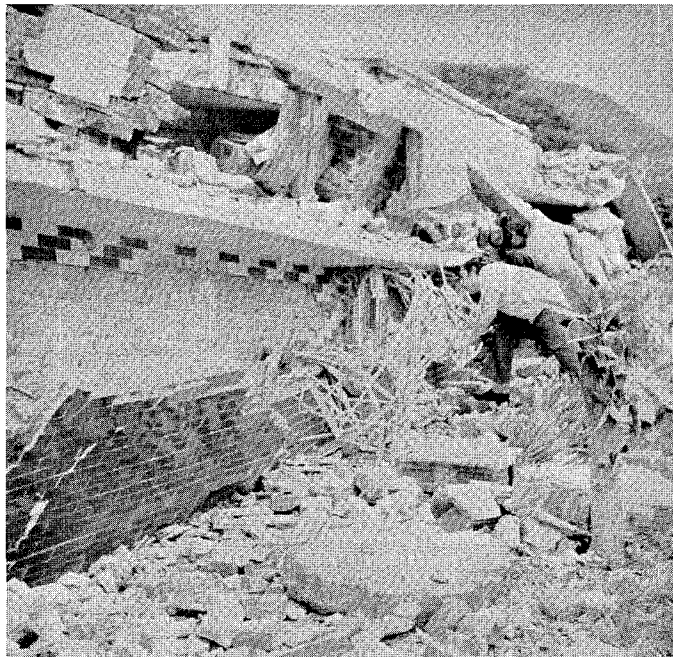
One house deserves particular mention. It was situated alongside the highway about halfway between Rio Blanco and Orizaba. The house was 13 years old and was of two stories, split-level, with a garage basement. It collapsed completely, fortunately after the residents had been able to escape. The building provided the first example of what later proved to be a rather common mode of failure, namely, the failure of the torsionally unbalanced building. Along one side (see Figure 5, p.18) long columns supported the building, while on the other side, short columns were used (see Figure 6, p. 18). Consequently, the center of stiffness was located away from the center of mass.

Figure 6 Collapse of two-story house
between Rio Blanco and Orizaba.

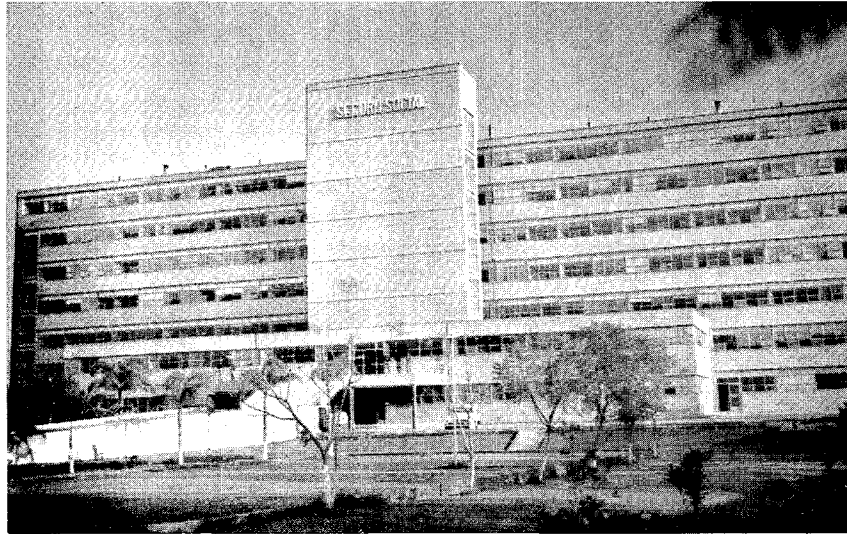
The boiler house is located adjacent to, but isolated from, the right-hand end of the main building (see Figure 8, p. 19). The building has a

single-story, single-bay reinforced concrete frame supporting a reinforced concrete floor slab. During the earthquake, plastic hinges formed in three of the four joints. Had the shaking been more intense, it is clear that this building would probably have collapsed and the danger of serious explosions would have been extreme, since the boilers are fed from exposed propane tanks nearby.

Figure 8 Social Security Hospital, Orizaba.

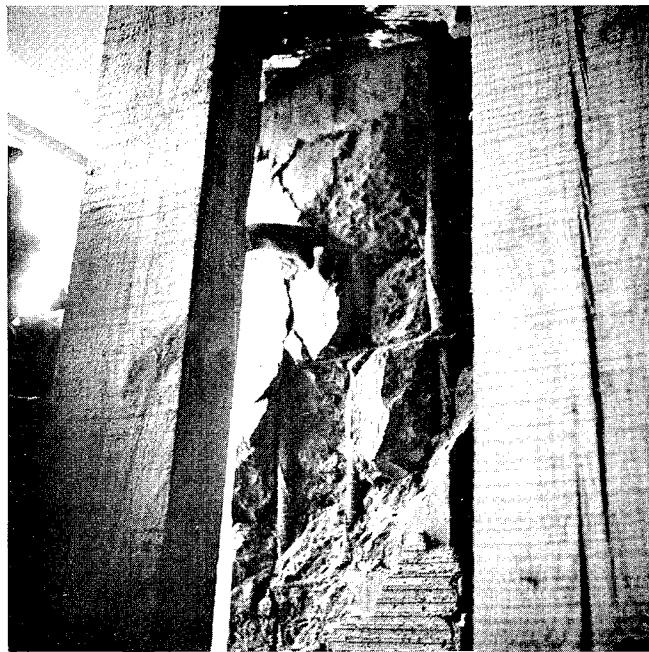
Figure 9 Spalled column, Social Security Hospital. Notice spacing of stirrups.

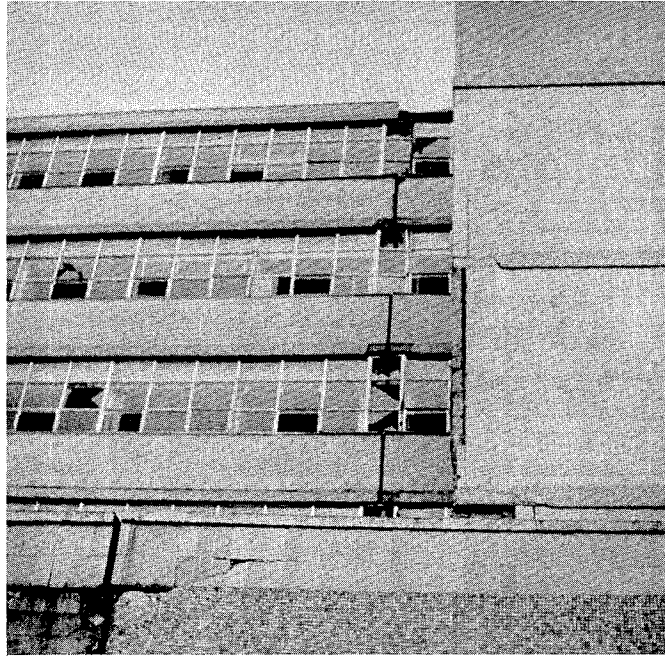
Figure 10 Working of a construction joint,
Social Security Hospital.

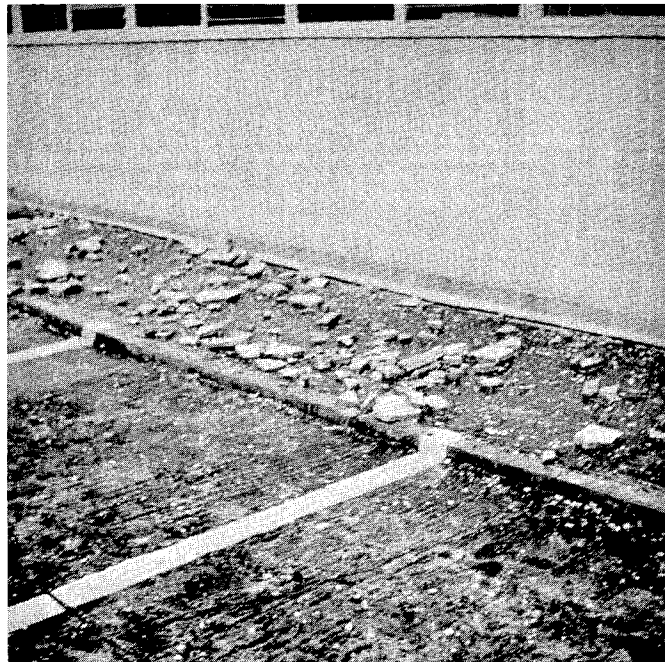
Settlements of 10-15 cm. had occurred in the filled ground in the parking lot in front of the hospital (see Figure 11, p. 20).

Figure 11 Soil settlement in parking lot,
Social Security Hospital.

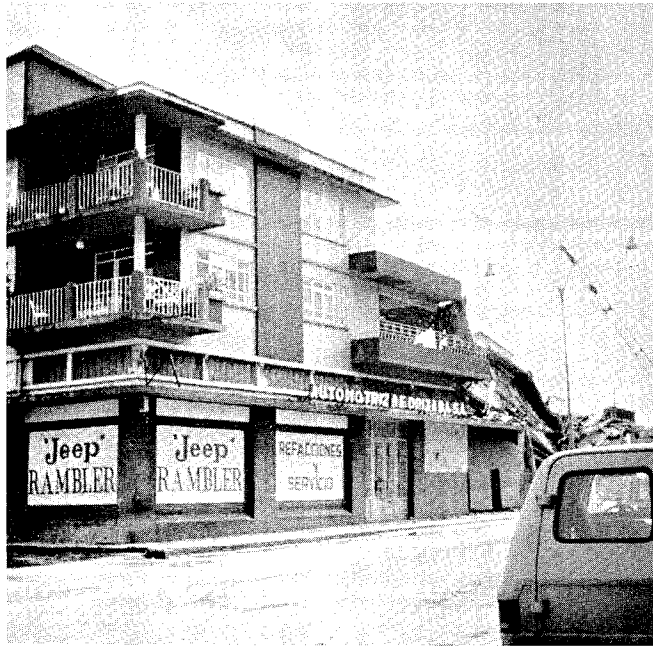
Figure 12

B. The "Packard" Apartment Building. — The complex consisted of three, three-story buildings linked by terraces and stairways. Two of the buildings collapsed killing ten people, injuring 40 and crushing 20 cars parked underneath on the ground floor (see Figures 12 and 13, p.21). The end of the building, still standing, was markedly stiffer than the other part which appeared to have been supported on slender columns (see Figure 14, p.22). Notice also, the flexural-shear failure of the short columns which provided the ventilation gap for the ground floor shops (see Figure 15, p.22). The whole complex was torsionally unbalanced because of the linking terraces and stairways which provided shear transfer between adjacent buildings.

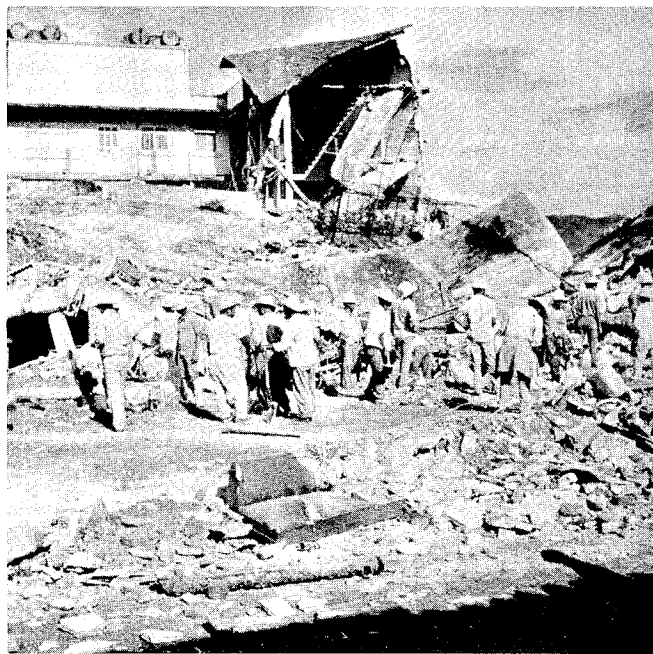
Figure 13 Collapse of "Packard" apartment building, Orizaba

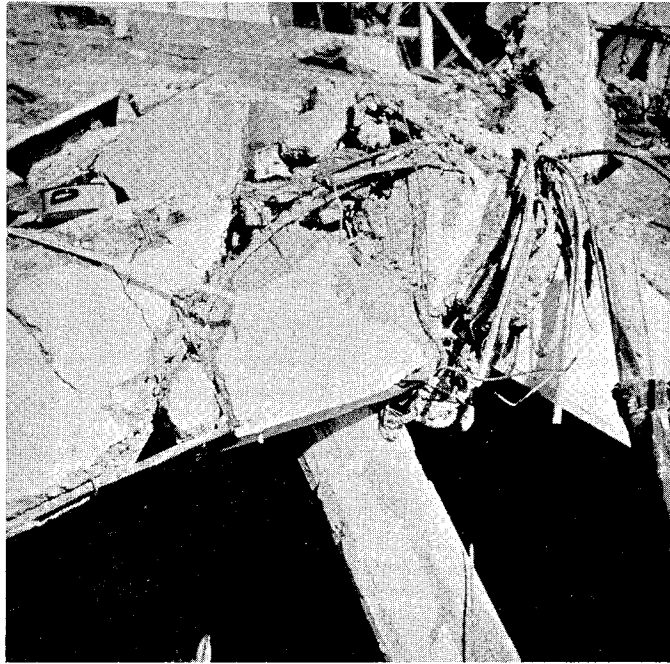
Figure 14 Beam-column failure,
Packard apartment building.

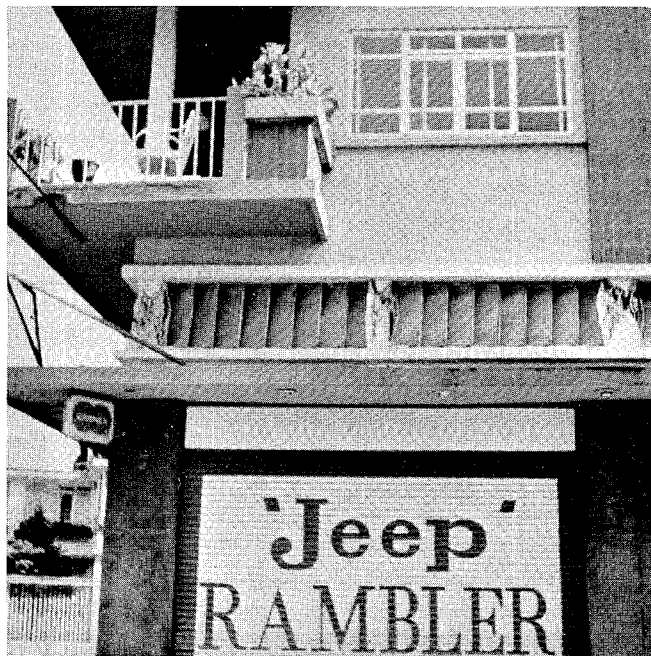
Figure 15 Failure of short columns, Packard
apartment building.

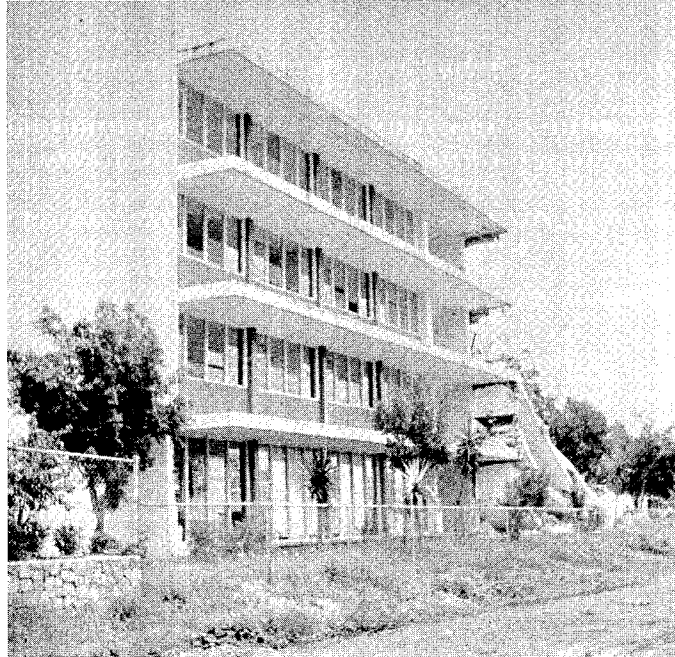
Figure 16 Collapse of classroom block
(Building A), Technologico of
Orizaba.

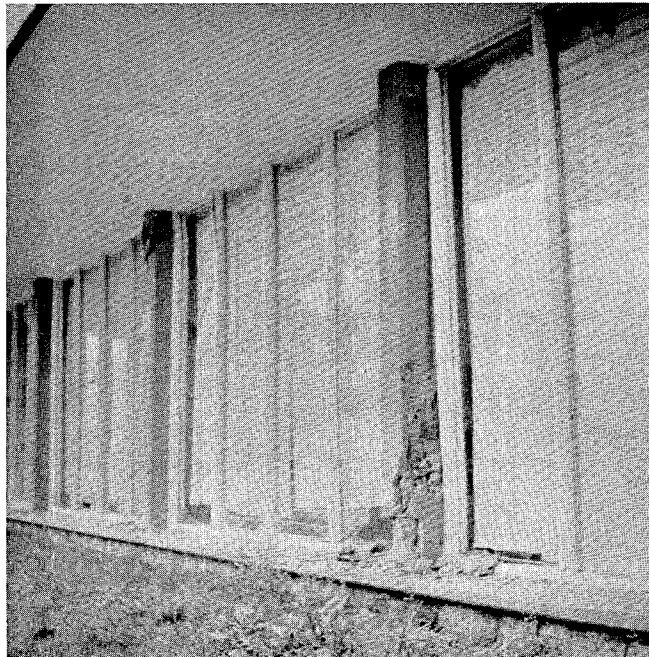
to the longer side; in plan, the column depth was approximately twice the width. Flexural-shear failure of the ground floor columns precipitated the collapse (see Figure 19, p.24). Figure 20 (p. 25) shows the behavior of post-tensioned floor slabs. The hollow cardboard cylinders had been placed in the floor to save weight, but they were instrumental in the slabs losing any continuity which the prestressing cables might have provided. It is most fortunate that the earthquake occurred before school had started for the day.

Figure 19 Failure of ground floor columns, Building A, Technologico of Orizaba.

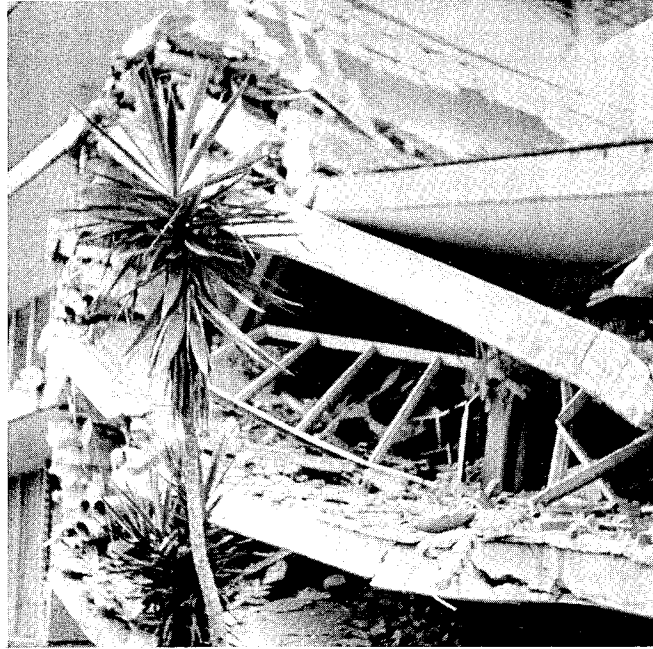
Figure 20 Behavior of floor slabs, Building A, Technologico of Orizaba.

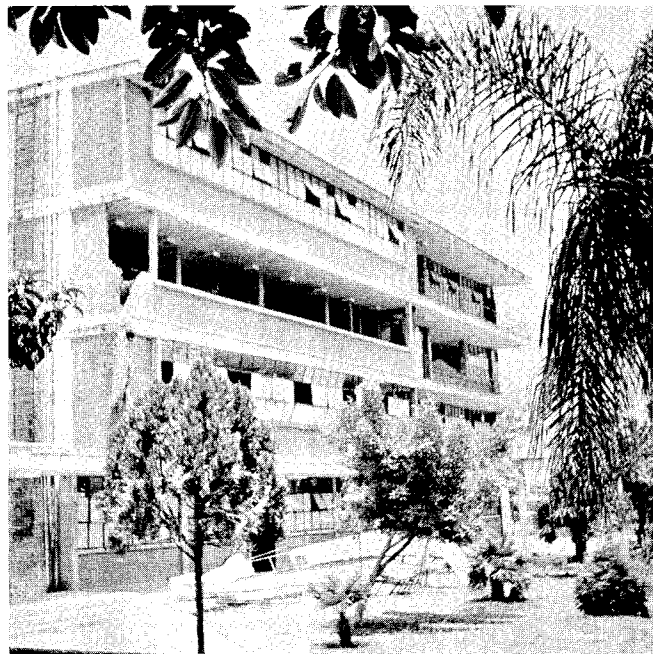
The other four-story building (Building B) remained standing, although it is likely that it will have to be completely rebuilt (see Figure 21, p. 25). Superficially, this building appeared to be similar to Building A; it was of the same height and plan area and stairways separated the building into two parts. However, closer examination revealed major structural differences. The center of mass of the building was towards the left-hand end, while the center of stiffness was nearer the stairway (see Figures 21 and 22, pp. 25, 26). Hence, the building responded primarily in torsion. Good evidence of this is provided by Figure 23 (p. 26) which shows classical torsional cracking of a second-story column located adjacent to the stairway.

Figure 21 Damage to classroom block (Building B), Technologico of Orizaba.

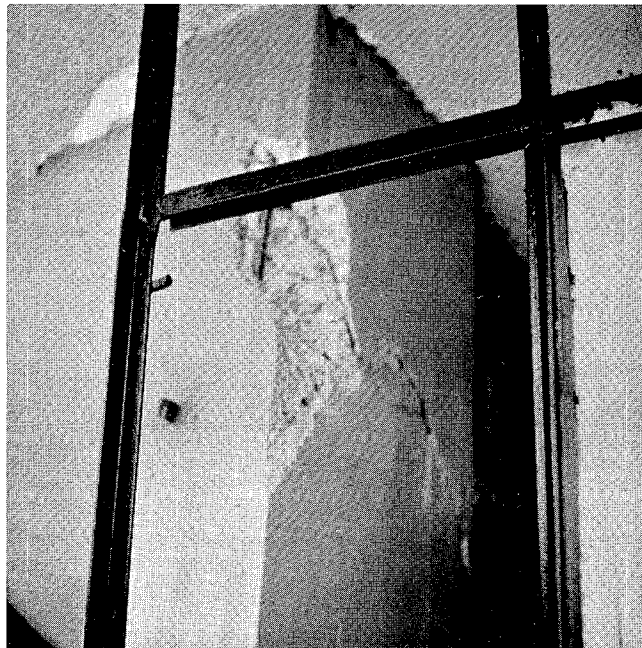
Figure 23 Torsional cracking of second story
column, Building B, Technologico
of Orizaba.

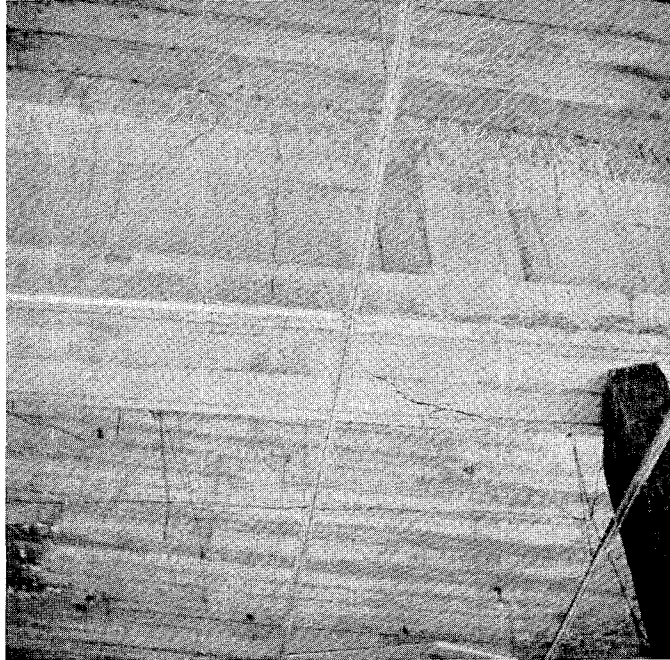
point indicated that the roof beams were under-reinforced, and had cracked under the bending moments induced by the vertical vibrations of the roof (see Figure 26, p. 28).

Figure 26 Flexural cracking at midspan of roof beam, VW Garage Showroom, Orizaba.

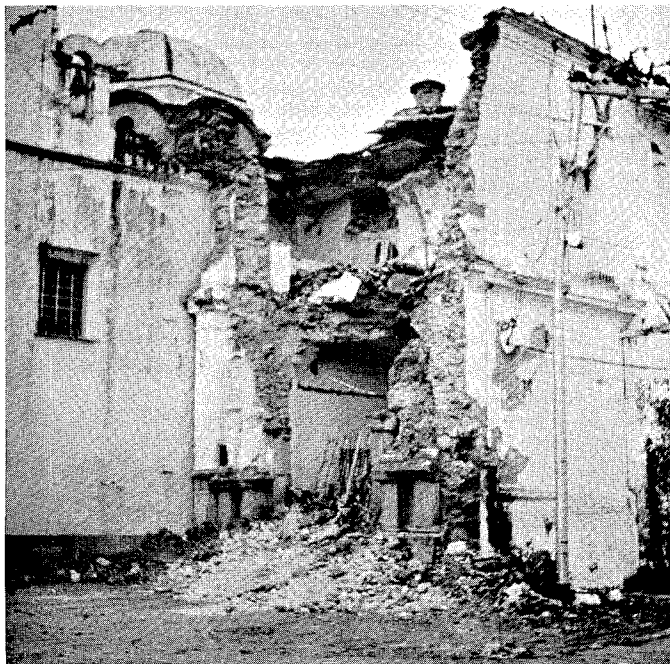
E. Other buildings. — Damage to churches in the area was extensive. These buildings were generally old, sometimes as much as 300 years old, and usually were built of stone or brick with clay or cement mortar. Walls, spires and arch roofs had frequently collapsed. Figure 27 (p.28) shows typical damage to a church-hospital in Orizaba.

Figure 27 Damage to a church-hospital in Orizaba.

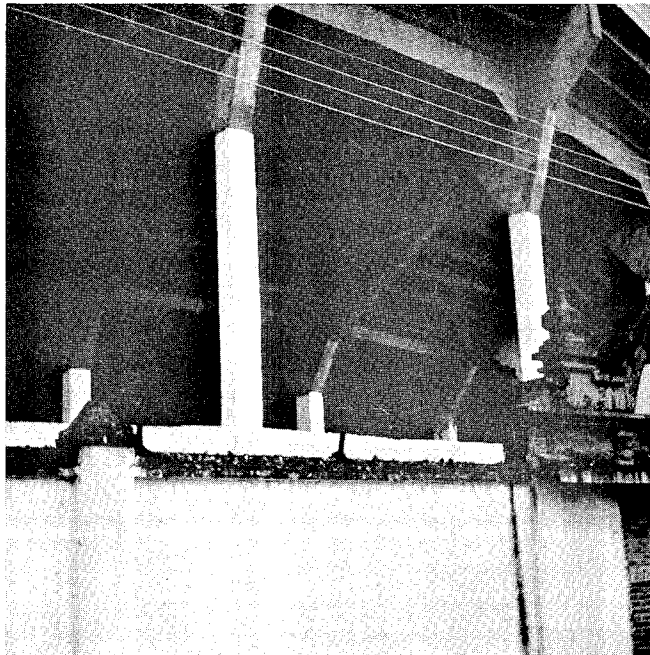
Orizaba's bull ring survived the earthquake with practically no damage. However, Figure 28 (p. 29) shows a plastic hinge which had formed in the column at an interior beam-column joint, again due to short column effects.

Figure 28 Plastic hinge formation at an interior column, Orizaba Bull Ring.

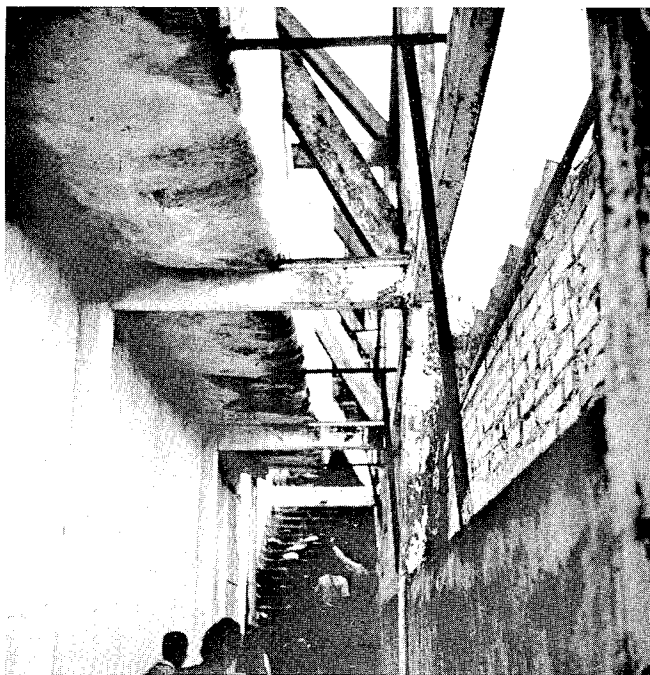
There was some damage to cinemas in Orizaba. In the case of the Cinema Real, the reinforced concrete buttress frame had been pushed out by the roof load. (See Figure 29, p.29).

Figure 29 Damage to buttress frame, Cinema Real, Orizaba.

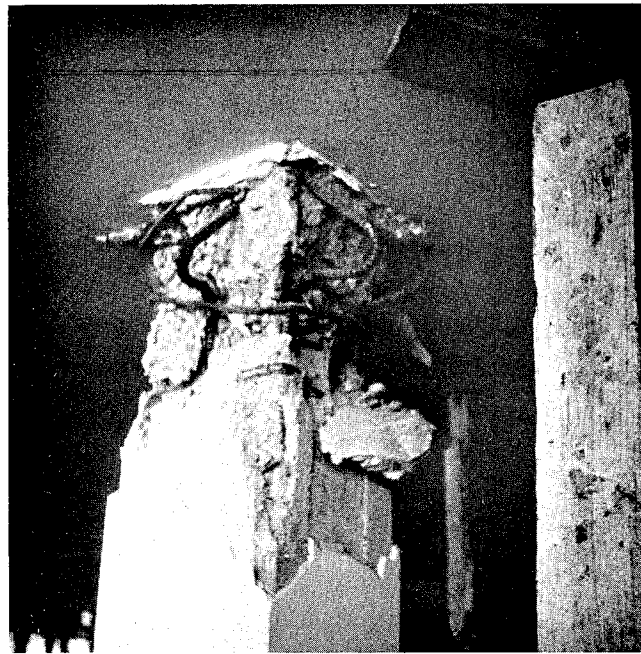
A. Five-Story Business House. — The failure of this building was one of the most interesting, from an engineering standpoint. This building, which had a reinforced concrete frame with brick filler walls, is owned by Mr. Kushida, a Japanese businessman, and was built in 1968. The bottom three floors house shops, offices and warehouses, whereas the top two floors, which are set back (see Figure 30, p.30), are occupied by Mr. Kushida and his family. The overturning moment resulting from the motion of the top two floors caused axial compression failures of columns on the third floor (see Figure 31, p.30). The upper floors had dropped approximately 30 cm. Damage to the

Figure 31 Axial compression failure of third-floor column of business house, Córdoba.

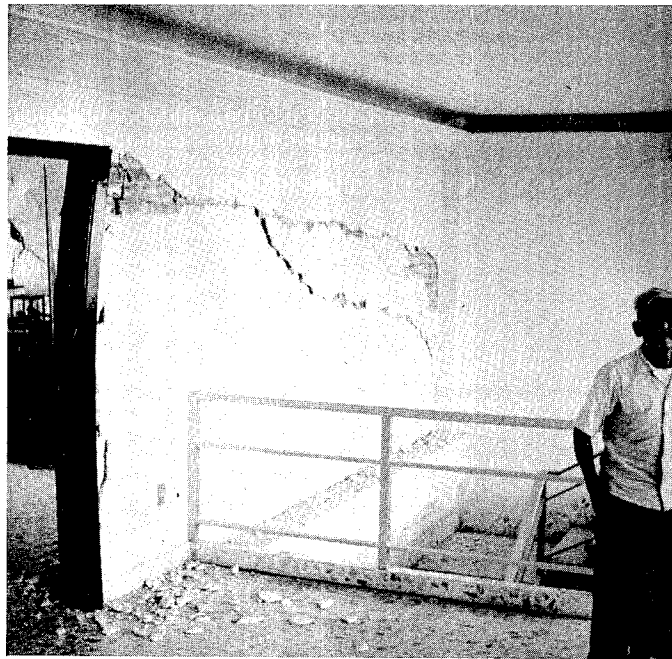
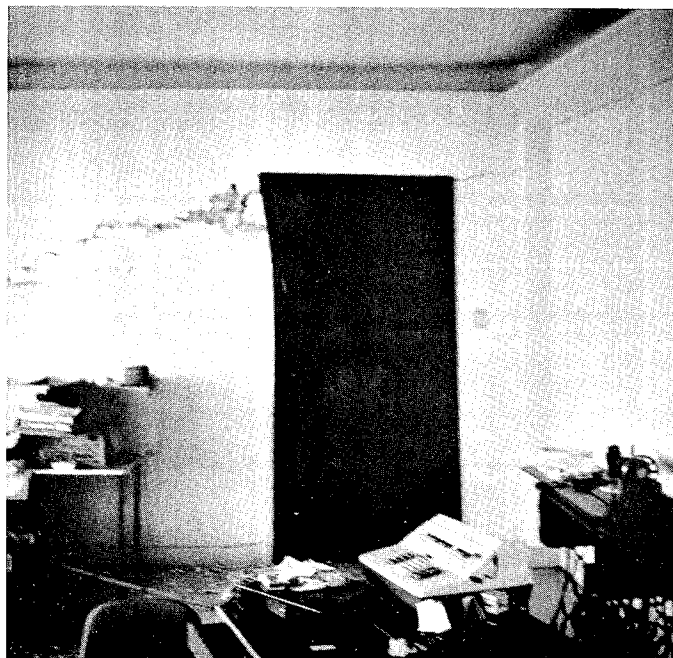
three upper floors was severe. Figures 32 and 33, (p.31) show damage to brick and mortar walls on the fourth and fifth floors; the plywood door was buckled in shear. Goods stored in this building were subsequently damaged by heavy rainfall.

Figure 32 Damage on upper floors of business house, Córdoba.

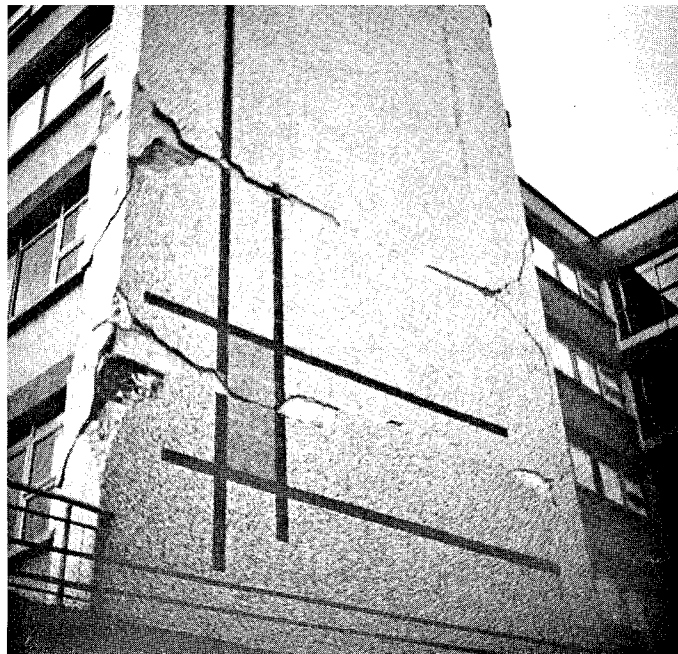
B. Hotels. - The Hotel Trueba, which has a reinforced concrete frame with brick filler walls, suffered extensive secondary damage, mainly to unreinforced brick and mortar walls which had been made continuous with the structural frame. The six-story shear walls showed evidence of cracking at the second and third floors (see Figure 35, p. 32). This could indicate some second-mode response to the excitation. However, this seems unlikely since the participation factor for second-mode response is usually too small to be significant. The building is more likely to have responded strongly in the first mode, in which case local weaknesses in the construction at the second and third floors could have led to the cracking which occurred there. Another possibility is that the wall behaved as a coupled shear wall (the coupling between the two columns being provided by the floors and the infill walls) where, typically, laminar shear stresses attain their maximum values about one-third of the way up the shear wall.

Figure 35 Cracking in shear wall, Hotel Trueba.

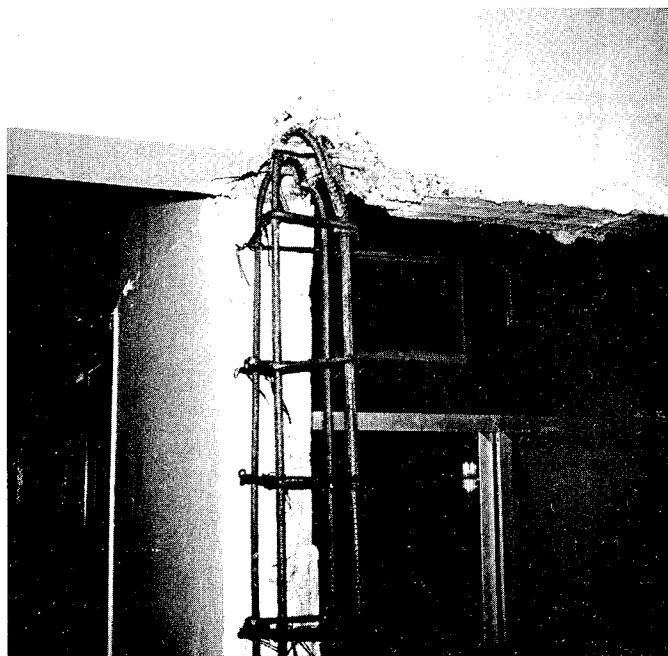
For whatever reason, the behavior of the wall is peculiar since Figure 34 (p.32) shows an obvious zone of weakness at the level of the ground floor columns. Yet inspection showed no sign of damage to these columns. It can only be concluded that sufficient stiffness was present in the ground floor to avoid damage there. Figure 36 (p.33) shows a typical interior beam-column joint. Since many of the rooms in the hotel were uninhabitable owing to broken partition walls, the owner was very keen to have repairs made as soon as possible. Unfortunately, the philosophy behind the repair scheme left much to be desired, as Figure 37, (p.33) shows.

Figure 37 Repair scheme for partition wall, Hotel Trueba.

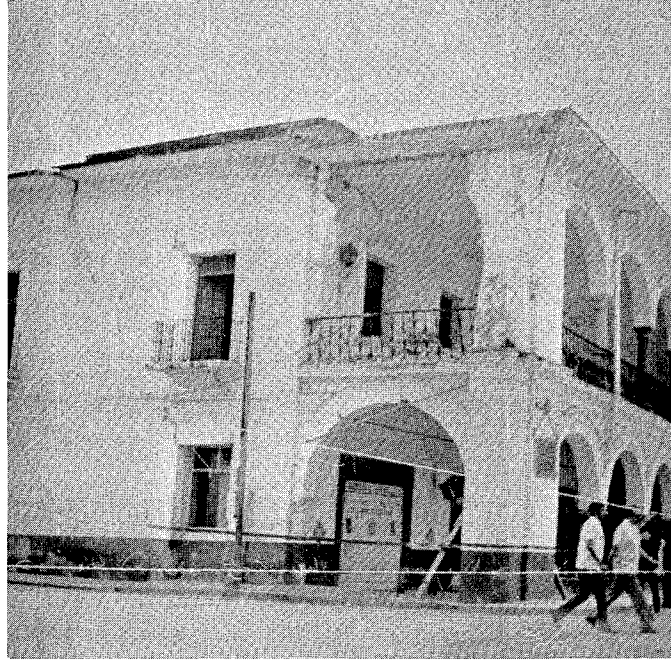
The Hotel Zevallos is one of the oldest buildings in Córdoba, having been built in 1687, just 70 years after the Spaniards founded the town. Although the exterior of the building has changed somewhat (see Figure 38, p. 34) and a reinforced concrete roof was placed earlier this century, the interior courtyard is substantially unaltered. The view of the all-but-failed three-way arch (see Figure 39, p. 34) is taken from this courtyard. It appears that the roof slab saved the outer corner of the building from collapsing.

Figure 38 Damage to exterior corner of the Hotel Zevallos, Córdoba.

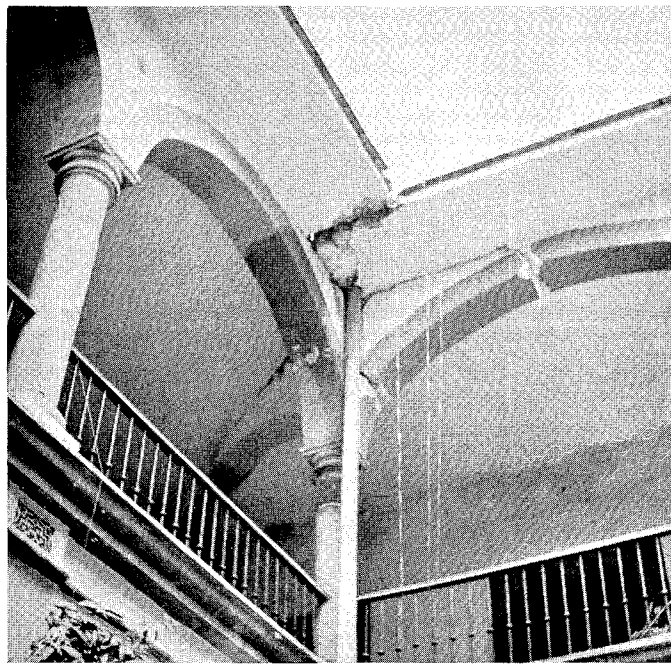
Figure 39 Damage to three-way arch, interior courtyard, Hotel Zevallos.

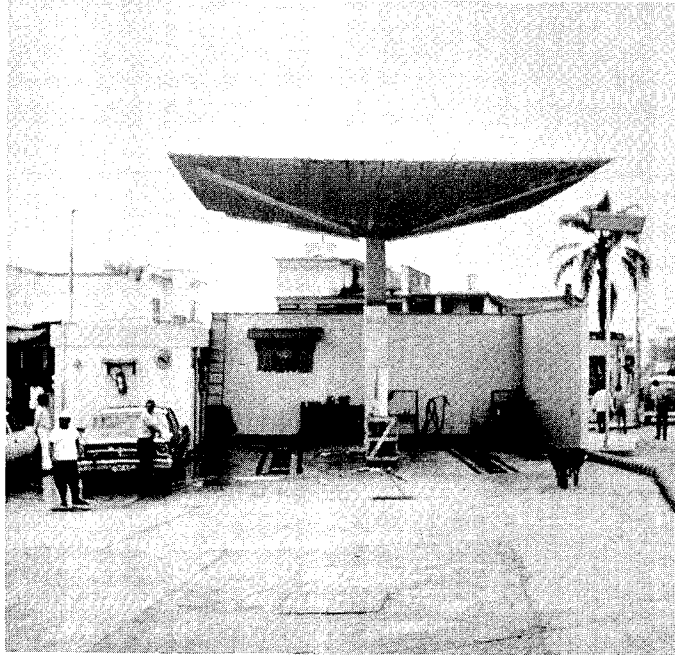
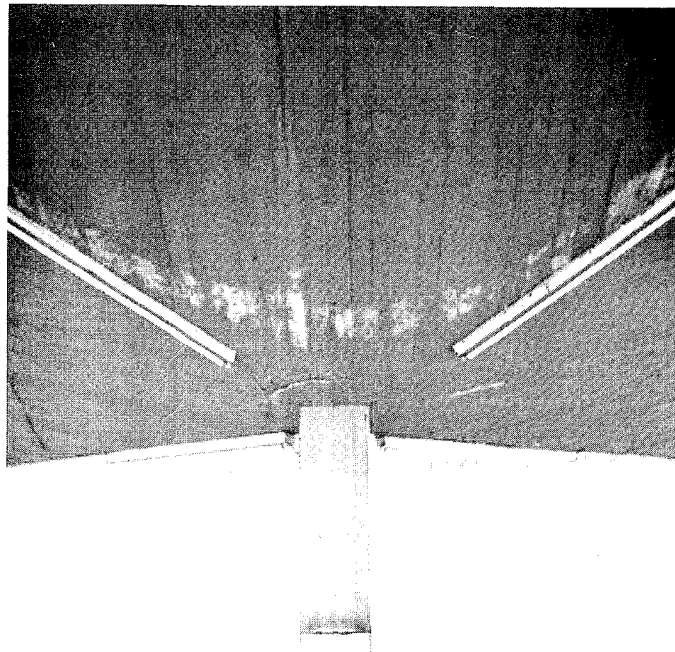
C. Service Station Shelter. — The cantilevered service station shelter shown in Figures 40 and 41 (p.35) had cracked at the junction of column and roof slab. It appears that the rotary inertia associated with the roof had been ignored in the design. The rotary inertia had two effects: first, under horizontal excitation the true bending moment diagram is trapezoidal, not triangular; secondly, the rotary inertia may so lower the fundamental frequency that an earthquake may cause strong excitation of what, at first, appears to be a relatively stiff single-story structure. Punching shear may have contributed to the behavior of the shelter, although the cracking did not extend to the other side of the column junction.

Figure 41 Damage to service station shelter.

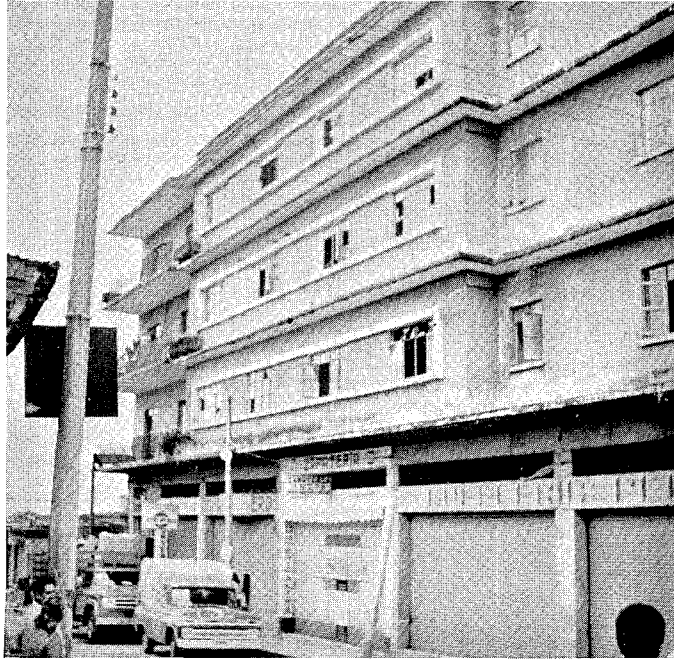
D. Other buildings. — The four-story apartment building shown in Figure 42 (p. 36) housed some 150 persons. It had survived the earthquake but was in imminent danger of collapse owing to severe damage to the main structure. The building had been evacuated, and was soon to be demolished.

Figure 42 Apartment building, Córdoba. There was extensive internal structural damage to this building.

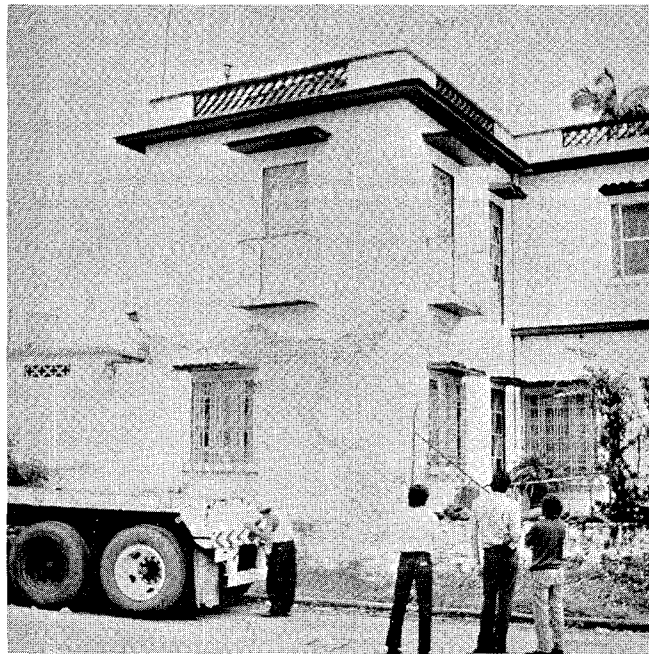
Figure 43 (p. 36) shows typical damage to one of the better constructed houses in Córdoba. The next three views (Figures 44, 45 and 46, pp. 37, 38)

Figure 43 Typical damage to a better constructed house, Córdoba.

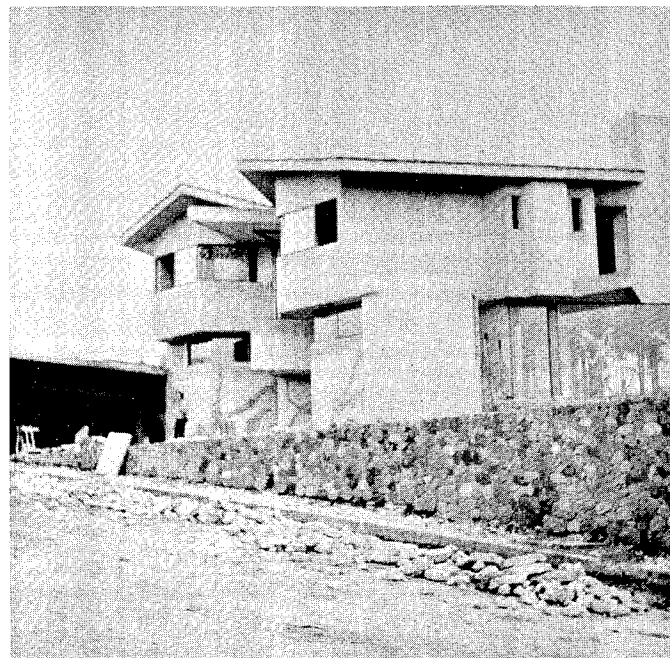
show damage to an architecturally modern house on the outskirts of Córdoba. The house is torsionally unbalanced, and it appears that very little attention had been given to engineering details.

Figure 45 Damage to exterior walls of house.

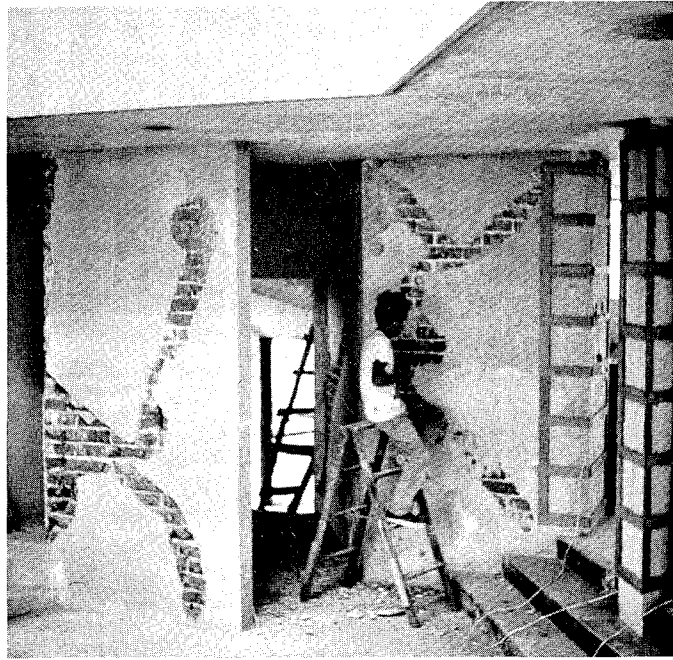
Figure 46 Damage to interior walls of house.

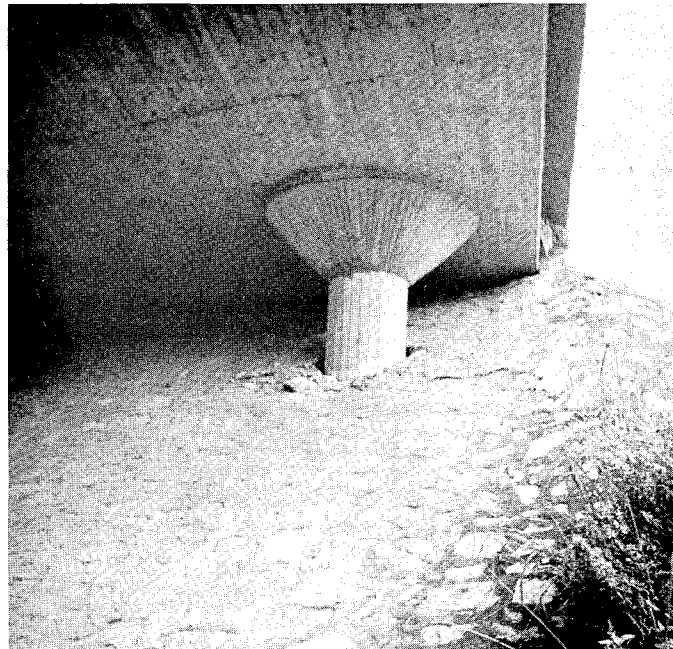
About 15 cm. of settlement of an embankment occurred around the piers of this freeway bridge between Córdoba and Orizaba (see Figure 47, p. 38). There was no sign of any cracking in the bridge deck.

Figure 47 Settlement of embankment around bridge pier, Córdoba.

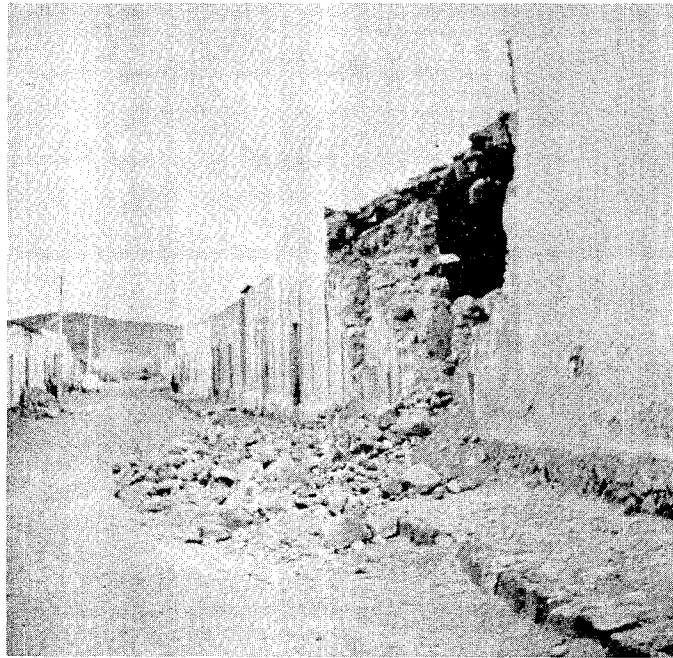
The City of Serdán was the last visited. It was clearly the worst hit by the disaster, with perhaps 300 deaths and many of the homes were damaged or destroyed. Serdán is a very poor agricultural town, and the houses consisted of walls of stone and clay mortar and tile roofs. Figure 48 (p.39) shows typical damage to such buildings. It appears that the town is too poor to finance an adequate rehousing project, and the Federal Government will have to assume responsibility for the rebuilding. In the meantime, some of the houses, which were only partially damaged, will be rebuilt using the age-old methods. Consequently, the next strong earthquake will again wreak havoc in the town. The pattern is, unfortunately, all too familiar in the country areas of Latin America.

Figure 48 Typical view of damage to houses in Serdán.
