university of california • santa barbara

NSF/RA- 780550

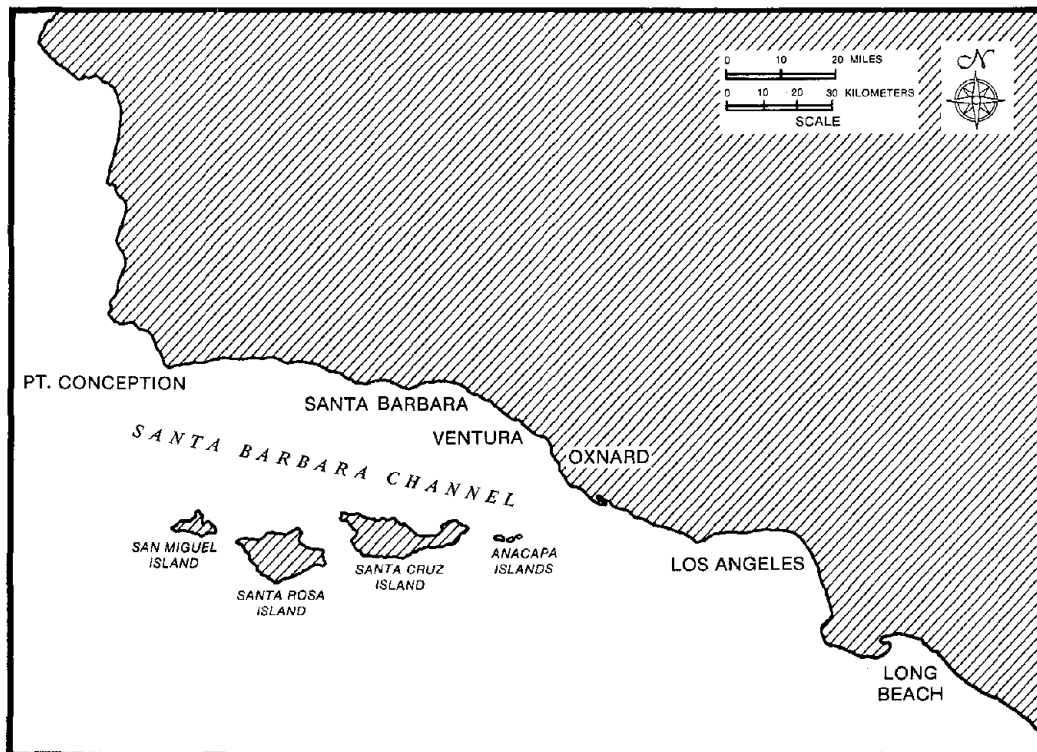
Fig. 1.1 The Southern California Coastline and the Santa Barbara Channel.

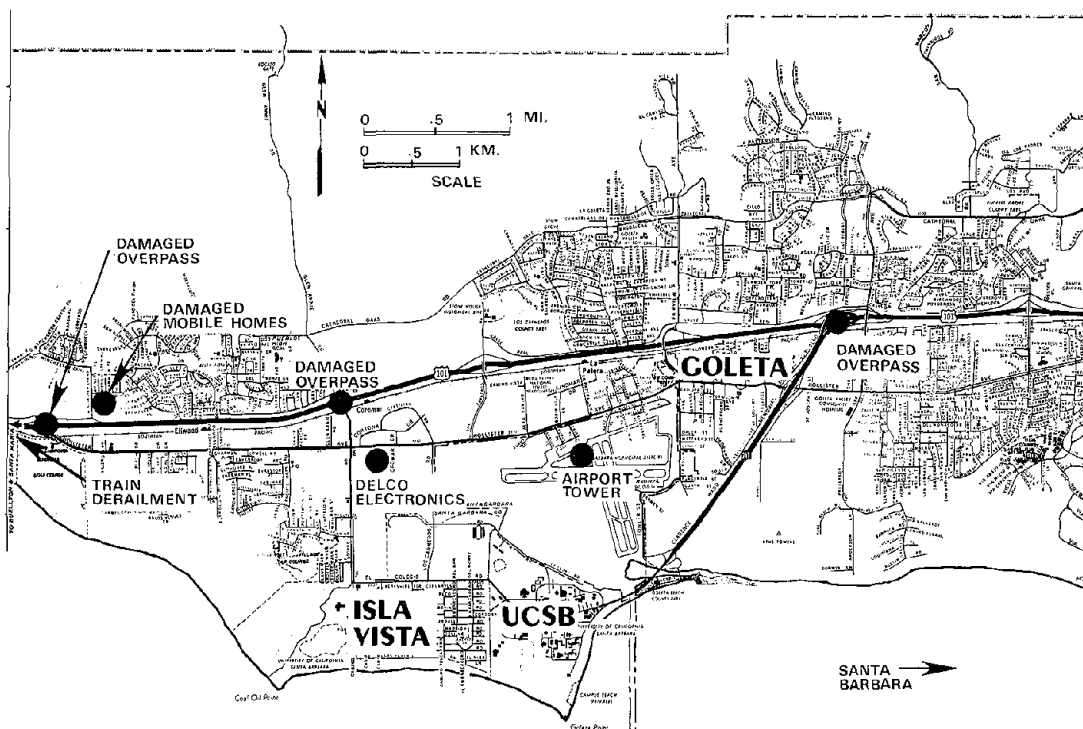
Fig. 1.2 Map showing earthquake damage in Goleta, 16 km west of Santa Barbara (Copyright Automobile Club of Southern California. Reproduced by permission).

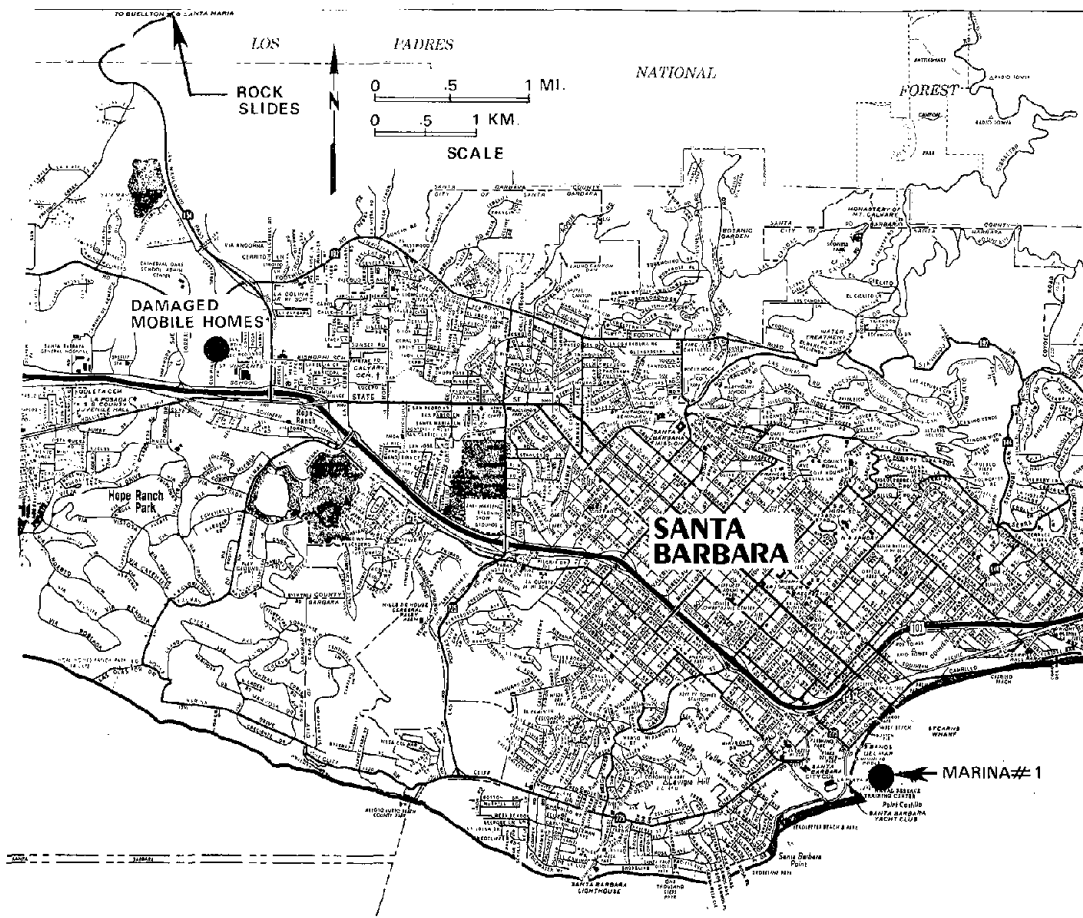
Fig. 1.3 Map showing earthquake damage in Santa Barbara (Copyright Automobile Club of Southern California. Reproduced by permission).

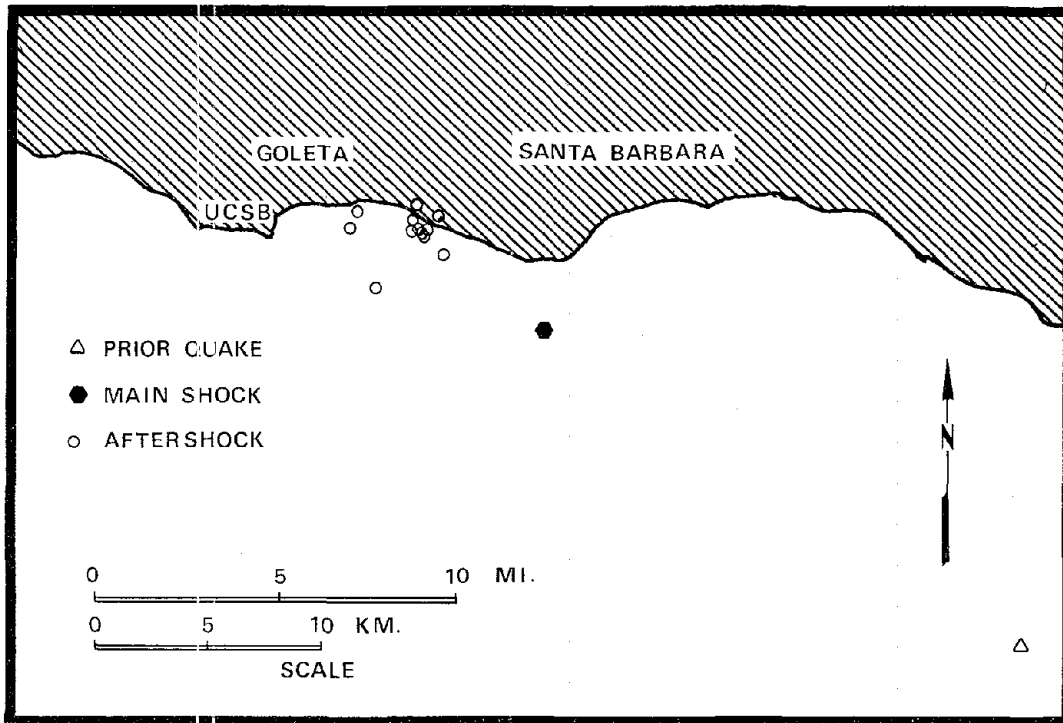
Fig. 2.3 Location of Epicenters of Preceding Earthquake, Main Event, and Significant Aftershocks within 20 minutes, 13 August 1978 (based on data reported by Lee and others, 1978).

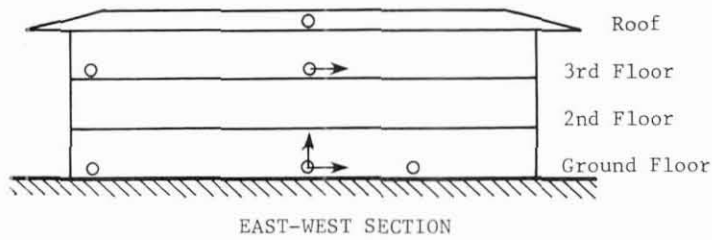
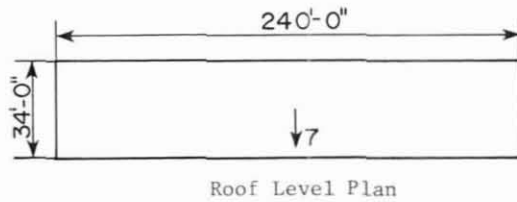
Fig. 3.4 Location of accelerometers within North Hall, UCSB.

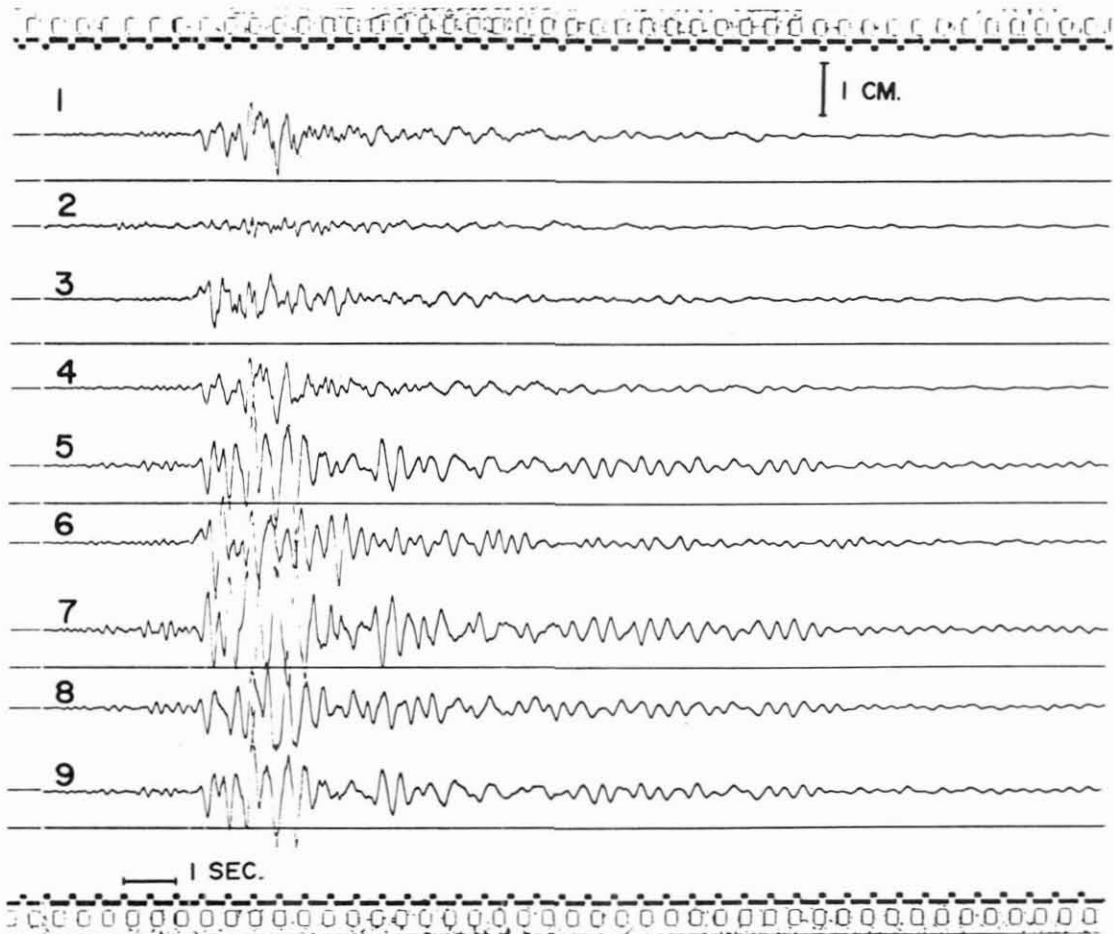
Fig. 3.5 Uncorrected Raw Accelerogram
Recorded at North Hall, UCSB.
1.8 cm \approx 1g. (Obtained by Office
of Strong Motion Studies, California
Division of Mines and Geology).

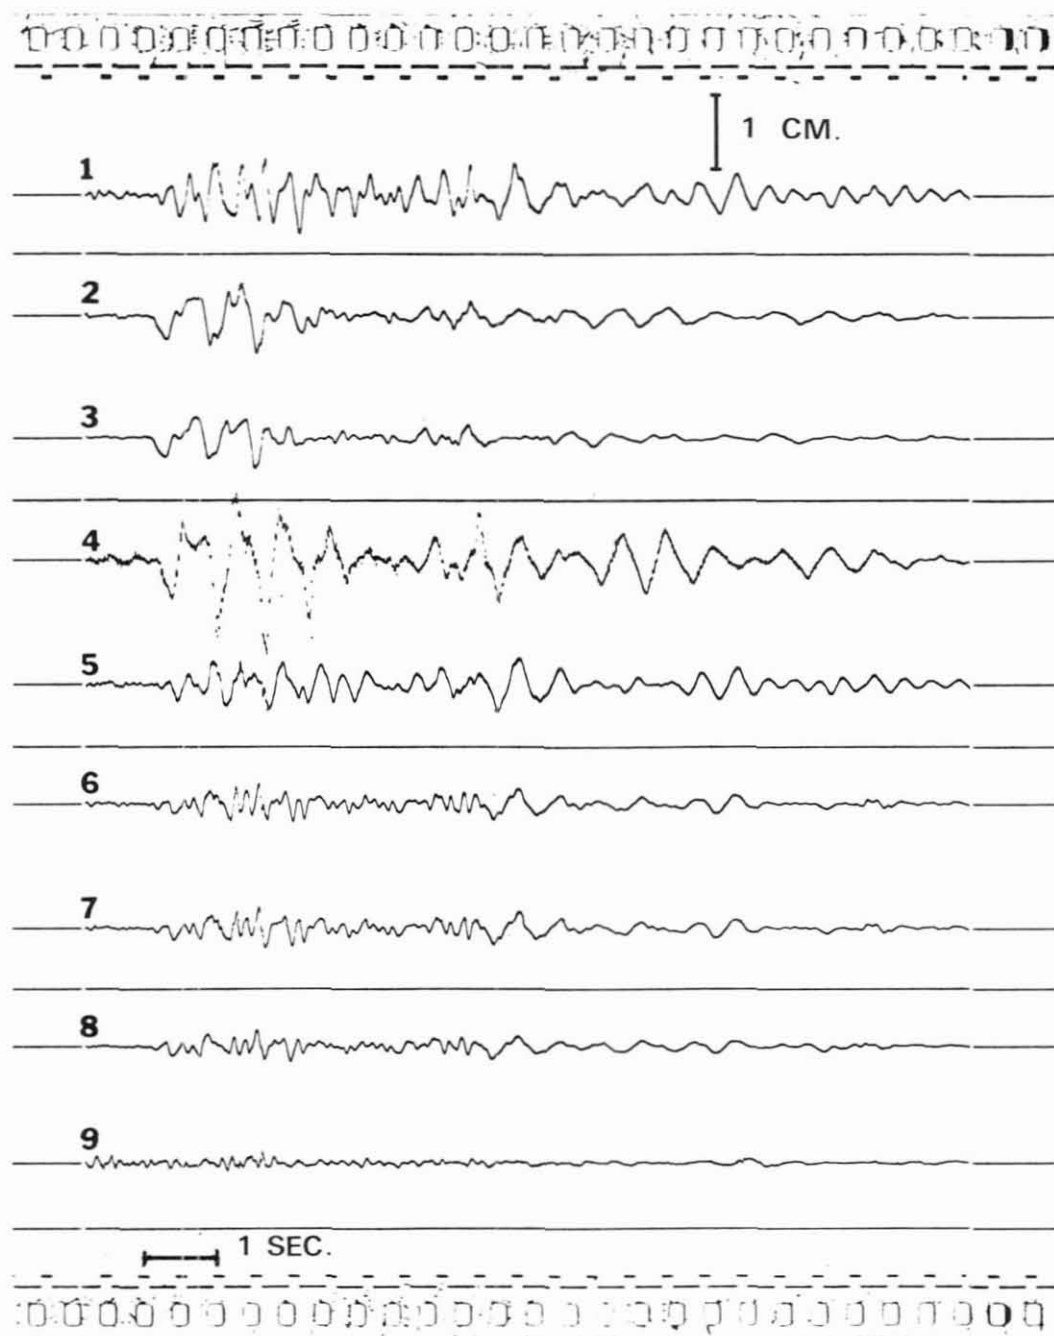
Fig. 3.8 Uncorrected Raw Accelerogram Recorded at Freitas Building, Santa Barbara. 1.8 cm \approx 1g. (Provided by Office of Strong Motion Studies, California Division of Mines and Geology.)

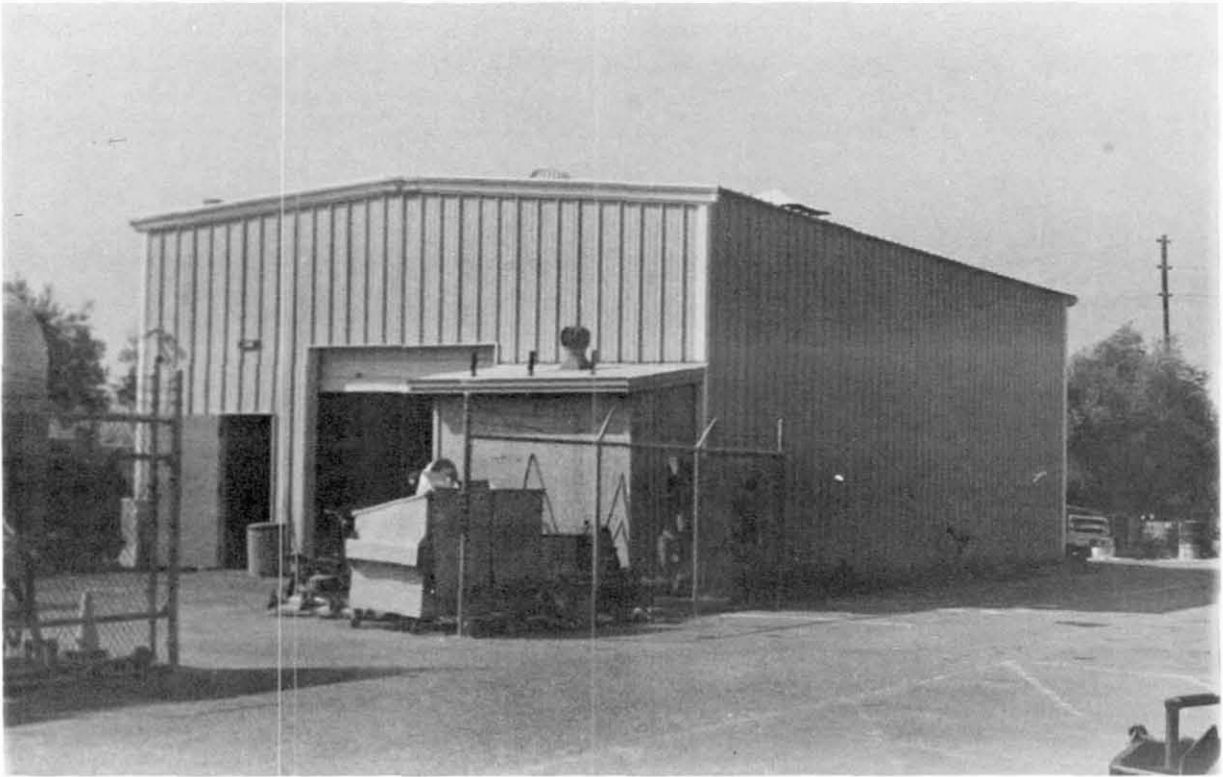
Fig. 3.9 Building 340, UCSB campus. (Location of Goleta Free Field instrument).

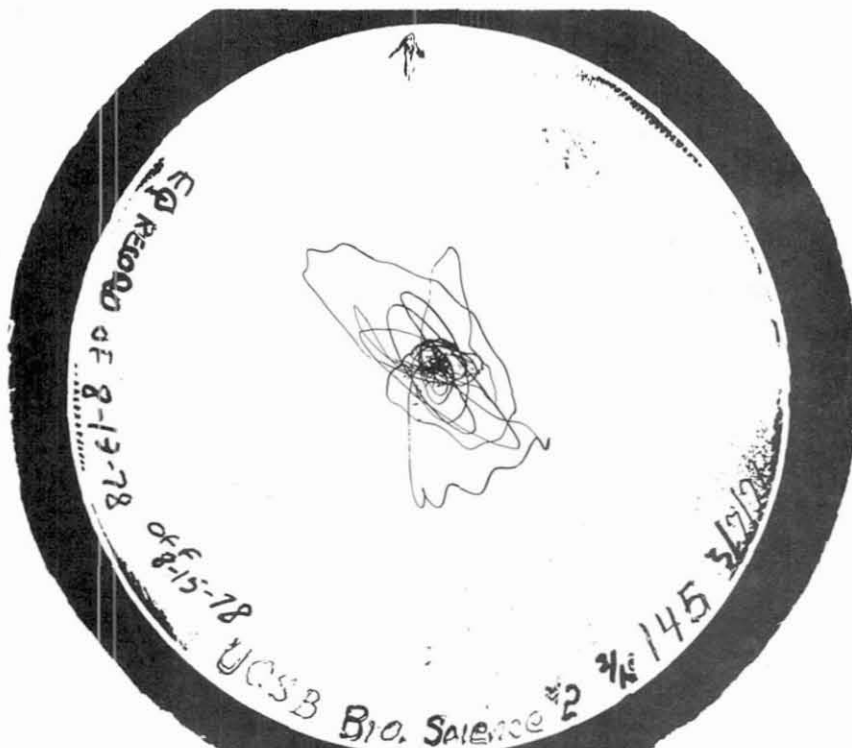
Fig. 3.15 Seismoscope record from Biological Sciences II, UCSB. Arrow points N 00° E. (Provided by Seismic Engineering Branch, U.S. Geological Survey). High frequency motion at lower right probably caused by impact with a falling door.

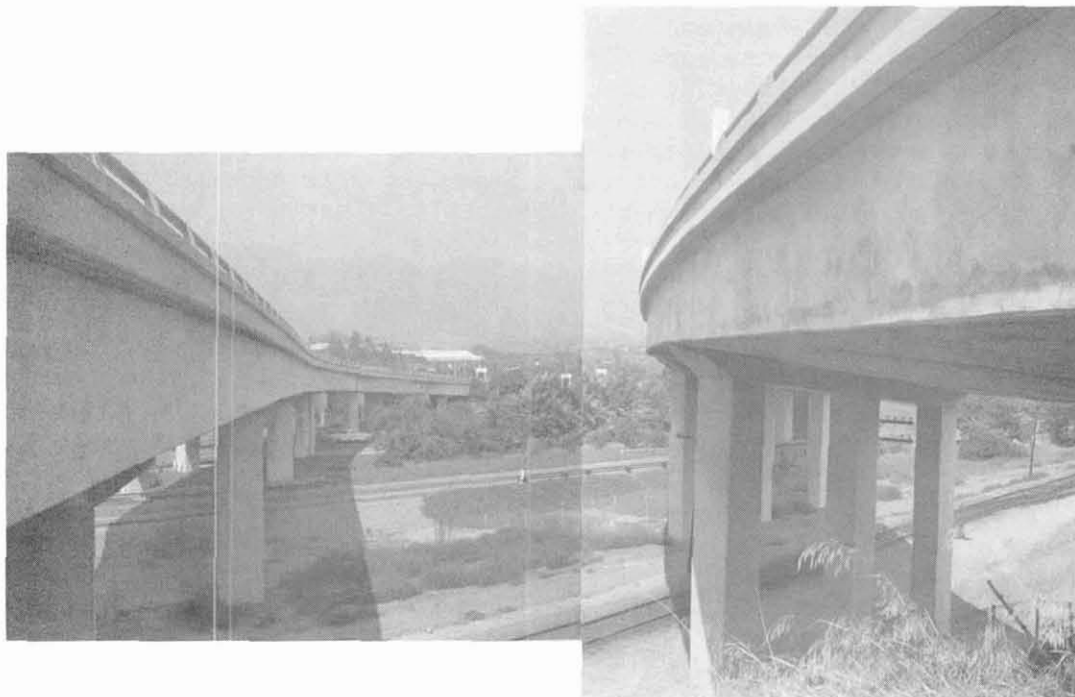
Fig. 5.4 Ward Memorial Boulevard bridges over U.S. Highway 101 (see Fig. 1.2 for location). View looking north from southern abutment.

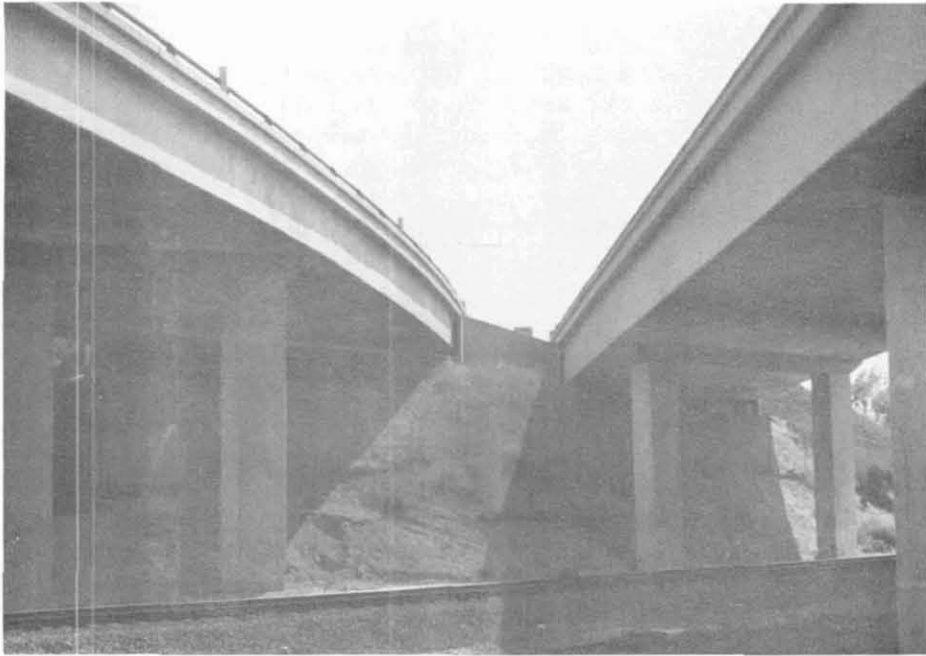
Fig. 5.5 Ward Memorial Boulevard bridges. View looking south towards southern abutment.

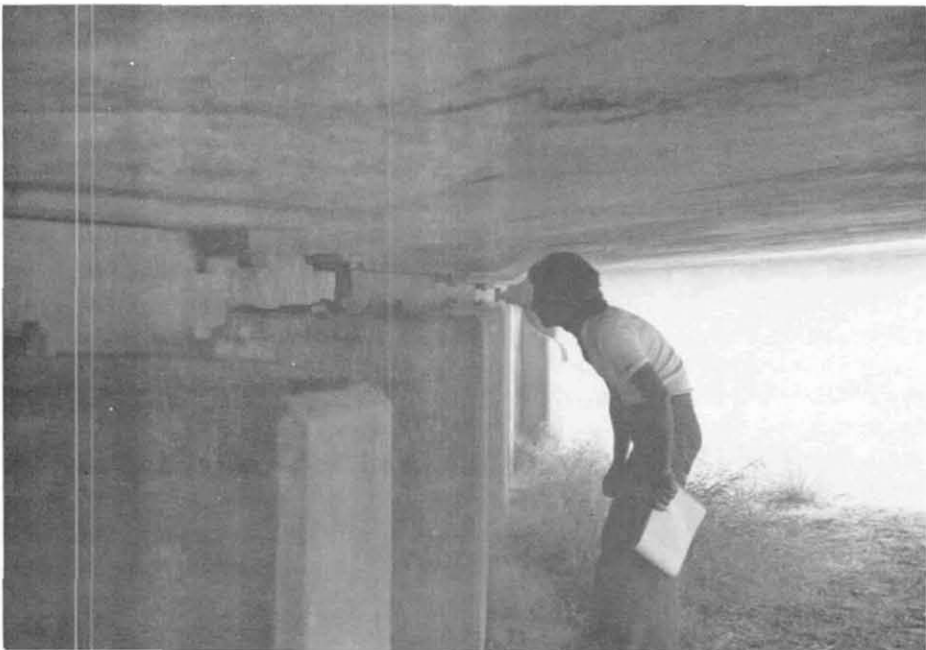
Fig. 5.6 Support of Ward Memorial Boulevard bridge deck at southern abutment. View shows piers capped by damaged rocket bearing assemblies under bridge on left in Fig. 5.5.

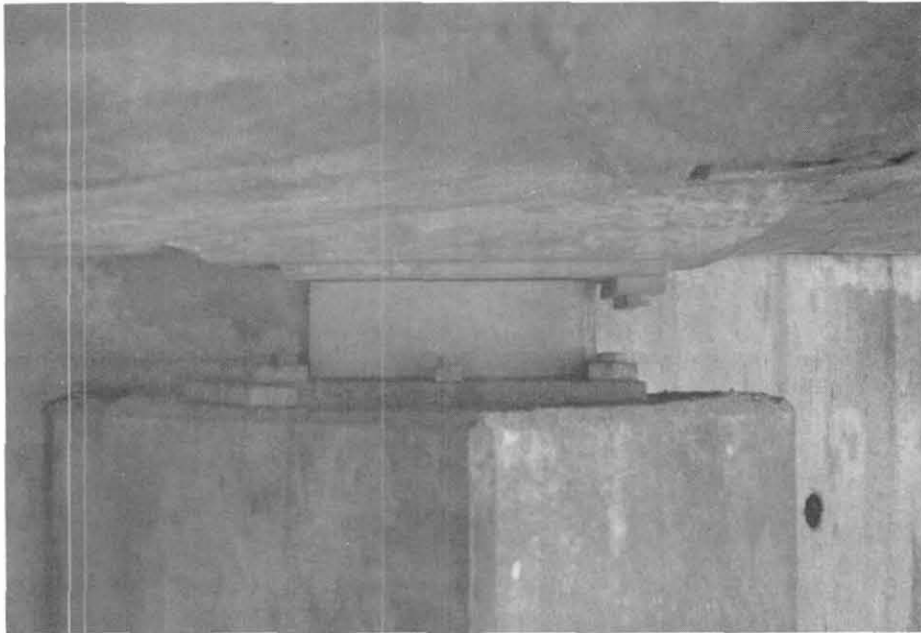
Fig. 5.7 Rocker bearing resting between sole plate above and masonry plate below, with missing keeper plate at top left (eastern end of bearing).

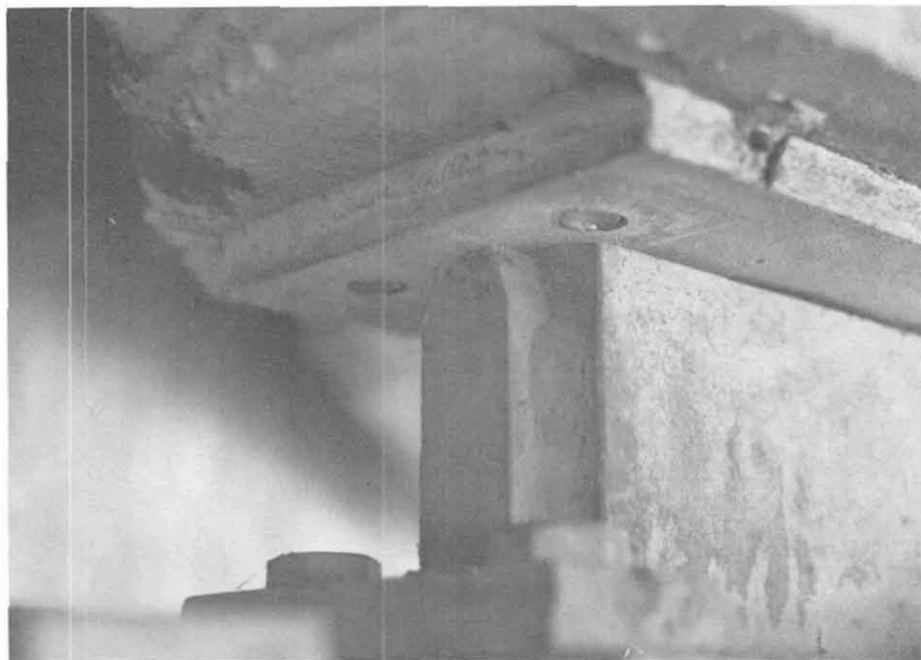
Fig. 5.8 Close-up of rocker bearing showing remnants of sheared keeper plate bolts at top.

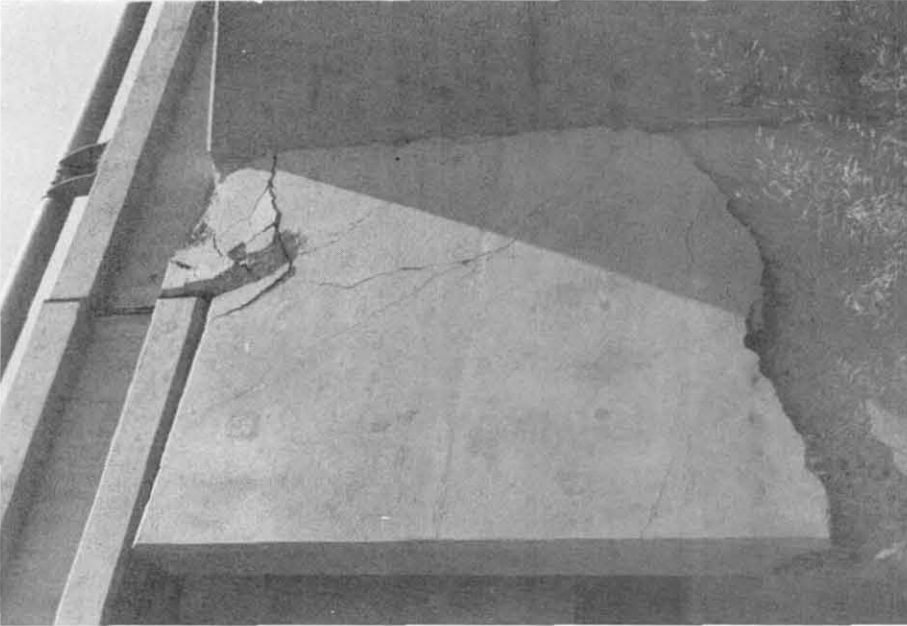
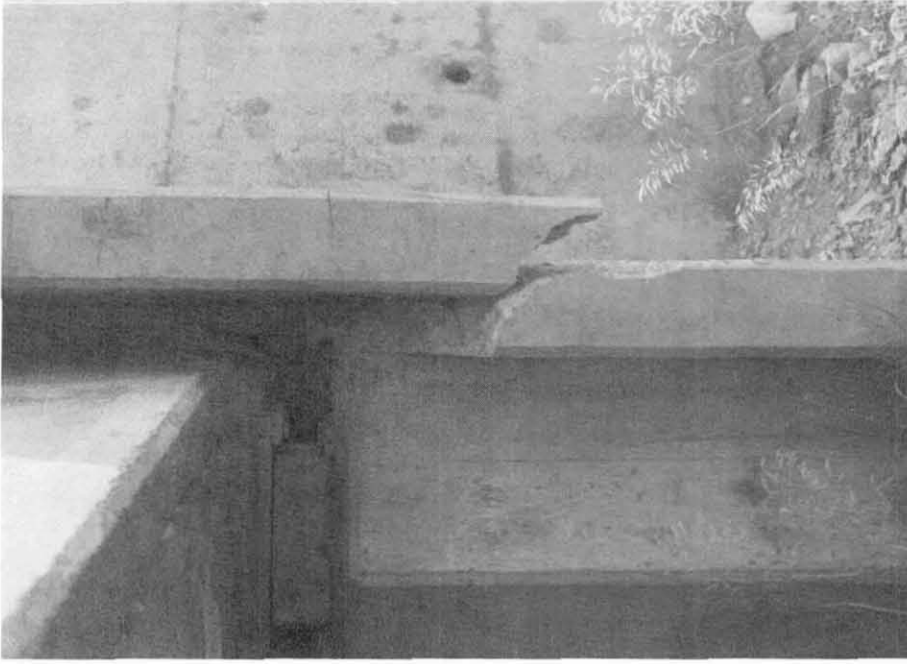
Fig. 5.9 Cracked curtain wall of Ward Memorial Boulevard bridge at southern abutment joint, curtain wall visible in Fig. 5.5 against left bridge.

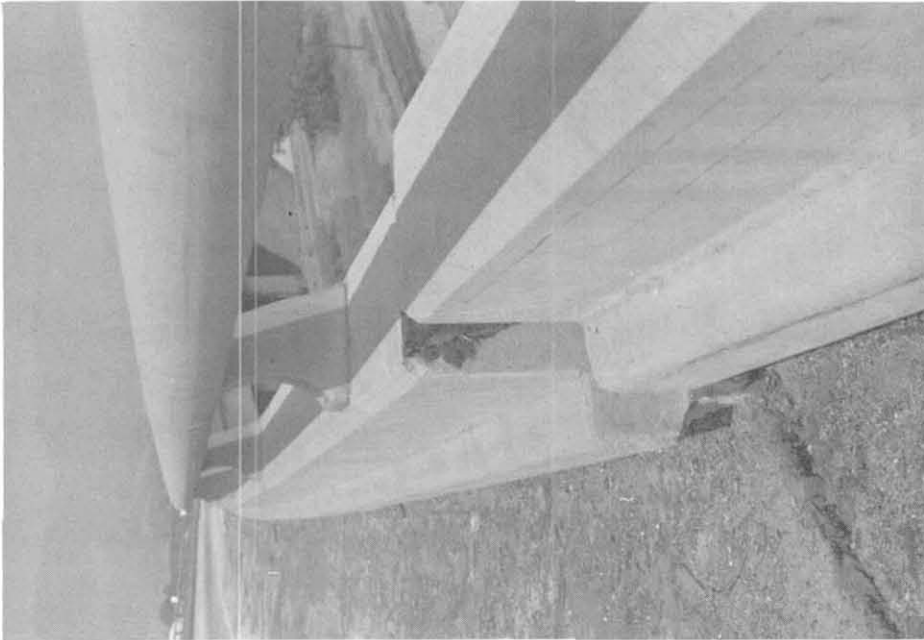
Fig. 5.10 Transverse displacement of Ward Memorial Boulevard bridge deck at southern abutment joint. (Bridge on right in Fig. 5.4). View looking north along railing. Offset is three inches.

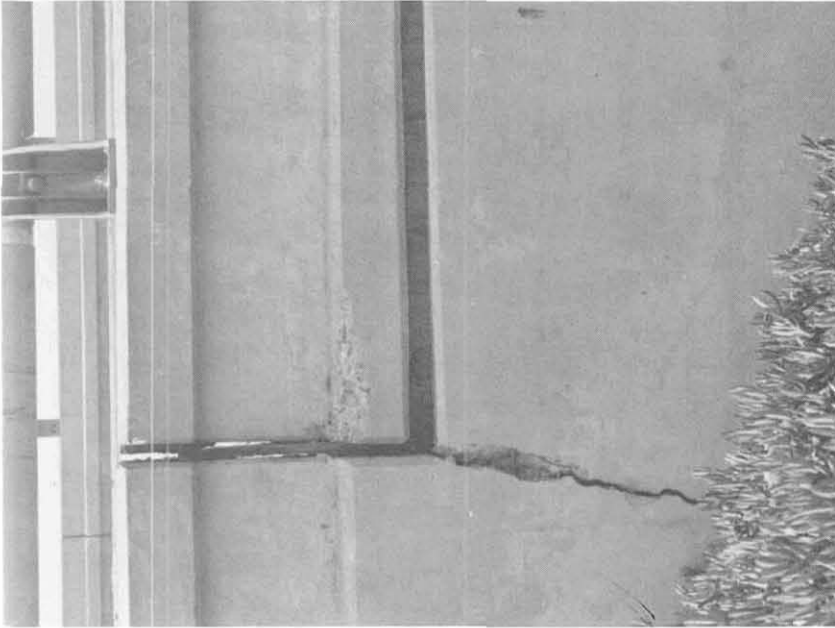
Fig. 5.11 View looking west at joint shown in Fig. 5.10. Vertical crack is on line with face of abutment backwall.

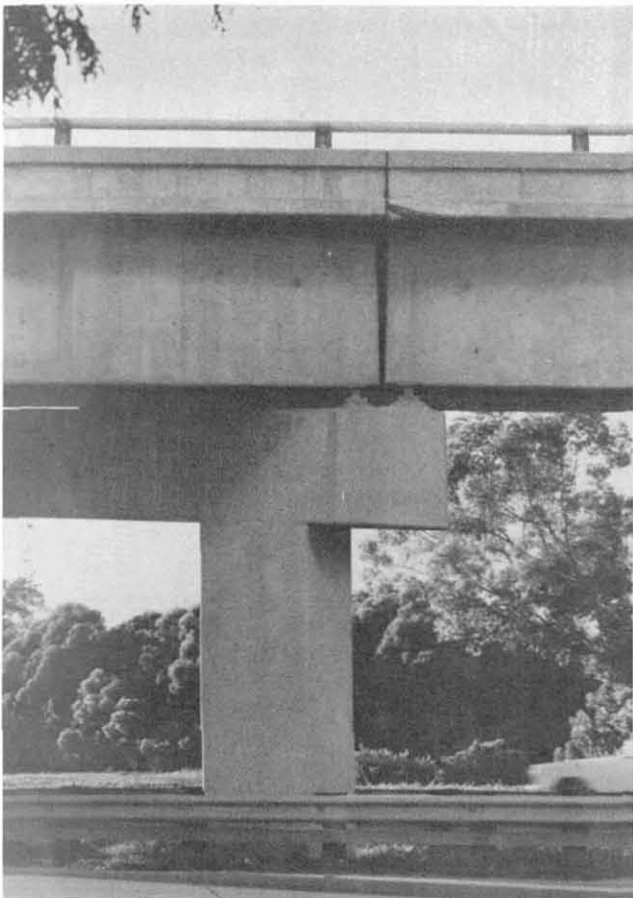
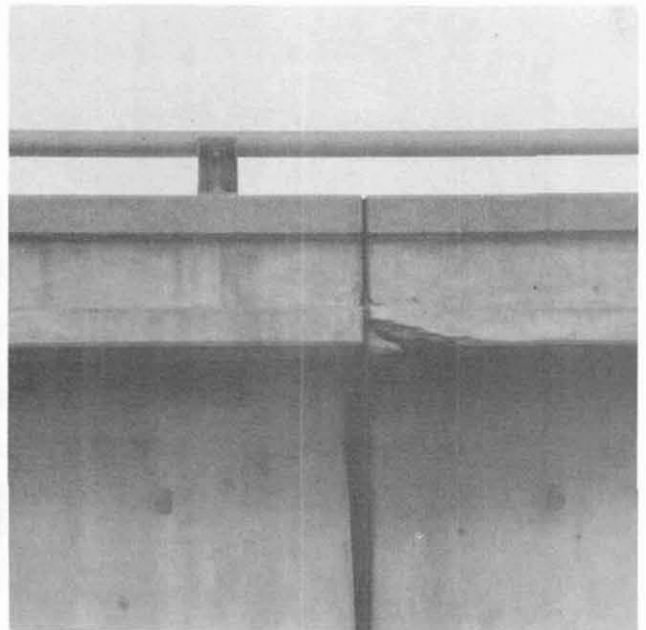
Railing separation along Ward Memorial Boulevard bridge at southern abutment joint, view looking west across bridge on right in Fig. 5.5.

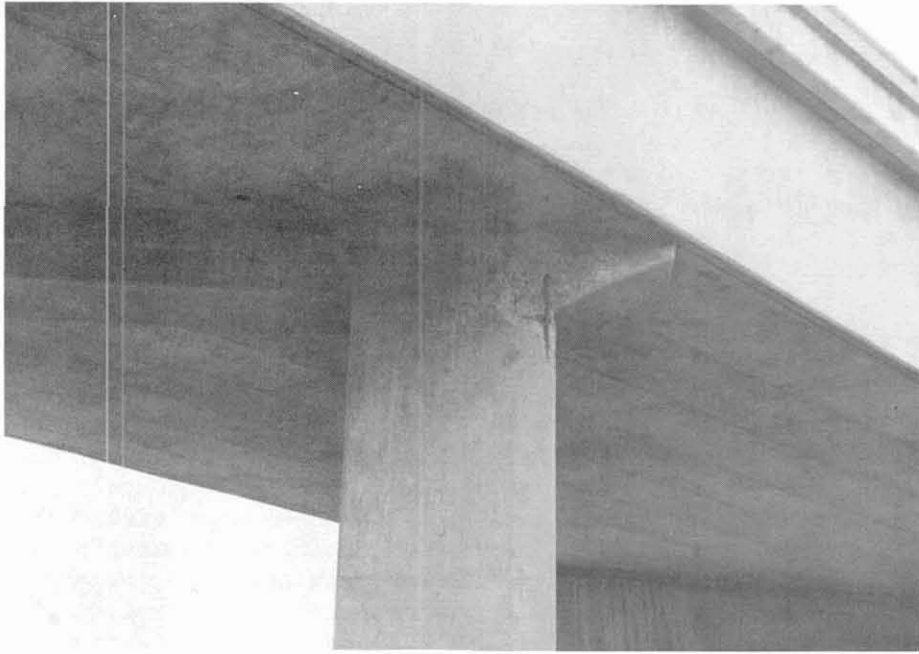
Fig. 5.14 Damaged bent supporting Ward Memorial Boulevard bridge deck, view looking west, at bridge on left in Fig. 5.4.

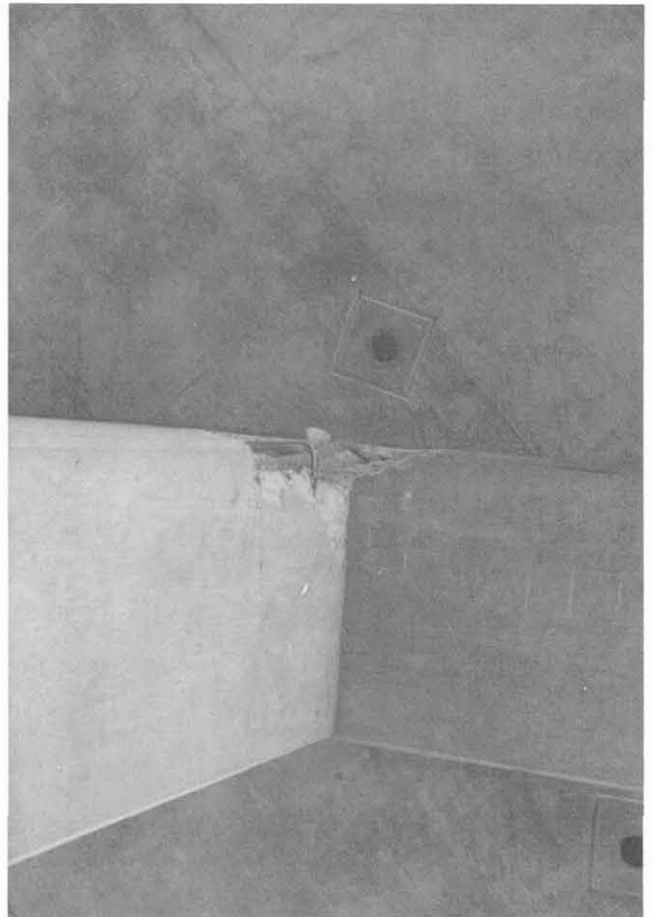
There was also evidence from the contour of the ground surface in the vicinity of the Ward Memorial bridges' southern abutment footings, and nearby column footings, that the soil had undergone large displacements. Apparently, the footings were subjected to considerable movement. However, because the surface soil was a loose and sandy silt material, no clearly defined earth edges were created. It was also found that the approach fills at the southern abutment had settled causing the pavement to sag. A settlement of 2" was noted near the paving notch, and 5" against the wingwalls.

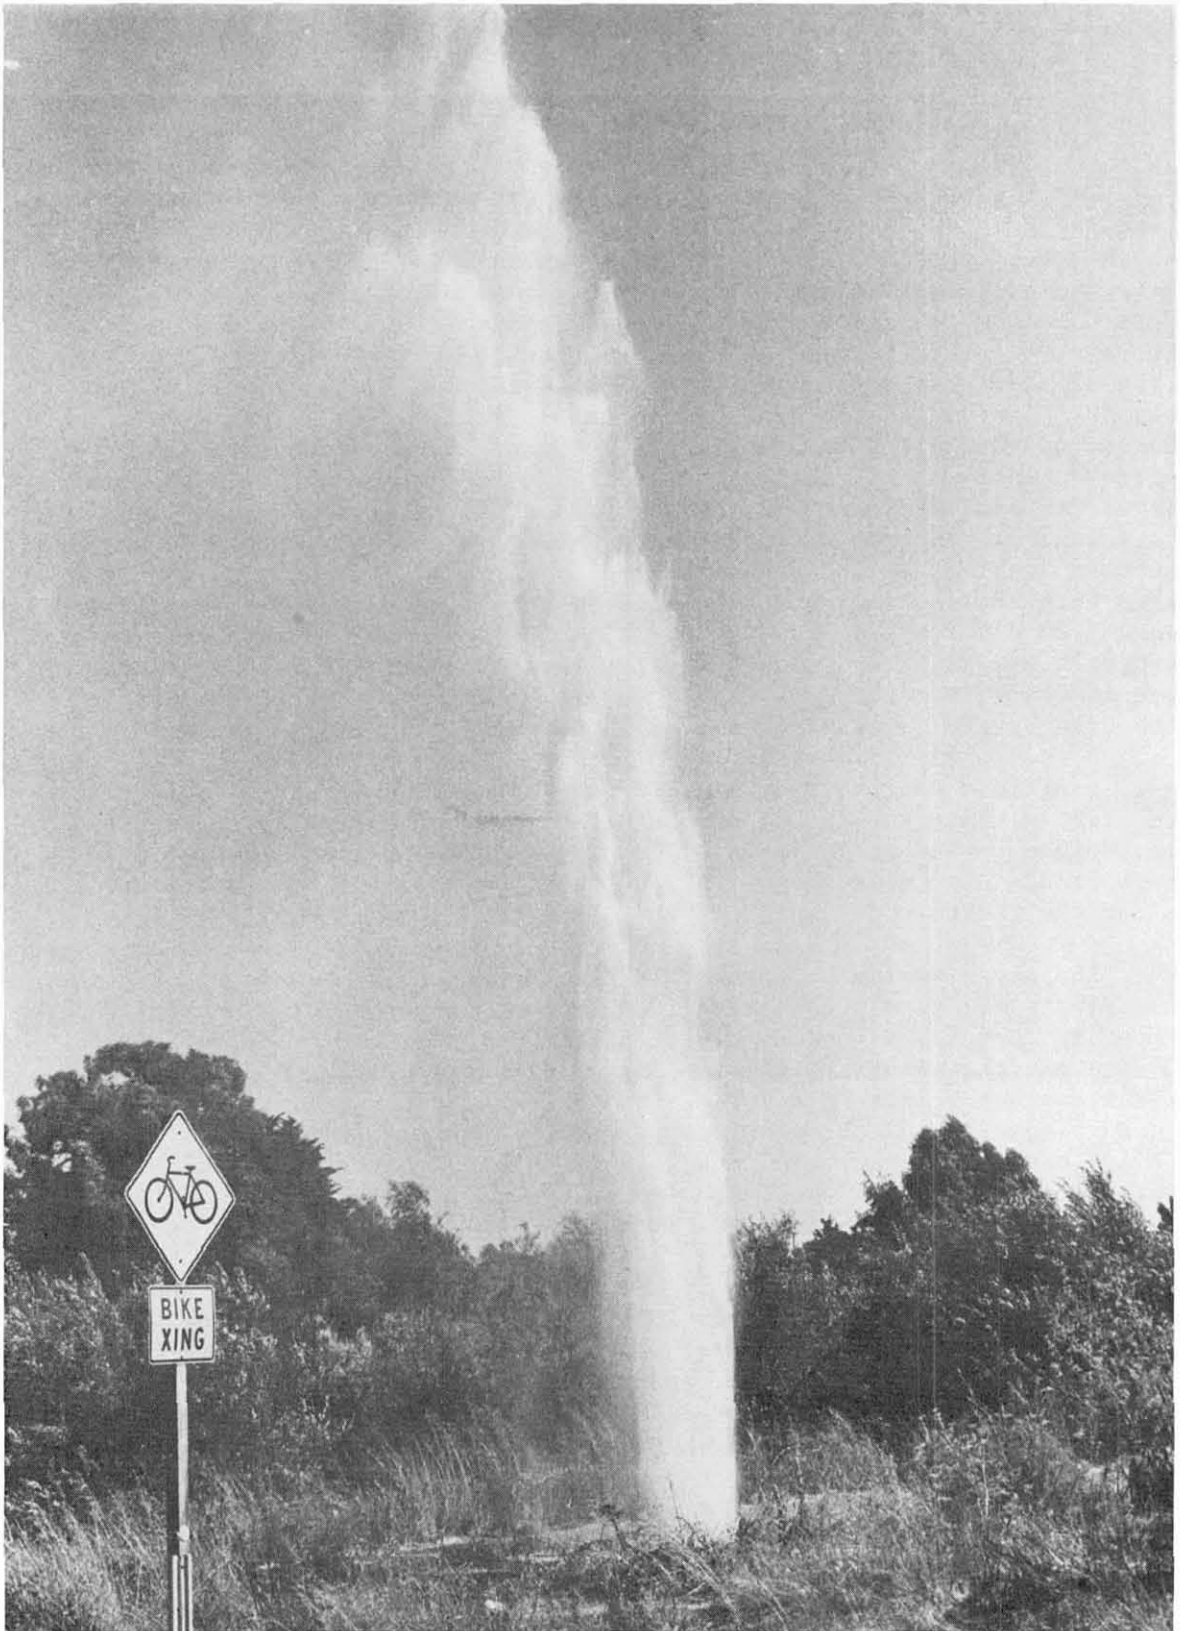
Fig. 6.1 Broken eight inch diameter water line along Los Carneros Road.
(Goleta Today photo. Reproduced by permission.)

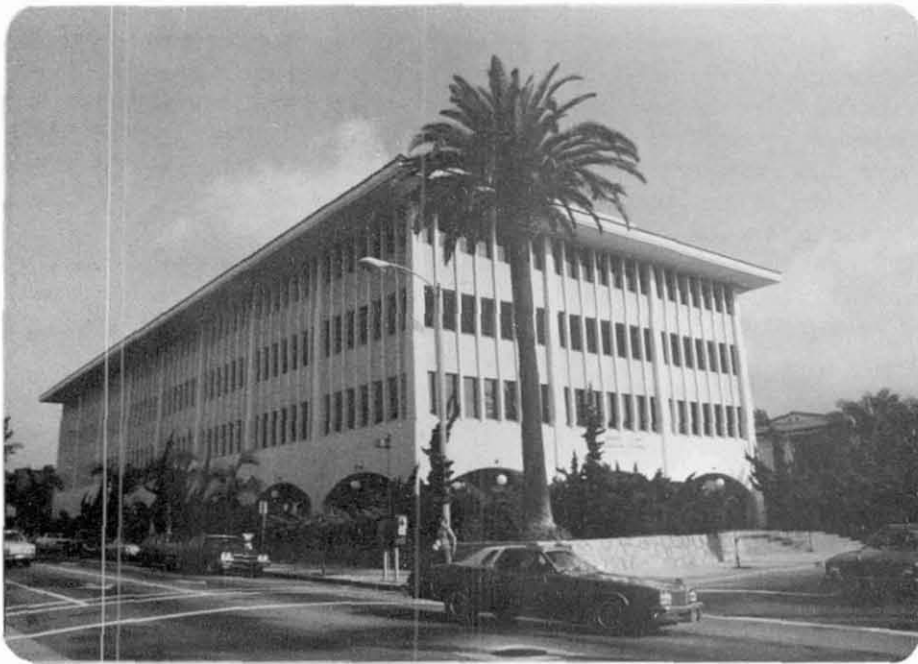
Fig. 7.1 Santa Barbara County Administration Building, a reinforced concrete rigid frame structure.

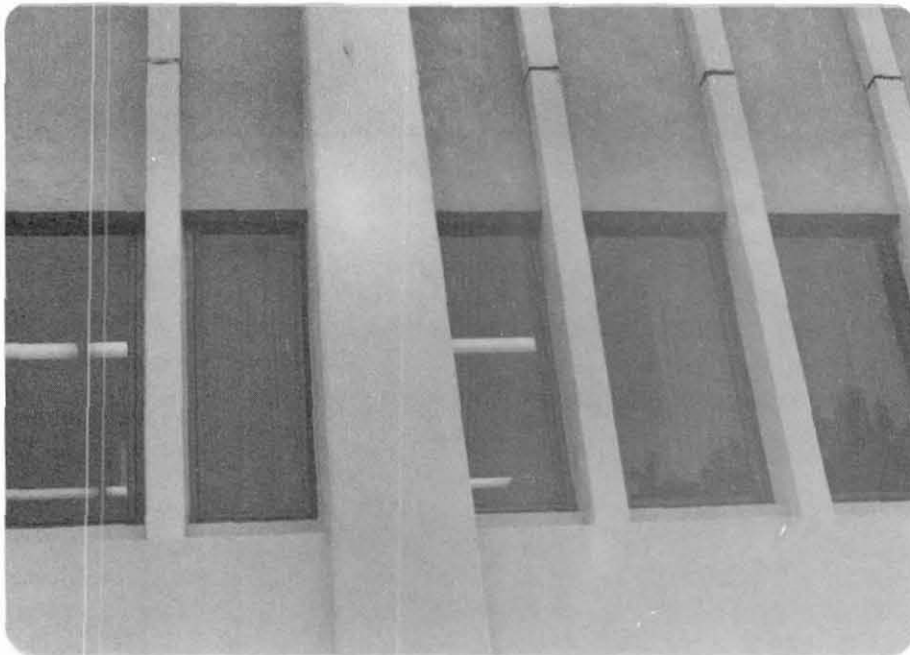
Fig. 7.2 Shear crack forming an X pattern in column in second story of Santa Barbara County Administration Building.

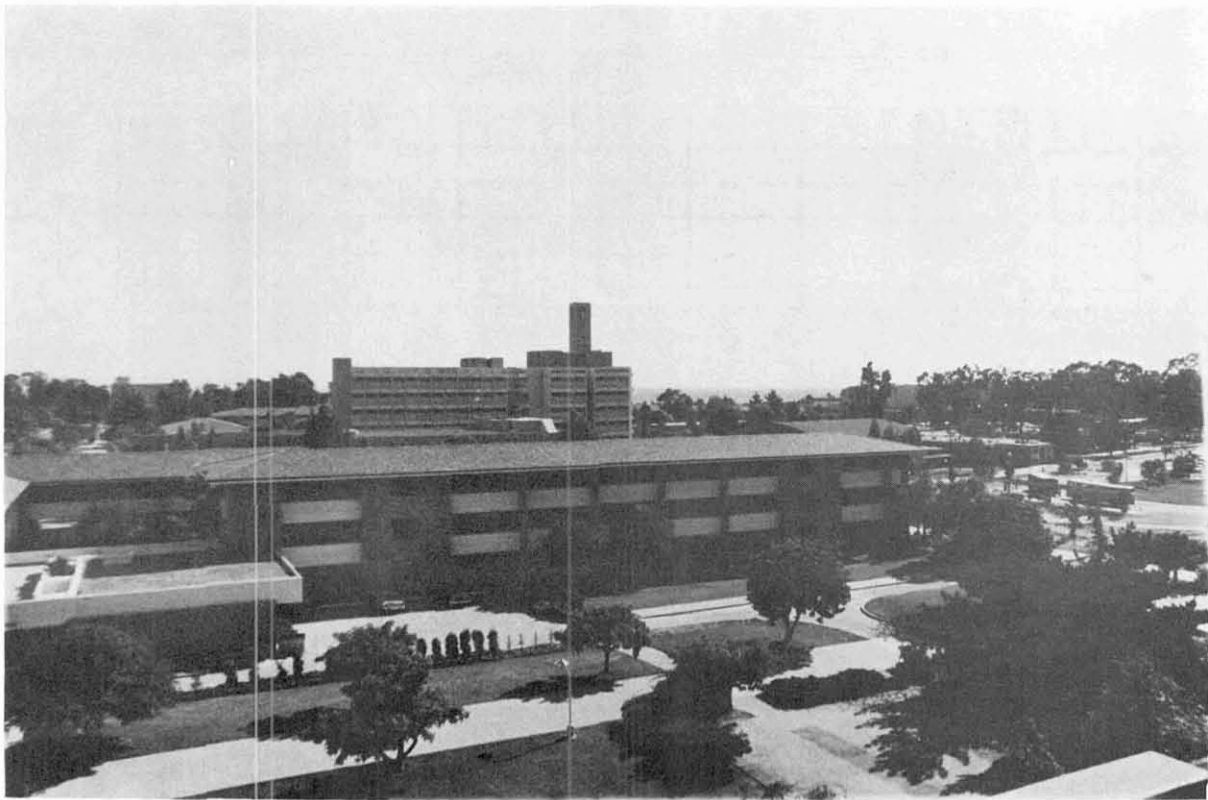
Fig. 7.3 East-west elevation of North Hall, UCSB, showing the east-west shear walls constructed during rehabilitation in 1976.

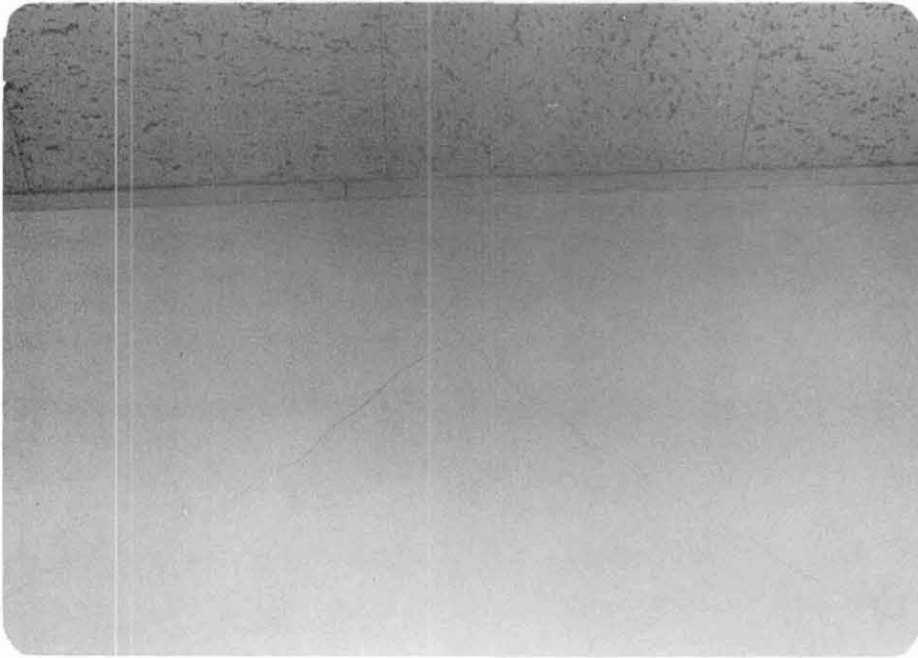
Fig. 7.11 Typical pattern of X cracking of north-south shear walls in first story of North Hall.

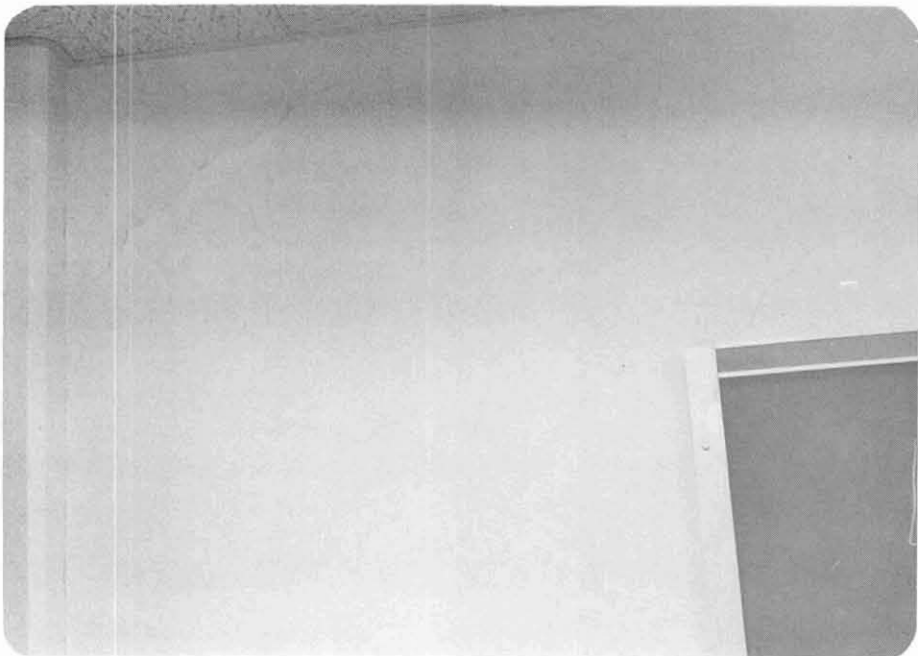
Fig. 7.12 Diagonal cracking of north-south shear wall in first story of North Hall. Vertical member at left is an interior column.

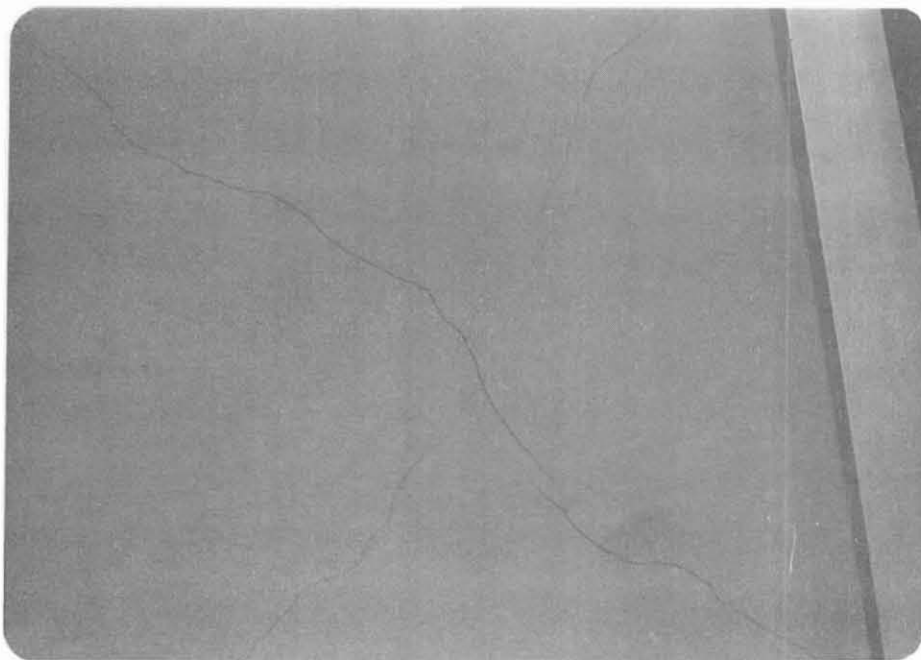
Fig. 7.13 Close up of cracking of shear wall in Fig. 7.12. Orientation is provided by the vertical black-board frame at right.

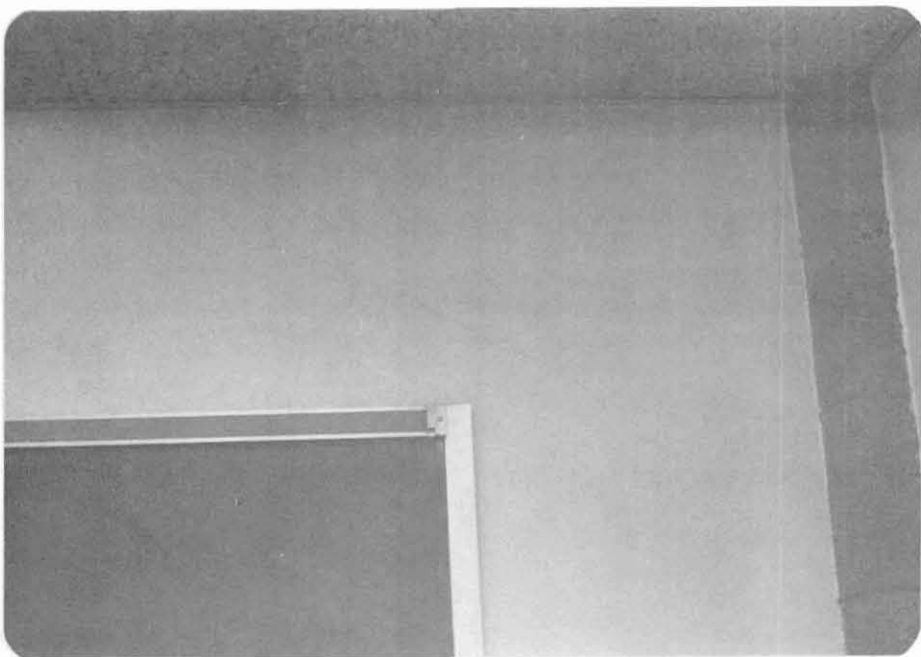
Fig. 7.14 More diagonal cracking of the same shear wall shown in Figs. 7.12 and 7.13.
