university of california • santa barbara

NSF/RA- 780550

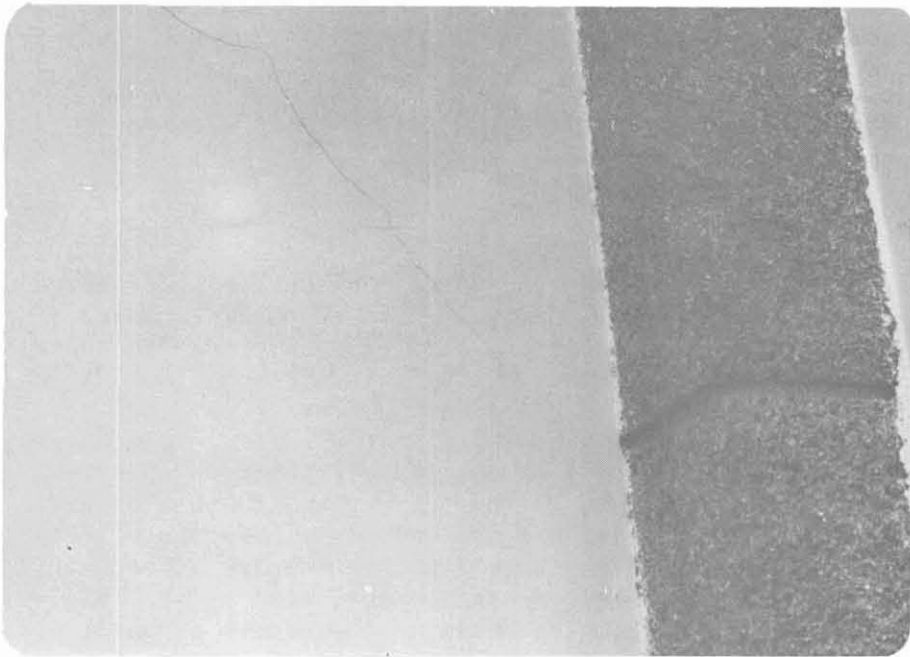
Fig. 7.15 Close up of right edge of diagonal crack in shear wall shown in Fig. 7.14. Vertical member is an exterior column.

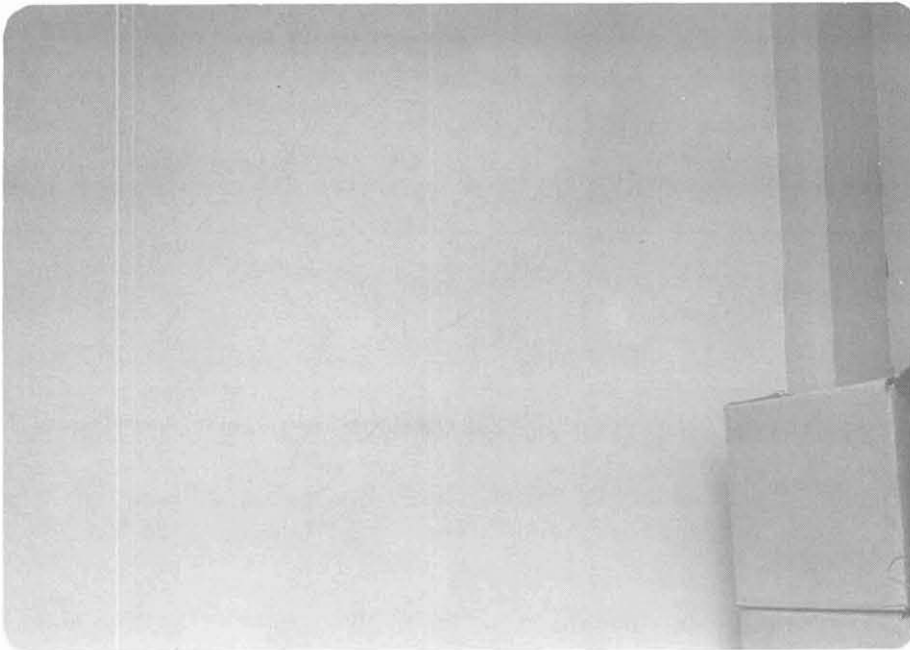
Fig. 7.16 Diagonal crack in north-south shear wall, North Hall.

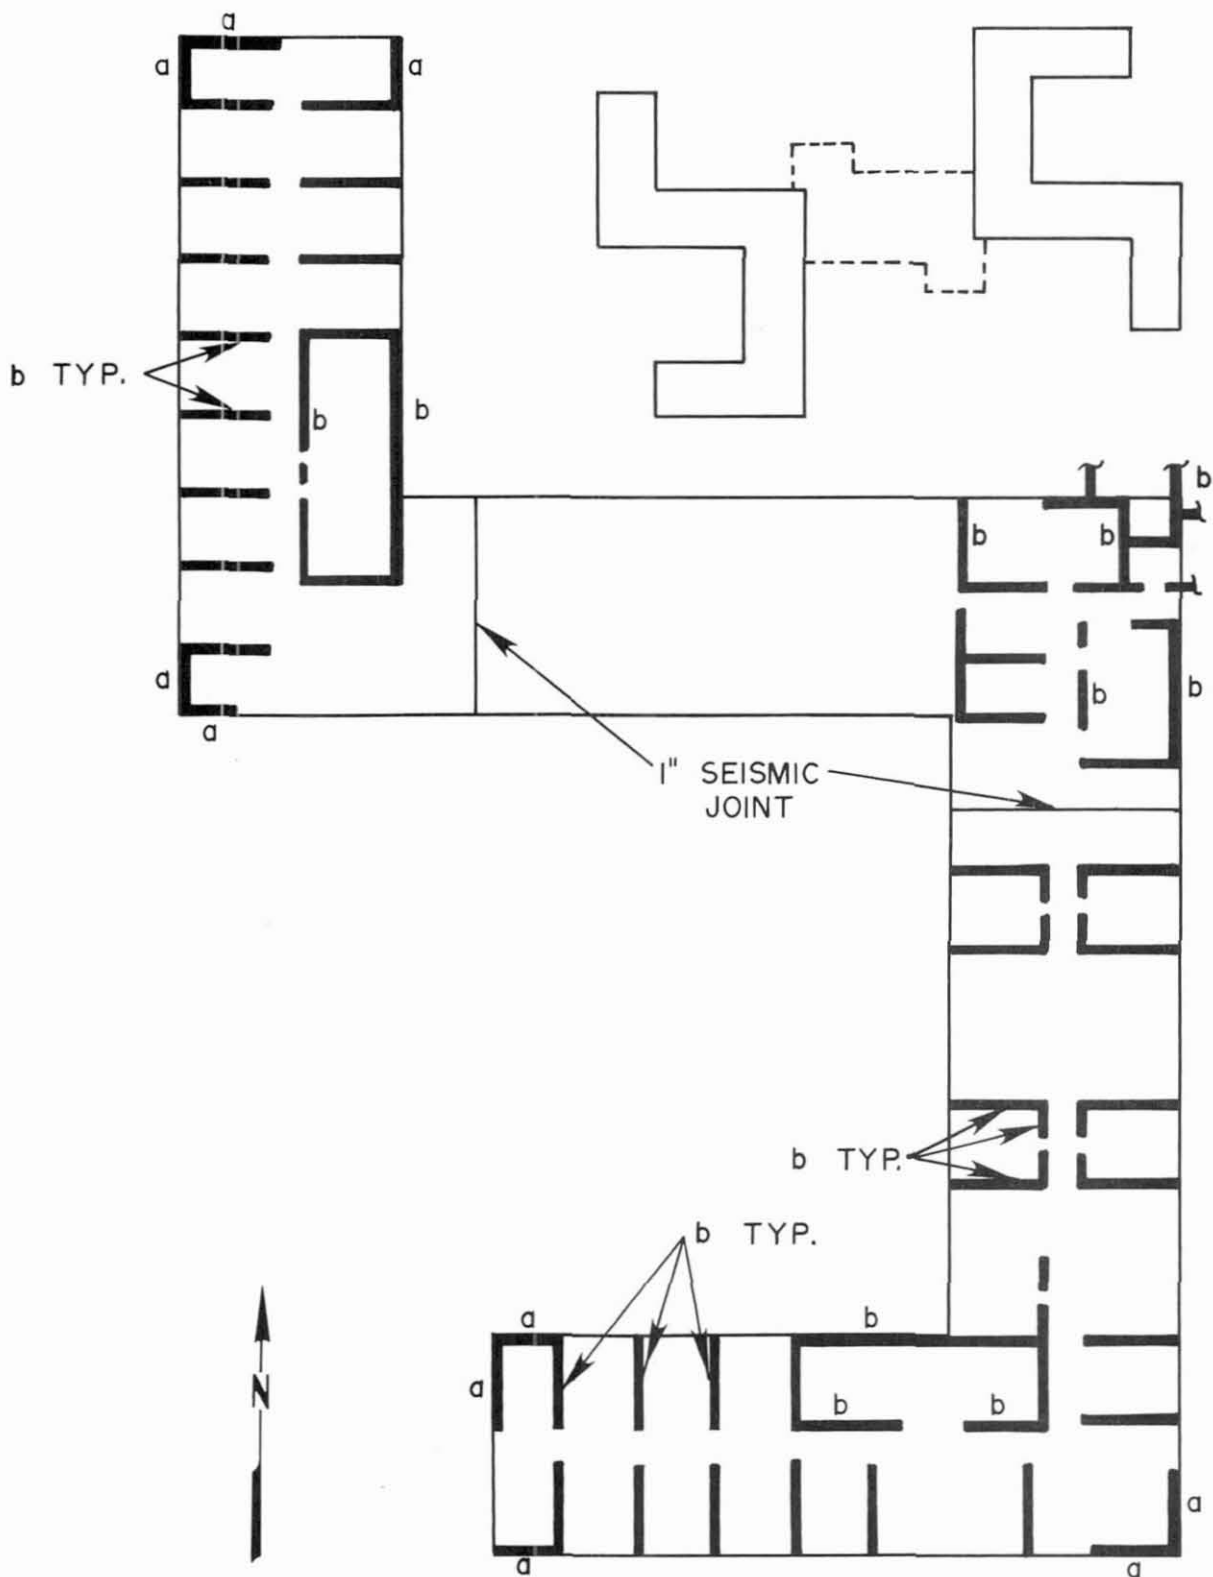
Structural damage to Anacapa Residence Hall caused by the earthquake consisted of extensive cracking of the concrete block shear walls in several wings. The most severe cracking occurred in the north-south

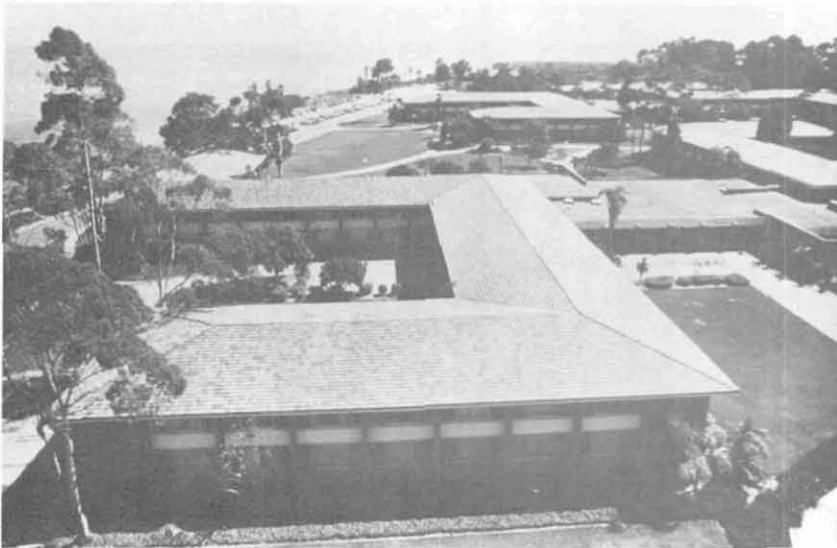
Fig. 7.19 Anacapa Residence Hall, UCSB.

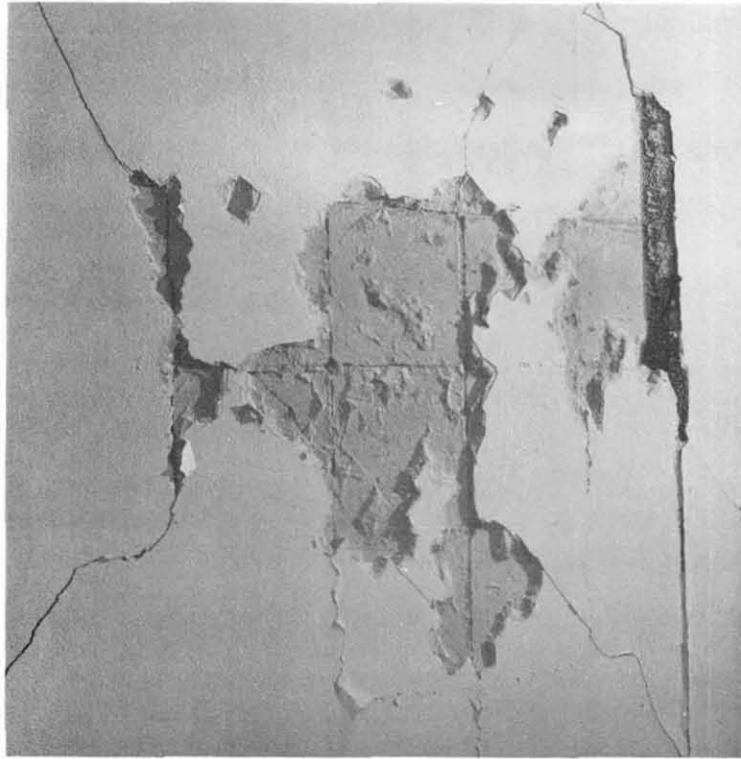
Fig. 7.20 Diagonal cracks in north-south shear wall in first story of Anacapa Residence Hall.

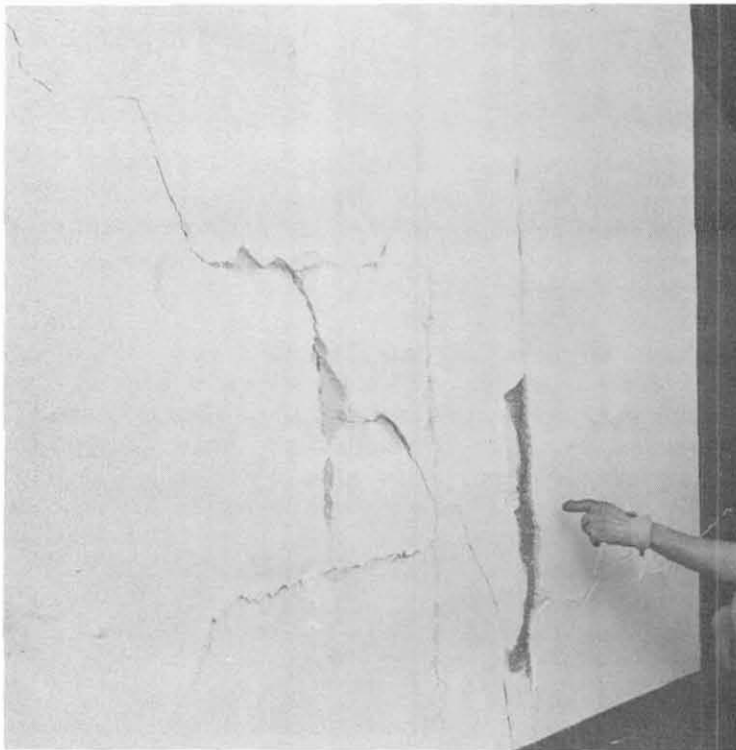
Fig. 7.21 More diagonal cracks in north-south shear walls in first story of Anacapa Residence Hall.

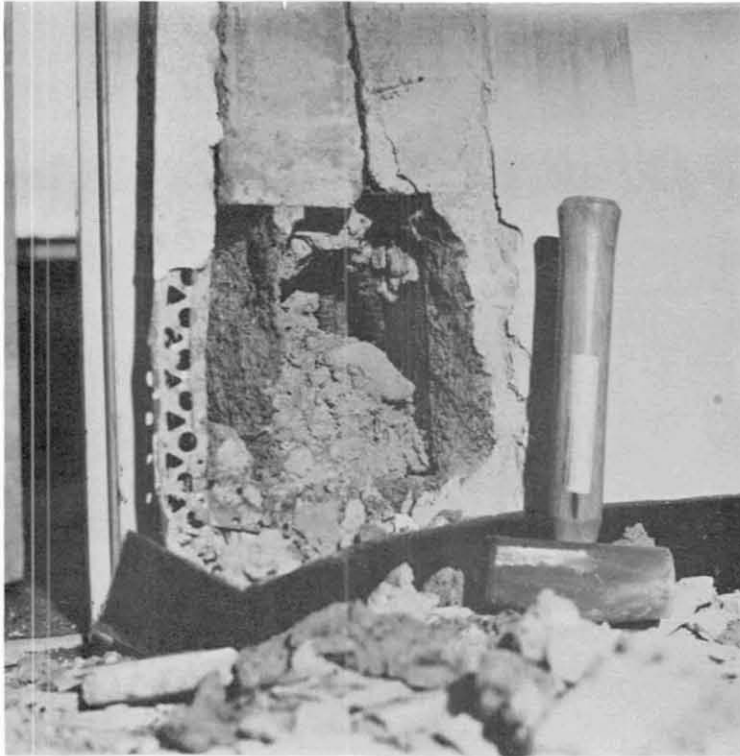
Fig. 7.22 Face of concrete block removed to expose ungrouted reinforcing steel, shear wall in Anacapa Residence Hall.

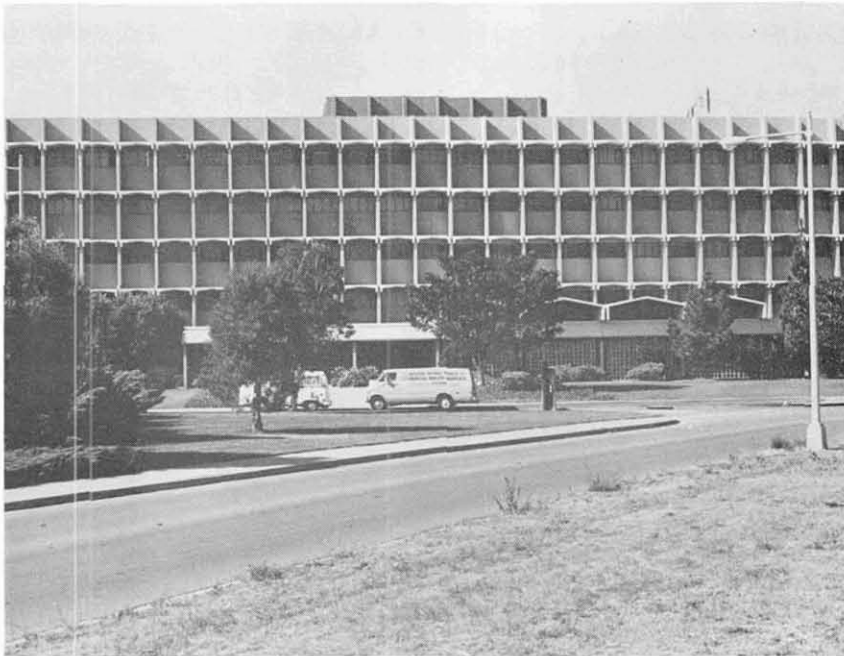
Fig. 7.26 Engineering Building UCSB. (View from south).

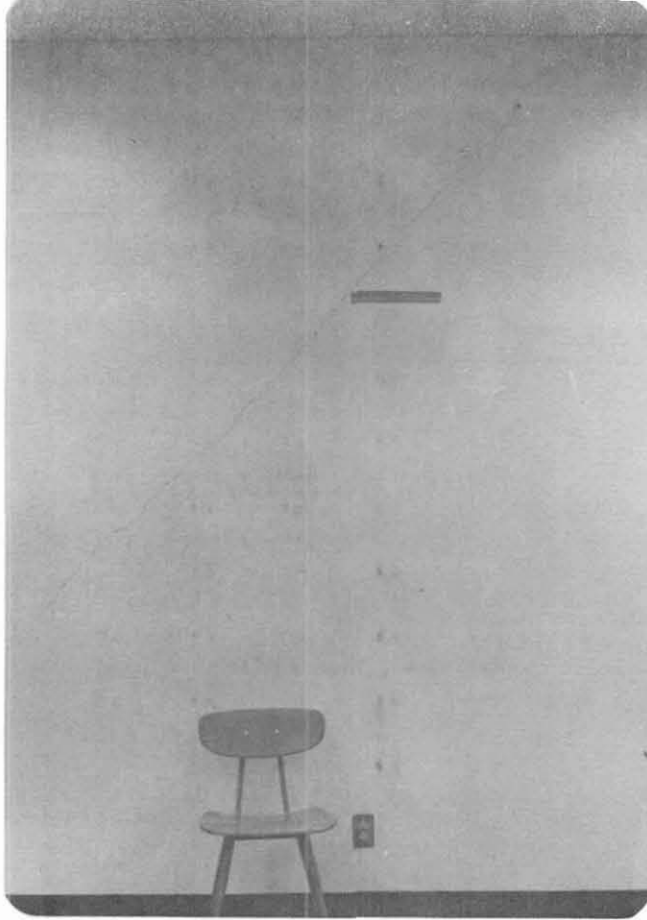
Within a five mile radius of the UCSB campus there are a number of commercial buildings which received significant earthquake damage.

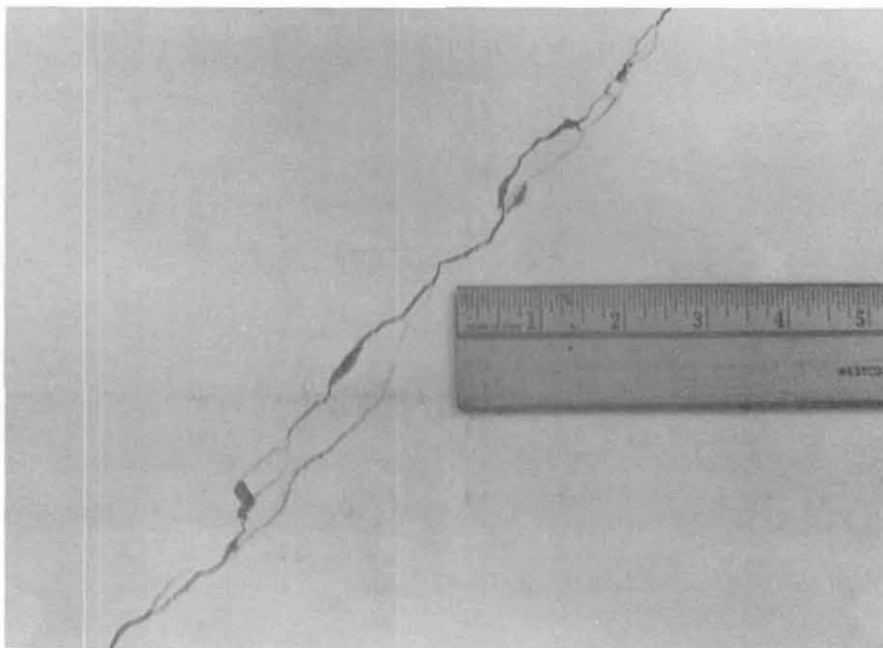
Fig. 7.28 Close up view of crack shown in Fig. 7.27.

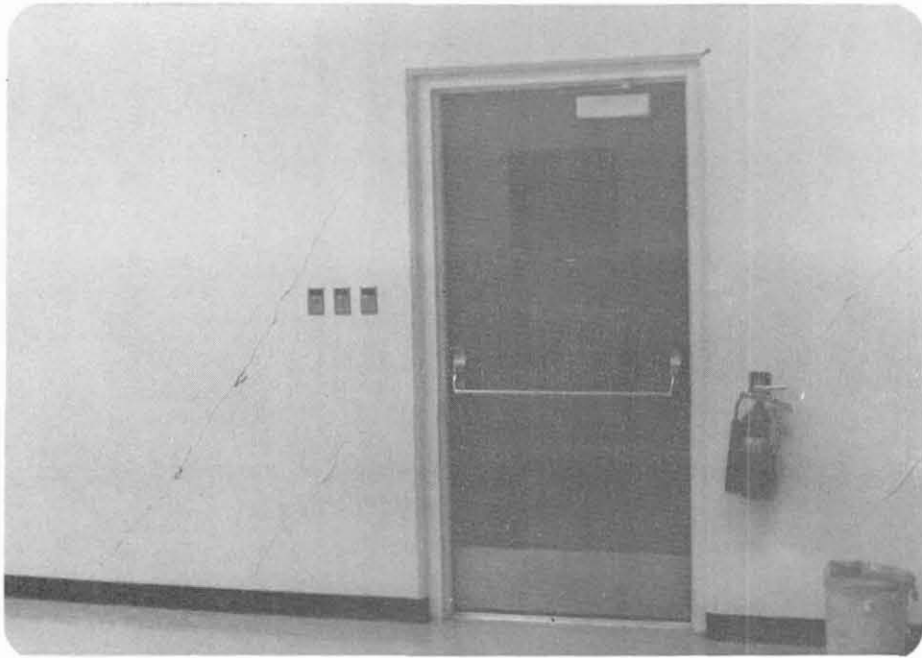
Fig. 7.29 Diagonal cracks in east-west shear wall in first story of Engineering Building, UCSB.

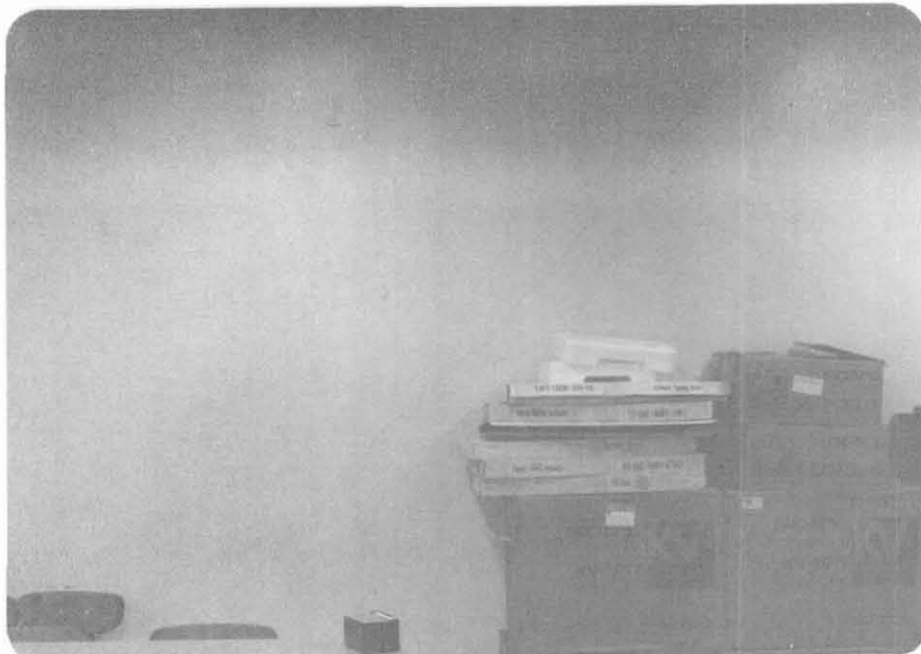
Fig. 7.30 Cracks in another portion of the north-south shear wall in the first story of Engineering Building, UCSB.

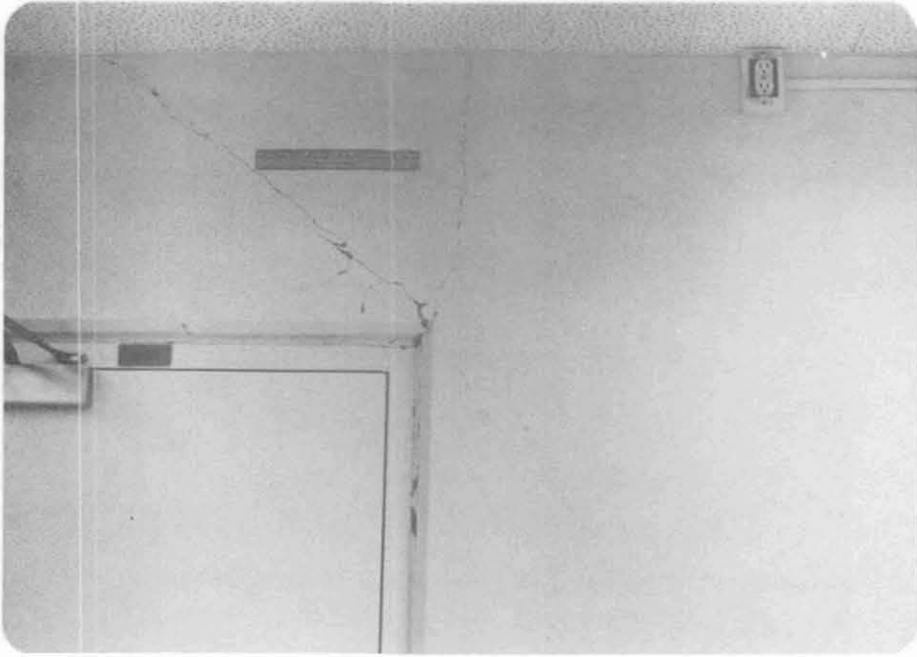
Fig. 7.31 Cracks in header over doorway in north-south shear wall in third story of Engineering Building, UCSB.

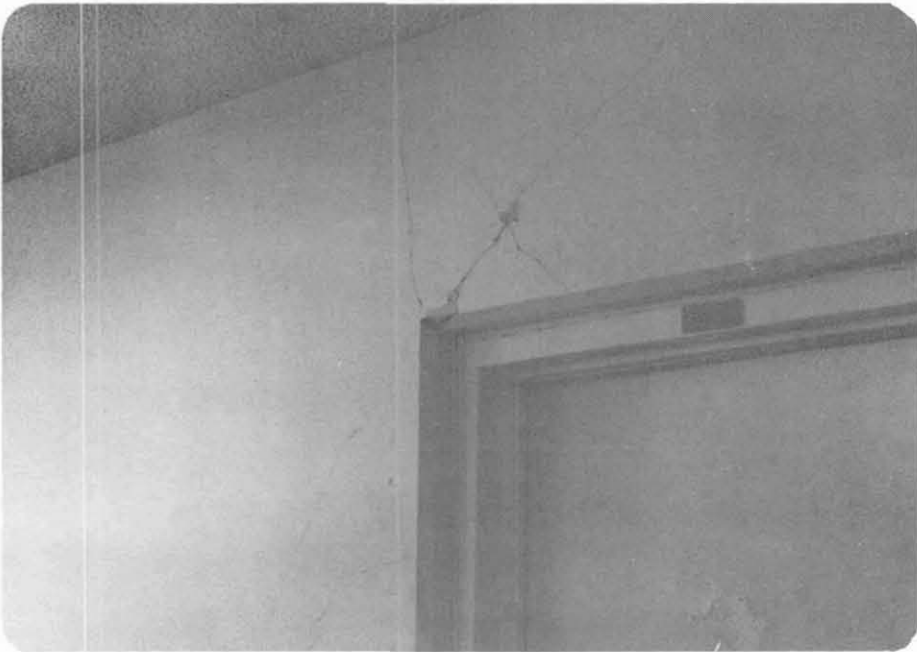
Fig. 7.32 Cracks in reverse side of shear wall shown in Fig. 7.31.

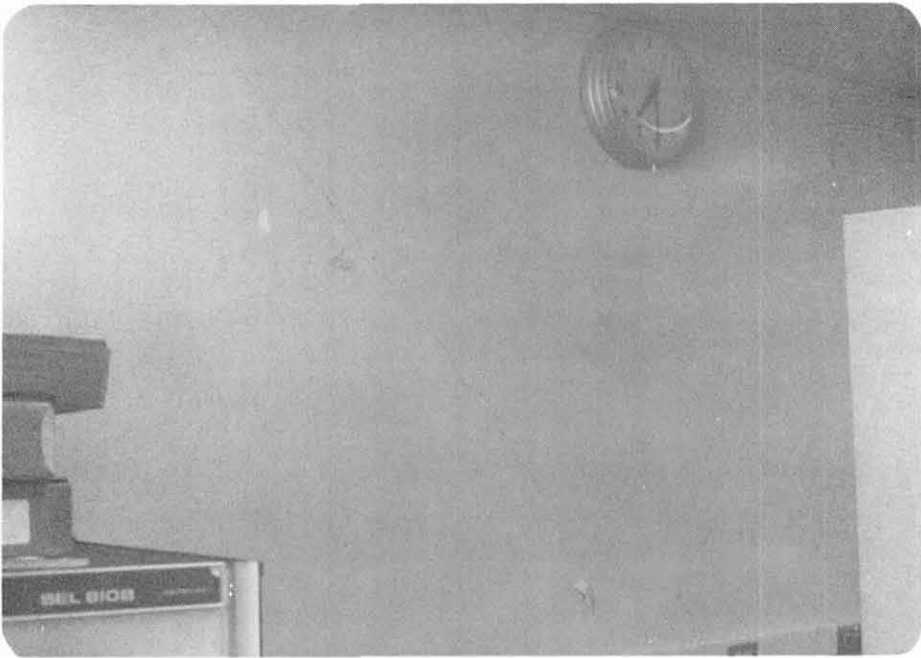
Fig. 7.33 Diagonal crack in north-south shear wall in third story of Engineering Building, UCSB.

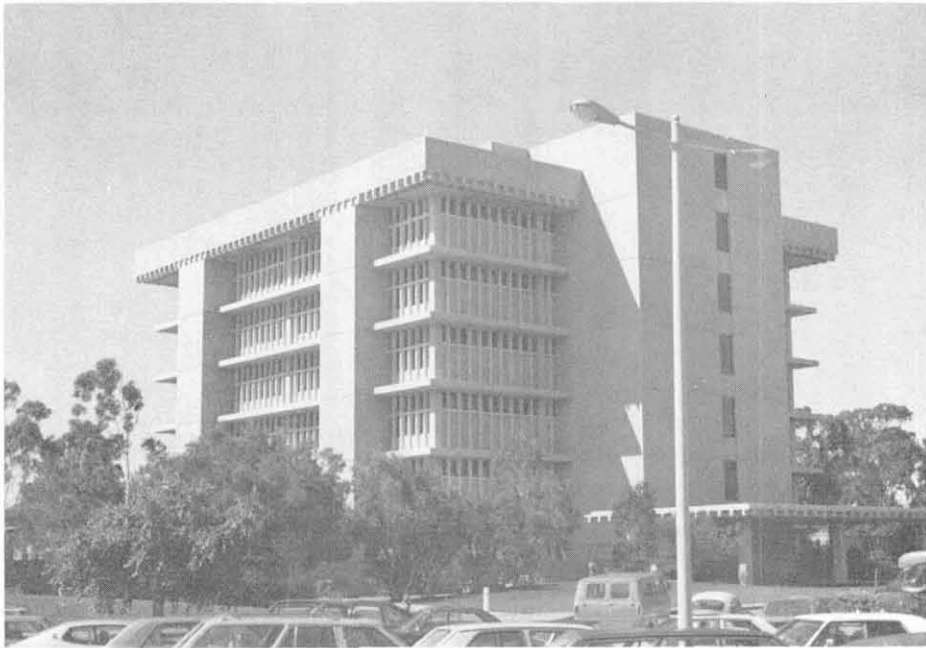
Fig. 7.34 Biological Science II Building, UCSB. (View from northeast).

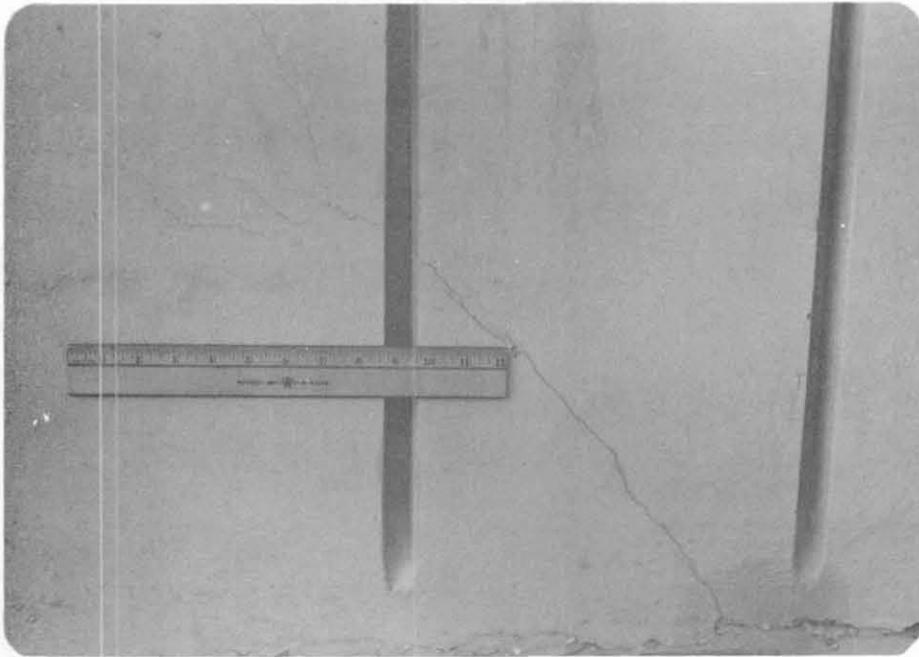
Fig. 7.35 Cracks in exterior of east-west shear wall near base of south stair tower of Biological Science II Building, UCSB.

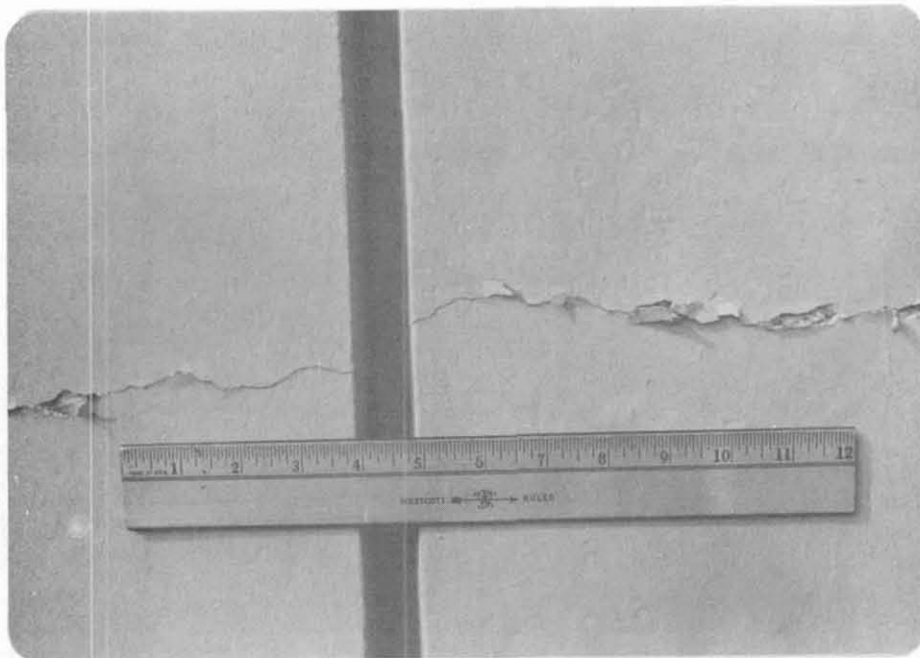
Fig. 7.36 Nearly horizontal cracks in east-west shear wall near base of south stair tower of Biological Science II Building, UCSB.

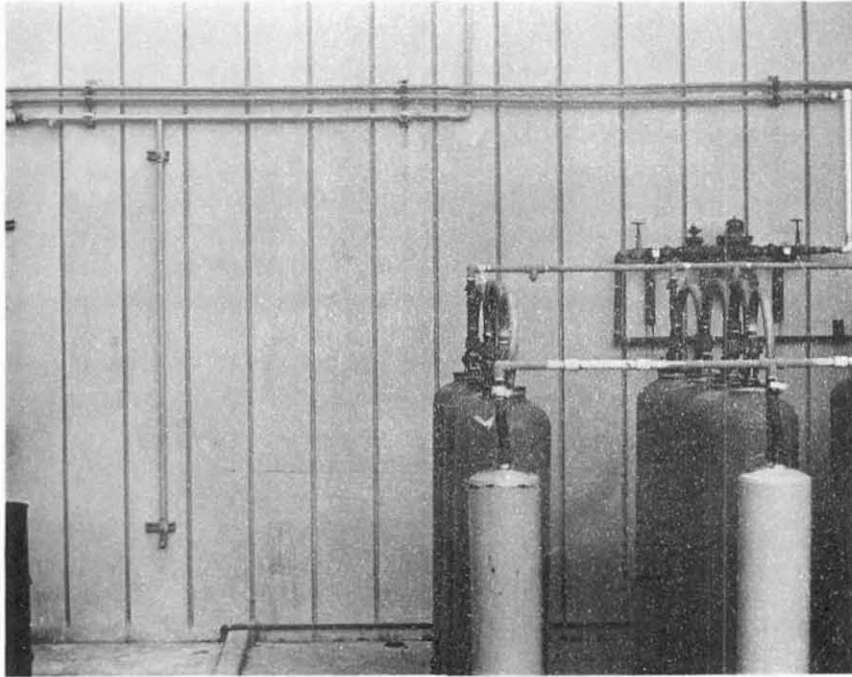
Fig. 7.37 Diagonal crack in north-south shear wall near base of north stair tower of Biological Science II Building, UCSB. (View from west).

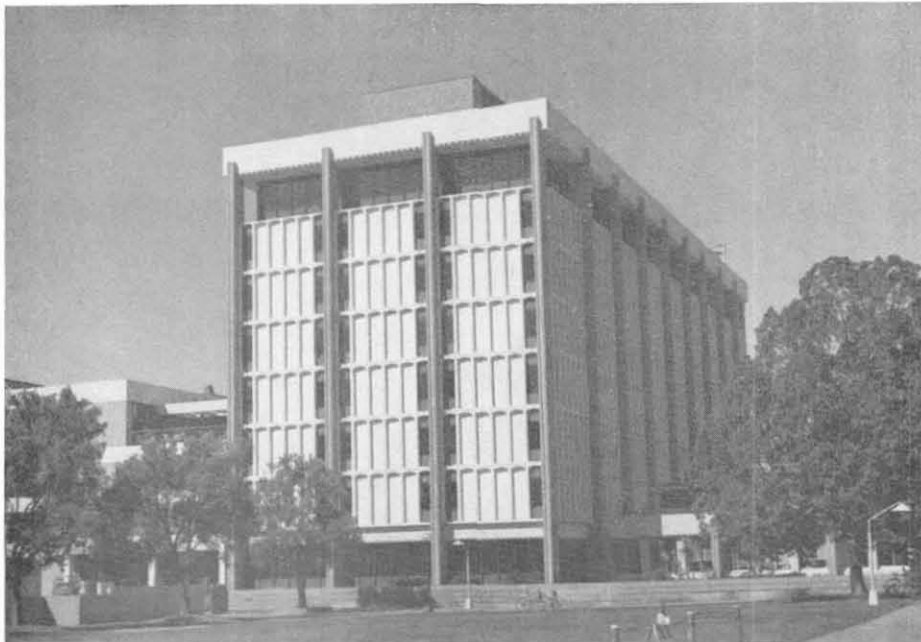
Fig. 7.38 Eight story Library III Building, UCSB. This building also sustained cracks in shear walls in lower stories.

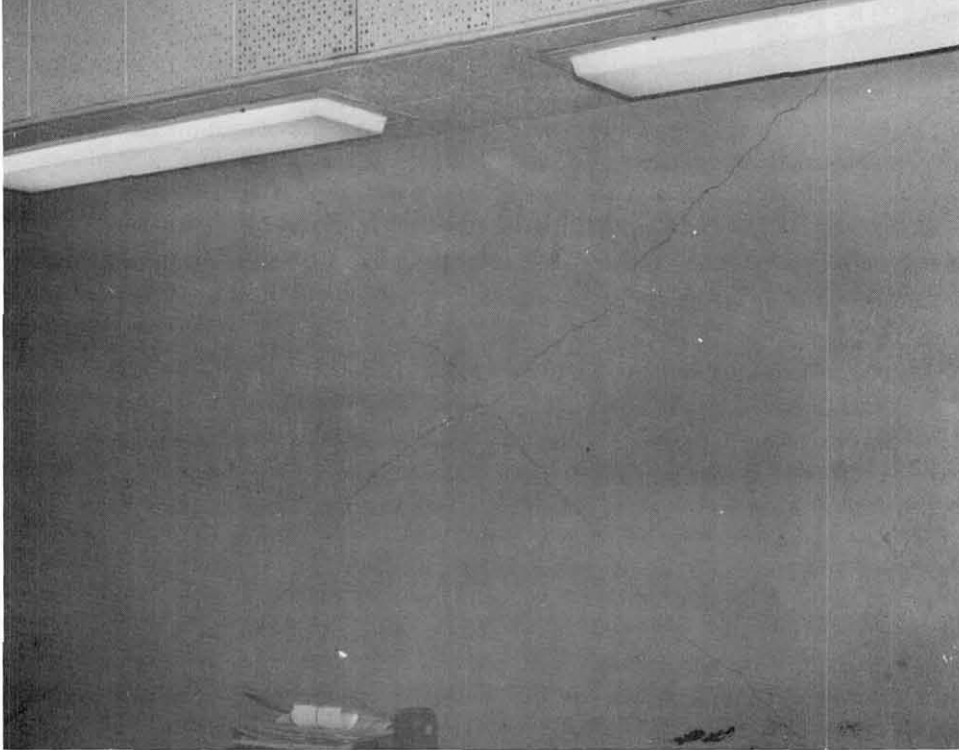
Fig. 7.39 Pattern of X cracks in 10 inch thick R/C shear wall at east end of first story of Administration Building, Delco Electronics facilities.

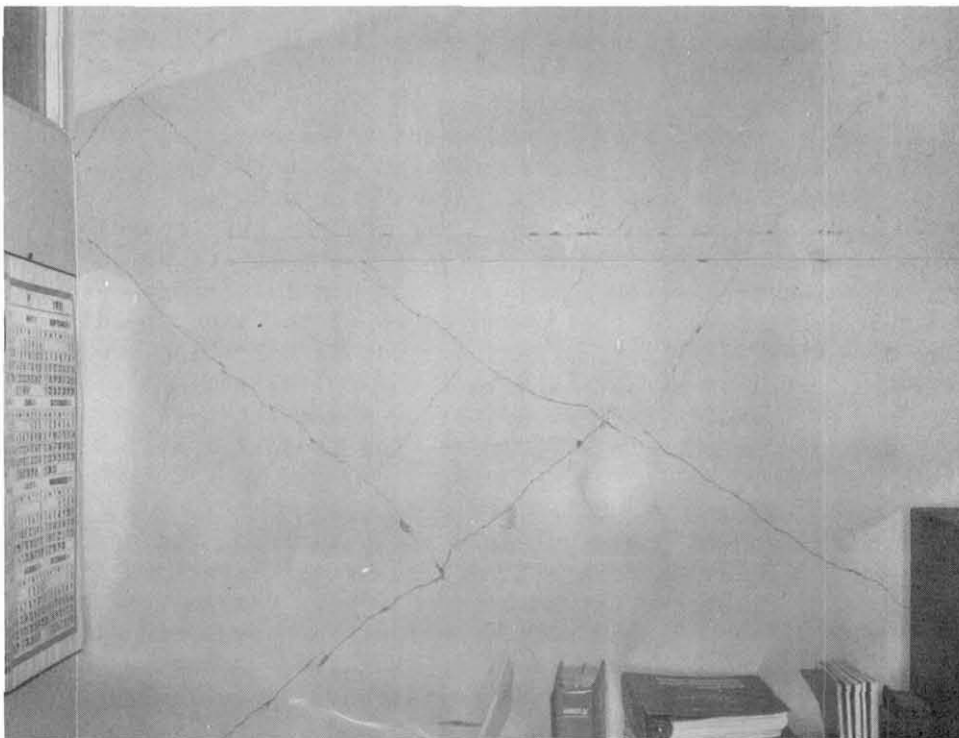
Fig. 7.40 Pattern of X cracks in shear wall at west end in first story of Administration Building, Delco Electronics facilities.

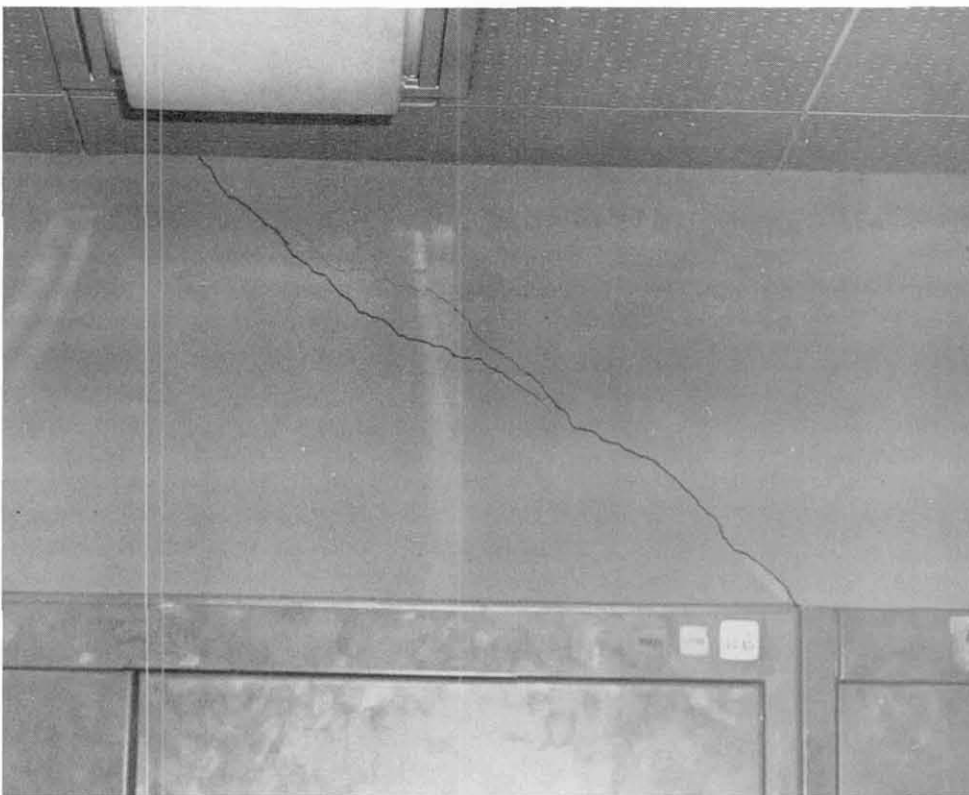
Fig. 7.41 Diagonal crack in shear wall near center stair tower in second story of Administration Building, Delco Electronics facilities.

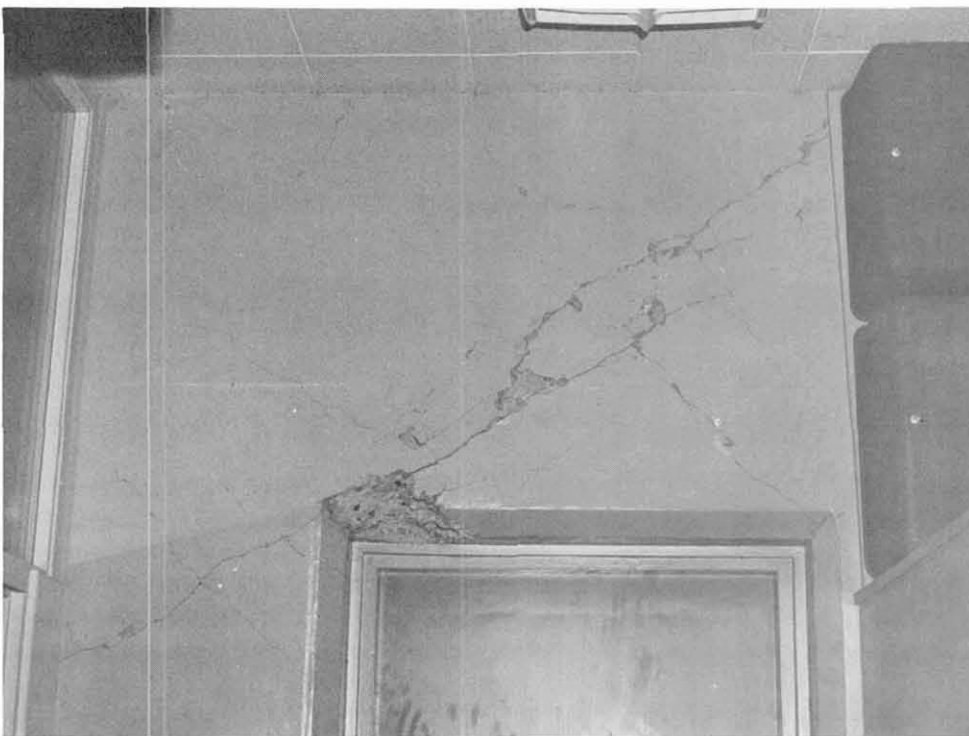
Fig. 7.42 Cracks in shear wall over doorway at west end in first story of Administration Building, Delco Electronics facilities.

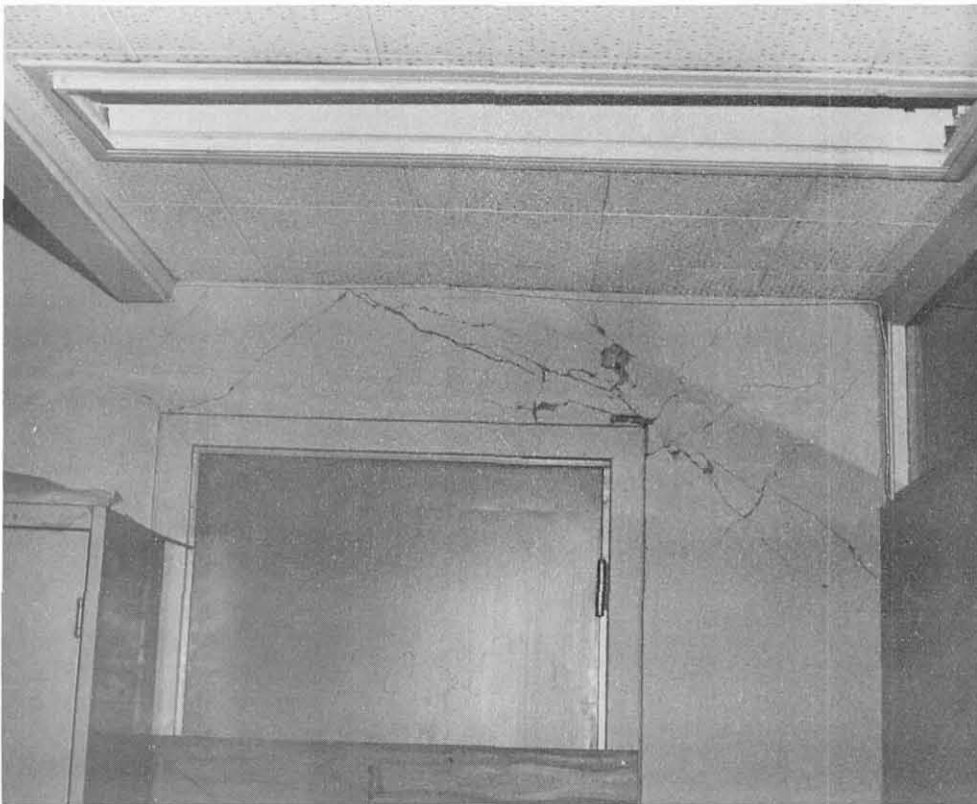
Fig. 7.43 Cracks in reverse side of shear wall shown in Fig. 7.42.

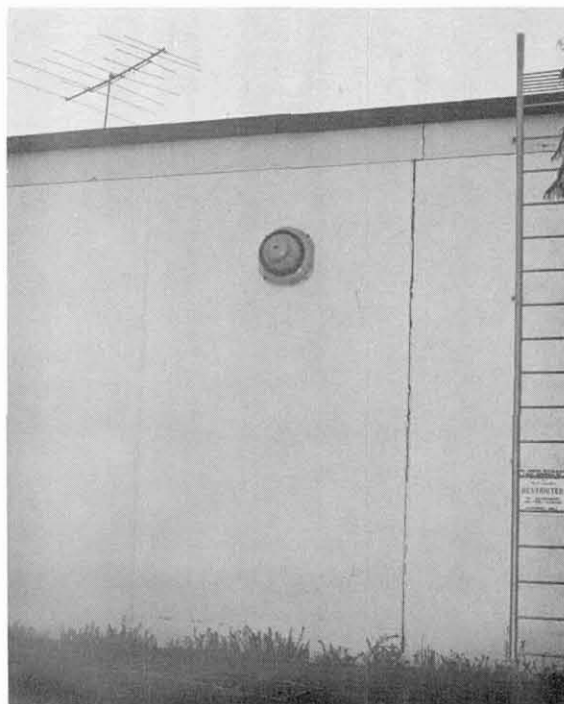
Fig. 7.44 Cracks at joints between precast concrete tilt-up panels, Research and Development Building, Delco Electronics facilities.

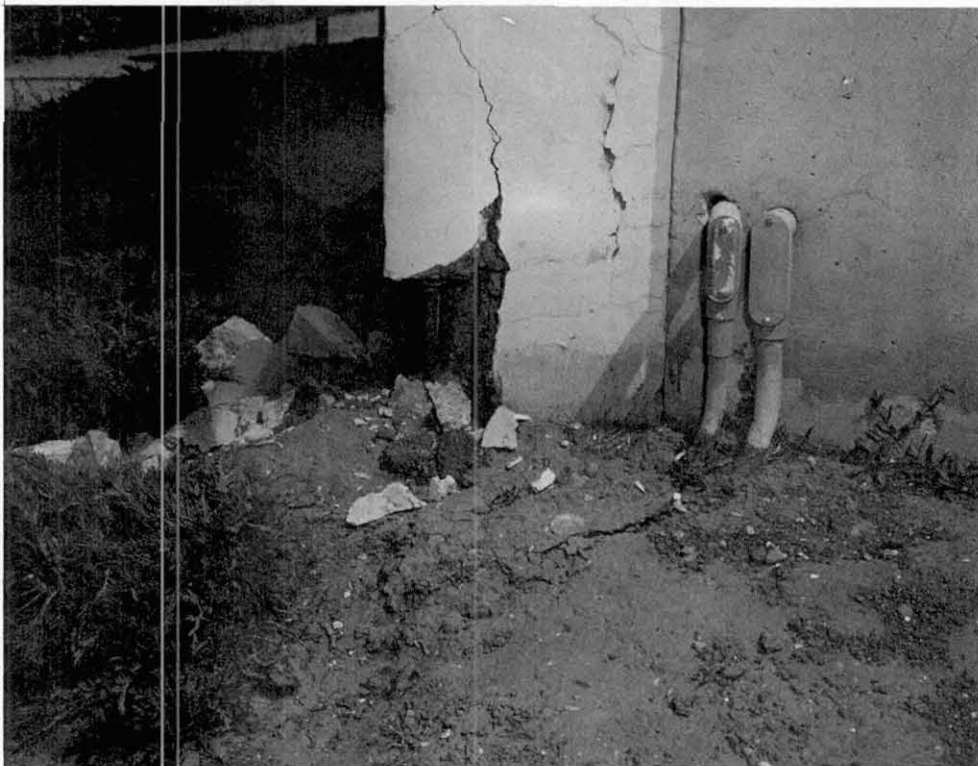
Cracks at joints between panels and doors, Research and Development Building, Delco Electronics facilities.

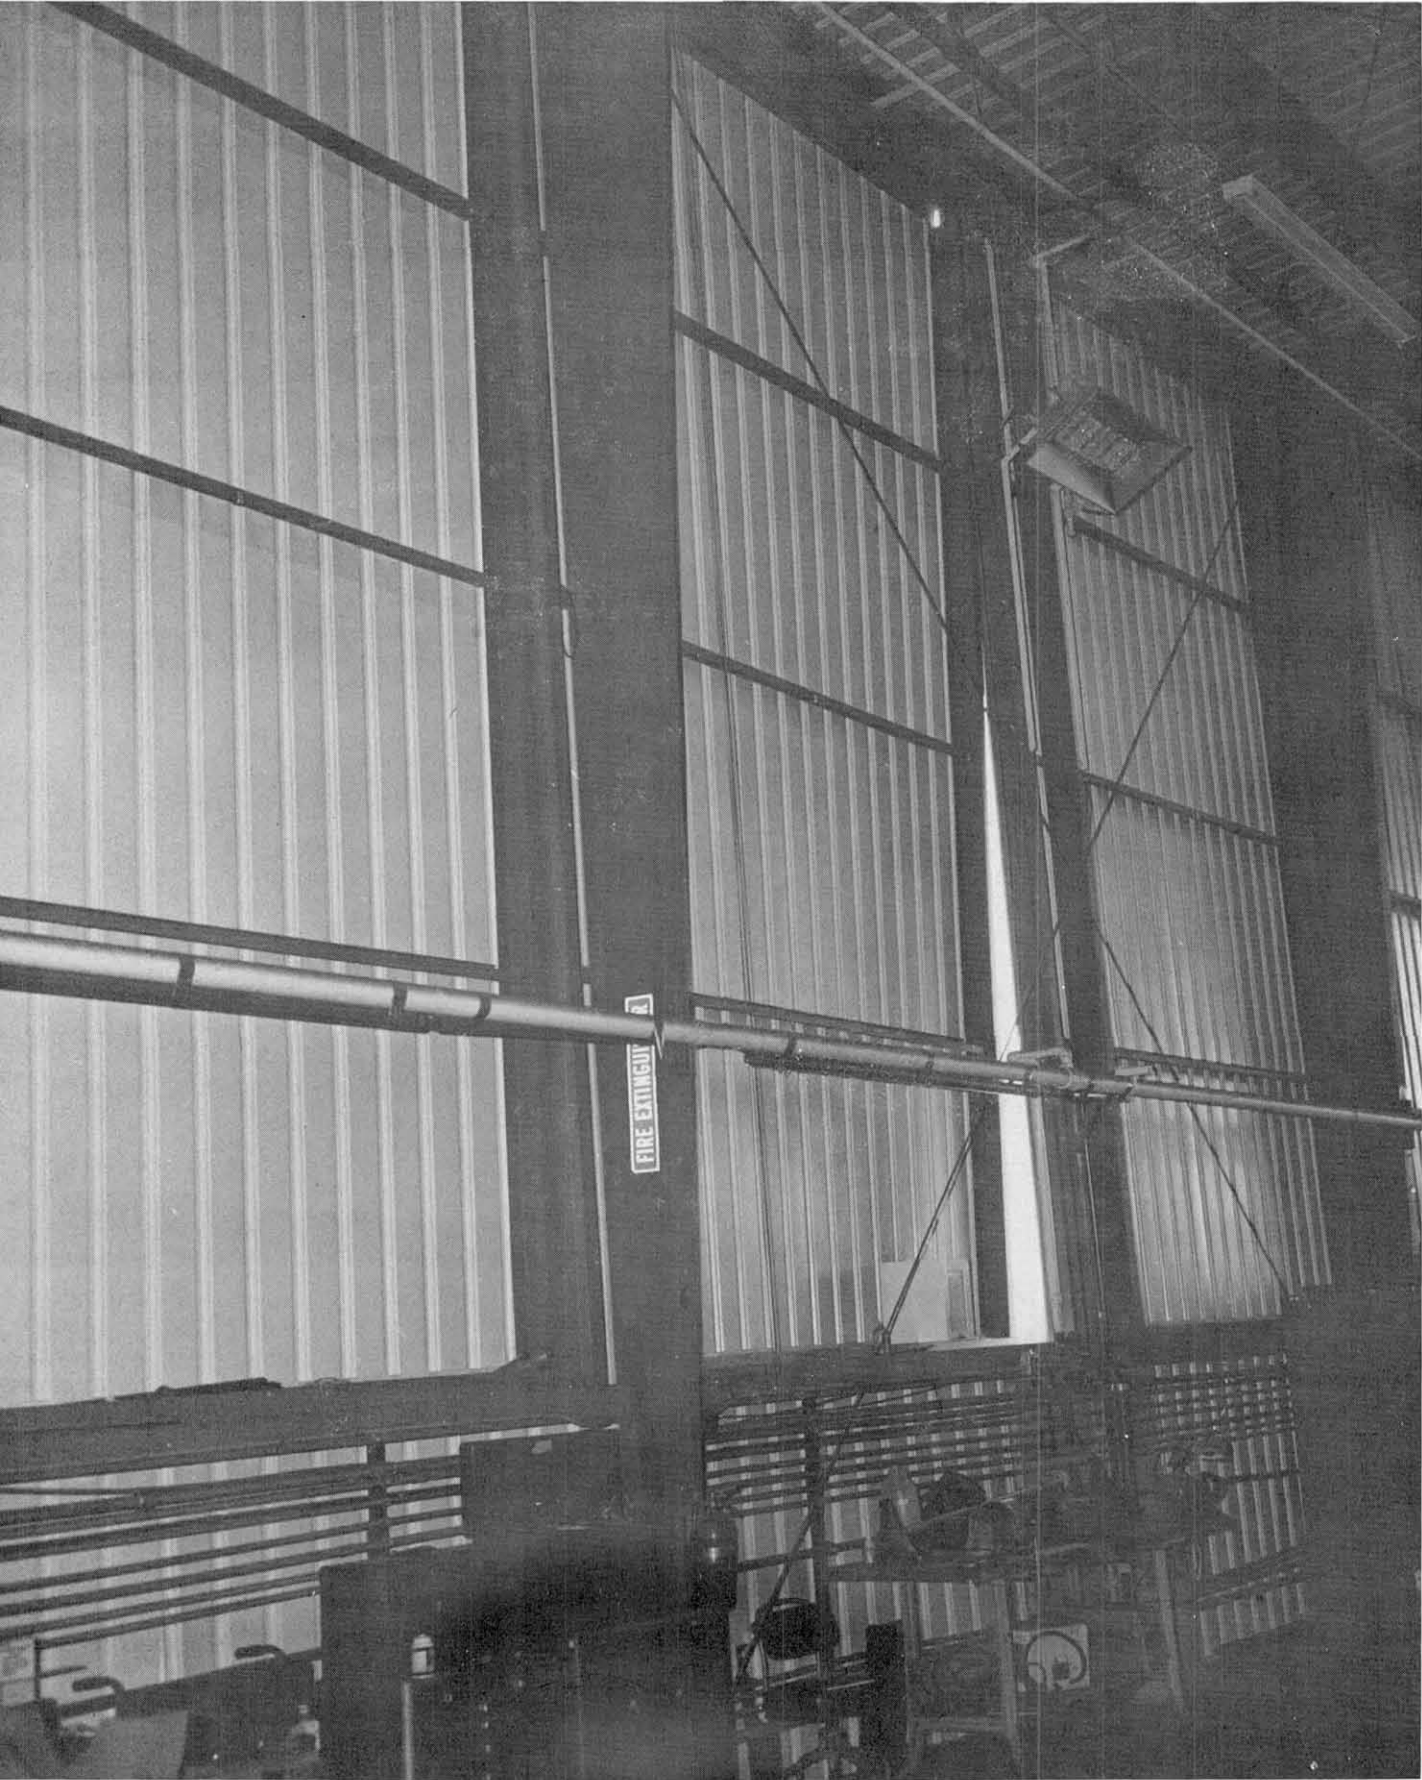
Fig. 7.47 Explosion panel which broke loose at the corner during the earthquake, Flight Physics Laboratory, Delco Electronics facilities.

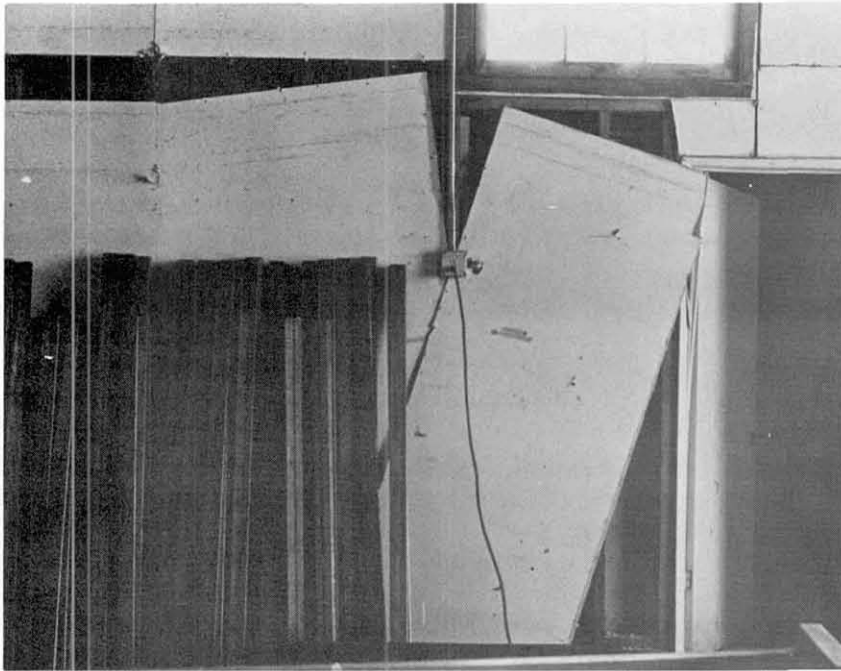
Fig. 7.48 Wall panels were torn loose from wood studs in single story commercial building at the Santa Barbara Municipal Airport.

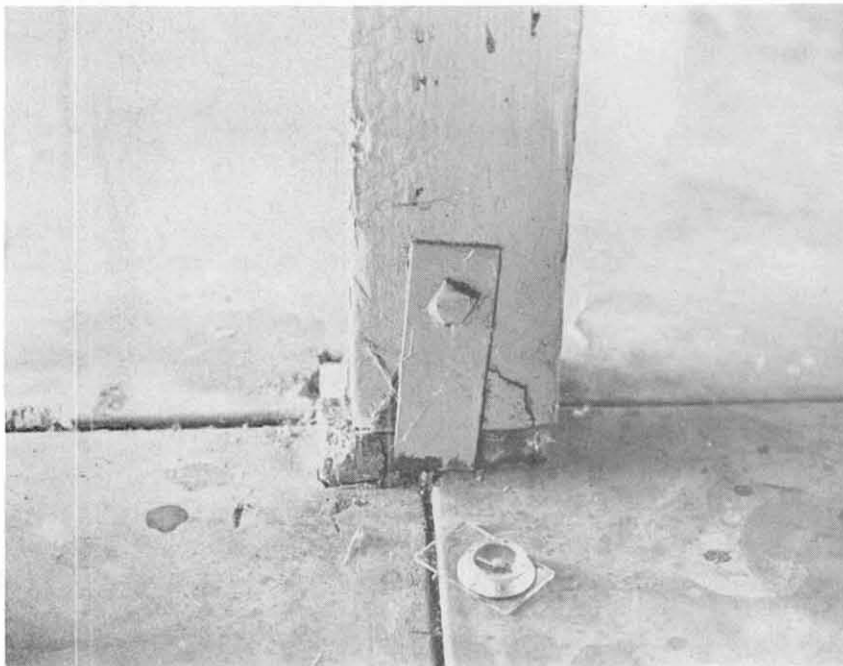
Fig. 7.49 Wood column shifted north in single story commercial building at the Santa Barbara Municipal Airport.

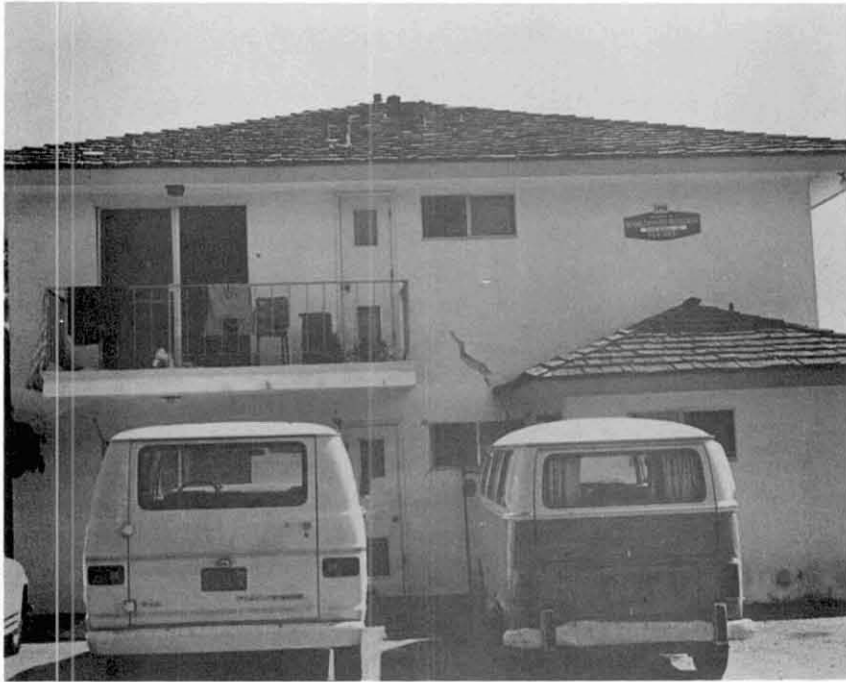
Fig. 7.50 Cracks in exterior plaster walls of two story residential building in Isla Vista.
