university of california • santa barbara

NSF/RA- 780550

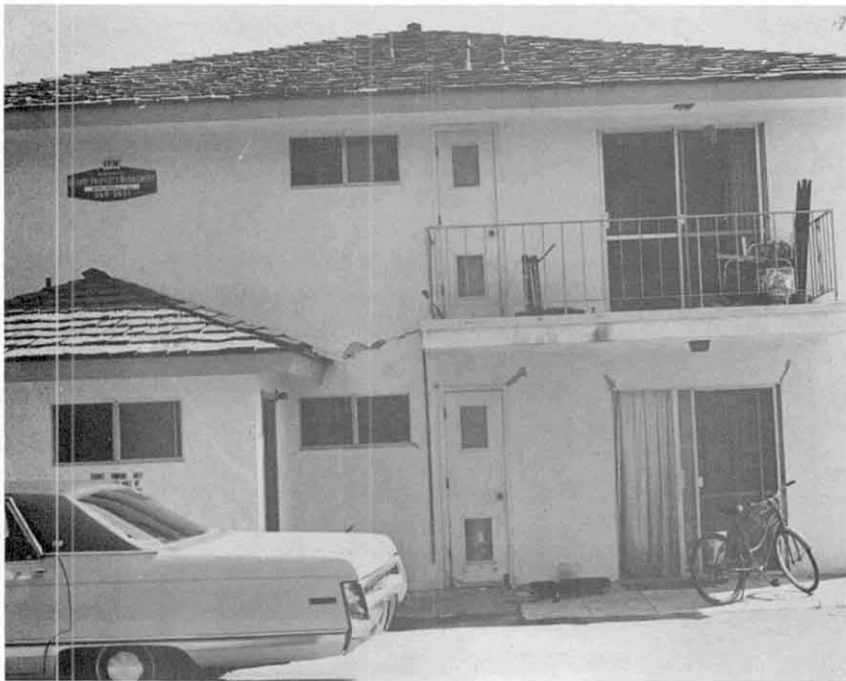
Fig. 7.51 Cracks in exterior plaster walls of two story residential building in Isla Vista.

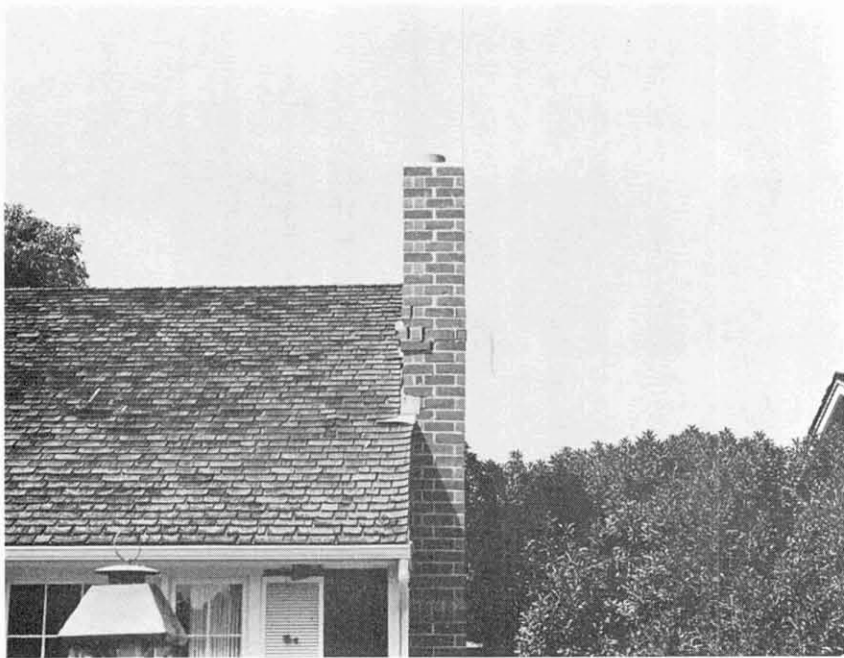
Fig. 7.52 Damage to chimney on modern residence in Isla Vista.

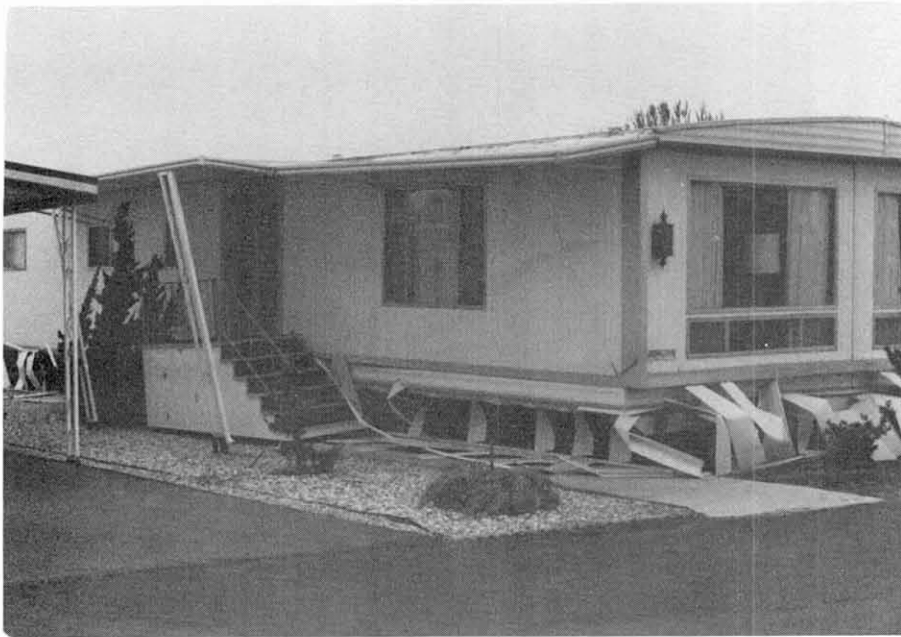
Fig. 7.53 Mobile home which was shaken off its foundation at Santa Barbara West Mobile Home Park on Winchester Canyon Road.

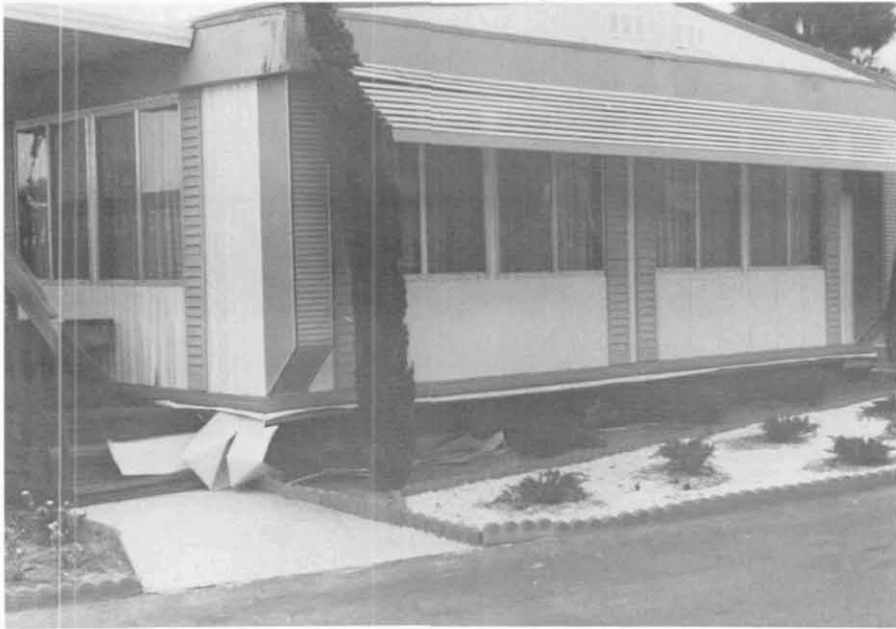
Fig. 7.54 Another view of a mobile home which was shaken off of its foundation at Santa Barbara West Mobile Home Park.

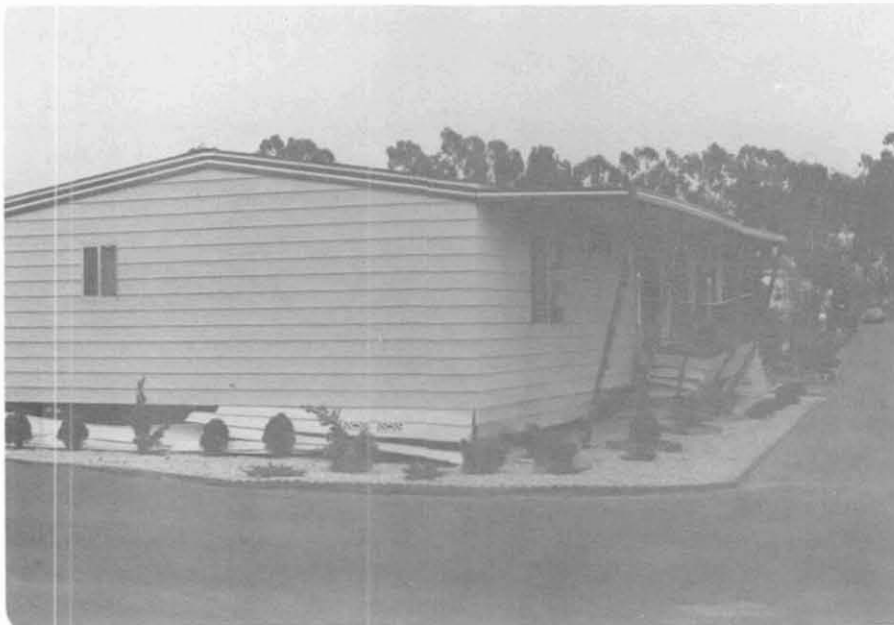
Fig. 7.55 View of damaged porch, awning, and skirt of mobile home which fell from its foundation at Santa Barbara West Mobile Home Park.

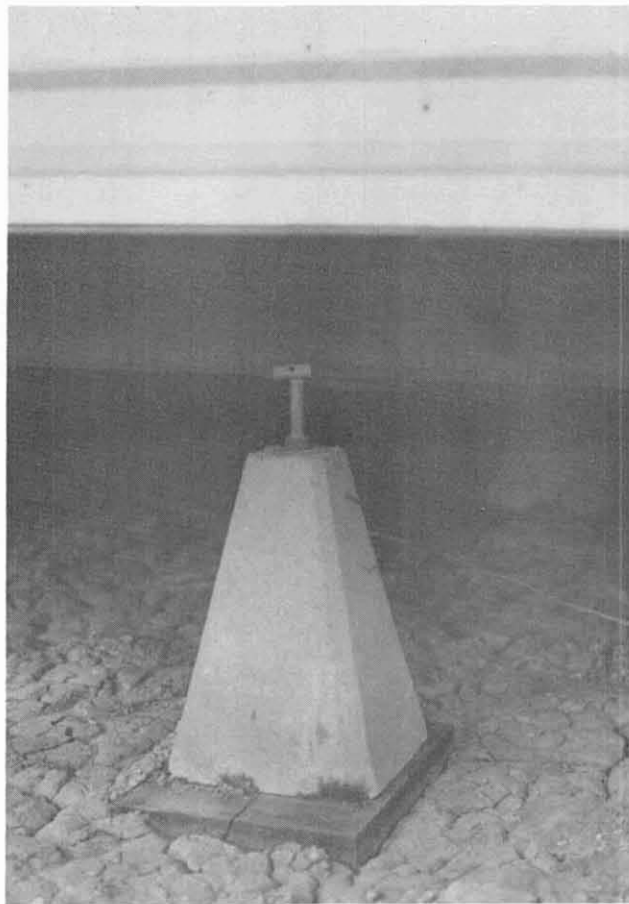
Fig. 7.56 Typical concrete pier upon which some mobile homes are mounted.

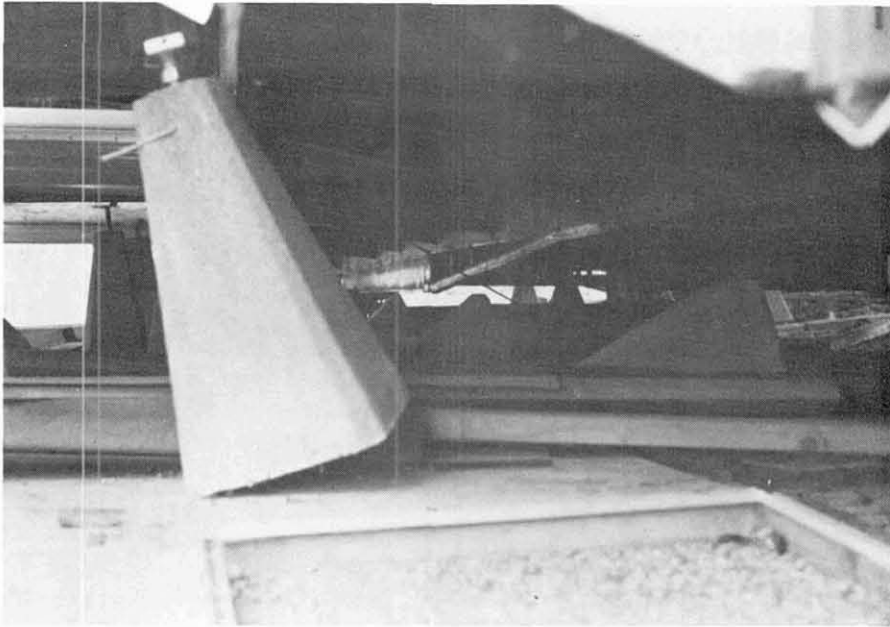
Fig. 7.58 View of overturned concrete piers under a mobile home which fell from its foundation.

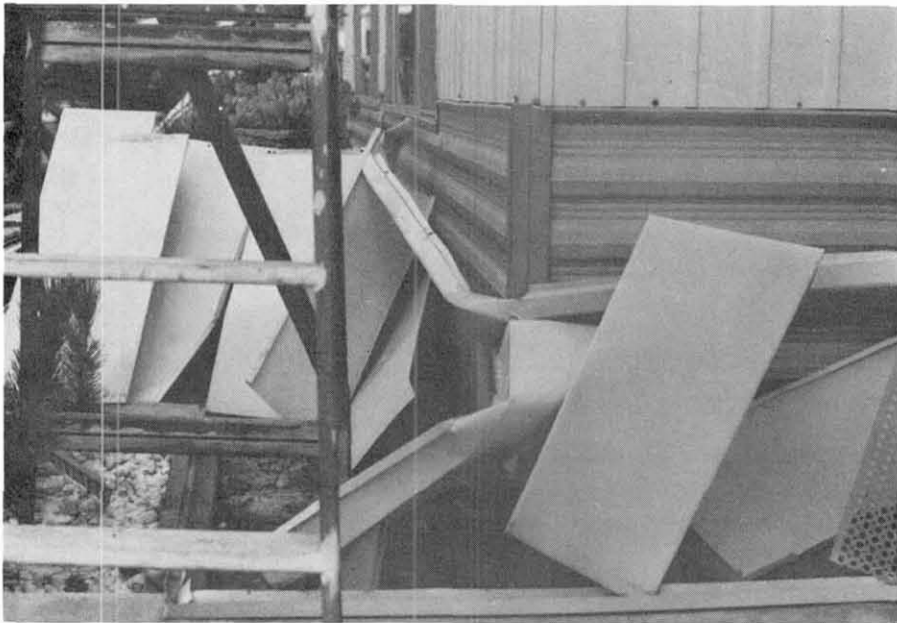
Fig. 7.59 Close up of fallen mobile home showing total horizontal shift of approximately 1 to 2 feet.

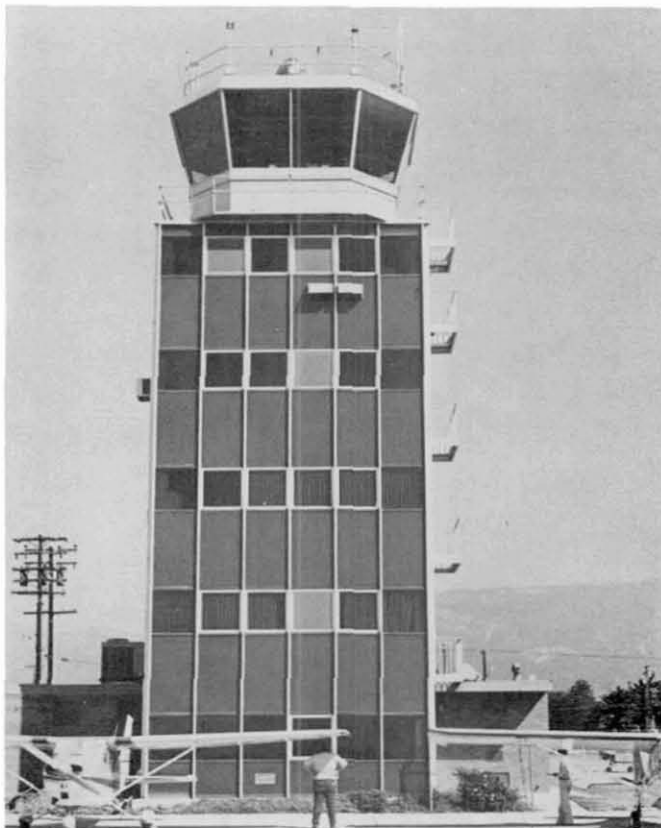
Fig. 7.60 Air traffic control tower, Santa Barbara Municipal Airport (view from south).

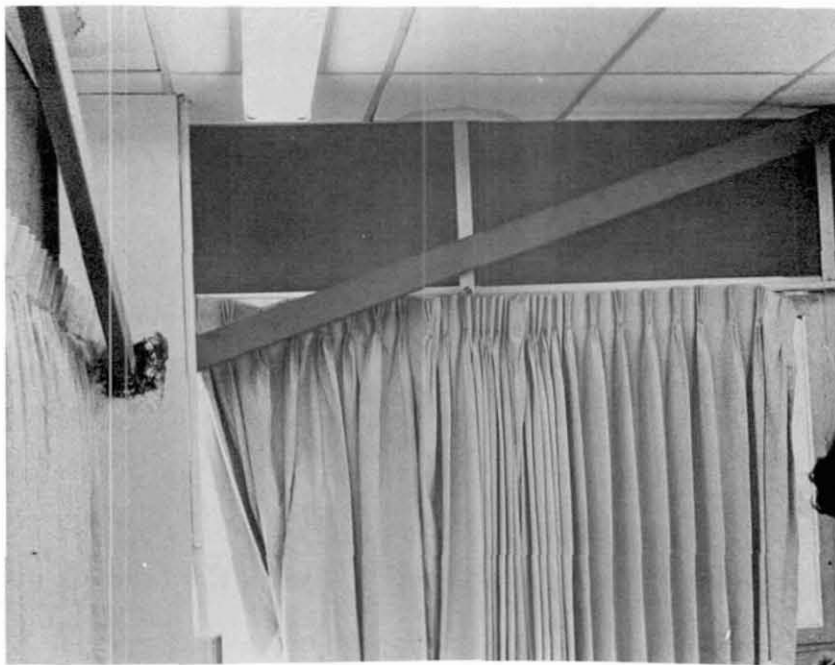
Fig. 7.61 Damage to joint between steel bracing tube and column in southeast corner, second story, air traffic control tower. Damaged tube runs north and south.

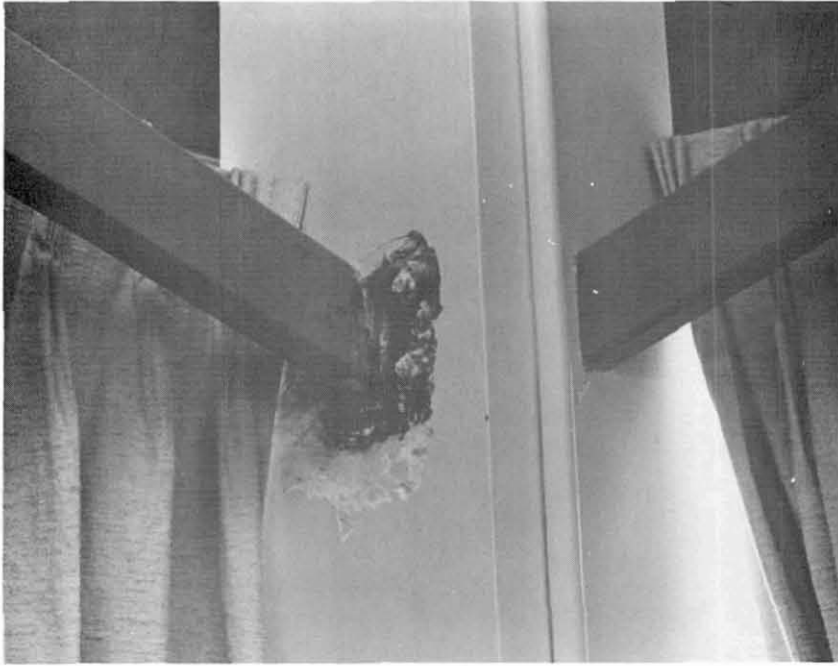
Figure 7.62 Close up of damaged joint shown in Fig. 7.61

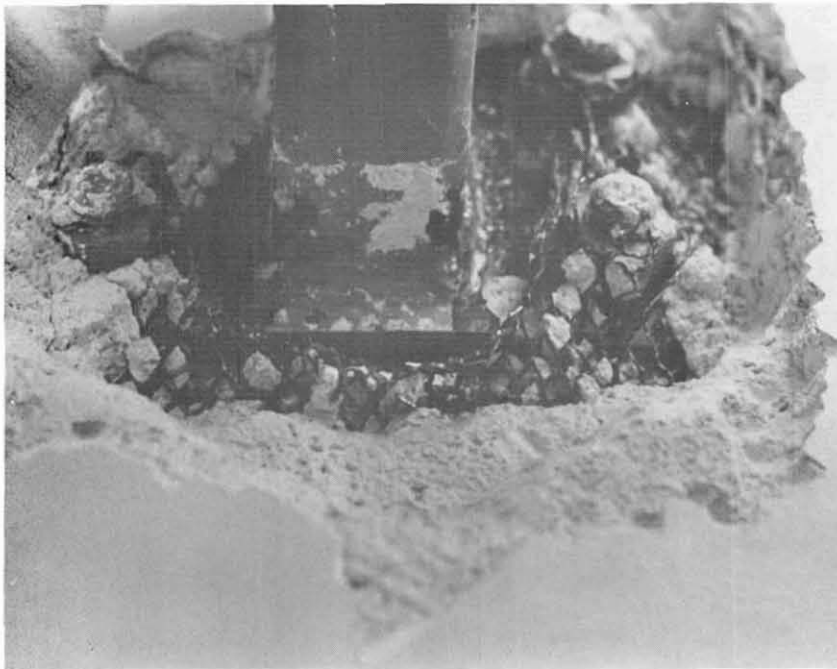
Figure 7.63 View from under bracing tube of damaged joint shown in Fig. 7.62. Note gap between column and bottom edge of connection plate

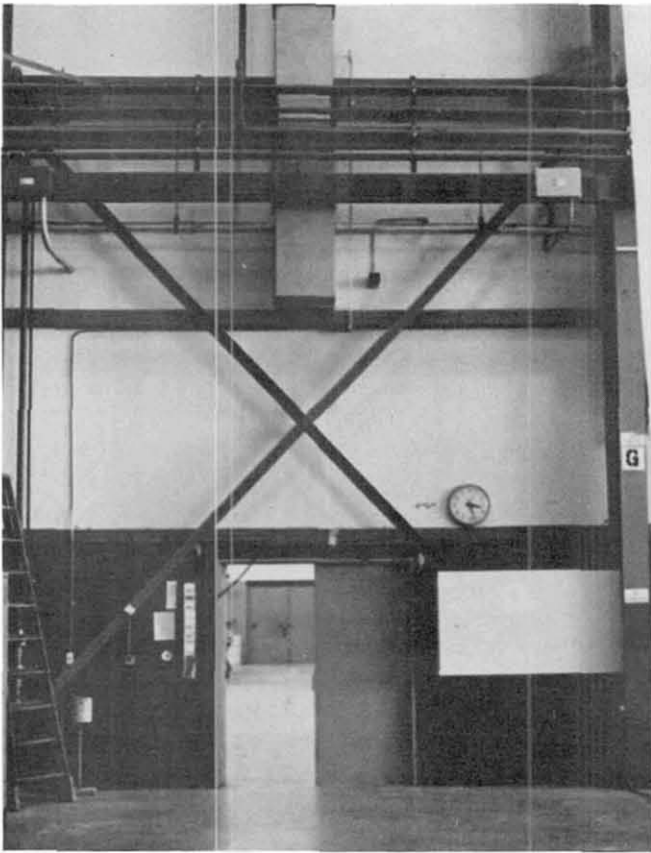
Figure 7.64 Diagonal bracing steel along east-west wall of large hanger at facilities of Aero Spacelines, Inc.

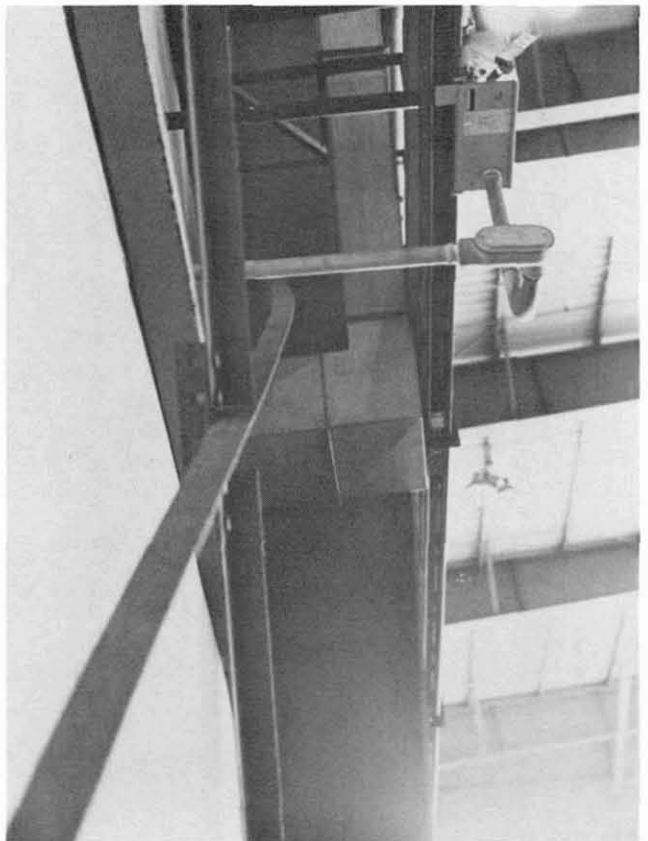
Figure 7.65 Buckling of diagonal bracing steel shown in Fig. 7.64

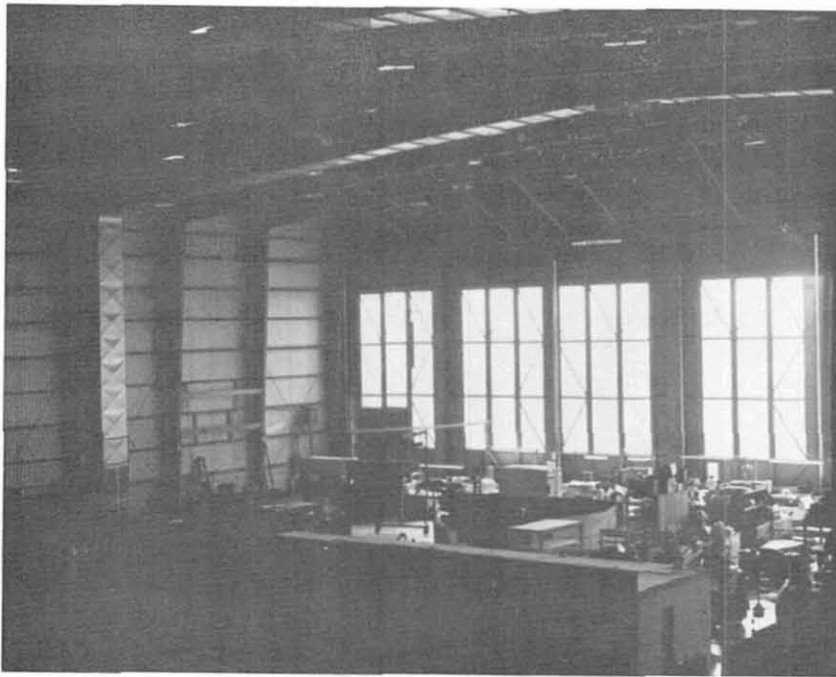
Figure 7.66 Interior of large hangar at facilities of Aero Spacelines, Inc., showing large sliding doors and damaged steel bracing which angles up to the roof from the rail at top of doors

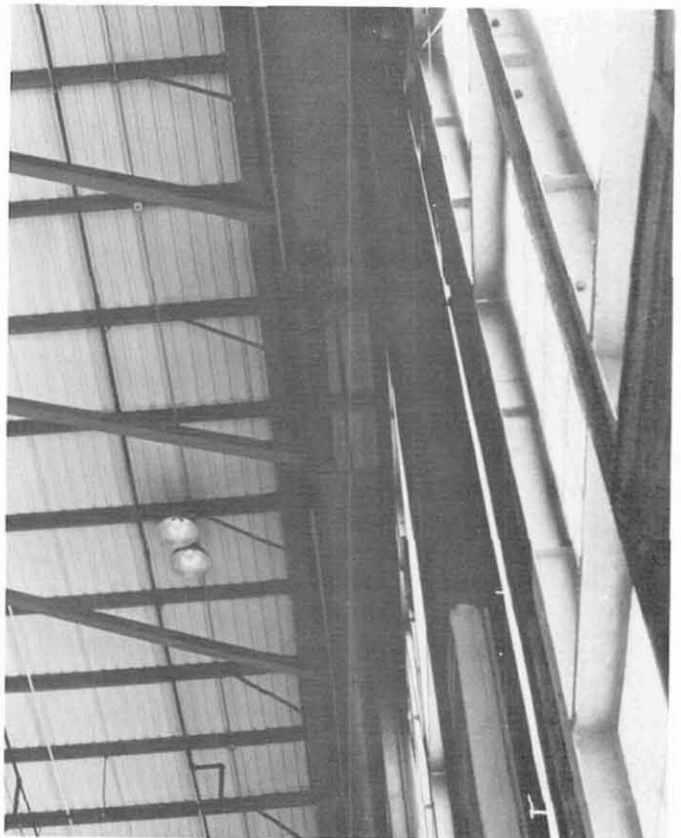
Figure 7.67 Close up from directly under damaged steel bracing of sliding doors shown in Fig. 7.66. Note separation of rail and bracing in center of picture

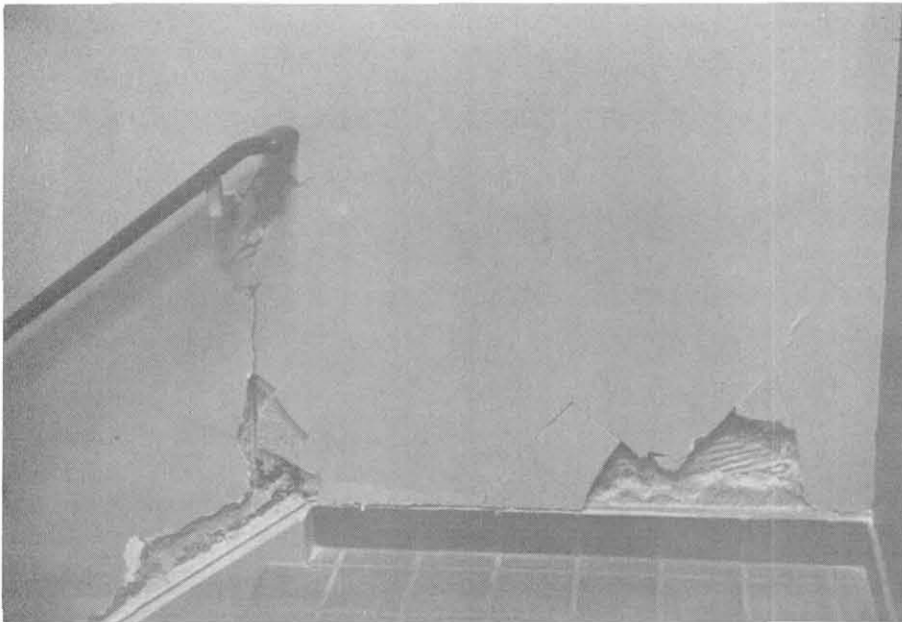
Fig. 8.7 Cracks in plaster wall of Santa Barbara County Administration Building.

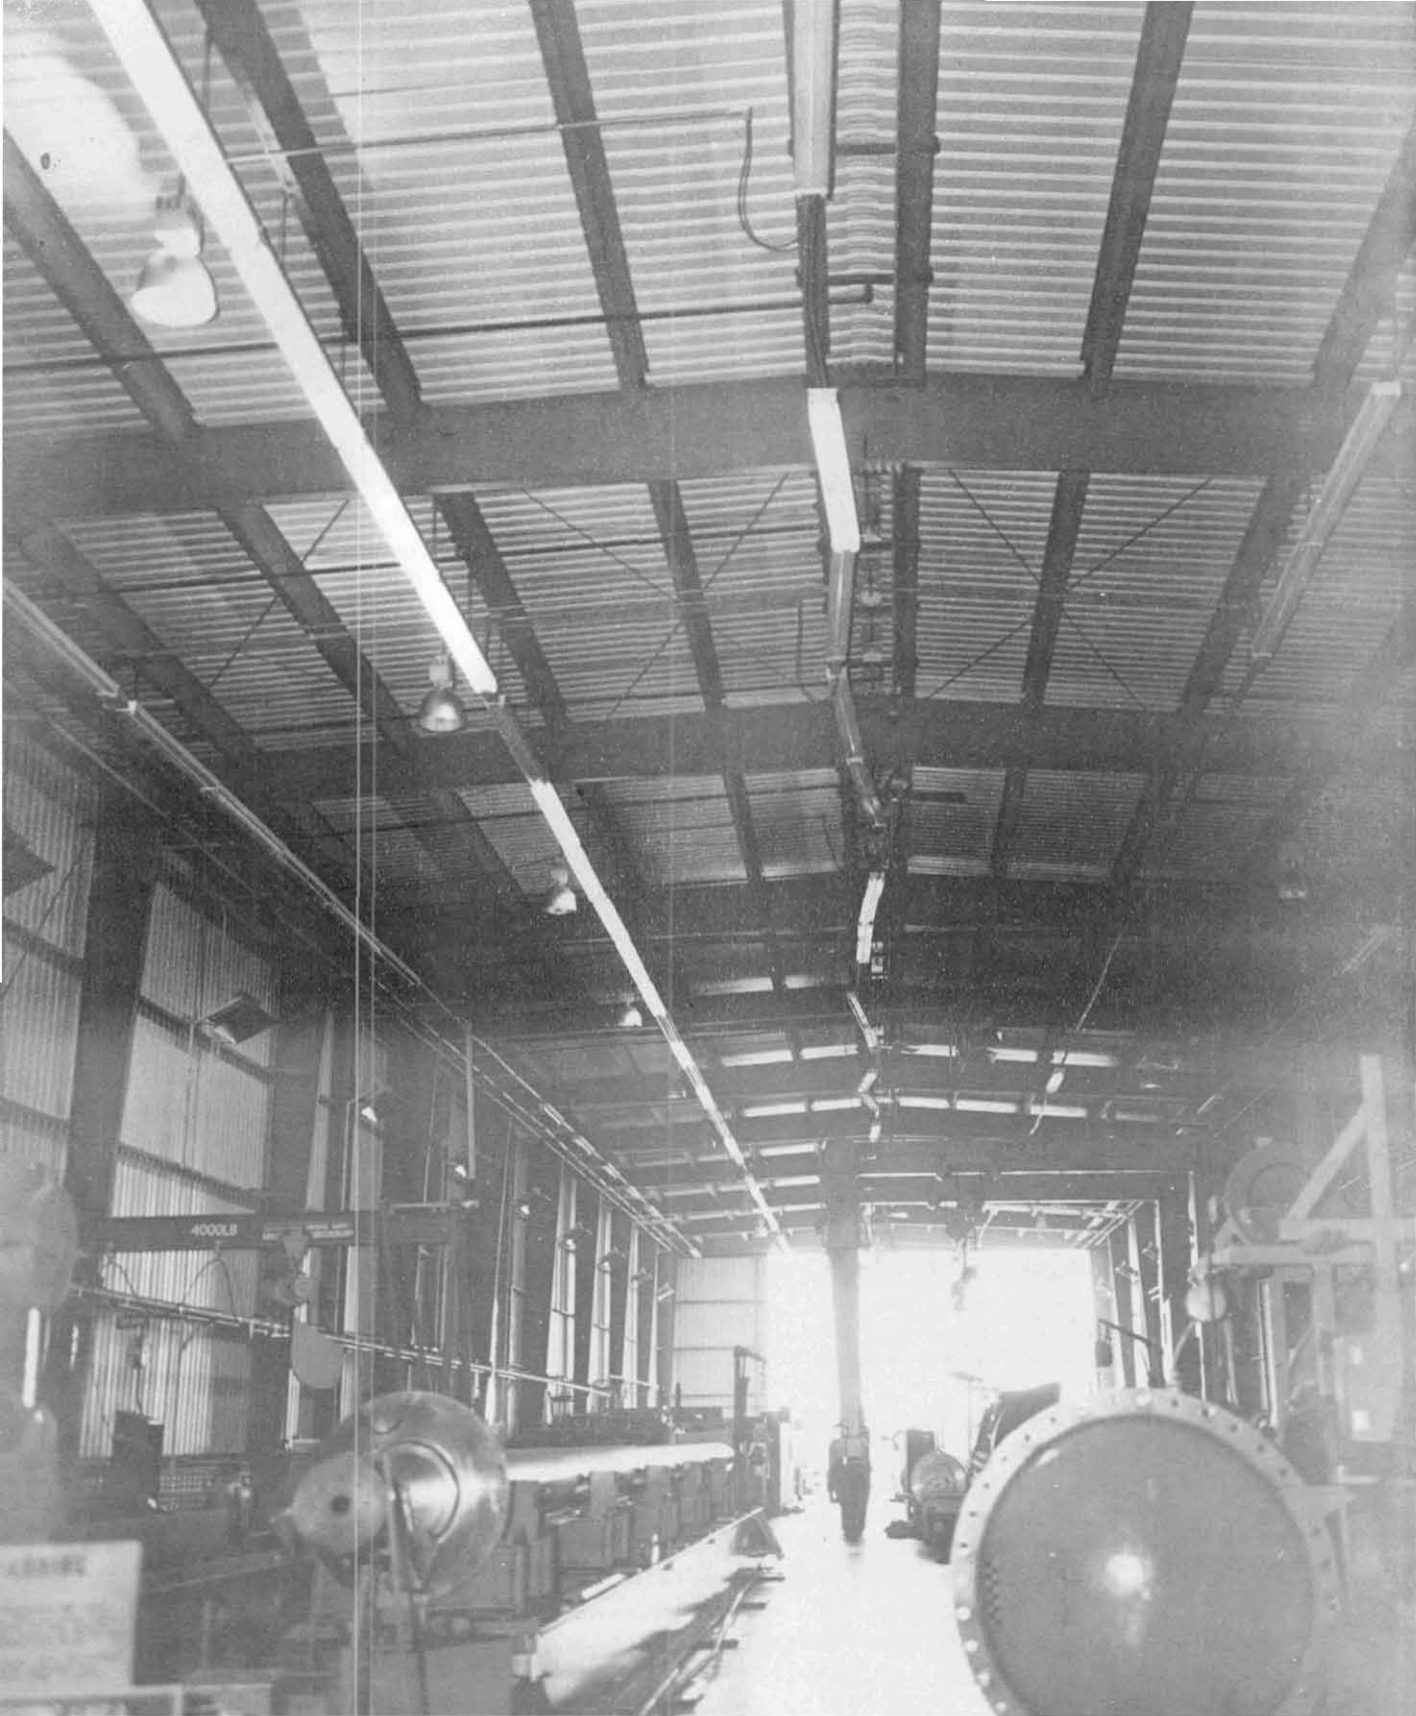
Fig. 3.6 Dislodged and missing fluorescent lighting fixtures from overhead electrical raceways, in Flight Physics Building, Delco Electronics.

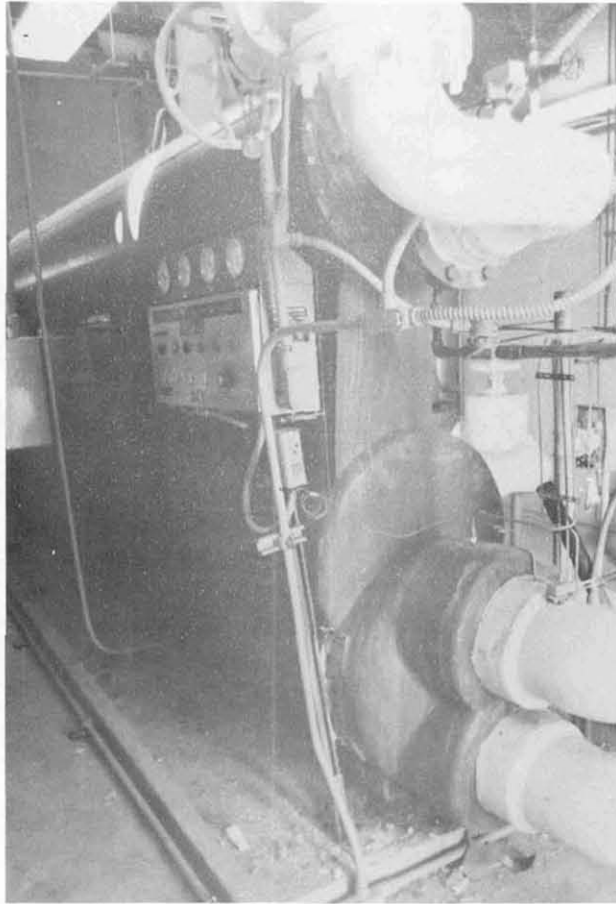
The lack of antisway braces on mechanical equipment piping, combined with the excessive unrestrained motion of the connected machinery, caused pipes and their hangers to bend and break. As a result, large sections of piping networks were shifted from their normal positions. Pipe connections were put under exceptionally high stresses and, in some cases, the pipes sheared in two as visible in Fig. 8.18. Where flexible connections were provided, such as between fans and their outlet ducts, or between pumps and pipes, these were invariably damaged or broken when the attached machinery was displaced. At places where pipes and ducts penetrate walls, the penetrating conduit or the wall tended to be damaged. For example, the piping system supplying sea water to the UCSB Marine Research facility suffered several system disabling breaks at wall

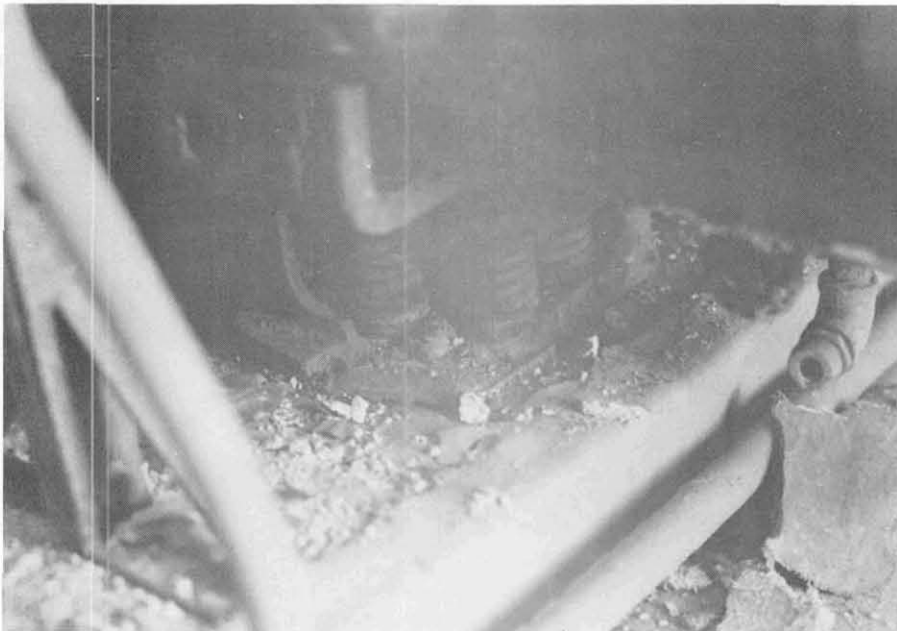
Fig. 8.9 Close up of damaged supports at front of chiller (Fig. 8.8).

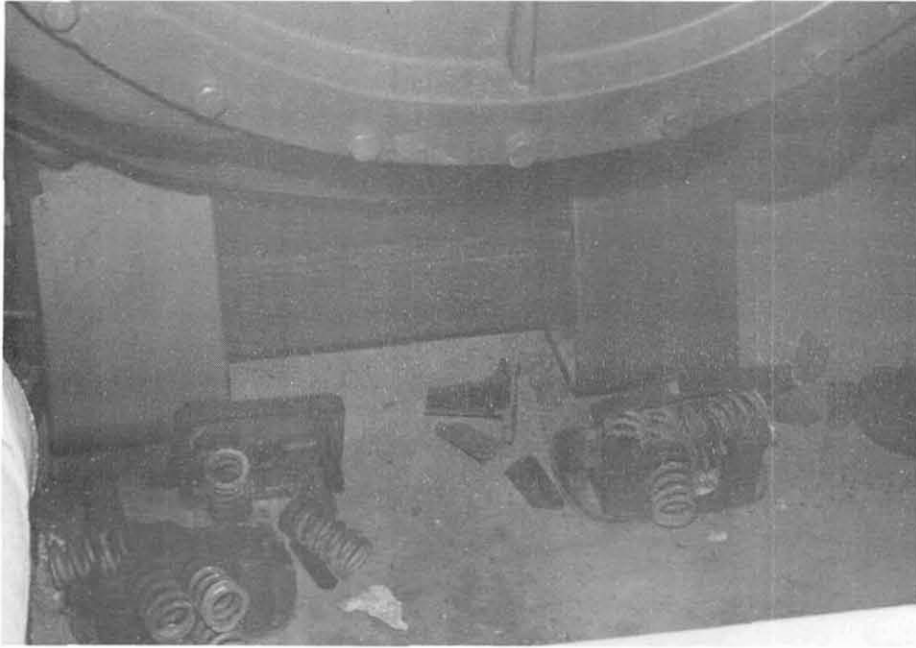
Fig. 8.10 Close up of damaged supports at back of chiller (Fig. 8.8).

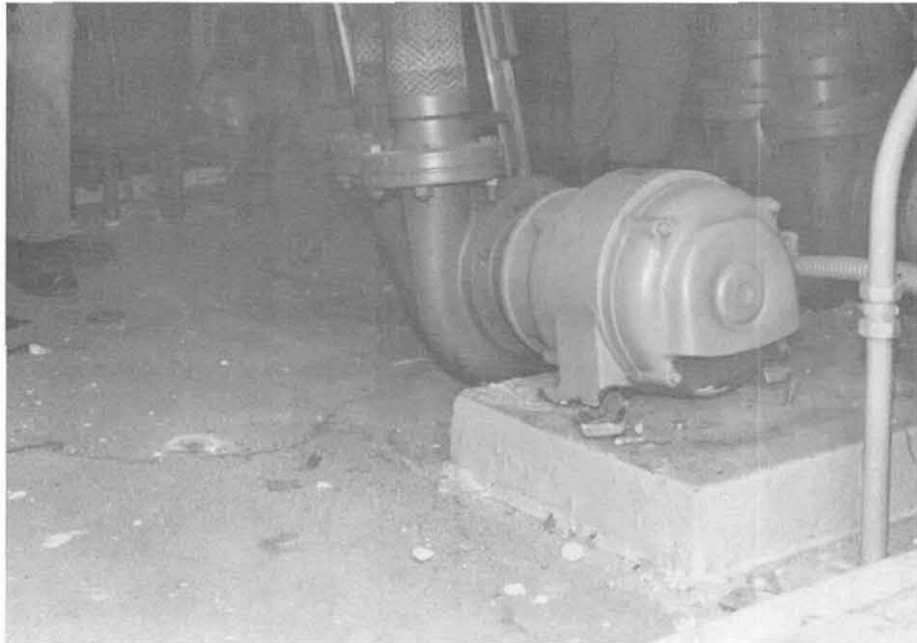
Fig. 8.11 Broken mounting base of hot water pump on top of Library III Building, UCSB.

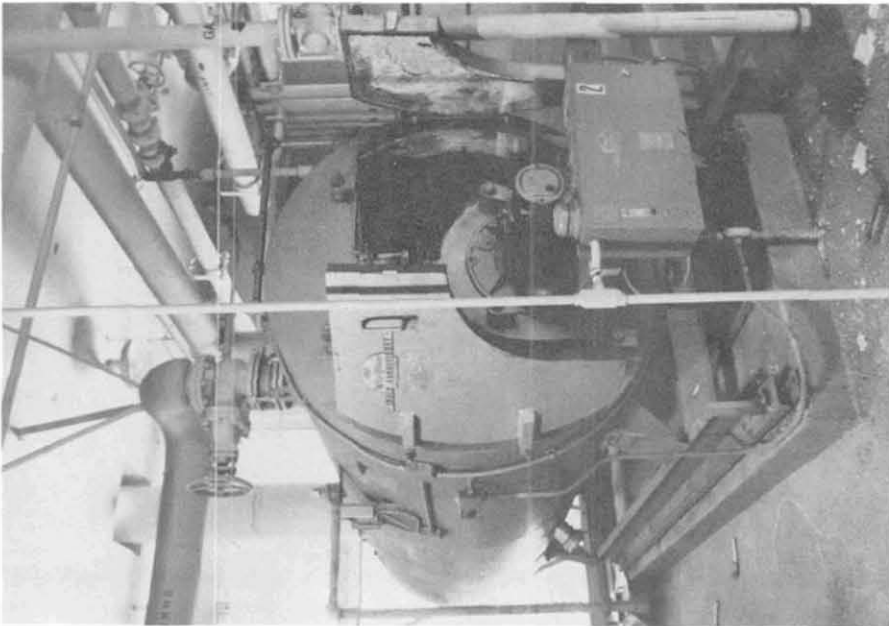
Fig. 8.12 Boiler on top of six-story Ellison Hall, UCSB. Vibration isolation supports were damaged.

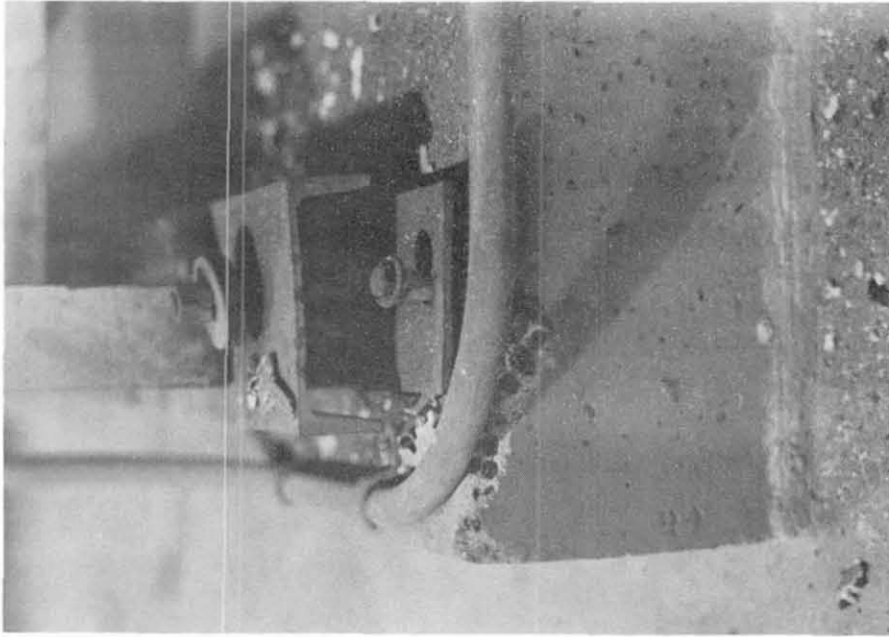
Fig. 8.13 Close up of damaged support on left side of boiler (Fig. 8.12).

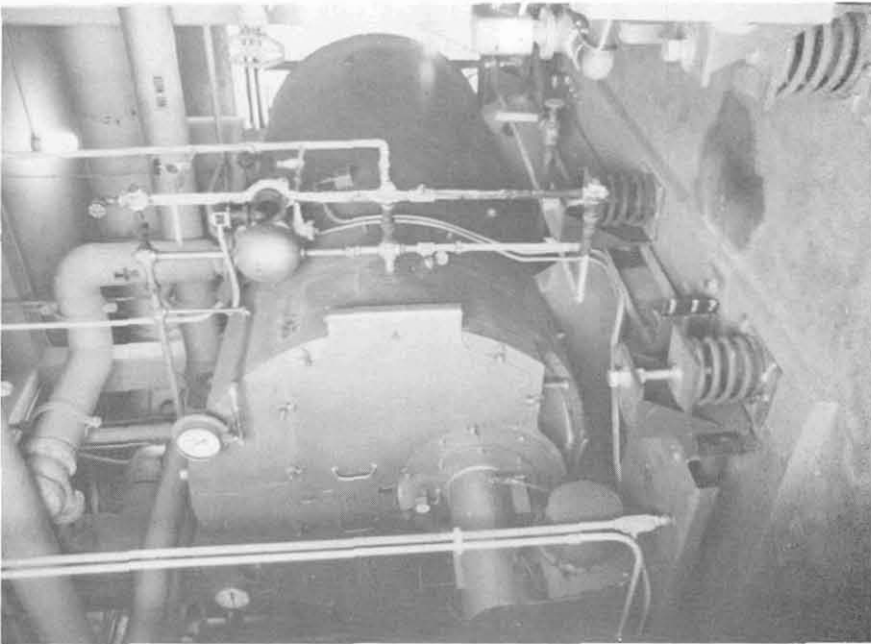
Fig. 8.14 Boiler on top of six-story Phelps Hall, UCSB. Vibration isolation supports were not damaged.

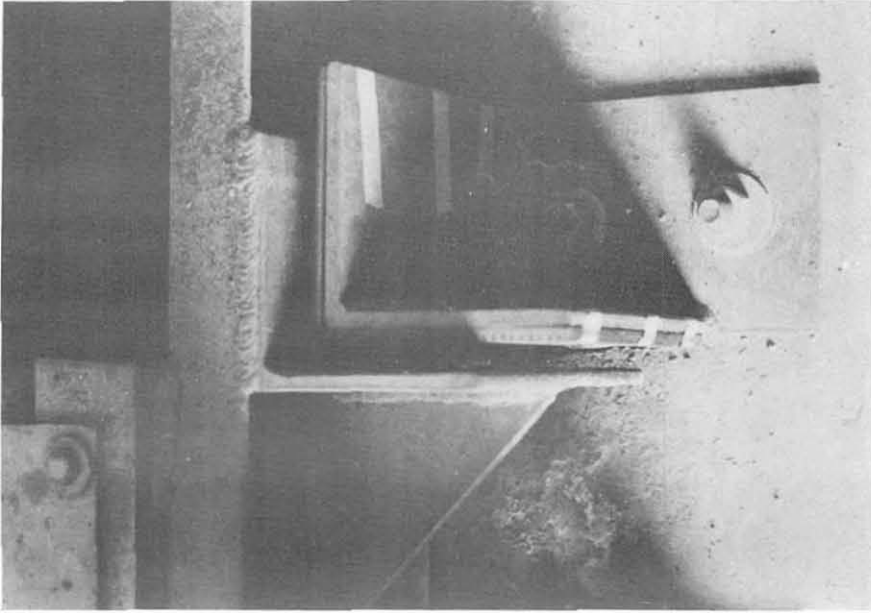
Fig. 8.15 Overhead close up of seismic restraint on boiler (Fig. 8.14).

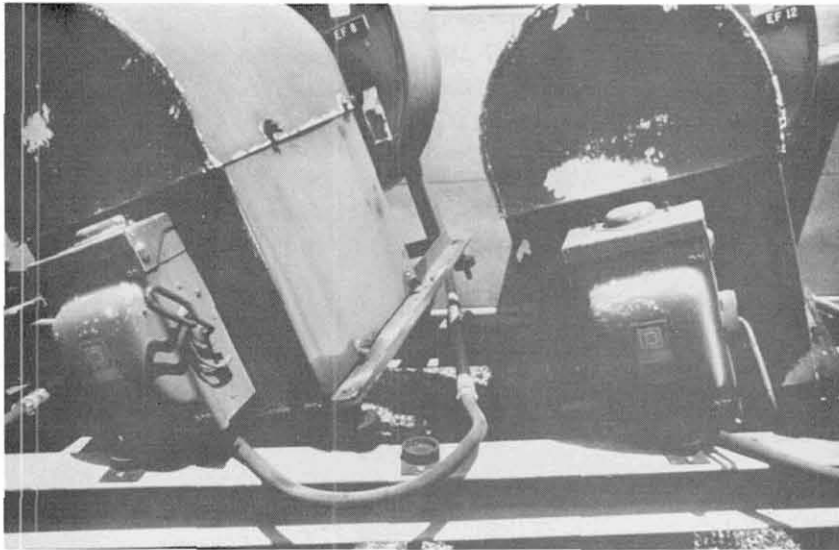
Fig. 8.17 Close up of damaged supports in Fig. 8.16.

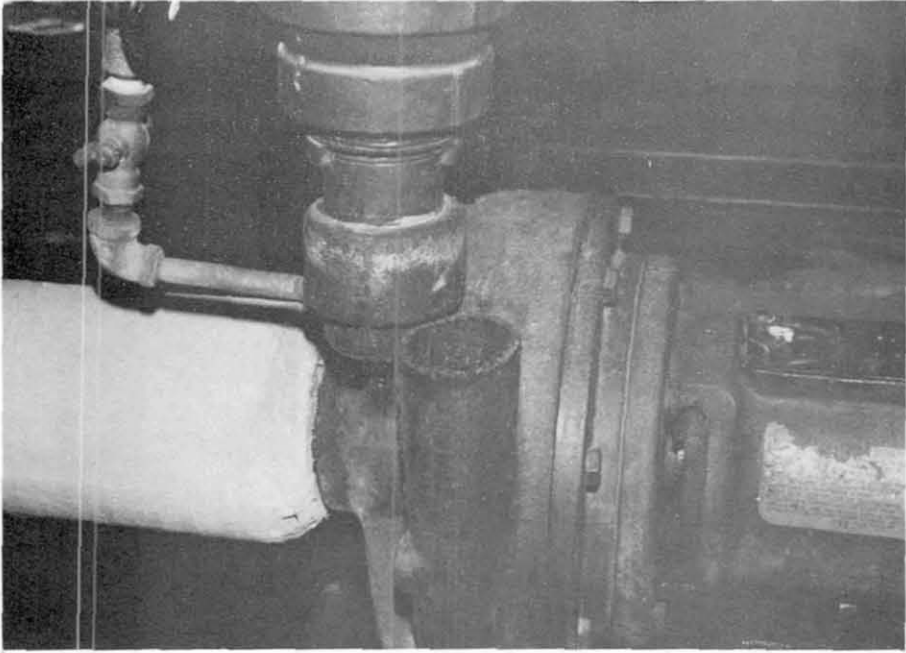
Fig. 8.18 Broken cast-iron valve at discharge connection of pump on top of six-story Ellison Hall, UCSB.

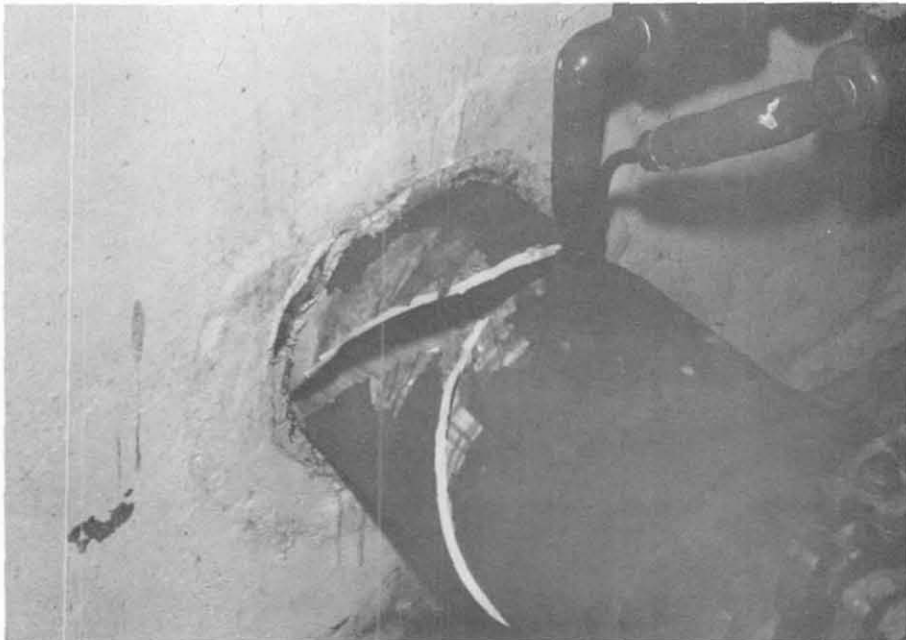
Fig. 8.19 Break in 8 inch sea water discharge pipe at wall penetration, UCSB Marine Research Facility.

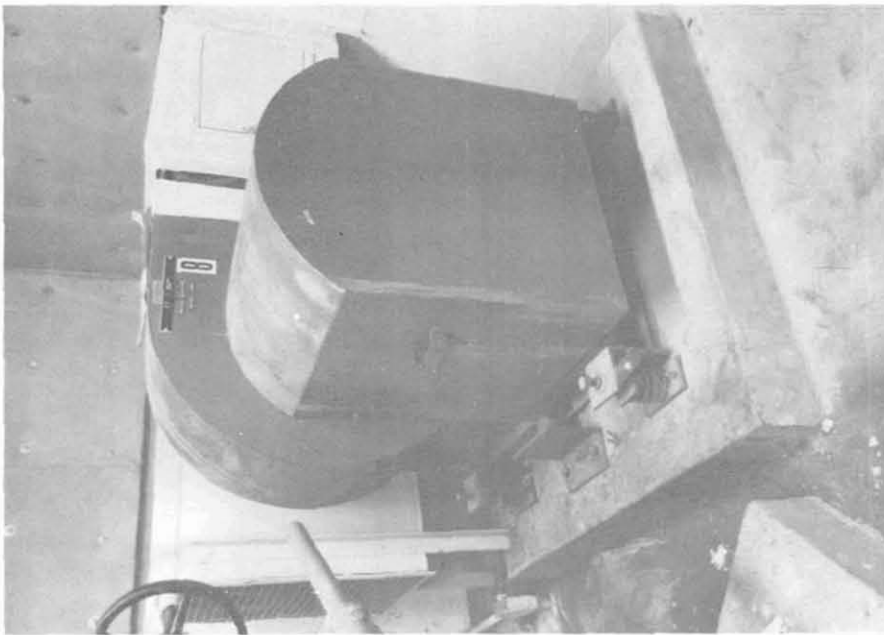
Fig. 8.20 Fan in basement of four-story Library IV Building, UCSB. Vibration supports were not damaged.

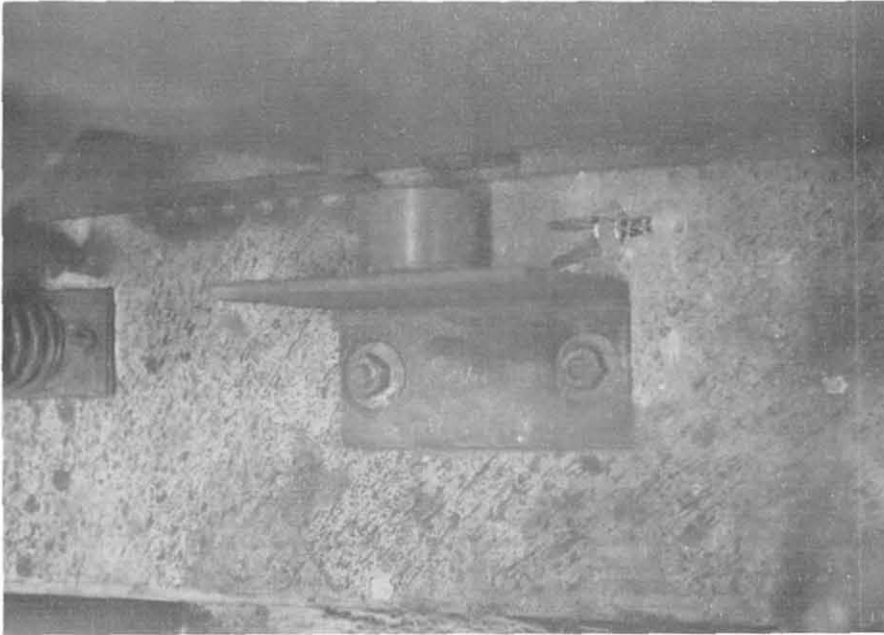
Fig. 8.21 Close up of commercially available seismic restraint on fan (Fig. 8.20).

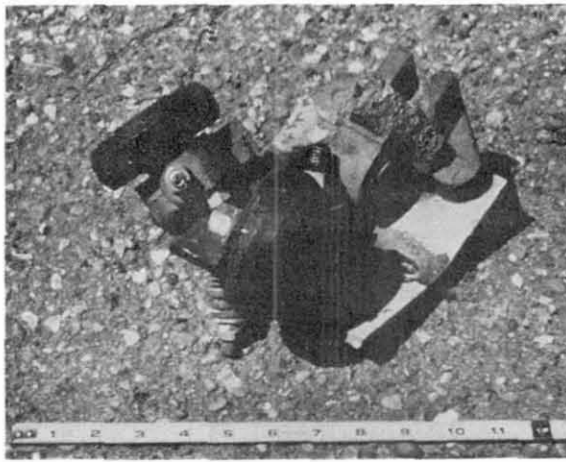
Fig. 8.22 Broken roller guide/shoe from electric traction elevator in five-story Engineering Building, UCSB.

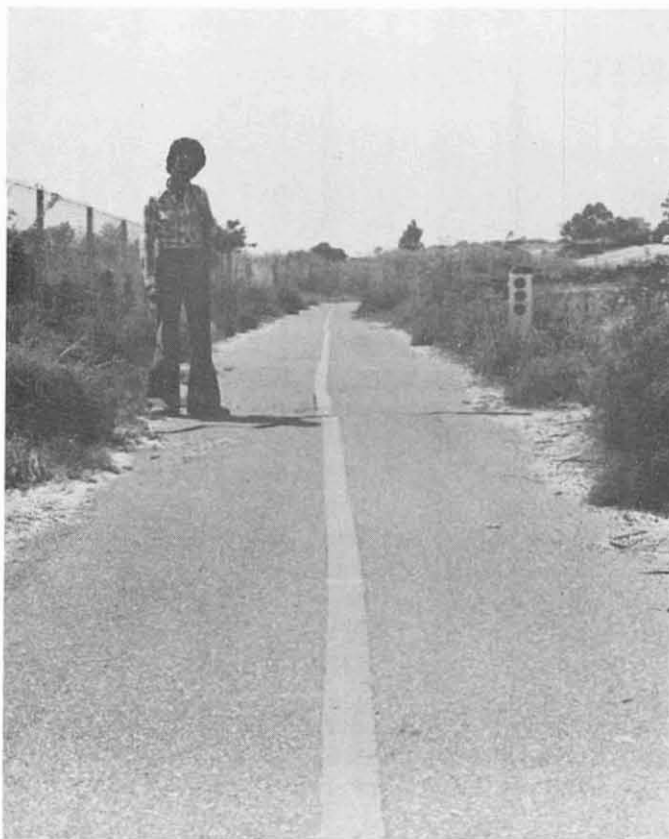
Fig. 9.1 Extension fracture in the bicycle path north-east of UCSB. Note misalignment of centerline. Building at upper right is Biological Sciences II, UCSB. Cracks runs in a northwesterly direction.

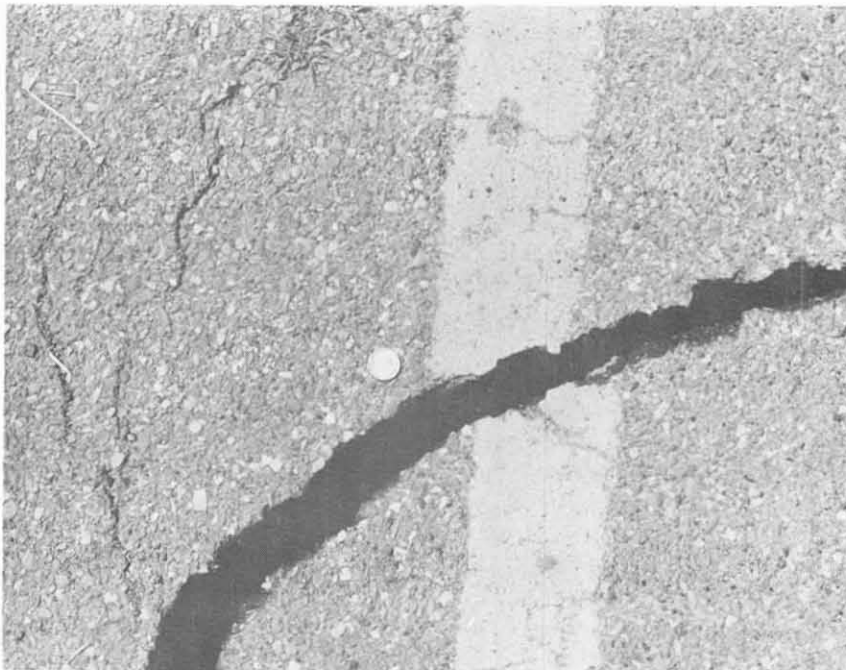
Fig. 9.2 Close up of extension fracture shown in Fig. 9.1. Scale given by the coin (quarter) in the center of the picture.

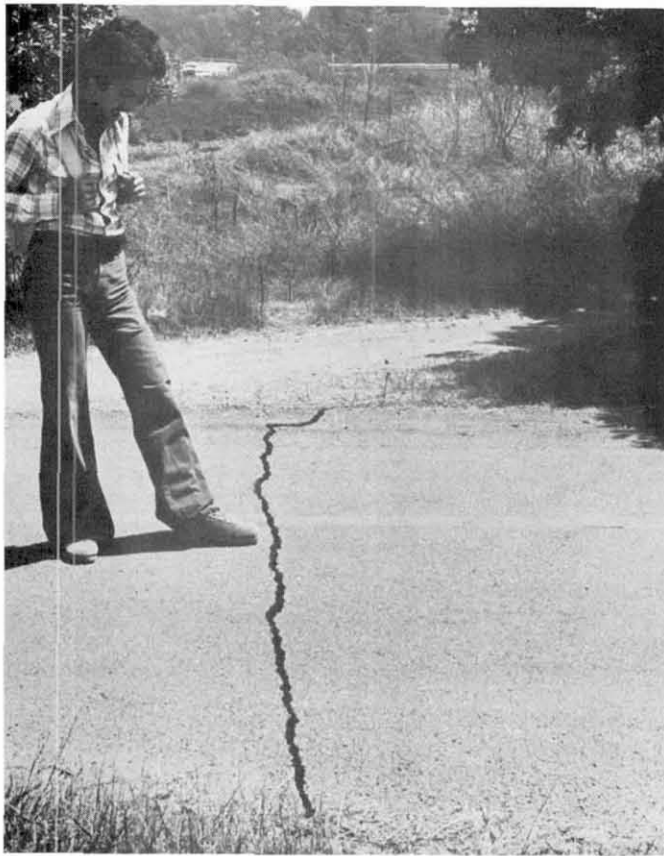
Fig. 9.3 Another extension fracture in the bicycle path shown in Fig. 9.1. This crack also runs in a northwesterly direction.

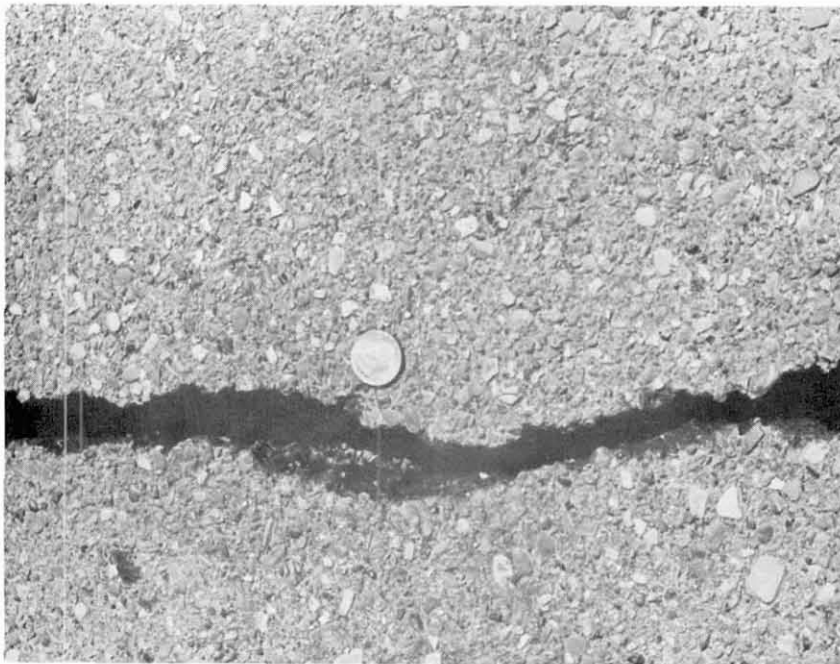
Fig. 9.4 Close up of the extension fracture shown in Fig. 9.3. Scale given by the coin (quarter) in the center of the picture.
