university of california • santa barbara

NSF/RA- 780550

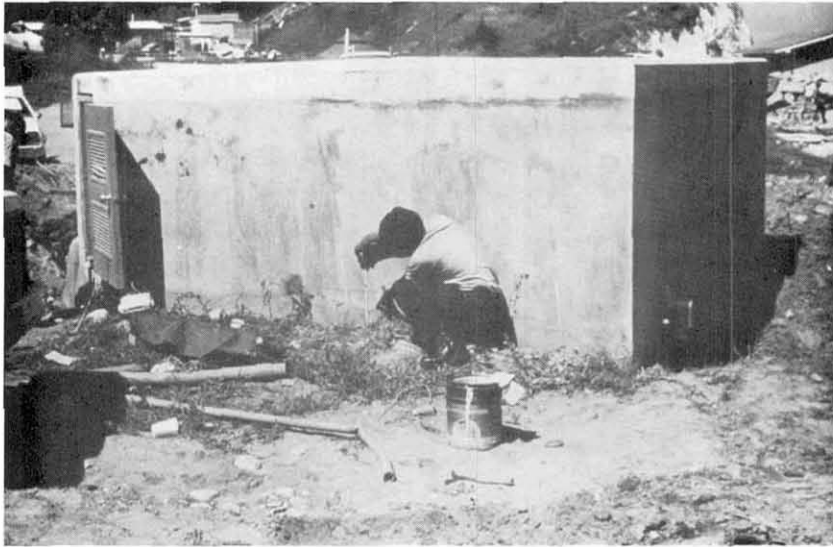
Fig. 9.5 Settlement of soil near pumping facility at sand spit, UCSB. Note previous soil line on concrete.

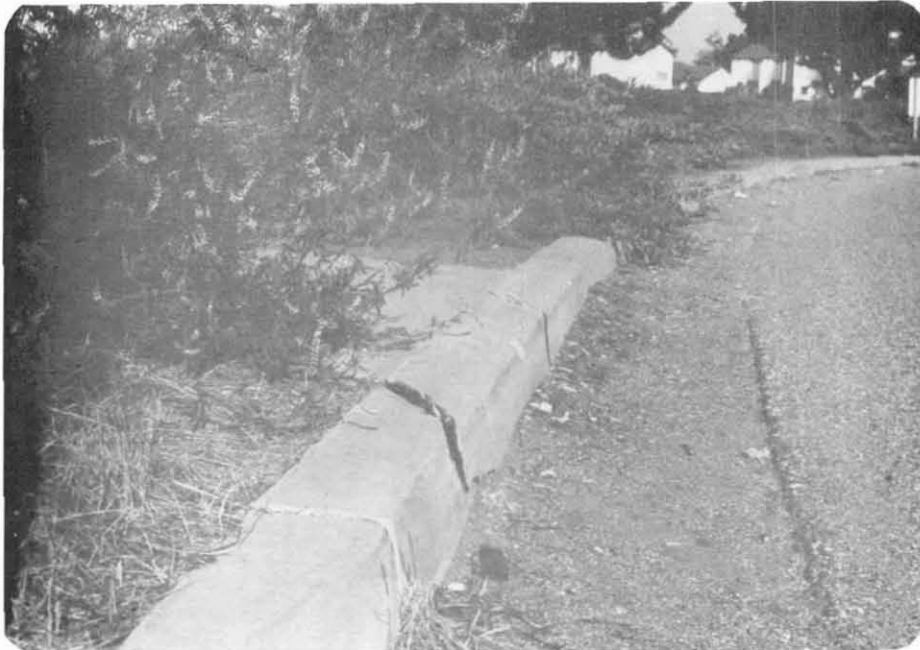
Fig. 9.10 Close up of curb push out shown in Fig. 9.9. (View from south.)

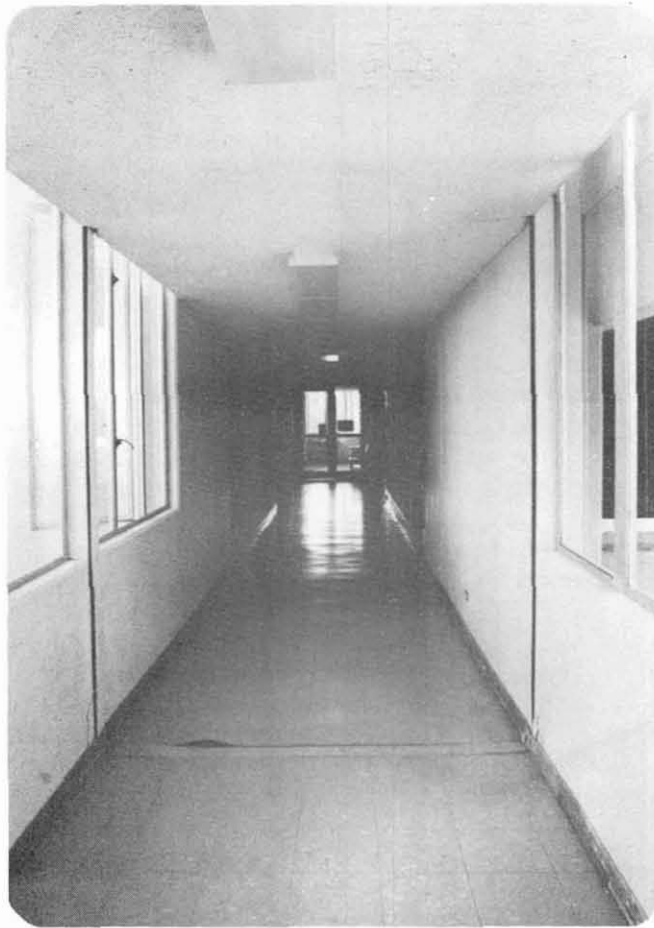
Fig. 11.1 Damage to seismic joint in South Hall, UCSB.

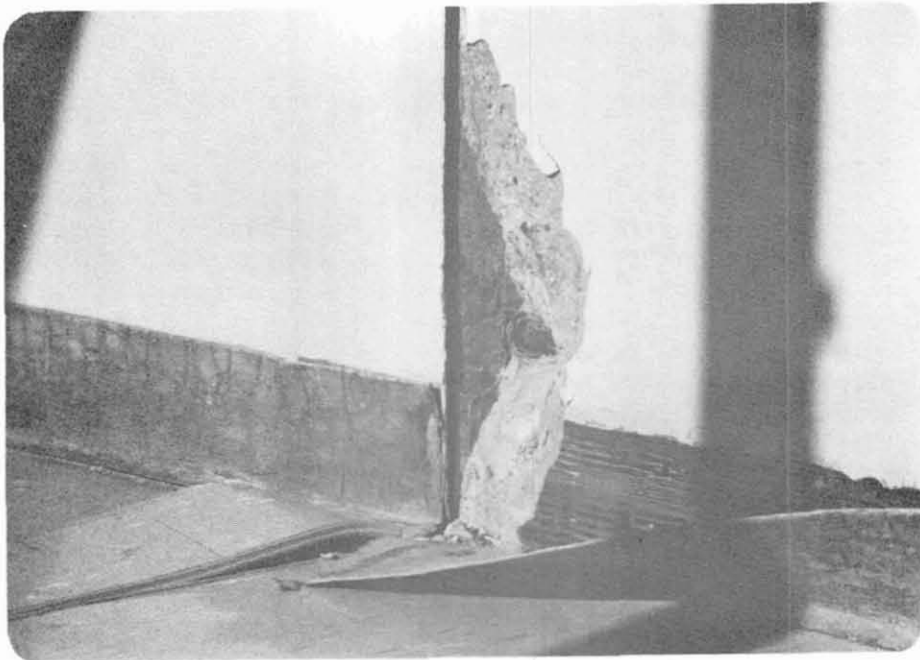
Fig. 11.2 Damage to seismic joint in South Hall, UCSB.

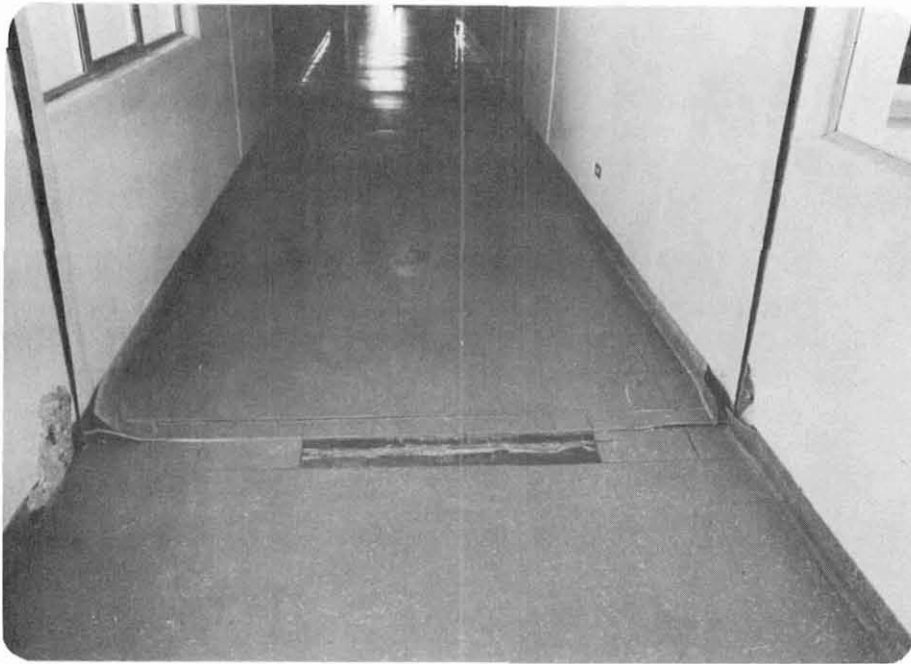
Fig. 11.3 Another damaged seismic joint in South Hall, UCSB.

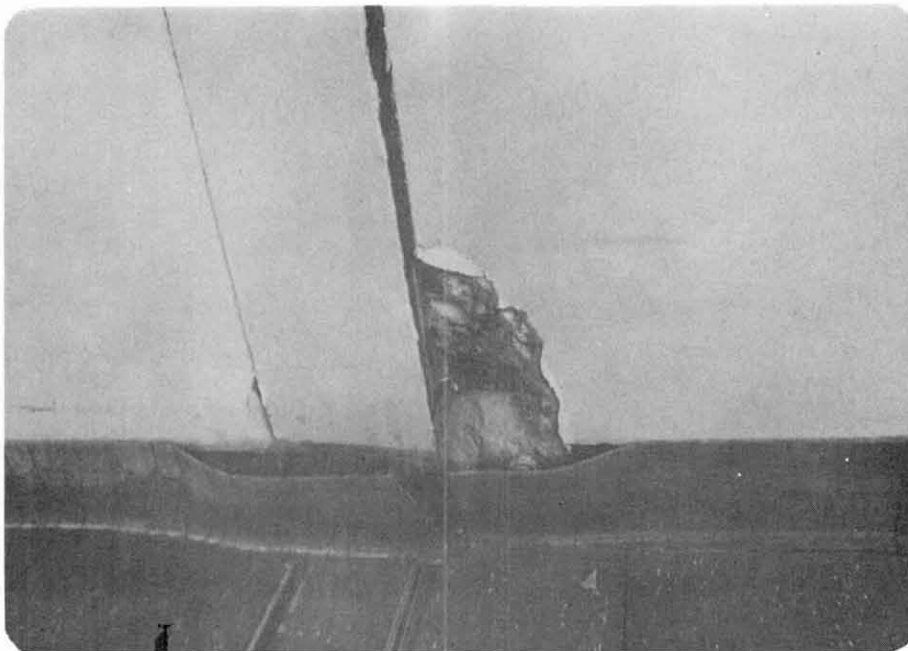
Fig. 11.4 Close up of the damage in the corner at the right in Fig. 11.3.

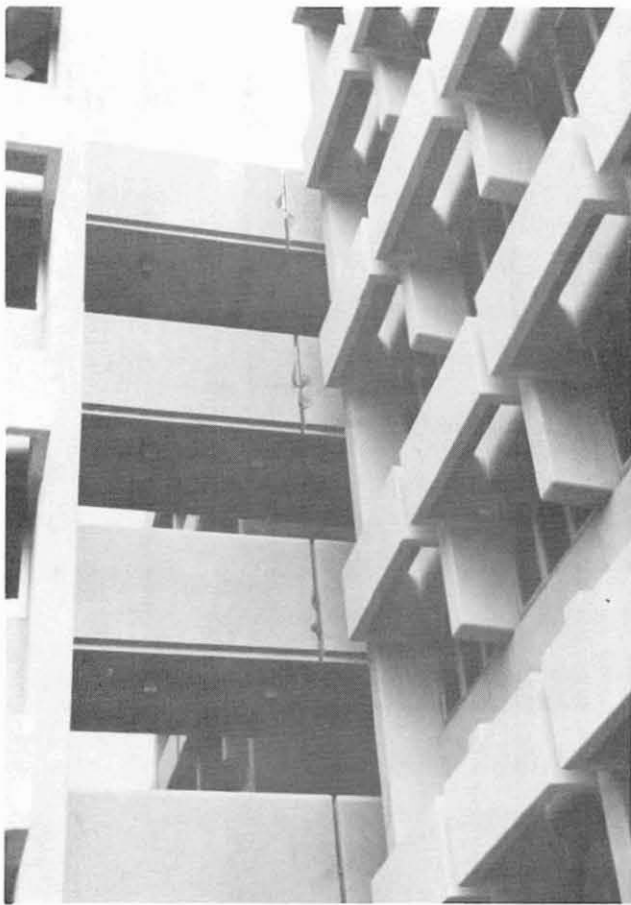
Fig. 11.5 Damage to seismic joints on third through sixth floor walkways between South Hall and the Graduate Tower, UCSB campus.

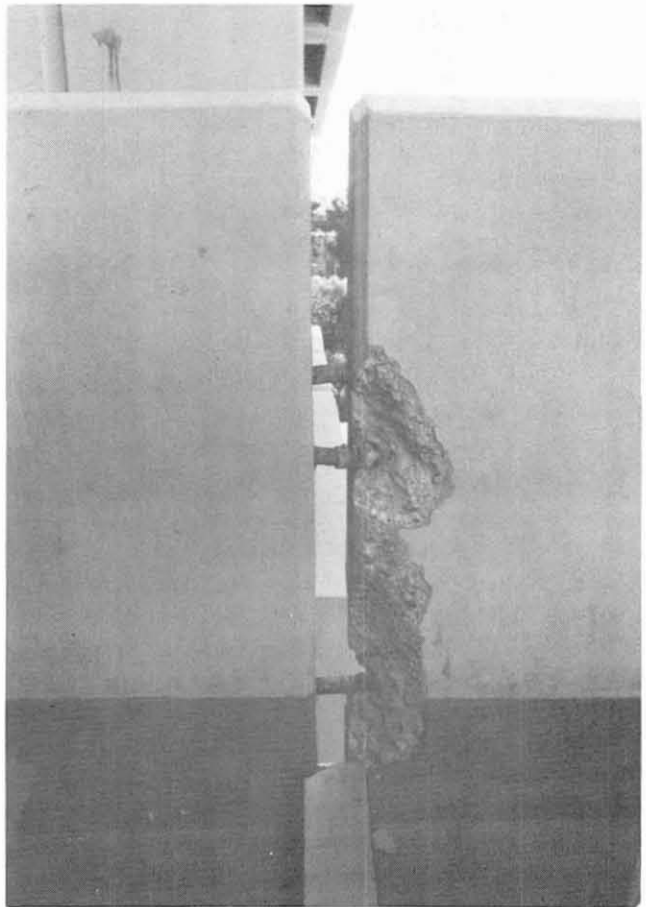
Fig. 11.6 Close up of damage to seismic joints shown in Fig. 11.5. View from inside walkway.

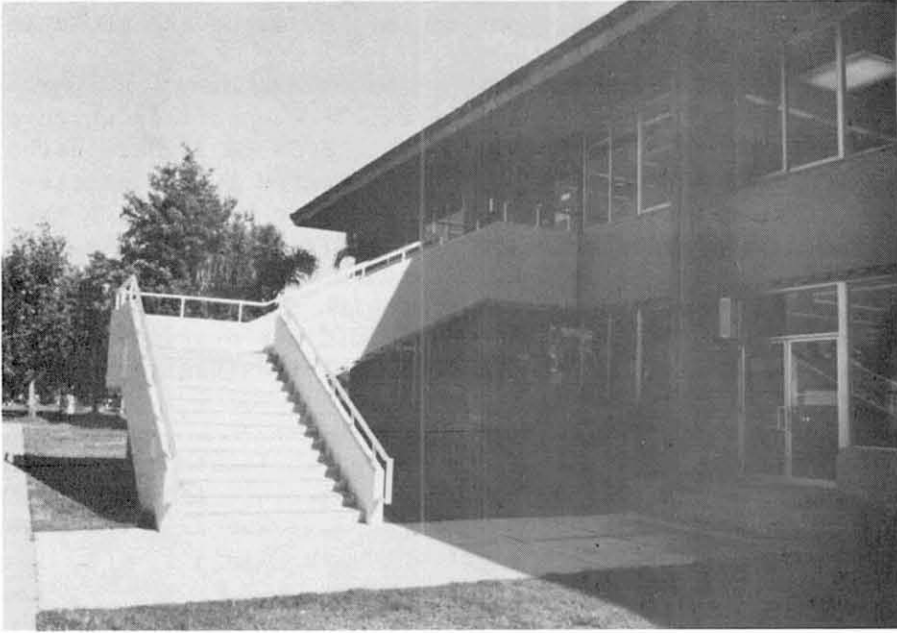
Fig. 11.7 Stairway from emergency exit on north side of UCSB Library I Building. Stairway and building are separated by a seismic joint.

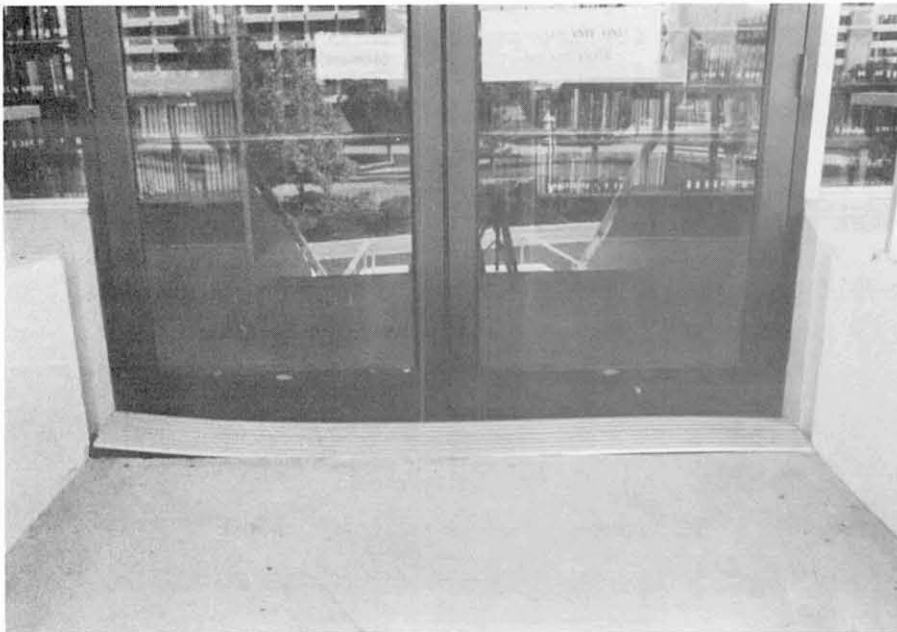
Fig. 11.8 Close-up of damage to seismic joint between stairway and building in Fig. 11.7. Note that damaged cover plate blocks the opening of emergency doors.
