***Landslide of  
April 25, 1974  
on the  
Mantaro River, Peru***

LANDSLIDE OF APRIL 25, 1974 ON THE MANTARO RIVER, PERU

report of inspection

Kenneth L. Lee  
University of California, Los Angeles

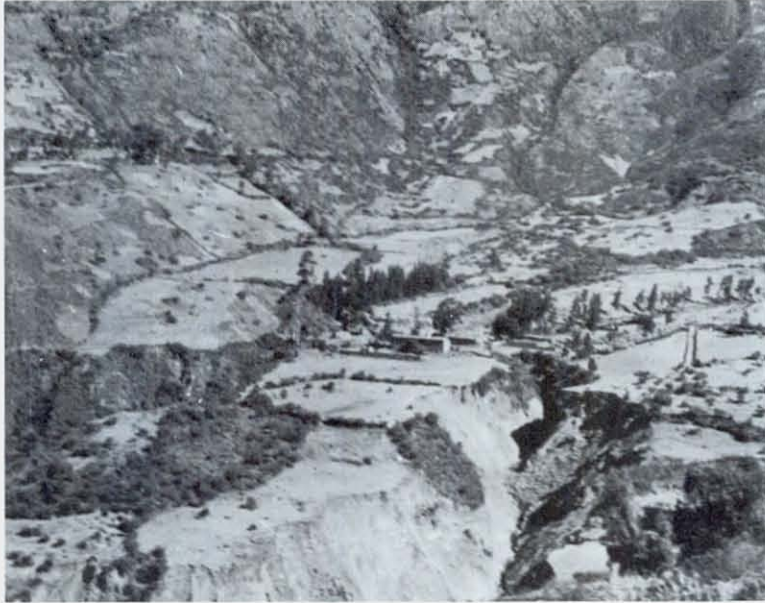
FIGURE 5. Panoramic view looking from North to South showing the community center of Mayunmarca, and the unstable slopes of the Sojosbamba ravine. (Photograph courtesy of Galdos Bustamante)

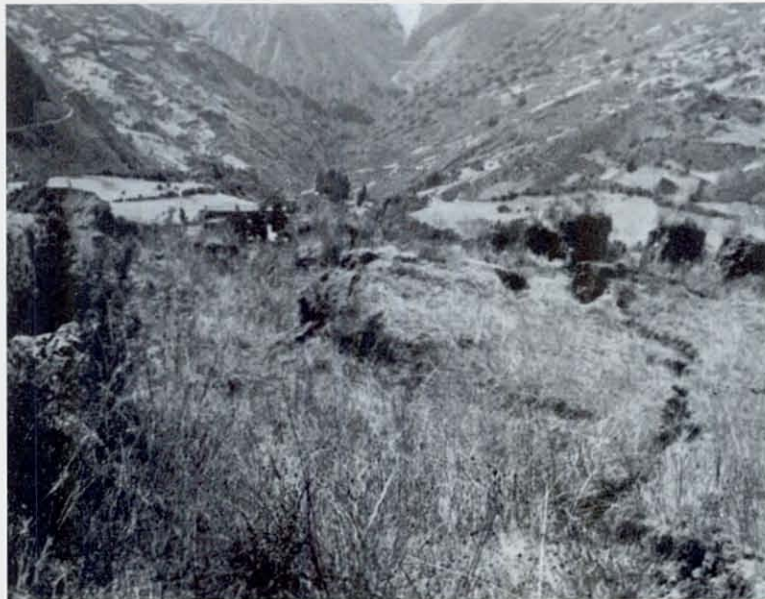
Figure 6 is another panoramic view looking down past the town of Mayunmarca in the center of the photograph, to the Mantaro river not seen, but located in the upper third of the picture. The white slide scarps in the upper part of the photograph are on the banks of Quebrada Tinte (Q5), which flows into the Mantaro river directly across from Quebrada Ccochacay (Q4). Note that the Quebrada Tinte area was also unstable before the landslide. In the foreground of Figure 6, there are some major recent ground cracks or fractures, indicating the general marginal stability of the detritus cover at that location.

FIGURE 6. Panoramic view looking from South to North showing a system of recent fractures located 300 meters from the community center of Mayunmarca. (Photograph courtesy of Galdos Bustamante)

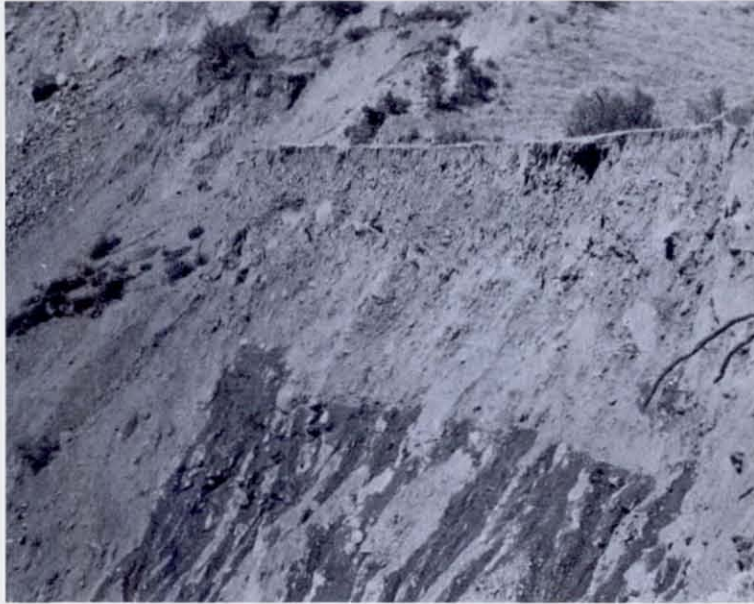
FIGURE 7. Left side of the Huachac ravine, 400 meters from Mayunmarca showing water seeping from the detritus slope. (Photograph courtesy of Galdos Bustamante)

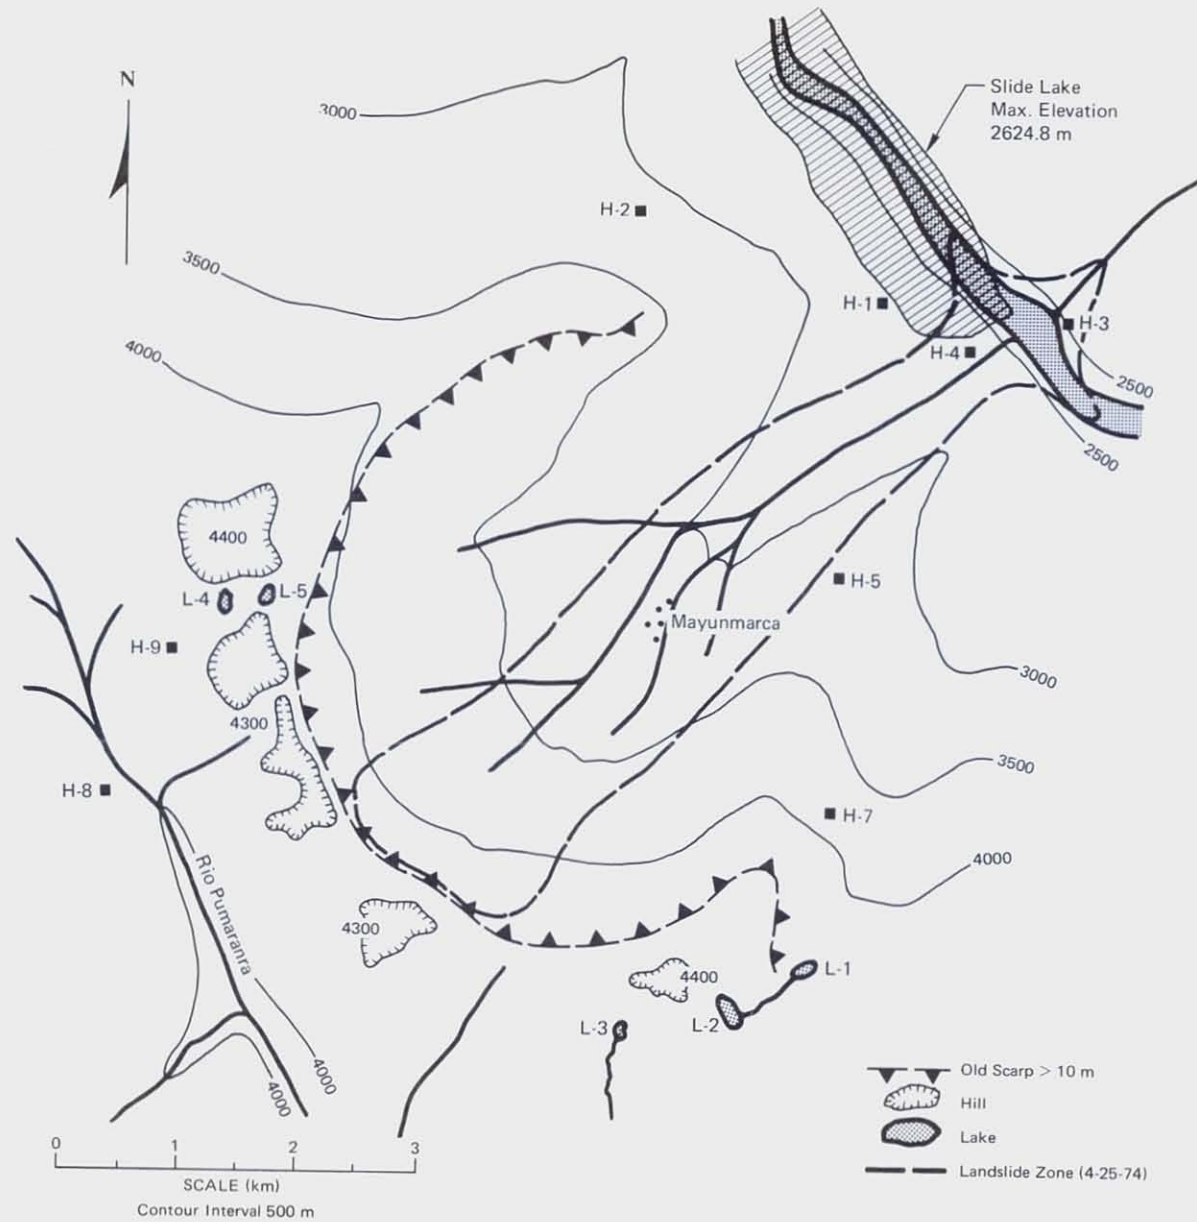
A plan view of the slide area is shown in Figure 11. Reference to Figure 3 indicates that the area which actually slid was approximately the same as the endangered area indicated by Galdos Bustamante. The entire town of Mayunmarca on the slope was carried away and the haciendas, Huaccoto (H3) and Ccochaca (H4), were buried by the slide debris. The vibrations caused by the slide movement were transmitted as seismic ground waves and recorded on several seismological stations, indicating the duration of major movements to be about three minutes, from which the 140 km/hr velocity was determined.

There is also other evidence to indicate that high velocities must have been developed. In at least one location, above the hacienda Huanupata (H1) on Figure 11, the sliding debris appeared to have become airborne as it encountered a major rock spur. A large amount of mud splatter was found on the slopes high above the river on the Quebrada Tinte side (opposite the river from the slide). Furthermore, the slide material appeared to have first flowed up the slopes of the Quebrada Tinte, across the river from the major slide, and then flowed back down 150 to 200 m to a lower final position, indicating that the debris must have been in a fairly fluid state during the sliding. Some sand boils were found in the debris near the Quebrada Tinte bank, again indicating that some of the material at least must have been in a liquefied state during the sliding with the sand boils becoming created as the debris consolidated after coming to rest between the two banks of the Mantaro river.

FIGURE 11. Plan of the Ccochacay ravine area showing the limits of the landslide zone of 4/25/74.

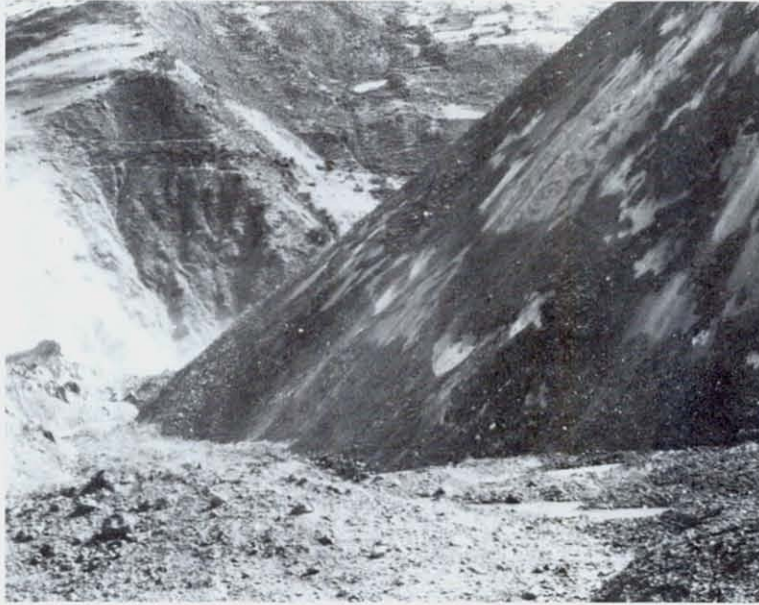
FIGURE 12. Steep slope of the Mantaro river valley opposite the main slide showing where the slide debris had run up and then fallen back down the slope. (Kojan-Hutchinson, Ref. 11)

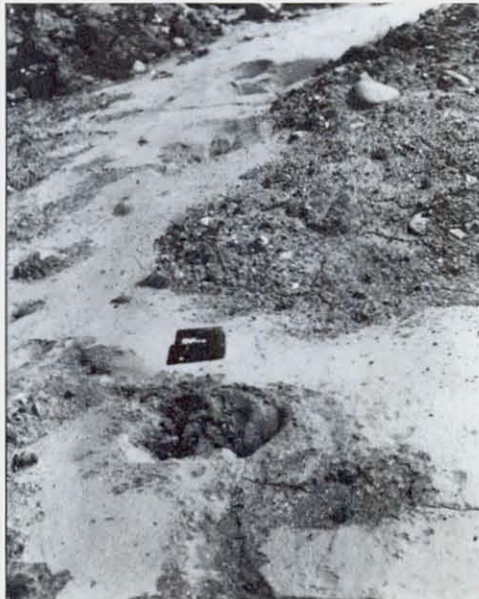
A further evidence of the liquefied state of at least part of the slide debris is the sand boil shown in Figure 13, which was typical of several such sand boils found along the trench between the rock slope and the small ridge on the debris shown in Figure 12.

FIGURE 13. Sand boils located in the fall back debris from the slope shown in Figure 12. (Kojan-Hutchinson, Ref. 11)

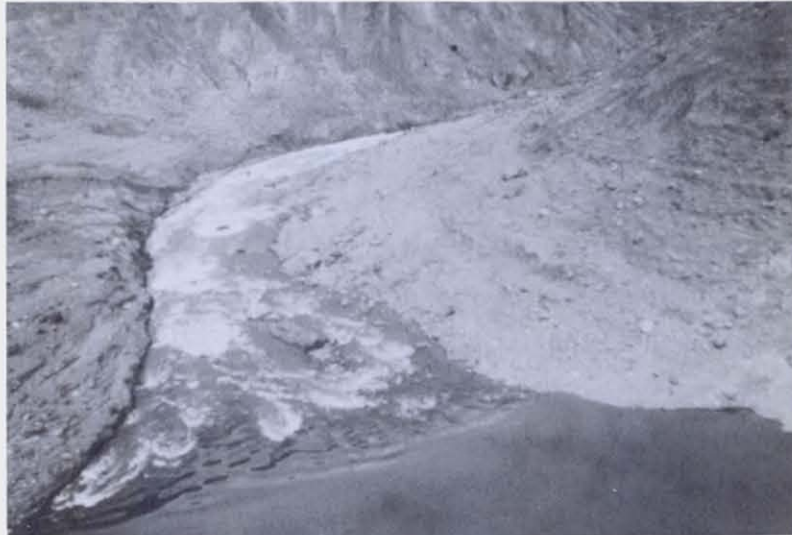
(b) After overtopping, showing nature of material exposed in the erosion slopes.

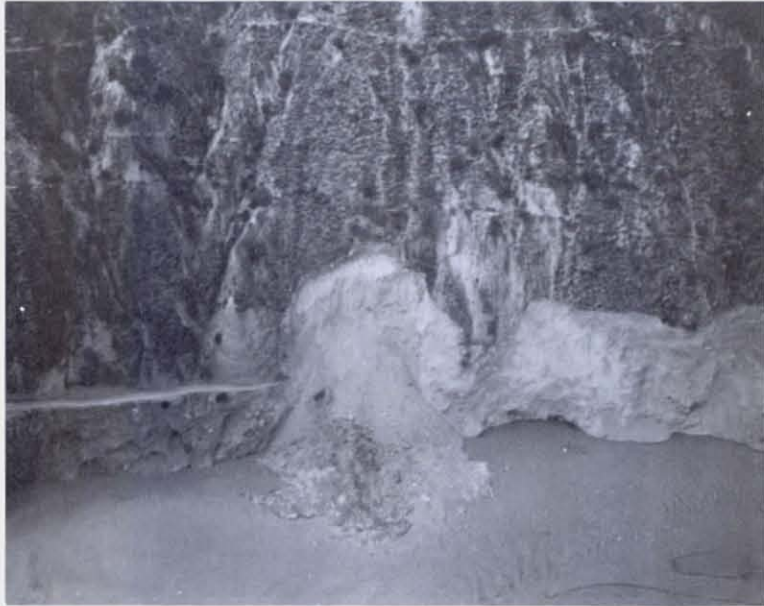
FIGURE 27. Small landslide on the lake shore caused by rising water.

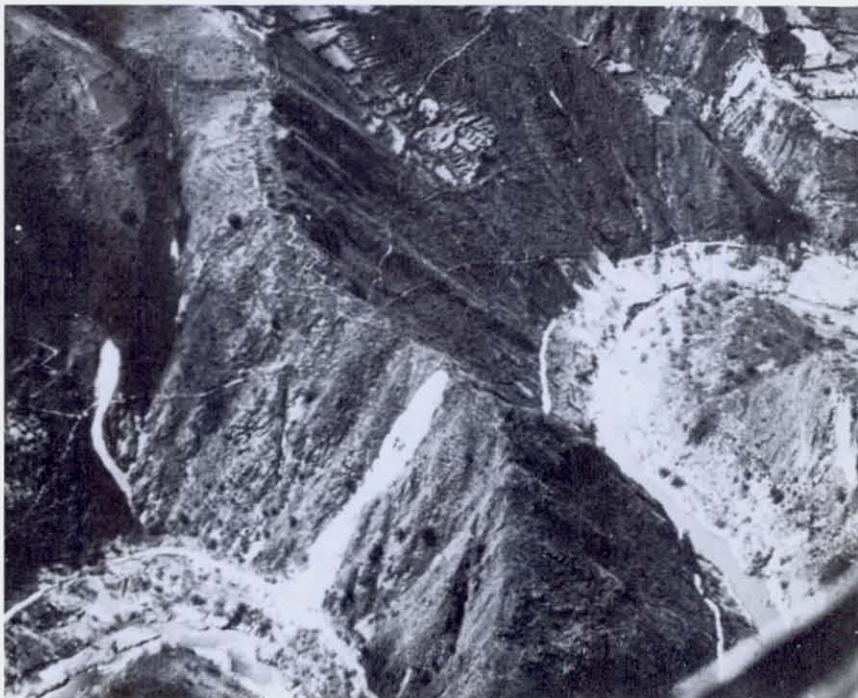
FIGURE 28. Landslide along lake shore caused by rising water.

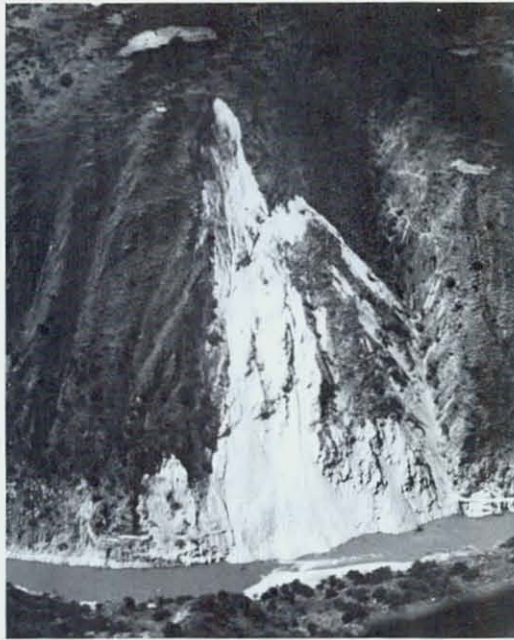
FIGURE 29. Landslide along the lake shore caused by rising water.

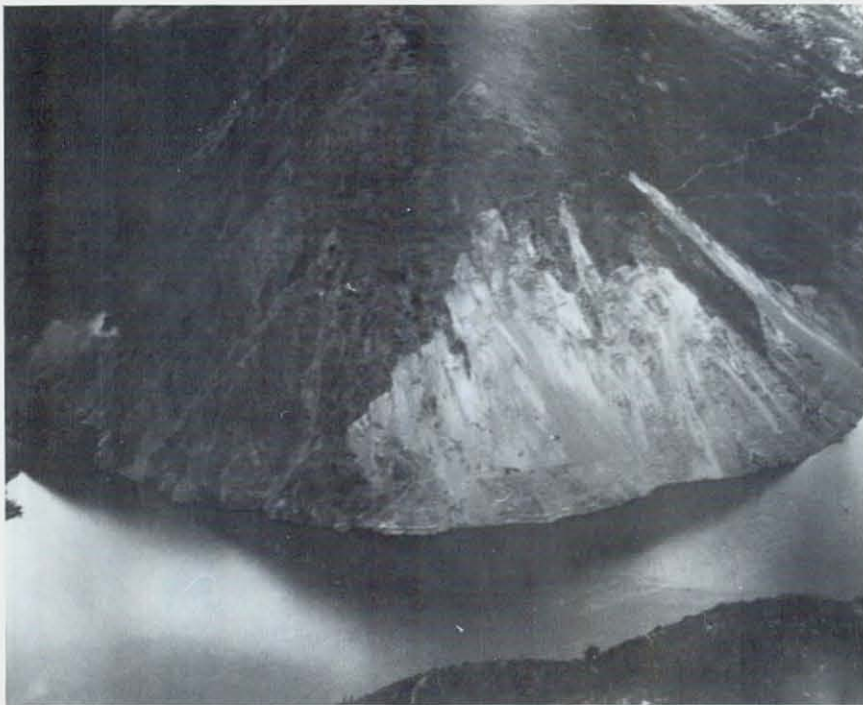
FIGURE 30. Extensive landsliding along the lake shore caused by rising water.

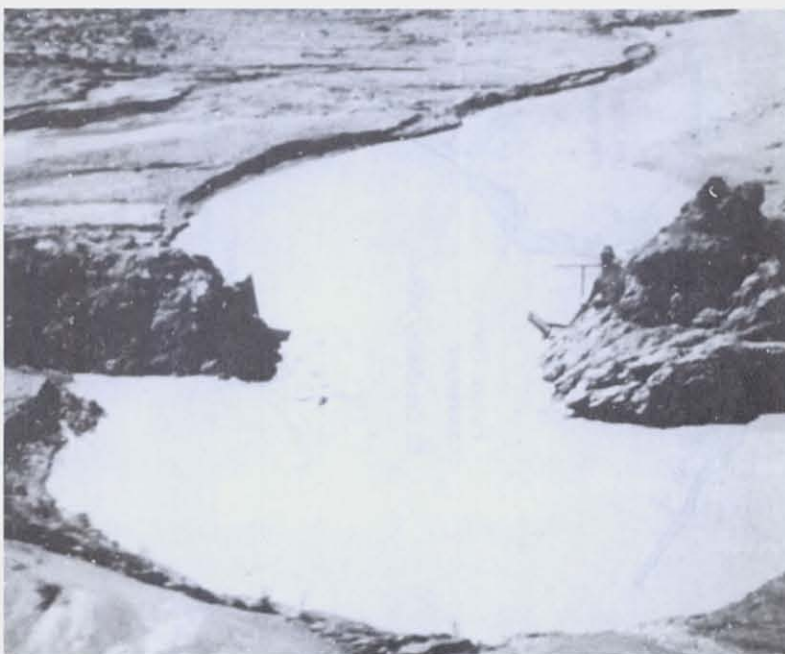
Because the inhabitants of the region had all been evacuated from the lower ground by the river prior to overtopping, the flood passed without causing any loss of life or human accident. However, there was considerable property damage. Upstream in the lake areas new slides developed as the lake level was rapidly lowered. Downstream, farmlands, houses, towns, and bridges were destroyed. A photograph of a concrete arch bridge at the town of Mayoc taken before the flood is shown in Figure 38. Another photograph of the same bridge taken just after it was destroyed during the flood is shown in Figure 39.

FIGURE 39. Mayoc bridge across the Mantaro River after destruction by the high flood water. (Photograph courtesy of Gen. Rodolfo Acevedo del Campo)

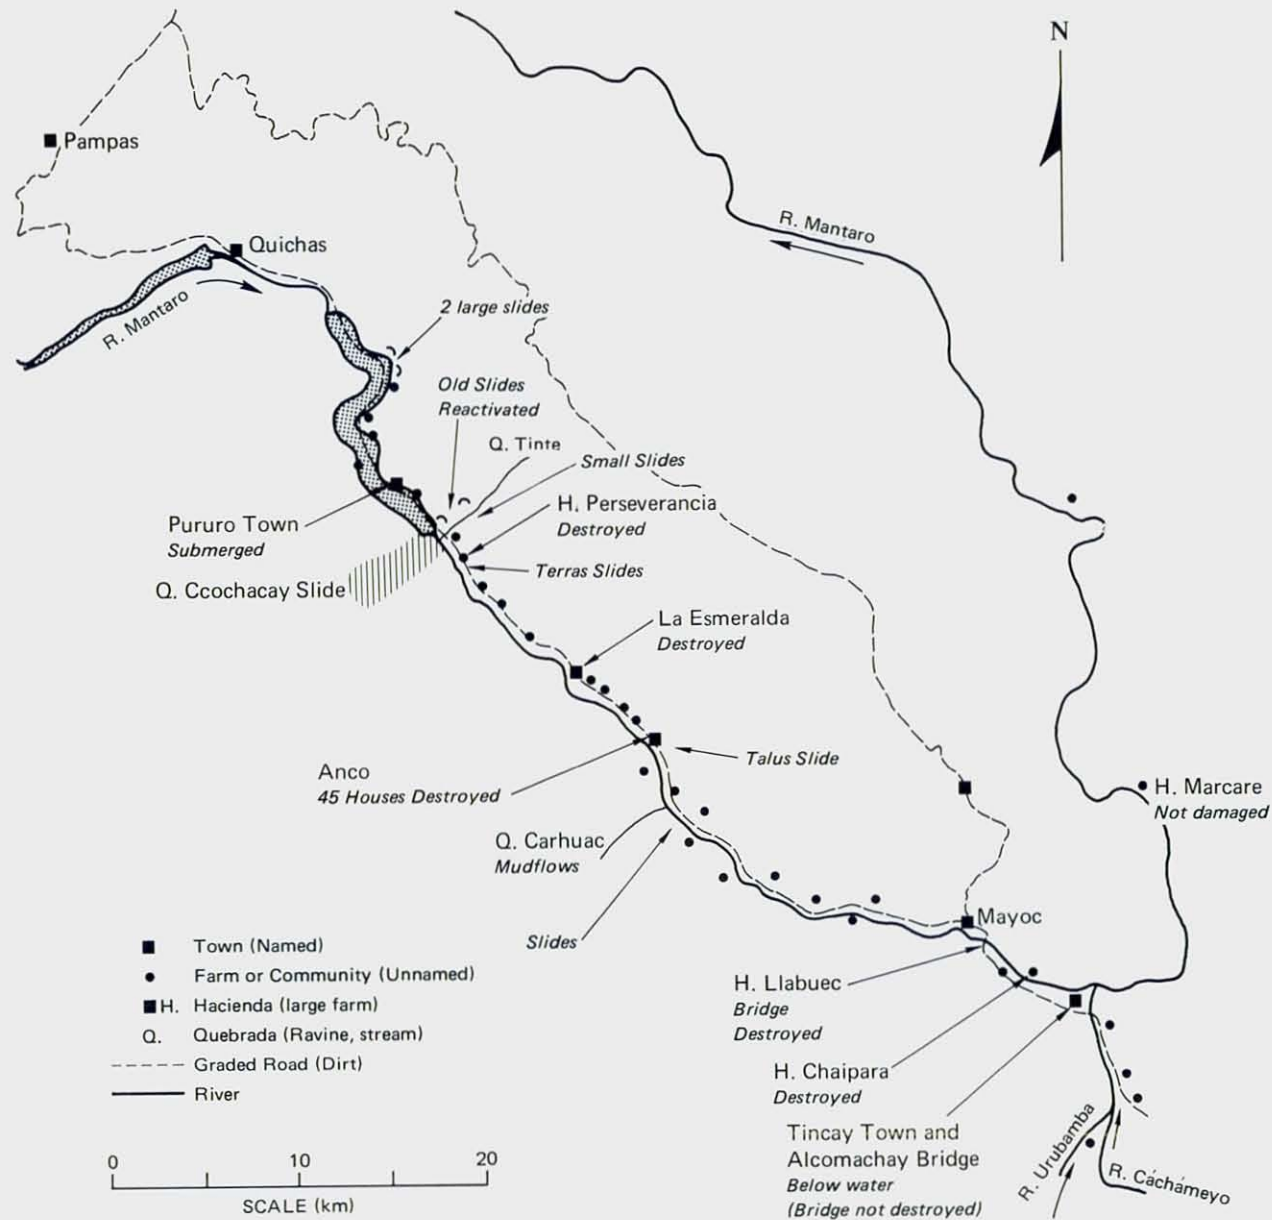
A map of the Mantaro River with notes describing types of damage caused at various locations is presented in Figure 40.

FIGURE 40. Location of major damage.
