CSCPRC REPORT NO. 8

Earthquake Engineering and Hazards Reduction in China

**A Trip Report of the American Earthquake Engineering and
Hazards Reduction Delegation**

Edited by Paul C. Jennings

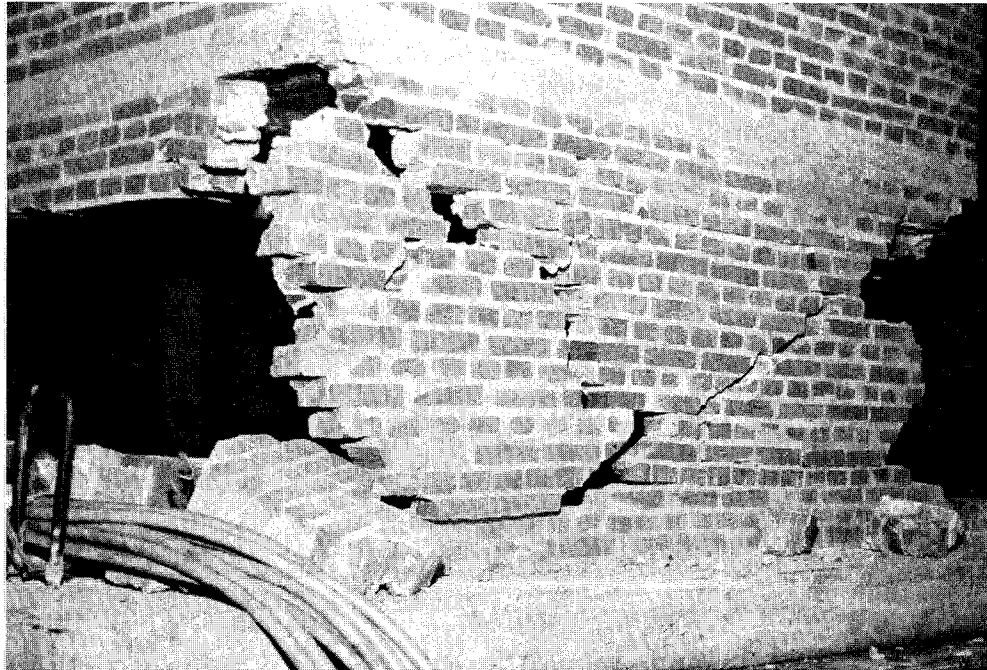
FIGURE 3.13 Close-up view of the lower floor of the end wall of the model shown in the previous figure. The end wall has failed in shear, with fracture occurring mainly through the bricks, rather than the grout.

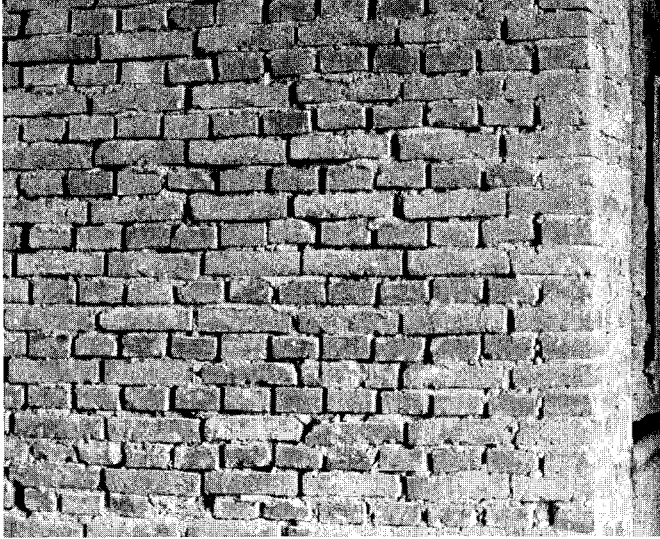
FIGURE 3.26 Typical brick wall construction, Harbin electronics factory. Note that head joints are typically not filled.

The quality of the brickwork in the building was quite poor by U.S. standards, as shown in Figure 3.26. This appears typical of masonry construction seen in China. The brick is often soft and the mortar very weak; normally, it can be broken with one's fingers. Head joints are rarely filled, and even the bed joints often have large gaps. An interesting practice also seen throughout our visit is shown in Figure 3.27; temporary fences are made of brick to be used later in the building.

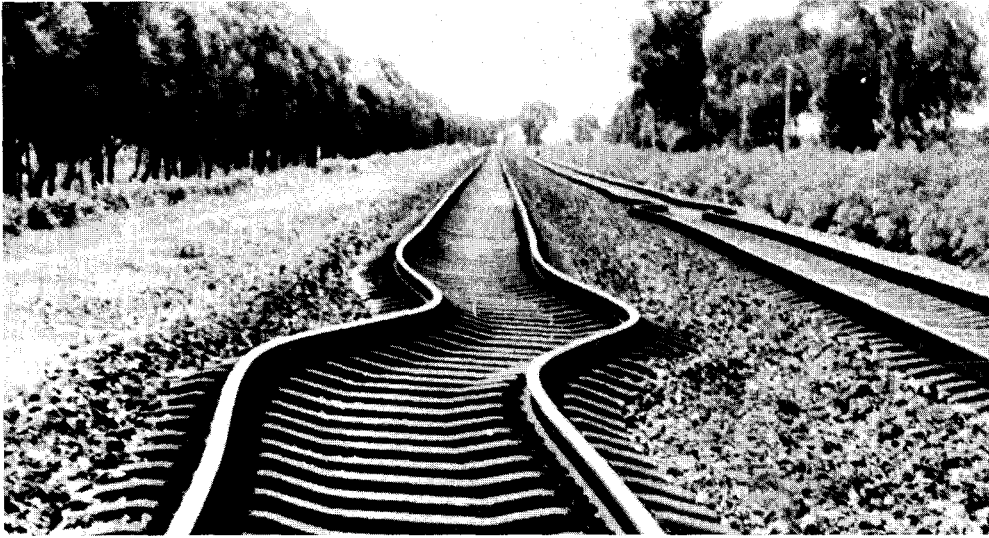
FIGURE 4.3 Buckling of rail lines due to ground deformations. The general Tangshan region had many soft soils that behaved poorly during the earthquake.

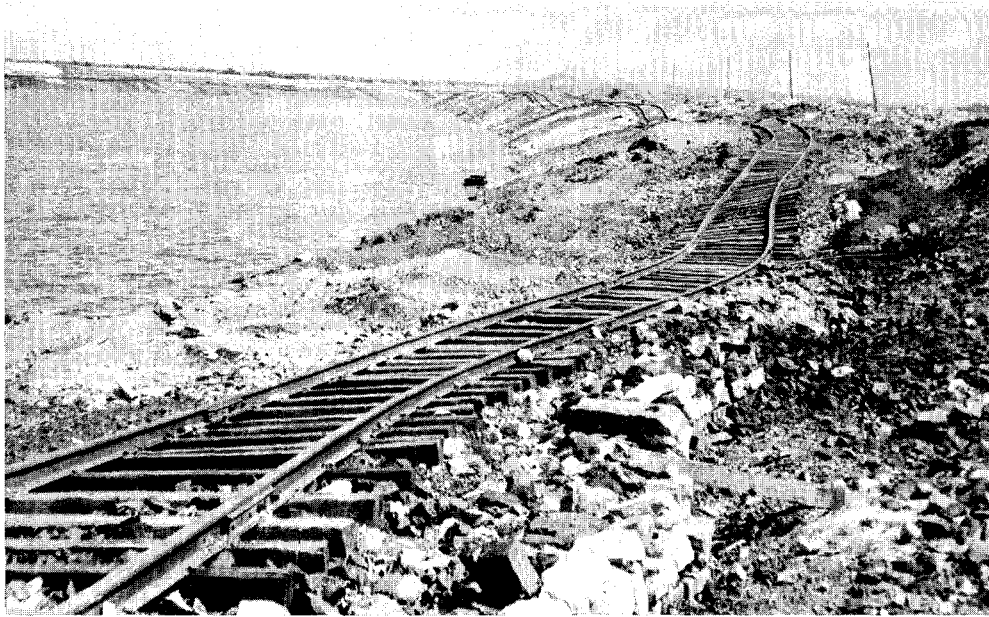
FIGURE 4.4 Failure of ground under railway line. Extensive damage was done to the rail system in the Tangshan region.

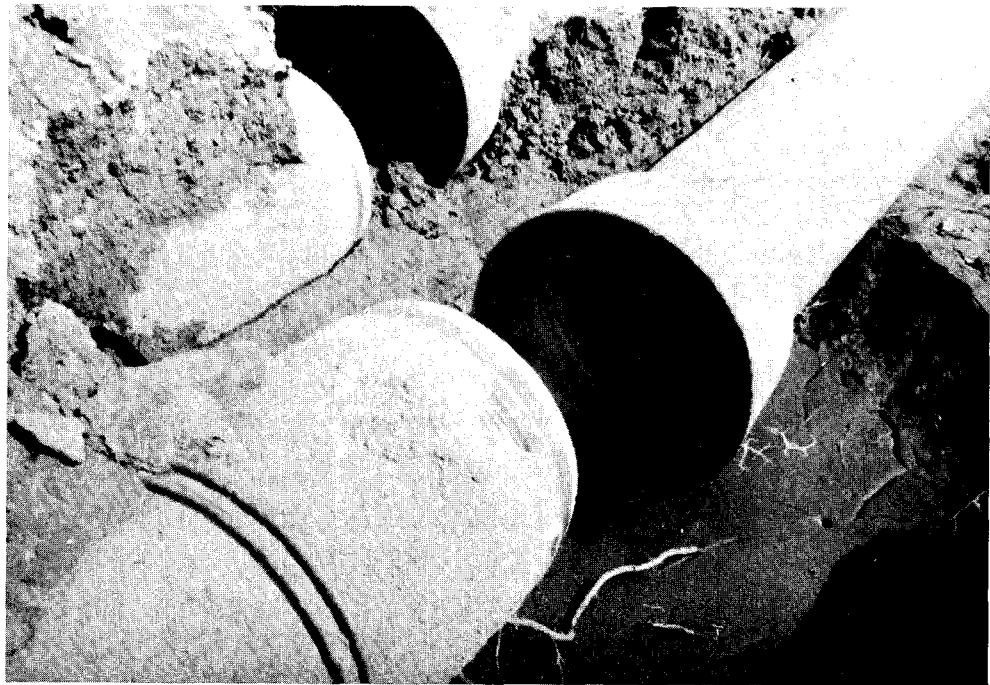
FIGURE 4.6 Underground pipes separated by extensional ground deformation.

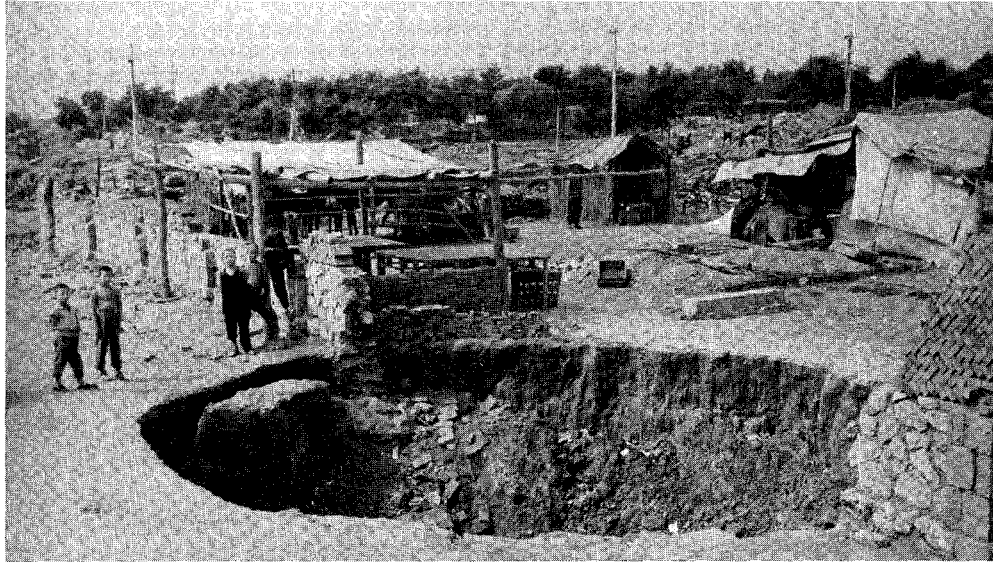
FIGURE 4.7 Ground collapse near Tachuangtuo Commune, Kuyeh Hsien. The Tangshan earthquake triggered the formation of a number of such craters. Geological investigations had not yet determined the underlying cause of these craters.

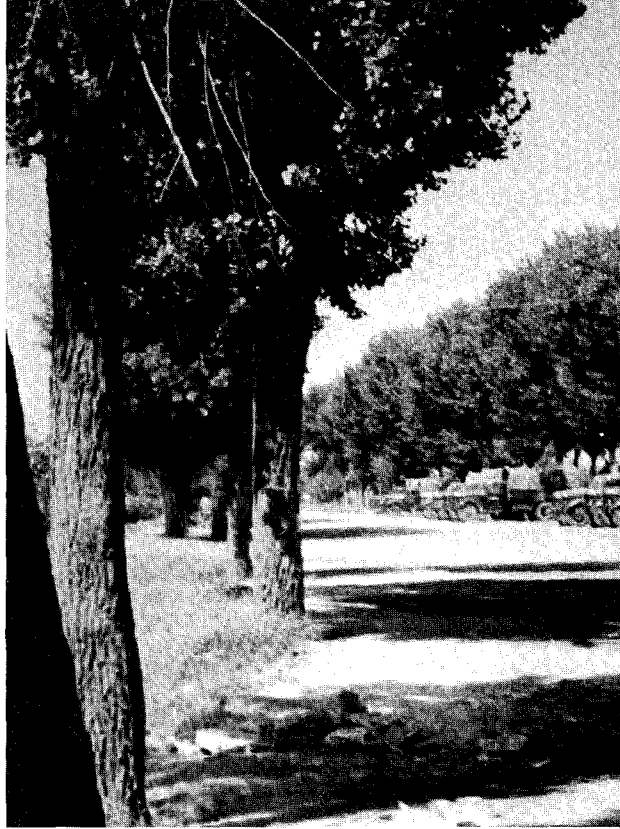
FIGURE 4.20 Offset in row of trees due to horizontal tectonic movement, in Tangshan.

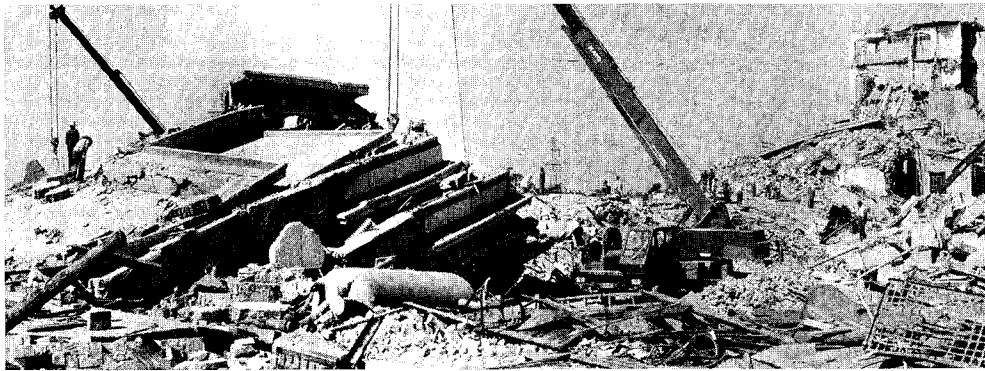
FIGURE 4.24 Collapsed out-patient service building of the Kailuan coal mine general hospital, Tangshan.

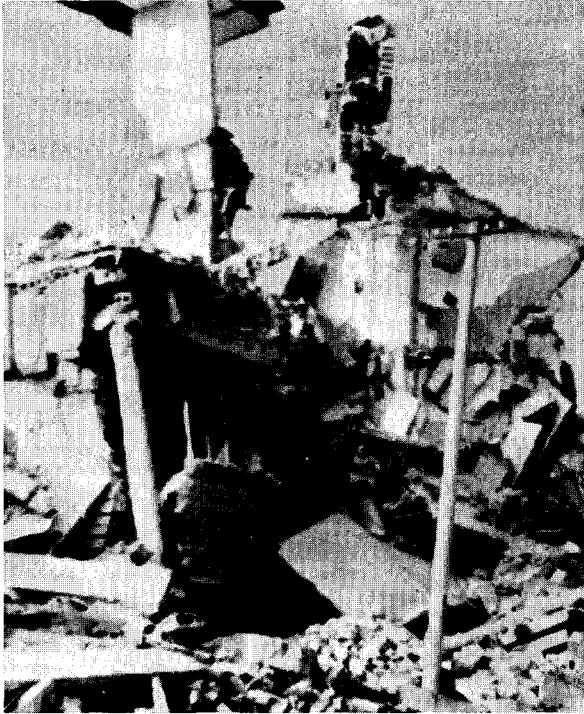
FIGURE 4.31 Collapsed building, Tangshan.

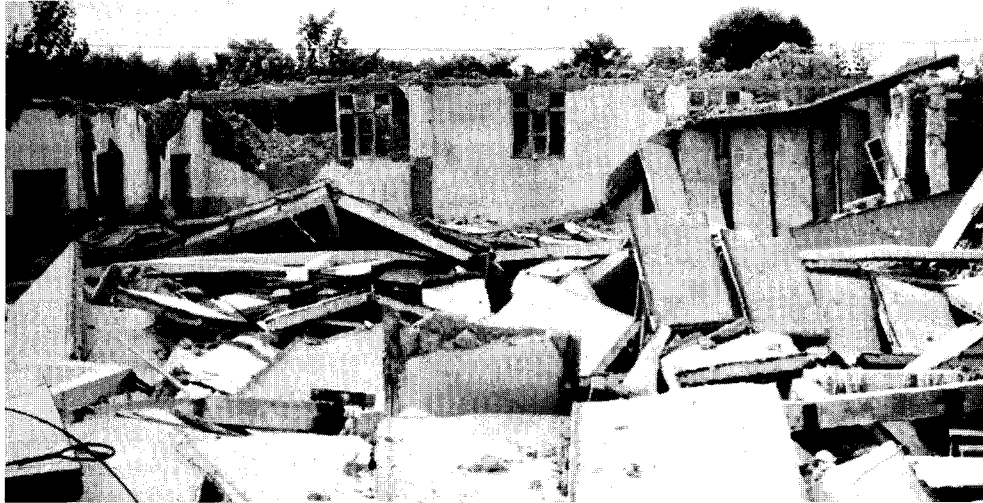
FIGURE 4.33 Collapsed workers' cafeteria building of the Chinkechuang coal mine.

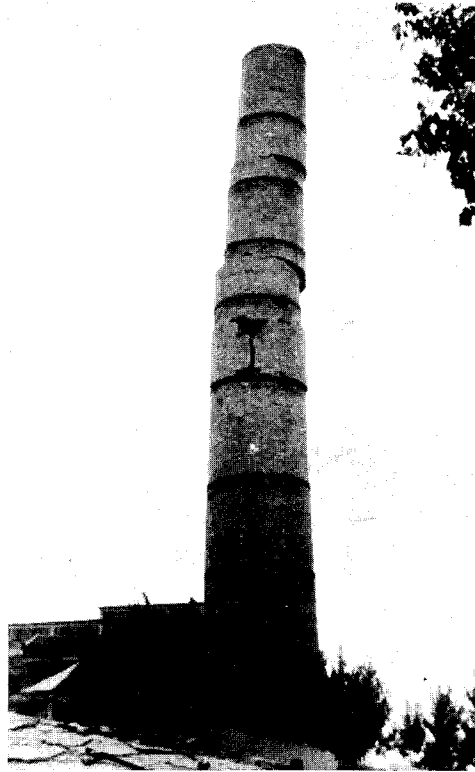
FIGURE 4.40 Damaged brick chimney at Chaokenchuang mine. The top of the chimney fell off, and four horizontal cracks appeared in the remaining portion.

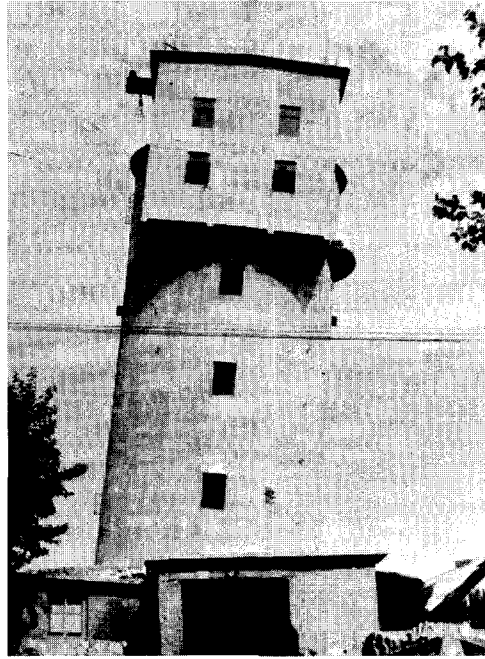
FIGURE 4.42 Tilted ventilation tower at Tangshan coal mine.

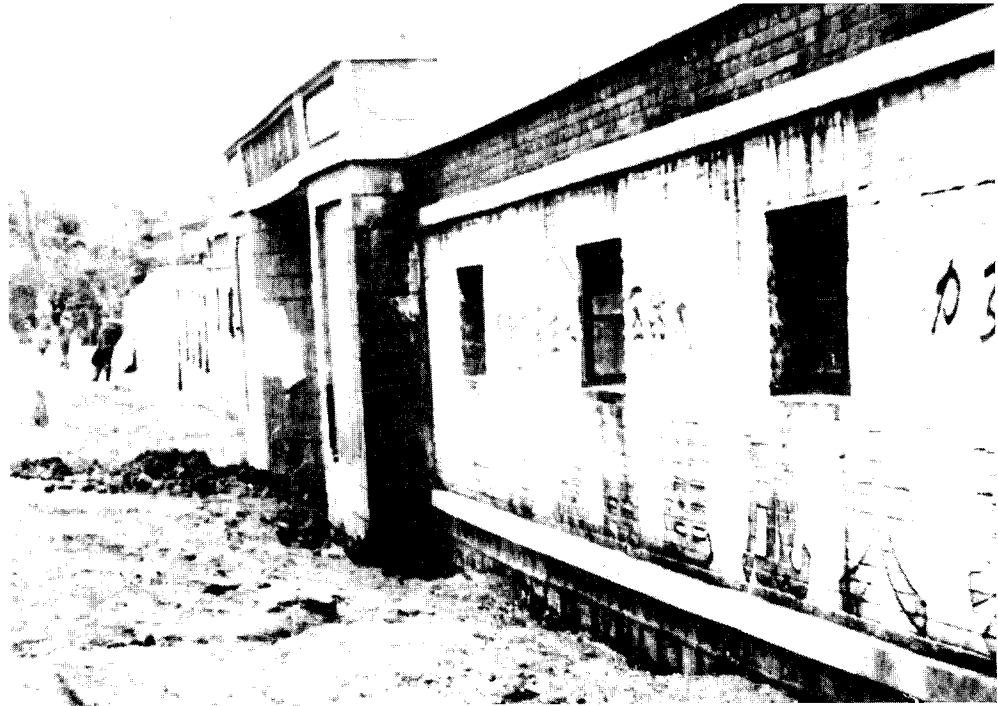
FIGURE 4.47 Uneven settlement of office building, Fanken Chuang Commune, Luan-nan Hsien.

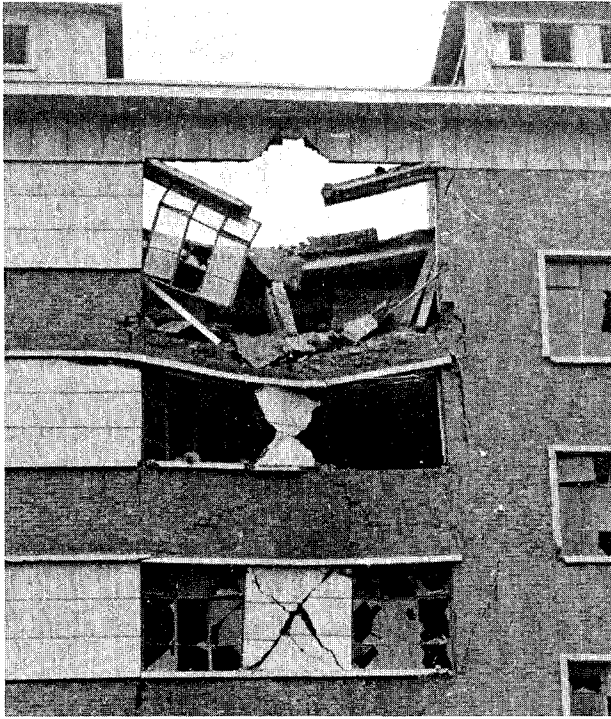
FIGURE 4.49 Damaged reception building in Tangshan.

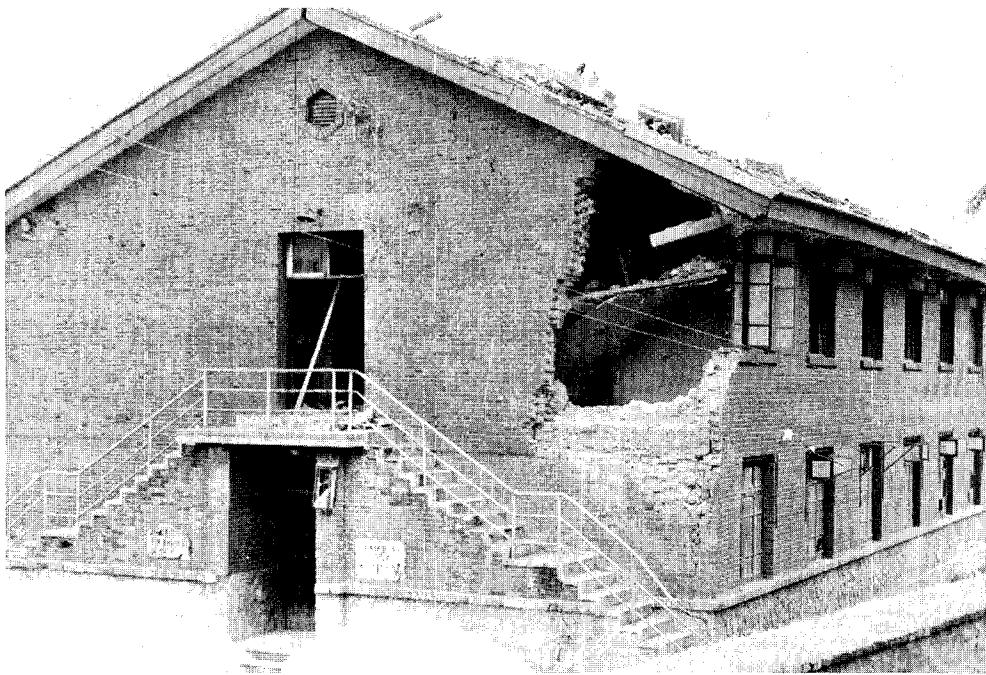
FIGURE 4.51 Damaged car factory dormitory building in Tangshan. The first story was most severely damaged but the building remained standing.

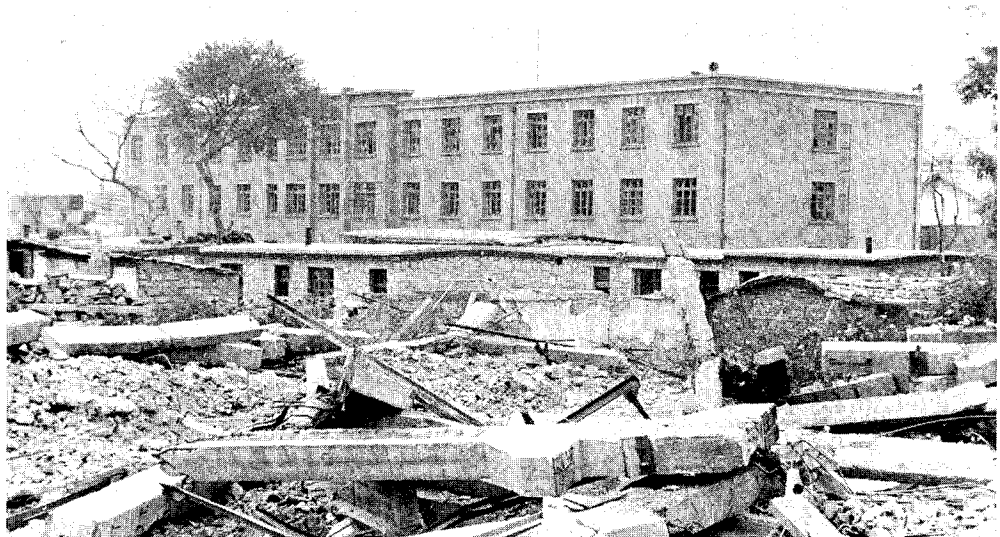
FIGURE 4.52 Tangshan light-machine plant official building. This structure, which was located in district 13 of Figure 4.21, was only slightly damaged. The remains of a collapsed building can be seen in the foreground.

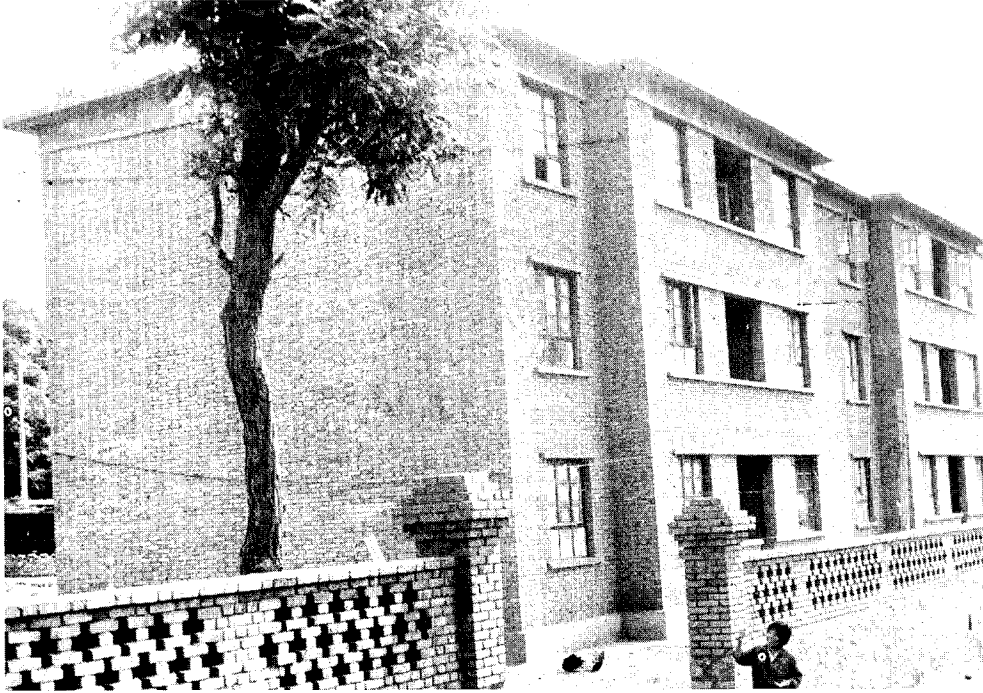
FIGURE 4.53 Cement factory worker apartment building 422. This structure was located on bedrock north of Tangshan and received only slight damage.

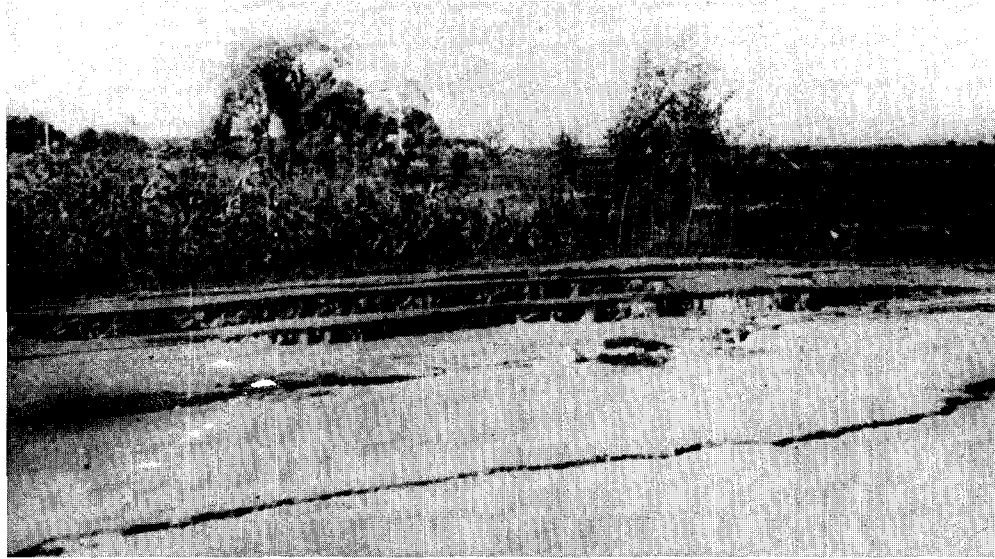
FIGURE 4.54 Large landslide at east bank of Tanshan River, which caused damage to the Yenchuang Bridge.

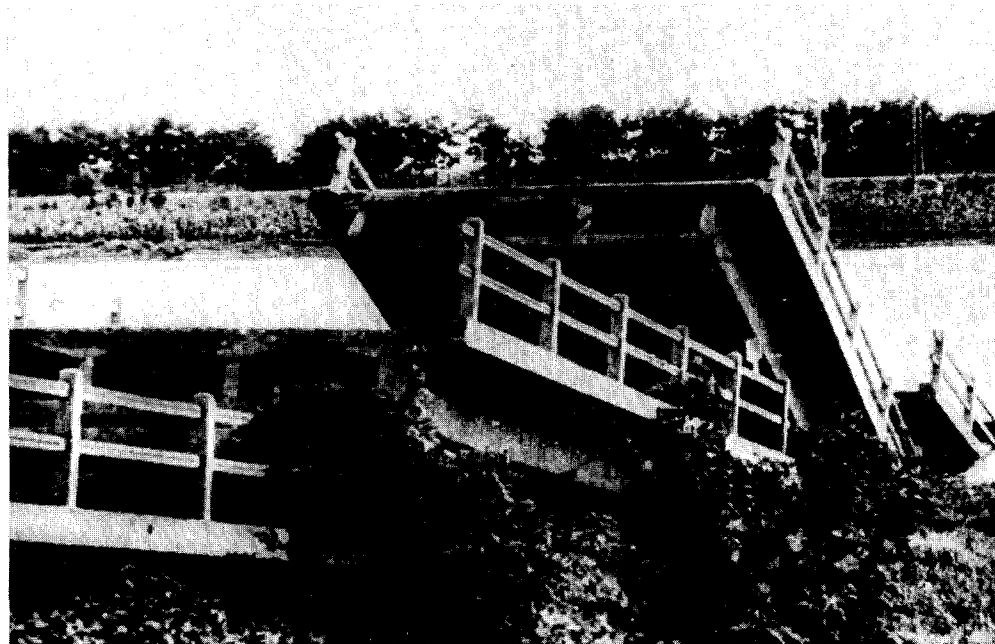
FIGURE 4.55 Deck spans of Yenchuang Bridge were pushed off their supports by the landslide.

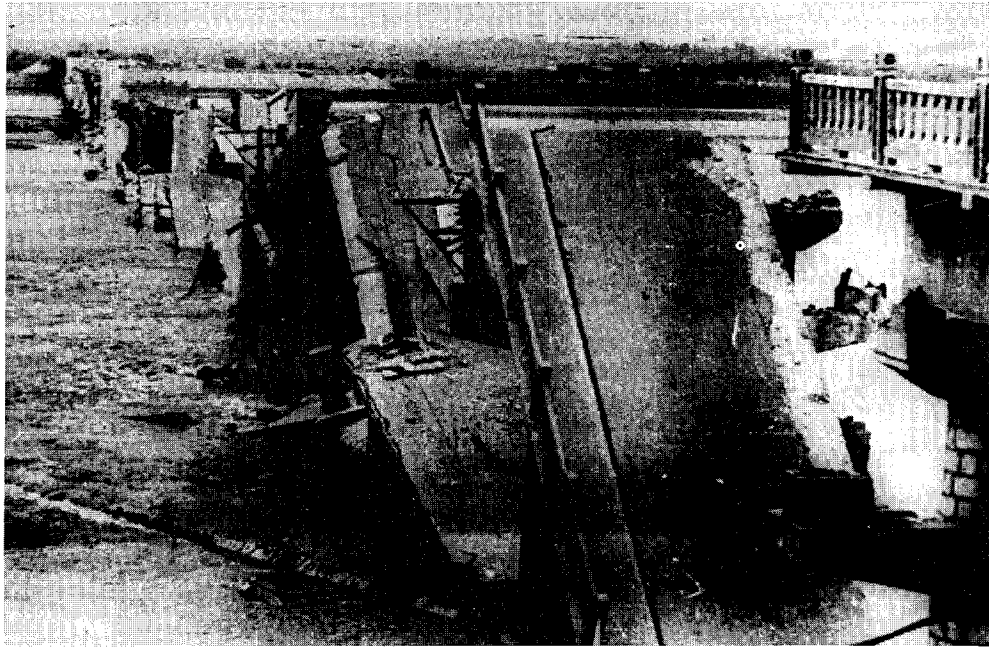
FIGURE 4.56 Fallen spans of the Janshan Bridge.

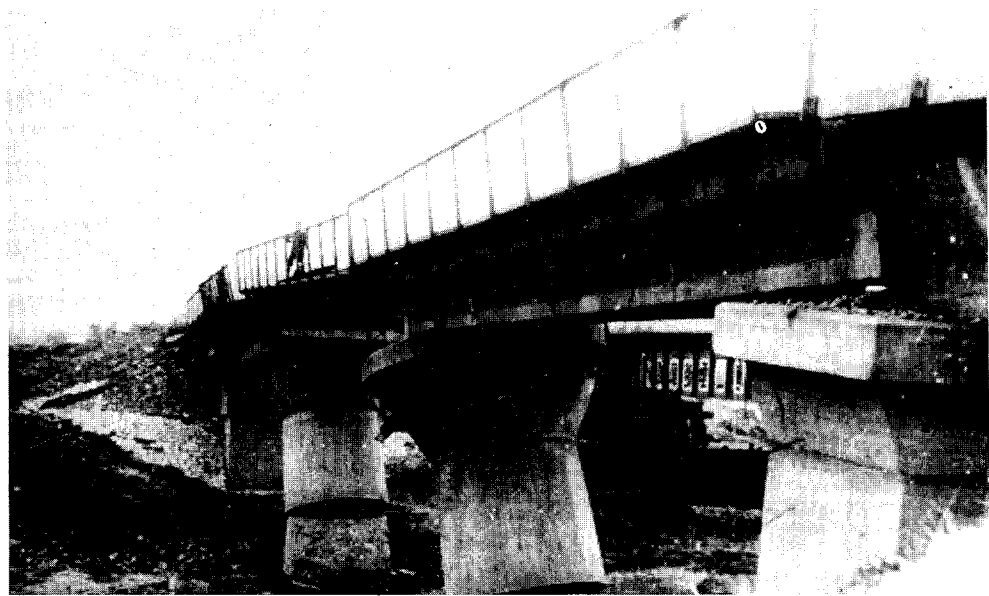
FIGURE 4.57 Tilted piers and broken abutment of the railway bridge on Tangshan-Kenhua Line.

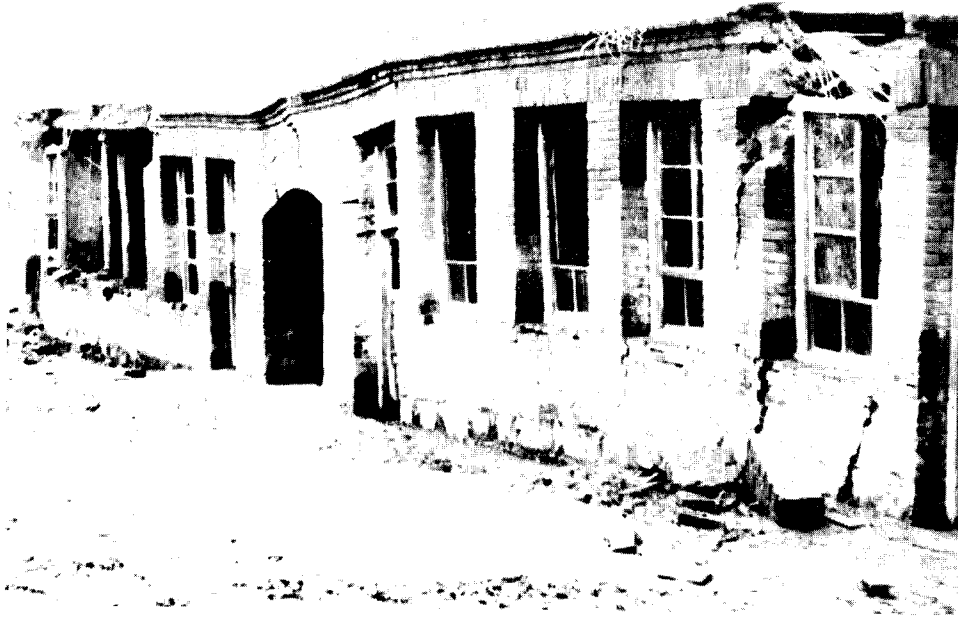
FIGURE 4.61 Structure damaged by unequal ground settlement.

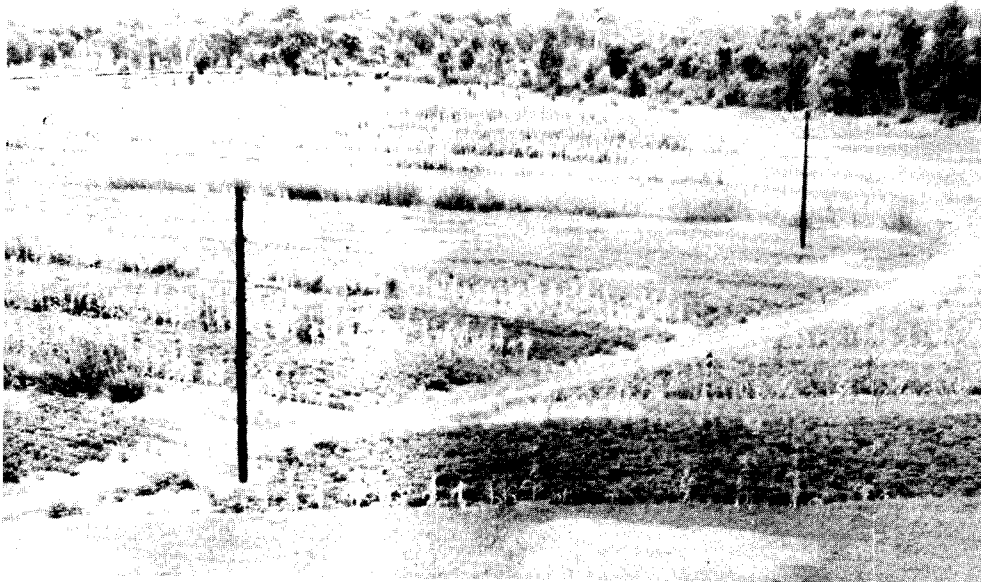
FIGURE 4.62 View of sandblows in a field.

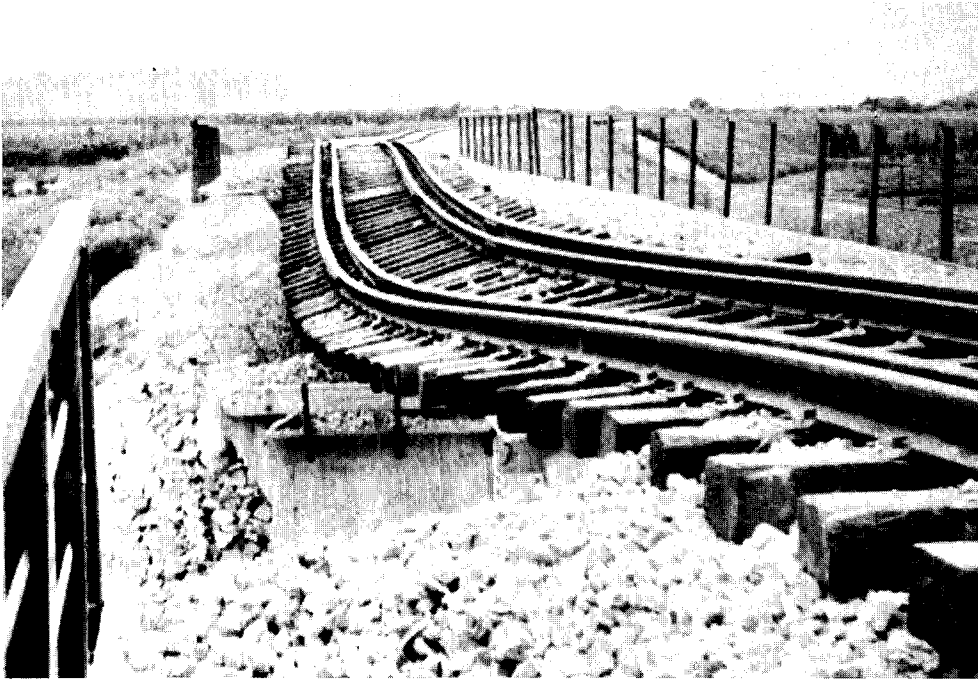
FIGURE 4.64 Damage to railway line caused by loss of support.

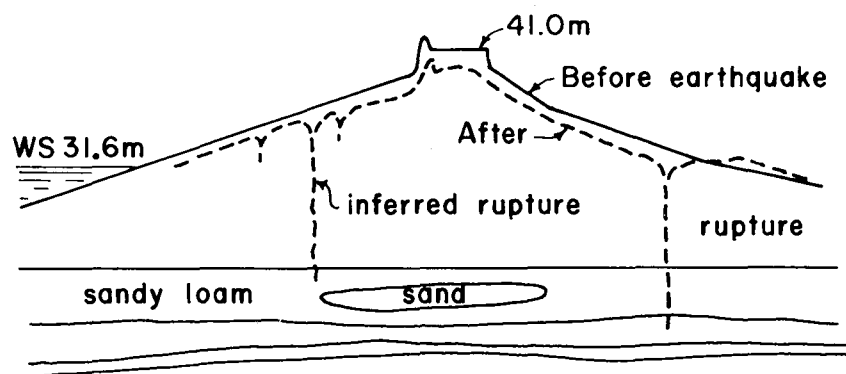
FIGURE 4.66 Sketch showing settlement of the earth dam at Touho reservoir.

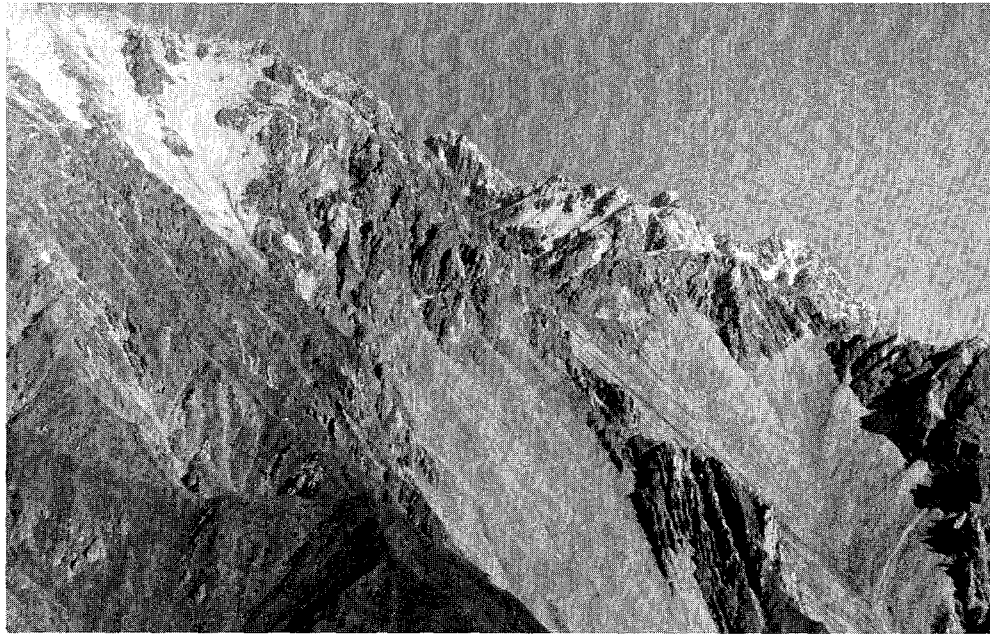
FIGURE 5.13 Slides and rockfalls in the mountainous terrain affected by the SP earthquakes.

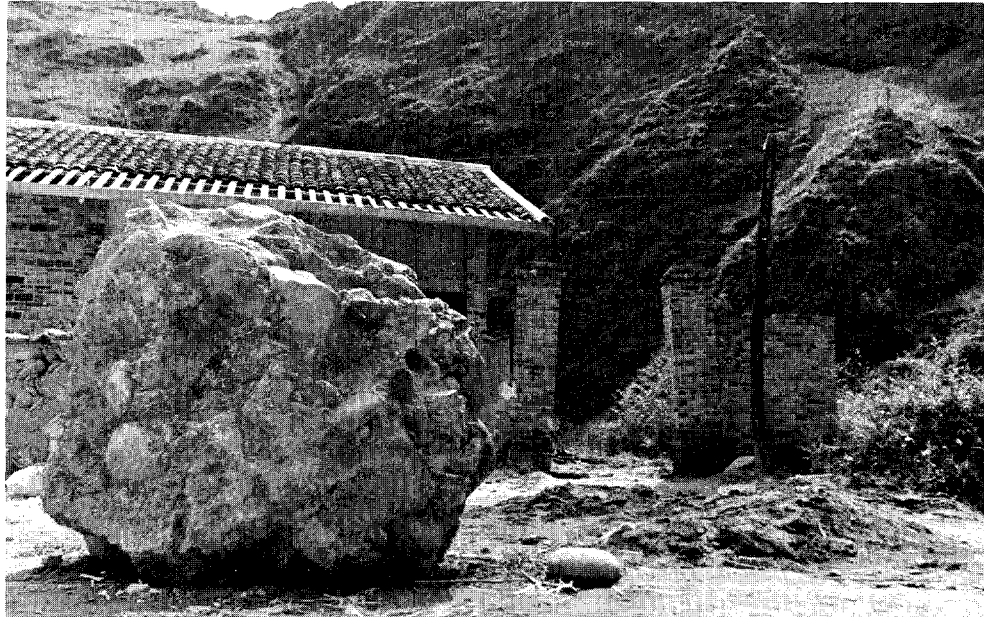
FIGURE 5.16 Large conglomerate boulder that fell during the SP earthquakes. Note also the structural damage to the building.

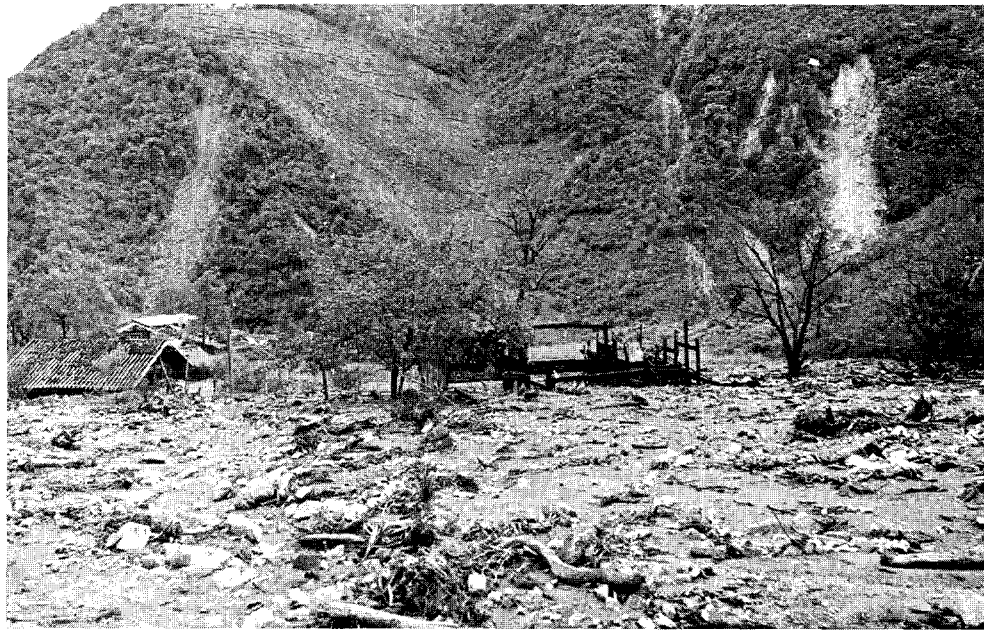
FIGURE 5.17 Mud flow damage from the SP earthquakes. Heavy rain occurred before the second and third shocks, and many mud flows occurred.

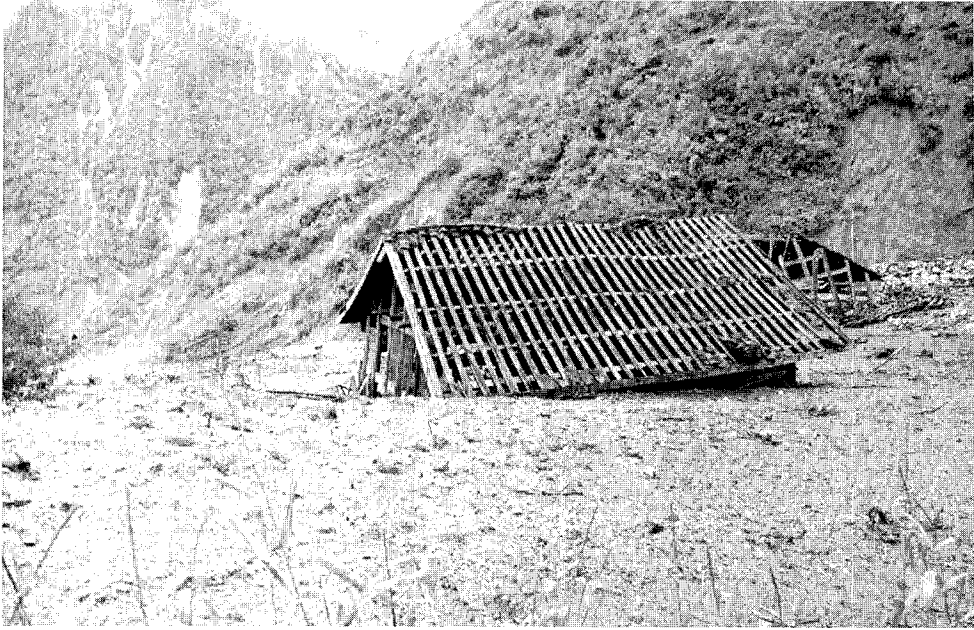
FIGURE 5.18 Mud flow damage from the SP earthquakes.

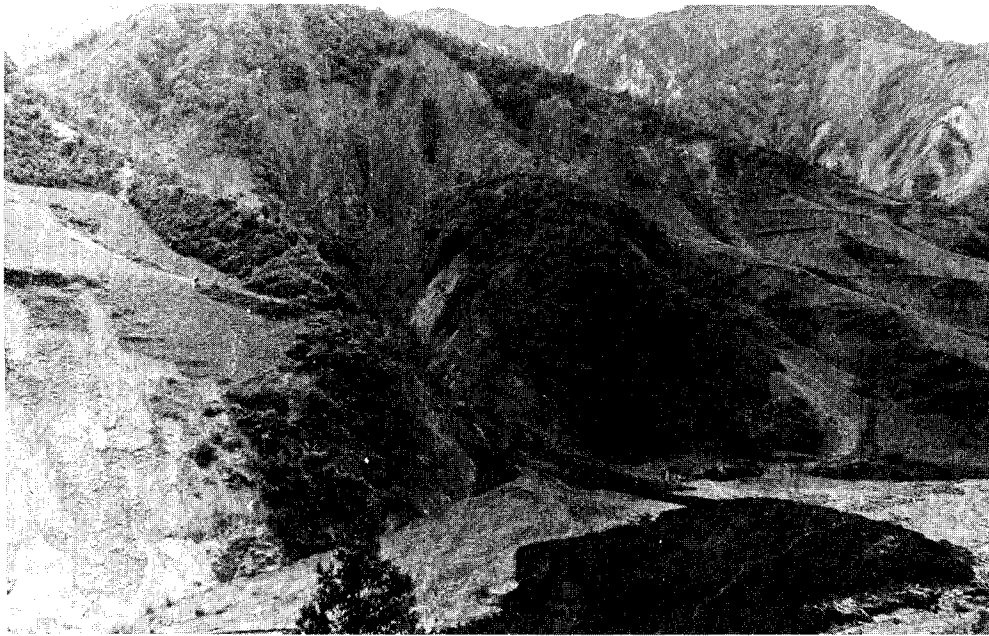
FIGURE 5.19 Fresh mud flow (light colored material) on a recent alluvial fan, SP earthquakes.

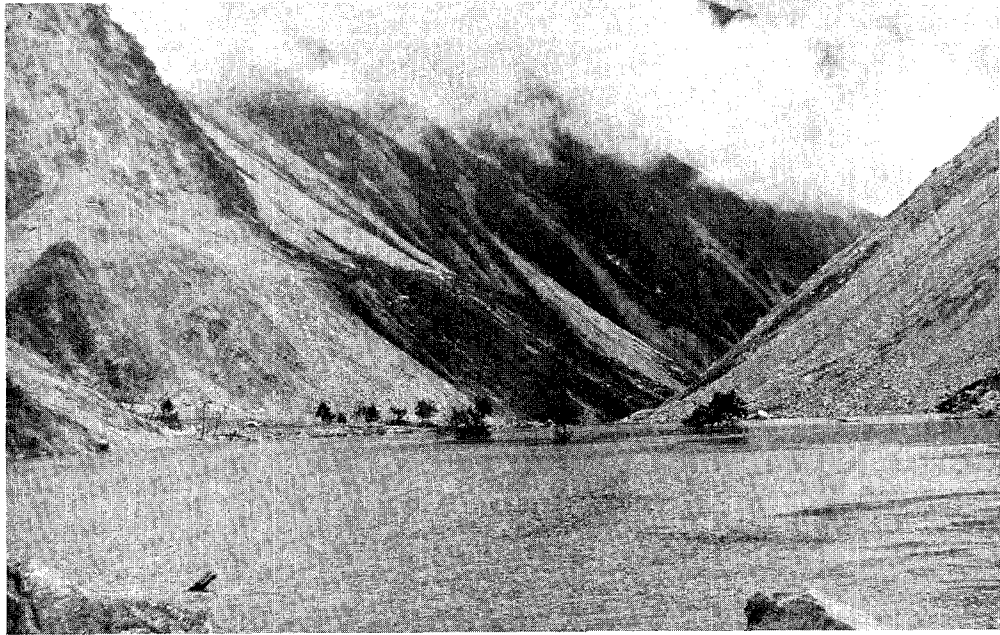
FIGURE 5.20 "Earthquake lake" formed during the SP earthquakes by a rockfall.
