Analytical Modeling of Buried Pipeline Response to Permanent Earthquake Displacements

T. D. O'Rourke and C. H. Trautmann

July 1980

GEOTECHNICAL ENGINEERING REPORT 80-4

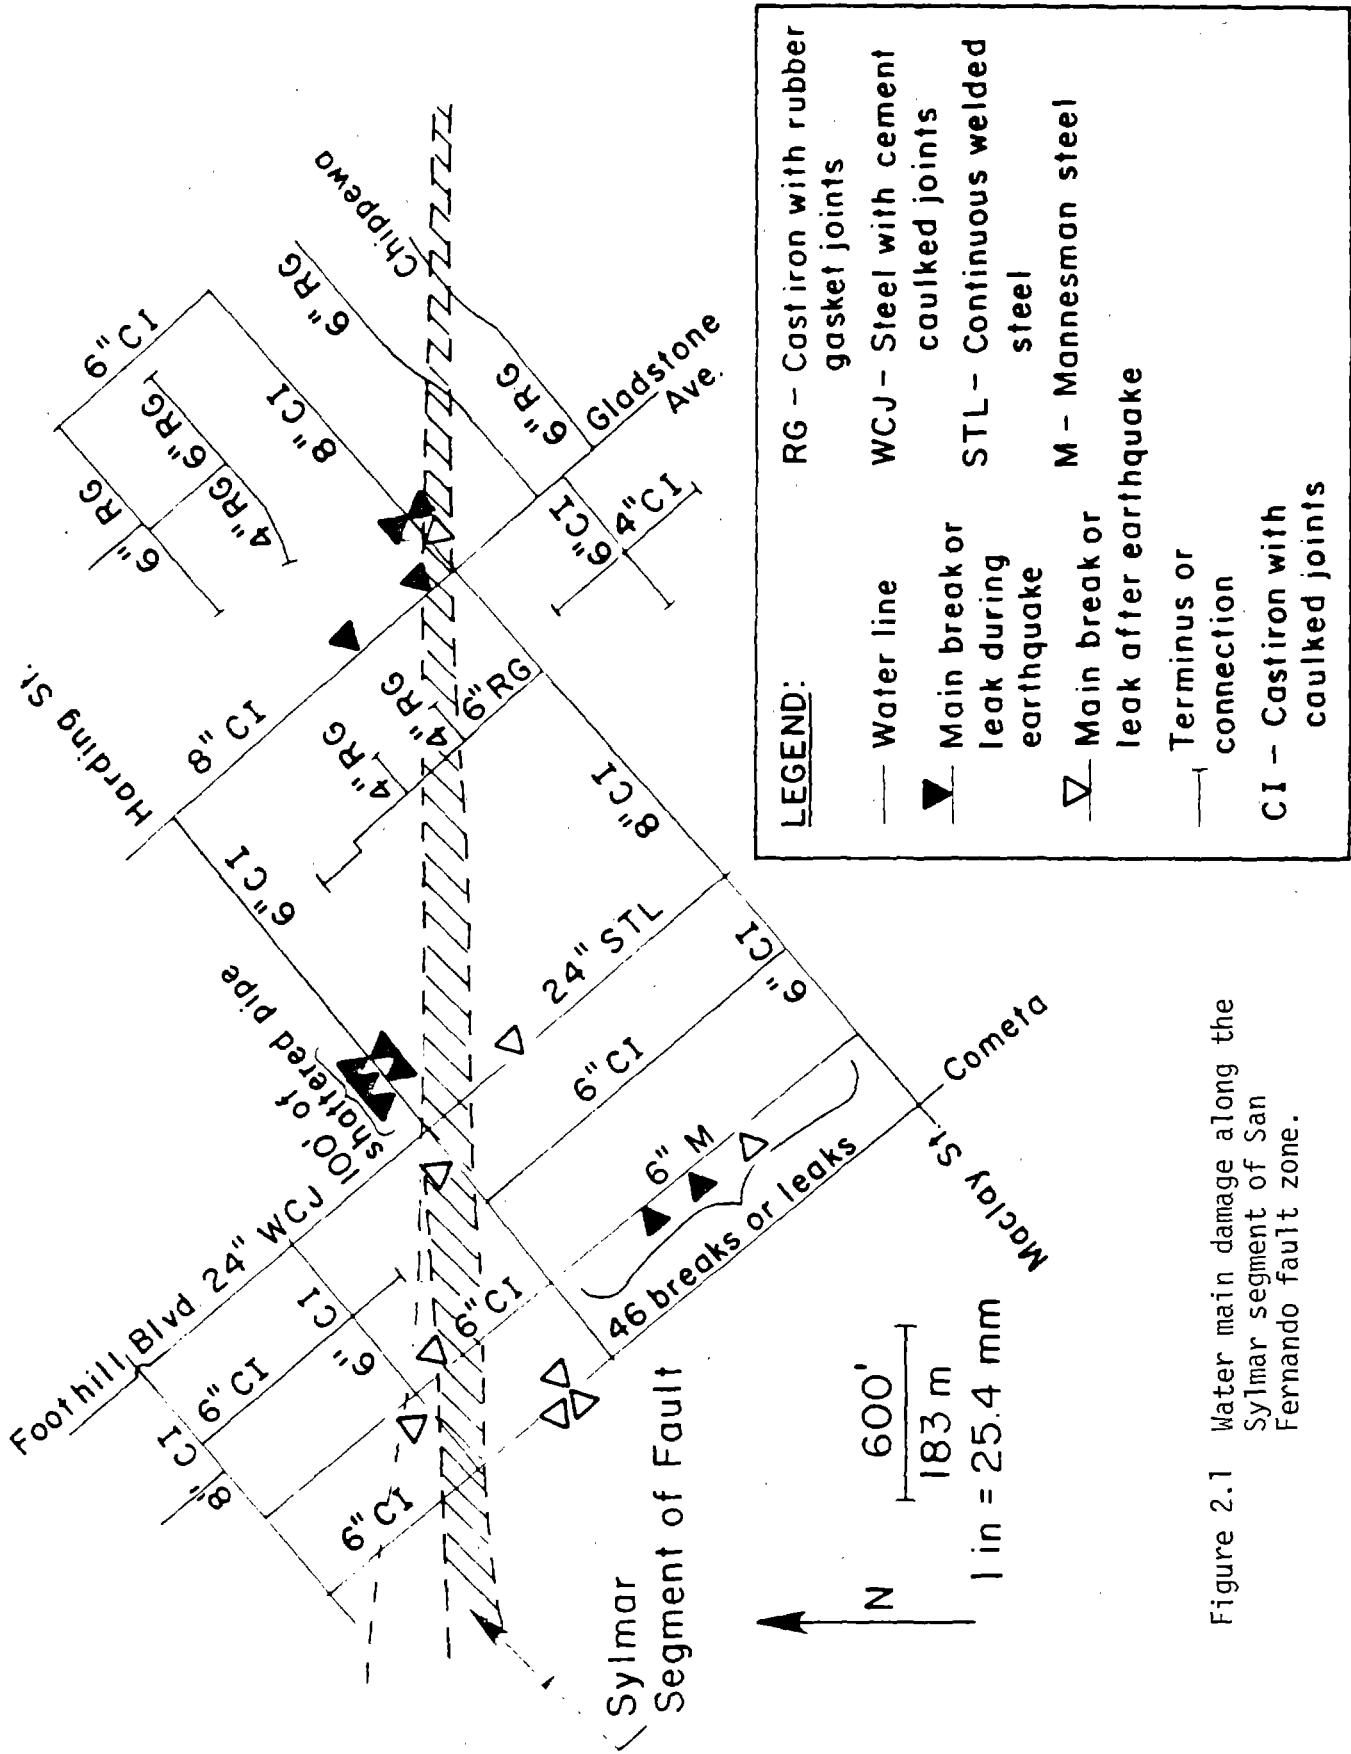
Figure 2.1 Water main damage along the Sylmar segment of San Fernando fault zone.

In contrast to the lines with cement-caulked couplings, cast iron mains with rubber gasket joints showed no damage in the area under consideration. These pipelines were composed of 18 ft (5.5 m) lengths of gray, cast iron pipe joined by rubber gasket, or push-on, couplings. Most of these pipelines crossed the fault in the vicinity of Maclay Ave. and Chippewa St. In the same area, four repairs were required at cement-caulked couplings.

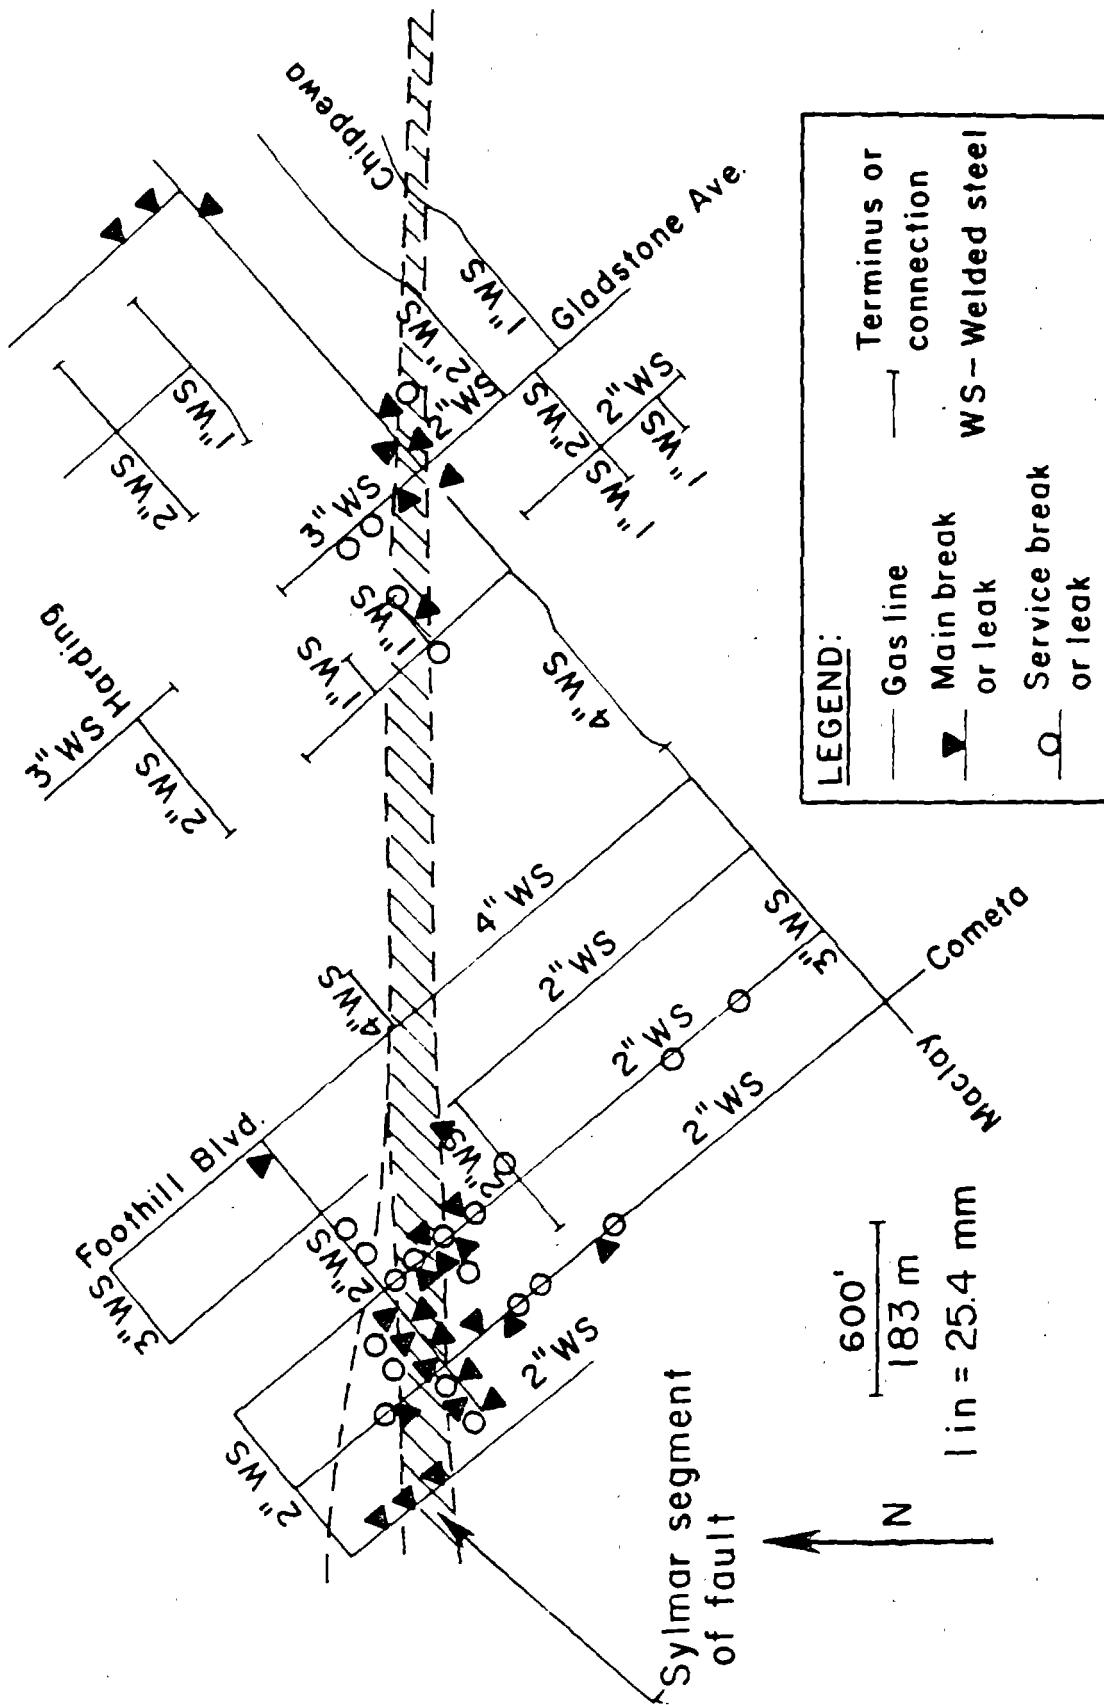
Figure 2.2 Gas main damage along the Sylmar segment of San Fernando fault zone.

in this vicinity immediately after the earthquake except for the shattered line on Harding St. It is difficult to explain the absence of damage in the water mains immediately adjacent to the extensive gas main ruptures at this location.

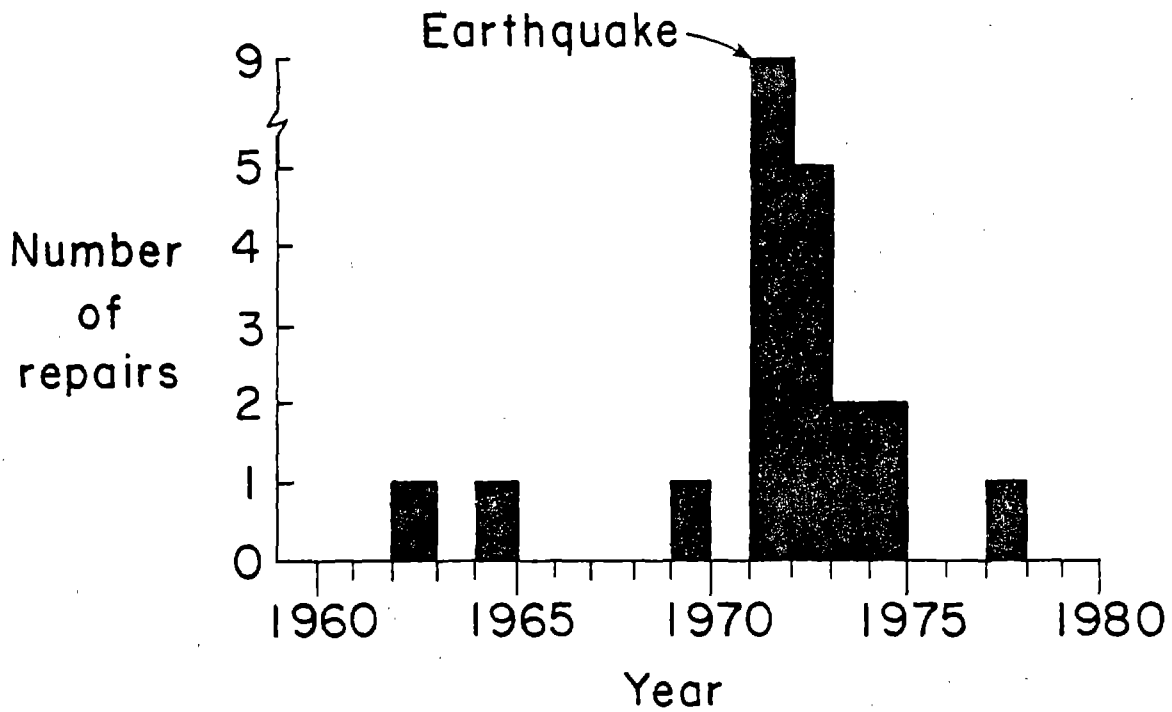
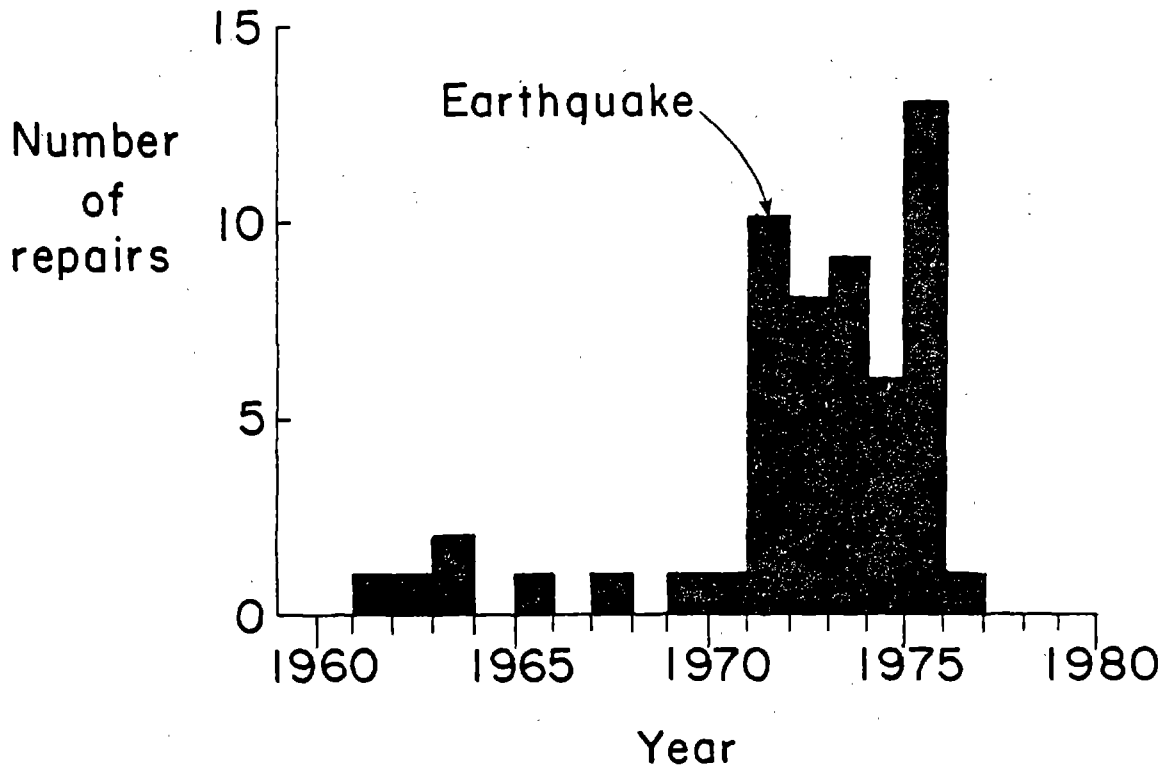
a) repairs to lines within 1000 ft of the fault

b) repairs to Mannesman line

Figure 2.5 Frequency of repair to water mains.

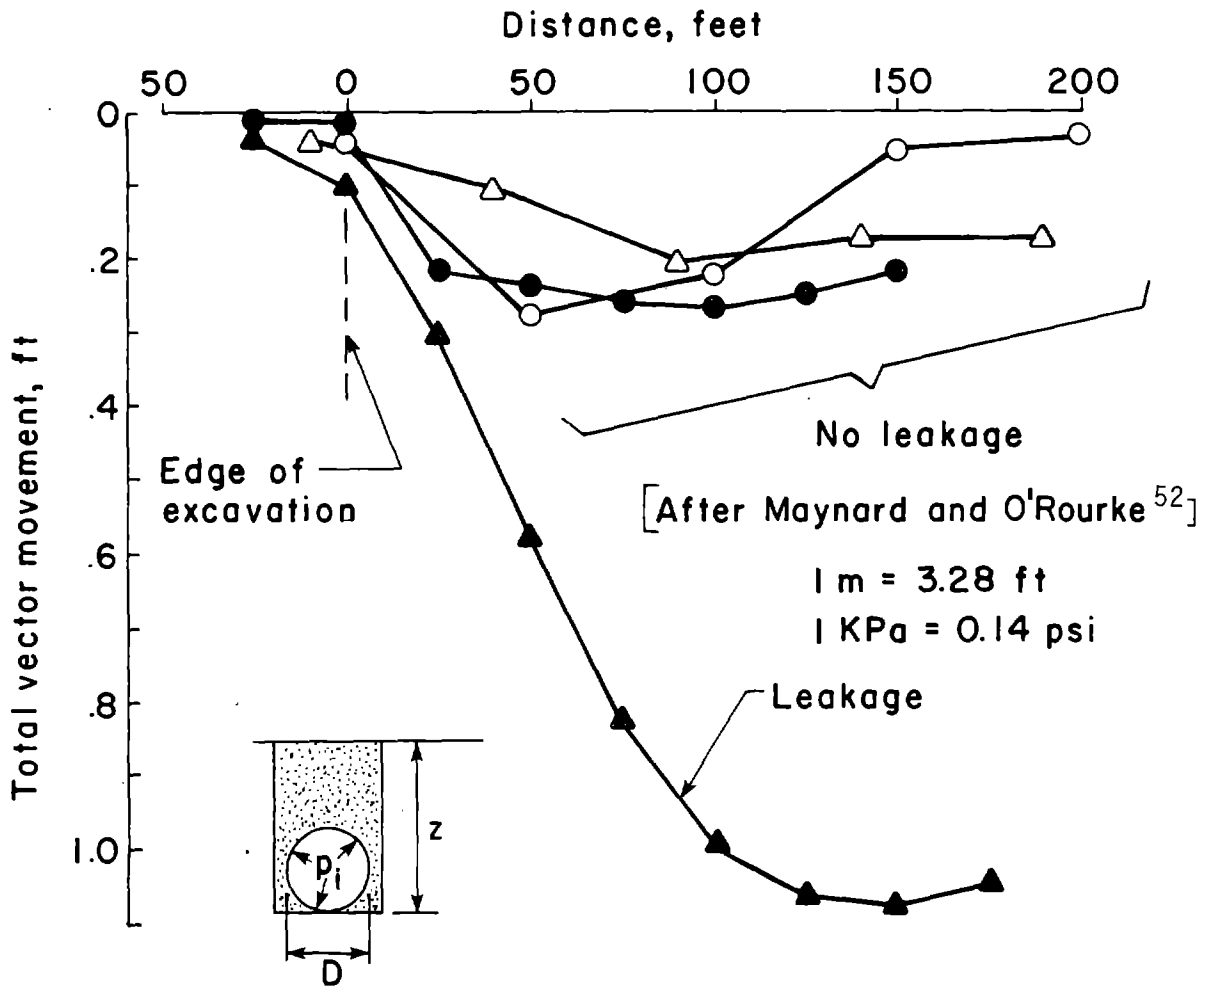
Figure A.2 Field observations of buried pipeline response to ground movements.

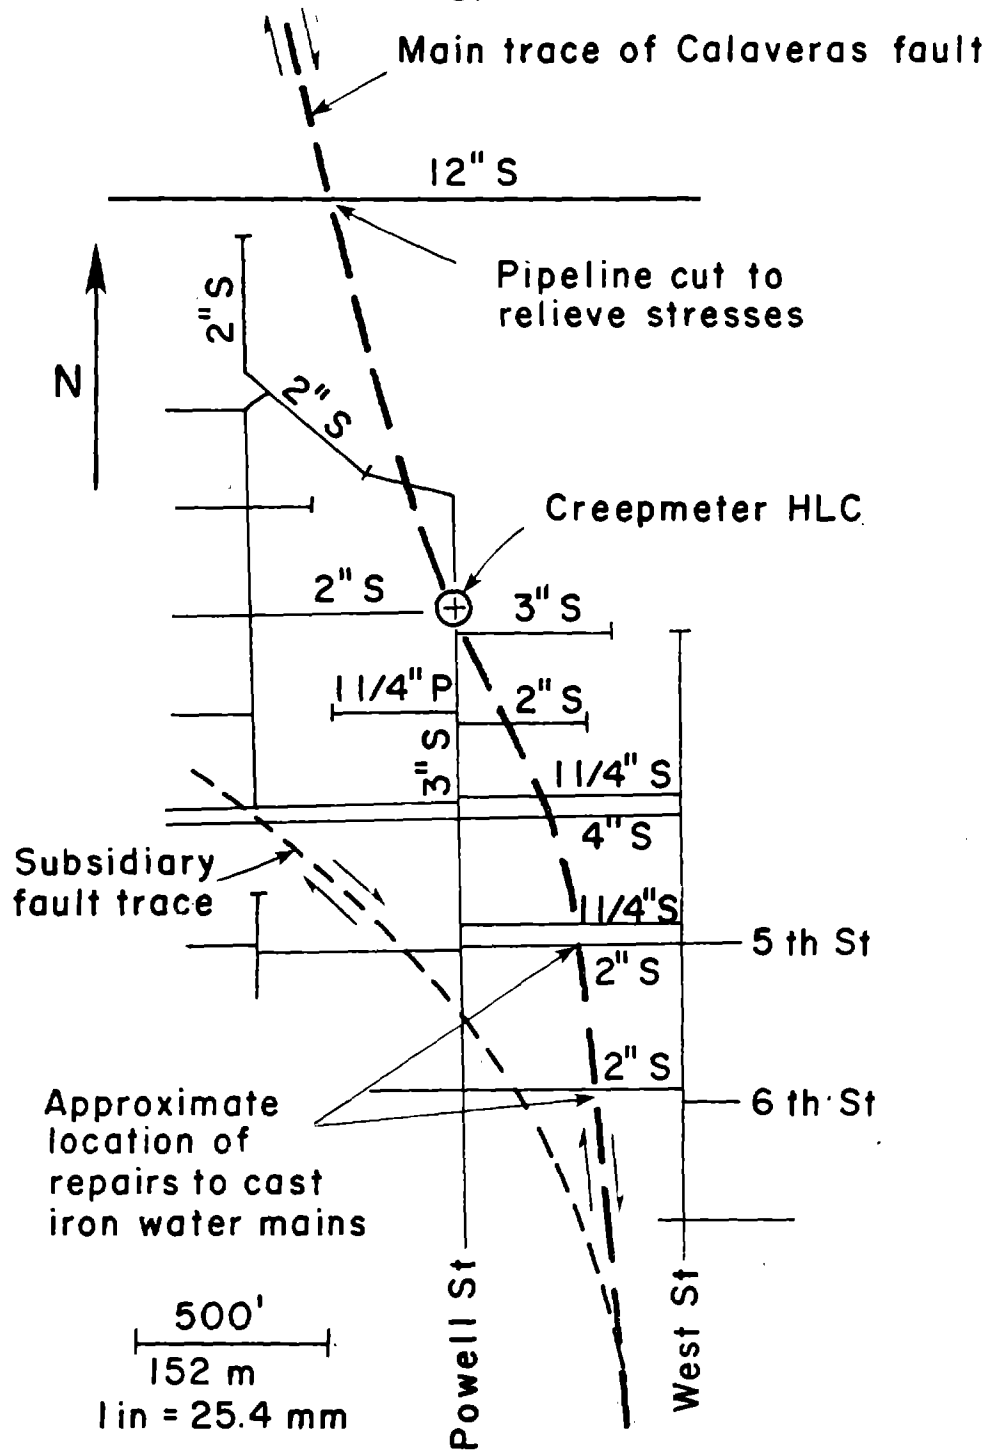
Since the Pacific Gas and Electric Company acquired the system in 1954, there have been no gas main repairs indicative of fault-induced damage. Visible bends in the mains have been observed by line foremen who work in the area. In addition, deformation of the 12-in (305 mm) diameter transmission line has been observed and recorded. The line, which was installed in 1930, is composed of continuous, welded steel and is buried at a depth of approximately 6 ft (1.8 m). In 1968, the line was excavated at its intersection with the

Figure B.3 Plan view of a portion of the gas distribution system in Hollister, CA, showing location of the Calaveras fault.
