# INVESTIGATION OF REINFORCED BRICK MASONRY BUILDINGS UNDEMANAGED BY THE SAN FERNANDO EARTHQUAKE

May 1981

AGBABIAN ASSOCIATES  
El Segundo, California

<b>REPORT DOCUMENTATION PAGE</b>		1. REPORT NO. NSF/CEE-81014	2.	3. Recipient's Accession No.
4. Title and Subtitle Investigation of Reinforced Brick Masonry Buildings Undamaged by the San Fernando Earthquake		5. Report Date May 1981

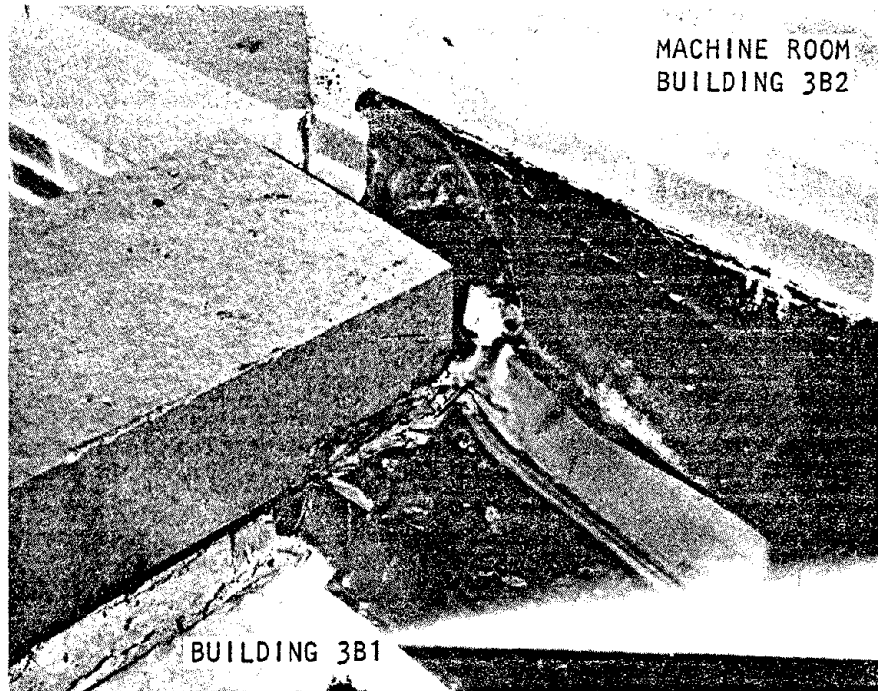
Figure 3-12 shows typical wall cross sections at the roof of Buildings 3B1 and 3B2. Figure 3-13 shows damage to the flexible expansion joint at the corner of Building 3B1 adjacent to the machine room at the roof of Building 3B2. Examination of the details of this corner and other parts of Building 3 indicated the following:

FIGURE 3-13. DAMAGE TO FLEXIBLE EXPANSION JOINT AT ROOF LEVEL  
(See Fig. 3-1a for location)

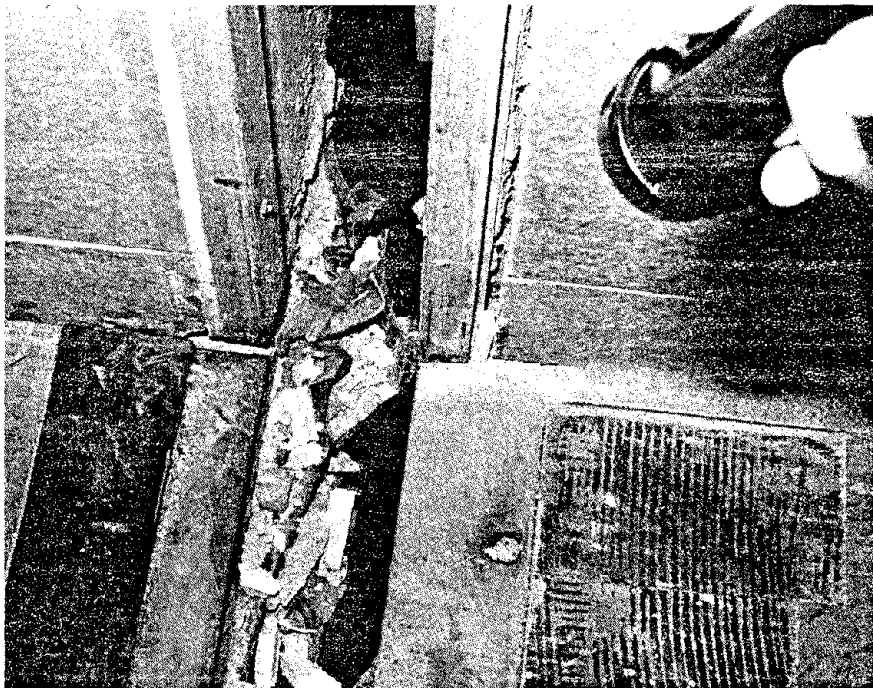
FIGURE 3-14. DAMAGE TO FLEXIBLE EXPANSION JOINT AT FIFTH FLOOR  
LEVEL OF BUILDING 3B

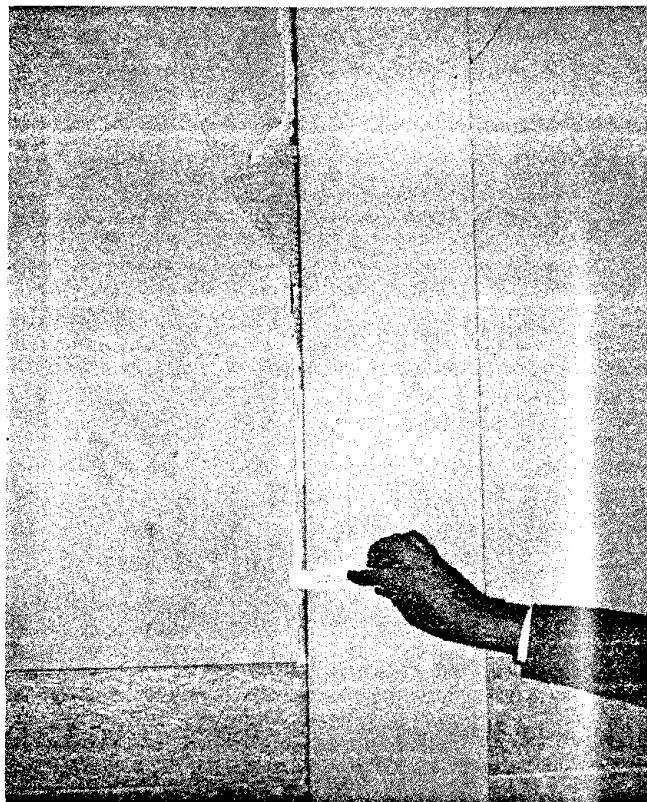
- b. The heavy gage metal flashing, covering the expansion joint at the roof, is embedded in the ATC cope at one end and in the brick facing at the other end. During the earthquake, this flashing exerted a tremendous pull on the ATC coping shown in Section 2-2, resulting in the cracks found in both the exterior and interior faces of the ATC coping (Fig. 3-13).
- c. The flashing at the expansion joint appears to have been damaged by severe seismic cycles of tension and compression, as illustrated in Figure 3-14.
- d. The permanent lateral displacement of the building was reported to be 0 in. at ground level to 1 in. at the sixth floor level (Brandow and Johnston, 1972), as illustrated in Figure 3-15.

FIGURE 3-15. PERMANENT DISPLACEMENT OF APPROXIMATELY 1 INCH AT THE SIXTH FLOOR LEVEL OF BUILDING 3B

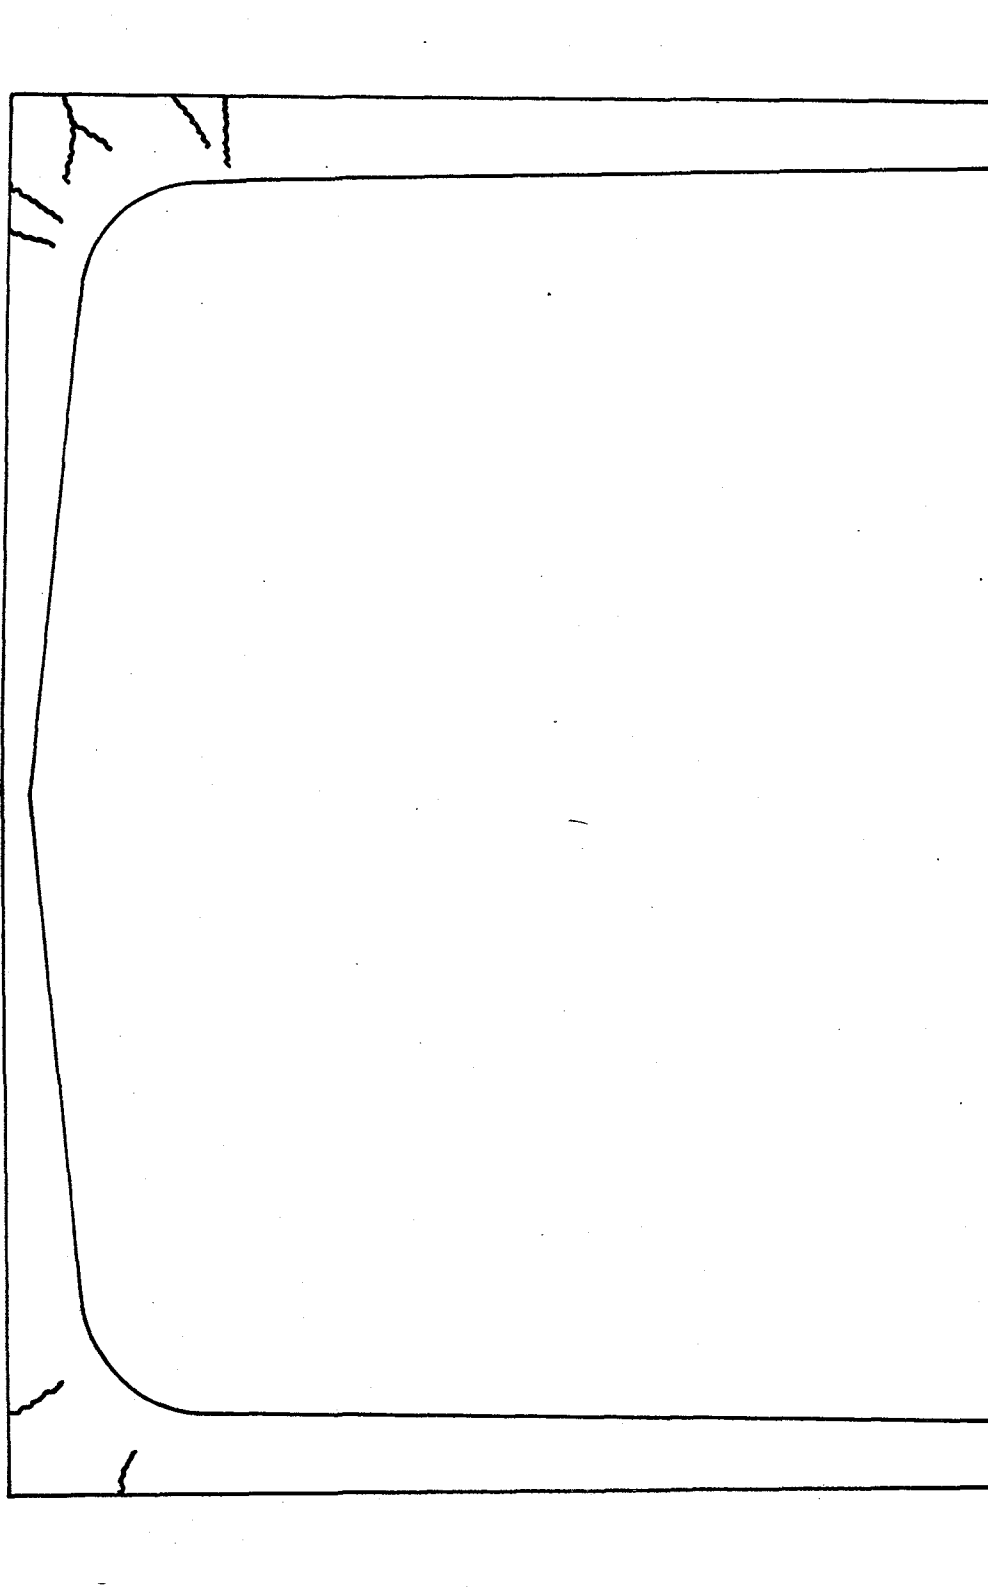
FIGURE 4-6. CRACK PATTERN OBSERVED IN BOILER HOUSE BUILDING AS A  
RESULT OF THE 1971 SAN FERNANDO EARTHQUAKE
