# THE 1976 TANGSHAN, CHINA EARTHQUAKE

Papers Presented at the  
2nd U.S. National Conference  
on Earthquake Engineering  
Held at Stanford University  
August 22-24, 1979

The severe disaster of Tangshan earthquake ranked it among the most serious ones which have ever been recorded in history. In this paper the catastrophe and its causes are outlined. Emphasis will be laid on damages on buildings, life lines and equipments as well as aseismic experience, secondary disasters and related problems in urban planning. Developments in repairing and strengthening of existing buildings, aseismic design and research work after 1976 shock in our country will also be included.

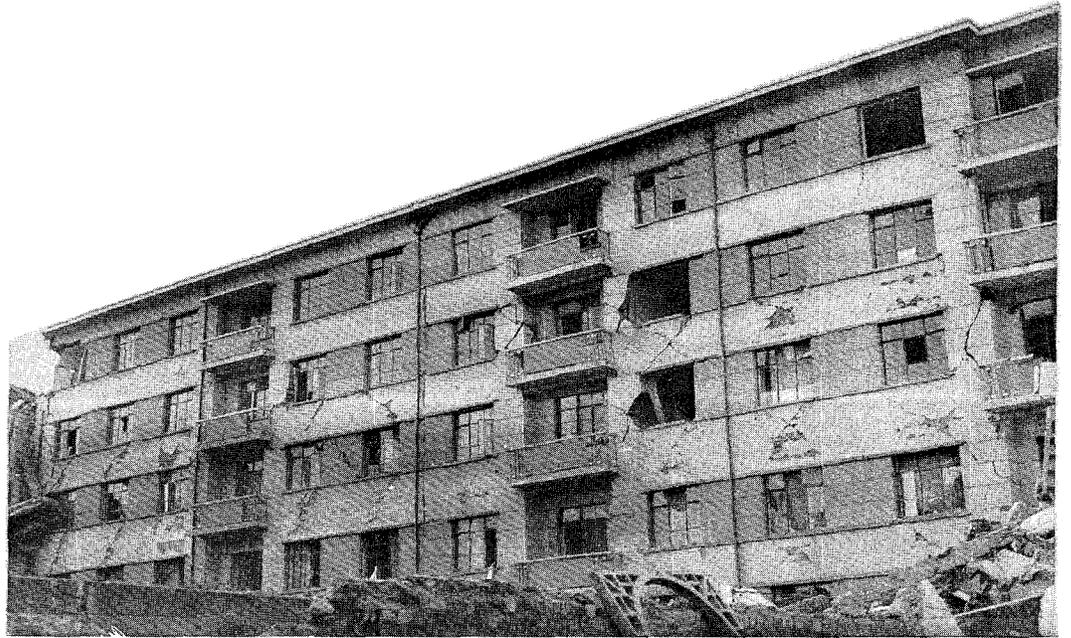
In Tangshan, hundreds of multi-storey brick buildings collapsed mainly as a result of spread of shear cracks on load bearing wall . (Figs.2,3 a,b) However,

Fig. 2 Shear cracks occurred diagonally in walls of a multi-storey brick building

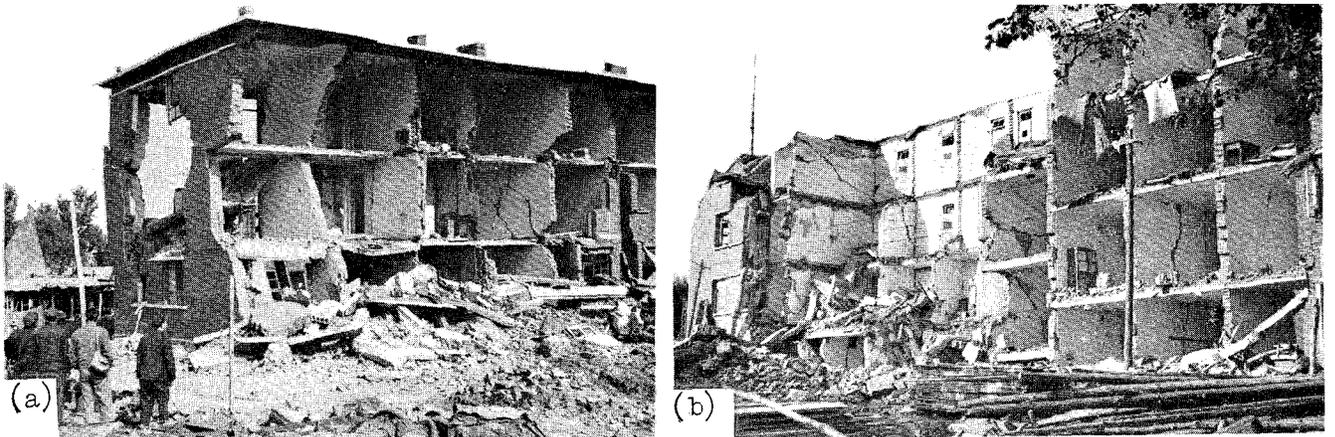
Fig.3 Collapse of a multi-story brick building

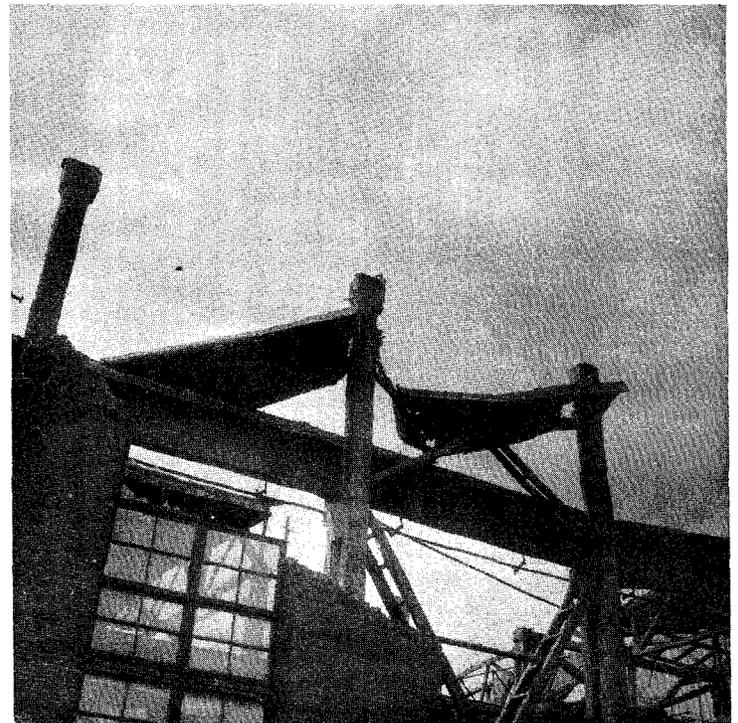
Fig.5 Roof structure fallen due to damage of connections and insufficient diagonal braces

grade V111-X1. In region of high intensity, roof structures fell down due to breaks of columns at the bottom or at the points of cross-sectional change. Weakness of bracing systems between roof frames and between columns caused buildings to collapse longitudinally. Weak connections between roof frame and column, between roof panel and frame as well as overturning of load bearing gable walls at end bays, were also causes of collapse. (Figs. 5,6,7) However, generally no collapse occurred

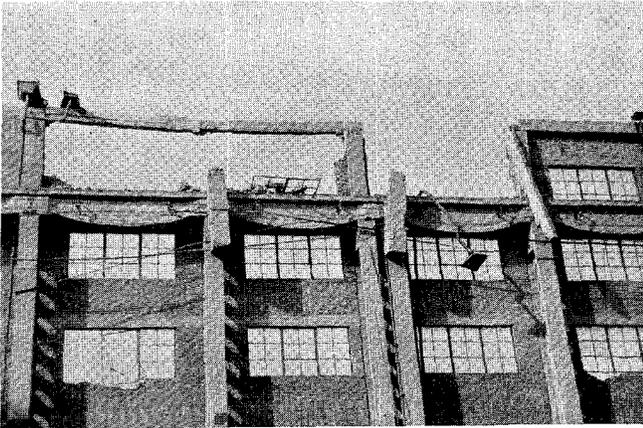
Fig. 6 Roof structure fallen due to rupture in upper parts of columns

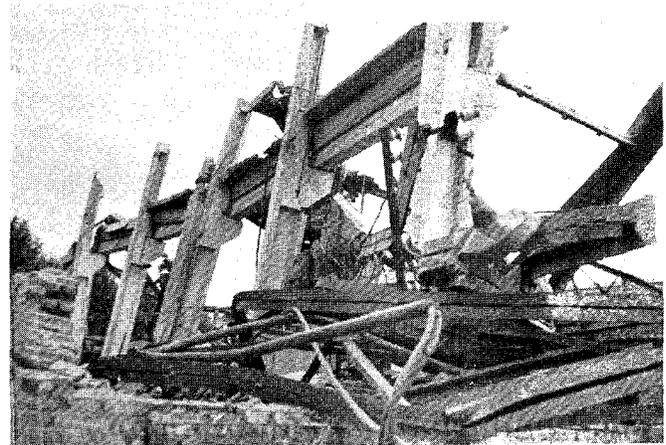
Fig. 7 Columns overturned and building collapsed due to ruptured column bottom

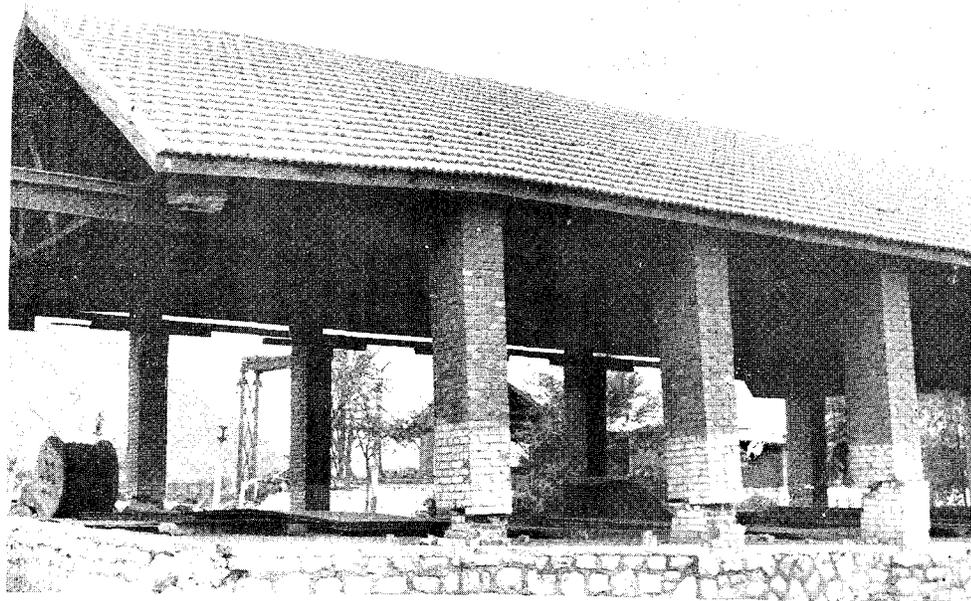
in industrial buildings with strong columns, light-weight roofs and perfect bracing systems, as well as in buildings with folded plate roofs. Therefore, it can be seen that bracing systems, connections and columns are the key points to protect these buildings from collapse. Industrial buildings with unreinforced brick columns often failed due to ruptures at lower portions or partial failure of columns, showing little capability of earthquake resistance. (Figs. 8,9)

Fig. 8 Shear failure at the lower part of brick column

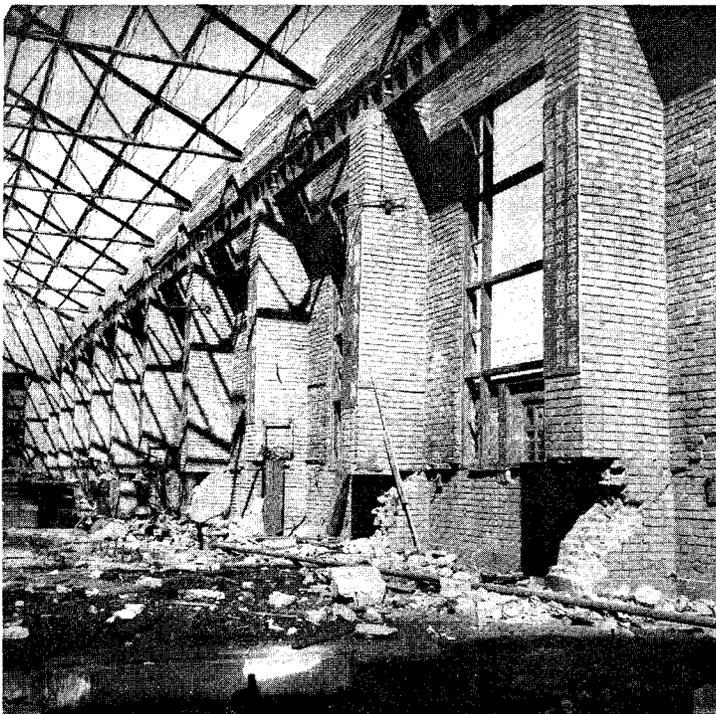
Fig.9 The lower parts of the columns crashed and fell

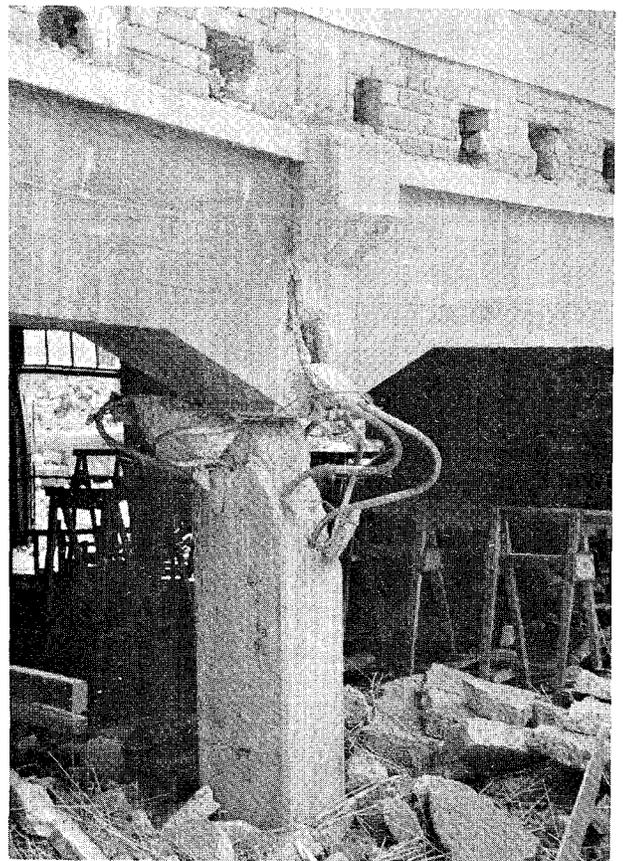
In the area where the intensities of earthquake were of grade X-X1, the percentage of reinforced concrete frame structures collapsed was not high, but most of the structures were seriously damaged. Collapse of frame structures were all correlated with column ruptures. Column damages are : horizontal cracks at tops and bottoms, buckling of main bars, shear cracks on column shafts, sliding of steel bars due to stripping of

Fig.10 Buckling of main reinforcements

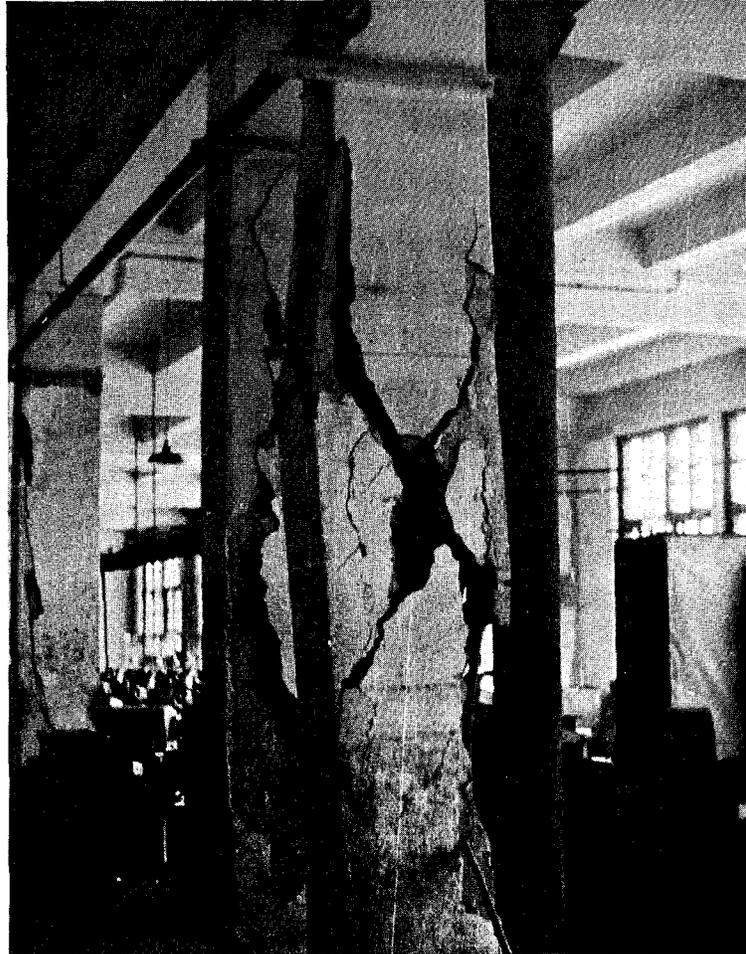
Fig.11 Shear cracks in a column shaft

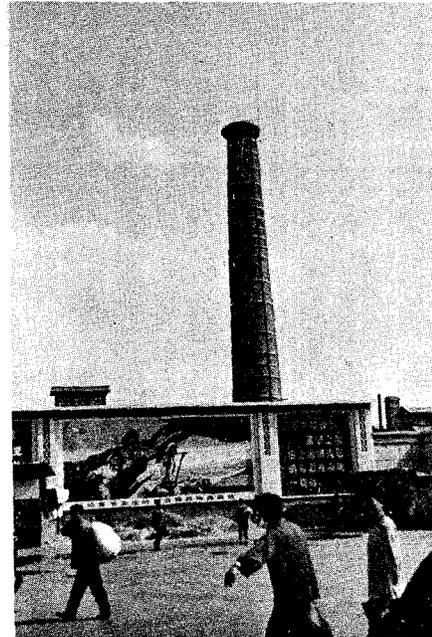
Fig.14 A brick chimney  
strengthened by means  
of steel straps

There were ten thousand chimneys in Tangshan seismic areas, of which nearly all were destroyed. Even those with horizontal and vertical reinforcements in mortar joints at the upper portion were broken at that height and fell down in sections. But the brick chimneys with vertical reinforcements anchored to ring beams were intact. Well anchored vertical reinforcements proved to be effective. Chimneys strengthened with vertical and circumferential steel angles or straps had no damage. This provides us with a successful experience of strengthening existing brick chimneys ( Fig. 14 ).

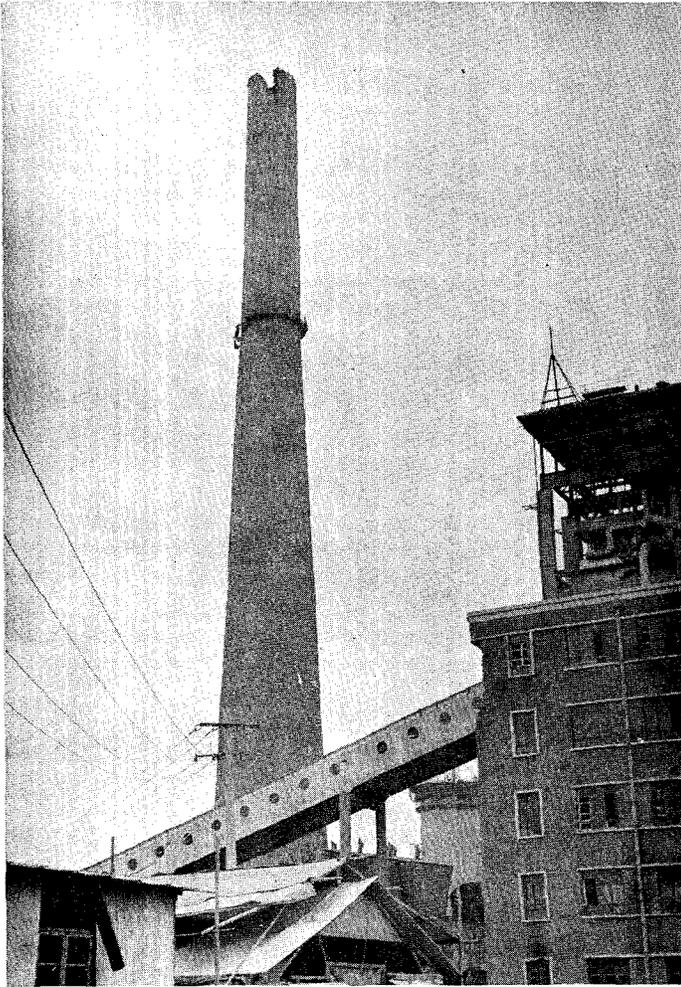
A few chimneys in the seismic area were in reinforced concrete. Those below 100 m high were intact. One of 180 m high, located in the area of grade 1X, being designed according to grade V11, thus incapable of resisting strong shock, broke at the height of 132 m during the main shock, and fell down in the aftershock of magnitude 7.1. (Fig. 15 ) Few of the round silos for grain storage in mud and brick in the area of grade 1X-X were damaged, except the old ones. It indicates that round low structures have a good behavior in earthquake resistance.

Fig. 15 180m high reinforced concrete chimney broke at the upper portion

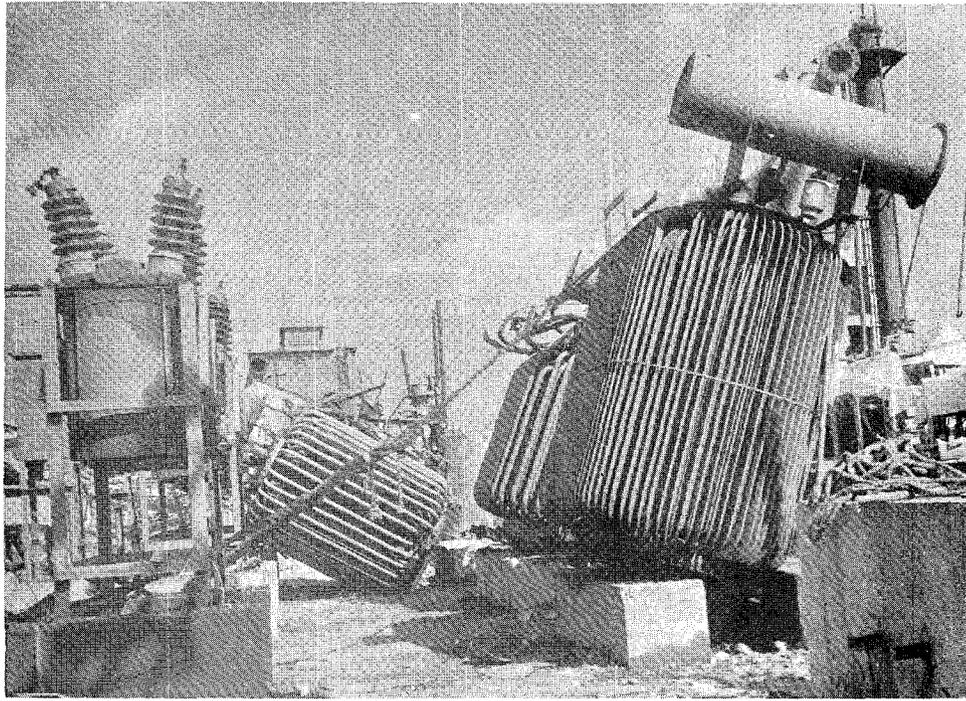
Fig. 18 Overturned transformer

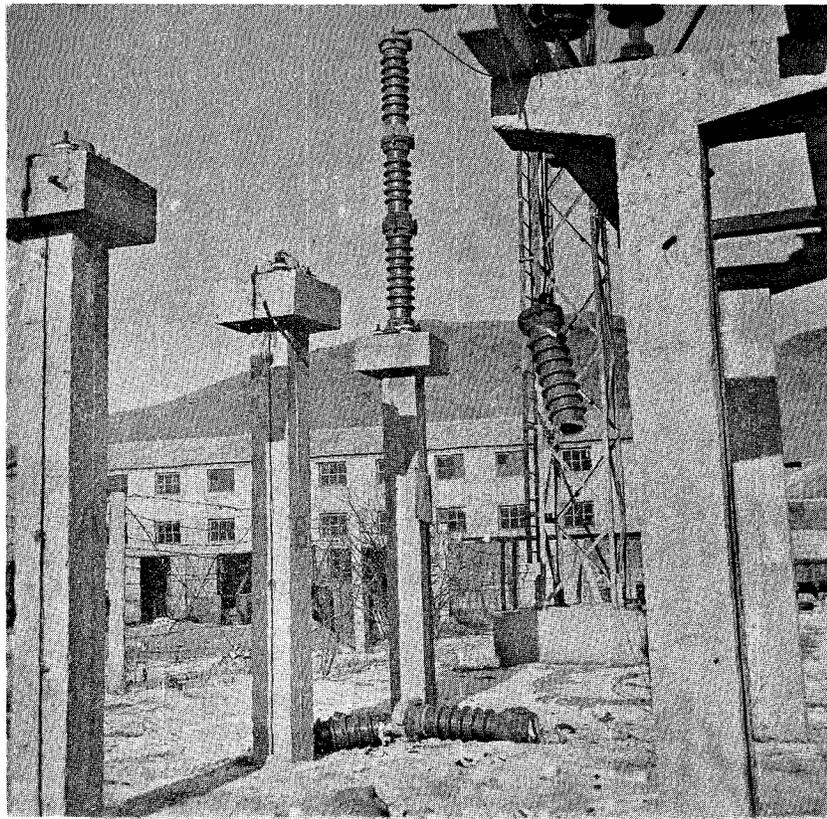
Fig. 19 Ruptured porcelain insulators

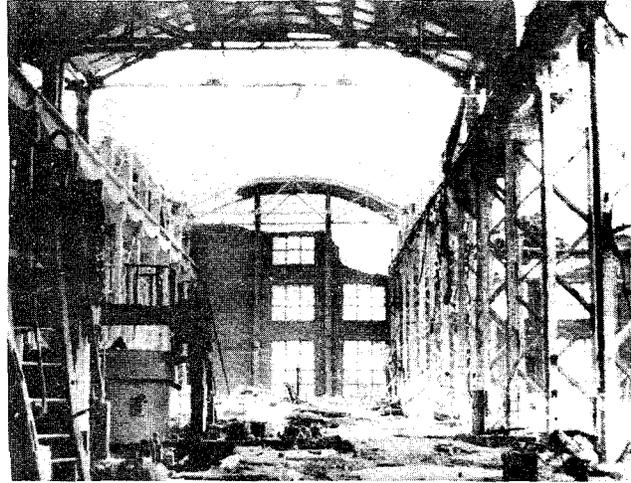
Photo 2. Failed Roof System.

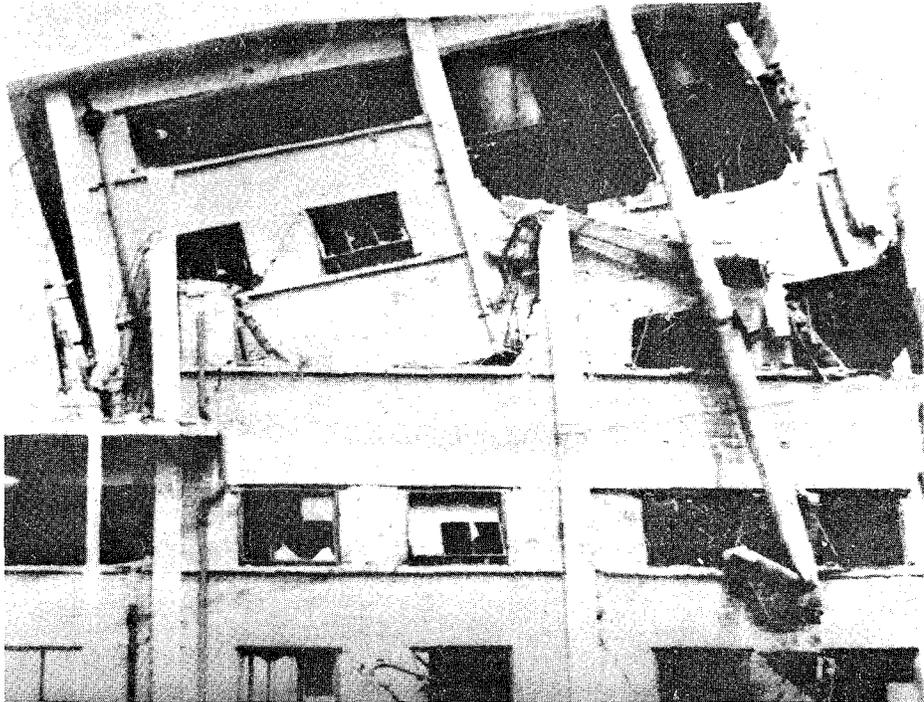
Photo 3. Column Failure.

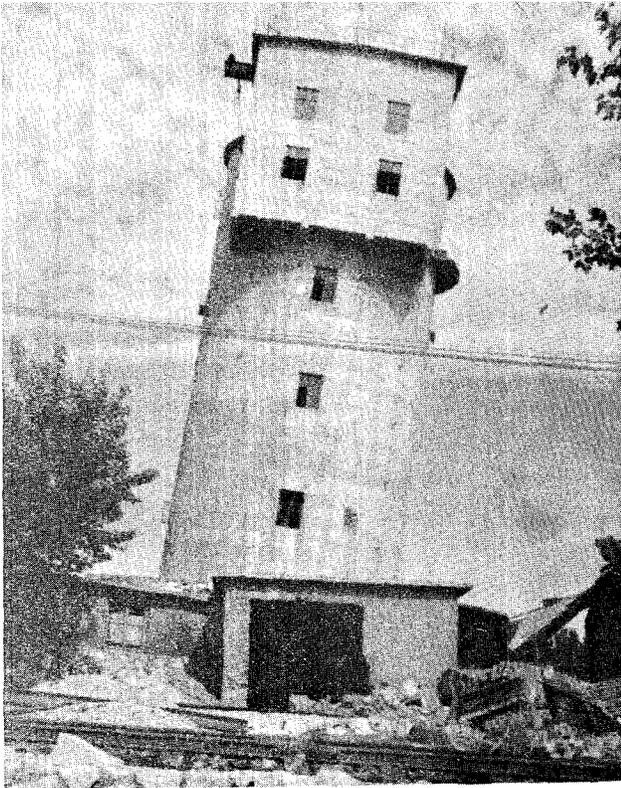
Photo 4. Collapsed Mine Shaft.

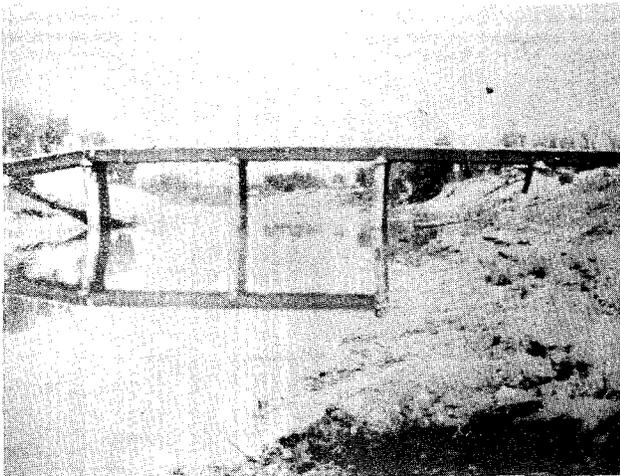
Photo 6. Bridge Damage.

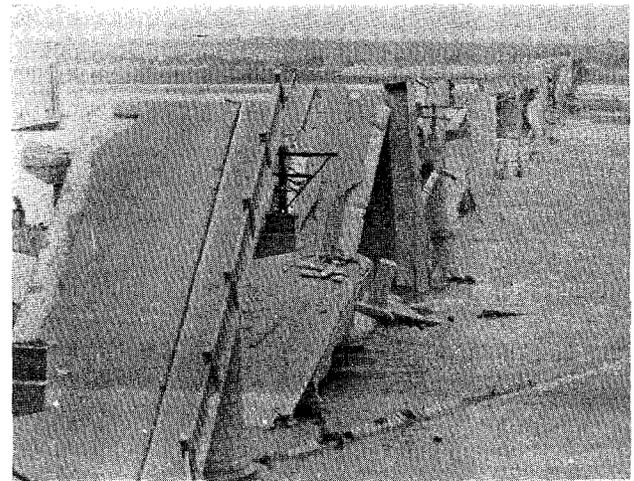
Photo 7. Bridge Damage.

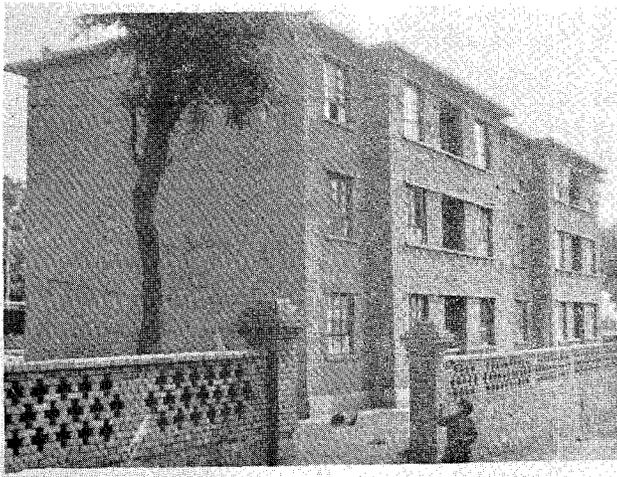
Photo 8. Pre-stressed, Hollow Slab Building on Unreinforced Brick Walls, Region 8, Tangshan. Minor Damage.

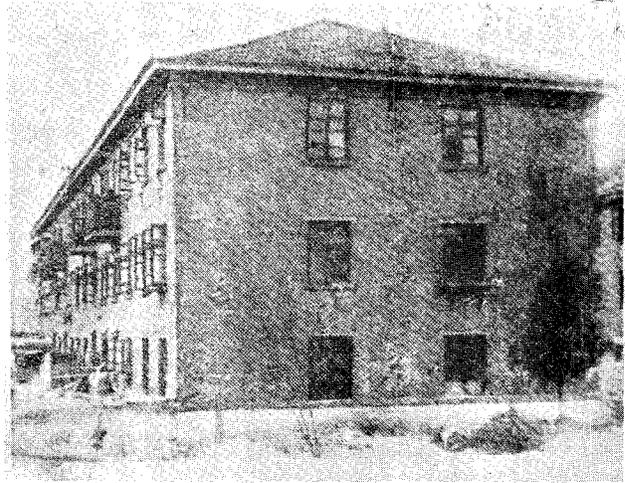
Photo 10. One of 11 Buildings With Minor Cracks.

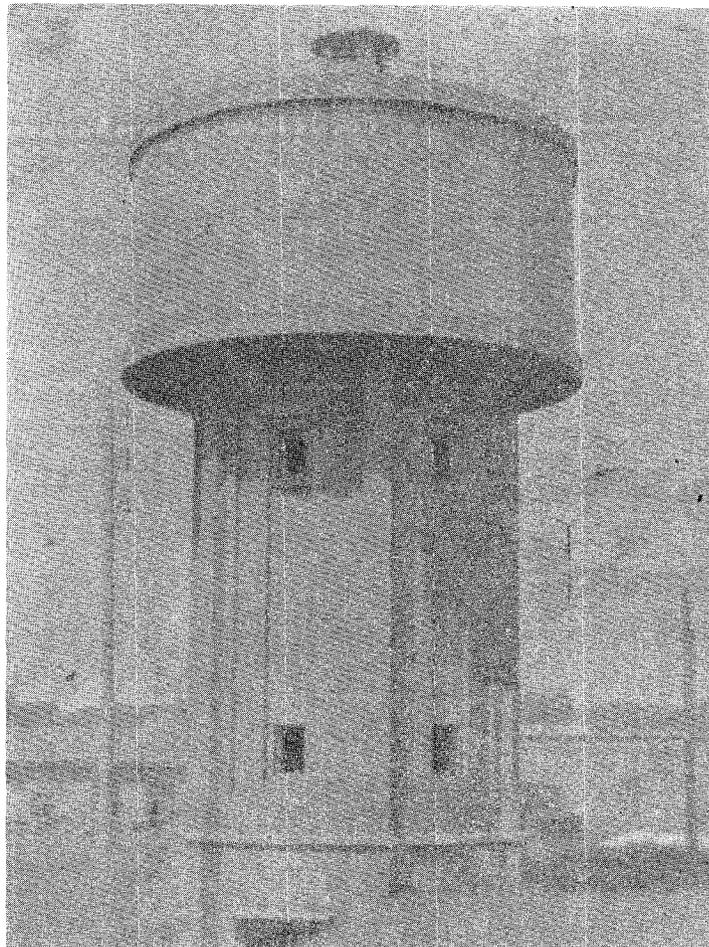
Photo 9. Elevated Water Tank on Unreinforced Brick Shaft.

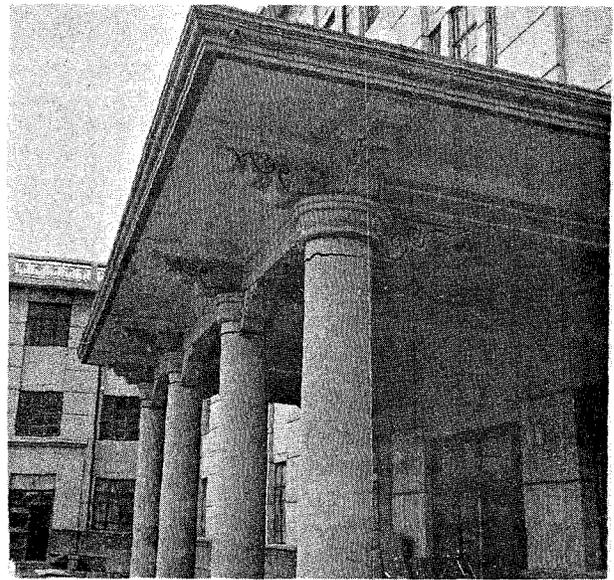
Fig. 8. Four-Story Brick Building Settled, Cracking Canopy Column.

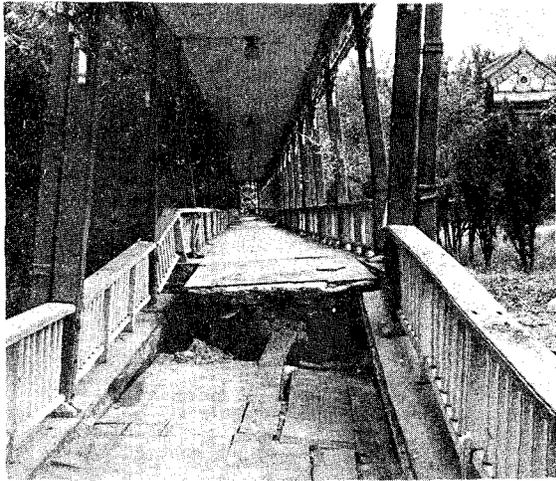
Fig. 9. Cracks in Hospital Veranda.

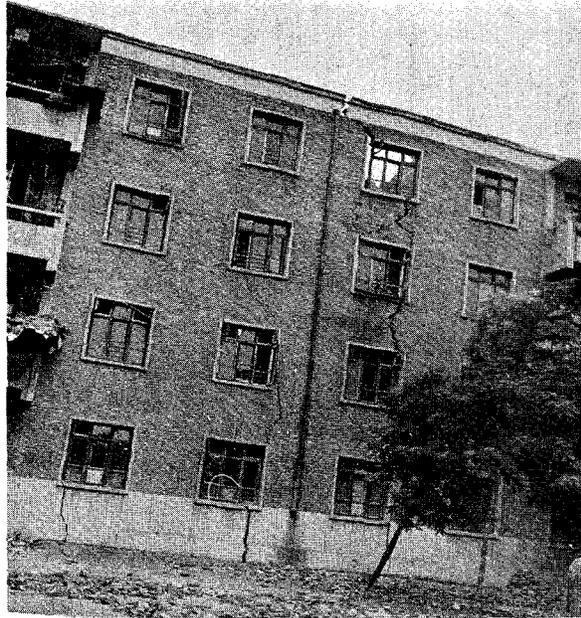
Fig. 10. Cracks in Four-Story Brick Apartment House.

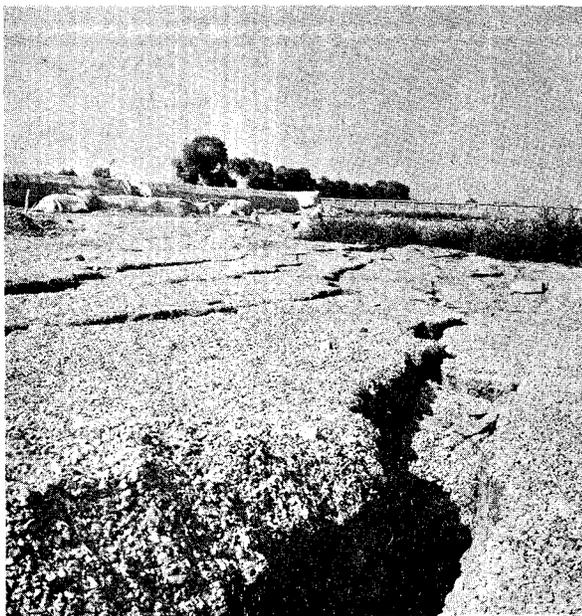
Fig. 11. Parallel Ground Cracks in Hangu Fu Village.

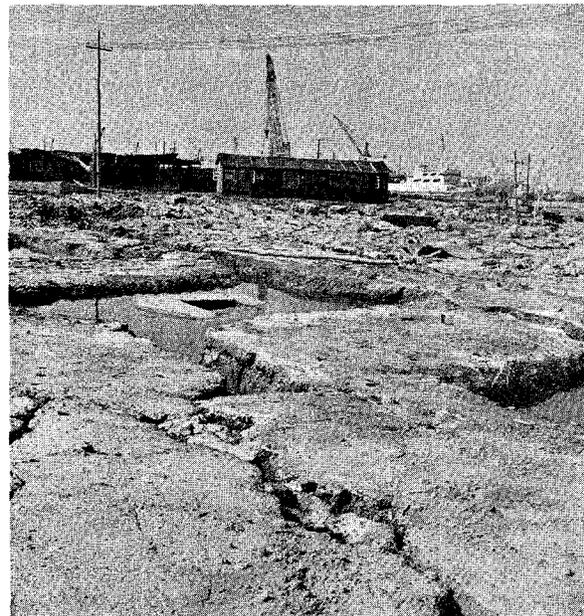
Fig. 12. Distorted Spread Footing of Mill Building in Tanggu.

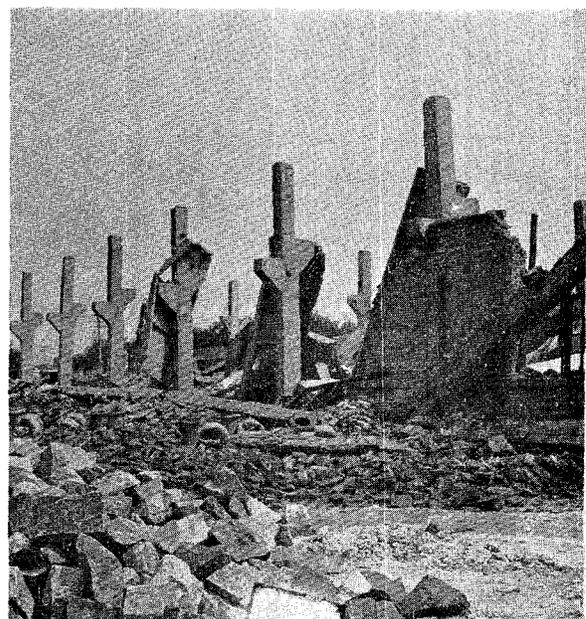
Fig. 16. Collapsed Reinforced Concrete Mill Building, With Tilted Columns, in Hangu.

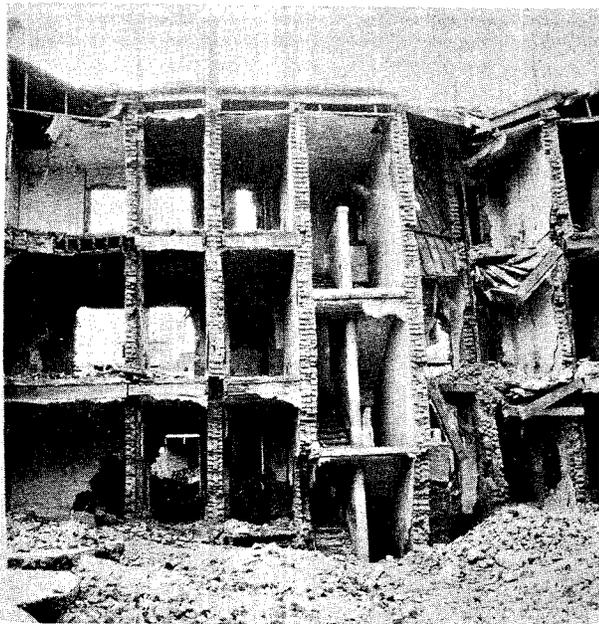
Fig. 17. Partially Collapsed Three-Story Brick Building With Timber Floors.

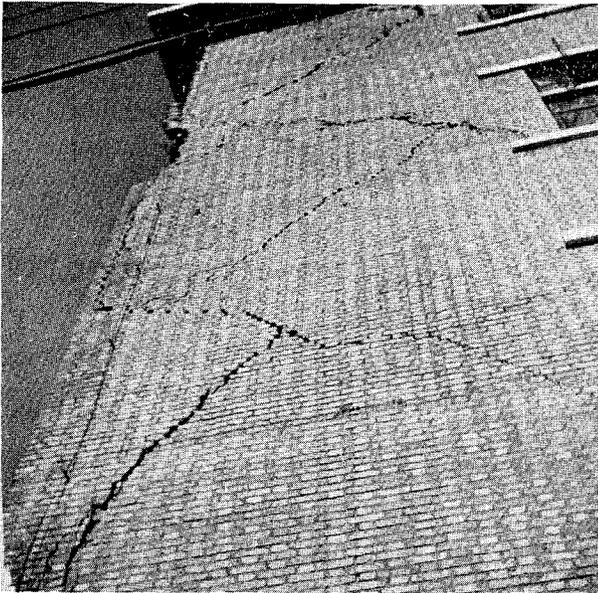
Fig. 19. Shear Damage in Newly Constructed Five-Story Brick Building.

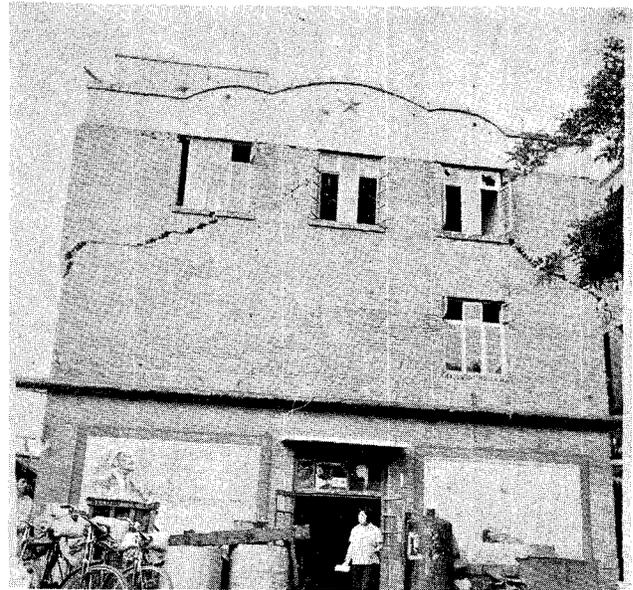
Fig. 20. End Wall Damage in Newly Constructed Three-Story Brick Building.

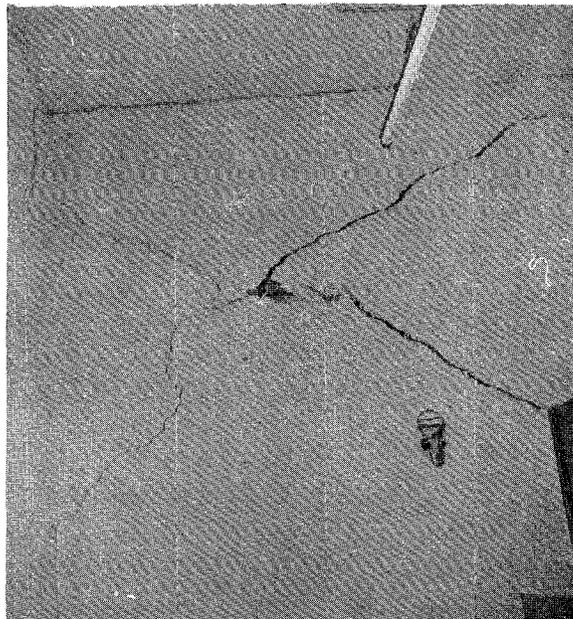
Fig. 21. X-Crack in Brick Wall.

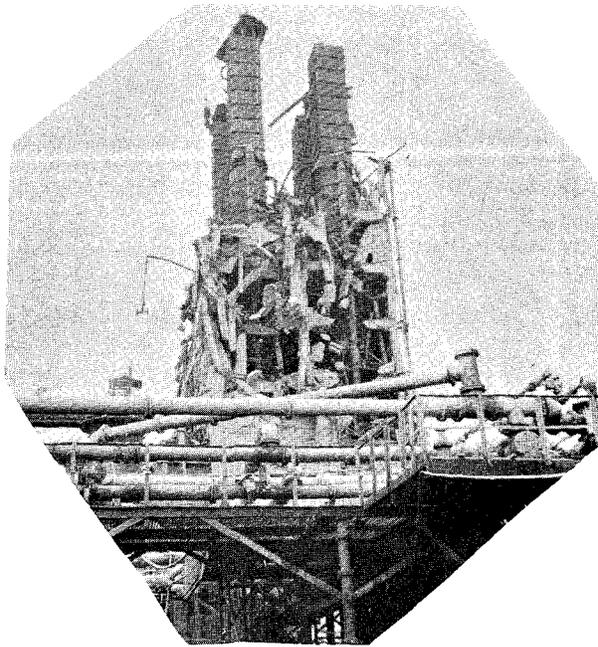
Fig. 25. Collapsed 13-Story Frame Building in Tanggu.

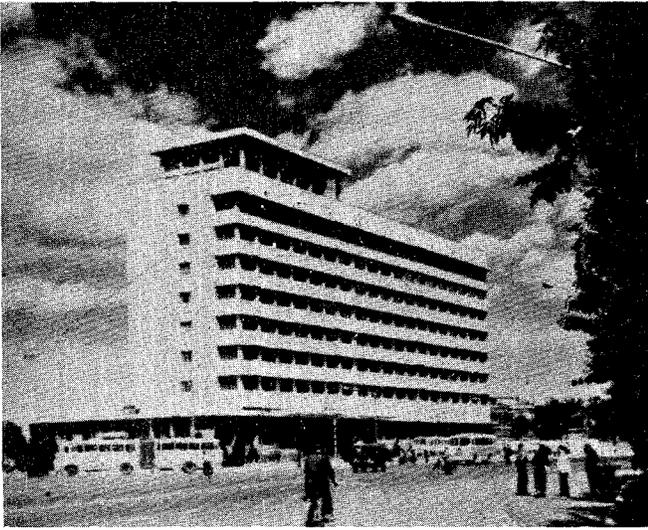
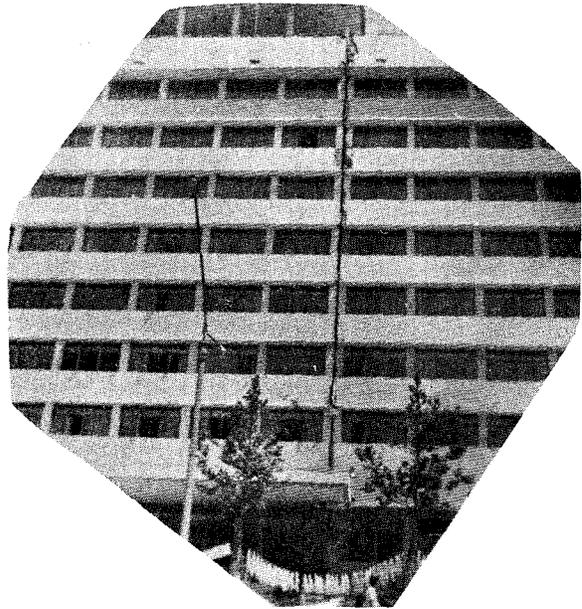
Fig. 26 shows an eight-story reinforced concrete frame hotel with an expansion joint at the center of the building. During the Tangshan earthquake, the walls at both sides of the expansion joint broke due to impact, and many hollow brick infilled walls broke. After the earthquake, this building was restored to its former condition; but during the Ninghe earthquake it broke again, as during the Tangshan earthquake. This means that the frames had deformed to such a large degree that they easily caused destruction of the infilled walls. We conclude that a building should be strengthened rather than merely restored to its original condition as a result of this experience.

Fig. 26. Tianjin Friendship Hotel Damage.

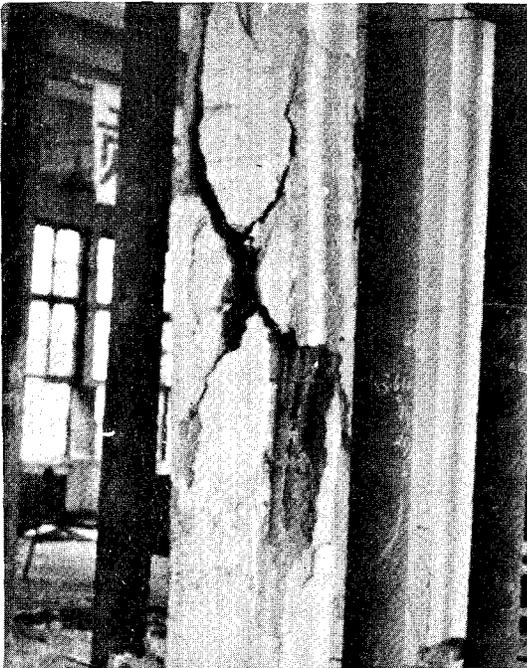
Fig. 27. Shear Failure of Column.

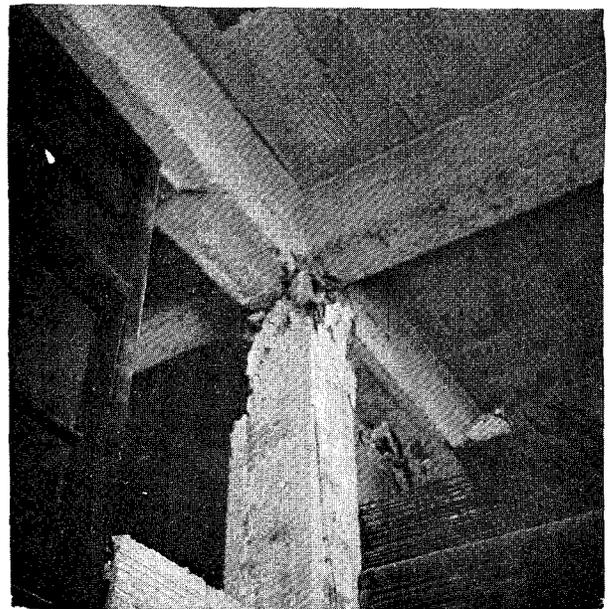
Fig. 28. Bending Failure of End of Column.

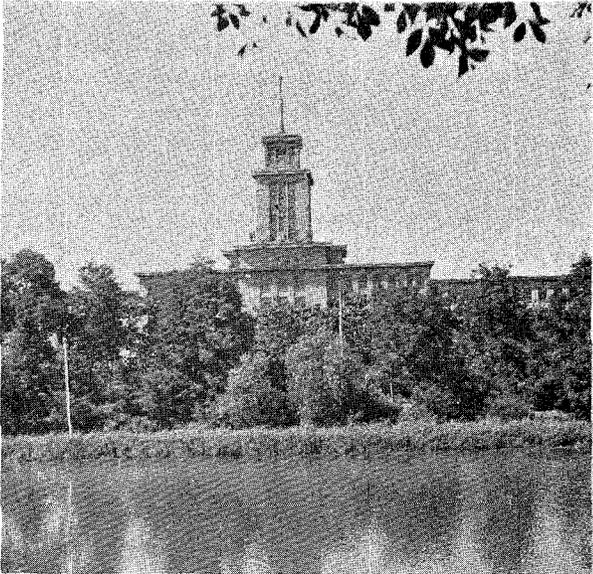
Fig. 29 shows the damaged tower on the main building of Nankai University. It was damaged during the Tangshan earthquake and fell down during the Ninghe earthquake. Fig. 30 shows the damaged tower of a department store. These are good examples of tip effect.

Fig. 29. Damaged Tower in Nankai University.

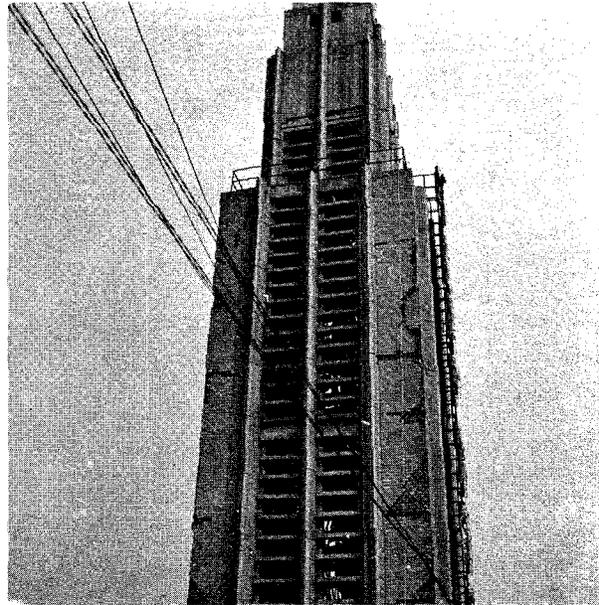
Fig. 30. Damaged Tower in Department Store.

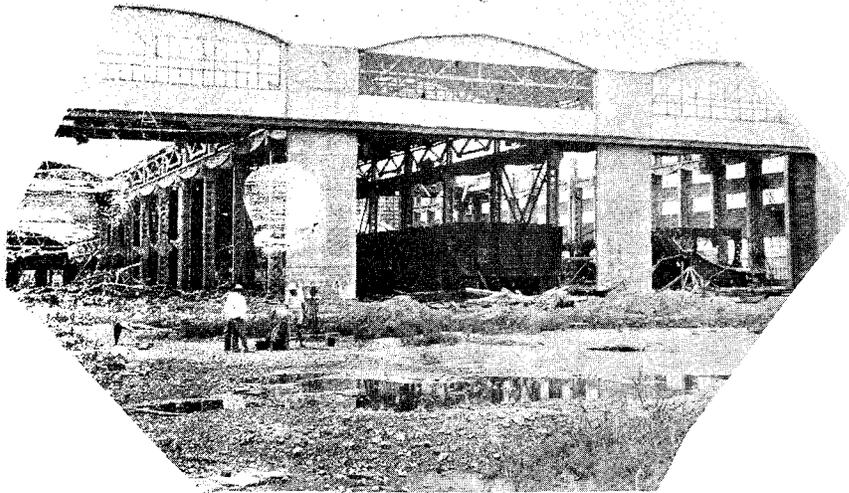
Fig. 31. Collapsed Mill Building in Tangshan.

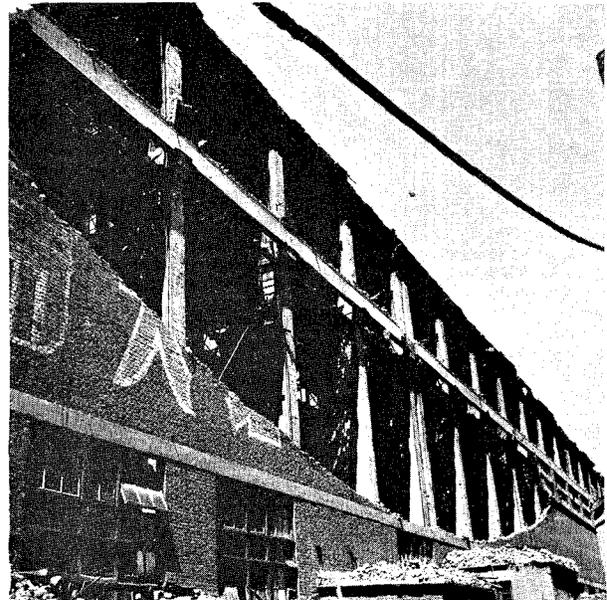
Fig. 33. Damaged Mill Building in Tianjin.

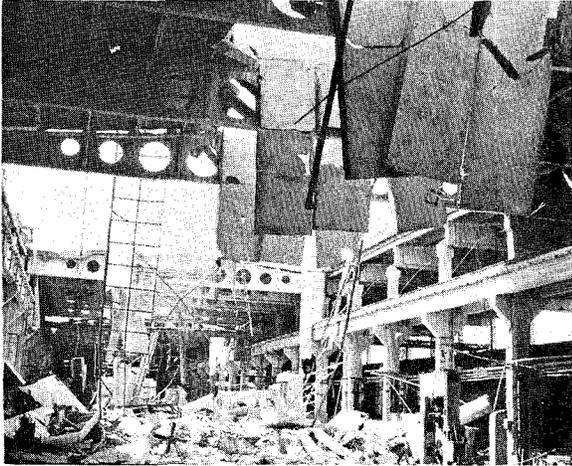
Fig. 34. Cracked Mill Building.

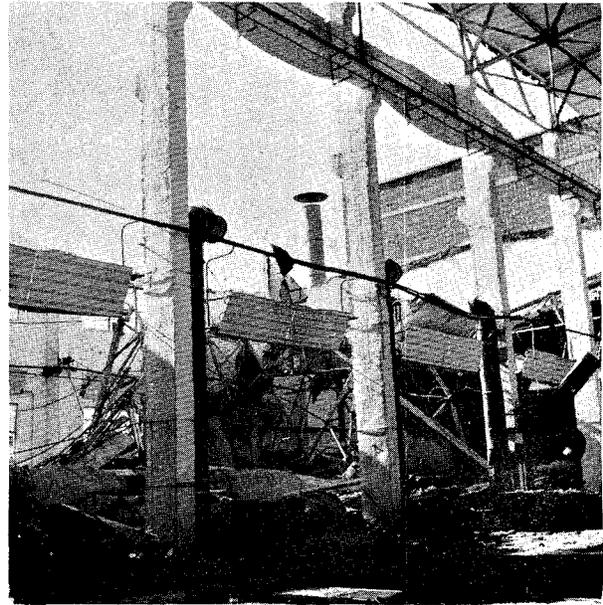
Infilled walls of many mill buildings collapsed because the connections between walls and columns were weak. Figs. 35 and 36 are damaged infilled walls of mill buildings. Fig. 37 shows the damage of vertical bracing between columns.

Fig. 35. Damaged Eaves and Walls in a Workshop.

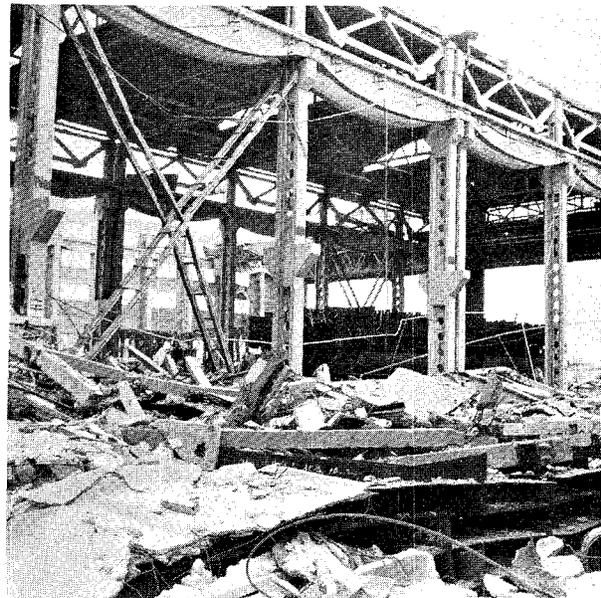
Fig. 37. Damaged Vertical Bracing Between Columns in Building in Tanggu.

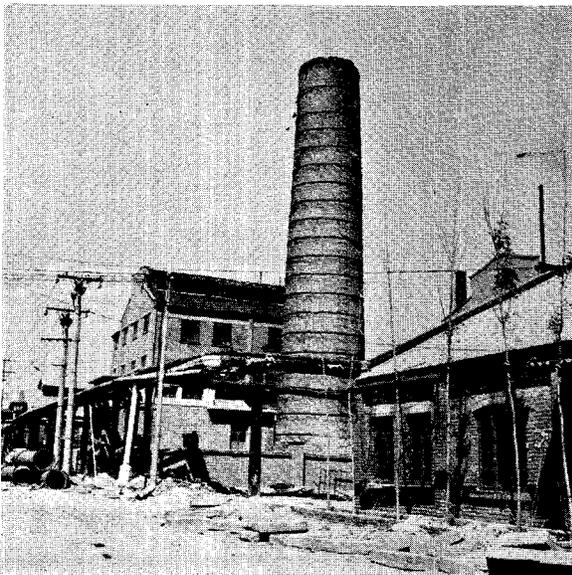
Fig. 38. Horizontally Cracked Brick Chimney; Upper Part Fell Down.

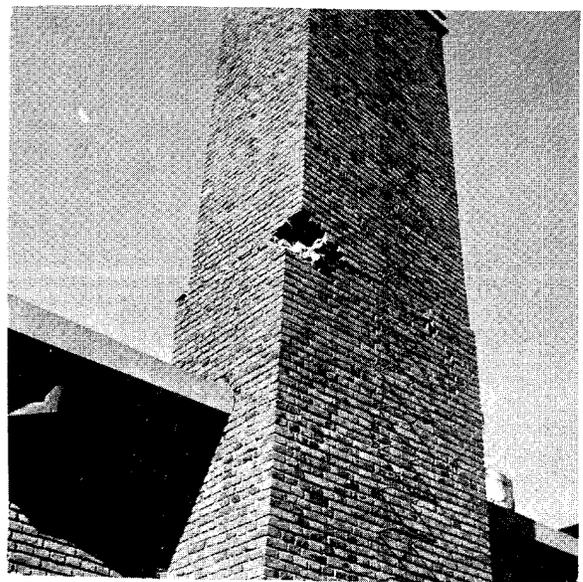
Fig. 39. Twisted Brick Chimney
